Evaluation of Roadside Vegetation for Erosion Control in West Virginia

Thesis submitted to the Benjamin M. Statler College of Engineering and Mineral Resources at West Virginia University

Master of Science in Civil and Environmental Engineering

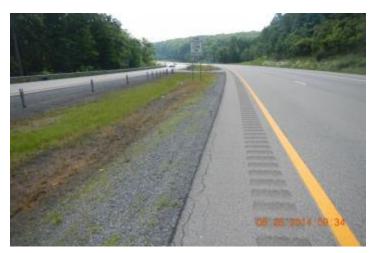
Figure 9: Interstate 68 Median

The location was on Interstate 68 at the emergency turn around before the Coopers Rock exit. The site had partial to full cover. It also had rocky soil and cinders on the surface (Figure 9).

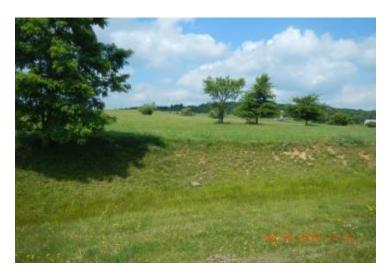
Figure 10: Interstate 68 West Virginia Welcome Center

The WV Visitor Center site was located on the exit ramp to the facility. The site had full cover and was predominantly flat (Figure 10).

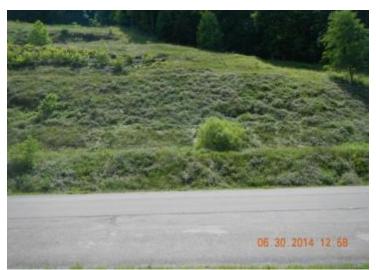
Figure 11: Phillipi Bypass

The Phillipi Bypass site was located on Route 250 just off of Route 119. The site was steeply sloped and covered predominantly with crownvetch (Figure 11).

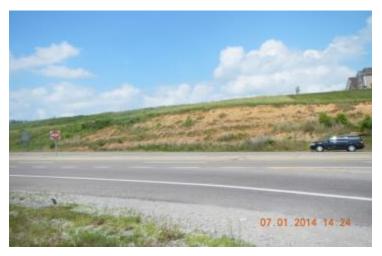
Figure 13: 279 Site 2

The 279 Site 2 was located on Route 279 just west of the Benedum Drive exit. The slope was steep with good cover (Figure 13).

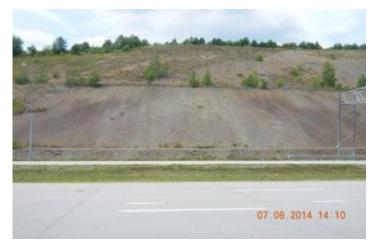
Figure 16: Corridor H Site 1

The Corridor H Site 1 was located on U.S. 48 approximately 1 mi. (1.61 km) from the intersection of 92 and 48. The site was off of the west bound lane of U.S. 48. This site had minimal coverage and was predominately red and gray shale (Figure 16).

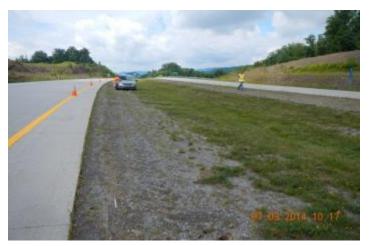
Figure 17: Corridor H Median 1

The Corridor H Median Site was located on U.S. 48 approximately 2500 feet (762 m) from where the corridor currently ends. The site was relatively flat and had good coverage (Figure 17).

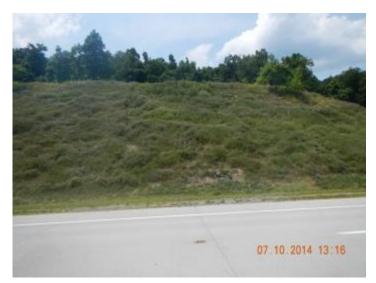
Figure 20: Corridor H Site 3

The Corridor H Site 3 was located on U.S. 48. This site was steep and had good

coverage by crownvetch (Figure 20).

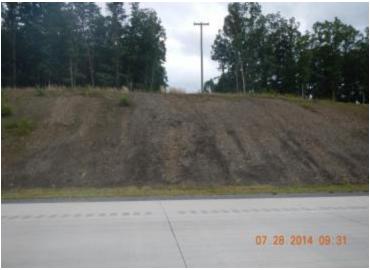
Figure 22: Corridor H Site 4

The Corridor H Site 4 was located on U.S. 48. This site was fairly steep and had minimal coverage. The only notable coverage on either side of the site was blackberry bushes and white pine (Figure 22).

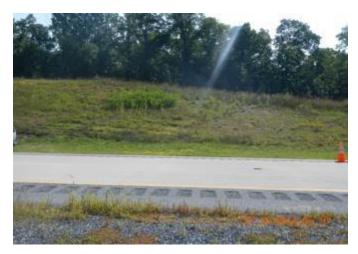
Figure 25: Route 9 Site 2

The Route 9 Site 2 was located just past the Short Road exit 9/19 westbound on Route 9. This site was composed of serecia lespedeza, tall fescue, and birdsfoot trefoil (Figure 25).

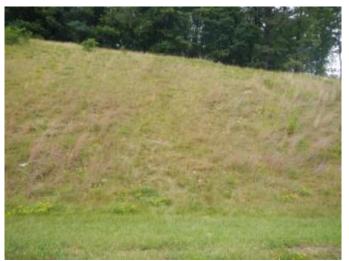
Figure 31: East Beckley Bypass

(805 m)from the intersection of East Beckley Bypass and Route 41. This site had a steep slope,

and the site had consistently good vegetation throughout (Figure 31).

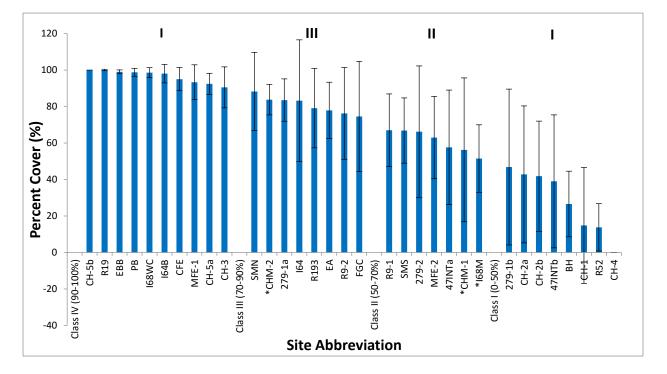
There was a relatively equal distribution of the field sites among the defined cover classes, and mean vegetation cover included a large range (Figure 36). Ten of the 33 locations had excellent cover (> 90%), eight of the sites had acceptable cover (70% - 90%), seven of the sites had poor cover (50% - 70%), and eight sites had bad cover (0% - 50%). The three median locations were located between acceptable and poor cover (51.5% - 83.8%). The poorest performing locations were steep with exposed shale. The area of exposed rock was not removed in the calculations. Therefore, the percent cover calculated for permit release may be greater than the values calculated in this study.

Figure 36: Mean vegetation cover defining cover class (I-IV) for each field site. Error bars denote standard deviation. I (0-50%), II (50-70%), III (70-90%), IV (90-100%); *indicates a median site.

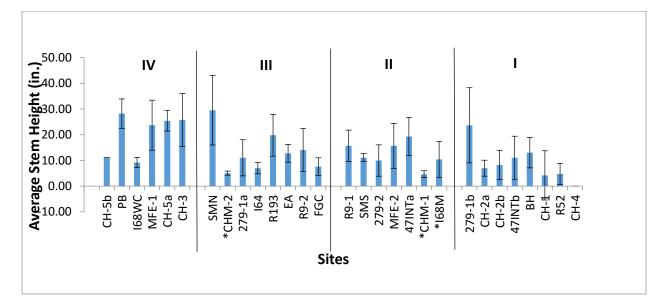
Figure 37 presents the average stem height of each site within the respective cover class. Although there is a reduction in average stem height from the highest percent cover to the lowest, there are large inconsistencies throughout the table. The average stem diameter is presented in Figure 38 and shows minimal difference throughout the cover classes. The

inconsistencies presented in the graphs are attributed to improper mowing. Because of these inconsistencies due to mowing, these data was not included in the statistical review. For erosion control effectiveness and the health of the vegetation establishment, a more consistent mowing schedule should be implemented. Although cool season grasses can tolerate close mowing, to promote the growth of native vegetation, vegetation should be mowed no shorter than 6 in, and mowing should not be conducted during times of drought or when soil conditions are soft or saturated (Salon and Miller 2012).

Figure 37: Average stem height per each site divided by cover class

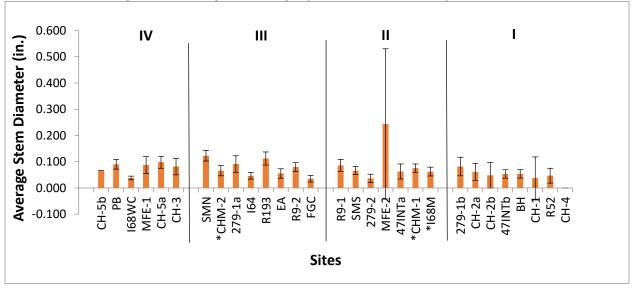
Figure 38: Average stem diameter per each site divided by cover class

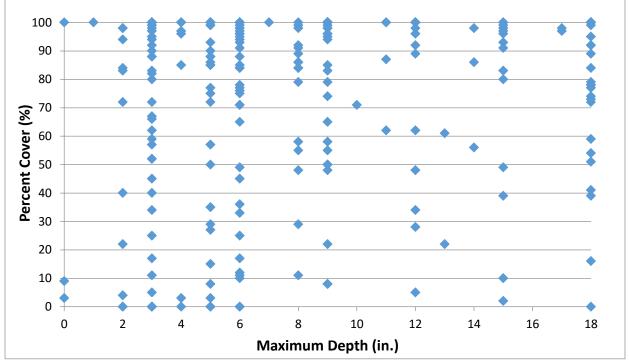
The comparison of percent cover to the maximum depth that the penetrometer reached is presented in Figure 40. As can be seen, the compaction rate of the soil at each subsite had minimal effect on the percent cover that was achieved by vegetation. Sites having a high compaction and low maximum depth still showed good vegetation. It must be noted that soils having high compaction typically have a difficulty of getting good seed penetration (Salon and Miller 2012). There is minimal change in percent cover from high compaction to loose soil.

Figure 40: Percent cover vs. compaction depth

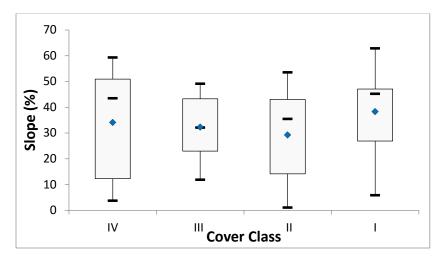
Local slope measured at the cut and fill roadside sites reached a steep grade of 89%. While local slopes reached this steep gradient, the majority of the slopes were less than 50%. Dominating local vegetation cover (>90%) was present on slopes up to 80%. Results from Wilcoxon tests indicated that there were limited statistical differences in cover class as defined by slope. Median sites were characterized by mild slopes (<25%). Figure 41 summarizes the average slopes for each cover class.

Figure 41: Percent cover vs. slope; 25%-75% (box); min and max (whisker); and mean (diamond)

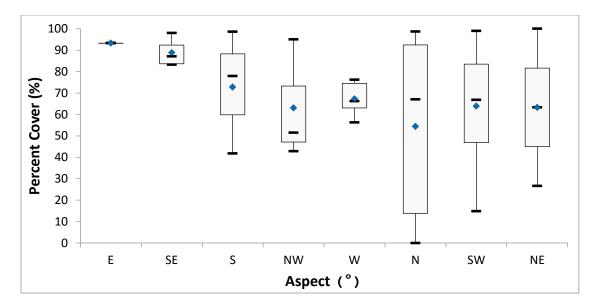
Local measurements of aspect were distributed among the eight cardinal direction with the majority of slopes facing in the north, south, southwest, and west directions (N: 15.8%, NE: 7.9%, E: 4%, SE: 13.4%, S: 10.3%, SW: 23.7%, W: 17.4%, NW: 7.5%). Data for median locations were removed as the median sites were characterized as gently sloping with no dominant direction. The greatest local percent cover values were present on the eastern facing slopes; however, only 4% of the local slopes faced the east direction. Percent cover poorly performed on the NE facing slopes (Figure 42).

Figure 42: Percent cover vs. direction; 25%-75% (box); min and max (whisker); and mean (diamond)

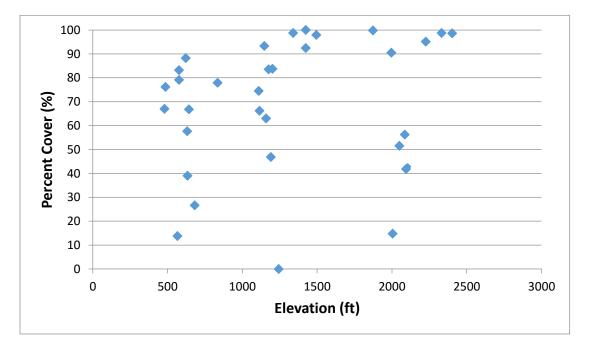
Elevation ranges were 172-641 m, 146-636 m, 175-366 m, and 350-732 m for sites within CC I, II, III, and IV, respectively. Elevations of CC IV were statistically different than CC III when analyzed with Wilcoxon tests; however, there were no other statistically significant comparisons. There was no significant linear correlation between percent cover and elevation (Figure 43).

Figure 43: Percent cover vs. elevation

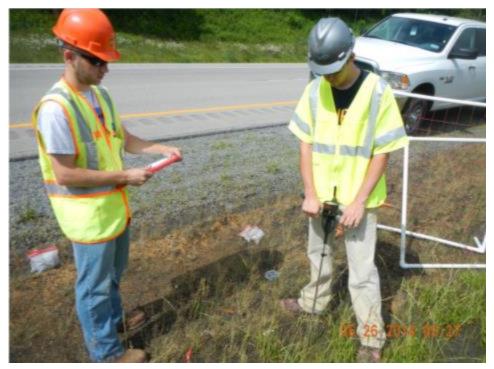
Figure 54: Soil compaction testing with penetrometer at I-68 median

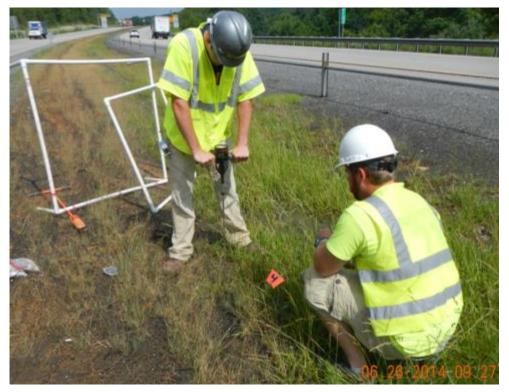
Figure 56: Compaction testing with penetrometer at I-68 median

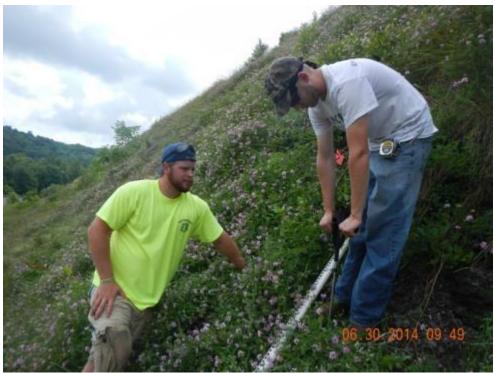
Figure 61: Compaction testing with penetrometer at Philippi Bypass

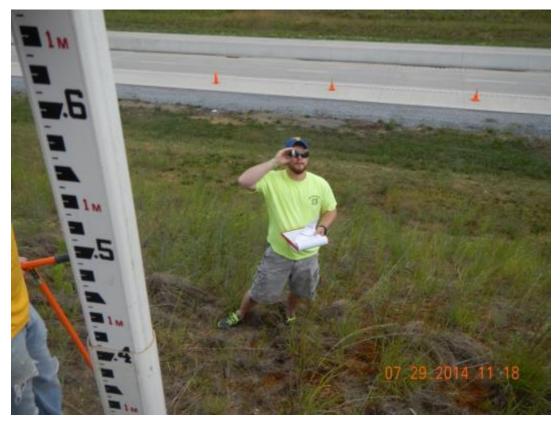
Figure 80: Measurement of slope with clinometer at Route 9 Site 1

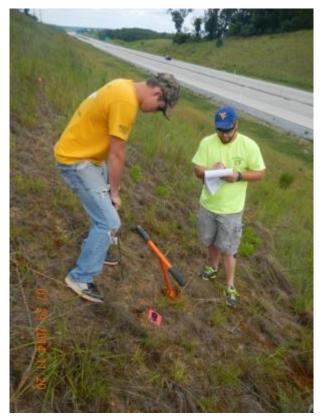
Figure 81: Compaction testing with penetrometer at Route 9 Site 1
