Long-Term Performance of Pot Hardware in Continuous Galvanizing Lines

Thesis Submitted to the
College of Engineering and Mineral Resources
at West Virginia University
in partial fulfillment of the requirements
for the degree of

Master of Science
in
Mechanical Engineering

Long-Term Performance of Pot Hardware in Continuous Galvanizing Line.

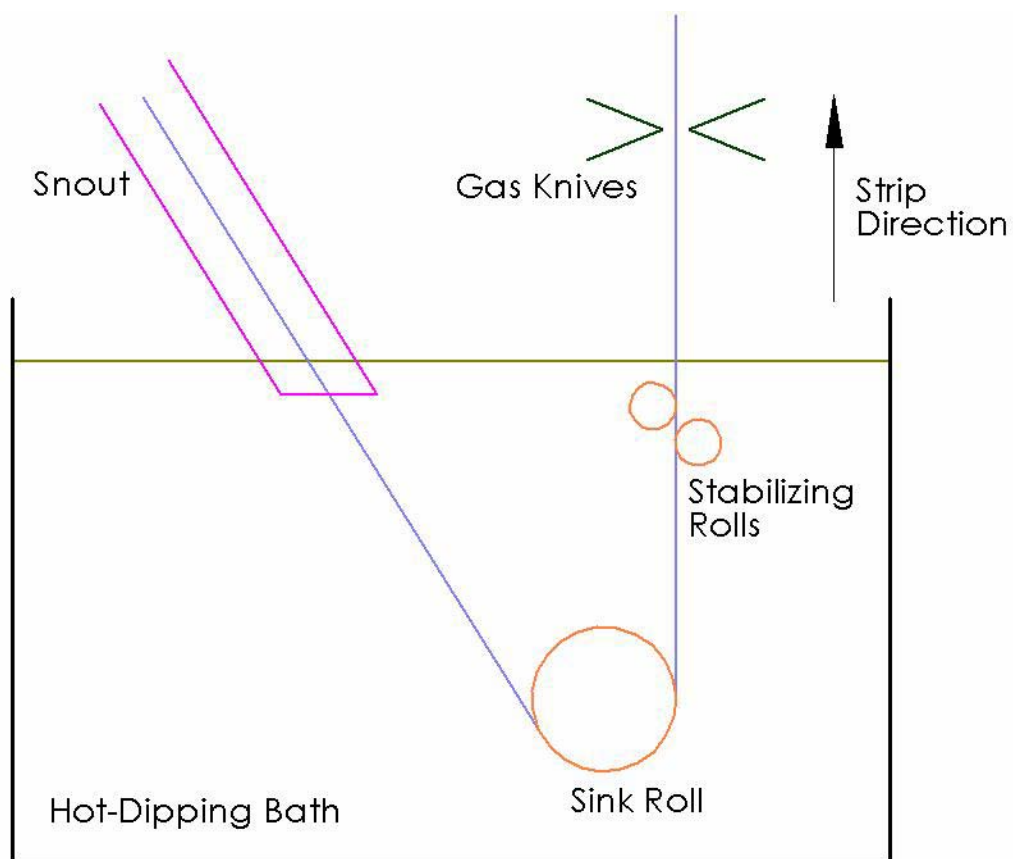
Figure 1 Schematic of Continuous Galvanizing Line

The continuous hot-dip galvanizing process for steel sheet was developed over fifty years. Molten zinc coating is applied onto the surface of the steel sheet during continuous hot dip process. Continuous ribbon of steel sheet is passed through a bath of molten zinc at selected speed. Steel sheet reacts with the molten zinc to form coating on the steel surface inside the molten bath. Gas knives are used to remove the excess coating sticking on the sheet surface. Figure 1 shows the schematic of continuous galvanizing line.

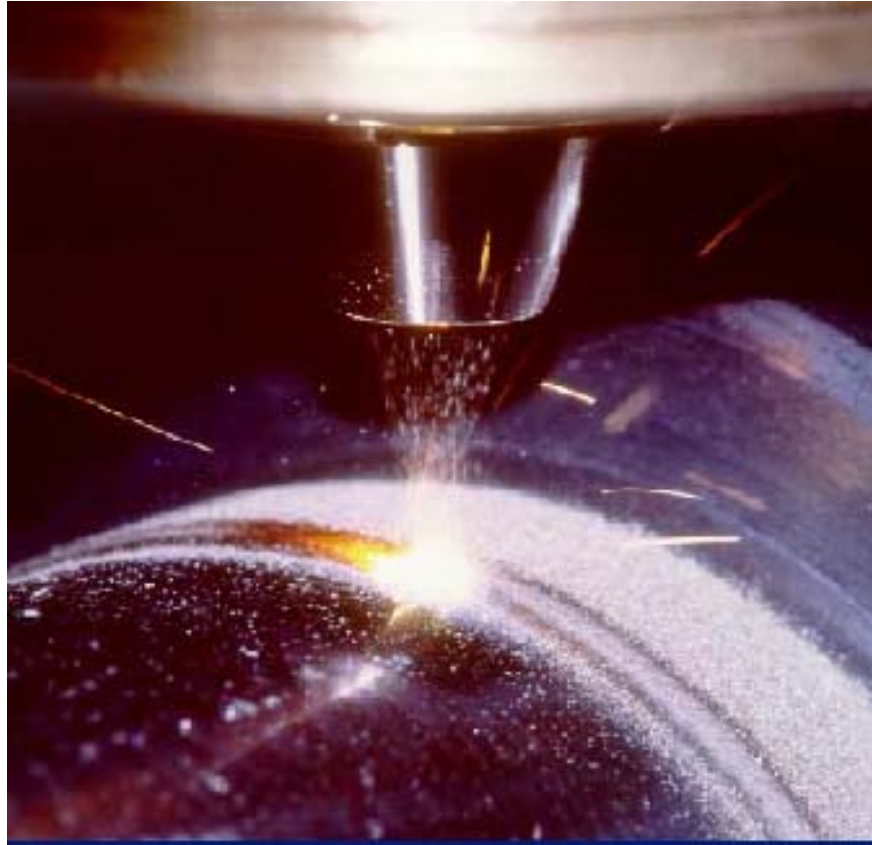
Figure 2 Tungsten Carbide Composite is Metallurgically Bonded by a Laser Process to a 316L Stainless Steel Sleeve [1]

According to Praxair S.T Technology Inc. Patent # 6,037,287 [1], laser cladding and hard-surfacing provided unique methods for applying metallurgically bonded coatings to virtually any size and configuration of work piece. The CO₂ laser generator directs a collimated CO₂ laser beam to a selected work cell through an enclosed laser duct using optically polished, water cooled mirrors. Appropriate optics attached to the tooling end-effector directs the laser beam to a spot of high power density. The focused beam when translated over the work piece surface rapidly melts and solidifies the cladding or hardsurfacing alloys. Precise control of laser energy permits accurate deposition of coating thickness ranging from 0.01 to 0.08 inches (250 – 2000 microns) in single pass. Figure 2 shows a typical laser cladding process. The laser clad coatings are impervious overlays metallurgically bonded to the substrate alloy. The dilution caused by intermixing of the coating alloy and the substrate alloy is routinely controlled at less than 5%. Due to low heat input of the laser cladding process, coated components exhibit minimal distortion. Also metallurgical changes in the substrate alloy are negligible. Various component geometry, desired size, shape and different coating thickness can be obtained by the laser cladding and hard surfacing processes. To ensure a uniform coating thickness for broad surface area, parallel beads of clad deposit are applied with sufficient overlap. Laser cladding and hardsurfacing processes are applicable to all combinations of iron-base, nickel-base and cobalt-base alloys, both as clad overlays and substrate alloys. Through the laser cladding process, hard, wear-resistant carbides can be incorporated in zinc-resistant alloys in the protective overlay.

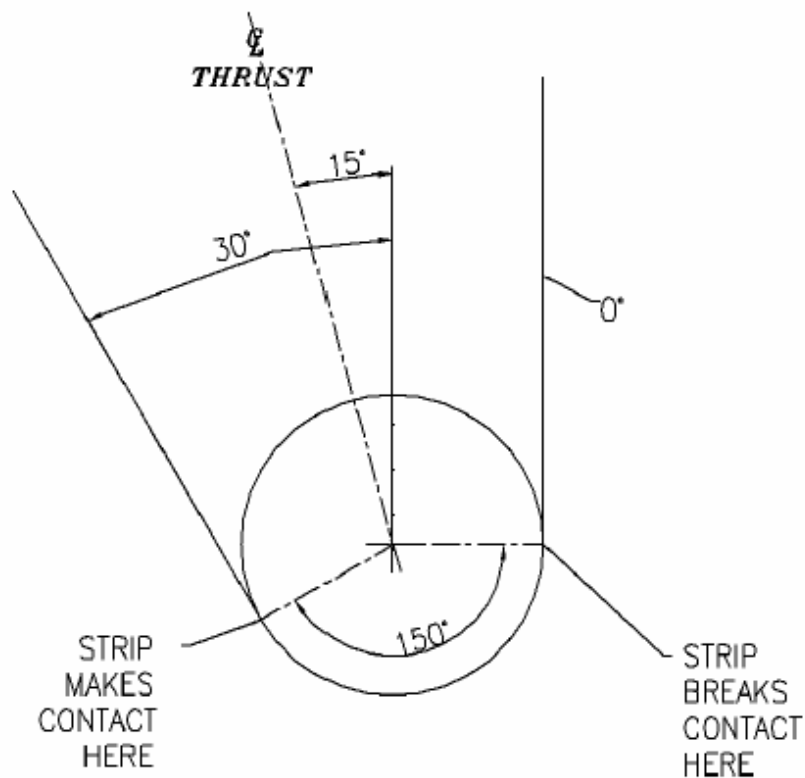
Figure 3 Center of Thrust [6]

The center of thrust is the line of action of the force of the strip on the roll. The center of thrust is determined by the wrap of the strip on the roll and the center of thrust is located at the center of the wrap [6]. The figure shows the schematic drawing of center of thrust between roll and the steel strip.

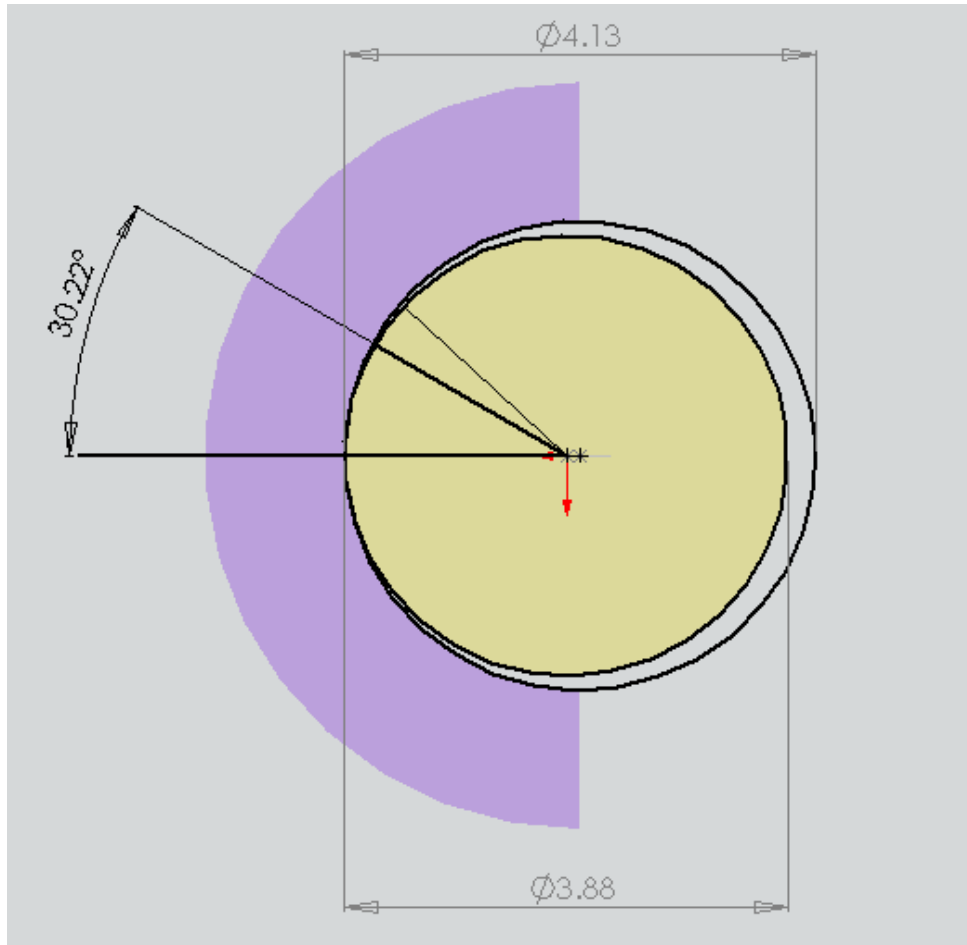
Figure 4 Area of Contact between Stellite 6 Bearing and Tribaloy T-400 Bushing

Table 9 shows the dimensions of bearing sleeve and bushing used in wearing test. Area of contact of bushing and bearing is obtained from Solid WorksTM. Applied load for the laboratory test condition is calculated as shown in Table 10. Figure 5 shows the front view of test bath with the loads. The relation between load acting between contact surface and dead weight is calculated by taking moment about the point O as shown in Table 11.

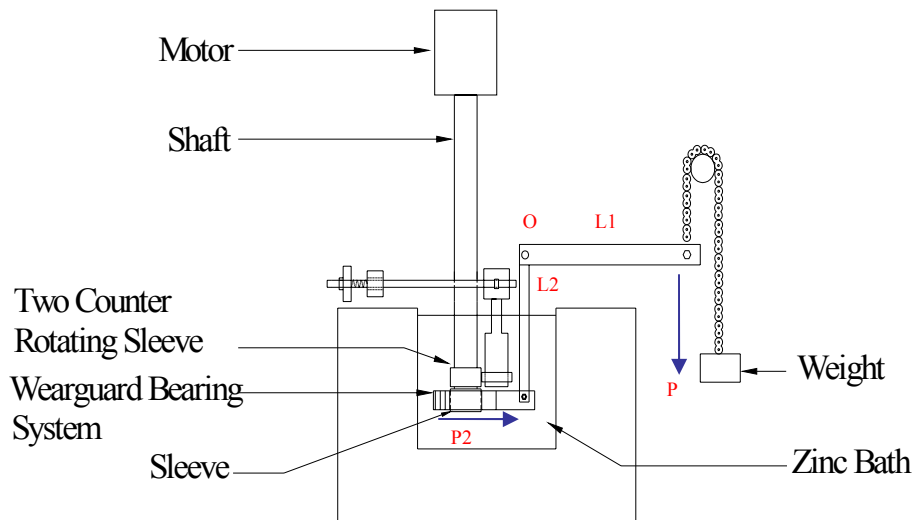
Figure 5 Front View of Test Bath

Figure 5 represents the front view of the 500 lb zinc Test bath. The motor is used to rotate the shaft with the tungsten carbide sleeve to the speed equivalent to the production line speed. For the dross build-up test, a 316 L sleeve with tungsten carbide spray coating is rotated against the low carbon steel sleeve which are in line contact with each other. Spring force is used to keep the two sleeves in line contact so as to keep the roll pressure the same as in the production line. When calculated spring load is applied the low carbon sleeve moves towards the tungsten carbide sleeve, thereby producing the line contact between them. For the wearing test the three SiAlON ceramics are placed inside the Wearguard bearing system. Simulated load equivalent to percentage of production line tension is applied by adding suitable amount of weight to the loading arm . When the load is applied the loading arm (L1) moves up, thereby pulling (via arm L2) the wearguard bearing system towards the center. The three SiAlON ceramic inserts placed in the wear guard system comes in line contact with the sleeve. Diametric measurement is taken on the sleeve after each test cycle. The change in diameter of the sleeve with respect to time represents the wearing of the sleeve.

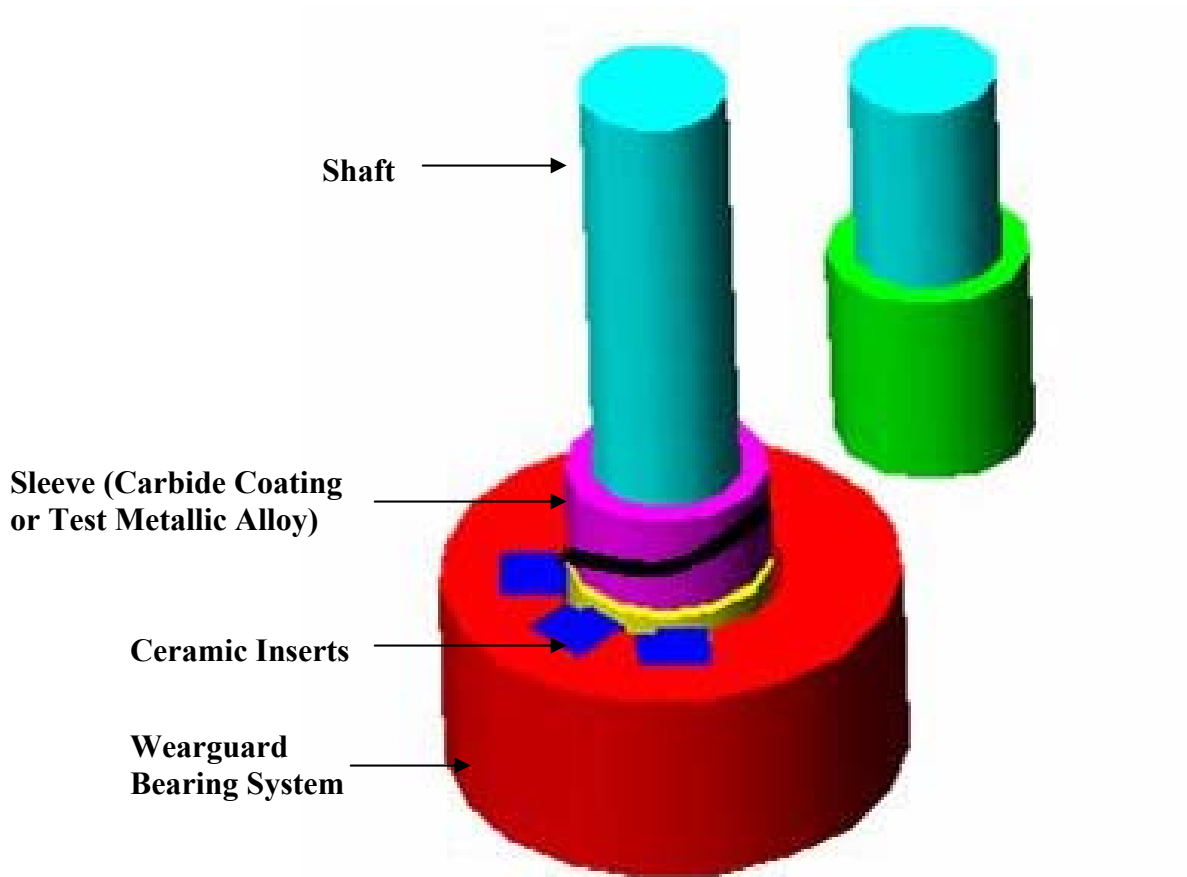
Figure 6 Schematic Representation of Wearing and Dross Build-up Test

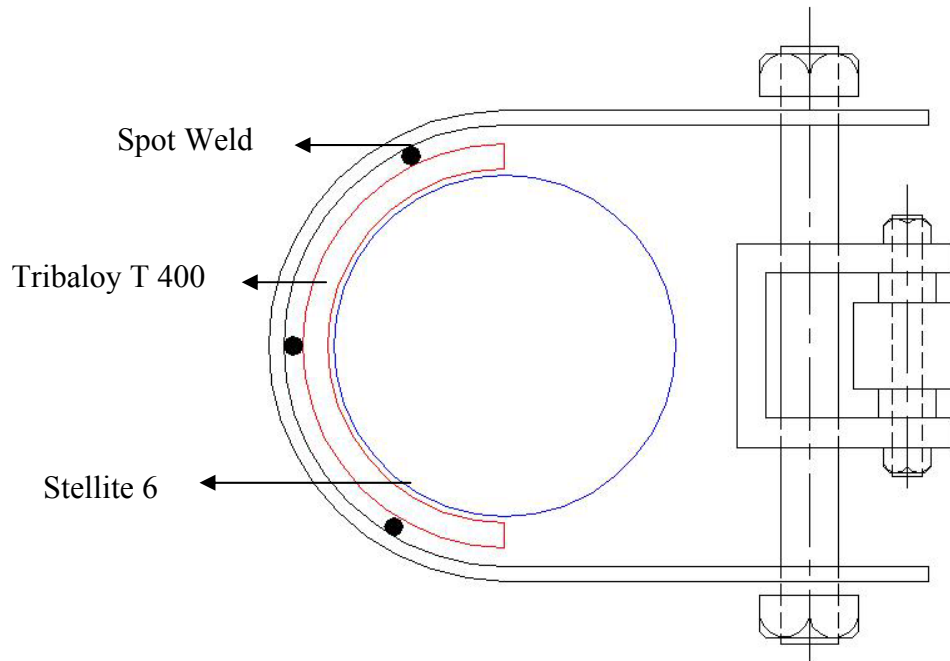
Figure 7 Schematic of Test Setup

Figure 7 shows the schematic of Stellite 6 against Tribaloy T-400 wearing test set up. The wearing test for the Stellite 6 was run with the typical set up as shown below.

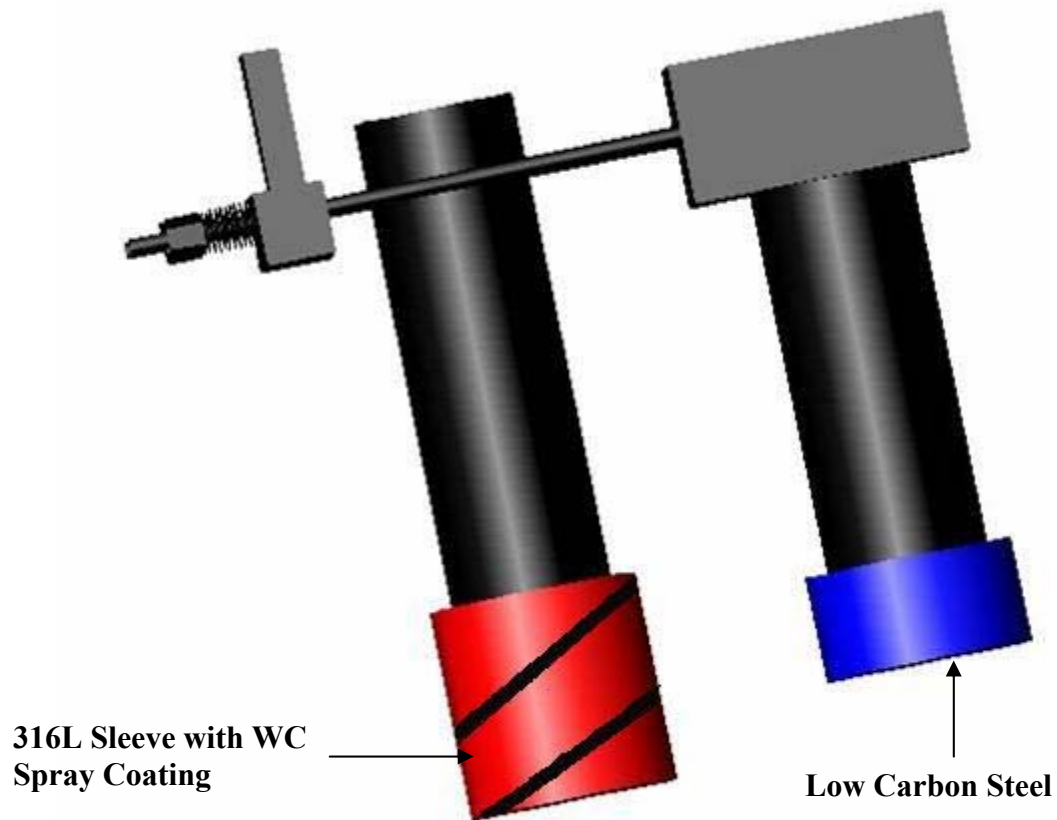
Figure 8 Schematic of Dross Build-up Test

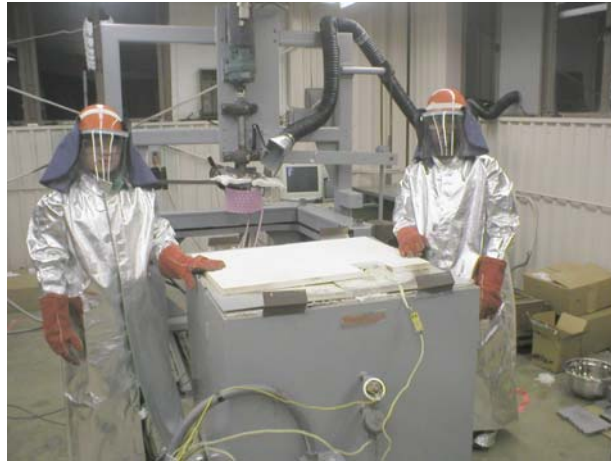
Figure 9 The 500 lb WVU Test Bath

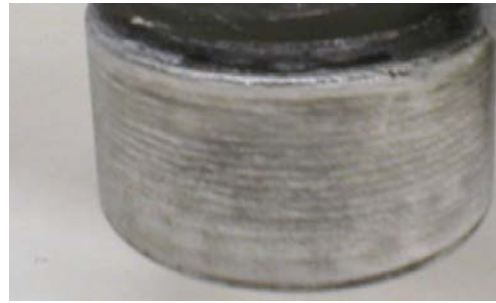
Figure 10 CF3M Coated with Tungsten Carbide by Laser Cladding process

The sleeve was cut into 2” in length using a wire cut EDM. The outside and inside diameter of sleeve was 3.875” and 2.85” respectively. The sleeve was then welded to the shaft for the wearing test.

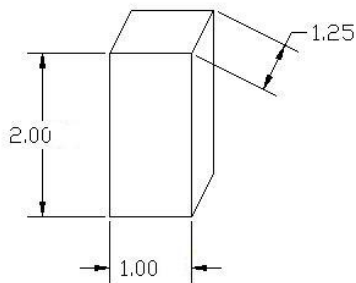
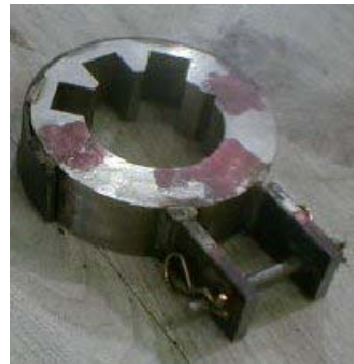
Figure 11 Wearguard System and SiAlON Ceramic Bar

Three ceramic bar of dimensions 2" x 1" x 1.25" was placed inside the wearguard system with 2" x 1" surface facing the test bearing.

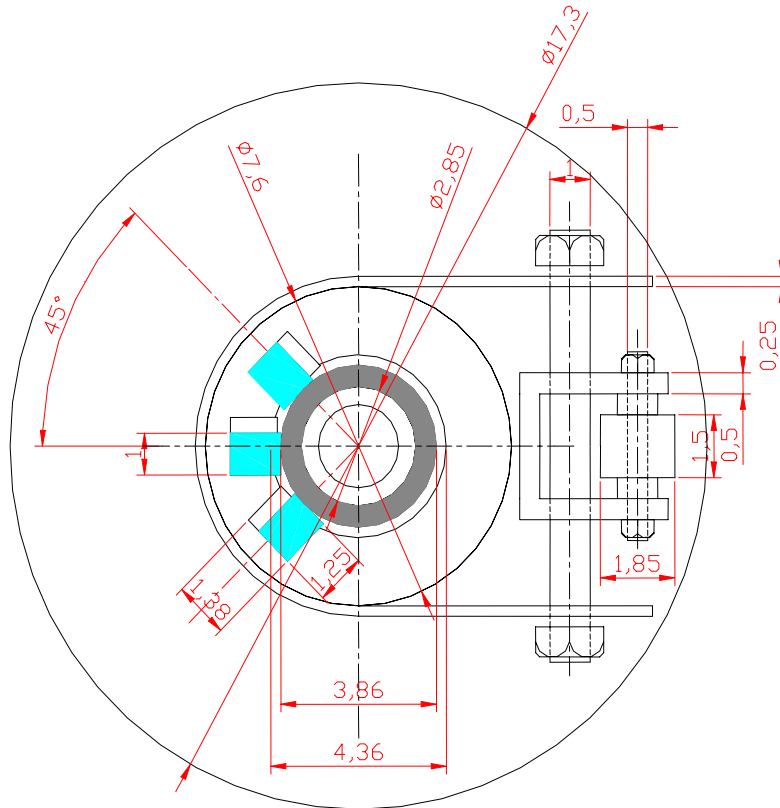
Figure 12 Top View of the Wearguard Test Set Up

bearing with 1/2" hole machined at the end bar and a 1/2" steel rod was used to connect the bearing to the loading arm. The rod was locked at the ends by pull pins. The pull pin was preferred to nut to enable the easy removal of the wearguard system after each test cycle. When the calculated load is applied on the loading arm the wearguard system is pulled towards the sleeve, thereby bringing the ceramic bar in contact with the sleeve. The contact pressure is set to be either 30% or 50% of the production line tension.

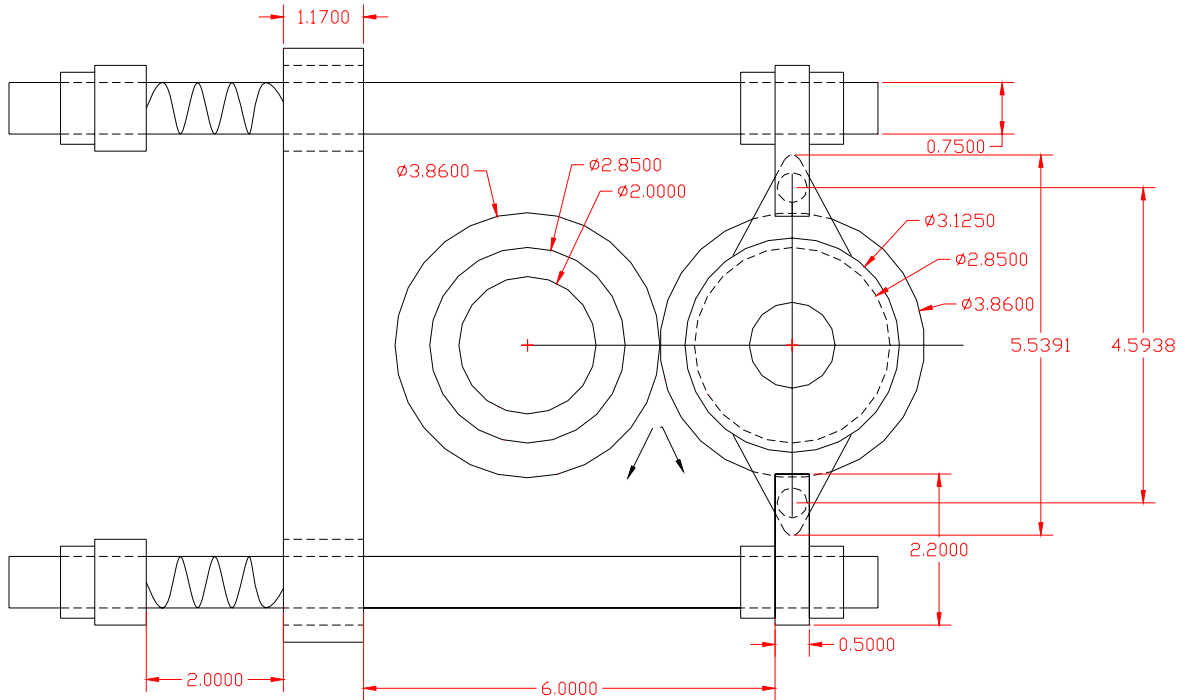
Figure 13 Top View of Dross Build-up Test

Figure 13 represents the top view of the dross build-up test setup. A typical roll surface groove as shown in Figure 14 was machined.

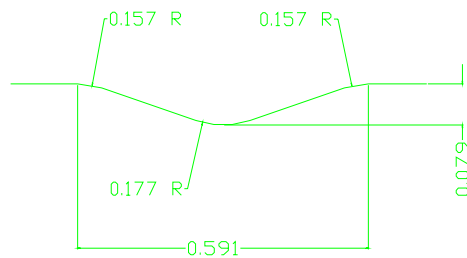
Figure 14 Groove Pattern on Roll Surface

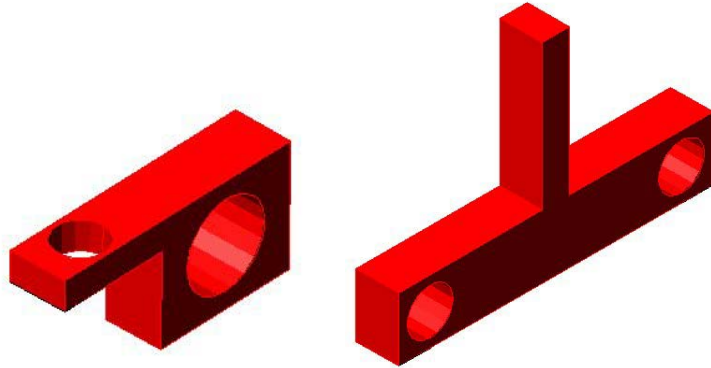
Figure 15 Mounting Adapters

The low carbon steel shaft simulating the steel sheet in the production line, was fixed to the high temperature self aligning bearing which is held by two steel rods connected to the mounting adapters. The self aligning bearing was fixed to the test bath frame using the mounting adapters shown in Figure 15. Figure 16 shows the test set up of the high temperature bearing with mounting adapters.

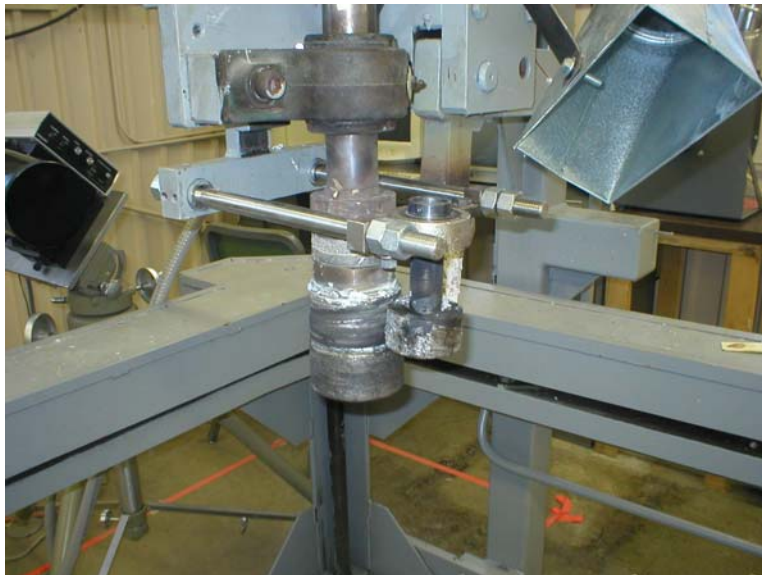
Figure 16 Test Setup with Mounting Adaptors

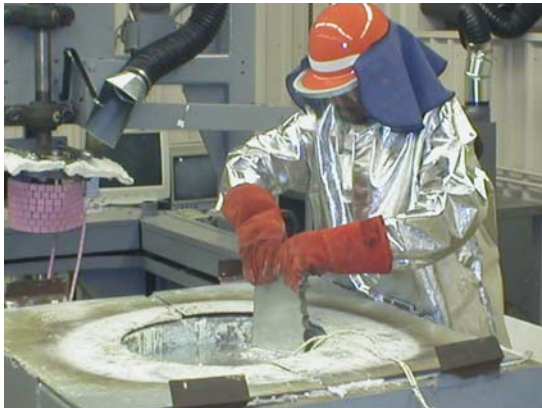
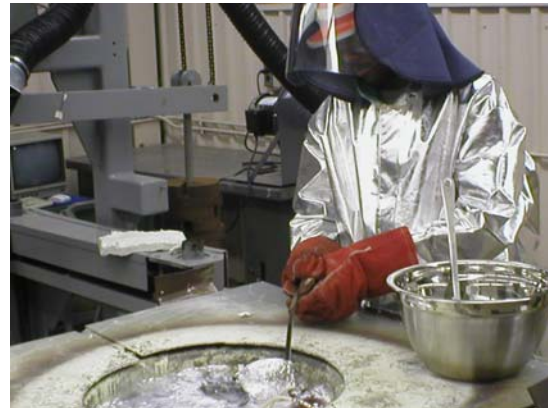
Cut zinc bars were melted in the furnace before the start of the preheating stage as shown in Figure 17a. A ceramic insulator was used to cover the zinc pot. Figure 17b shows the cleaning of impurities floating on top of the bath. The temperature of molten zinc bath was maintained at 860 F. The pull pin connecting the wearguard system to the loading arm was painted with boron nitride paint. This paint prevents the molten zinc from sticking to the pin surface during testing, which enabled the easy removal of the wearguard system for wearing measurement. The initial diameter, hardness and microstructure of the bearing sleeve were measured before starting the test.

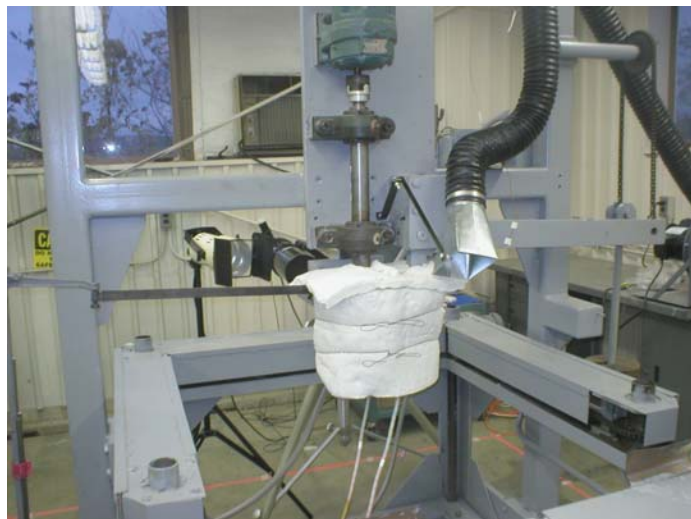
feedback to the temperature controller during the preheating stage. Then the flexible heater was covered with the insulation to reduce the loss of heat during preheating as shown in Figure 19. The bearing sleeve is usually preheated upto a temperature of 850 F. The insulation and the preheater were unwrapped and moved away. The k-type thermocouple was also removed before immersing the bearing sleeve into the zinc pot.

Figure 19 Preheating Stage

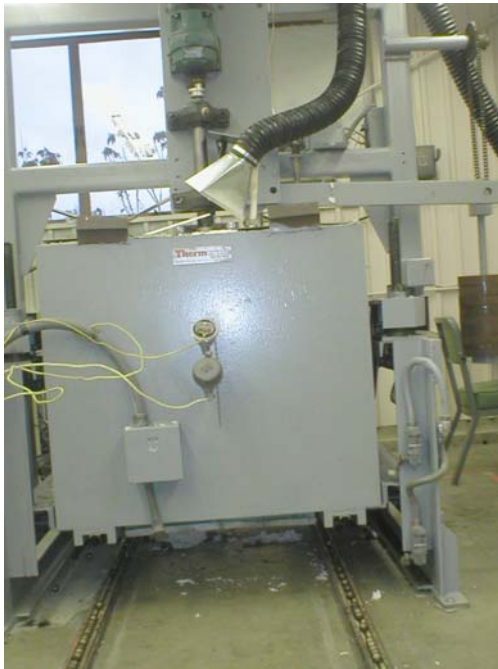
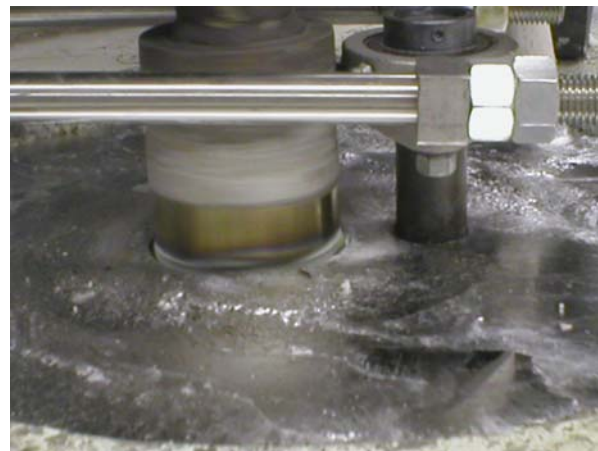
After preheating, the zinc pot was moved below the bearing sleeve. The calculated load was applied to the loading arm to bring the bushing in contact with the bearing sleeve surface. Figure 20a shows that the zinc pot was raised to immerse the test sleeve in to the molten zinc. The sleeve was made to rotate inside the zinc pot at the speed same as that of the production line as shown in Figure 20b.

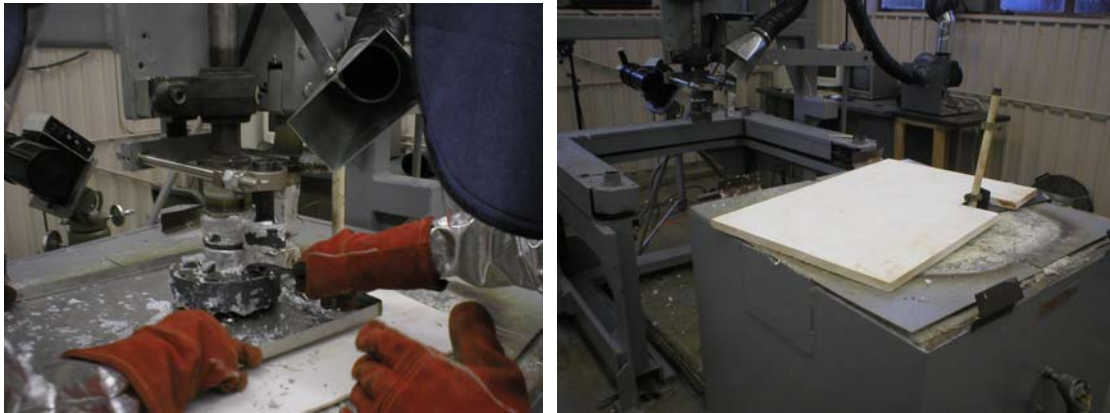
The test was stopped at periodic intervals. The zinc pot was lowered down and wearguard system was cleaned with wooden shims to remove the molten zinc sticking on the surface. A steel plate was placed on top of the zinc pot, then the load was removed from the loading arm and pull pin was pulled out. Figure 21a

shows the wearguard system dropped to the steel plate, the steel plate along with the wearguard system was moved out. The zinc pot was moved out as shown in Figure 21b.

Figure 21 (a) Removing the Wearguard System (b) Zinc Pot Moved Out

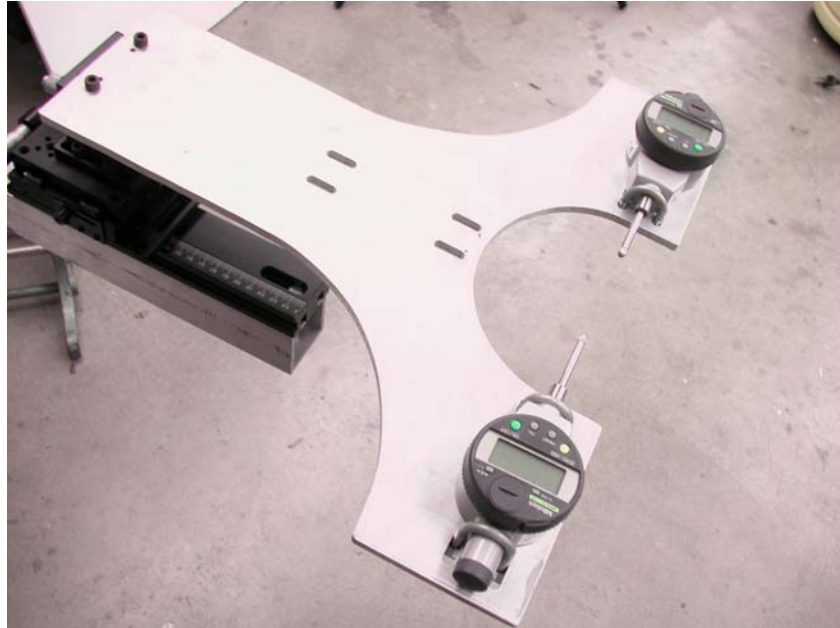
Figure 22 Diametric Measurement Unit

The difference of initial diameter and the new diameter gives the wearing rate after each test cycle.

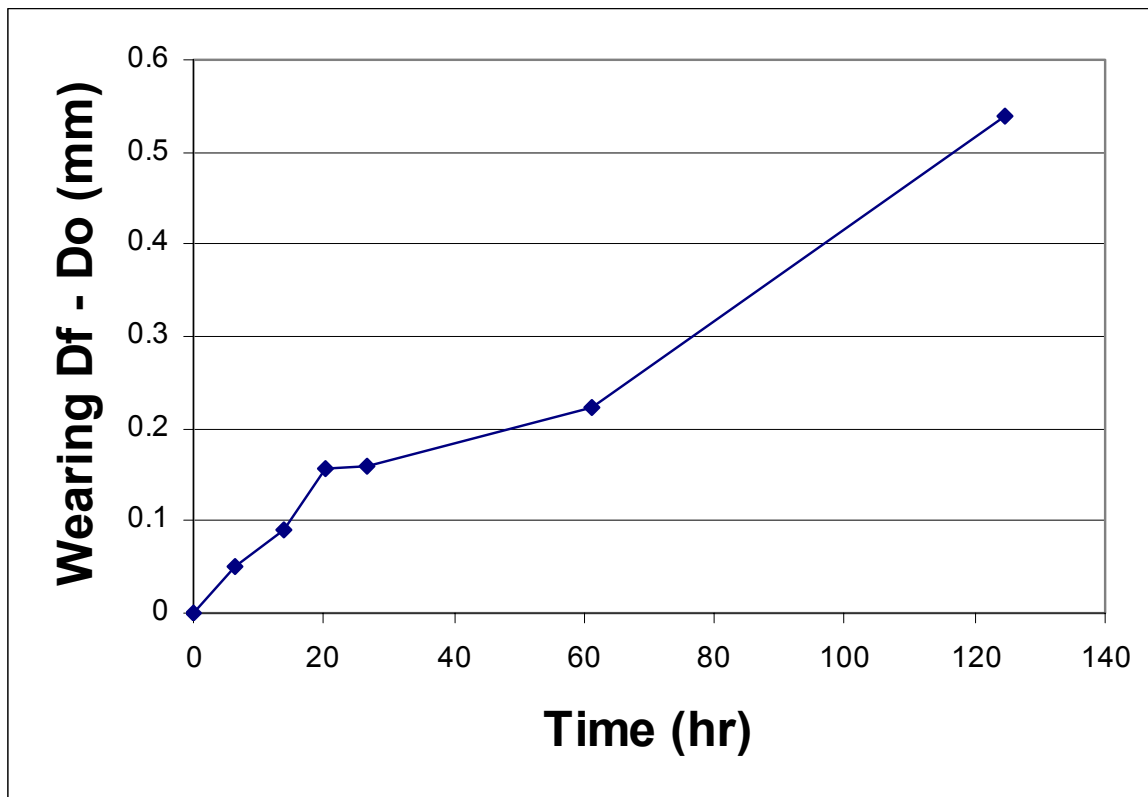
Figure 23 Wearing Result of 316 LS with WC-L against SiAlON Ceramic Inserts

Figure 23 shows wearing of the tested sleeve versus time. The bearing sleeve had a high wearing rate in the early stages up to test cycle 3. There was smaller wearing on the bearing sleeve between test cycle 3 and test cycle 4 as seen from the graph. The sleeve is expected to have a constant wearing rate after test cycle 4.

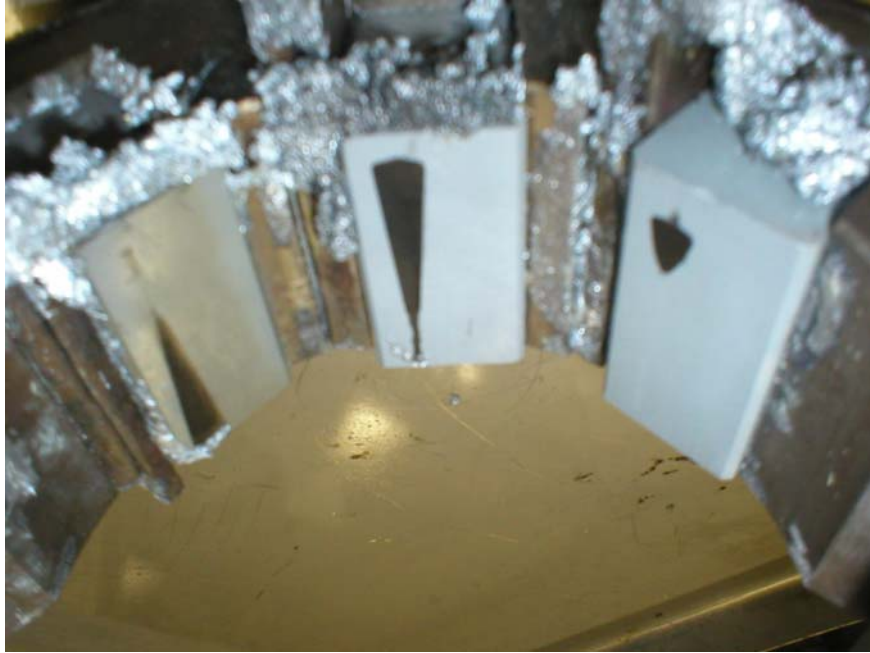
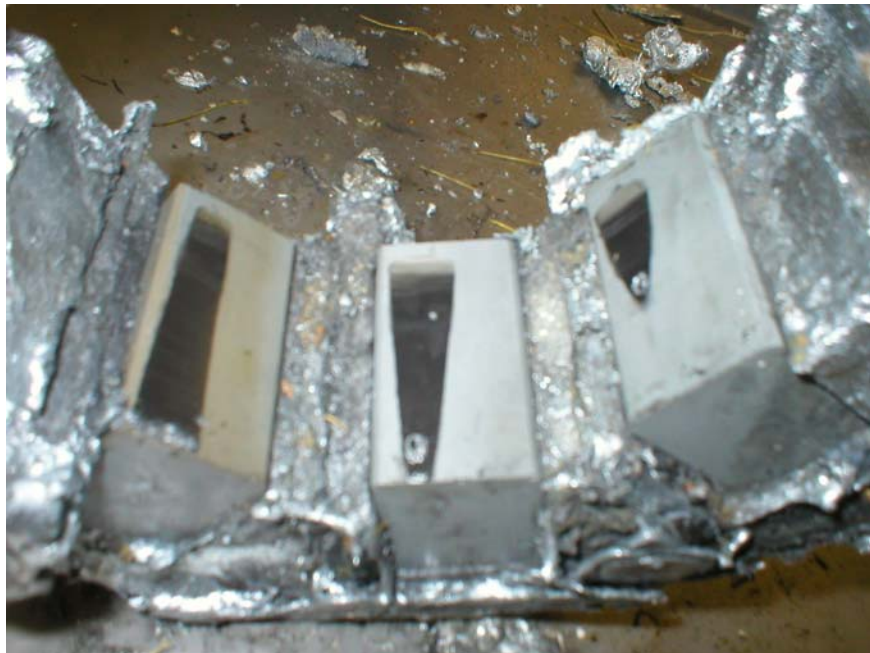
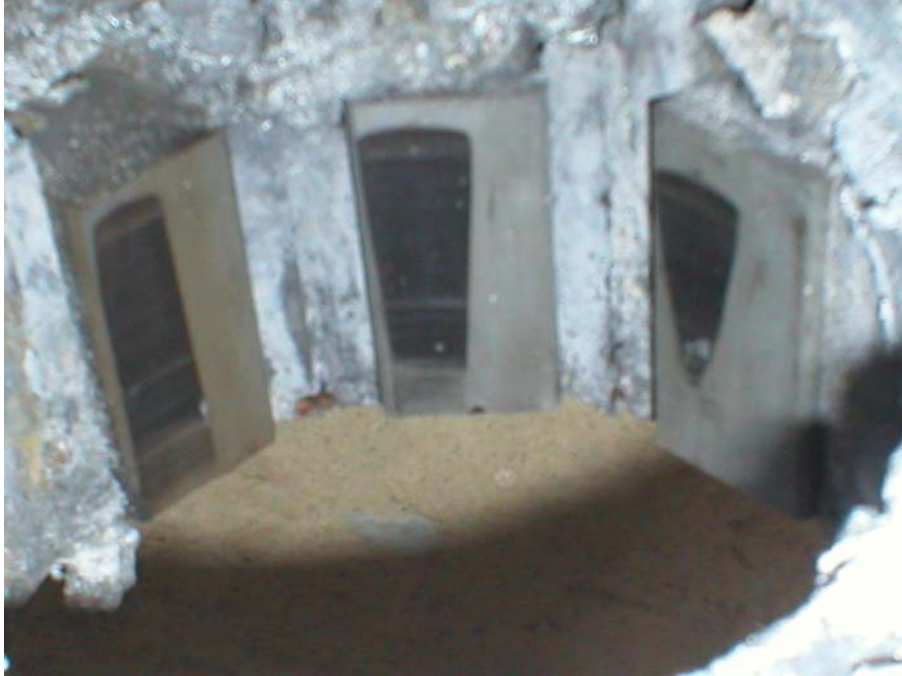
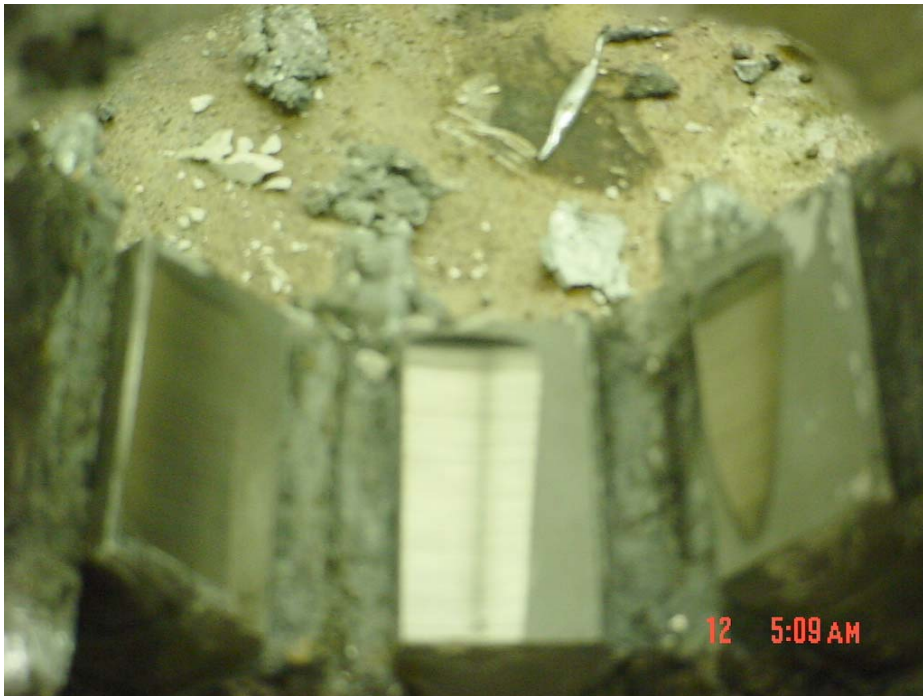
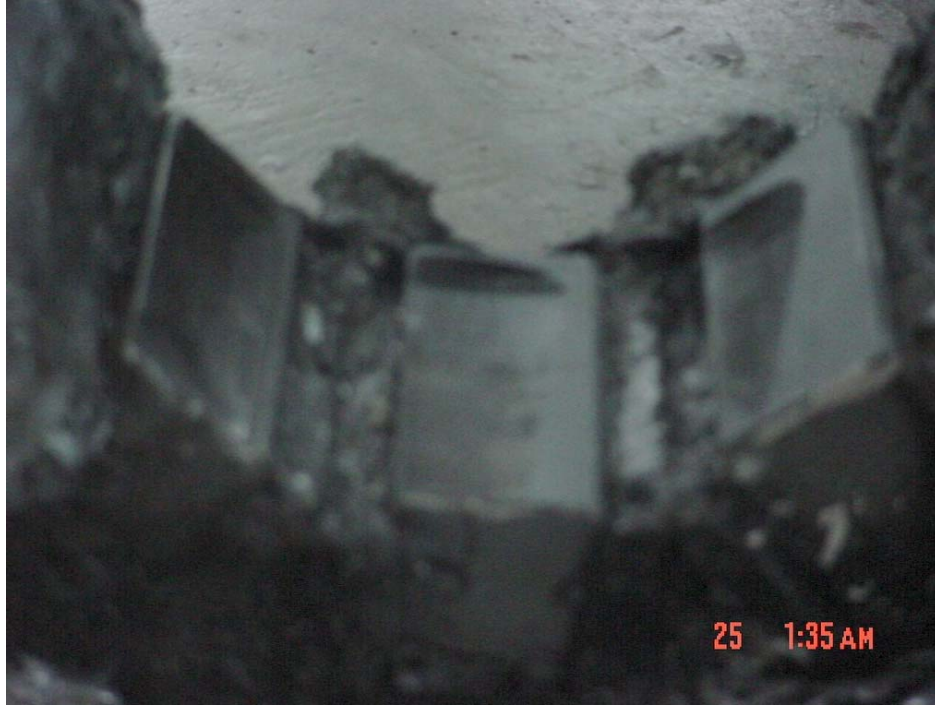
Figure 24 Wearing on Ceramic Insert after Cycle 1 (6 hr & 15 min)

Figure 25 Wearing on Ceramic Insert after Cycle 2 (13 hr & 45 min)

Figure 26 Wearing on Ceramic Insert after Cycle 3 with Grooves (20 hr & 15 min)

Figure 27 Wearing on Ceramic Insert after Cycle 5 (61 hr)

Figure 28 Wearing on Ceramic Insert after Cycle 6 (124 hr & 30 min)

Table 13 shows the wearing rate of CF3M with WC laser clad coating against SiAlON ceramic material. The three bar bushing design resulted in uneven wear of the bar components. The three ceramic bars experienced maximum wear at the top. Figure 26 shows that the groves were formed on the ceramic after the third test cycle. A mould was made to replicate the wearing surface of the ceramic inserts after each test cycle and further research is carried out to measure the wearing rate of the SiAlON ceramic using optical shadow moiré method by another graduate student. Figures 24 to 28 shows the wearing of ceramic inserts after each test cycle. Figure 29 shows the typical microstructure of the bearing sleeve after test cycle 6.

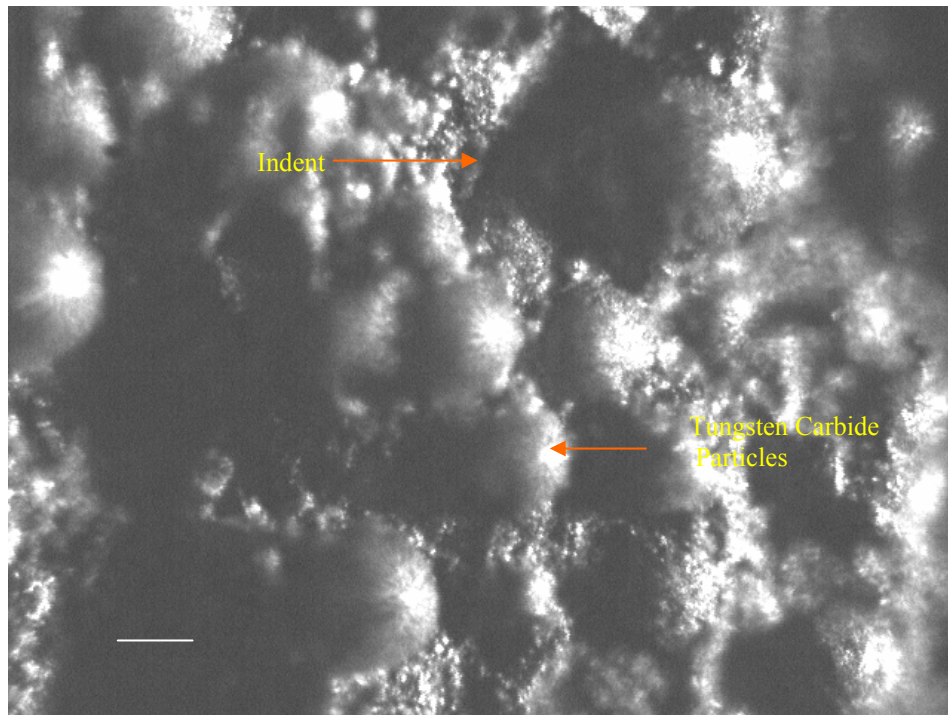
Figure 29 Bearing Sleeve Microstructure after Cycle 6 (124 hr & 30 min)

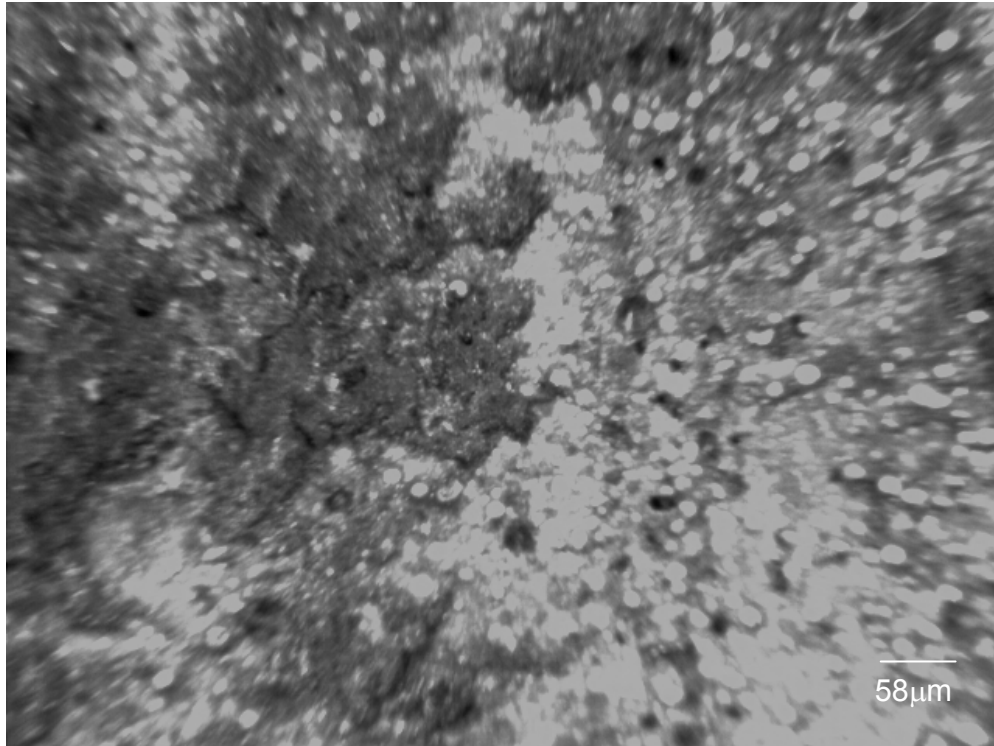
Figure 30 Ceramic Particles Sticking on the Bearing Sleeve

At the early stages of wearing, the ceramic particles from the bar struck to the soft matrix of the bearing sleeve and got imbedded in the surface of the bearing sleeve. This ceramic particle sticking on the bearing sleeve might have acted as protective layer and possibly even reduce wearing of the bearing sleeve as indicated in test cycle 3 and 4. Thickness of ceramic coating layer was measured to be from 15 μ m-30 μ m. Figures 30 and 31 confirmed the presence of ceramic particles on the bearing sleeve surface.

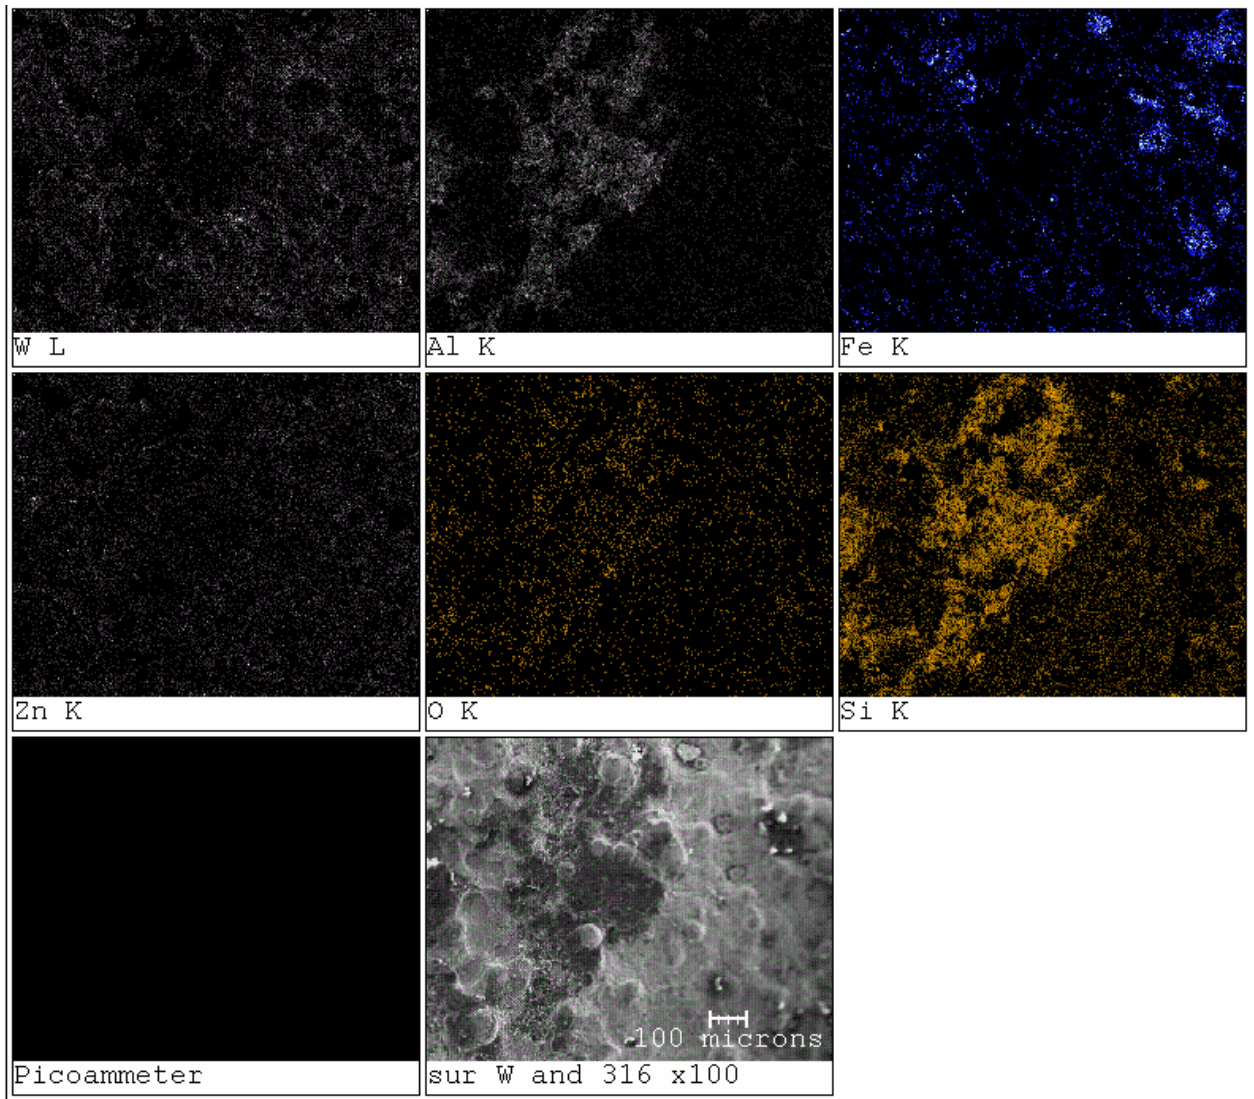
Figure 31 SEM Picture of Ceramic Particles Sticking on the Bearing Sleeve

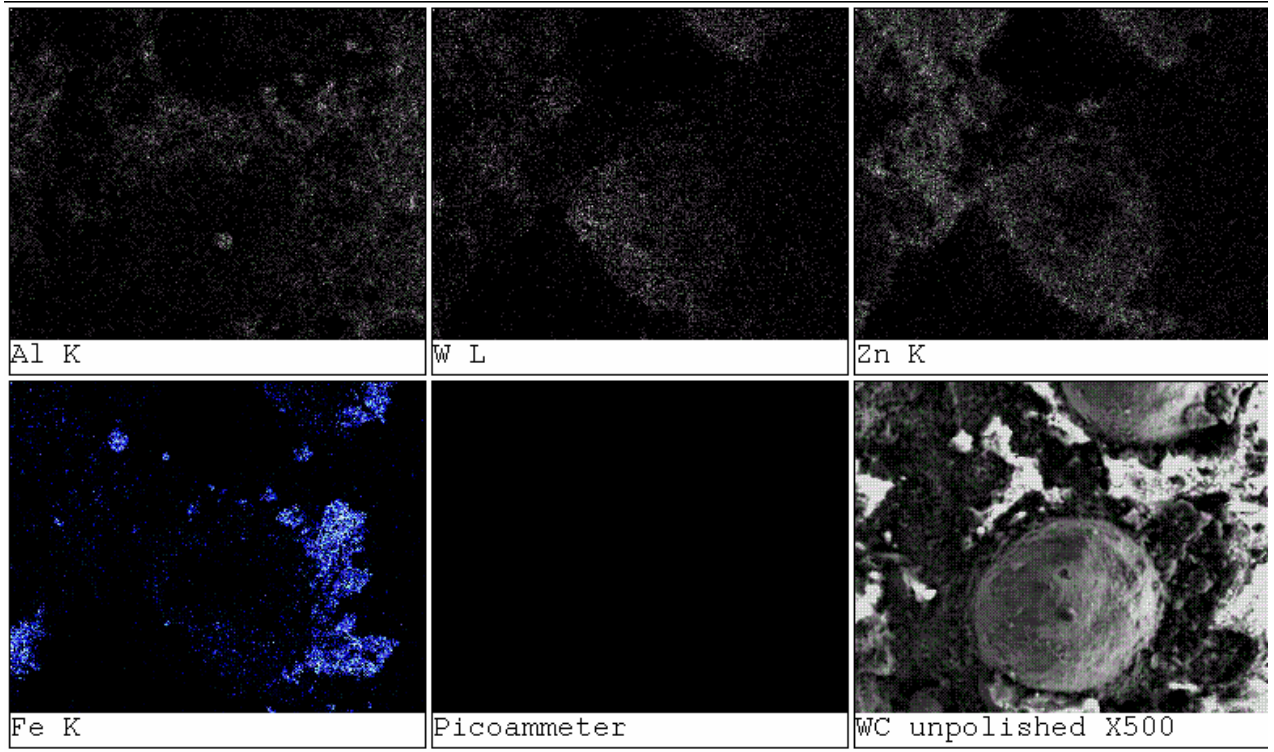
Figure 32 SEM Picture of the Bearing Sleeve

After the test cycles, the bearing sleeve was removed from the shaft. Specimens were cut from the bearing sleeve using the wire EDM. These specimens were then polished and prepared for microstructure analyses. As shown in Figure 32, SEM results indicated the possibility of intermetallics between iron –aluminum and zinc – aluminum formed on the bearing sleeve surface. Figure 33 shows the density of the WC particles at the wearing cross section of the bearing sleeve.
