Long-Term Performance of Pot Hardware in Continuous Galvanizing Lines

Thesis Submitted to the
College of Engineering and Mineral Resources
at West Virginia University
in partial fulfillment of the requirements
for the degree of

Master of Science
in
Mechanical Engineering

Long-Term Performance of Pot Hardware in Continuous Galvanizing Line.

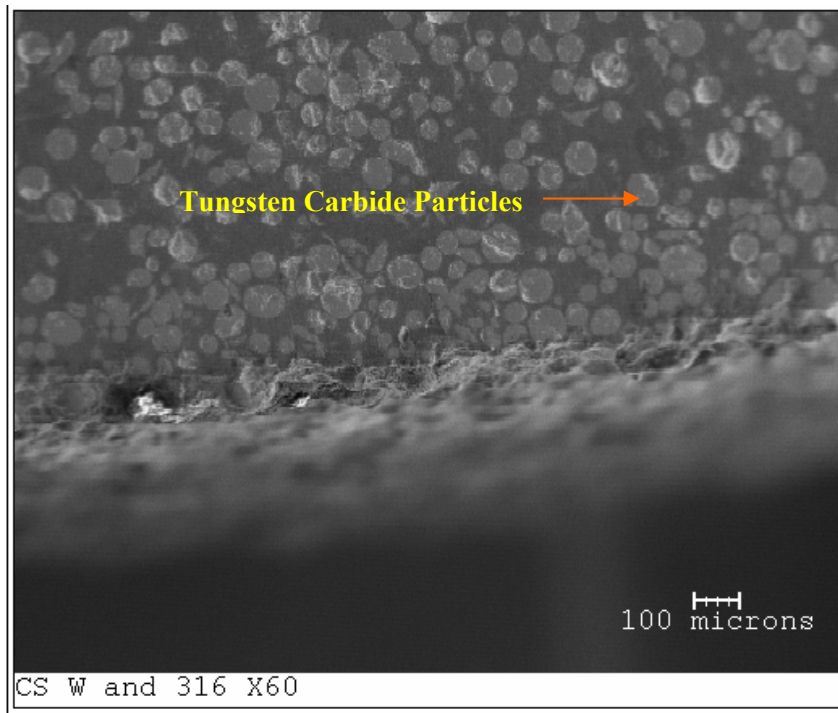
Figure 33 Density of the Tungsten Carbide Particles at Wearing Cross Section

After the test cycles, the bearing sleeve was removed from the shaft. Specimens were cut from the bearing sleeve using the wire EDM. These specimens were then polished and prepared for microstructure analyses. As shown in Figure 32, SEM results indicated the possibility of intermetallics between iron –aluminum and zinc – aluminum formed on the bearing sleeve surface. Figure 33 shows the density of the WC particles at the wearing cross section of the bearing sleeve.

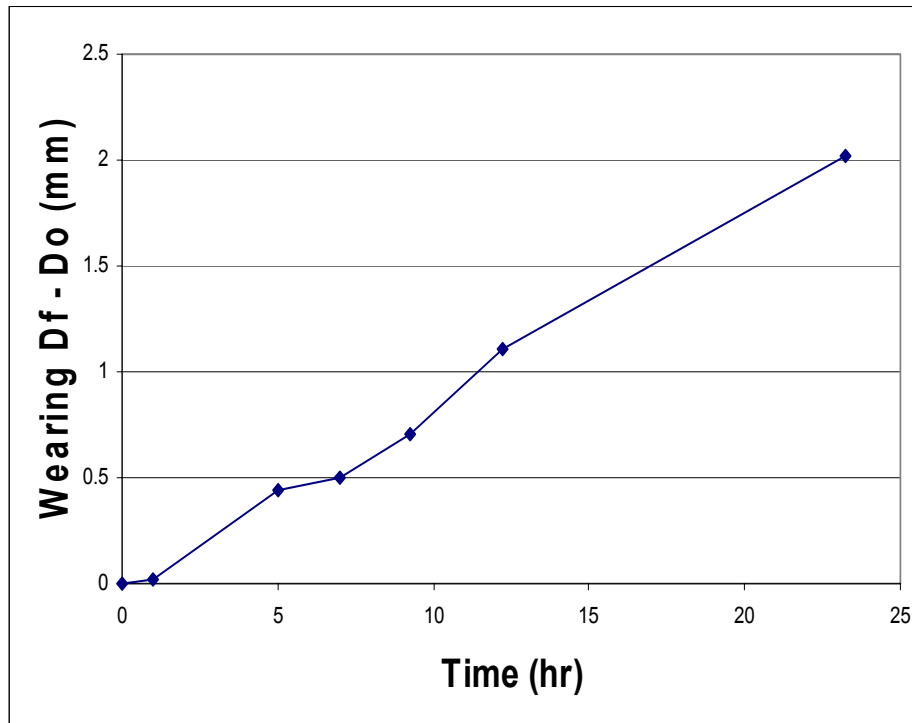
Figure 34 Wearing Result of 316 LS with WC-L against SiAlON Ceramic Inserts

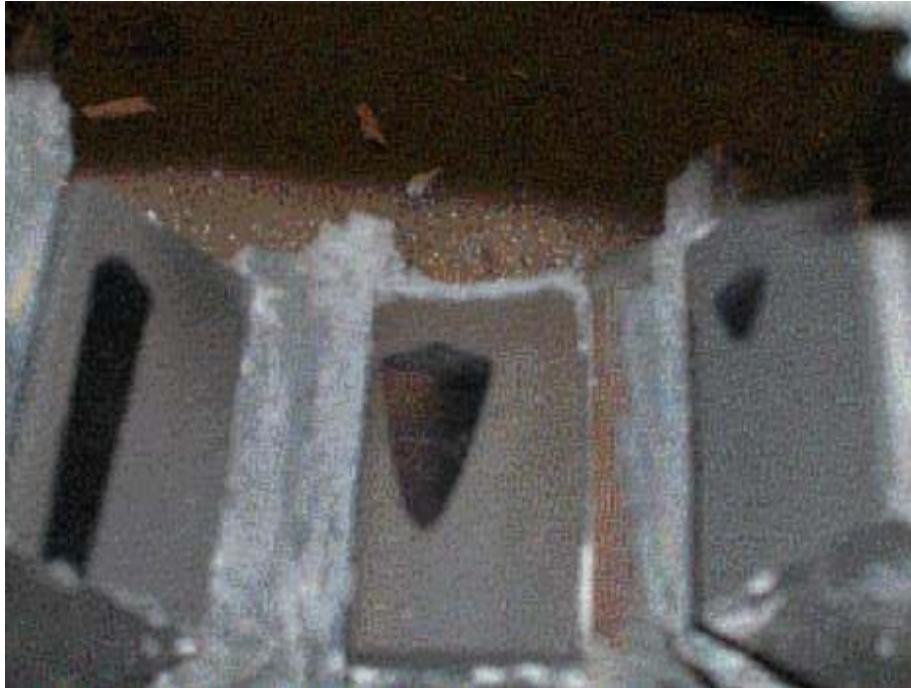
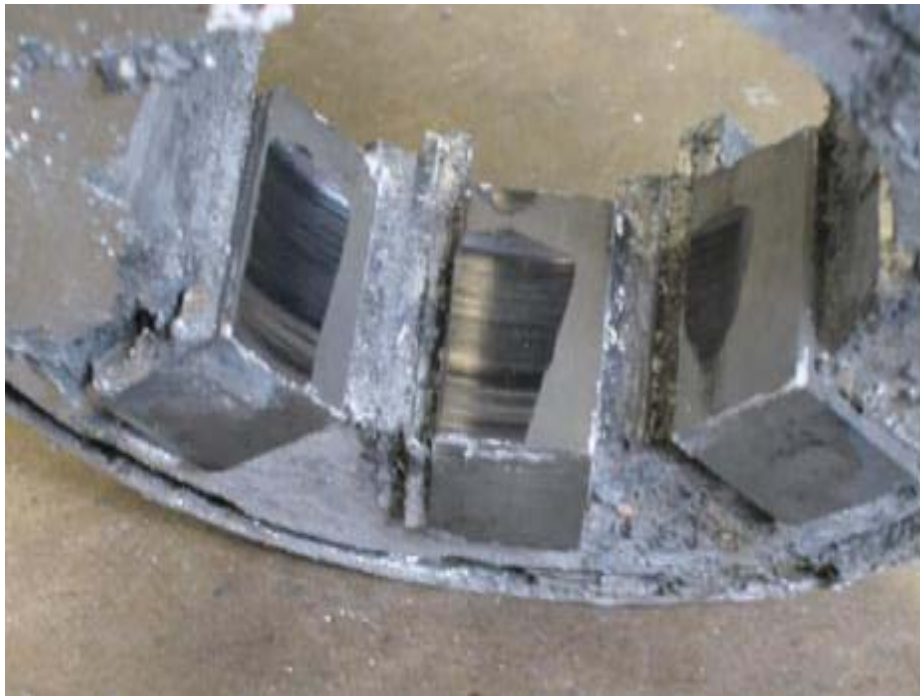
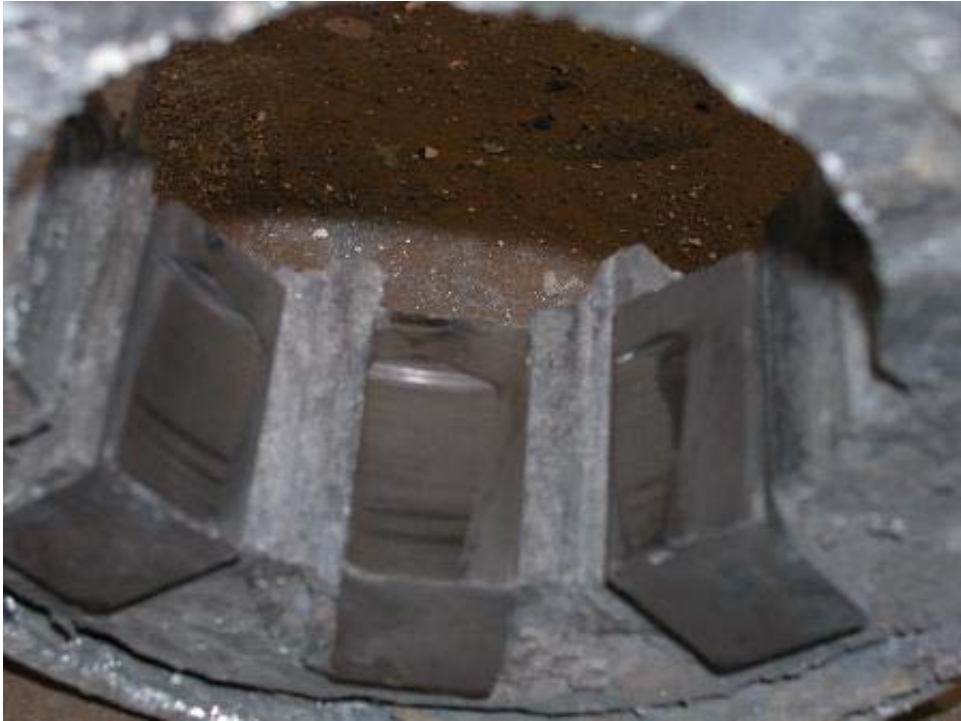
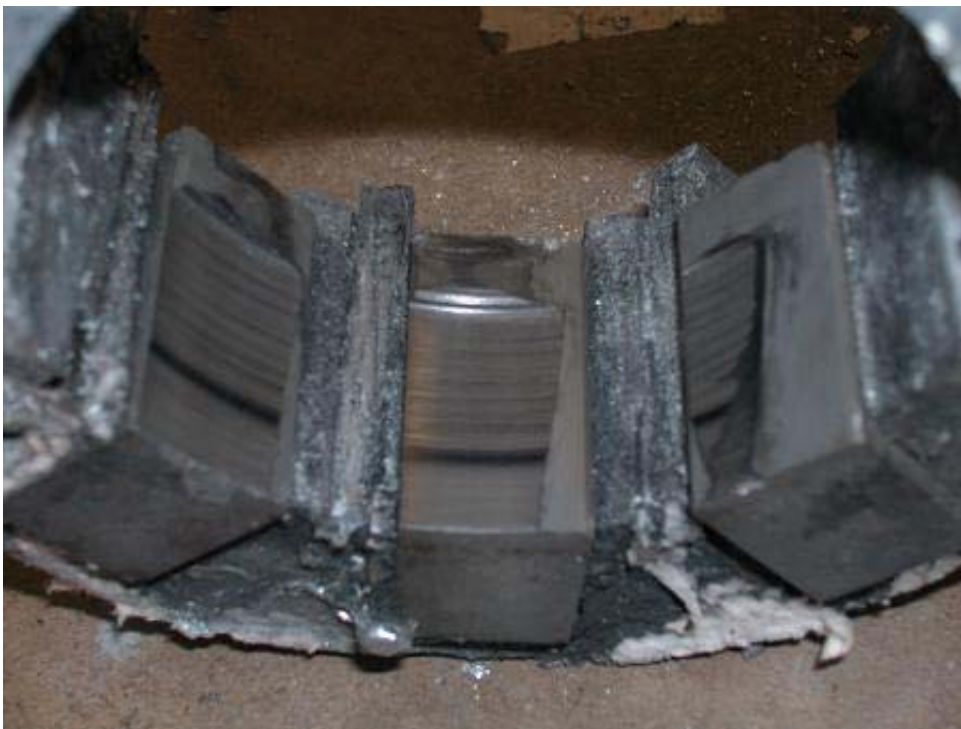
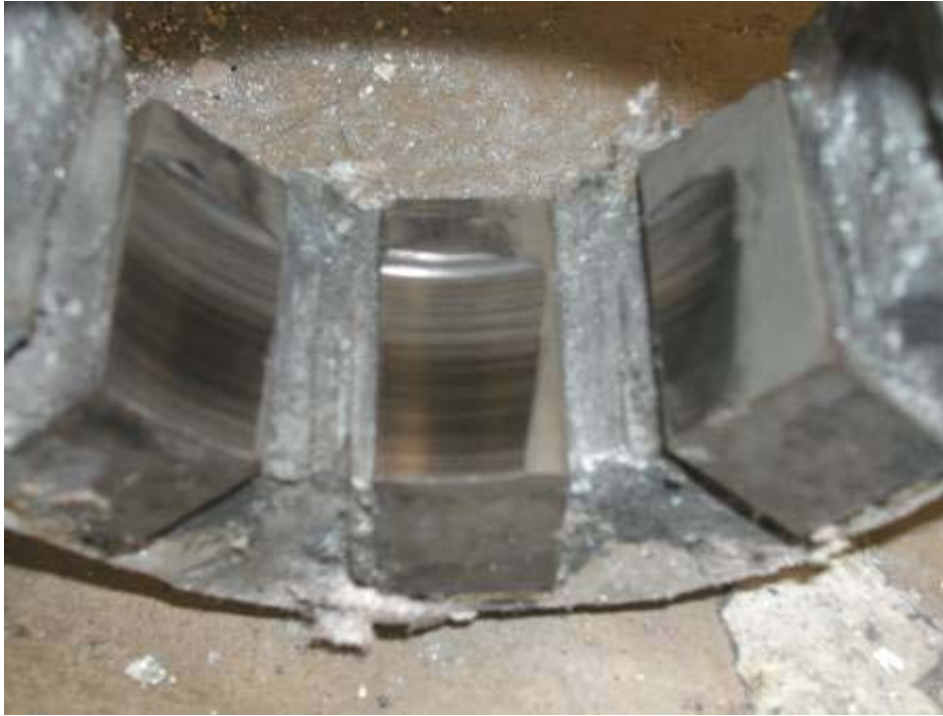
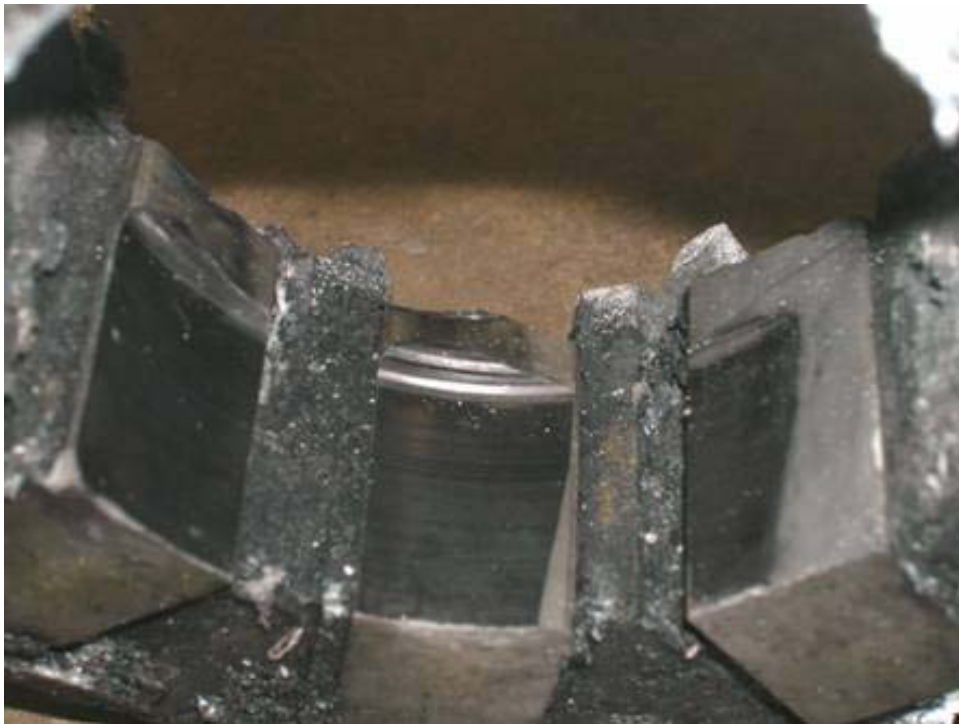
Figure 35 Wearing on Ceramic Insert after Cycle 1 at Production Line Tension(1hr)

Figure 36 Wearing on Ceramic Insert after Cycle 2 (2hrs at 70% Production Line Tension and 2 hrs at 50% Production Line Tension)

Figure 37 Wearing on Ceramic Insert after Cycle 3 (2 hrs at 50% Production Line Tension)

Figure 38 Wearing on Ceramic Insert after Cycle 4 (2 hrs & 15 min at 50% Production Line Tension)

Figure 39 Wearing on Ceramic Insert after Cycle 5 (3 hrs at 50% Production Line Tension)

Figure 40 Wearing on Ceramic Insert after Cycle 6 (11 hrs at 50% Production Line Tension)

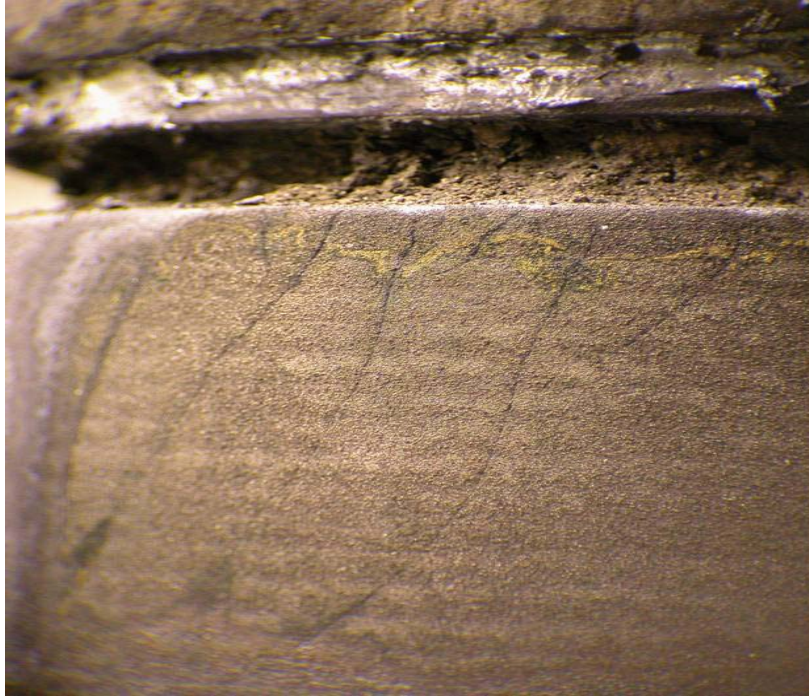
Figure 41 Cracks on the Wearing Sleeve Surface after Test Cycle 2

The on site microstructure picture was taken on the bearing sleeve after cycle 2. This revealed the formation of cracks on the wearing sleeve surface. These cracks caused easy wearing of the tungsten carbide laser clad coating from the matrix and hence high wearing rate when scaled and compared to Test 1 at 32% production load tension.

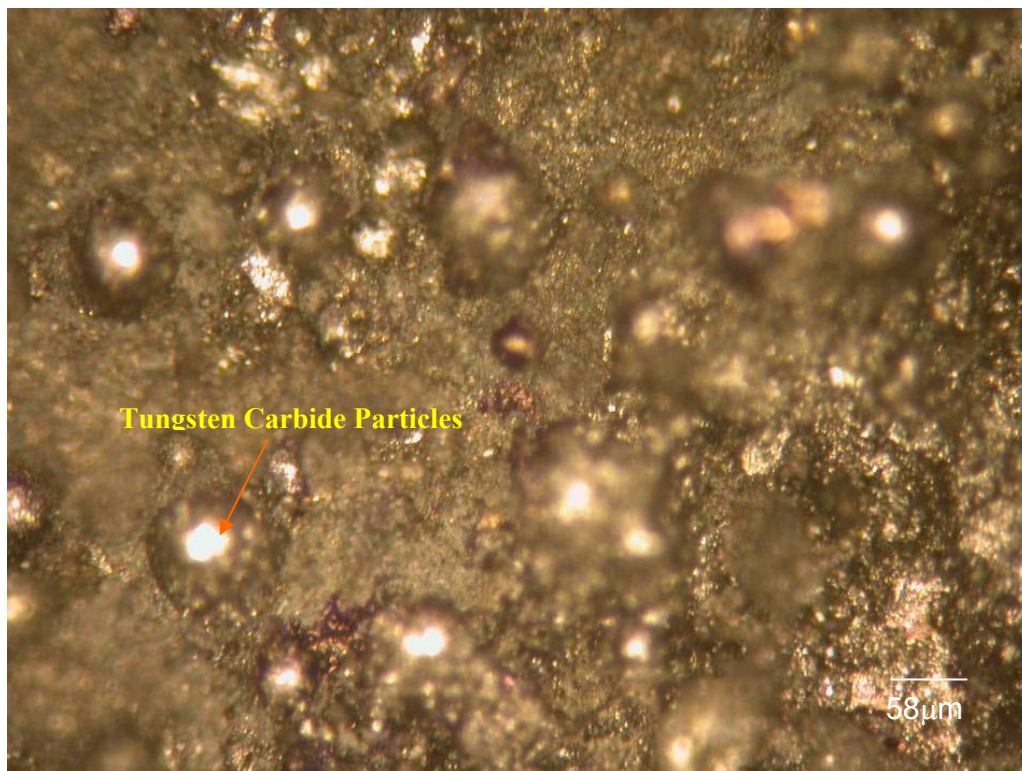
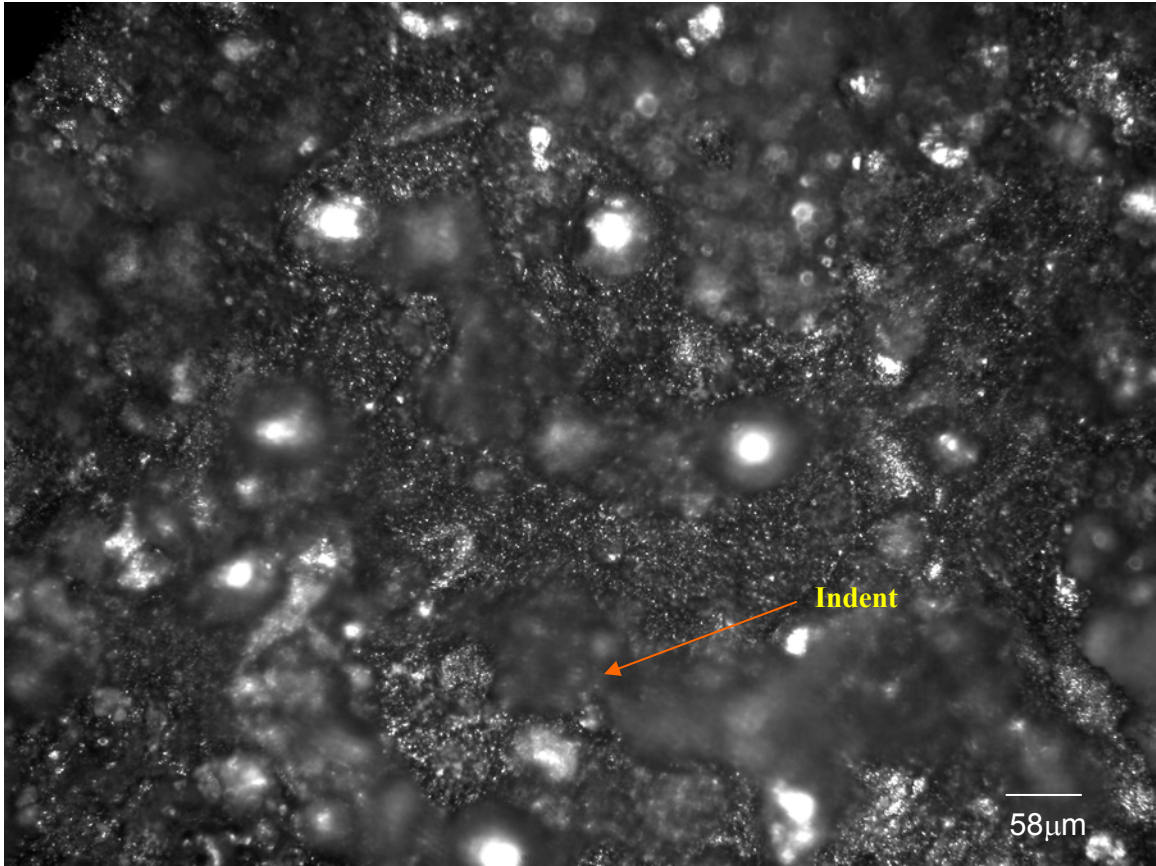
Figure 43 Microstructure of the Wearing Sleeve Surface after Test Cycle 3 (804 HV)

Figure 44 Microstructure of the Wearing Sleeve Surface after Test Cycle 4 (624 HV)

Hardness was measured on the wearing and non wearing region of the bearing sleeve surface. Area of indentation was much smaller for non-wearing as compared to wearing region. Typical hardness of the wearing region ranges from 600 HV – 850 HV as shown in Figures 43 and 44 and non-wearing region ranges from 1050 HV - 1250 HV as shown in Figure 45. The drop in hardness values may be correlated to the depletion of the tungsten carbide particles from the matrix.

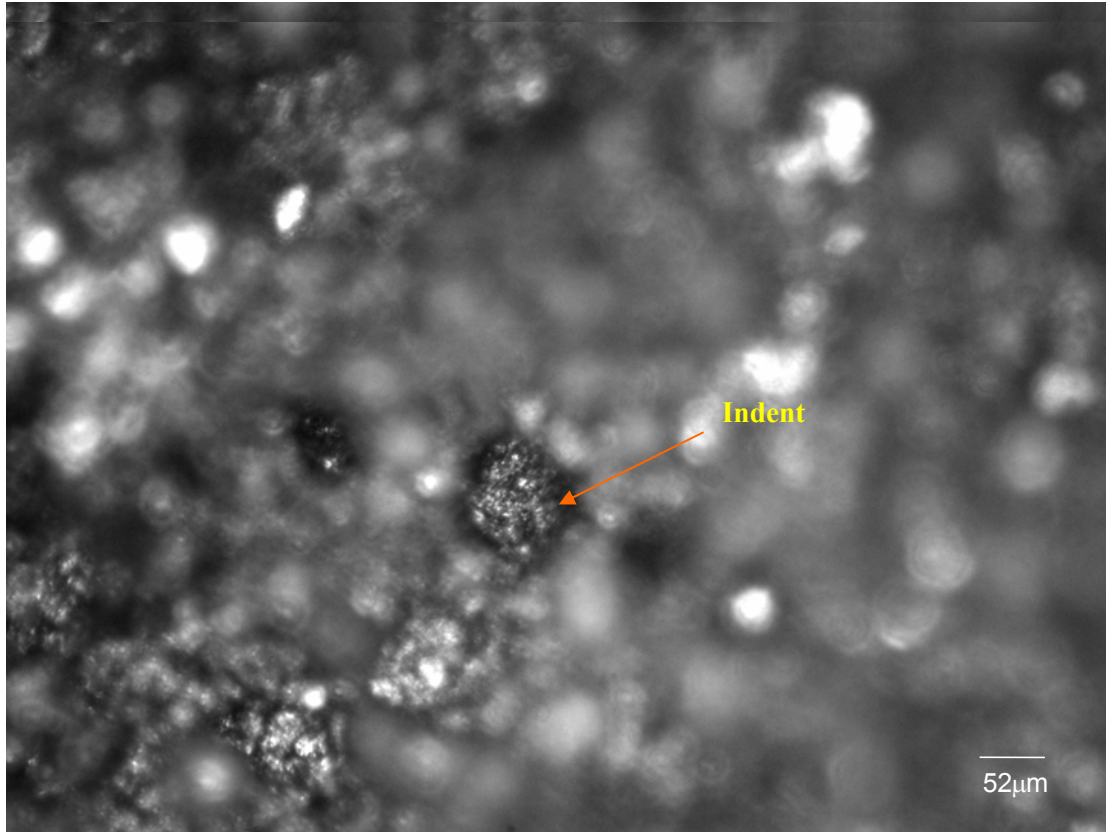
Figure 45 Microstructure of the Non Wearing Sleeve Surface after Test Cycle 4 (1250 HV)

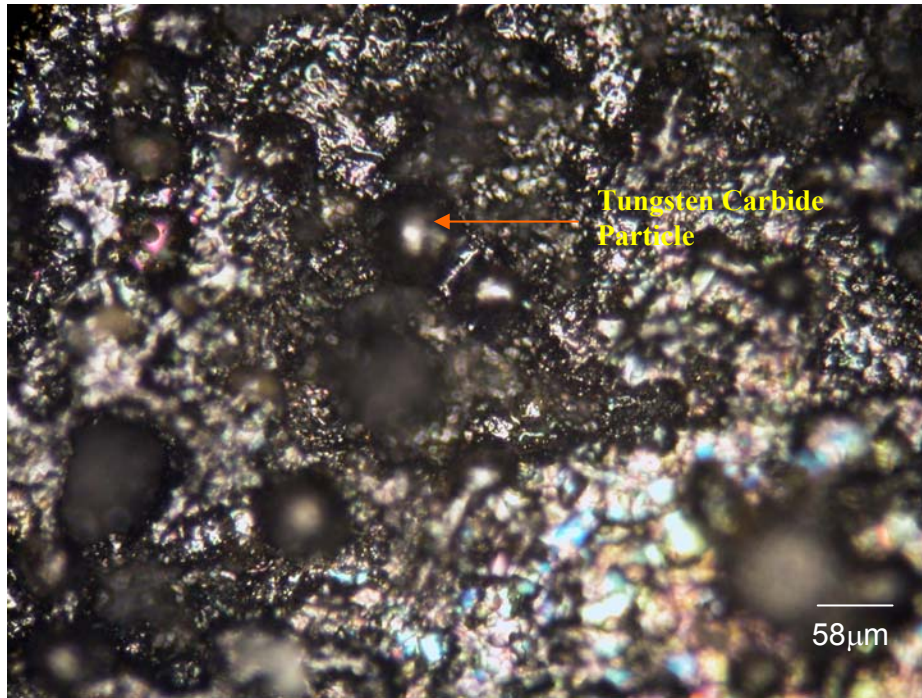
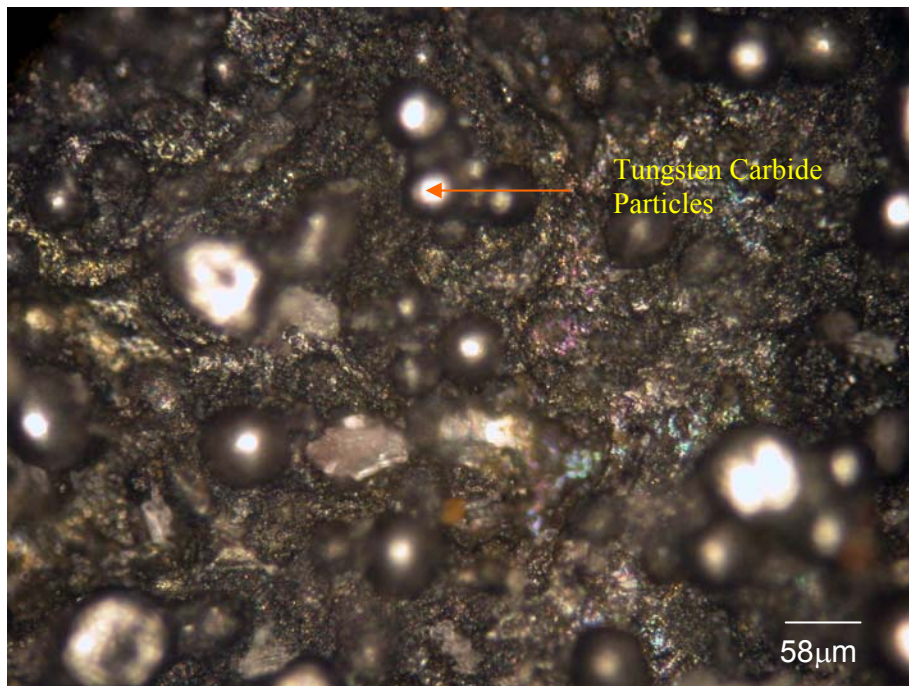
Figure 46 Microstructure of the Non Wearing Sleeve Surface before Polishing

Figure 47 Microstructure of the Non Wearing Sleeve Surface after Polishing

After the non-wearing surface of the sleeve was polished to remove any zinc layer formed on the surface, the density of tungsten carbide particles increased on the surface. This showed the presence of a layer (might be oxides formed on the sleeve surface) formed on the sleeve surface during the test. Figures 46 and 47 show that the density of the tungsten carbide particles increased after slightly polishing the surface.

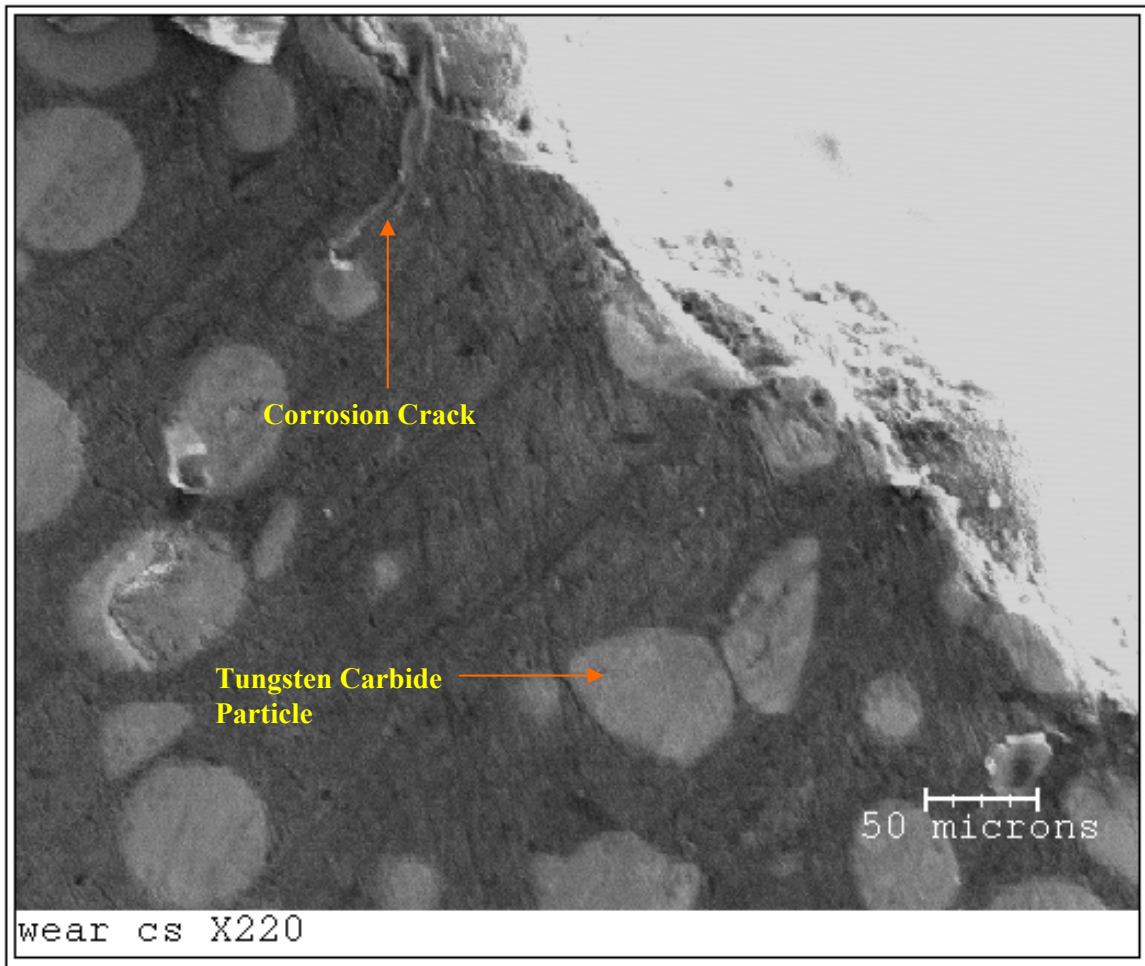
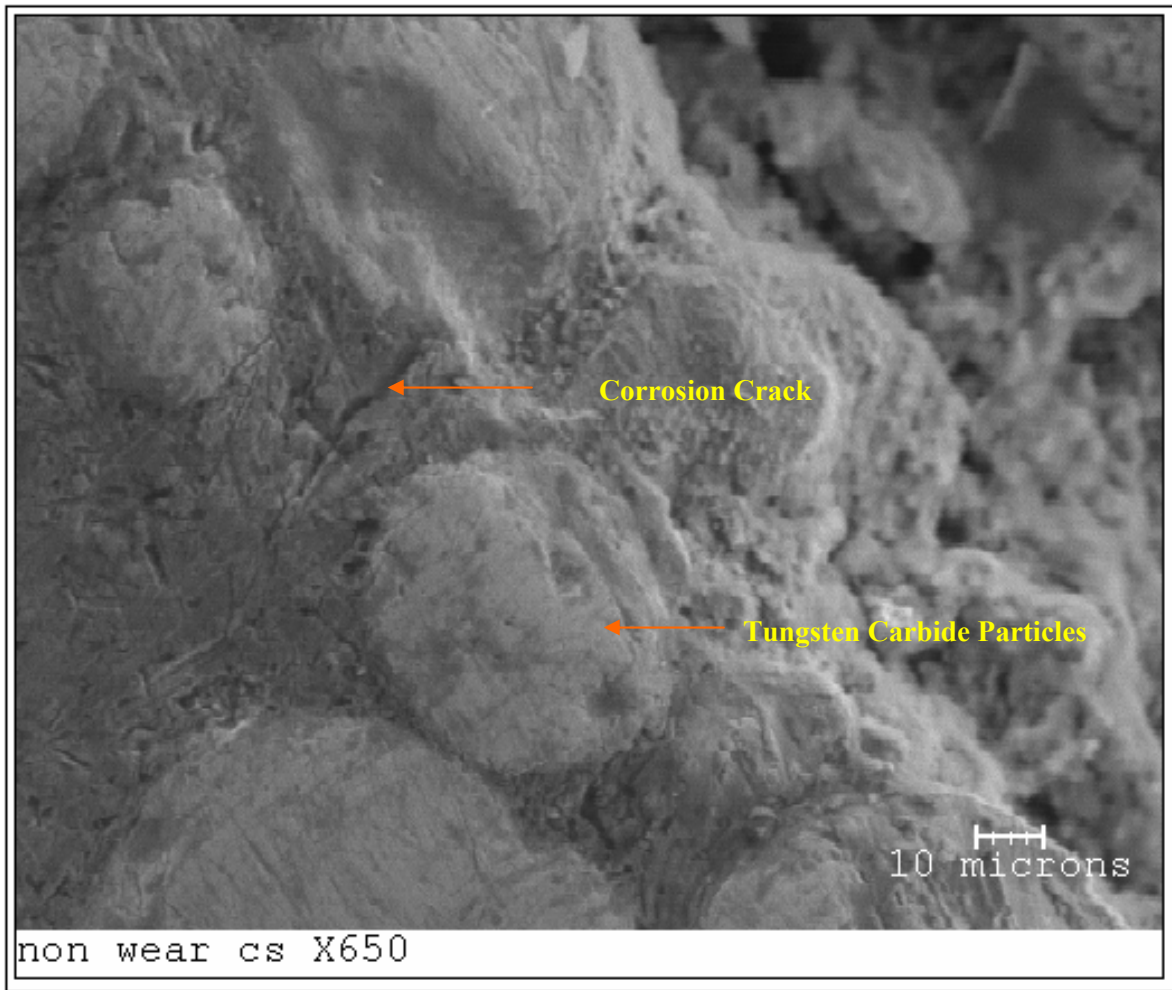
Figure 48 Microstructure of the Wearing Sleeve Surface with Corrosion Attack

Figure 49 Microstructure of the Non Wearing Sleeve Surface with Corrosion Attack

SEM analysis of the wearing and non-wearing surface of the sleeve showed corrosion attack on both the surface. Loss of material on the wearing surface of the sleeve was possibly due to corrosion assisted abrasive wear. Figure 48 shows the corrosion attack on the wearing sleeve surface. Figure 49 shows the corrosion cracks on the non wearing surface.

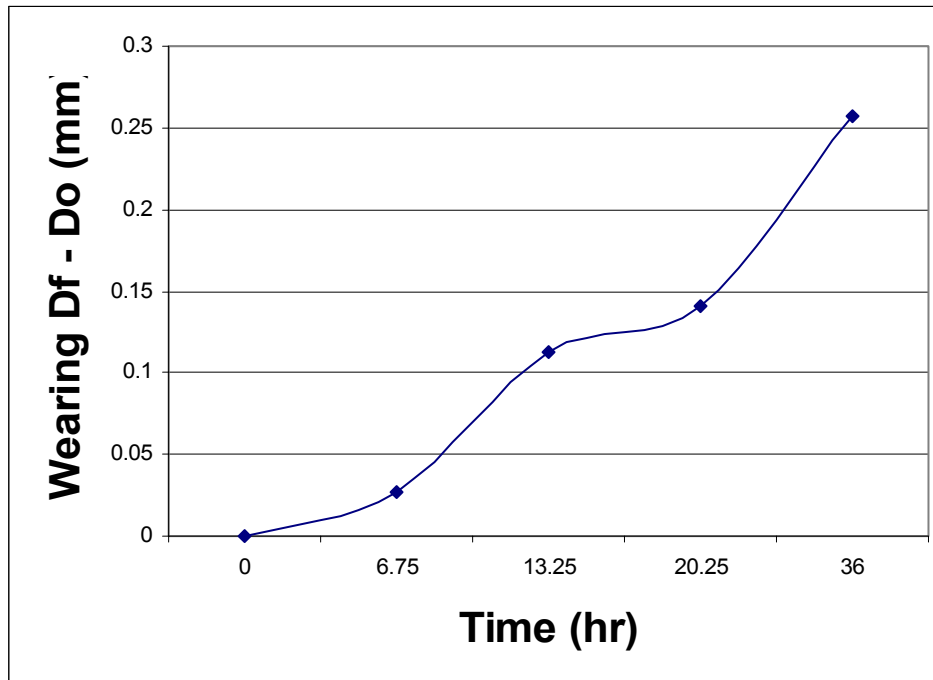
Figure 50 Wearing Result of Stellite 6 against Tribaloy T-400

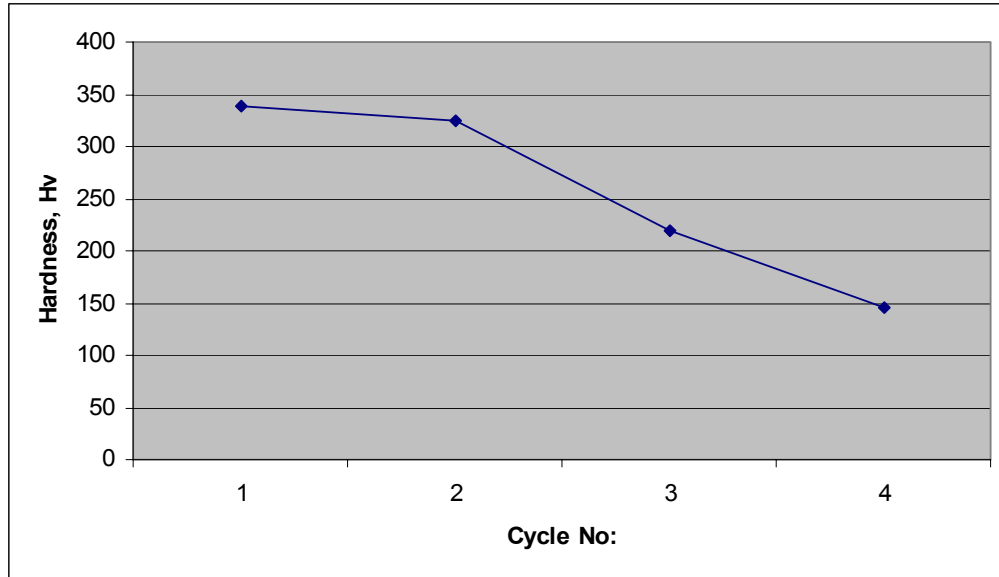
Figure 51 Hardness Variation of Stellite 6 Bearing Sleeve

After each test cycle selected area of the bearing sleeve was cleaned using hydrochloric acid. Hardness measurement was done on the bearing surface and a graph was plotted between hardness variation and test cycle as shown in Figure 51. Microstructure picture of the test surface was taken after each test cycle.

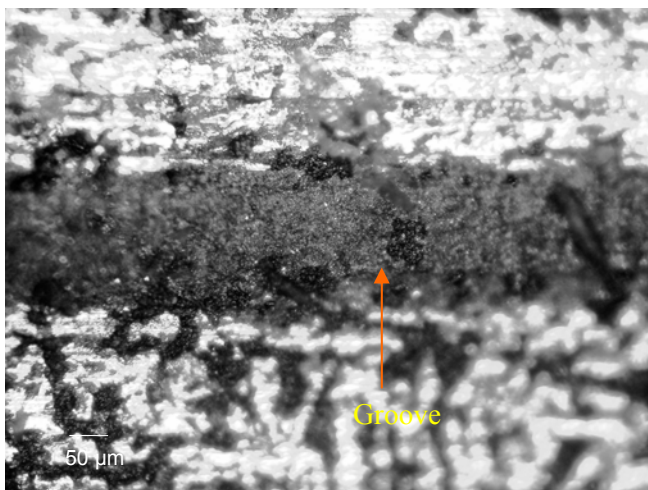
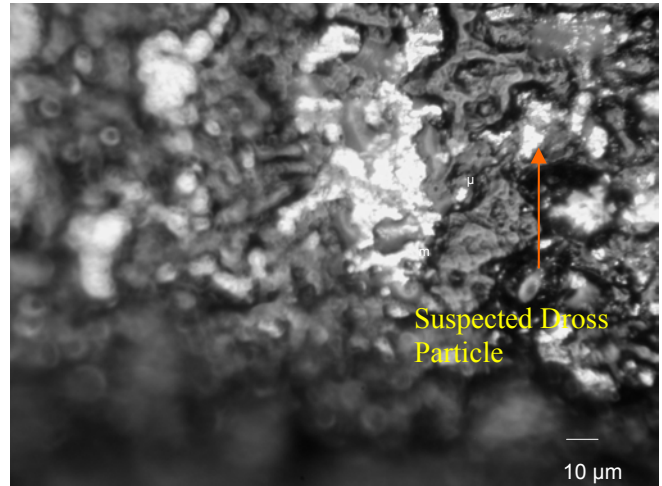
Figure 52 (a) Microstructure Picture of Grooves on Bearing Surface (b) Particles inside the Groove after Cycle 1 (6 hrs & 45 min)

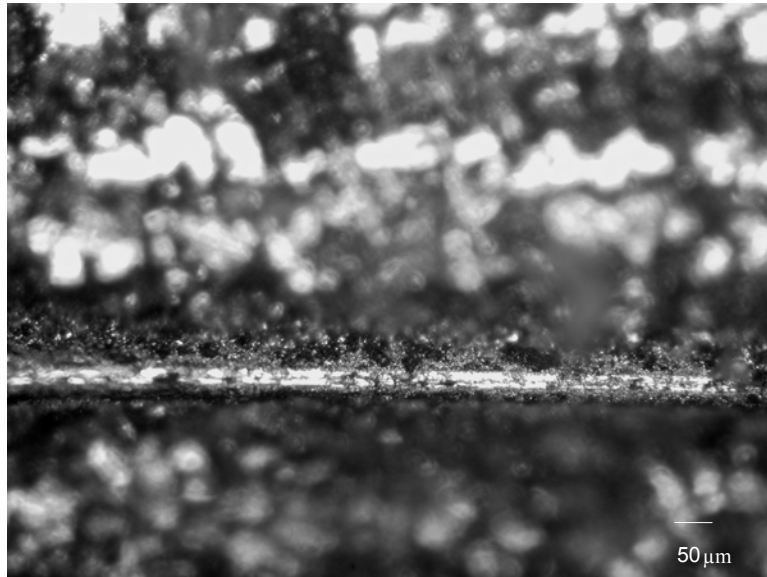
Figure 53 Microstructure Picture of Narrow Grooves on Bearing Surface after Test Cycle 2 (13 hrs & 15 min)

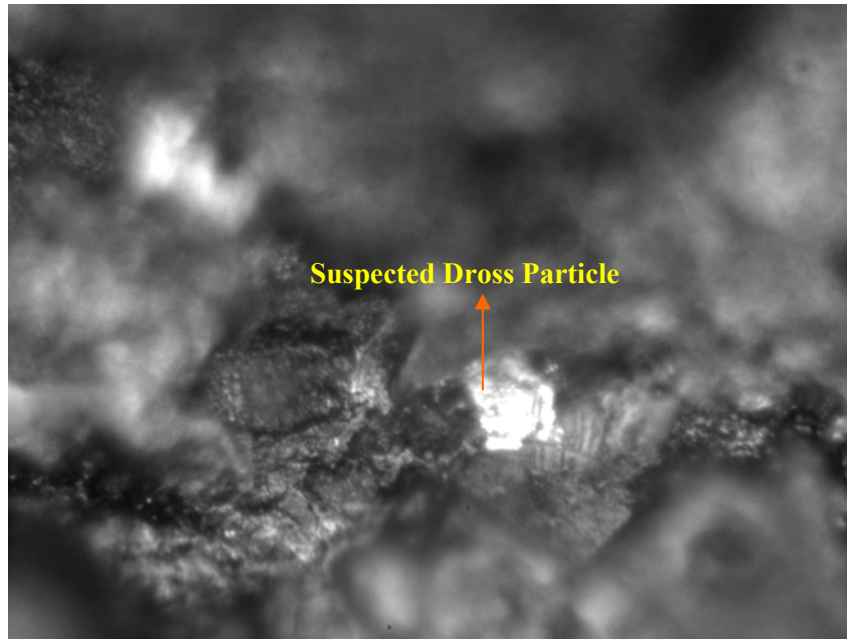
Figure 60 Suspected Dross Particle inside the Groove of Test Roll after Cycle 4 (36 hrs)

Figure 61 Existence of Intermetallic formed between Fe–Cr inside Test Roll Groove

Dross build-up test was conducted. The tungsten carbide spray coated sleeve simulates the roll surface and low carbon sleeve simulates steel sheet in galvanizing lines. Preliminary study was done on the dross formation in the roll groove. SEM analysis showed the existence of intermetallics between iron–chromium (Tetragonal Sigma Phase) [15] formed inside the groove of test roll sleeve as shown in Figures 60 and 61.
