Mapping and Restoration Inventory of Fringing Marsh Habitat in the Casco Bay Estuary, Project Report

Peter Hayes

Wells National Estuarine Research Reserve

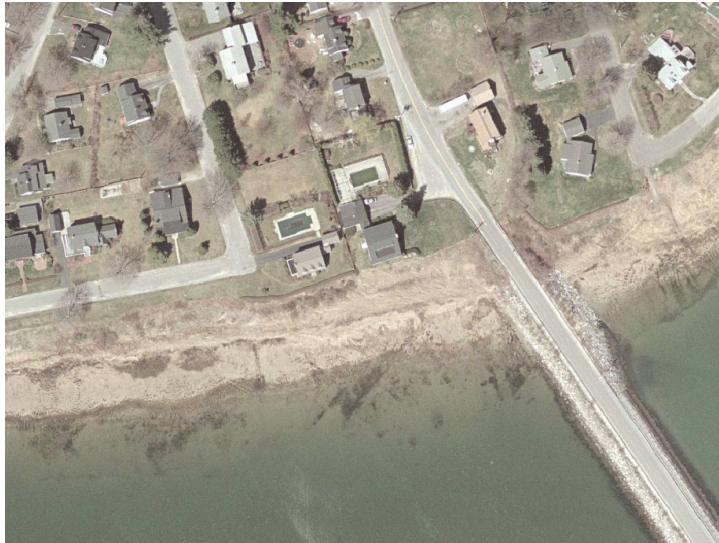
Figure 2: Citipix (or Ortho_HF) imagery of Falmouth coastline.

Through a series of inquiries and a subsequent chain of contacts, a set of imagery was found at The DeLorme Publishing Company of Yarmouth, Maine, that had the characteristics desired. The resolution was approximately twelve inches and the clarity was excellent, owing partly to the equipment used to obtain the images. The flights had all been made during the summer season – in July – so that there was a full cover of marsh vegetation. DeLorme graciously loaned us the imagery and copies of XMap (the mapping software they produce and in whose format the imagery was saved) for use on the project. This served as our primary image source for identification of fringing marshes. Images of a common location in Falmouth taken from all three sources allow comparison (**Figures 2, 3, and 4**).

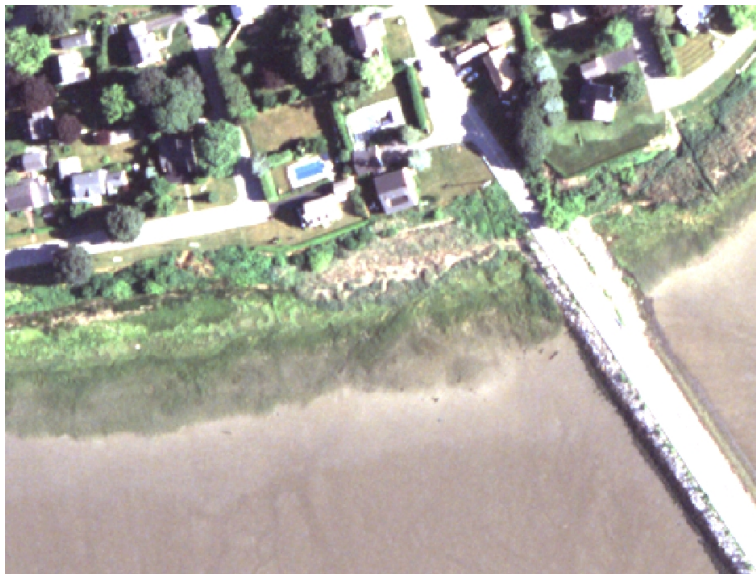
Figure 3: Maine Department of Marine Resources eelgrass imagery of Falmouth coastline.

The Maine Department of Marine Resources (DMR) possessed another set of imagery that was of use. These aerial photos had good resolution, were taken during the summer (with the intended use of identifying eelgrass beds in coastal waters, so vegetation was present), and some were orthorectified and georeferenced. Unfortunately, they were never intended to provide coastal coverage, so that there were missing sections of the coastline, and not all images were georeferenced. They might do for much of the coast, but would leave 'holes' in which there was no coverage and the georeferencing could easily be less than ideal. They were, however, obtained and used as another 'backup' to the primary imagery, to check a questionable location and for an alternative, possibly better, view, as well as to ensure that eelgrass beds were not mistaken for fringing marsh.

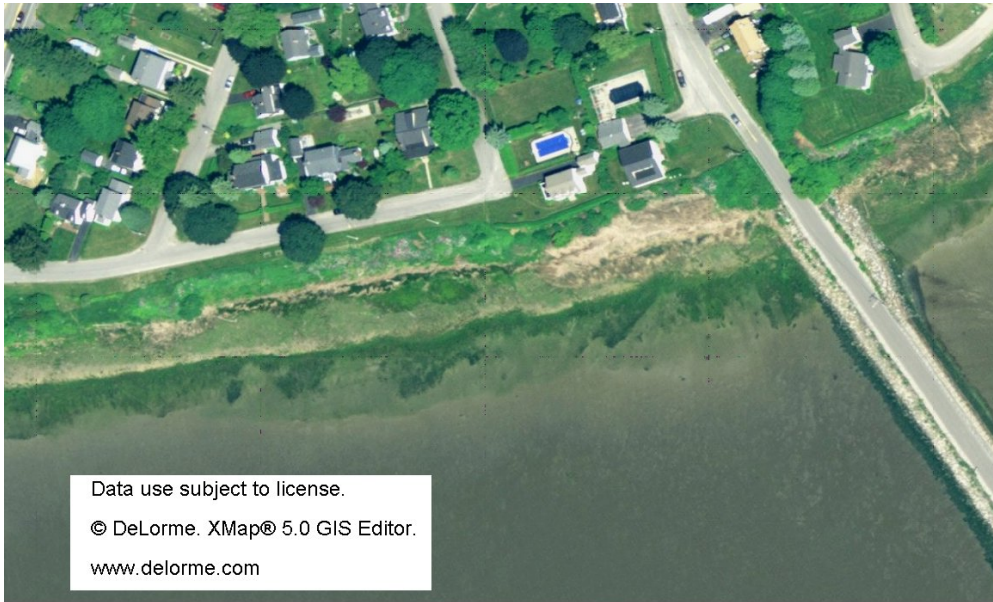
Figure 4: DeLorme Topobird Imagery of Falmouth coastline.

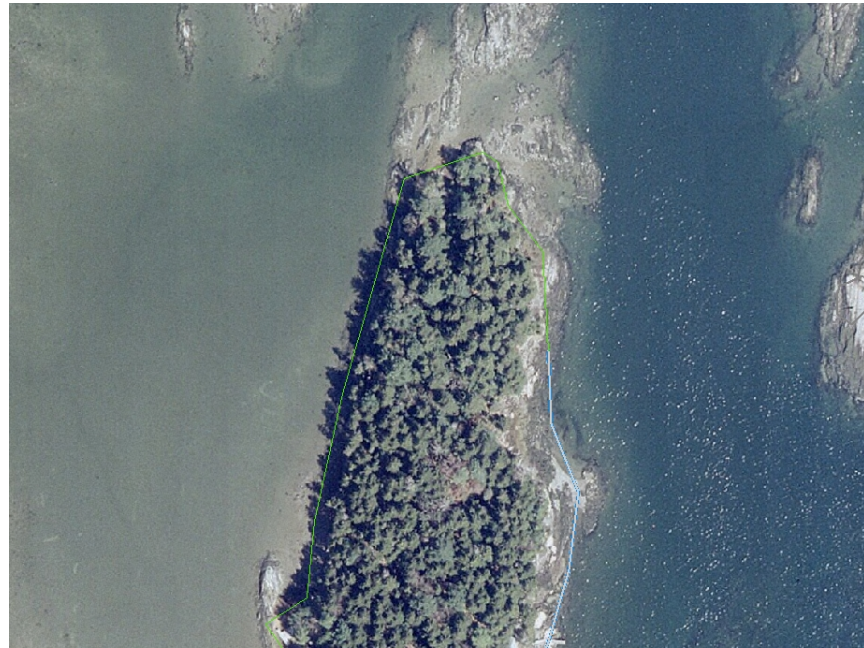
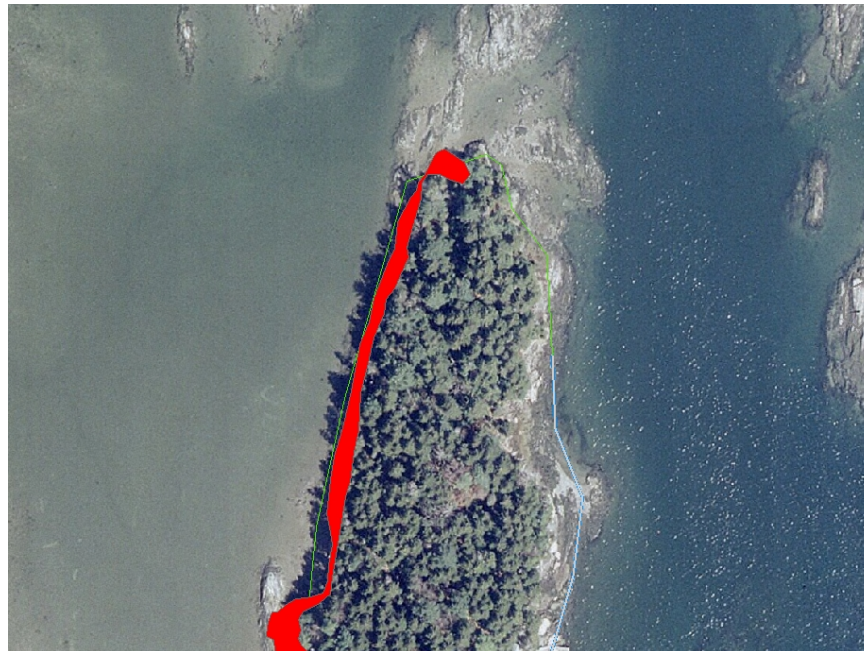
Figure 5: (top) An example of commonly-encountered difficulties - an identification area in which shading by foliage obscured coastal habitat; (bottom) the marsh coverage shown was eventually identified using multiple resources.

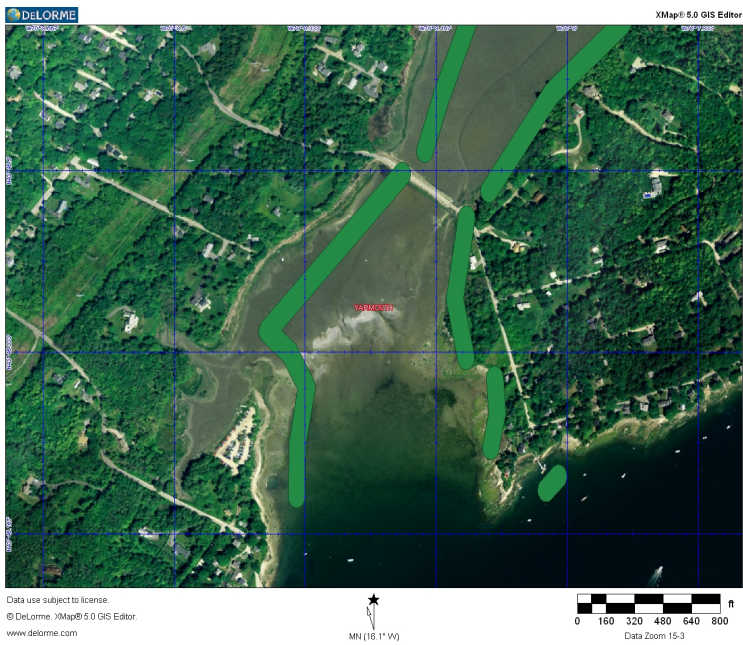
Figure 6: Boat transect lines from Xmap indicating linear direction and location of fringing marsh (top) and lines surrounded by 20 m radius buffer (bottom); please see page 29 for further explanation of the processing performed.

GPS data points were converted to lines in ArcMap. These lines, in turn, were used to form ellipses (using several radius values) by surrounding the line with a buffer of a specified width. The ellipses were then geographically overlain on the marshes delineated from the imagery to determine where the boat ellipses and the image-identified marshes overlapped. The percentage of boat-surveyed marshes corresponding or overlapping with image-based marshes provided an estimate of the proportion of marshes correctly identified through photo-interpretation (remembering that the four years time gap between data collection for the two efforts would lead to some unmeasurable change in marsh area and location; see **Figure 6**).

Comparison of the two sets of marshes was accomplished by buffering the boat-surveyed marsh lengths (visible earlier as lines in the top image of **Figure 6**) with an elliptical polygon of a given radius (bottom image of **Figure 6**). These polygons were then tested for intersection (using a GIS program) with the polygons from the image-based marsh set. The result was the number of boat-identified marshes that were within the buffer radius of a marsh identified using the imagery – the accuracy of our marsh photo-interpretation can be estimated by using the fraction of boat-surveyed marshes that intersect with the photo-interpreted marshes. Obviously, the number of intersections increased as the buffer radius increased, so a range of radii were used to create a plot of the success rate as a function of buffer radius. Some minimum radius was necessary because the boat could often not approach closer than twenty or even forty meters to

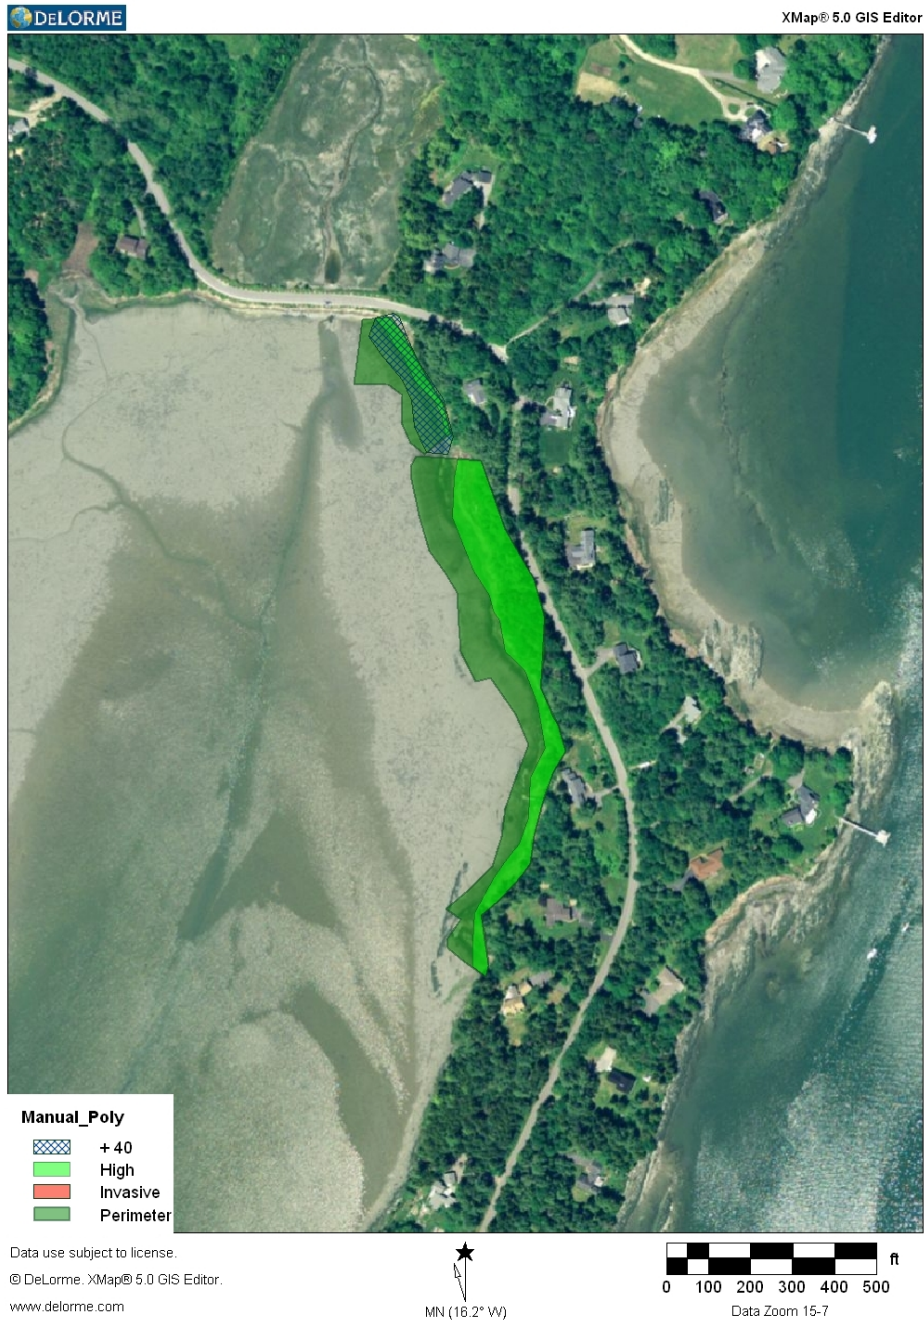
Figure 7: Marsh delineation during field survey. This figure shows two marshes with high and low marsh ('Perimeter' includes both low and high marsh) indicated in both; the top marsh also shows the +40 cm measurement, the upper edge of which is coincident (to the GPS accuracy) with the existing marsh due to a steep slope; no invasives are present.

Common GPS measurements included marking with GPS waypoints the perimeter of each marsh, the high-low marsh boundary, any significant patch of invasives (primarily *Phragmites australis*), and (for the one marsh at each sample point) the perimeter + 40 cm of elevation. The water-marsh boundary of the perimeter was estimated based on the presence of *Spartina alterniflora* in the substrate (usually silt). The high-low marsh boundary was determined based on a visual estimation of dominance of low marsh species (primarily *S. alterniflora*) and high marsh species (primarily *S. patens*, but also including other high marsh plants such as *Distichlis spicata*, *Scirpus americanus*, *S. robustus*, and *P. australis*). The upper boundary of the marsh was approximated by visual estimation of plant dominance, where high marsh vegetation was dominated by upland vegetation. Large patches of invasives were measured separately and receive their own measure. The perimeter of each marsh was first marked by walking the boundaries (as described above) while recording GPS points along the route. The high-low marsh boundary was then similarly marked. During processing, the total marsh area was encompassed by the perimeter points; the high marsh area was then determined by dividing the total area at the GPS line, marking the high-low marsh boundary (**Figure 7**).

At the one marsh per sample point for which response to sea-level rise was to be estimated, the process was slightly different. A laser transit was placed such that it was visible from all points in the marsh to be measured (sometimes a challenge!). As the perimeter was walked, an elevation measurement and GPS waypoint measurement were made. A second GPS waypoint measurement was made at the point uphill from each perimeter point at which the elevation was 40 cm higher. These perimeter + 40 cm points would thus form a second perimeter with an elevation of forty centimeters higher than the actual marsh, and would indicate the potential marsh response to sea-level rise (ignoring any marsh accretion or other such response to a slow rise) (**Figure 7**).

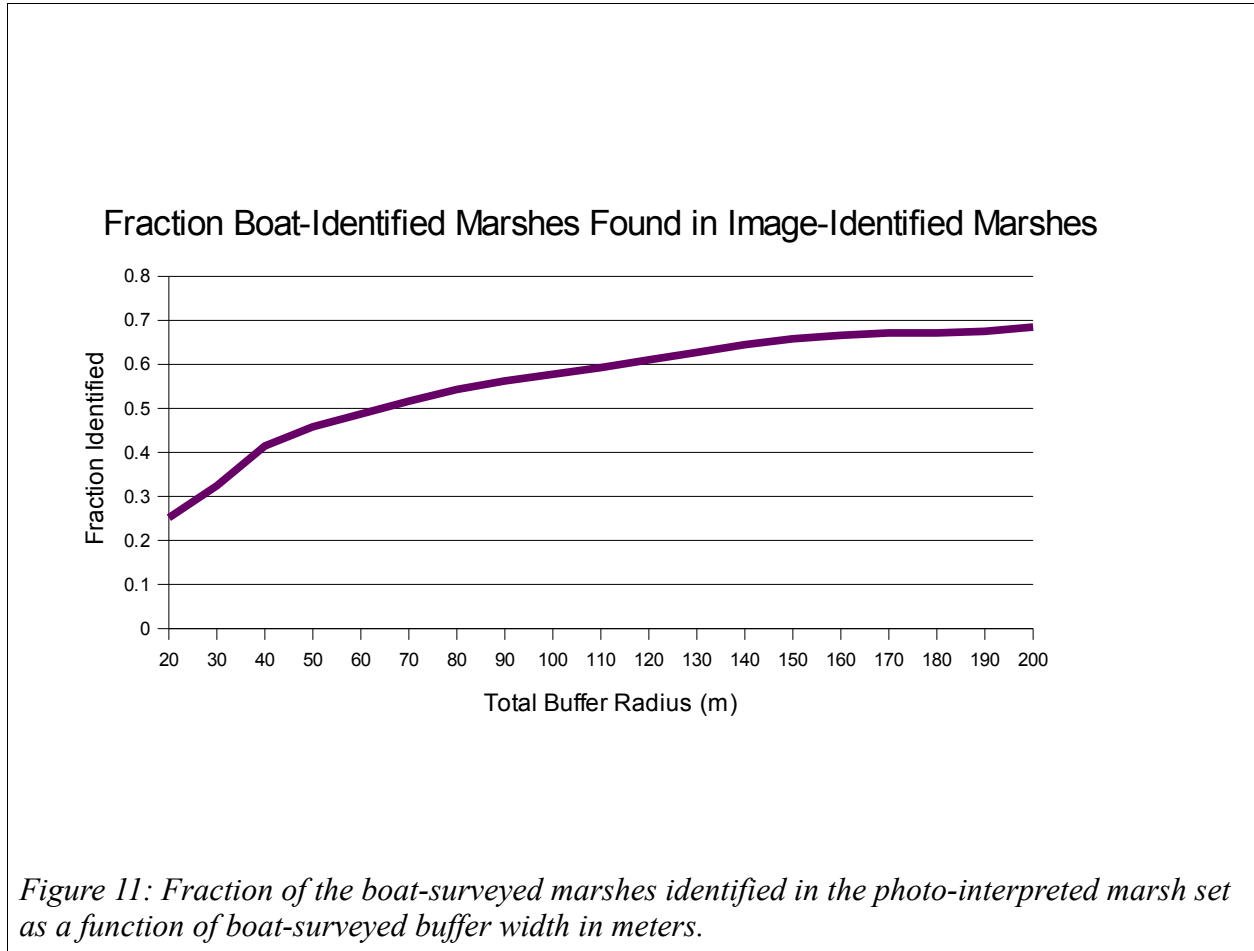
The shape of the curve (which appears to approach 0.7 asymptotically as the radius increases) might be taken to indicate an upper limit of approximately 70% of the existing marshes identified (using a radius of 200 meters) from photo-interpretation. This could, in part, indicate the change in marshes between the two periods (in other words, approximately 30% of the existing marshes were not present – within 200 meters – four years earlier). In terms of accuracy of the image-based identification, the identification successfully found between 40%

and 65% (where the curve seems to level off significantly) of the marshes present, depending on the radius used to draw the ellipse used to create marsh polygons from the marsh length transects measured in the boat survey.

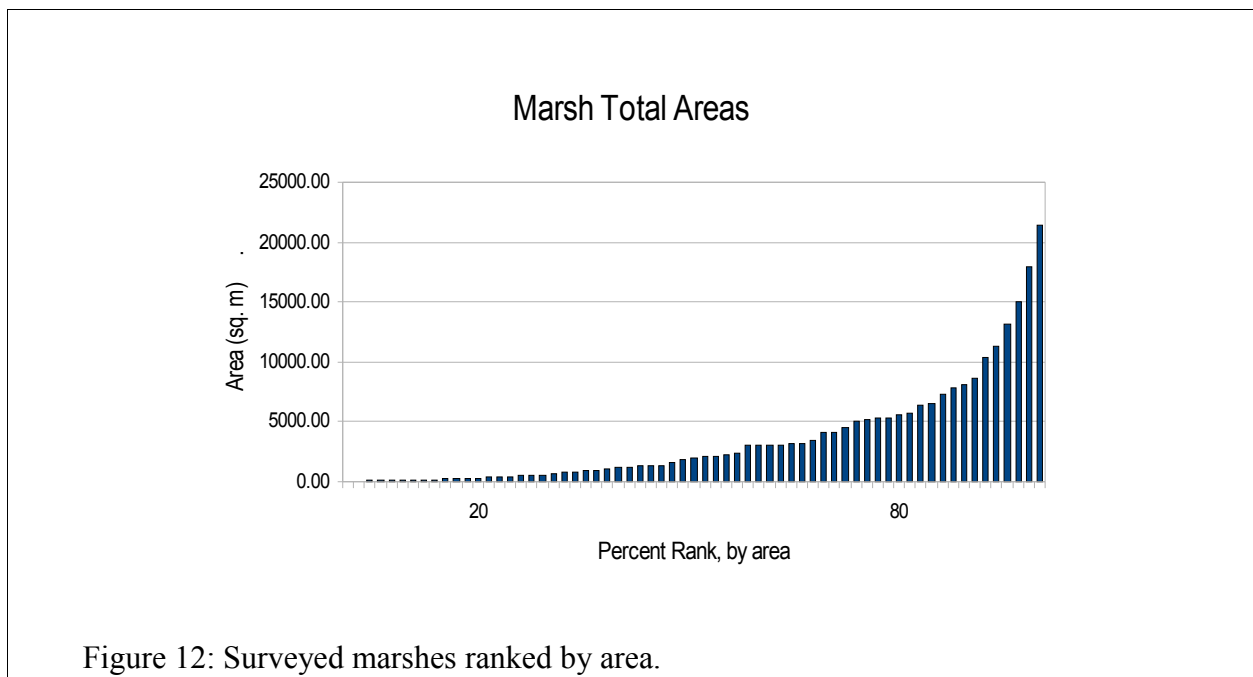
Measurements of marsh areas (**Figure 12**) were limited at the upper end of the range because a maximum of approximately 300 meters of marsh length was surveyed. Measurement of marshes above this length (constituting approximately 8 % of the measured marshes) were truncated at approximately 300 meters of length. Consequently, area estimates for the larger marshes are less than the true marsh areas and descriptive statistics are biased lower than the true values. The average area was 3570 m² (with a standard error of 570 m²); the median marsh area was 2055 m², while 80% of the marshes were of 5500 square meters or less. Approximately 46.5

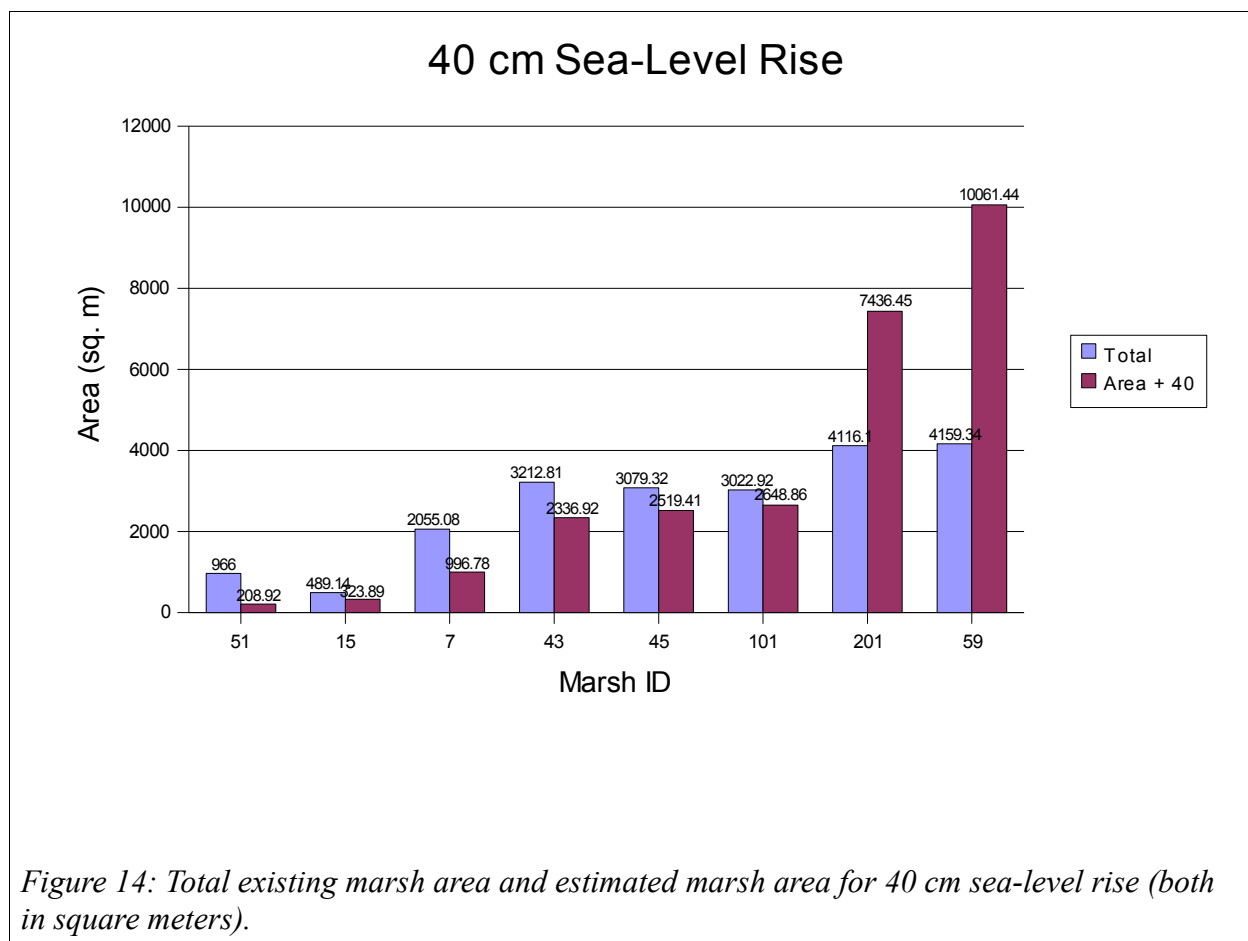
At ten sample points (the original number of planned sample points, but not at all sixteen sample points for which field surveys were completed) additional measurements were made to estimate marsh response to a 40 centimeter rise in sea level. Two of these data sets (the GPS points taken of the perimeter at 40 cm higher elevation) were sufficiently corrupted that perimeters could not be determined. Total marsh area (as it presently exists) was generally larger than the new area estimated for a 40 cm rise in sea level. While a majority of the marshes lost area, the two larger marshes gained area. This pattern – a potentially shrinking area of smaller marshes, but potentially expanding area of some larger marshes with sea-level rise – was an apparent trend noted by the survey teams in several additional locations visited but not measured for elevation. This was a function of the upland slope, which tended to be steeper for small marshes, shallower for large marshes.

The measured marshes indicated a gain (5432 square meters) of marsh area after sea-level rise. The total gain in area was due to two larger marshes measured. Since they were randomly selected, this trend would result in a change in the landscape pattern of marsh distribution with small marshes shrinking and larger marshes expanding with a sea level rise.
