Assessment of Hyporheic Exchange at In-stream Restoration Structures on Savage River, Garrett County, Maryland

Thesis submitted to the Eberly College
at West Virginia University in partial
fulfillment of the requirements for the
degree of

Master of Science
in
Geology

Department of Geology and Geography
Morgantown, West Virginia
2013

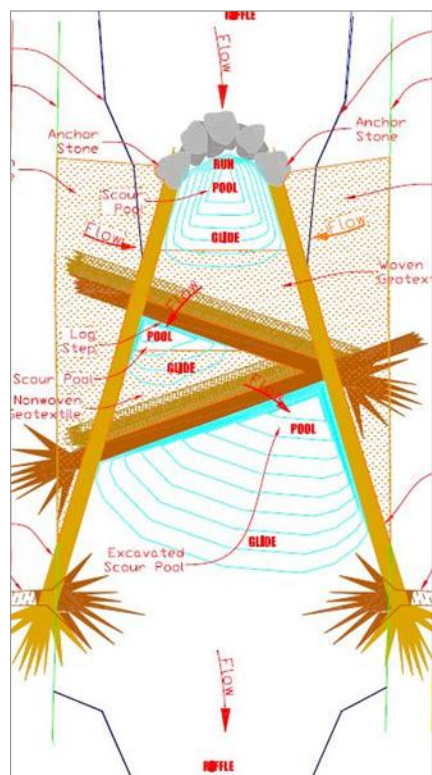
Figure 4: Plan view of log cross-vane design by Postlethwait (2010a). Log cross-vanes were built with two log arms; the cut were ends buried in the streambed and the rooted ends were buried in the banks. Two log cross-vanes were installed on the constructed reach.

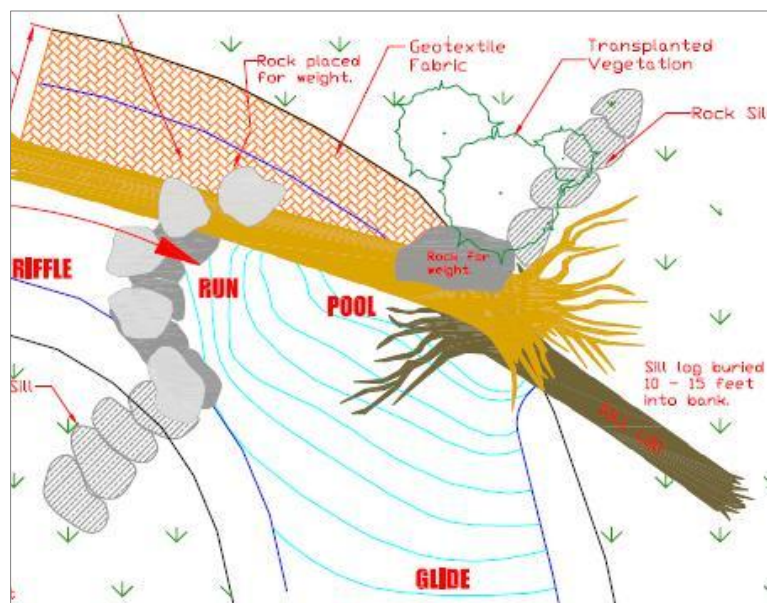
Figure 5: Plan view of log/rock combination J-hook vane design by Postlethwait (2010a). Log/rock combination J-hook vanes were built with one log arm and a 'hook' constructed out of boulders. Five log/rock combination J-hook vanes were installed on the constructed reach.

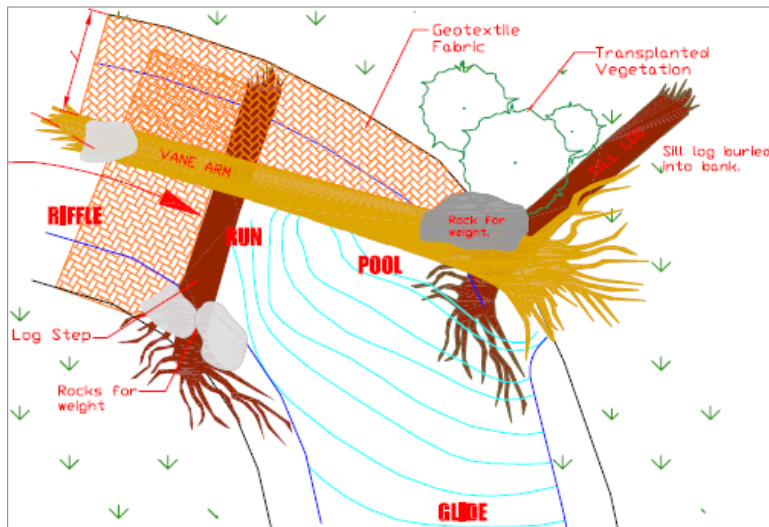
Figure 6: Plan view of log J-hook vane design by Postlethwait (2010a). Log J-Hook vanes were built with one log arm and a log step. Two log J-hook vanes were installed on the constructed reach.

The log J-Hook vanes were constructed with one log arm and a log step between the arm

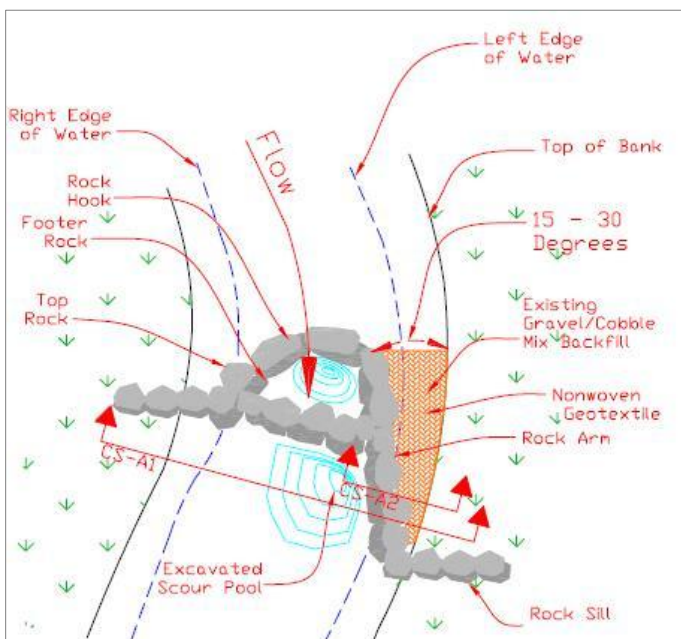
Figure 7: Plan view of rock J-hook vane design by Postlethwait (2010a). The rock J-hook vane was built with one arm and a hook, both constructed out of layers of boulders. One rock J-hook vane was installed on the constructed reach.

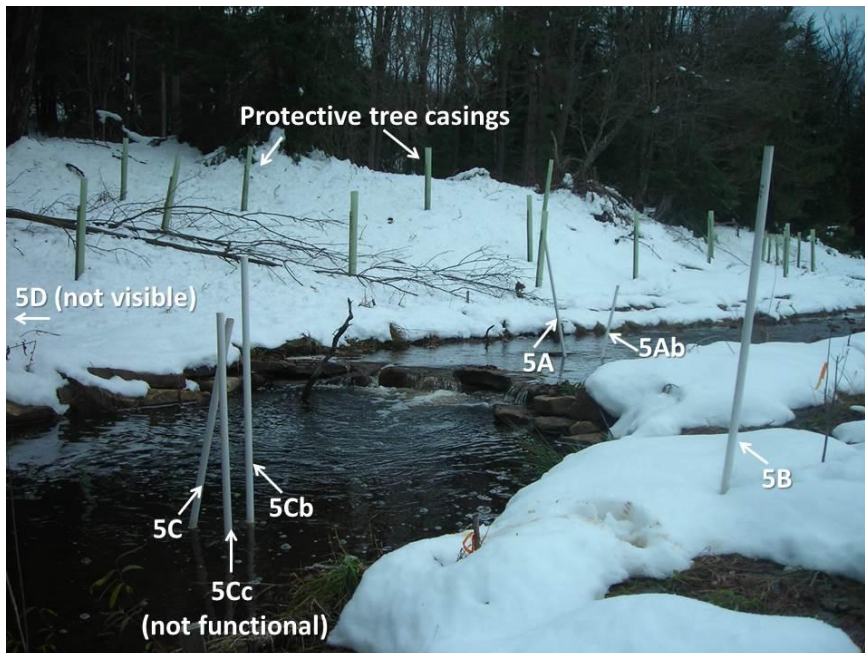
Figure 8: Structure 5, an instrumented rock J-hook vane. Piezometers (labeled) are white PVC pipes installed in the stream banks and streambed. Two iButton dowels (Y and X, not pictured) were installed in the stream near piezometers 5A/5Ab and 5C/5Cb, respectively. Light green casings are protective casings for tree plantings and were not relevant to the study.

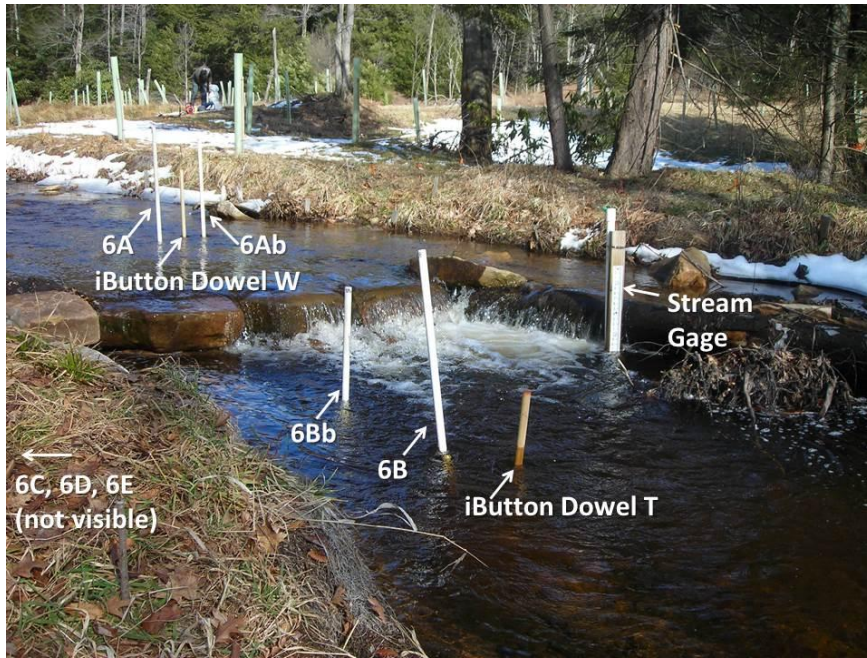
Figure 9: Structure 6, an instrumented log/rock combination J-hook vane. Piezometers (labeled) were installed in the stream banks and streambed. Two iButton dowels (W and T) were installed in the stream near piezometers 6A/5Ab and 6B/6Bb. The stream gage and staff plate are attached to the log arm of the structure. Light green casings are protective casings for tree plantings and were not relevant to the study.

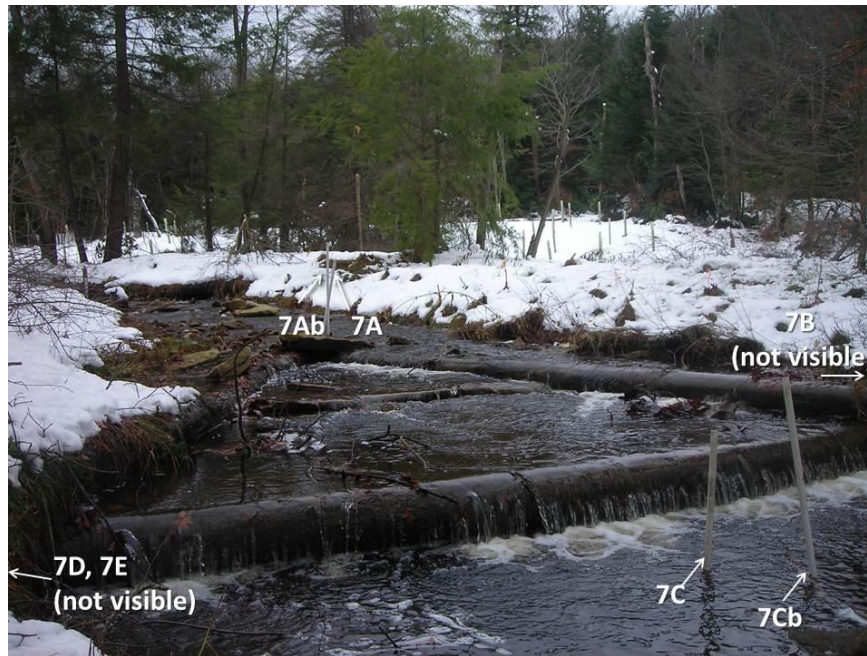
Figure 10: Structure 7, an instrumented log cross-vane. Piezometers (labeled) are white PVC pipes installed in stream banks and streambed. Two iButton dowels (V and S, not pictured) were installed in the stream near piezometers 7A/7Ab and 7C/7Cb, respectively. Light green casings are protective casings for tree plantings and were not relevant to the study.

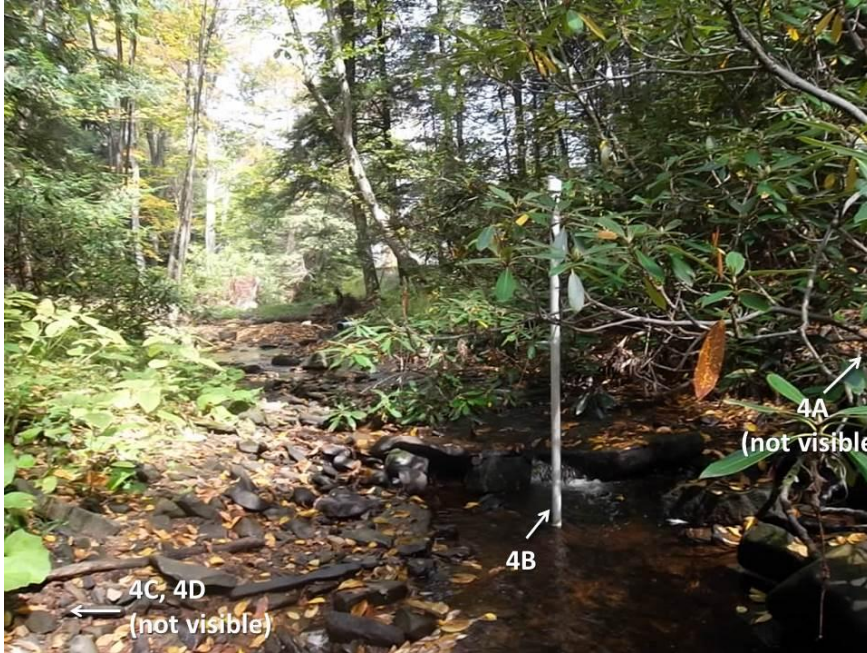
Figure 11: Reference riffle downstream from the constructed channel. Only piezometer 4B is visible in this picture; 4Bb was installed later next to 4B. The iButton dowel (Z, not pictured) was installed next to 4B and 4Bb.

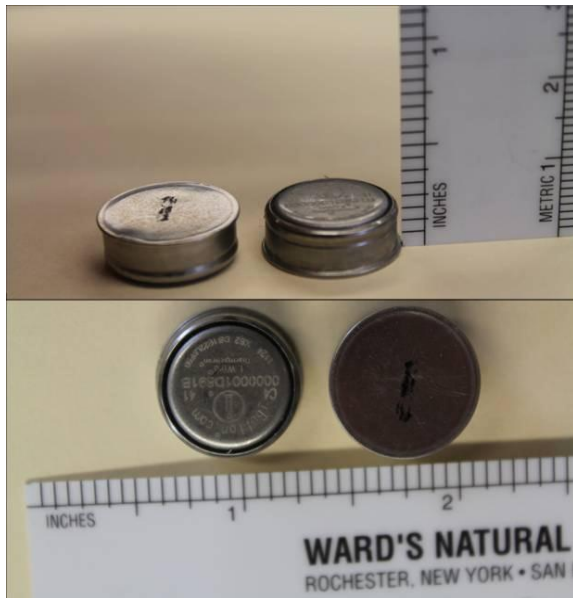
Figure 13: ThermoChron iButton model DS1922L. Twenty-one iButtons were attached to wooden dowels and installed in the streambed. They logged temperatures at 15 -minute intervals from 18 February to 26 March, 2012

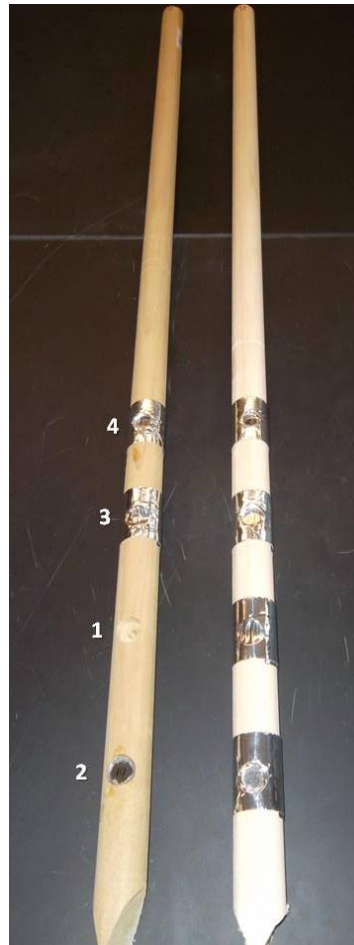
Figure 14: iButton dowel construction. The left dowel shows each stage of construction. 1) Hole drilled in 3.18 cm diameter wooden dowel (second from bottom), 2) iButton sealed in the hole (bottom), 3) iButton covered with waterproof tape (second from top), 4) Hole cut in waterproof tape to expose the face of the iButton (top). The dowel on the right shows a complete dowel construction. Four holes were drilled on each dowel, but iButtons were installed in only three holes.

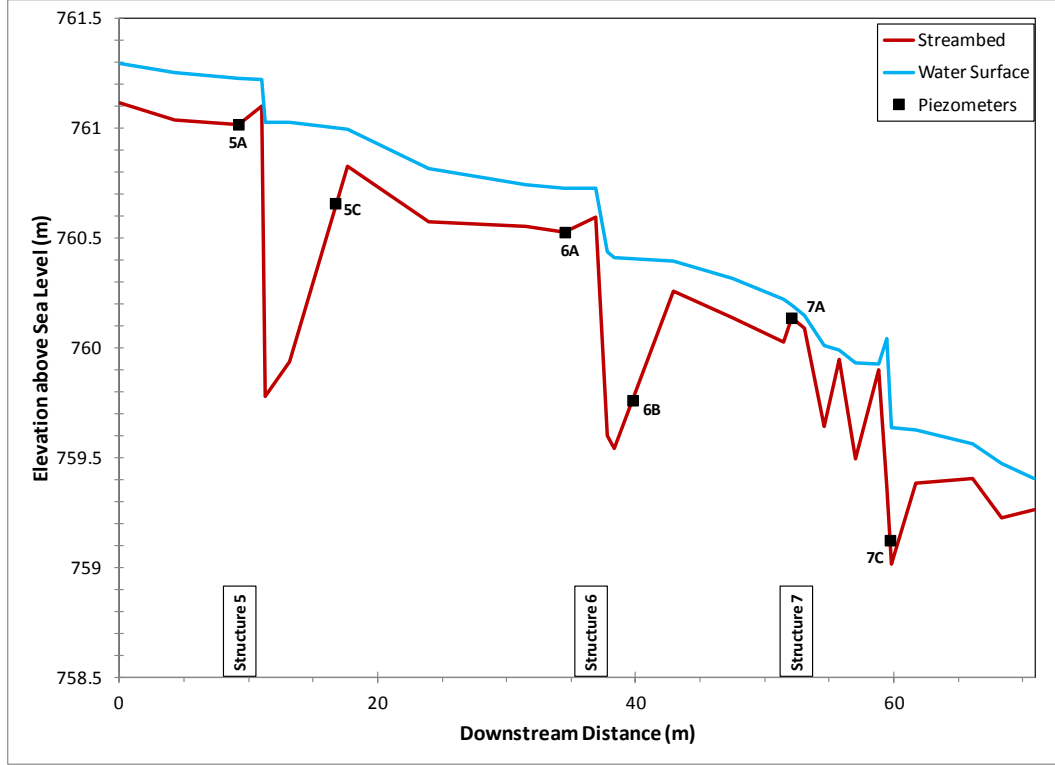
Figure 15: Longitudinal profile across restoration structures. Structure 5 had the lowest hydraulic head change (0.20 m) while Structure 7 had the greatest hydraulic head change (0.51 m). Piezometer locations are provided for reference.

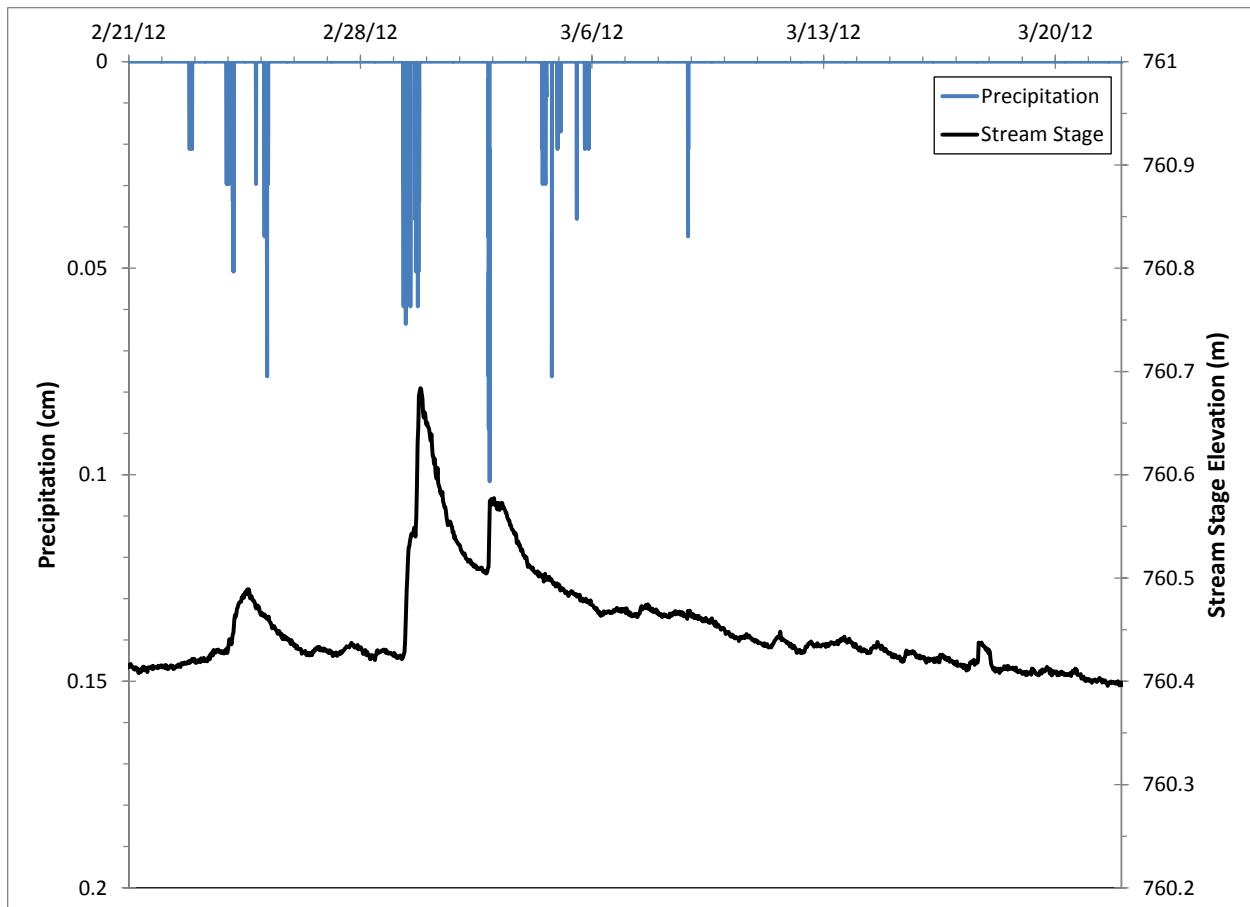
Figure 16: Precipitation amount and stream stage for 21 February through 22 March 2012. Stream stage was collected by a pressure transducer installed on Structure 6 and converted to elevation above sea level. Precipitation data were obtained from a Maryland Department of Transportation (MDOT) weather station located on Savage Mountain. Table 5 summarizes the storms during the study period, most of which were reflected in the stream stage data.

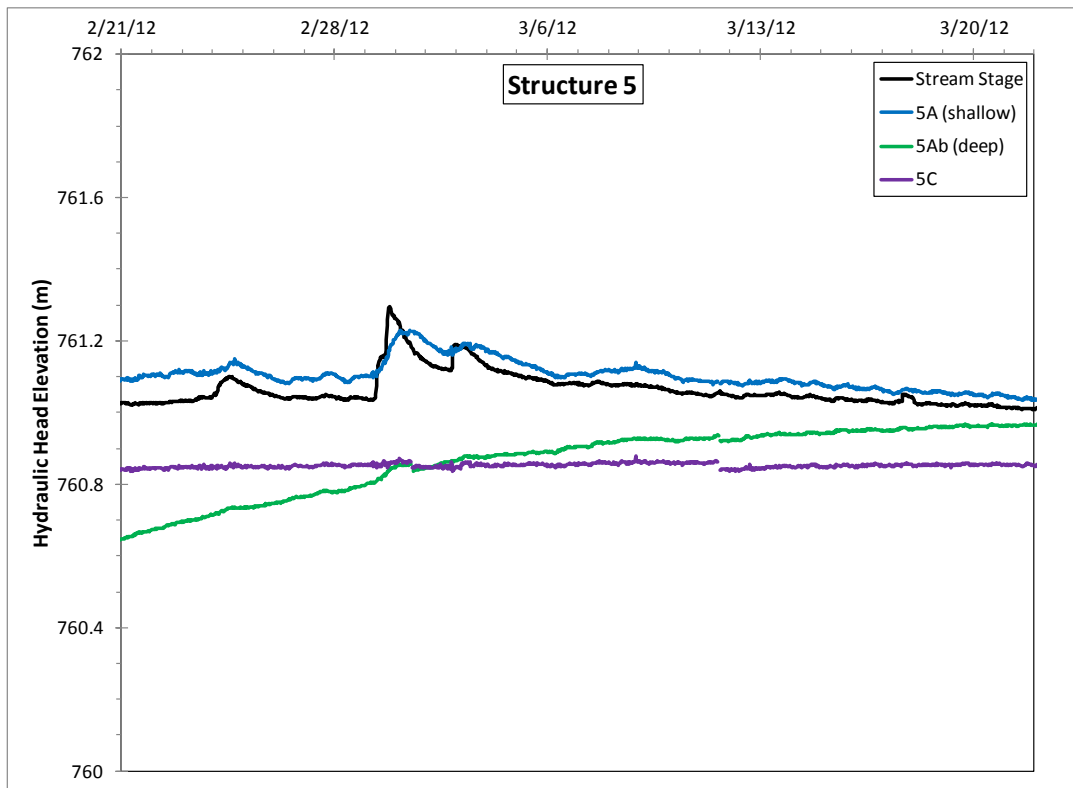
Figure 17b: Hydrometric data from Structure 5. Stream stage was collected at Structure 6 and extrapolated to Structure 5 using water level differences from the longitudinal profile.

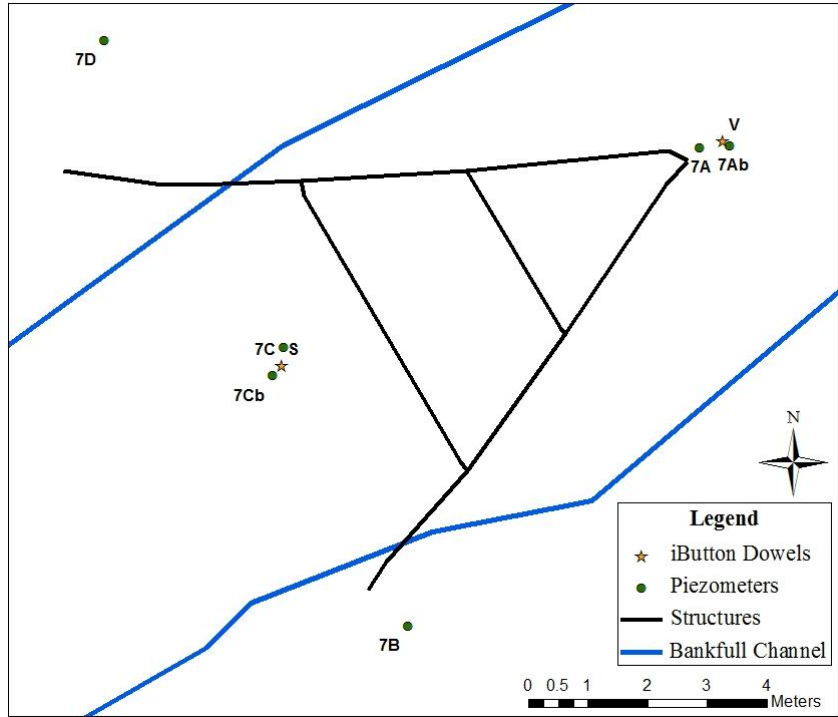
Figure 18a: Instrumentation at Structure 7. Nested pairs of piezometers and iButton dowels (V, S) were installed upstream and downstream of the structure. Single piezometers were also installed on both stream banks.

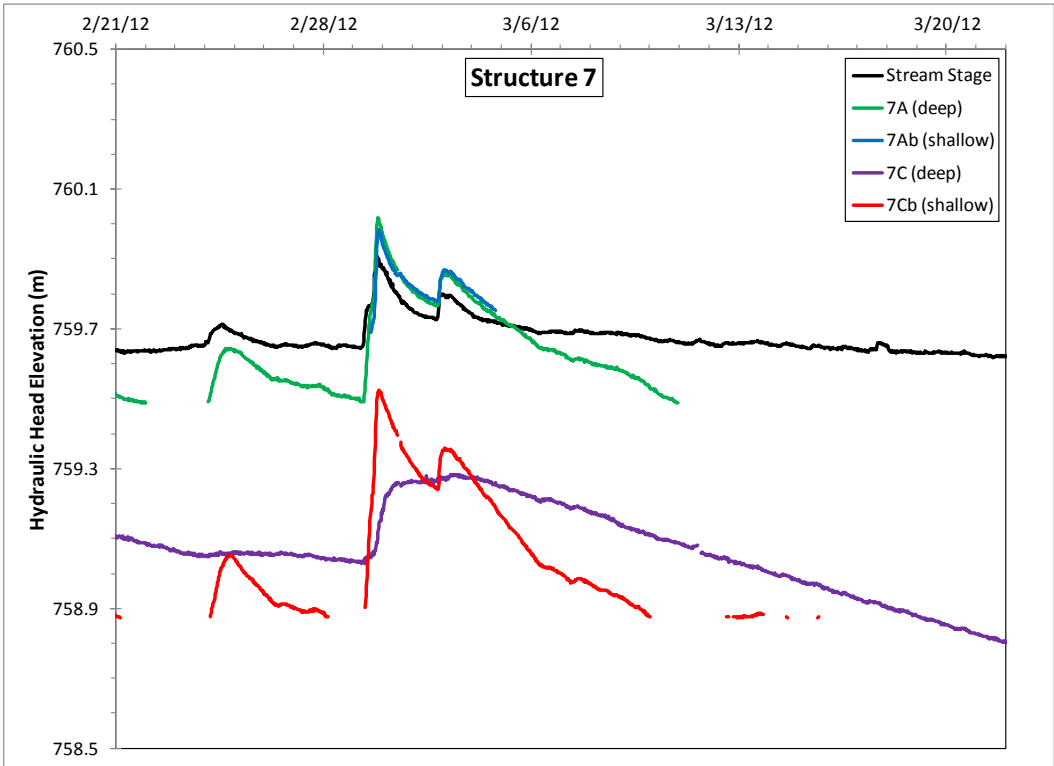
Figure 18b: Hydrometric data from Structure 7. Stream stage was collected at Structure 6 and extrapolated to Structure 7 using the water level differences in the longitudinal profile. The gaps in data for 7A, 7Ab and 7Cb indicate that these piezometers were dry during these time periods.

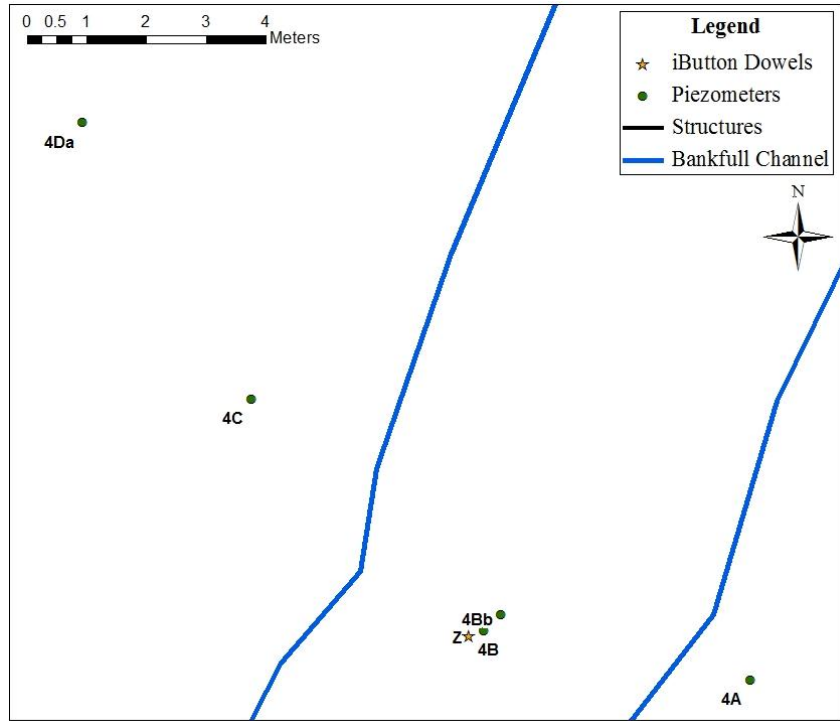
Figure 19a: Instrumentation at the reference riffle. A nested pair of piezometers and an iButton dowel (Z) were installed in the stream channel, and single piezometers were installed on the stream banks.

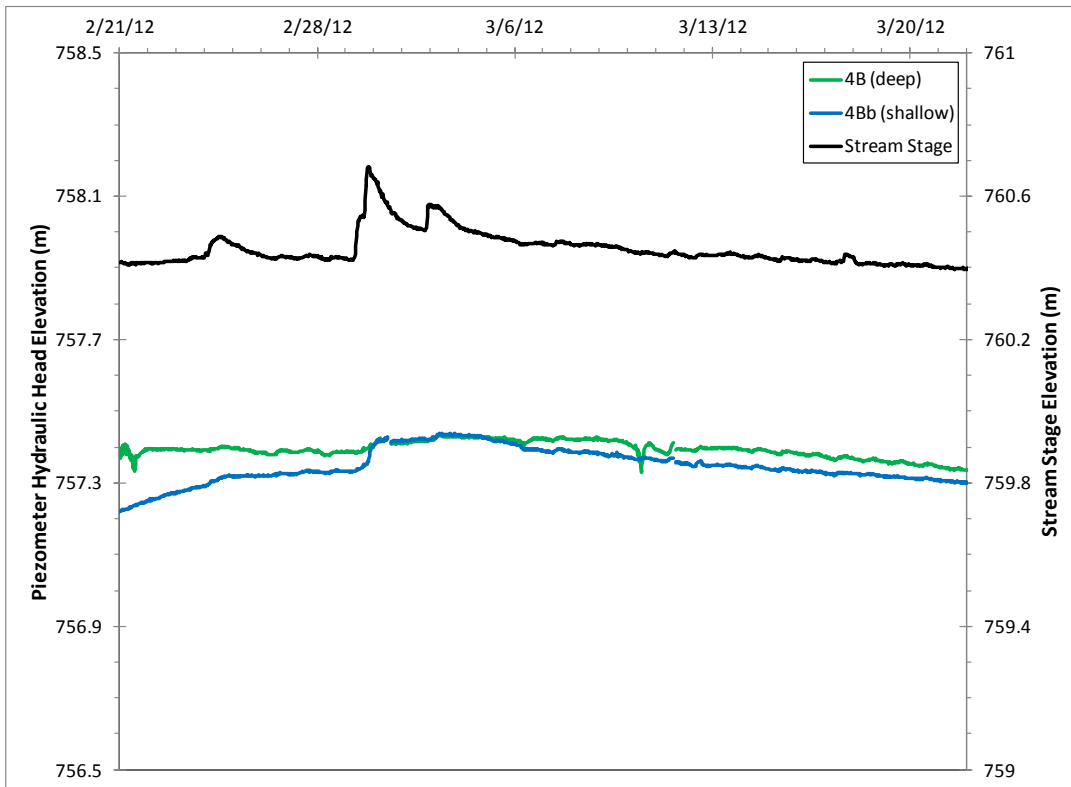
Figure 19b: Hydrometric data from the reference riffle. Stream stage (right axis) was collected at Structure 6. Piezometer 4Bb may have been plugged early in the study period.

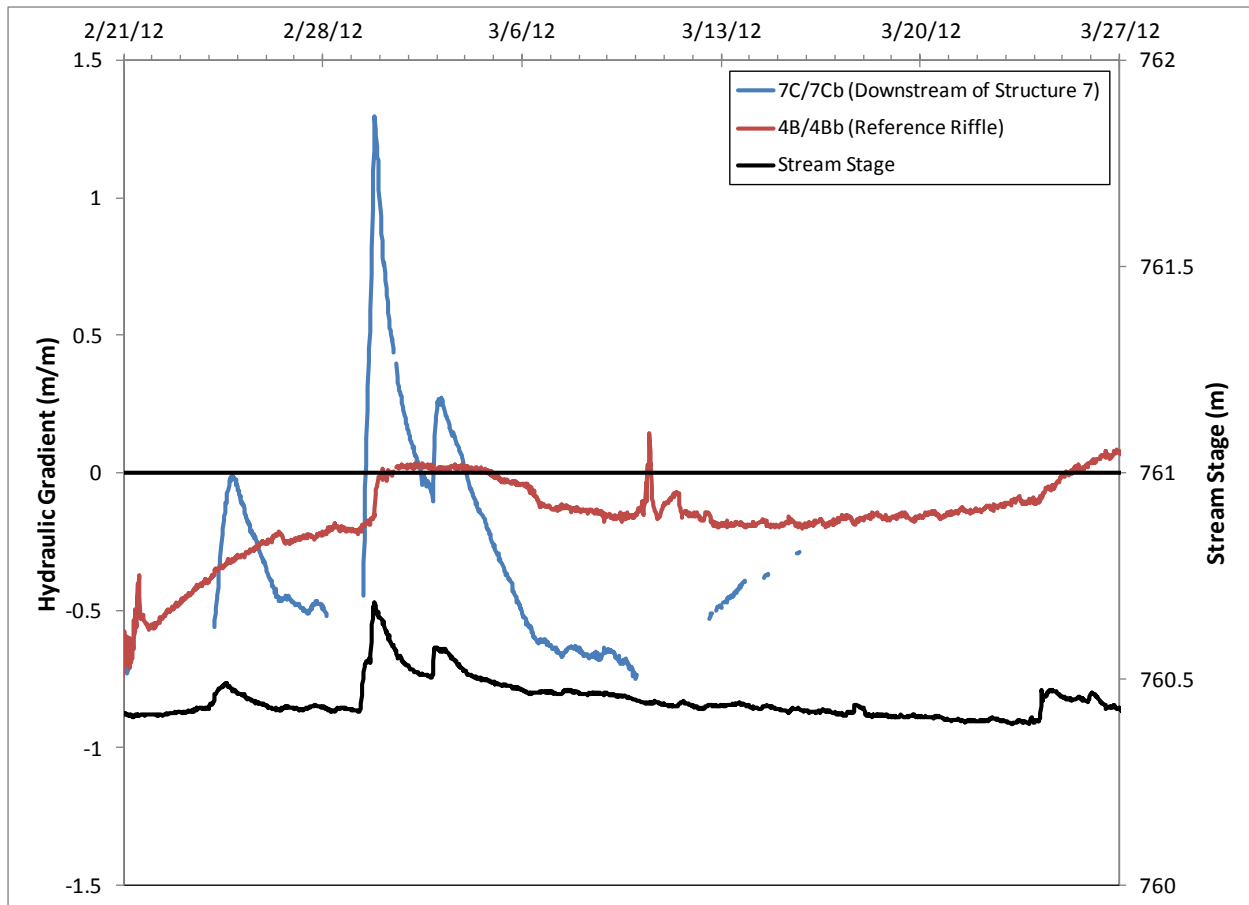
Figure 20: Vertical hydraulic gradients determined from hydrometric data. Positive values indicate downwelling, and the bold horizontal line at zero represents no gradient. Gaps in data indicate that at least one of these piezometers was dry during these time periods. Stream stage (right axis) was collected at Structure 6.

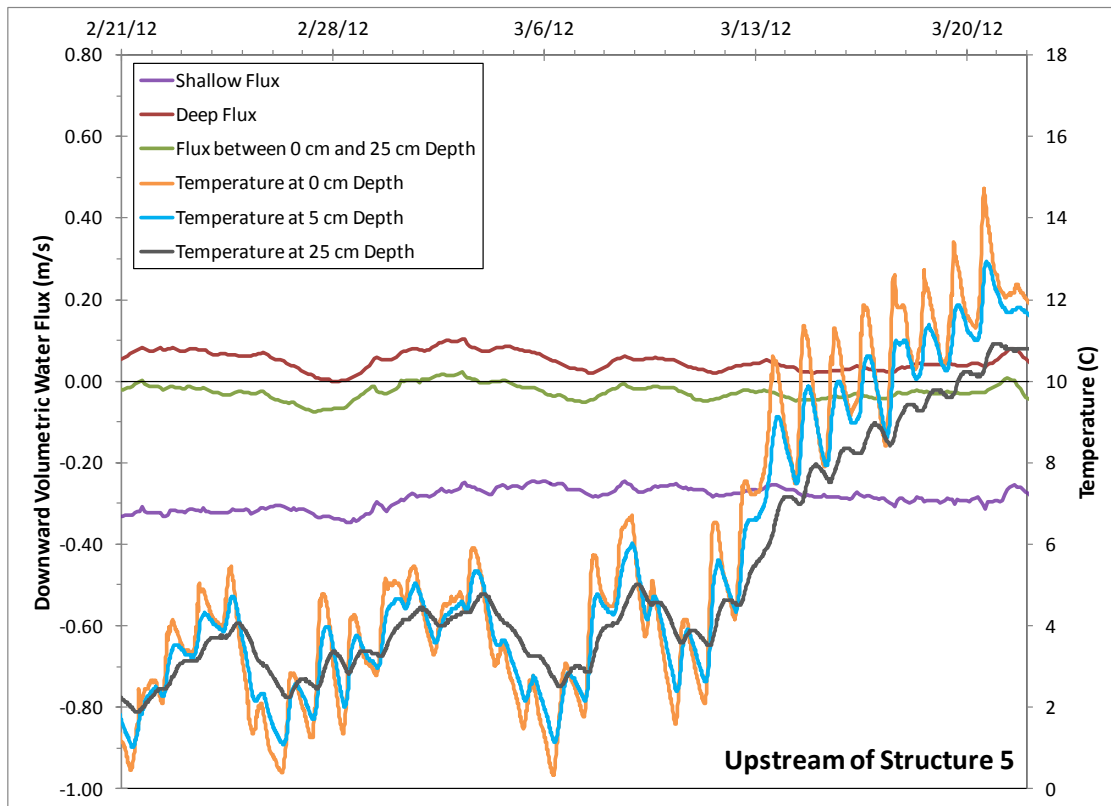
Figure 21: Temperature time series for 3 iButtons and hyporheic fluxes upstream of Structure 5. Positive flux values indicate downwelling, and the horizontal line at zero represents static flux.

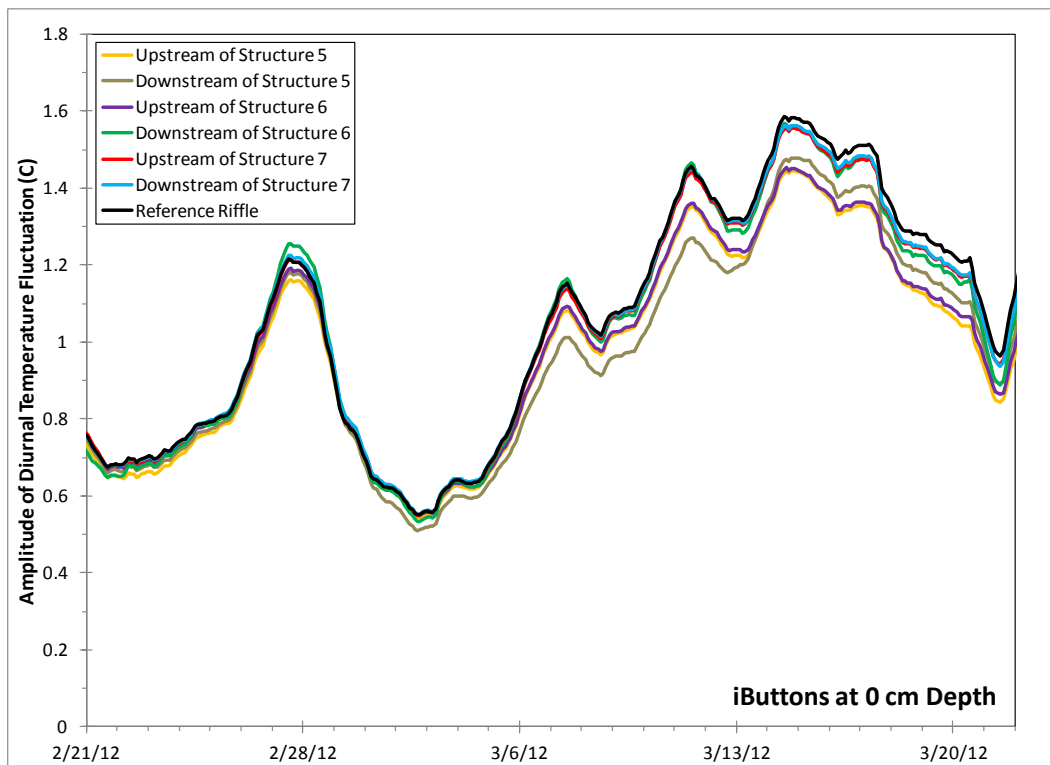
Figure 22: Diurnal temperature variation amplitudes for all iButtons at 0 cm depth.

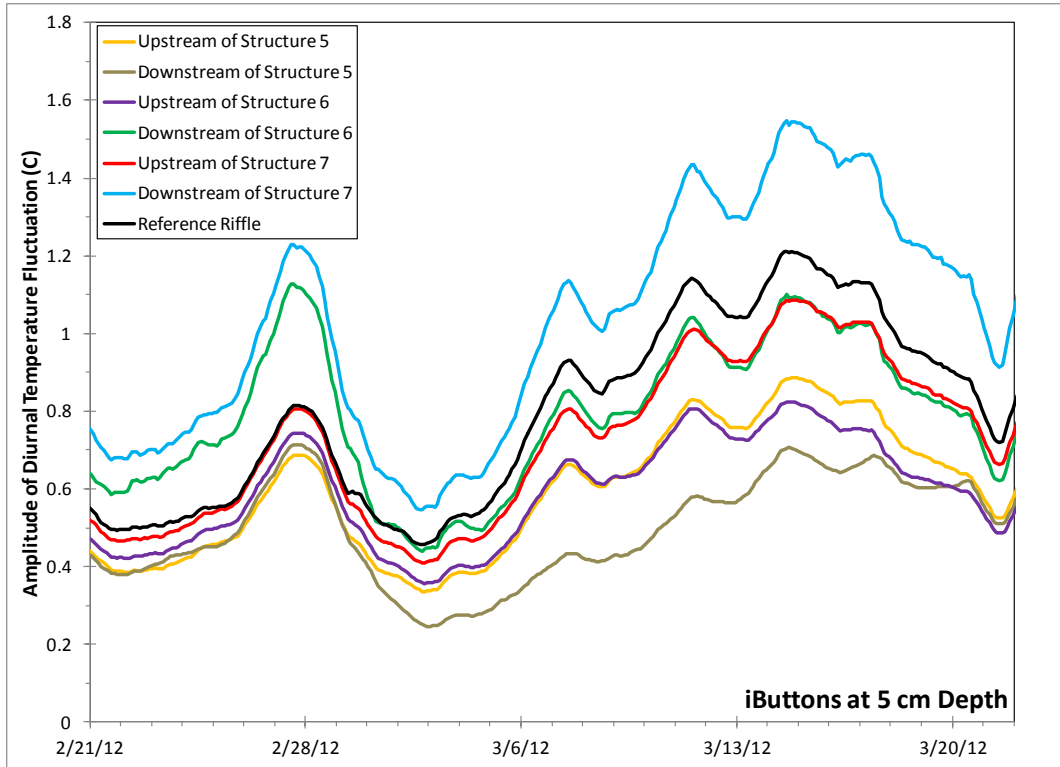
Figure 23: Diurnal temperature variation amplitudes for all iButtons at 5 cm depth.

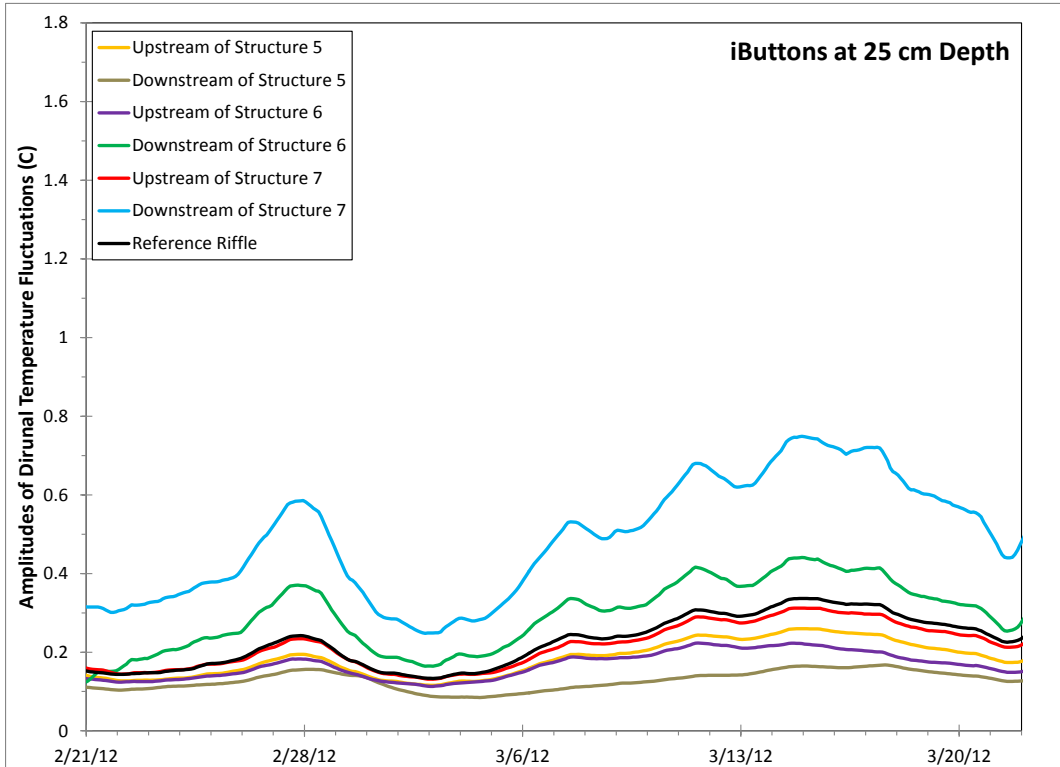
Figure 24: Diurnal temperature variation amplitudes for all iButtons at 25 cm depth.

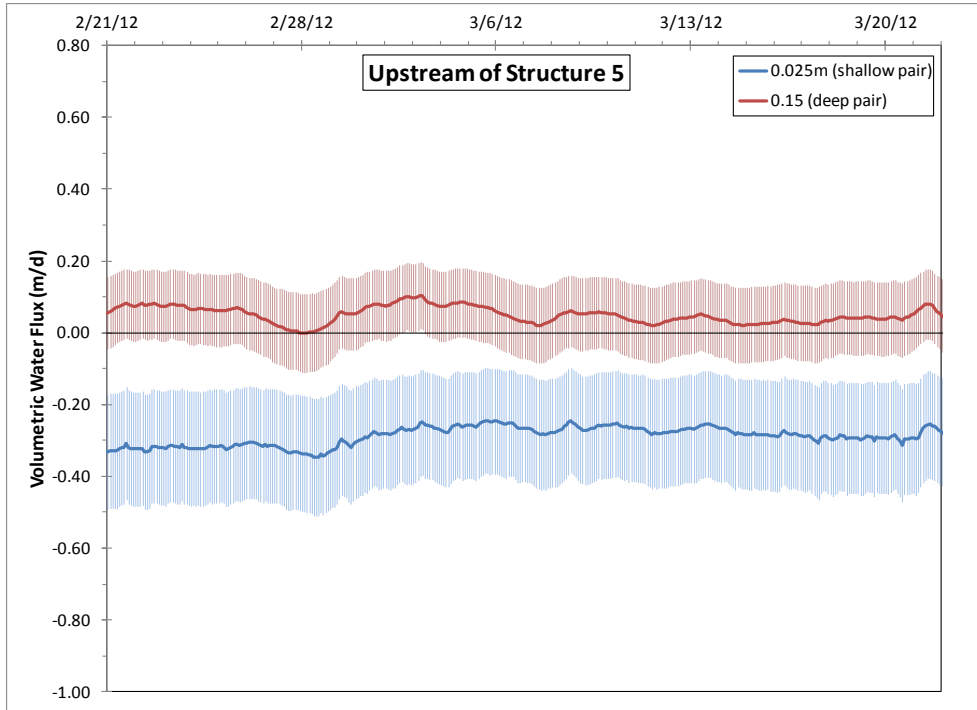
Figure 25: Shallow and deep vertical water fluxes upstream of Structure 5. The shaded area represents a confidence interval determined by Monte Carlo error analyses for thermal parameter uncertainty. Positive values indicate downwelling, and the horizontal line at zero represents static flux.

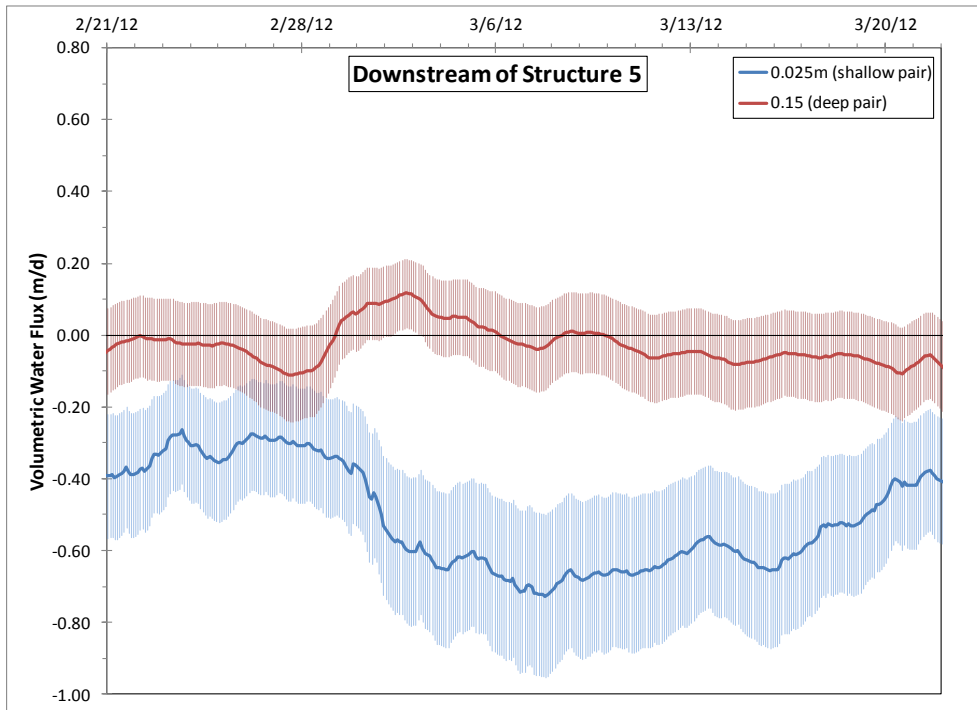
Figure 26: Shallow and deep vertical water fluxes downstream of Structure 5. The shaded area represents a confidence interval determined by Monte Carlo error analyses for thermal parameter uncertainty. Positive values indicate downwelling, and the horizontal line at zero represents static flux.

Fluxes were low for all sites throughout the study period, ranging from a maximum downwelling of 0.66 m/d (2.2 ft/d; Figure 28) to a maximum upwelling of -0.73 m/d (-2.4 ft/d; Figure 26). Fluxes at the reference site were comparable in magnitude to fluxes in the constructed channel, which contrasts the results of Daniluk *et al.* (2012), who found hyporheic fluxes at restoration structures to be an order of magnitude higher than in corresponding

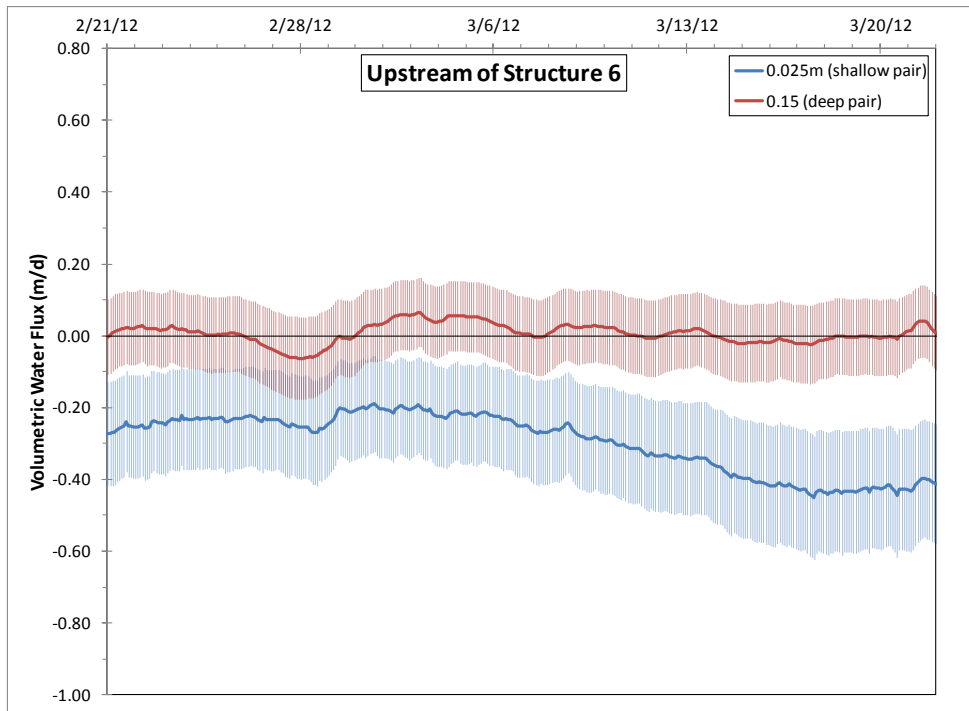
Figure 27: Shallow and deep vertical water fluxes upstream of Structure 6. The shaded area represents a confidence interval determined by Monte Carlo error analyses for thermal parameter uncertainty. Positive values indicate downwelling, and the horizontal line at zero represents static flux.

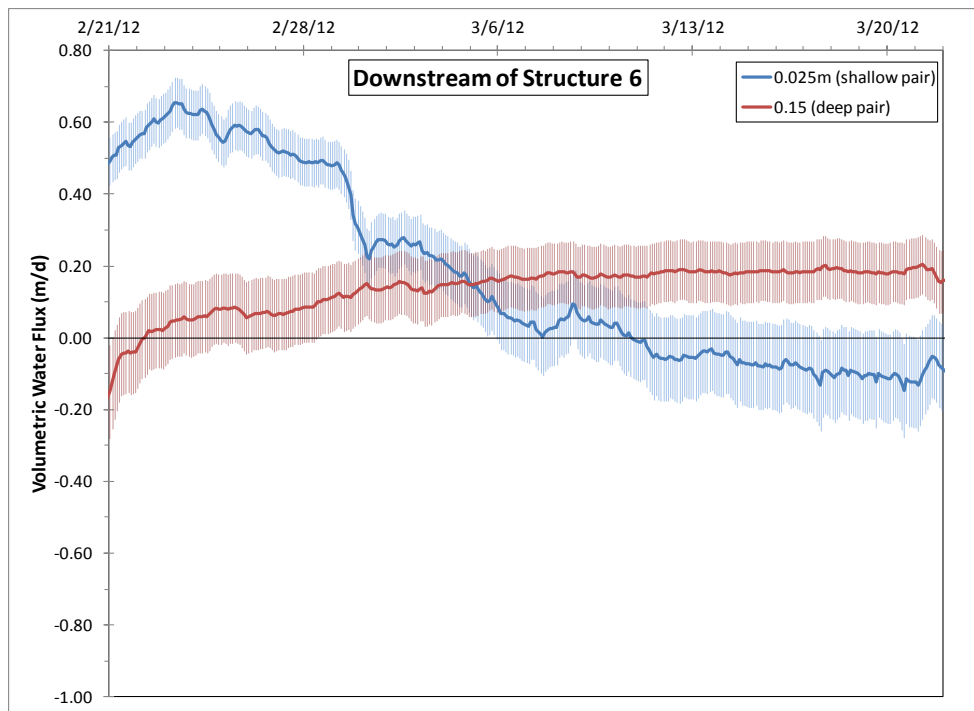
Figure 28: Shallow and deep vertical water fluxes downstream of Structure 6. The shaded area represents a confidence interval determined by Monte Carlo error analyses for thermal parameter uncertainty. Positive values indicate downwelling, and the horizontal line at zero represents static flux.

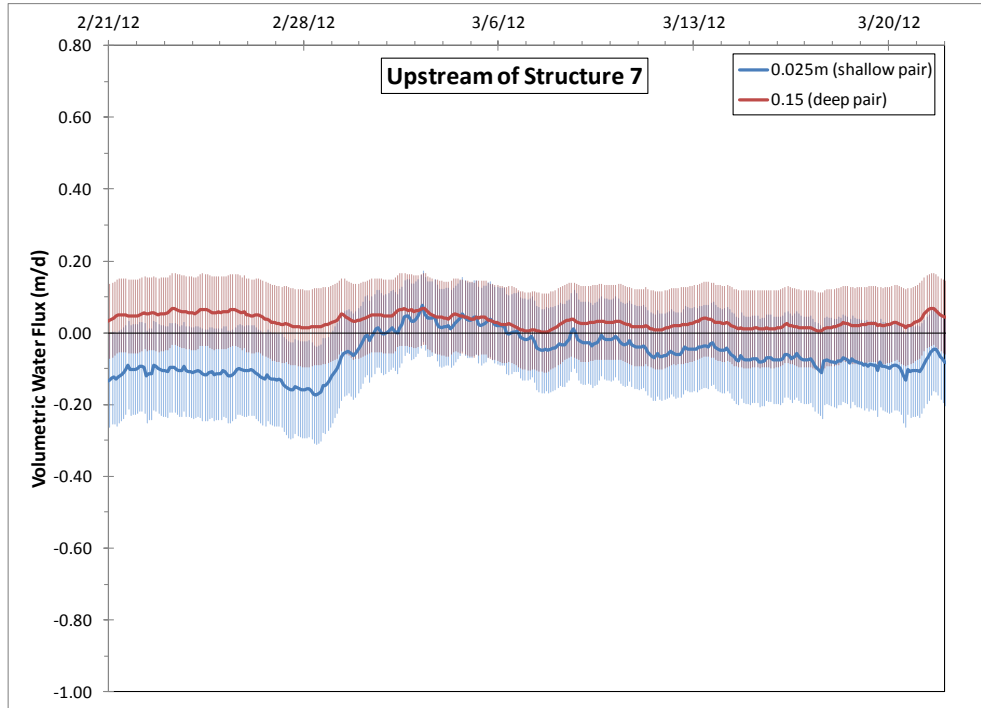
Figure 29: Shallow and deep vertical water fluxes upstream of Structure 7. The shaded area represents a confidence interval determined by Monte Carlo error analyses for thermal parameter uncertainty. Positive values indicate downwelling, and the horizontal line at zero represents static flux.

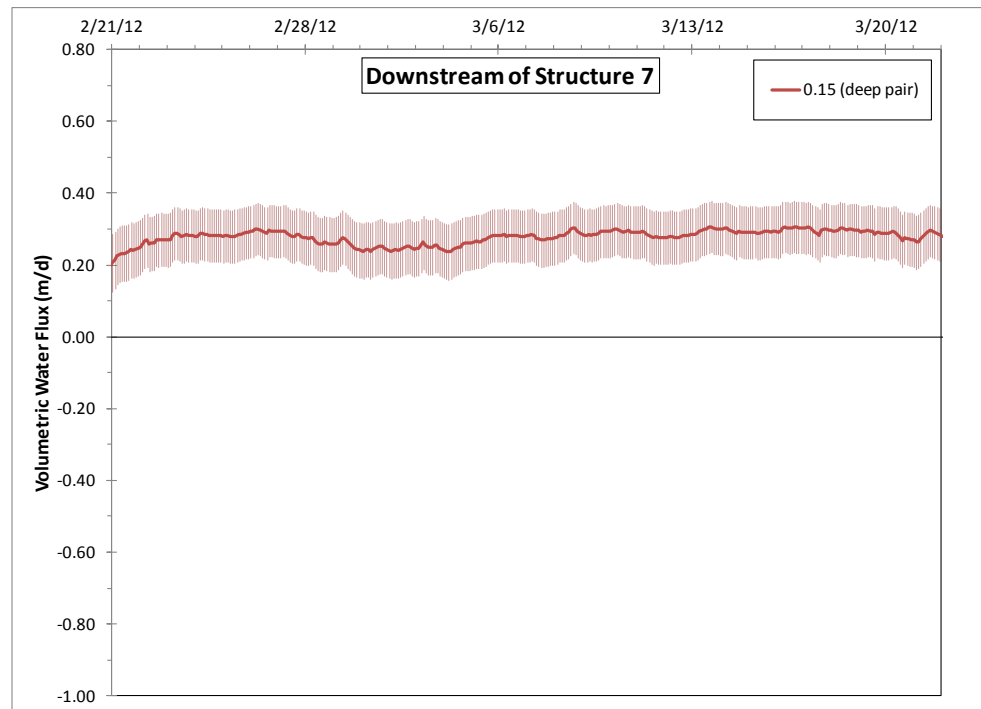
Figure 30: Deep vertical water flux downstream of Structure 7. Shallow flux was not calculated for this location because streambed scour exposed the 5 cm iButton. The shaded area represents a confidence interval determined by Monte Carlo error analyses for thermal parameter uncertainty. Positive values indicate downwelling, and the horizontal line at zero represents static flux.

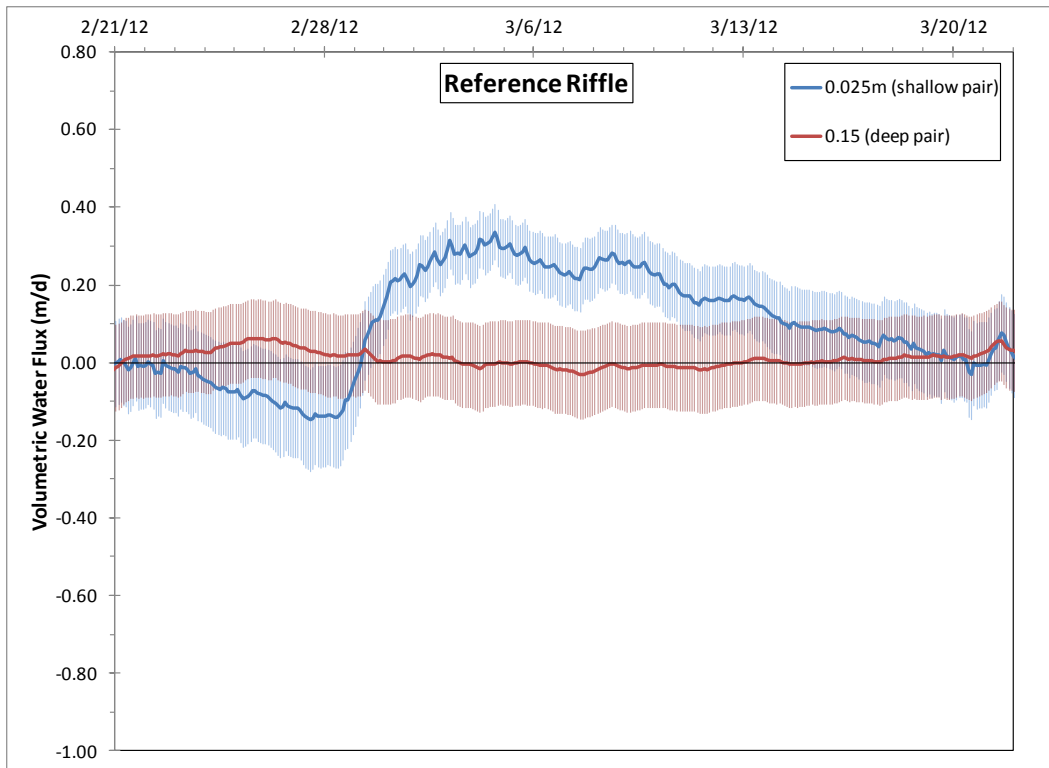
Figure 31: Shallow and deep vertical water fluxes at the reference riffle. The shaded area represents a confidence interval determined by Monte Carlo error analyses for thermal parameter uncertainty. Positive values indicate downwelling, and the horizontal line at zero represents static flux.

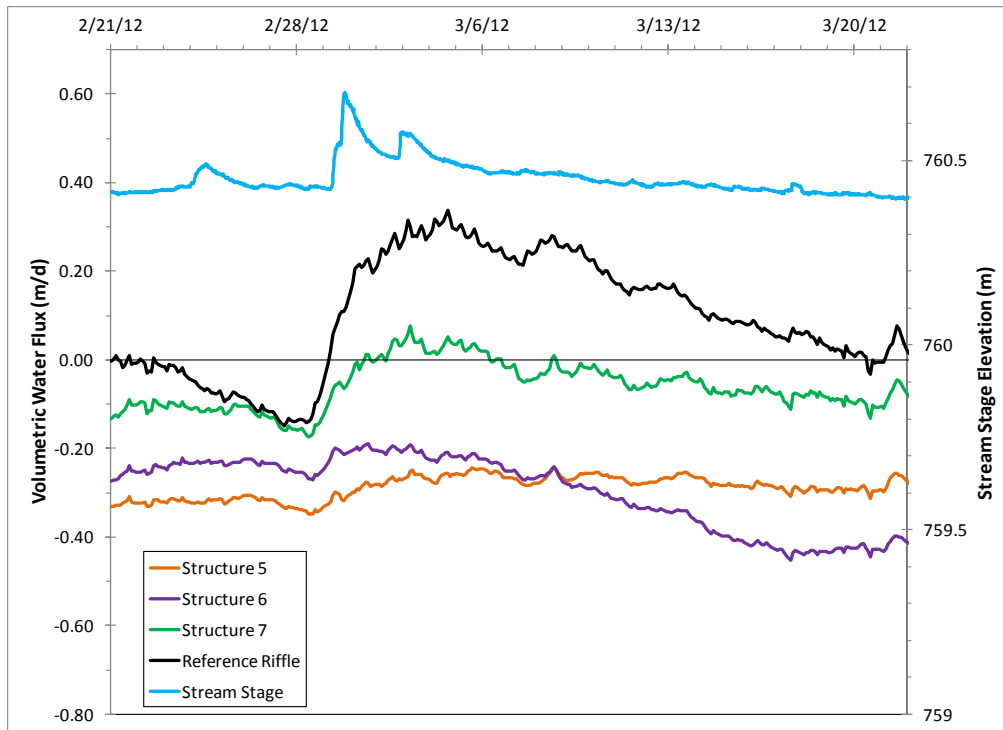
Figure 33: Shallow fluxes upstream of restoration structures and at the reference riffle. Positive values indicate downwelling, and the horizontal line at zero represents static flux. Stream stage (right axis) was measured at Structure 6.

Several patterns emerge in Figures 33 and 34, which show all the water flux results upstream of restoration structures and in the reference riffle. Shallow upwelling upstream of structures occurred for most of the study period (Figure 33). During the 29 February event, upwelling decreased or downwelling started for all the structures and the reference riffle. Thus, as stream stage rose during the event, head along the streambed increased at each of these sites. Each site responded differently after the event, which likely reflected local conditions. Flux upstream of Structure 5 remained relatively constant, which may reflect its proximity to the wetland or installation in low conductivity material. The reference riffle and the bed of the channel upstream of Structures 6 and 7 slowly returned to pre-event conditions, less downwelling or more upwelling, as pressure head decreased along the streambed.
