Assessment of Hyporheic Exchange at In-stream Restoration Structures on Savage River, Garrett County, Maryland

Thesis submitted to the Eberly College
at West Virginia University in partial
fulfillment of the requirements for the
degree of

Master of Science
in
Geology

Department of Geology and Geography
Morgantown, West Virginia
2013

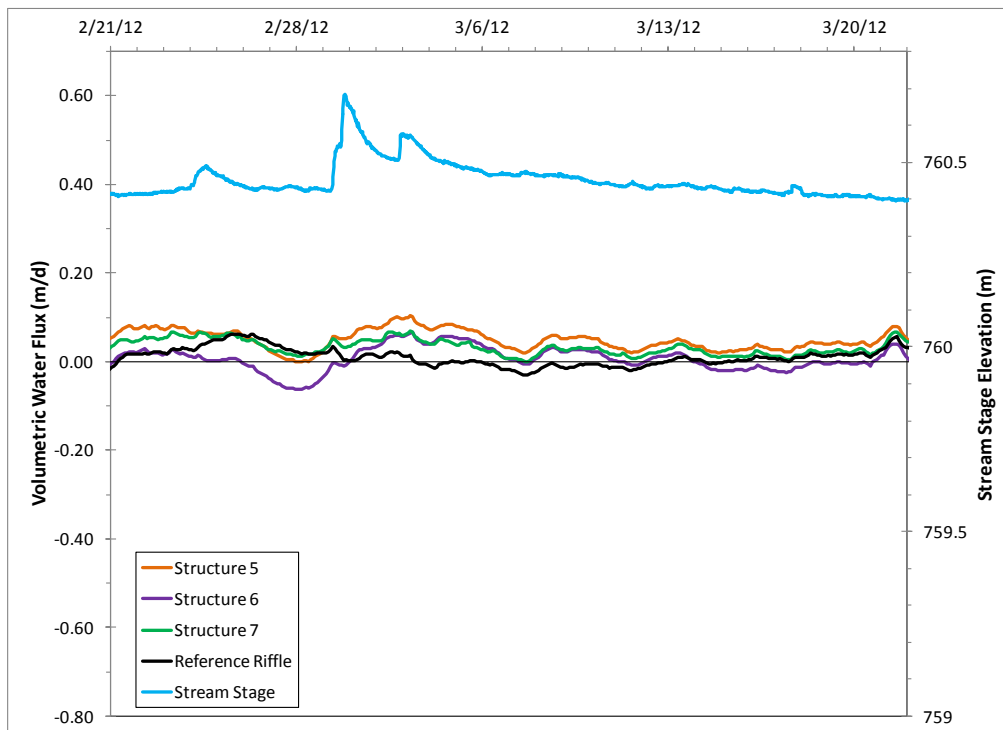
Figure 34: Deep fluxes upstream of restoration structures and at the reference riffle. Positive values indicate downwelling, and the horizontal line at zero represents static flux. Stream stage (right axis) was measured at Structure 6.

Several patterns emerge in Figures 33 and 34, which show all the water flux results upstream of restoration structures and in the reference riffle. Shallow upwelling upstream of structures occurred for most of the study period (Figure 33). During the 29 February event, upwelling decreased or downwelling started for all the structures and the reference riffle. Thus, as stream stage rose during the event, head along the streambed increased at each of these sites. Each site responded differently after the event, which likely reflected local conditions. Flux upstream of Structure 5 remained relatively constant, which may reflect its proximity to the wetland or installation in low conductivity material. The reference riffle and the bed of the channel upstream of Structures 6 and 7 slowly returned to pre-event conditions, less downwelling or more upwelling, as pressure head decreased along the streambed.

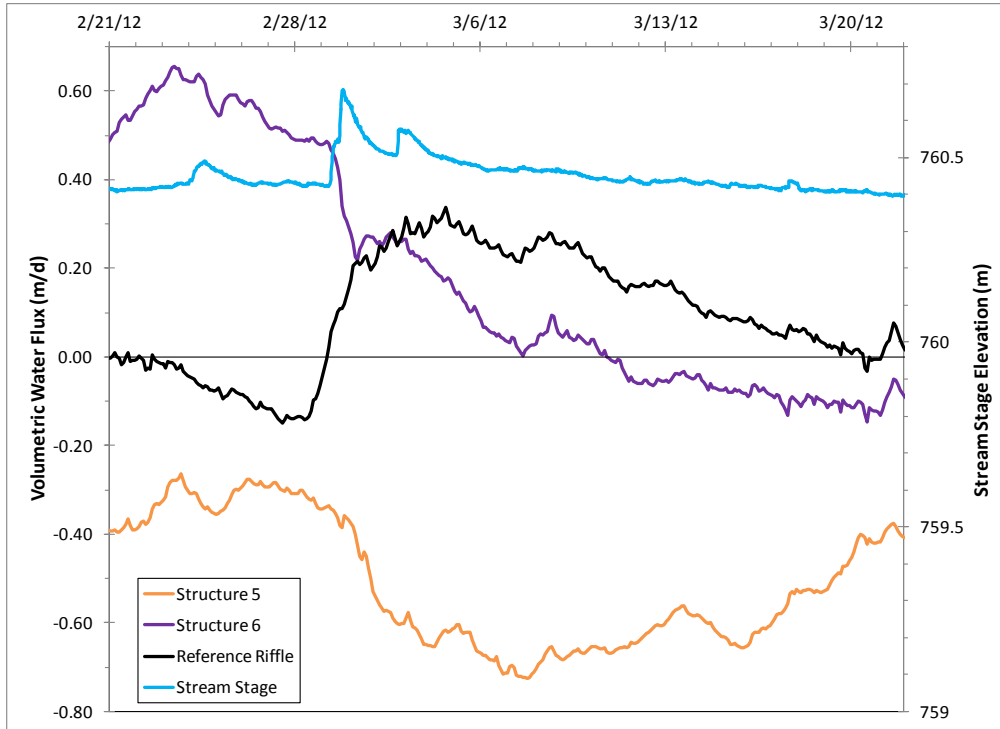
Figure 35: Shallow fluxes downstream of restoration structures and at the reference riffle. Positive values indicate downwelling, and the horizontal line at zero represents static flux. Stream stage (right axis) was measured at Structure 6.

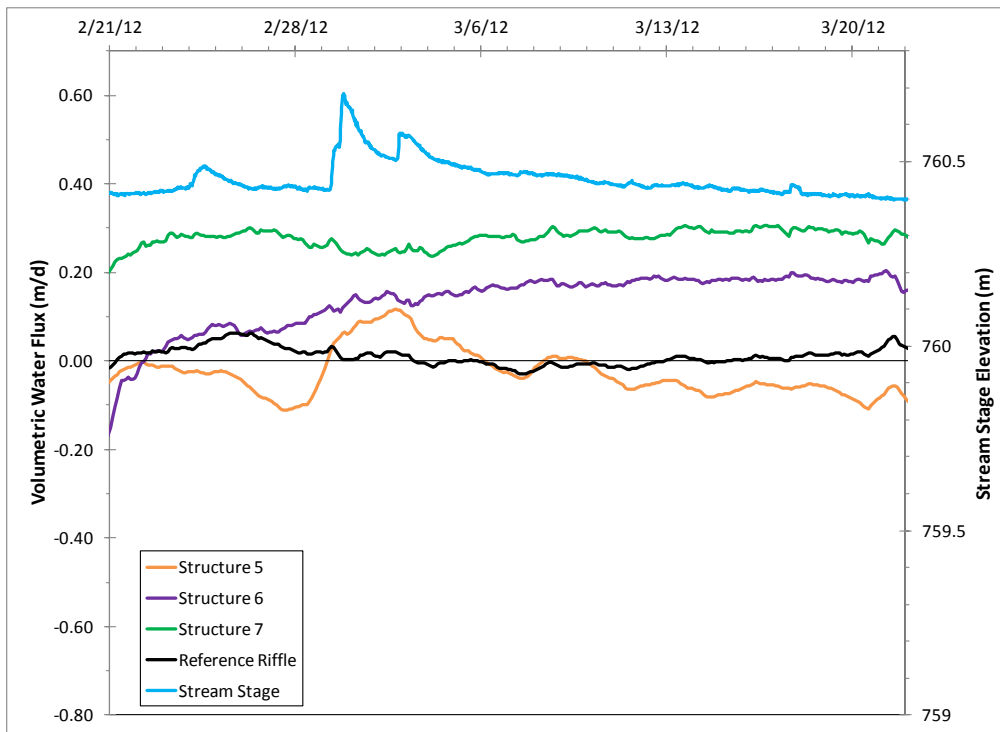
Figure 36: Deep fluxes downstream of restoration structures and at the reference riffle. Positive values indicate downwelling, and the horizontal line at zero represents static flux. Stream stage (right axis) was measured at Structure 6.

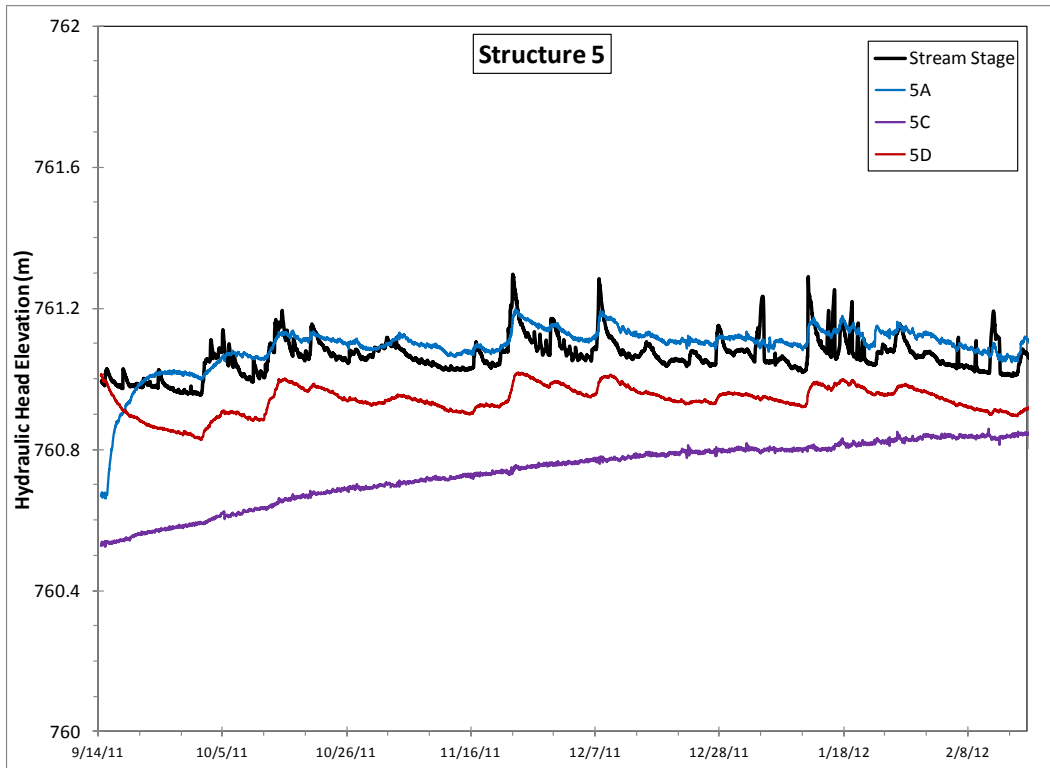
Figure A1: Hydrometric data from Structure 5 for 14 September 2011 to 18 February 2012. Stream stage was collected at Structure 6 and extrapolated to Structure 5 using the water level differences in the longitudinal profile.

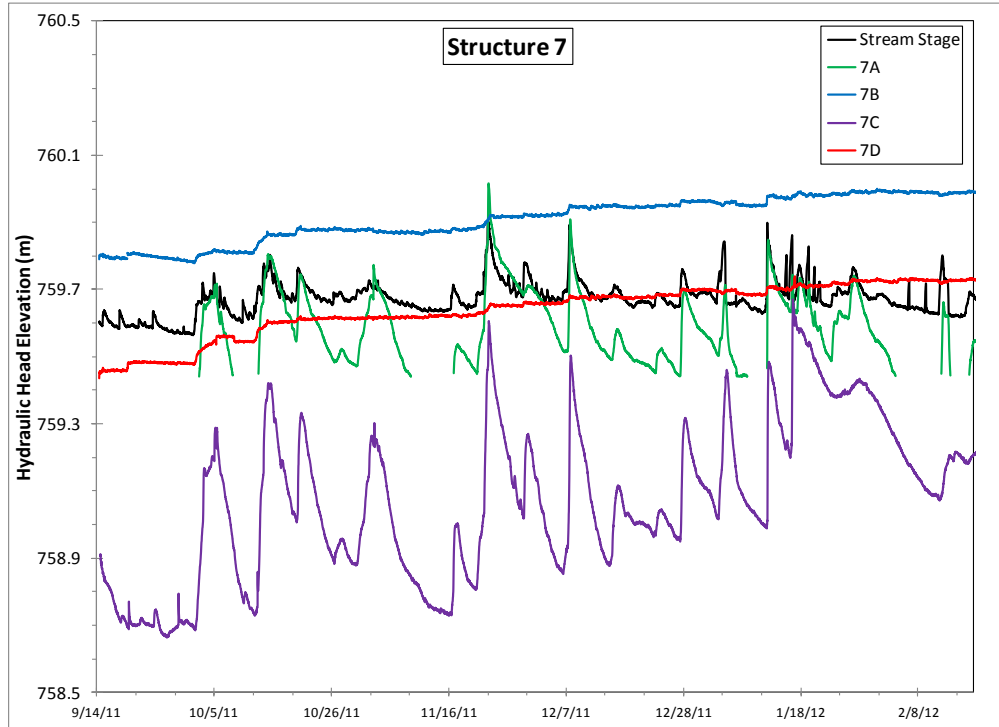
Figure A2: Hydrometric data from Structure 7 for 14 September 2011 to 18 February 2012. Stream stage was collected at Structure 6 and extrapolated to Structure 7 using the water level differences in the longitudinal profile. The gaps in data for 7A indicate that this piezometer was dry during these time periods.

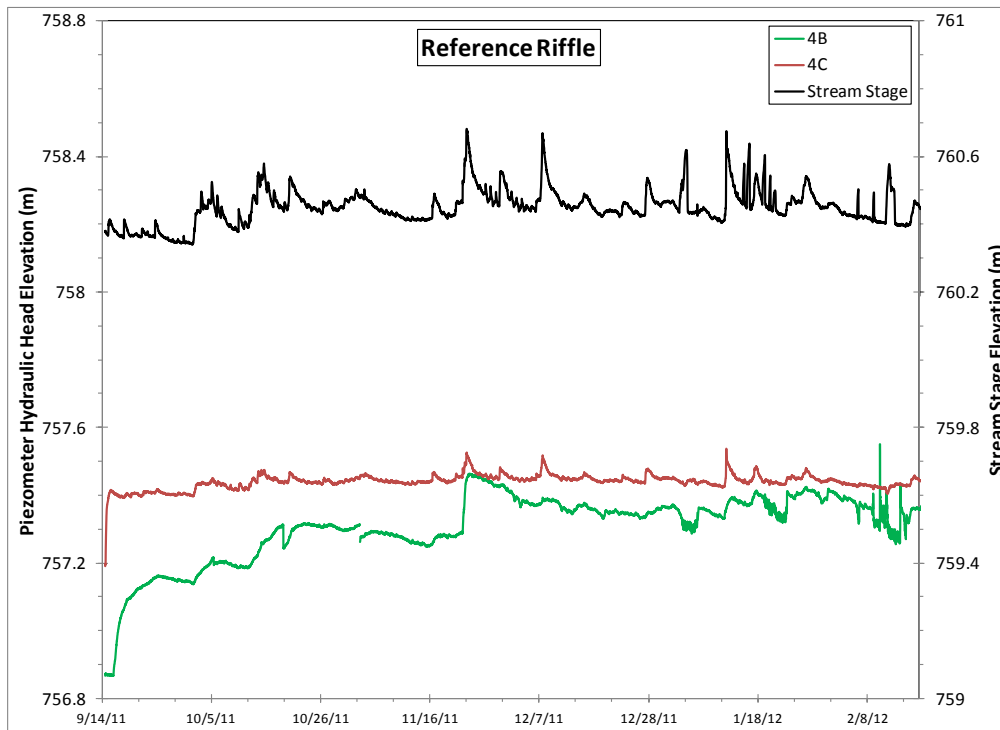
Figure A3: Hydrometric data from reference riffle for 14 September 2011 to 18 February 2012. Stream stage (right axis) was collected at Structure 6.

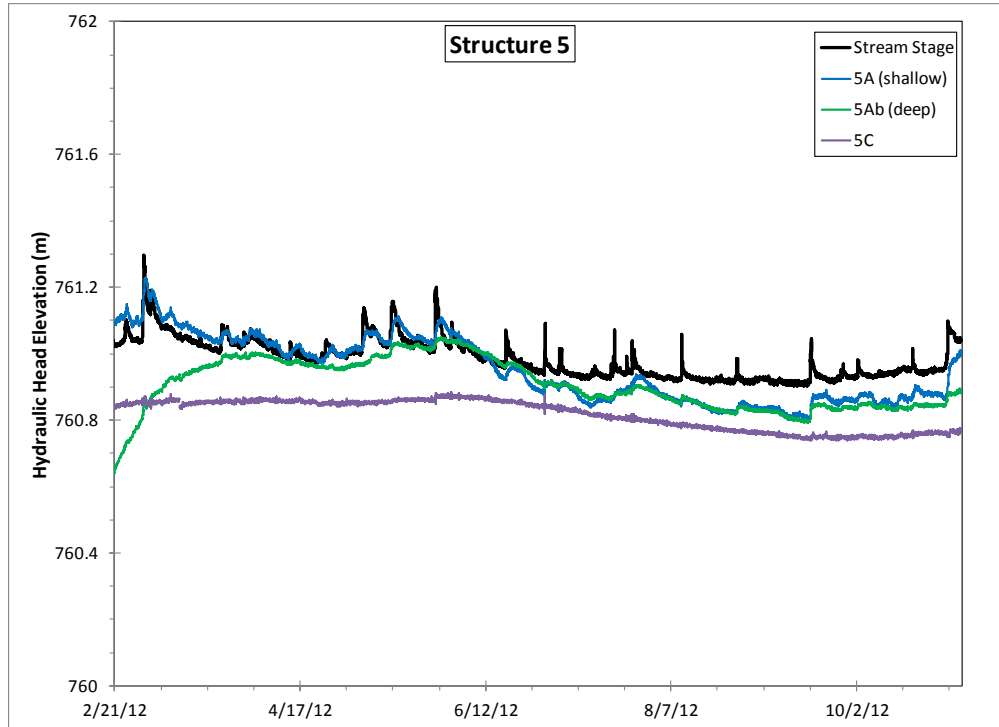
Figure A4: Hydrometric data from Structure 5 for 21 February to 2 November 2012. Stream stage was collected at Structure 6 and extrapolated to Structure 5 using the water level differences in the longitudinal profile.

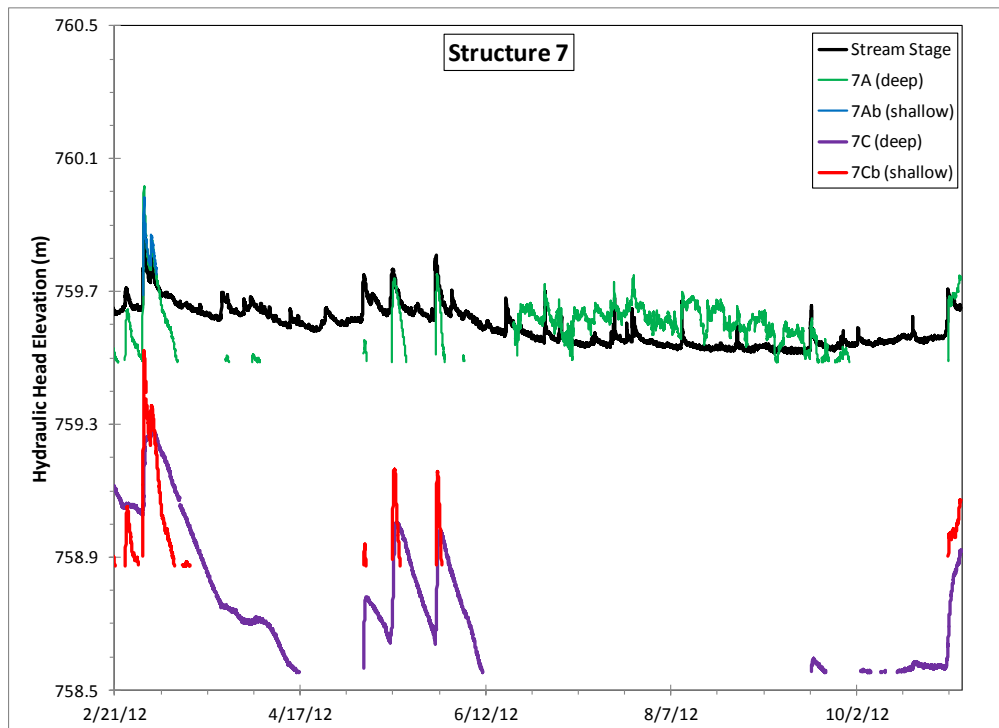
Figure A5: Hydrometric data from Structure 7 for 21 February to 2 November 2012. Stream stage was collected at Structure 6 and translated to Structure 7 using the water level differences in the longitudinal profile. The gaps in data indicate that these piezometers were dry during these time periods.

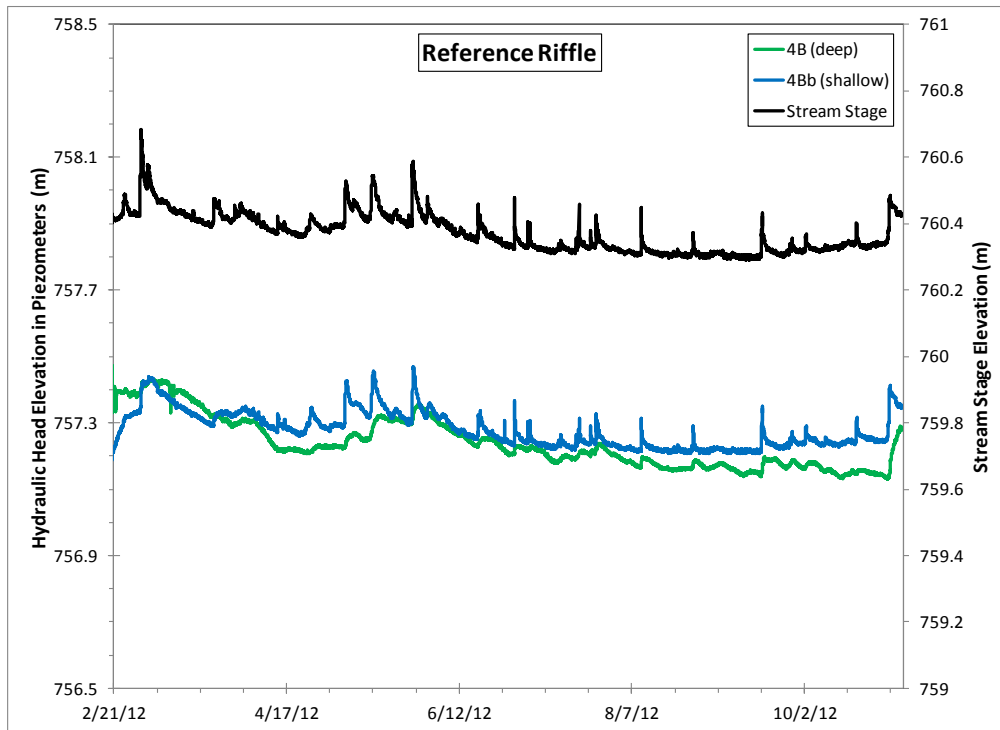
Figure A6: Hydrometric data from reference riffle for 21 February to 2 November 2012. Stream stage (right axis) was collected at Structure 6.

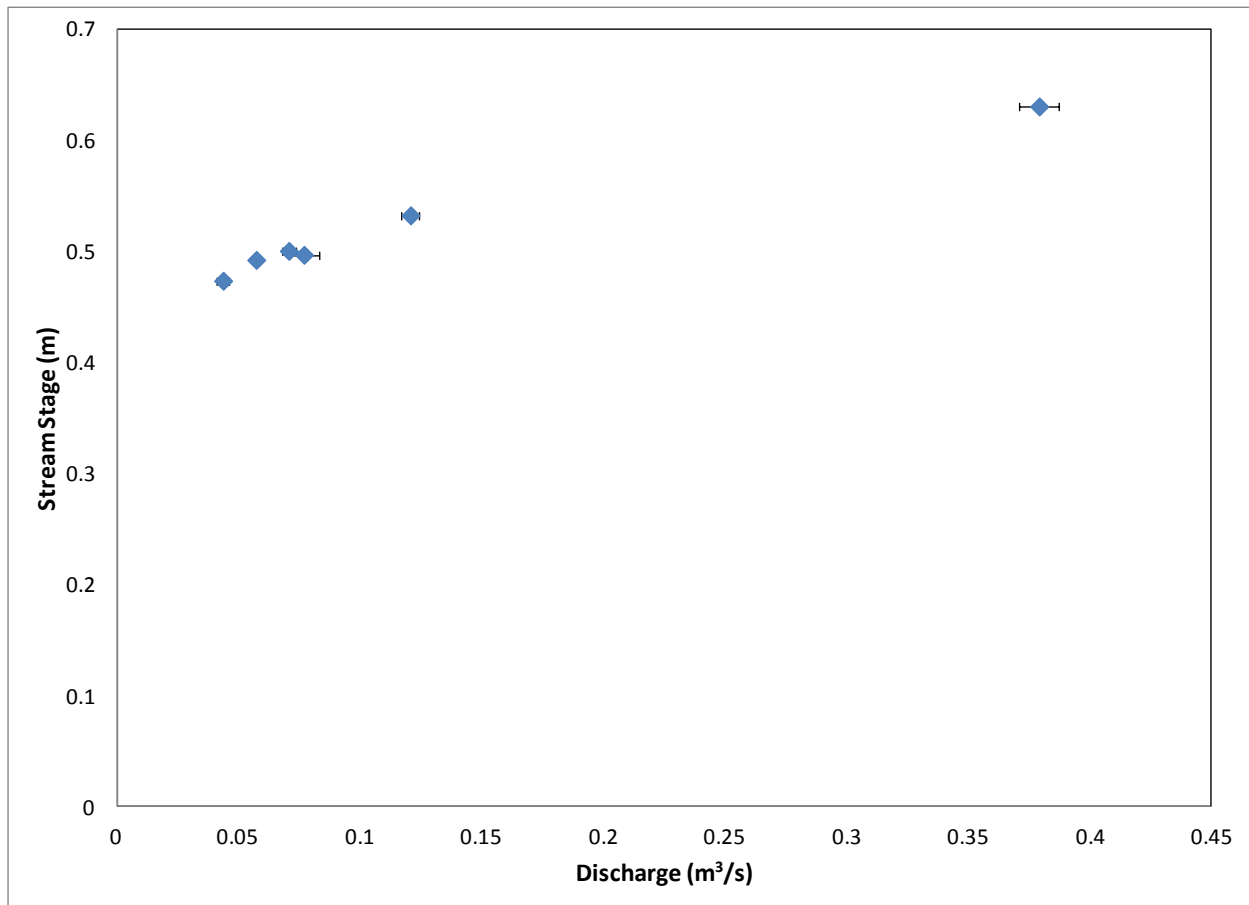
Figure B1: Relationship between stream stage and discharge for gage downstream of Structure 6. Error bars indicate standard deviation of 3 discharge measurements taken for each stream stage.

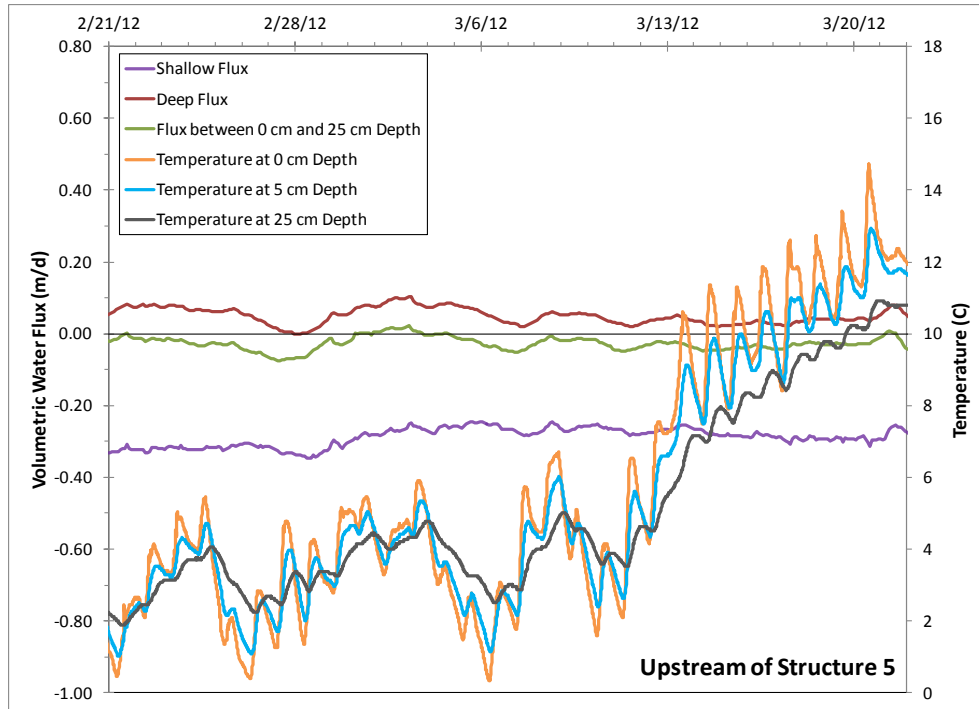
Figure D1: Temperature time series for 3 iButtons and hyporheic fluxes upstream of Structure 5. Positive flux values indicate downwelling, and the horizontal line at zero represents static flux.

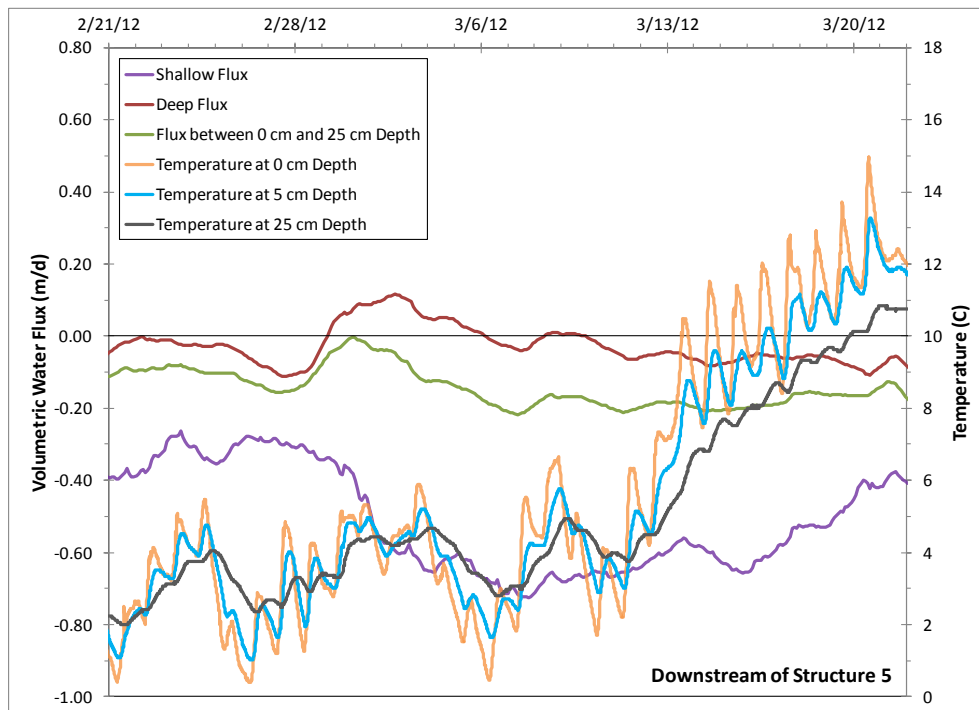
Figure D2: Temperature time series for 3 iButtons and hyporheic fluxes downstream of Structure 5. Positive flux values indicate downwelling, and the horizontal line at zero represents static flux.

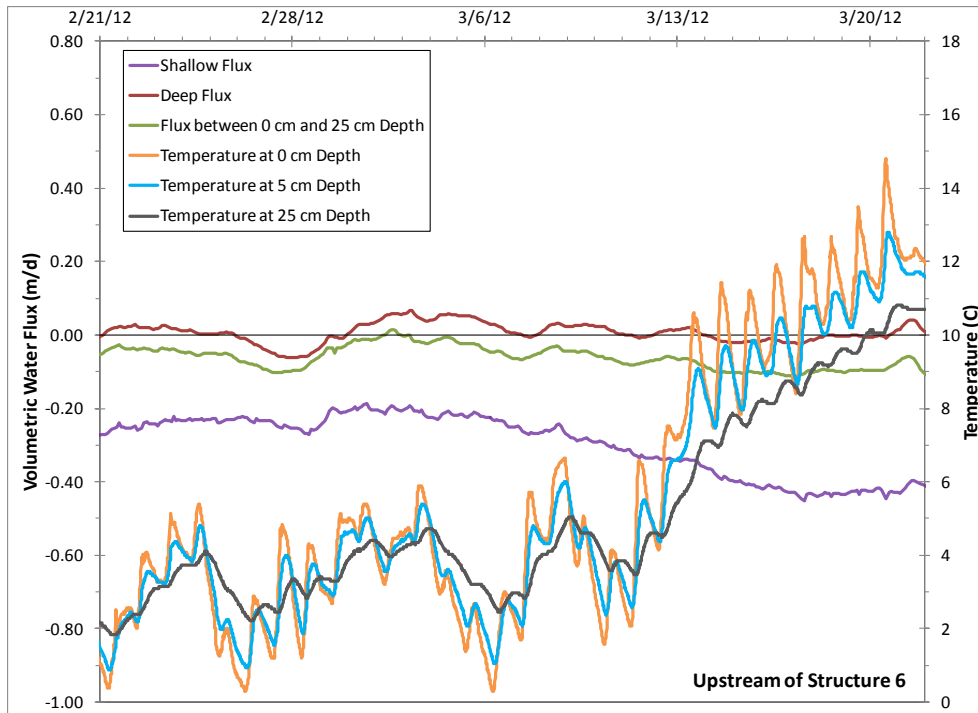
Figure D3: Temperature time series for 3 iButtons and hyporheic fluxes upstream of Structure 6. Positive flux values indicate downwelling, and the horizontal line at zero represents static flux.

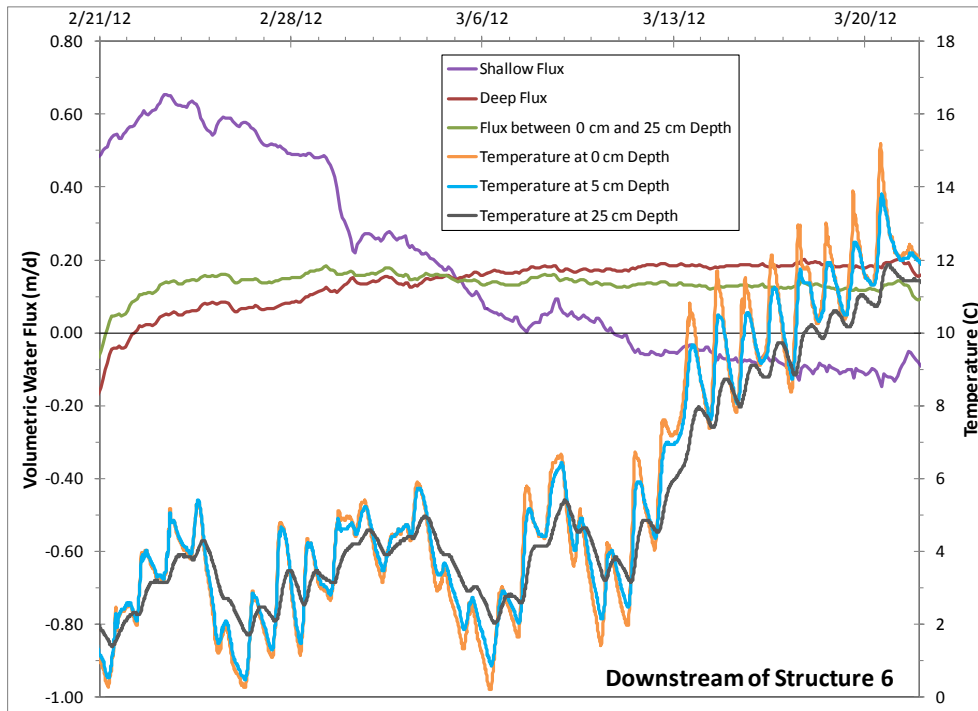
Figure D4: Temperature time series for 3 iButtons and hyporheic fluxes downstream of Structure 6. Positive flux values indicate downwelling, and the horizontal line at zero represents static flux.

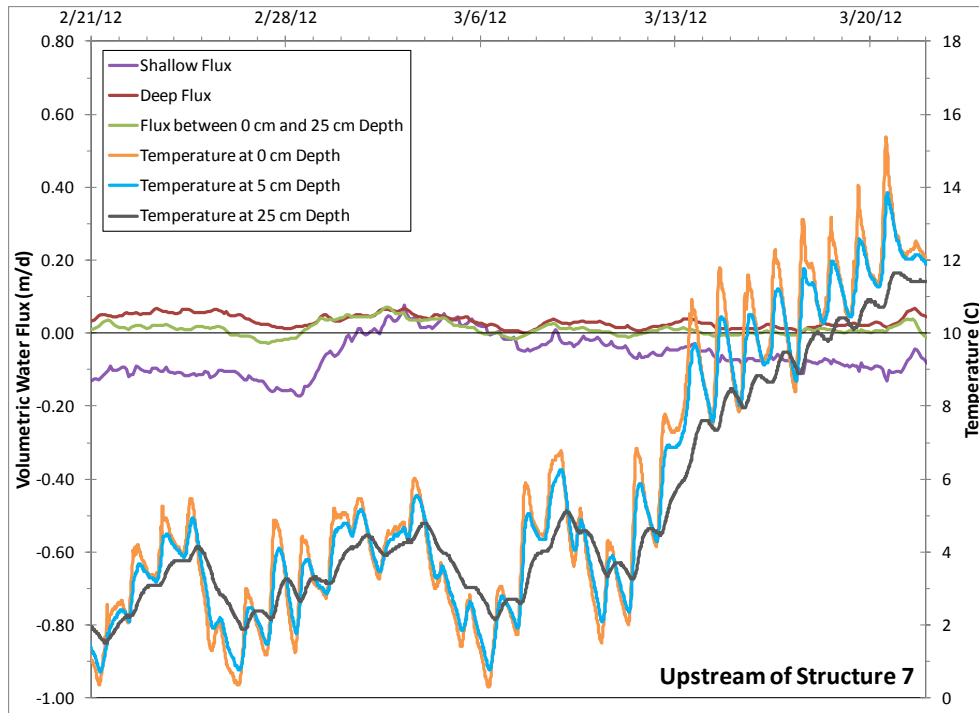
Figure D5: Temperature time series for 3 iButtons and hyporheic fluxes upstream of Structure 7. Positive flux values indicate downwelling, and the horizontal line at zero represents static flux.

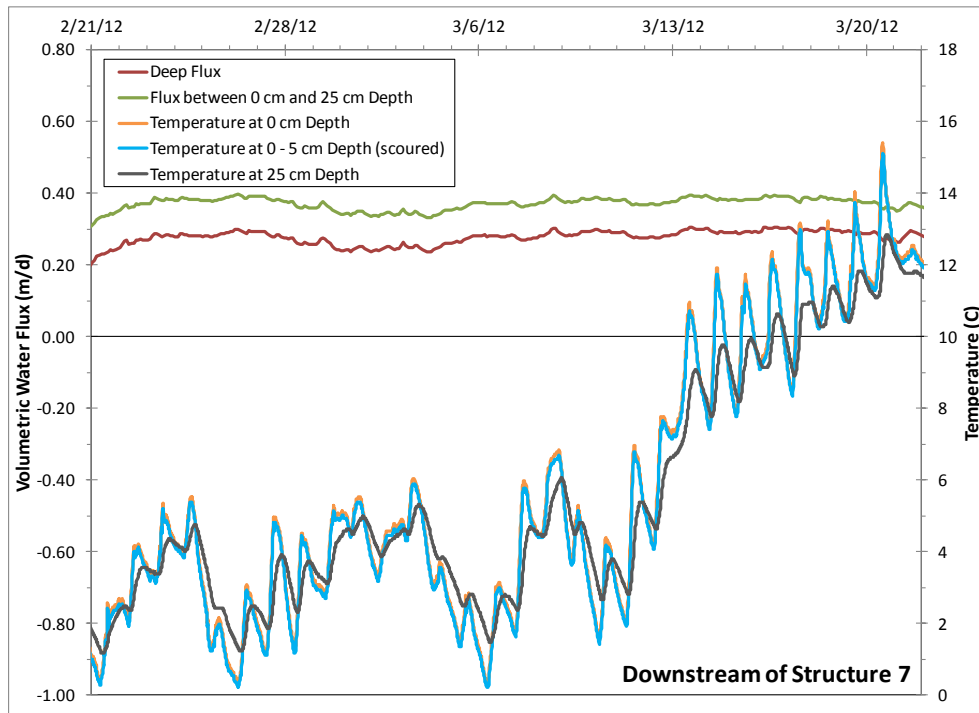
Figure D6: Temperature time series for 3 iButtons and hyporheic fluxes downstream of Structure 7. Positive flux values indicate downwelling, and the horizontal line at zero represents static flux.
