Brazilian Journal of Applied Technology for Agricultural Science, Guarapuava-PR, v.7, n.3, p.17-24, 2014

### Scientific Paper

## Caracterização morfométrica da bacia do rio Verruga, em Vitória da Conquista - BA.

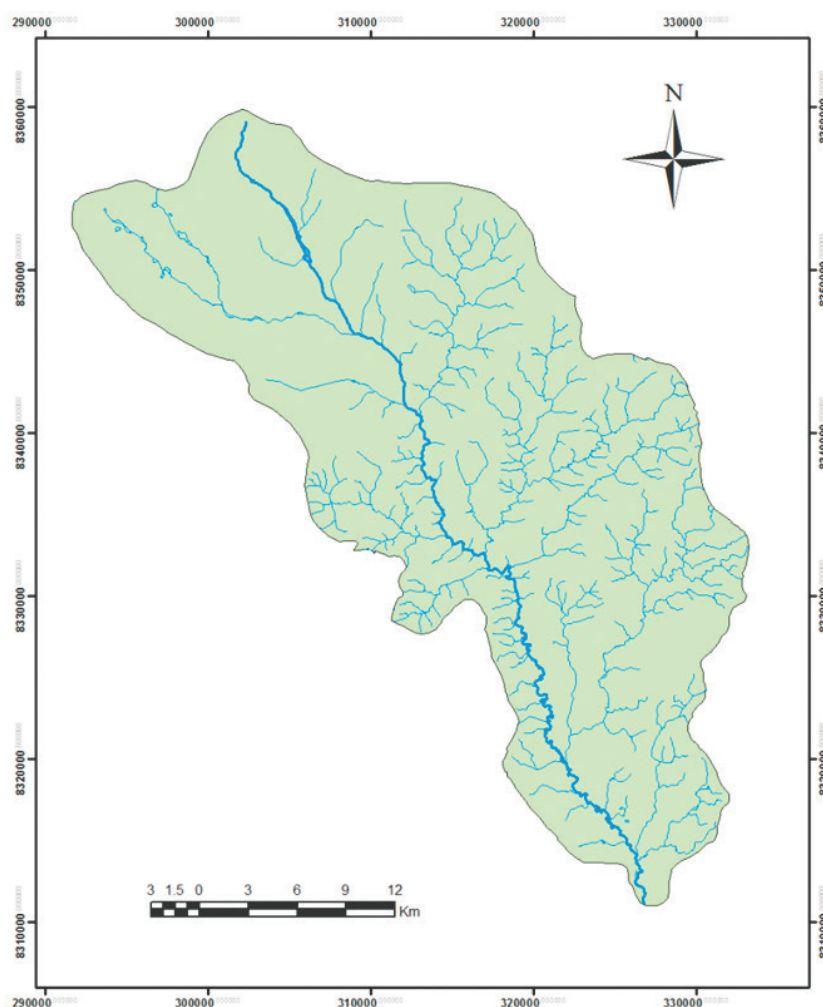
Figure 1. Verruga River basin, Vitória da Conquista - BA.

The Hydrographic basin of Verruga River drains the South-Central portion of the city of Vitória da Conquista - BA, part of the Southwest portion of Barra do Choça and part of the North portion of Itambé city. Its waters run from Northwest to Southeast, flowing on Pardo River, next to the city of Itambé-BA. It occupies an area of approximately 883.38 km<sup>2</sup>. It is located between the geographic coordinates: 14°48' to 15°18' latitude S and 40°56' to 40°32' longitude, WGr.(Figure 1).

The drainage system of the studied basin, according to the Strahler hierarchy, has a fourth order ramification, which means a lot of ramifications for the scale in the map used (Figure 1).

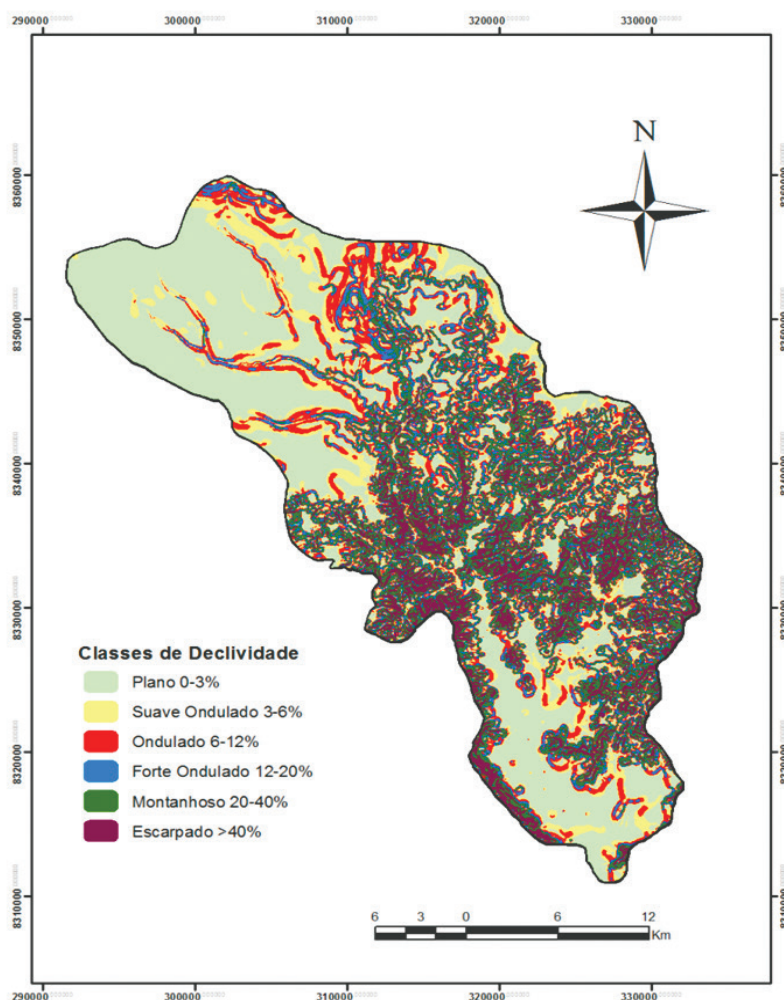
(Declivity classes | Plain 0-3%, Gently Undulated 3-6%, Undulated 6-12%, Strongly Undulated 12-20%, Mountainous 20-40%, Steep >40%)

Figure 2. Spatial distribution of the declivity classes of the Verruga River basin, Vitória da Conquista - BA.

The declivity classes (Figure 2 and Table 2)

show that there was a higher predominance of areas with 0 to 6% declivity, constituting in 46.87% of the basin (41406.9 ha). These areas were classified as plain relief to gently undulated by CHIARINI and DONZELI (1973) and LEPSCH et al. (1991), who defined those as areas destined for the planting of annually crops with use of simple practices of soil conservation, since the planting in crop level already controls the erosion process of the soil. These classes encompass 29482.50 ha (33.37%), with slopes varying from 0 to 3% and 11924.40 ha (13.50%) with slopes of 3 to 6%. However, it is important to emphasize that the areas with 20-40% declivity and >40%, are also expressive in the basin, totaling 29.02% of the basin (25638.6 ha), which, according to the referred authors, are not recommended for agriculture.
