The Integration of a Coal Mine Emergency Communication Network into Pre-Mine Planning and Development

**The Integration of a Coal Mine
Emergency Communication Network
into Pre-Mine Planning and Development**

Master of Science
in
Mining Engineering

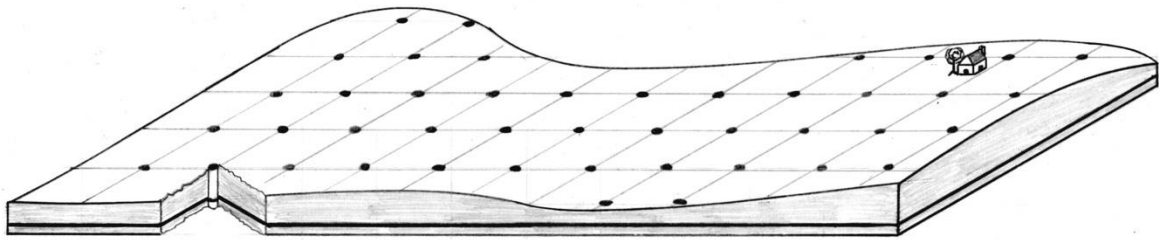
Figure 1.1: Exploration boreholes for an underground coal seam.

Mining companies invest hundreds of thousands of dollars on exploratory drilling which is a fundamental element of mine pre-planning. Often using a grid pattern with approximate half-mile centers, drillholes are made through the depth of the reserves to determine roof conditions, seam thickness, floor conditions, and coal characteristics. These point observations are then analyzed using a variety of methods. The drillholes are then fully grouted and sealed to prevent water and/or methane from gathering in the hole and, subsequently, the developed mine. Figure 1.1 illustrates this concept.

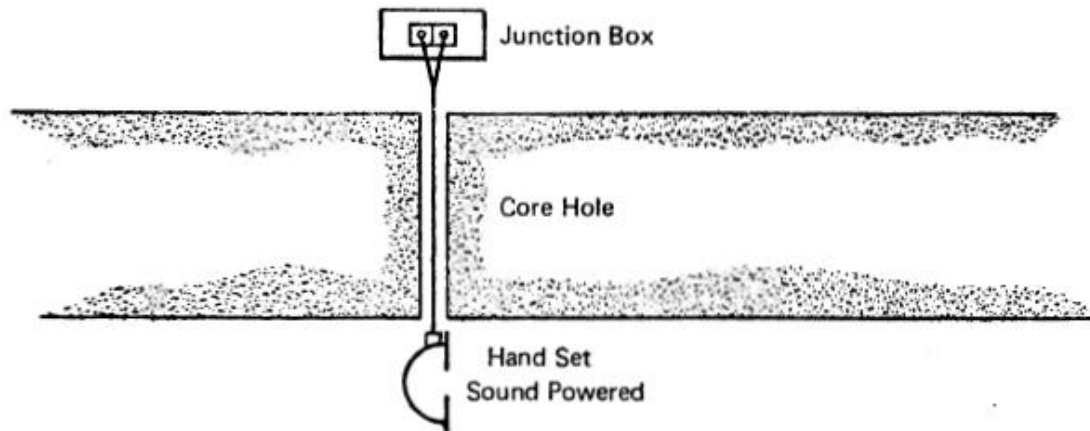
Figure 2.1: Corehole phone system (from Parkinson, 1972, p. 7).

This is illustrated in Figure 2.1. It is assumed that this concept was not explored much further due to the aforementioned stated objective of creating a comprehensive communication system. In addition, this report and the Foster-Wilson (1983) report assume open boreholes for the communication link which differs from the perspective taken with using exploration boreholes that are backfilled with grout. Also, possible hazards associated with the use of boreholes were not addressed by these reports, although they were occasionally mentioned. The research herein provides a communication link where some of the perceived hazards are eliminated, others can be shown to be no more likely than a random event, and still others must be addressed by significant additional research.

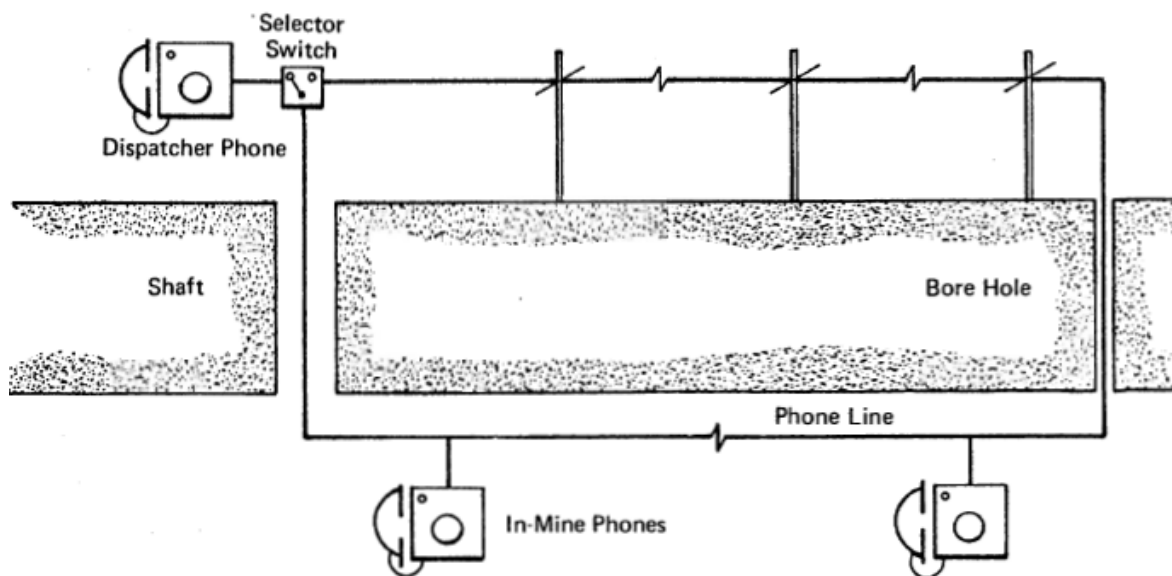
Figure 2.2: Looped Phone System (from Parkinson, 1972, p. 4)

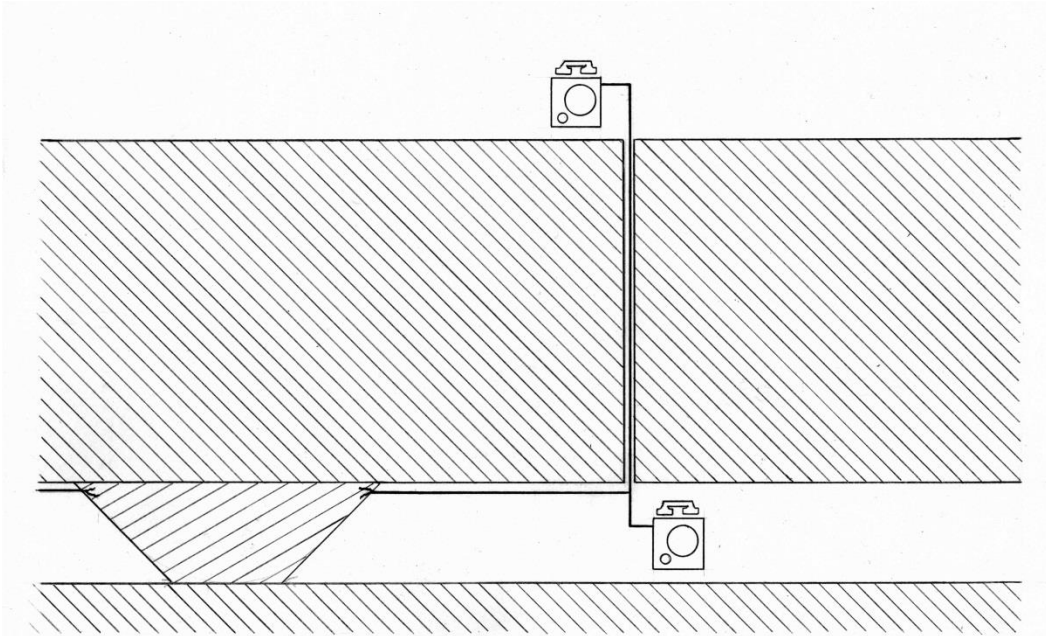
Figure 3.1: Basic concept of underground to surface communication using a drillhole, with primary communication system damaged by roof fall or similar event.

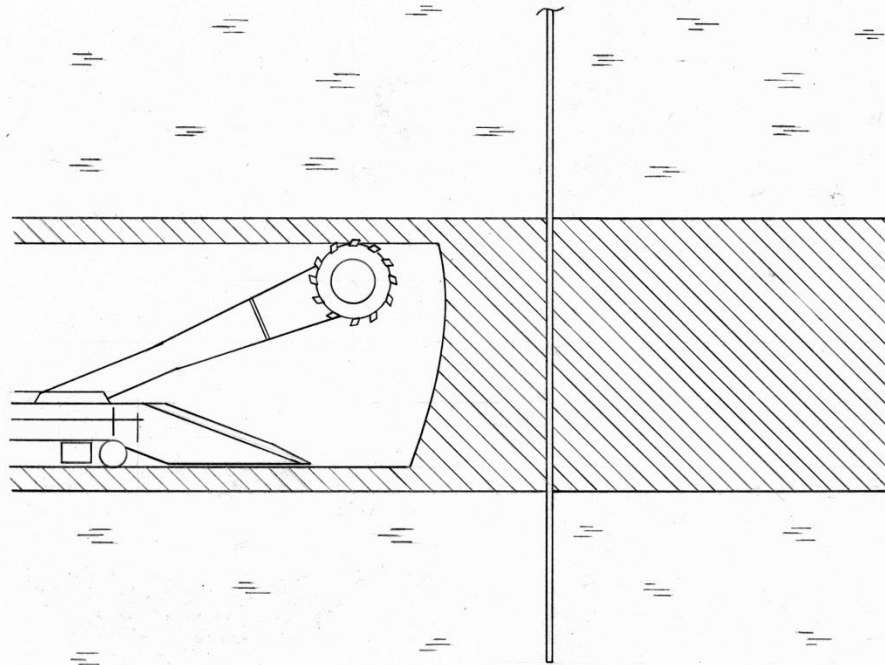
Figure 3.2: Depiction of continuous miner in coal seam prior to intersecting drillhole communication link. Drawing is to scale and represents an 8-foot coal seam with a 3-inch diameter drillhole extending approximately 7 feet below the bottom of the coal seam.

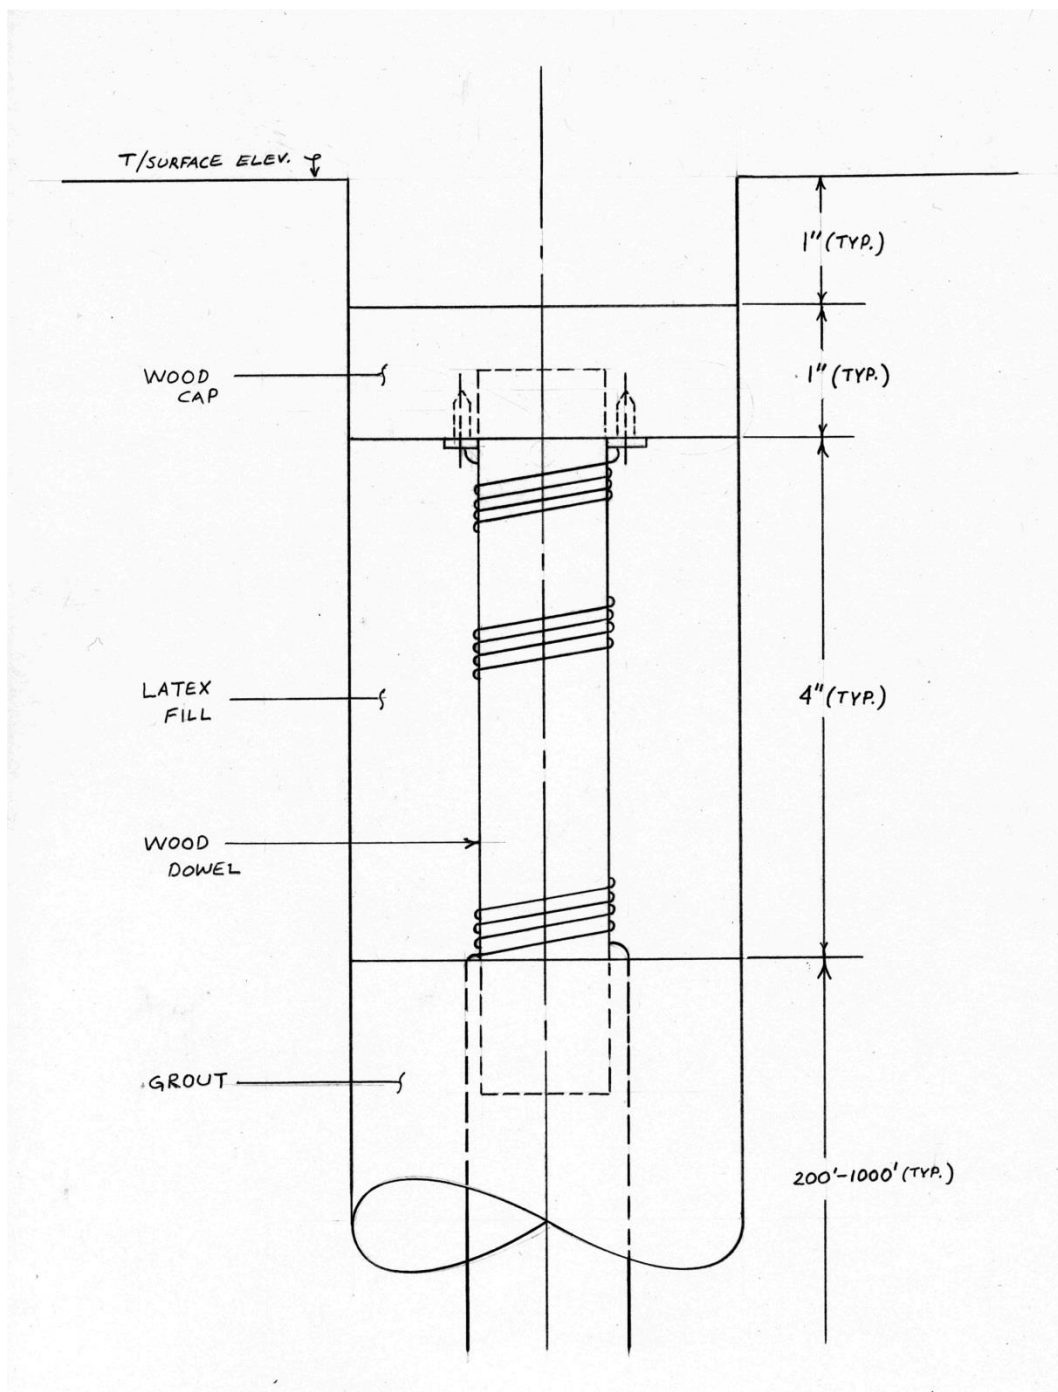
Figure 3.3: Suggested method of protection for surface elevation wires of communication link using exploration drillholes.

While the drillhole communication link is protected underground by the overburden until development reaches it, on the surface additional measures must be taken. Figure 3.3 shows a suggested method of protecting the communication link during the dormancy period between exploratory drilling (including placement of the embedded conductors) and underground mine development. As the conductors emerge from the grout, they are coiled around a wooden dowel approximately six inches below grade. The ends of the coiled wires are attached to a wooden cap using screws. Before the wooden cap is placed over the dowel rod around which the slack wire is coiled, the drillhole void is filled with latex rubber to provide a moisture barrier for corrosion protection. Earth is placed on top of the wooden cap, which can be marked to indicate that a communication wire is attached beneath it. When it is desired to activate the link, the cap is exposed and pulled upward, extracting the wires from the latex and rendering them available for connection to a sound-powered telephone, mine pager phone or other suitable communication device.

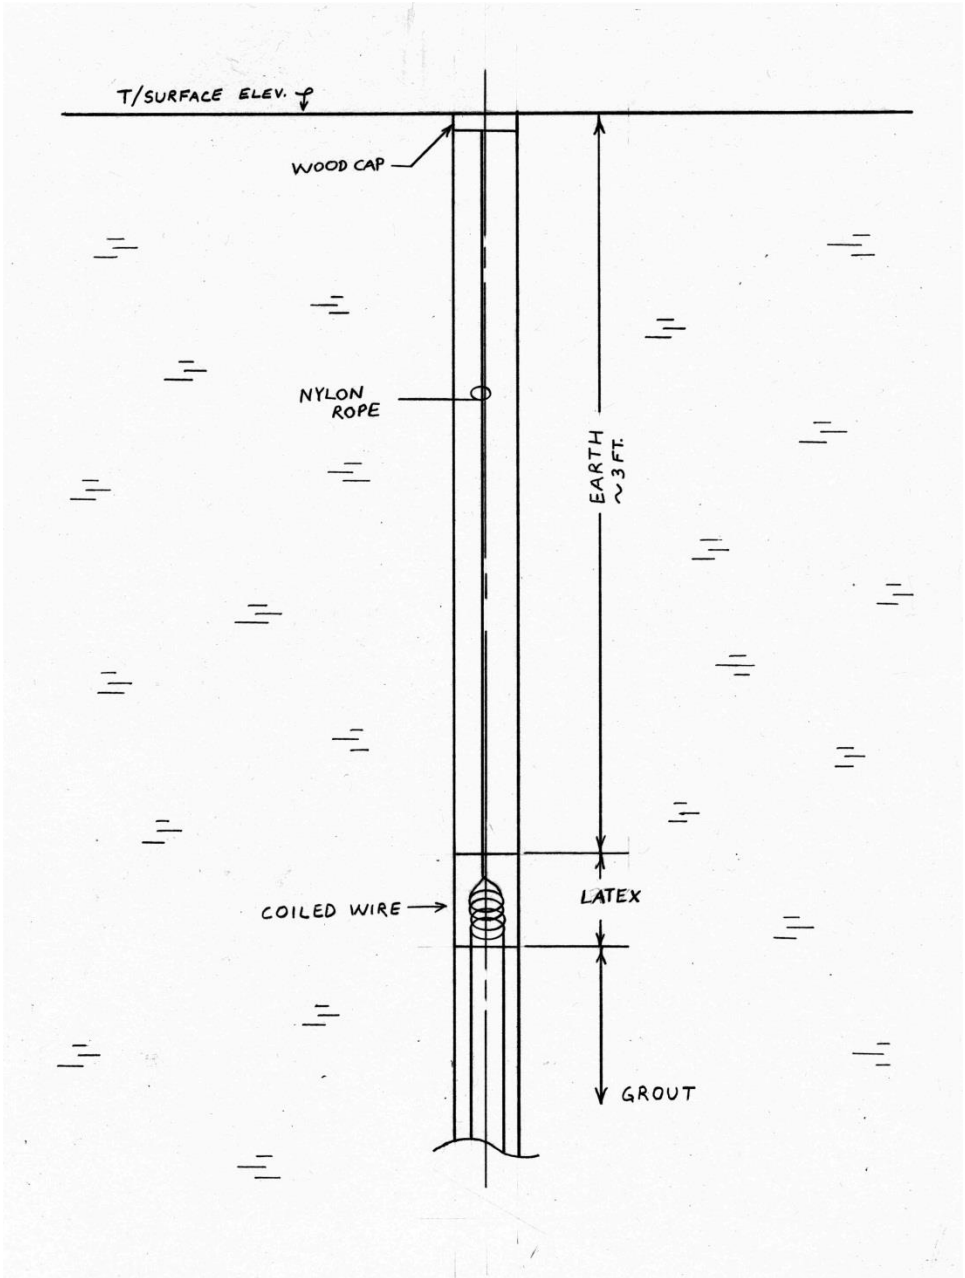
Figure 3.4: Alternate suggestion for top termination of drillhole communication link when top elevation of device must be placed significantly below grade.

Although it would be less desirable, and obviously more difficult to install, an alternate suggestion is shown in Figure 3.4 for the requirement that the top elevation of the drillhole communication link must be buried several feet below grade. The main difference between Figure 3.4 and Figure 3.3 is the addition of a nylon rope between the top cap and the coiled wires. Note that, in this scenario, a significantly larger quantity of wire would need to be cached in the drillhole above the grout.

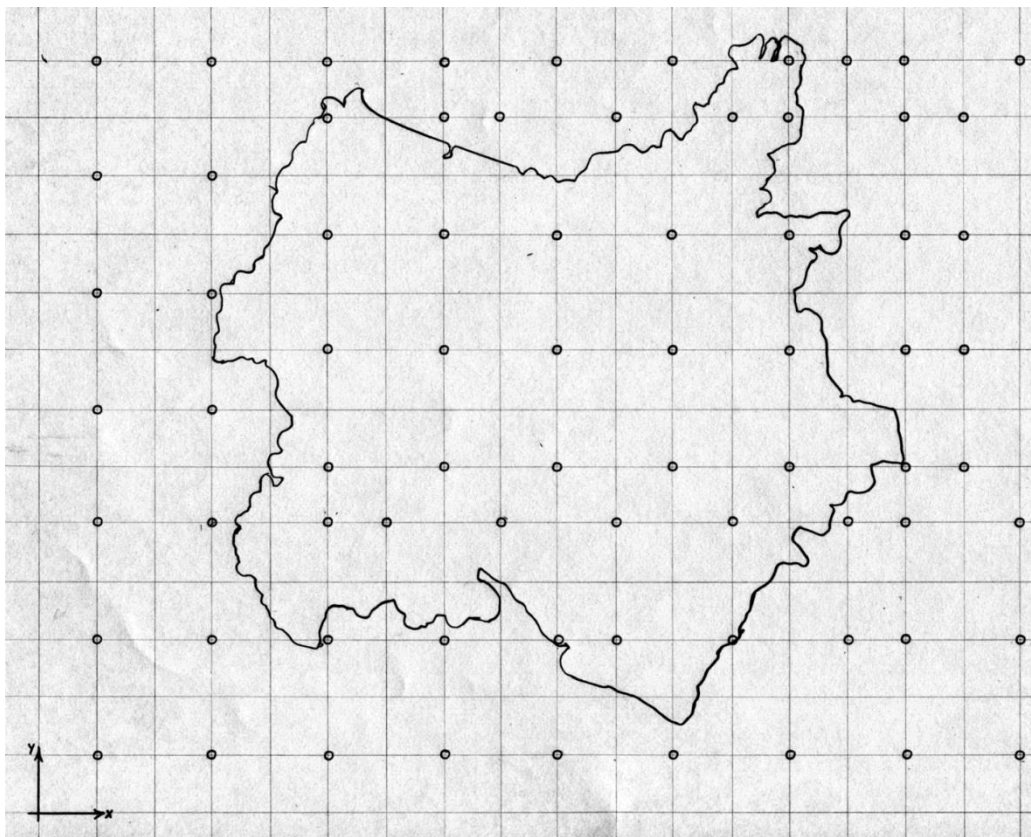
Figure 3.5: Exploration boreholes over a coal reserve.

Figure 3.5 represents a plan view of a coal reserve, with the layout of exploration boreholes, with the grid representing approximate half-mile spacing.

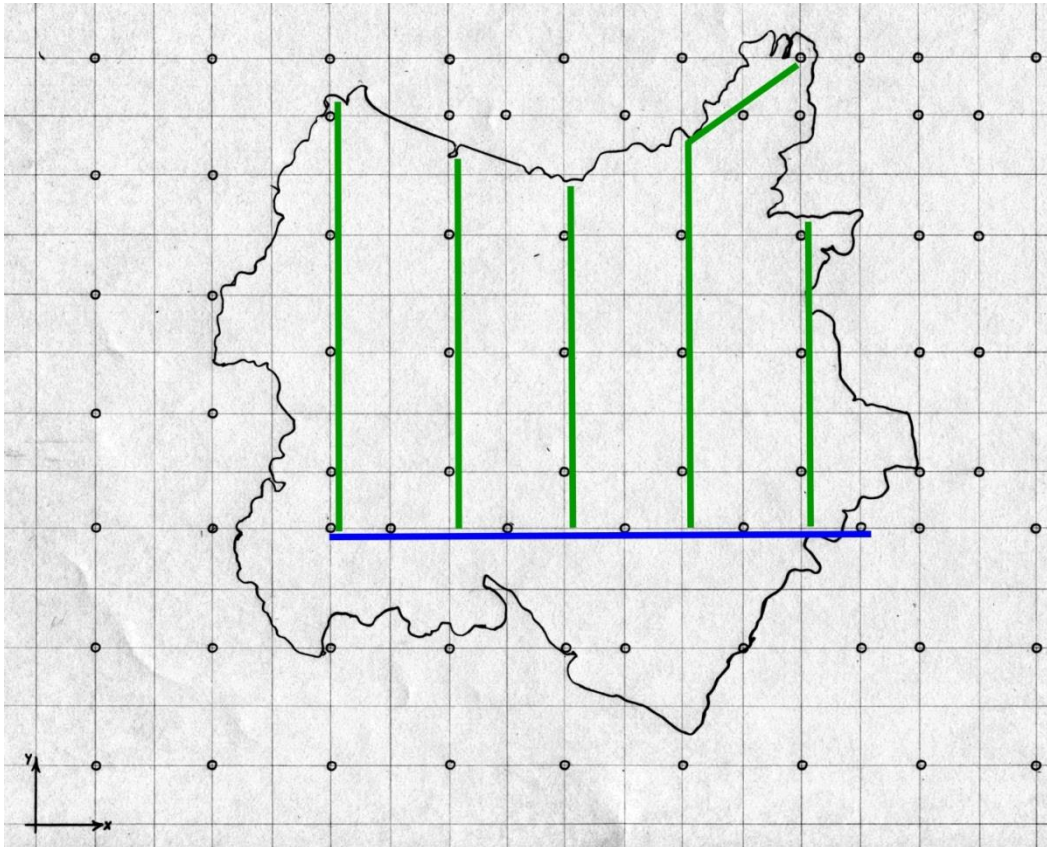
Figure 3.6: Proposed entries along paths that intersect exploration boreholes.

The principal directive is, during mine design, to layout the exploratory drillholes, which are generally located on half-mile centers, so that they also coincide with the planned underground mains, preferably at crosscuts forming intersections. This is recommended so that the holes are located in intake air instead of return or belt entries and it is desired to make any communication system as visible as possible. Additionally, locating the devices in mains provides a larger volume of intake air which may assist with the dilution of any methane which may be present. Main entries are usually part of the primary escapeway. With half-mile spacing connecting a single pager phone directly at the drillhole communication links would provide an emergency communication path, at best, every half mile along the entries as shown in Figure 3.6.

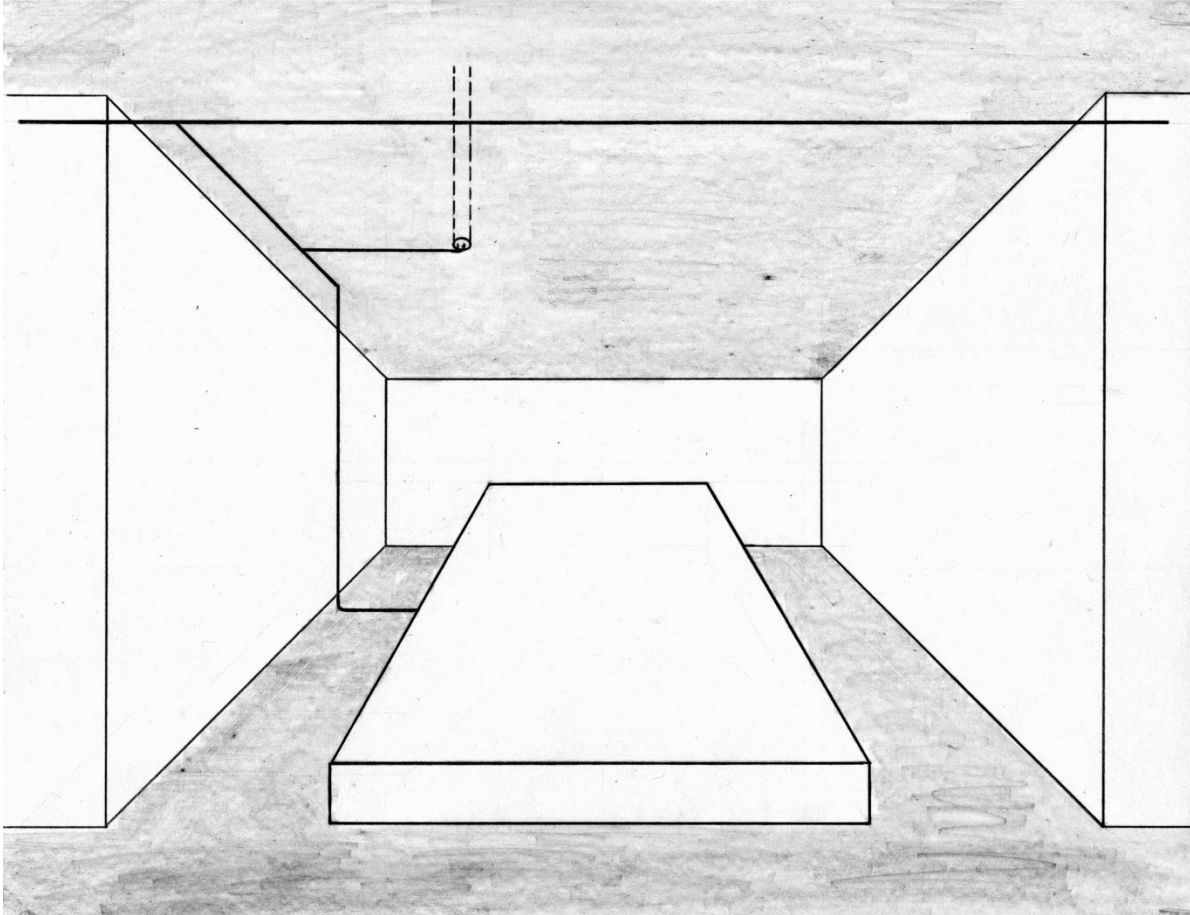
Figure 3.7: Drillhole communication link wires connected to mine telephone system and refuge chamber in crosscut.

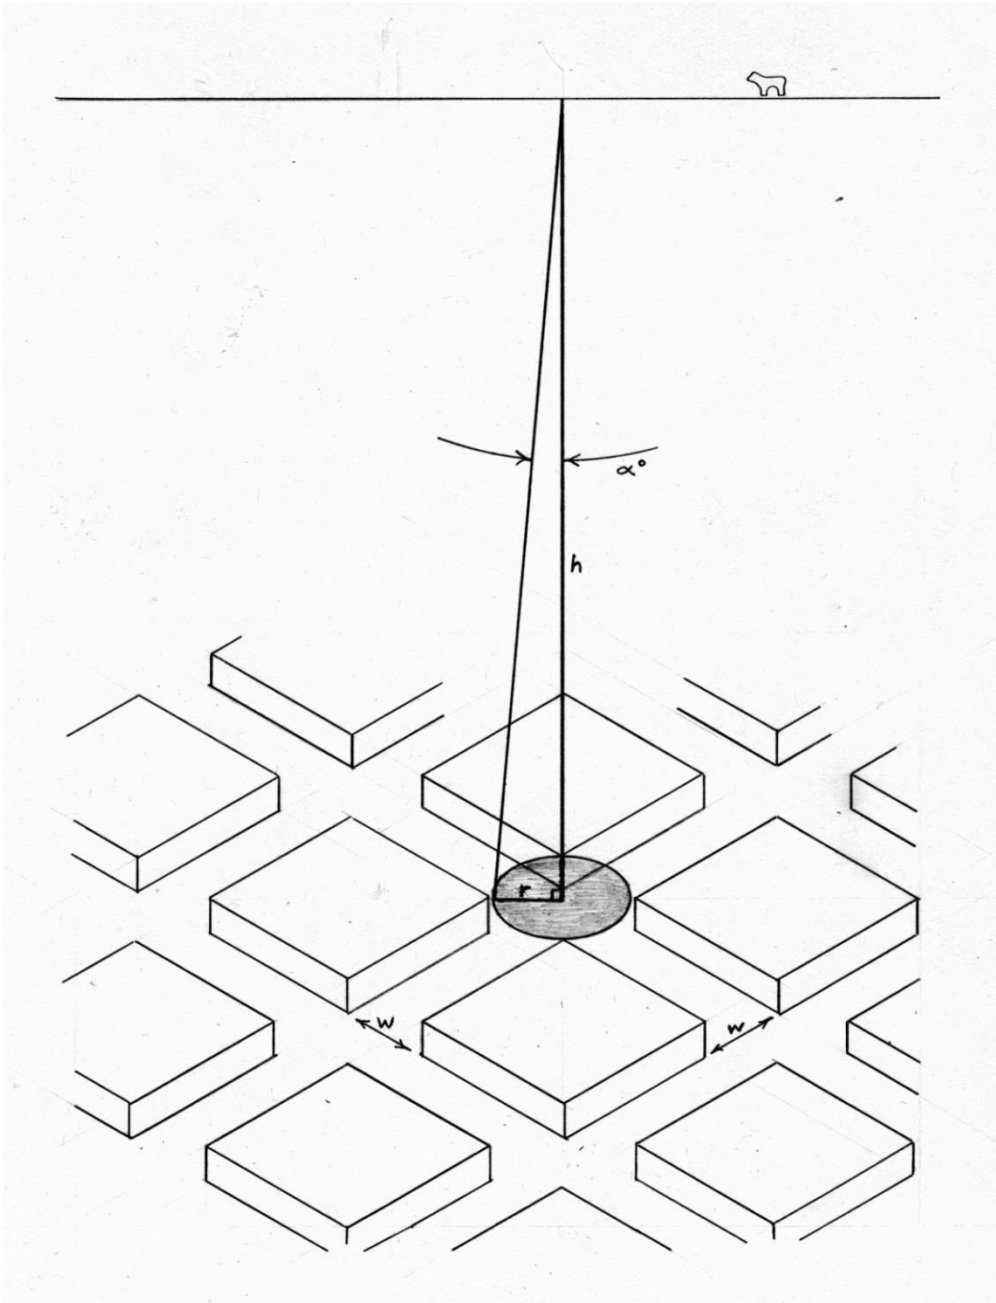
Figure 3.8: For calculation of maximum allowable angular deflection from vertical.

As an example, assume an entry width for the mains is a nominal twenty (20) feet, then the maximum allowable angular deflection can be tabulated as a function of overburden height, h , as shown in Table 3.1.

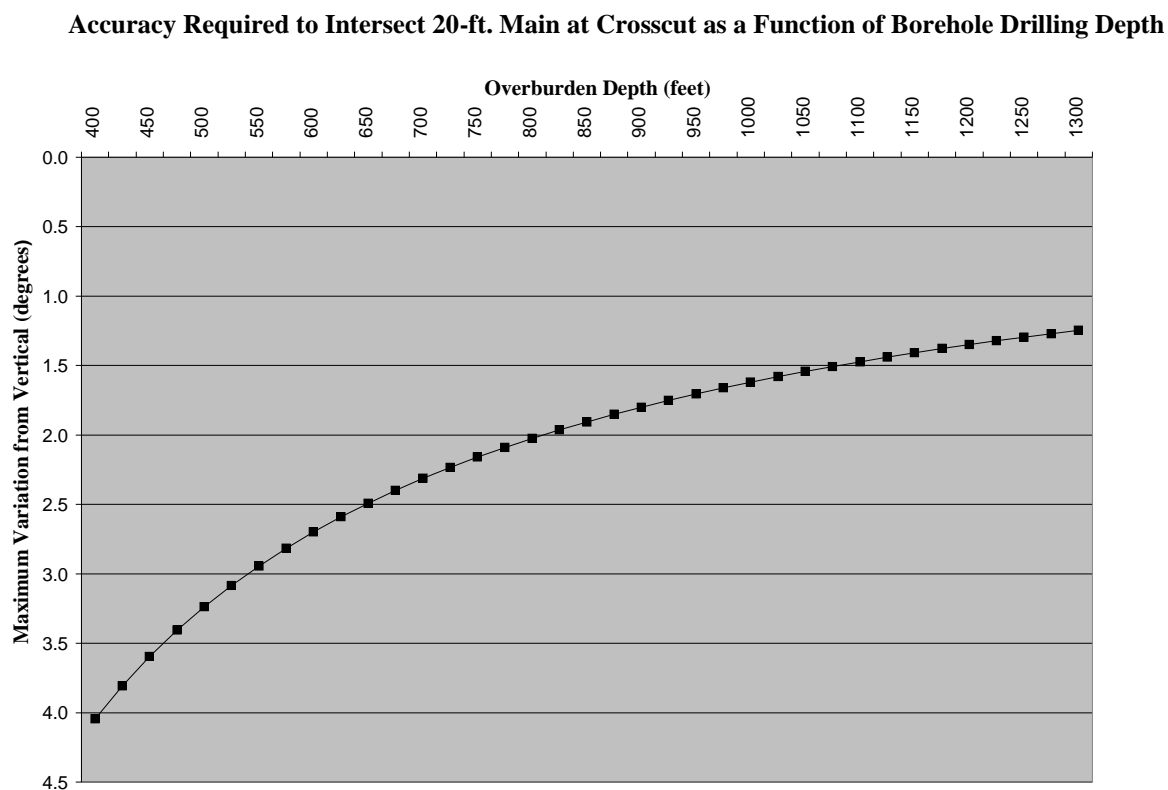
Figure 3.9: Maximum deviation from vertical for an exploration drillhole rig to be able to intersect a 20-ft. x 20-ft. intersection, as a function of overburden depth.

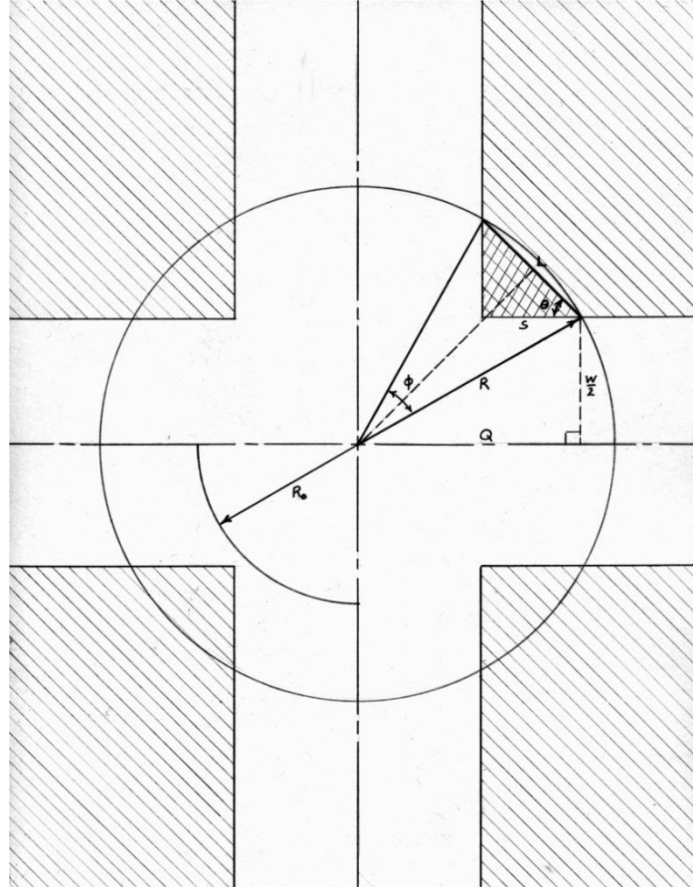
Figure 3.10: Drilling deviation radius with relation to underground intersection.

where the area occupied by coal can be represented by the sum of the triangles $S-L-S$ plus the circular segment at L in Figure 3.10, with the area of the circular segment calculated by subtracting the area of triangle $R-L-R$ from the sector created by the angle ϕ .

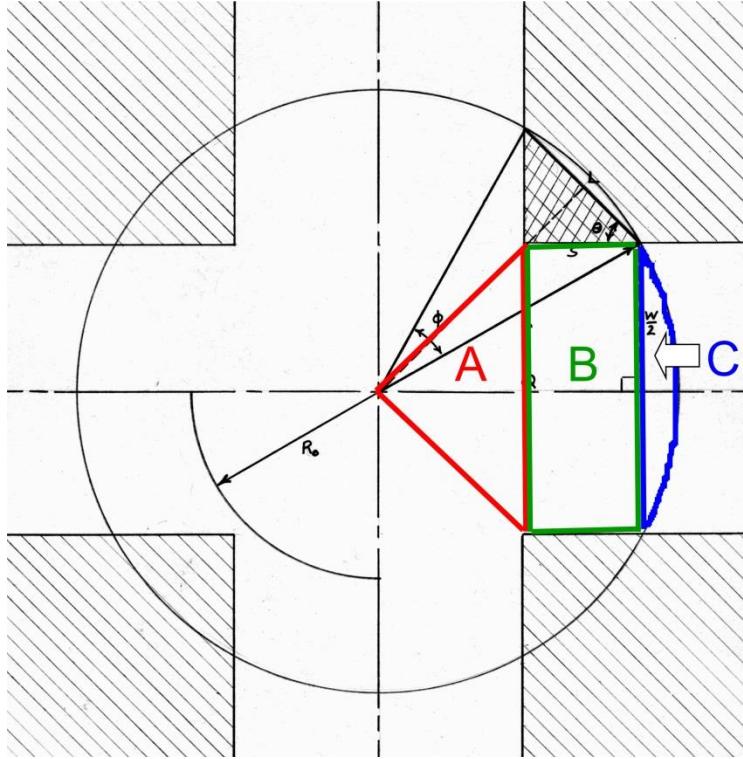
Figure 3.11: Three areas used for calculation of open workings.

This will be substituted back into the derivation later. For now, consider Figure 3.11. Instead of dividing the circle into the four standard quadrants, as in Figure 3.10, consider four quadrants separated by axes defined on $(\pi/4)$ and $(-\pi/4)$. Now, the open workings for any such quadrant are comprised of the area of the triangle, A , the rectangle, B , and the circular segment, C .

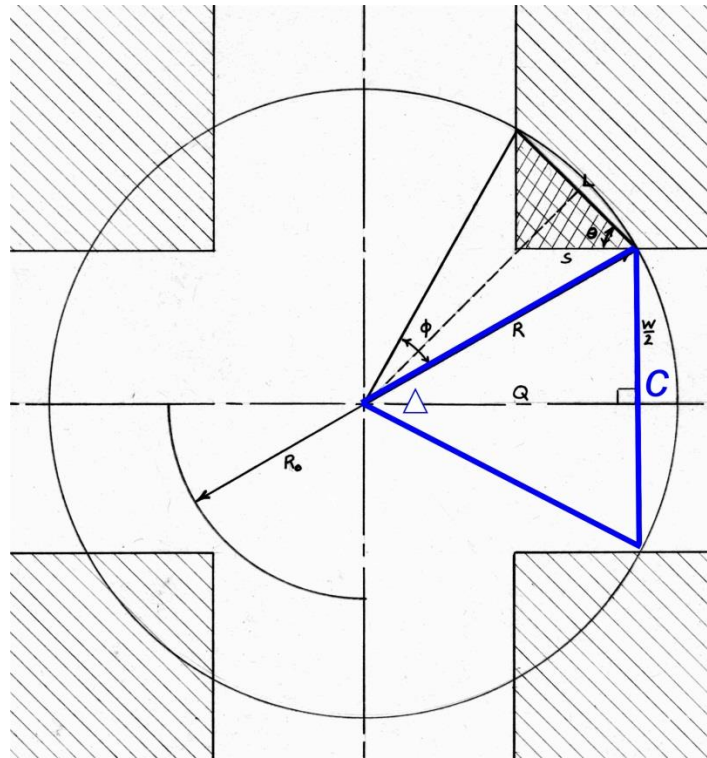
Figure 3.12: Deflection angle and long chord.

As Figure 3.12 shows, for a deflection angle Δ , a triangle can be formed with a hypotenuse equal to the deviation radius, R , and a short side with a length of half an entry width.

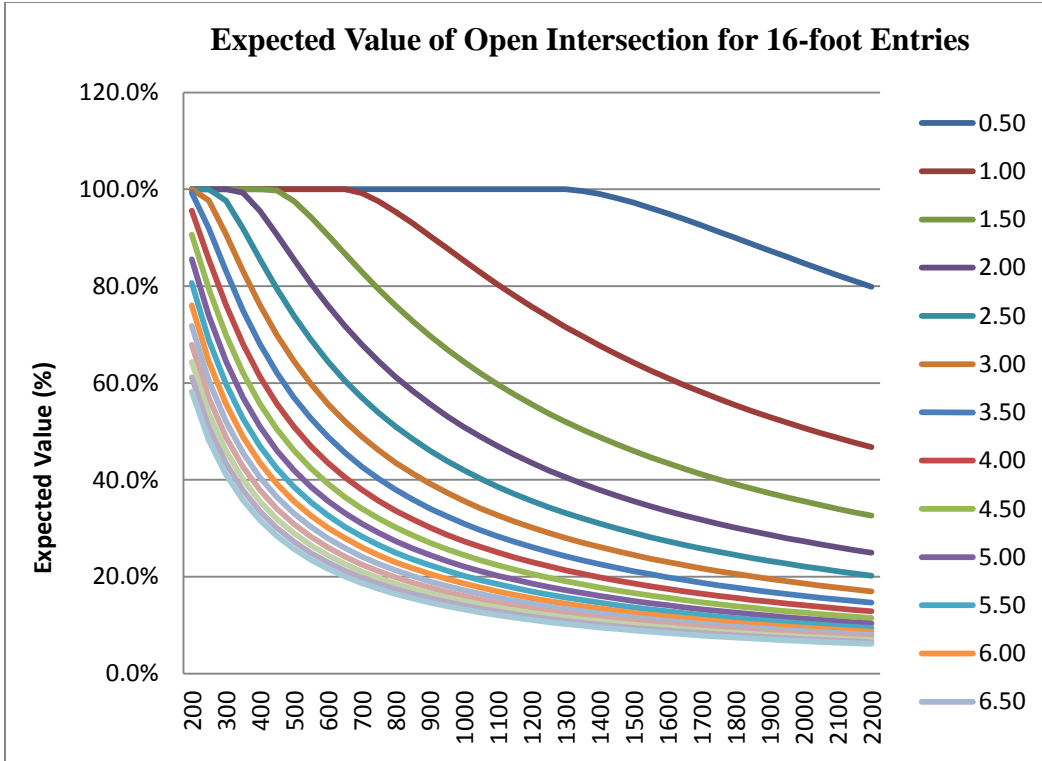
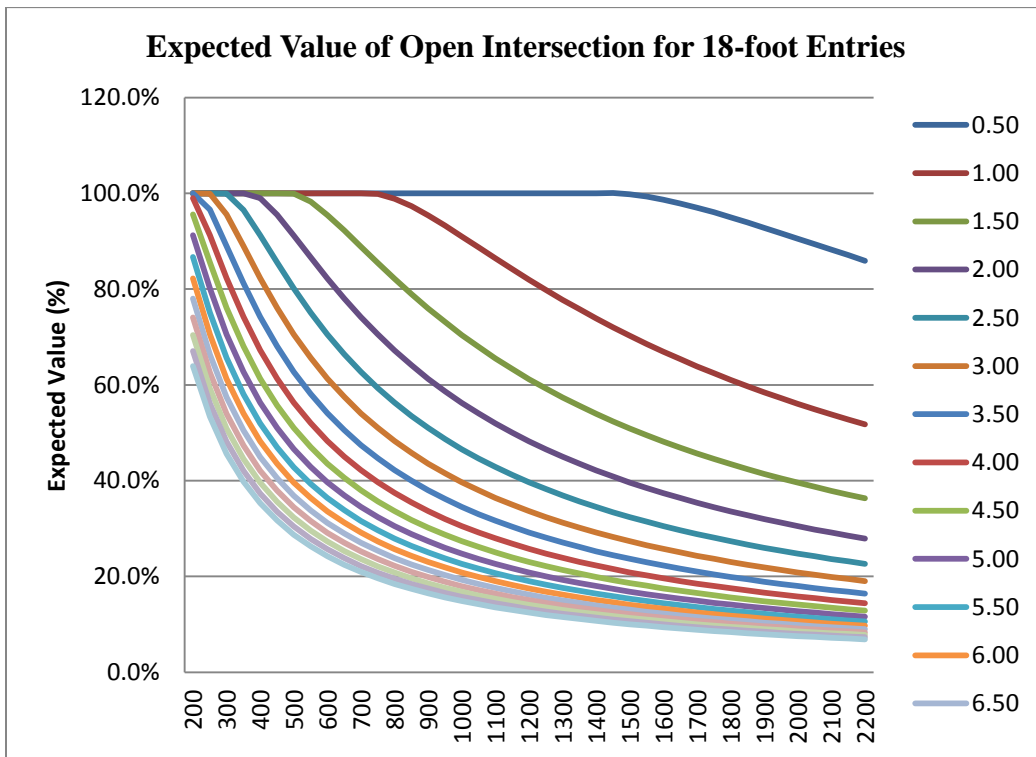
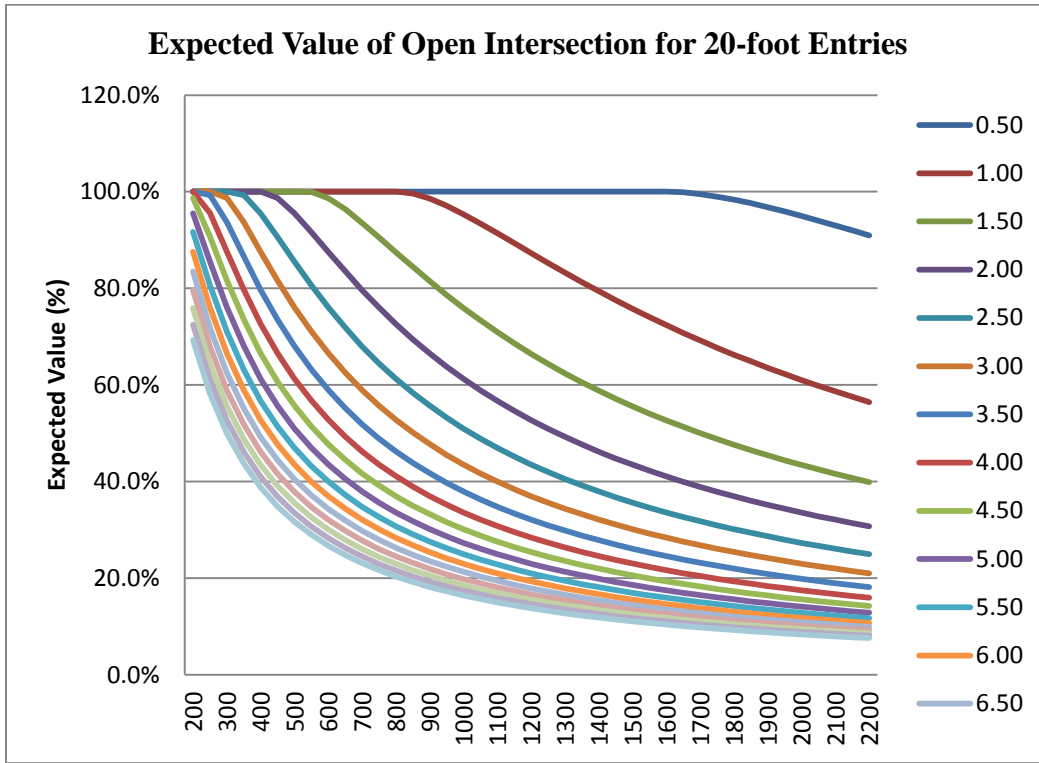
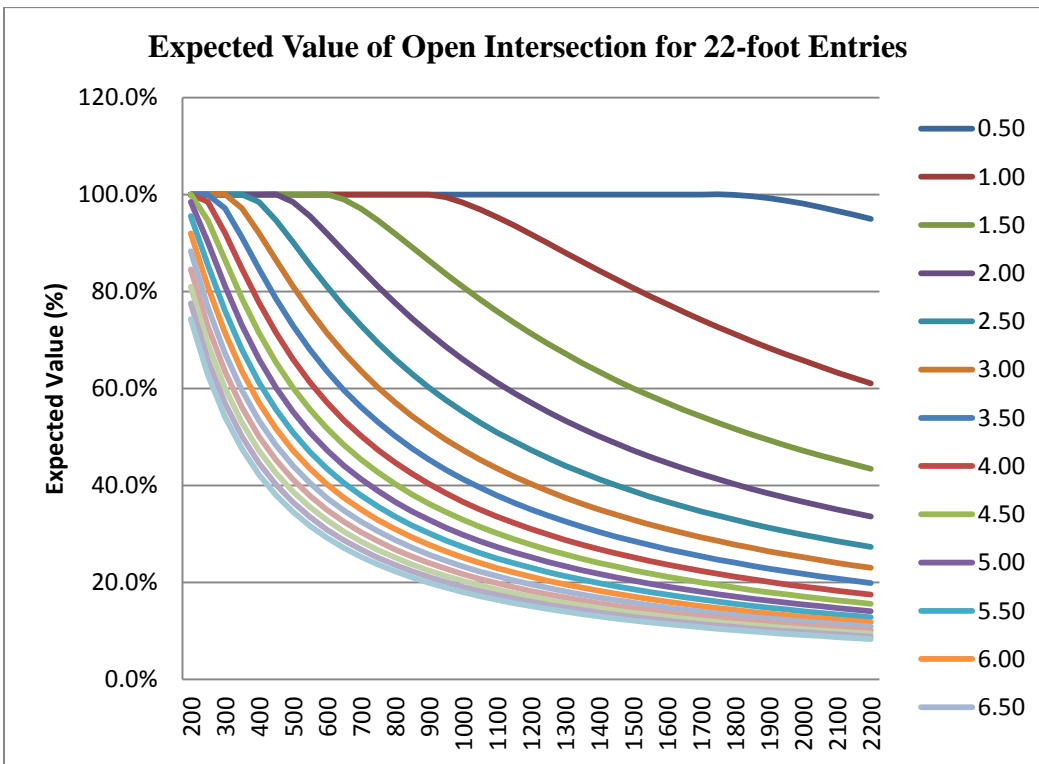
Figure 3.13: Likelihood of intersecting open area vs. overburden, 0.5-8.5 degrees deviation, 16 ft. entry.

Figure 3.14: Likelihood of intersecting open area vs. overburden, 0.5-8.5 degrees deviation, 18 ft. entry.

Figure 3.15: Likelihood of intersecting open area vs. overburden, 0.5-8.5 degrees deviation, 20 ft. entry.

Figure 3.16: Likelihood of intersecting open area vs. overburden, 0.5-8.5 degrees deviation, 22 ft. entry.

These calculations and curves should be viewed as generating a conservative estimate since empirical studies have indicated that “. . . the sum of the diagonals was 3-4 ft. wider than in the shallow mines with the same entry width, probably because of greater rib sloughage” (Molinda *et al.*, 2000, p. 69).

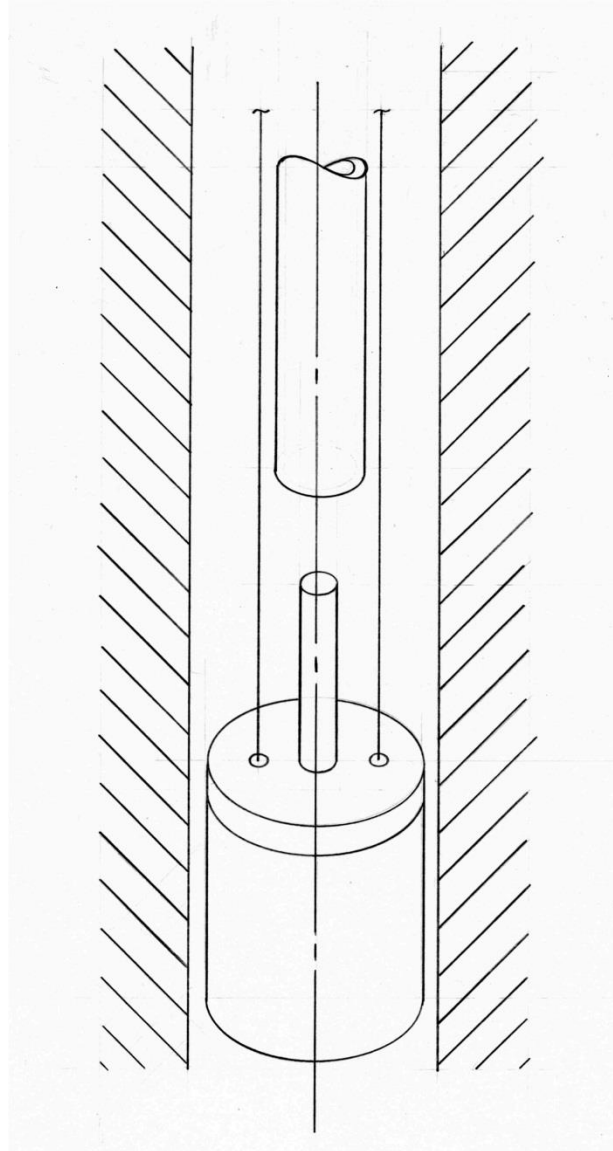
Figure 3.17: Original concept sketch depicting a “plug” delivered to the bottom of the drillhole via the grout delivery pipes.

Figure 3.17 shows the original concept drawing for a sacrificial plug which could be pushed to the bottom of the drillhole by the one-inch diameter grout delivery rigid pipe (or tubing), with the conductors extending upwards toward the surface. The pilot shaft on the plug would engage the grout delivery pipe to keep the plug vertical until it reached bottom. As grout would be pumped through the delivery pipe, it would quickly surround the plug in the drillhole and the viscosity of the grout would provide enough weight and frictional fluid restriction to prevent significant movement on retraction of the grout delivery pipe, leaving the plug to hold the conductors in place in the drillhole, embedded within the grout. Should the grouting operator be concerned about flotation of the plug, a spring assembly such as that found on extensometers could also be used.

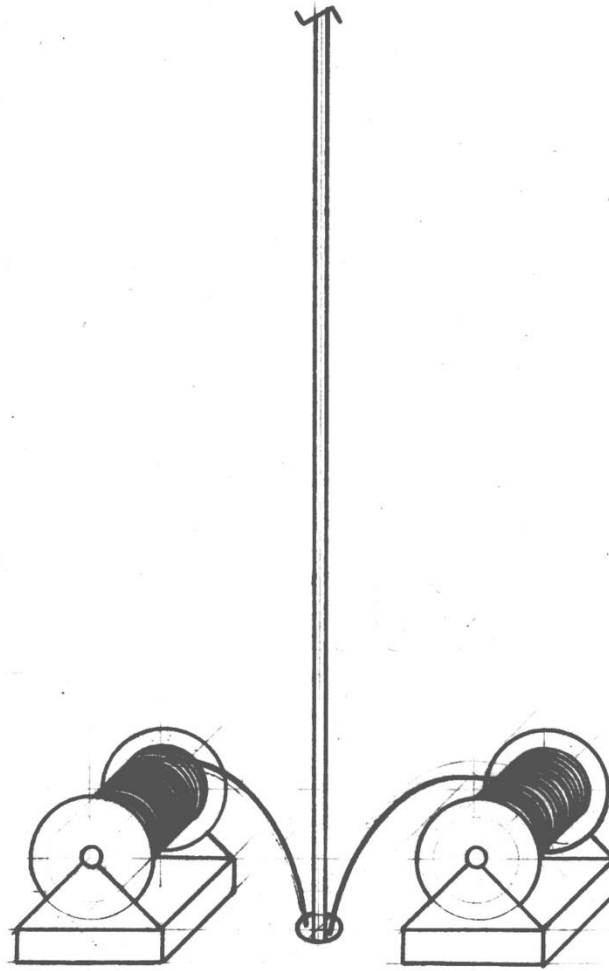
Figure 3.18: Original concept sketch for feeding of communication conductors.

Figure 3.18 shows the concept sketch for two spools of conductors, located approximately 180 degrees apart and generally in an area that would be clear of other equipment required for the grouting operations. This arrangement is similar to that which is used for the installation of borehole extensometers and time domain reflectometry (see Dowding *et al.*, 1986, for example). The conductors are slowly fed from the spools as the grout delivery pipe pushes the plug to the bottom of the drillhole. Minimal resistance would need to be applied to the spools to maintain tension on the conductors during descent.

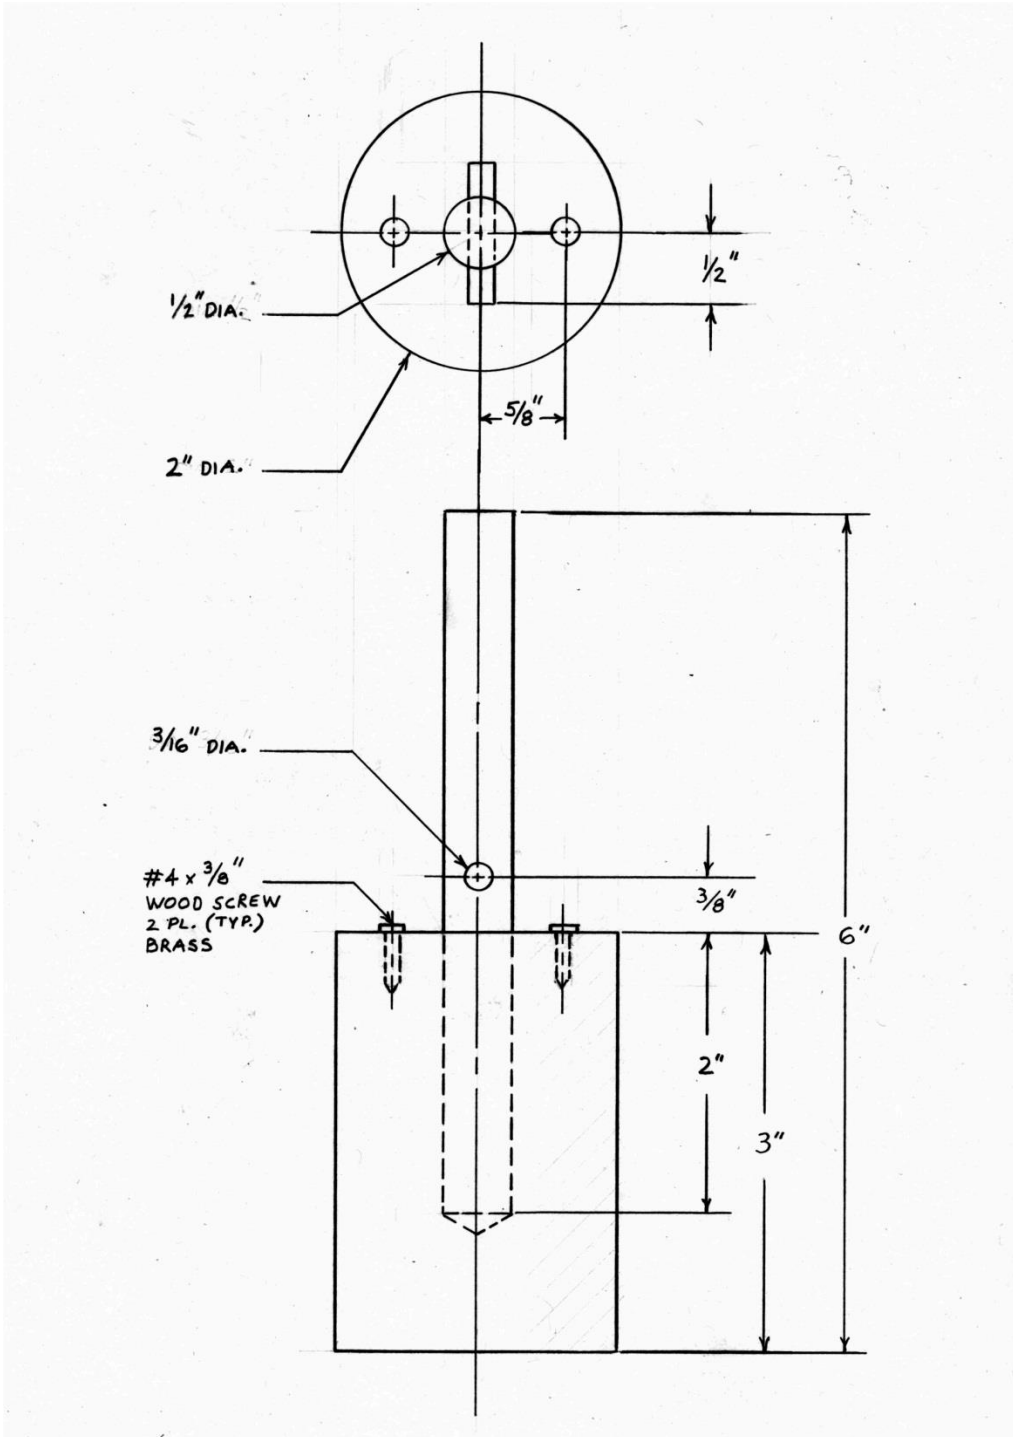
Figure 4.1: Plug design with anti-spin pin.

This design also incorporates a pin that fits into a slot on the inboard end of the grout delivery pipe, as shown in Figure 4.1. While the pilot shaft provides vertical alignment, the pin prevents rotation of the sacrificial plug on descent. If such a slot has not been prepared in a pipe delivered to the field site, a “V”-shaped notch can be cut in the end of any one of the grout delivery pipes to saddle the alignment pin shown in Figure 4.2. Combined with the tension on the conductors this assembly would hold the plug in place until delivery of grout cause it to remain at the bottom of the borehole.

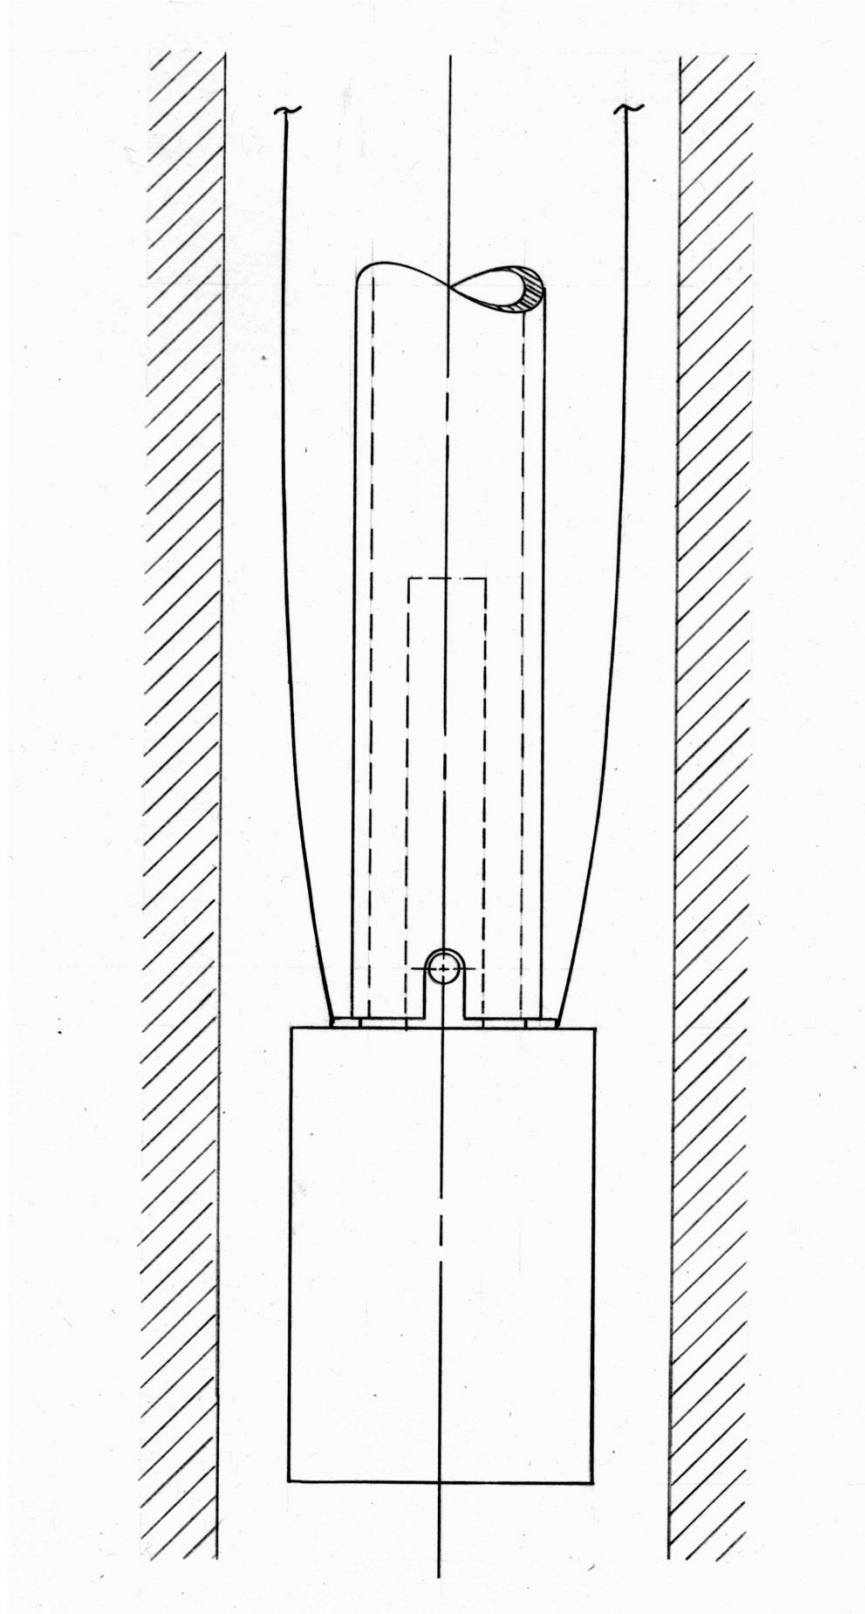
Figure 4.2: Plug with anti-spin pin on end of grout delivery pipe inside drillhole.
