The Integration of a Coal Mine Emergency Communication Network into Pre-Mine Planning and Development

**The Integration of a Coal Mine
Emergency Communication Network
into Pre-Mine Planning and Development**

Master of Science
in
Mining Engineering

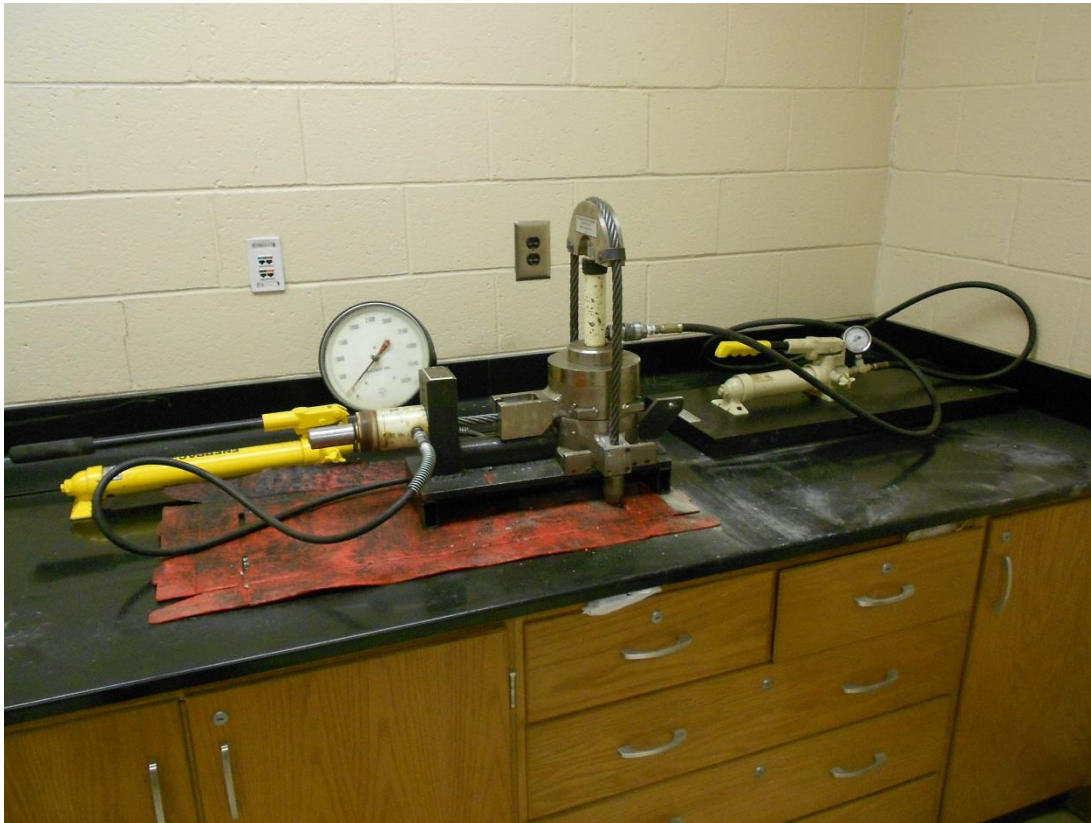
Figure 5.1: Direct shear testing device. Hydraulic press for normal load on top right (white) and for shear load on left (yellow).

The test was performed by placing each three-inch diameter sample into two 2-1/2” tall circular platens stacked vertically on their centerline. With the bottom platen is held in a fixed position, the top platen was moved by a hydraulic ram attached to a dial indicator that recorded the highest strength obtained before failure of the sample. A normal load was also applied. The testing device used was the Structural Behavior Engineering Laboratories, Inc. Direct Shear Machine, Model No. RM101.⁴ This machine is pictured in Figure 5.1.

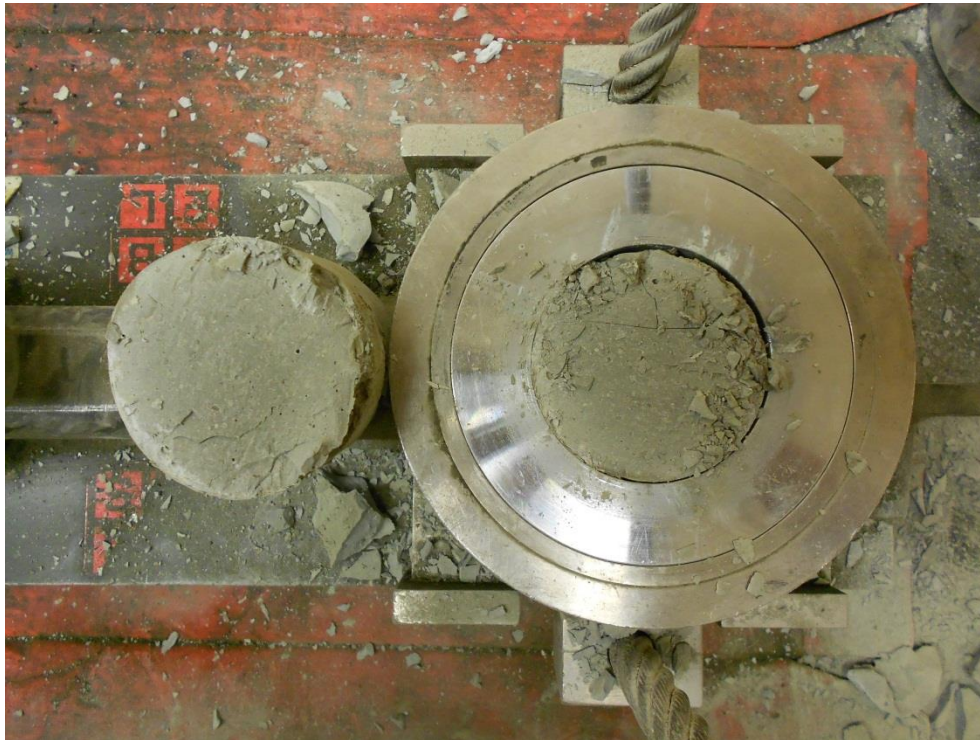
Figure 5.2: Sample A05 Post-Test. Lean grout without embedments.

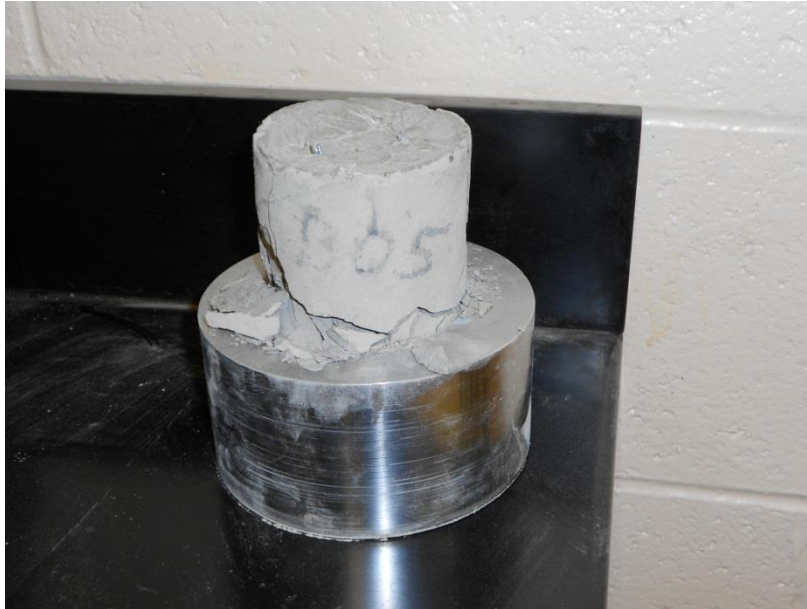
Figure 5.3: Sample B05 Post-Test. Fractures propagating along embedments.

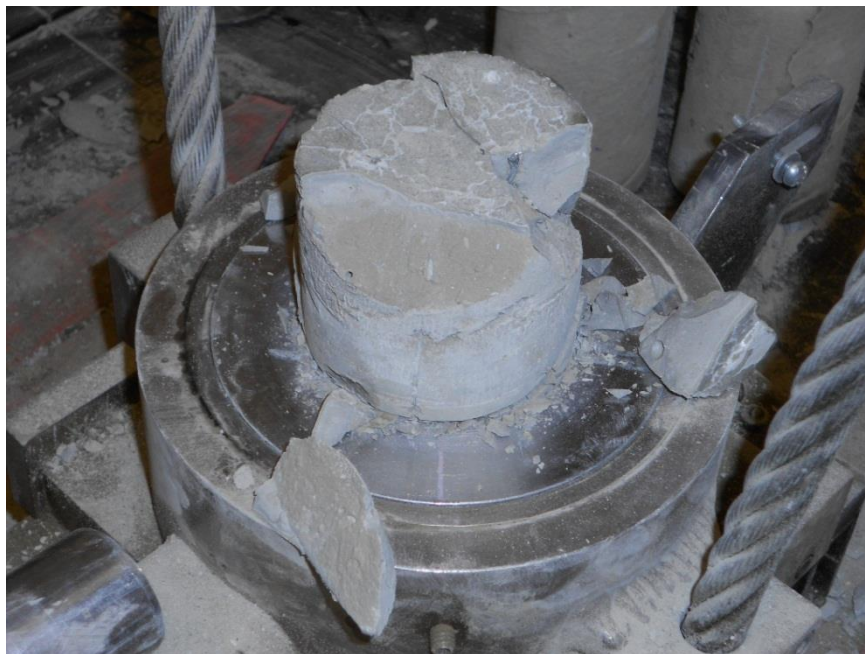
Figure 5.4: Sample B01 Post-Test. Fractures propagating along embedments.

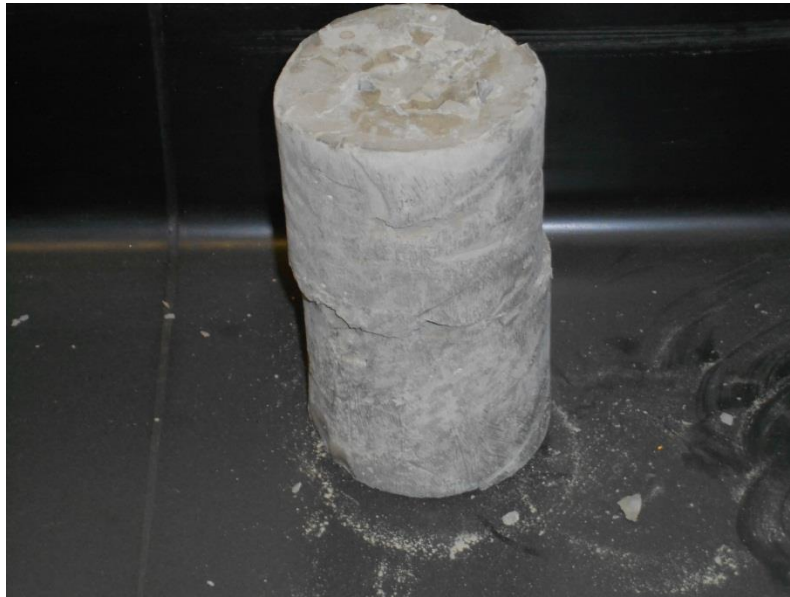
Figure 5.5: Sample C03 Post-Test. Embedments solid with fracture confined to plane of shear force.

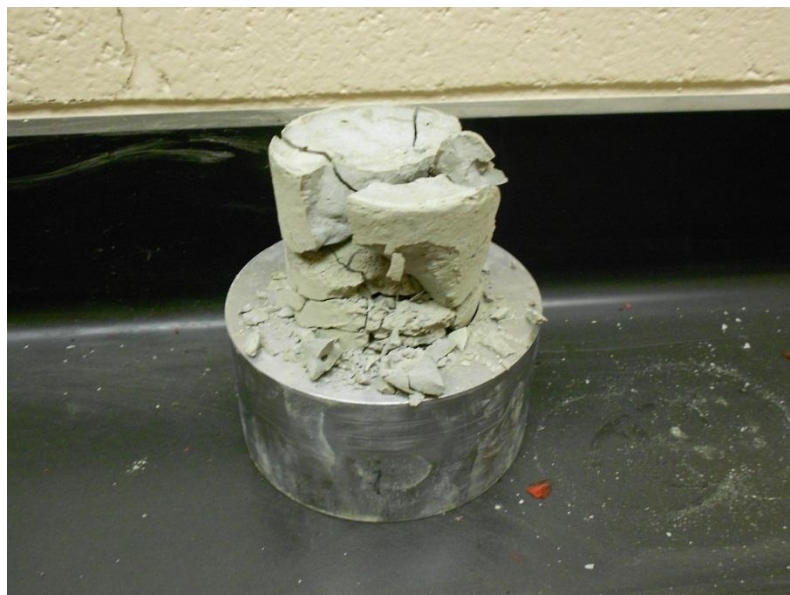
Figure 5.6: Sample C05 Post-Test. Shattering around embedments.

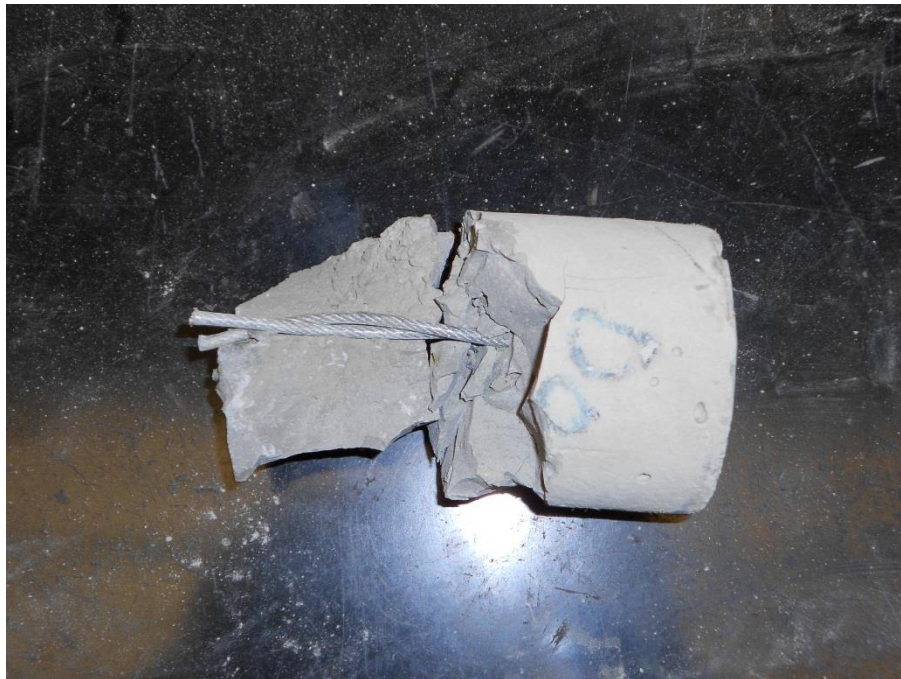
Figure 5.7: Sample D05 Post-Test. Top of sample to right.

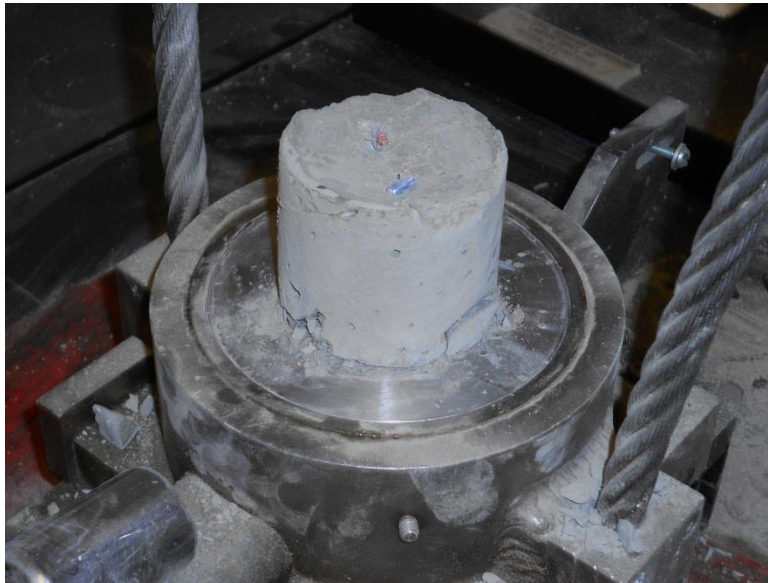
Figure 5.8: Sample E05 Post-Test. Before removal from platen. Shows structure of fracture.

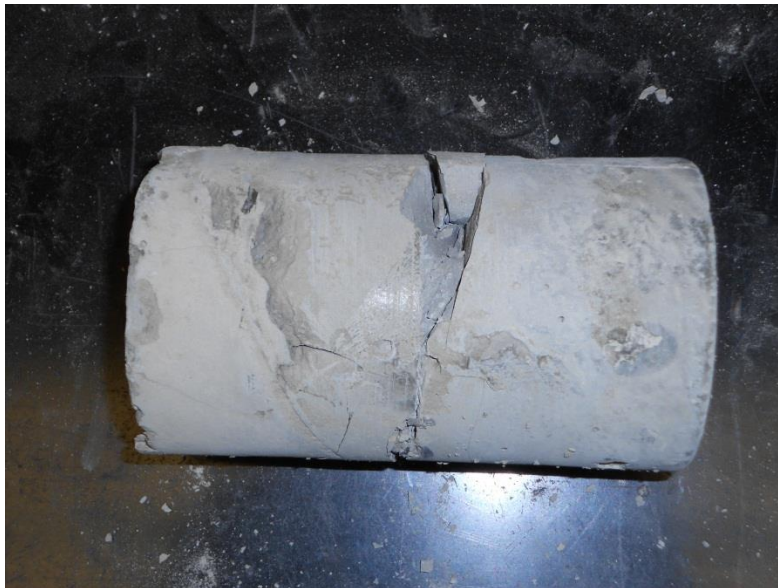
Figure 5.9: Sample E01 Post-Test. Fracture along plane of direct shear load.

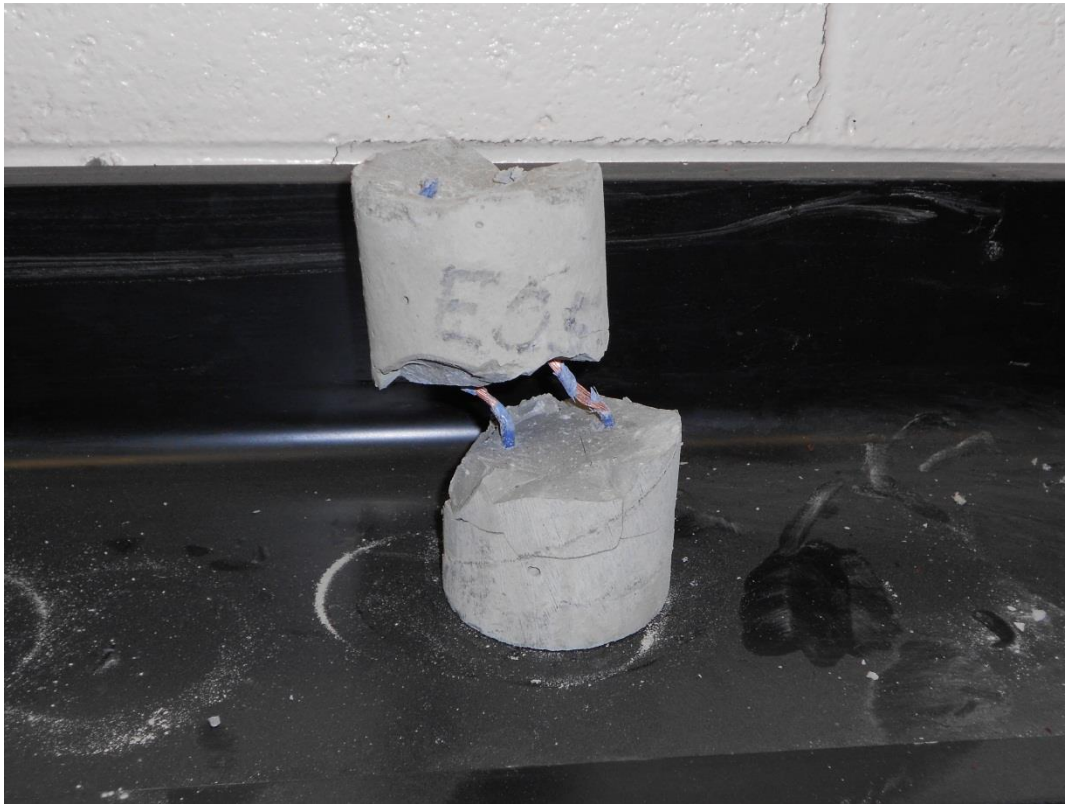
Figure 5.10: Sample E05 Post-Test, after displacement pull.

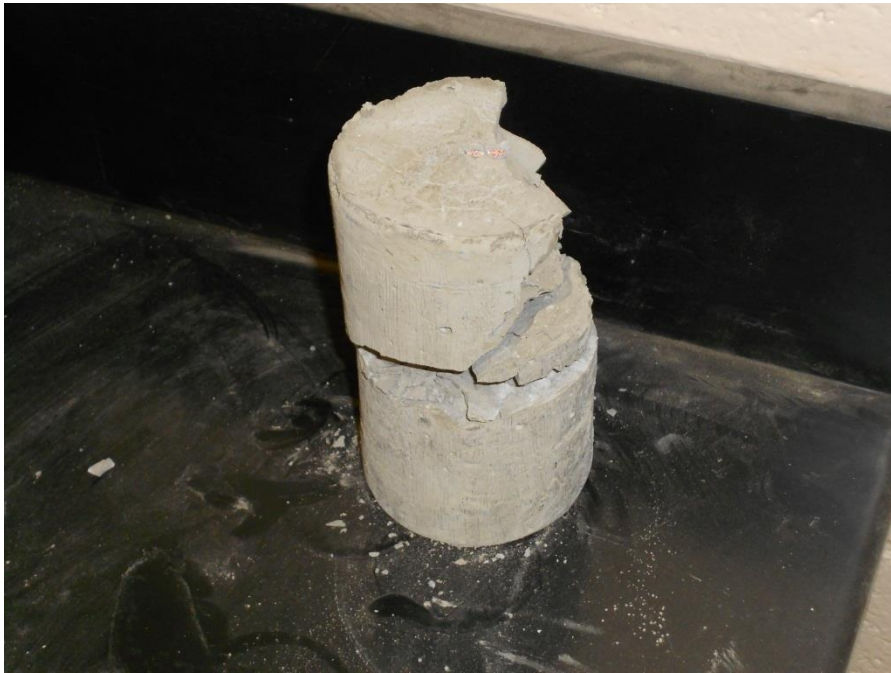
Figure 5.11: Sample F04 Post-Test. Angular cracks from plane of direct shear load.

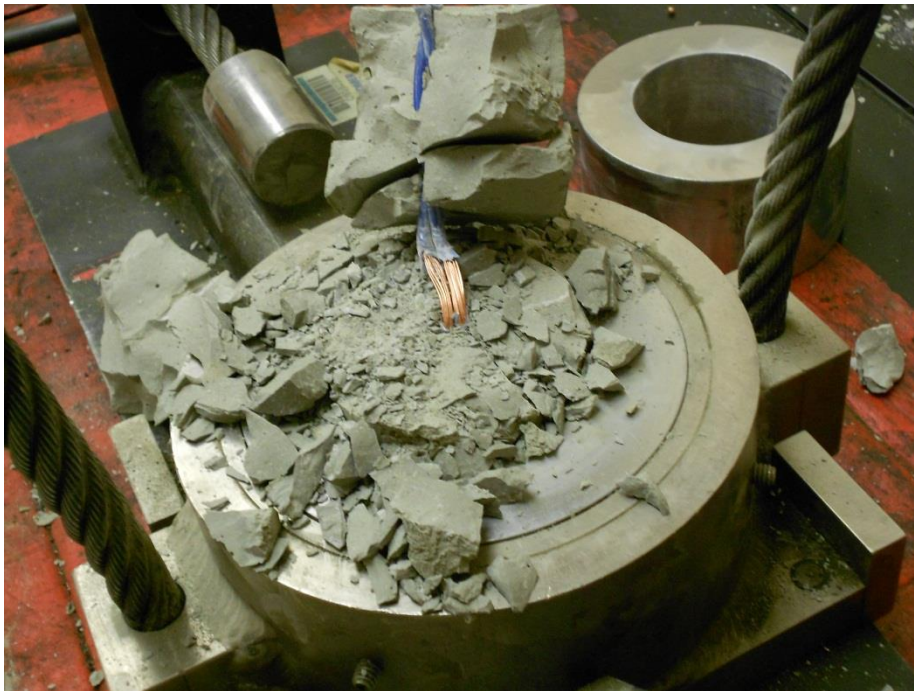
Figure 5.12: Sample F06 Post-Test. On displacement pull, exposed copper wires can make contact.

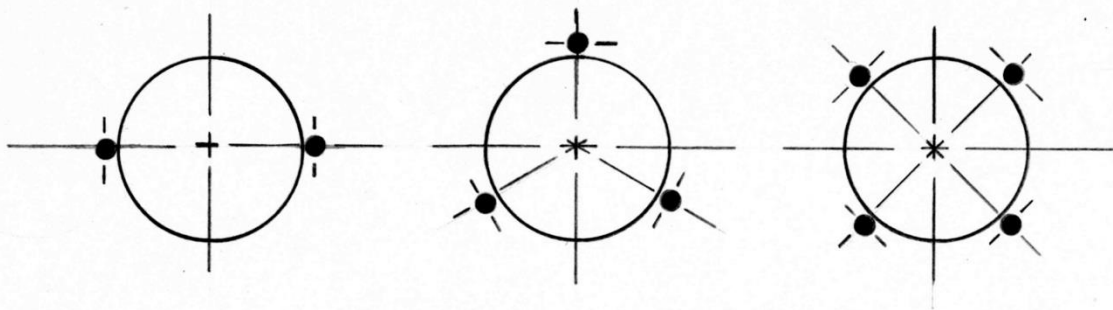
Figure 5.13: Two-, three-, and four-wire configurations.

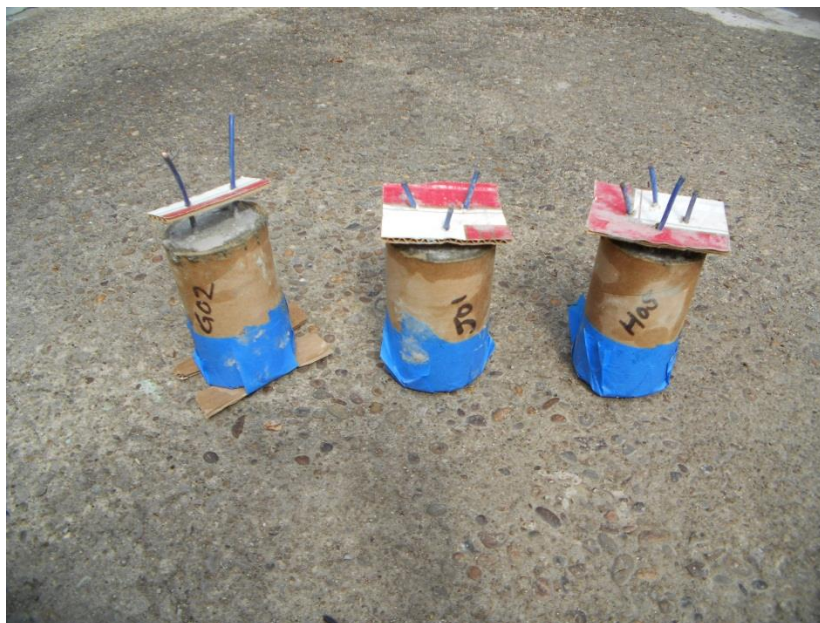
Figure 5.14: Two-, Three-, and Four-Wire configurations with stabilizers to maintain separation radius.

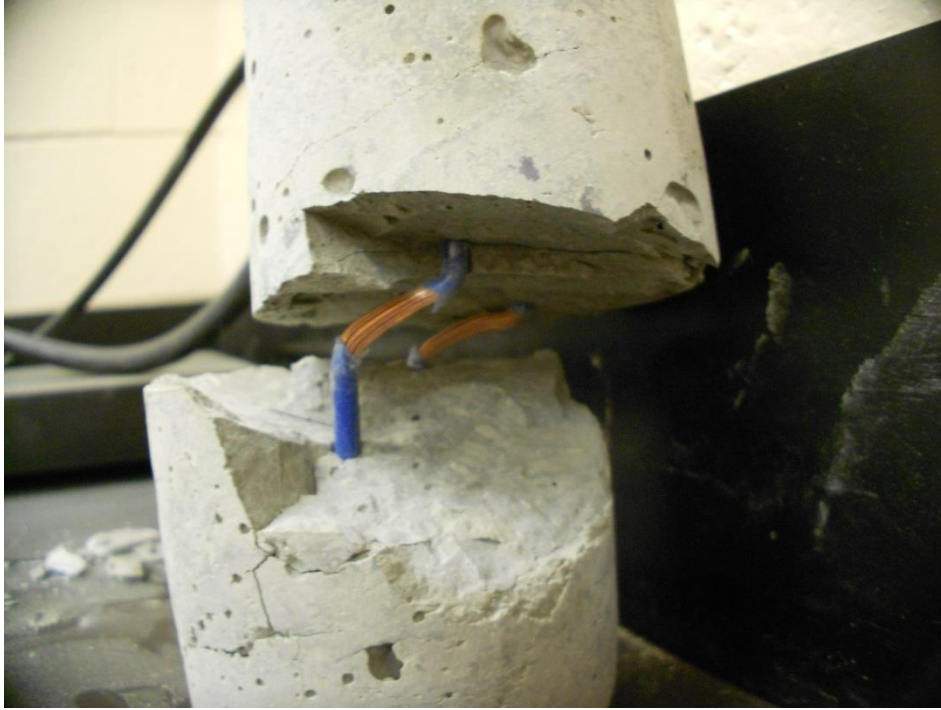
Figure 5.15: Sample G04 Post-test. Wires stripped but are not in contact on displacement.

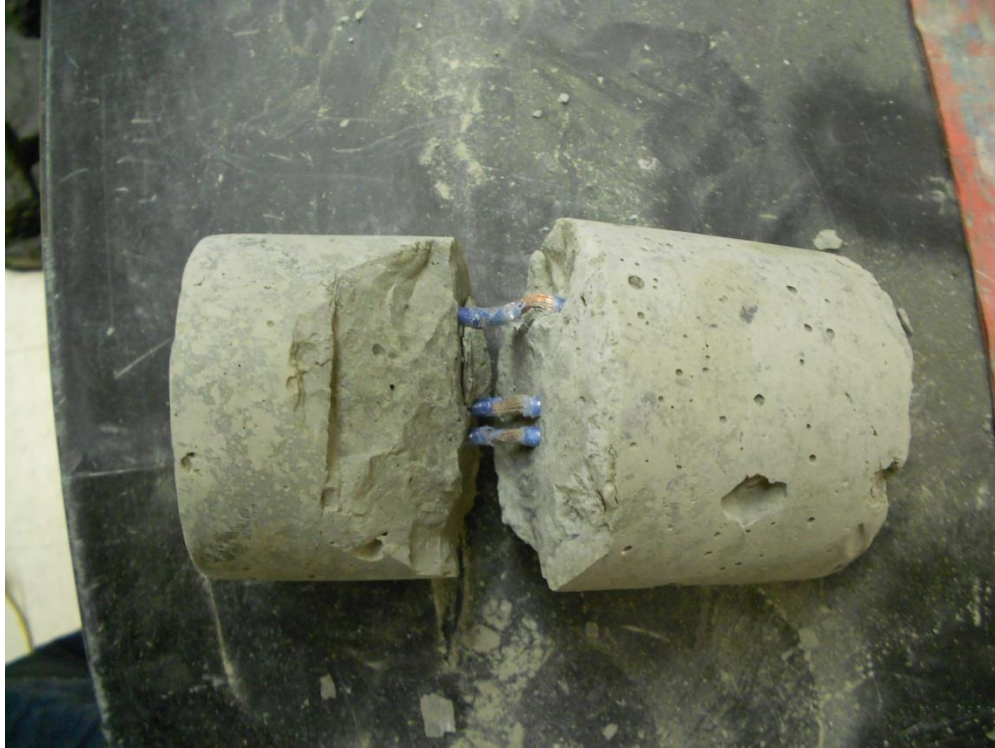
Figure 5.16: Sample J03 Post-test. Note also breakout wedge on left (top of sample).

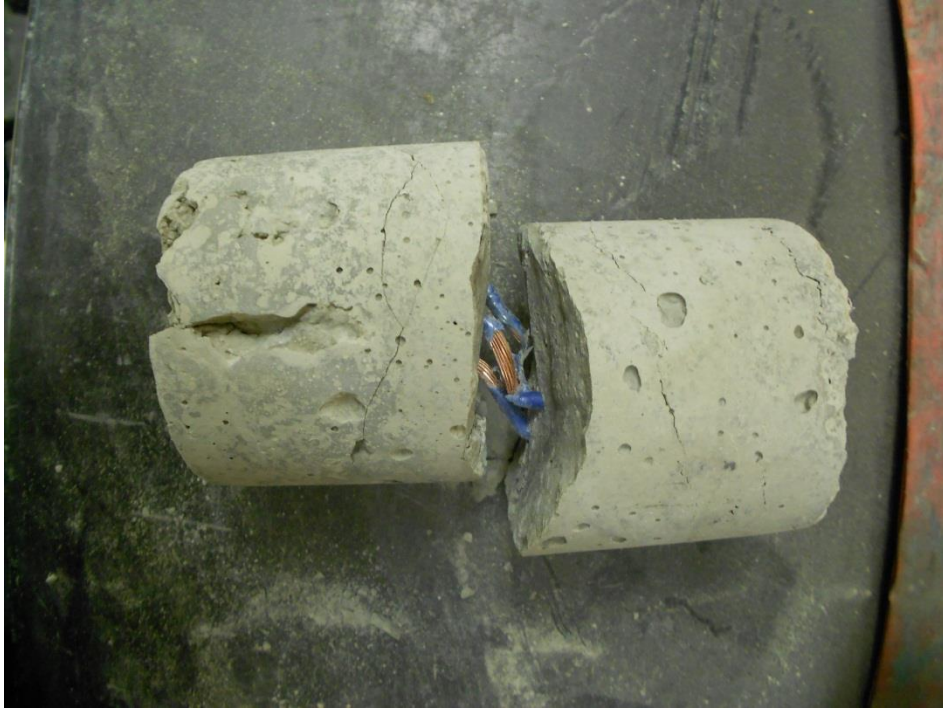
Figure 5.17: Sample H02 Post-test. Typical result for the square configuration.

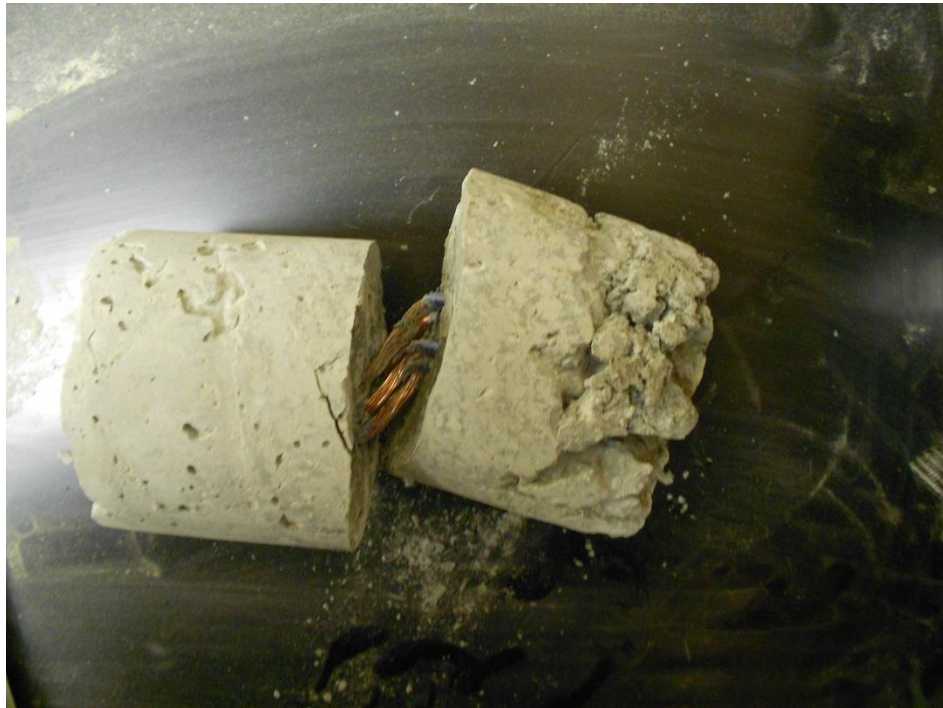
Figure 5.18: Sample H04 Post-test. Two wires were found to be in contact (note that some separation resulted on removing samples from platens).

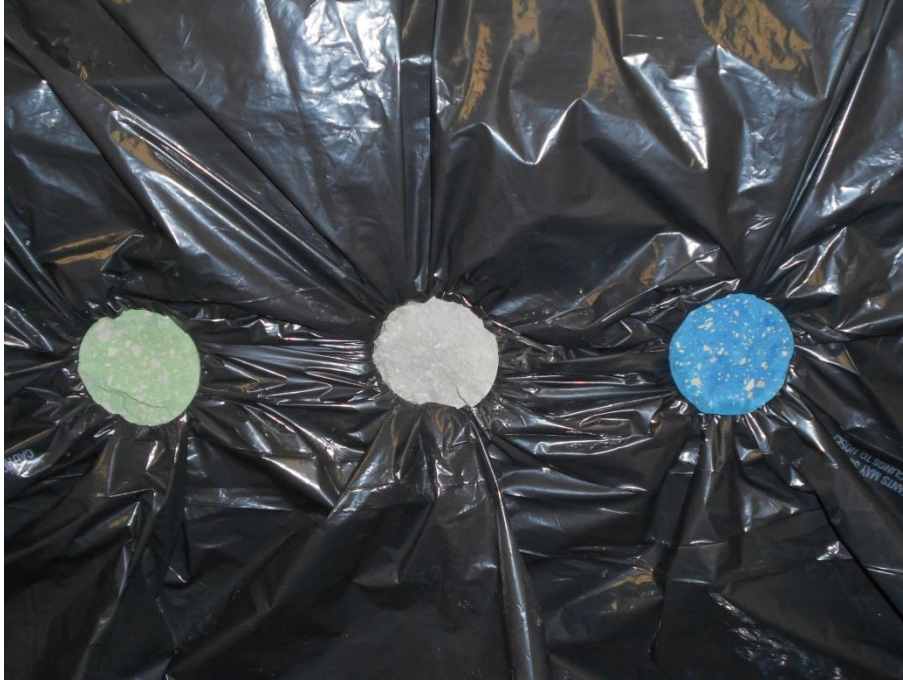
Figure 5.19: Pigmented grout samples in simulated coal face.

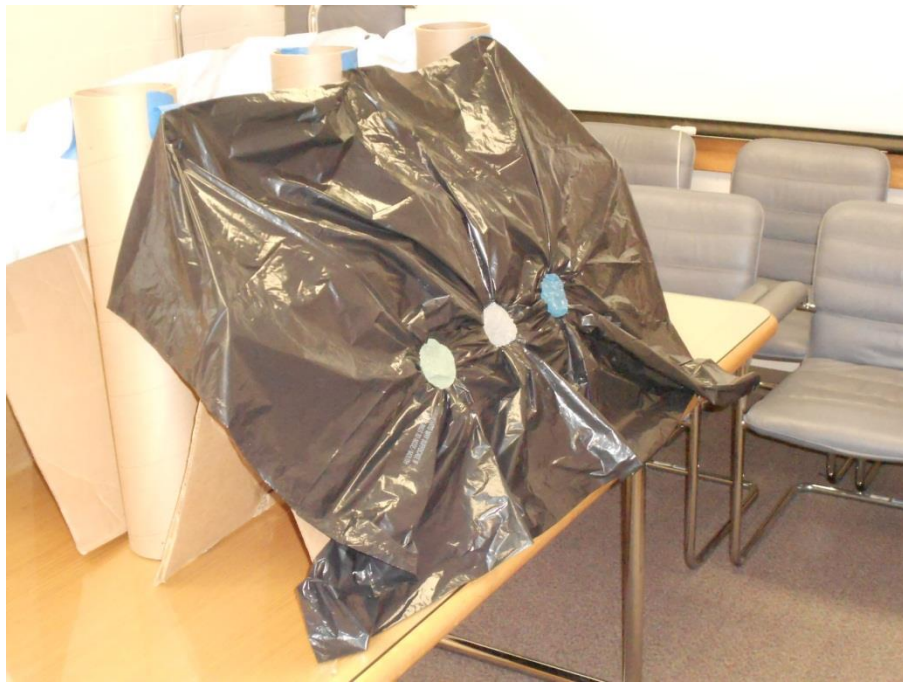
Figure 5.20: Model with dark background to simulate coal.

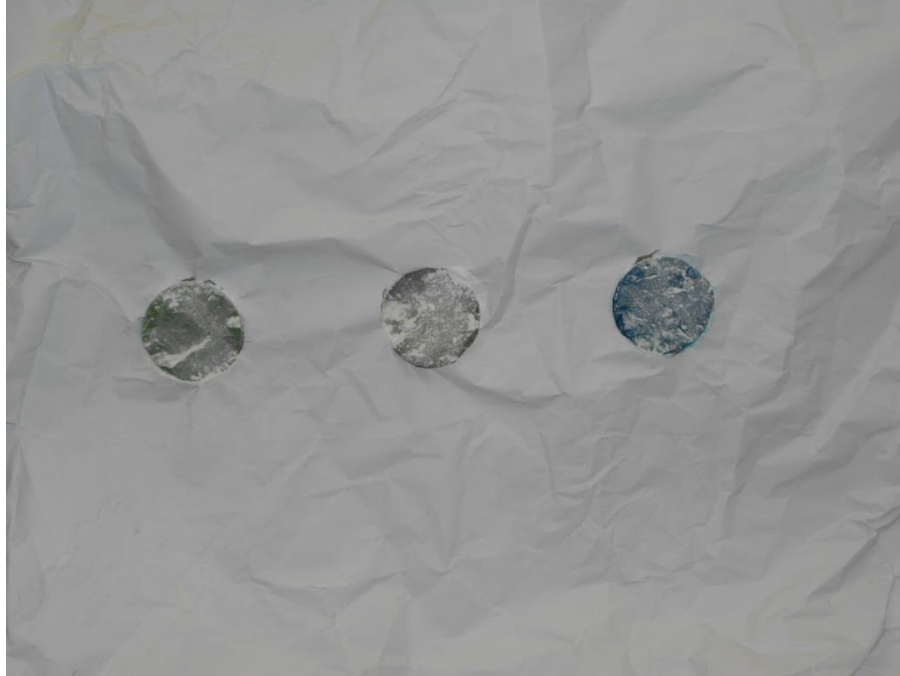
Figure 5.21: Pigmented grout samples in simulated coal face with rock dust or light-colored rock.

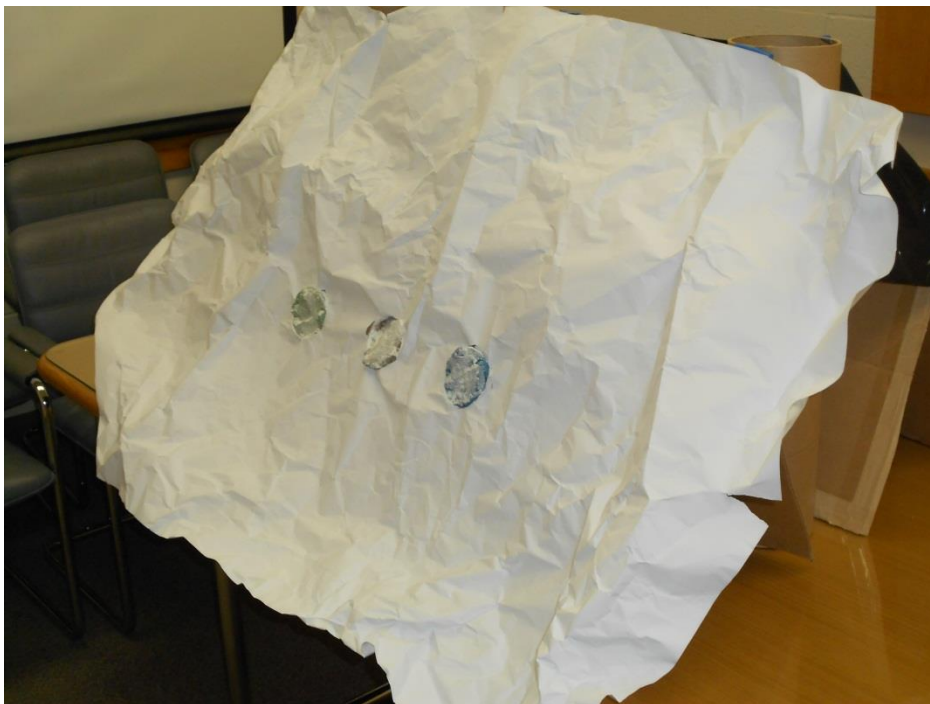
Figure 5.22: Model with light background to simulate coal with rock dust or light-colored rock.

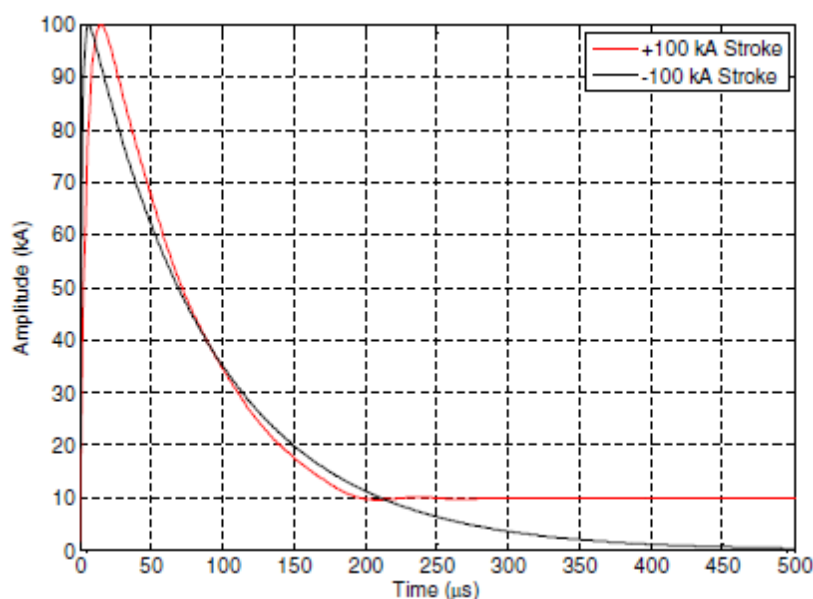
Figure 6.1: Basic Positive and Negative Lightning Waveforms (Higgins and Morris, 2006, p. 49).

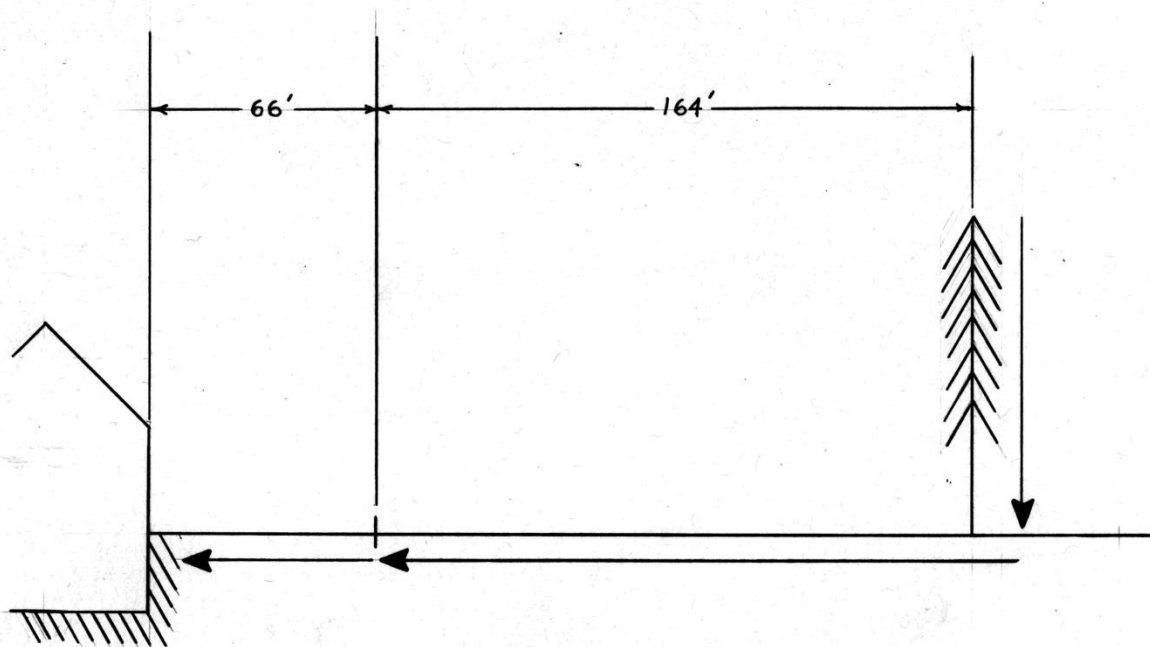
Figure 6.2: Example of side flashing to residential structure (scale approximate). Adapted from illustration in Golde (1975) illustrating phenomenon documented by Müller-Hillebrand (1957). Lightning current follows the path marked by large arrows.

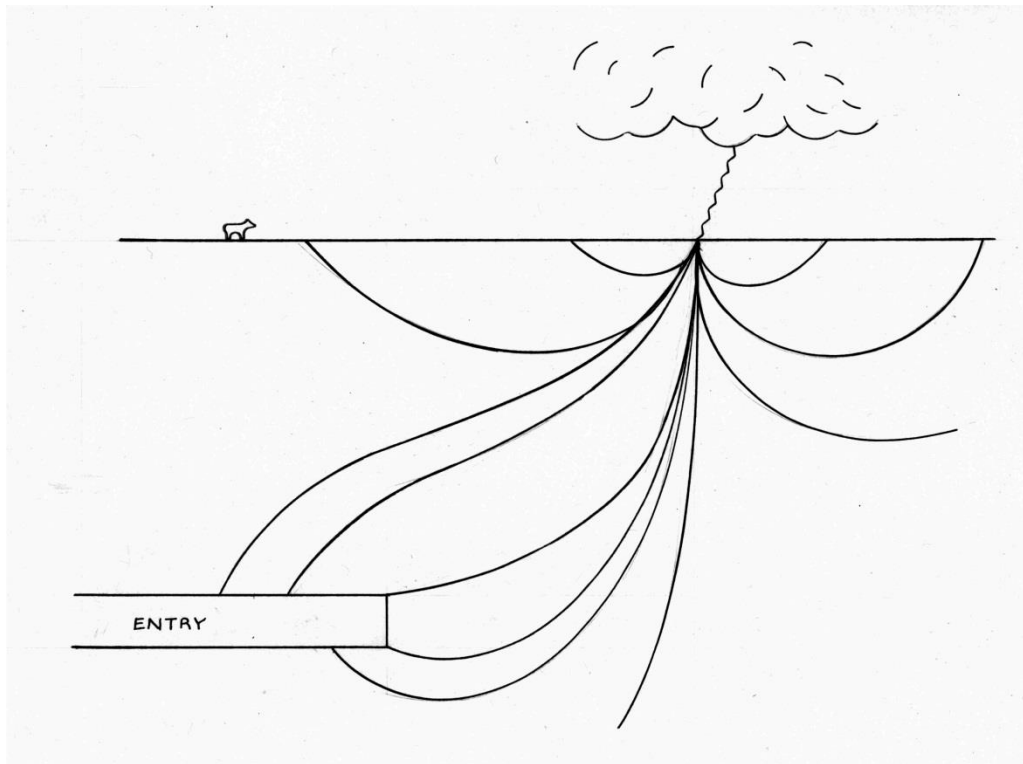
Figure 6.3: Example of ground currents surrounding a mine entry. Adapted from Golde (1975).

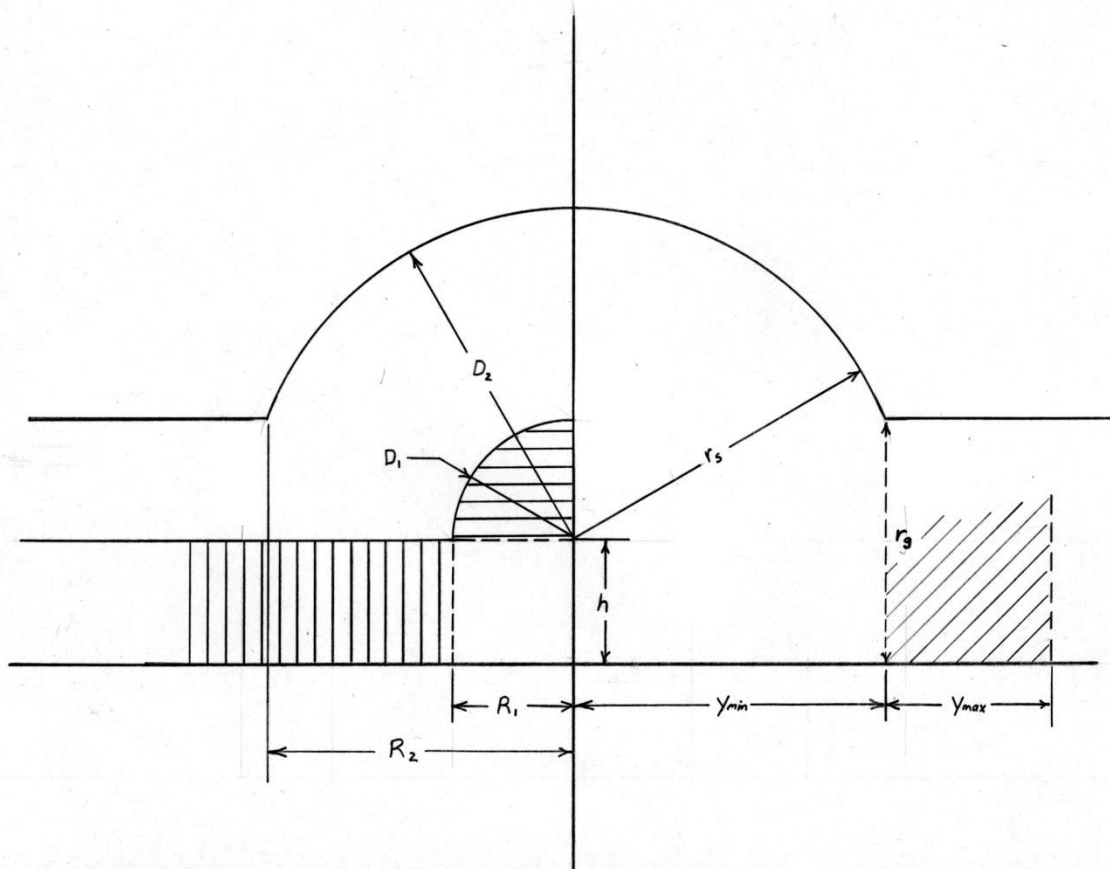
Figure 6.4: “Protective zone” for vertical lightning rod (left) adapted from Golde (1973) and “attraction zone” for high voltage utility lines (right) adapted from IEEE Standard 1410-2004.

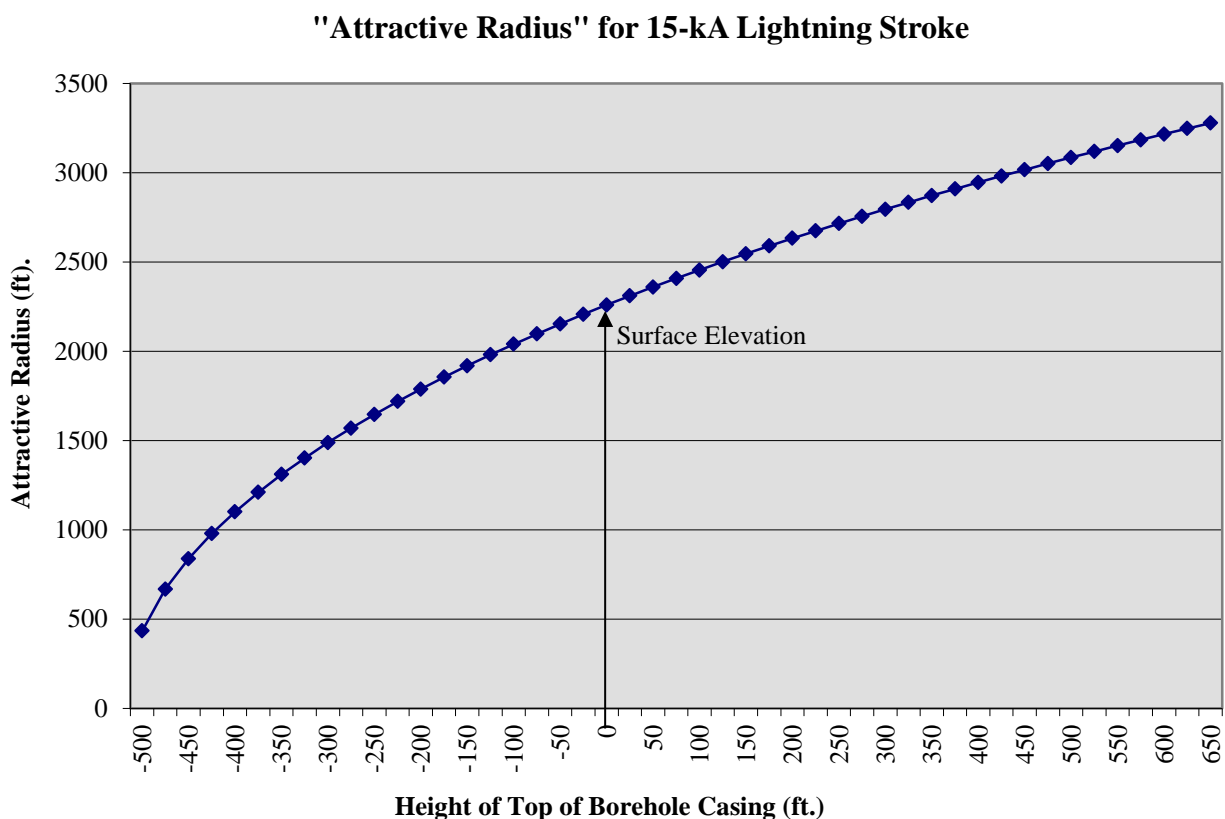
Figure 6.5: “Attractive Radius” for lightning rod when analysis is performed underground.

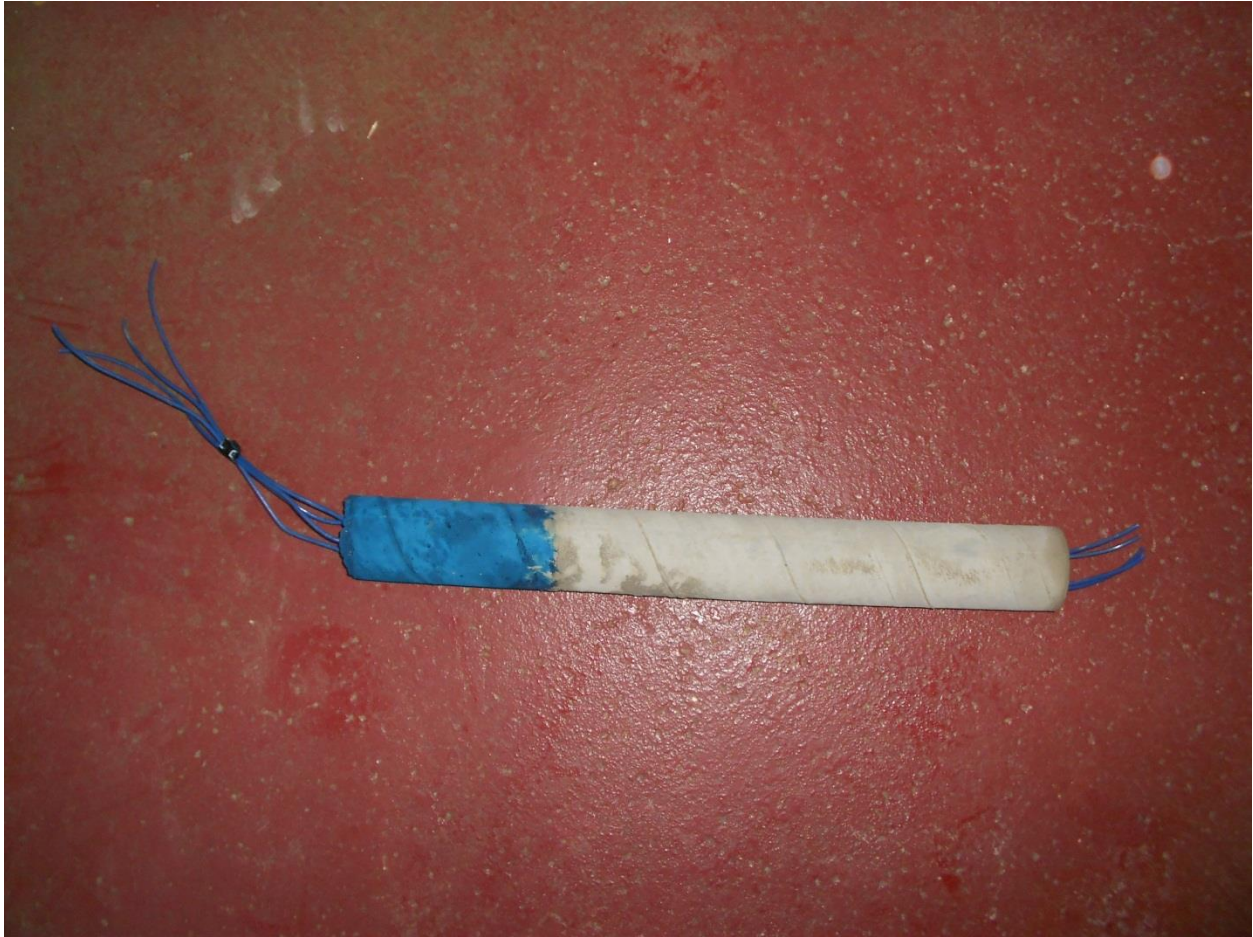
Figure 7.1: 36” Model of Borehole Communication Link with pigmented grout and four conductors.
