Factors and processes influencing streambank erosion along Horseshoe Run in Tucker County, West Virginia

**Factors and processes influencing streambank erosion along
Horseshoe Run in Tucker County, West Virginia**

A Thesis submitted to the
Davis College of Agriculture, Natural Resources, and Design
at West Virginia University
in partial fulfillment of the requirements
for the degree of

**Master of Science
in
Forestry**

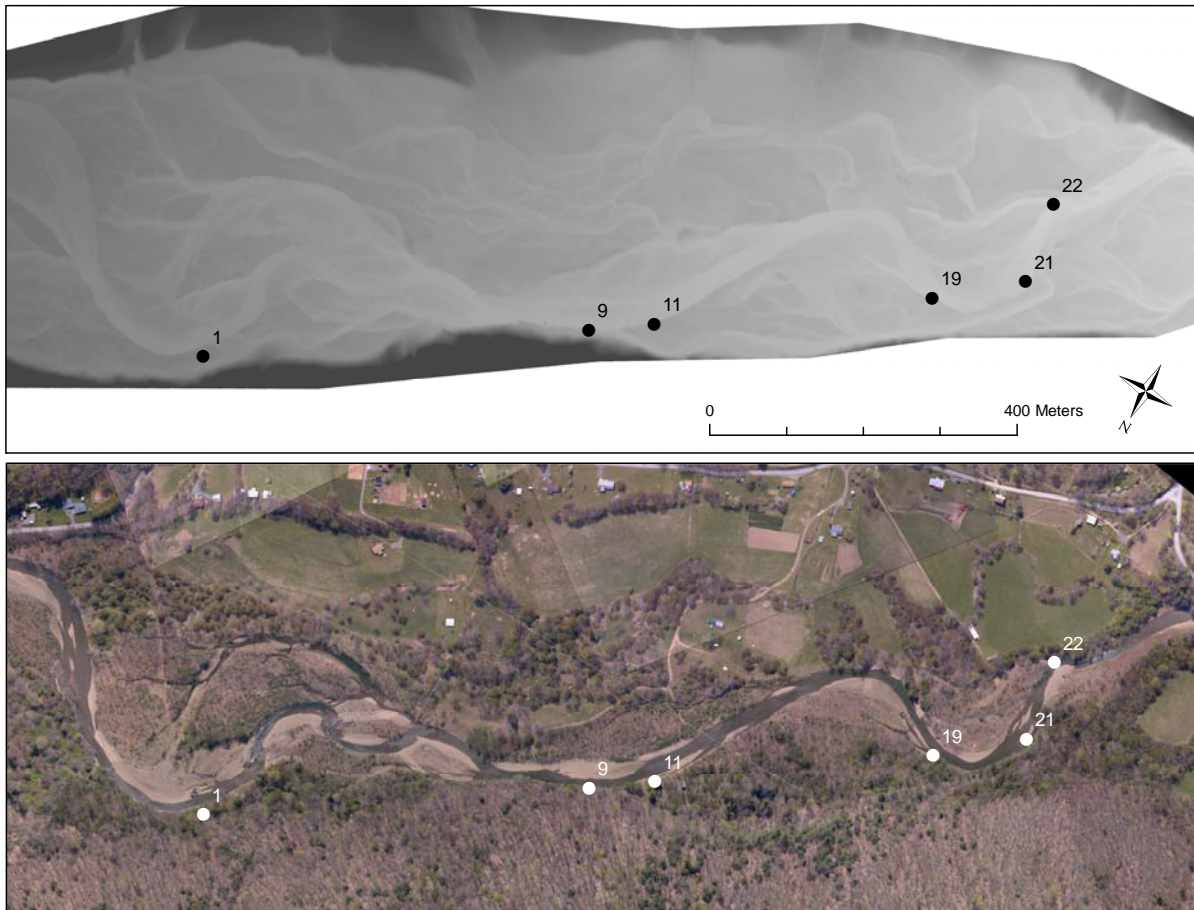
Figure 2.2: Streambank sites used for calibrating and testing BSTEM. Streamflow is from left to right. (2006 LiDAR digital elevation model and aerial photo maps provided by Canaan Valley Institute).

Annual erosion was monitored at twenty four streambank sites along Horseshoe Run, representing a range of conditions. Six of these sites (sites 1, 9, 11, 19, 21, and 22) were selected to simulate erosion using BSTEM (Figure 2.2). Three sites from the lower reach (19, 21, and 22) were selected for calibration and testing of the toe erosion component of the model for the lower reach. Mass failure was not predicted or observed at these sites so the bank stability submodel was not used. Site 21 had an intermediate amount of erosion and was used to calibrate the toe erosion parameters and a site with more erosion (site 22) and a site with less erosion (site 19)

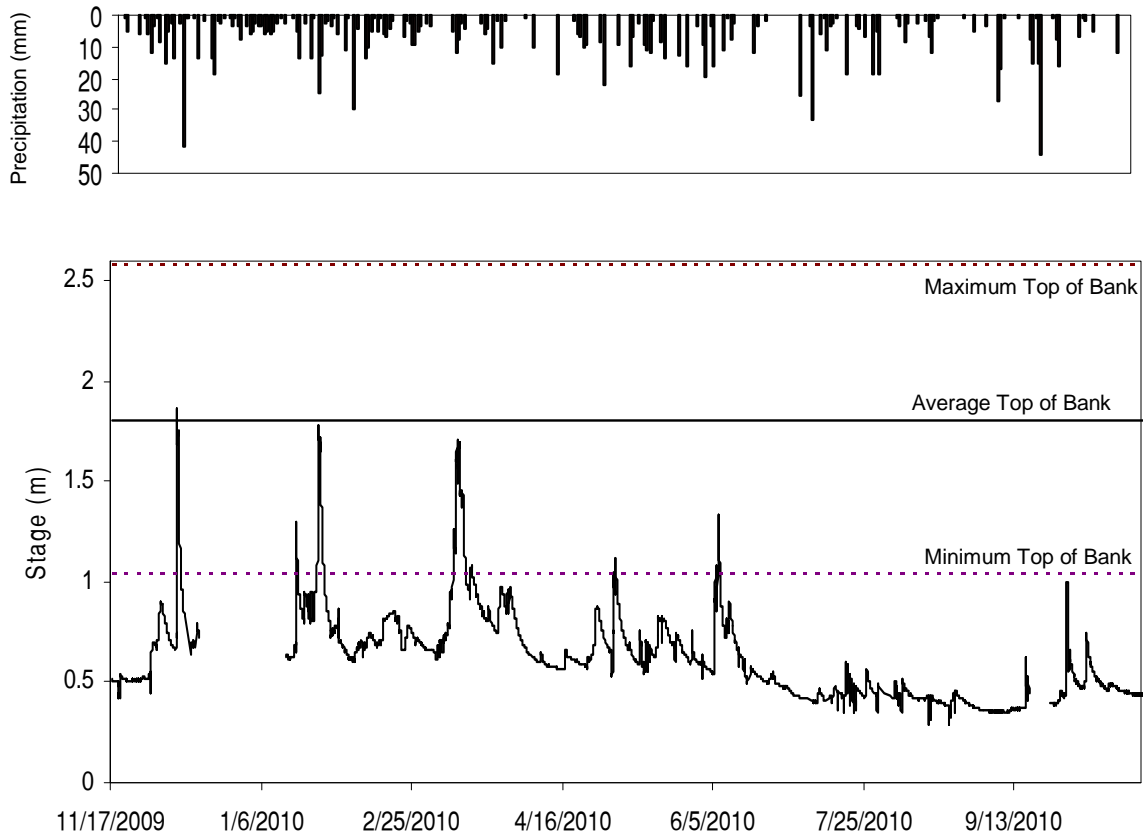
Figure 2.3: Averaged precipitation from the Davis 3SE and Parsons 1NE National Climate Data Center weather stations and streamflow stage from the Canaan Valley Institute streamgauge for the study period. Solid horizontal line represents the stage required for flow to overtop banks for the average bank height through the study area. Lower dotted line represents the stage required to overtop the shortest study bank while upper dotted line represents the stage required to overtop the tallest study bank. Gaps in streamflow represent missing data.

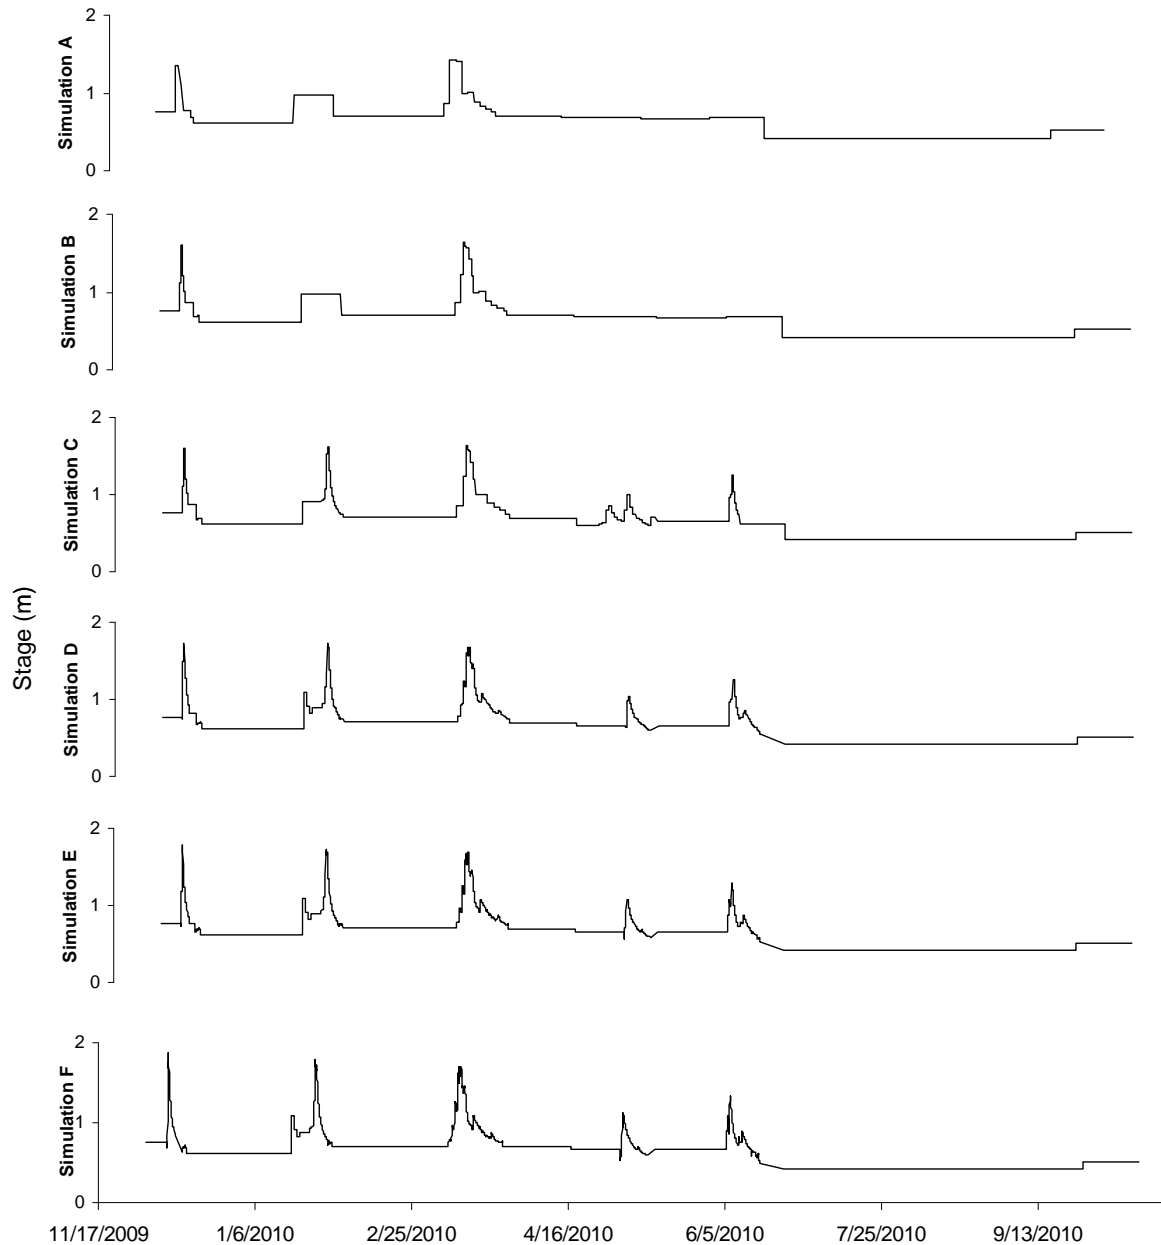
Figure 2.4: BSTEM was run iteratively where the input elevation and duration of flow were changed with each iteration to model the entire study period. Stage data from the upstream gage were discretized into various duration intervals. Each simulation (A-F) represents a unique series of duration intervals and total number of model iterations. 22 iterations were run to generate predicted erosion for simulation A where the minimum flow duration was 24 hours and the maximum was 1,767 hours. 685 iterations were run to generate predicted erosion for simulation F where the minimum flow duration was 1 hour and the maximum was 1,767 hours. Simulation D was found to be the most efficient series of duration intervals and model iterations for sites 9 and 21. These flow duration intervals and corresponding streamflow elevation data were used to model erosion at the other four sites.

22 discrete events and used as input into BSTEM with individual event durations that ranged from 24 to 1767 hours. Simon et al (2009) used a hydrograph with similar duration events (24-1767 hours) in their study of mass-failure and sediment load reductions using toe protection and other means. This initial discretization significantly underpredicted erosion at all sites. To increase the model performance, several simulations were run decreasing the time steps and subsequently increasing the maximum streamflow elevations based on a refinement of the hydrograph into more discrete events (Figure 2.4, Table 2.3). Hydrograph discretization simulation D, with event durations ranging from 6 to 1767 hours, was selected as the input hydrograph for further calibration and testing based on the stabilization of the predicted erosion values for sites 9 and 21 at this simulation (Figure 2.5). All other model parameters were held constant for each site to enable comparison between simulations. The duration for the first three peak flows was modeled at 6 hour intervals and the duration for the next two smaller peak flows was modeled at 12 hour intervals. Reducing the duration to 1 hour intervals did not increase the model performance.

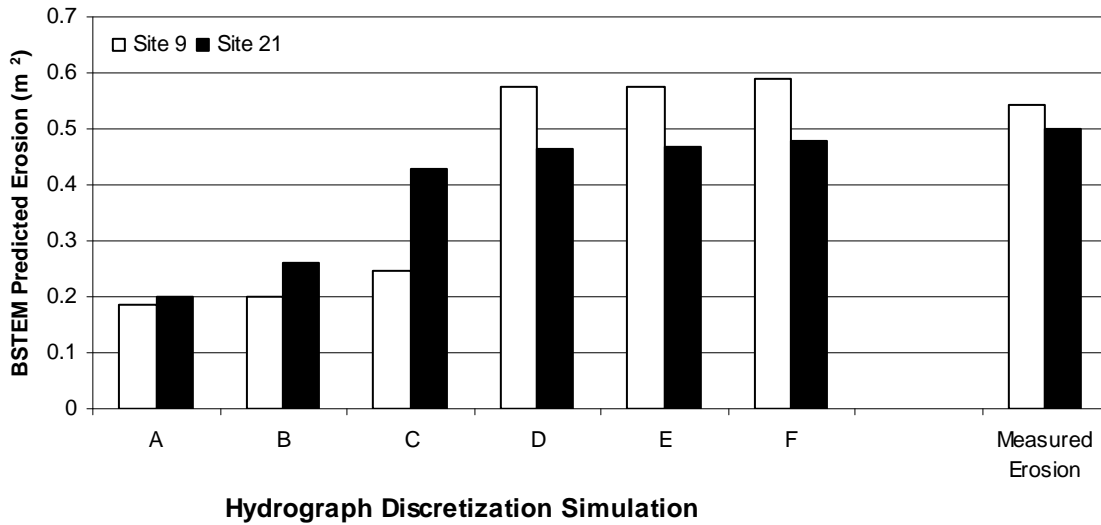
Figure 2.5: BSTEM was run iteratively where the input elevation and duration of flow were changed with each iteration to model erosion for the entire study period. Stage data from the upstream gage were discretized into various duration intervals. Each simulation (A-F) represents a unique series of duration intervals and total number of model iterations. Bars below represent the predicted erosion for each simulation and the measured erosion at these two sites. Simulation D was found to be the most efficient series of duration intervals and model iterations for sites 9 and 21. These flow duration intervals and corresponding streamflow elevation data were used to model erosion at the other four sites.

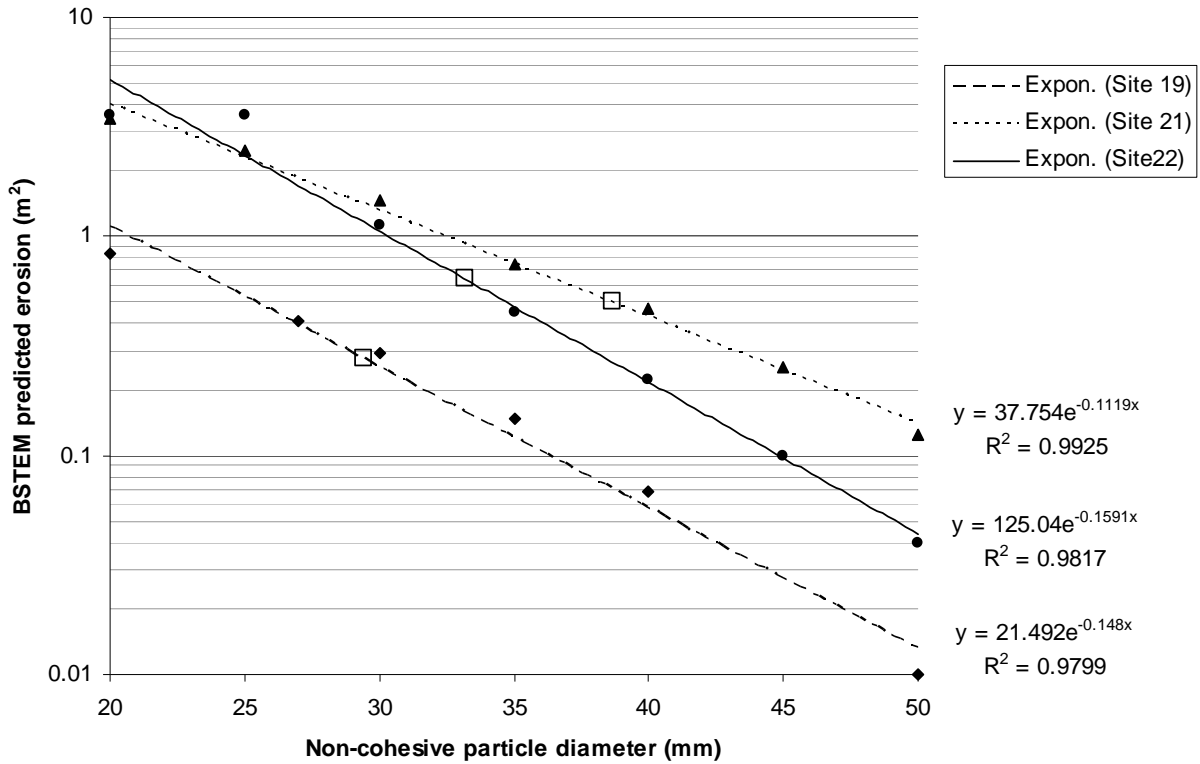
Figure 2.6: BSTEM predicted erosion as a function of the particle diameter used to infer critical shear stress for sites 19, 21 and 22. A number of simulations (solid symbols) were run for each streambank site altering only the critical shear stress which was determined from the non-cohesive particle diameter and the Shields curve and Lane adjustment. The actual measured erosion for each site is identified on the curve with squares.

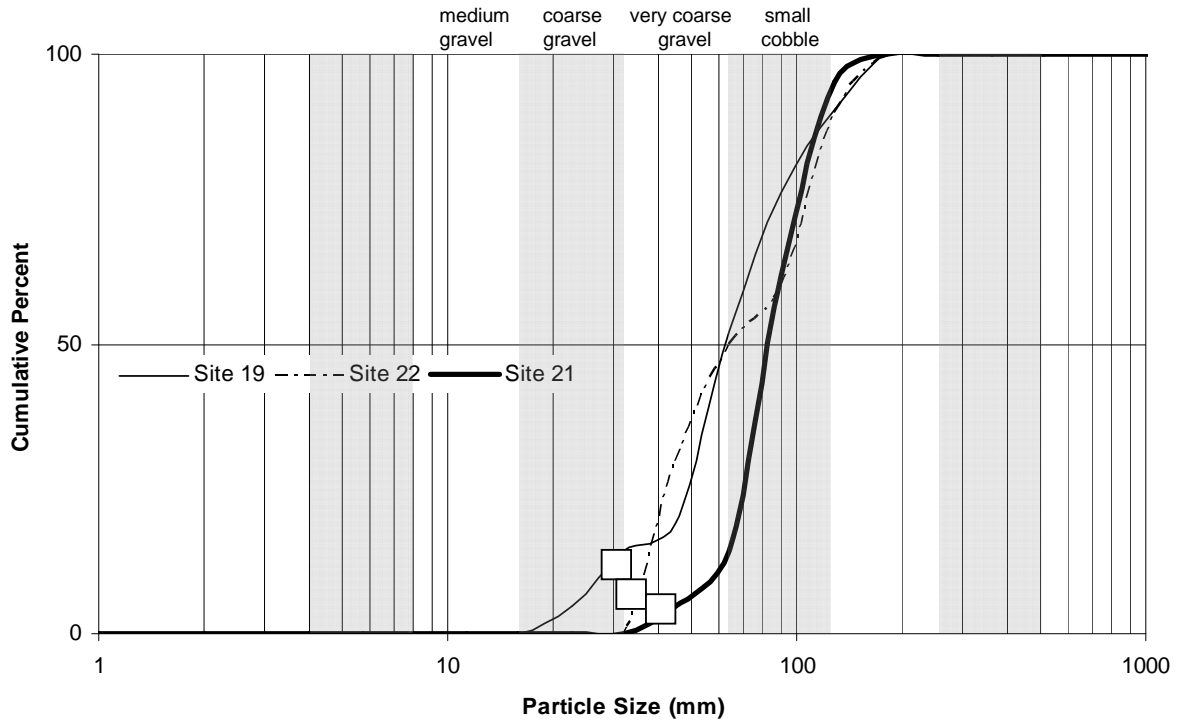
Figure 2.7: Cumulative percent graph of the 20 particle diameters measured along the bank profile for sites 19, 21, and 22. The non-cohesive particle diameters corresponding to the actual erosion amount from Figure 2.6 are also included in the graph with squares.

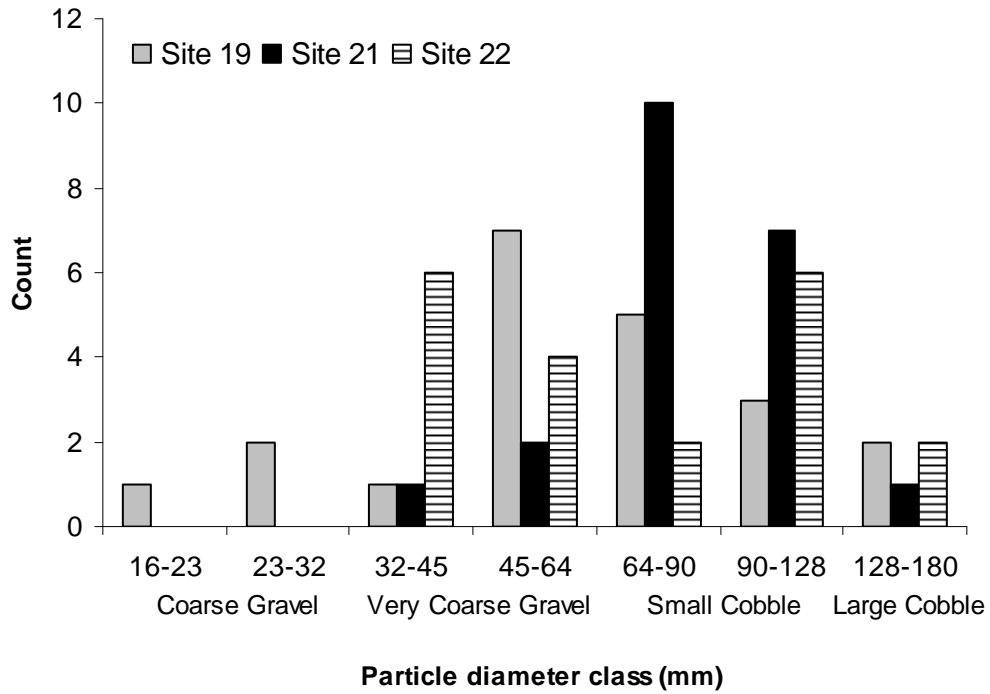
Figure 2.8: Particle diameter distribution from the pebble counts for sites 19, 21, and 22. Site 22 has a slightly bimodal distribution with a peak in the very coarse gravel range and a peak in the small cobble range.

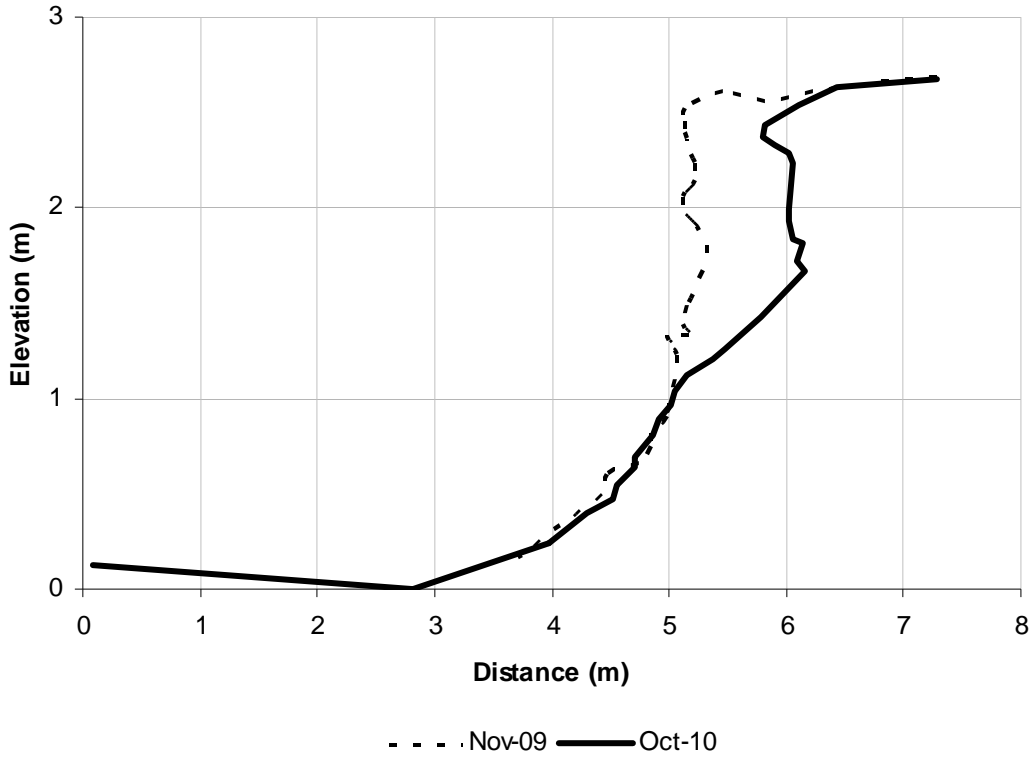
Figure 2.9: The bank profile overlays for site 11 indicate that the majority of erosion occurred in the upper bank layers.

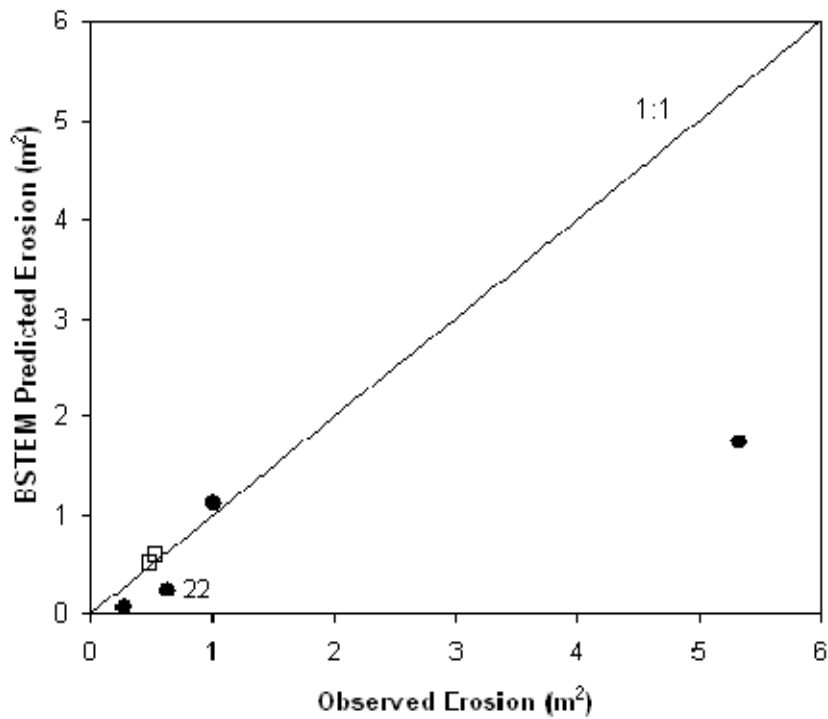
Figure 2.10: A plot of the observed versus BSTEM predicted erosion indicated that the model accurately predicted relative amounts of erosion with only one exception, site 22. Squares are calibrated sites, circles are test sites. A 1:1 line is depicted on the diagonal. Site 22 had the third highest observed erosion but the second lowest BSTEM predicted erosion. This difference is likely due to the local variation in shear stress.

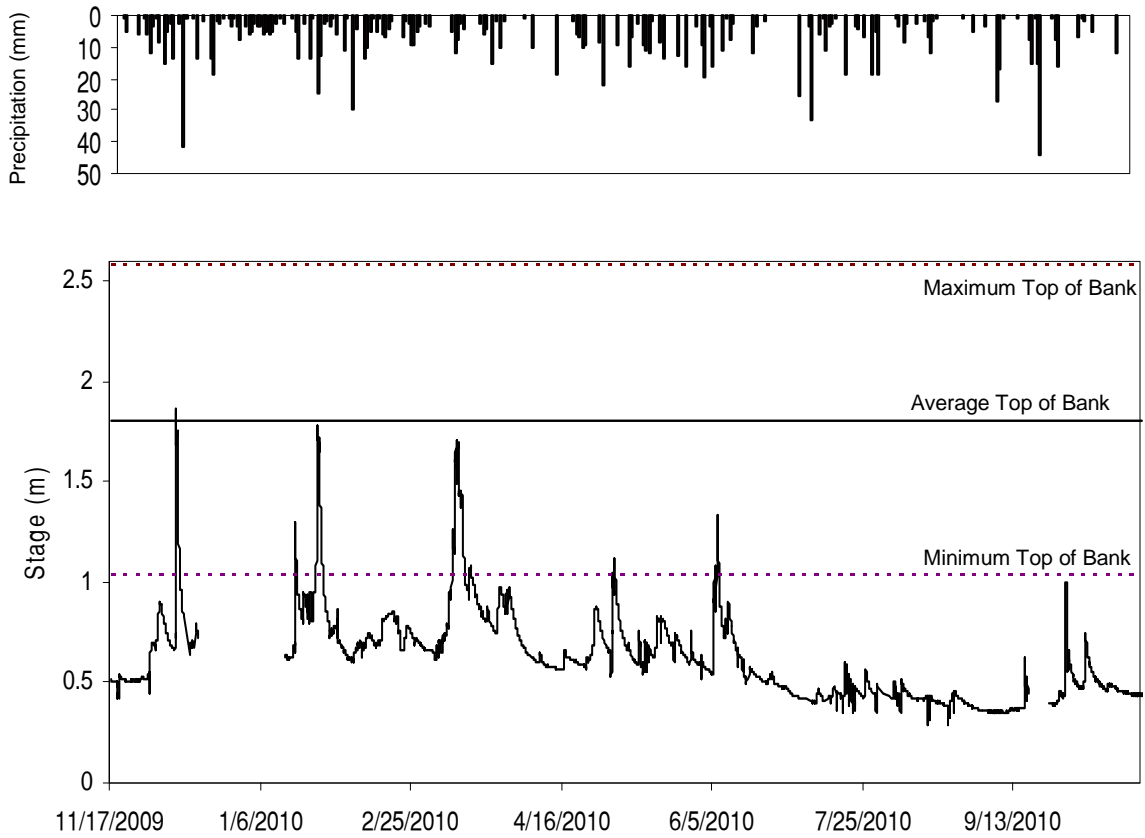
Figure 3.2: Averaged precipitation from the Davis 3SE and Parsons 1NE National Climate Data Center weather stations and streamflow stage from the Canaan Valley Institute streamgauge for the study period. Solid horizontal line represents the stage required for flow to overtop banks for the average bank height through the study area. Lower dotted line represents the stage required to overtop the shortest study bank while upper dotted line represents the stage required to overtop the tallest study bank. Gaps in streamflow represent missing data.

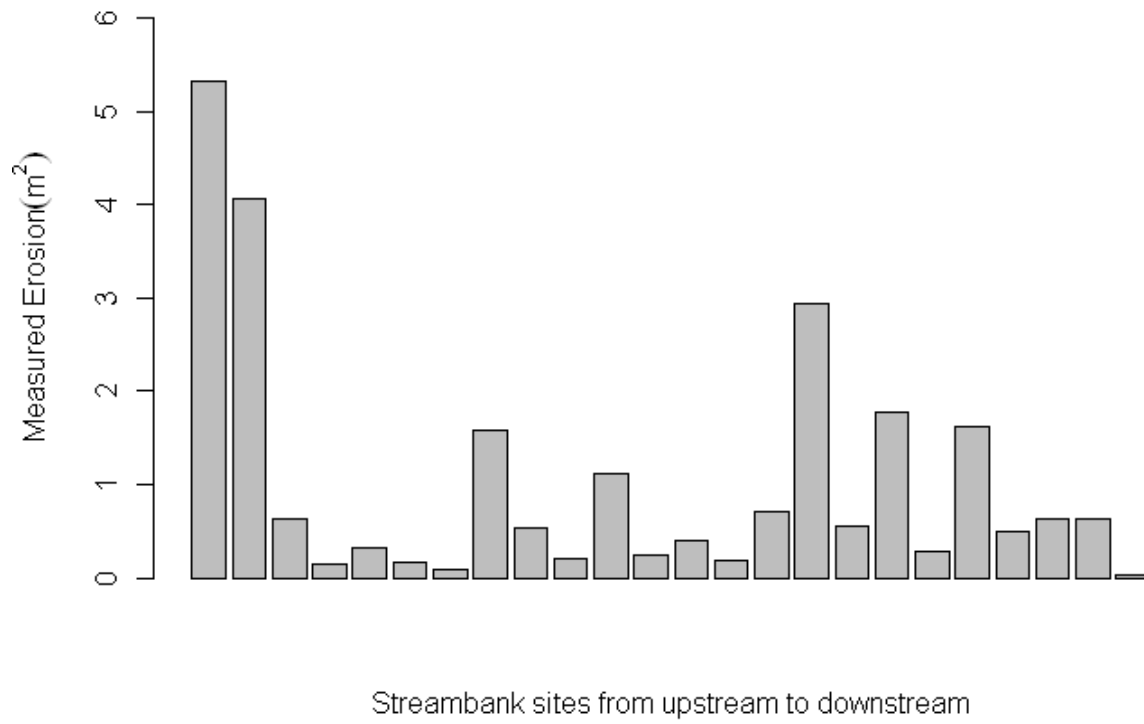
Figure 3.3: Barplot of measured erosion (m^2) at the streambank sites in order from upstream to downstream.

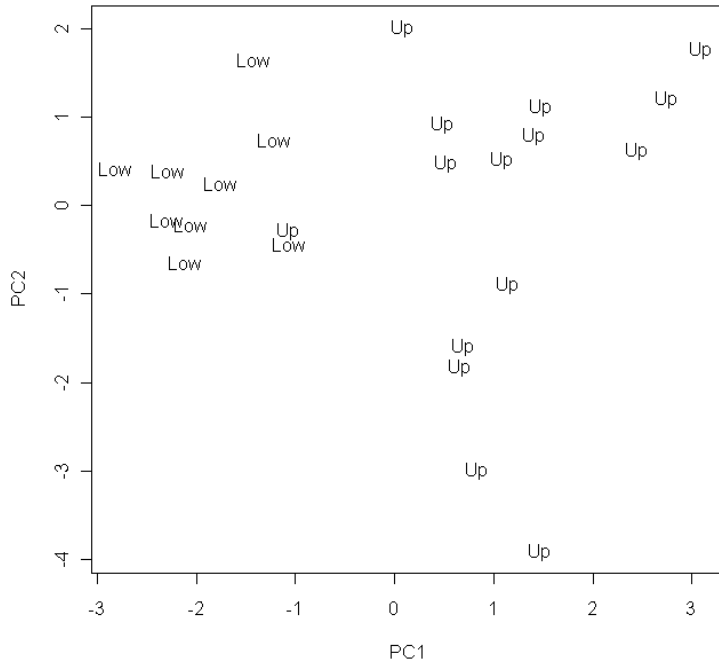
Figure 3.5: Scatterplot of streambank characteristic principle component scores 1 and 2 where observations are coded by location: upper reach (Up) or lower reach (Low). Separation between the upper and lower reach is evident on the PC1 axis controlled by bank angle, bank material, and stratification. Separation within the upper reach sites is evident on PC2 controlled by the vegetation parameters.

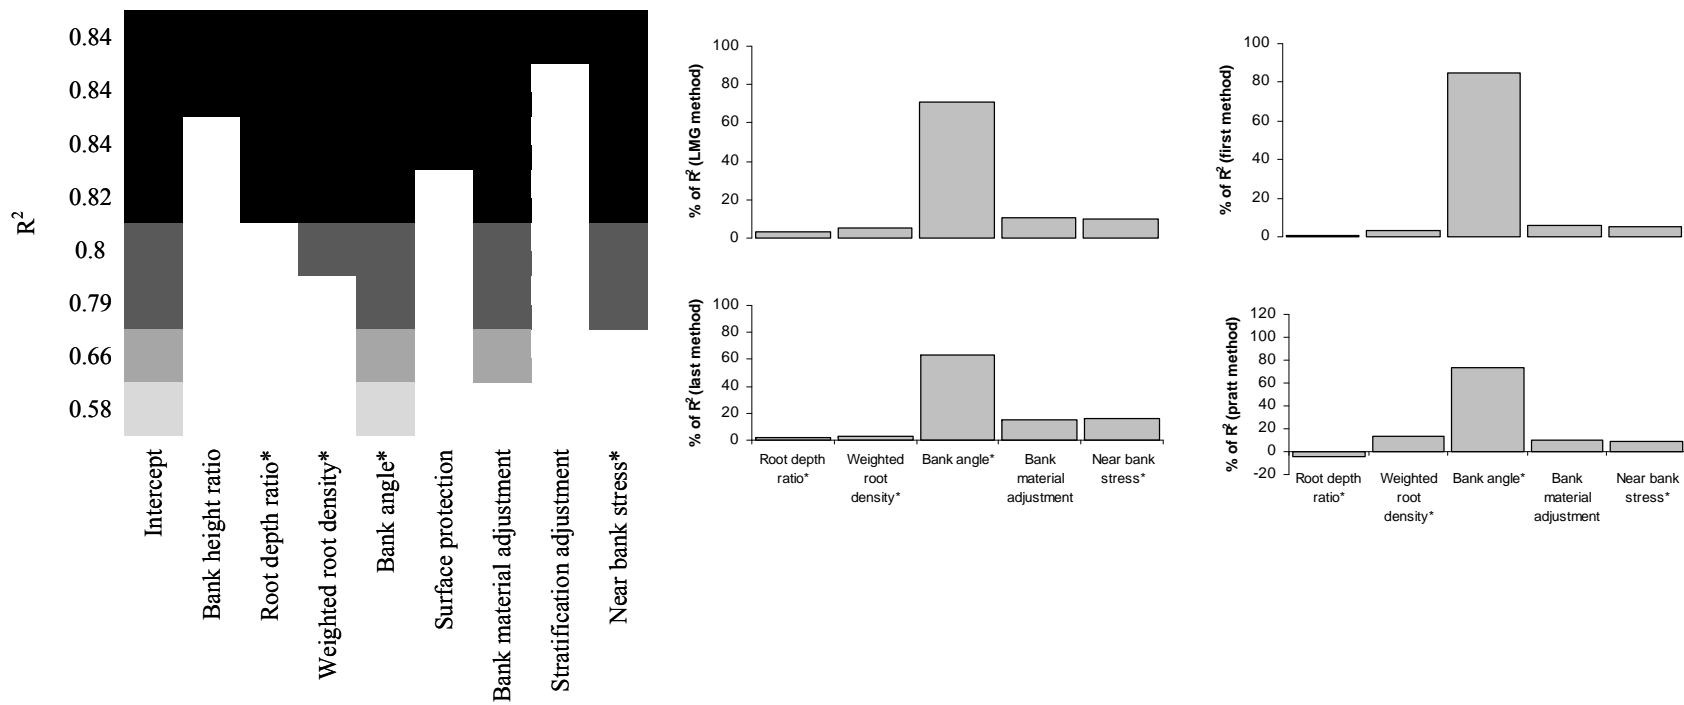
Figure 3. 7: All-possible-subset regression was used to identify the subset of BANCS model parameters that could best predict erosion. The best model determined for each subset size in the all subset regression analysis for the upper reach is represented on the left. Bank angle had the highest correlation with erosion when each parameter was correlated with erosion separately, explaining 58% of the variation in erosion (R^2). The best model for each pair of parameters included bank angle and bank material adjustment, explaining 66% of the variation in erosion. The model including bank angle, bank material adjustment, near bank stress, and the vegetation parameters was selected as the most parsimonious. Relative importance metric plots were plotted for this model. Relative importance measures were calculated using the following methods: average sequential sums of squares over all orderings of regressors, Lindeman, Merenda, and Gold method (lmg) (Lindeman et al. 1980); comparison of what each regressor was able to explain in addition to all other variables (last); comparison of each regressor alone (first); and comparison of the importance to a variable in proportion to the product of its standardized regression coefficient (Pratt 1987). These metrics all indicate that bank angle was the most important variable. * indicates the parameter was log base 10 transformed.
