## Measurement and evaluation of the performance of an integral abutment bridge deck

**MEASUREMENT AND EVALUATION OF THE PERFORMANCE  
OF AN INTEGRAL ABUTMENT BRIDGE DECK**

**A Thesis**

**Master of Science  
In  
Mechanical Engineering**

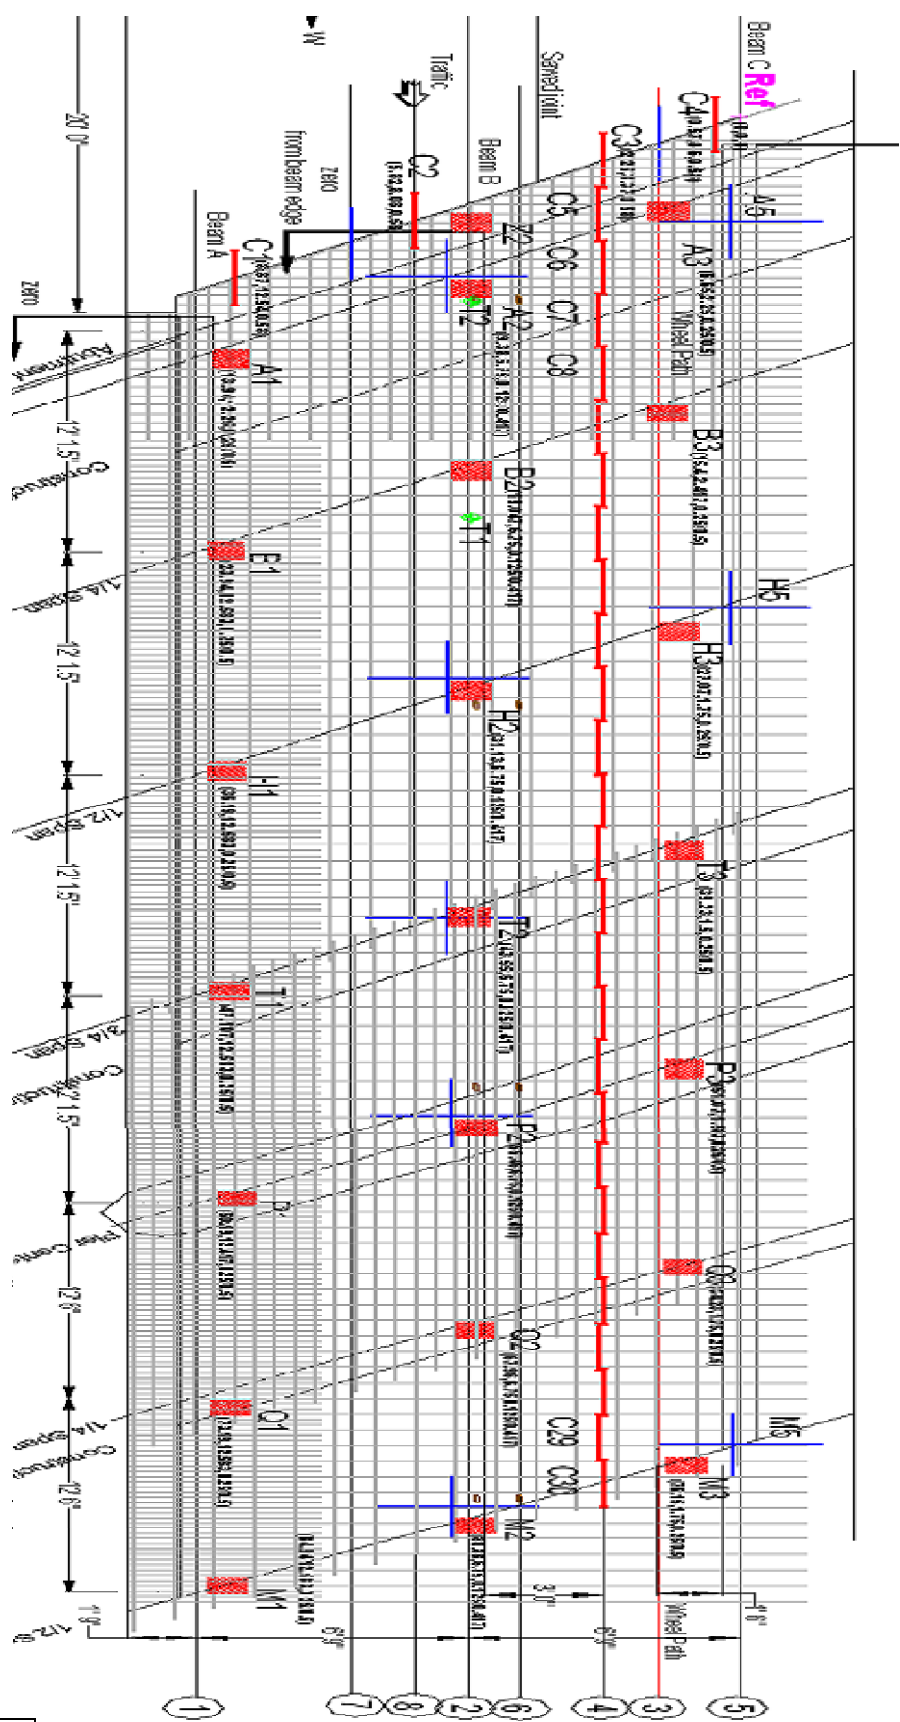
Figure 3.1: Deck Instrumentation Plan (Shoukry et. al., 2005)

- Sister Bars
- Crack Meters
- Strain Trees
- Thermistors

Strains were measured using strain gages; displacements were measured with displacement transducers, inclination with inclinometers, and temperature with thermistors. Figure 3.1 shows a layout of the instrumentation system used in the deck of Evansville Bridge.

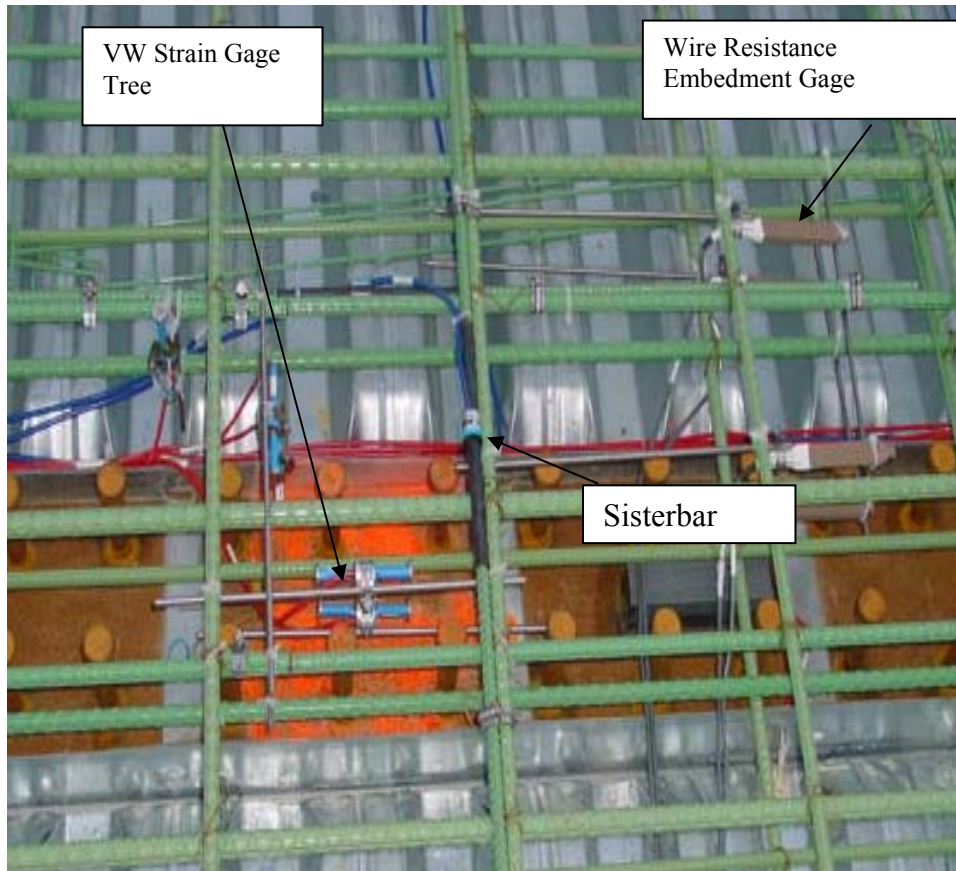
Figure 3.2: Instruments Used to Measure Strains (photo courtesy of Dr. Shoukry, WVU)

Two different types of strain gages were utilized to capture the strain distributions present in Evansville Bridge: vibrating wire gages were used to measure long-term strains due to static loading and environmental effects, and wire resistance strain gages were used to measure the short-term, dynamic strains, caused by traffic passing over the bridge.

Vibrating wire embedment strain gages were placed in 22 locations, with 5 or 6 gages at each location in tree form (6 gages is ideal, but only 5 could be placed at some locations due to space constraints). A strain gage tree is made up of a total of 6 gages, with gages in the X, Y and Z directions at both the top and the bottom of the deck, as shown in figure 3.2. These gages aim to capture the triaxial state of strain caused by environmental effects throughout the bridge deck. Geokon manufactures the VCE 4200 vibrating wire strain gages used for embedment in the bridge deck. The VCE 4200 strain gage has a gage length of four inches, a midrange of 2500 microstrain, and a sensitivity of one microstrain (Geokon, 1996). The electronic excitation coil is detachable, which makes installation simpler and more convenient. A thermistor is provided with each gage (located in the detachable plucking coil) to allow for temperature compensation, since the coefficients of thermal expansion of the gages and the concrete they were placed in differ. The gages were initially secured in place with nylon cable ties, and were later bonded to the reinforcement steel using epoxy adhesive (JB weld).

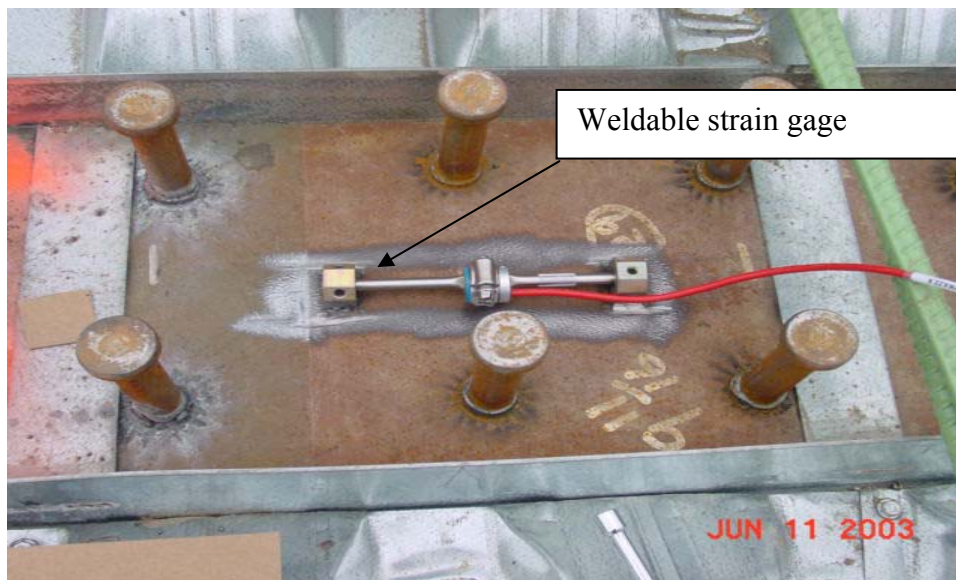
In order to measure the strains in the steel girders, a total of eight weldable strain gages were used. Gages were placed in four locations, with two gages (top and bottom of the girder) at each location. The gages were mounted near the abutment, at half span, at the pier, and at the midpoint of the middle span. Geokon model VSM 4000 strain gages were used; these gages are 5.875 inches long, have a midrange of 2500 microstrain, and one microstrain sensitivity (Geokon, 1996). The electronic plucking coil is detachable, similar to the VCE 4200. A thermistor is provided in the plucking coil for temperature measurement. The VSM 4000 gage is not welded directly to the girder, as welding would cause distortion of the gage and would likely destroy its effectiveness. Instead, two mounting blocks are provided with the gage; one has a single cone point set screw, and one has two oval point set screws. In order to mount the gage, the surface of the girder must first be free of rust, dirt or oil; therefore the surface was cleaned using an angle grinder. After cleaning the surface of the girder, the mounting blocks were fixed to the end flanges of the gage, and the block positions were marked on the girder. The gage was then replaced with a spacer, and the mounting blocks were held in place firmly with a jig. The blocks were then arc welded to the surface of the girder. The strain gage was then mounted in the end blocks, and covered to protect it from environmental hazards. A typical weldable strain gage is shown installed on the girder in figure 3.3

Figure 3.3: Weldable Strain Gage Installed on the Top Flange of a Girder (photo courtesy of Dr. Shoukry, WVU)

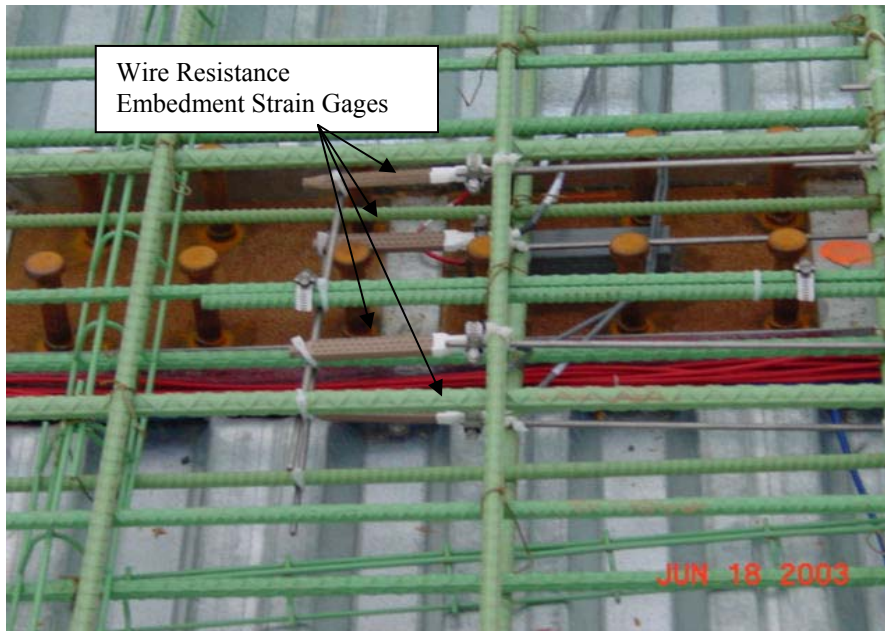
To measure the dynamic response of the bridge, 16 wire resistance type embedment strain gages were installed near the vibrating wire strain gage trees. These gages were installed in eight locations, with two gages at each location. One gage was placed at the top reinforcement of the deck, and one was placed at the bottom reinforcement. The wire resistance strain gages used are from Micro Measurements, and are designed for concrete embedment. Their model number is EGP-5-120. The gages are constructed of karma alloy, and have a resistance of 120 ohms (Micro Measurements). Each gage is mounted on a carrier, and cast into a proprietary polymer cement body five inches in length. The cement body protects the delicate strain gage from damage due to concrete pouring, moisture, and corrosion. Temperature compensation is automatic with these gages. The resistance strain gages were installed similarly to the VCE 4200 gages; they were first attached to the reinforcement steel using nylon wire ties, and were later bonded to the rebar using JB weld. A typical installation of resistance-type embedment strain gages is shown in figure 3.4.

Figure 3.4: Wire Resistance Embedment Strain Gages (photo courtesy of Dr. Shoukry, WVU)

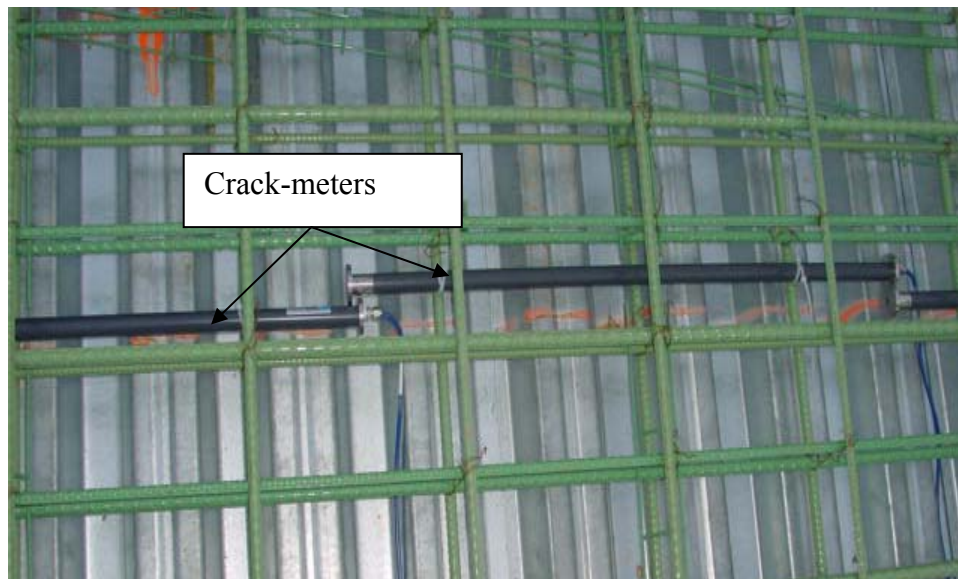
In total, 30 crack meters were placed on the bridge to measure crack growth and axial deformation along the wheel path. Four were placed in the construction joint between the approach slab and the deck, and the remaining 26 were placed in series through half the length of the bridge. The crack meters used in Evansville Bridge were Geokon model 4430 deformation meters. These displacement transducers can be embedded in series along an axis through the concrete, to give the deformation pattern along that axis. The model 4430 transducer is made up of a vibrating wire sensing element in series with a precision music wire spring, which is coupled to a movable shaft. As the shaft moves in or out of the body of the sensor, the spring and the vibrating wire are stretched, which changes their tension. The change in tension results in a change in the frequency of vibration of the wire, which can be measured (Geokon, 1996). A crack meter installation is illustrated in figure 3.5.

Figure 3.5: Crack Meters Installed in Deck of Evansville Bridge (photo courtesy of Dr. Shoukry, WVU)

Two different displacement transducers were used on Evansville Bridge: crack-meters and convergence meters. The crack meters were used to measure crack openings

and axial deformations in the concrete deck. Convergence meters were used to measure relative motion between the bridge supports (abutments and piers).

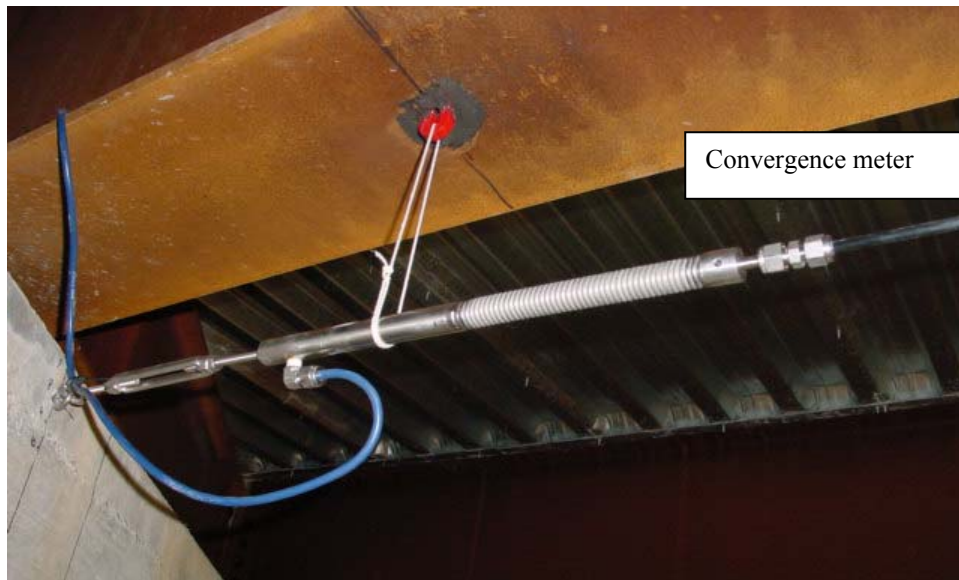
Two convergence meters, placed between the abutment and pier 1, and piers 1 and 2, were used to measure relative movement between the abutments and piers. The convergence meters used were Geokon model 4425 vibrating wire convergence meters. They are designed to measure deformation between two fixed anchor points. The model 4425 convergence meter consists of a vibrating wire sensing element in series with a heat-treated, stress-relieved spring. The spring is connected to a six-millimeter diameter connecting rod. The operating principle is similar to that of the Geokon model 4430 transducer (Geokon, 1996). The mounting procedure for the convergence meter is as follows: first, holes are drilled in the concrete for the two anchor points, and the anchor points are affixed in the holes. A turnbuckle assembly was attached to the convergence meter, and carbon fiber connecting rods were linked together to fit between the two fixed endpoints using the supplied swagelok fittings. The rods were then connected to the sensor using swagelok fittings, and finally a swagelok eyehook was attached to the carbon rod and hooked to the anchor point. The convergence meter as installed at Evansville bridge is shown in figure 3.6.

Figure 3.6: Convergence Meter (photo courtesy of Dr. Shoukry, WVU)

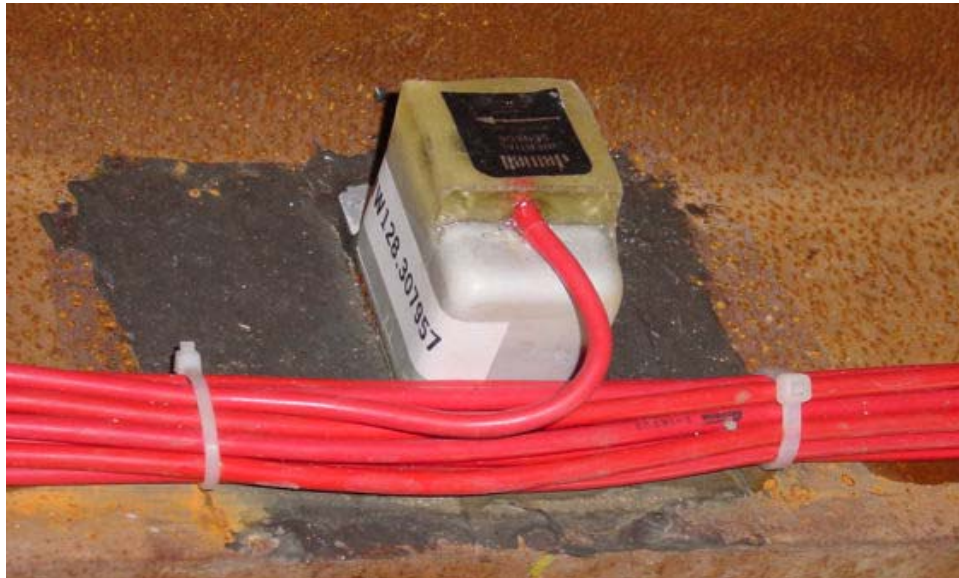
Inclinometers were used to monitor changes in the inclination of the girders. A total of seven inclinometers were mounted on the bottom flange of girder B along the

edge span, between pier 1 and mid-span, as shown in figure 3.7. The inclinometers used were Jewell LCI inclinometers. The sensing element in the Jewell LCI is called a torquer, and it operates as follows: the torquer is intentionally unbalanced in the plane of allowable rotation, and a torque is developed on it in proportion to the unbalance of the mechanism and the angular input. An optical position detector, whose output is compared to a reference voltage, detects the angular motion of the torquer. The difference between the output of the position detector and the reference voltage is sent as an error signal to a servo amplifier, and the servo amplifier current is applied to the torquer in opposition to the tilt torque or angular acceleration. The output of the servo amplifier is directly proportional to the acceleration applied in dynamic cases, or the tilt in static cases. The Jewell LCI inclinometer is sensitive to tilts of less than one microradian, and its output is an analog voltage (Jewell Instruments). The inclinometers were mounted to the bottom flange of the girder using epoxy adhesive after the steel surface had been ground and cleaned with acetone.

Figure 3.7: Inclinometer, Installed on Lower Flange of Girder B (photo courtesy of Dr. Shoukry, WVU)

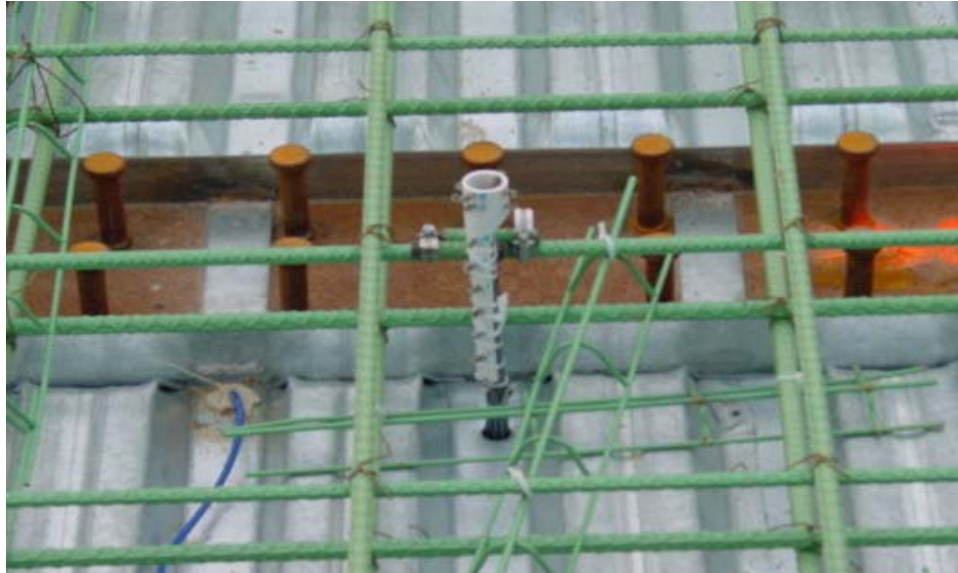
To measure the temperature distribution through the deck's cross section, two thermistor trees, consisting of 17 thermistors mounted on an 8-inch long, 1-inch diameter

PVC tube, were used. Each tree was constructed as follows: eight thermistors were placed in the topmost inch of the tube, and the rest were placed at one-inch intervals along the remainder of the tube, as shown in figure 3.8. A thermistor is designed so that its resistance decreases as temperature rises.

Figure 3.8: Thermistor Tree (photo courtesy of Dr. Shoukry, WVU)

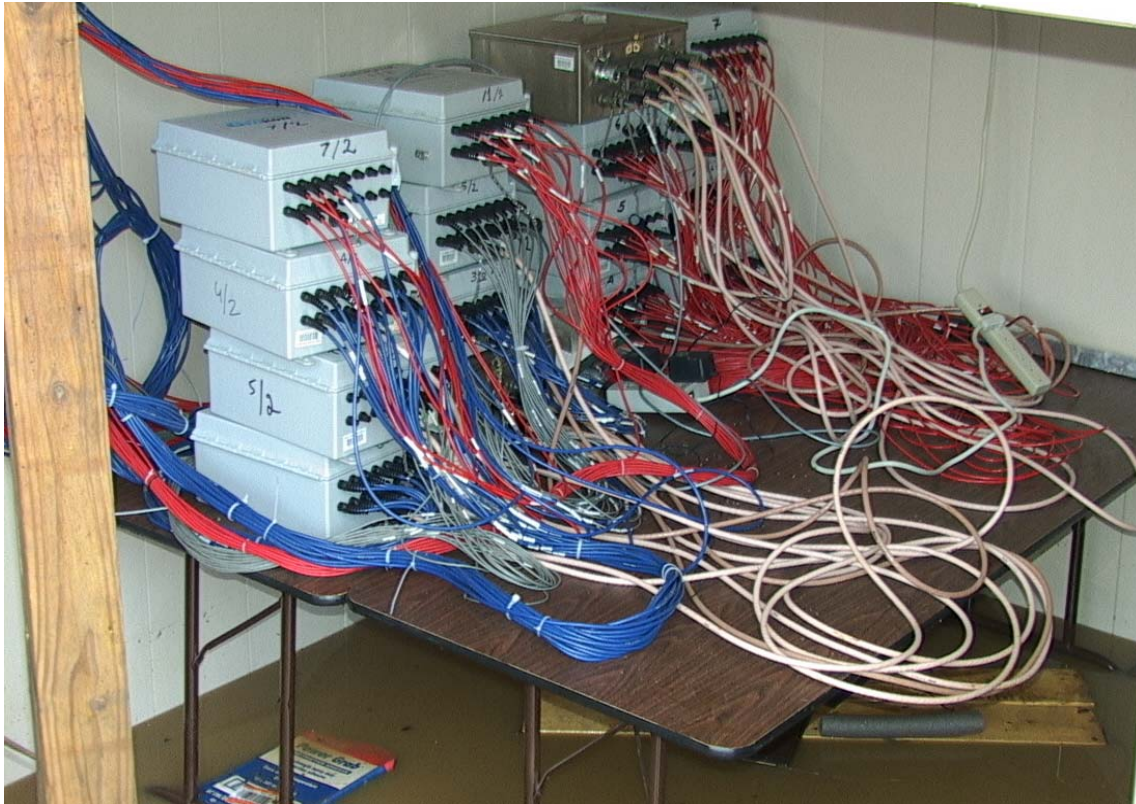
The dataloggers and multiplexers in use at Evansville bridge are housed inside a small vinyl storage shed, as shown in figure 3.9, both to protect them from the elements and to allow easy access to them for collection of data, as well as inspection, repair, and maintenance of equipment. Originally, standard AC power was used in conjunction with AC power adapters to provide power to the equipment, but the electrical service installed

Figure 3.9: Inside the Instrumentation Shed at Evansville Bridge (photo courtesy of Dr. Shoukry, WVU)

at Evansville Bridge was temporary, and was removed after construction was completed. After the removal of the AC power source, the data acquisition system was powered by a system of deep-cycle marine batteries (12V DC output), which are charged by a solar panel. This system requires little maintenance, and has proven more reliable even than the AC power, which is prone to interruptions in remote rural areas.

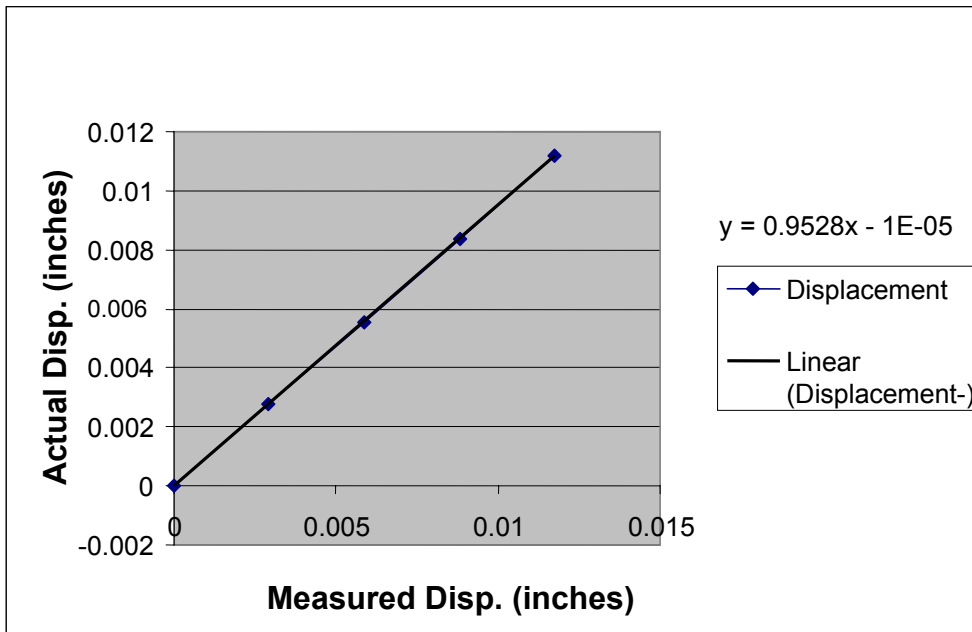
Figure 3.10: Vibrating Wire Strain Gage Calibration Curve

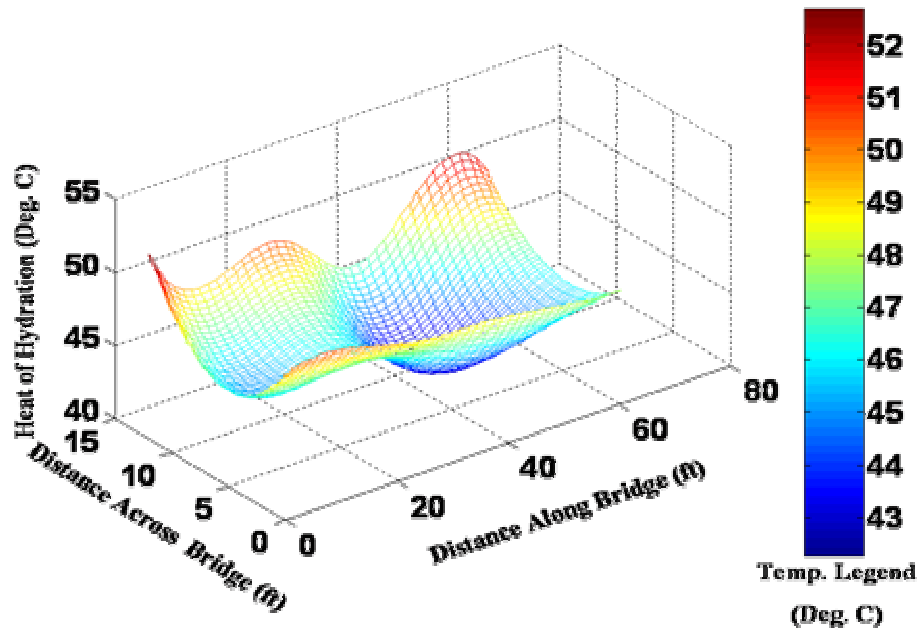
The largest temperature variations occur during the initial pouring of concrete. Due to the exothermic reaction of the cement with water, the temperature of the concrete increases initially during hydration and curing. This temperature increase causes the

concrete to expand, leading to increased tensile strain. As the exothermic reaction slows (10-12 hours after pouring), the concrete cools and starts to shrink. The concrete is delivered in several trucks; differences in the thermal properties of the concrete in different trucks cause different maximum temperatures and strains to occur in different sections of the deck, at different times. Figure 4.1 shows a thermal map of the bridge deck, and figure 4.2 is a map indicating the time of maximum heat of hydration.

Figure 4.1 Thermal Map of the Bridge Deck (Shoukry et. al., 2005)

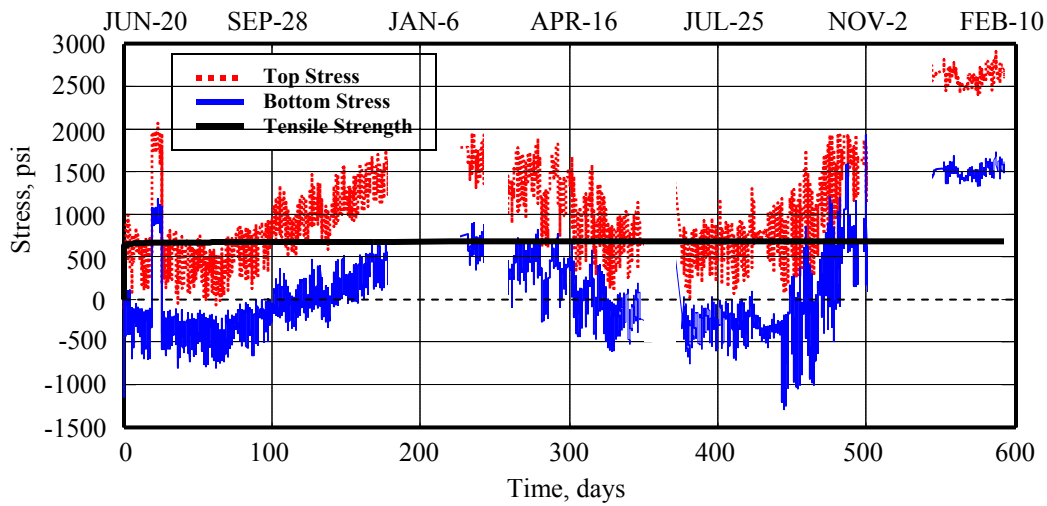
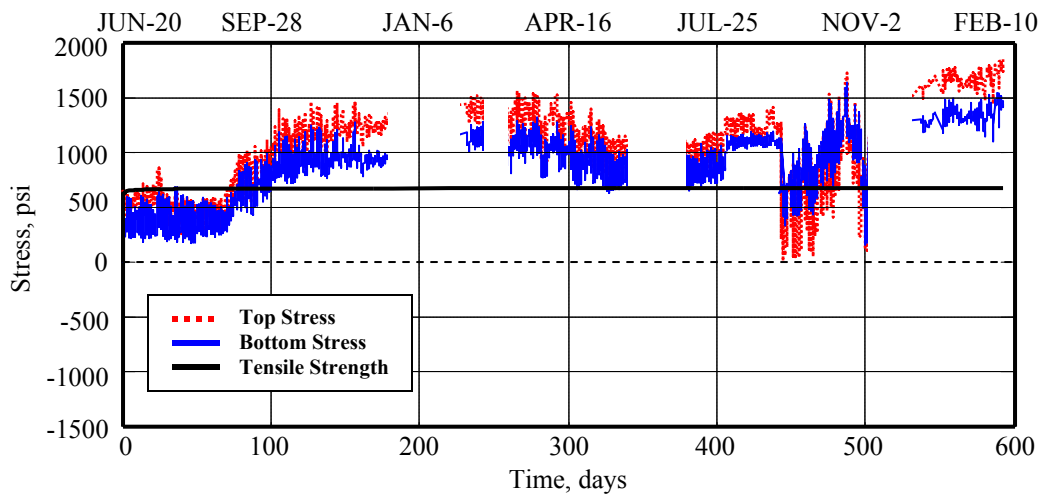
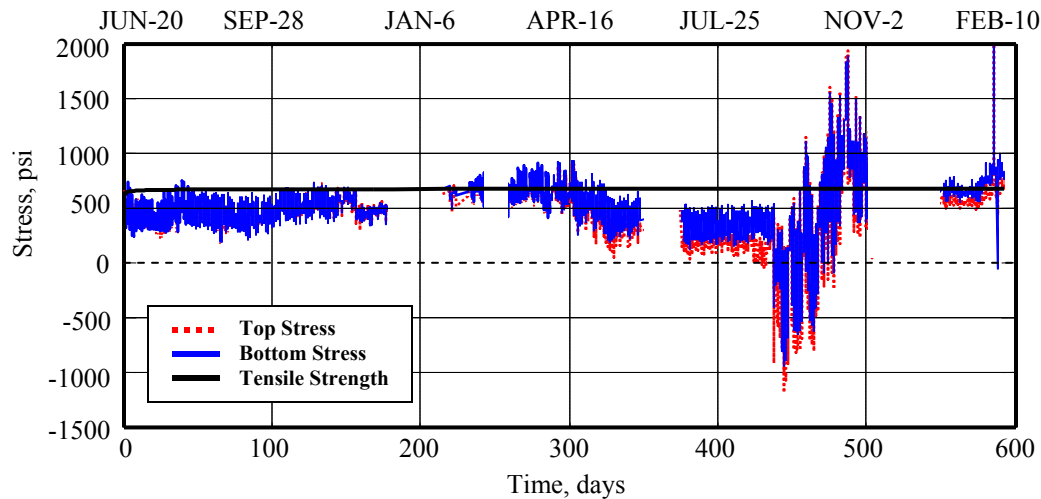
Figure 4.3.19-4.3.21 Time-History of Longitudinal Stresses at Mid Span # 2.

Based upon the stresses calculated from the measured strains, it is quite obvious that stress levels have surpassed those necessary to cause cracking. Stress levels were high enough to cause cracking at all locations. Based upon the results of the stress analysis, it is quite likely that extensive cracking has occurred throughout the deck of Evansville Bridge.

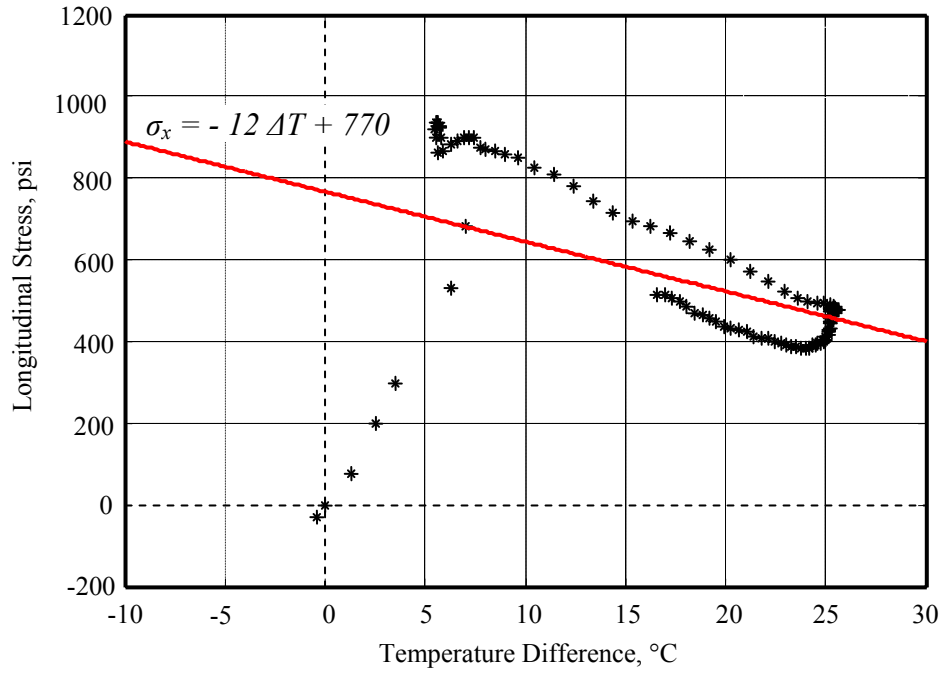
a. At Mid Span # 1

In order to examine the phenomenon described above as it occurs at Evansville Bridge, plots of stress versus temperature change were created at ages of 1, 3, 7, 14, and 28 days in two locations (mid-span #1 and the pier). These plots are shown in figures 4.4.1-4.4.5 a and b.

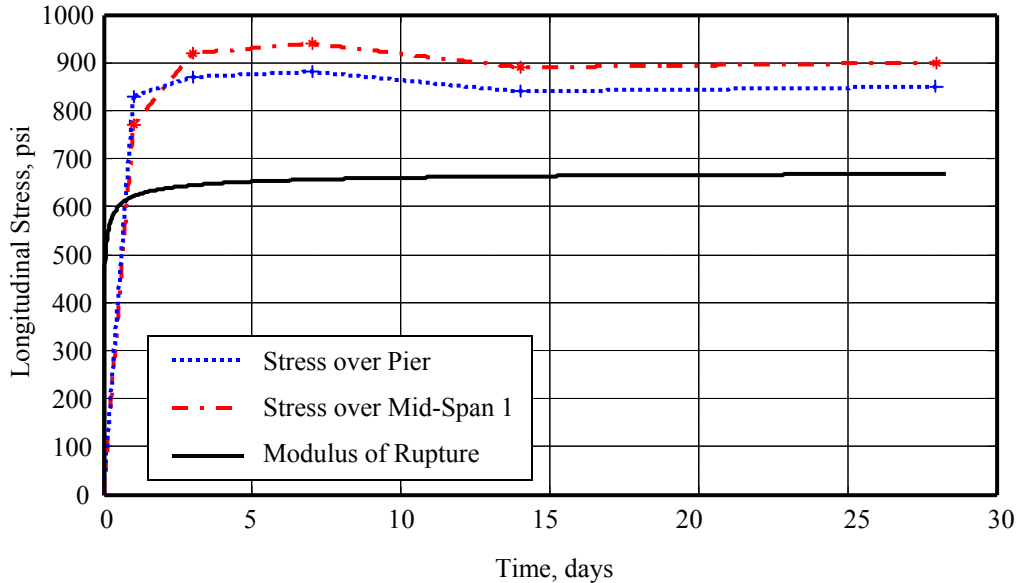
Using the data from the above plots, it is possible to generate time histories of the stresses to due restrained shrinkage, as shown in figure 4.4. The stresses exceed the modulus of rupture of concrete during the first day after casting; at this point the bond between the concrete and the steel reinforcement is weak, which means that the reinforcement provides very little tensile strength, and the concrete can't sustain the stresses, which leads to cracking.

Figure 4.5 Longitudinal Stresses Due to Drying Shrinkage.

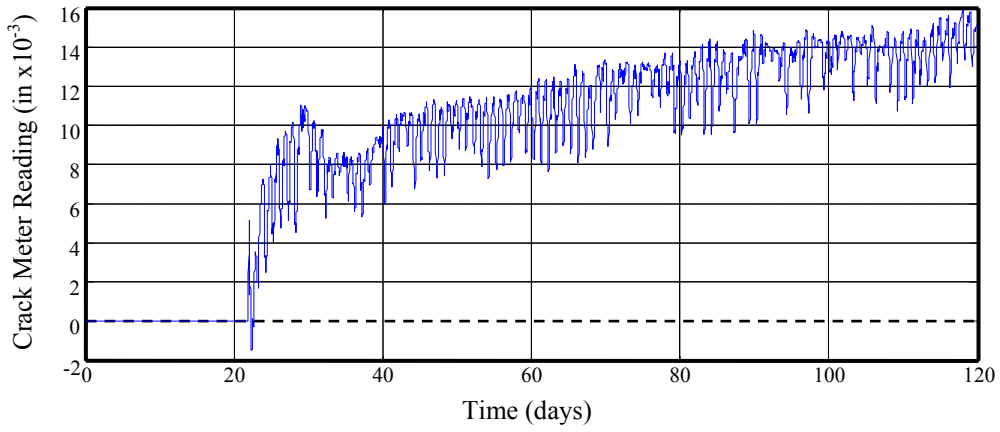
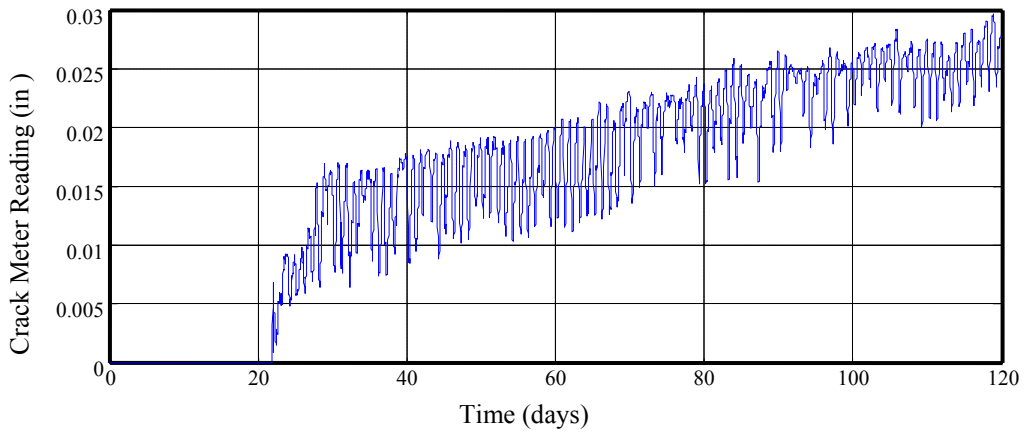
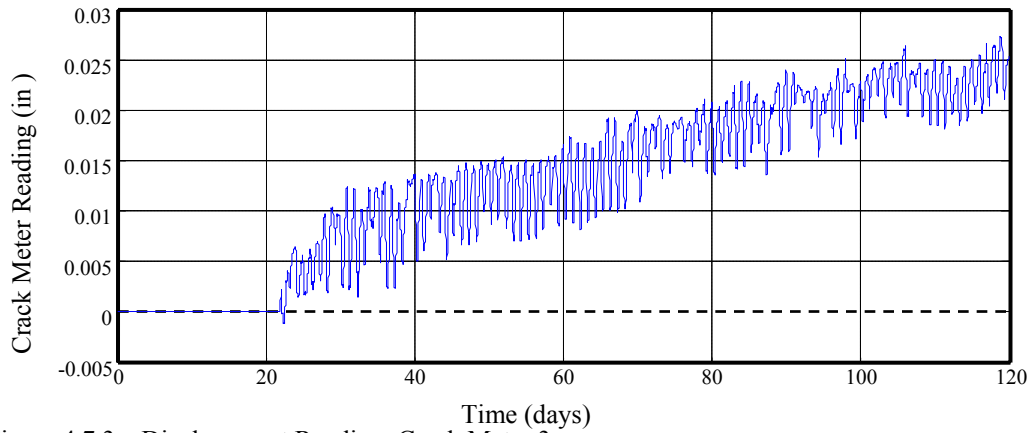
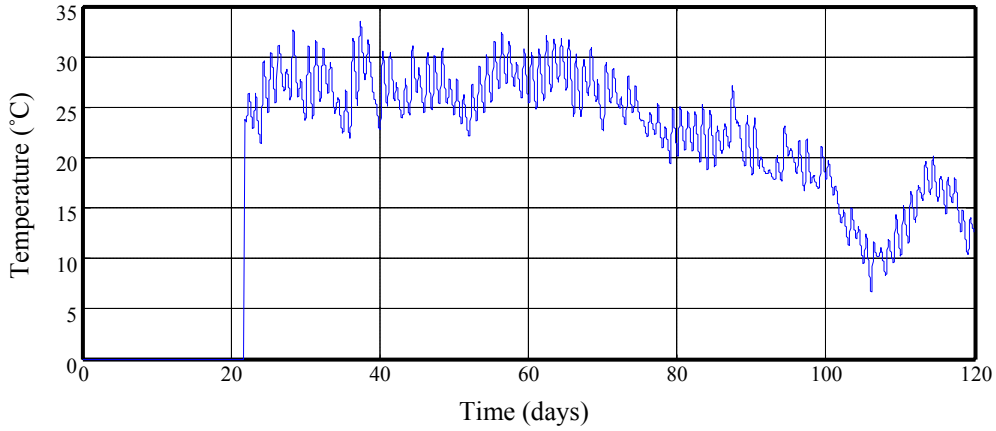
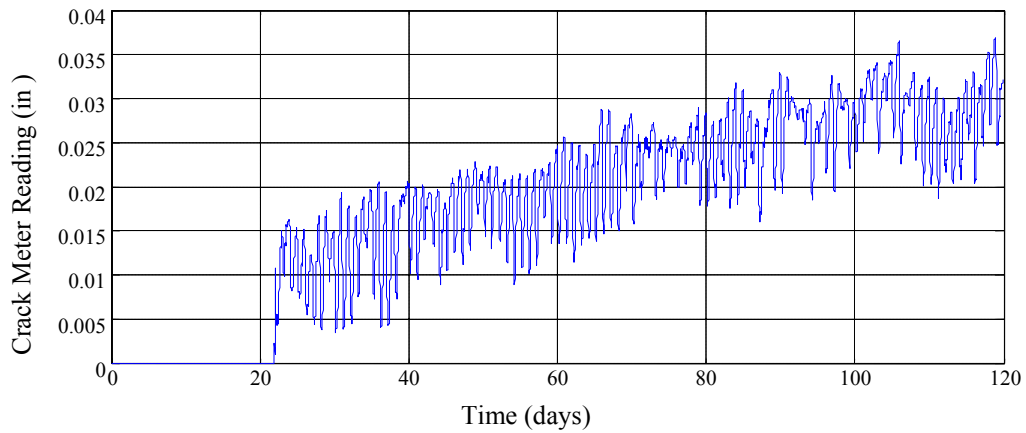
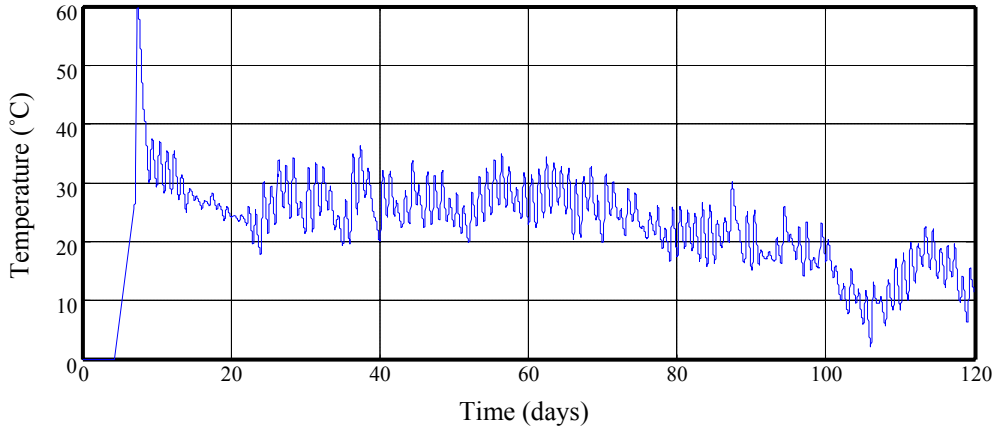
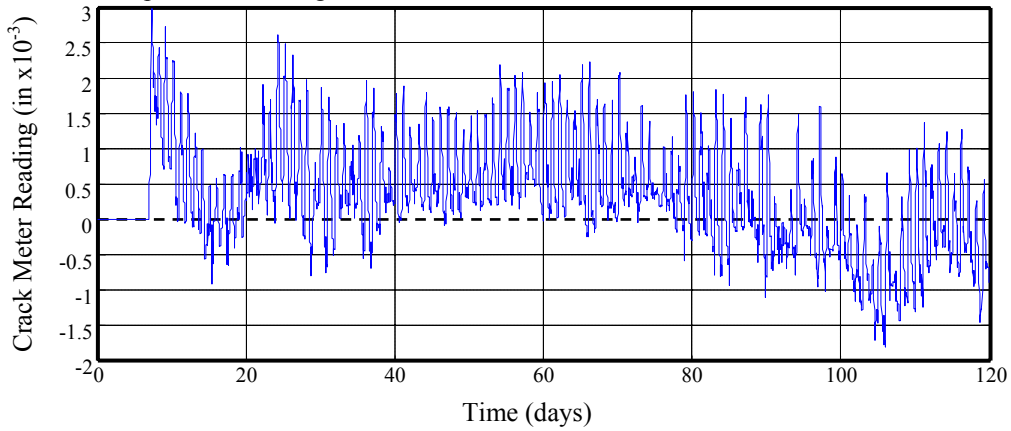
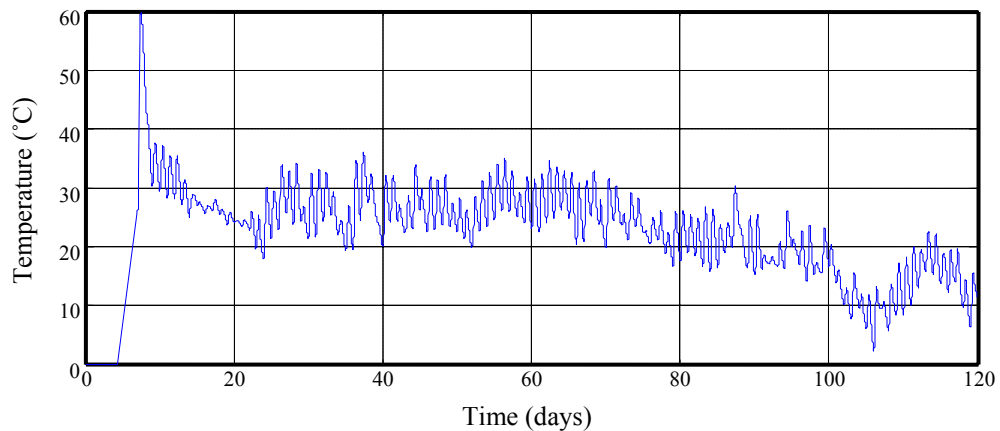
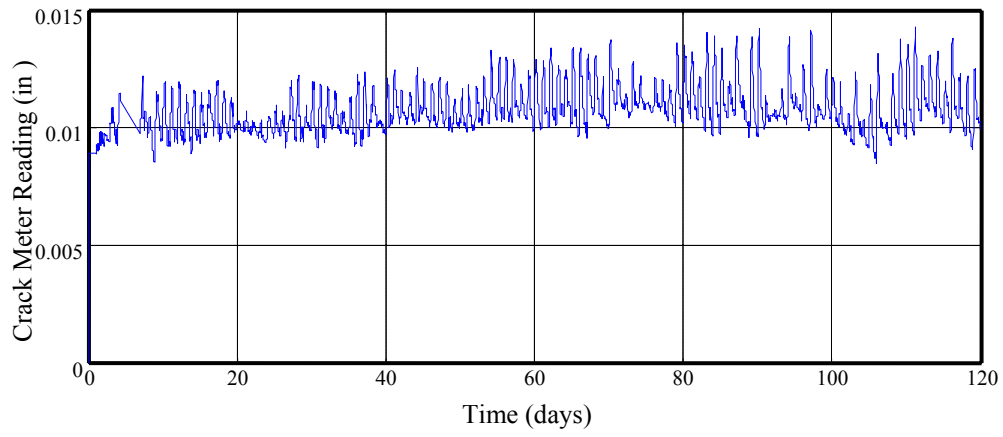
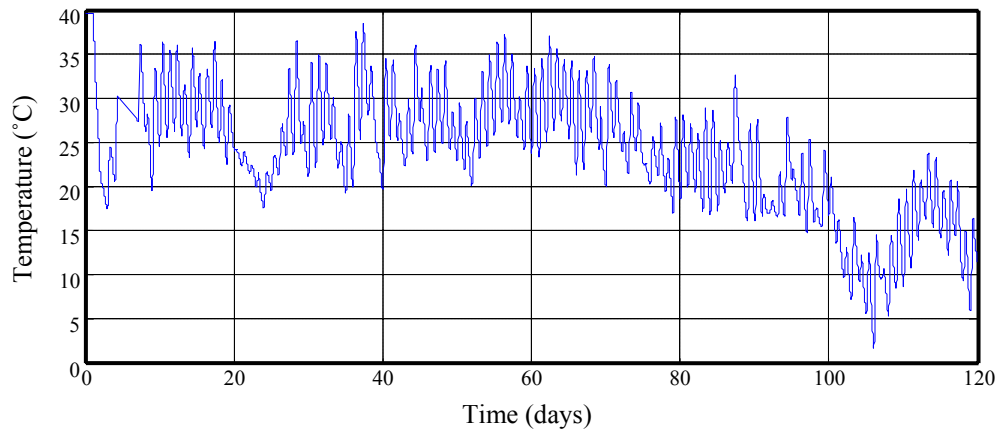
In order to determine whether the bridge deck is cracked at the location of a given crack meter, a short section of data (120 days worth) was plotted versus time. By observing the trend of the data, it is possible to determine if a crack is present. If the displacement reading increases with decreasing temperature, then a crack is very likely present. These short plots are shown in figures 4.7.1-4.7.30 a and b.

Figures 4.7.1-4.7.30a, b: Time-History Plots of Crack Meter Reading and Temperature

Crack Meter Number	Condition
1	Joint
2	Joint
3	Joint
4	Joint
5	Cracked
6	Uncracked
7	Bad Sensor
8	Cracked
9	Uncracked
10	Uncracked
11	Cracked
12	Uncracked
13	Cracked
14	Uncracked
15	Uncracked
16	Cracked
17	Cracked
18	Cracked
19	Uncracked
20	Cracked
21	Cracked
22	Cracked
23	Uncracked
24	Cracked
25	Uncracked
26	Uncracked
27	Cracked
28	Uncracked
29	Uncracked
30	Cracked

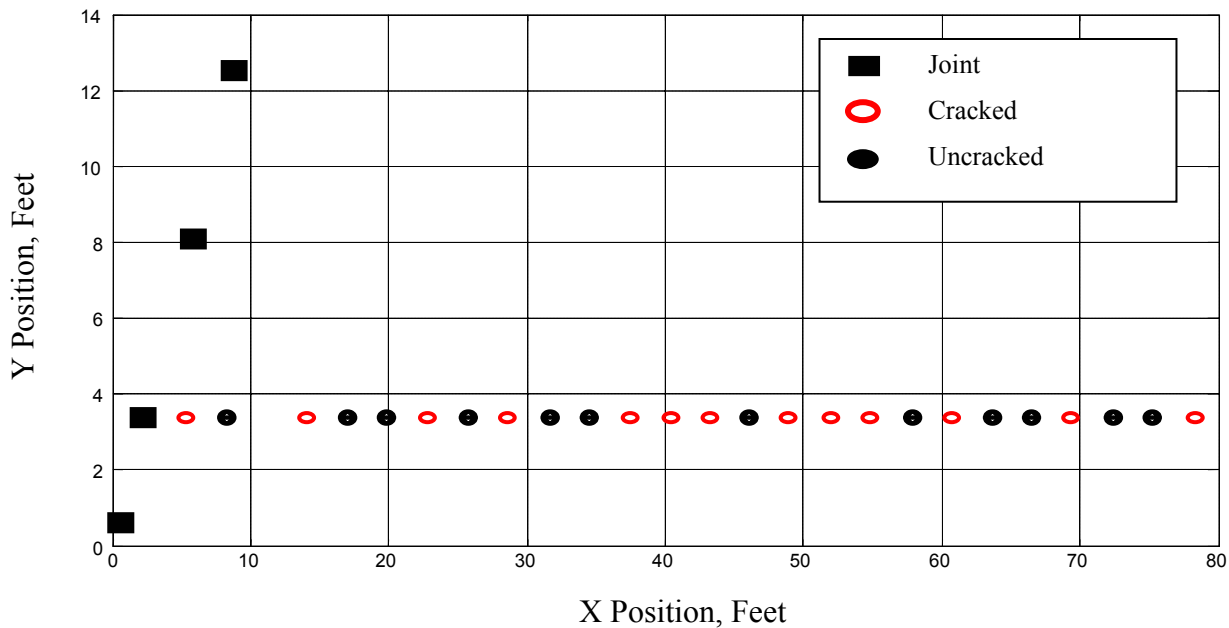
Figure 4.8: Map of Bridge Deck Showing Sensor Locations and Cracks Detected

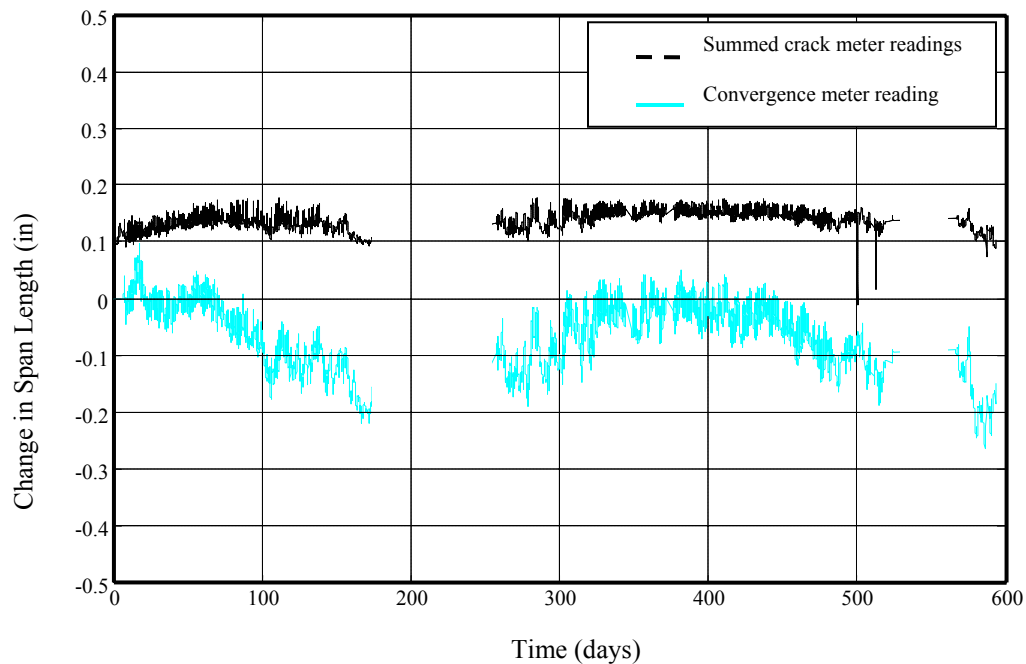
Constraint of the lower surface of the bridge deck causes curling, since the upper surface of the concrete is freer to expand and contract. This curling effect contributes to the noncomposite behavior of the deck and girders of Evansville Bridge by causing additional stresses in the vertical direction on the interface between the concrete and the shear studs. Figure 5.4 illustrates the curling effect.

Figure 5.4: Change in Span Length as Measured by Crack Meters and Convergence Meters

The convergence meter measures span length by the relative motion of the abutment and the pier; this is effectively the change in length of the girders. The crack meters measure span length as the change in length of the deck. If the deck and the girders behave as a composite unit, the two span lengths should be equal. They are not equal, and the fact that the summation of the crack meter readings is always positive indicates that the deck has curled to some degree. Additional evidence of the curling phenomenon is shown in the strain profiles. Strain profiles indicate that although the girders deflect downward due to dead loads (the weight of the concrete deck and the weight of the girders themselves), the concrete deck exhibits upward curling. Some examples of measured strain profiles are shown in figure 5.5. Similar plots of strain profiles for the other instrumented locations are similar. None of them show a continuous, linear profile that should be present if composite action occurs.

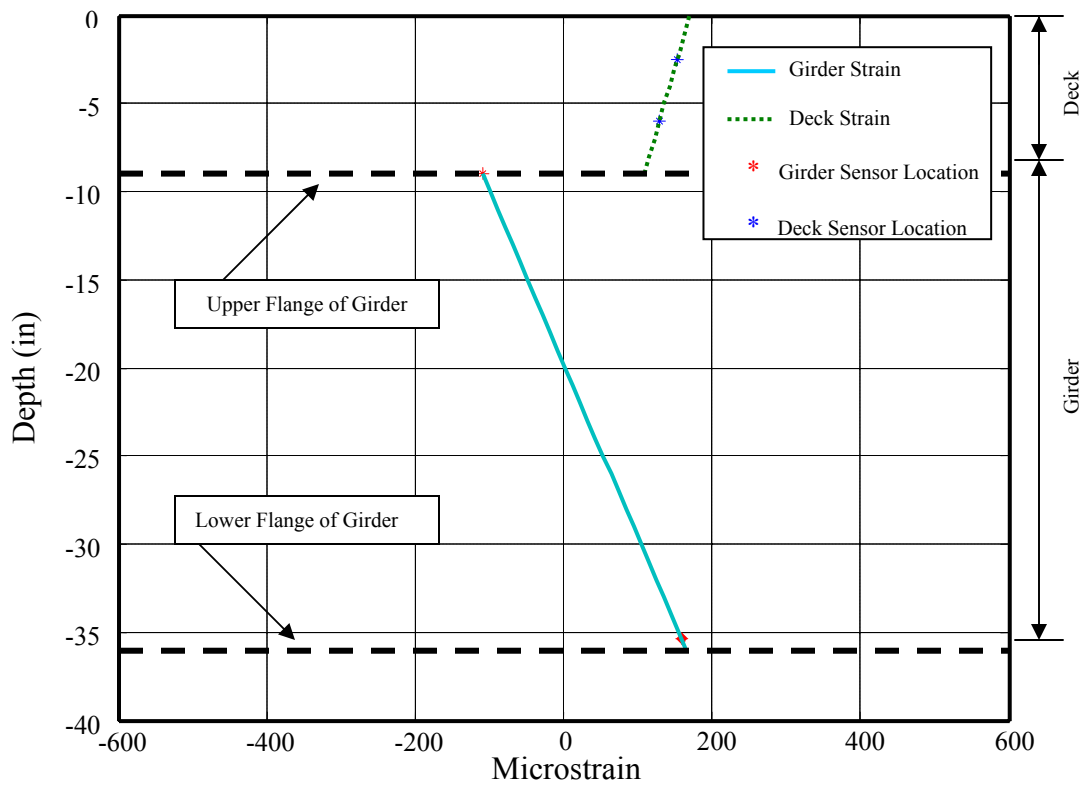
Figure 5.5: Strain Profile through the Deck and Girders at Midspan After 15 Days

It is apparent from the measured data and the analysis of this data that complete composite action does not occur between the concrete deck and steel girders of Evansville Bridge.

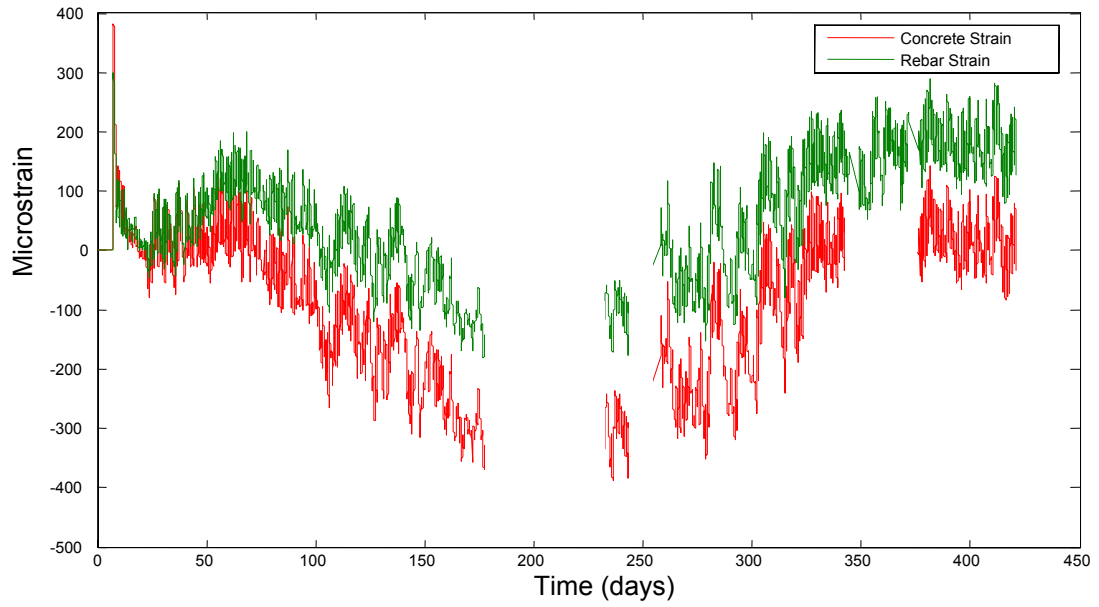
a) Strain in Wheelpath Direction at Abutment along Beam B

<b>Direction</b>	<b>Location</b>	<b>Condition</b>
Along Wheelpath	Abutment, Beam B	Debonded
Transverse to Wheelpath	Abutment, Beam B	Bonded
Along Wheelpath	½ Span, Beam C	Bonded
Transverse to Wheelpath	½ Span, Beam C	Debonded
Along Wheelpath	½ Span, Beam B	Bonded
Transverse to Wheelpath	½ Span, Beam B	Bonded
Along Wheelpath	¾ Span, Beam B	Bonded
Transverse to Wheelpath	¾ Span, Beam B	Bonded
Along Wheelpath	Pier, Beam B	Imperfectly Bonded
Transverse to Wheelpath	Pier, Beam B	Bonded
Along Wheelpath	Midspan, Beam C	Bonded
Transverse to Wheelpath	Midspan, Beam C	Bonded
Along Wheelpath	Midspan, Beam B	Bonded
Transverse to Wheelpath	Midspan, Beam B	Bonded
