# **Progression in Non-Destructive Spallation Prediction and Elevated Temperature Mechanical Property Evaluation of Thermal Barrier Coating Systems by Use of a Spherical Micro-Indentation Method**

Dissertation submitted to the  
College of Engineering and Mineral Resources  
at West Virginia University  
in partial fulfillment of the requirements  
for the degree of

**Doctor of Philosophy  
In  
Mechanical Engineering**

**Department of Mechanical and Aerospace Engineering**

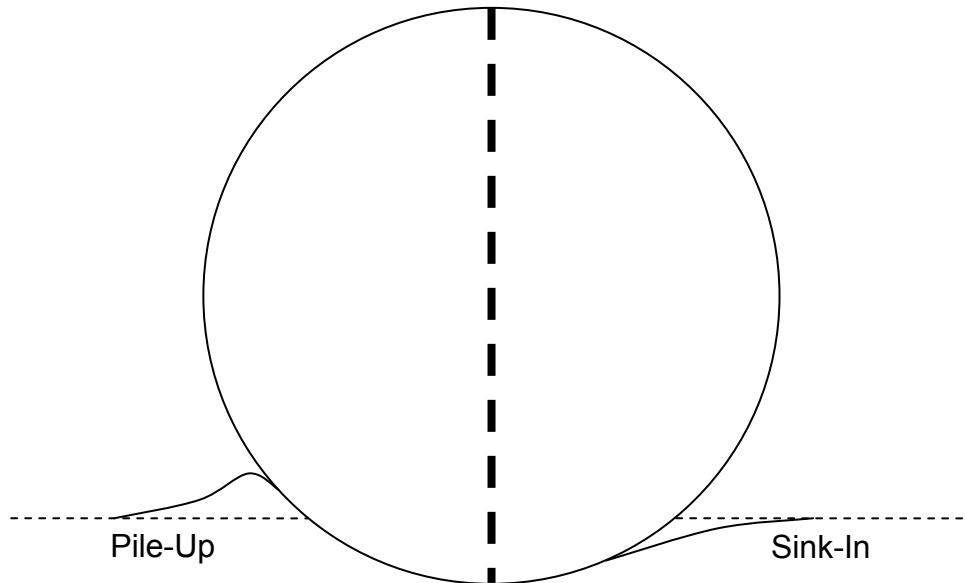
Throughout spherical indentation of an elastic material, the specimen's surface is typically drawn in and downwards toward the indenter, as a result, a sink in effect around the indenter is observed, Figure 2.

**Figure 2: Pile-up and sink-in (not simultaneously) occurring during spherical indentation.**

Yet, when the contact involves plastic deformation, the material may either sink-in or pile-up around the indenter. In a fully plastic region, the behavior is found to

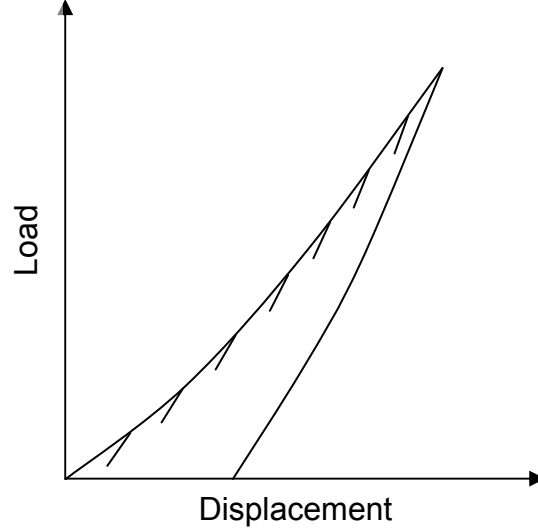
**Figure 4: Load displacement curve for multiple partial unloading algorithm.**

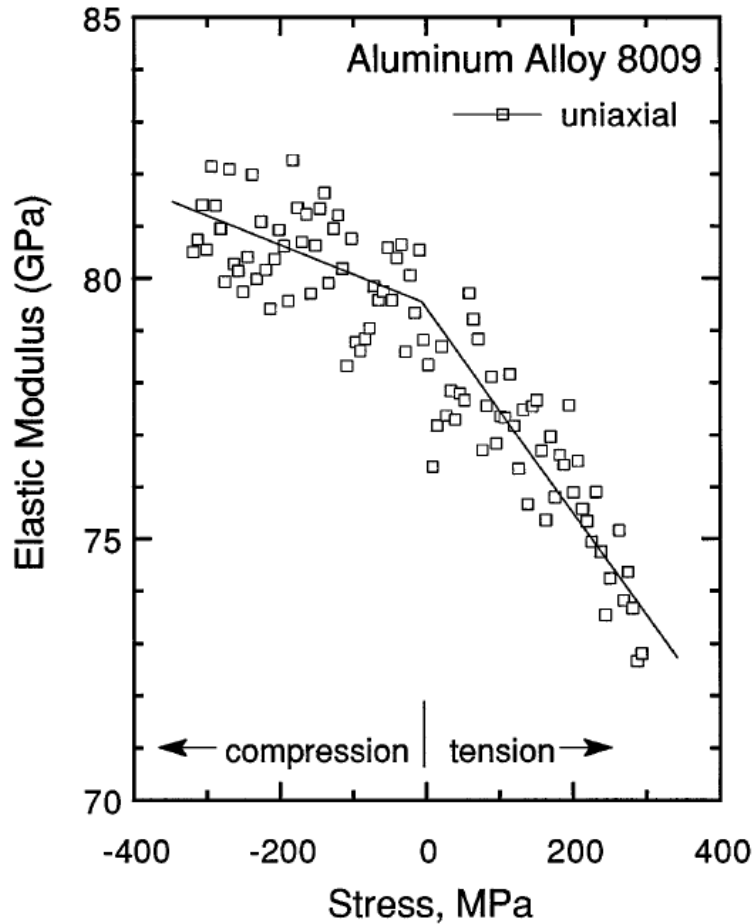
performed on materials under uniform compressive stresses and reduce under uniform tensile stresses, Figure 6 [23, 24].

Figure 6: Elastic modulus variance with an imposed residuals stress [23].

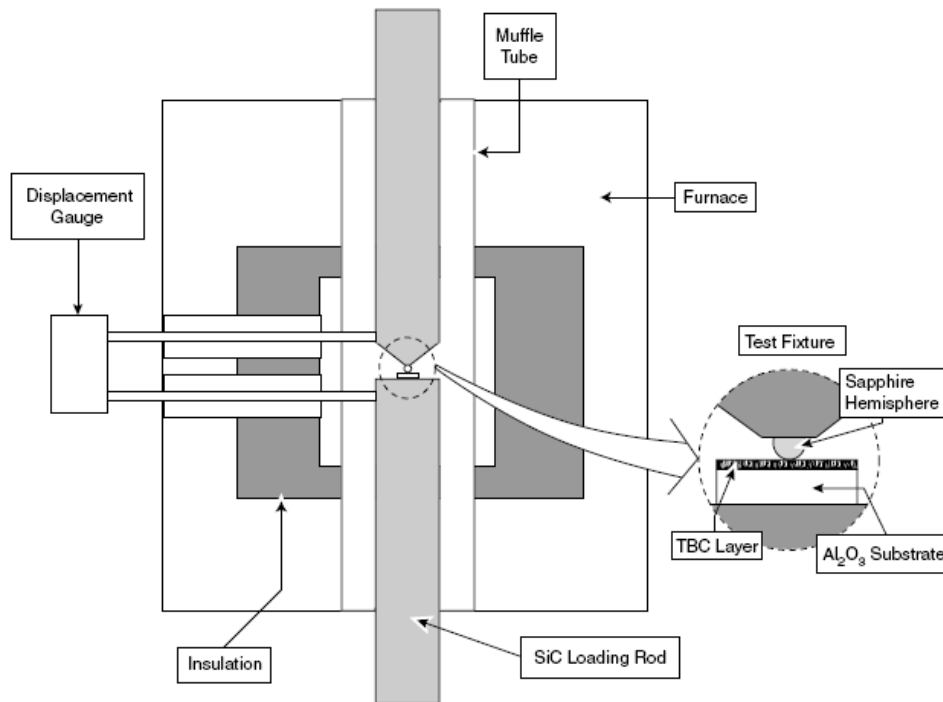
**Figure 8: Micro-indentation probe for measuring plastic deformation of porous thermal barrier oxides at temperatures between 937°C and 1137°C [37].**

These high temperature impression tests performed on various thermal barrier oxides deposited by EB-PVD revealed the columnar microstructure

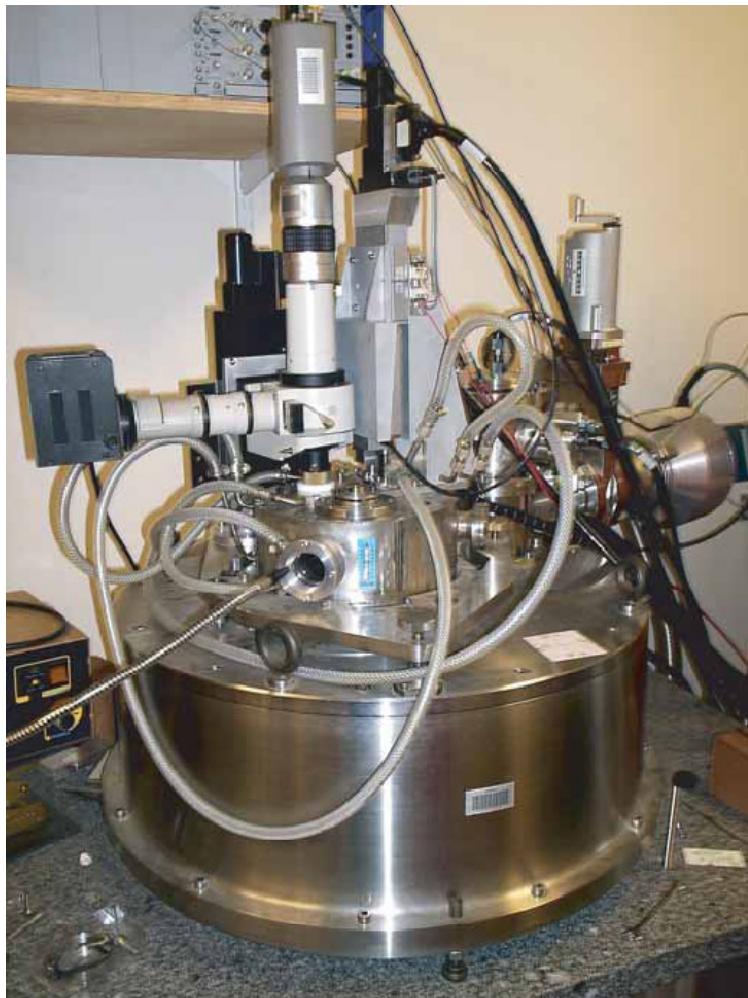
**Figure 9: Instrumented micro-indentation equipment for experiments up to 1000°C [38].**

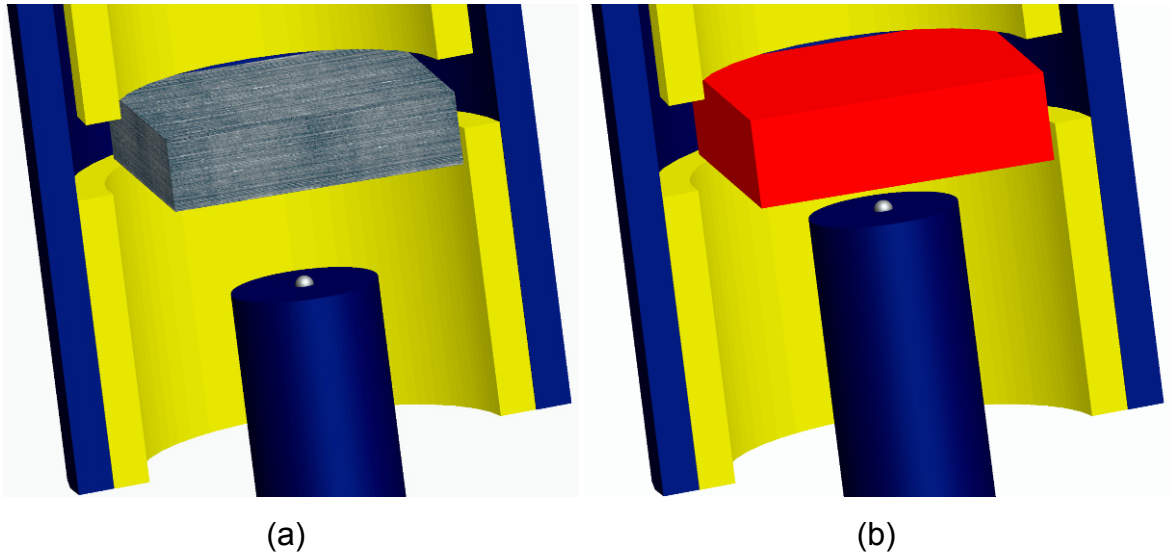
implemented where the sample and indentation chain positions are reversed. This inverted design allowed all heat lost to radiate in the direction opposite to that of the indentation chain. However, as a result of this inverted design, a unique sample constraint system had to be developed, Figure 11.

**Figure 11: High temperature indentation system design, a) room temperature and b) high temperature.**

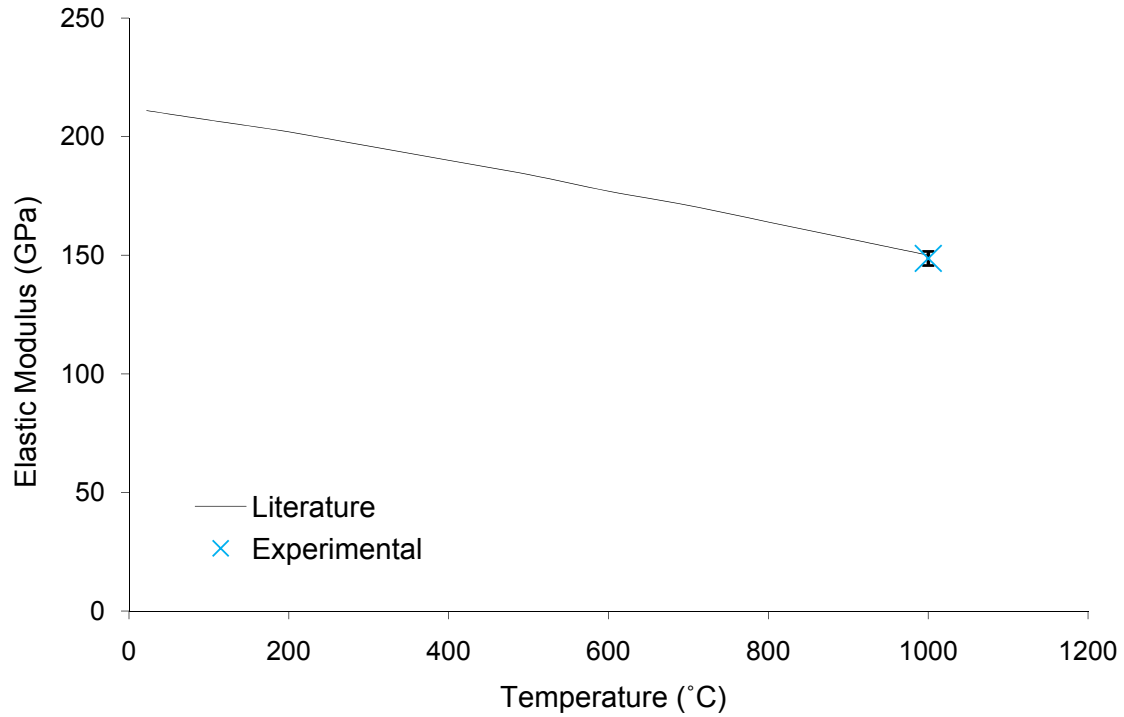
At all temperatures five multiple partial unloading micro-indentation elastic modulus evaluation tests were performed using a 2  $\mu\text{m}$  loading and 1  $\mu\text{m}$  unloading displacement. Although a total actuator displacement of 30  $\mu\text{m}$  was used throughout testing, the maximum load reached during each test decreased along increasing thermal load. This load reduction is the result of hardness decreases with increasing temperature of the H13 Tool Steel. Additionally, elastic modulus evaluation of a single crystalline Haynes 230 superalloy at 1000°C show good correlation with reported literature values, Figure 13 [44].

**Figure 13: High temperature indentation elastic modulus results on a Haynes 230 coupon with  $\pm 1$  standard deviation [44].**

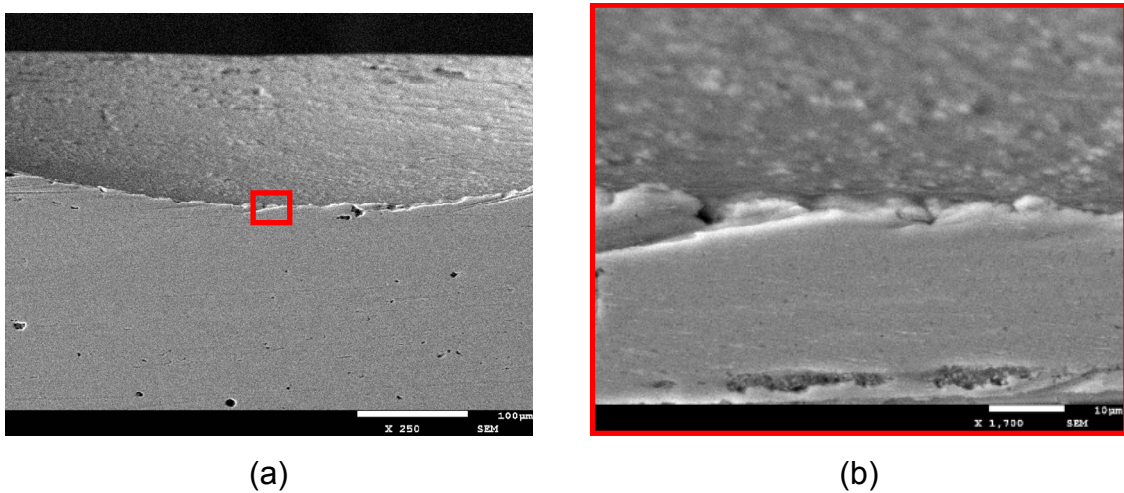
**Figure 14: Iron oxide scales grown on H13 Tool Steel at 500°C; a) x250 and b) x1700**

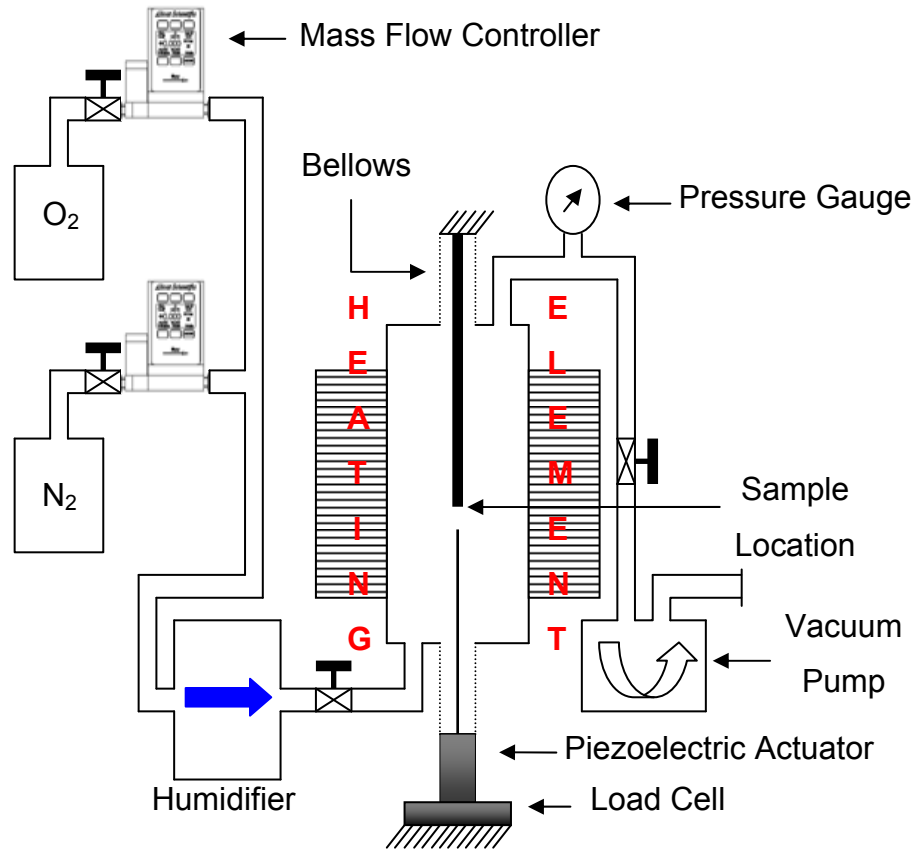
**Figure 15: Controlled environment high temperature indentation system.**

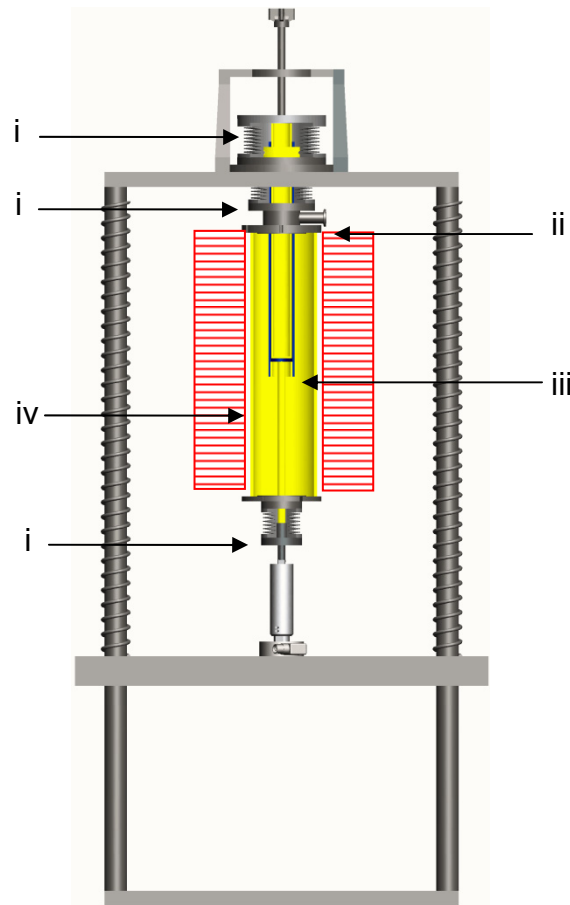
Developed through alteration of the previously presented high temperature micro-indentation system, the controlled environment high temperature indentation system requires the use of several additional components, Figure 16.

**Figure 16: Controlled environment high temperature indentation system schematic; i) stainless steel bellows, ii) gas/moisture/vacuum port, iii) sample (shown schematically in Figure 11) and iv) cylindrical alumina tube.**

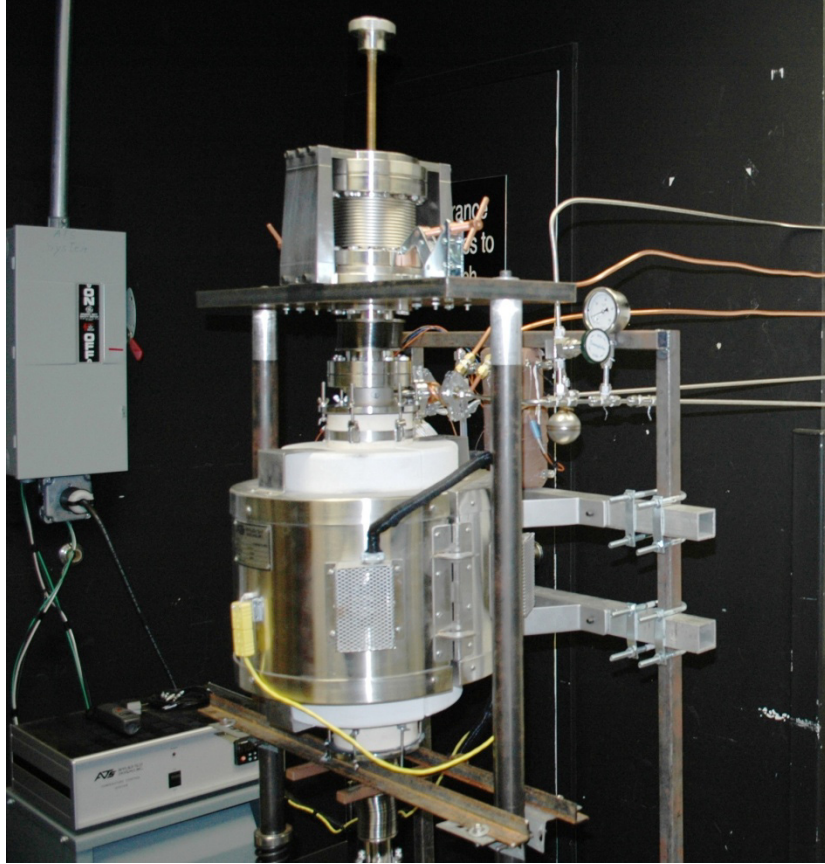
Although the evaluation chamber requires vacuum capability, indentation chain components must not be exposed to harsh environmental conditions and thus should remain external, thus a series of bellows is utilized to allow actuator to indenter displacement but prevent environmental damage of the indentation chain. Furthermore, losing its mechanical strength at temperatures above  $\sim 500^{\circ}\text{C}$  [47], stainless steel requires external heat removal while under thermal loads above this level. Consequently, an external cooling system is required to prevent both oxidation and lose of mechanical strength of several system components at elevated temperatures, Figure 17.

**Figure 17: Controlled environment high temperature indentation system, gas/steam and water cooling lines.**

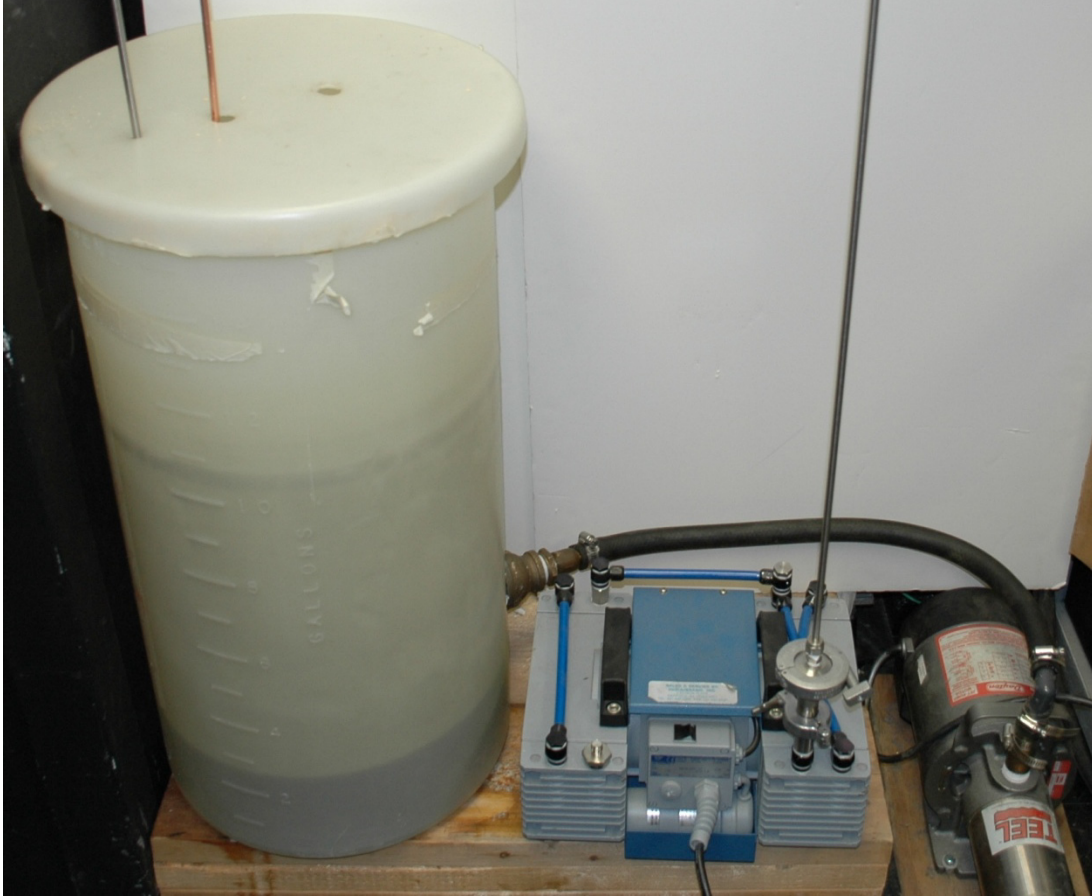
Composed of stainless steel, the inlet inert gas line is initially fed through a liquid humidifier where it is first saturated with steam prior to entering the thermal chamber. Although the gas bottle is under a positive pressure, differential losses through the gas/steam line require the chamber first be brought to a vacuum state prior to the introduction of steam. Thus, a vacuum pump has been installed and will allow the thermal chamber to be purged multiple times to achieve a steady-state gas/steam state prior to thermal loading, Figure 18.

**Figure 18: Controlled environment high temperature indentation system, external water pumps and cooling tank.**

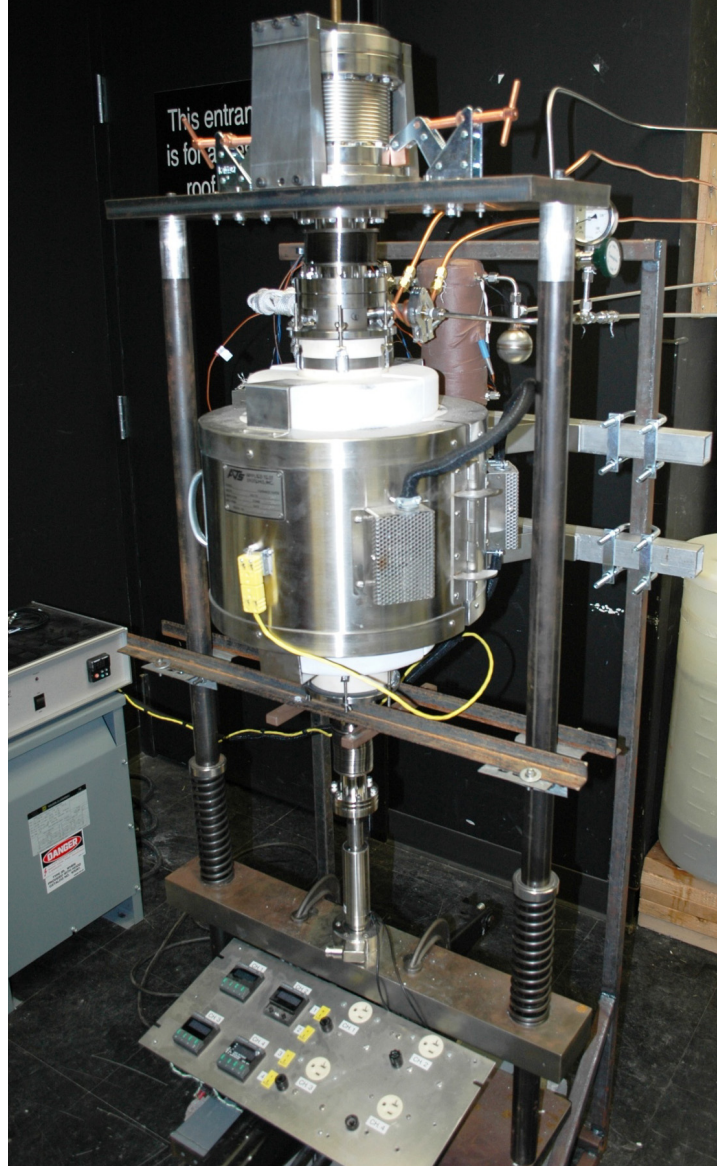
This vacuum purging procedure is repeated until a desired level of steam and inert gas mixture within the chamber is reached. In order to control the humidity content, a series of thermal pads are applied on the gas/steam lines leading to the thermal chamber. A total of three thermal pads have been installed, all of which are powered through a controller placed at the bottom of the indentation system, Figure 19.

**Figure 19: Controlled environment high temperature indentation system; overview.**

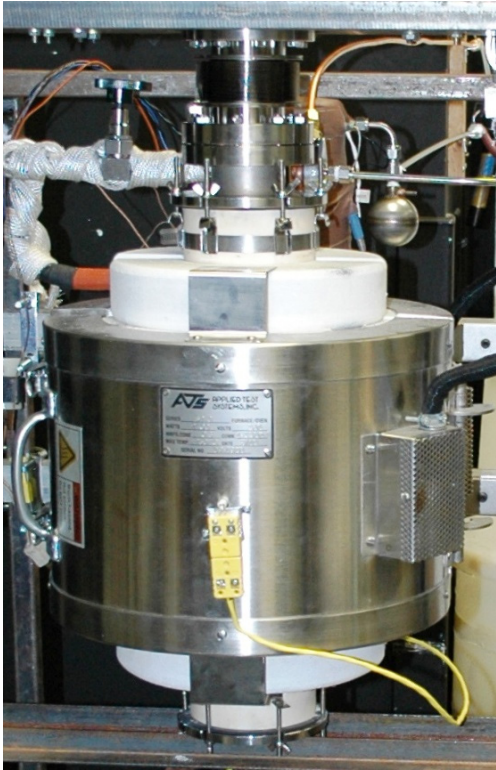
(a)

**Figure 20: Controlled gas high temperature indentation system at a) room temperature and b) 1100°C.**

Warming of the lines between the humidifier and the thermal chamber will ensure no water vapor condensation will occur prior to reaching the preheated sample chamber. Once a sufficient level of saturated steam exists in the thermal chamber, all outlets are sealed and the furnace is then brought to the desired testing temperature. This increase in temperature will cause pressures within the chamber to increase, thus a 1PSI poppet check valve is installed to release all additional gases exhausted by the system. With the completion of the inert

gas/controlled moisture content high temperature environmental chamber, initial simulated TBC thermal cycling has been conducted, Figure 20.

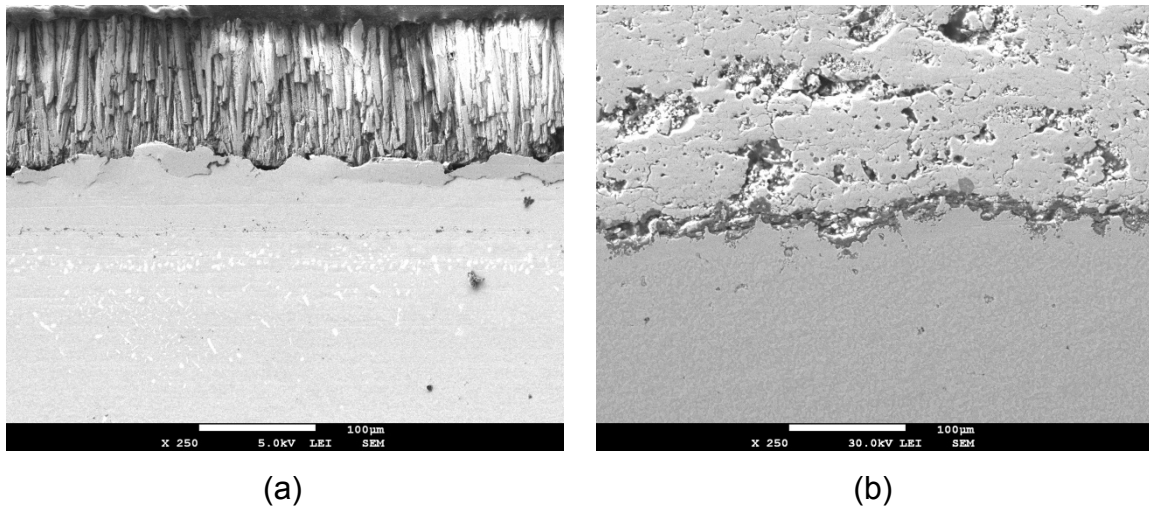
**Figure 24: TBC Cross-sectional SEM Micrograph, a) EB-PVD and b) APS.**

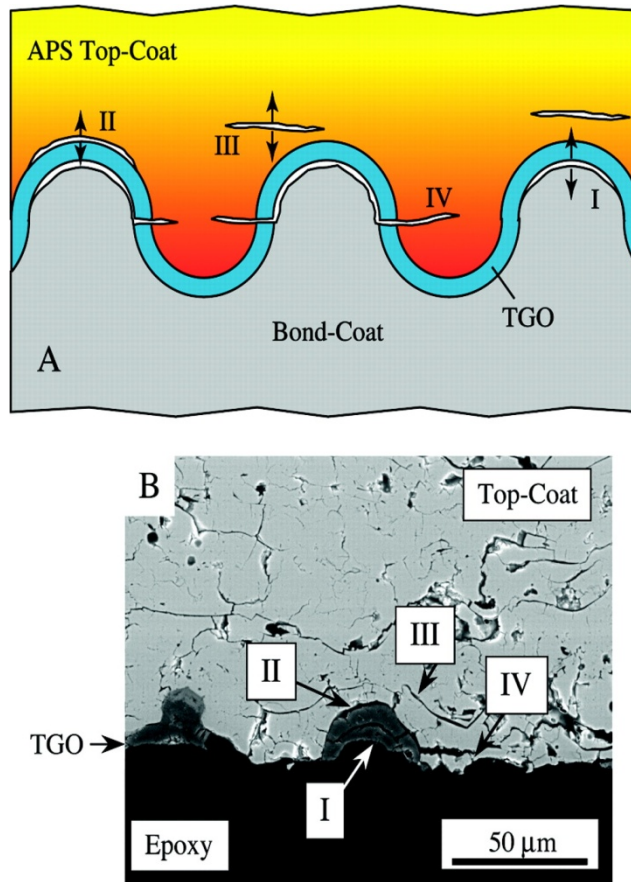
**Figure 29: Schematic diagram and scanning electron micrograph showing the four different cracking mechanisms of a failed APS TBC after 240 cycles [93].**

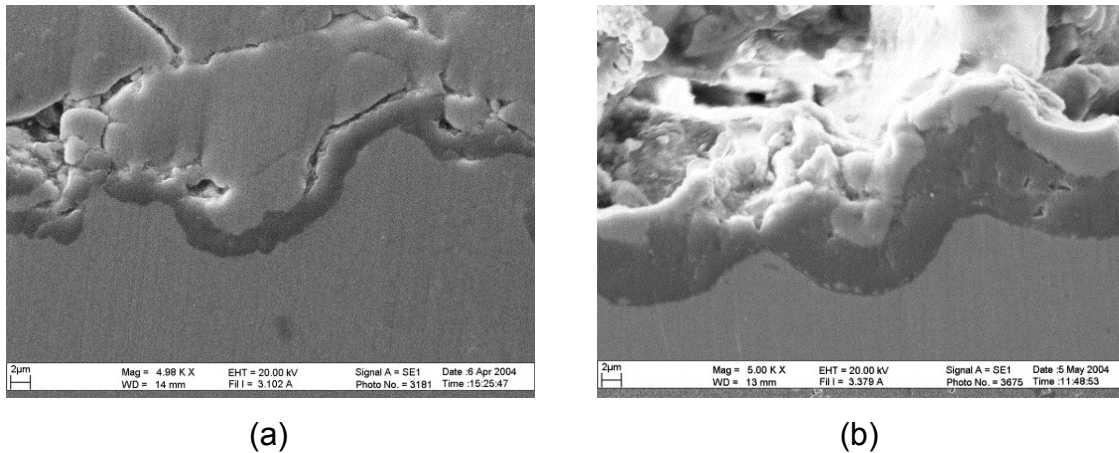
**Figure 30: Cross-sectional scanning electron micrograph of an APS TBC system thermal load at 1070°C in air after a) 95 and b) 585 hours [94].**

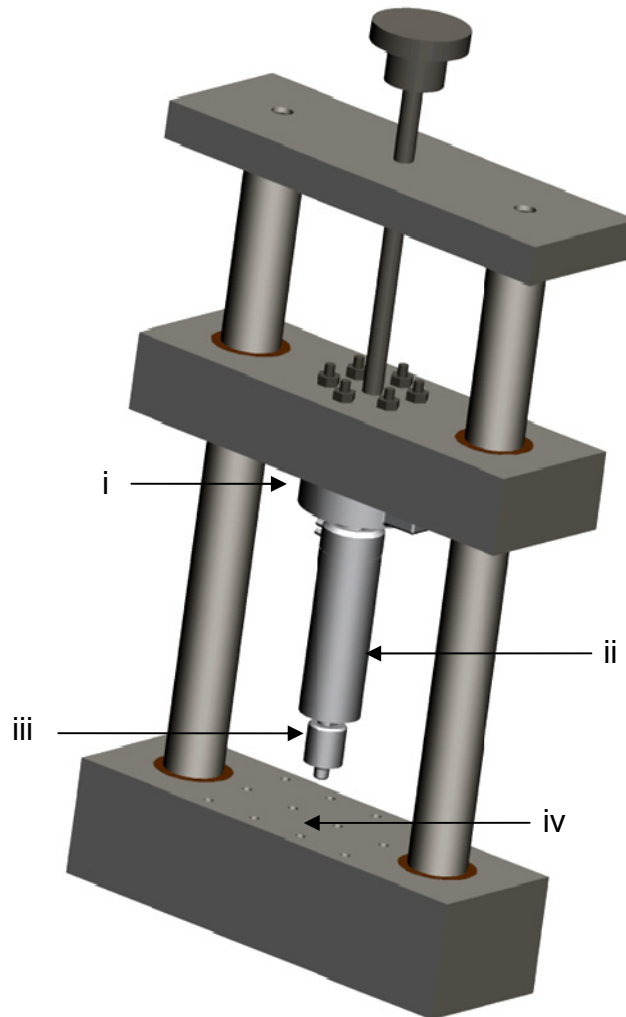
**Figure 37: Experimental setup, i)  $\pm 0.15\%$  accuracy Honeywell Model 31 100 lb. load cell, ii) 3.6 nm resolution Physik Instrumente P-239.9S 180  $\mu\text{m}$  piezoelectric actuator, iii) spherical tungsten carbide (WC) 750 $\mu\text{m}$  radius indenter, and iv) coupon stage.**

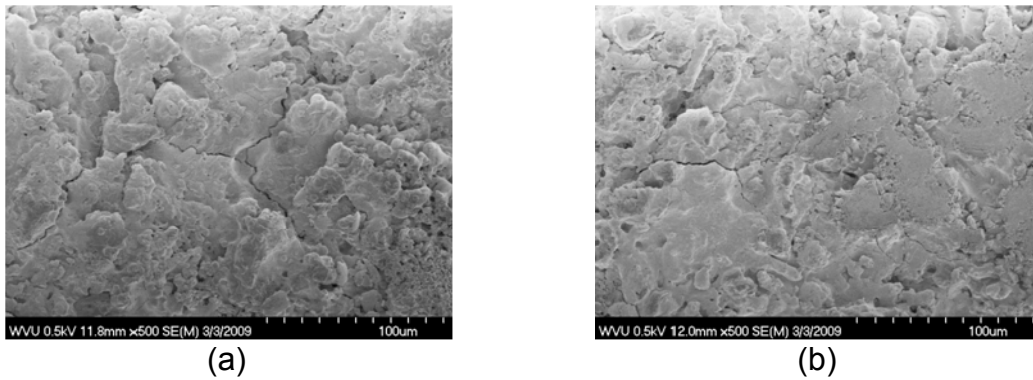
Figure 38: Top coat SEM micrographs of an APS/MCrAlY/Ren N5 obtained after a cumulative 375 isothermal hours, a) Non-Indented Region and b) Indented Region.

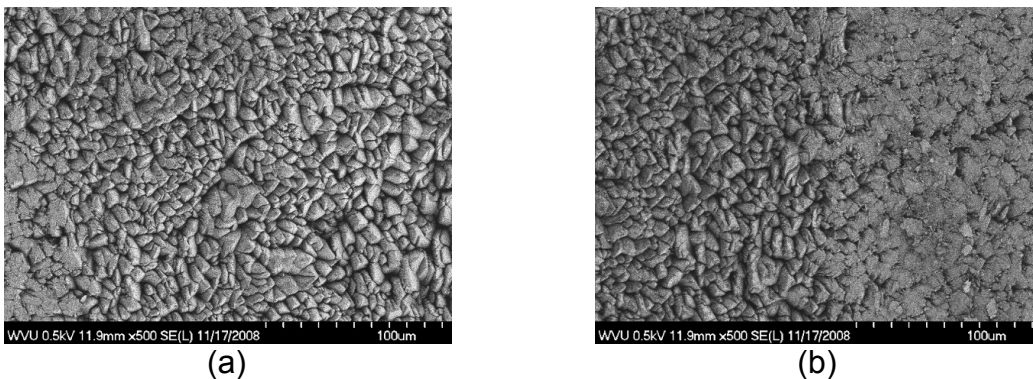
Figure 39: Top coat SEM micrographs of an EB-PVD/MDL/Ren N5 obtained after a cumulative 60 cycles, a) Non-Indented Region and b) Indented Region.

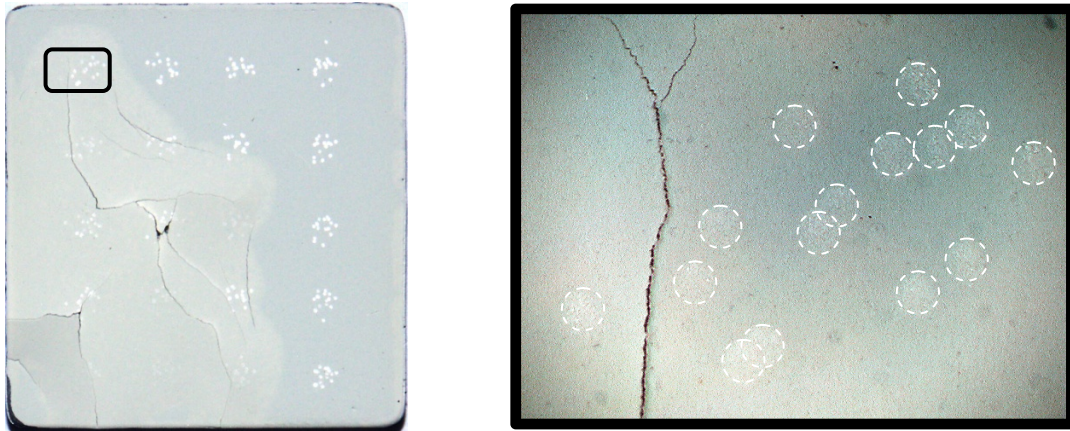
**Figure 40: Failure location along the surface of the thermally cycled EB-PVD/MDL/RenéN5 coupon.**

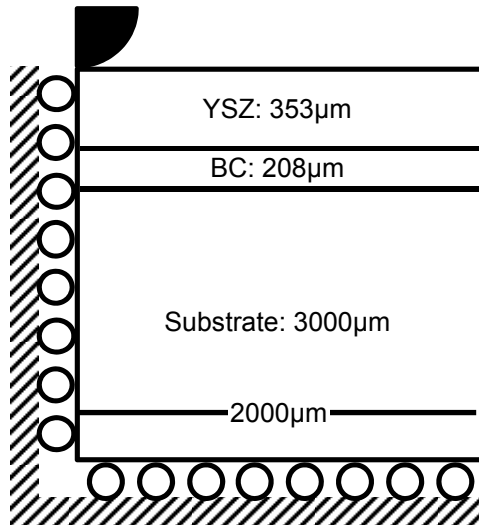
Figure 41: Axisymmetric numerical TBC indentation model boundary conditions and indenter radius of 793.5 $\mu\text{m}$ .

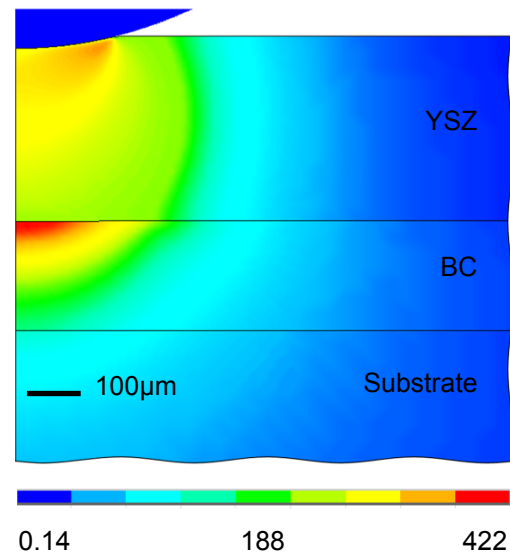
Figure 42: 90 N indentation inference zone shown to exist in all layers of the TBC system, Von Mises Stress (MPa).

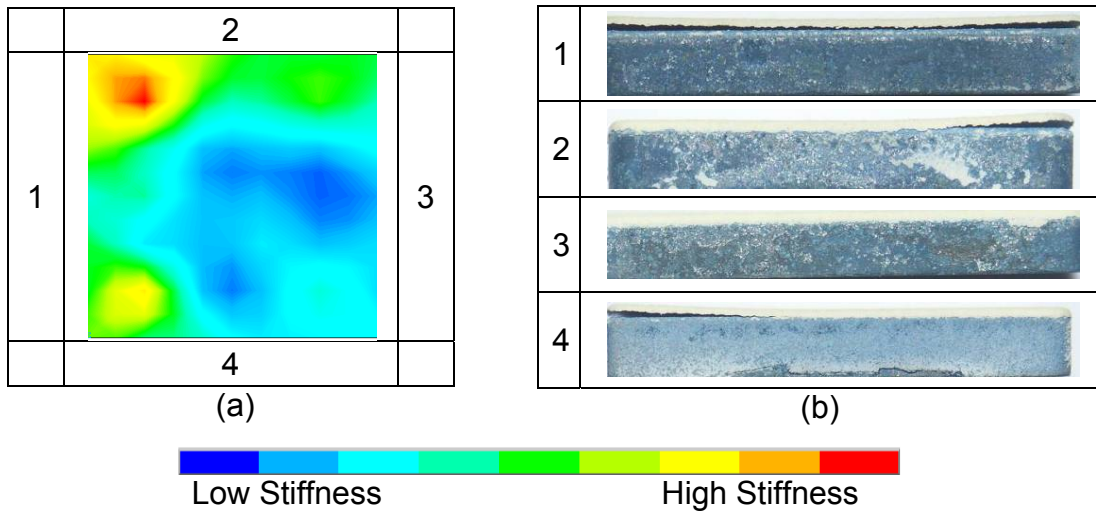
**Figure 45: APS/MCrAlY/RenéN5 coupon A, a) surface stiffness response contour map after 450 hours of isothermal exposure at 1100°C and b) edge spallation following 500 hours of isothermal exposure.**

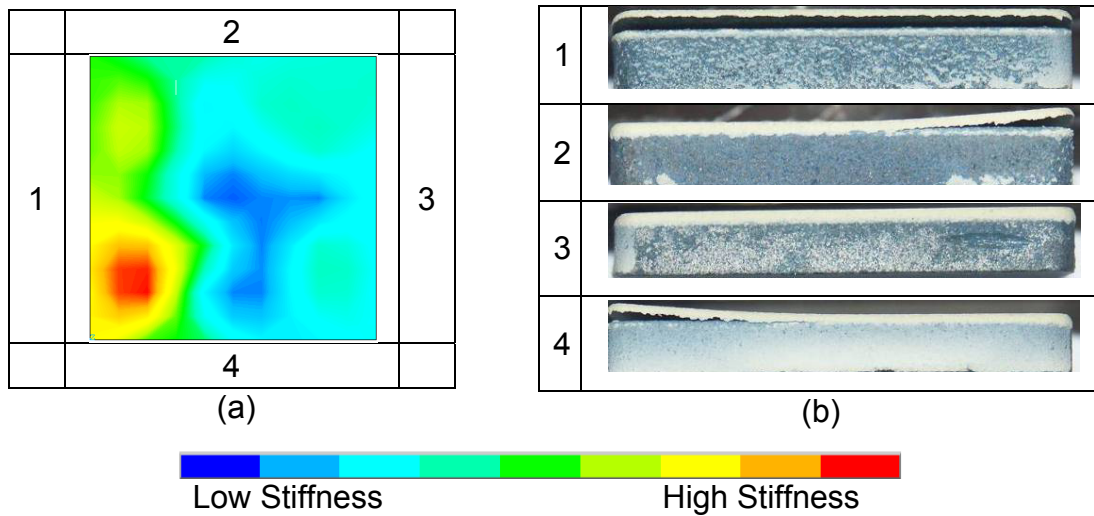
**Figure 46: APS/MCrAlY/RenéN5 coupon B, a) surface stiffness response contour map after 360 hours of isothermal exposure at 1100°C and b) edge spallation following 400 hours of isothermal exposure.**

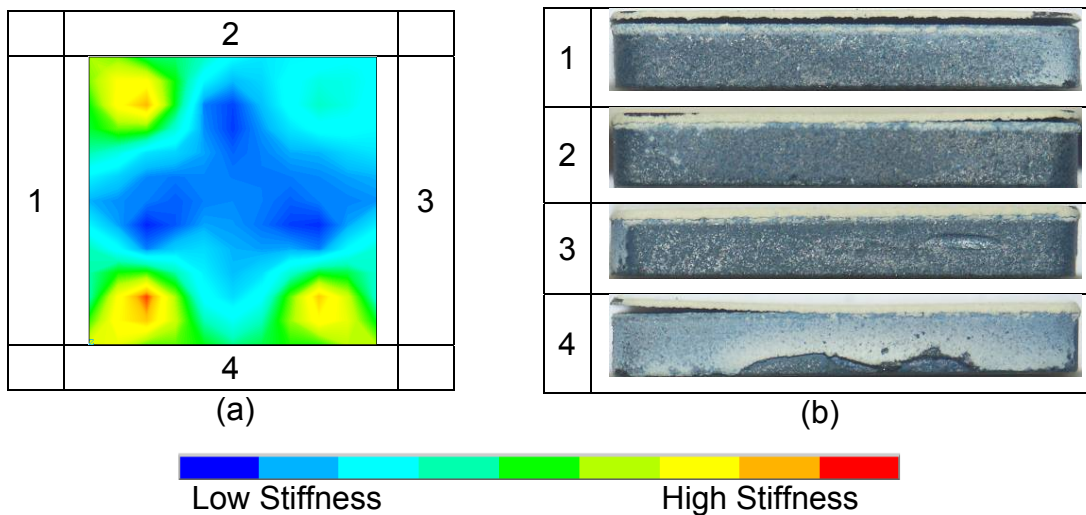
**Figure 49: APS/MCrAlY/RenéN5 Coupon E, a) surface stiffness response contour map after 360 thermal cycles and b) edge spallation following 400 thermal cycles.**

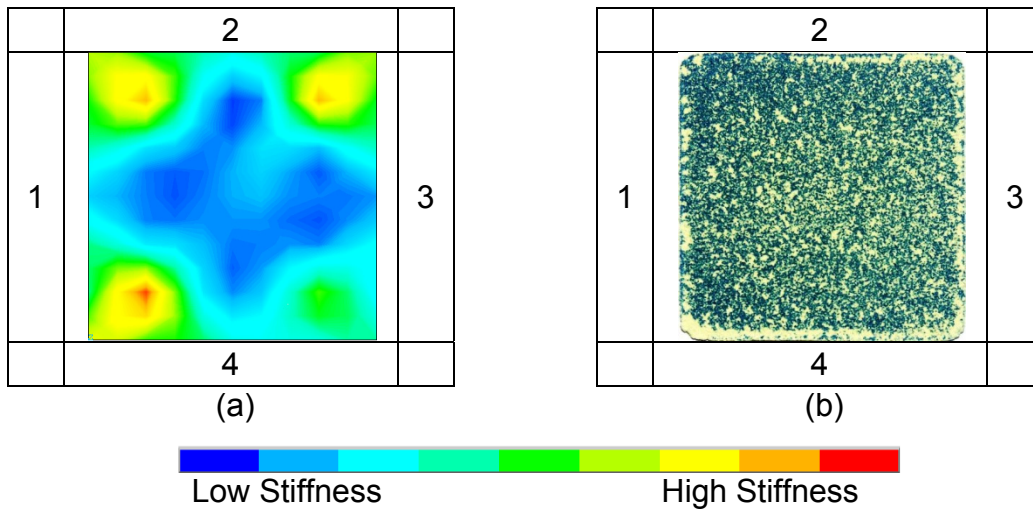
**Figure 50: APS /MCrAlY/Ren N5 Coupon F, a) surface stiffness response contour map after 400 thermal cycles and b) complete debonding of the APS YSZ along the TGO/metal interface after 440 thermal cycles.**

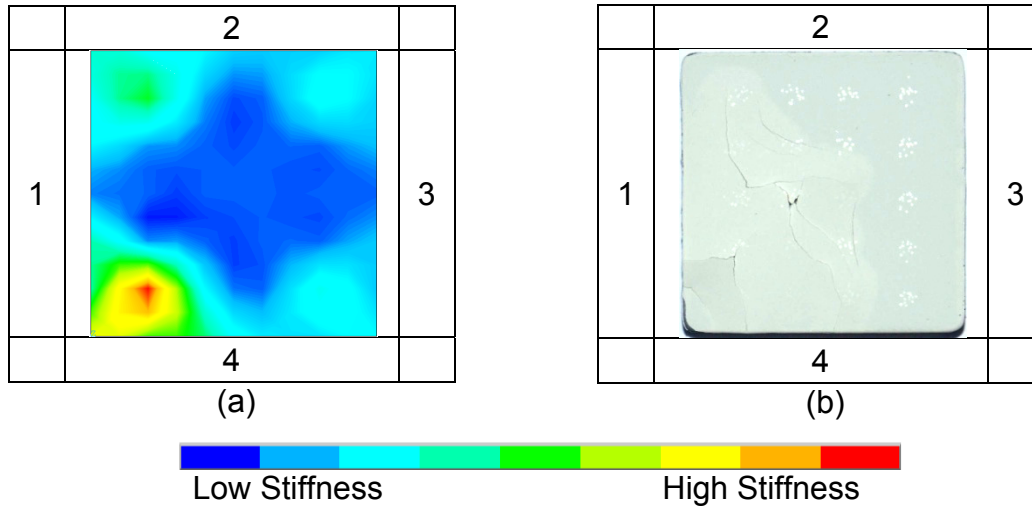
**Figure 52: EB-PVD/MDL/RenéN5 Coupon H, a) surface stiffness response contour map after 600 thermal cycles and b) extensive spallation after 640 thermal cycles.**

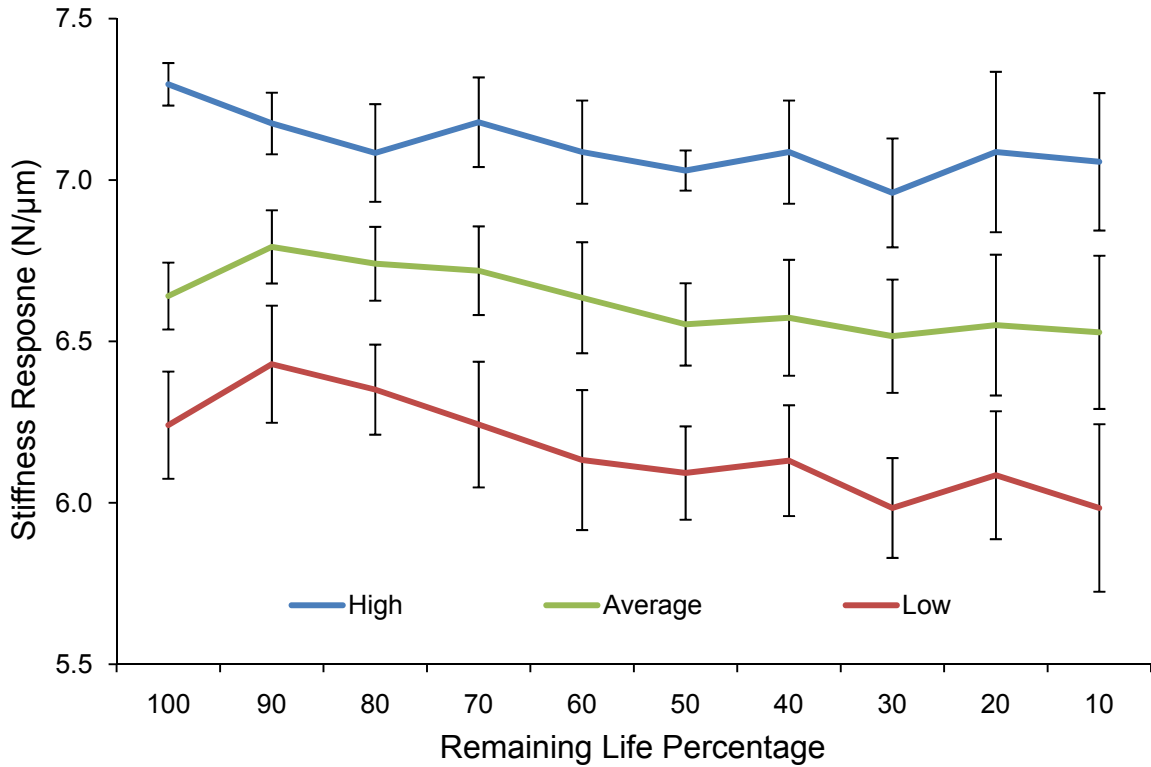
**Figure 53: Average APS TBC high, low and average surface stiffness responses along TBC life percentage with 1 $\sigma$  (standard deviation) shown.**

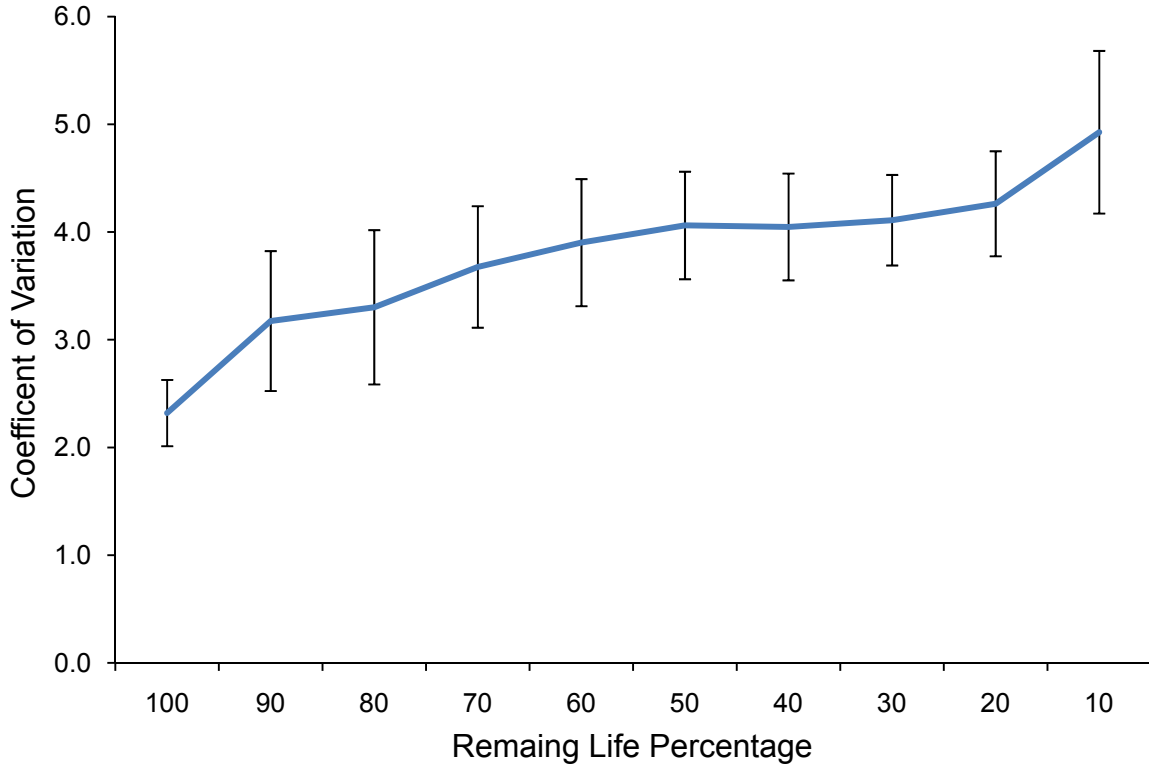
**Figure 54: Average APS TBC coefficient of variation in surface stiffness response measurement with  $1\sigma$  (standard deviation) shown.**

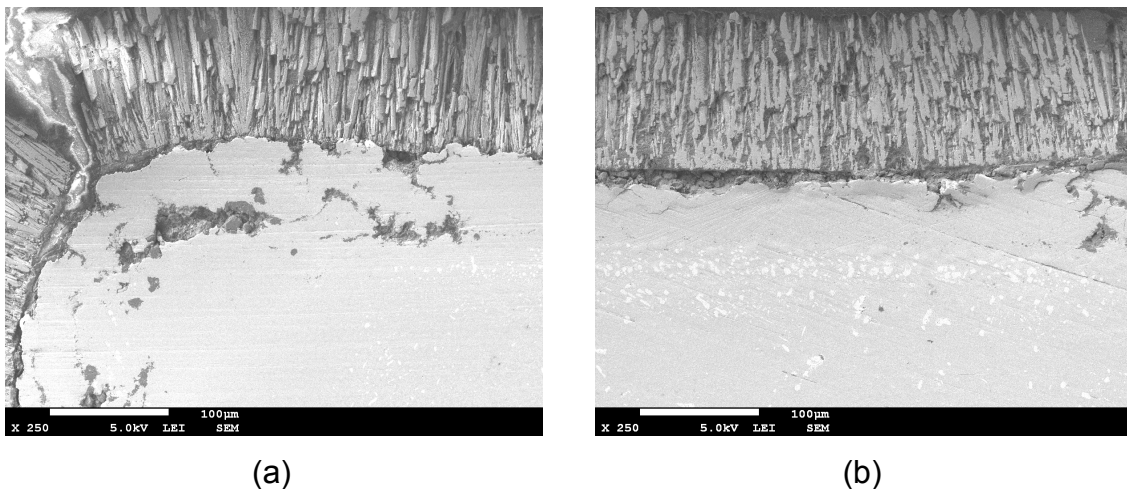
**Figure 56: EB-PVD/MDL/RenéN5 coupon edge cross sectional scanning electron micrographs after 640 isothermal cycles, a) high and b) low residually stressed region.**

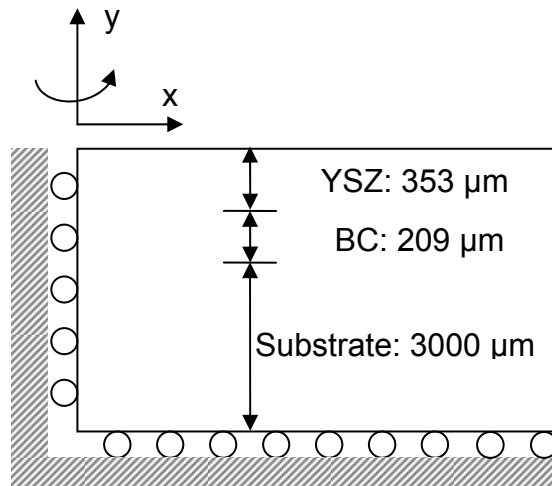
**Figure 58: Object oriented finite element analysis model having a thickness of 12700 microns.**

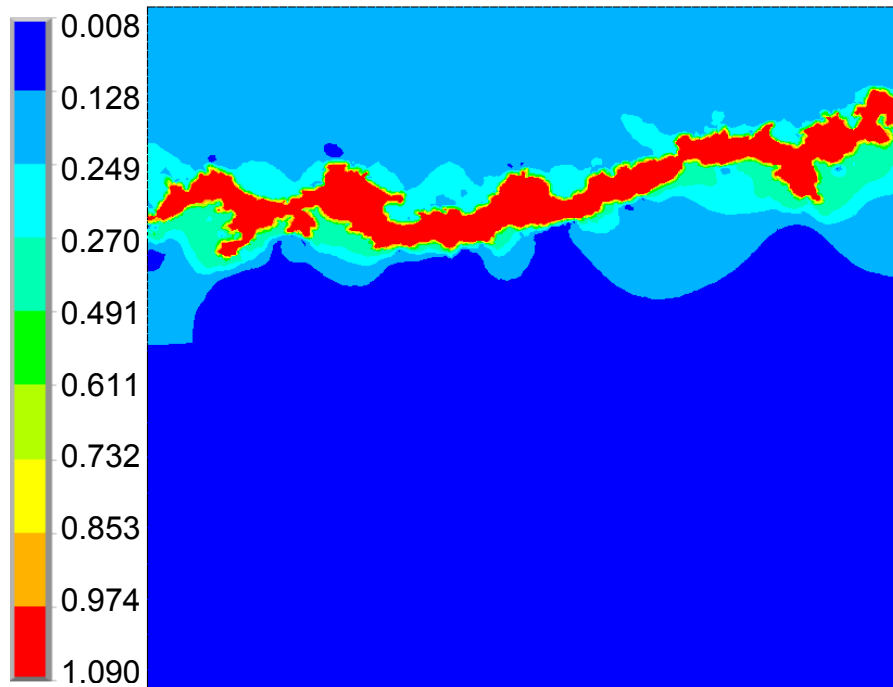
**Figure 59: Object oriented finite element analysis Von Mises residual stress in GPa.**

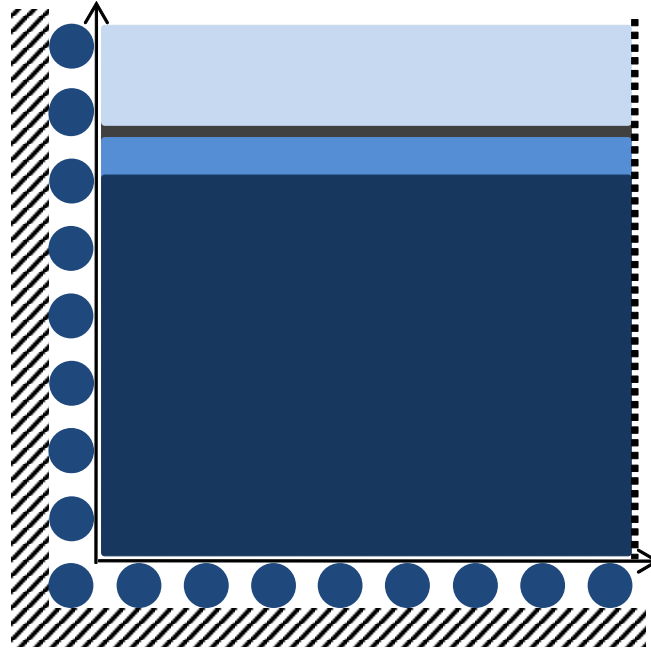
**Figure 66: Boundary conditions applied to the numerical TBC model.**

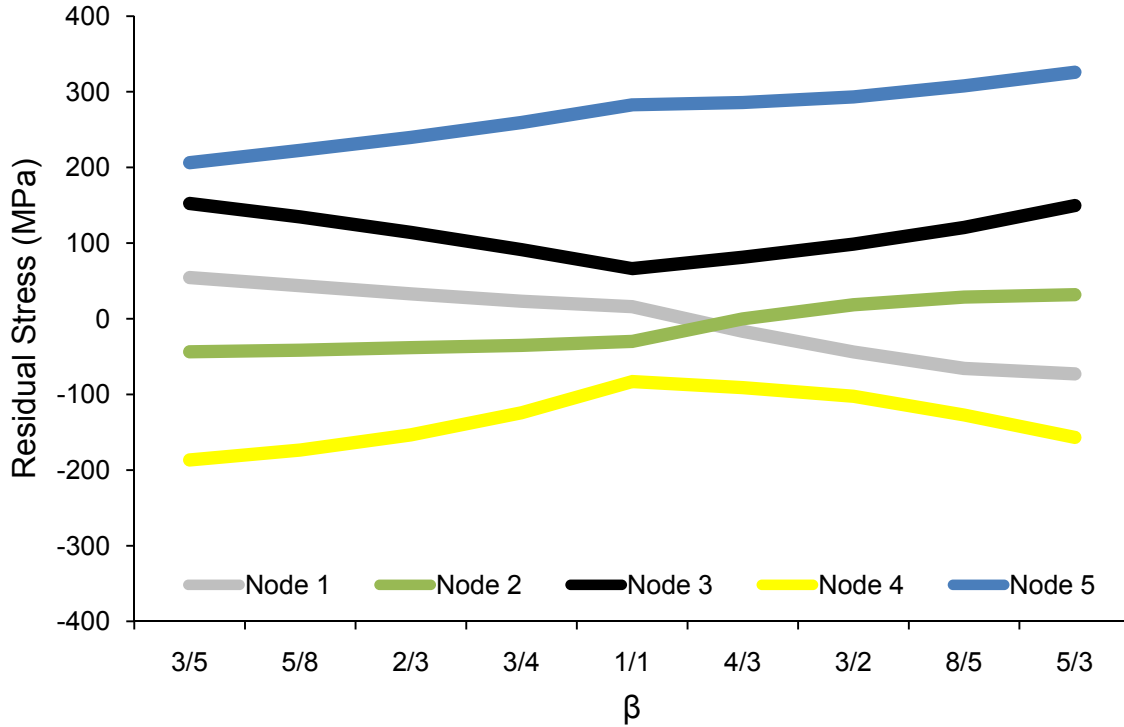
Figure 68: Finite elemental node residual stress state along  $\beta$ .
