# **Progression in Non-Destructive Spallation Prediction and Elevated Temperature Mechanical Property Evaluation of Thermal Barrier Coating Systems by Use of a Spherical Micro-Indentation Method**

Dissertation submitted to the  
College of Engineering and Mineral Resources  
at West Virginia University  
in partial fulfillment of the requirements  
for the degree of

**Doctor of Philosophy  
In  
Mechanical Engineering**

**Department of Mechanical and Aerospace Engineering**

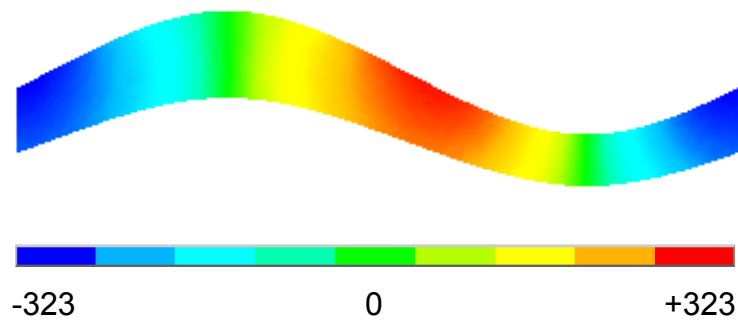
Figure 69: Oxide scale shear stress profile (MPa).

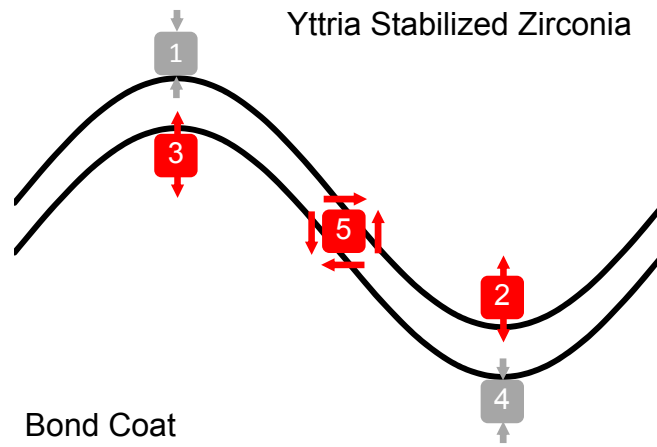
**Figure 70: Oxide scale failure inducing stress pattern created as  $\beta$  approaches a maximum.**

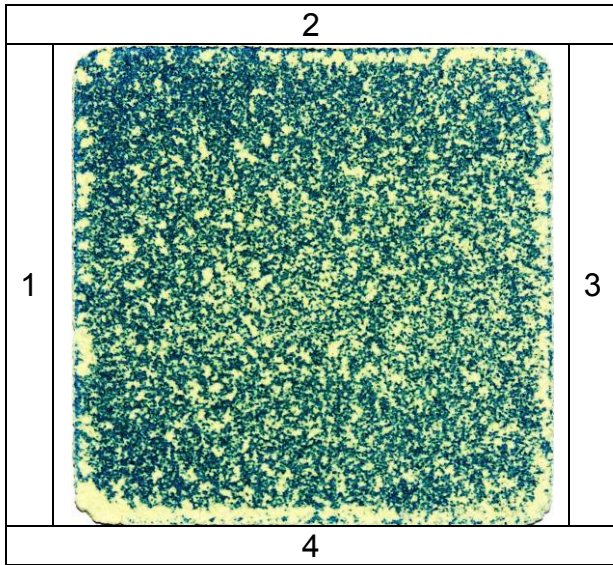
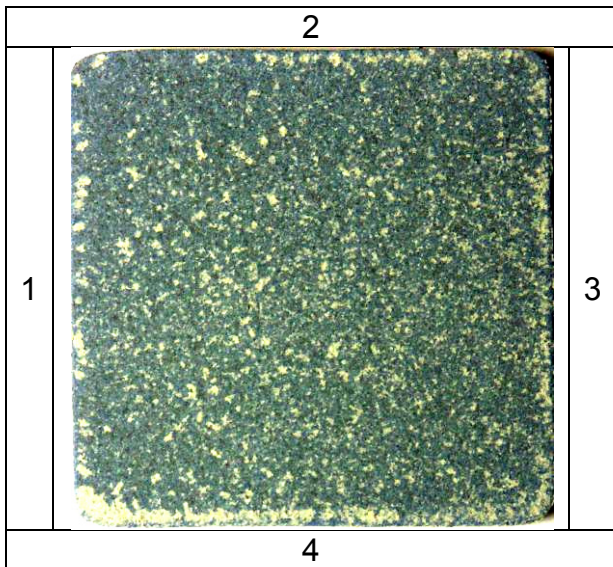
**Figure 82: YSZ surface and failure surface photographs of APS/MCrAlY/RenéN5 Coupon F after cumulative 440 cycles of heat treatment at 1100°C in an ambient air environment.**
