Nondestructive testing of concrete bridge decks using ground-penetrating radar and the chain drag method

Nondestructive Testing of Concrete Bridge Decks Using Ground Penetrating Radar and the Chain Drag Method

Master of Science
in
Civil Engineering

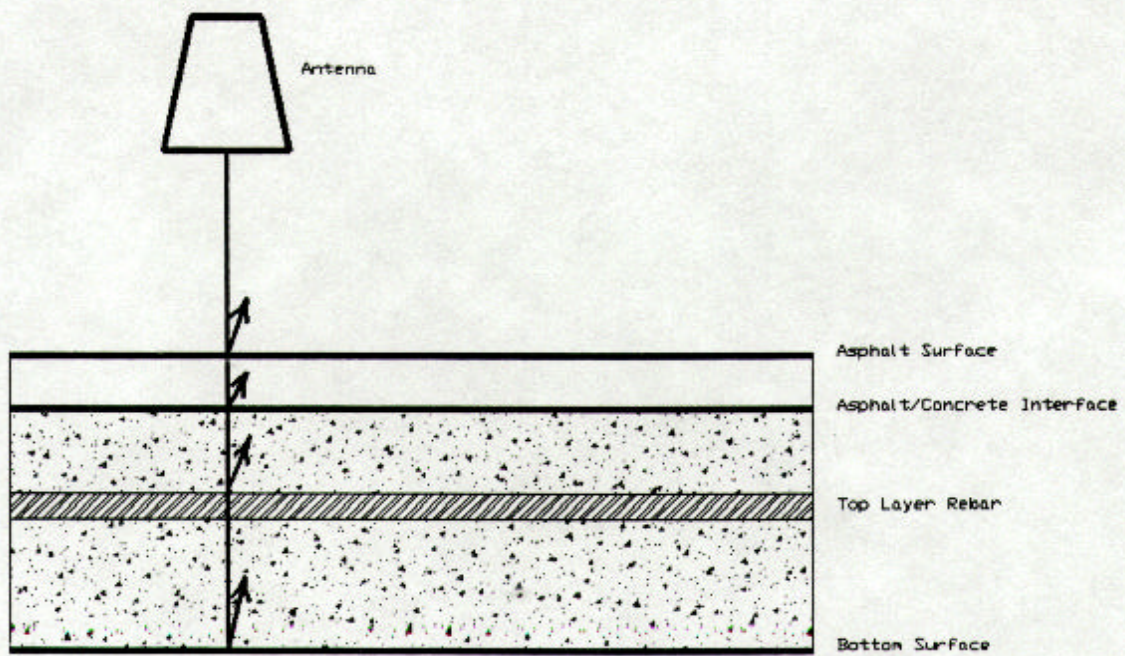
Figure 2.4: Transmission and Reflection of Radar Waves at Different Interfaces

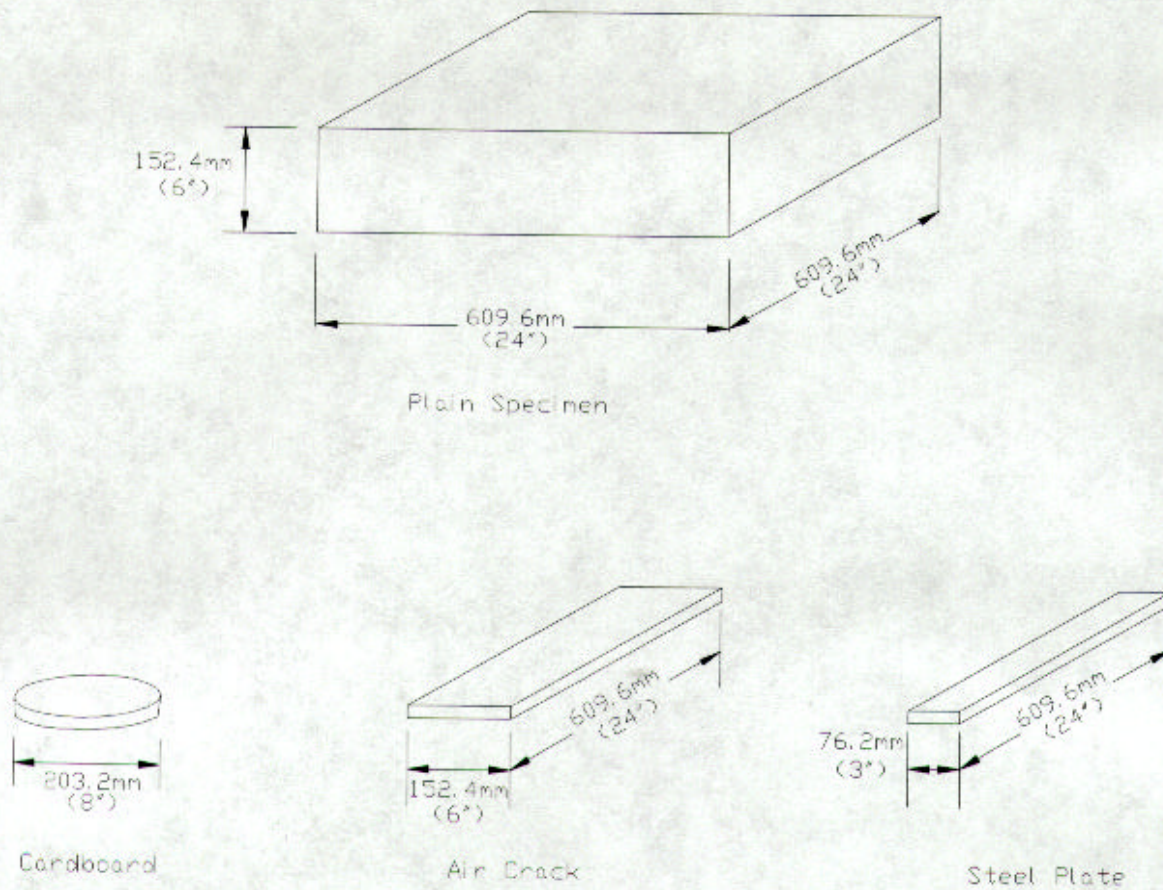
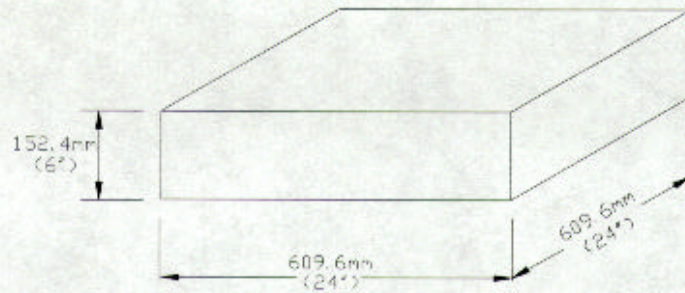
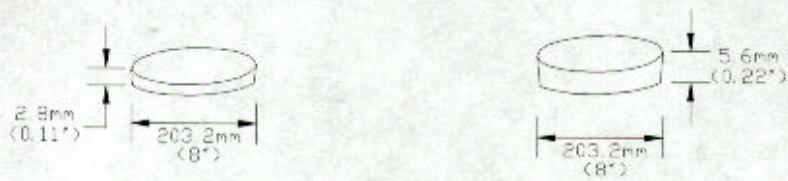
Embedded Crack Shape and Sizes
(Thickness = 0.76mm)

Figure 3.1: Details of Specimens in Batch 1
(Chen et al., 1994)

Plain Specimen

Embedded Crack Shape and Sizes
(Plexiglass)

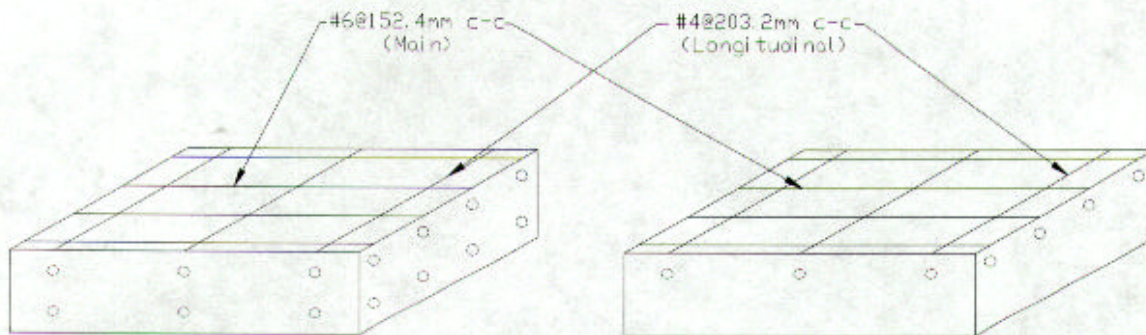
Clear cover of longitudinal rebars: 57.2mm top, 44.5mm bottom
 Clear cover of main rebars: 38.1mm top, 25.4mm bottom

Figure 3.2: Details of Specimens in Batch 2
(Chen et al., 1994)

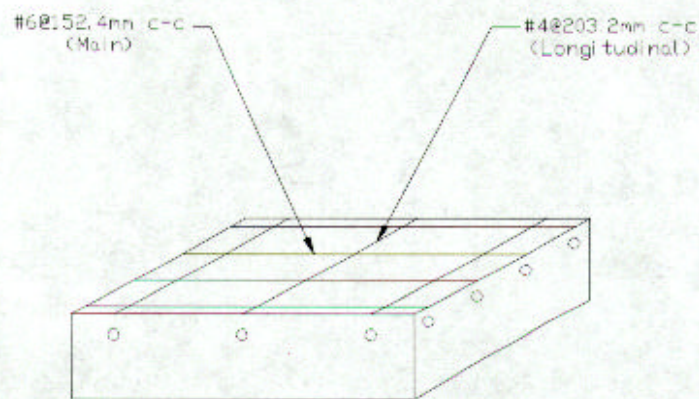
Clear cover of longitudinal rebars: 57.2mm (2.25") top
 Clear cover of main rebars: 38.1mm (1.50") top

Figure 3.3: Details of Specimens in Batch 3 (Chen et al., 1994)

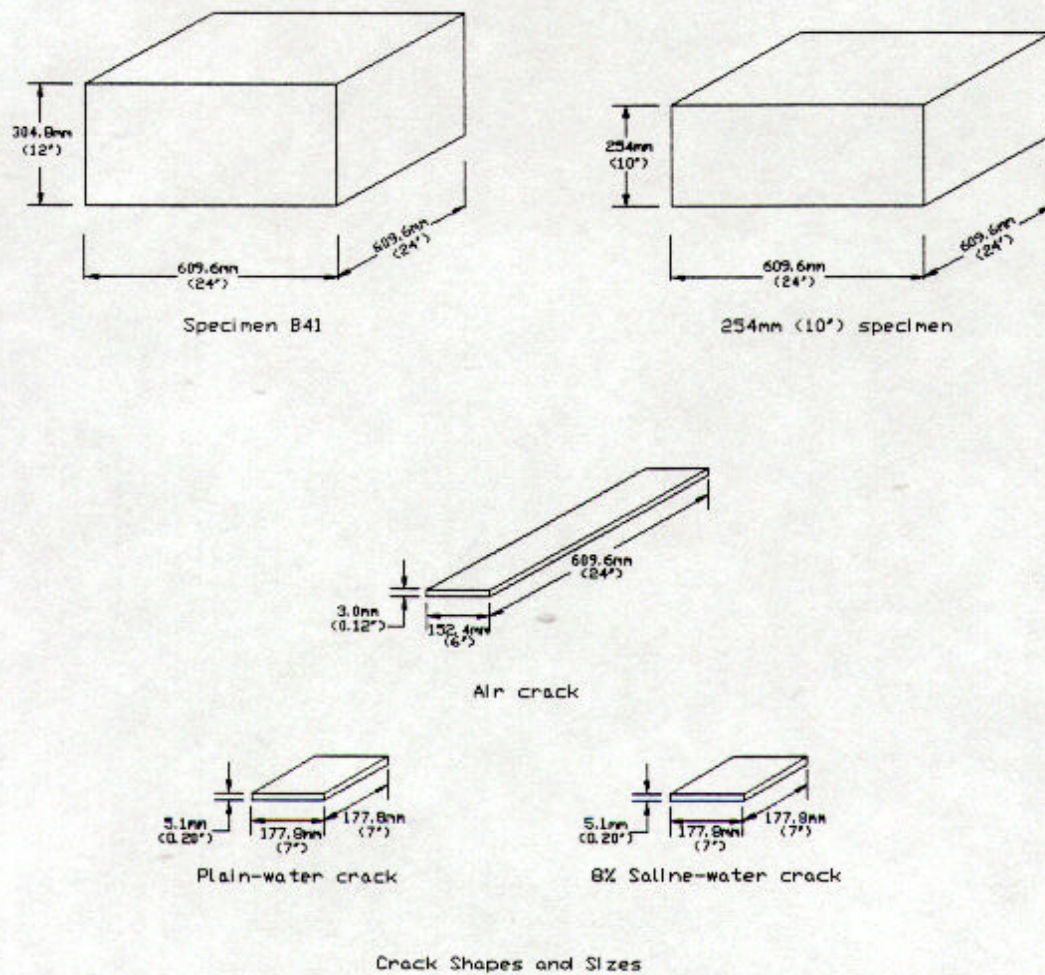
Figure 3.4: Details of Specimens in Batch 4 (Halabe et al., 1996)

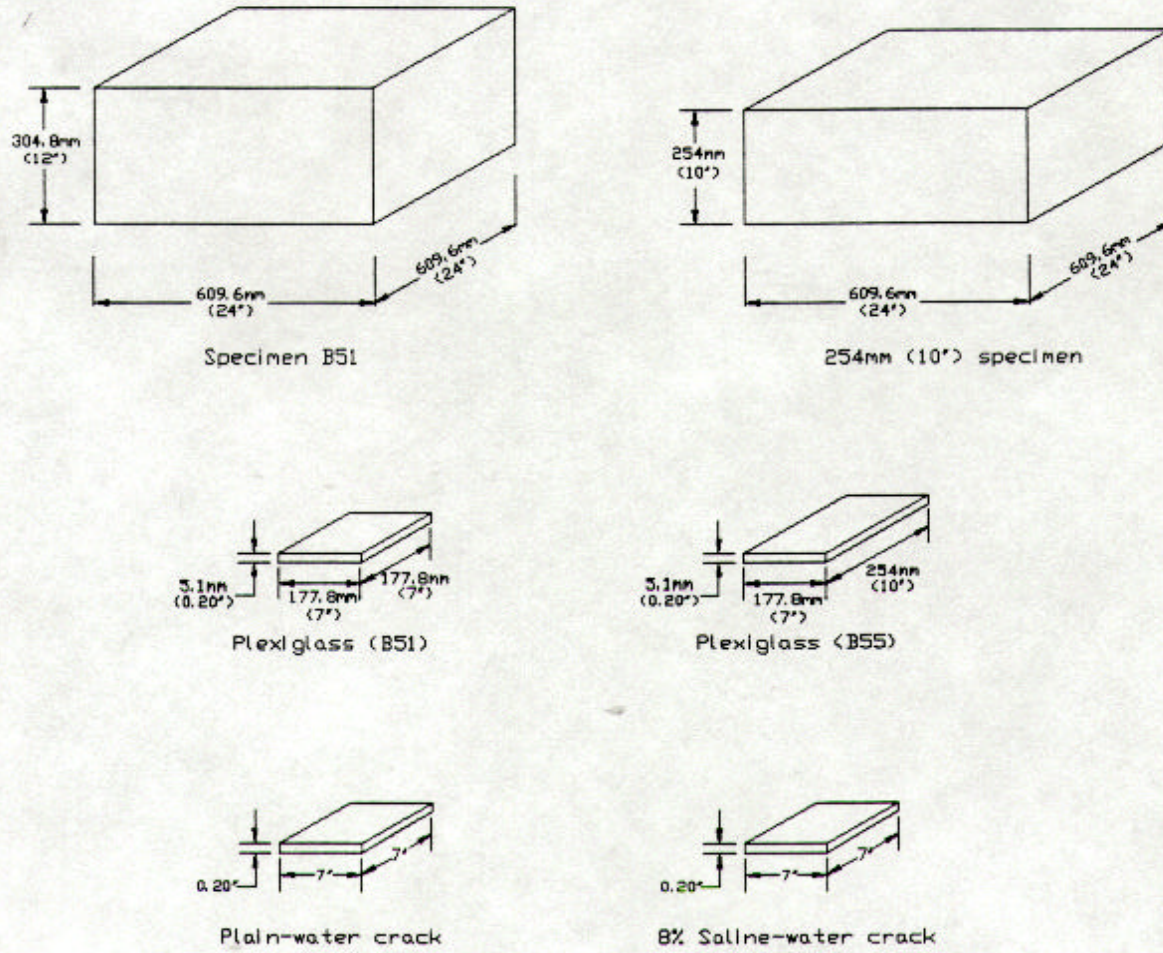
Figure 3.5: Details of Specimens in Batch 5
(Halabe et al., 1996)

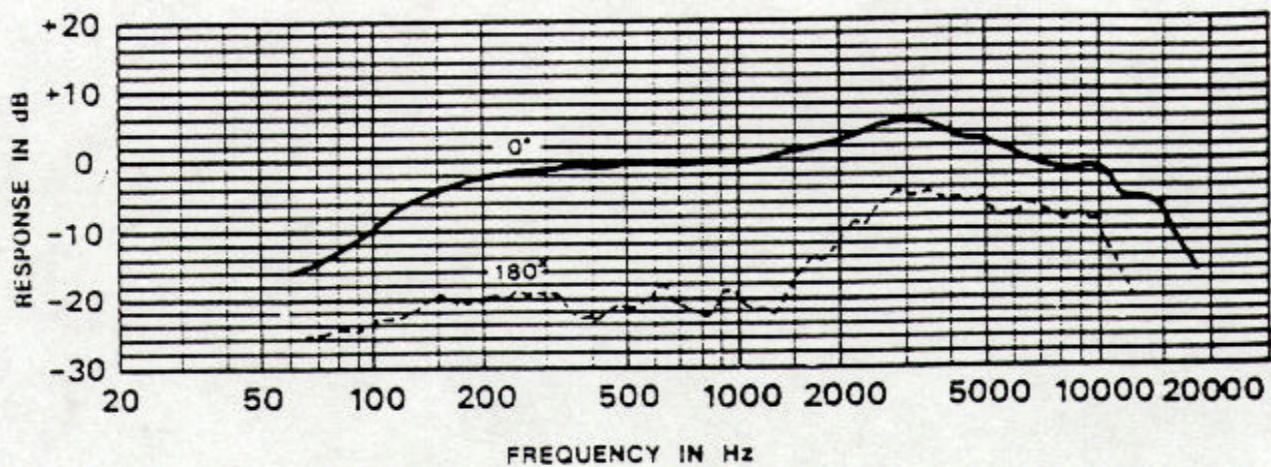
Figure 3.6: Frequency Response Curve for Microphone Used in Testing

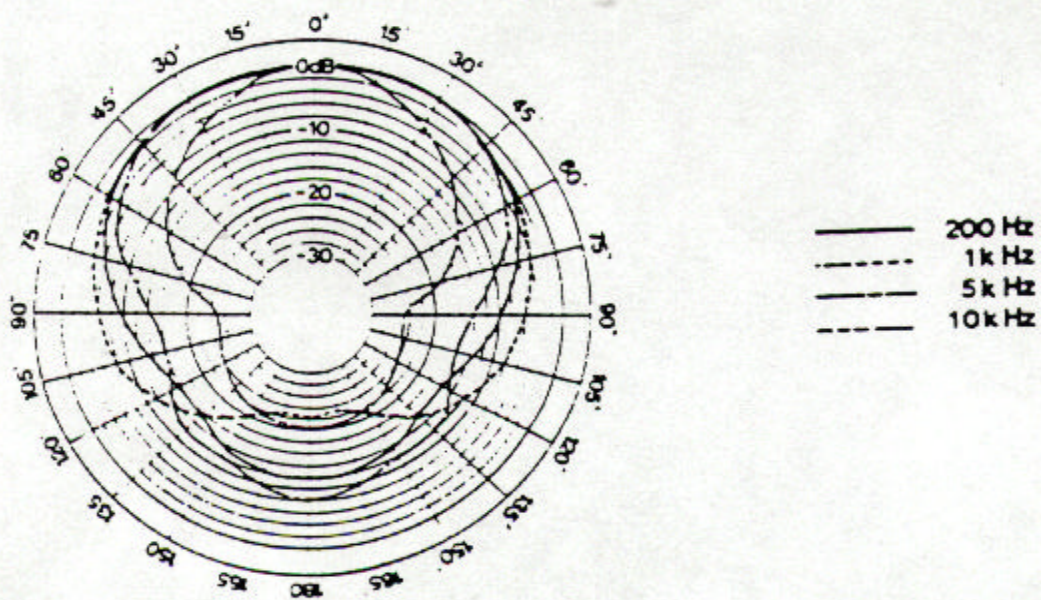
Figure 3.7: Pick-Up Pattern for Microphone Used in Testing

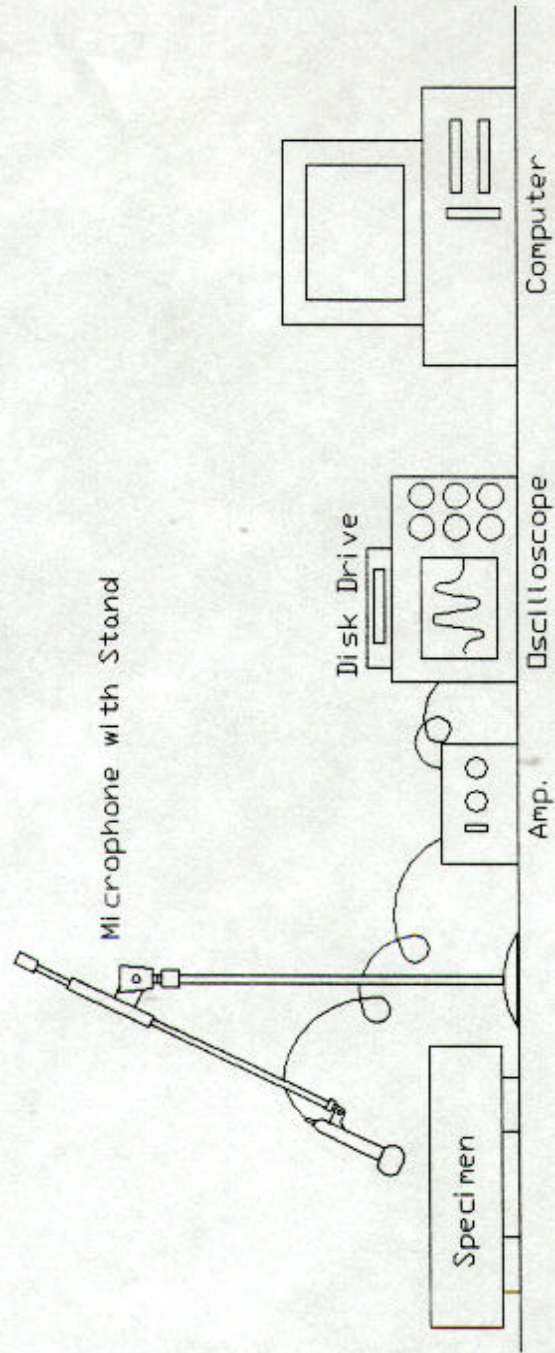
Figure 3.8: Schematic of Laboratory Test Set-Up

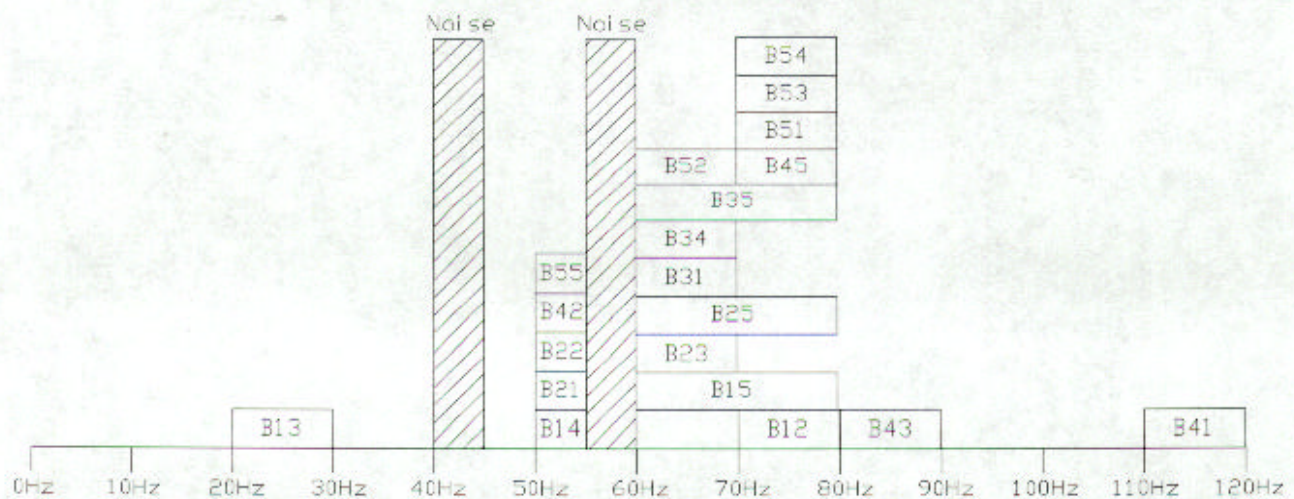
Figure 4.1: Specimens with Corresponding High Amplitude Frequency Ranges

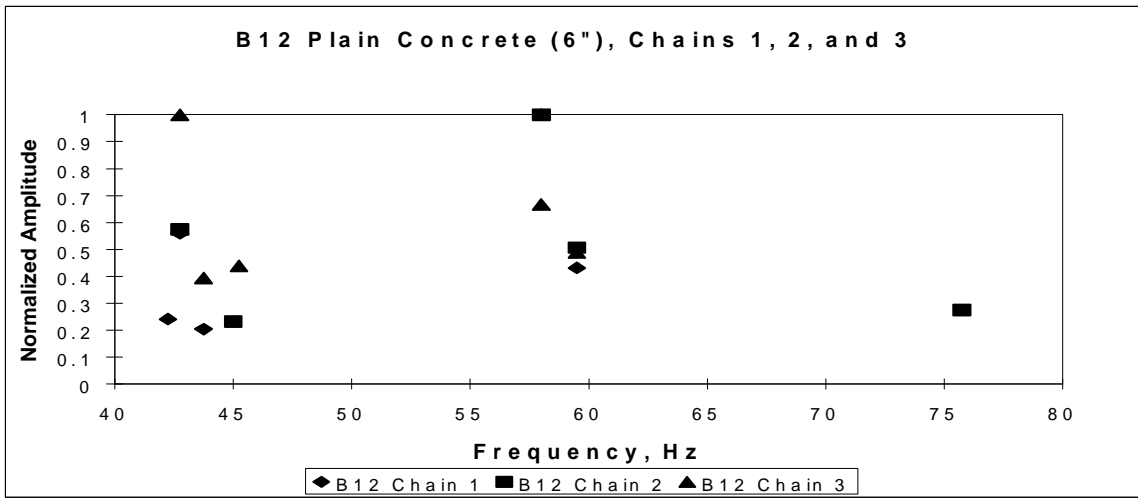
Figure 4.5: Specimen B12 with Chains 1, 2, and 3

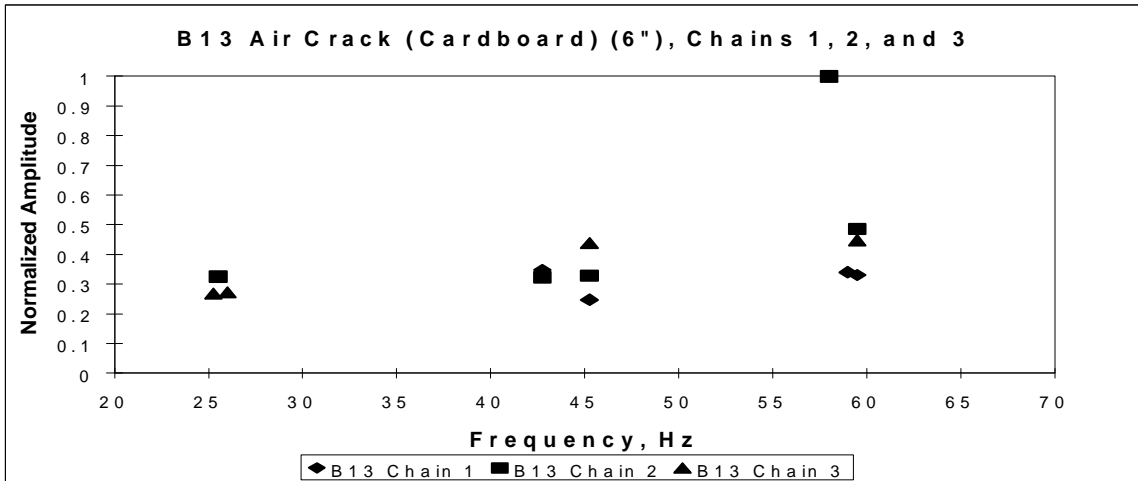
Figure 4.6: Specimen B13 with Chains 1, 2, and 3

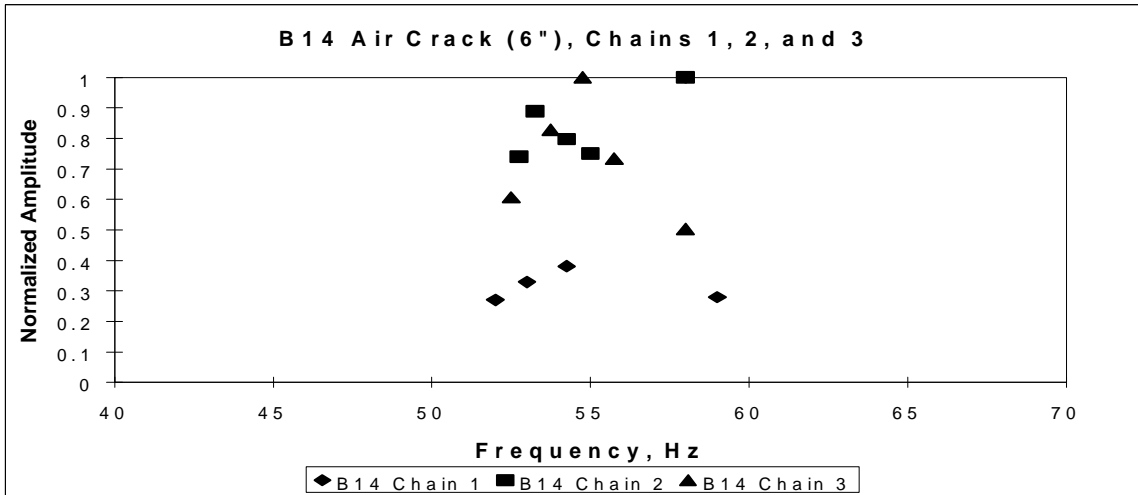
Figure 4.7: Specimen B14 with Chains 1, 2, and 3

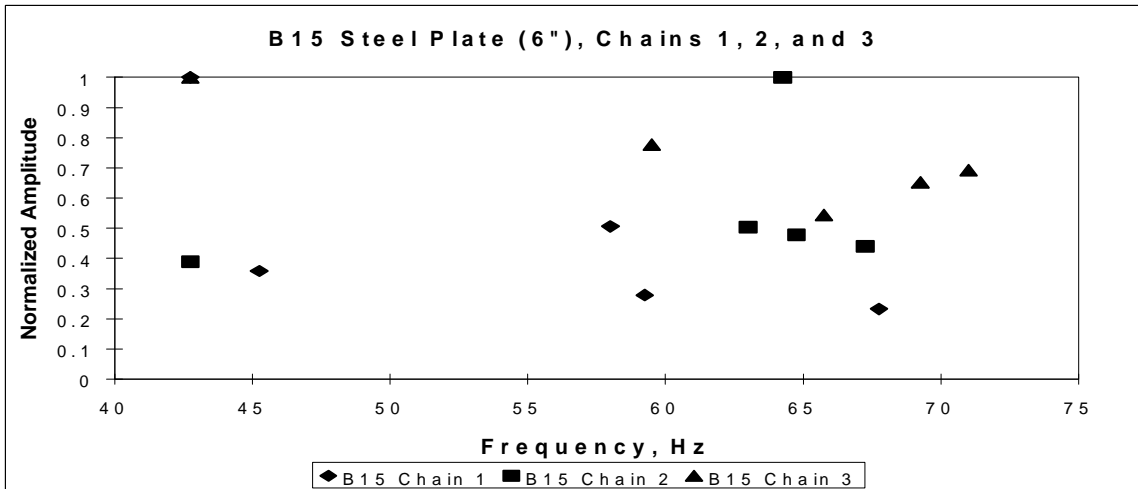
Figure 4.8: Specimen B15 with Chains 1, 2, and 3

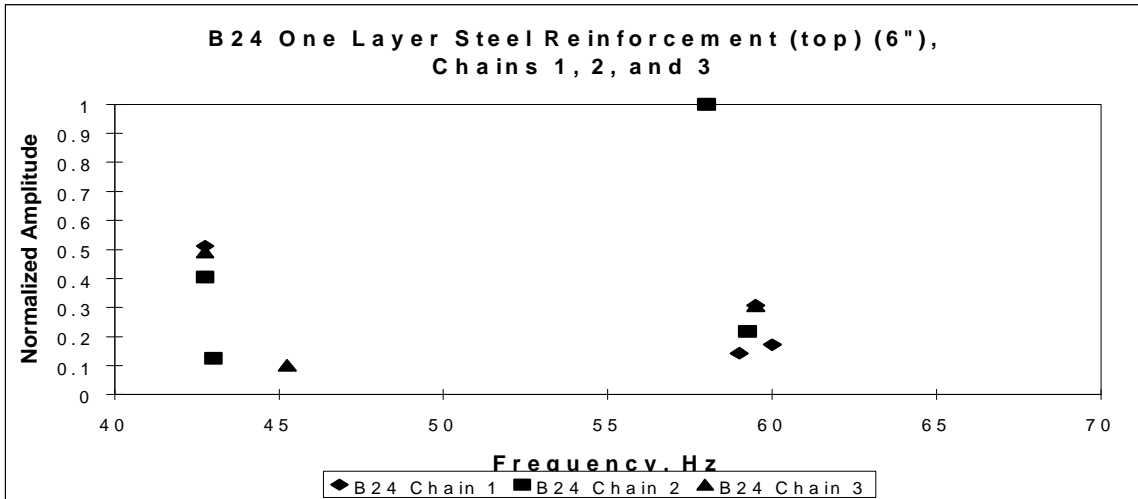
Figure 4.15: Specimen B24 with Chains 1, 2, and 3

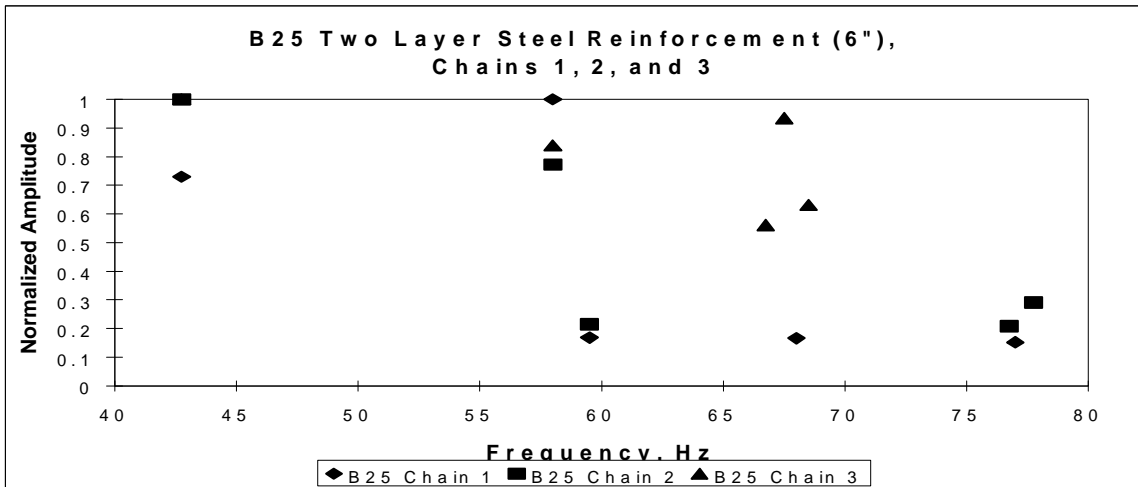
Figure 4.16: Specimen B25 with Chains 1, 2, and 3

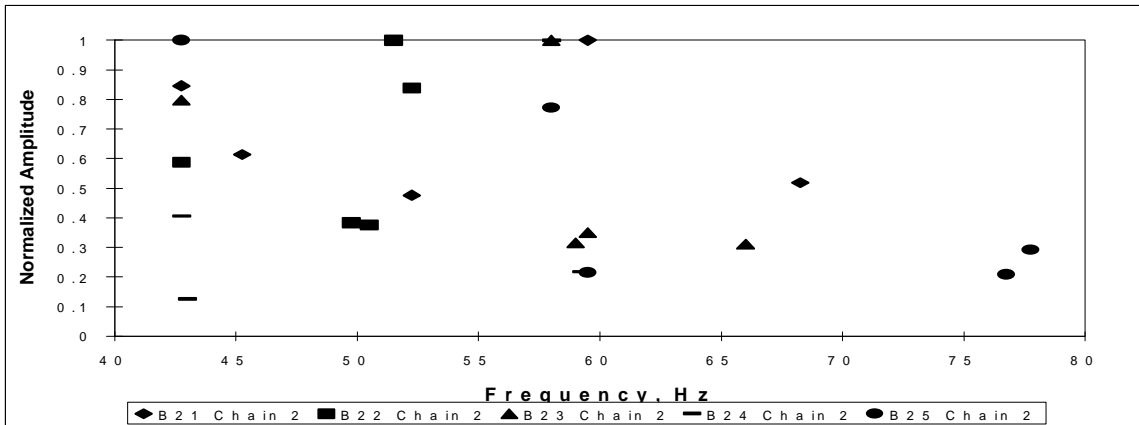
Figure 4.18: Comparison of Batch 2 with Chain 2

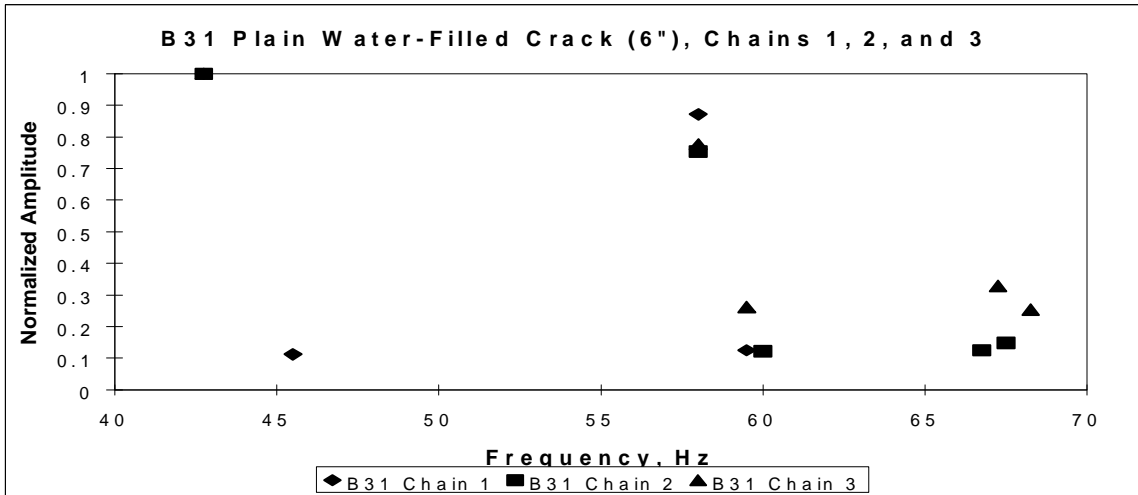
Figure 4.20: Specimen B31 with Chains 1, 2, and 3

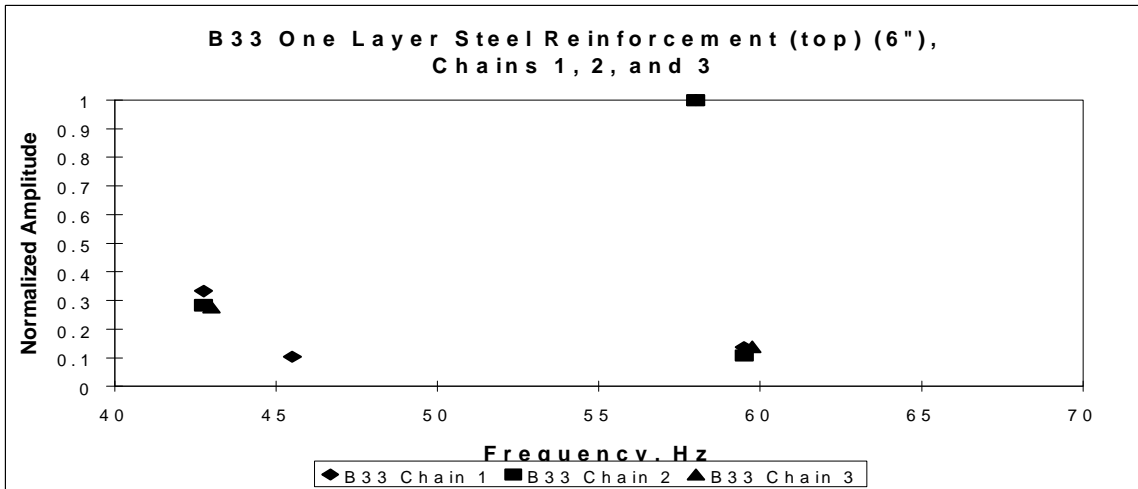
Figure 4.21: Specimen B33 with Chains 1, 2, and 3

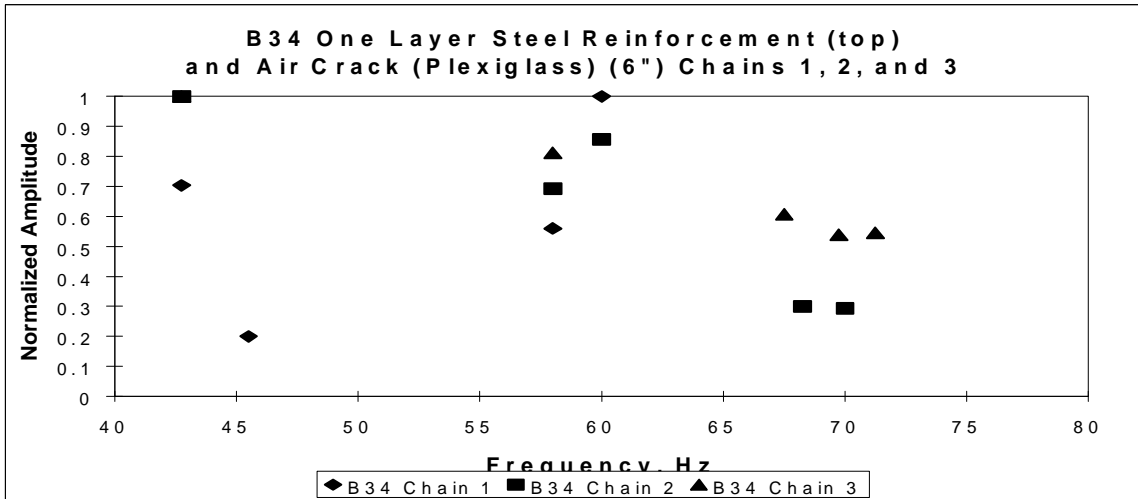
Figure 4.22: Specimen B34 with Chains 1, 2, and 3

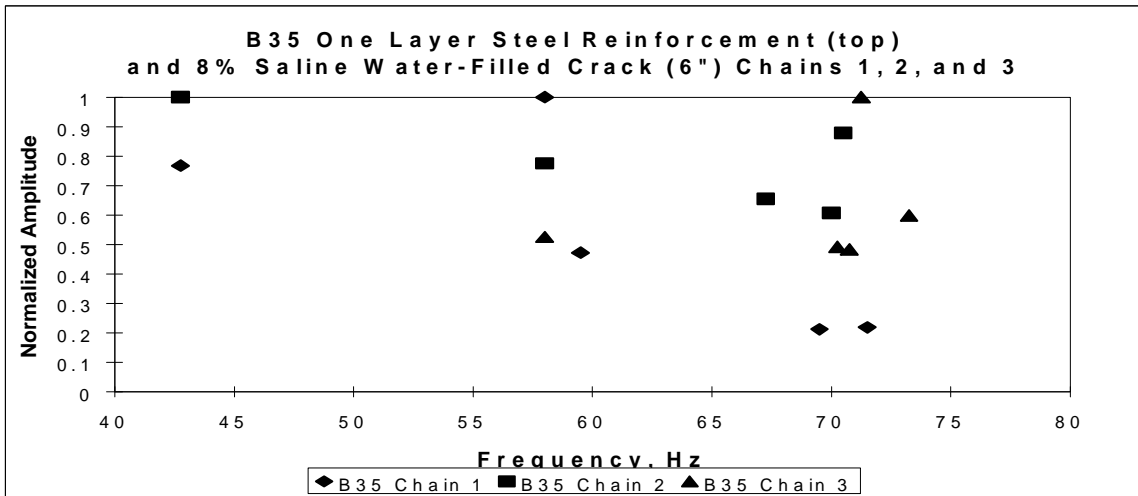
Figure 4.23: Specimen B35 with Chains 1, 2, and 3

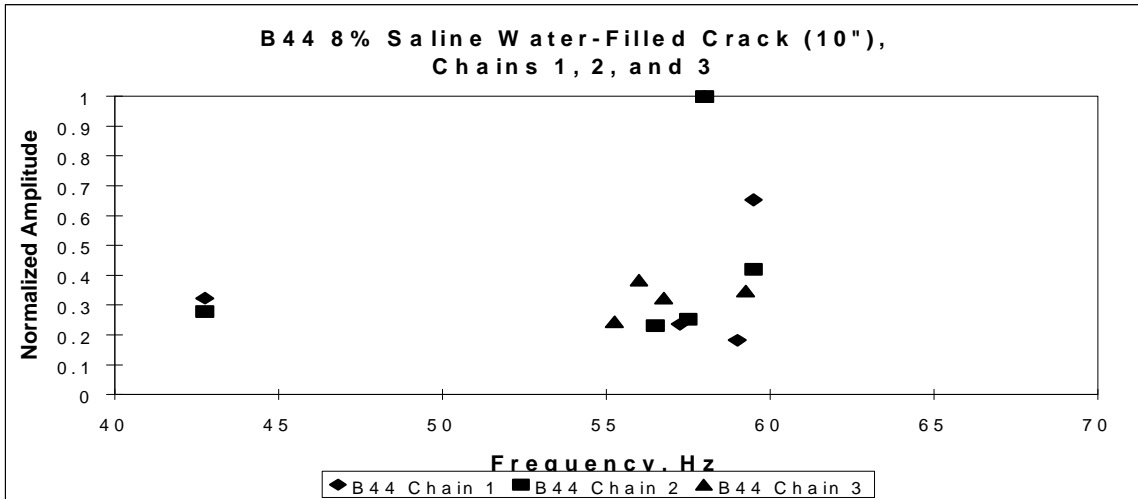
Figure 4.30: Specimen B44 with Chains 1, 2, and 3

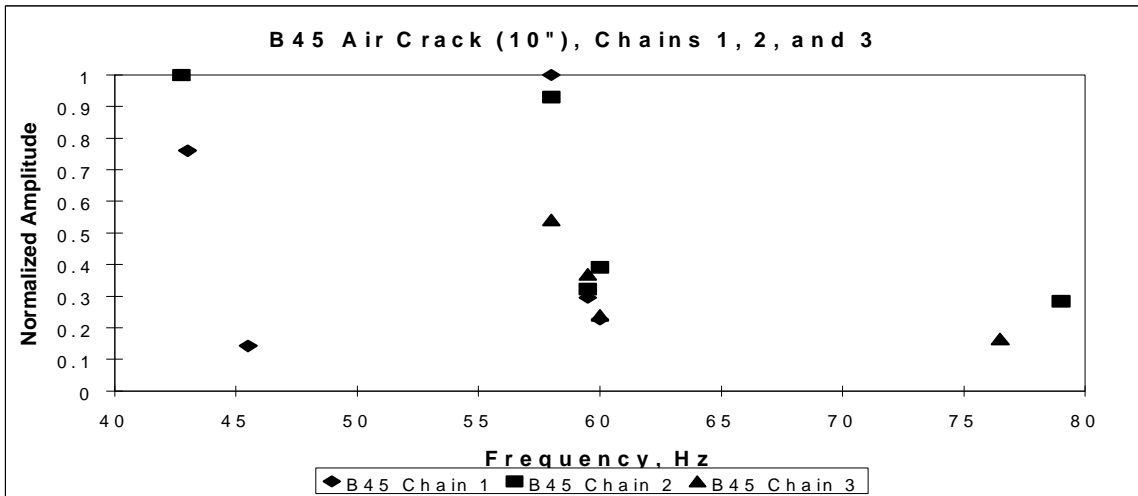
Figure 4.31: Specimen B45 with Chains 1, 2, and 3

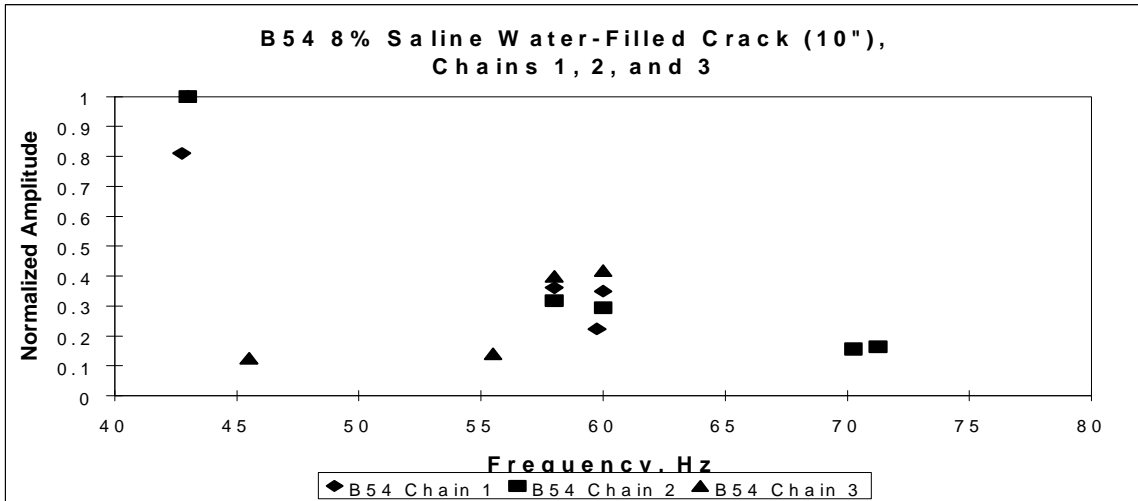
Figure 4.38: Specimen B54 with Chains 1, 2, and 3

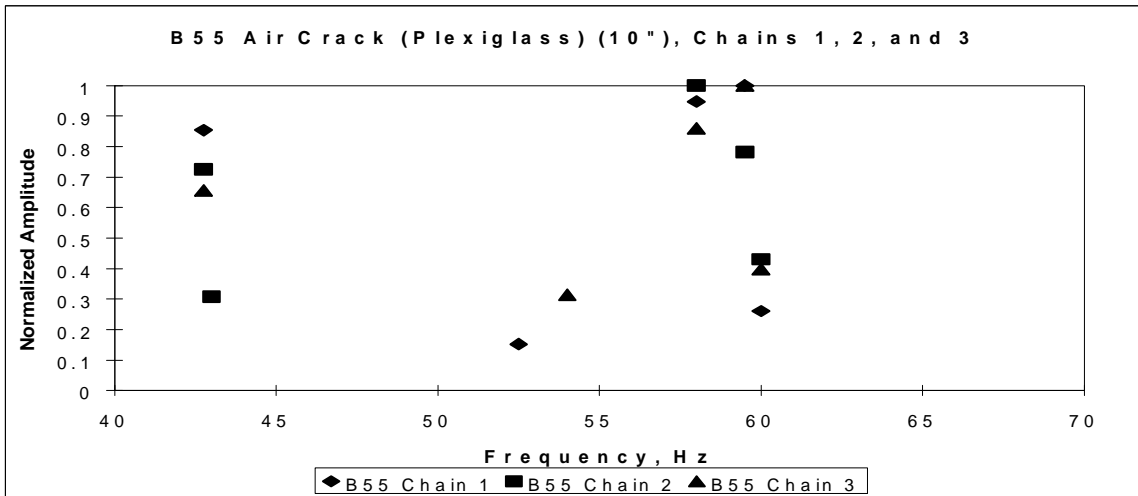
Figure 4.39: Specimen B55 with Chains 1, 2, and 3

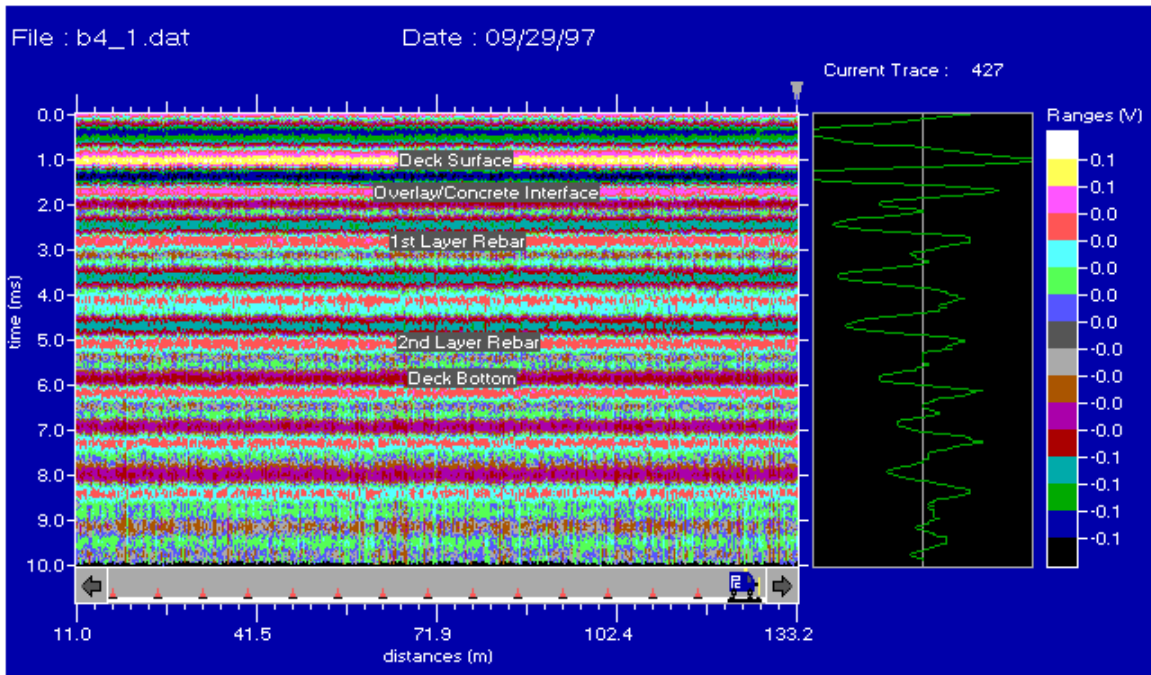
Figure 6.12: Color Intensity Plot of Bridge 3, Pass 1

The results of the GPR scanning show that color intensity plots are useful tools in determining thickness profiles of highway bridge decks. The maximum error encountered when using the color intensity plots was 10%. The postprocessing software is not as reliable as the direct method of using the color intensity plots, as indicated by the 29% maximum error associated with its use. In addition, engineers must practice caution when performing radar inspections on bridge decks with material that has unknown relative dielectric constants.

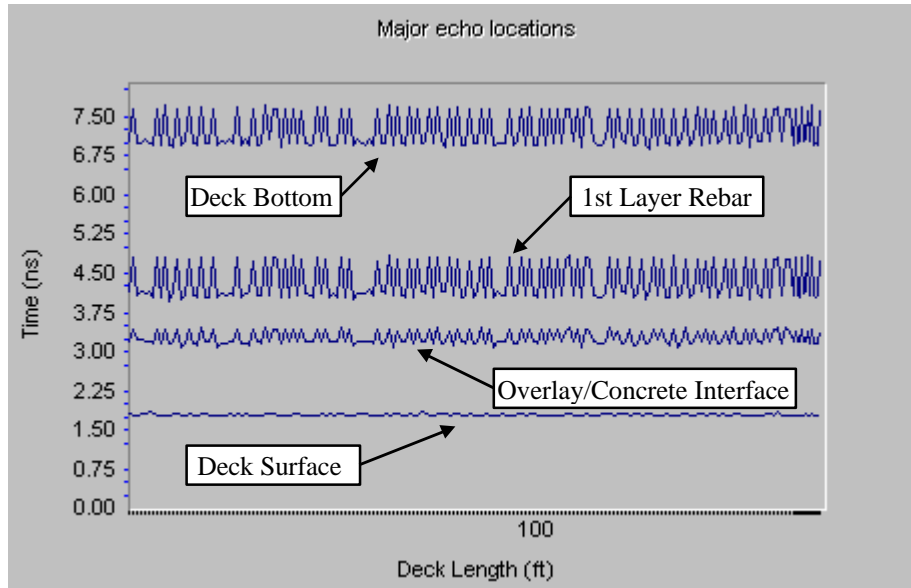
Figure 6.16: Time vs. Deck Length for Bridge 1

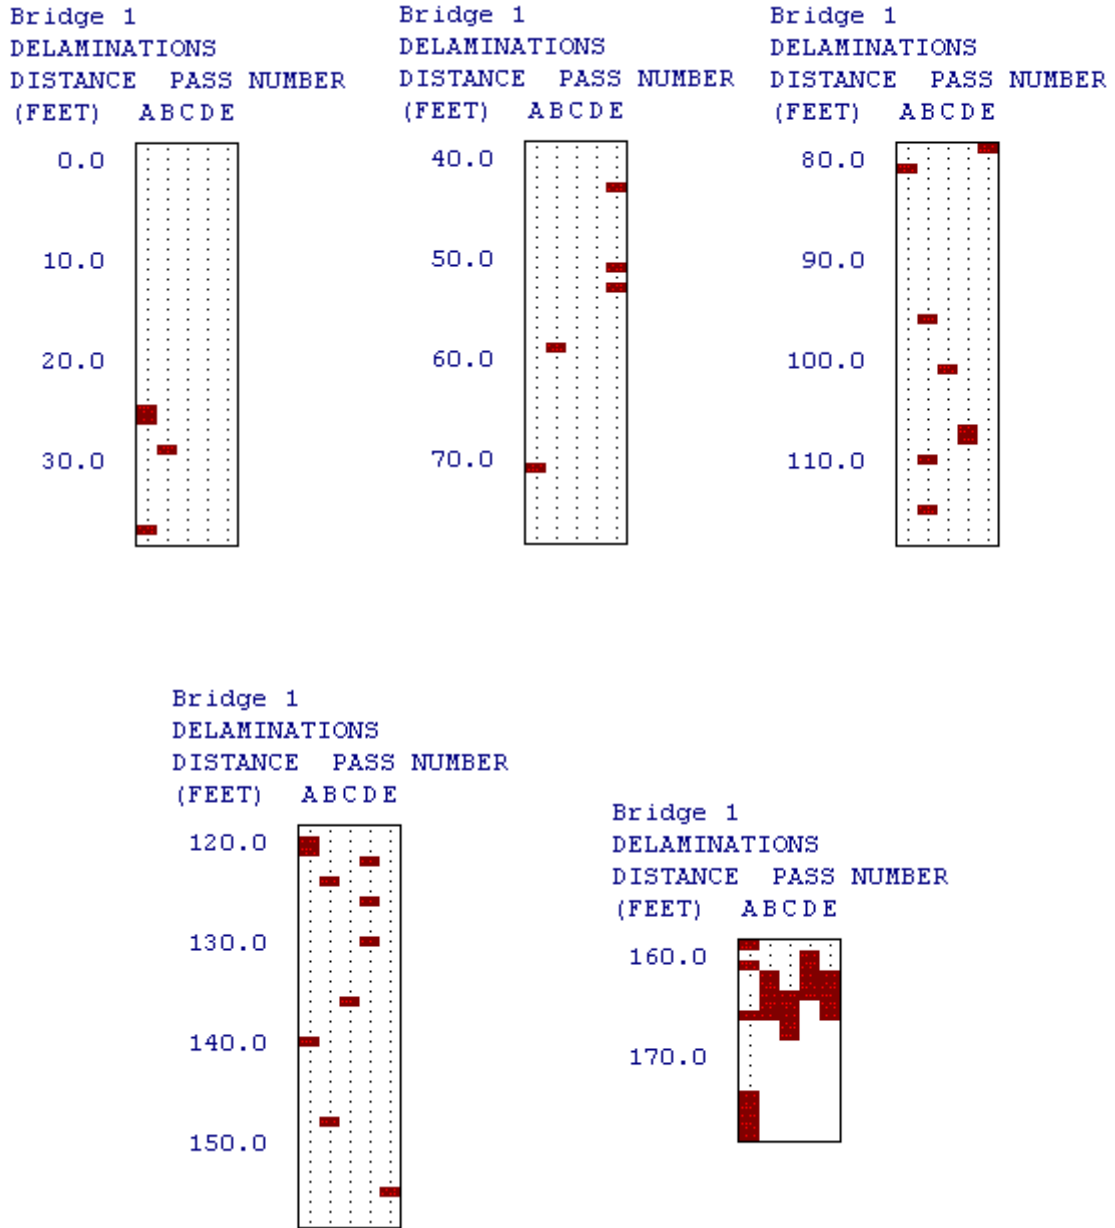
Figure 6.17: Bridge 1 Deterioration Map

The results of the deterioration investigation showed that the postprocessing software used in this project needs some revision. In fact, new software has hence been produced, as mentioned previously. The reason for the uncertainty lies in the fact that the deterioration maps vary considerably from minute adjustments of the postprocessing parameters. Therefore, engineers conducting deck inspections must exercise caution when utilizing the 1995 version of this particular software.

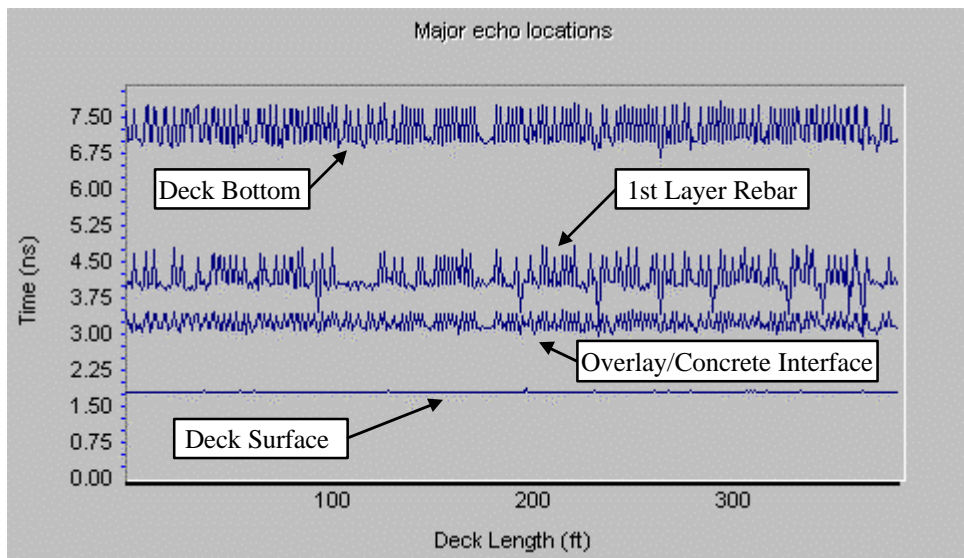
Figure 6.18: Time vs. Deck Length for Bridge 2

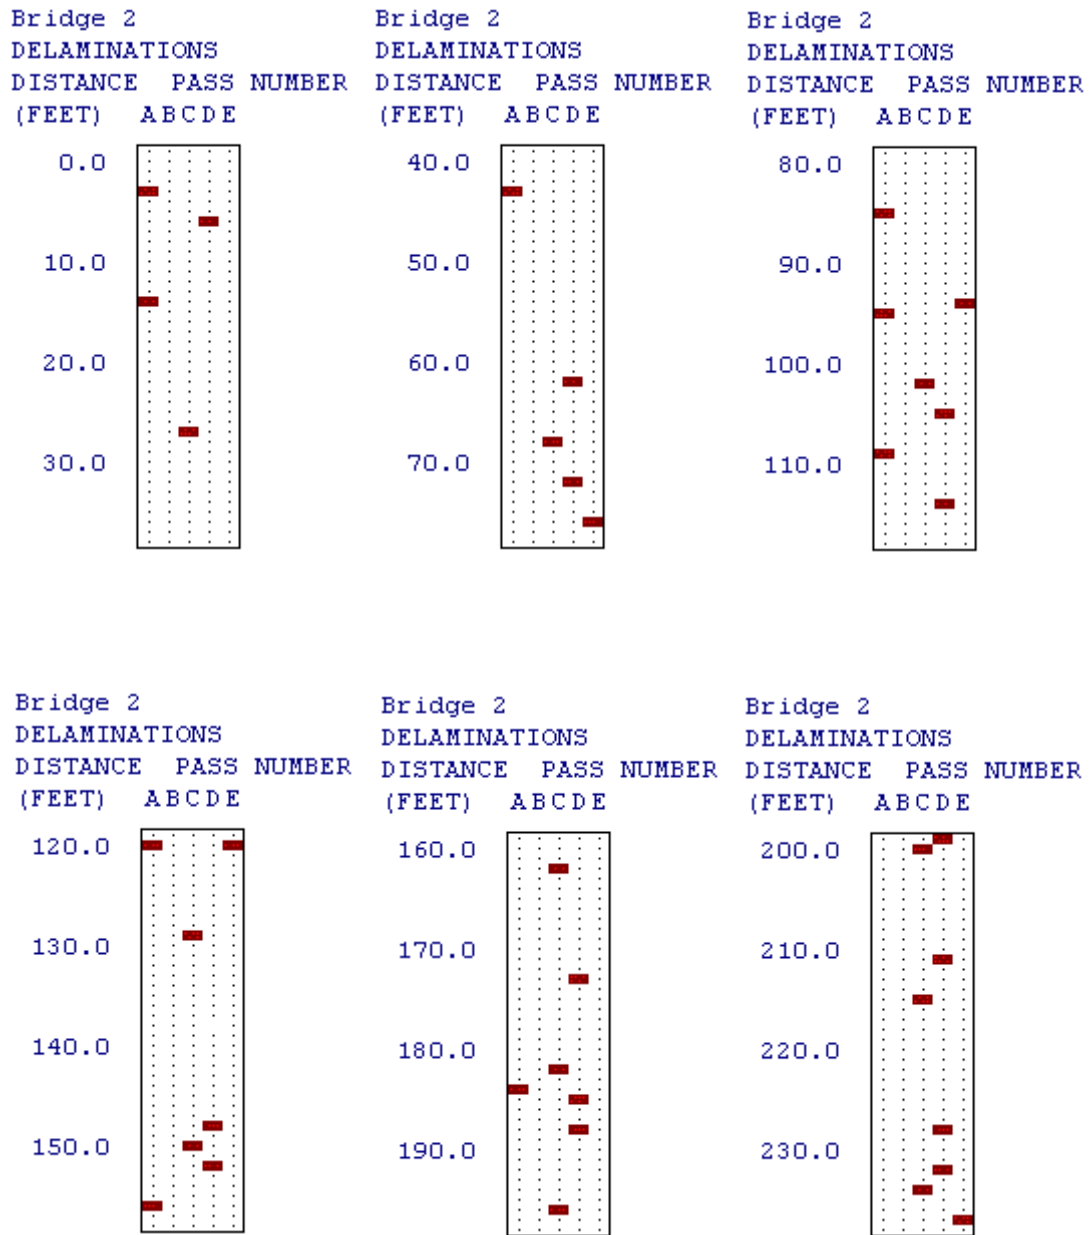
Figure 6.19a: Bridge 2 Deterioration Map

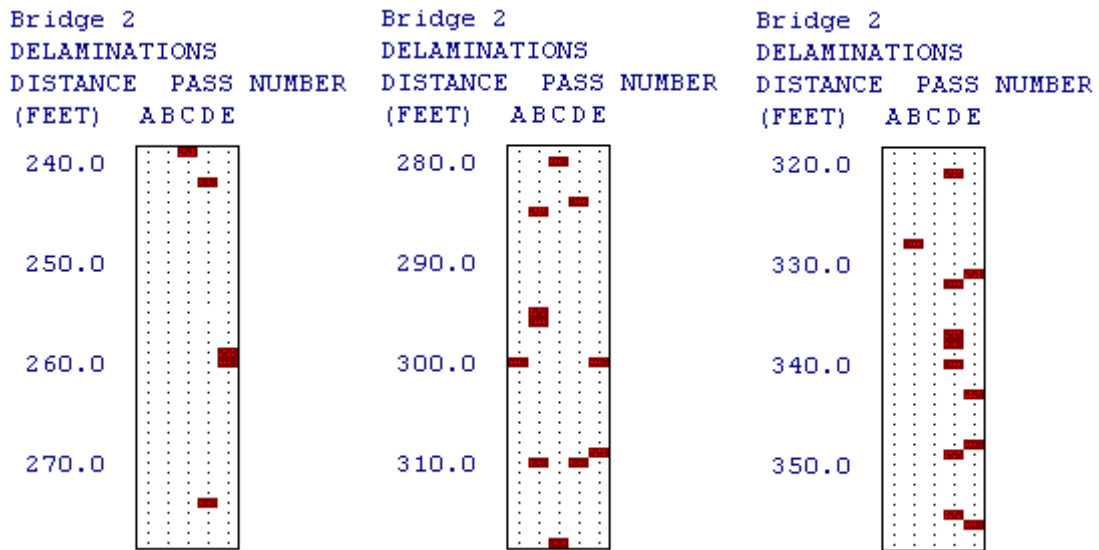
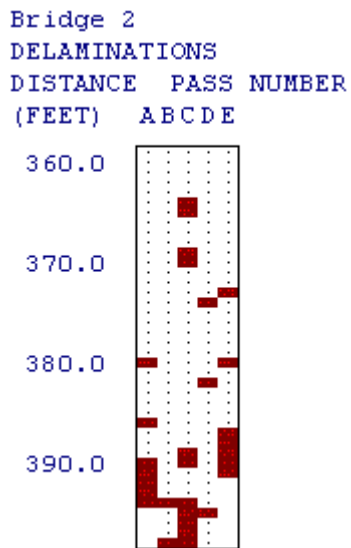
Figure 6.19b: Bridge 2 Deterioration Map, Continued

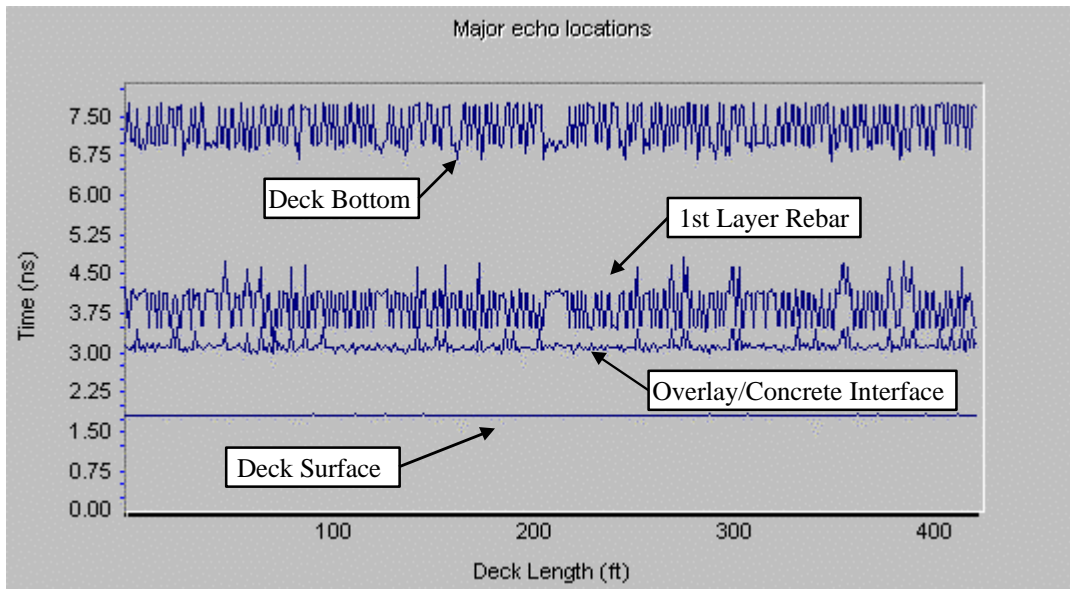
Figure 6.20: Time vs. Deck Length for Bridge 3
