Nondestructive testing of concrete bridge decks using ground-penetrating radar and the chain drag method

Nondestructive Testing of Concrete Bridge Decks Using Ground Penetrating Radar and the Chain Drag Method

Master of Science
in
Civil Engineering

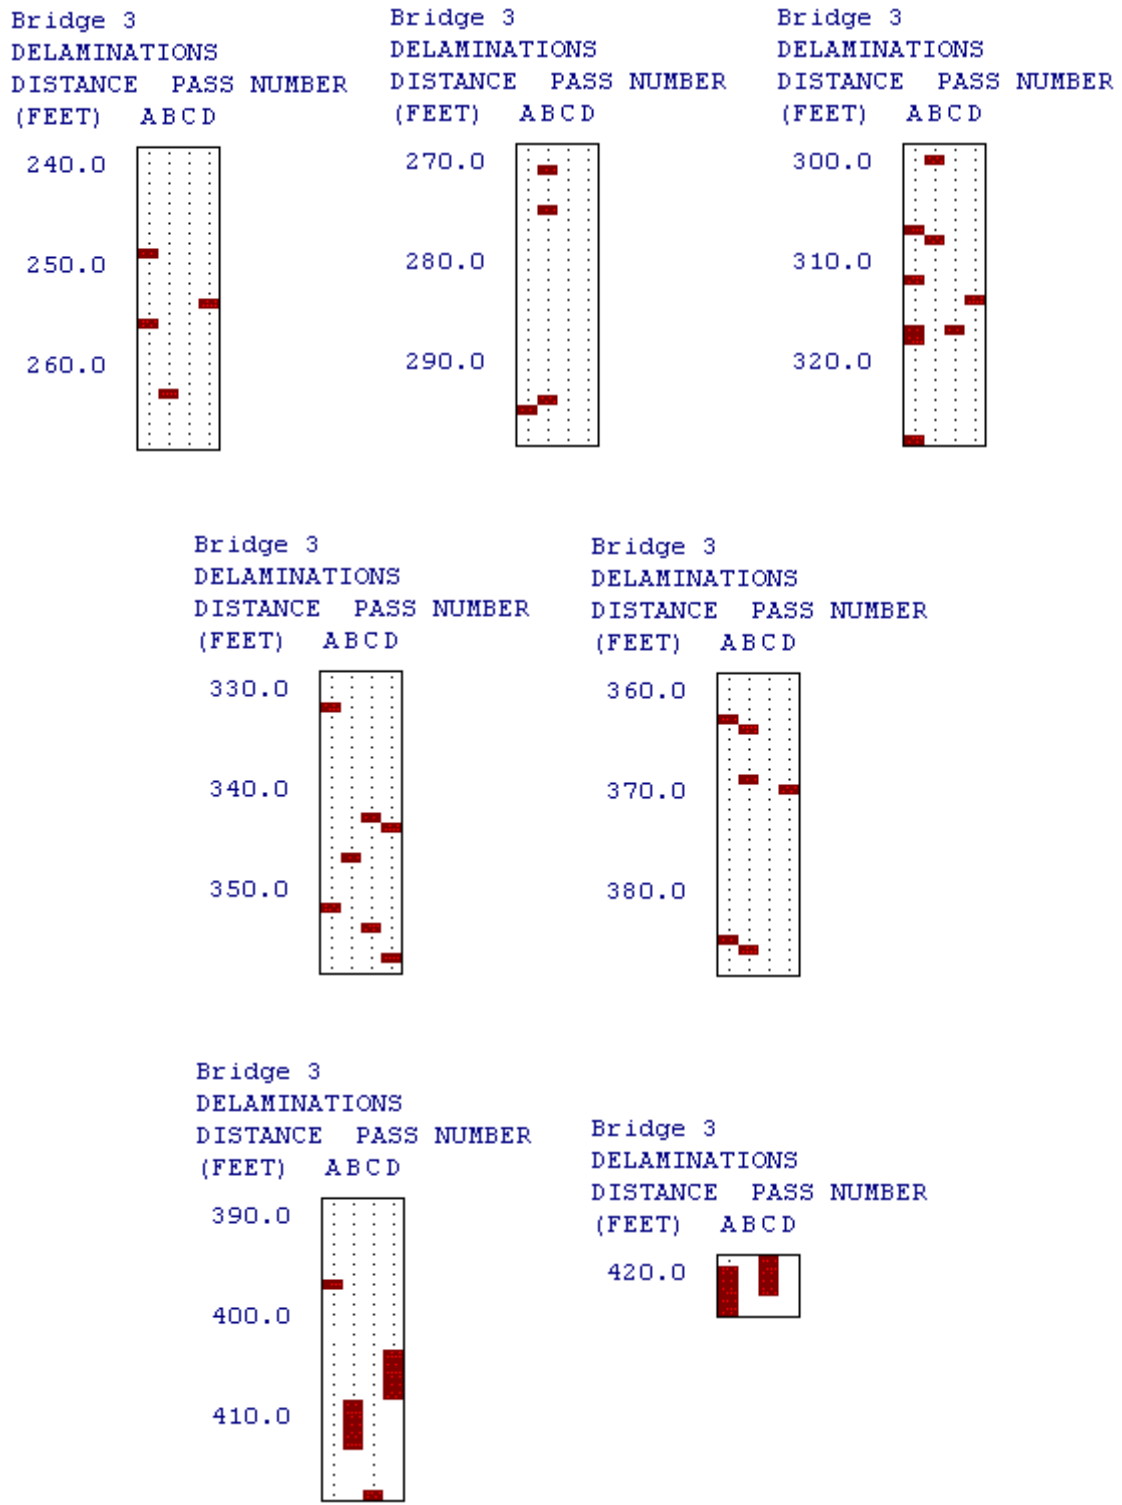
Figure 6.21b: Bridge 3 Deterioration Map, Continued

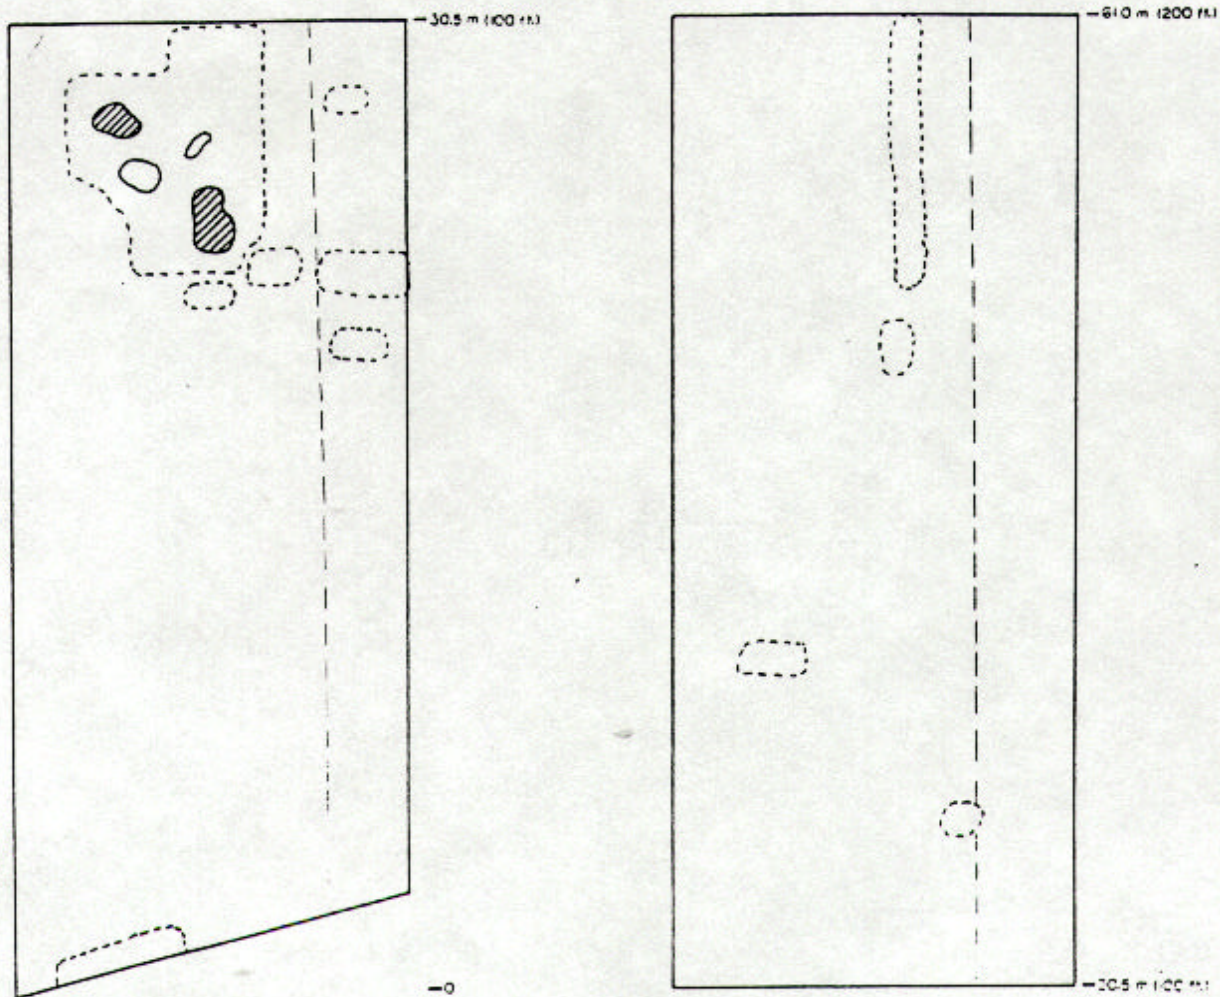
Figure 6.22a: Knollwood Bridge, I-79 South Delamination Survey from 1993 Chain Drag Testing (WVDOT)

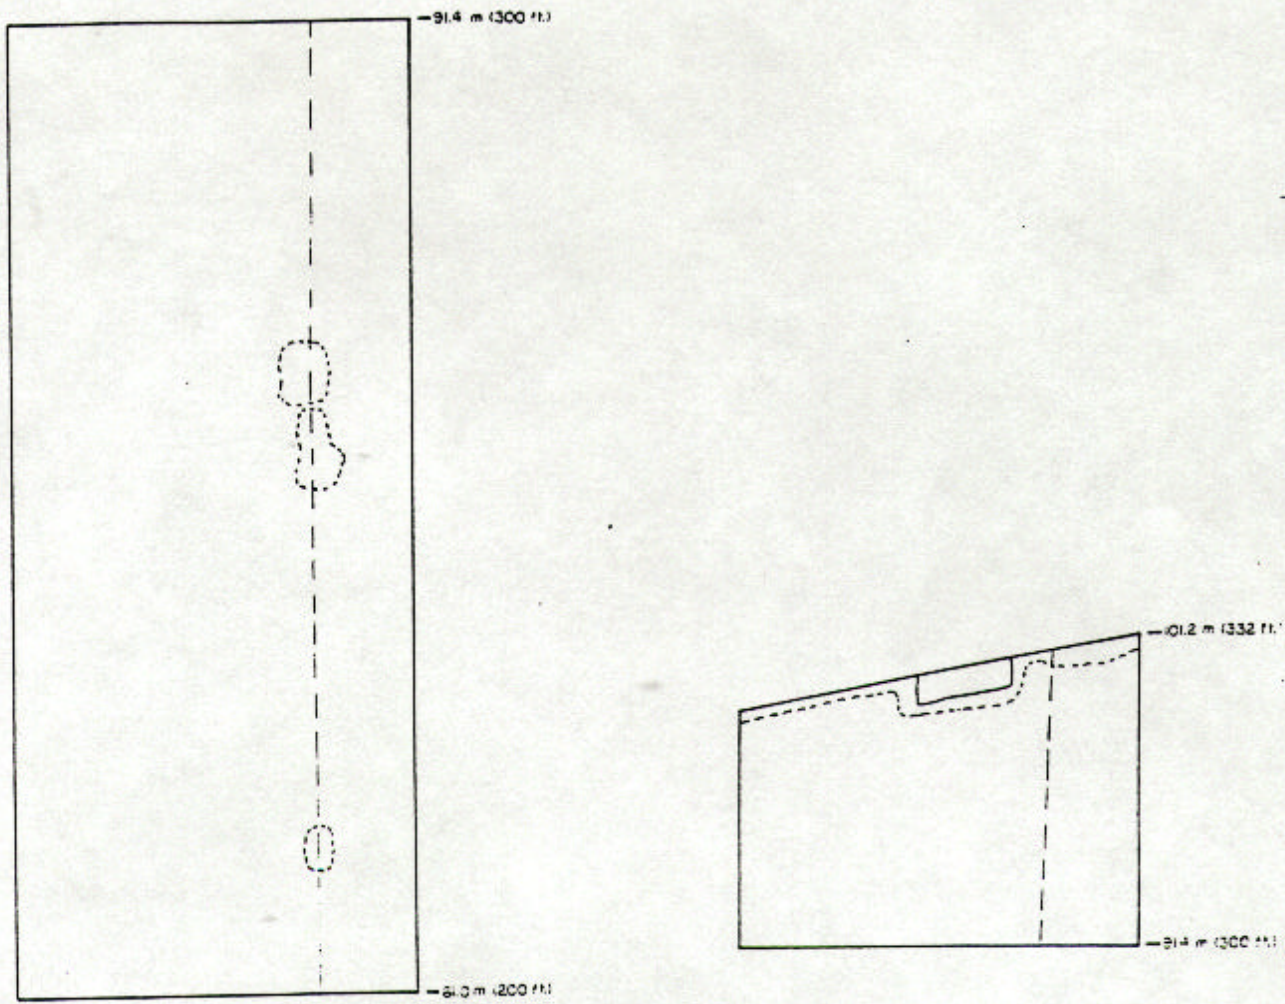
Figure 6.22b: Knollwood Bridge, I-79 South Delamination Survey from 1993 Chain Drag Testing, Continued (WVDOT)

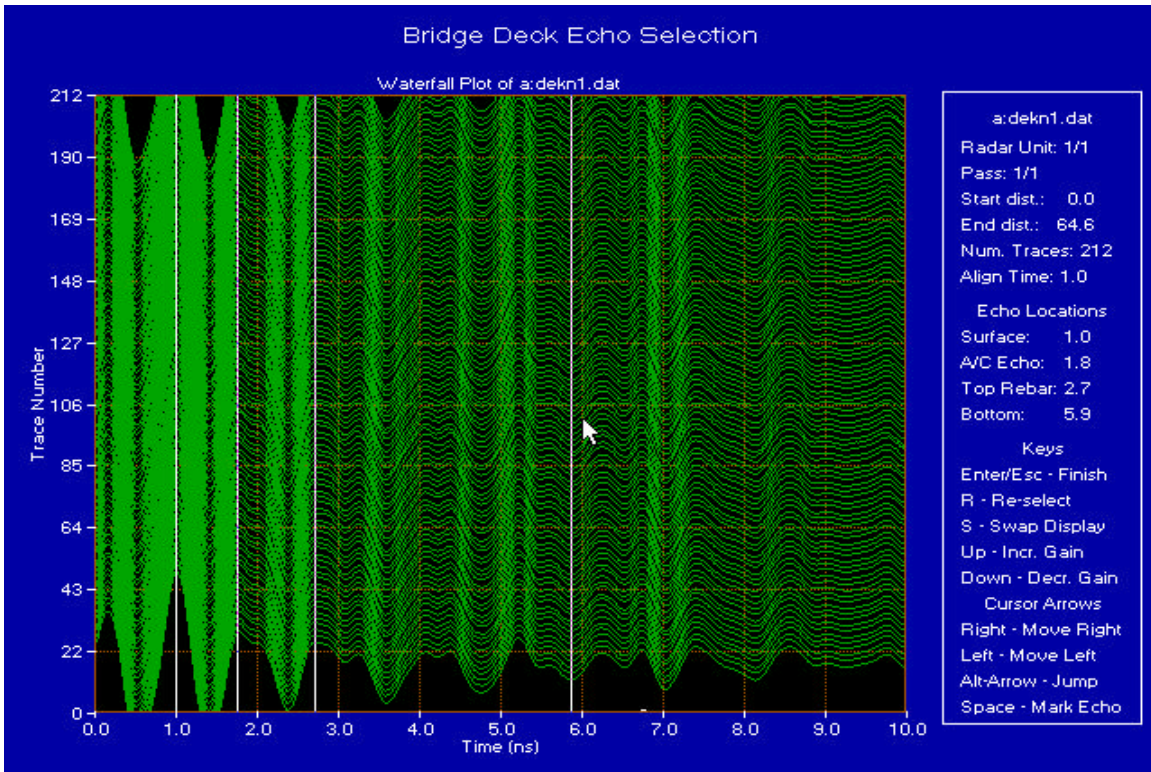
Figure 7.3: Waterfall Plot of Greenbrier Bridge

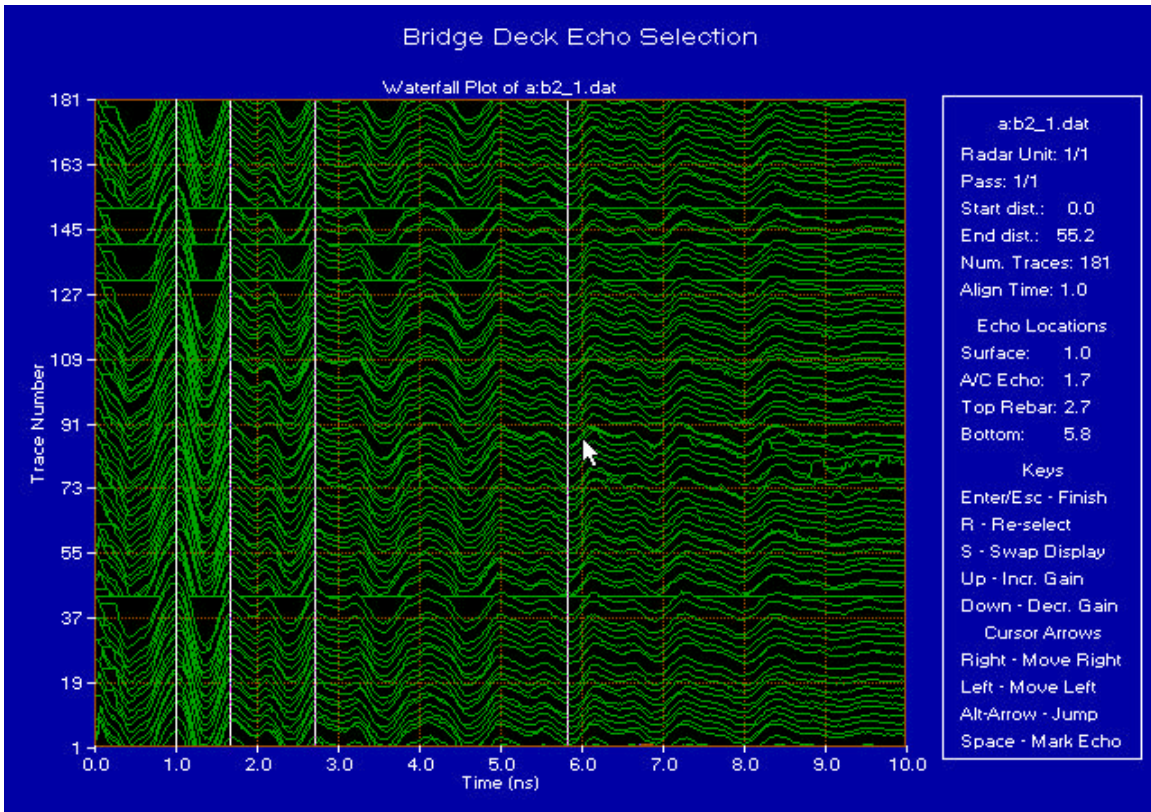
Figure B-10: Waterfall Plot for Choosing Echo Locations

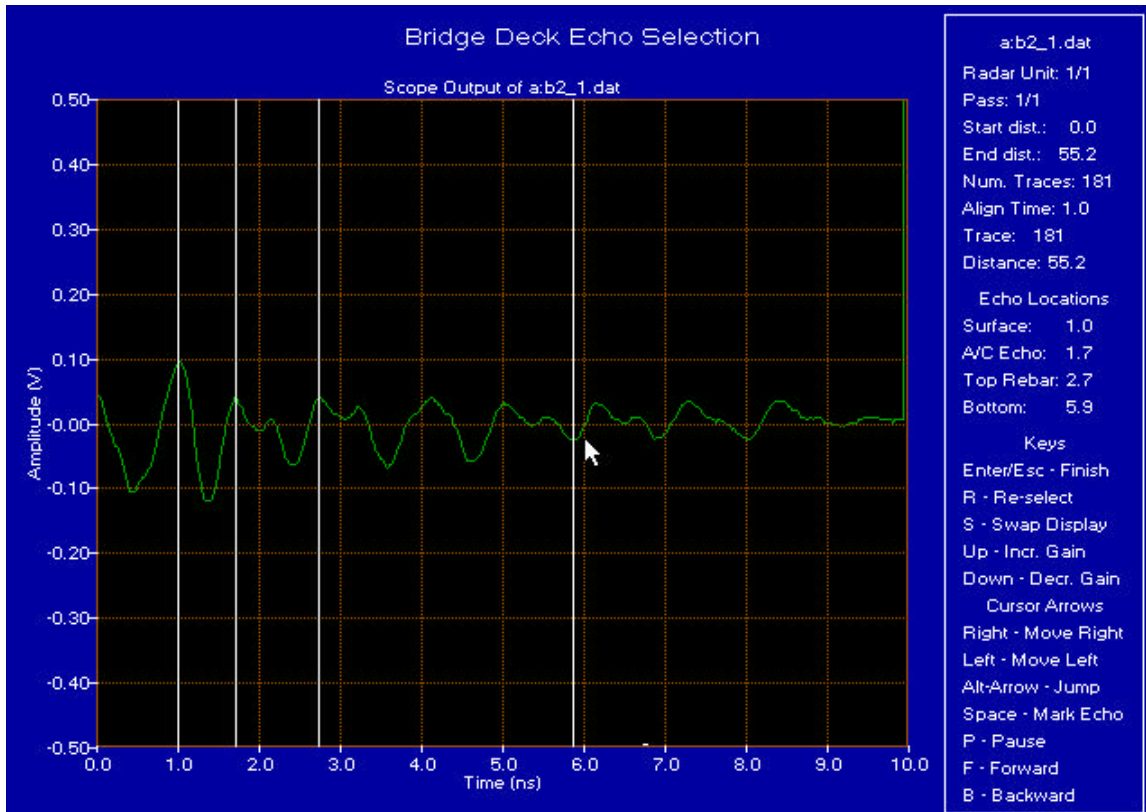
Figure B-11: Scope Display Screen for Choosing Echo Locations
