Load testing and recommended repairs for dailey branch bridges - milepost 1.4 to 5.8

**Load Testing and Recommended Repairs for Dailey Branch Bridges
– Milepost 1.4 to 5.8**

**Master of Science
In
Civil Engineering**

The West Virginia Department of Transportation State Rail Authority sponsored a study to evaluate the condition of the railroad bridges on the Dailey Branch in Elkins, WV. The evaluations included field inspections, load rating, load testing, and a repair plan. A total of 2 steel bridges and 3 timber bridges were part of the study. The repair plan focused on identifying deteriorated timber bridge members for potential Glass Fiber Reinforced Polymer (GFRP) wrap repair. Information on dimensions and deterioration was gathered through field inspections. A timber specialist determined the species and grade of the timber bridges, finding most members to be Select Structural lumber of Southern Pine species. A preliminary analysis was performed to ensure that the bridges would withstand a hi-rail dump truck and a locomotive during load testing. A total of 76 strain gages were installed on all 5 bridges to record bending, shear, and axial compression data.

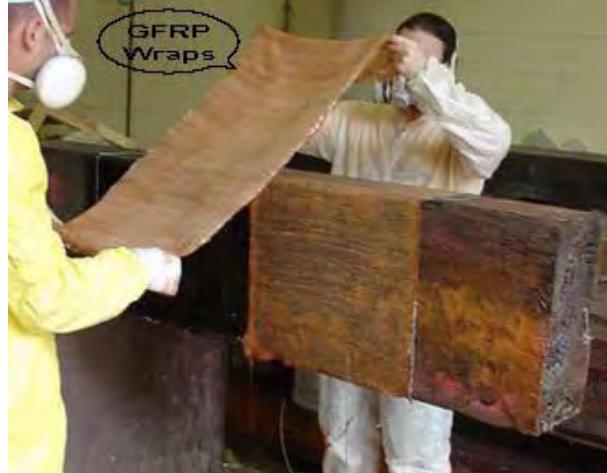
Figure 1 - Timber Stringer Rehabilitation using GFRP (Abhari, 2007)

The importance of timber in the history of bridge construction is said to date back to several thousand years. The first human made timber bridge is assumed to have been built by a Neolithic human who felled a tree across a chasm with a hand-fashioned stone axe circa 15,000 B.C. (Eby, 1986). Timber bridges later became key components in the United States railway infrastructure, bridging gaps over rivers, ravines, roads, and other obstacles. Timber bridges represent approximately 7 percent of the 576,874 bridges listed in the National Bridge Inventory (Duwadi & Ritter, 1997). In the railroad system alone, there are about 35,000 timber bridges in service today, many of which are over 50 years old (Mee, McCown, Davids, & Nejikovsky, 1994). Railroads usually run through very rural areas of the United States, sometimes populated with dense vegetation along narrow waterways and the access locations for maintenance are very poor. When timber is poorly maintained, and exposed to harsh environments over long periods of time, decay is very prominent. The most common type of Timber Bridge used in railroad industry is the trestle bridge, a bridge with short spans supported by rigid timber frames usually referred to as bents. These timber trestle bridges are usually struck and covered by debris which is dragged downstream by the rivers and creeks usually being crossed. In states like West Virginia, flash flooding is a very common occurrence, thus generating large areas of splash zone in the timber leading to massive decay or rot. Wood being a naturally occurring composite material, also exposes it to biological attacks such as termites and fungi. While accounting for all these factors of structural deterioration, timber structures are weakened and in need for repair. In today's tight budgetary constraints, bridge replacement is not feasible. Therefore, innovative and economic repair approaches are still being developed by the engineering community. A very common rehabilitation procedure, still being tested, is the use of fiber reinforced polymer (FRP) composite wraps to strengthen deteriorated structures. Man-made composite materials are those composed of at least two components, one being the reinforcing agent (fiber) providing the strength, and is the matrix (polymer) where the reinforcing is embedded. The composite wrap acts by wrapping the reinforcing fibers, previously impregnated with the polymer, around or along a member. Once the polymer (resin) cures, it holds the wrap in place and the fibers begin to act as reinforcement together with the member. The use of FRP composites also allows for in-situ rehabilitation of in service bridges, which allows the bridge to remain in service through the rehabilitation process in many occasions. Laboratory experiments previously performed by WVU-CFC (Smith, 2004) helped conclude that using Glass-FRP composite materials, to repair as well as strengthen previously failed beams, allows the recovery of 55 – 60 % of the initial strength (Figure 1).

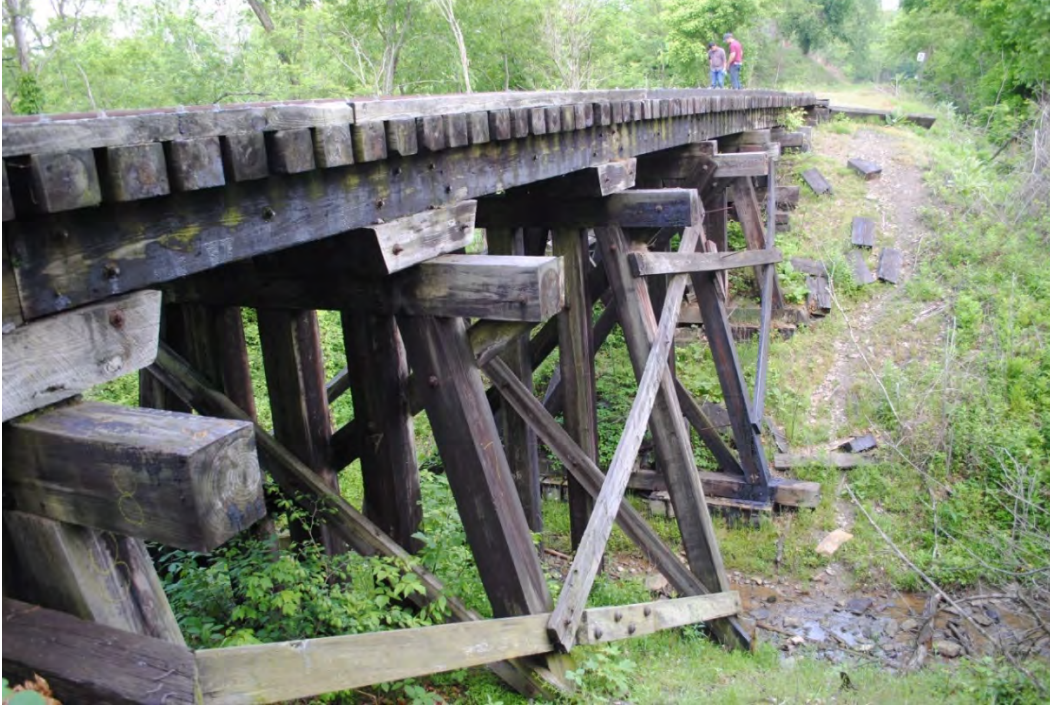
Figure 5 - Bridge DB 1.9

This timber trestle bridge has an 89' overall length divided into 9 spans averaging about 10' in length. Bridge 1.9 has a total of 2 abutments and 8 timber-bent frames. The 4 interior bents are also braced together using tower braces. Interior bents have also been braced against sway (sway braces). Figure 5 shows the East face bridge 1.9, found in milepost 1.9 spanning over an unknown stream.

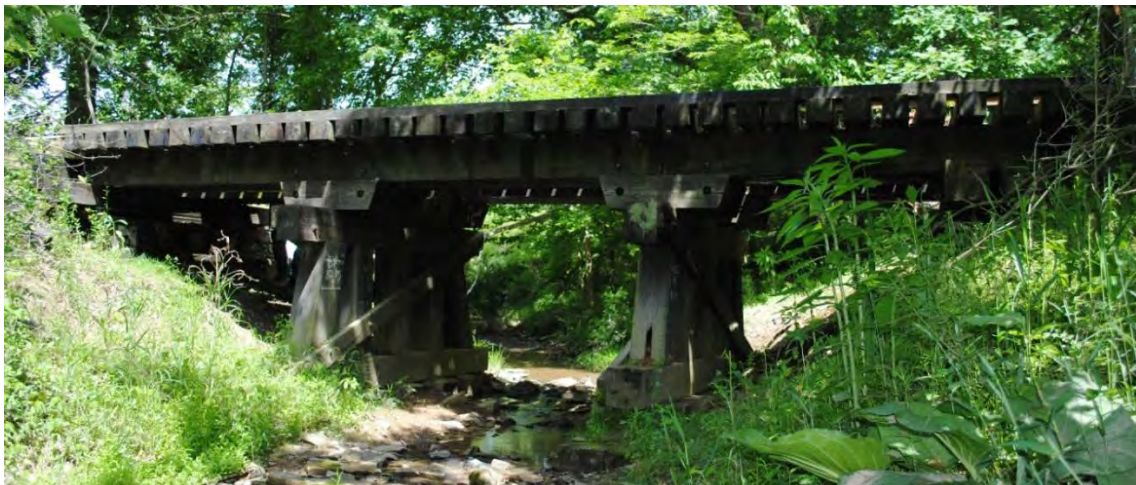
Figure 6 - Bridge DB 4.3

This timber trestle bridge has a 34.5' overall length divided into three 11'-5", 11'-10", and 9'-2" spans. Bridge 4.3 has a total of two abutments and 2 timber bent frames as shown in Figure 6. Interior bents have also been braced against sway (sway braces). It can be found in milepost 4.3 spanning over Crouches Creek.

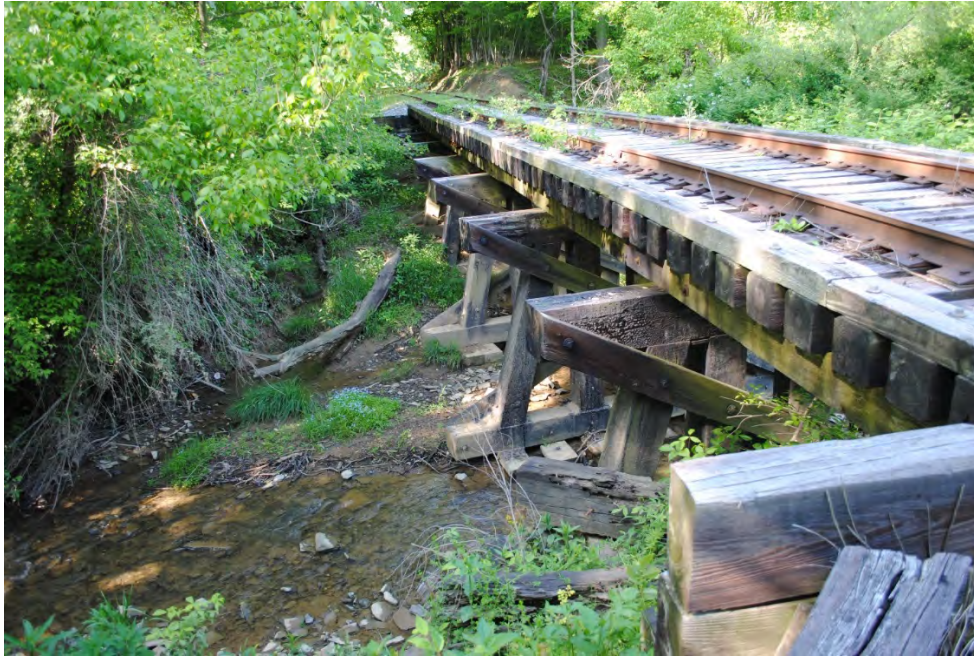
Figure 7 - Bridge DB 5.1

This timber trestle bridge has an 81' overall length divided into span lengths ranging from 10' to 12'1.75". Bridge 5.1 has a total of two abutments and 6 bent frames. Interior bents have also been braced against sway (sway braces). It can be found in milepost 4.3 spanning over Kings Run as shown in Figure 7. The interior bents of bridge 5.1 are skewed up to 9% in reference to the stream alignment.

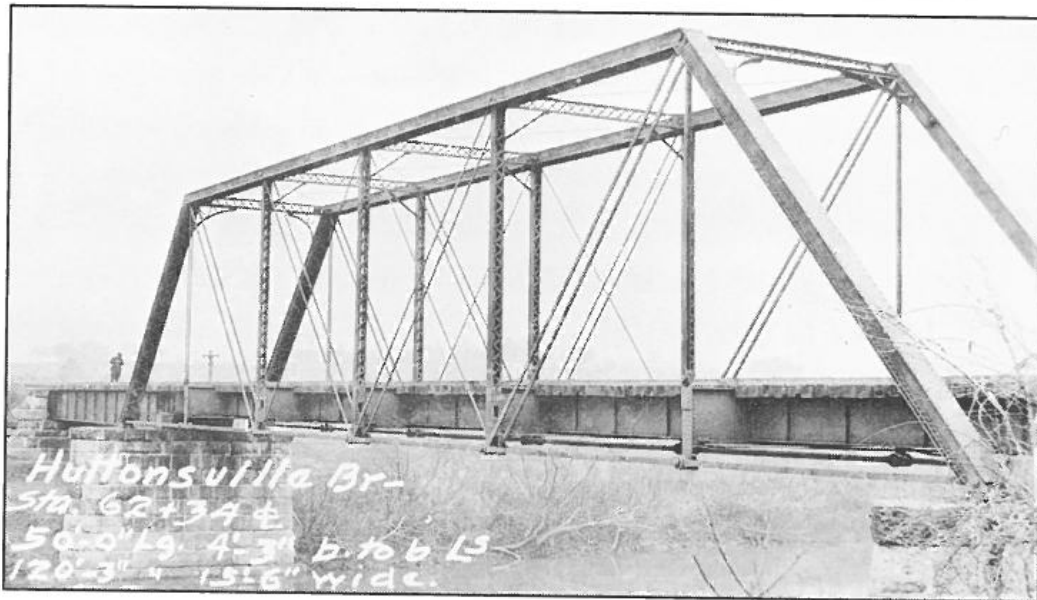
Figure 8 - Old Truss Bridge Replaced by Bridge 1.4. Source: Collection of the Western Maryland Railway Historical Society

Bridge 1.4 was originally built in 1891 (opened on August 27) as a 3-span bridge, where the end spans were typical deck girder superstructures and the middle span a truss bridge as show in Figure 8 (Clarke, 2003). This bridge was later replaced with the current 2-span through girder bridge, which according to the WVSRA has plans dating back to 1886 and had been originally used for the Piedmont and Cumberland Railroad (PCR) over the Baltimore and Ohio Railroad (B&O). The old pier structures of the 3-

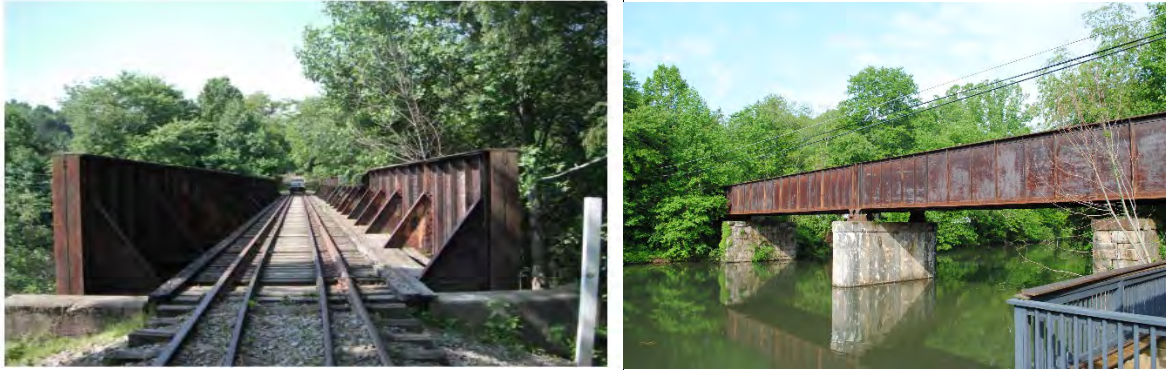
Figure 9 - Bridge 1.4

The current bridge is a typical through Girder Bridge as defined in the AREMA manual, having an open deck design. It is a 2-span simply supported bridge, with rocker bearings on the North end of each span, and pinned bearings on the South end of each span. Span 1 is 98'-8" feet long, and span 2 is 97'-2.5" feet long. Table 2 shows a summary of the member dimensions of the superstructure for bridge 1.4, and Figure 9 below shows a view of bridge 1.4 from the north abutment looking south.

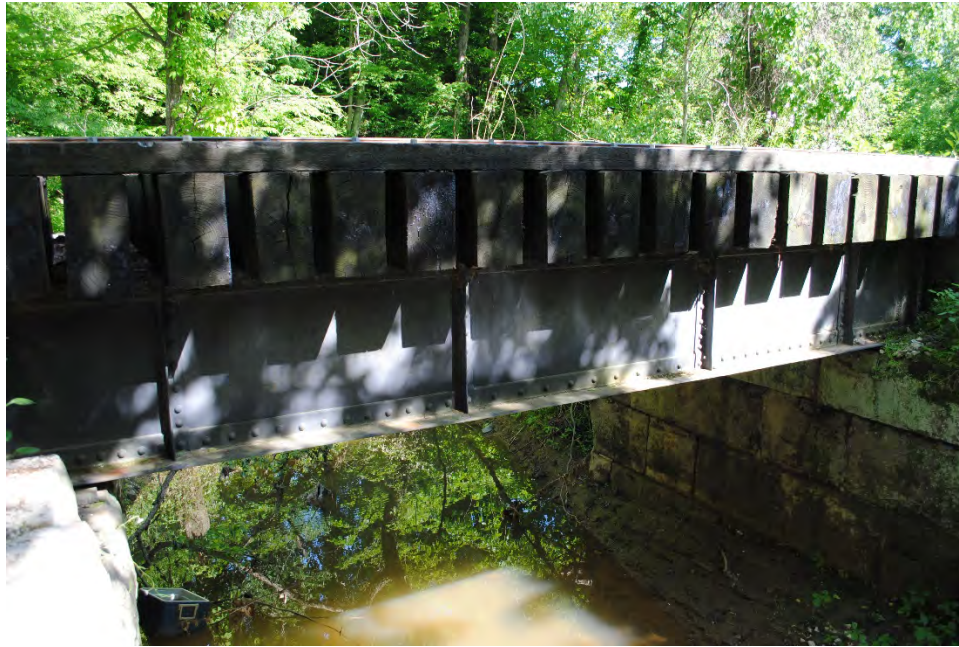
Figure 10 - Bridge 5.8

does not have other load carrying members (floor beams and stringers), making the girders fracture critical. Figure 10 below shows the West face of bridge 5.8.

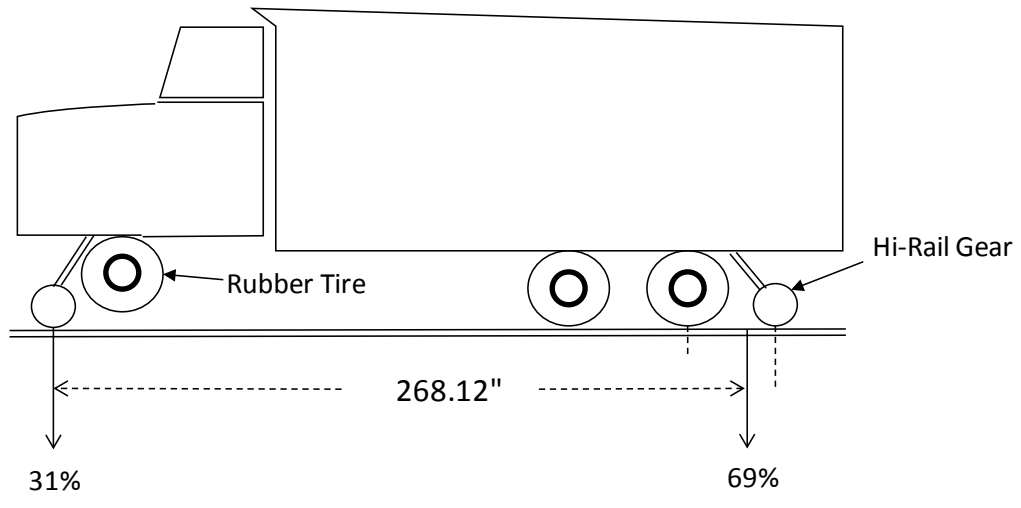
Figure 15 - Hi-Rail Dump Truck

Due to potential decay in the timber structures, a hi-rail dump truck loaded with gravel lower in axle load than a 286 kip rail car was recommended for load testing the bridges in order to be conservative during the loading procedure. When the dump truck went from the road onto the tracks, a front and rear rail gear was lowered onto the rails, where the front rubber tires axle was lifted up the, but the rear rubber tires remained on the tracks. Photo sensors and strain gages helped determine the center of gravity of the rear axle where the rubber tires and rail gear came into contact with the tracks. The front rail gear carried all of the weight for the front axle. Figure 15 below shows the respective axle weight distribution and axle spacing.

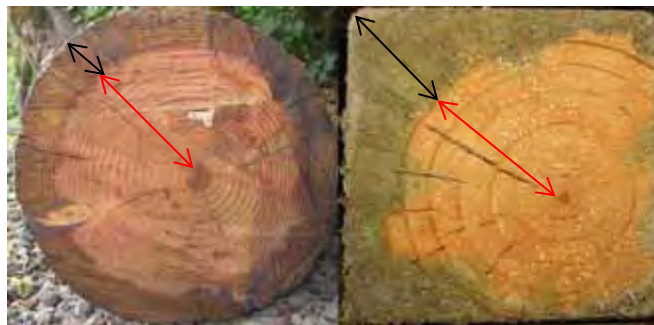
Figure 19 - Cross Section of Pressure Treated Wood Logs (Wood Handbook, 2010)

The extent of penetration and retention of a preservative chemical in wood highly affects its effectiveness in preservation. Sapwood is easily penetrated when compared to the heartwood, which usually goes untreated due to the shallow reach of preservative penetration. Figure 19 shows an example of preservative penetration in a wood log. The untreated area (red arrows) is more vulnerable to biological attacks than the treated area (black arrows), which can be verified with findings from the inspections in section 3.2 where timber posts and some stringer are rotted in the core.

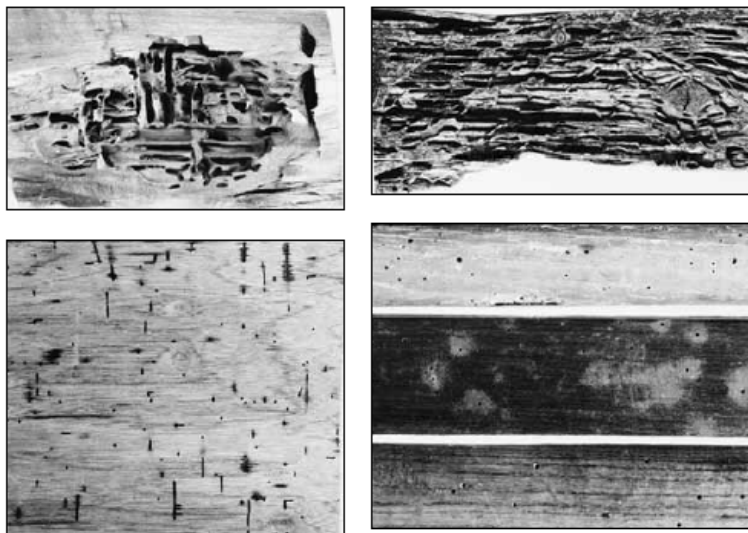
Insects can also attack wood and leave small tunnels through the cross section of wood products. Insects attacking wood include beetles, termites, carpenter ants, and carpenter bees. Figure 20 shows wood attacked by different insects.

Figure 20 - Upper Left- carpenter ant attack. Upper Right- termite attack. Lower Left- beetle attack. Lower Right -powder-post beetle attack (Forest Products Laboratory, 2010).

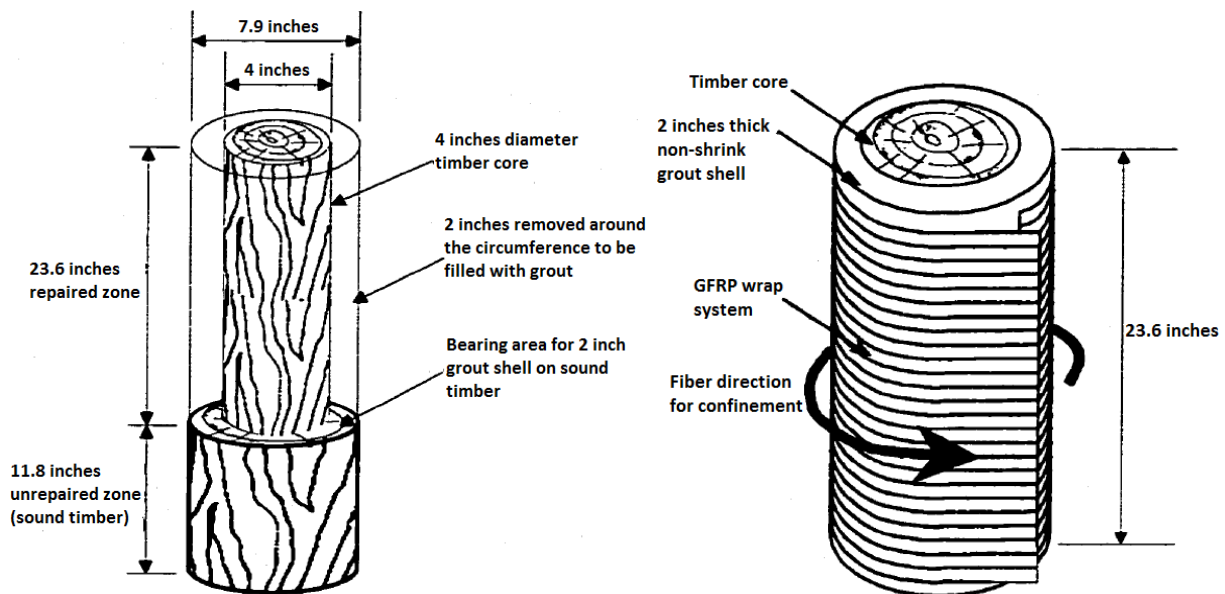
These testing techniques involved the simulation of damage on control piles, so the test results are only compared to control specimens created in the lab. Hagos (2001) was able to test similar repair techniques on in service damaged piles to produce real life scenarios. His research involved the testing of a total of 43 pile specimens in axial compression and 10 specimens in bending. Three different GFRP configurations were tested; a single layer of GFRP wet-wrap, double layers of GFRP wet-wrap, and a prefabricated GFRP shell. Actual decayed timber piles were used in the testing of the control specimens and the repaired specimens. Three different levels of decay were tested throughout the experiment, mildly decayed core, highly decayed core, and man-made void core. Two different diameter piles were also tested, one being an 11.8 inches diameter pile with a reduced damaged core of 7.9 inches in diameter, and the second one having a 7.9 inches diameter and damaged core of 4 inches in diameter. All repaired specimens had a non-shrink cementitious grout shell with a thickness of 2 inches surrounding the damaged core, which was then wrapped using either single or double layers of GFRP wet-wrap, or a GFRP prefabricated shell. Figure 30 shows the schematic of prepared specimen and repair technique using GFRP wet wrap sheets and grout filling.

Figure 30 - Schematic of Specimens and Repair Technique Using GFRP Wet-Wrap Sheets (Hagos, 2001)

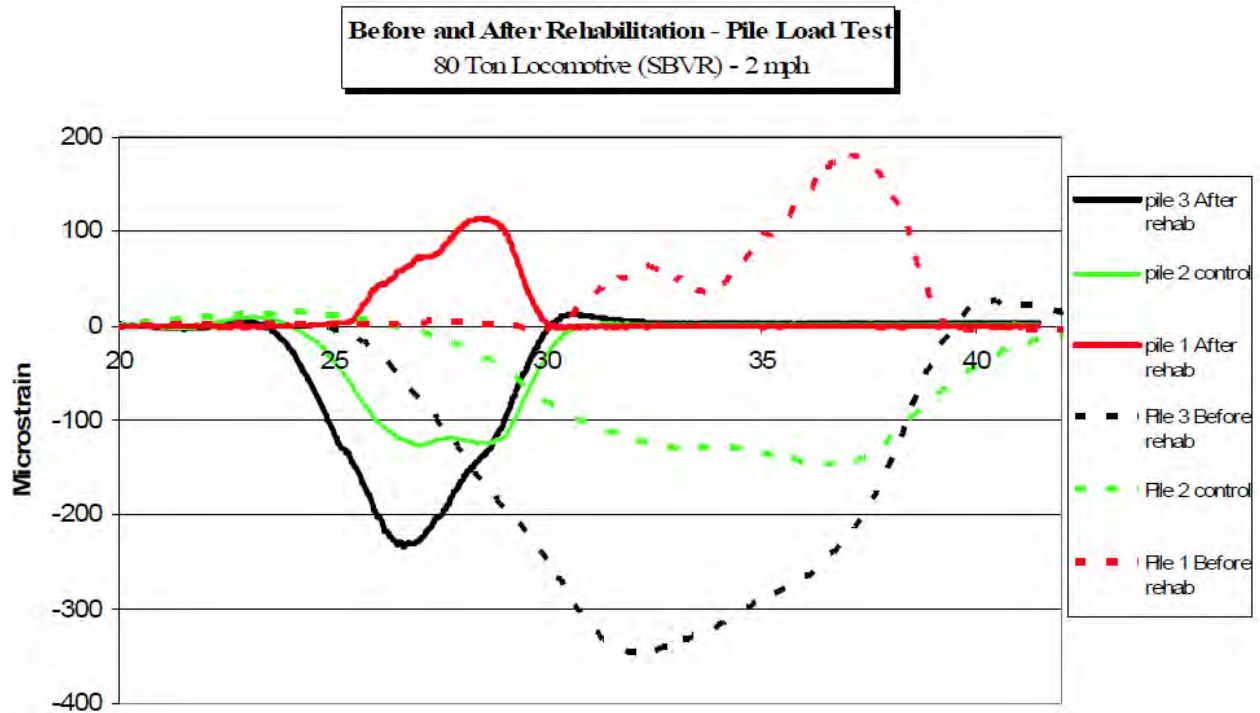
uniform pressure on the GFRP layers during curing. A UV protective coating was applied to the wrap after curing. Figure 31 compares microstrain data from the piles being load tested before and after rehabilitation. An 80-ton locomotive was used for load testing at a speed of 2 mph. A reduction in strains can be observed in Figure 31 by the rehabilitated piles in comparison with the same piles before rehabilitation.

Figure 31 - Strain Distribution in Piles Before and After Rehabilitation for Train Speed of 2 mph (Abhari, 2007)

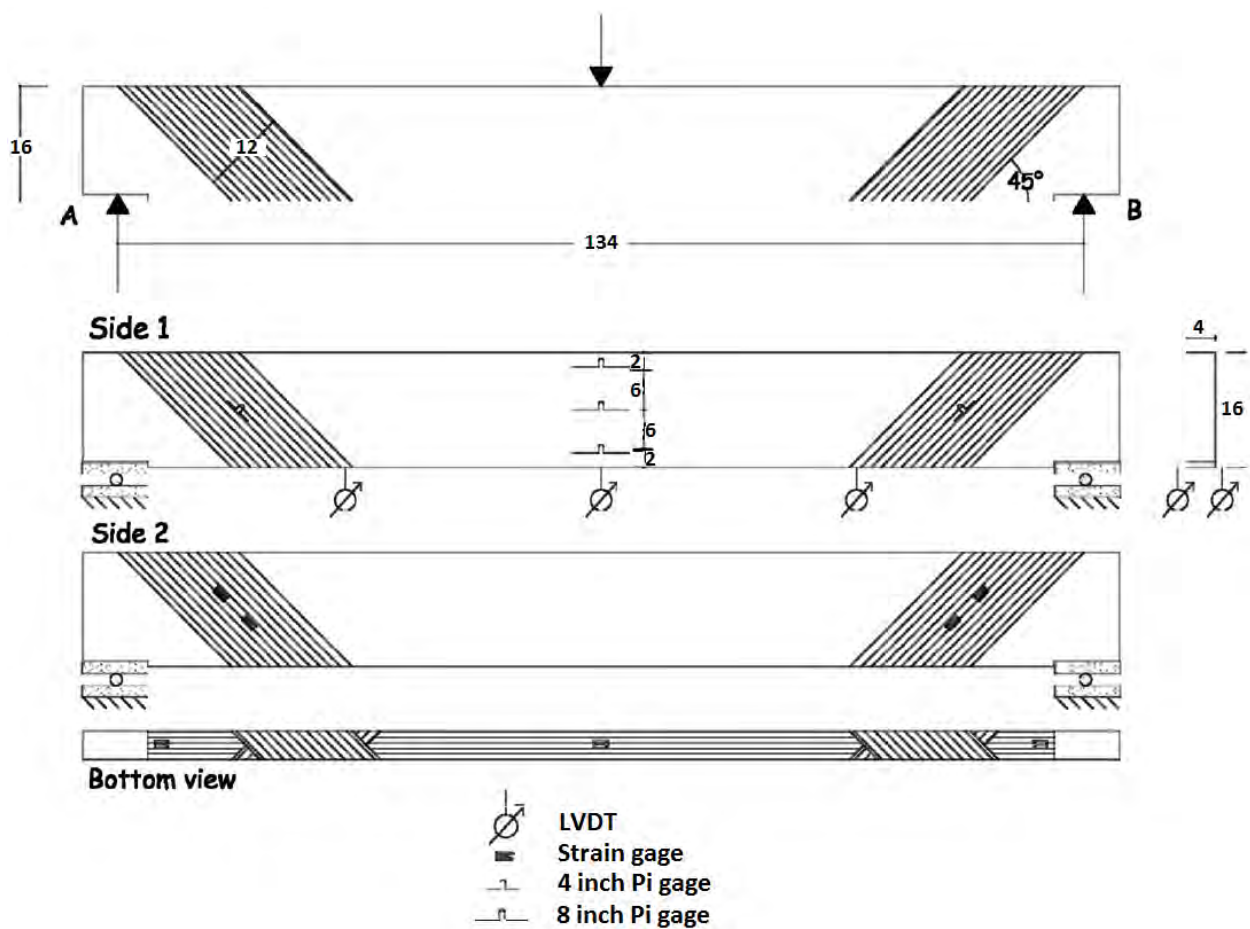
different faces of the beam and in different orientations. Gómez and Svecova's (2008) technical paper covered the results obtained by testing GFRP-repaired split timber stringers of treated Douglas fir species under 3-point bending loads. All 5 stringers tested were originally of select structural grade, but had to be graded again due to aging related damages. The new grades left 2 select structural, 2 No. 1, 1 No. 2 stringers, and four reject stringer samples. The stringers were reinforced using glass fabric sheets saturated in an epoxy matrix for both bending and shear. Bending reinforcement consisted of two layers of FRP sheets bonded to the tension face of the stringer. One layer of FRP sheets was placed at 45 degrees around each end of the beam in order to add shear strength. Figure 32 shows the repair scheme of the stringers with its corresponding dimensions.

Figure 32 - Repair and Instrumentation of Specimens, all dimensions in inches (Gómez & Svecova, 2008)

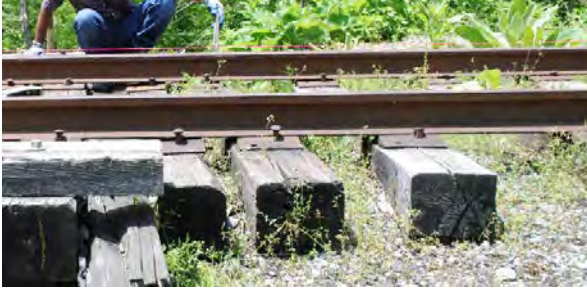
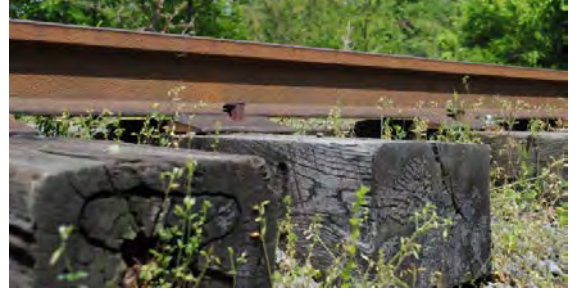
Figure 34 - Approach Condition: North (left) and South (left)

The condition of the track at the approaches is poor due to defective ties and low ballast (Figure 34). On the North approach, the track dips approximately 1 inch, and approximately 2 inches at the south approach.

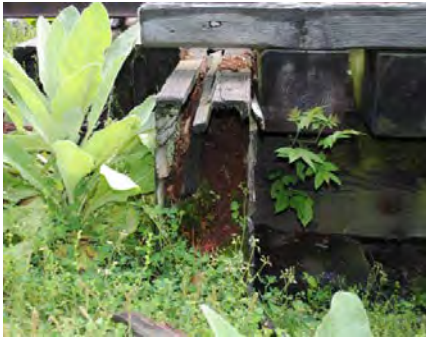
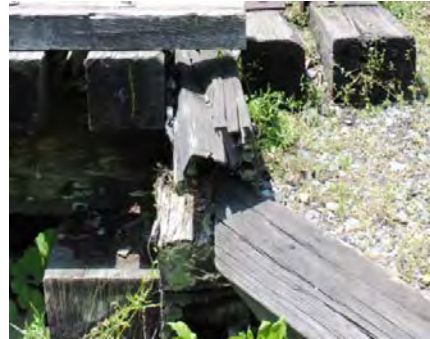
Figure 35 - North Backwall West End (left) and East End (right)

The timber back wall on the north end has full heart rot for the entire length (Figure 35). The north east wingwall exhibits heart rot and it is leaning outward. The south abutment is located between Bent 8 and Bent 9. This backwall exhibits heart rot on the West end for about a third of the member length. The west wingwall timbers have begun to rot.

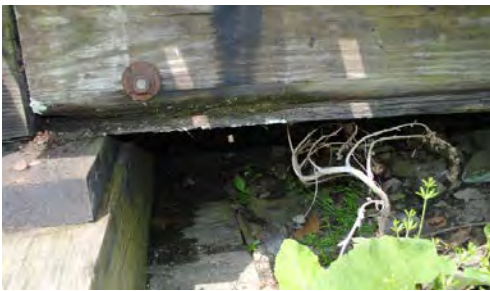
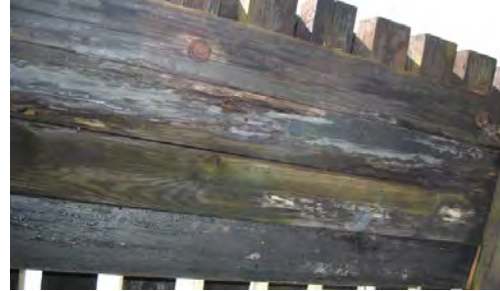
Figure 36 – Rot Span 1 Stringer 1 over Bent 2 (left) and Span 3 Stringer 2 (second stringer from the top down) rotting (right).

A few stringers showed substantial rot, and some other showed softening when tapped. Span 1, Stringer 1, has a 2"x8" rot with 4' in length ending over bent 2 (Figure 36 left). Stringer 2 in span 3 and 4 has a 2"x8" rot for a length of 17'-6" (Figure 36 right). Span 5 and 6 also show rot in stringers 2, 3 and 4. Stringer 3 in spans 4, 5, 8, and 9 shows softening.

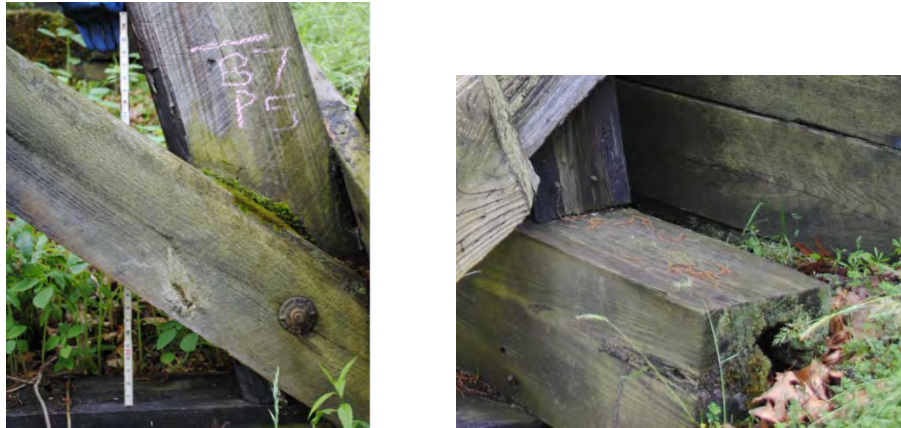
Some posts had visible surface rot, while others sounded hollow indicating heart rot. Posts 2 and 3 from Bent 4 sound hollow from hammer tapping, and post 1 has visible heart rot. Post 3 in bent 6, and posts 3 and 5 in bent 7 exhibit heart rot from sounding hollow by hammer tapping (Figure 37 left). The sills in bents 3, 4, 6, 7, and 8 show heart rot. Sills in bent 6, 7, and 8 (Figure 37 right) all have heart rot for more than 2' in length. Block 5 in both bent 2 and 3, and blocks 1, 2, and 4 in bent 9 have high levels of decay.

Figure 37 – Bent 7 Post 5 (left) and Bent 8 Sill end rot (right)

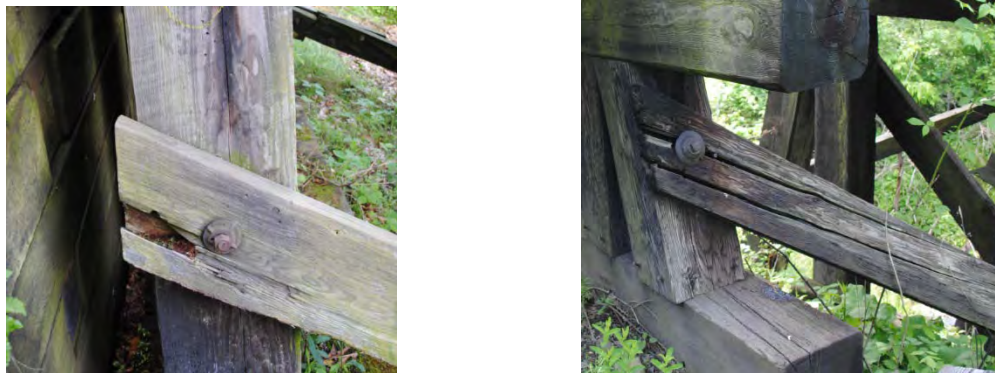
Figure 38 - East Tower Brace 4 rot/split (left) and West Tower Brace 1 split (right)

The north sway brace on bent 6 has split through the bottom bolt, some rot is noticeable as well (Figure 39 left). On the east side of the bridge, tower brace 3 has visible rot on the surface through the cross section of the member, and tower brace 4 has been spliced and shows rot (Figure 38 left). On the west side of the bridge, tower brace 1 has a large split (Figure 38 right) through the North bolt and tower brace 4 has been spliced (Figure 39 right).

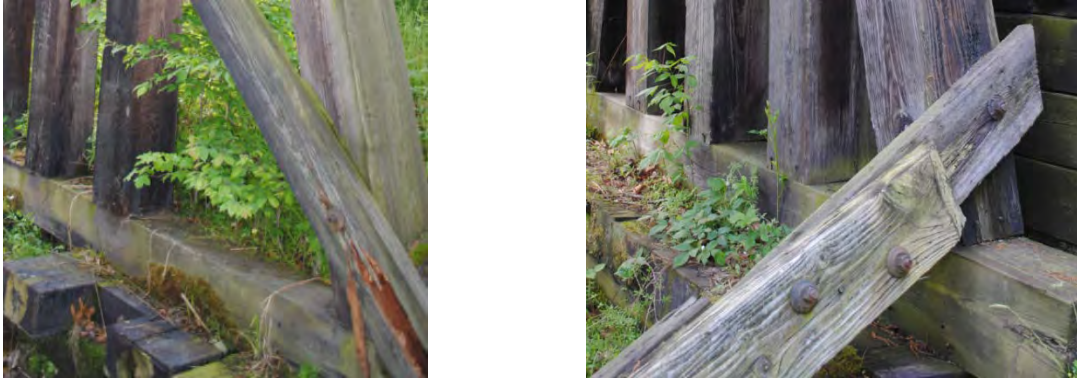
Figure 39 - Bent 6 Sway Brace split/rot (left) and West Tower Brace 4 splice (right)

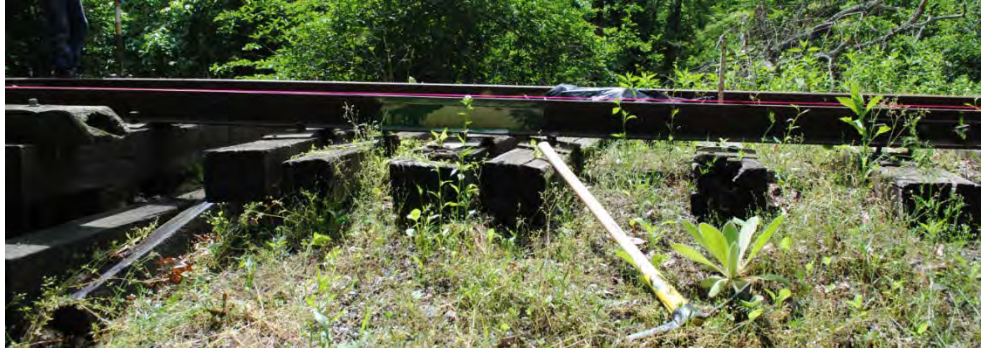
Figure 40 – North End Approach

The south approach is in very good shape (sound ties and sufficient ballast) and with no appreciable dip in the rails. The north approach has decayed/missing ties and very low ballast (Figure 40). The two last ties before bent 1 are missing, and 7 ties away from the north approach are not bearing on any ballast. The track dips approximately 1 inch on the North approach, but would defect further with train movement as the track is not resting on several ties/ballast. 4 ties over the bridge structure are decayed.

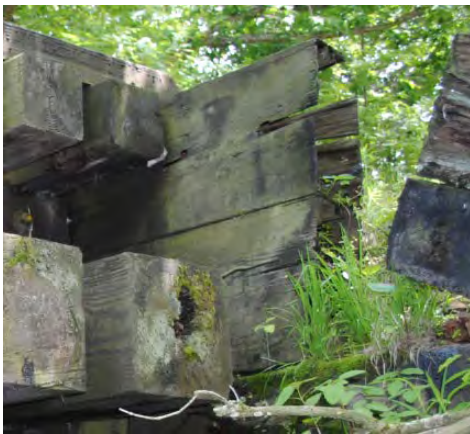
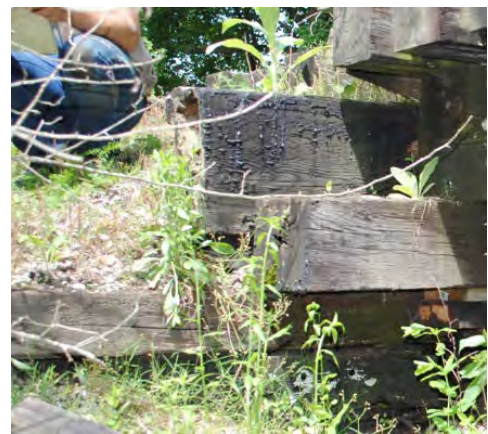
Figure 41 - South Backwall and South West Wingwall heart rot (left). North Backwall West End heart rot (right)

The North timber back wall has full heart rot, while the South back wall is rotten on west end (Figure 41 left). The Northwest wingwall consists of 1 member (Figure 41 right) and the Northeast wingwall is rotting and leaning outward. The Southwest wingwall shows some rot and is leaning outward.

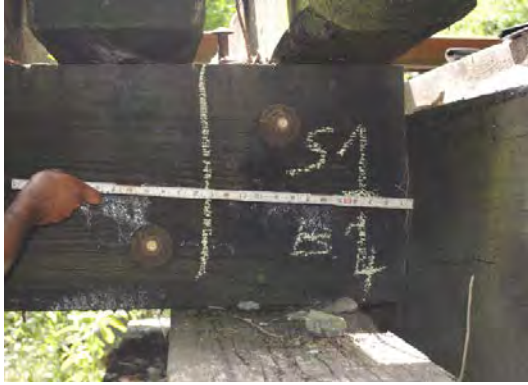
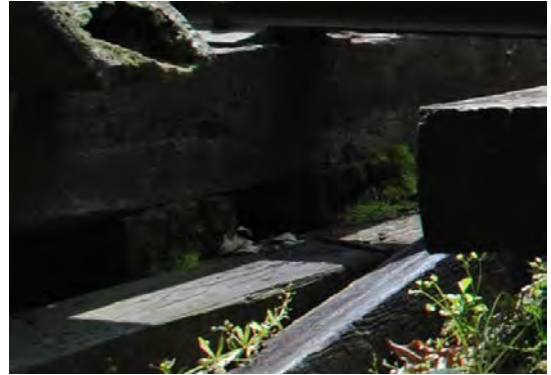
Figure 42 - Span 1 Stringer 1 end rot over Bent 1 (left) and Span 1 Stringers 1 & 2 end rot over Bent 1(right).

On Span 1, stringers 1, 2, 5, and 8 have end heart rot over bent 1 (Figure 42). Stringers 7 and 8 have heart rot over bent 3 on span 3.

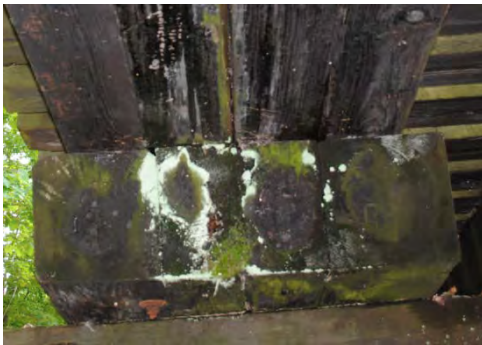
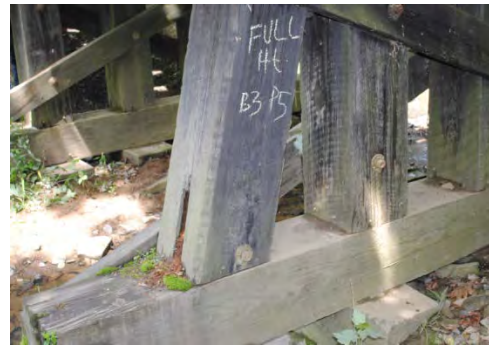
Figure 43 - Bent 3 Corbel 2 rot (left) and Bent 3 Post 5 heart rot (right).

In bent 2, post 1 (Figure 44 left) exhibits heart rot coming through the outer surface of the post estimated to continue for its full height. Posts 2 and 5 were tapped with a regular hammer and were found to be hollow for a length of about 2'. In bent 3, posts 1 and 5 (Figure 43 right) exhibit signs of heart rot either visibly or through hollow soundings for their full height. Bent 1, 2, and 4 have sills that exhibit varying degrees of end rot. The sill on Bent 1 has heart rot for 2' on the East end. Bent 2 sill shows heart rot on the East end 14" in length. Bent 4 sill and cap beam exhibit heart rot for 4' and 2' respectively. The following blocks exhibit high rot: block 6 in bent 1, block 4 in bent 3, and blocks 4, 5 and 6 in bent 4 (Figure 44 right). Mud blocks 2 and 5 in bent 4 are also highly rotted. The corbels in bent 2 show softening (Figure 43 left), specifically corbels 1, 2, 3, and 7. Corbel 2 in bent 3 is highly rotted.

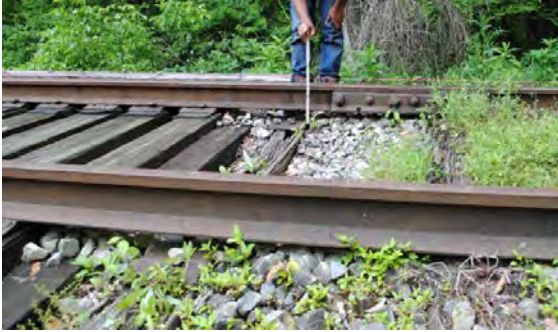
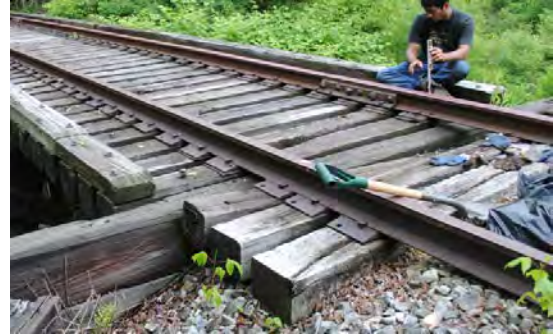
Figure 45 - North Approach Condition (left) and South Approach Condition (right).

The North approach has two highly rotted ties with low ballast with a gap of nearly 3 inches between the rail and ballast (Figure 45 left). The rail on the North approach dips by 1.25 inches. Ballast in the South approach is very low; the first two ties are hanging by the rails with no support beneath them, even with a dip in the rails of 1.1875 inches (Figure 45 right).

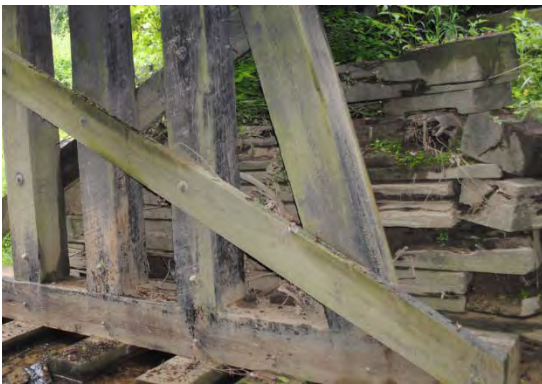
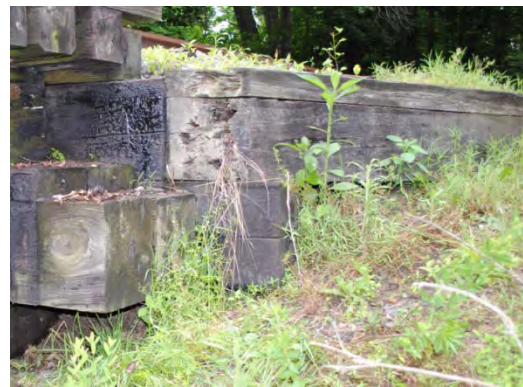
Figure 46 - South Retaining Wall & West Wingwall (left) and North East Wingwall heart rot (right).

The top timber member on the Northeast wingwall is fully rotted (Figure 46 right). The Southwest wingwall shows minor rot. The south retaining wall structure between bents 7 and 8 is leaning outward on the west, and some rot is noticeable on the top west timber members (Figure 46 left).

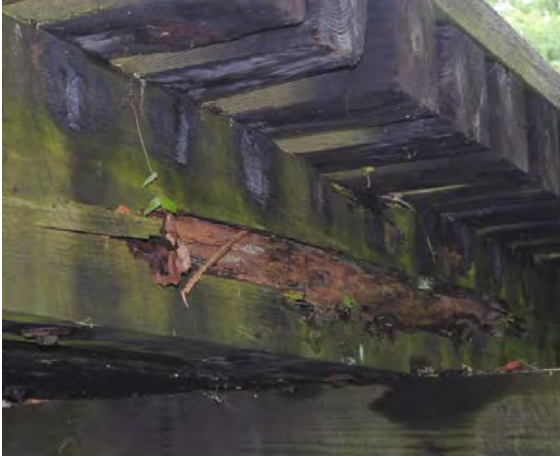
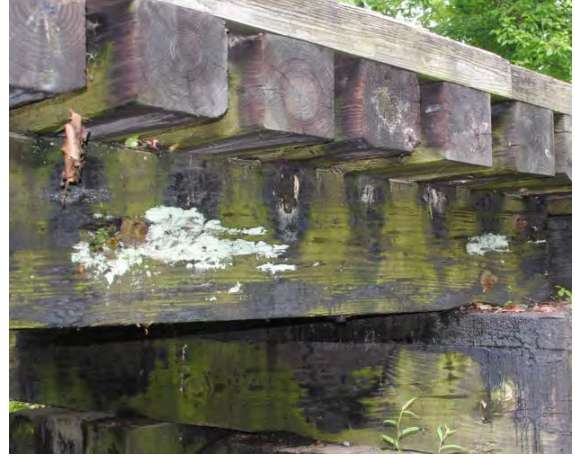
Figure 47 - Span 3 & 4 Stringer 8 highly rotted (left) and Span 1 Stringer 1 East face fruiting bodies (right).

Stringer 1 in span 1 is highly rotted on the East face of the member near bent 1 for 2' in length and at center span for another 2', both about 5" by 2" in cross section (Figure 47 right). Stringer 4 in span 1 also shows some rot near bent 2, 2" by 4" in cross section for a length of 3'. Stringer 8 in span 3 is highly rotted on the West face, the decayed area being 4" by 10" in cross section, and as long as 11' spanning over to span 4 (Figure 47 left). Stringer 6 in span 3 and 4 shows softening.

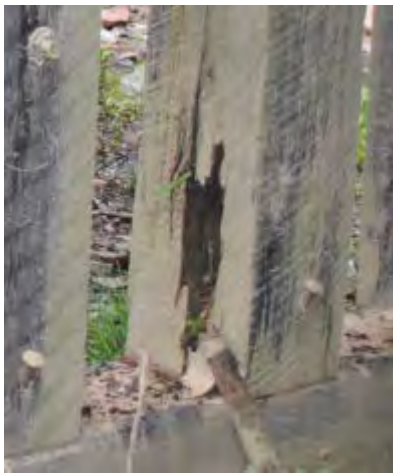
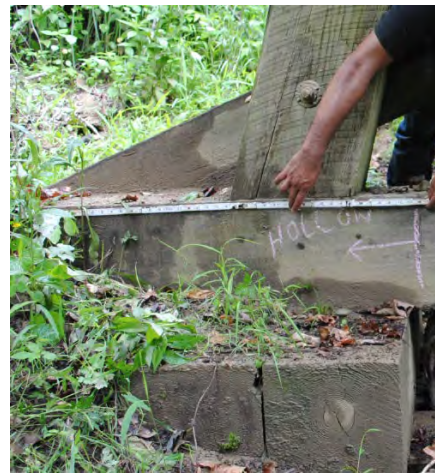
Figure 48 - Bent 5 Post 3 heart rot (left) and Bent 3 Sill end rot (right).

Flood debris has lodged against the upstream edge of bent 3 and other areas of the bridge. Post 1 in bent 3 has heart rot for the entire length of the member. Post 3 in bent 5 has heart rot near the bottom (Figure 48 left). Post 6 in bent 3 has heart rot present for the entire length of the member. The sill in bent 3 was found to be hollow for the end 4' below post 5 using the tapping technique (Figure 48 right). Blocks 5 and 6 in bent 1 are softening and beginning to rot.

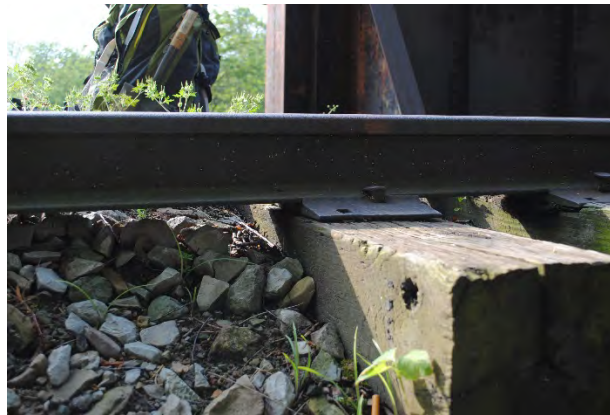
Figure 49 - North approach

Ballast is low near the approaches (Figure 49), and numerous ties show degradation.

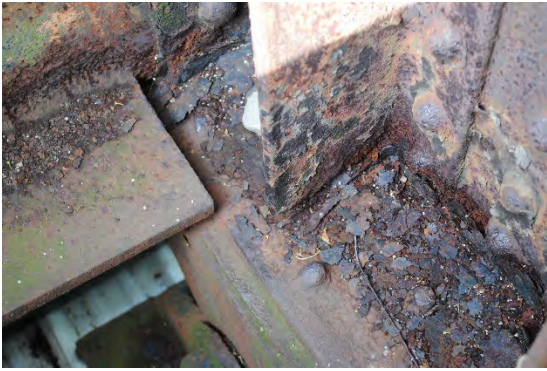
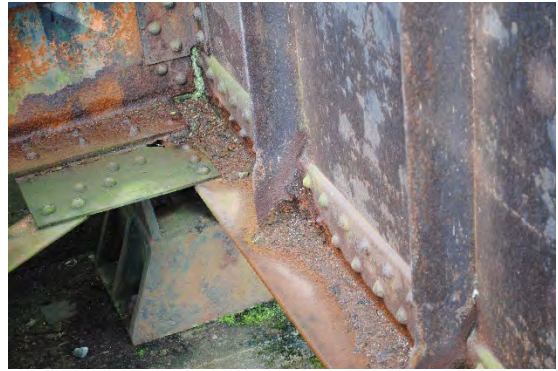
Figure 50 - Corrosion in angle of girder (left) and corrosion in gusset plate & web stiffeners (right)

Overall, the entire bridge exhibits minor corrosion. Span 1, Girder 2 exhibits corrosion on the bottom flange angles at Northwest end near bearing with losses up to ¼” to the interior vertical angle for up to 3” in height (Figure 50 left). Girder 1 has a bent bottom flange near abutment. Anchor bolts have section loss at the bottom up to ¼” loss for ½” in height. The rocker bearings are tilted strongly north, and the anchor bolts in Span 2 are bent. Gusset plate for the longitudinal bracing show corrosion, with corners rusted through in places, but this is not a structural issue as the area around the rivets is in good condition (Figure 50 right). Numerous web stiffeners in the gusset plate have 100% section loss at the bottom resting on girder flanges, but it does not affect the structural integrity of the girders as the section loss is below the rivets (Figure 50 right).

1. - Interior bottom vertical leg of horizontal angle with cross sectional loss up to $\frac{1}{4}$ " for 3" in height, located right above North West bearing on Girder 2.
ACTION: Remove rust, paint and monitor.
2. - Outer bottom vertical angle on the opposite side of the angle noted in picture 1. Shown as an example of an angle in good condition.
3. - Girder 1 is bent upwards near North support.
ACTION: Monitor.
4. - The cross section at the bottom of the anchor bolts in the North roller supports is corroded for about $\frac{1}{2}$ " in height and about $\frac{1}{4}$ " loss in cross section.
ACTION: Clean, paint and monitor OR replace at WVSRA discretion.
5. - North ends of both spans: Rocker bearings are tilted strongly north. Anchor bolts on span 2 bent.
ACTION: Reset bearing and replace bolt or monitor at WVSRA discretion.

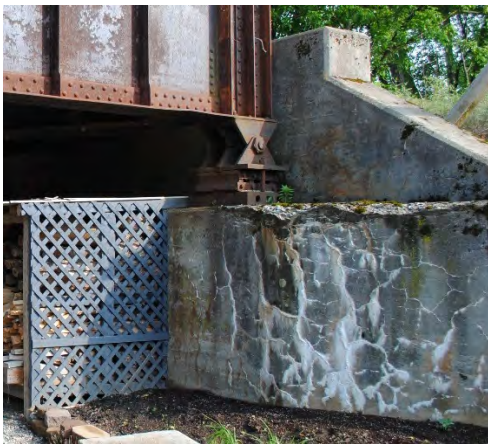
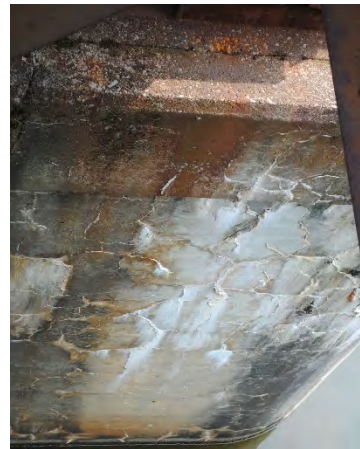
Figure 51 - Map cracking in north abutment (left) and pier (right)

Both concrete abutments exhibit map cracking, minor scaling, beam seats have hairline cracks (Figure 51 left). Concrete backwalls exhibits map cracking. Wingwalls are extensions of abutments. All exhibit minor map cracking, and minor delamination. Piers have heavy efflorescence, rust staining from super structure, and the top face has scaling up to 2 inches (Figure 51 right).

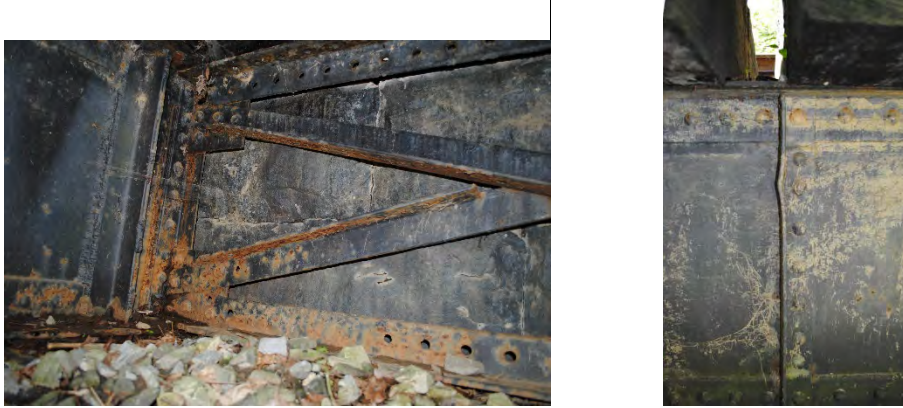
Figure 52 - Bracing corrosion (left) and bend in web stiffener (right)

Bridge 5.8 is good structural shape with very few signs of decay/corrosion. The most noticeable amount of corrosion was found in the end cross frame bracing (Figure 52 left) on the north end of the bridge. The bearing sole plates also show minor corrosion. Some web stiffeners show a small bend, which is considered nonstructural in nature (Figure 52 right). Some of the mortar in the cut stone abutments is missing or cracked. The west end of the north abutment is missing the top abutment stone (stone has been pushed into creek). Both approaches are in good condition and the timber ties and spacers are in good condition.

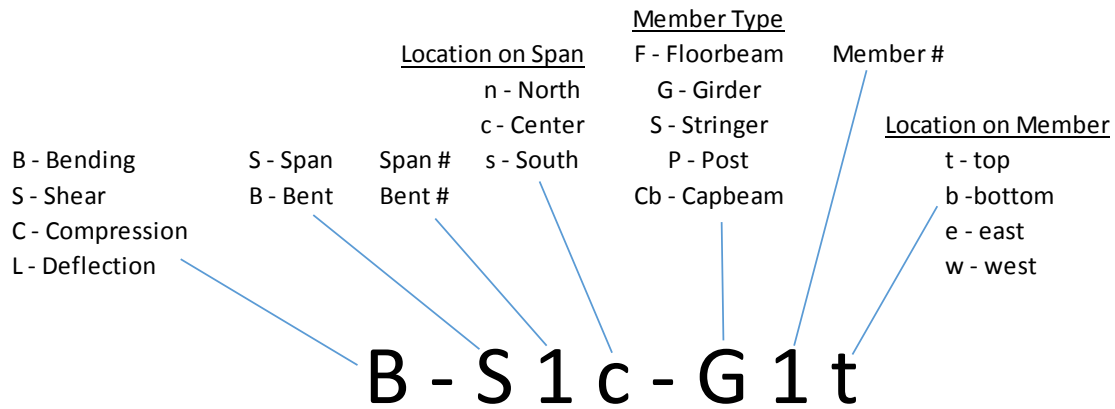
shear strain gages was needed since the strain gages are designed to provide shear strain data. Figure 53 shows the designation used to identify each individual strain gage.

Figure 53 - Strain Gage Identification According to Purpose and Location

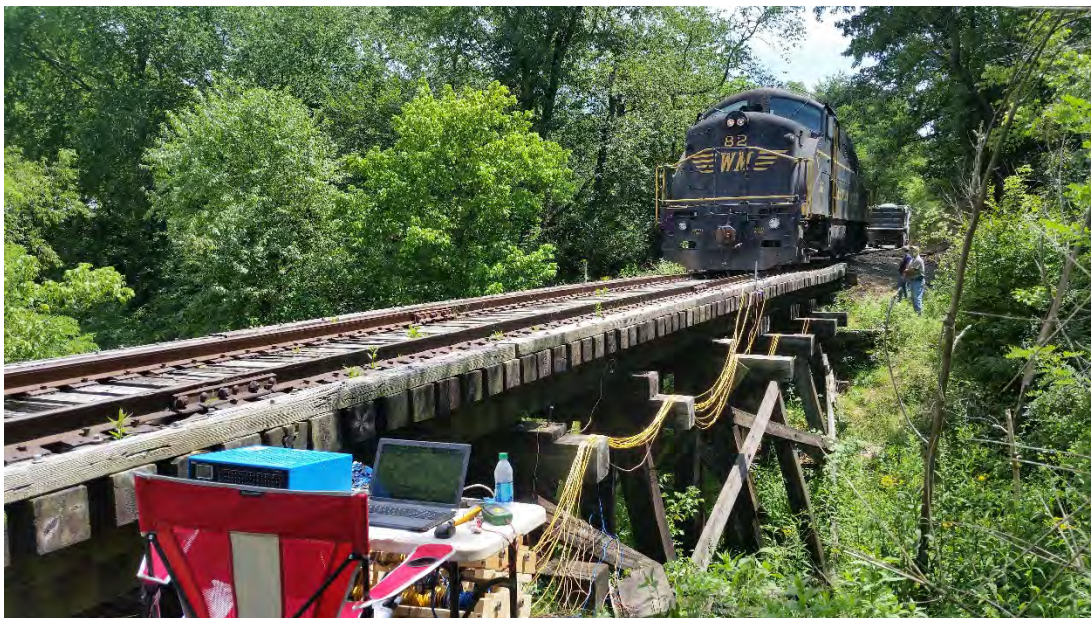
Figure 57 - WM 82 Locomotive Testing on Bridge 1.9 After Dump Truck Testing

In order to obtain maximum strain values under each vehicle for all five bridges, both rail vehicles were slowly rolled over the bridges three times for each bridge, slow enough (crawl speed) to reduce any impact effects. The strain values obtained were taken as static loading values in order to compare the results with the theoretical analysis.

The data acquisition system shown in Figure 57 recorded 10 data points per second for the duration of each test. The same test was ran three times on each bridge, two runs with the vehicle moving in the same direction (North or South) and one run traveling the opposite direction. The dump truck was the first rail vehicle used during testing in order to determine if the structure was sound enough to withstand the locomotive loading. Bridges 1.4 and 1.9 were tested one day 1 with both the locomotive and the dump truck, while the remaining bridges were tested on day 2 only with the dump truck. Dump truck strain values on testing day 2 were prorated to the locomotive values using field data between both vehicles from testing day 1.
