Load testing and recommended repairs for dailey branch bridges - milepost 1.4 to 5.8

**Load Testing and Recommended Repairs for Dailey Branch Bridges
– Milepost 1.4 to 5.8**

**Master of Science
In
Civil Engineering**

The West Virginia Department of Transportation State Rail Authority sponsored a study to evaluate the condition of the railroad bridges on the Dailey Branch in Elkins, WV. The evaluations included field inspections, load rating, load testing, and a repair plan. A total of 2 steel bridges and 3 timber bridges were part of the study. The repair plan focused on identifying deteriorated timber bridge members for potential Glass Fiber Reinforced Polymer (GFRP) wrap repair. Information on dimensions and deterioration was gathered through field inspections. A timber specialist determined the species and grade of the timber bridges, finding most members to be Select Structural lumber of Southern Pine species. A preliminary analysis was performed to ensure that the bridges would withstand a hi-rail dump truck and a locomotive during load testing. A total of 76 strain gages were installed on all 5 bridges to record bending, shear, and axial compression data.

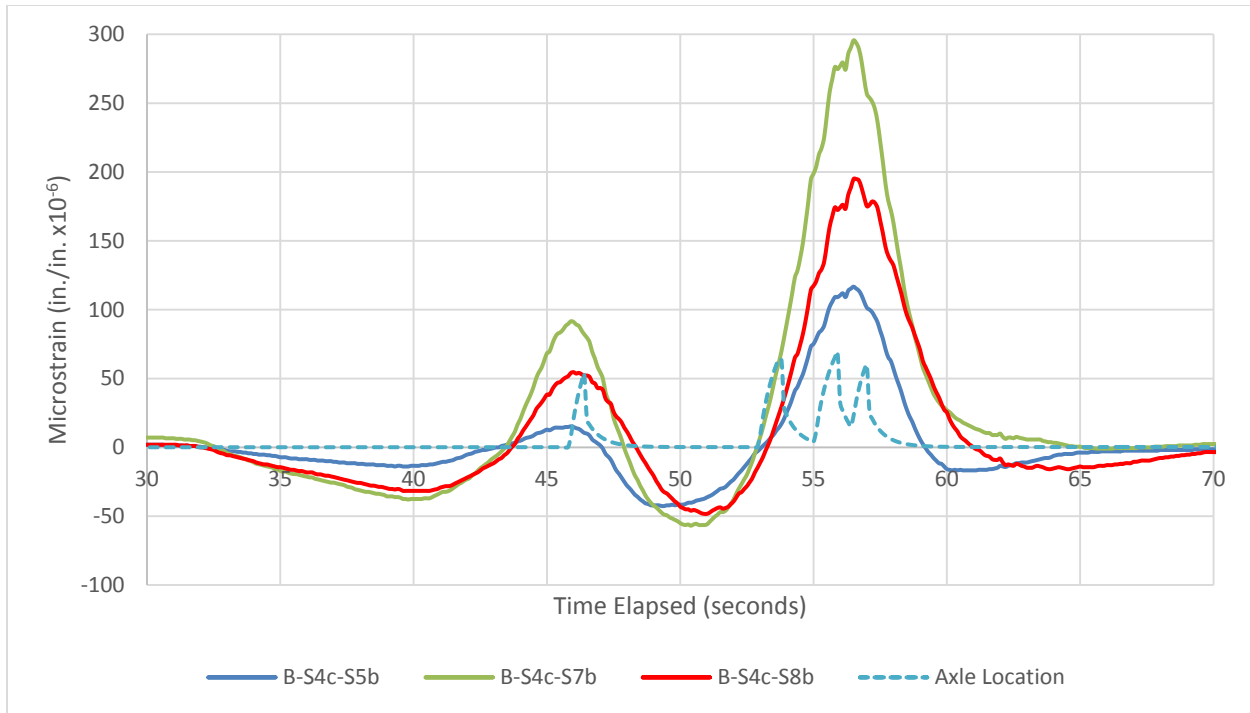
Figure 58 - Timber Stringer Bending Strain (Bridge 5.1, Truck Test 2)

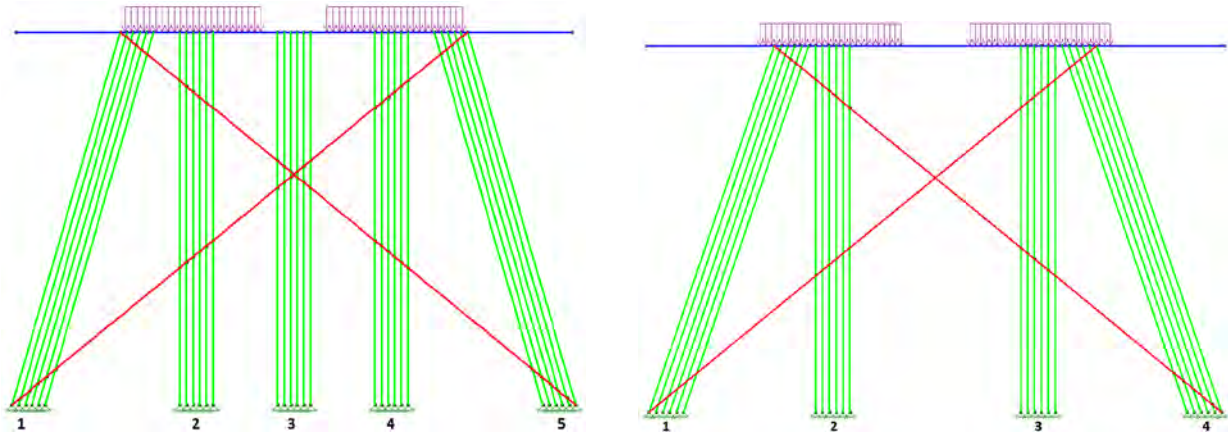
reaction at each bent was applied to the cap beams as uniformly distributed loads with a width equal to the stringer chords, or corbels if present, which then transferred the load down to the posts. The posts were modeled as six 2 inches wide by 12 inches high members (posts are 12" by 12") to provide proper bearing areas for the cap beam. The cap beams were fixed to the top of the posts, and the posts rest on pin supports. Figure 59 shows the 5 post model and 4 post model from RISA, and the load distributions are summarized in Table 21.

Figure 59 - Bent Model for 5 Posts (left) and 4 Posts (right)

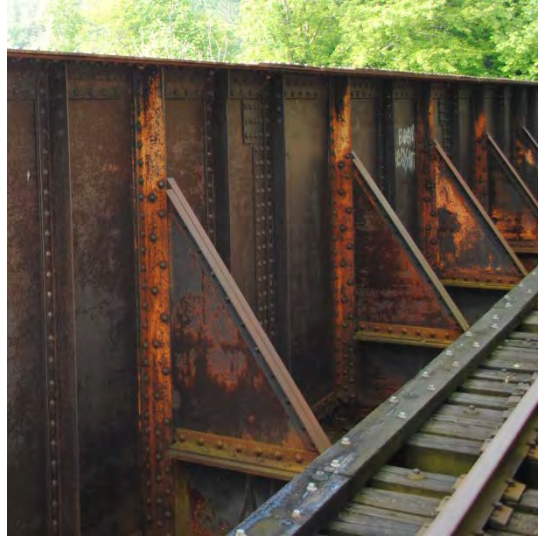
Figure 62 - Triangular Stiffeners on Floor Beam Top Flanges (Bridge 1.4)

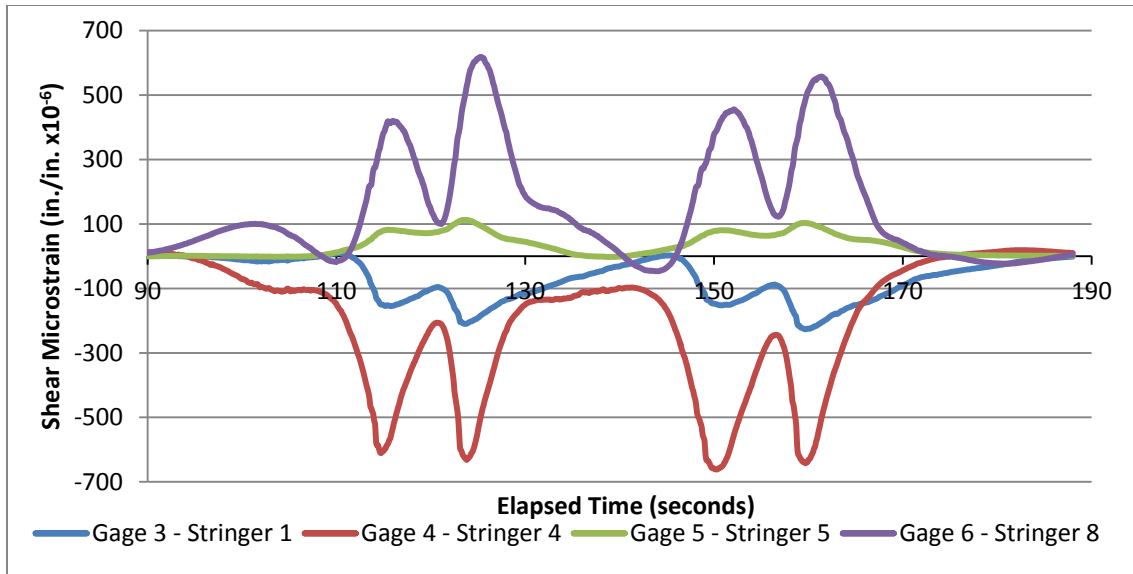
Figure 64 - Shear Microstrain Response of Timber Stringers (Bridge 1.9, WM82 Test 2)

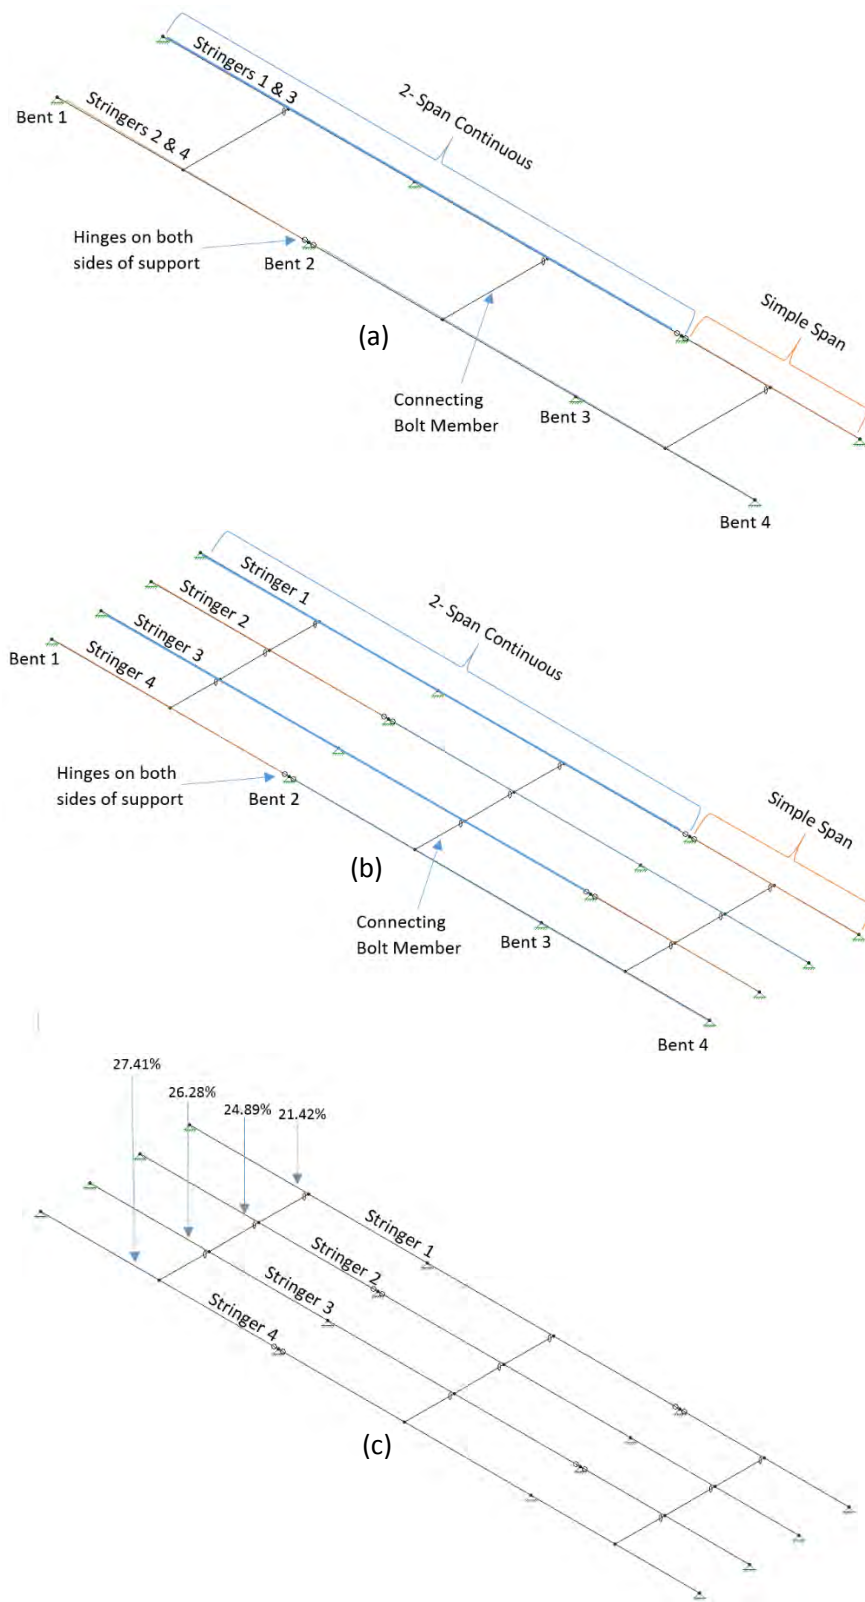
4. Parabolic Full Semi Continuous: This model is equal to the full semi continuous model in all aspects except for the application of the live load. The live load distribution to each stringer was determined through AREMA 2014 Chapter 7 Appendix 1 Section A1.2, and it was determined that stringers 1, 2, 3, and 4 carry 21.42%, 24.89%, 26.28%, and 27.41% of the wheel load (half the axle load) respectively. This parabolic distribution of the load is shown in Figure 65(c).

Figure 66 - Bridge 4.3 RISA models for (a) semi continuous, (b) full semi continuous, and (c) parabolic semi continuous analysis

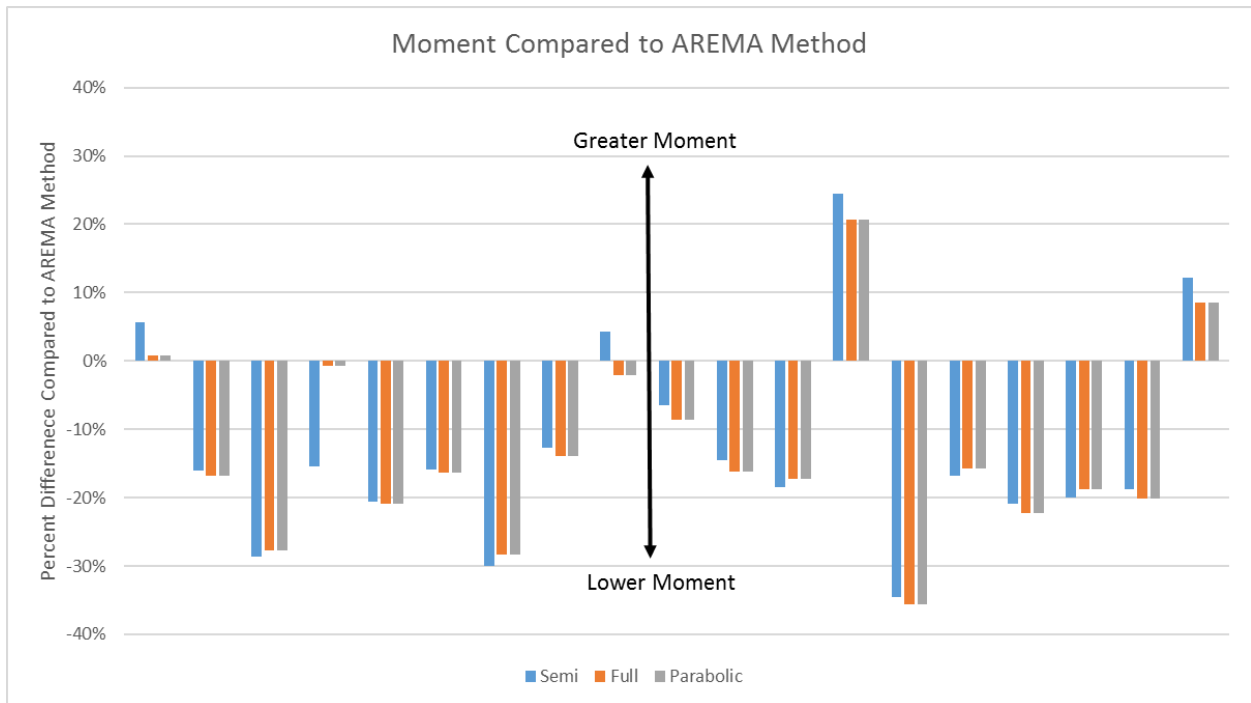
A uniformly distributed load (dead load) was applied to the entire length of the stringer for all models. The deflection and bending moment values from all 4 models were compared to the AREMA recommended procedure values. For the parabolic and full semi continuous models, the results for each of the 4 stringers on one given span were averaged to provide one value. Stringers for the semi continuous model, the average of the two sets of stringers per span were used. This was completed for all 19 spans, and the percent difference was calculated using the AREMA method as a baseline. The bending moment comparisons are shown in Figure 66 for each span. The comparison shows that the semi, full and parabolic models generally predict a smaller moment than AREMA does. Thus the AREMA method is a more conservative estimate for calculating the strength of the bridge, though using this comparison there is no way to measure its accuracy as there is no comparison to field data. The comparison also shows that the full and parabolic models predict nearly the same values, thus there is no advantage of using the parabolic load distribution if the results are averaged across the stringers. Figure 67 shows similar trends for the deflection predictions, as well.

Figure 67 - Comparison between Models and AREMA Predicted Values for Bending Moment

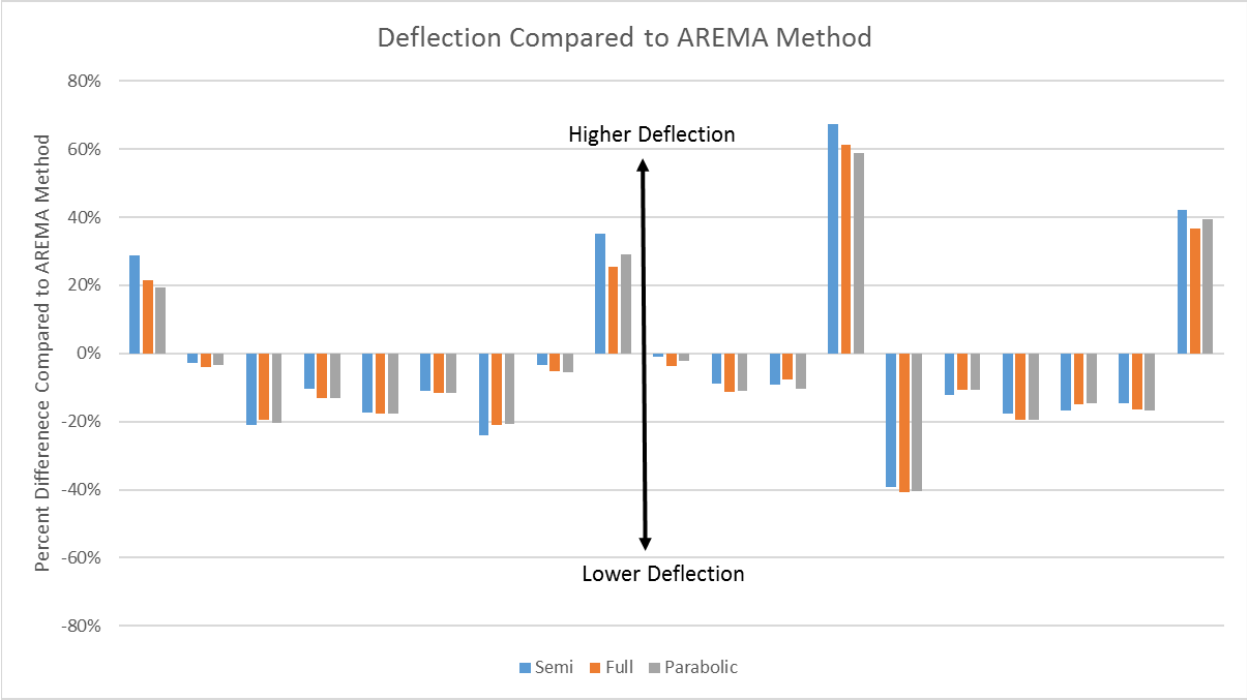
Figure 68 - Comparison between Models and AREMA Predicted Values for Deflection

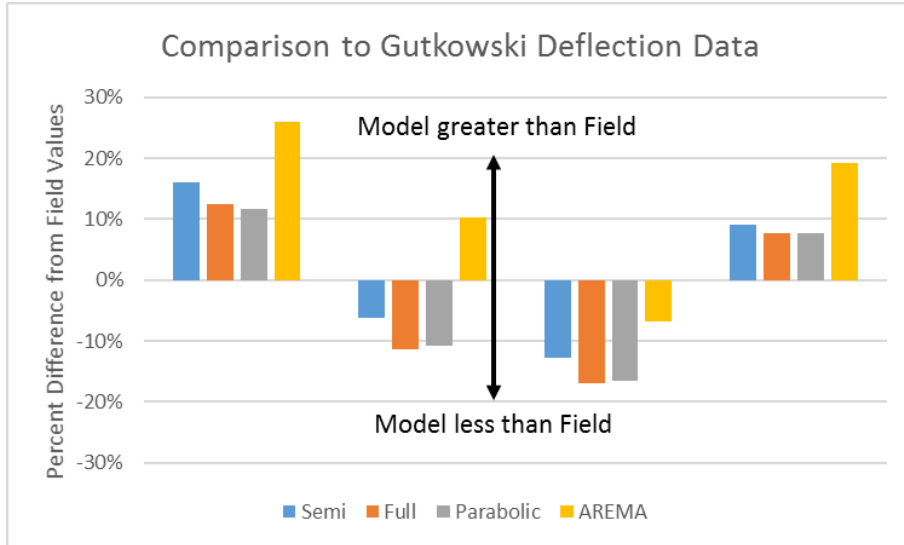
To determine the accuracy of different models with AREMA results, model data comparisons with field data is needed. Gutkowski’s study of timber stringers in Texas provides deflection data points for comparison, whereas the microstrain readings from the truck testing on Dailey Branch can be used to assess the bending moments. Figure 68 shows that the AREMA method predicted greater deflections than measured in the field for 3 of the 4 cases, while the other models split evenly. The AREMA method had an overall average error of about 15%, while the other models had an average error of 11-12%. This suggests that the AREMA model is conservative, i.e. it predicts greater deflections than measured, but with the limited deflection data, no firm conclusions can be made at this stage.

Figure 69 - Comparison to Gutkowski Deflection Data

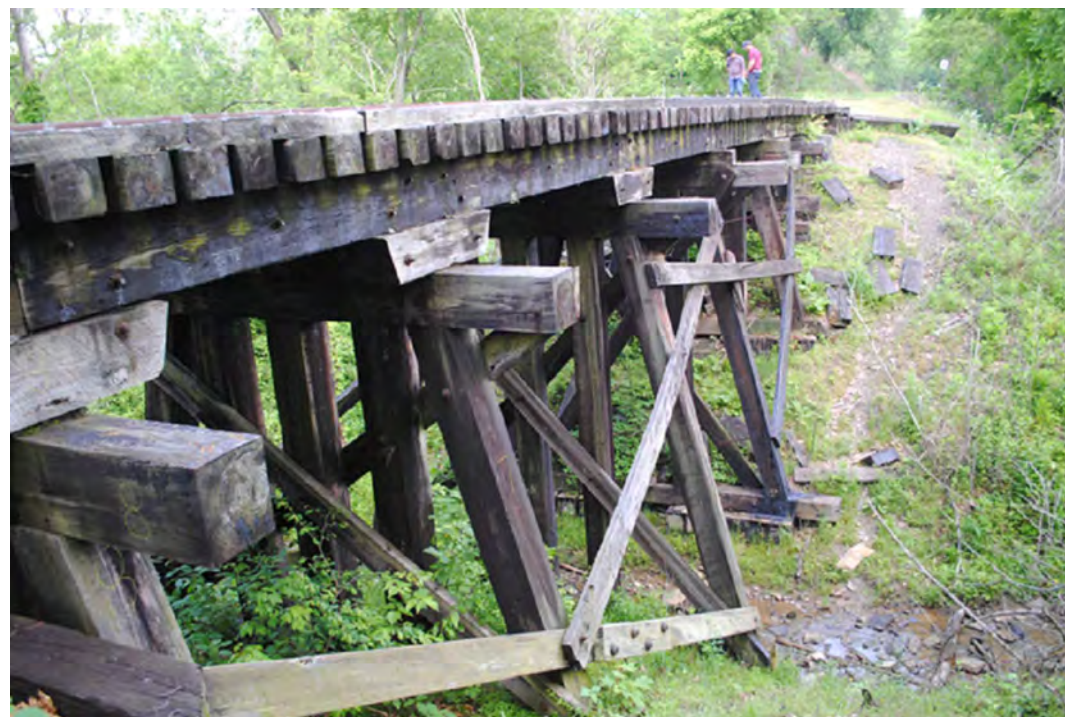
The West Virginia Department of Transportation Division of Highways	
PROJECT	WV Central Rail Road Dailey Branch Bridges
TITLE	Bridge 1.9 Inspection - Superstructure
Drawn By	Date
LCP	12-9-2015
Constructed Facilities Center West Virginia University	
Scale	Sheet
None	7

- The following color coding is used:
 - **RED**: Significant deterioration in member, replacement of member is recommended.
 - **GREEN**: Softening noted in member, no repair is needed but monitoring is recommended.
 - **BROWN**: Member in good condition, no repair is needed.
- The damage in Span 3-Stringer 2 extends over to Span 4-Stringer 2 (same member).

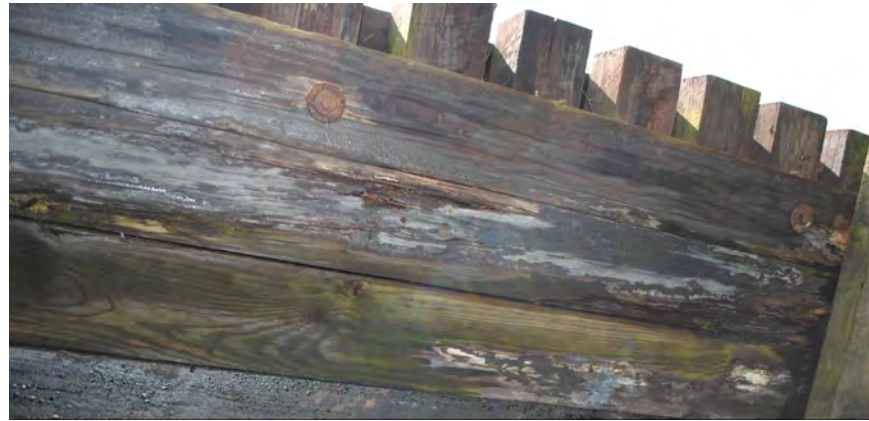
Span 3 - Stringer 2 Rot

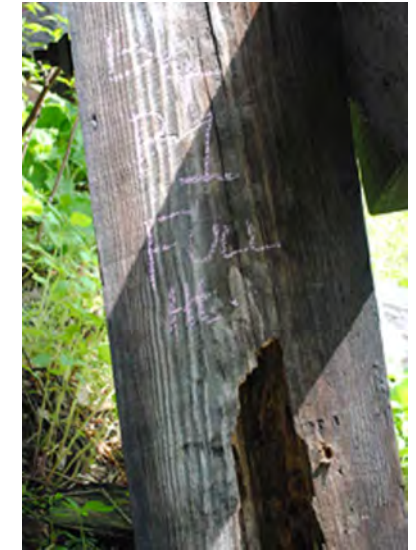
Bent 4 - Post 1 Rot

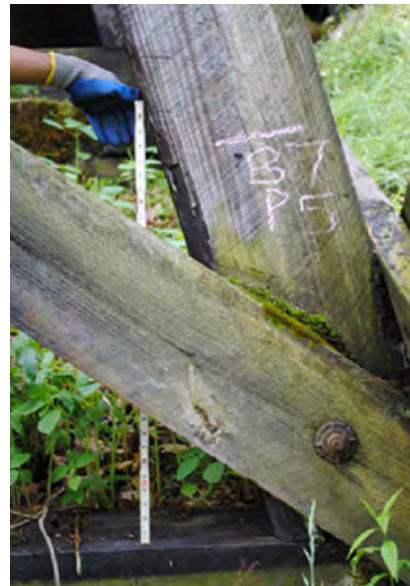
Bent 7 - Post 5 Rot

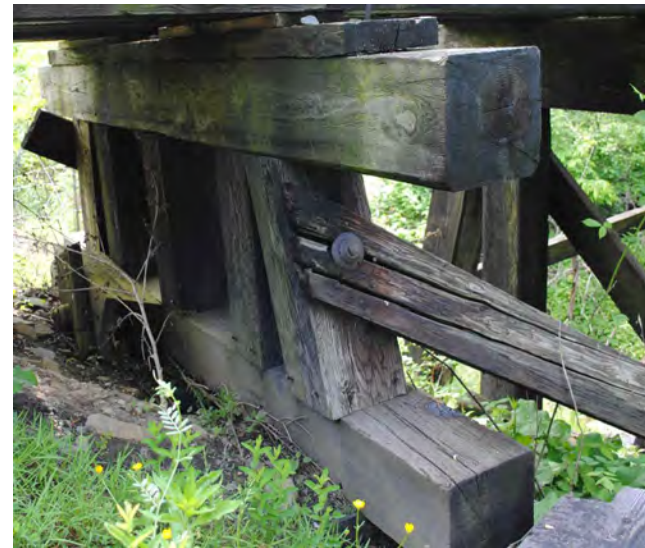
Tower Brace 1 West

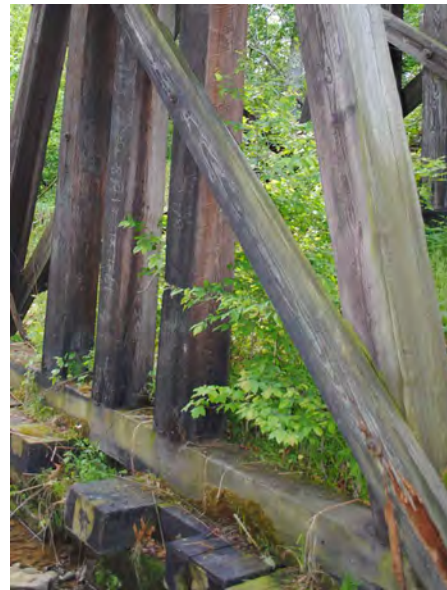
Bent 6 - North Sway Brace

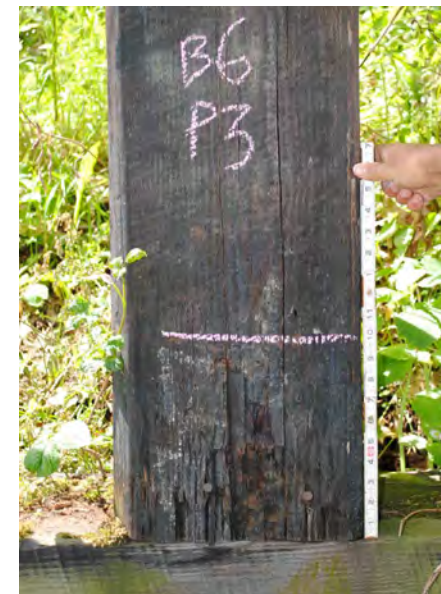
Bent 6 - Post 3 Rot

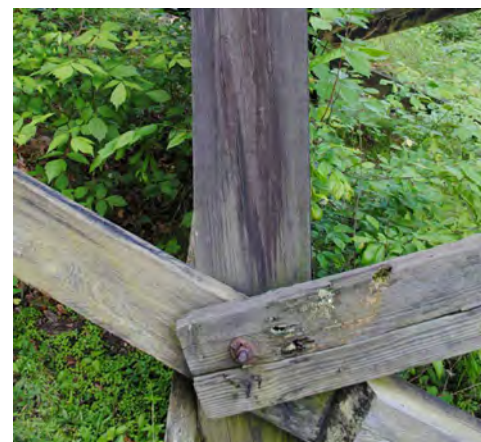
East Tower Brace 3 - Fruiting Bodies

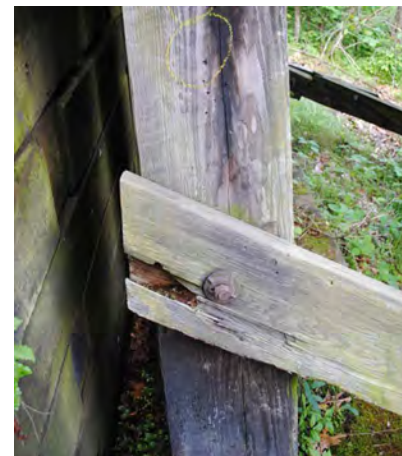
East Tower Brace 4 - Rot/Split

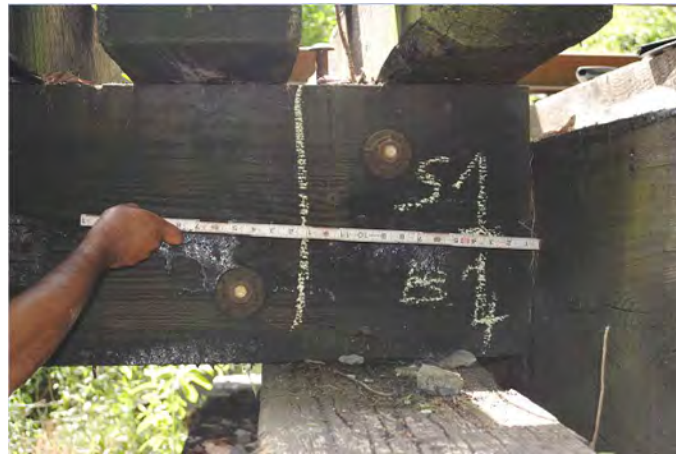
Span 1 - Stringer 1 Rot

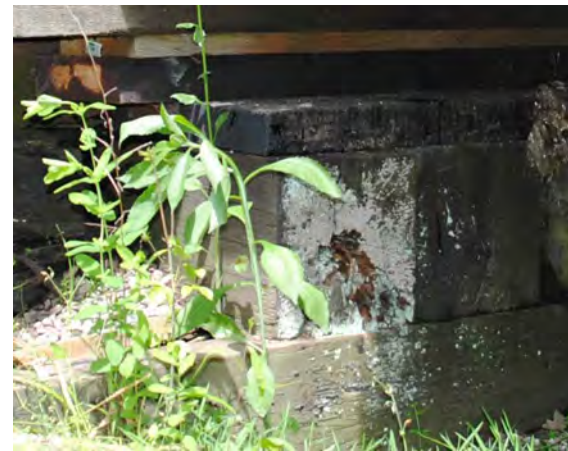
Bent 1 - Block 6 Rot

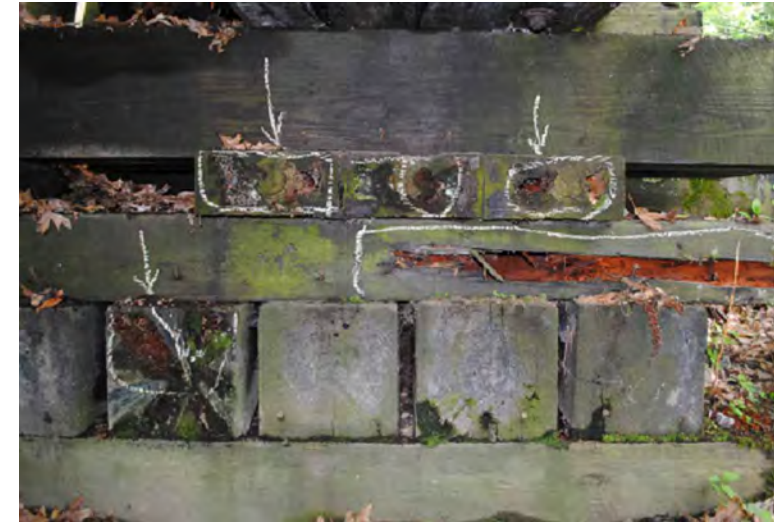
Bent 4 - Rot in Blocks and Sill

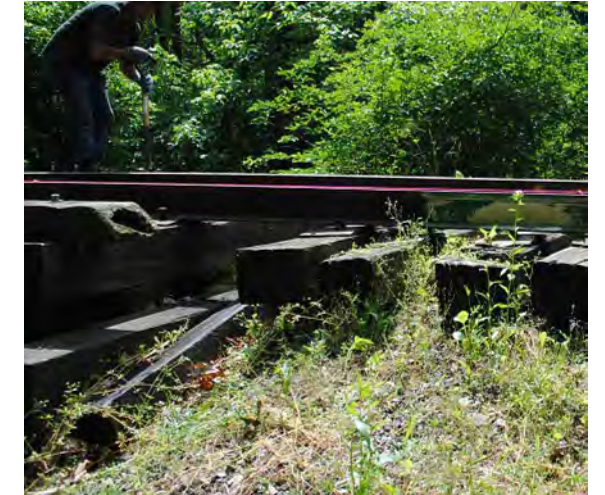
North Approach Poor Condition

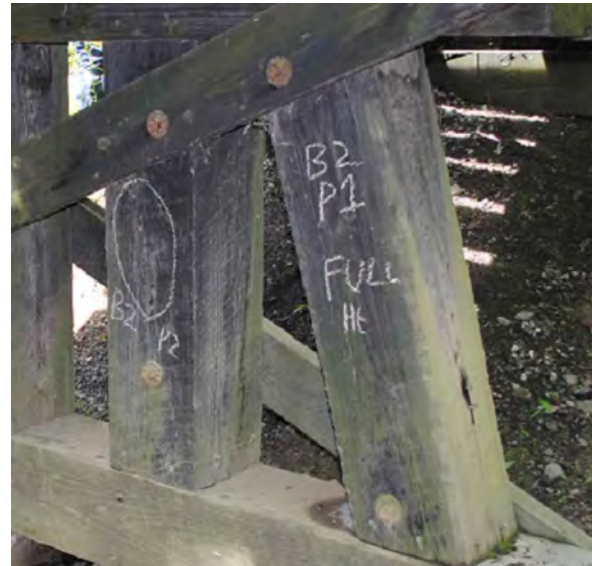
Bent 2 - Posts 1 & 2 Rot

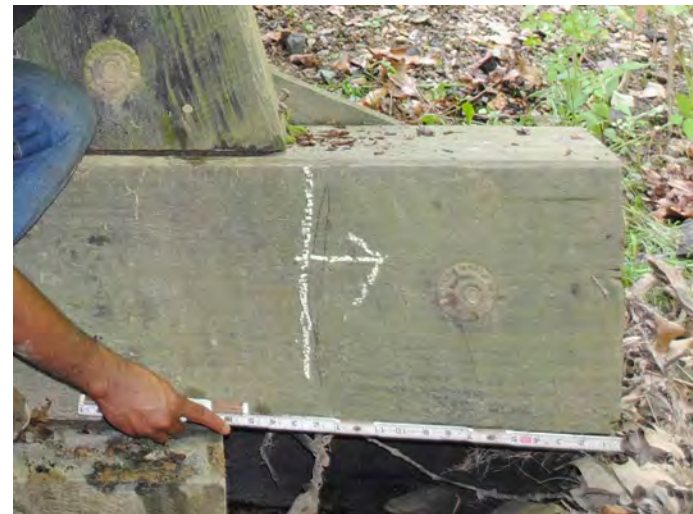
Bent 2 - Sill Rot

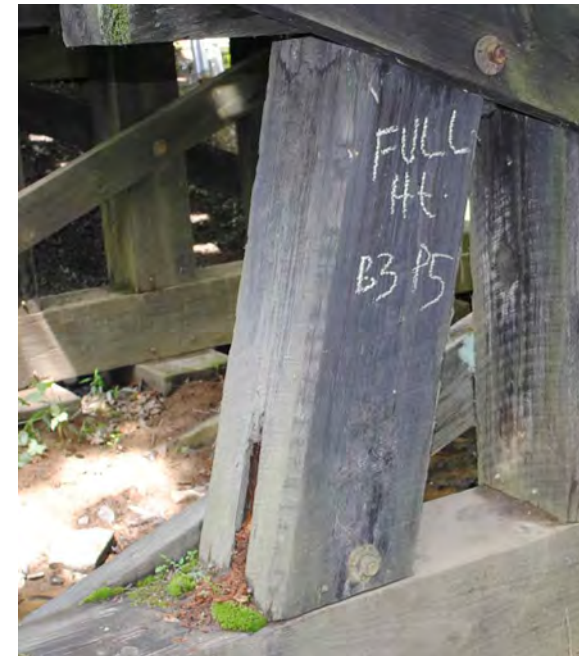
Bent 3 - Post 5 Rot

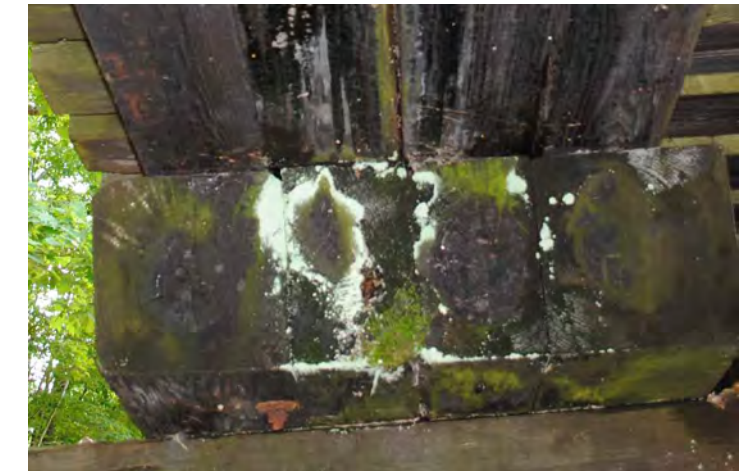
Bent 3 - Corbel 2 Rot

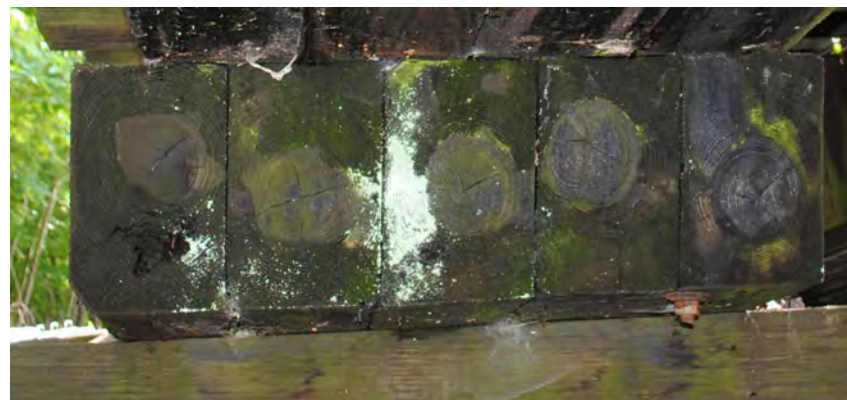
Bent 2 - Corbels 1, 2 & 3 Rot

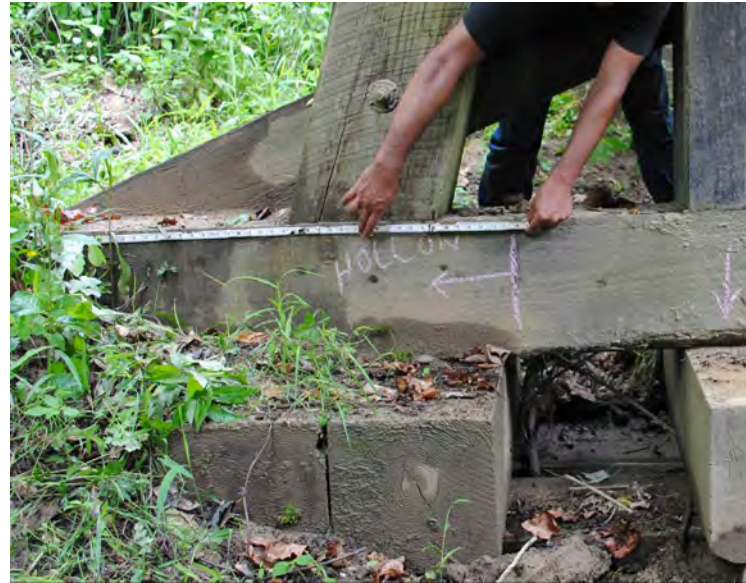
Bent 3 - Sill Rot

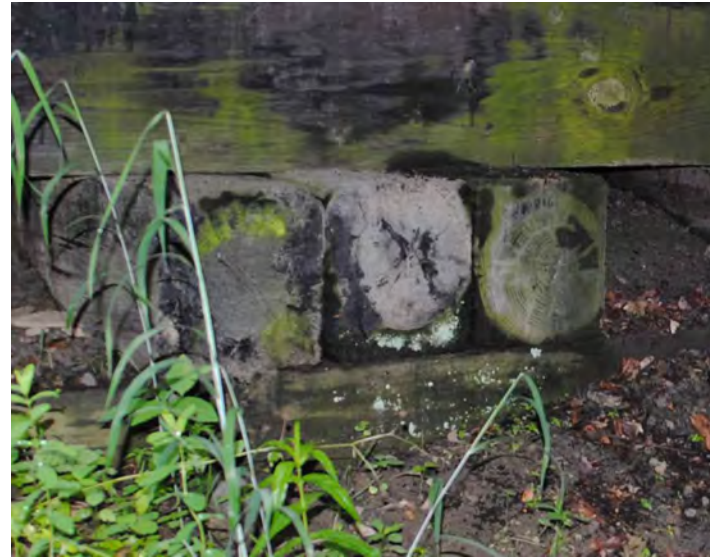
Bent 1 - Blocks 5 & 6 Softening

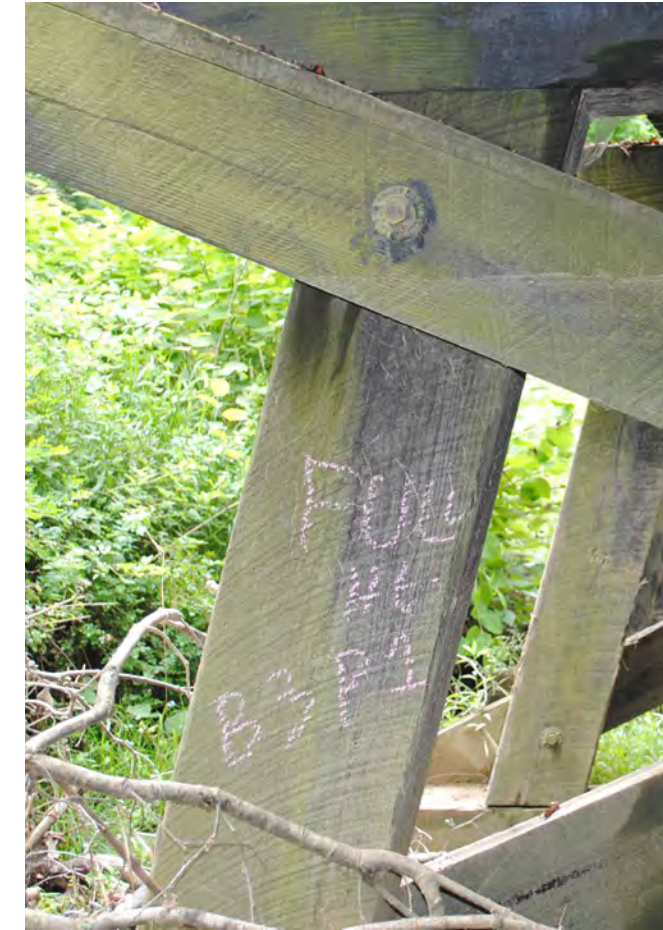
Bent 3 - Post 1 Rot

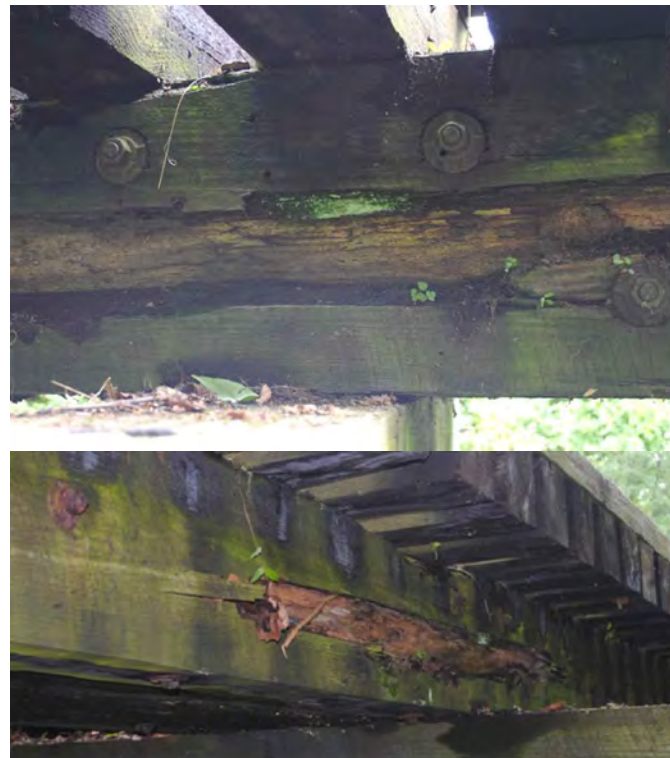
Span 3 & 4 - Stringer 8 Rot

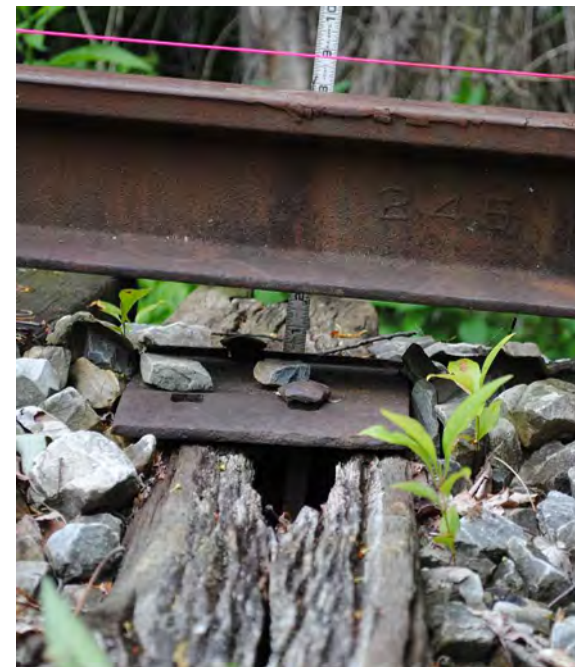
North Approach
Low Ballast and Rot Tie

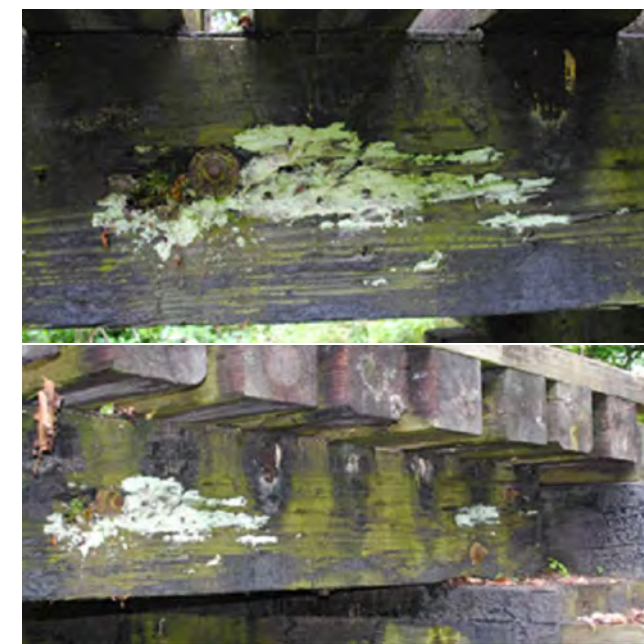
Span 1 - Stringer 1 Fruiting Bodies

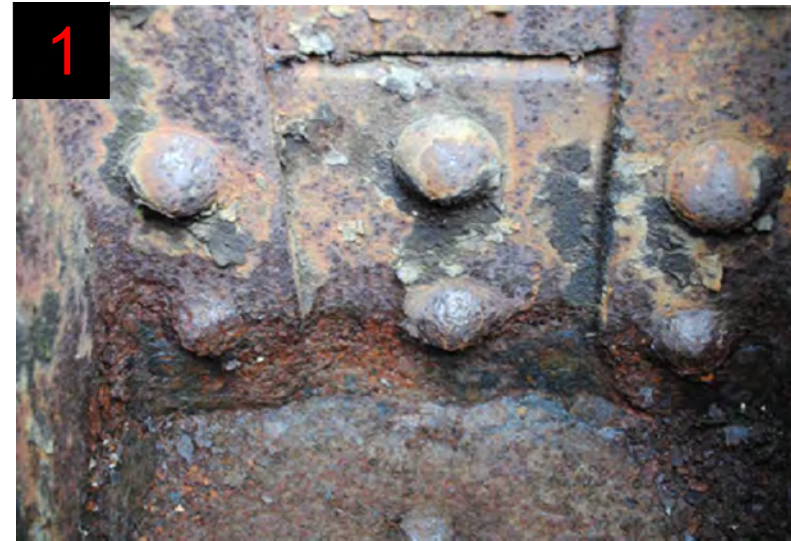
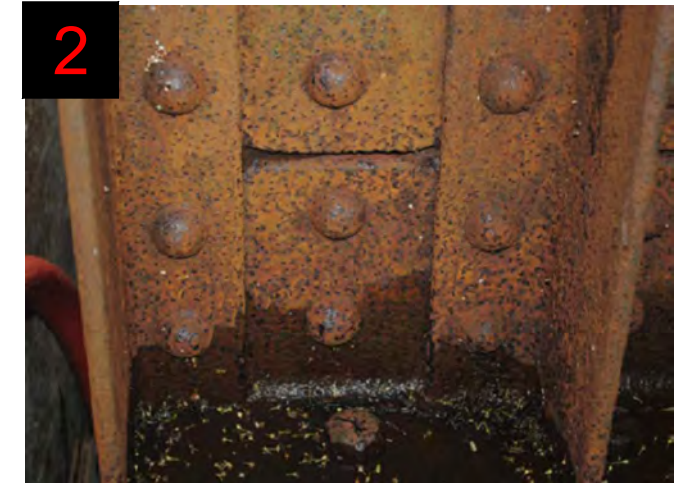
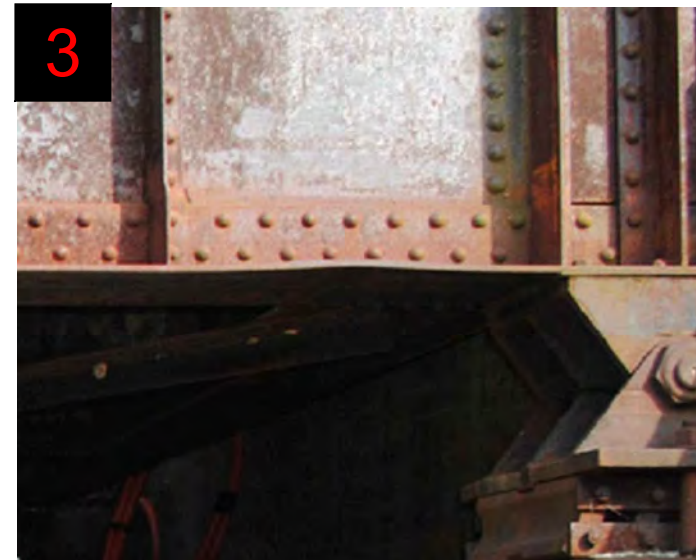
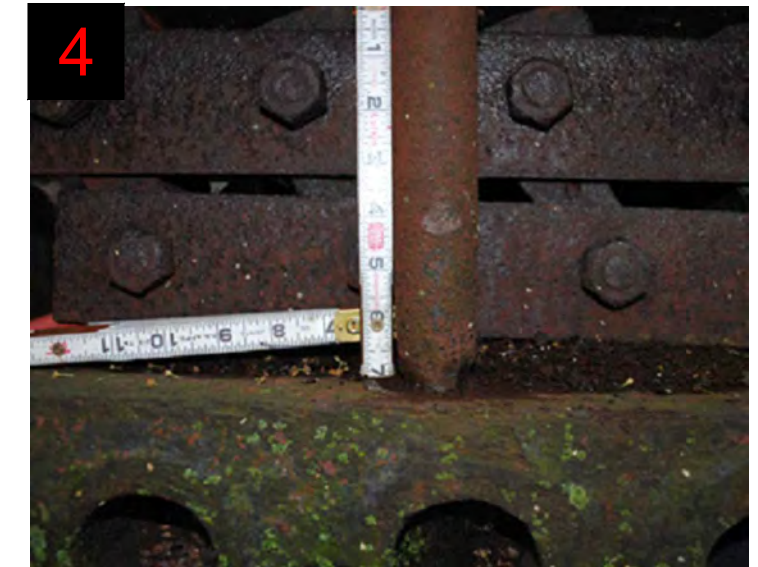
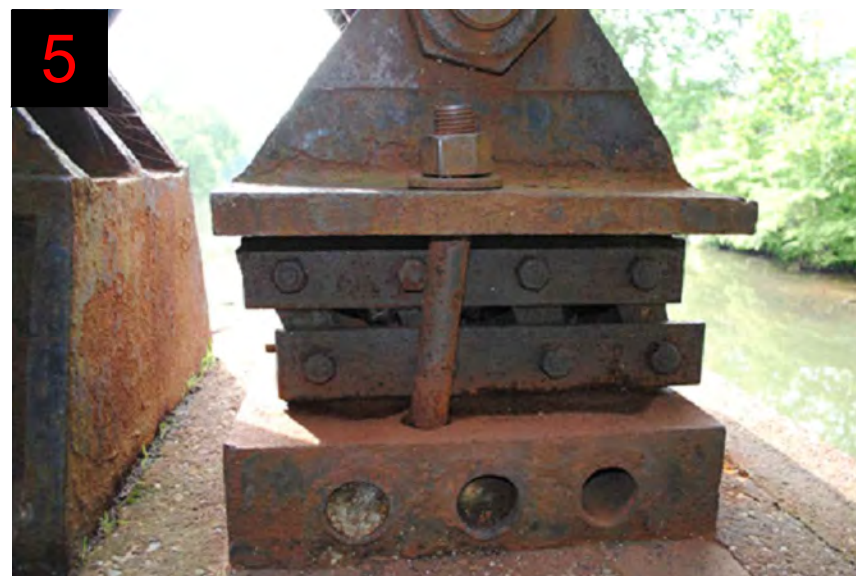
The West Virginia Department of Transportation State Rail Authority	
PROJECT WV Central Rail Road Dailey Branch Bridges	
TITLE Bridge 1.4 Inspection - Pictures	
Drawn By LCP	Date 12-9-2015
Constructed Facilities Center West Virginia University	
Scale None	Sheet 4

1. - Interior bottom vertical leg of horizontal angle with cross sectional loss up to $\frac{1}{4}$ " for 3" in height, located right above North West bearing on Girder 2.
ACTION: Remove rust, paint and monitor.
2. - Outer bottom vertical angle on the opposite side of the angle noted in picture 1. Shown as an example of an angle in good condition.
3. - Girder 1 is bent upwards near North support.
ACTION: Monitor.
4. - The cross section at the bottom of the anchor bolts in the North roller supports is corroded for about $\frac{1}{2}$ " in height and about $\frac{1}{4}$ " loss in cross section.
ACTION: Clean, paint and monitor OR replace at WVSRA discretion.
5. - North ends of both spans: Rocker bearings are tilted strongly north. Anchor bolts on span 2 bent.
ACTION: Reset bearing and replace bolt or monitor at WVSRA discretion.

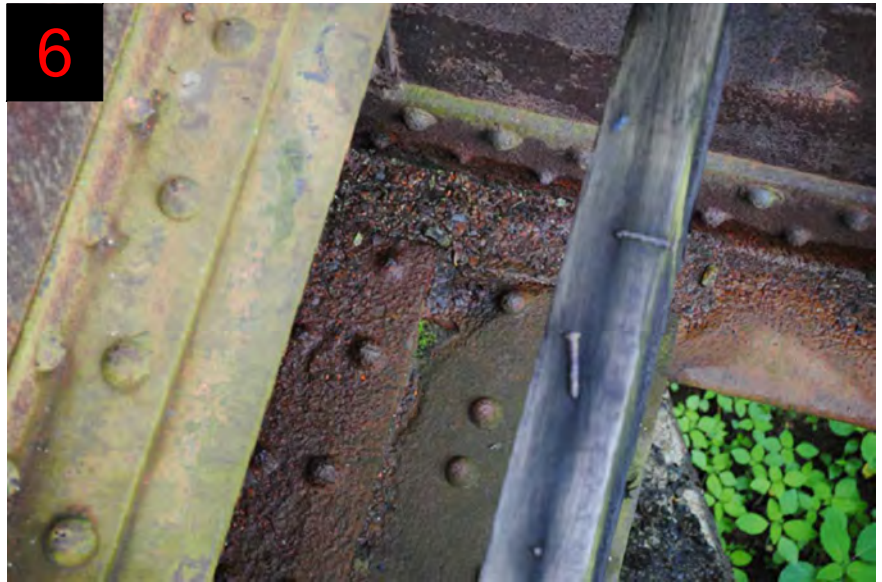
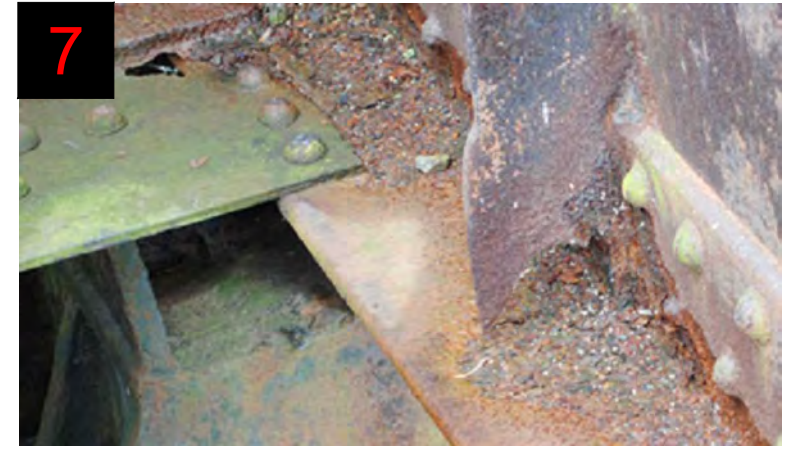
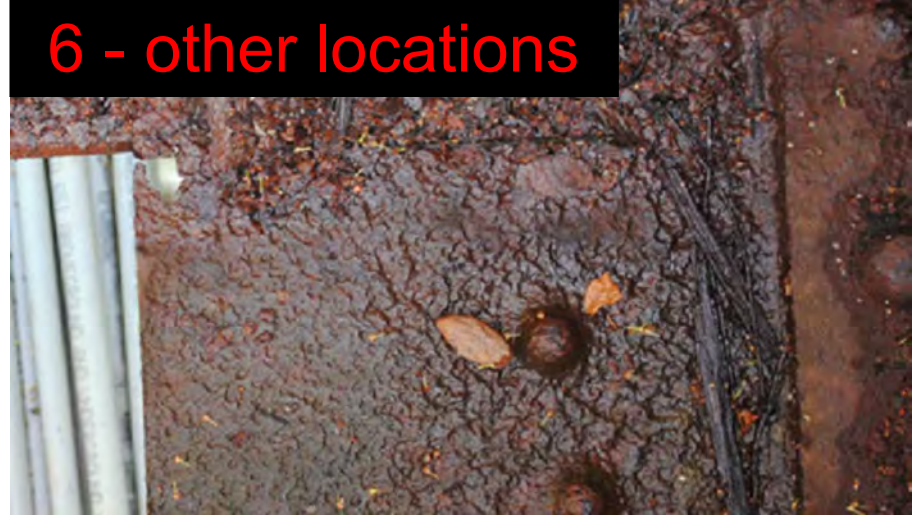
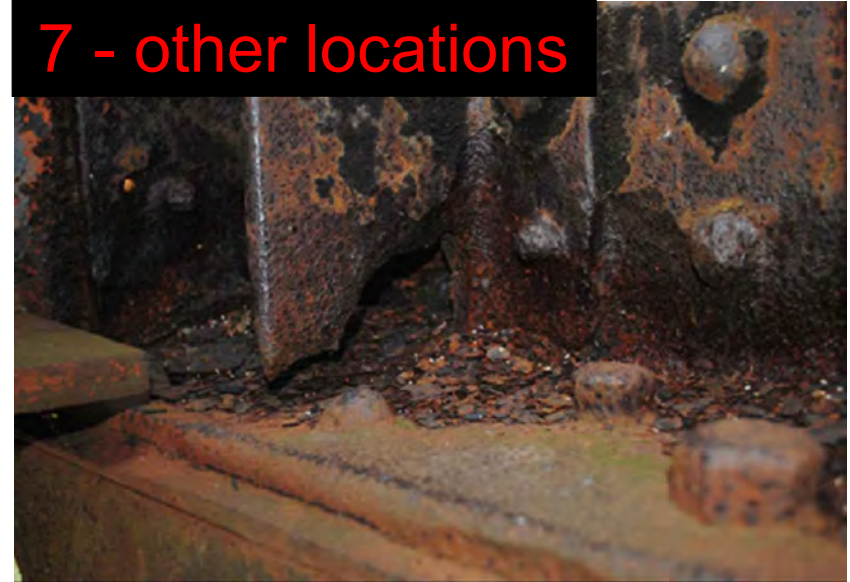
6. - Gusset plates on multiple locations show corrosion, corner connections of gusset plates corroded away. Many gusset plates connecting floor beam show some corrosion.
