Load testing and recommended repairs for dailey branch bridges - milepost 1.4 to 5.8

**Load Testing and Recommended Repairs for Dailey Branch Bridges
– Milepost 1.4 to 5.8**

**Master of Science
In
Civil Engineering**

The West Virginia Department of Transportation State Rail Authority sponsored a study to evaluate the condition of the railroad bridges on the Dailey Branch in Elkins, WV. The evaluations included field inspections, load rating, load testing, and a repair plan. A total of 2 steel bridges and 3 timber bridges were part of the study. The repair plan focused on identifying deteriorated timber bridge members for potential Glass Fiber Reinforced Polymer (GFRP) wrap repair. Information on dimensions and deterioration was gathered through field inspections. A timber specialist determined the species and grade of the timber bridges, finding most members to be Select Structural lumber of Southern Pine species. A preliminary analysis was performed to ensure that the bridges would withstand a hi-rail dump truck and a locomotive during load testing. A total of 76 strain gages were installed on all 5 bridges to record bending, shear, and axial compression data.

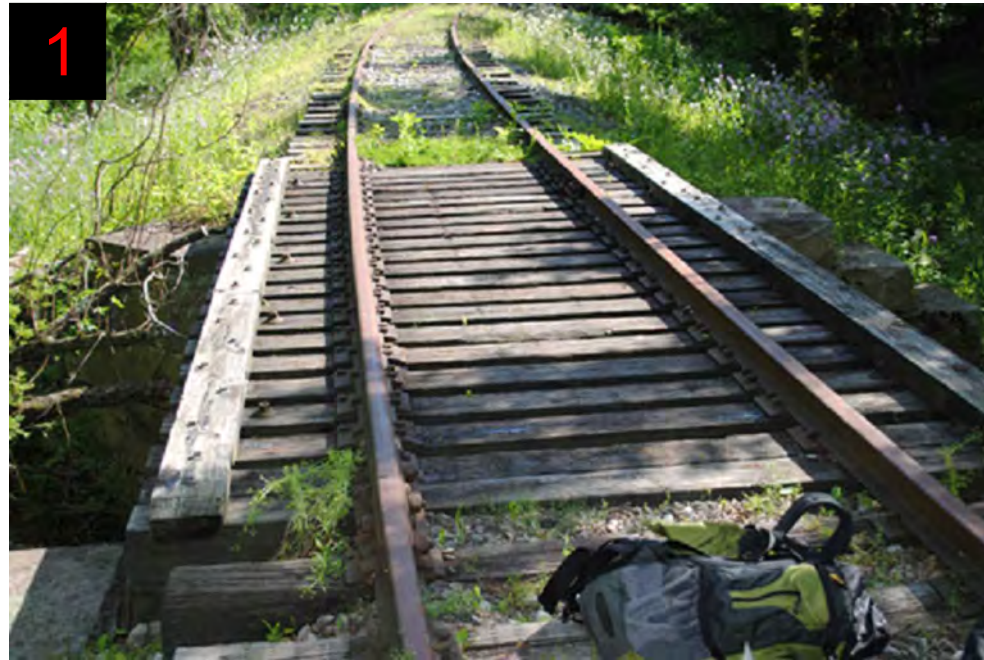
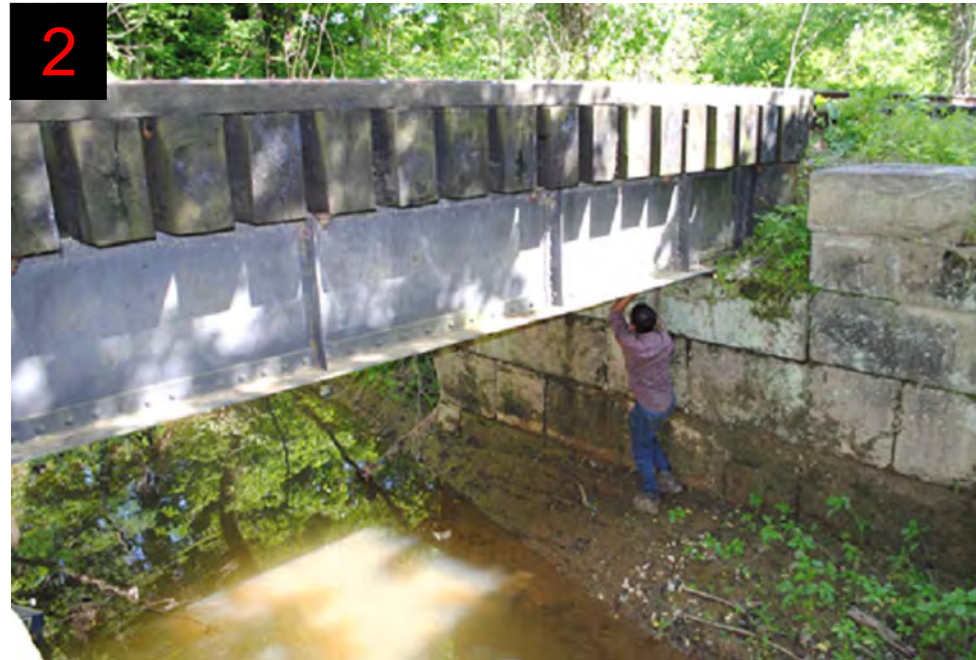
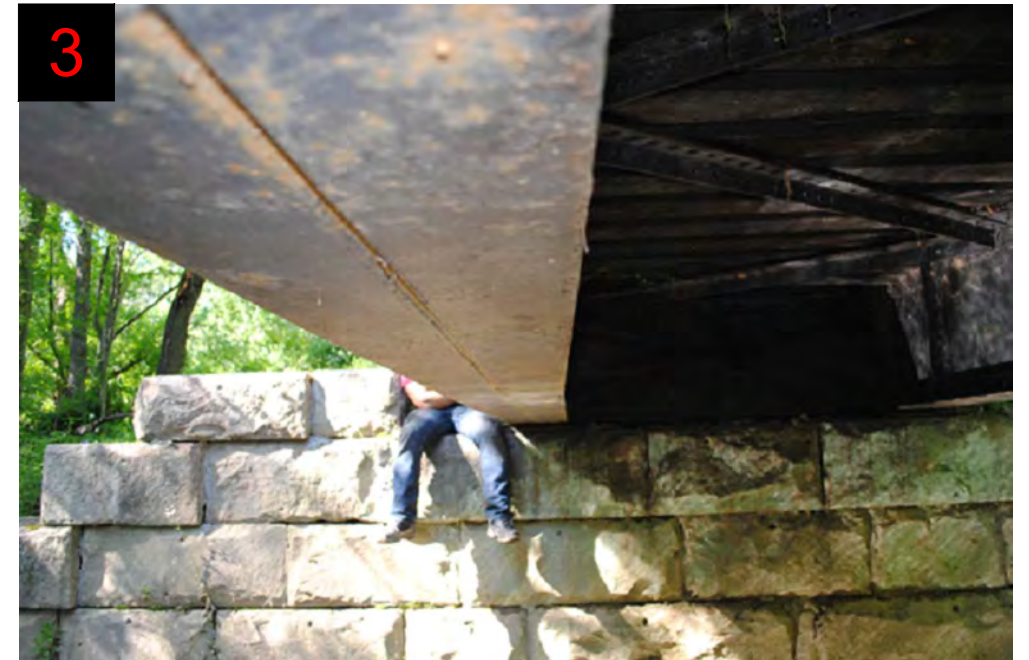
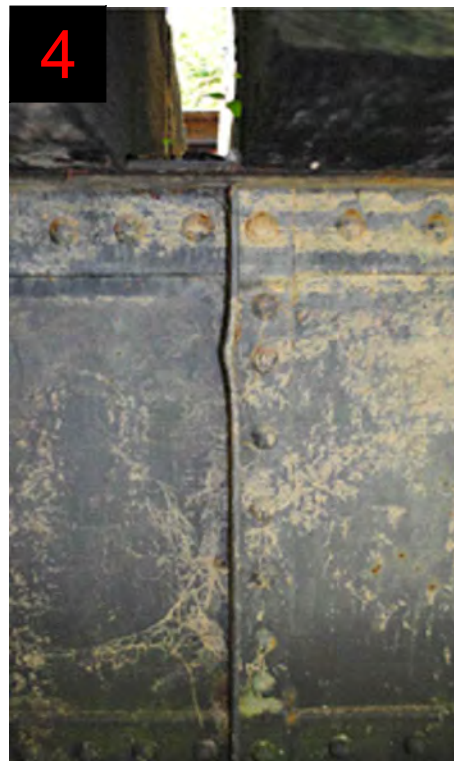
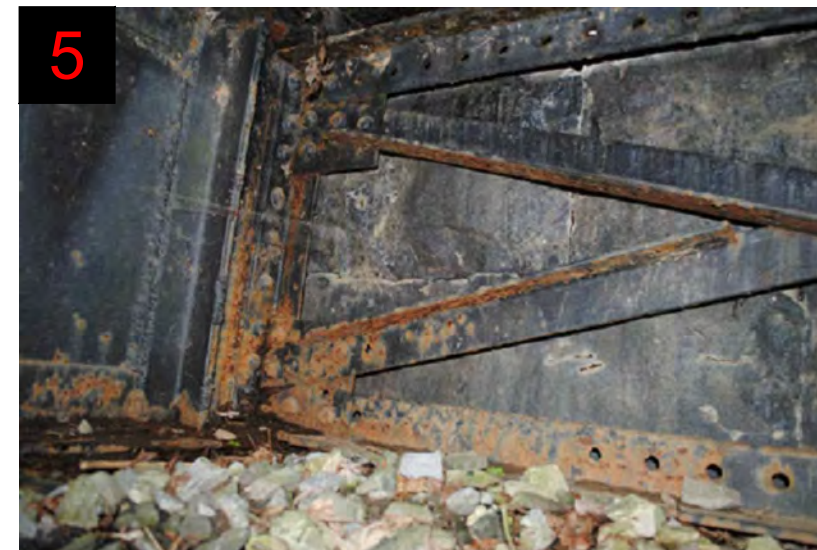
The West Virginia Department of Transportation State Rail Authority	
PROJECT	WV Central Rail Road Dailey Branch Bridges
TITLE	Bridge 5.8 Inspection - Pictures
Drawn By	Date
LCP	12-9-2015
Constructed Facilities Center West Virginia University	
Scale	Sheet
None	9

- 1. - End view of bridge.
- 2. - Elevation view of bridge.
- 3. - Abutment stone from West side of North abutment has been dislodged and is in the creek.
- 4. - Bent stiffener.
ACTION: Monitor for future changes.
- 5. - Light corrosion on cross bracing.
ACTION: Monitor and clean/paint as needed.
