Factors controlling landslide initiation as a result of July 2001 high-precipitation events in a section of the Lower New River Gorge, West Virginia

**FACTORS CONTROLLING LANDSLIDE INITIATION AS A
RESULT OF JULY 2001 HIGH PRECIPITATION EVENTS IN
A SECTION OF THE LOWER NEW RIVER GORGE,
WEST VIRGINIA**

**Thesis Submitted to the
Eberly College of Arts and Sciences at
West Virginia University
In Partial Fulfillment of the Requirements for the Degree of
Master of Science
in
Geology**

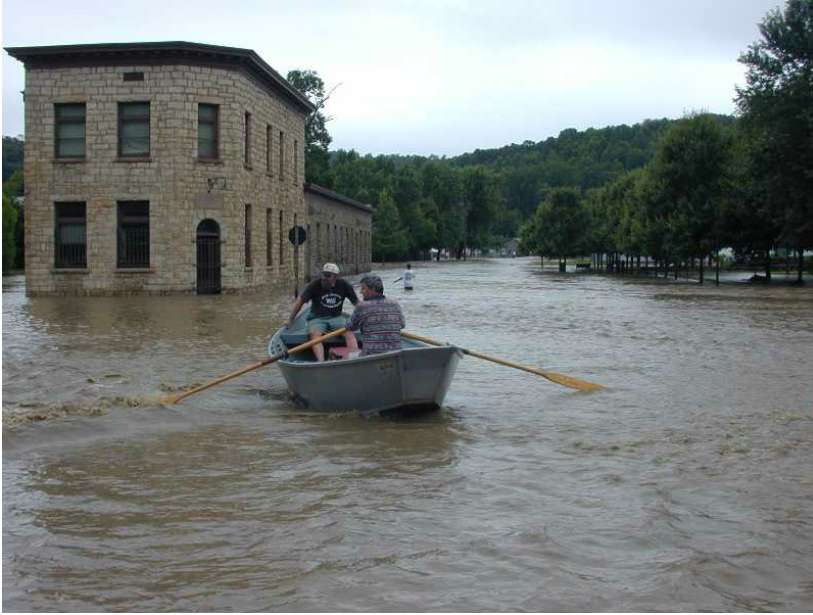
Figure 2: Flood waters inundated the former bank of Glen Jean, which is listed on the National Register of Historic Places (National Park Service photo, 2001).

the National Register of Historic Places during the July 8 flooding event (National Park Service Resource Assessment Team, 2001) (Figure 2). Loss of life was averted during this event by a NPS rescue effort that saved two residents from being washed away from their home (National Park Service Resource Assessment Team, 2001). At the end of July 2001, 26 West Virginia counties, including Fayette, were declared federal disaster areas.

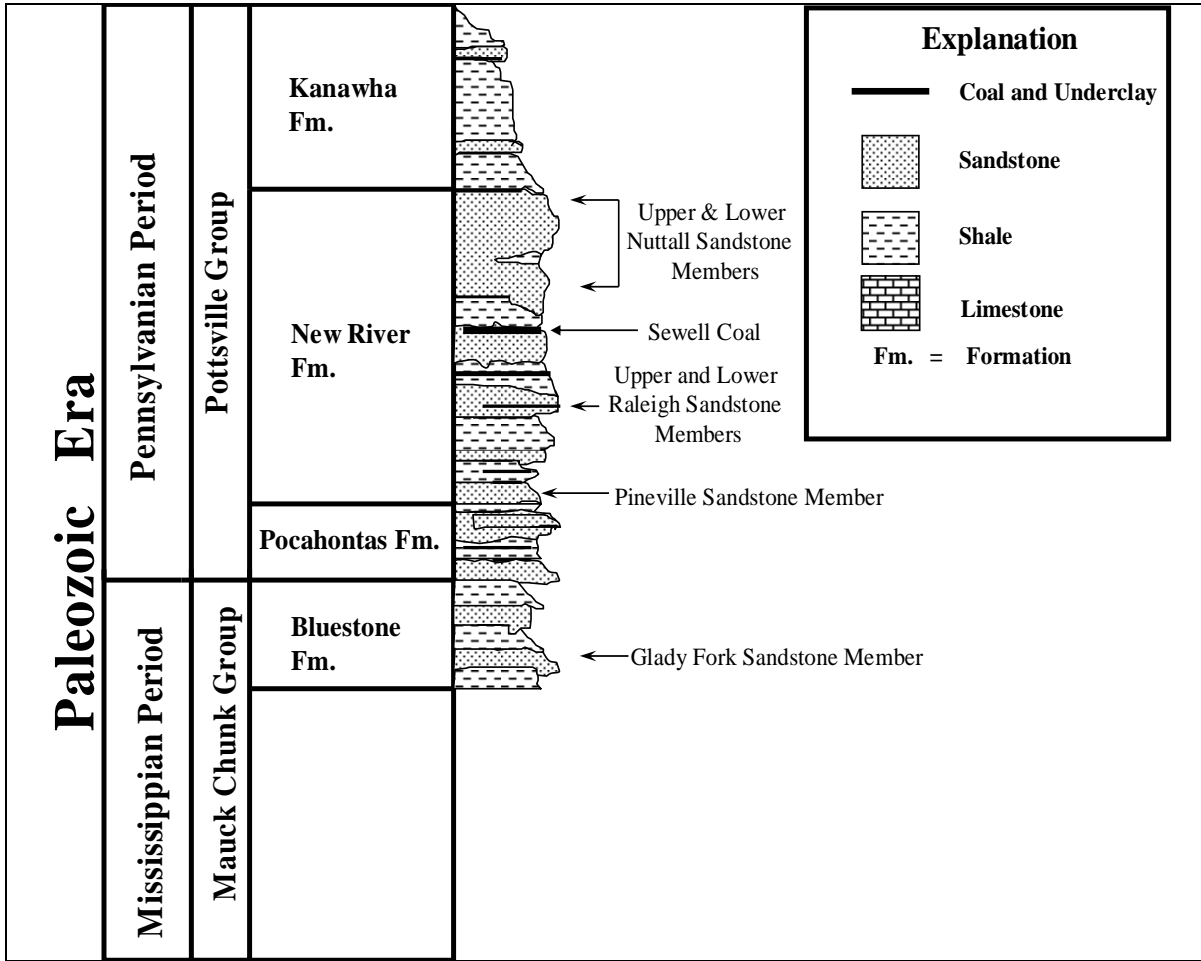
Figure 5: Stratigraphy of Lower New River Gorge study area. Stratigraphic column's not to scale. (Modified from Remo, 1999, and Englund *et al.*, 1977)

Four major stratigraphic units occur within the study area and have a regional dip of less than 2° to the northwest (Englund *et al.*, 1977) (Figure 4 and 5). The upper three lie within the Pennsylvanian Pottsville Group: the Kanawha, New River, and Pocahontas formations. The oldest formation in the study area is the Bluestone Formation within the uppermost Mississippian Mauch Chunk Group (Englund *et al.*, 1977).

The Kanawha Formation is approximately 90 m thick and is the uppermost bedrock unit within the study area (Figure 4 and 5). It is comprised mainly (65 %) of easily weathered siltstone and shale (Englund *et al.*, 1977). This formation contains the Gilbert and Eagle coal seams which were not mined within the study area.

The New River Formation occurs immediately below the Kanawha Formation (Figure 4 and 5). This extremely resistant unit is dominated by sandstone (50 to 60 %), with lesser amounts siltstone, shale, coal, and fireclay. The New River Formation ranges between 215 and 305 m in thickness and contains the upper and lower Nuttall sandstones, which act as the resistant capstone within the study area (Englund *et al.*, 1977). Coal from the New River Formation has been extensively mined within the study area, most notably the Sewell coal bed (Figure 5). The Fire Creek coal is stratigraphically lower than the Sewell coal and was mined within the study area, but not as extensively. The New River Formation unconformably lies over the Pocahontas Formation.

The 130 m thick Pocahontas Formation is largely comprised of sandstone (70 %) and shale (28 %) with minor amounts of coal and fireclay (Englund *et al.*, 1977) (Figure 4 and 5). The Pocahontas coal seams are located within this formation, but are not within the study area.

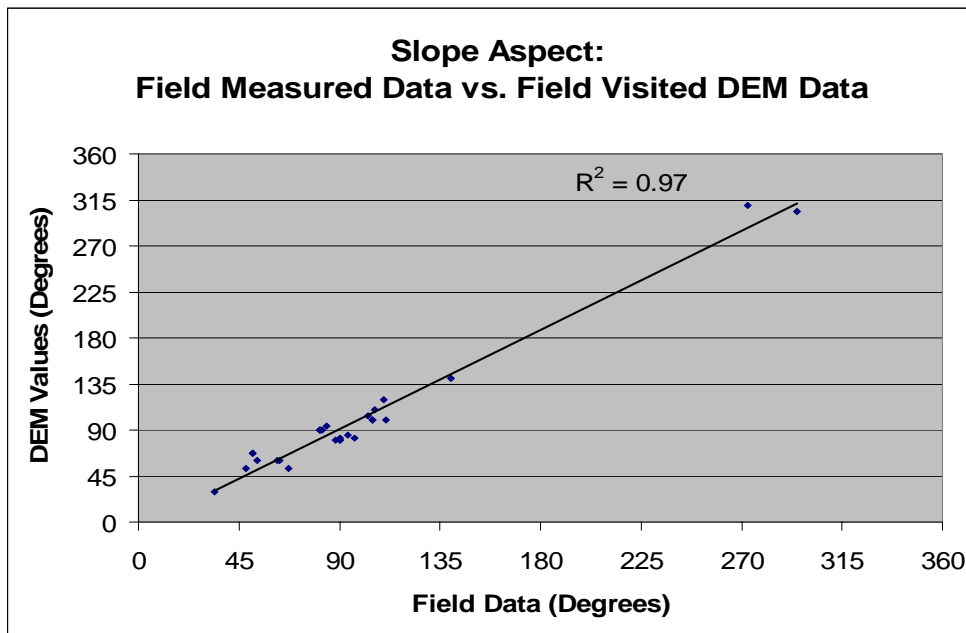
Figure 7: Field measured slope aspect data plotted against DEM derived slope aspect data. A linear regression has a coefficient of determination (R^2) of 0.97 which shows a strong relationship between field measured data and DEM derived data for the same points allowing DEM derived slope aspects for all landslides to be used in further statistical analyses.

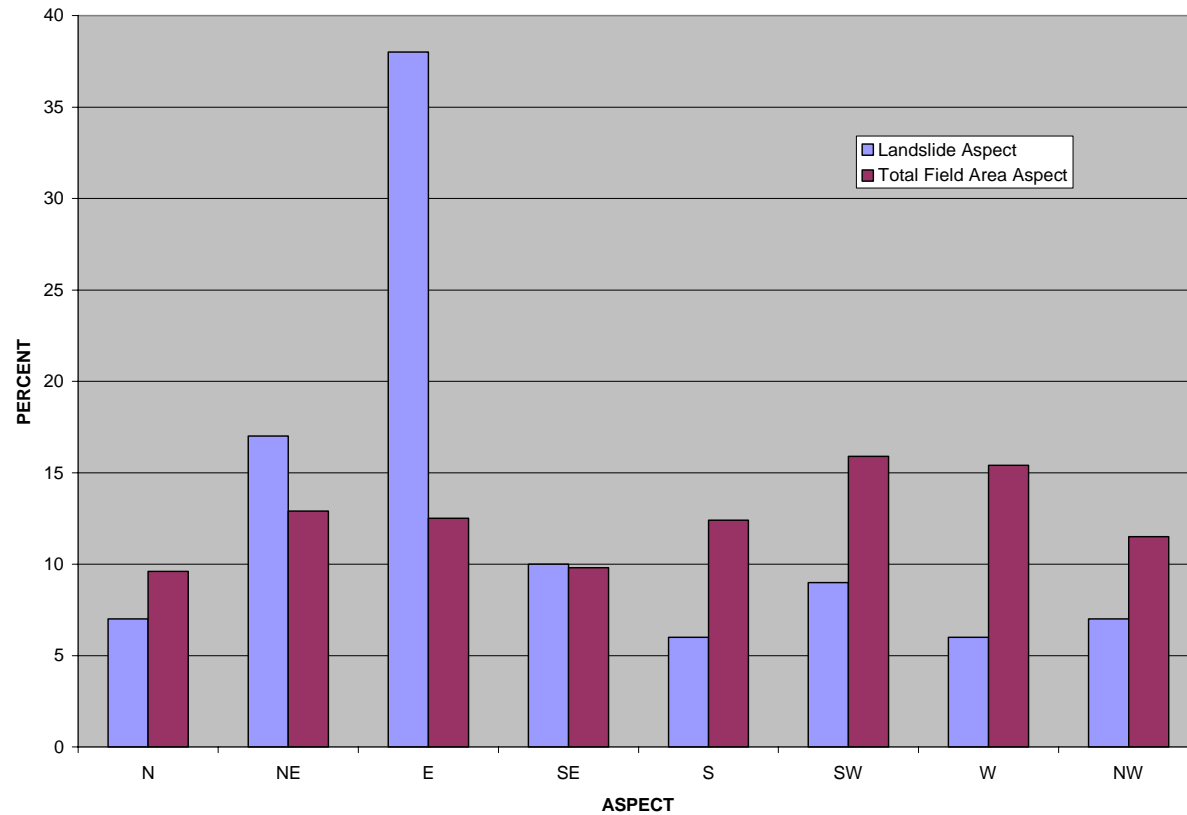
Figure 8: Histogram comparing slope aspect of all July 2001 landslides to all slope aspects for the study area. The percentage of landslides occurring on east or northeast-facing slopes outweighed the percentage of east and northeast-facing slopes in the study area.

The DEM for the study area is composed of 419,986 pixels that represent 100 m² each. Each pixel and its neighbors relate information about slope angle, slope aspect, and elevation. To find out if the preferential slope aspect of landslides could be explained, a chi-square goodness of fit test (Weimer, 1993) was run with a null hypothesis that the percentage of slope aspects for landslide locations was significantly different than the percentage of slope aspects for the entire study area (Table 8). This test compared the observed landslide slope aspects to the expected landslide aspects. The expected landslide aspects were derived by generating aspects for every pixel within the study area. When the expected aspects were compared to the observed aspects, the null hypothesis was rejected at a significance level of 0.005. That is, at a 99.5% confidence level, landslide locations were not randomly distributed with respect to slope aspect. Northeast and east facing slopes were the only two aspects that favored slope failure whereas other aspects were under-represented (Figure 8).

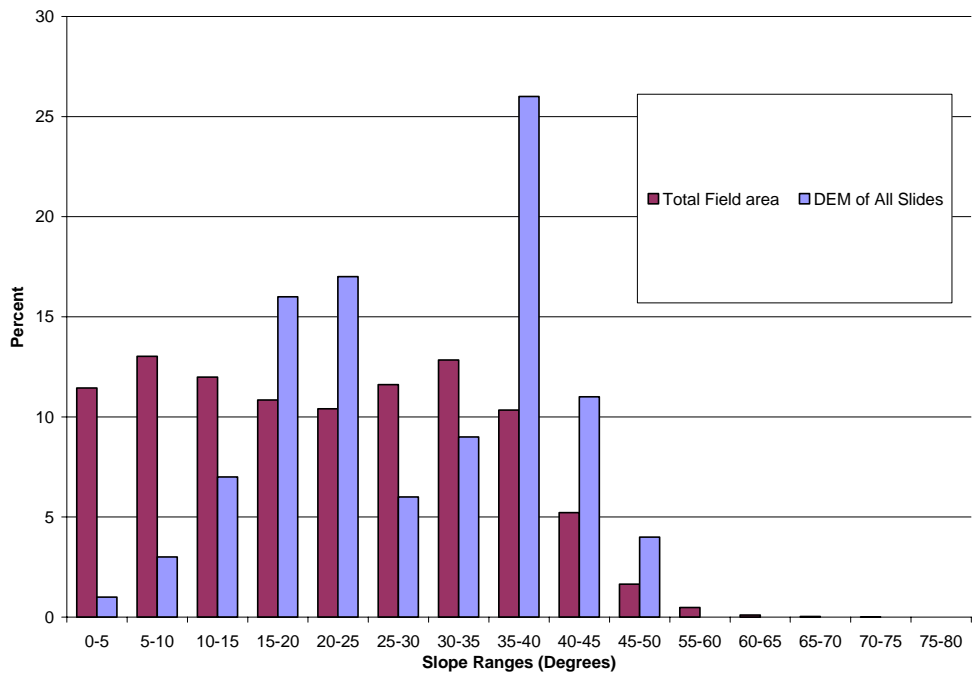
Figure 9: DEM generated slope angles for landslides compared to total study area and field measured adjacent slope angles. A spike in landslides in the 35-50 degree range most likely results from the increased role of physical factors, such as the angle of repose for bouldery, colluvial soils, on slope stability.

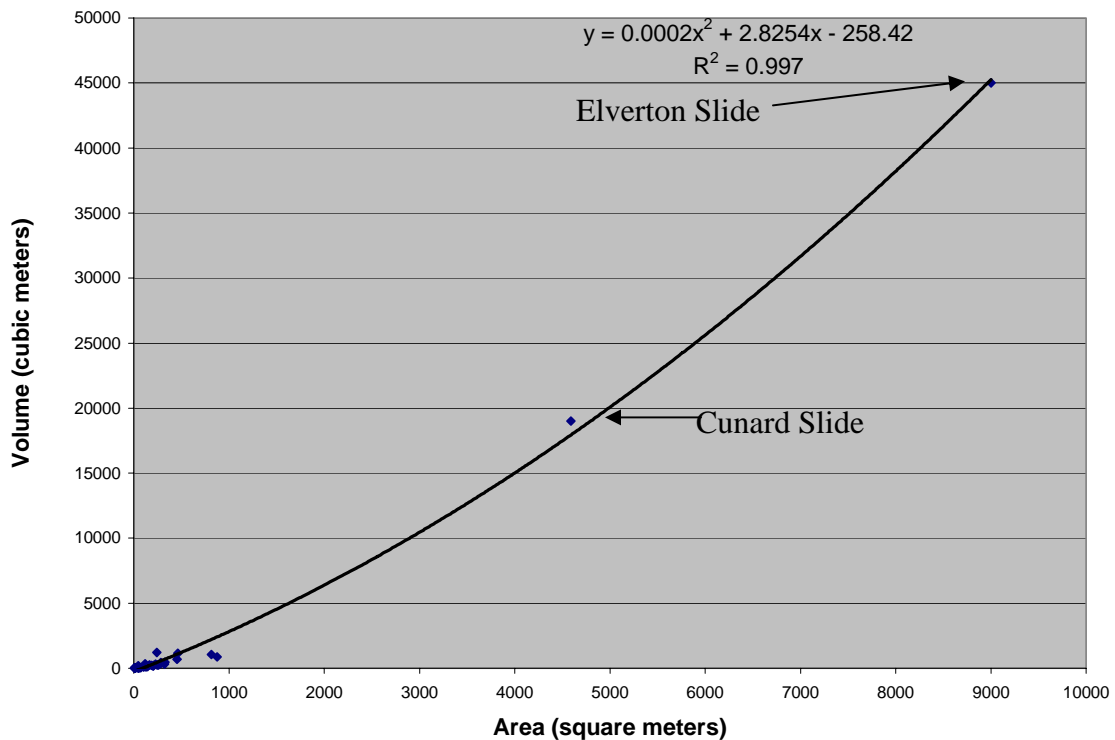
Figure 10: X-Y scatter plot showing landslide area versus landslide volume. The slope value of 0.997 indicates that there is a strong relationship between area and volume for the July 2001 landslides in Lower New River Gorge. The results indicated landslide areas can be used as a proxy for landslide volume in analyses.

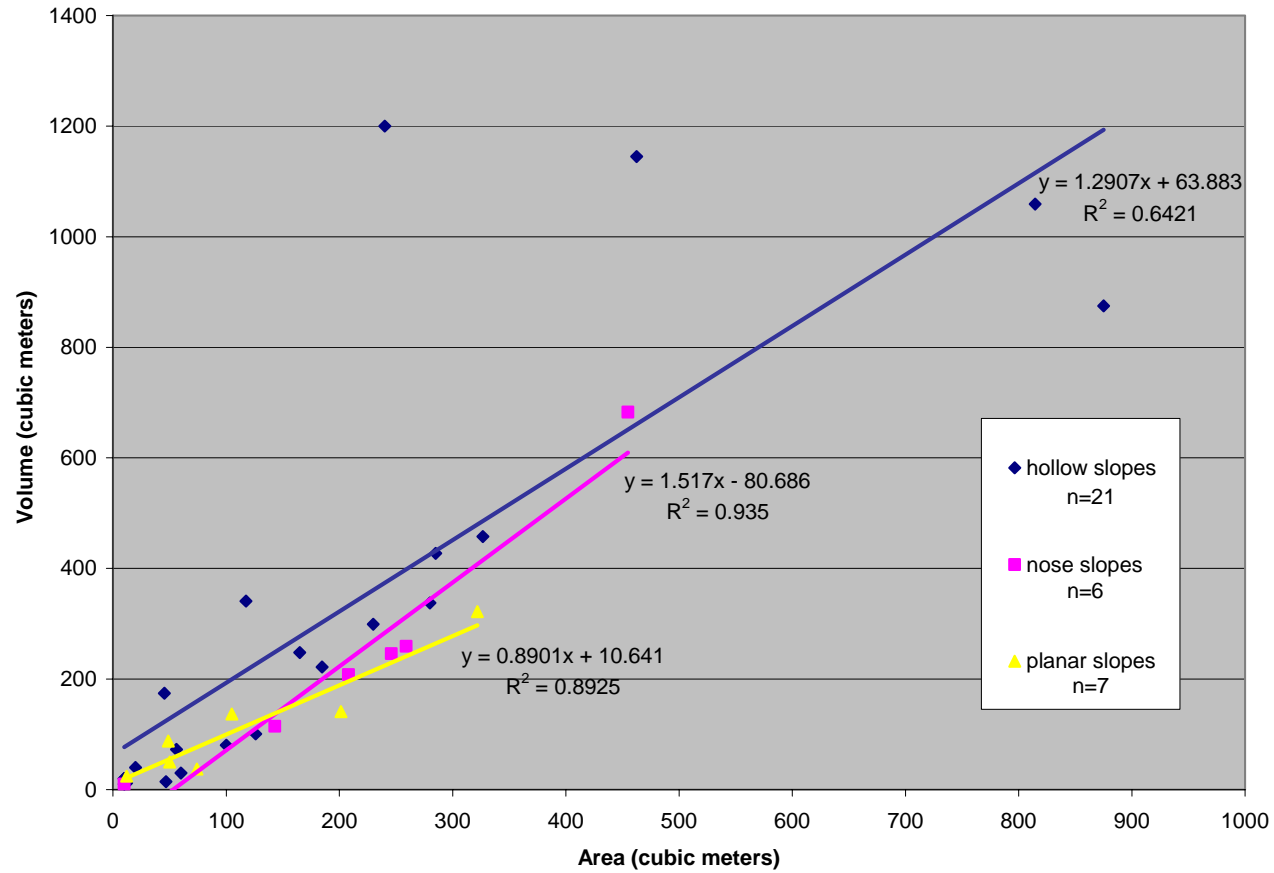
Figure 11: X-Y plots showing landslide area versus landslide volume segregated by slope geometry. R^2 values indicate nose slopes had the least volume/area variability, whereas hollow slopes had the largest variability

Hillside hollows within the Gorge produced most (63%) landslides, compared to nose slopes (13%) and planar slopes (24%). Landslide area and volume relationships vary in strength for the three slope geometries (Figure 11). The two largest landslides, Elverton and Cunard, were not included in the area-volume plot because these large slides extended over multiple slope geometries. Nose slopes had the strongest area-volume linear relationship, with an r² value of 0.935, indicating that the soil depths associated with nose slopes failures varied the least out of the 3 types of slope geometries. Planar slopes showed a slightly higher variation of area-volume, with an r² value of 0.893. The hillslope hollow geometry had the weakest linear area-volume relationship with an r² value of 0.642. The low correlation of area-volume may indicate

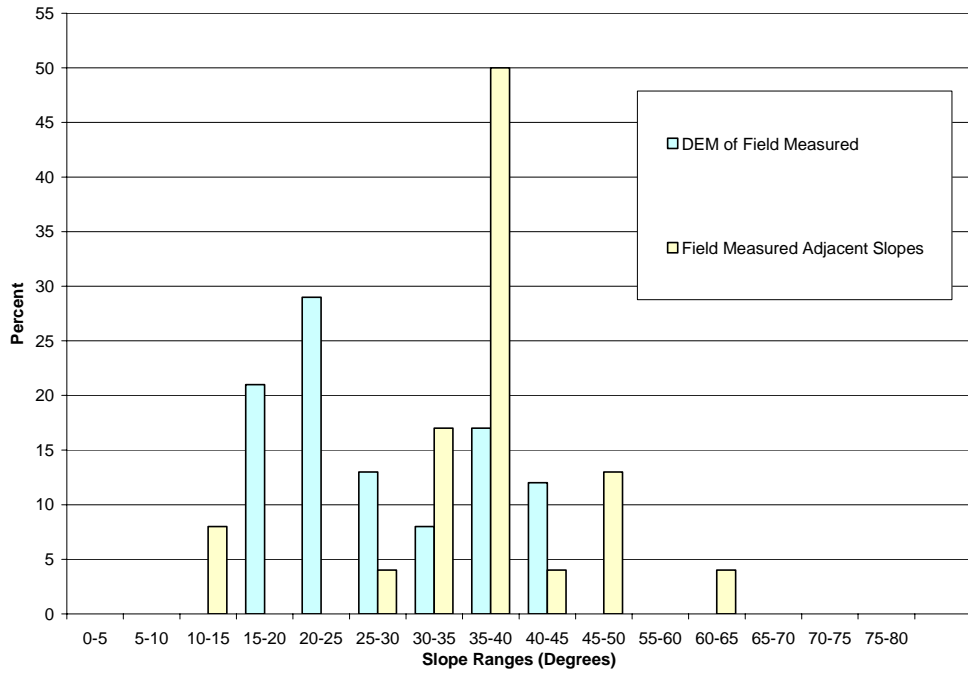
Figure 12: DEM field measured slopes compared to field measured adjacent slopes. Future work comparing DEM generated slope angles and field measured slope angle is suggested as a result of the lack of correlation between these two data sets.

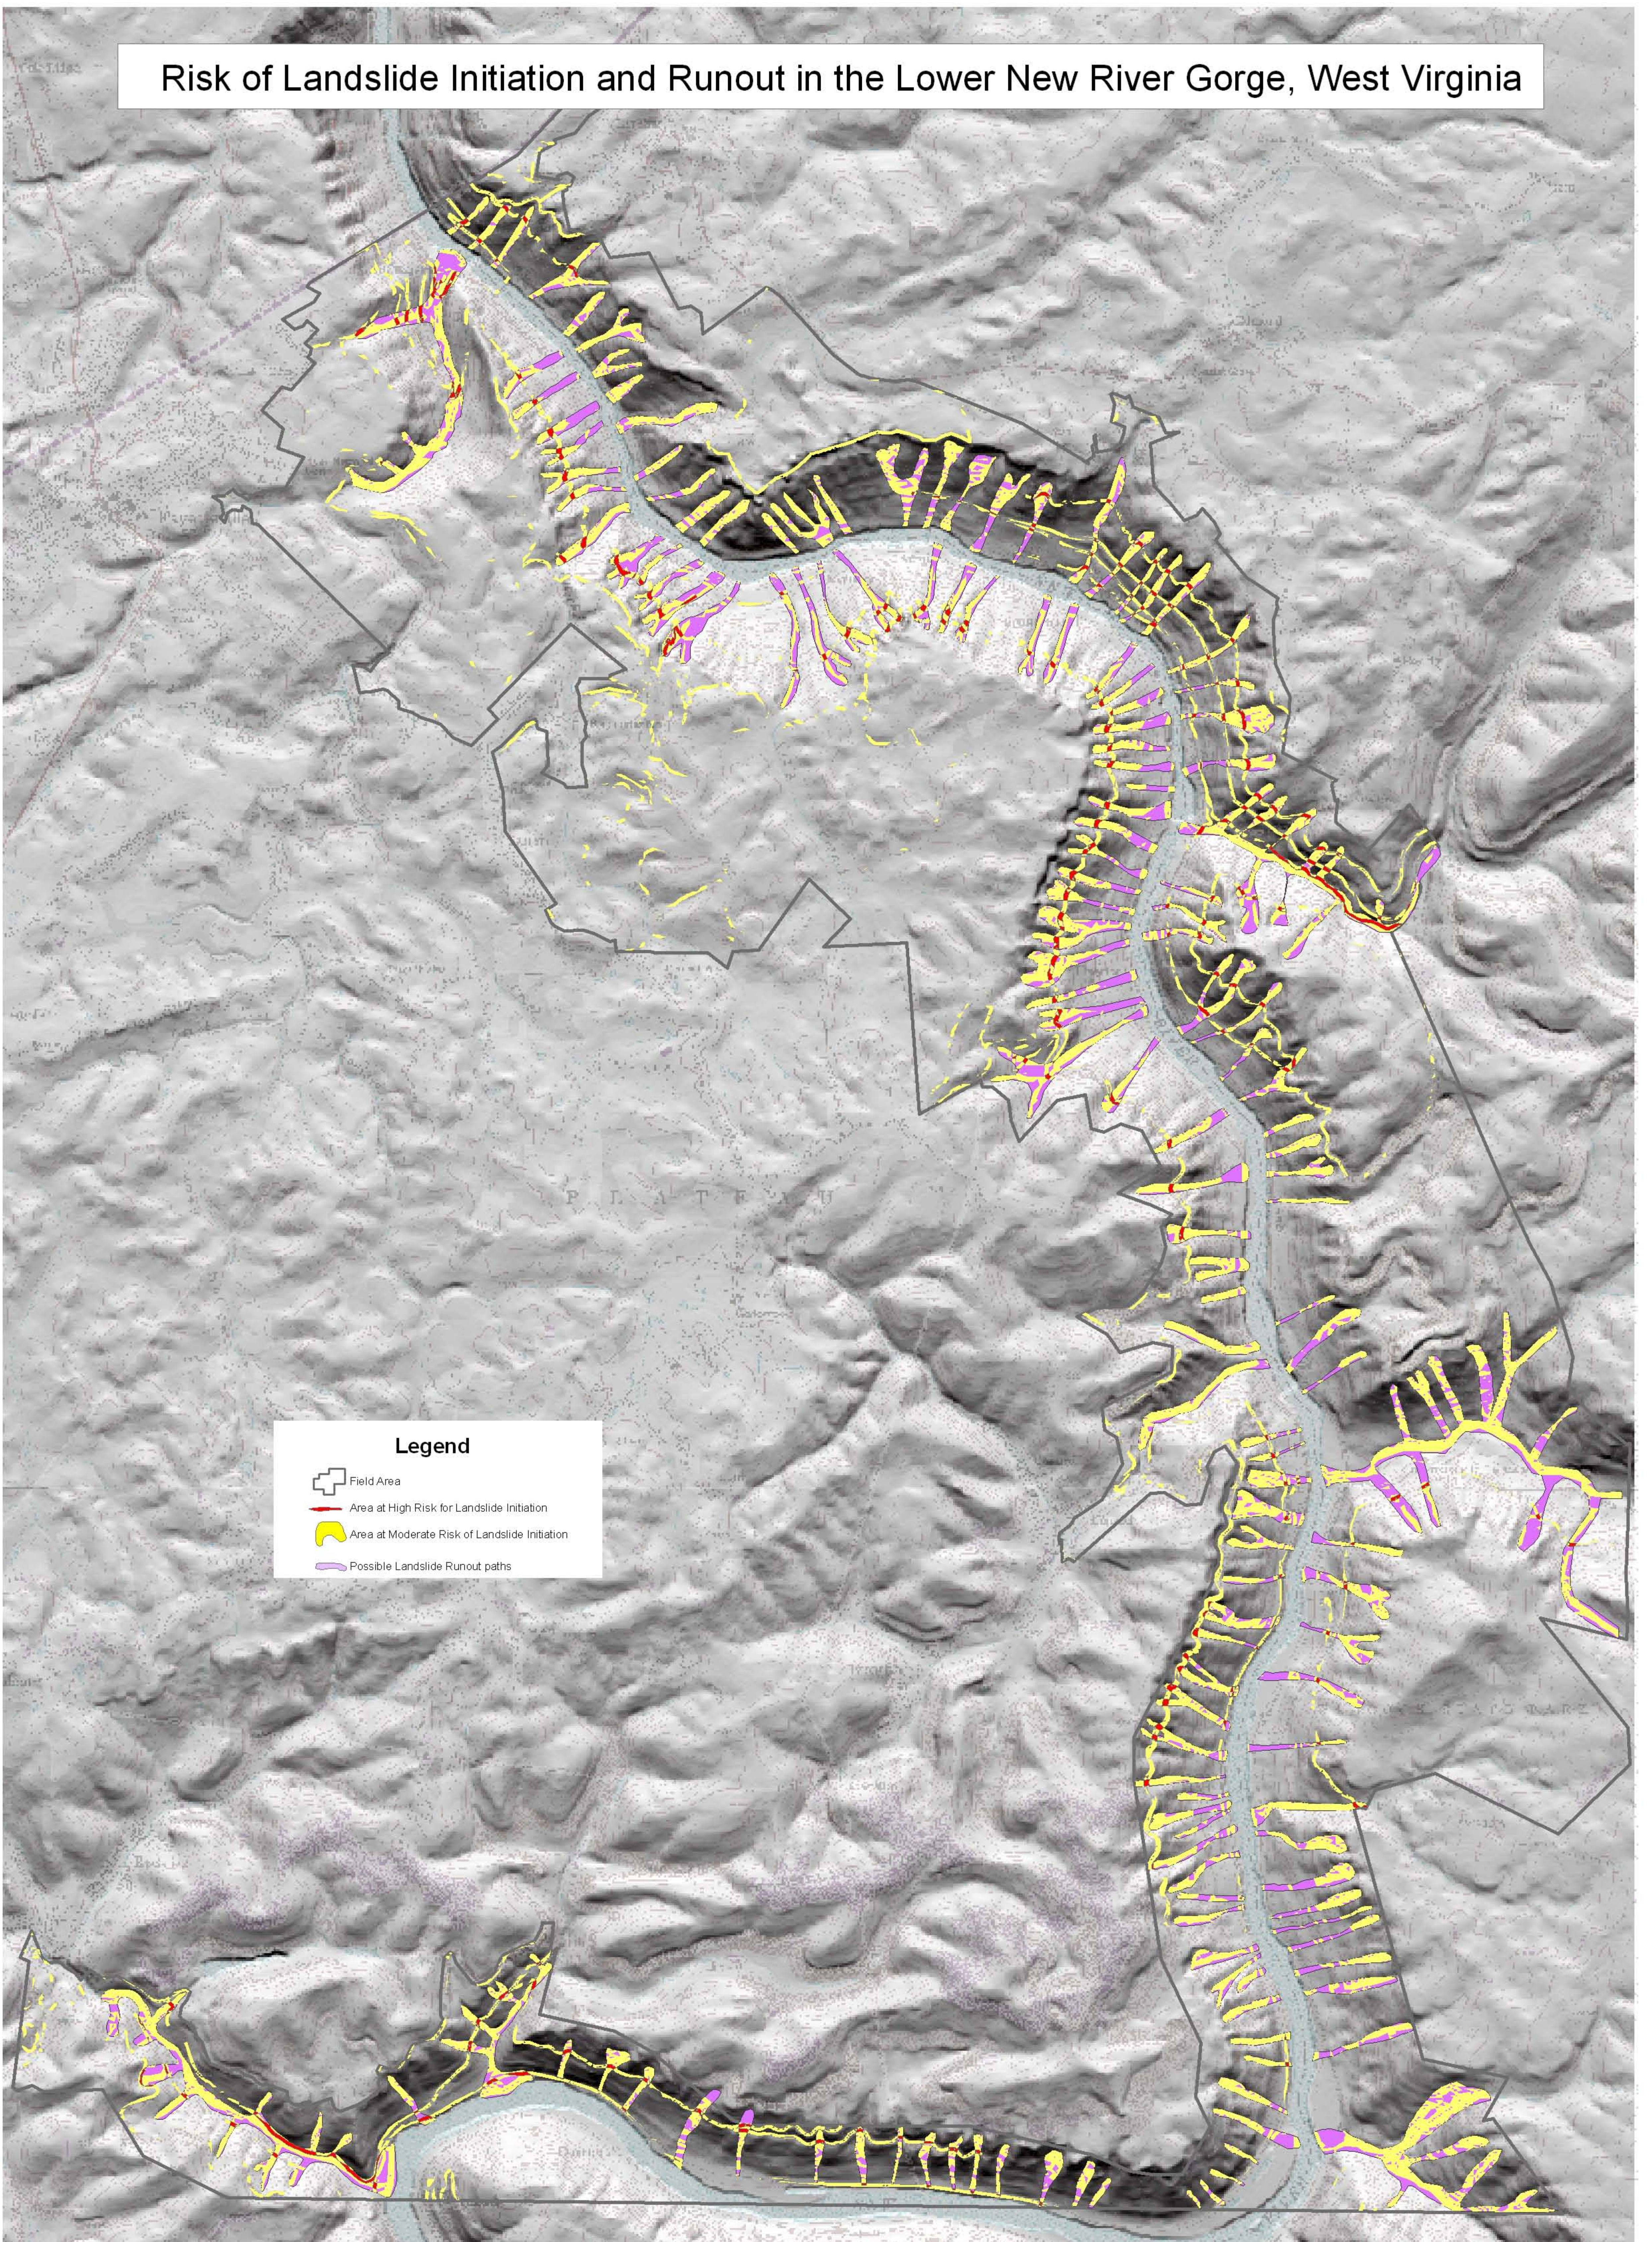
Risk of Landslide Initiation and Runout in the Lower New River Gorge, West Virginia

Selected factors were combined to create a 1:15,000 scale landslide-initiation and runout risk map using the Spatial Analyst extension in ArcGIS 8.3 (Plate 2). The physical factors used in delineating landslide hazard risk were
