**DEGRADATION OF THERMAL BARRIER COATINGS ON AN INTEGRATED
GASIFICATION COMBINED CYCLE (IGCC) SIMULATED FILM-COOLED TURBINE VANE
PRESSURE SURFACE DUE TO PARTICULATE FLY ASH DEPOSITION**

**Thesis submitted
to the Benjamin M. Statler College of Engineering and Mineral Resources
at West Virginia University**

**in partial fulfillment of the requirements for the degree of
Masters of Science in
Mechanical Engineering**

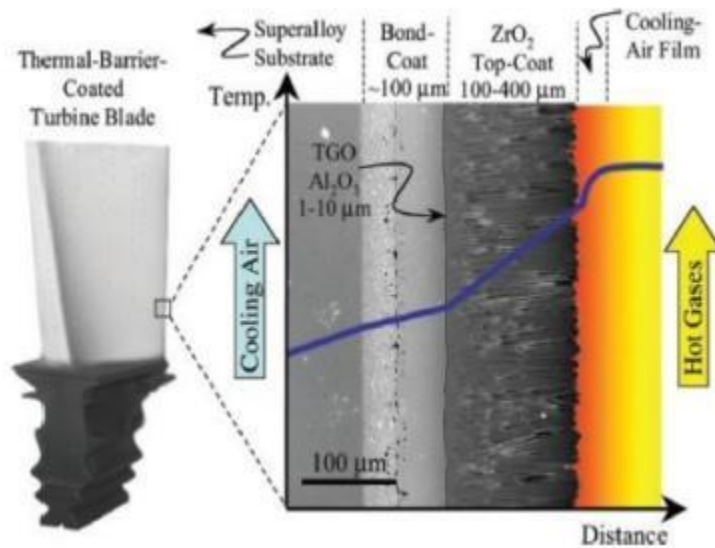
Figure 2: Cross-sectional scanning electron micrograph (SEM) of an electron-beam physical-vapor deposited (EB-PVD) TBC, superimposed onto a schematic diagram showing the temperature reduction provided by the TBC. The turbine blade contains internal air cooling and TBC to set up a temperature gradient [6]

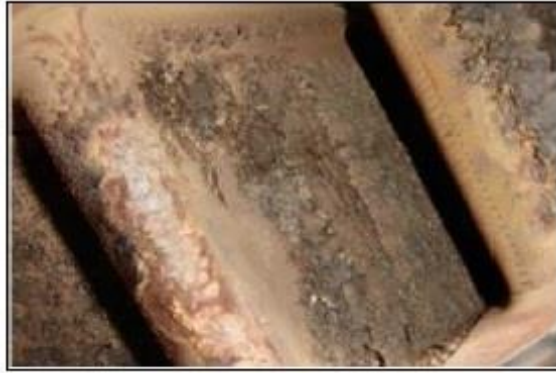
Figure 3: Film-cooled turbine vane covered by particulate matter from volcanic ash [8]

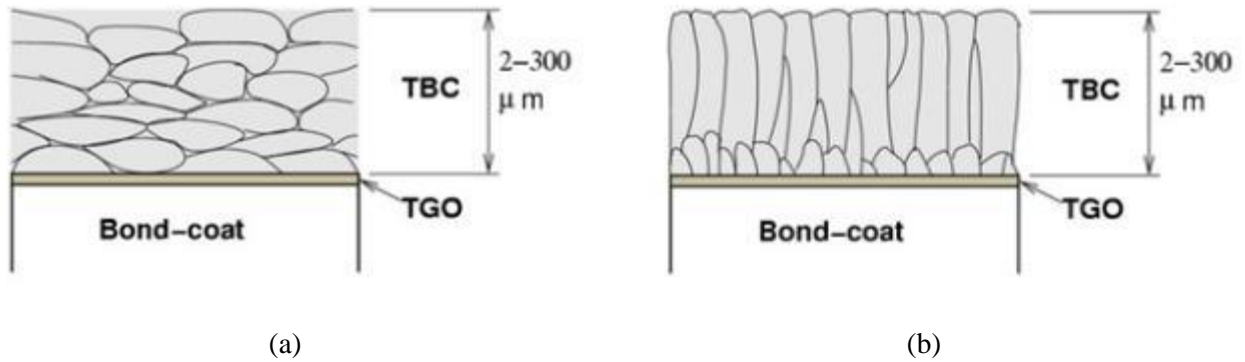
Figure 5: Schematic microstructure of TBCS applied by (a) air plasma spray (APS) and (b) electron-beam physical-vapor deposition (EB-PVD) [14]

The two most common TBC application methods are air plasma sprayed (APS) and electron-beam physical-vapor deposition (EB-PVD). Air plasma spray (APS) deposition is a low cost method that incorporates an intersplat process (successive impact of semi-molten powder particles on a substrate [12]) that lead to pores that lie parallel to the substrate surface and perpendicular to the temperature gradient. APS coatings have a very low thermal conductivity ($0.9-1 \text{ W/m} \cdot \text{K}$) [13] and are used in stationary and rotating components of hot stage parts in industrial turbines. EB-PVD coats have a higher thermal- k ($1.8-2 \text{ W/m} \cdot \text{K}$) but are usually preferred due to the strain tolerance of the coat. The strain tolerance of the EB-PVD is provided by the resultant columnar grain microstructure. The EB-PVD method is commonly used on rotating and non-rotating components in the hot stage such as blades and vanes in jet engines. Schematics of the two coating types are shown in Figure 4 [14] and as-deposited coatings are given in Figure 5 [9].

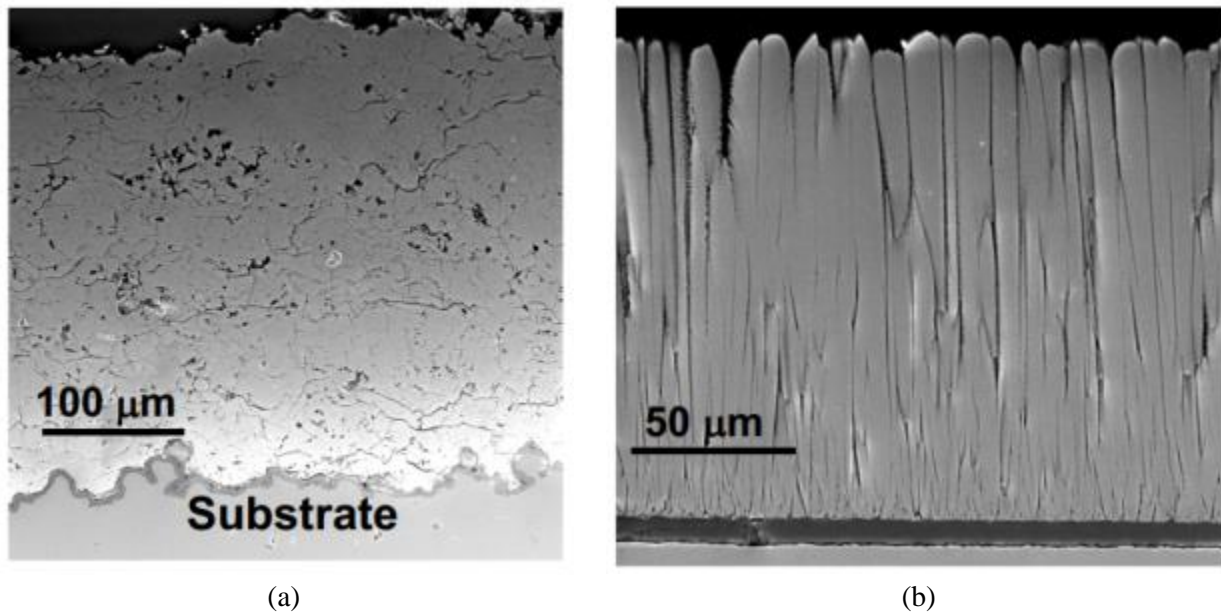
Figure 6: As-deposited SEM micrographs of TBCS applied by (a) air plasma spray (APS) and (b) electron-beam physical-vapor deposition (EB-PVD) [9]

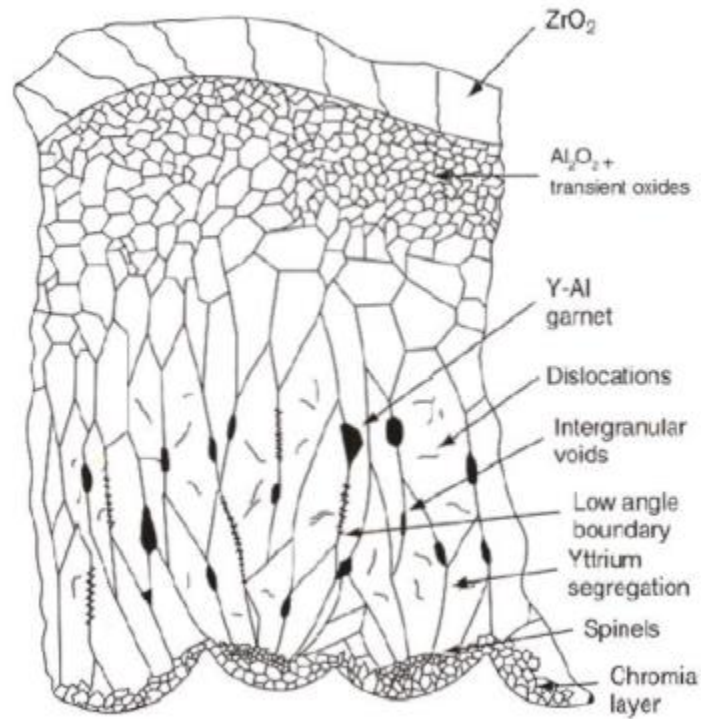
Figure 7: Thermally grown oxide (TGO) microstructure [17]

The primary TGO morphology is rapid inward oxygen diffusion and slow outward diffusion of the aluminum [15]. This causes the TGO to grown towards the bond coat instead of the ceramic top coat. The three layers within the TGO microstructure consist of an $\text{Al}_2\text{O}_3\text{-ZrO}_2$ interaction zone, a developed and crystalline Al_2O_3 , and a fined grained Al_2O_3 layer mixed with spinel oxides formed from the bond coat such as $\text{Ni}(\text{Cr,Al})_2\text{O}_4$ [16] and can be seen in Figure 7 [17]. This growth of the TGO is referred to as growth strains and is responsible for a majority of the spallation failures in the TBC system.

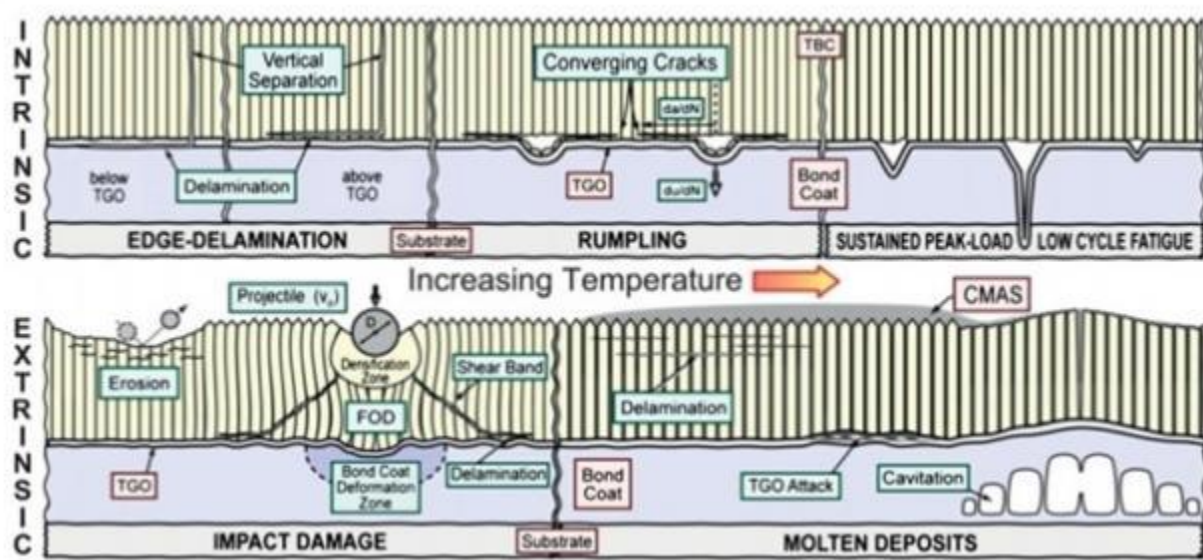
Figure 8: A summary of several mechanisms that promote spallation. Intrinsic mechanisms are governed by strain misfits between the layers during thermal cycling. Extrinsic mechanisms are from external factors [18]

The intrinsic failure mechanisms are associated with the strain differences and misfits within the constituent materials. The mechanisms are studied with the help of furnace cycle and burner rig tests. Final TBC failure is generally characterized by buckling and/or spalling of the top coat. One mechanism

involves the delaminations from the TGO formation between the BC and ceramic top coat and the grain boundary ridges on the BC surface. The bond coat exhibits imprints of the grains in the TGO, which suggests brittle failure from loss of adhesion at the metal/oxide interface [18]. Once the TGO reaches a critical thickness, delaminations around the TGO interfaces are common.

Another intrinsic mechanism is referred to as roughening, rumpling, or ratcheting. In rumpling, the BC surface along with the TGO becomes wavy upon thermal cycling [19]. Small cracks develop above the TGO and can lead to the buckling of the upper parts of the ceramic coat.

The last intrinsic failure mechanism comes from damages resulting from high temperature low cycle fatigue tests. Cracks initiate at the bond coat and TGO interface and propagate perpendicular to the load direction into the substrate [20]. Thus, integrity of the turbine components is compromised.

Extrinsic mechanisms cannot be reproduced in furnace cycling or conventional burner rig tests. One mechanism is foreign object damage (FOD). Large particle damage can cause spallation at the leading edge of airfoils [21]. Less severe particles may just thin the TBC via erosion. Erosion and spallation can have disastrous effects on the performance of critically loaded components when TBC is relied upon to keep the component substrate below the melting point.

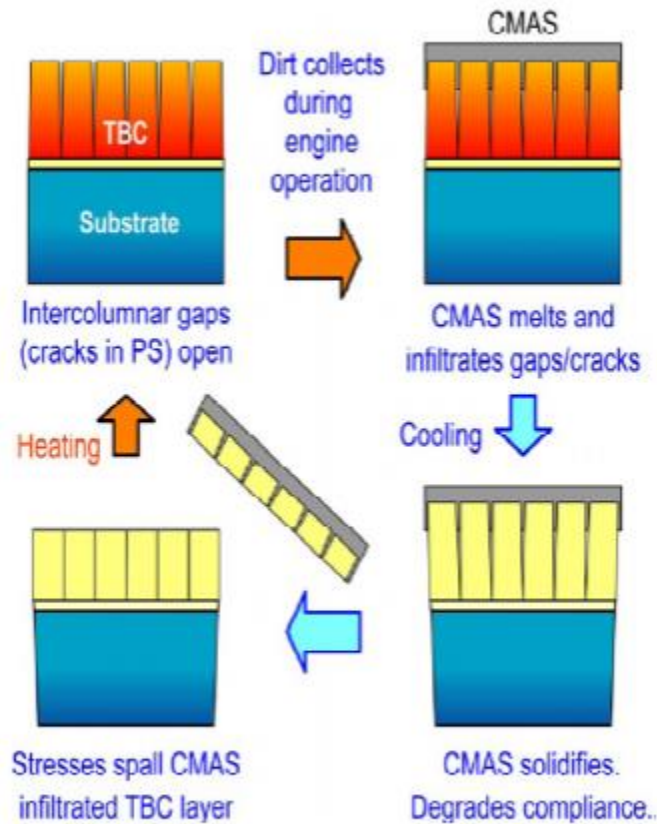
Figure 10: Schematic Illustration of the delamination mechanism associated with CMAS [25]

Levi et al. [24] also performed studies on the thermomechanical and thermochemical aspects of the CMAS interactions with an EB-PVD YSZ coating. The study found the molten deposits de-stabilized the non-transformable, metastable tetragonal t' -YSZ top coat as it infiltrate the ceramic top coat towards the TGO. The infiltration can lower the strain tolerance after the deposit cools within the TBC. In addition, the stress mismatch from the difference in the coefficient of thermal expansion (CTE) between the YSZ and the molten deposits during the CMAS solidification can cause spallation within the top ceramic coatings. This occurs when the turbine cools and heats up during shutdown and startup (low cycle fatigue). An illustration of the delamination mechanism of the YSZ coating from Whitman and Wellman is given in Figure 10 [25]. Levi also lists creep cavitation of the bond coat as a degradation mechanism if the CMAS heavily penetrates the TBC.

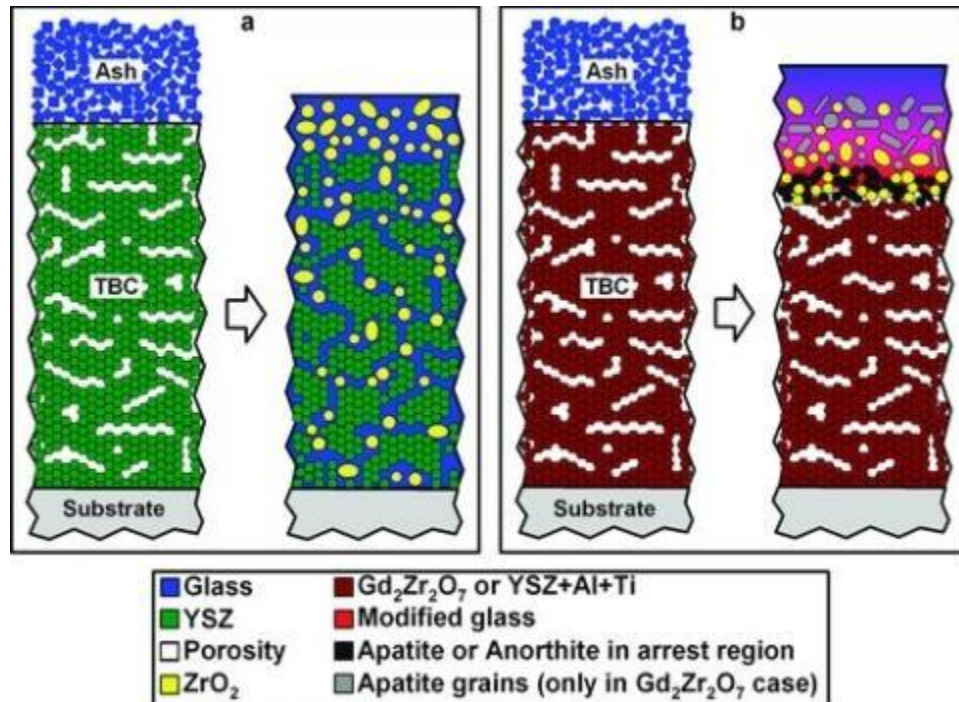
Figure 11: Cross-sectional schematic diagrams of APS TBCs with ash deposits before and after exposure to heat. a) 7YSZ and b) $Gd_2Zr_2O_7$ or YSZ+Al+Ti [26]

composed of ZrO_2 solid solution containing Y_2O_3 , Al_2O_3 , and TiO_2) and their mitigation to the volcanic ash. Figure 11a contains the general mechanism that molten volcanic ash can attack a conventional 7YSZ APS TBC [26]. Figure 11b shows that the newer TBCs prevent significant penetration of the molten ash.

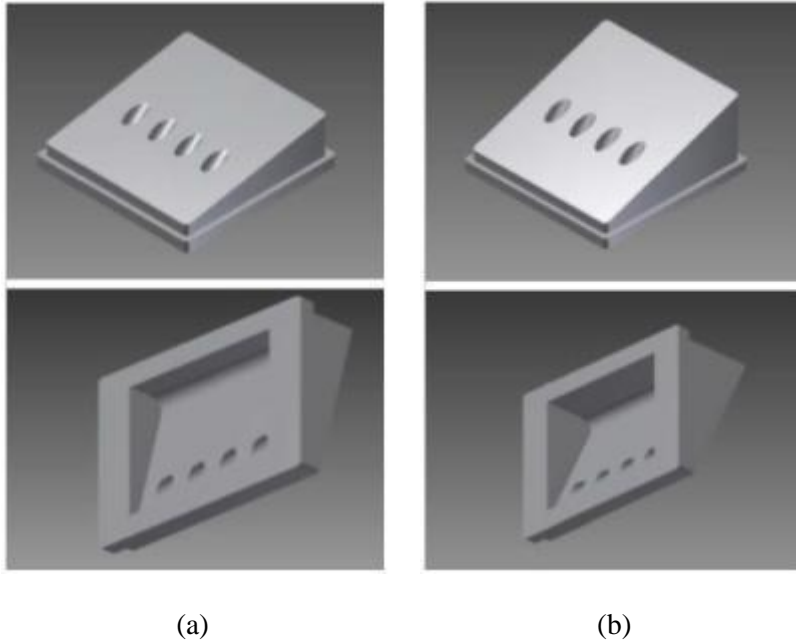
Figure 12: Isometric CAD model view of the (a) 10° and (b) 20° test articles [1]

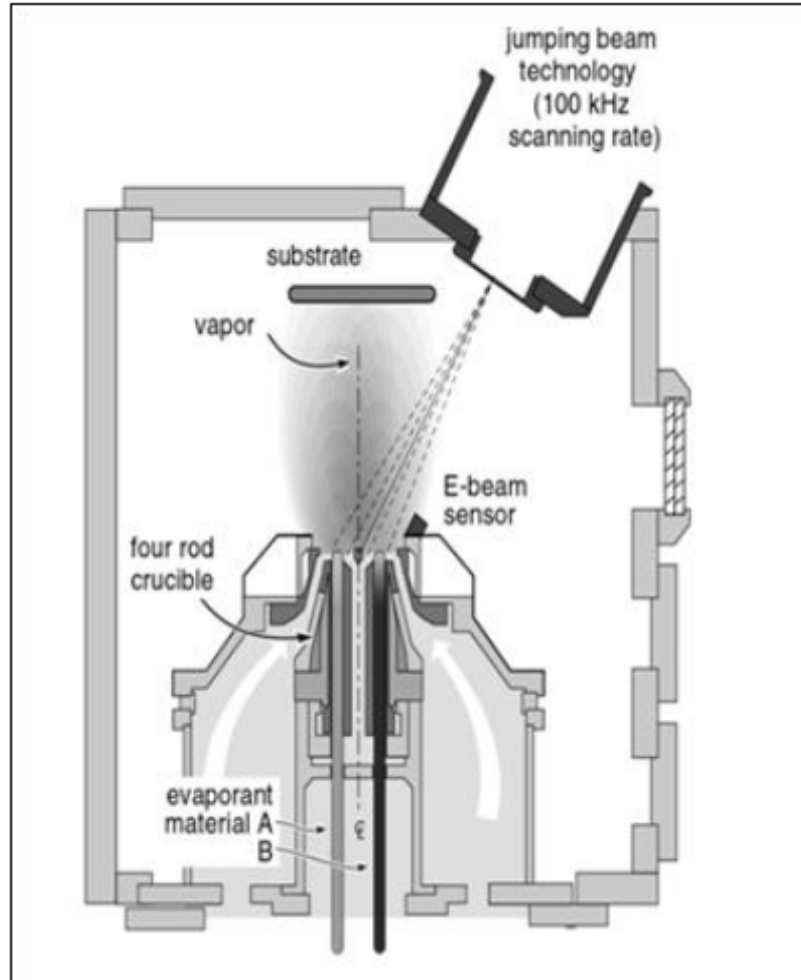
Figure 13: Schematic of the directed vapor deposition (DVD) process developed by DVTI [33]

Thermal barrier coatings (TBC) were applied to each test article using a Directed Vapor Deposition (DVD) process developed and applied by Directed Vapor Technologies International, Inc. (DVTI) [32]. The DVD process, shown in Figure 13, uses an inert gas jet around the vapor to direct it toward the surface, which is a more efficient process than electron beam physical vapor deposition (EB-PVD) [33]. In addition to the efficient high deposition rate, the DVD process features non line-of-sight deposition and controlled intermixing during multiple source evaporation. These two features allow for coating deposition on complex engine components and enable novel coating architectures. The bond coat of the TBC system is a γ - γ' platinum aluminide (PtAl) developed by Brian Gleeson at the University of Pittsburgh and Iowa State University and has an approximate thickness of 15-20 μm [34]. The γ - γ' PtAl bond coat allows for the phase properties to closely match those of the nickel-based superalloy. The ceramic top coat layer was applied as 7% Yttrium Stabilized Zirconia (7YSZ) with an approximate thickness of 400 μm . The cooling holes were masked during the coating process, which created a shallow trench. A trench is actually employed in modern day gas turbine film-cooling schemes [35]. Figure 14 displays the two angled test articles after TBC had been applied [1].

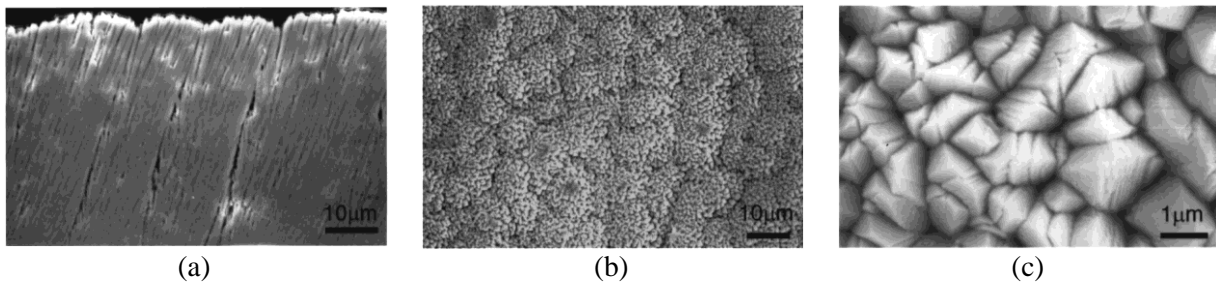
Figure 15: SEM micrographs of DVD 7YSZ layer using a deposition rate of $\sim 15.0 \mu\text{m min}^{-1}$ and temperature of 1000°C showing a) the polished cross-section, b) the twofold columnar structure, and c) the faceted surfaces of the finer columns [36]

Below in Figure 15 contains the morphology of a DVD YSZ coating during the development of the deposition process by Hass et al. [36]. The DVD YSZ layer reveals a columnar structure with fine columns with 1-2 μm diameter and coarser columns with diameters of 10-20 μm . The YSZ columns exhibit parallel growth and have perpendicular intercolumnar voids. The porosity was generally aligned to the substrate. The 7YSZ coatings produced using the DVD technique have also been found to have thermal conductivities as low as 0.8 W/mK if a zig-zag pore microstructure is used [37]. The zig-zag microstructure allows for a longer thermal diffusion path. A cross-section SEM micrograph of the as-deposited TBC system in the current study can be seen in Figure 16.

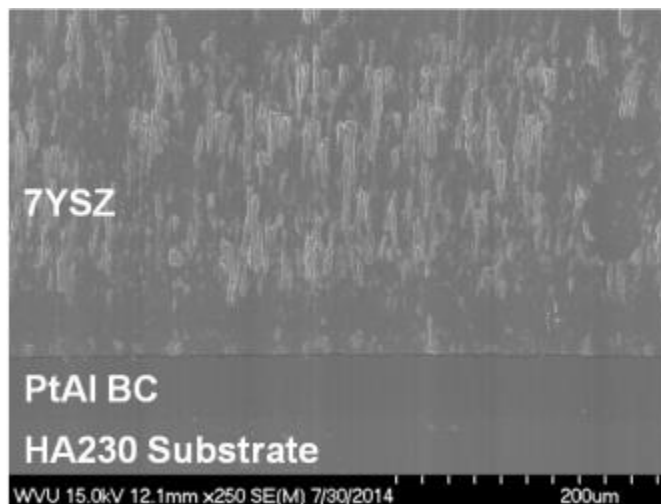
Figure 16: Polished cross-section SEM micrograph of the as deposited DVD TBC system

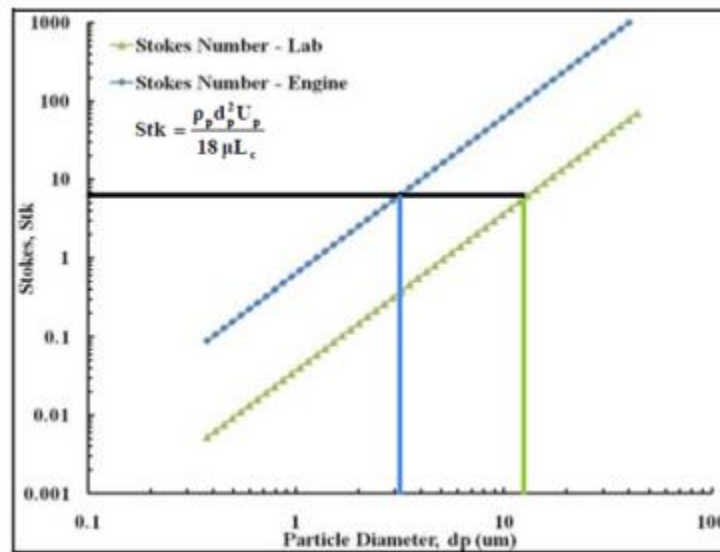
Figure 19: Stokes numbers plotted with respect to particle diameter for fly ash particles in engine and laboratory conditions [1]

The Stokes number was plotted relative to the fly ash particle diameter in laboratory and engine conditions and is shown in Figure 19 [1]. The results showed that, to match the inertial characteristics of an approximately 3 μ m particle in the engine, the laboratory fly ash particle was required to be 13 μ m. This meant that particle sizes greater than 13 μ m generated for the experiments would interact with the scaled-up film cooling jets in the same way that smaller particles would interact with true scale film cooling jets in an actual engine.

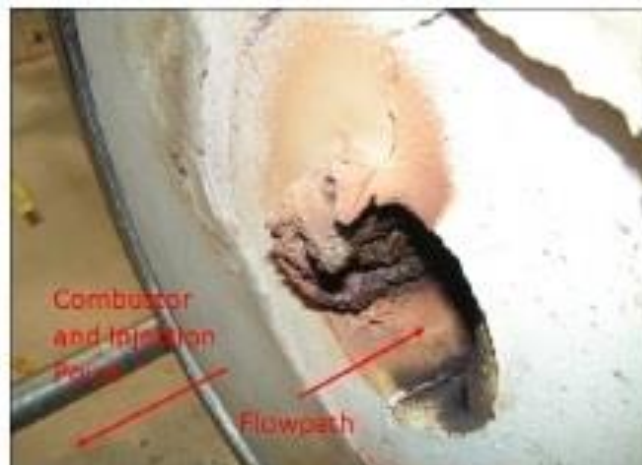
Figure 21: Image of large deposit formation on the left side of the transition piece [38]

Deposit formation on only one side of the test articles was due to a large deposit structure forming on the transition piece of the test section [38]. This transition piece is located upstream of the test articles. Figure 21 displays the structure with deposits on the left side of the piece [38]. The deposit structure on the test section transition piece created a swirl effect which promotes an uneven distribution of fly ash into the test section. This limited heavy deposition in areas and created a “stratified” amount of deposition. The swirl effect is unrealistic in a first stage vane flow of an actual gas turbine. Dilatation flow would help straighten the flow prior to entering the turbine.

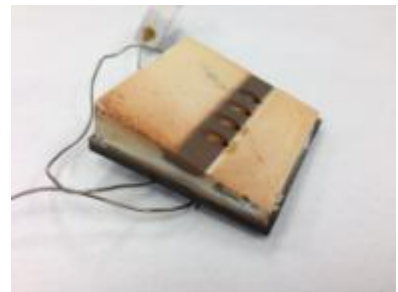
Figure 22: Labels of the Test Articles: a) Test Article 1 - 20°, Deposition, b) Test Article 2 - 20°, Unexposed, c) Test Article 3 - 10°, Deposition

Additional deposit testing was performed after those seen in Figure 12. The test articles that are used for material analysis in this study are displayed in Figure 22 in the next chapter. The deposition stratification allows for the study to test and compare different sections within the same test article.

To determine the effect of the fly ash deposition on the mechanical properties and microstructure of the TBC, the test articles had to be sectioned and trimmed into materials testing samples. A number of defects may be generated during the cutting process such as the formation of cracks. In order to section larger elements with ceramic coverings, devices such as abrasive saws and diamond precise saws are used [44]. The samples used in this study were sent to Westmoreland Mechanical Testing & Research, Inc. to be cut using an abrasive saw method. Three of the test articles that were labeled and sent to be cut are shown in Figure 22. Test article 1 is a 20-degree angled article with the heaviest amount of deposition adherence. Test article 2 is also a 20-degree angled article, but has been unexposed to testing. The last test article, test article 3, has an angle of 10-degree and experienced significantly less deposition than test article 1.

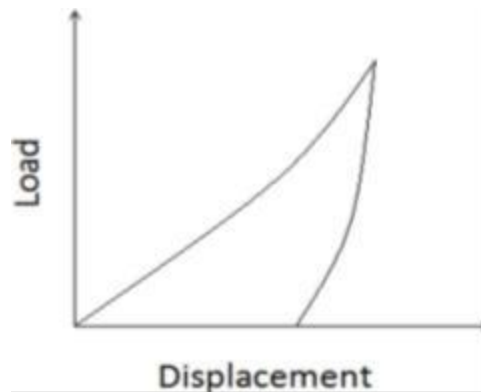
Figure 27: Load displacement curve for single point unloading algorithm [29]

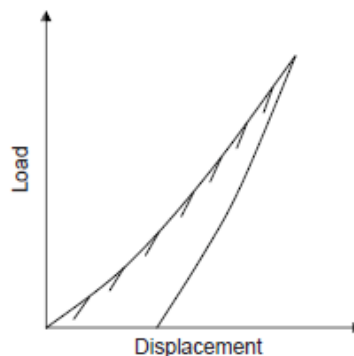
Figure 28: Load displacement curve for multiple partial unloading algorithm [29]

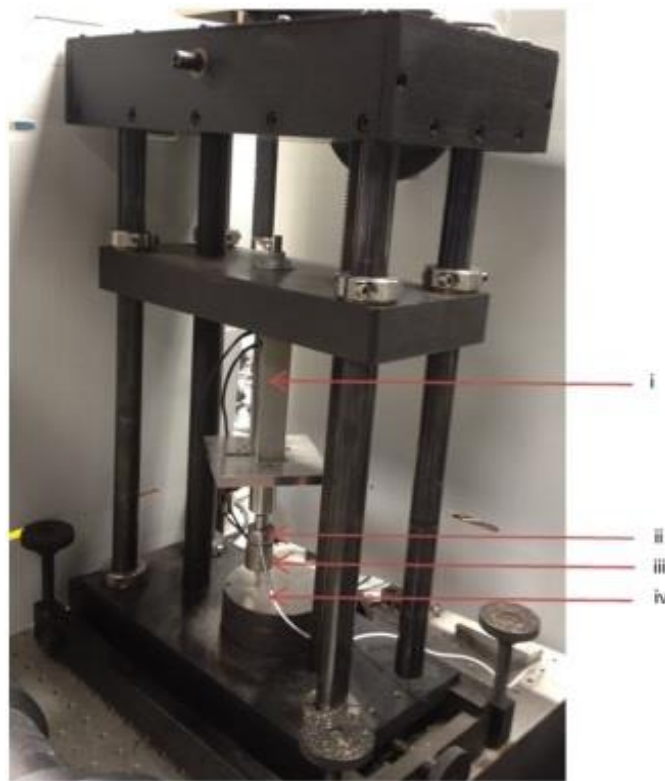
Figure 29: Experimental Setup, i) 3.6 nm Resolution, Physik Instrumente, P-239.9S, 180 μm piezoelectric actuator, ii) $\pm 0.15\%$ Accuracy, Honeywell, Model 31, 100 lb. load cell, iii) spherical tungsten carbide (WC) 793.5 μm radius indenter, and iv) sample stage [15]

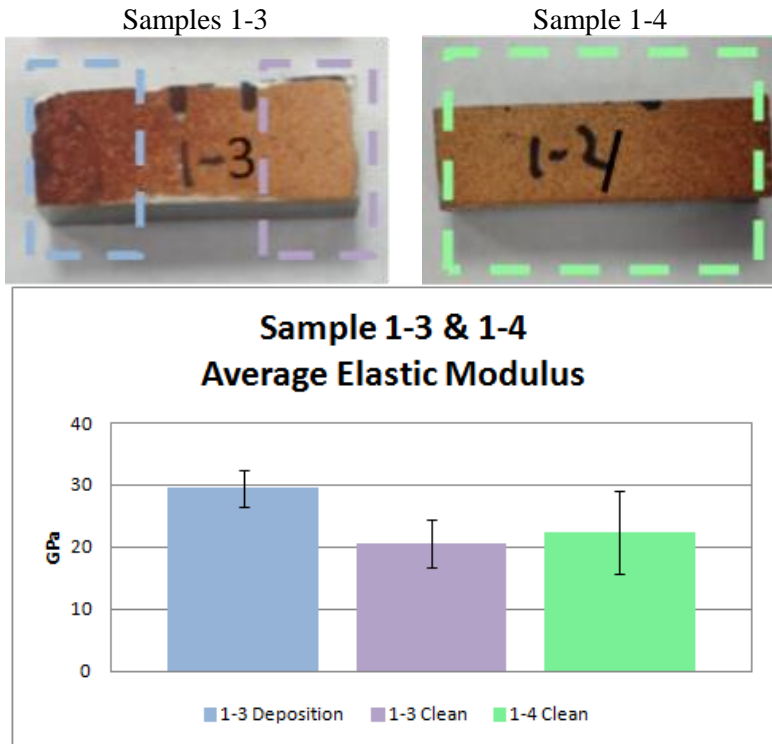
Figure 35: Image of samples 1-3 and 1-4 and their values for averaged TBC modulus elasticity

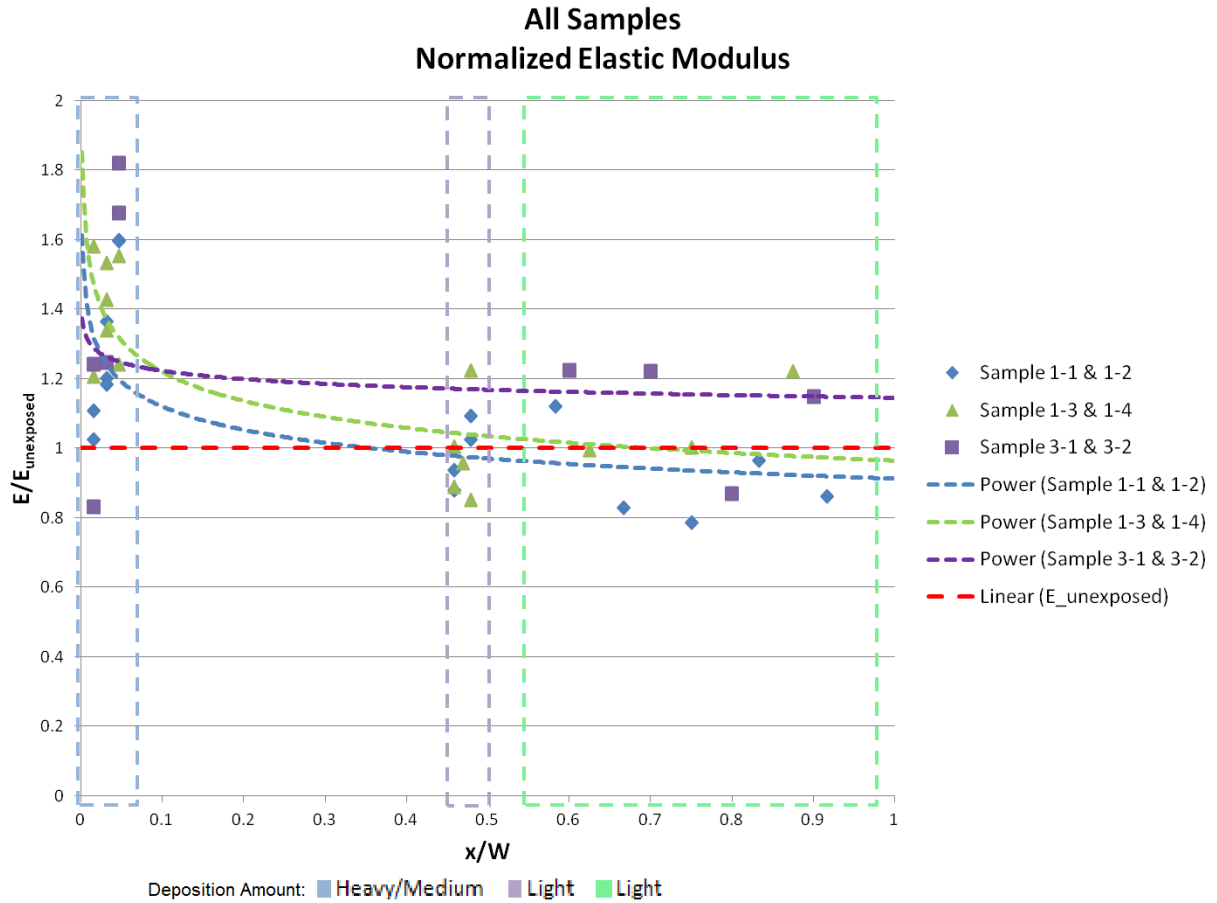
Figure 41: Normalized elastic modulus trends for samples 1-1, 1-2, 1-3, 1-4, 3-1, and 3-2

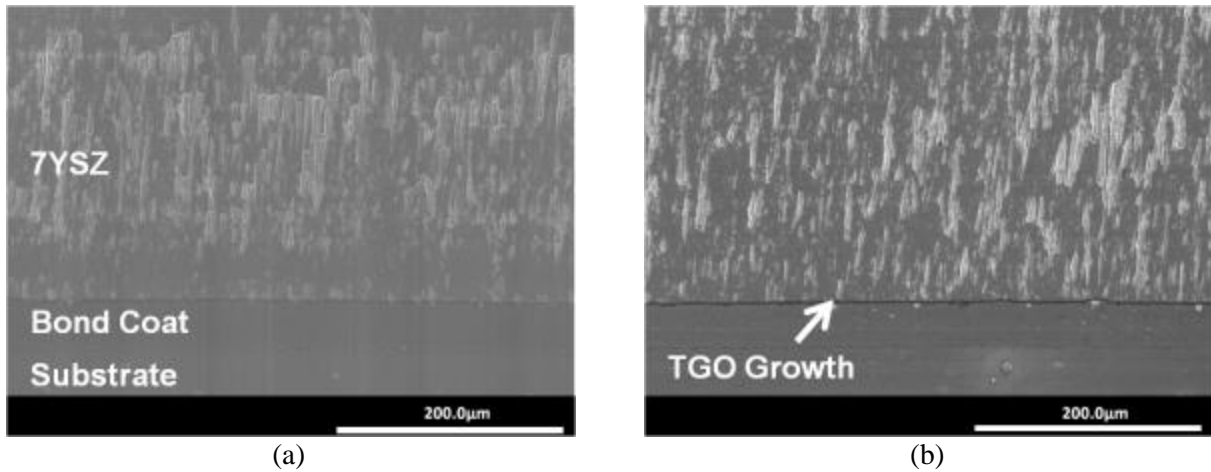
Figure 42: Cross-sectional SEM micrographs of a) samples 2-3 (unexposed) and b) samples 1-3 (deposition)

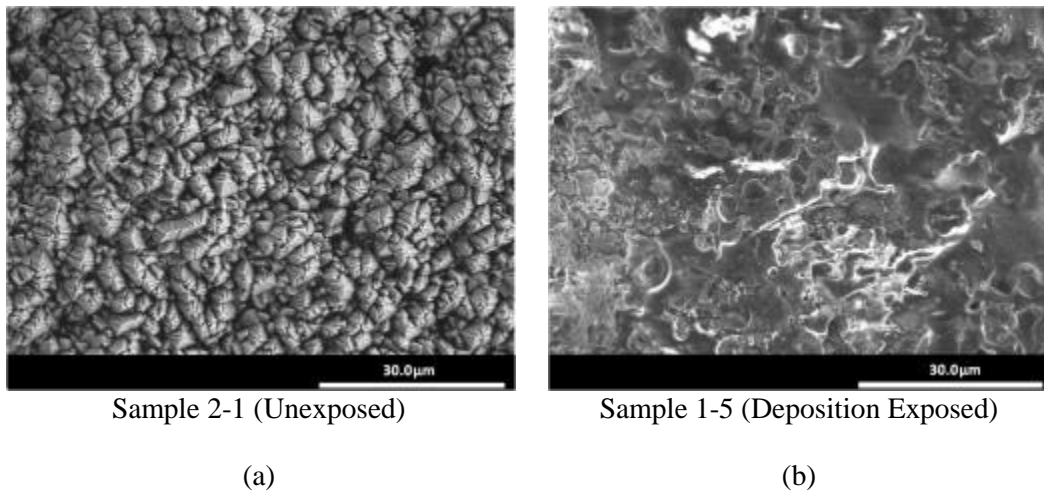
Figure 43: Top view SEM micrographs of a) samples 2-1 (unexposed) and b) samples 1-5 (deposition)

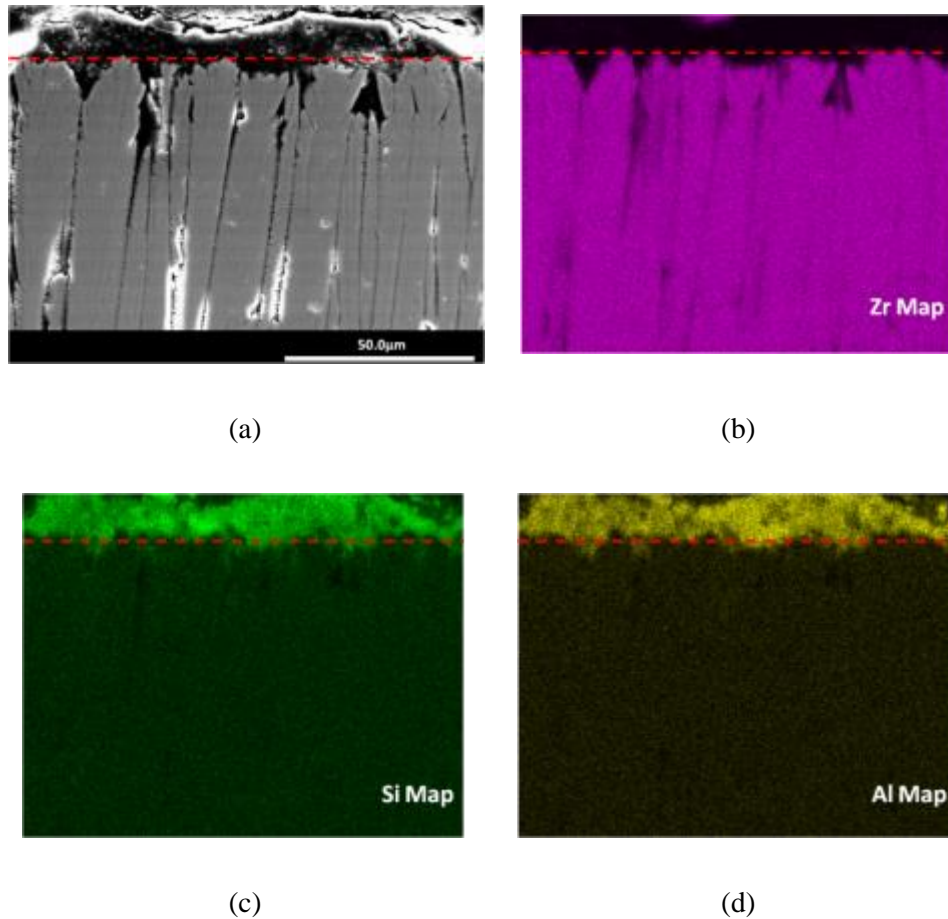
Figure 46: a) Cross-sectional SEM micrograph of sample 1-3 with molten fly ash interaction and their corresponding elemental maps: b) Zr, c) Si, and d) Al. The horizontal red line show the original top surface of the TBC

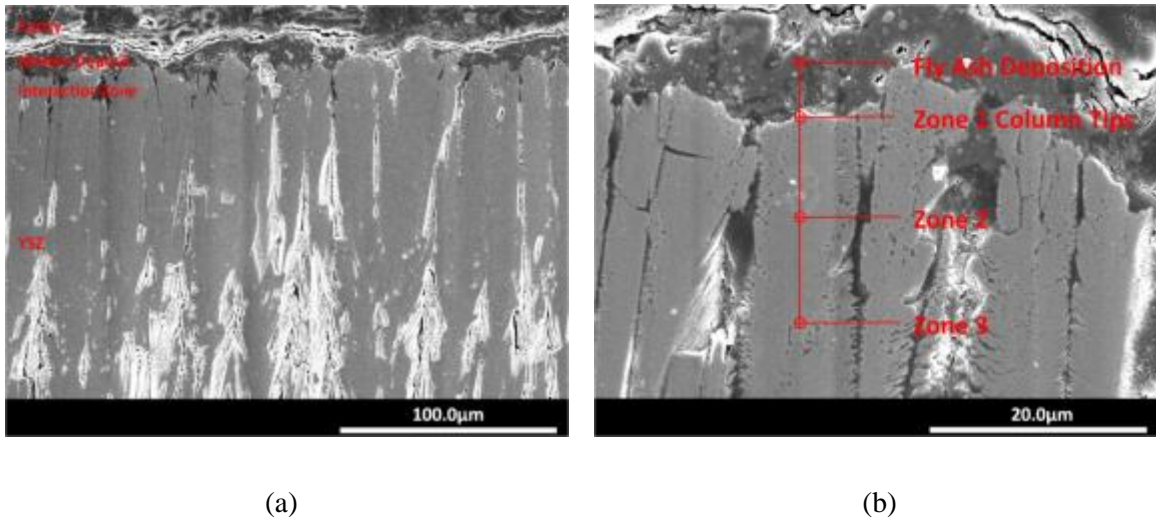
Figure 47: Cross-sectional views of a) top coating on sample 1-3 with molten deposits with their region label, and b) locations of EDS spectrum analysis

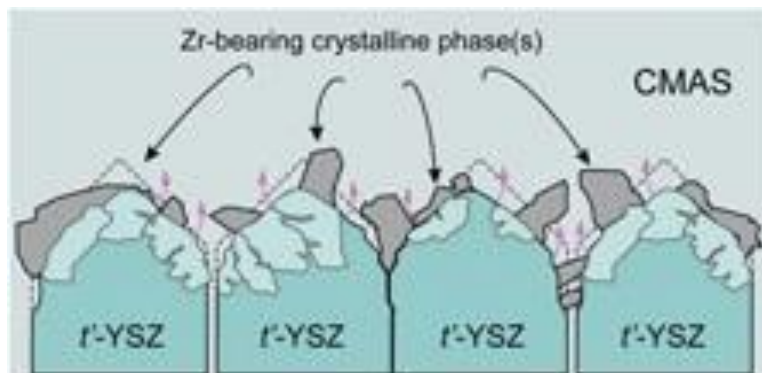
Figure 49: Schematic illustration of the dissolution-precipitation mechanism in YSZ due to CMAS [24]

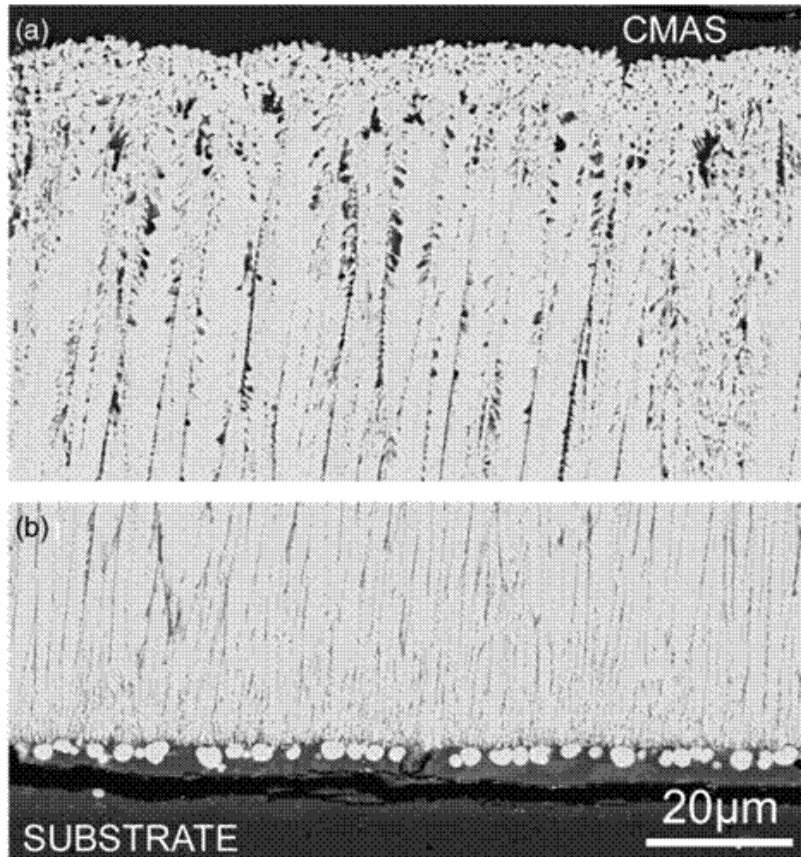
Figure 51: Cross-sectional SEM micrograph of TBC with exposure to CMAS a) near the outer surface of the TBC (severe attack) and b) at the TBC/substrate interface [70]

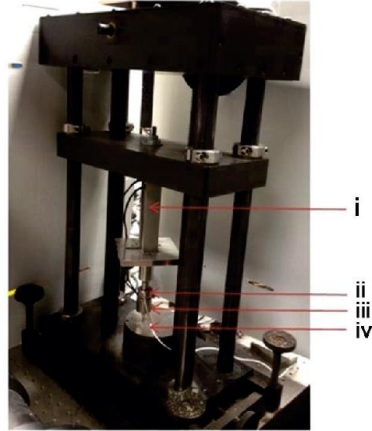
Figure 6. Table top micro-indentation setup: (i) 3.6 nm Resolution, Physik Instrumente, P-239.9S, 180 μm piezoelectric actuator; (ii) $\pm 0.15\%$ Accuracy, Honeywell, Model 31, 100 lb. load cell; (iii) spherical tungsten carbide (WC) 793.5 μm radius indenter; and (iv) sample stage [8].

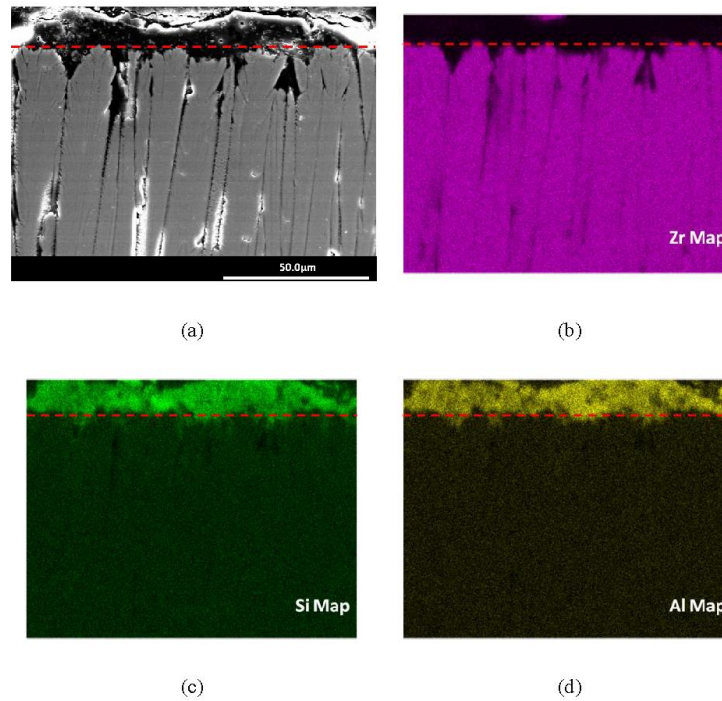
Figure 7. a) Cross-section SEM micrograph of Sample 1-3 that has interacted with molten fly ash and corresponding elemental maps: b) Zr, c) Si, and d) Al. The horizontal dashed lines denote the original top surface of the TBC.

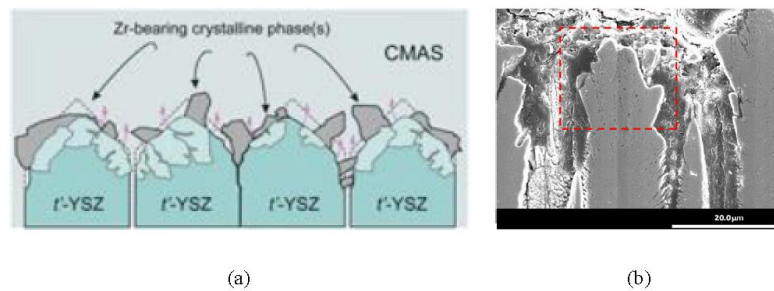
Figure 9. a) Schematic illustration of the dissolution-reprecipitation mechanism in YSZ [4] and b) SEM micrograph of a reprecipitated YSZ columnar tip of sample 1-3.
