## Effects of Slope Geometry Alterations on Rockfall Mitigation along Highway Rock Cut Slopes in West Virginia

# **Effects of Slope Geometry Alterations on Rockfall Mitigation along Highway Rock Cut Slopes in West Virginia**

Thesis submitted to the  
Benjamin M. Statler College of Engineering and Mineral Resources  
at West Virginia University  
in partial fulfillment of the requirements  
for the degree of

Master of Science  
in  
Civil and Environmental Engineering

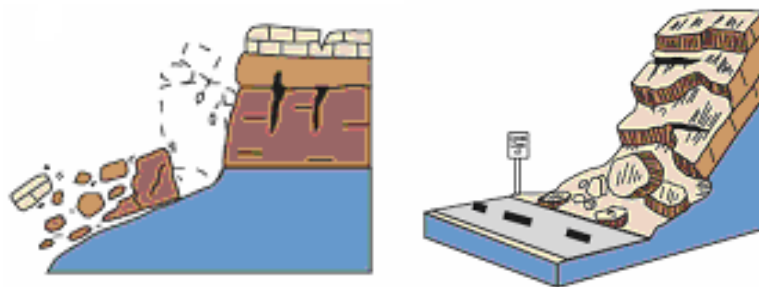
*Figure 2.1 Illustration of a “topple” slope failure (left) and a “fall” slope failure (right). (OHDOT 2007)*

There are two classifications of landslide types that deal with rockfall: topples and falls (OHDOT, 2007). A topple is a forward rotation out of the slope of mass of soil or rock about a point or axis below the center of gravity of the displaced mass. Toppling is sometimes driven by gravity exerted by material upslope of the displaced mass. A topple can also occur due to water or ice in the cracks of the rock mass. The cracks in the rock mass can be due to discontinuities and stratification of the material. Common causes of a topple include vibrations, undercutting, differential weathering, excessive excavation, and erosive forces. Topples can be independent events, or can lead to a fall if occurring high up on a slope.

A fall starts with a detachment of soil and or rock from a steep slope along a surface in which little or no shear displacement occurs. The detached material descends primarily through the air by falling, bouncing, or rolling down the remaining slope. Falls generally occur on slopes with angles ranging from 45 to 90 degrees and are caused by vibrations, undercutting, differential weathering, and erosion. Falls are generated from discontinuities in the rock or soil, creating weak points for failure. Falls can be especially dangerous near roadways or above residential areas. Falls can be easily classified by debris or rubble found at the toe of the slope. Catchment structures are the primary mode of confining the fallen debris and keeping debris from entering roadways (Das, 2006).

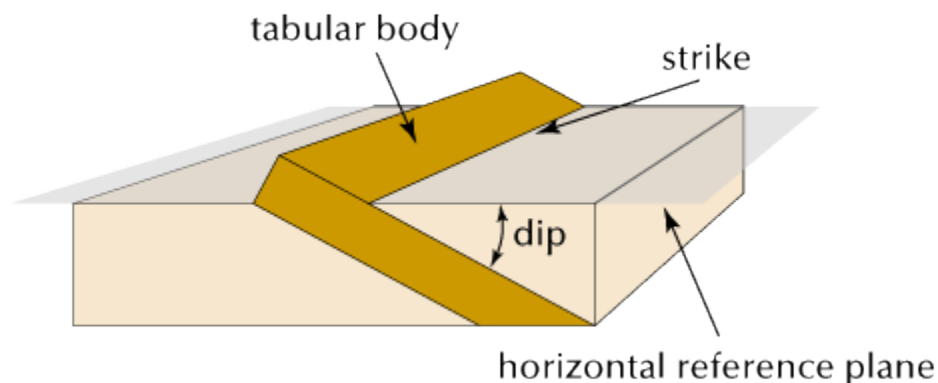
Figure 3.1 Visual Representation of “strike” and “dip” in a bedding plane (Myers 2010).

- 3. Dip Direction and Angle** - Reference Figure 3.1 aid in determining the average dip direction and angle of the layers in the slope.

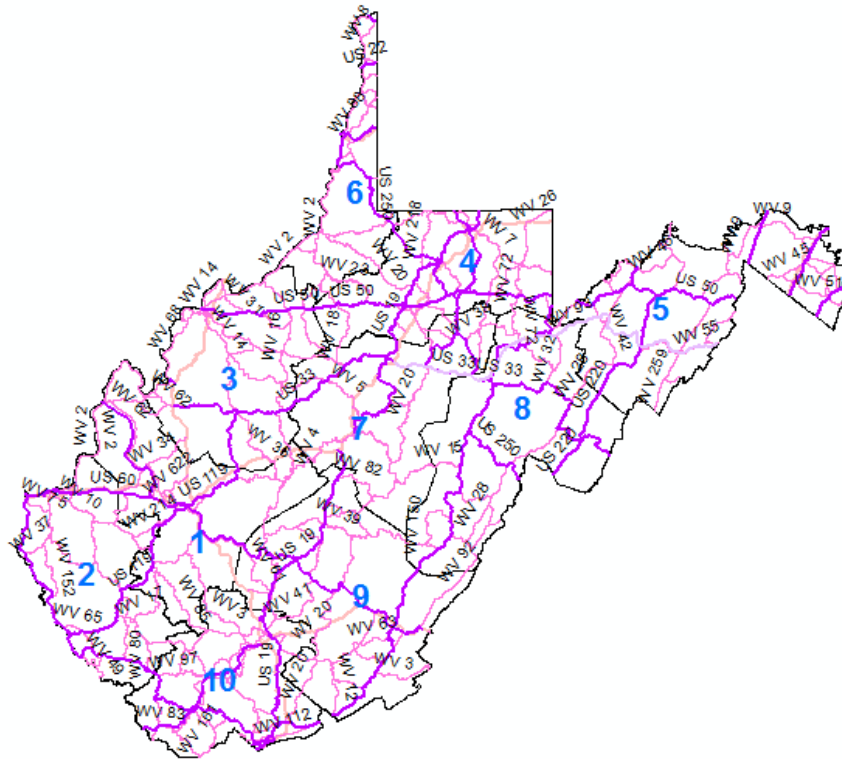
Figure 3.2 Map created in ArcGIS from 4 downloaded layers: WVDOT district outlines, State Routes, US Routes, and Interstates.

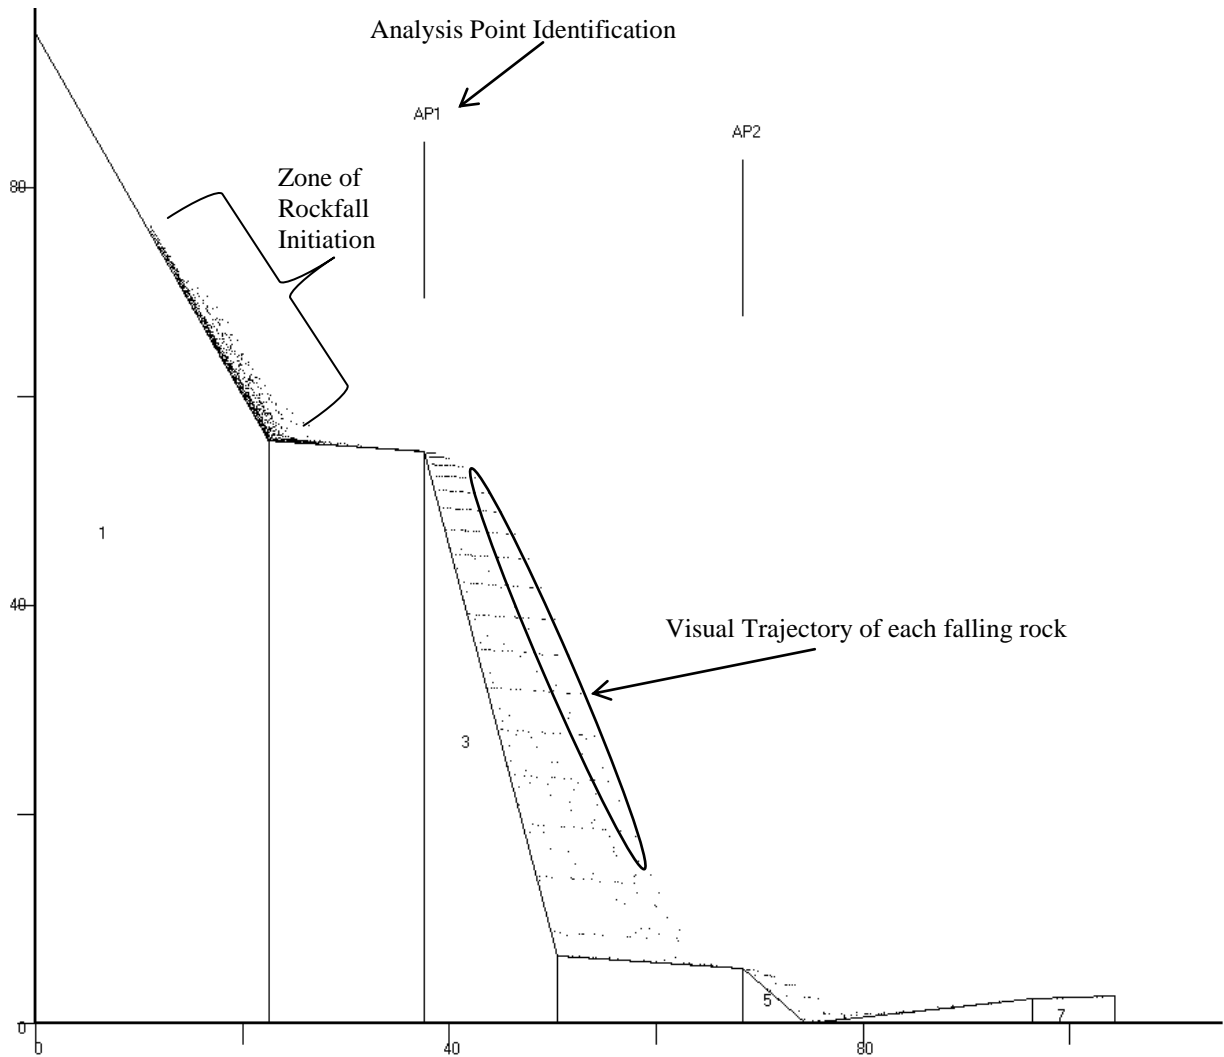
*Figure 4.2 CRSP 2-D Slope Profile showing simulation trial results*

The two-dimensional version of CRSP provides many useful diagrams, statistics, and graphs for each simulation trial. After accurately inputting all the parameters and clicking the “Begin Rockfall Simulation” button, the initial Results window shows the slope profile with a visual representation of the paths each falling rock took down the two-dimensional slope (see Figure 4.2).

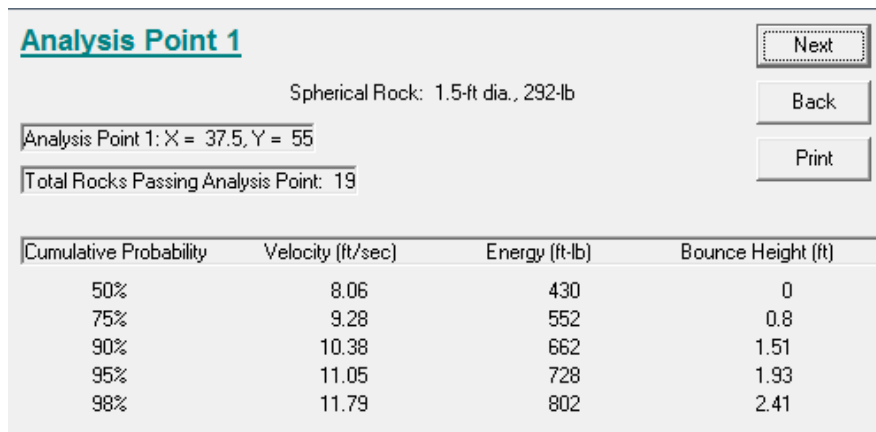
Figure 4.4 Probability analysis for each rock at “Analysis Point 1” in a CRSP simulation trial

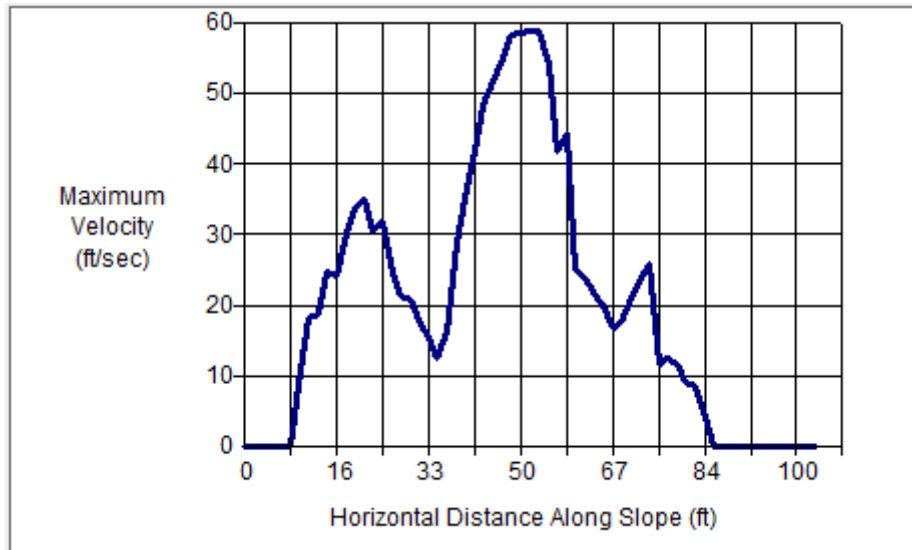
Figure 4.5 Line graph output by CRSP-2D depicting the maximum velocity of the fallen rocks as they travelled down the slope profile during simulation

Following these statistics are various histograms showing the frequencies of simulated rocks having specific velocities, bounce heights, or kinetic energies at each analysis point. Following the histograms are line graphs showing the maximum velocities (Figure 4.5) and bounce heights for the fallen rocks as they traveled down the slope profile. The final results tabs show individual statistics for each simulated fallen rock in tabular form.

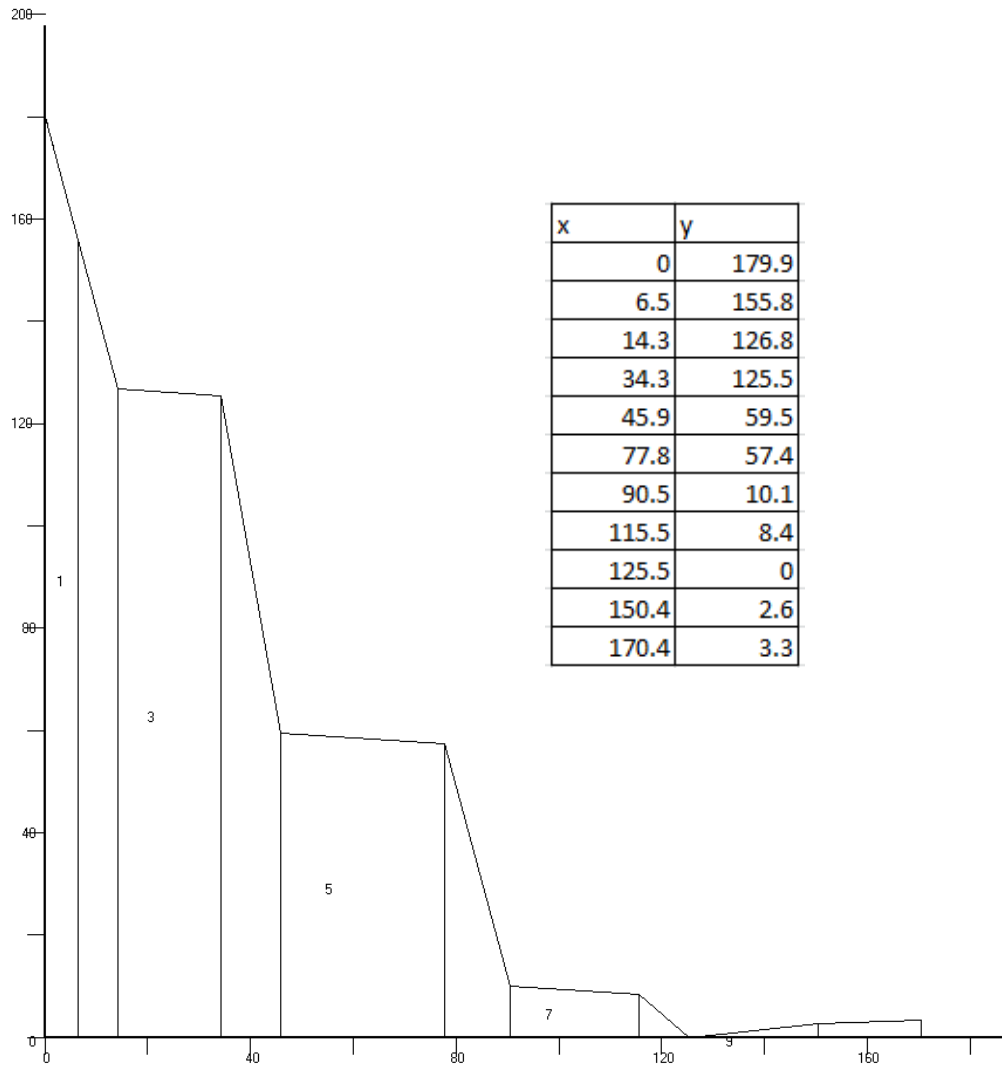
Figure 4.6 Soft Bedrock Calibration Site 1 Slope Profile created in CRSP-2D

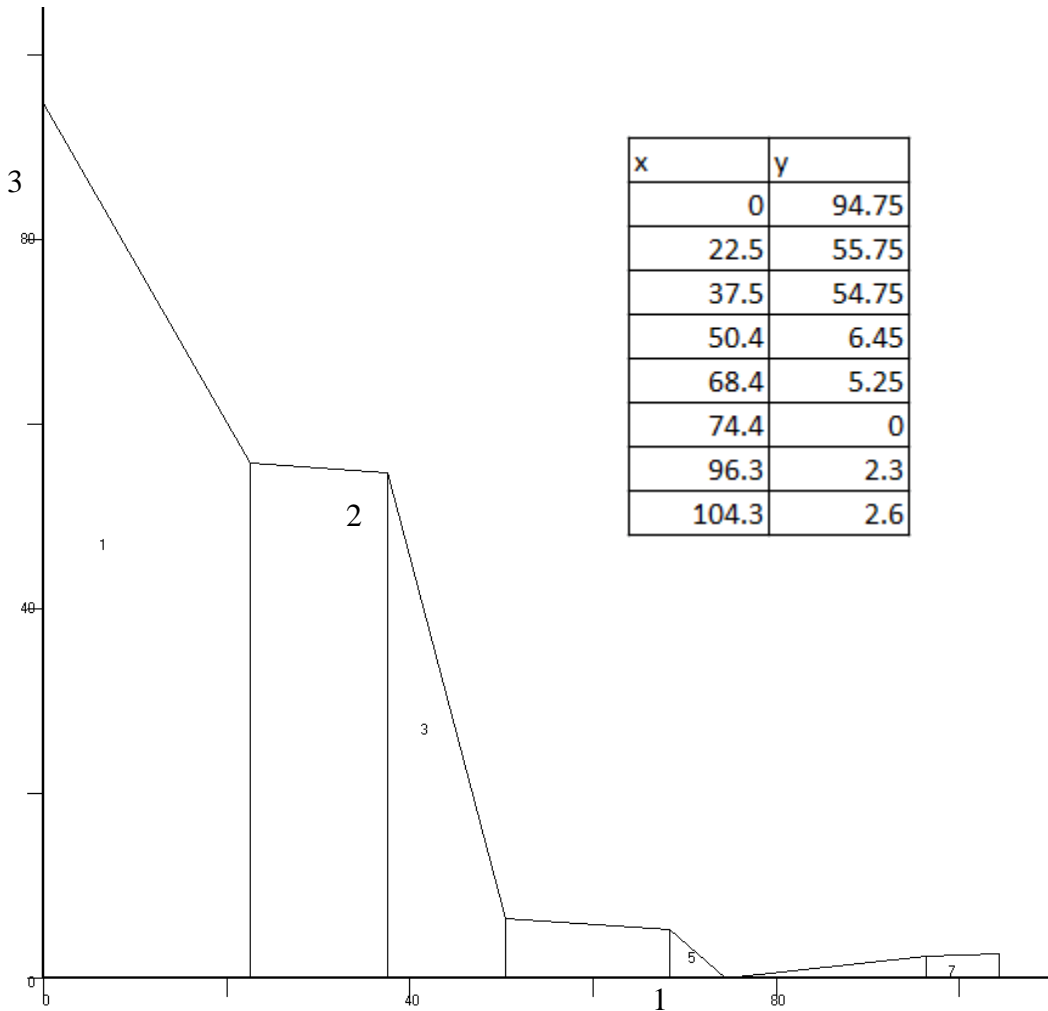
Figure 4.7 Hard Bedrock Calibration Site 1 Slope Profile created in CRSP-2D

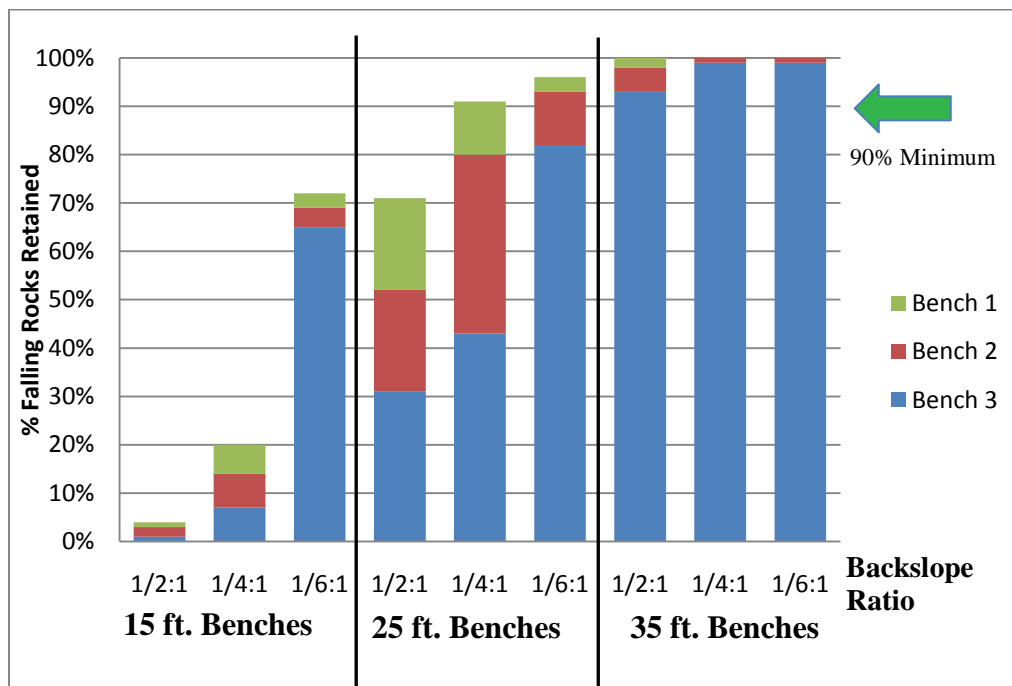
Figure 4.8 Graph depicting the ability of benches to be used as rockfall catchment on Type 1 Bedrock slopes with different backslope angles

To reiterate the results shown in Figures 4.8, 4.10, and 4.14, Figure 4.16 depicts a summary of these findings. The scatter plots show the trend lines for on-slope retention percentages with increased bench width. Figures 4.16a and 4.16c compare the relationships between bench width and percent retention for hard and soft bedrock slopes at different backslope ratios. Figures 4.16b and 4.16d compare these same relationships for slopes with RCAD ditches at the toe.

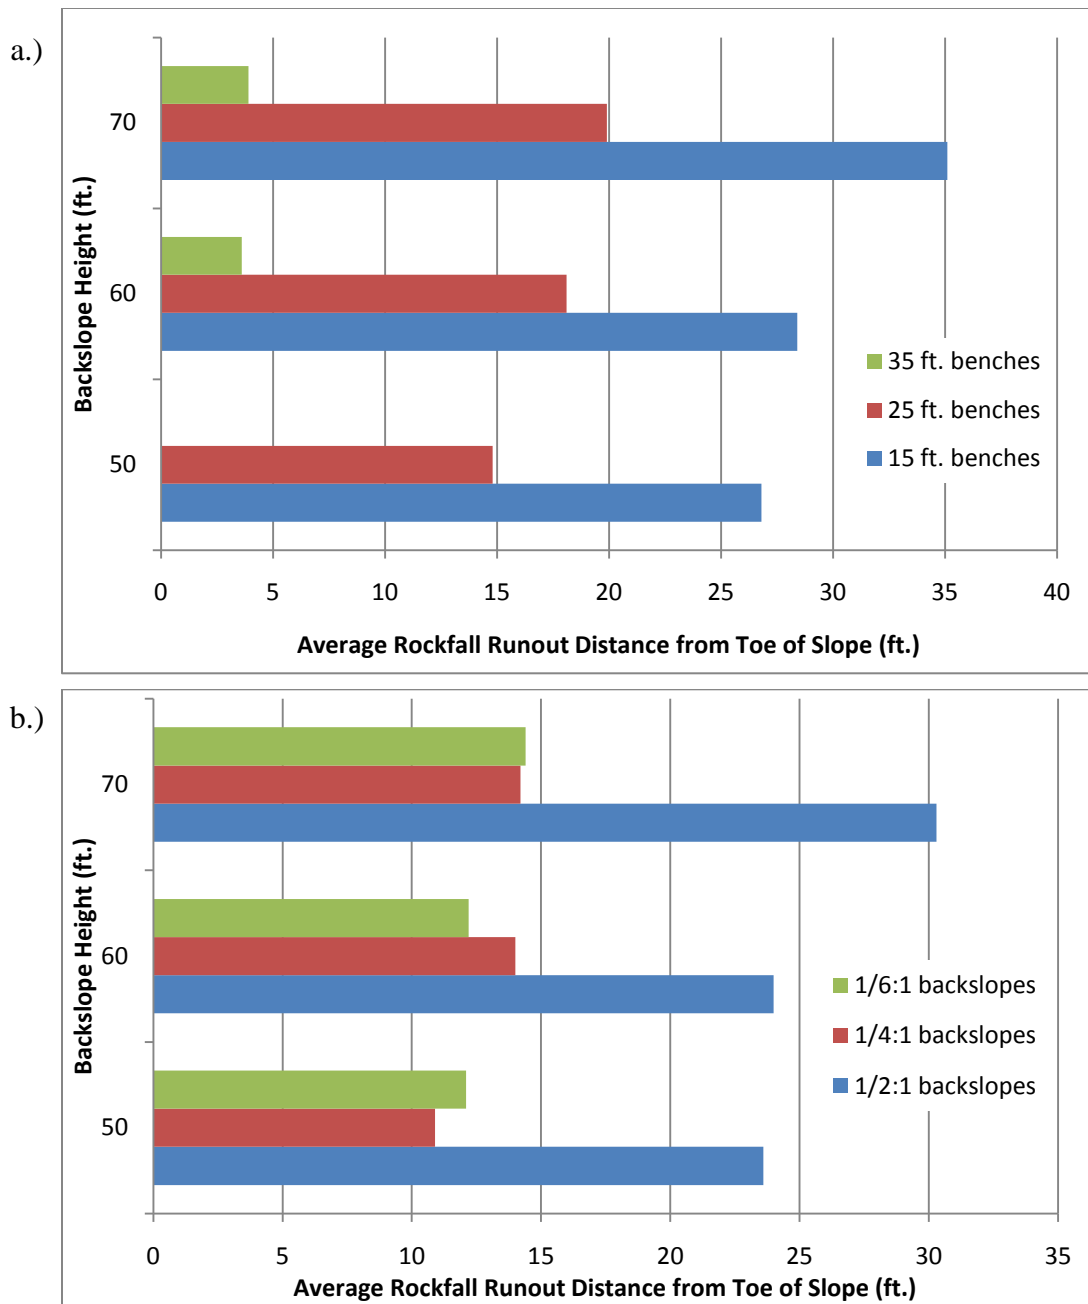
Figure 4.9 Graphs depicting the relationships between Bench Width (4.6a.) vs. Average Rockfall Runout Distance, and Backslope Angle (4.6b) vs. Average Rockfall Runout Distance for Type 1 Bedrock slopes

- The tabular results show that both backslope angle and bench width both have effects on rockfall runout, while the backslope height has a much smaller effect. Figure 4.9 compares the two factors with higher sensitivity side by side, showing that smaller benches and shallower slope angles cause noticeably larger average rockfall runout compared to larger bench widths and steeper slopes. Figure 4.9b shows that there is virtually no change in average runout between 1/4:1 and 1/6:1 backslope angles, suggesting that Type 1 Bedrock cut slopes should not be cut any shallower than 1/4:1 to reduce rockfall runout.

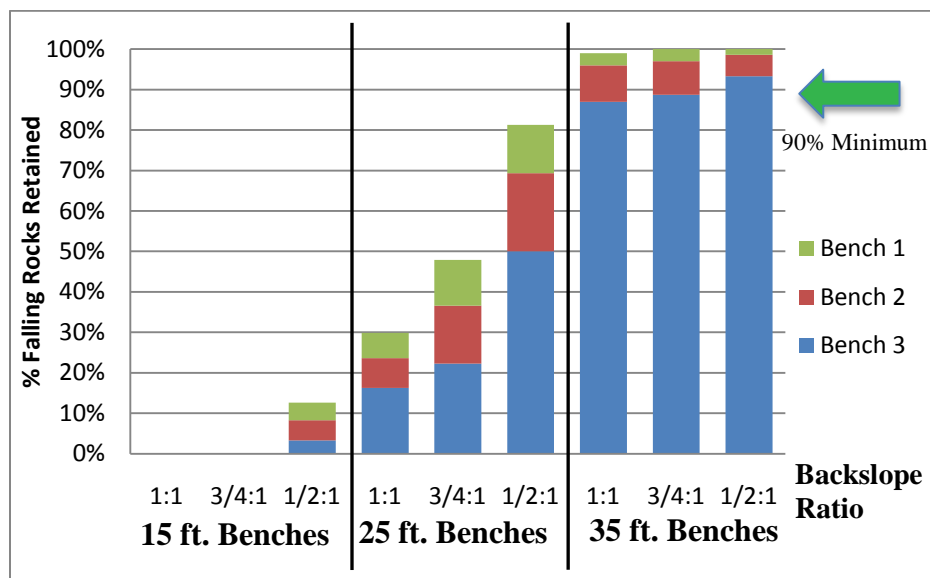
Figure 4.10 Graph depicting the ability of benches to be used as rockfall catchment on slopes with different backslope angles.

The rockfall simulations for Type 3 Bedrock produced similar results to those for Type 1 Bedrock. Figures 4.10 and 4.11 are graphical representations of the Type 3 results shown in Tables 4.19 through 4.21.

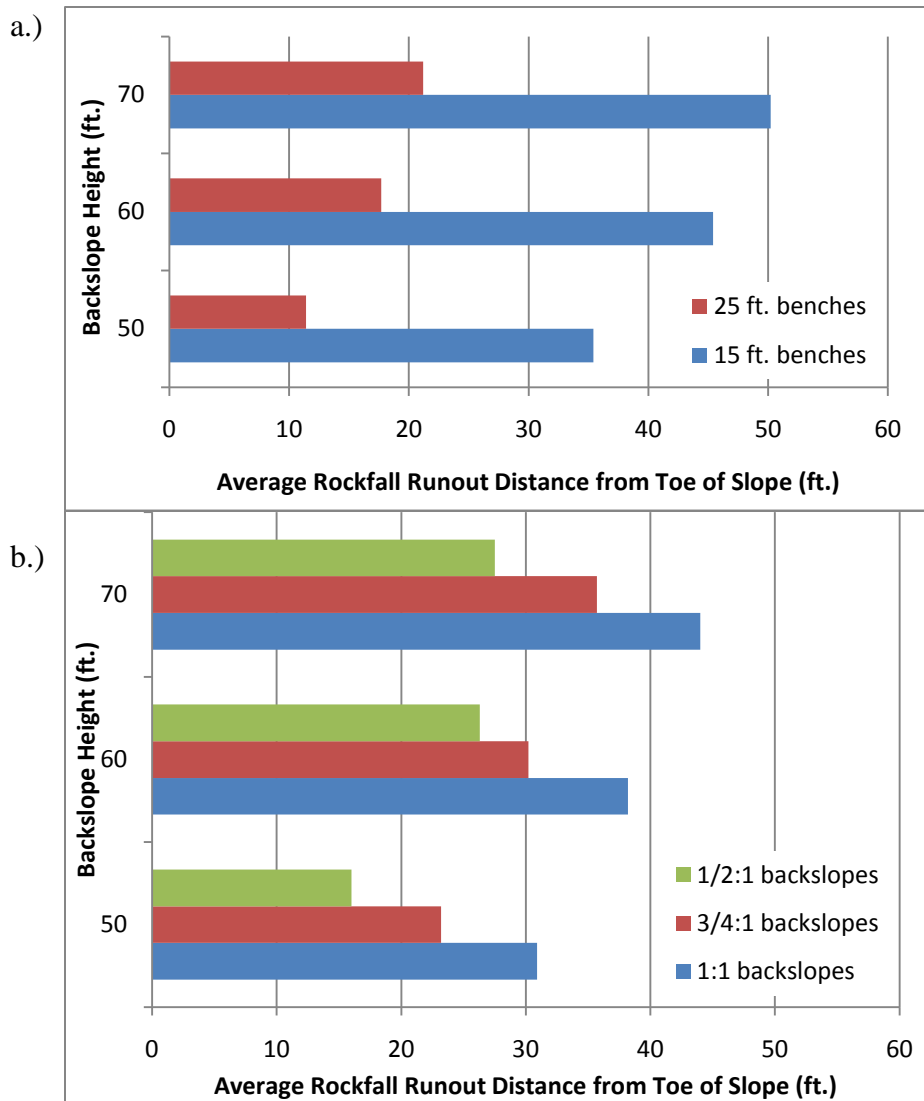
Figure 4.11 Graphs depicting the relationships between Bench Width (4.10a) vs. Average Rockfall Runout Distance, and Backslope Angle (4.10b) vs. Average Rockfall Runout Distance

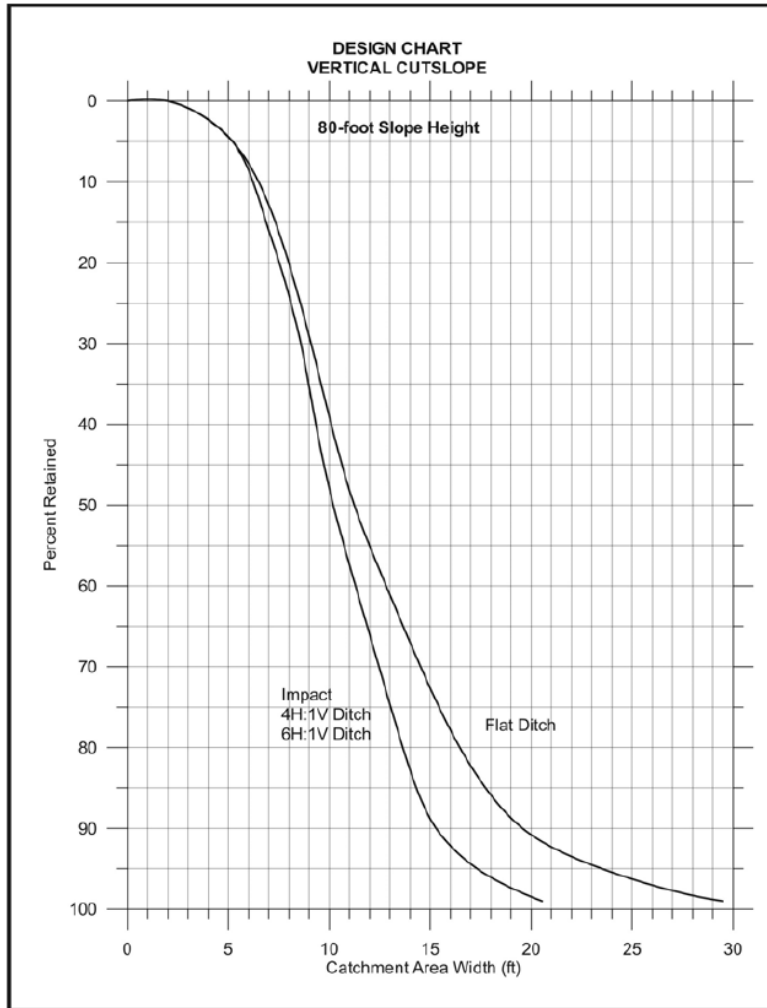
Figure 4.12 Sample RCAD Ditch Design Chart for 80-ft. slopes (ODOT 2001)

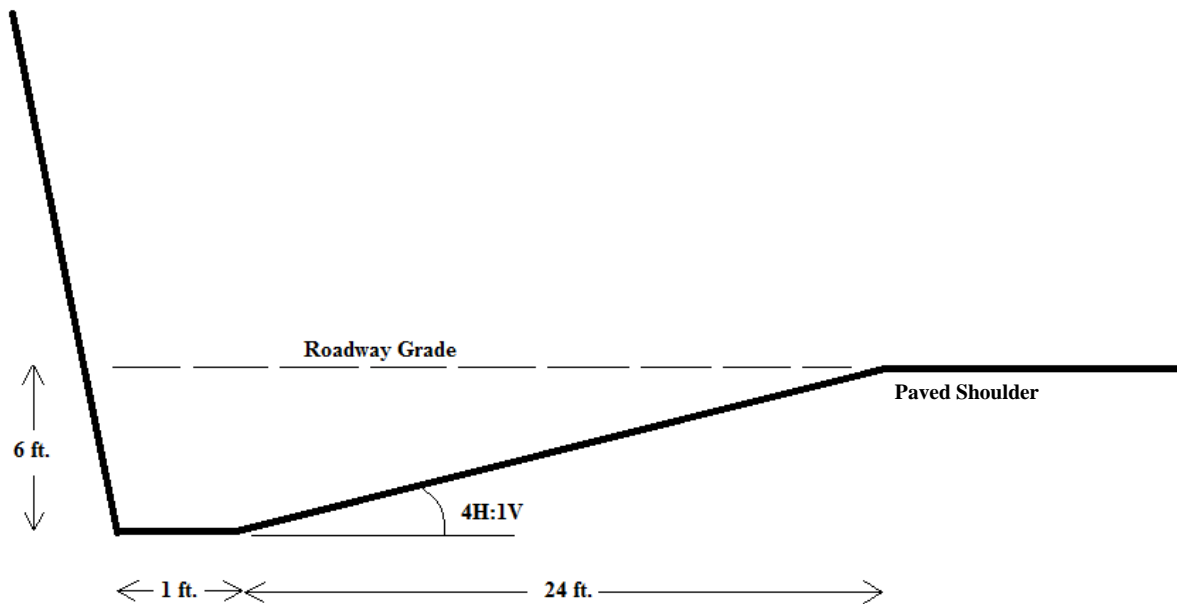
Figure 4.13 Visual Representation of the modified RCAD ditch developed for the CRSP-2D sensitivity analysis

- A sketch of the modified RCAD ditch created for this CRSP-2D sensitivity analysis can be found in Figure 4.13 below.

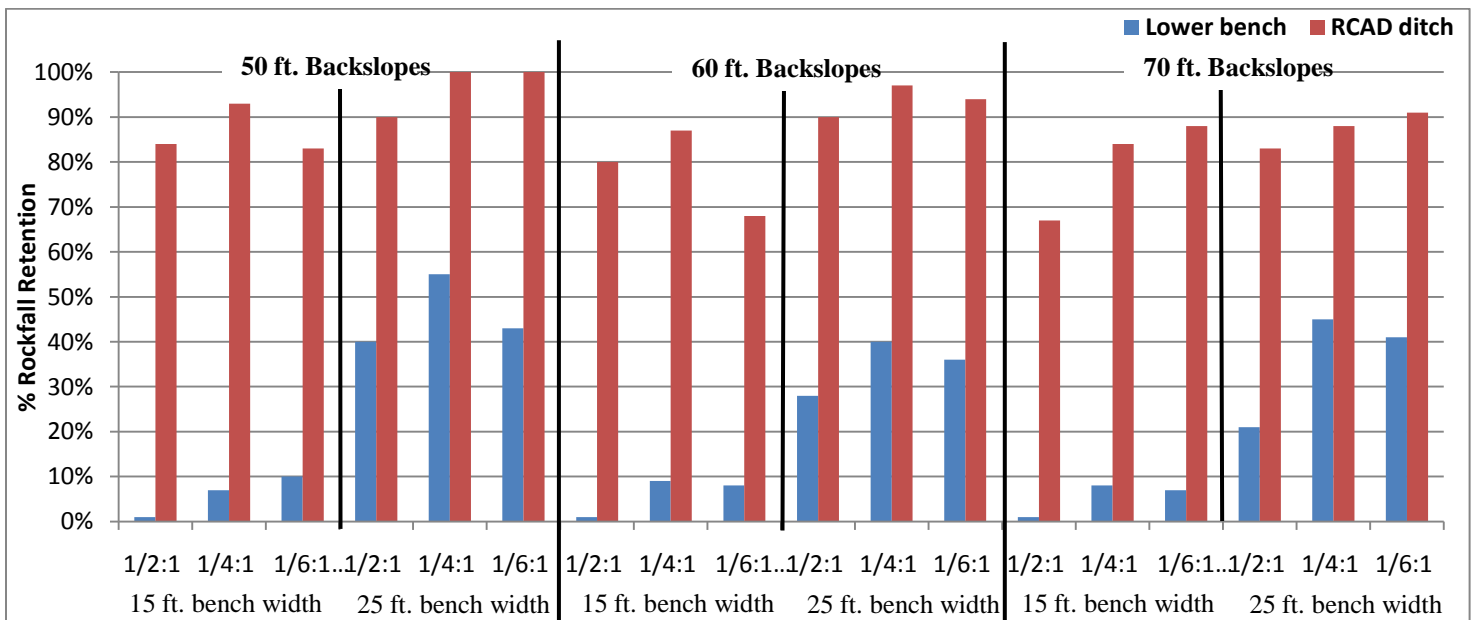
Figure 4.14 Graph comparing the rockfall catchment effectiveness of a WV DD-403 designed lower bench (blue) versus a RCAD designed ditch (red)

After re-simulating the slope models with the new ditch modifications, many results changed. Figure 4.14 shows the most drastic observable difference between the lower bench slopes and the RCAD ditch slopes in regards to rockfall catchment. The RCAD ditch, with an average width equal to that of the lower catchment ditch, caught an average of 65% more rocks than the bench design that WV DD-403 recommends, when simulated with CRSP-2D. While a cost analysis was not conducted, it should be considered that the reduction in additional mitigation and maintenance costs due to greater catchment exceeds the increase in excavation costs to implement a ditch design. Thus it is recommended that WVDOT adjusts their rock cut slope design directives to implement a rockfall catchment ditch similar to the Rockfall Catchment Area Design guidelines developed by Oregon DOT, in place of the current practice of a lower catchment bench.

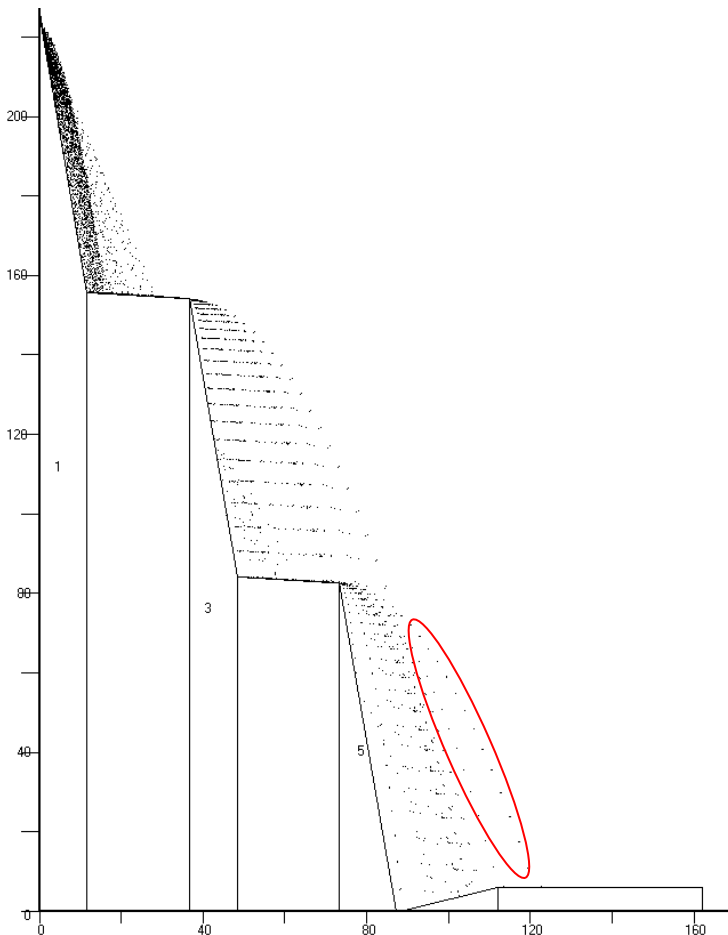
*Figure 4.15 CRSP-2D Simulation Results for a Type 1 Bedrock slope with 70 ft. tall backslopes, 25 ft. wide benches, and an RCAD-style ditch at toe. The red circle depicts the small percentage of rocks that launched over the ditch*

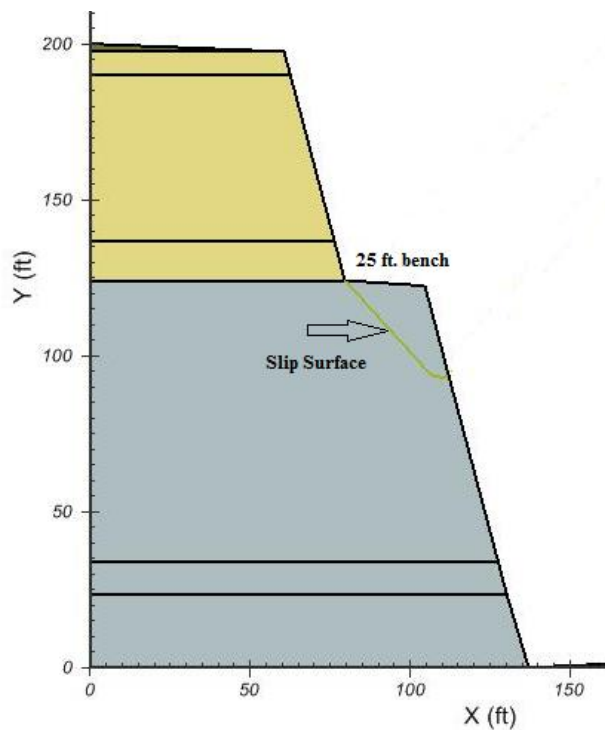
Figure 5.1 Example of a slip surface created with SVSlope<sup>®</sup> modeling software

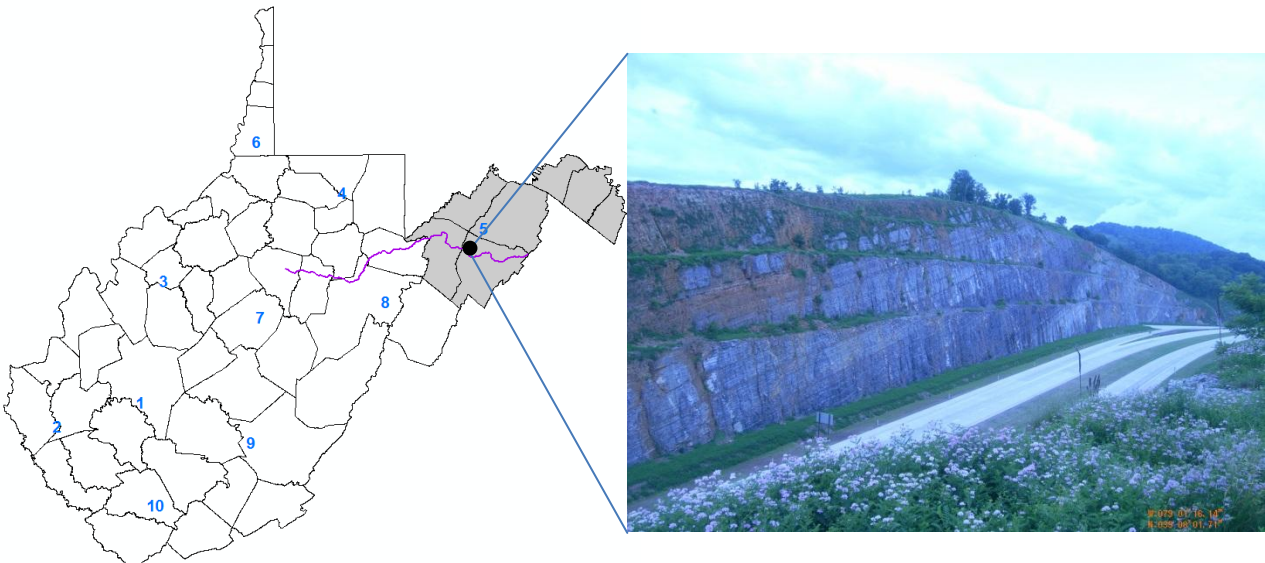
Figure 6.1 Slope Section of US Rt. 48 (Corridor H) in WVDOT District 5, Grant Co., WV

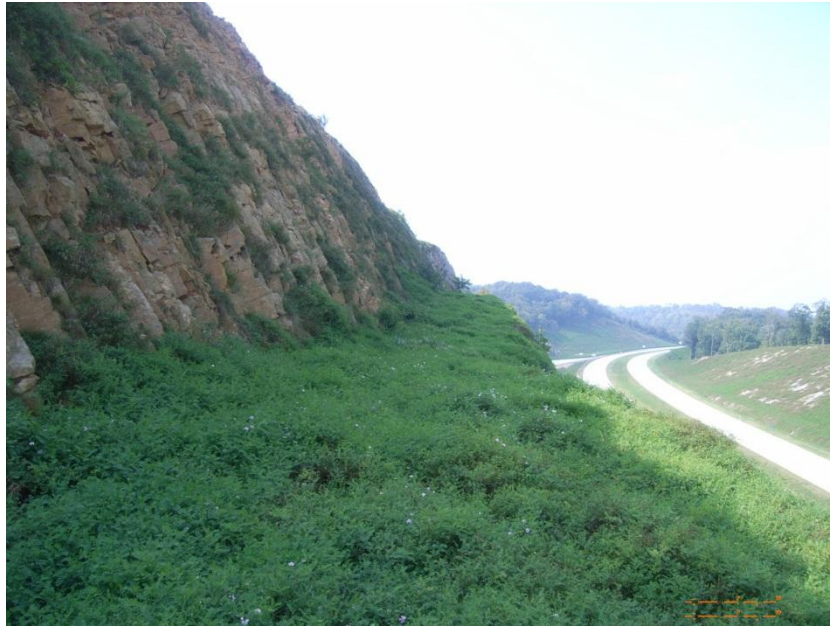
*Figure 6.2 Vegetative cover on bench and portions of backslope on the US Rt. 48 Cut Slope Section*

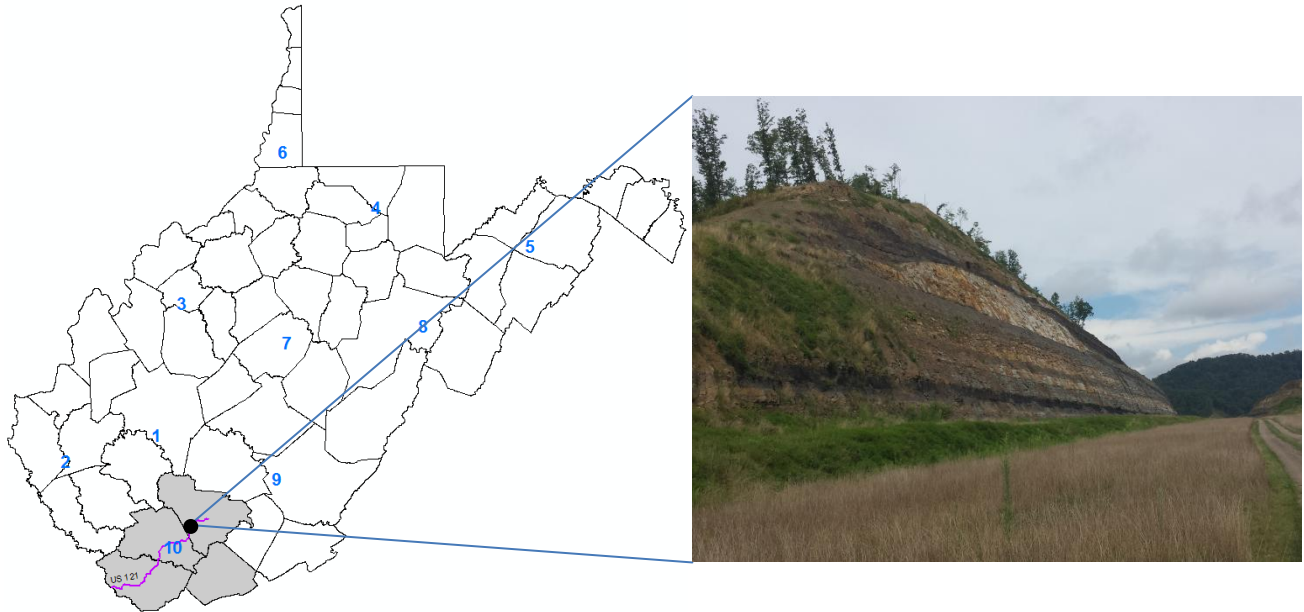
*Figure 6.3 Slope Section of US Route 121 (Coalfields Expressway) in WVDOT District 10, Raleigh Co., WV.*

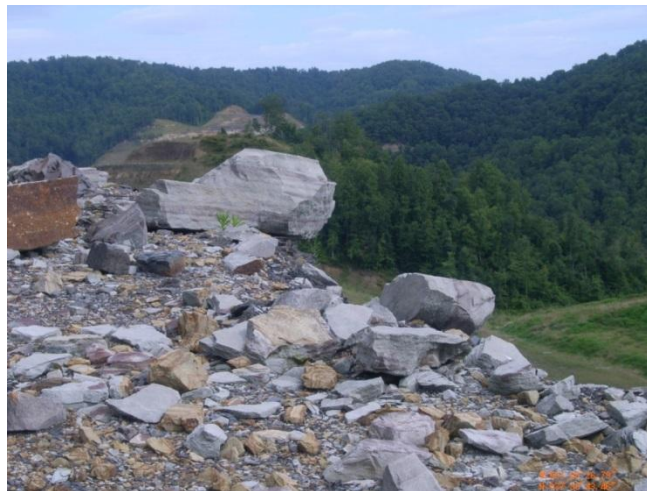
*Figure 6.4 Accumulation of large rocks on a bench on the US Rt. 121 Cut Slope Section*

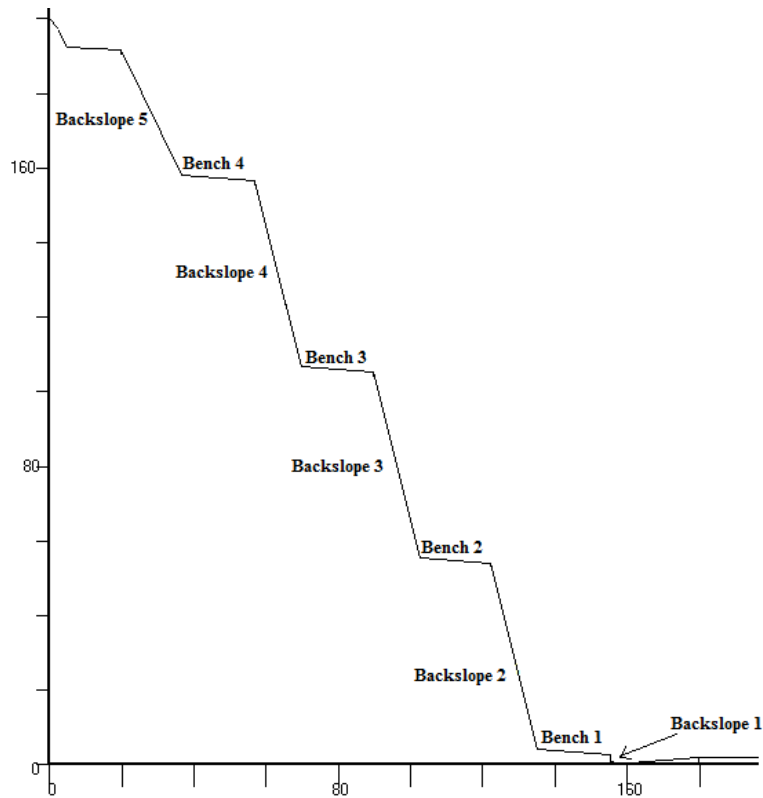
Figure 6.5 Two-Dimensional Profile of As-built Slope Section of US Route 48

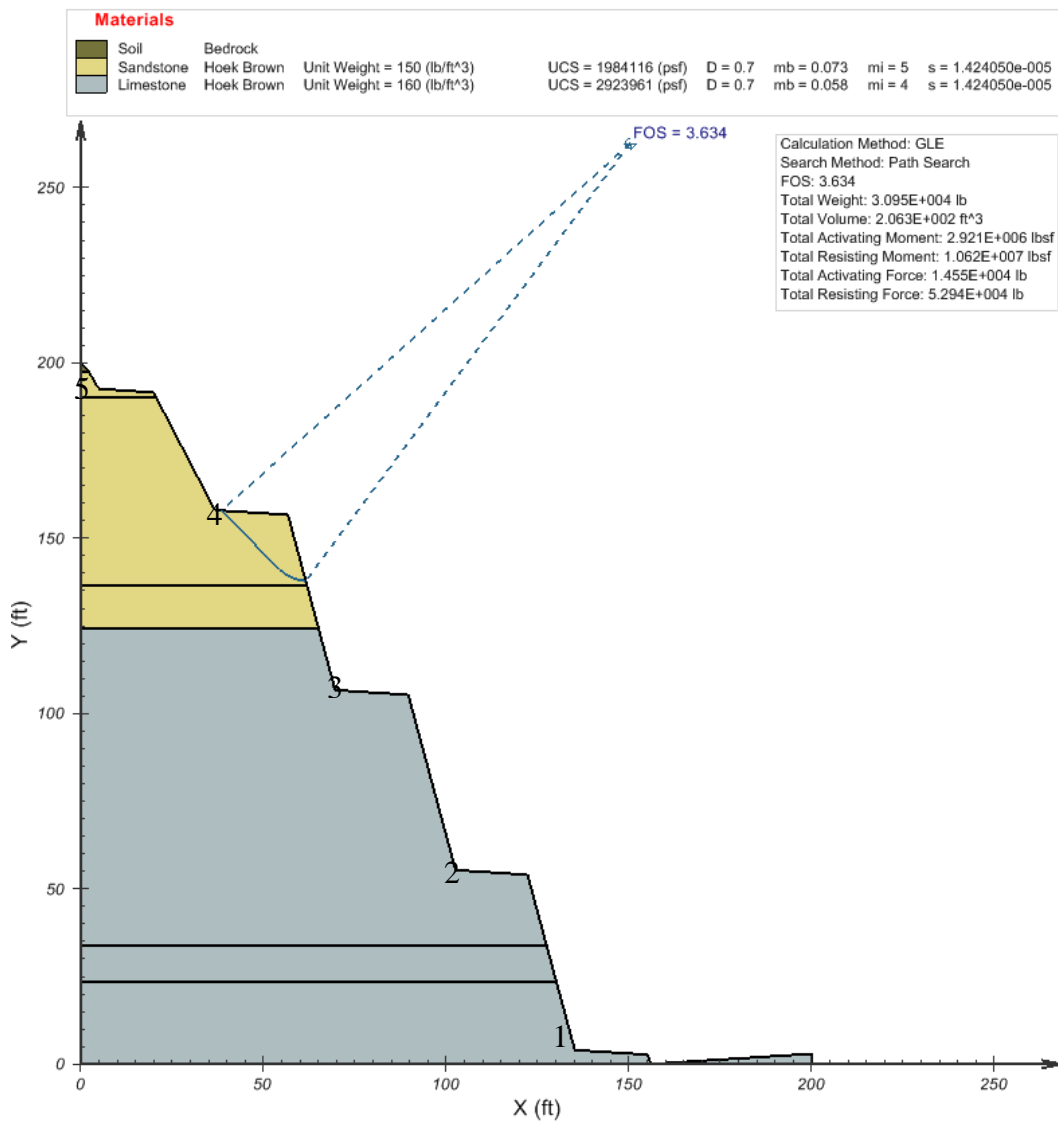
Figure 6.6 Two-Dimensional Slope Section Profile and Stability Analysis results for As-built slope section on US Route 48.

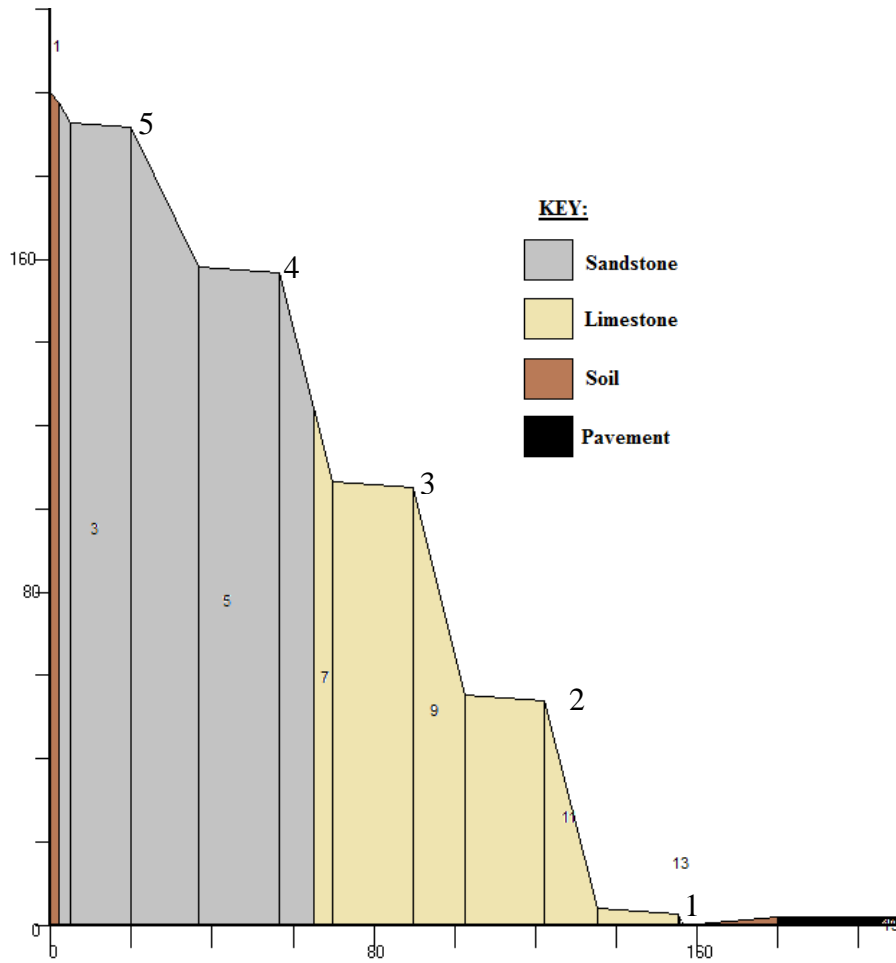
Figure 6.7 Two-Dimensional Slope Section Profile from As-built slope section of US Route 48 modeled in CRSP-2D

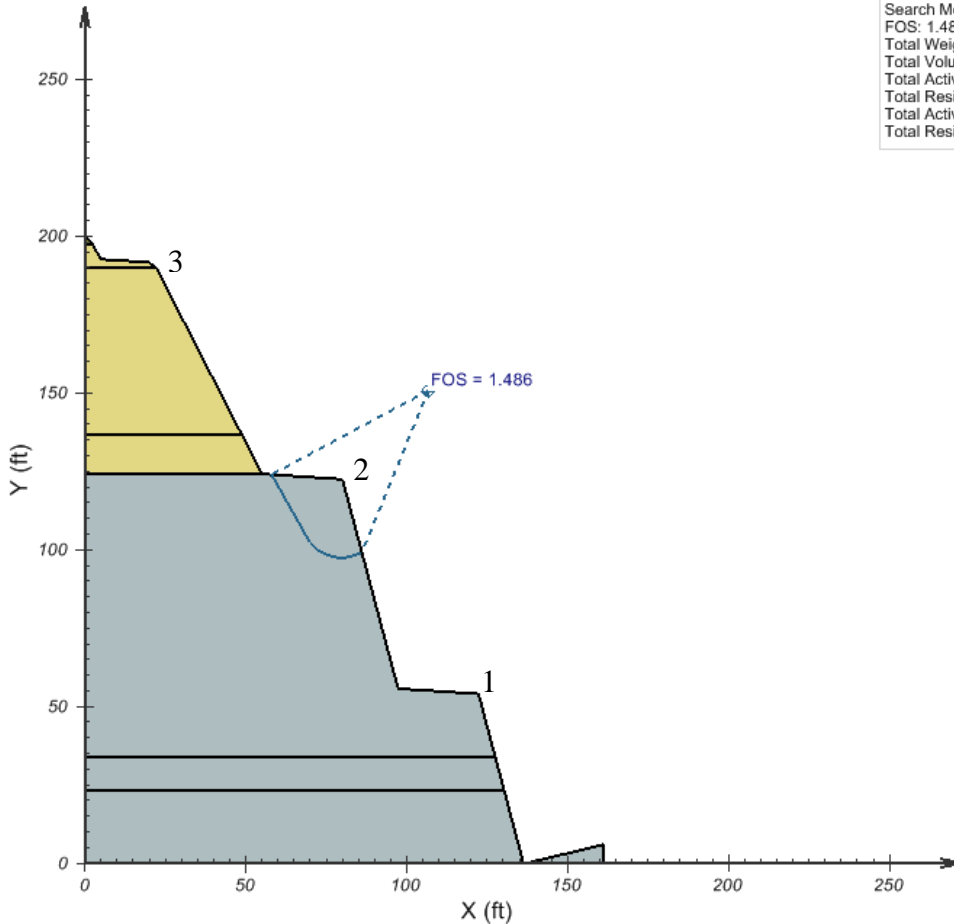
Figure 6.8 Two-Dimensional Slope Section Profile and Stability Analysis results for first bench removal case on US Route 48 slope section.

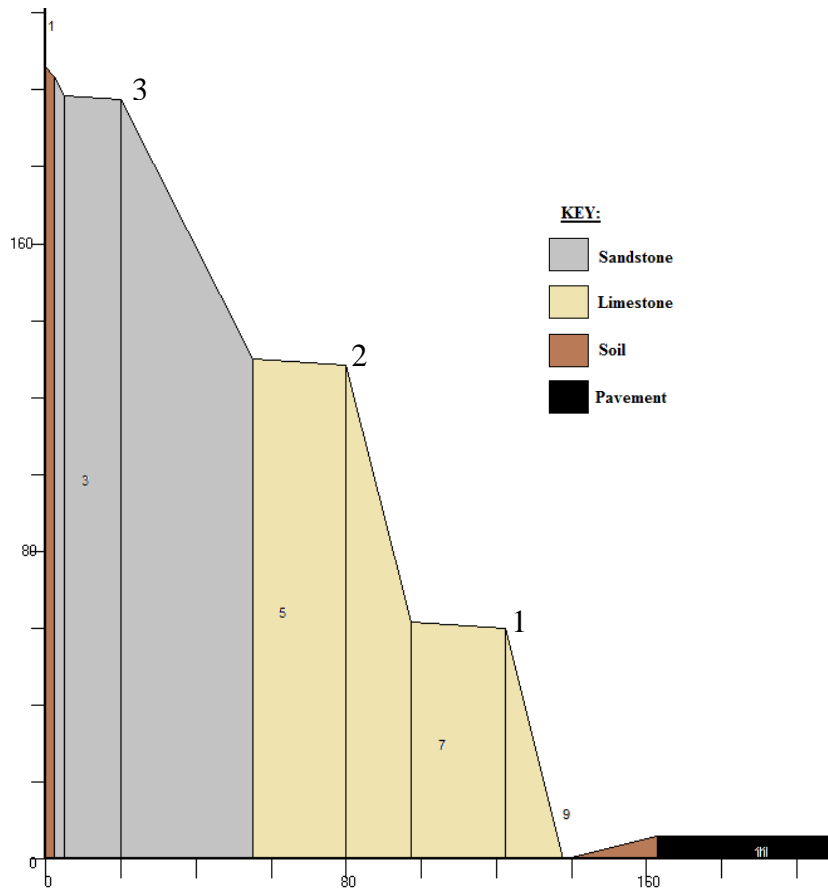
*Figure 6.9 Two- Dimensional Slope Section Profile from first bench removal case of slope section of US Route 48 modeled in CRSP-2D*

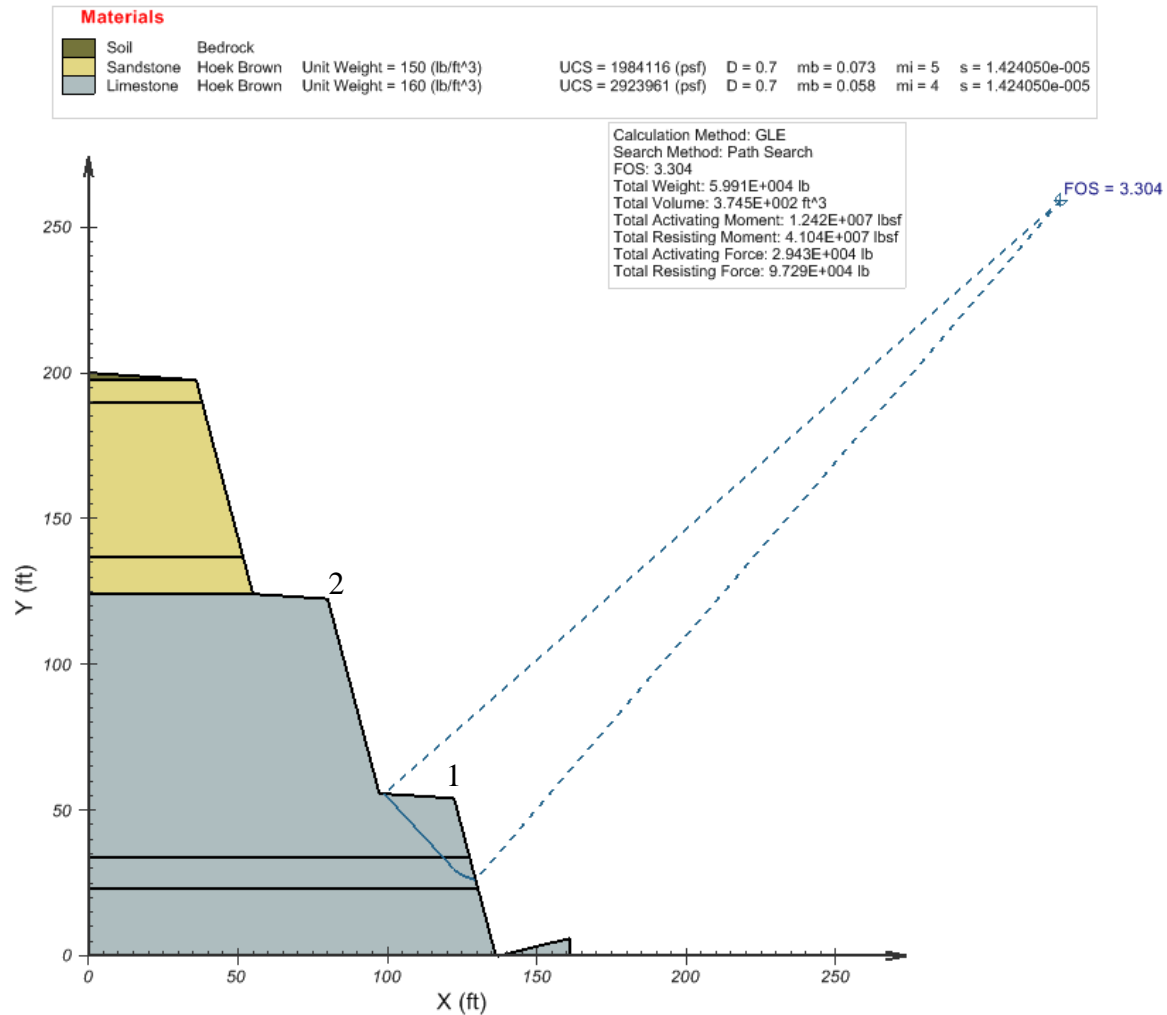
Figure 6.10 Two-Dimensional Slope Section Profile and Stability Analysis results for second bench removal case on US Route 48 slope section.
