## Effects of Slope Geometry Alterations on Rockfall Mitigation along Highway Rock Cut Slopes in West Virginia

# **Effects of Slope Geometry Alterations on Rockfall Mitigation along Highway Rock Cut Slopes in West Virginia**

Thesis submitted to the  
Benjamin M. Statler College of Engineering and Mineral Resources  
at West Virginia University  
in partial fulfillment of the requirements  
for the degree of

Master of Science  
in  
Civil and Environmental Engineering

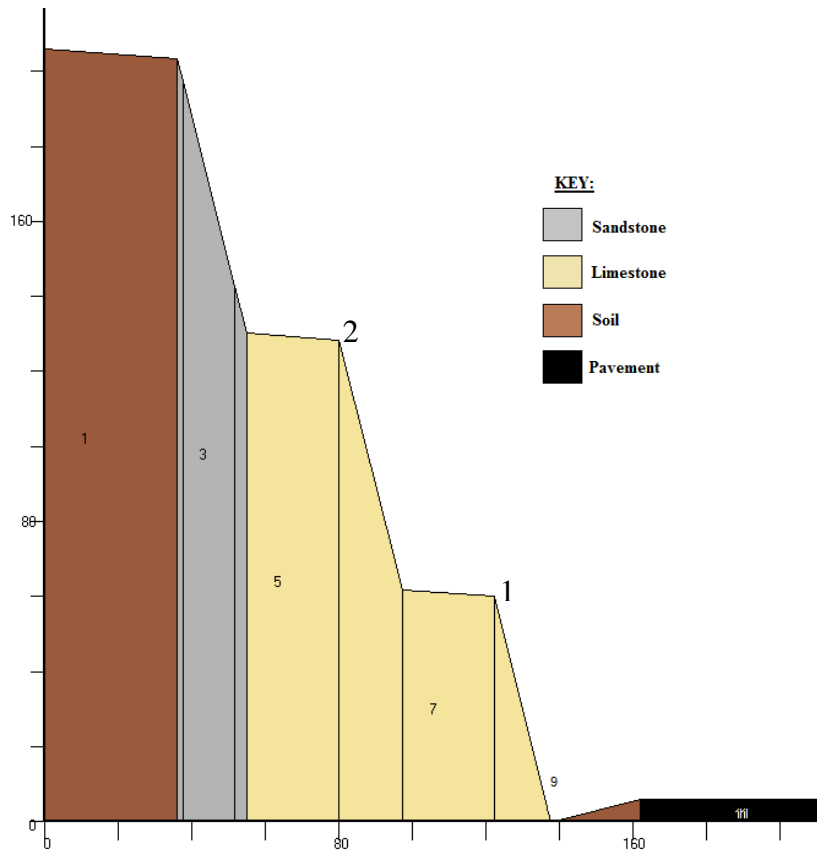
Figure 6.11 Two- Dimensional Slope Section Profile from second bench removal case of slope section of US Route 48 modeled in CRSP-2D

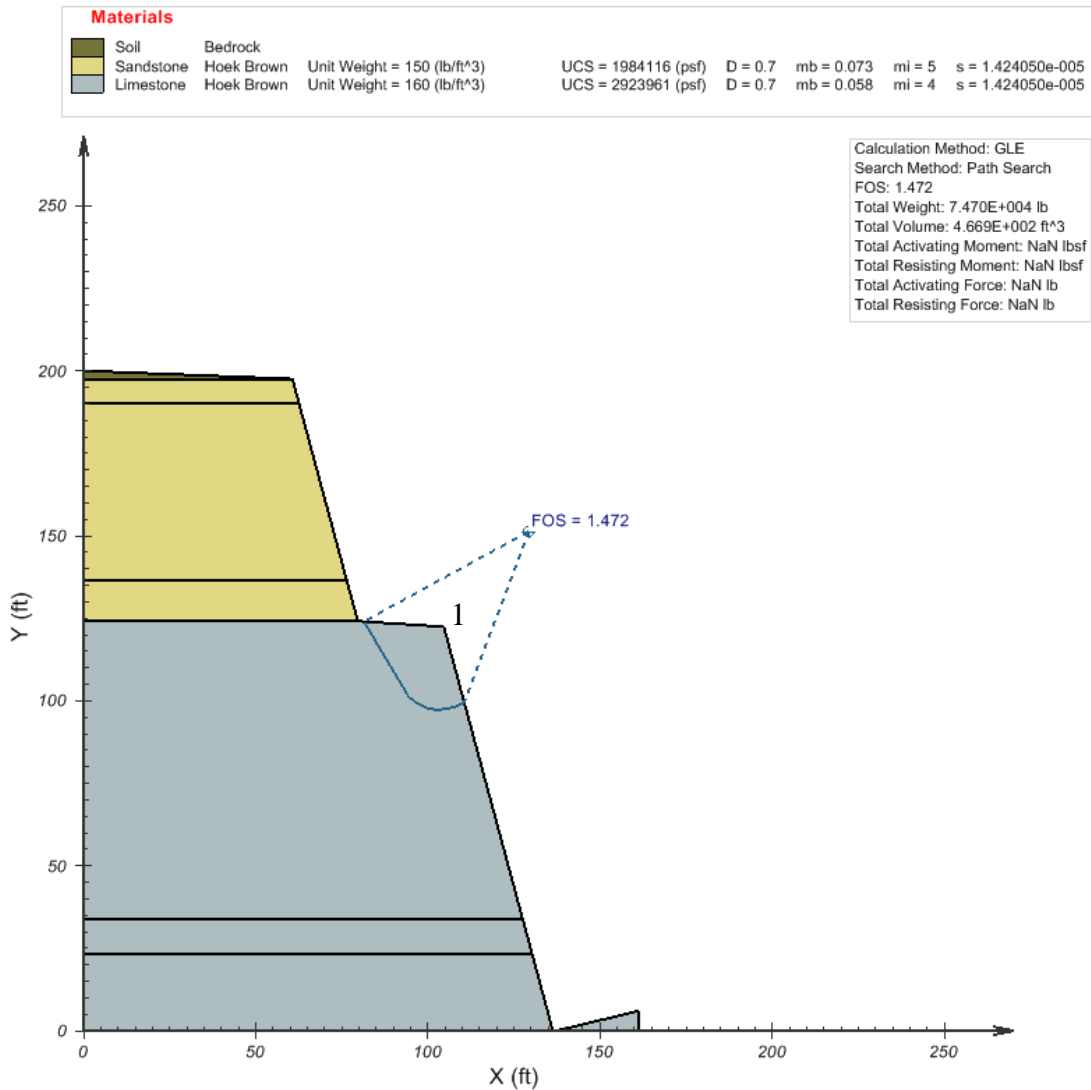
Figure 6.12 Two- Dimensional Slope Section Profile and Stability Analysis results for third bench removal case on US Route 48 slope section.

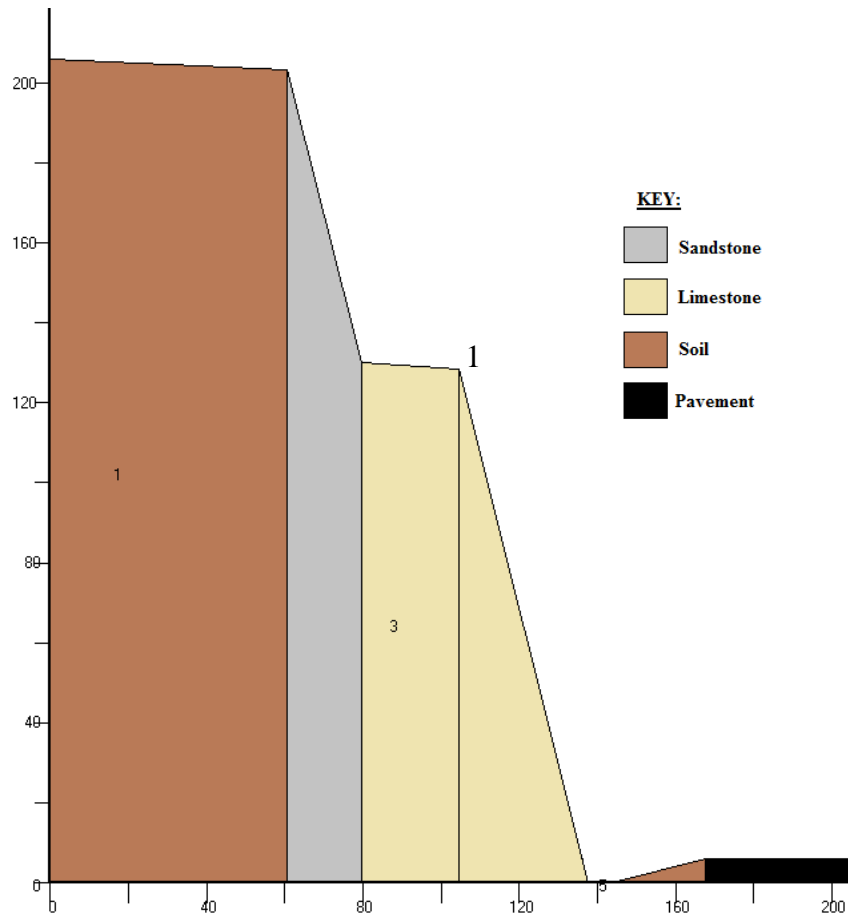
Figure 6.13 Two- Dimensional Slope Section Profile from third bench removal case of slope section of US Route 48 modeled in CRSP-2D

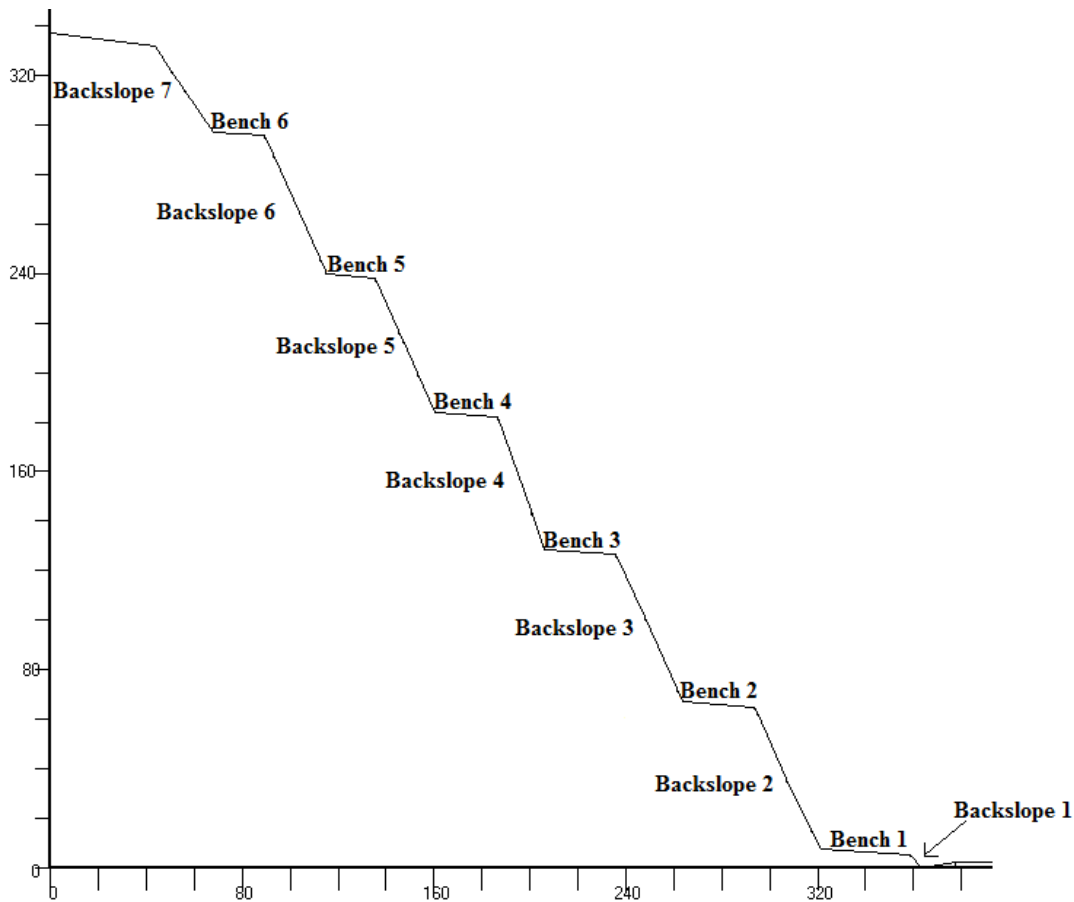
Figure 6.14 Two-Dimensional Profile of As-built Slope Section of US Route 121

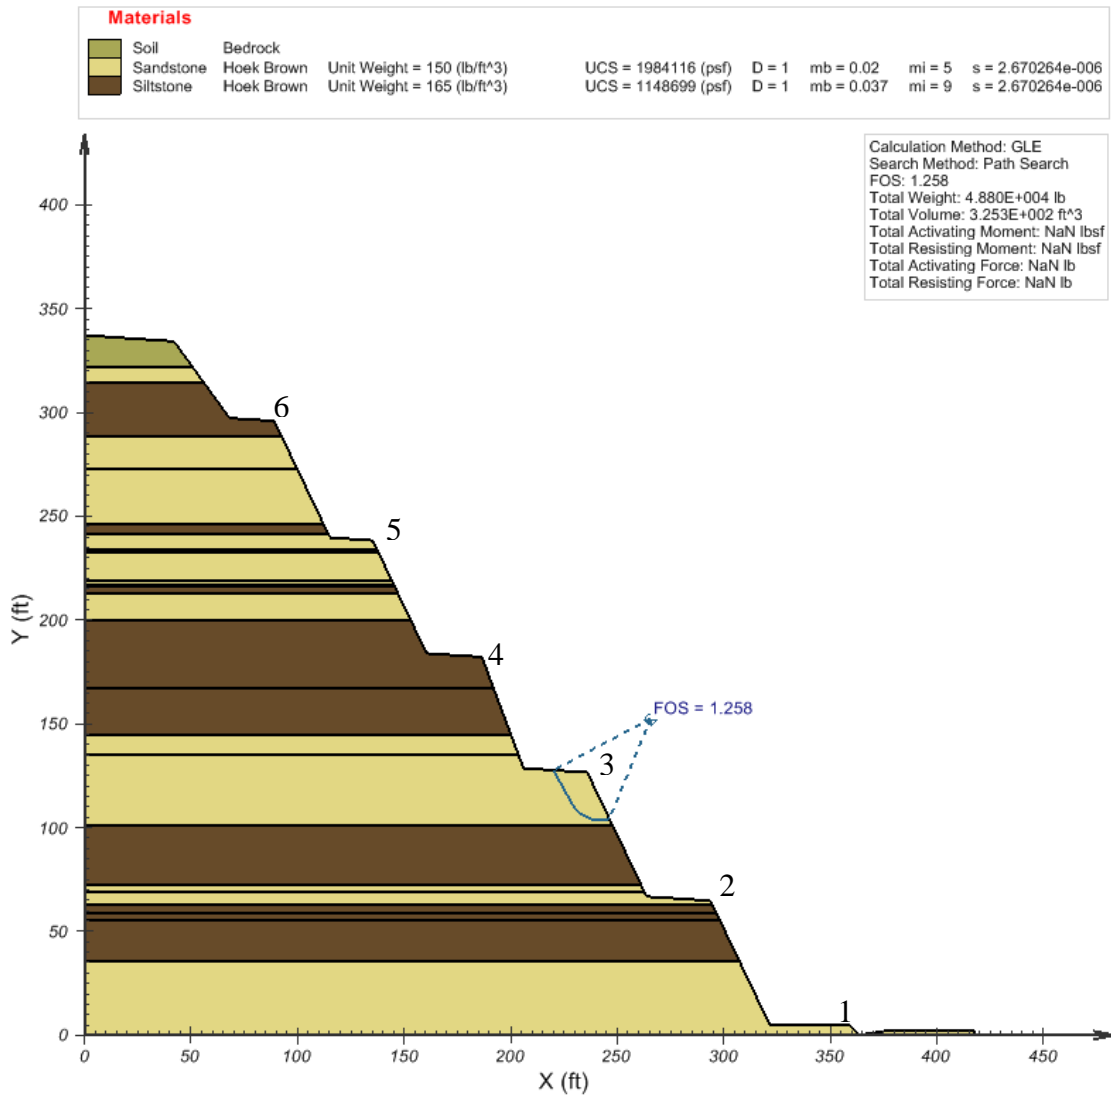
Figure 6.15 Two-Dimensional Slope Section Profile and Stability Analysis results for As-built slope section on US Route 121.

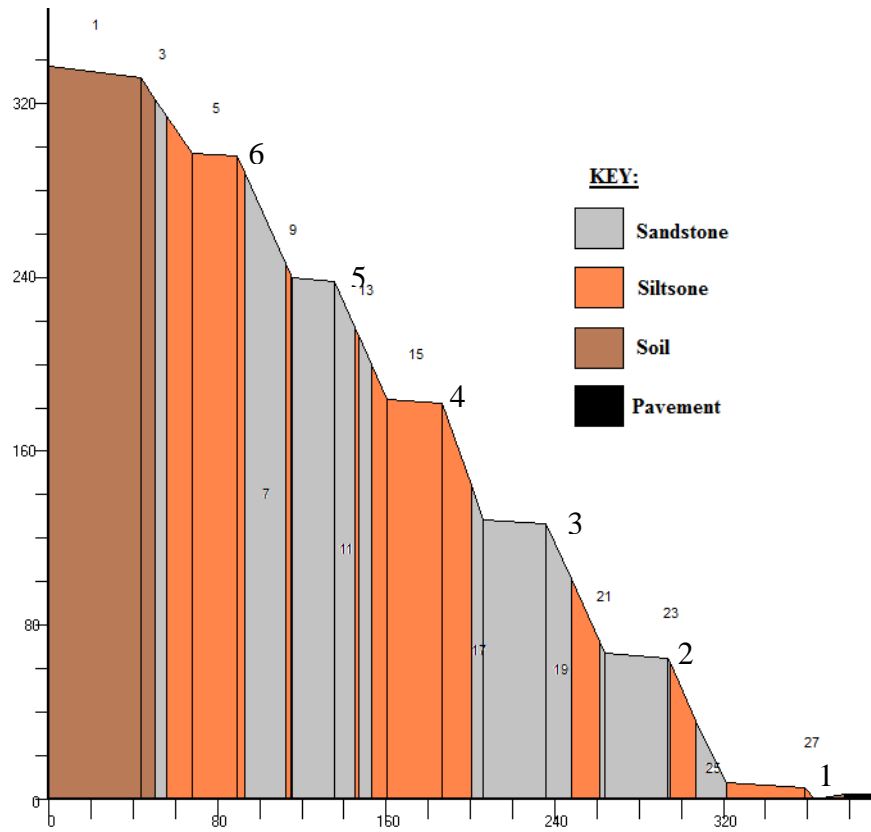
Figure 6.16 Two-Dimensional Slope Section Profile from As-built slope section of US Route 121 modeled in CRSP-2D

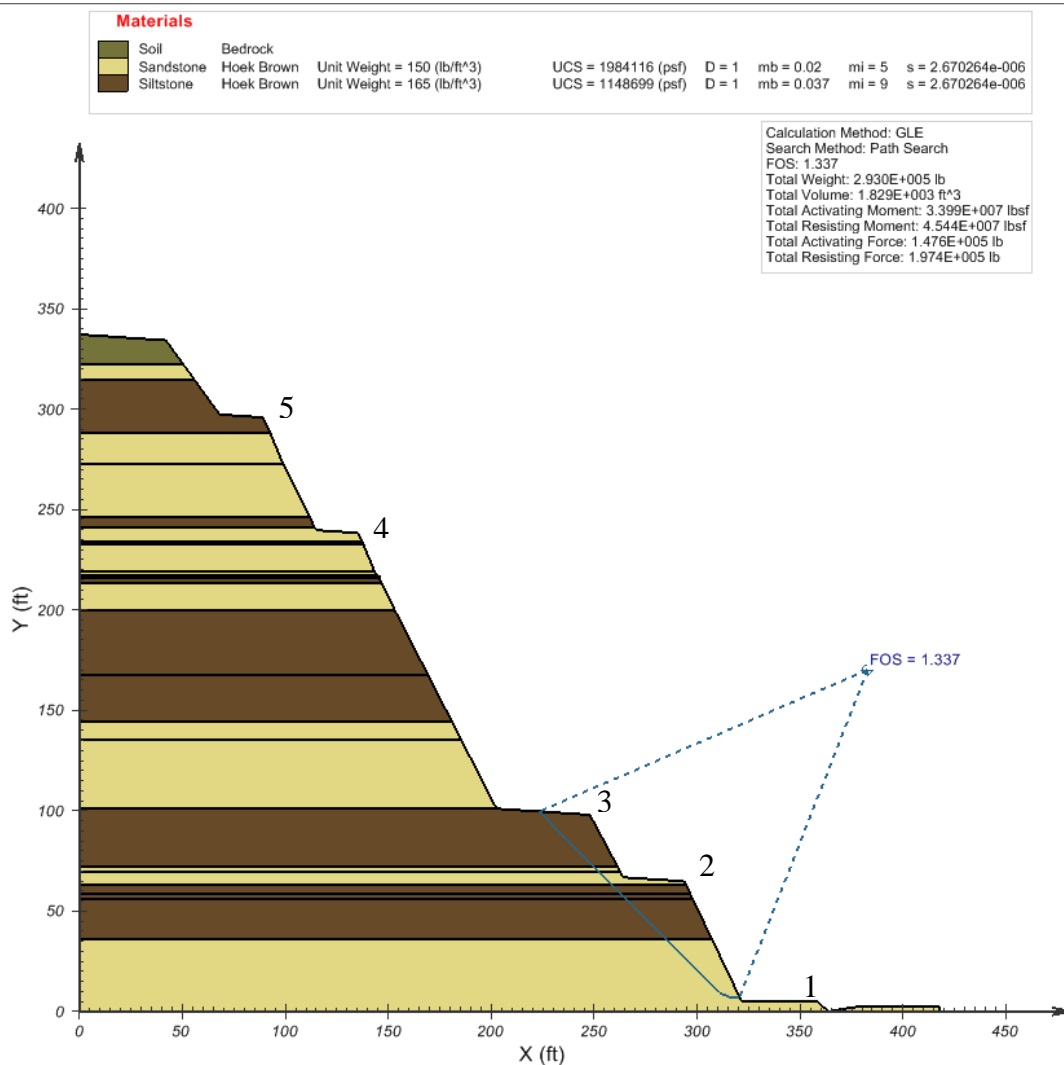
Figure 6.17 Two-Dimensional Slope Section Profile and Stability Analysis results for Bench Reduction Trial 1 slope section on US Route 121.

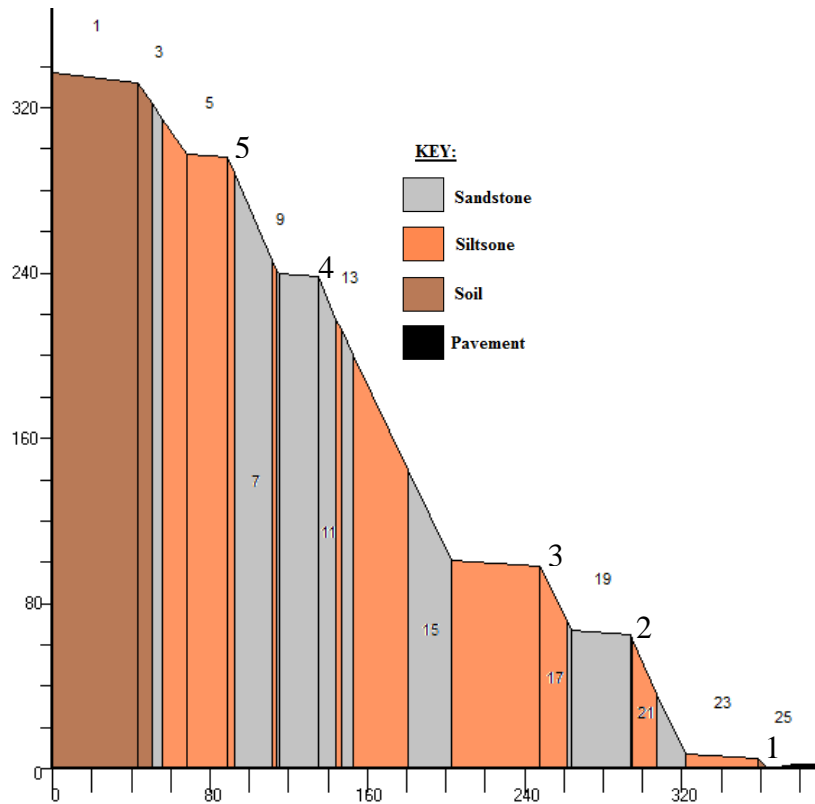
*Figure 6.18 Two- Dimensional Slope Section Profile from first bench removal case of slope section of US Route 121 modeled in CRSP-2D*

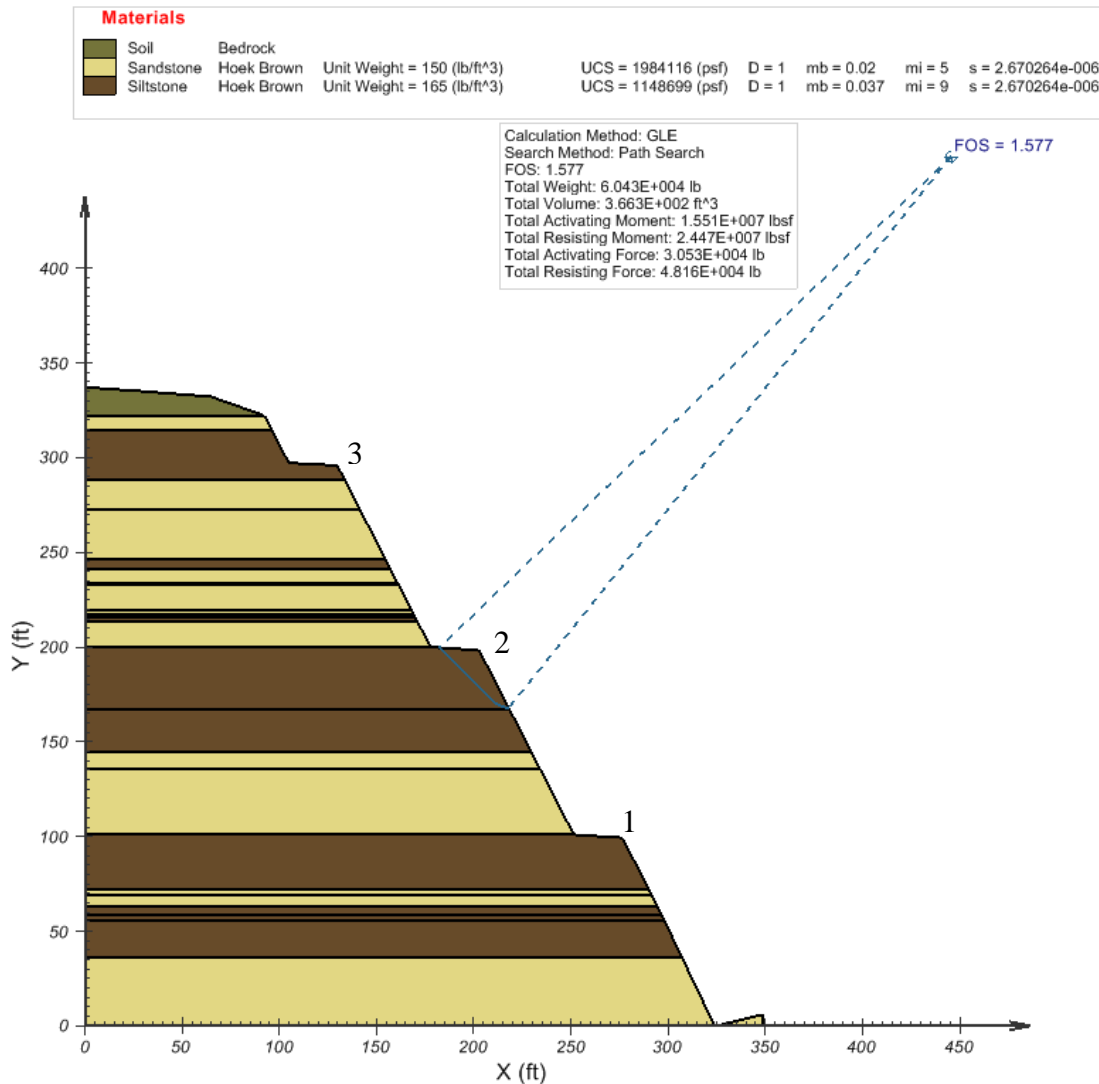
Figure 6.19 Two-Dimensional Slope Section Profile and Stability Analysis results for Bench Reduction Trial 2 slope section on US Route 121.

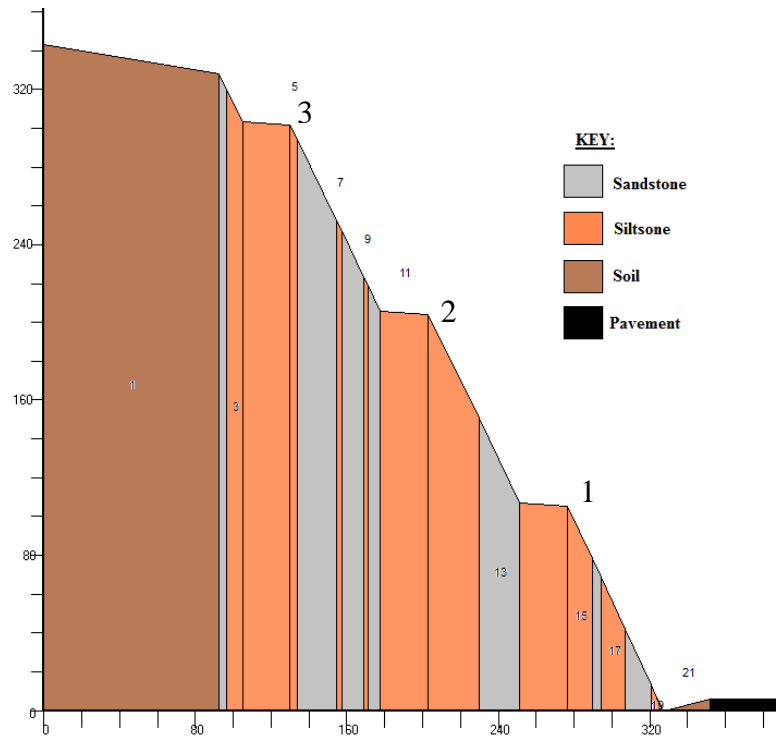
Figure 6.20 Two- Dimensional Slope Section Profile from second bench removal case of slope section of US Route 121 modeled in CRSP-2D

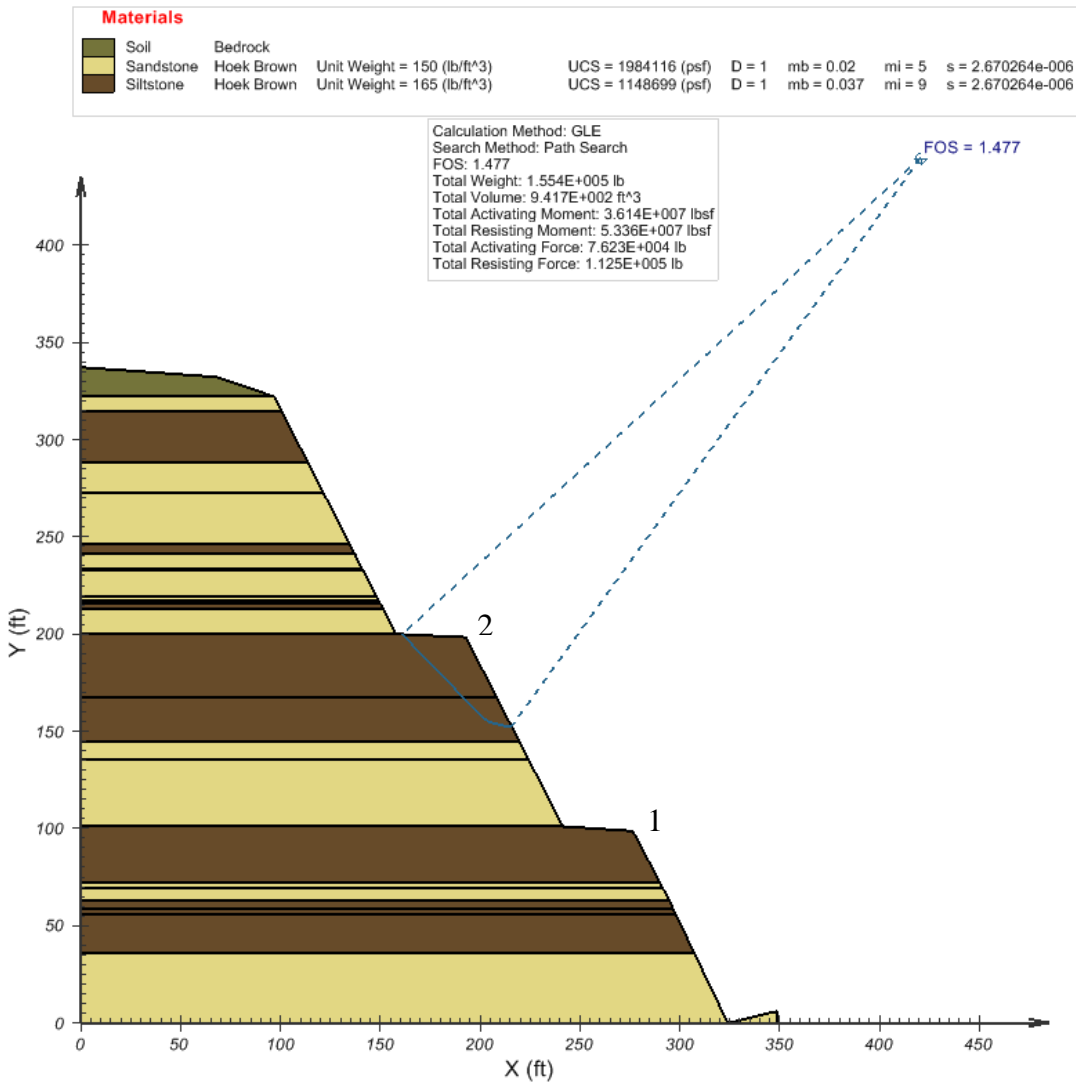
Figure 6.21 Two-Dimensional Slope Section Profile and Stability Analysis results for Bench Reduction Trial 3 slope section on US Route 121.

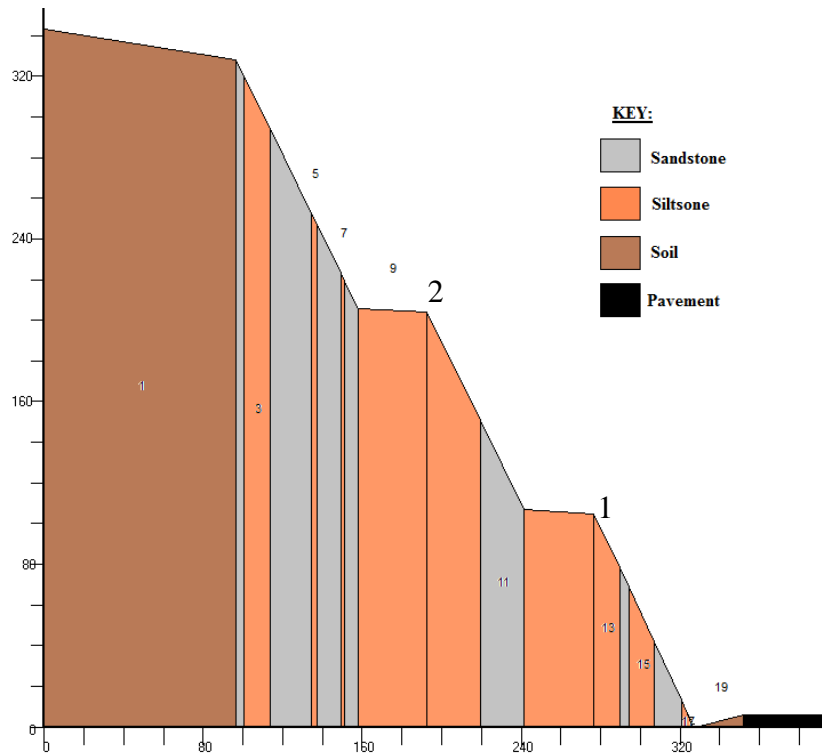
Figure 6.22 Two- Dimensional Slope Section Profile from third bench removal case of slope section of US Route 121 modeled in CRSP-2D

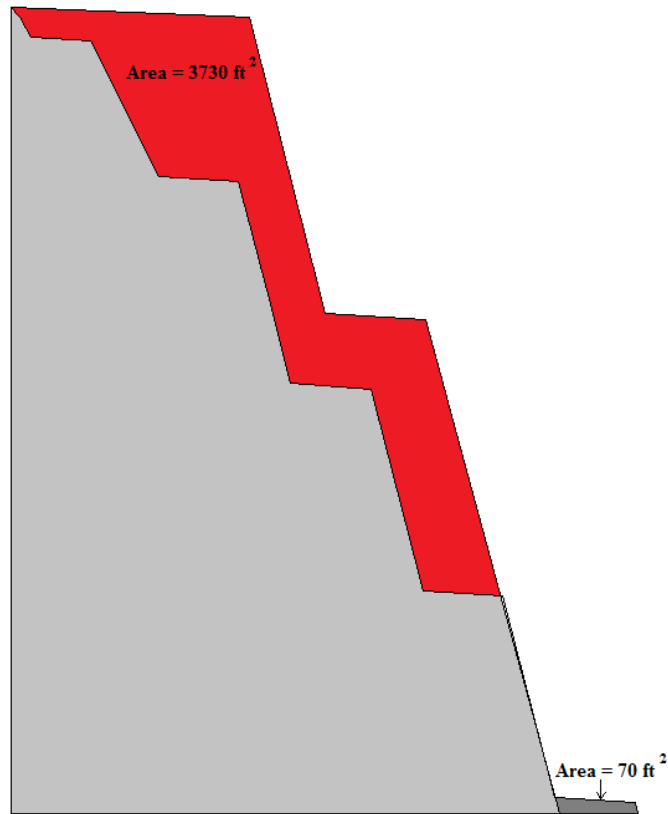
Figure 6.23 Cross-Sectional display of excavation reduction associated with bench removal on case study section of US Route 48.

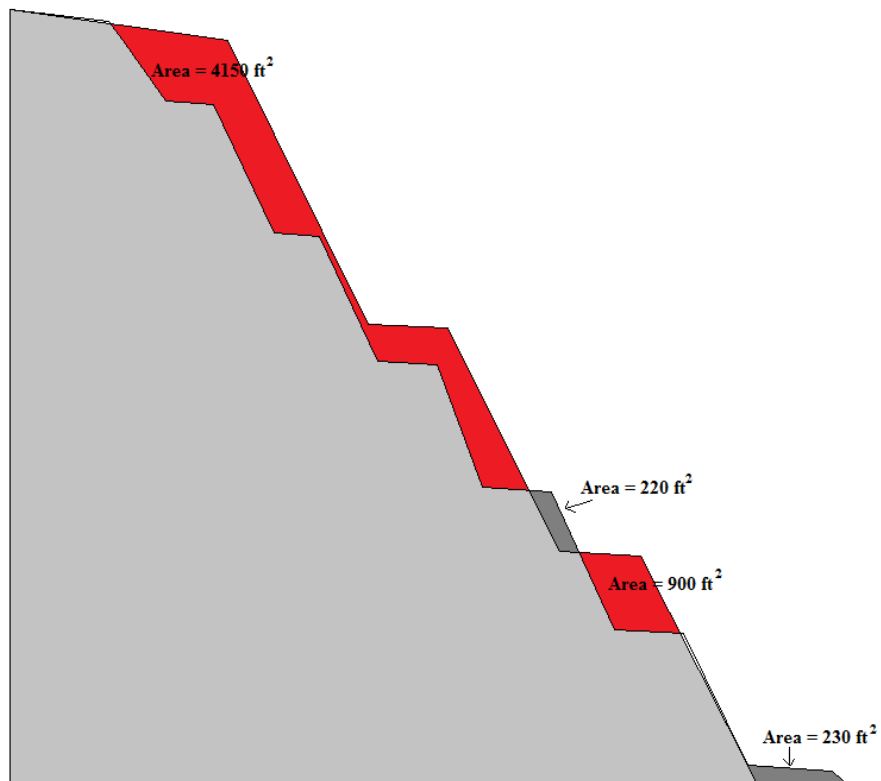
Figure 6.24 Cross- Sectional display of excavation reduction associated with bench removal on case study section of US Route 121.

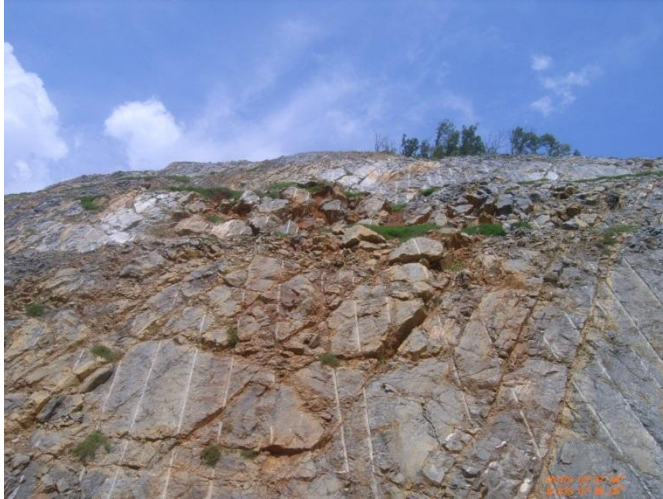
*Photo 1: Fractured backslope face with clay infilling at Location 1.*

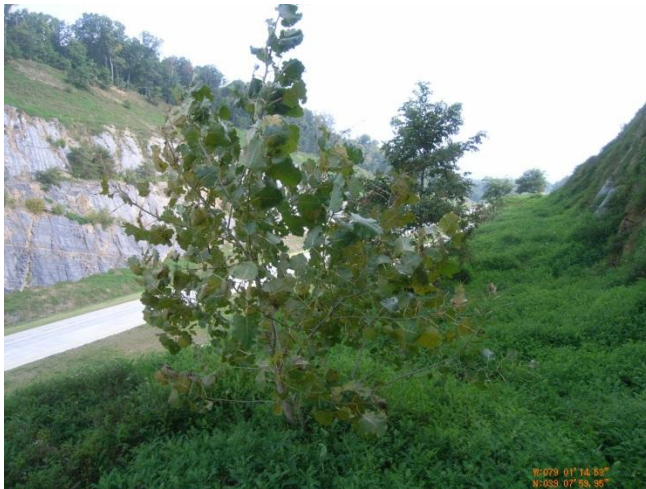
*Photo 2: Shrubbery on bench at Location 1.*

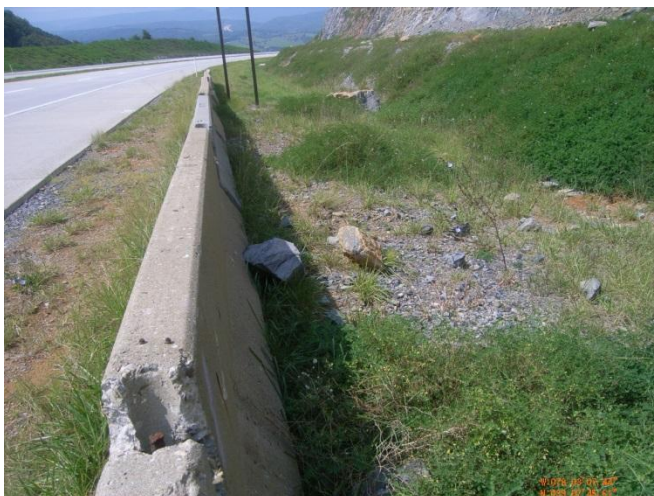
*Photo 3: Jersey barrier and small catchment ditch at toe of slope at Location 1.*

Category #	Note
2	Highly fractured faces on about 50% of backslopes. (See Photo 1)
3	Bedrock layers appeared flat or dipping slightly away from roadway.
4	A few small shrubs located on upper benches. (See Photo 2)
8	Total height = approximately 230 feet
9	Small catchment ditch and jersey barrier present; 2 rocks between jersey barrier and highway. (See Photo 3)
10	Distance = 24 feet
11	Taken from WVDOT website, Average Daily Traffic = approximately 4500
12	Estimated minimum Decision Sight Distance = 600 feet

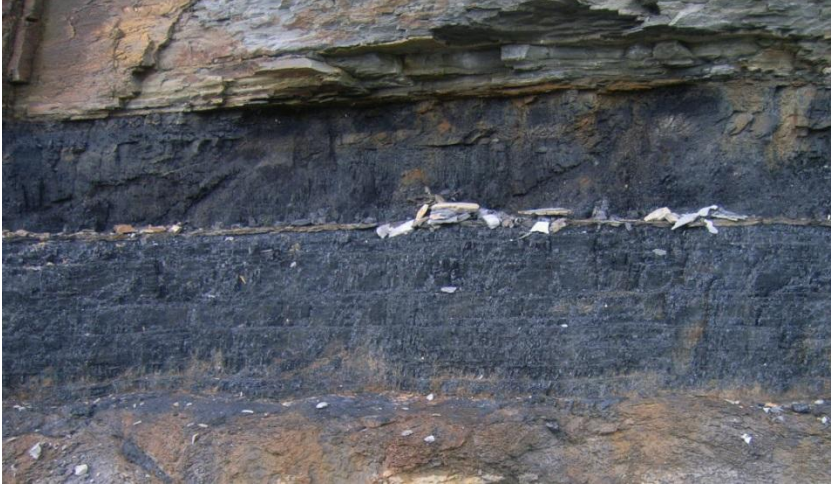
*Photo 1: Large undercut above a coal seam at Location 2.*

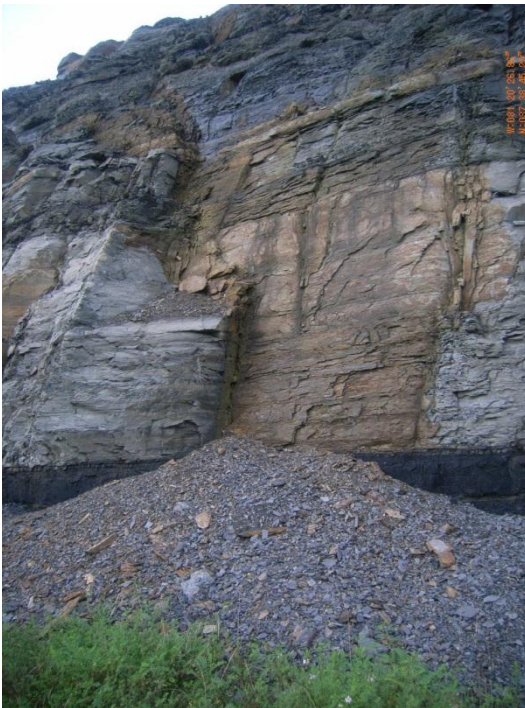
*Photo 2: Extensive eroding of siltstone layers on lower benches at Location 2.*

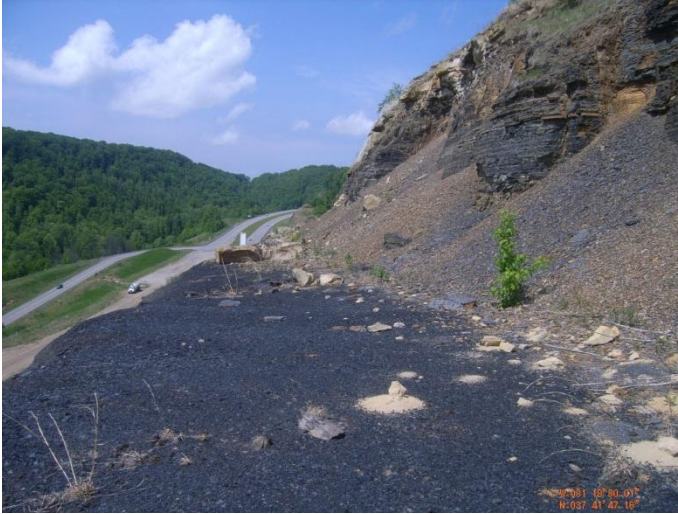
*Photo 1: Large amounts of siltstone erosion on benches at Location 3.*

Category #	Note
7	Large amount of siltstone erosion on upper benches. (See Photo 1)
8	Total slope height = approximately 180 feet.
9	No distinguishable catchment area at toe of slope.
10	Distance = 24 feet.
11	Taken from WVDOT website, Average Daily Traffic = 5000.
13	Majority of fallen rocks were small, localized larger blocks from more competent rocks on upper backslopes. (See Photo 2)

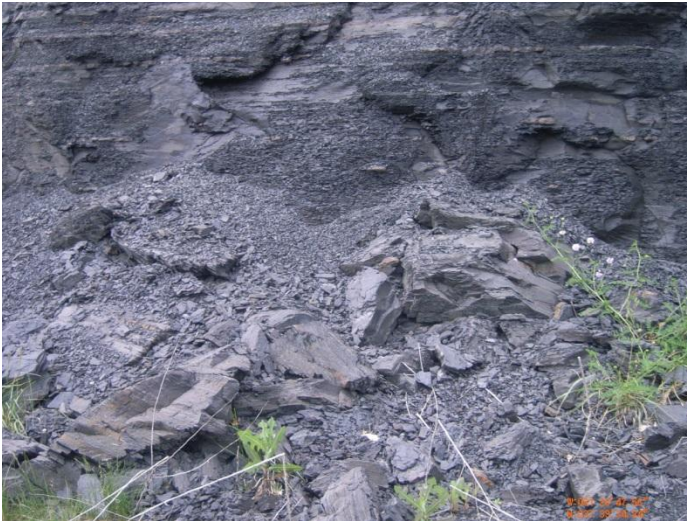
*Photo 2: Larger fallen rocks from localized failure on upper bench at Location 3.*

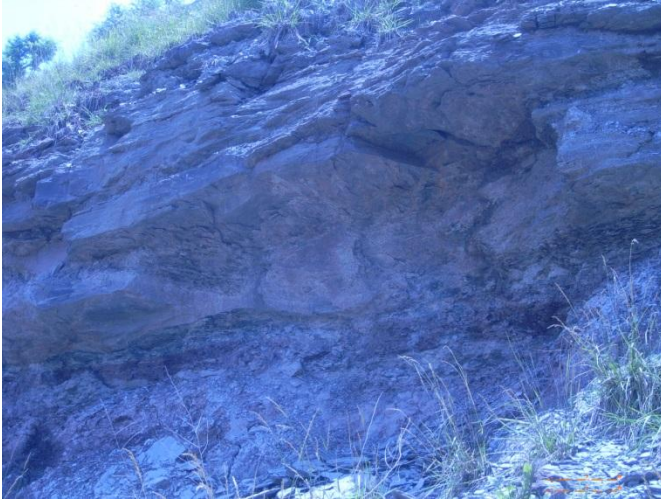
*Photo 1: Large undercut from Redbed shale erosion below more competent rock strata at Location 4.*

Category #	Note
1	Noticeably large undercuts from eroding redbed shales in some areas. (See Photo 1)
7	Large rate of erosion due to Redbed shales. (See Photo 2)
8	Total slope height = approximately 160 feet.
9	Ditch's primary function is for drainage, hasn't been tested by rockfall. (See Photo 3).
10	Distance = 25 feet.
11	Taken from WVDOT website, Average Daily Traffic = 500 (on-ramp).
12	Estimated minimum Decision Sight Distance = 450 feet.
13	Minimum rockfall events, but rocks are typically quite large when they do fall.
14	Falls only likely after large rains or during first thaw of season.

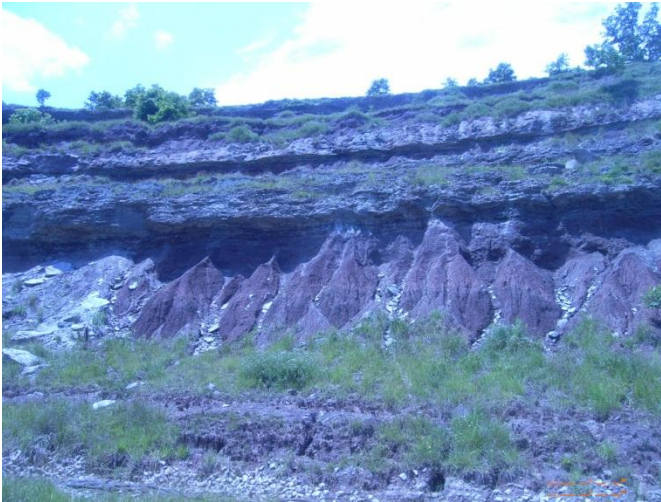
*Photo 2: Mounds of erosion from highly friable Redbed shales at Location 4.*

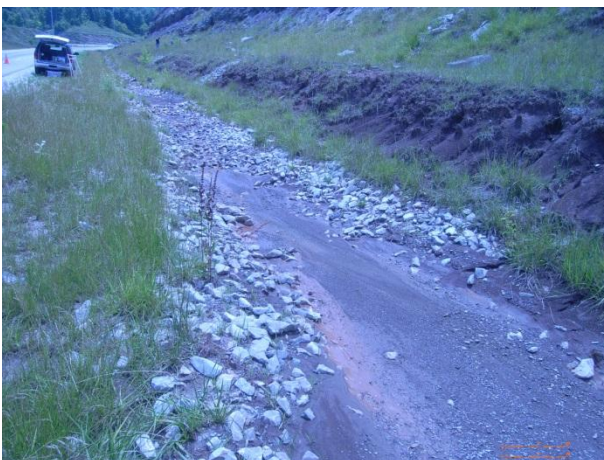
*Photo 3: Drainage ditch at toe of slope, filling with eroded material at Location 4.*

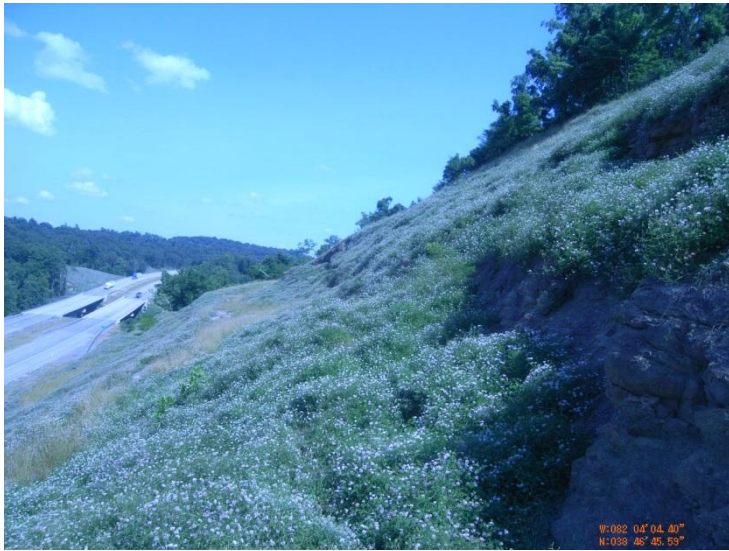
*Photo 1: All backslopes and benches highly vegetated.*

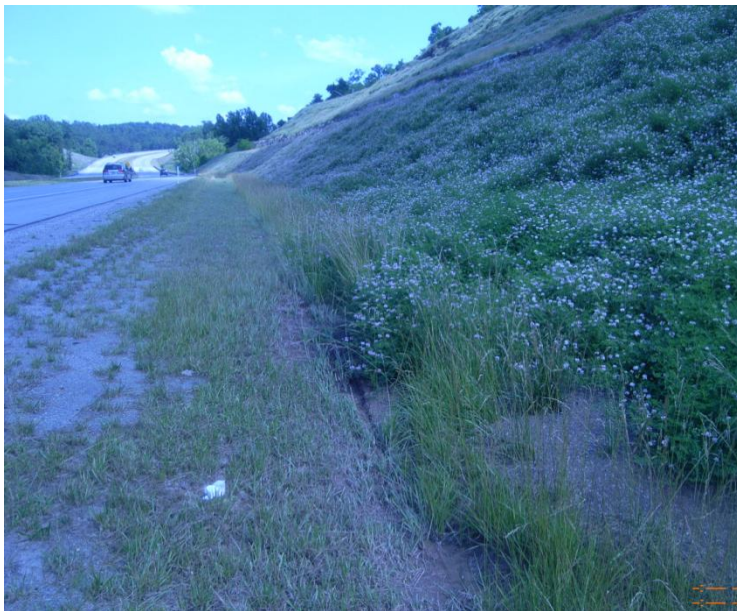
*Photo 2: Limited distance between roadway shoulder and toe of slope.*

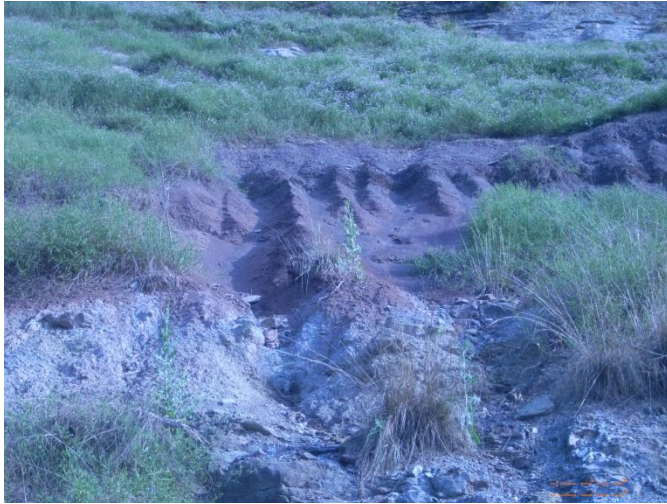
*Photo 1: Rills and gullies formed on lower backslopes.*

Category #	Note
5	Rills and gullies present on slope from excessive erosion; easily drained from slope. (See Photo 1)
8	Total slope height = approximately 225 feet.
9	Ditch's primary purpose is for drainage; filling with eroded material.
10	Distance = 17 feet.
11	Taken from WV DOT website, Average Daily Traffic = 12000.
14	Overall slope appears very stable, no rockfall events in near future.

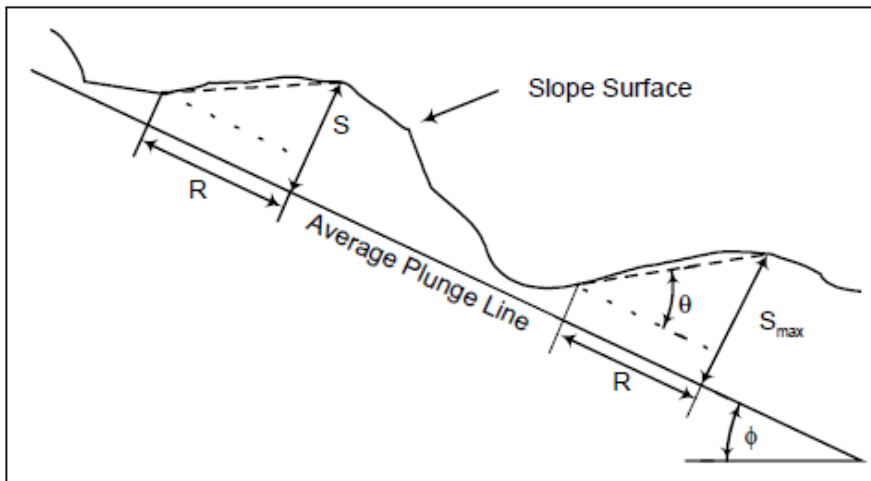
Figure 1: Visual Description of the Surface Roughness input in CRSP-2D

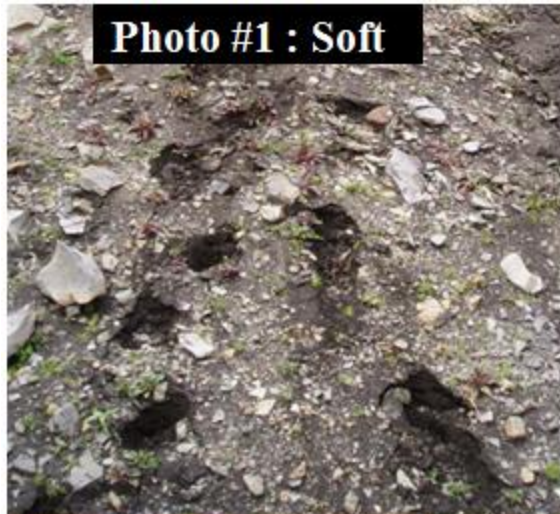
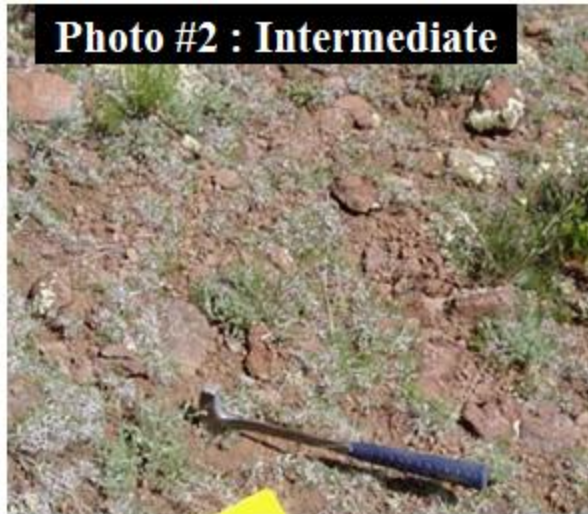
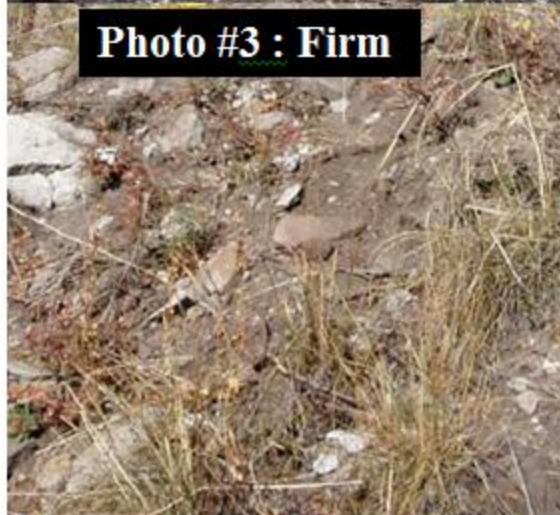
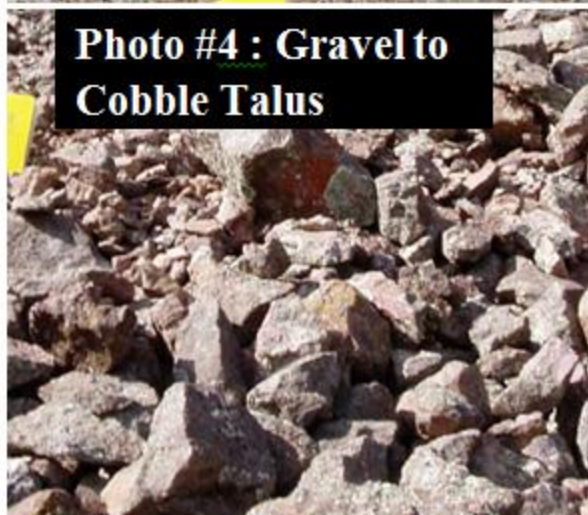
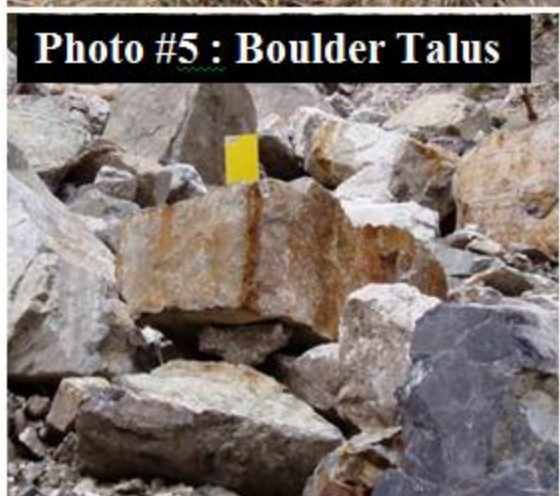
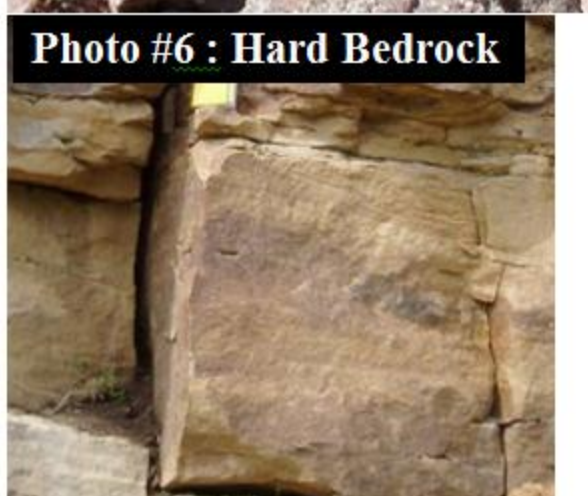
Figure 1: Photographic examples of surface material types available in CRSP (Andrews 2012)

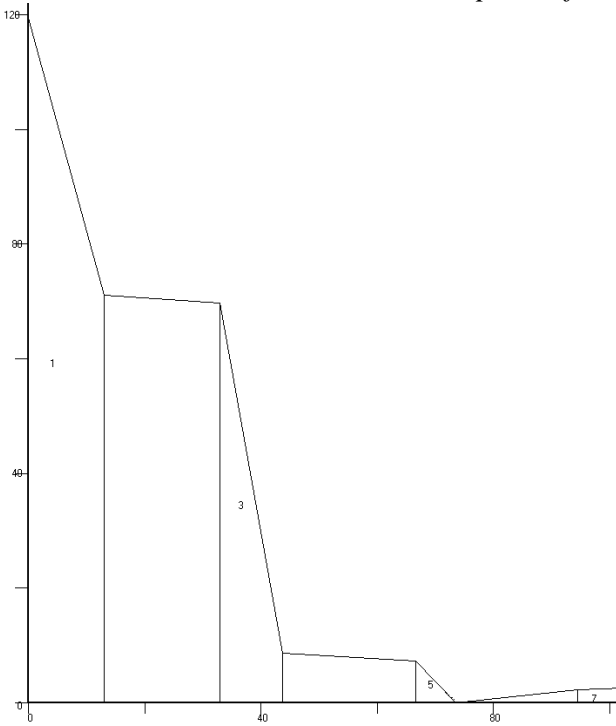
*Trial-and-Error CRSP-2D Calibration for Hard Bedrock Calibration Site 2*

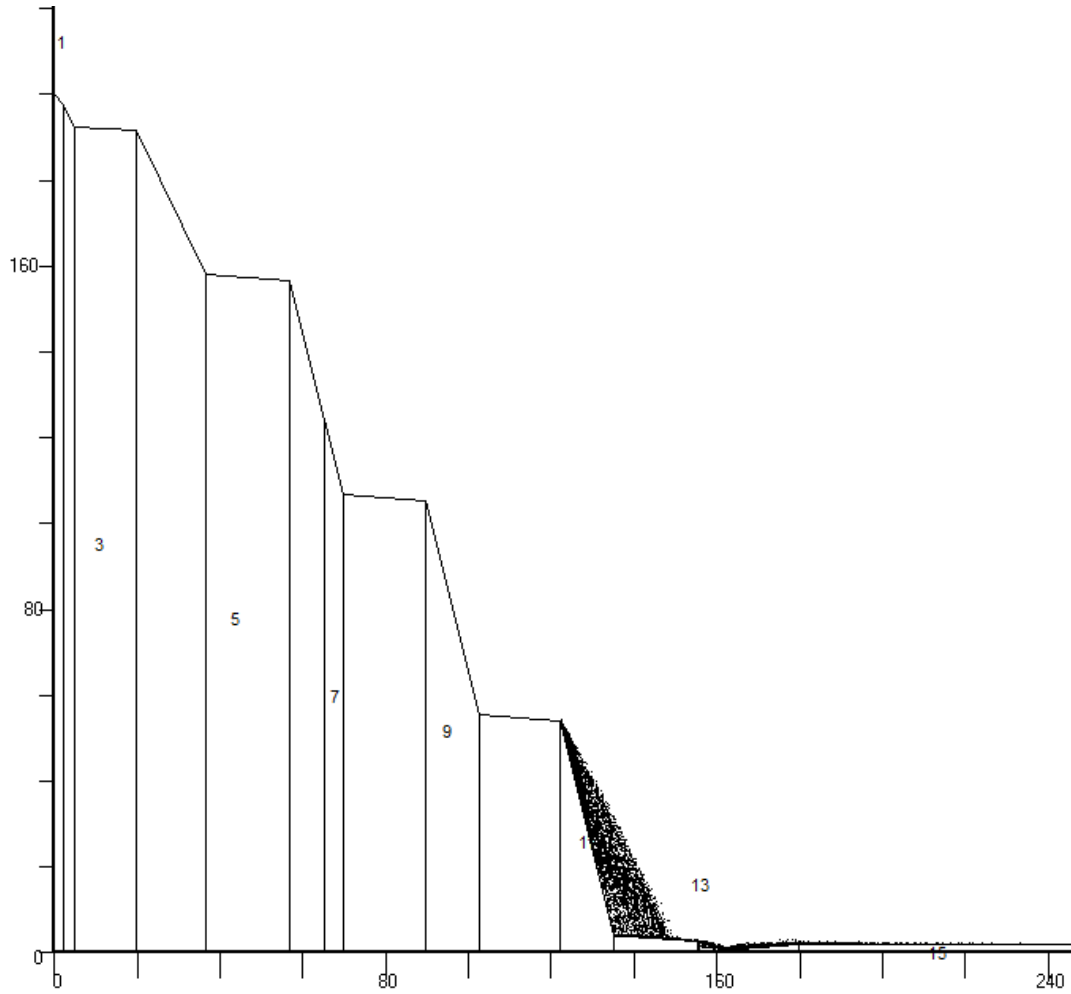
*Bench Removal Trial 4 for Case Study Slope Section of US Route 48 – Release Zone: Top of Backslope 1*

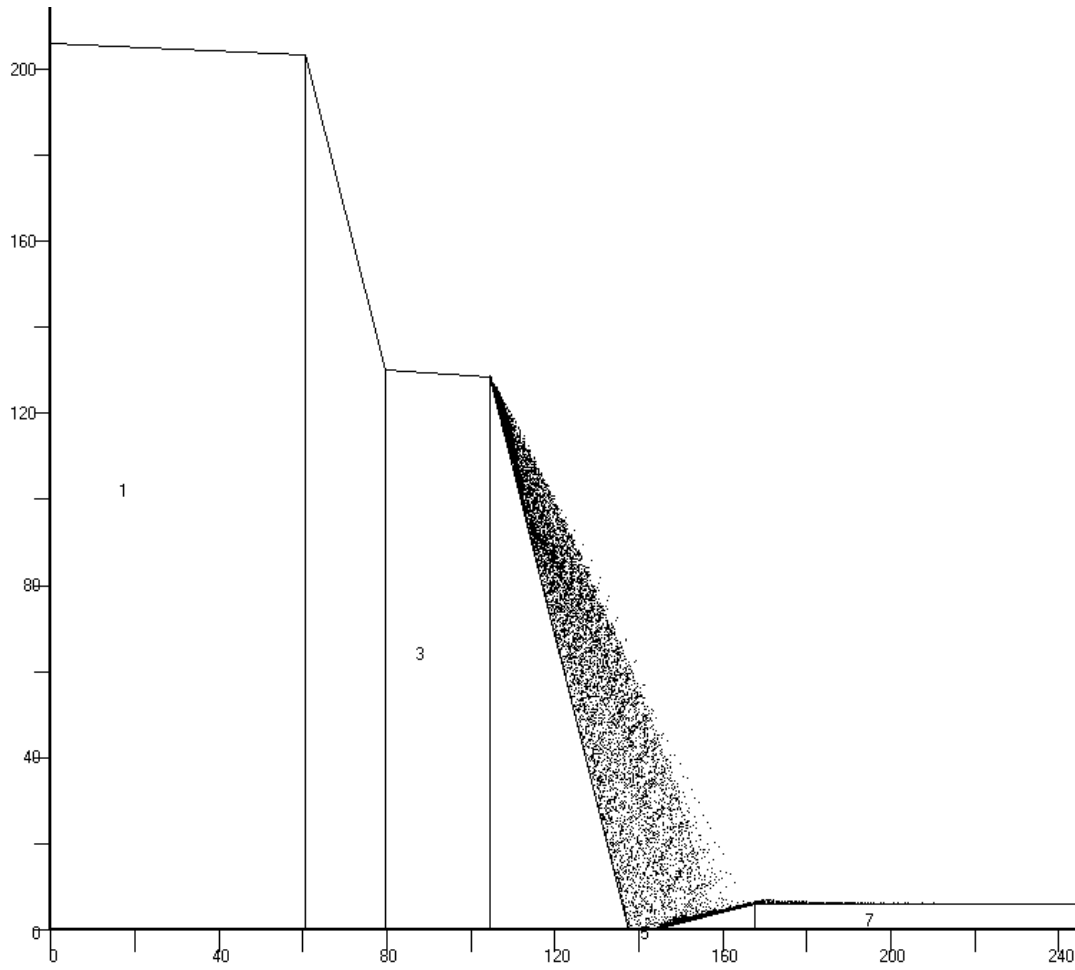
*Bench Removal Trial 3 for Case Study Slope Section of US Route 121 – Release Zone: Top of Backslope 1*
