## Effects of Slope Geometry Alterations on Rockfall Mitigation along Highway Rock Cut Slopes in West Virginia

# **Effects of Slope Geometry Alterations on Rockfall Mitigation along Highway Rock Cut Slopes in West Virginia**

Thesis submitted to the  
Benjamin M. Statler College of Engineering and Mineral Resources  
at West Virginia University  
in partial fulfillment of the requirements  
for the degree of

Master of Science  
in  
Civil and Environmental Engineering

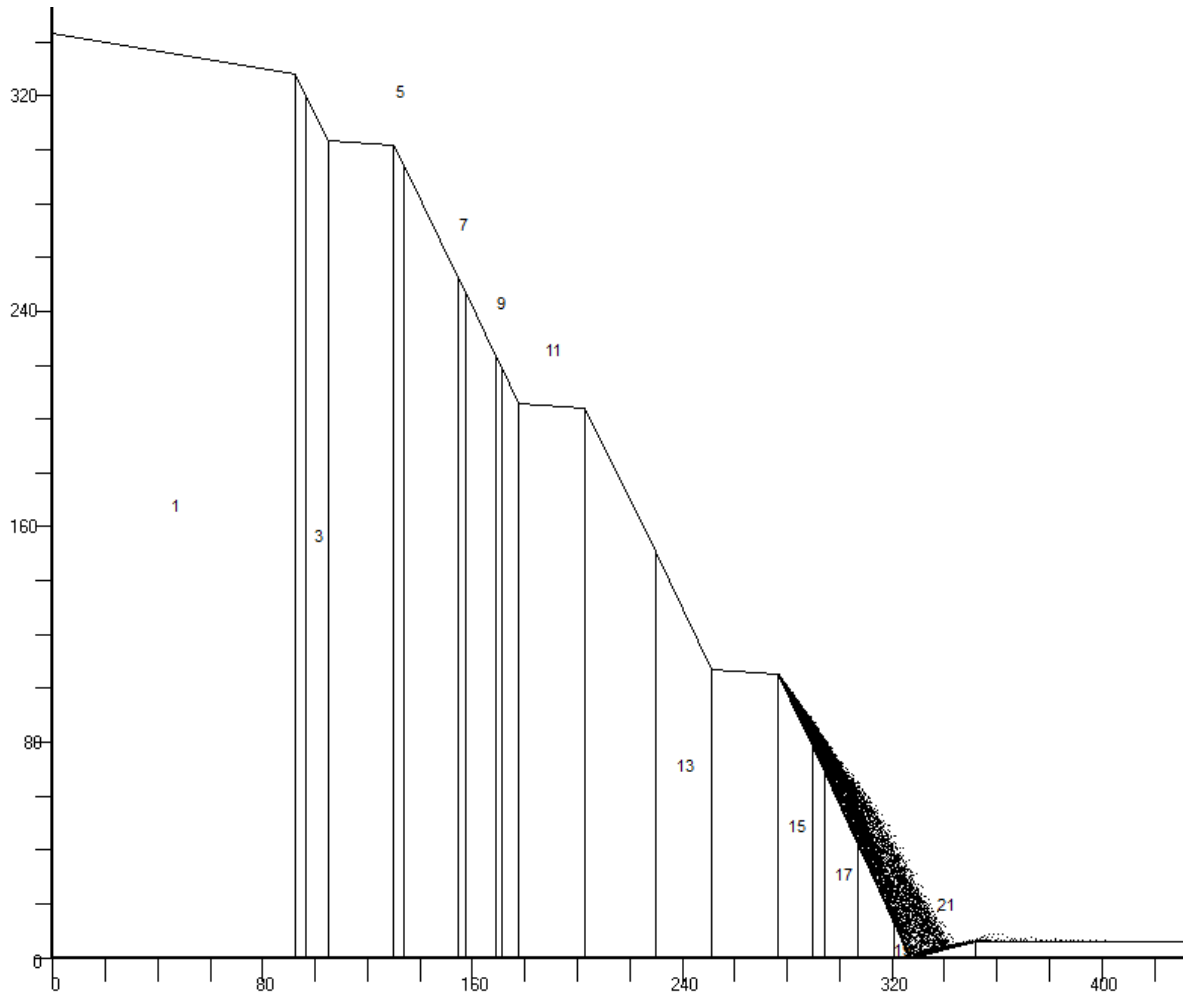
*Bench Removal Trial 3 for Case Study Slope Section of US Route 121 – Release Zone: Top of Backlope 2*

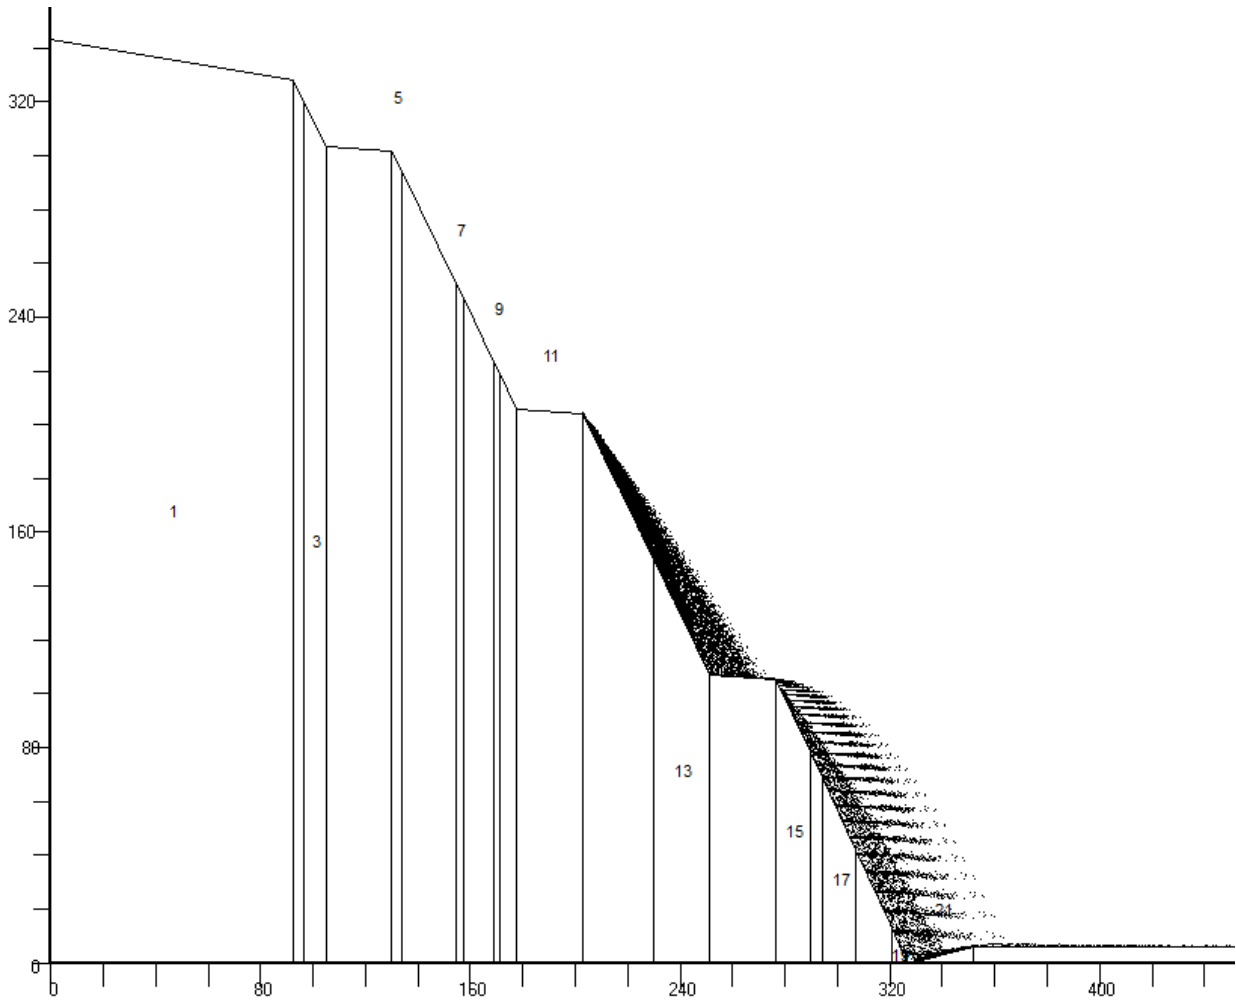
*Bench Removal Trial 3 for Case Study Slope Section of US Route 121 – Release Zone: Top of Backlope 3*

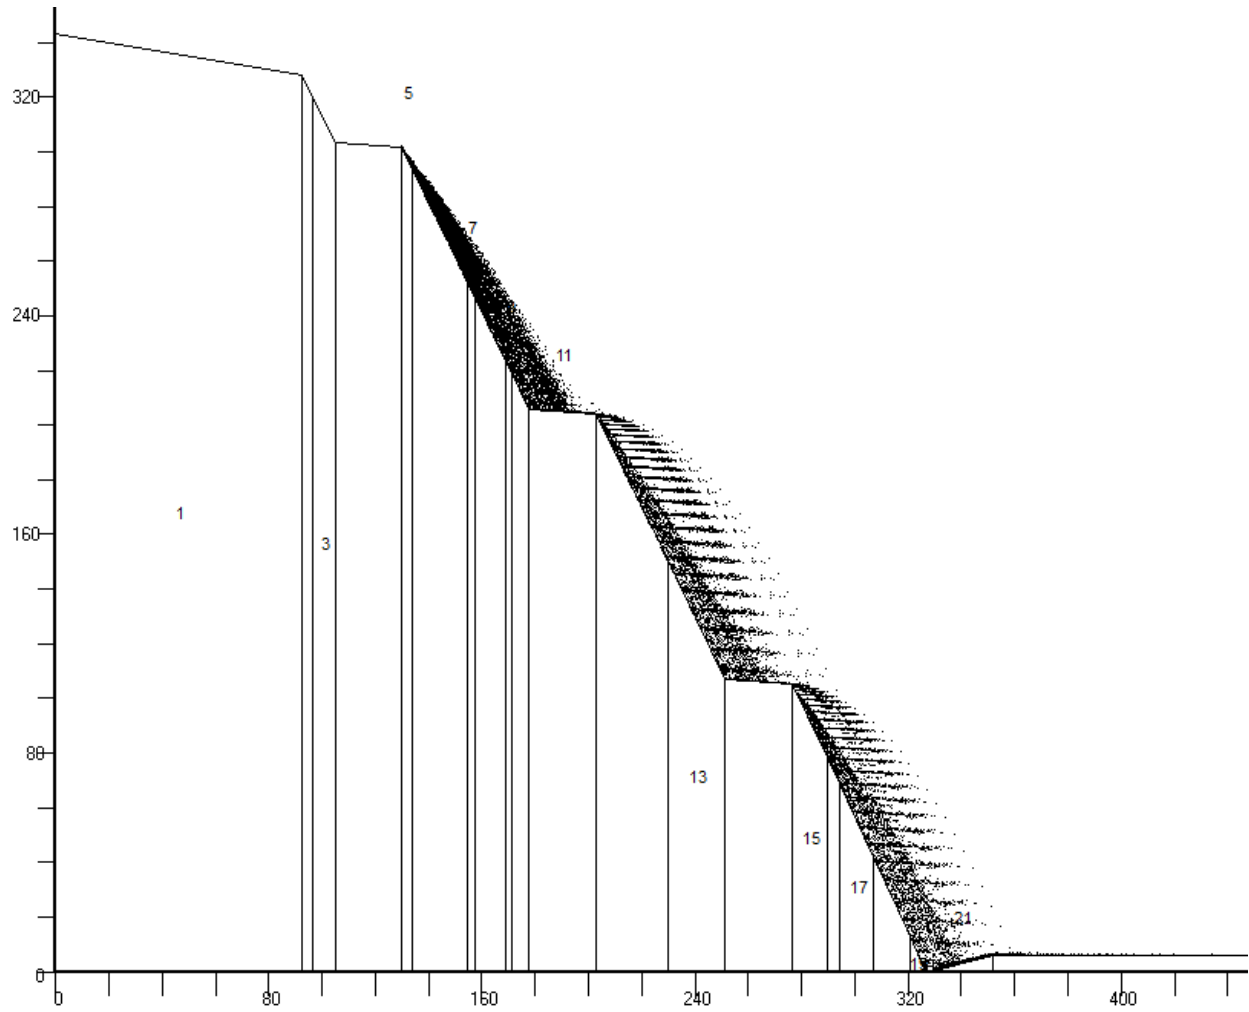
*Bench Removal Trial 4 for Case Study Slope Section of US Route 121 – Release Zone: Top of Backslope 1*

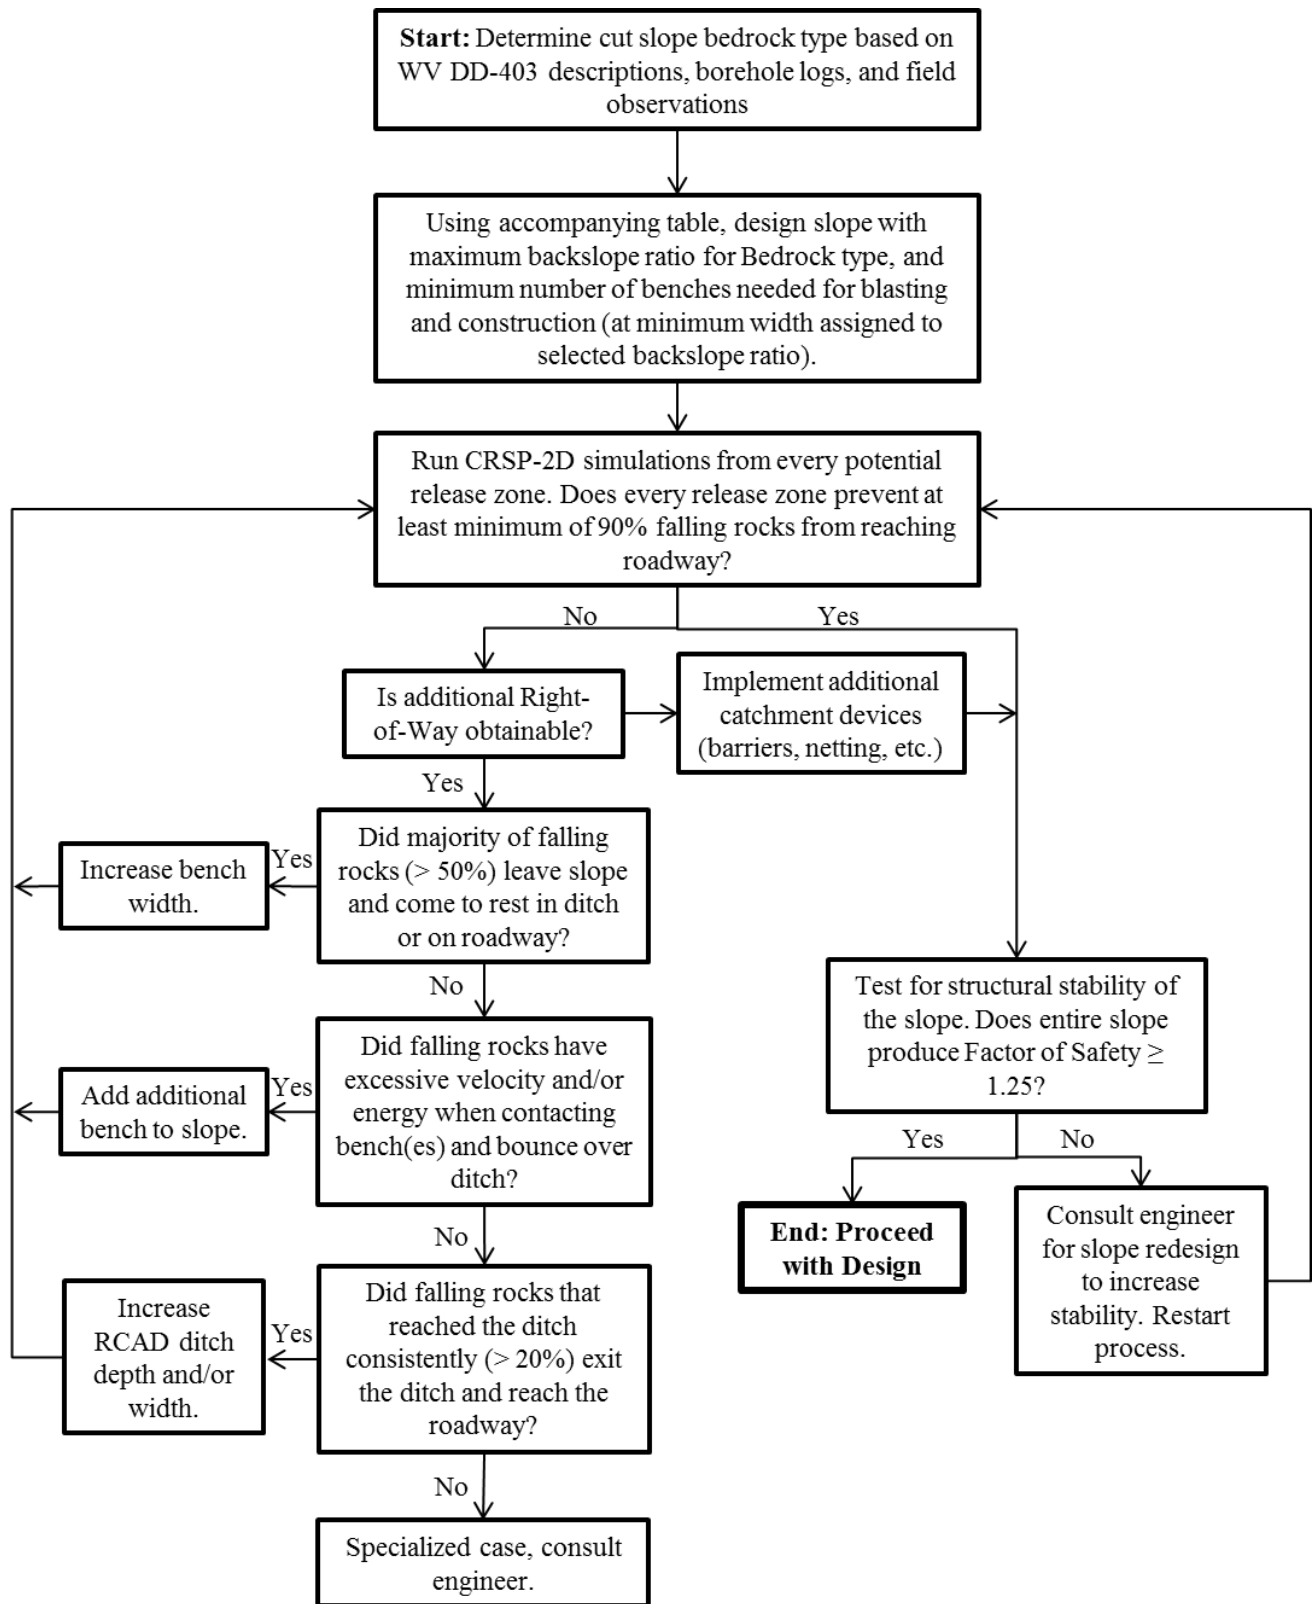
The flowchart on the following page is supplemental to this design guide.

9. If slope redesign options a. – c. were selected, return to Step 6. If slope redesign option d. was selected, proceed to Step 10.
  10. One minimum required rockfall retention has been reached, test slope for structural stability. If any portion of slope section produces a stability Factor of Safety < 1.25, remediation efforts must be made. Relationships between slope design and stability are outside the range of this design guide, and thus suggestions cannot be made. Backslope angle may be reduced, but must stay within the ranges displayed in the Table above. After redesigning the slope geometry to obtain a Factor of Safety above 1.25, return to Step 6.
