REHABILITATION OF CONCRETE STRUCTURE *USING COMPOSITE MATERIALS*

United Arab Emirates University

FOR THE DEGREE OF M. Sc. IN MATERIALS SCIENCE AND ENGINEERING

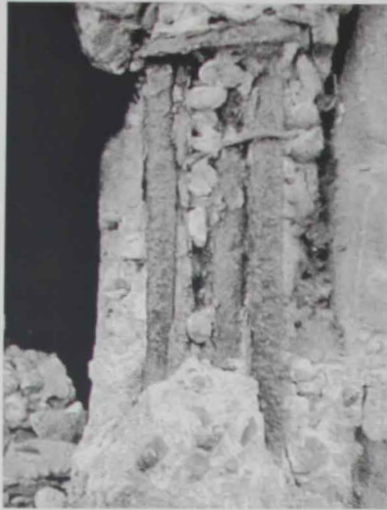
Figure (1-1): *The Electrochemical process of steel corrosion. (Mehta and Monteiro 1993).*

Corrosion of steel reinforcement having been rusted either, by carbonation or chloride contamination of the surrounding concrete or a combination of both. Under very moist conditions, black rust with very limited expansion may occur, leading to steel cross section reduction without the valuable warnings of cracks and spalling [3]. The electro-chemical process driven by the cell leads to local corrosion of reinforcement, which can also lead to cracking, or spalling of the surrounding concrete **Figure (1-1)**. A rare, but potentially more dangerous, form of chloride-induced corrosion can result when strong electrical forces are developed without sufficient oxygen being present to enable the corrosion products to oxidize. The resulting anaerobic corrosion products are not expansive and usually cause immediate damage to the surrounding concrete. In such cases the reinforcement can be reduced in cross-section due to pitting and in a very extreme case could be eaten away altogether. In many parts of the region particularly on the coast of the gulf the background presence of high levels of chloride makes chloride induced corrosion the most important durability issue. The basic lines of defense are however similar for both carbonation and chlorides involving the use and provision of high quality impermeable concrete of adequate thickness as cover to the reinforcement [2].

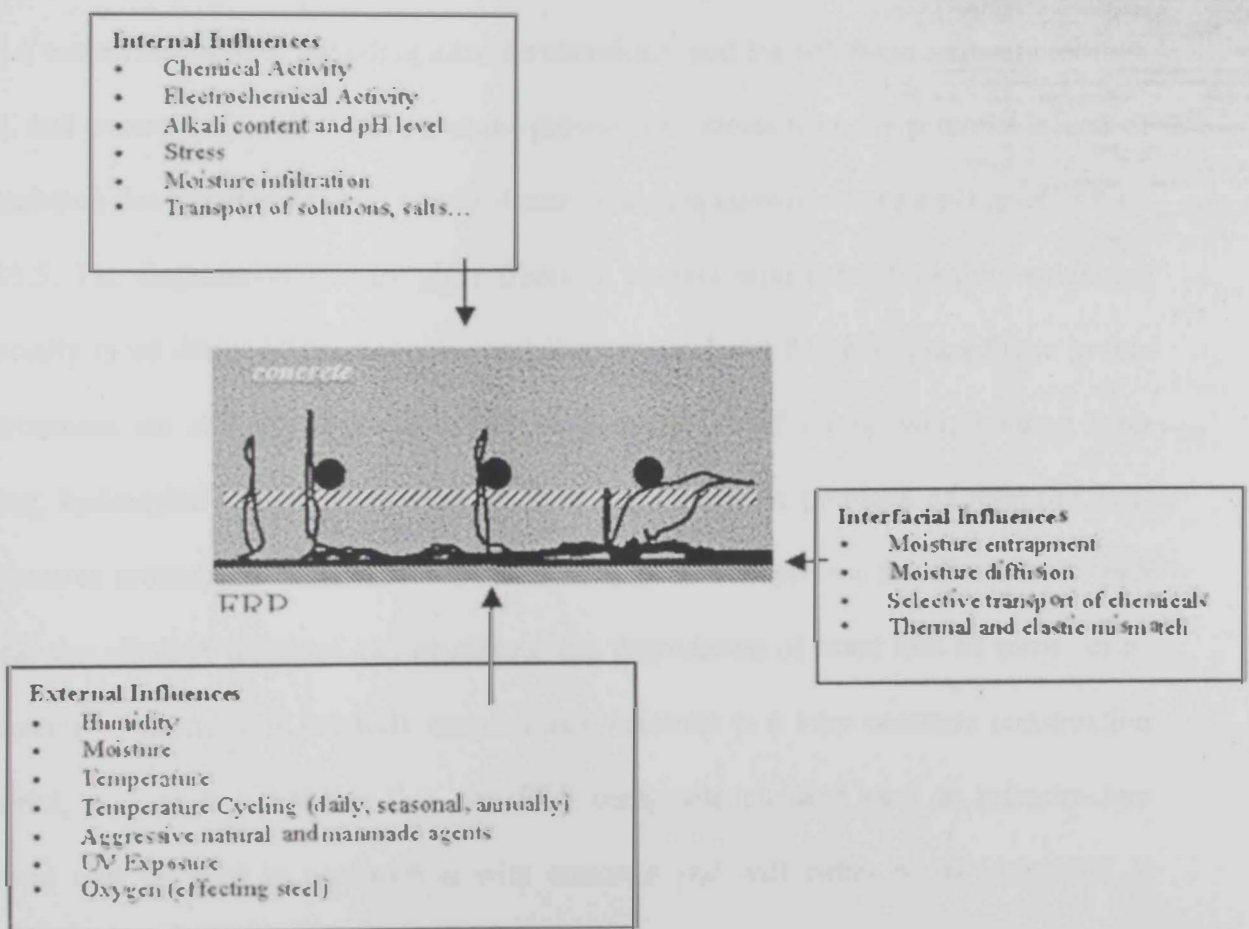
Figure (3-16): System level interaction (Karbhari 1997)

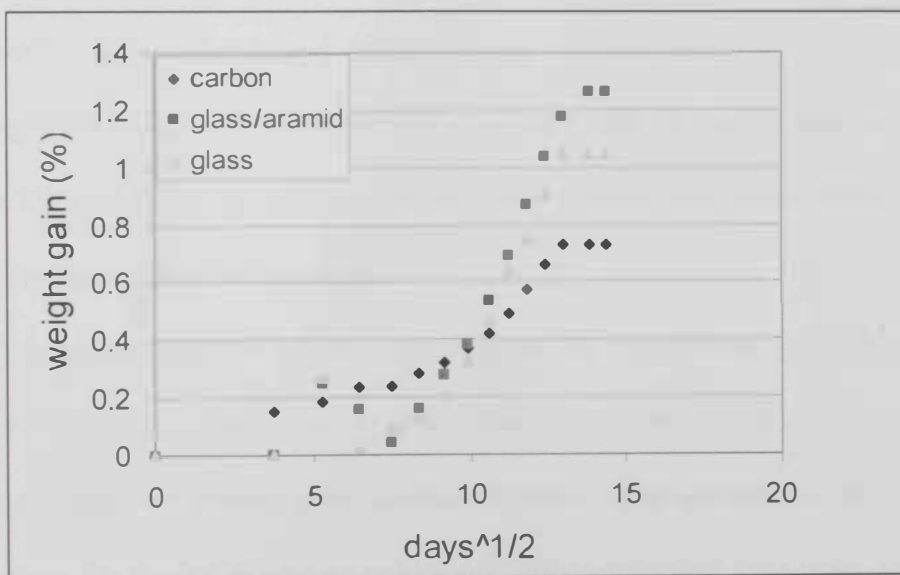
Figure (4.11): Weight gain following complete water immersion.

Composite samples which, immersed in water for a period up to a sixth month, a bi-weekly recording of their weight was performed. According to the results shown in (Figure 4.11), a common behavior was observed for the three different materials. Actually it is possible to identify three different regions for the moisture performance of these samples. A first region characterized by a very low water intake, then a second region where a high water intake is recorder and finally a constant region where water intake reaches saturation.

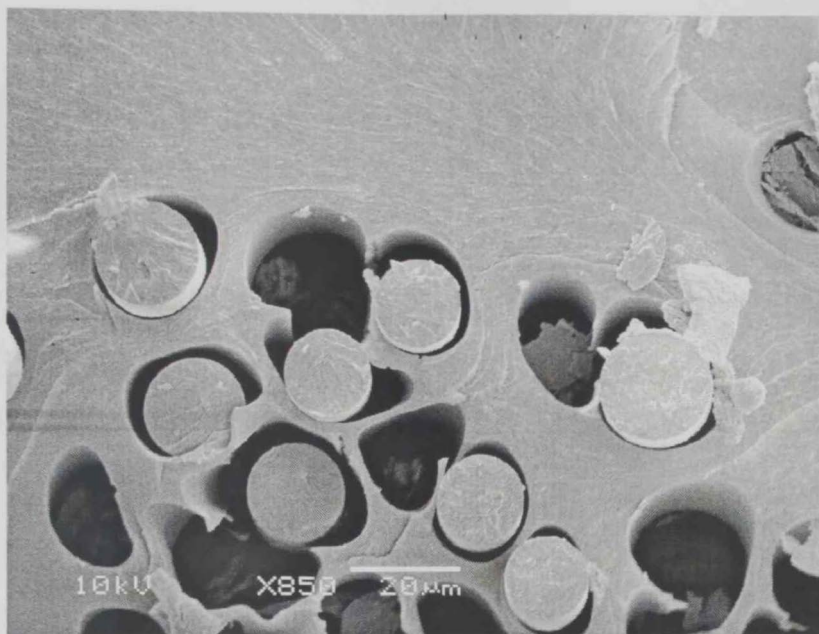
Figure (4.18): Enhanced magnification showing large gap surrounding the glass/aramid fibers (conditioned).

micrographs pictures shown in (Figures 4.18) and (Figure 4.19), it is clear that there was a large gap surrounding the fiber, it looks like some yielding of the matrix occurred. It seems that the testing temperature was close to the glass transition temperature of the resin (T_g).

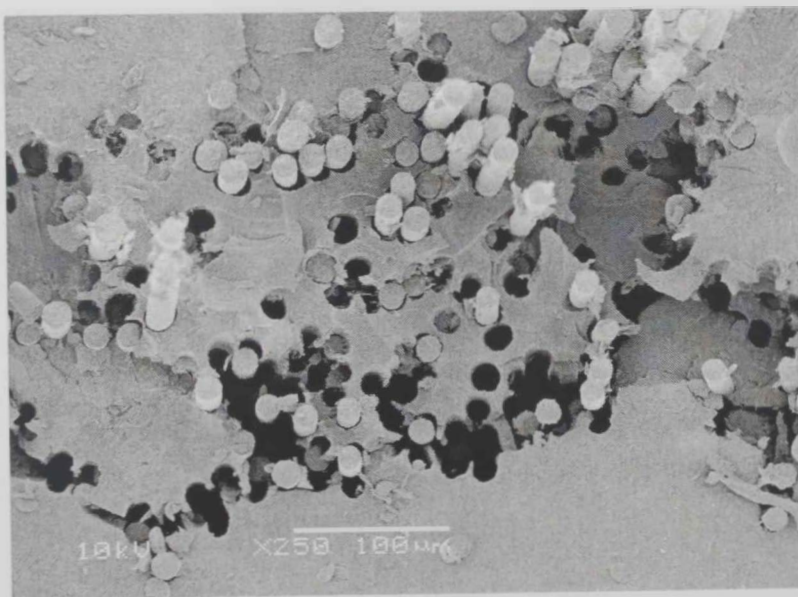
Figure (4.25): Poor adhesion between glass fibers and matrix as evidenced by SEM.

For virgin specimens, failure occurs as a consequence of the poor interface between the fiber and the matrix. It is important to enhance the fiber surface properties through better surface treatment in order to increase the adhesion between the fiber and the matrix see (Figures 4.24) and (Figure 4.25).
