The Effectiveness of SACP in Controlling Of Concrete Steel Reinforcement in Aggressive Environments

**U.A.E University
Deanship of Graduate Studies
Material Science and Engineering**

**Thesis Submitted as Partial Fulfillment of the Requirements for the
Degree of Master of Science in Materials Science and Engineering**

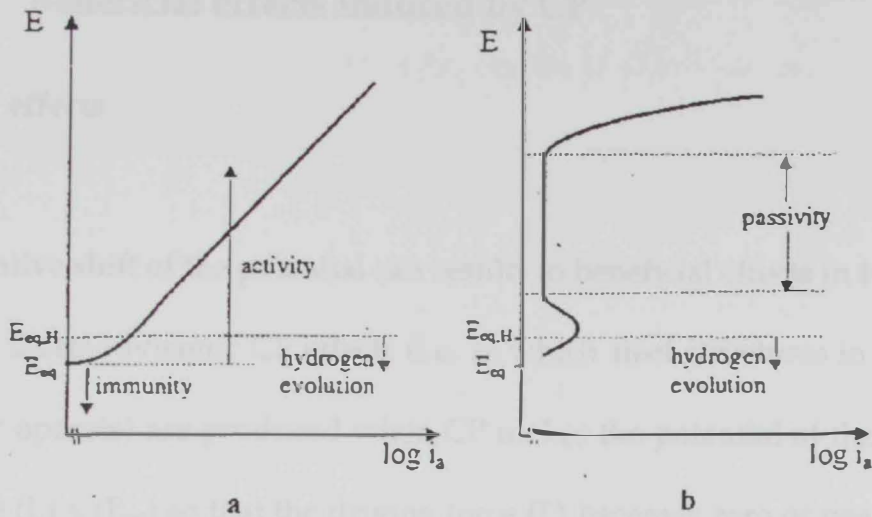
Figure 2-1 a) active b) active-passive anodic behavior of metals

Metal cannot corrode (i.e. 'immunity' condition) if the potential of the metal in the electrolyte contacting its surface (E) is lower than the equilibrium potential for the oxidation process (E_{eq}) which is given by Nernst's law. Corrosion can take place only if $E > E_{eq}$. In most of situations (e.g. steel in soil or in sea water but also in carbonated concrete) the corrosion rate (i_a) exhibits the behavior called 'active' in which it increases with the potential (Figure 2-1a). In some cases (e.g. steel in concrete and, more generally, in alkaline environments but also stainless steels in neutral media), the behavior, called 'active-passive', and i_a increases above E_{eq} in the (activity zone), then decreases to very small values in the (passivity zone) because of film formation on the metal surface, and finally when this film is destroyed, it increases again at high potentials (Figure 2-1b)[13].

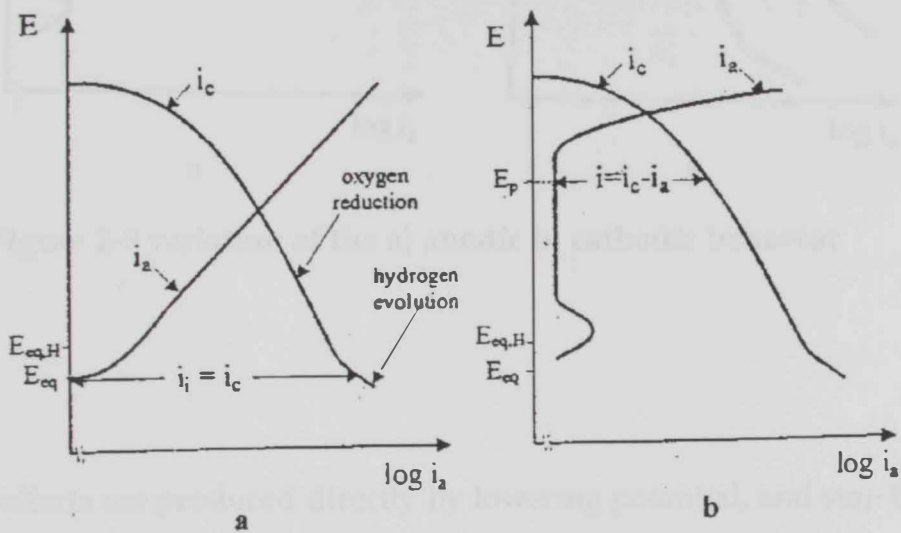
Figure 2-2 Cp in the case of a) active b) active-passive behavior

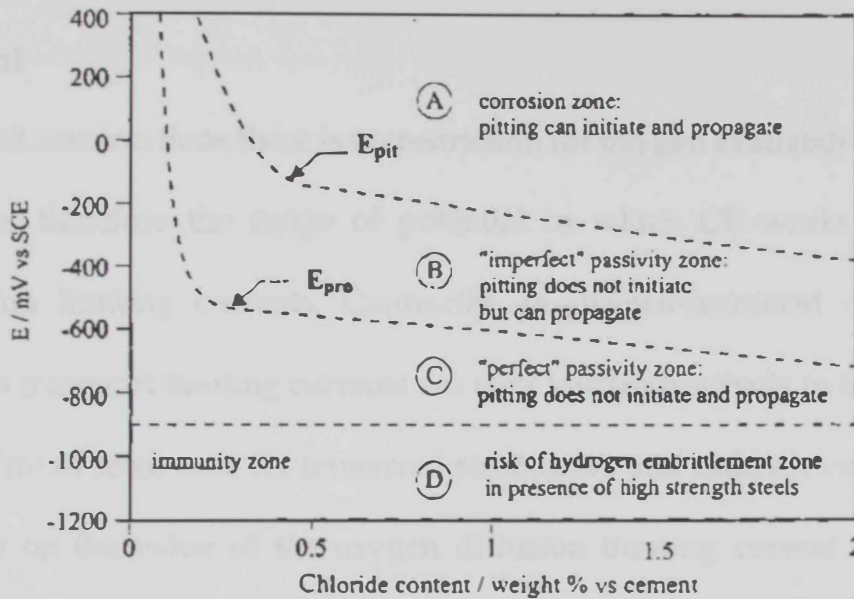
Figure 2-5 steel behavior in concrete as a function of chloride content

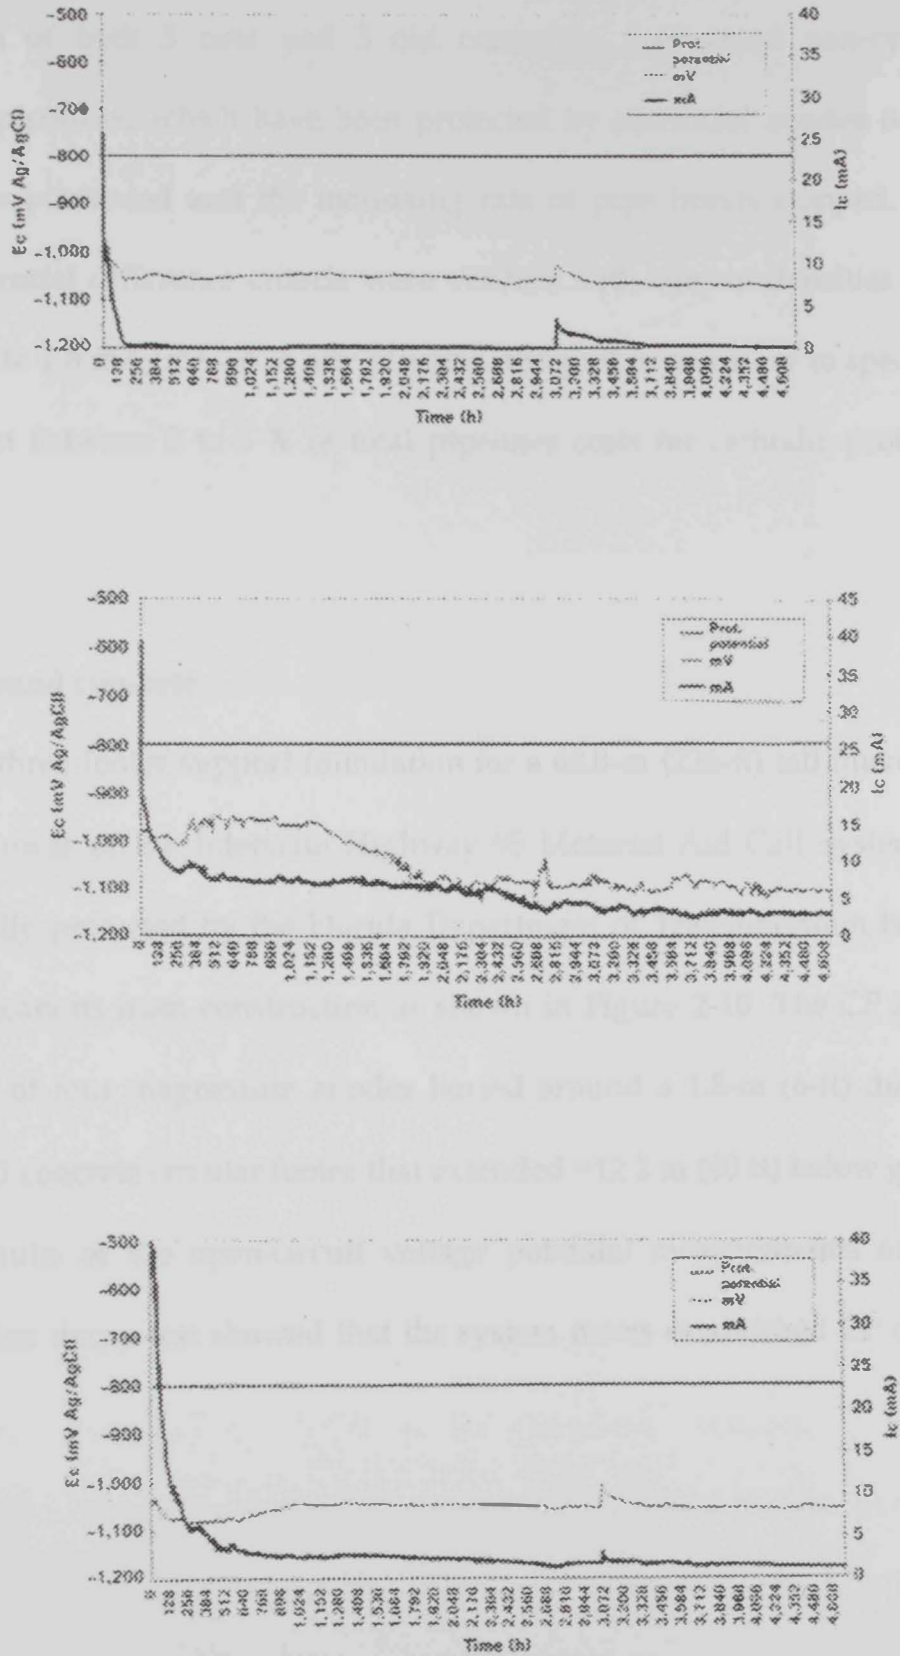
Figure 2-9 potential and current vs. time for protection with SA

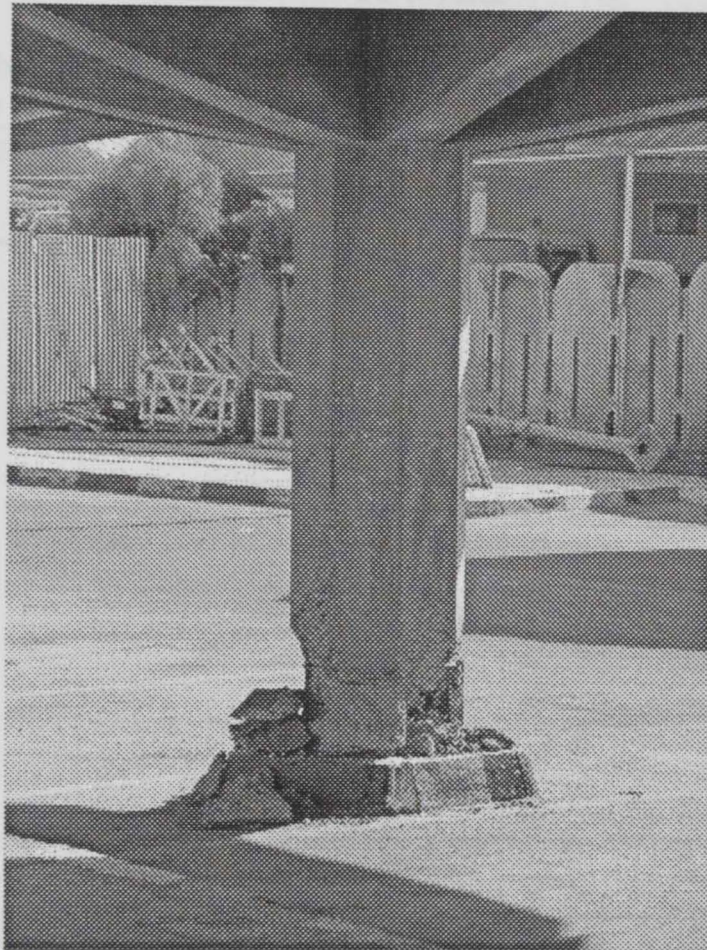
Figure 3-4 Initial state of column C1 before repair

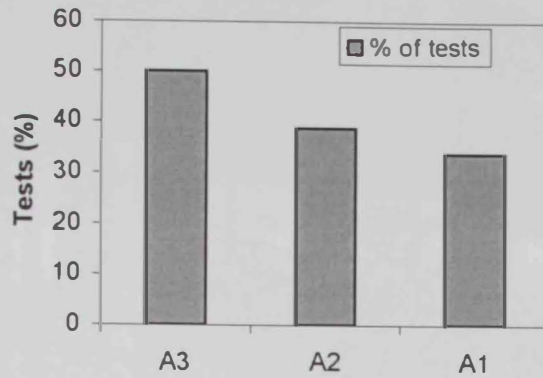
Figure 3-6 Cumulative frequency curve-more negative than -350 mV

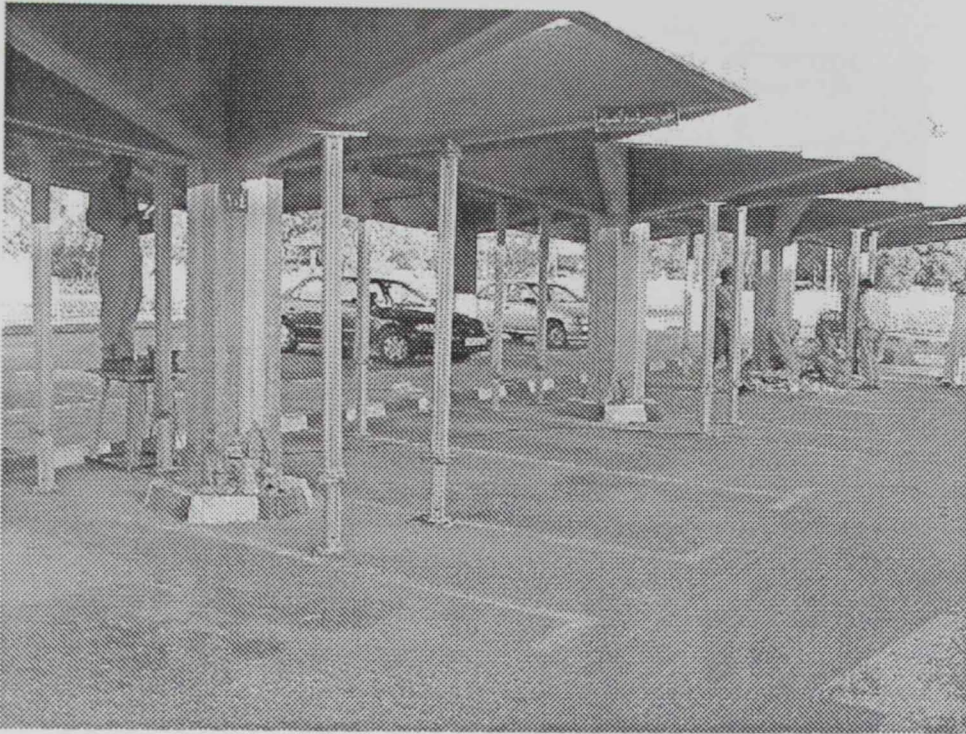
Figure 3-7 the columns were chosen for testing

Three columns were chosen for testing Figure 3-7. The first column was labeled (C1) and was repaired using conventional repair system. This column shall be considered the control. The second column which was labeled (C2) was repaired using conventional patch repair with sacrificial embedded anodes to investigate the effect of sacrificial anode in preventing the incipient anode phenomenon. The third column which was labeled (C3) was repaired in the same manner as column C2 with the additional of global sacrificial anode system. The effects of sacrificial embedded anodes as well as the combination of both sacrificial embedded anodes and global sacrificial anode shall be compared to the control (C1).

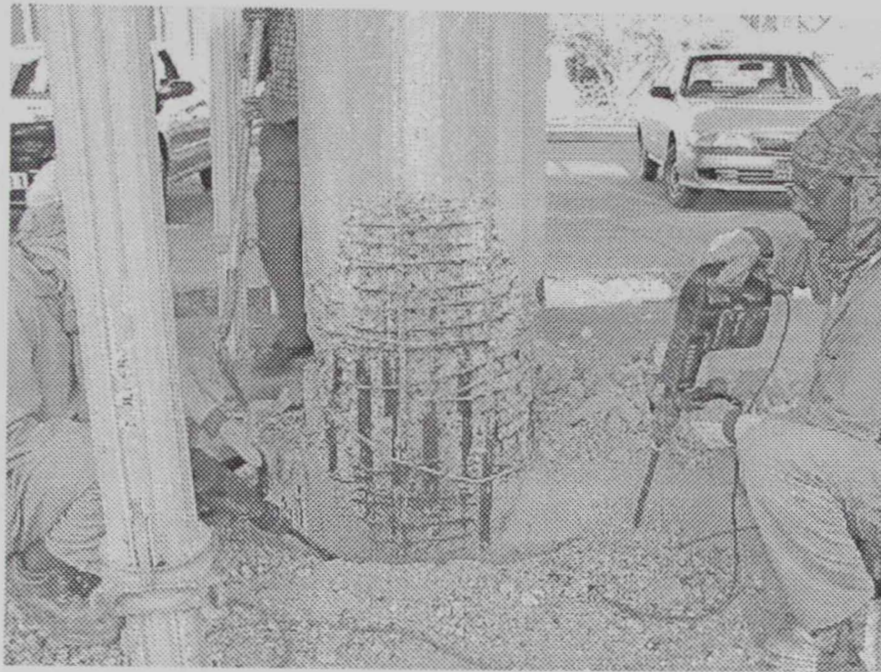
Figure 3-8 Breaking out deteriorated concrete using pneumatic hammer

All deteriorated concrete and corroded steel was removed using light pneumatic hammer till sound concrete and non-corroded steel was reached. The Deteriorated concrete that was removed, reached 3cm beyond the reinforcement, and was measured to be 10cm thick. This deterioration appeared in the region between 50cm above the ground level and 50cm under the ground level. The areas was marked out in the works and adjusted as work proceeds according to the condition found. Figure 3-8.

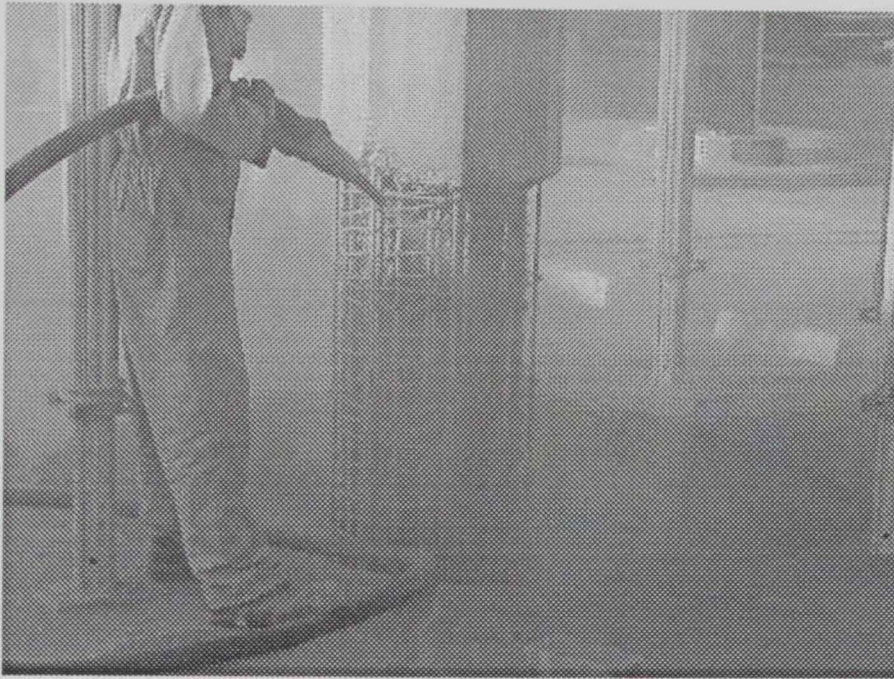
Figure 3-9 Concrete sandblasting with shotcreting equipment

- Heavily corroded reinforcement bars which have significant loss of section (more than ~25%) were replaced.
- Reinforcement bars were cleaned by successive sandblasting and air blasting performed with the shotcreting equipment. Figure 3-9.

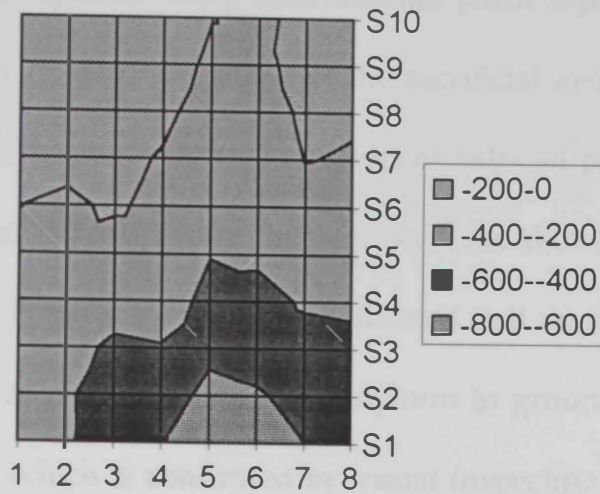
Figure 4-1 half-cell potential readings of column C1 before repair

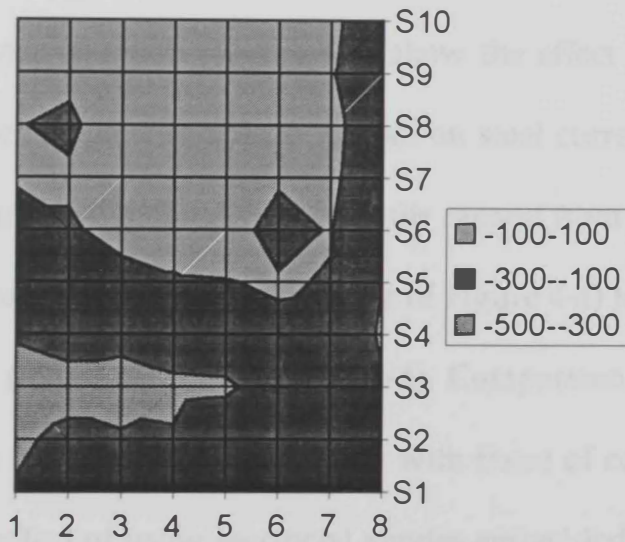
Figure 4-2 half-cell potential readings of column C1 at the age of 1 year

Figure 4-2 shows the results of half-cell potential survey for column 1 at the age of one year from the date of repairs. The results show the start of incipient anode formation around the repair zone. Half cell potential ranged from (-500- -300) mV at the location of formation of incipient anode to (-100- 100) mV at about 1.5 m above ground level). Comparison of the half cell potential values in Figure 4-2 of this column together with those of column 2 and column 3 will be used to assess the effects of sacrificial anodes in preventing incipient anode phenomena, as will be discussed in Section 4.4.

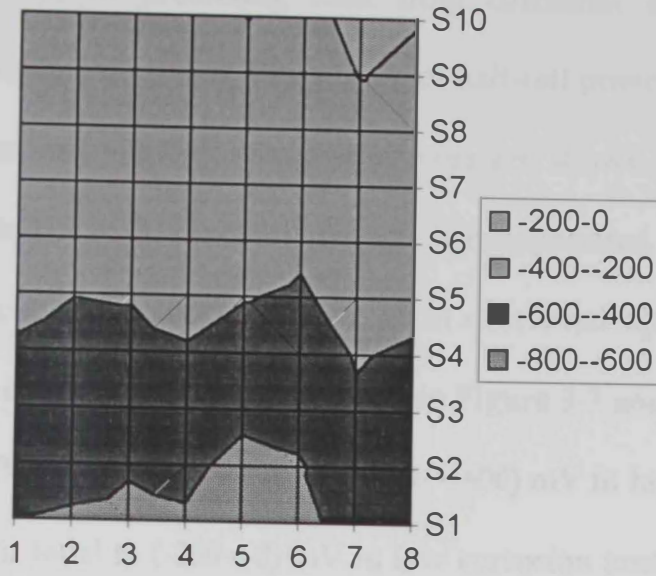
Figure 4-3 half-cell potential readings of C2 before repair

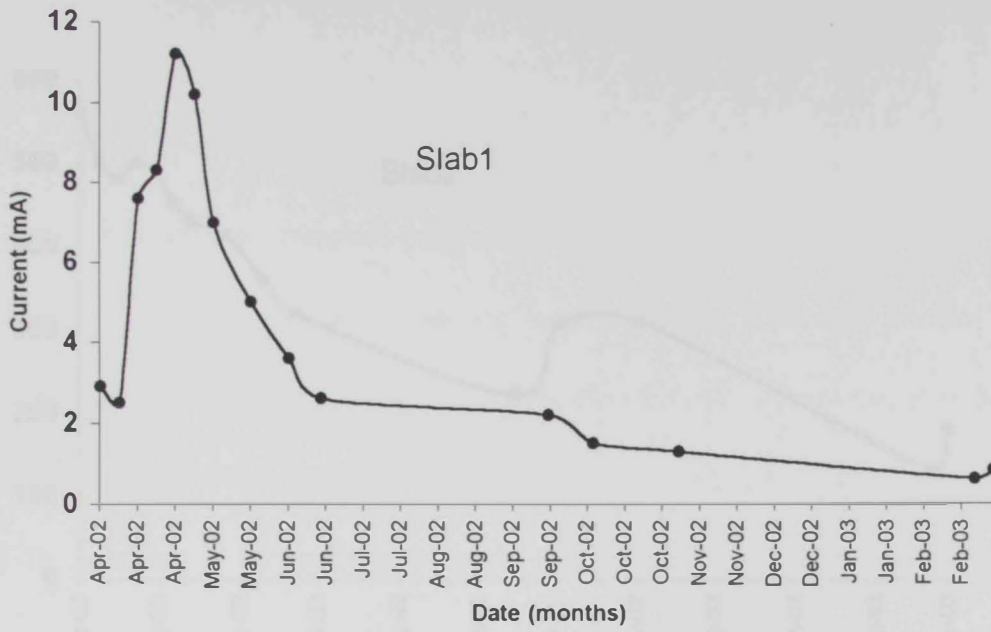
Figure 4-22 current output of slab 1

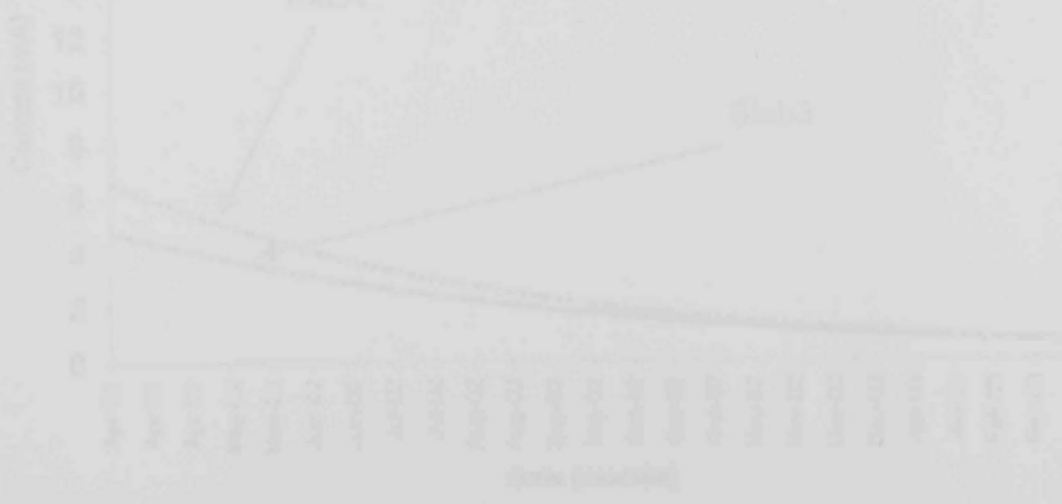
Figure 4-29 Effect of relative size of repair on SA performance

Figure 4-29 shows that slab 1 and slab 2 have similar behavior of current output although the difference in the relative size of repair between the two slabs. Both of slabs almost stabilized at about 1 mA. The explanation of this same stabilization could be because of slab 1 and slab 2 have the same amount of steel reinforcement. This reflects the fact that electrochemical equilibration under polarizing conditions requires a considerable period of time to be established, particularly in the case of passive steel. Because of this, switch-on current density levels for CP tend to be several times higher than the eventual operating levels. Clearly, other criteria for determining the effectiveness of cathodic prevention system needs to be developed. Such systems are required to cathodically prevent the onset of corrosion of the reinforcement and not necessarily for controlling existing corrosion, as is the case for CP systems. As such, a much lower current density is necessary for cathodic prevention, as reported by Bertolini et. al [33].

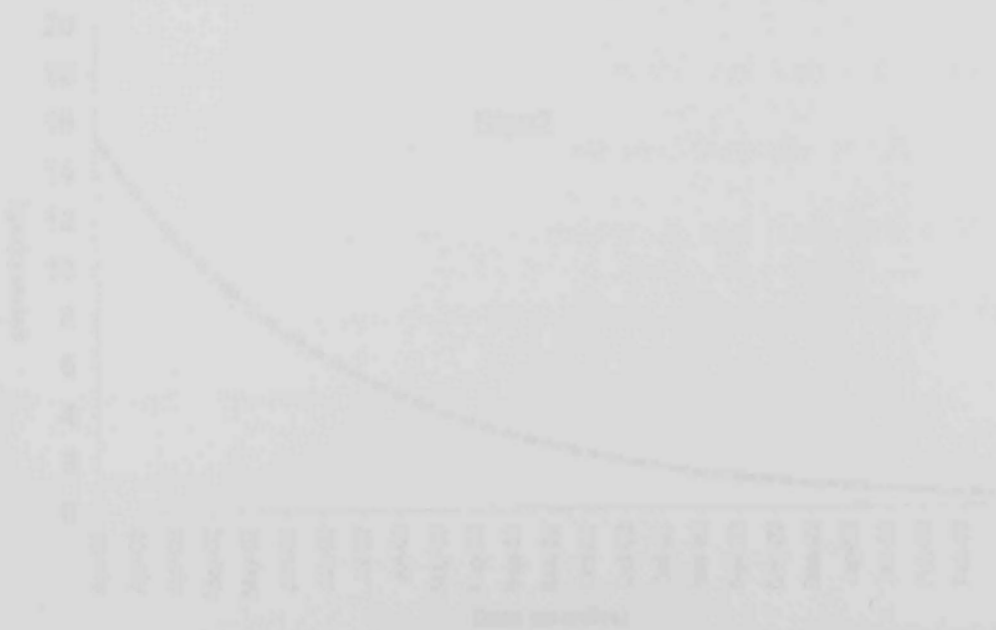
Figure 4-31: Trend of current output of slab 2

Figure 4-31 shows the trend of the current output delivered from the sacrificial anodes to the steel in slab 2. The readings were stabilized at about 0.5 mA through a potential difference at about 175 mV. The average current density recorded was in the region of 4-5 mA/m², a level appropriate for CP installations. It should be stated, however, that the intention was not to install sacrificial CP system but to study the performance of the sacrificial anodes in conditions where corrosion of steel reinforcement may be occurring nearby.
