Retrofitting of Shear-Deficient Reinforced Concrete T-Girders with Composite-Based Systems

RETROFITTING OF SHEAR-DEFICIENT REINFORCED
CONCRETE T-GIRDERS WITH COMPOSITE-BASED
SYSTEMS

This thesis is submitted in partial fulfillment of the requirements
for the degree of Master of Science in Civil Engineering

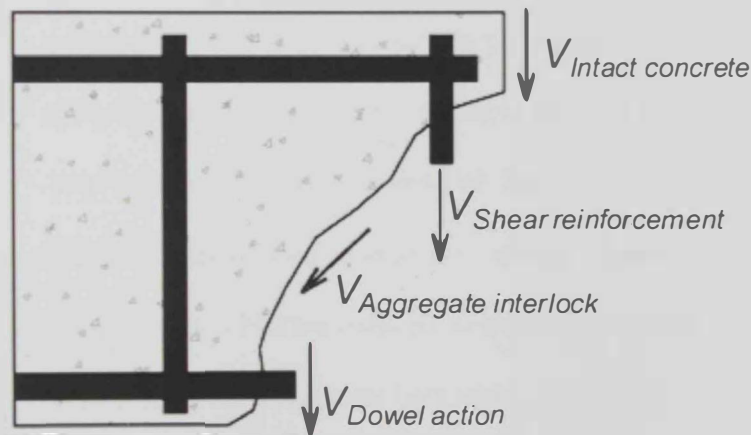
Figure 1.1: The contribution of concrete and steel reinforcement in shear resistance (Nogueira et al. 2013)

Where, V_c is the concrete contribution to the shear capacity and V_s is the contribution of the shear reinforcement (stirrups) and bent-up bars to the shear capacity. The contribution of concrete, V_c , includes shear resistance of un-cracked concrete, the dowel action of the longitudinal tensile reinforcement and the aggregates interlock as shown in Figure 1.1.

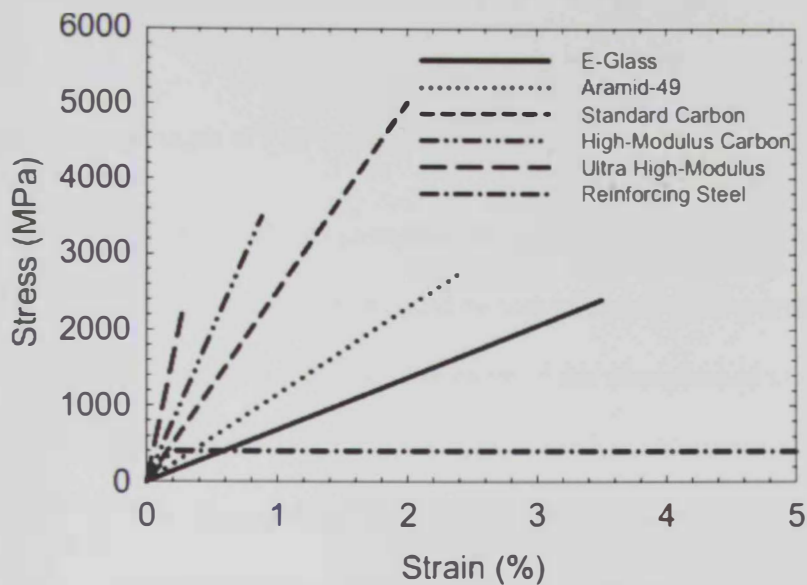
Figure 1.4: Stress strain diagram for different types of fibers and steel reinforcement (ISIS Canada 2006)

Aramid fiber reinforced polymers (AFRP) are sensitive to degradation by ultraviolet radiations as well as moisture. The AFRPs are known by their low density, moderate elastic modulus high strength, and low compressive and shear strengths. Figure 1.4 compares the stress-strain relationship of different types of FRP composites with that of steel reinforcement. (ISIS Canada 2006)

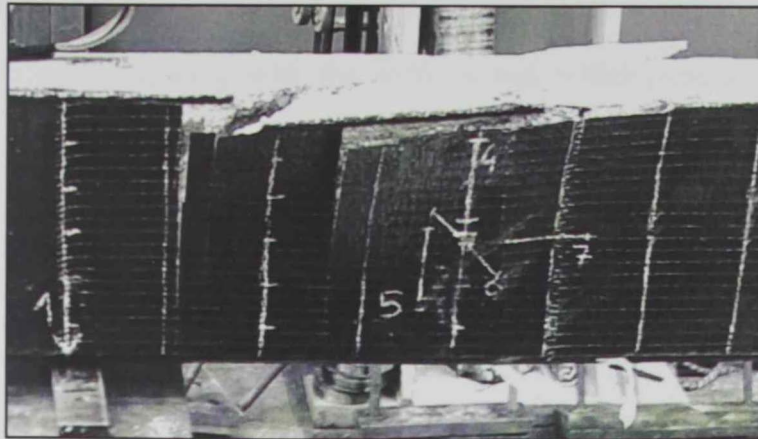
Figure 2.1: Peeling off of the CFRP reinforcement
(Pellegrino and Modena 2006)

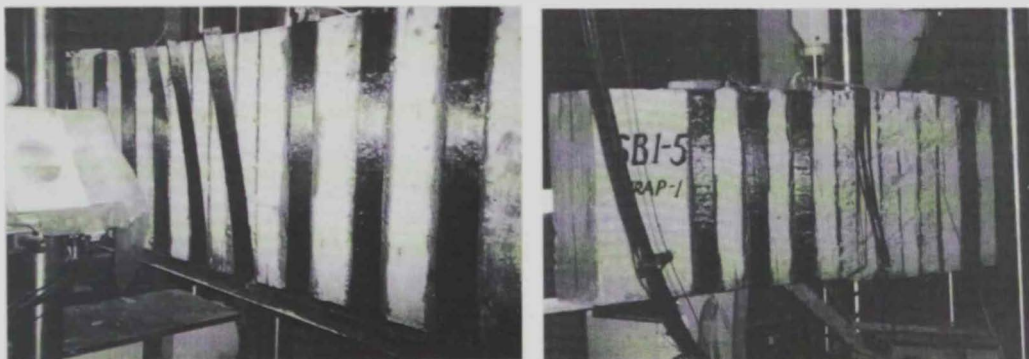
(a) Debonding of the CFRP sheets

(b) Rupture of the CFRP sheets

strengthened with the U-wraps failed by debonding of the CFRP sheets as shown in Figure 2.2(a), while the fully-wrapped beams failed by rupture of the CFRP sheets as shown in Figure 2.2(b). Test results indicated that beams strengthened with U-shaped CFRP sheets showed approximately 60% increase in shear capacity for the small beam, while the large and midsize beams showed only 4-7% increase in shear capacity. However, a similar range of 57 to 67% increase in shear capacity was observed for the beams strengthened by fully wrapped CFRP sheets regardless of the member size. The larger the spacing between the CFRP sheets, the less the contribution of the CFRP strips to shear resistance. It was concluded that for the fully-wrapped CFRP sheets regime, the variation of the CFRP strip width, spacing and thickness with the members of different sizes showed similar effectiveness of strengthening as long as the increase in the width, spacing and thickness of the CFRP is proportional to the increase of the cross section dimensions.

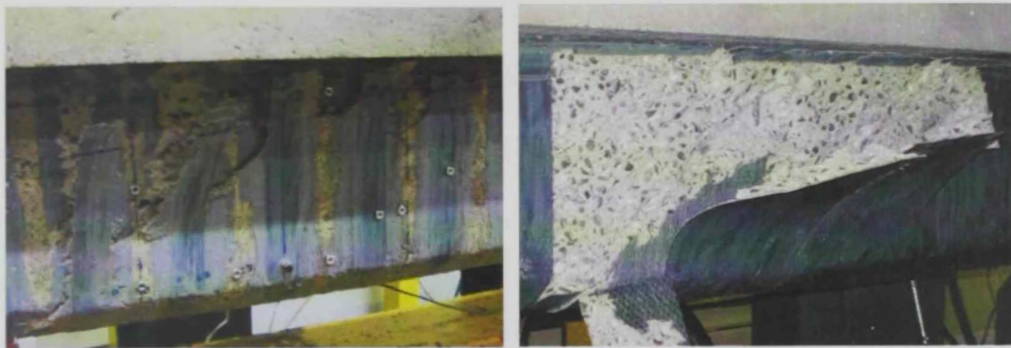
Figure 2.3: Debonding of CFRP sheets failure mode in the strengthened specimens (Mofidi and Chaallal 2011)

The specimens strengthened using CFRP sheets failed by crushing in concrete struts followed by CFRP debonding as shown in Figure 2.3. It is worth to say that local CFRP fracture was noticed, however, due to stress concentrations at the web corners. Test results indicated that specimens strengthened with U-shaped strips had 66% gain in shear capacity owing to CFRP compared to 31% for the specimens strengthened using continuous CFRP sheets. It was also concluded that the addition of stirrups has resulted in remarkable decrease in the shear strength gain caused by CFRP. The installation of CFRP strips in the same places of stirrups along the longitudinal direction showed more flexible behavior compared to specimens with CFRP strips installed at mid-positions between stirrups. The wider the CFRP strips, the higher the contribution of CFRP to shear resistance for the same CFRP strip-width-to-strip-spacing ratio.

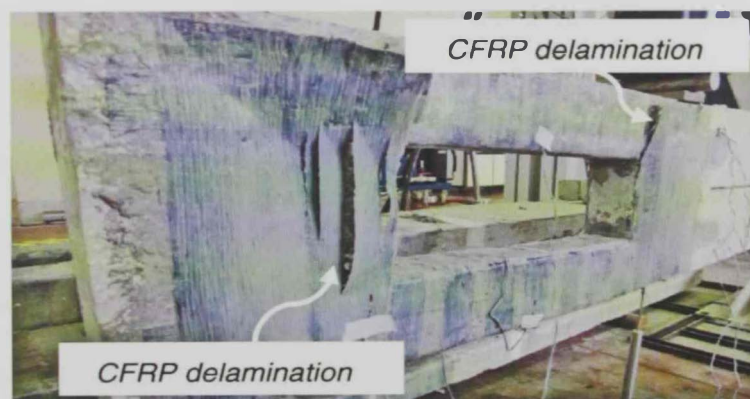
Figure 2.4: CFRP sheets delamination at the opening corners (El-Maaddawy and El-Ariss 2012)

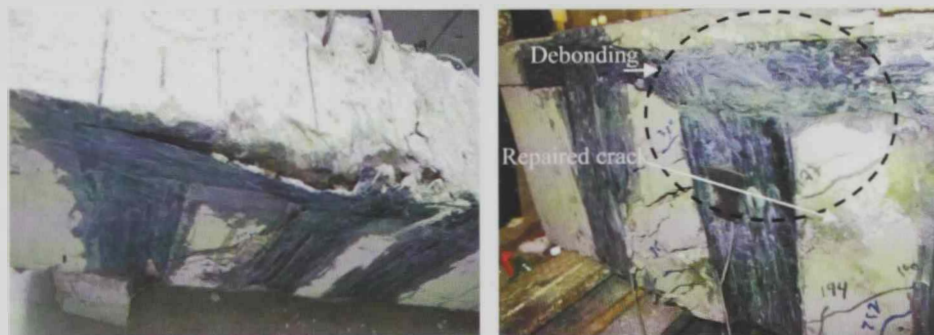
Figure 2.6: Typical CFRP debonding failure modes for the tested beams (Hussein et al. 2013)

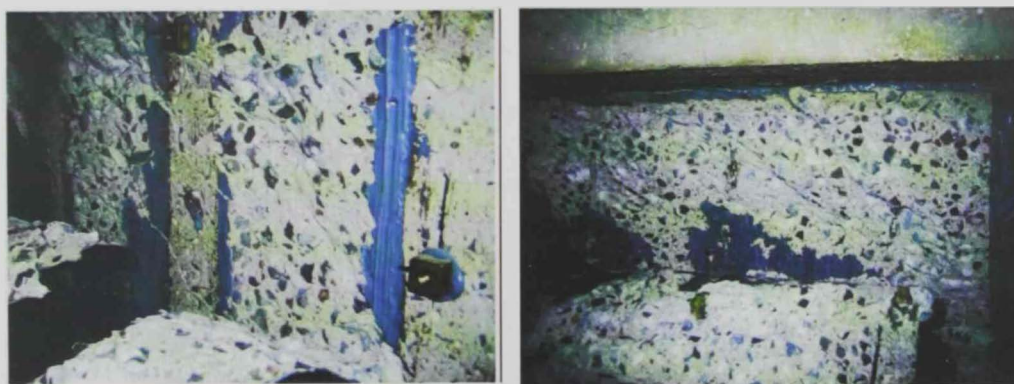
Figure 2.7: CFRP delamination failure mode (Mofidi and Chaallal 2014)

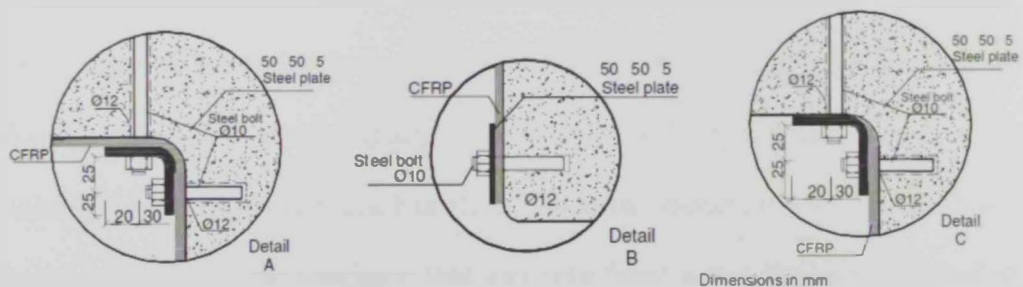
Figure 2.9: Anchorage details of strengthening specimen beams (Tanarslan and Ertutar 2008)

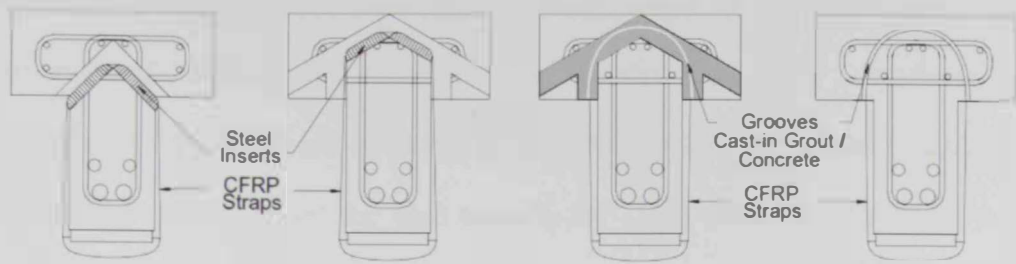
Figure 2.10: Strap configurations for test specimens
(Hoult and Lees 2009)

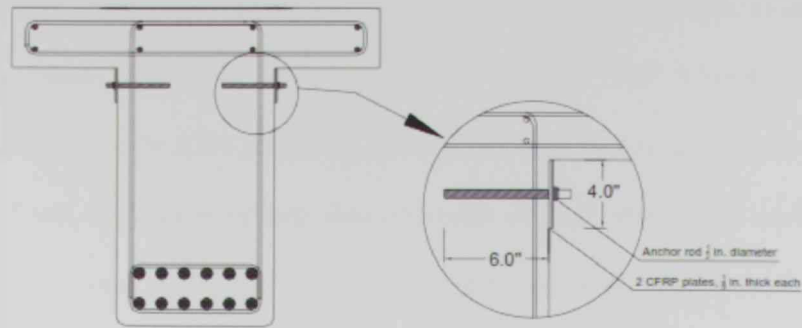
Figure 2.14: Details of mechanical anchorage system (Belarabi et al. 2010)

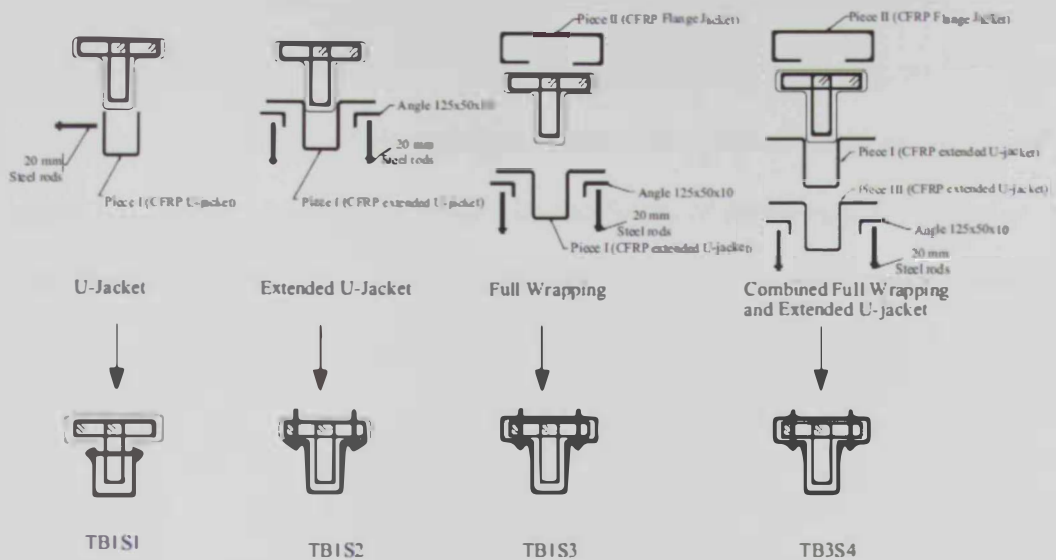
Figure 2.15: Implemented strengthening schemes (Deifalla and Ghobarah 2010)

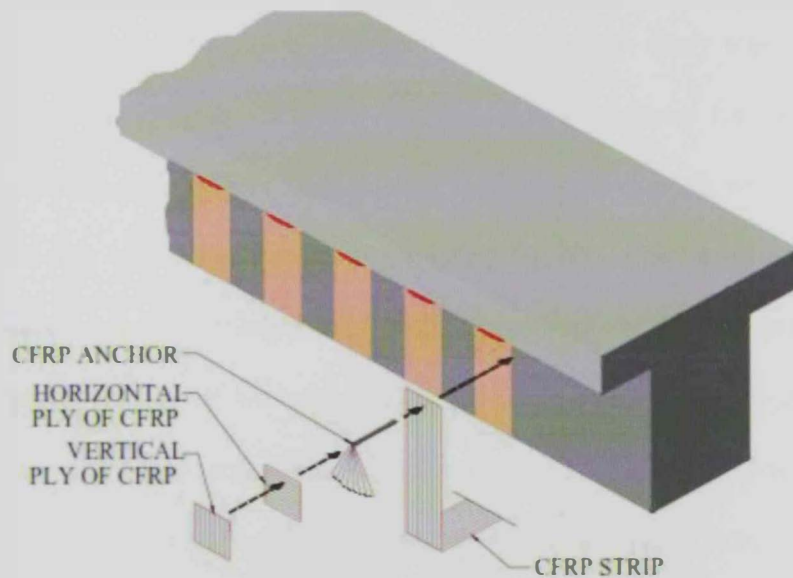
Figure 2.16: Isometric view-Details of CFRP anchors (Kim et al. 2011)

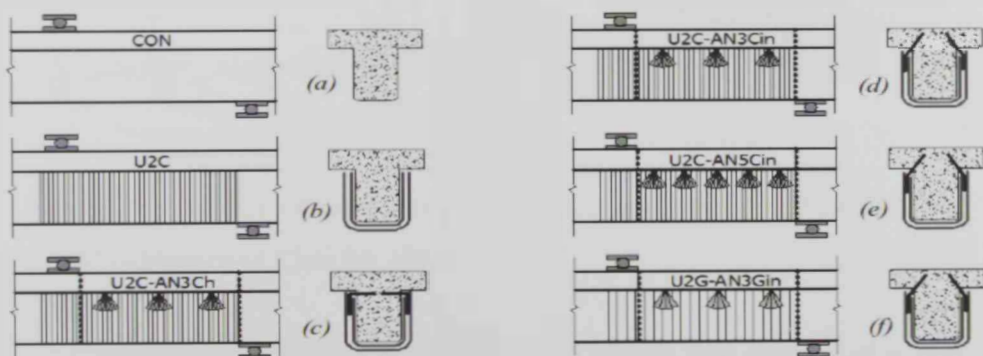
Figure 2.18: Strengthening configurations for the tested beams (Kuotas and Triantafillou 2012)

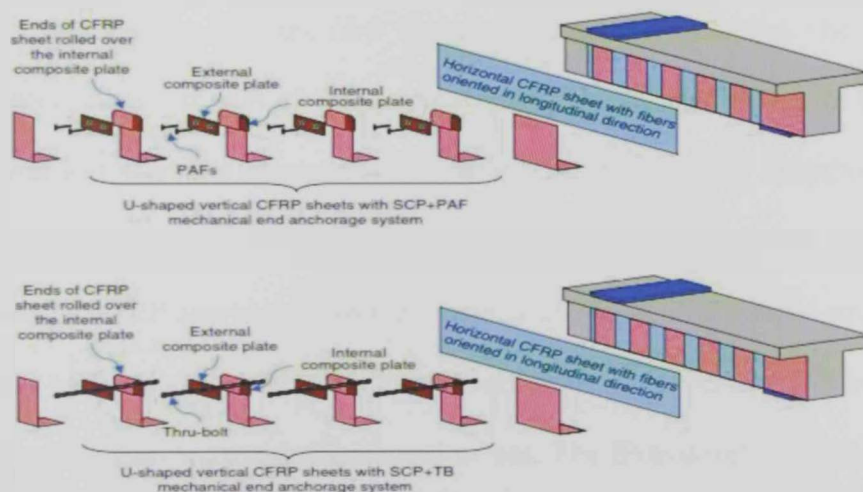
Figure 2.19: EB-CFRP retrofitting regime with mechanical end anchorage (EI-Maaddawy and Chekfeh 2012)

EI-Maaddawy and Chekfeh (2012) studied the effectiveness of using EB-CFRP system with mechanical end anchorage to repair severely damaged RC beams. A total of 14 tests were conducted on specimens with a T-shaped cross section. Test specimen had a length of 3200 mm. The T-section had a flange width and thickness of 300 and 50 mm, respectively, and a total depth of 240 mm with a thickness of 120 mm for the web. The beams were pre-failed in shear prior to strengthening. Test parameters included the number of EB-CFRP layers and type of end anchorage. The concrete compressive strength was 20 ± 0.4 MPa. The stirrups steel yield strength was 344 MPa. The shear span to effective depth ratio was $a/d = 3$. The strengthening regime consisted of U-shaped CFRP sheets without end anchorage and U-shaped CFRP sheets with mechanical end anchorage using sandwich composite panel (SCP) with either two short galvanized steel powder actuated fasteners (PAFs) or a galvanized steel threaded anchor bolt (TB) inserted through the entire web width as shown in Figure 2.19

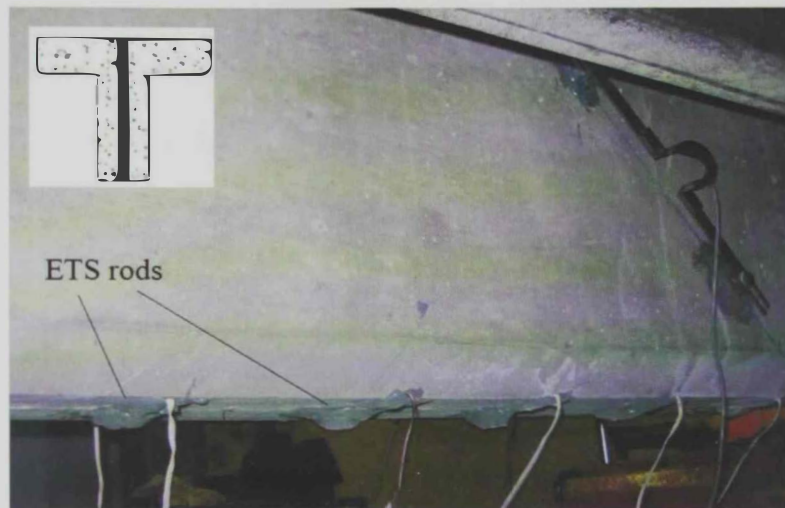
Figure 2.21: Strengthened specimens with ETS-CFRP rods
(Chaallal et al. 2012)

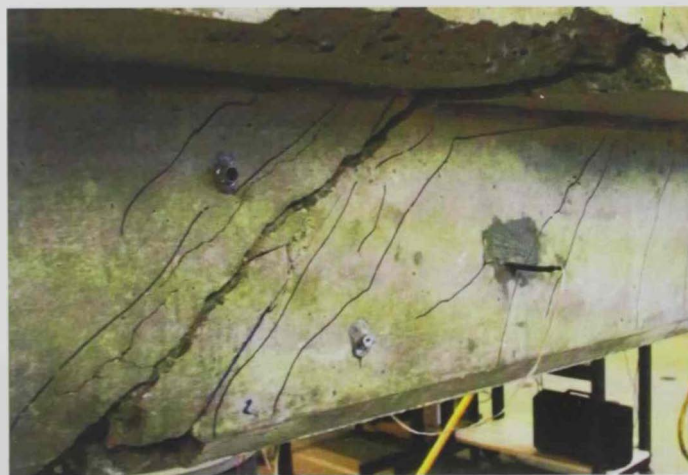
Figure 2.22: Diagonal tension shear mode of failure for the strengthened specimen (Mofidi et al. 2012)

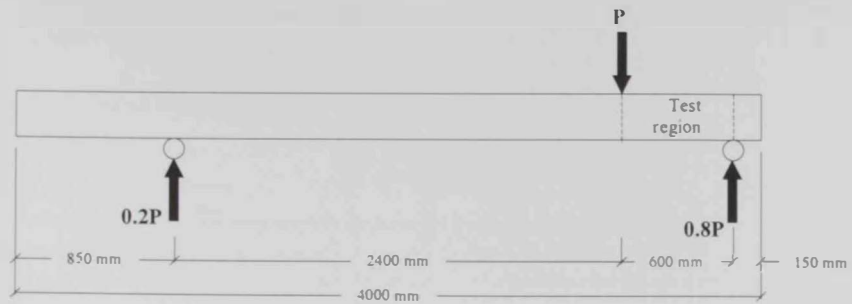
Figure 3.1: Test of the right shear span

provided as shear reinforcement at $s = 75$ mm through the long shear span in the beams of all groups in order to avoid shear failure outside the test region.

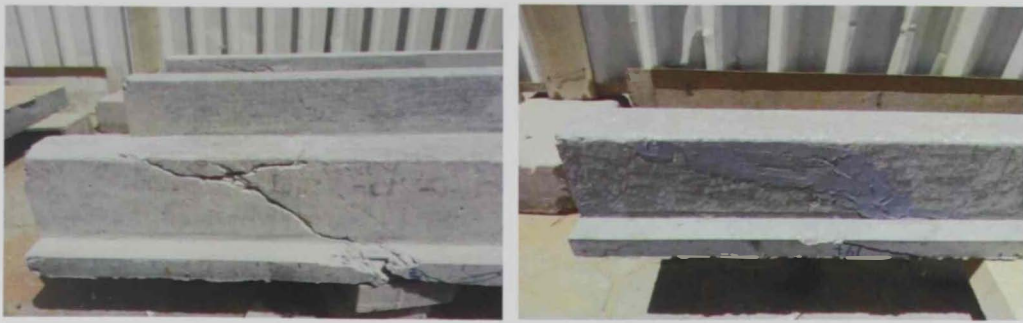
(a) Chasing-out of pre-existing cracks (b) After sealing of cracks and finishing of concrete surface

Two composite-based systems were used for shear strengthening/retrofitting of test specimens. The strengthening/retrofitting regimes and methodology are summarized in the following subsections. For the pre-failed specimens, the pre-existing cracks were chased-out in a V-shape to a depth of approximately 13 mm as shown in Figure 3.10(a), surface-filled with a cementitious grout, and struck off flush with the concrete surface as shown in Figure 3.10(b). Any damaged concrete in the flange were removed, cleaned of dust and loose particles using air blower, and then repaired with the cementations grout.

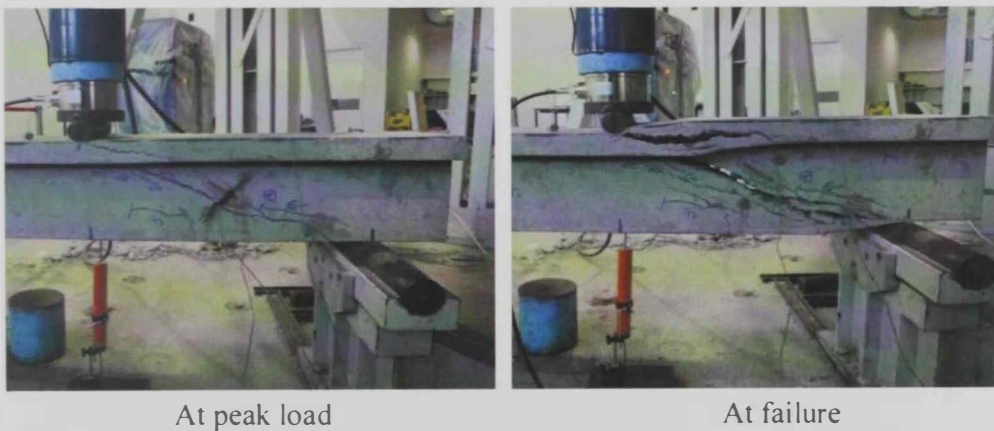
Figure 4.1: Failure mode of specimen ND-NS-NR

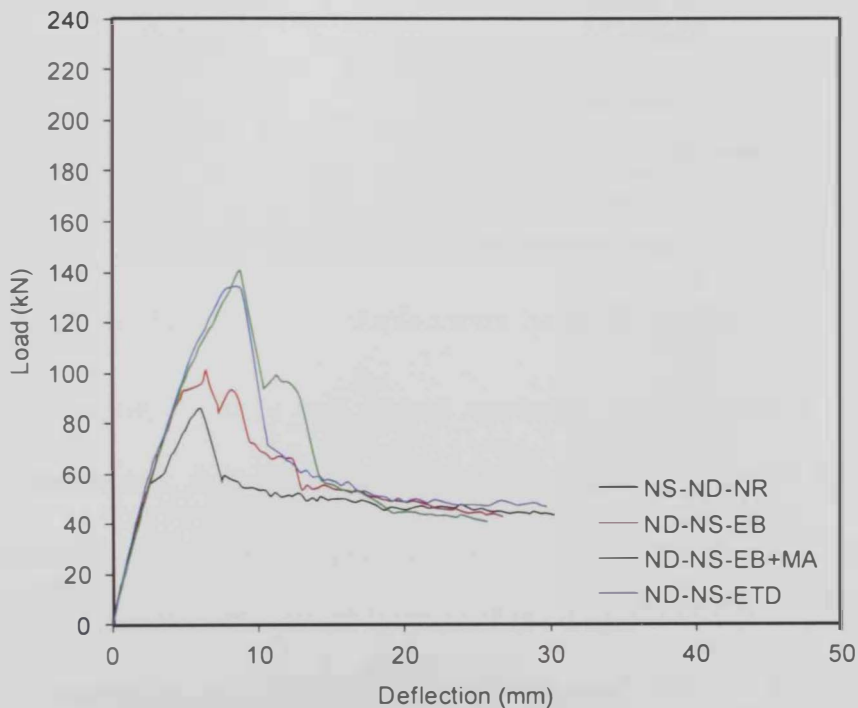
Figure 4.5: Load-deflection curves for specimens of group [A]

specimen could, however, sustain additional load due to the tension stiffening effect until it reached its peak load at a deflection of 6.1 mm. The strengthened specimens exhibited a quasi-linear deflection response in the post-cracking stage. Varying the strengthening system had no effect on the stiffness of the strengthened specimens. Specimen ND-NS-EB reached its peak load at a deflection of 6.4 mm. It experienced several drops/increases in the load in the post-peak stage possibly because of progressive debonding of the CFRP sheets. The specimens strengthened with the EB-CFRP system integrated with the MA and those with the ETD-GFRP system experienced a quasi-linear load-deflection behavior until they reached their peak loads at deflections of 8.8 and 8.0 mm, respectively. After reaching the peak load, specimens ND-NS-EB+MA and ND-NS-ETD exhibited a sudden drop in load followed by a plastic response where the deflection continued to increase without an increase in load.

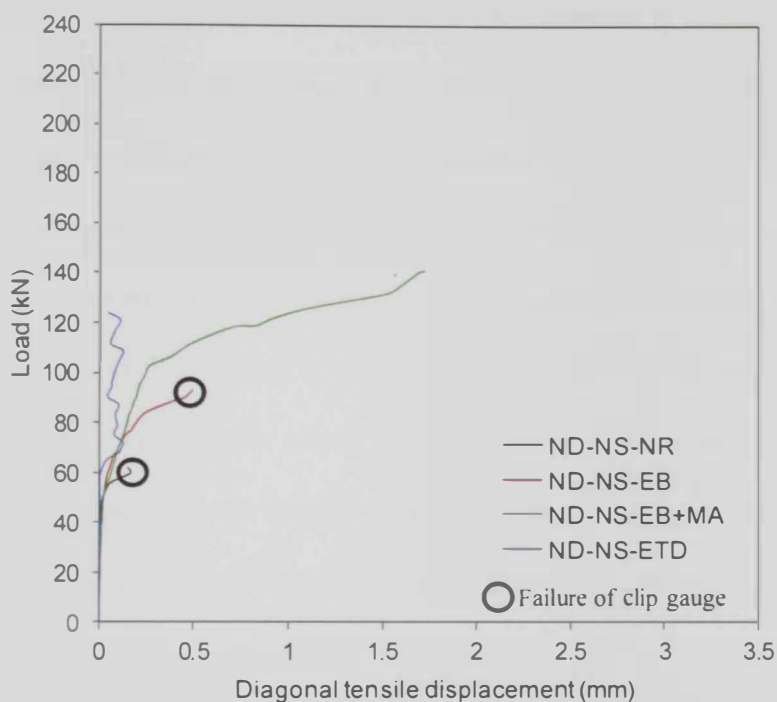
Figure 4.6: Load-diagonal tensile displacement curves for specimens of group [A].

The load versus the diagonal tensile displacement curves for specimens of group [A] are shown in Figure 4.6.

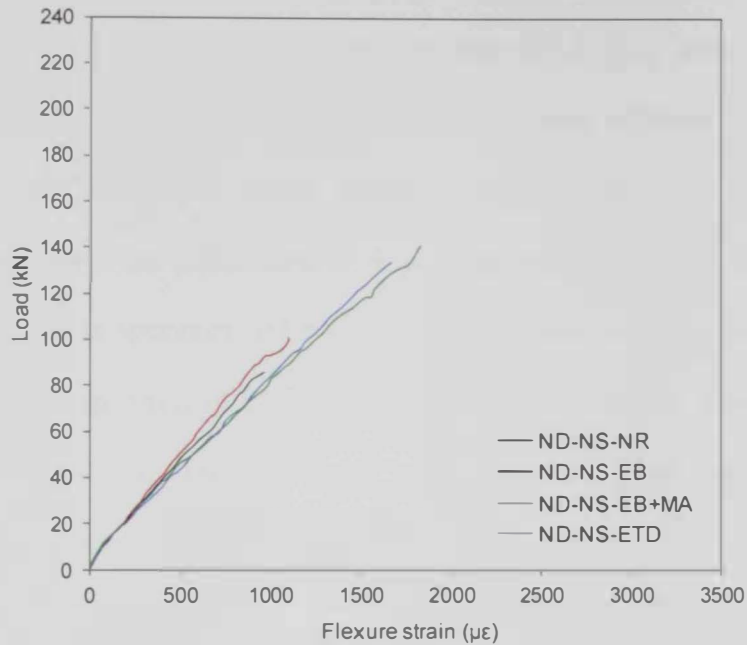
Figure 4.7: Load-flexural strain relationships for specimens of group [A]

reach the yielding strain prior to the peak load. The longitudinal steel reinforcement in specimen ND-NS-NR has reached a strain of 966 $\mu\epsilon$ at the peak load. However, specimen ND-NS-EB has reached a higher strain of 1098 $\mu\epsilon$ at the peak load. Specimens ND-NS-EB+MA and ND-NS-ETD reached their peak loads at strain values of 1830 and 1670 $\mu\epsilon$, respectively.

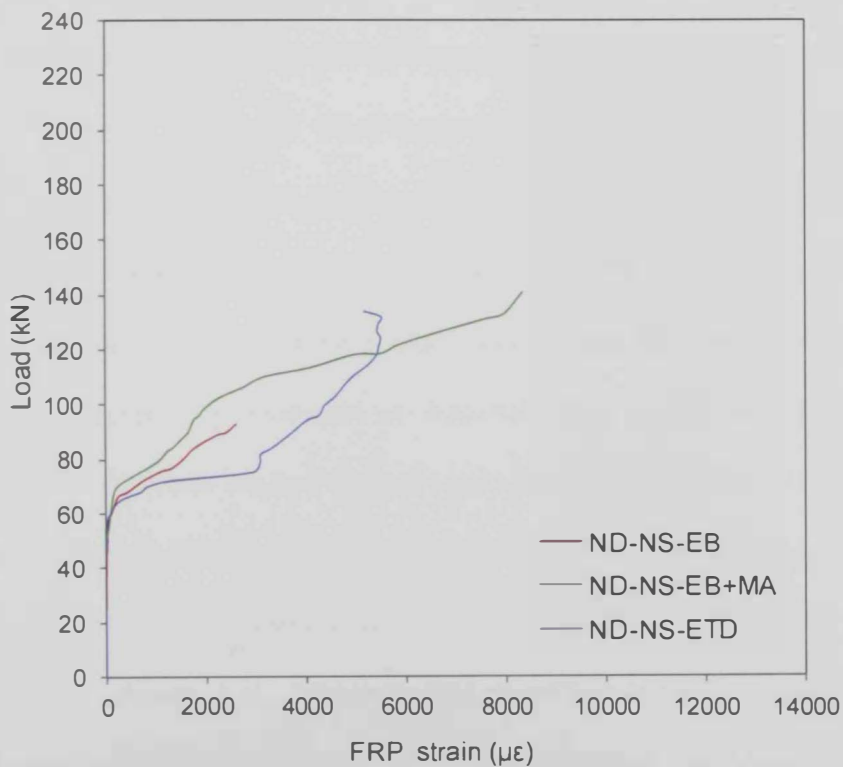
Figure 4.8: Load-FRP strain relationships for specimens of group [A]

until it reached a strain value of approximately 3000 $\mu\epsilon$. Subsequently, the GFRP strain increased at a constant rate until it reached a strain value of 5510 $\mu\epsilon$ at a load value of 120 kN, where local slippage/debonding of the concerned GFRP rebar may have taken place. Specimen ND-NS-EB experienced a bi-linear CFRP strain response whereas specimen ND-NS-EB+MA featured a tri-linear strain response. After crack initiation, the rate of the CFRP strain in specimen ND-NS-EB and ND-NS-EB+MA was insignificantly different. For specimen ND-NS-EB, the CFRP strain increased at a constant rate until sudden delamination of the CFRP sheet took place at a strain value of 2592 $\mu\epsilon$. The CFRP strain in specimen ND-NS-EB+MA increased at a constant rate until it reached a strain value of 2256 $\mu\epsilon$ at a load level of 100 kN. Then, the CFRP strain increased at a higher rate due to development of new cracks and/or an increase in the width of existing cracks.

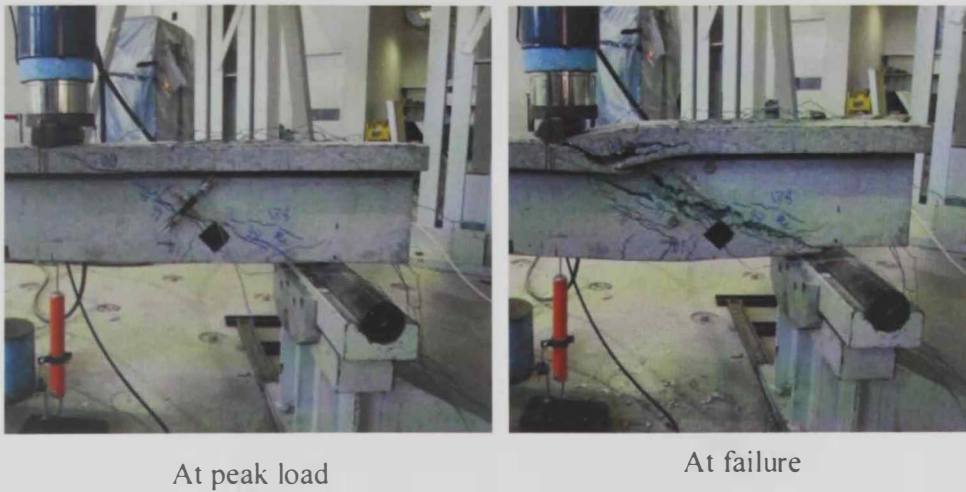
Figure 4.9: Failure mode of specimen ND-S1-NR

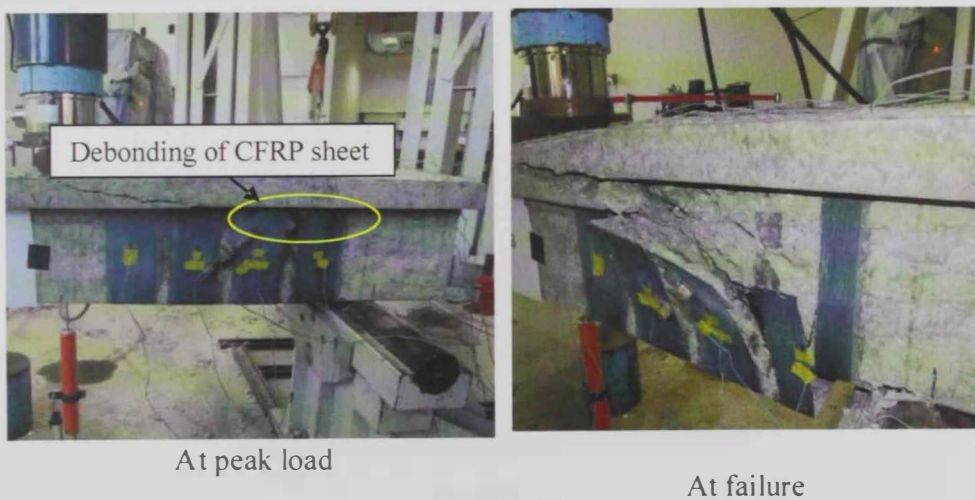
Figure 4.10: Failure mode of specimen ND-S1-EB

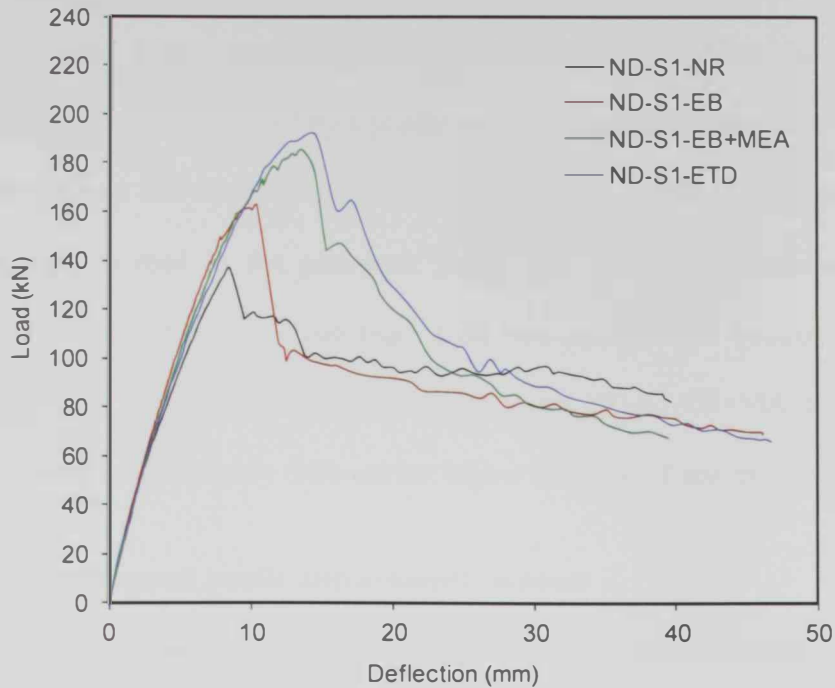
Figure 4.13: Load-deflection curves for the non-damaged specimens of group [B]

The load-deflection curves of the specimens of group [B] that were not damaged prior to strengthening and/or testing are illustrated in Figure 4.13.

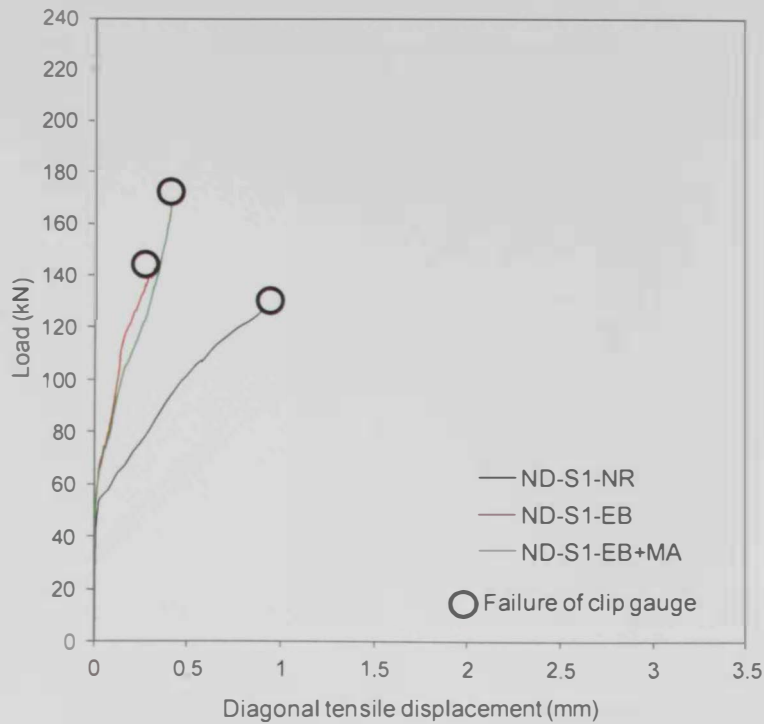
Figure 4.14: Load-diagonal tensile displacement curves for the non-damaged specimens of group [B].

Figure 4.14 shows the relationship between the load and diagonal tensile displacement for specimens of group [B] that were not damaged prior to strengthening and/or testing. The diagonal tensile displacement response of specimen ND-S1-ETD was not recorded due to malfunction of the clip gauge. All specimens exhibited no diagonal tensile displacement prior to initiation of shear cracks that took place at a load value of 60 kN, on average. Shear strengthening insignificantly increased the cracking load. In the post-cracking stage, the diagonal tensile displacement increased almost at a constant rate. Shear strengthening remarkably reduced the rate of increase of the diagonal displacement across cracks. Specimens ND-S1-EB and ND-S1-EB+MA exhibited almost similar rate of increase of the diagonal displacement across cracks. This indicated that although the MA system prevented the premature delamination of the CFRP sheets, and hence increased the shear strength gain, it had no effect on the rate of increase of the diagonal tensile displacement response in the post-cracking stage.

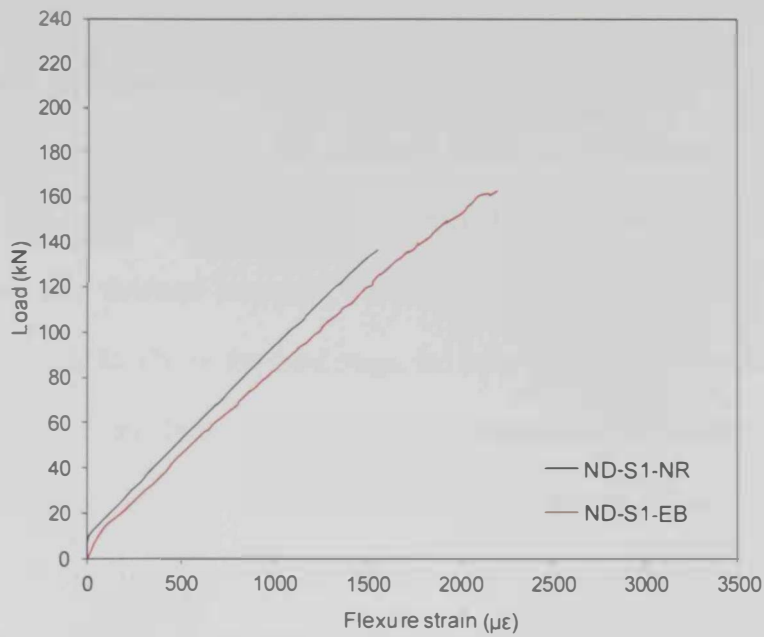
Figure 4.15: Load-flexural strain relationship for the non-damaged specimens of group [B]

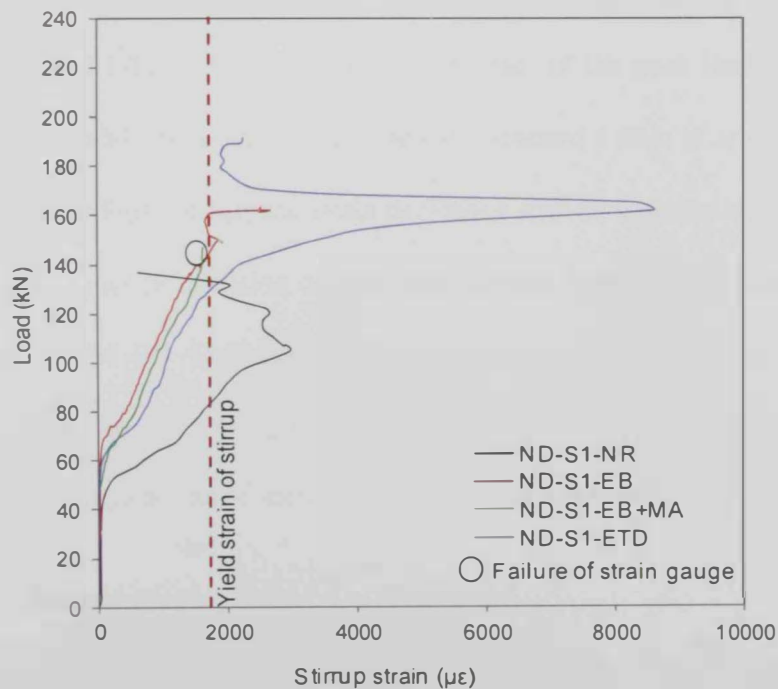
Figure 4.16: Load-stirrups strain curves for the non-damaged specimens of group [B]

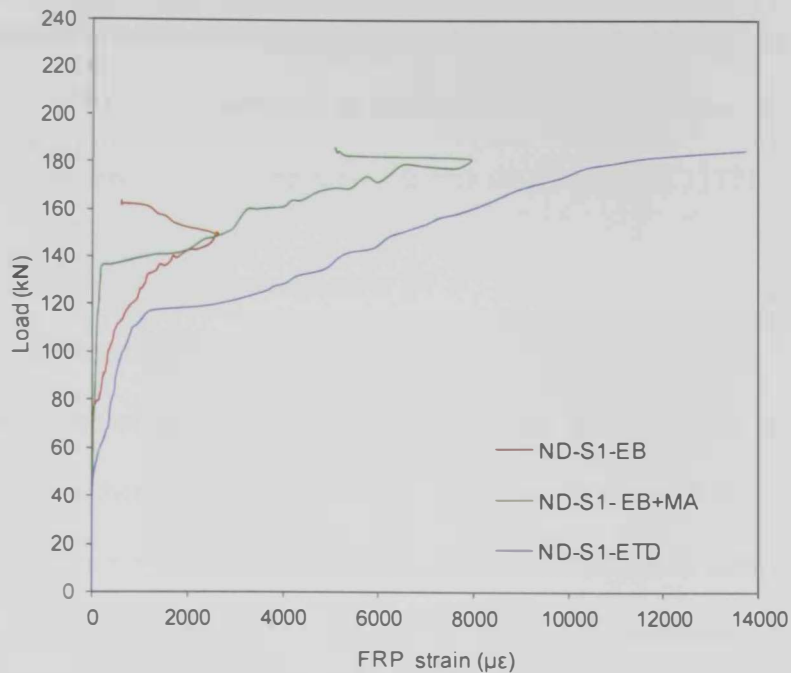
Figure 4.17: Load-FRP strain relationships for the non-damaged specimens of group [B]

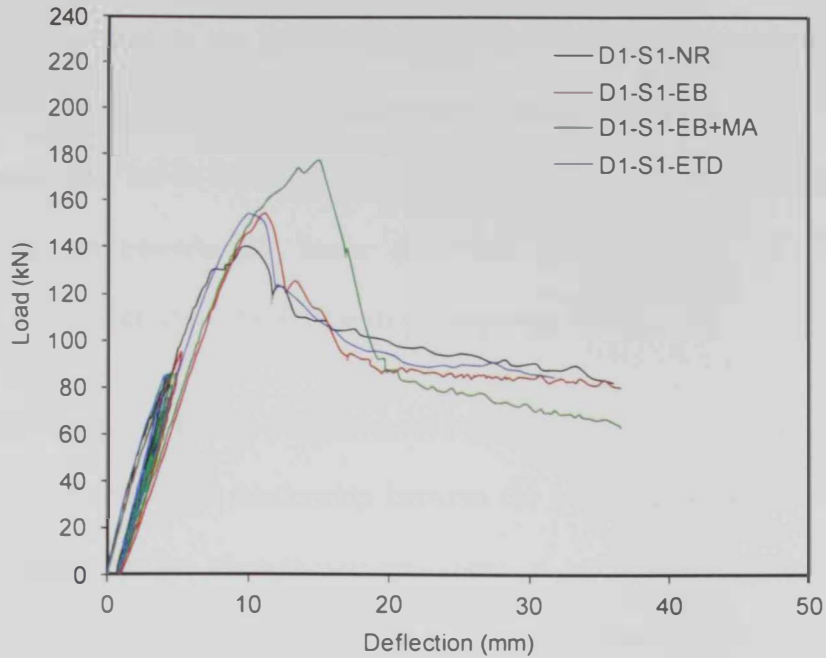
Figure 4.22: Load-deflection curves for specimens of group [B] with damage state D1.

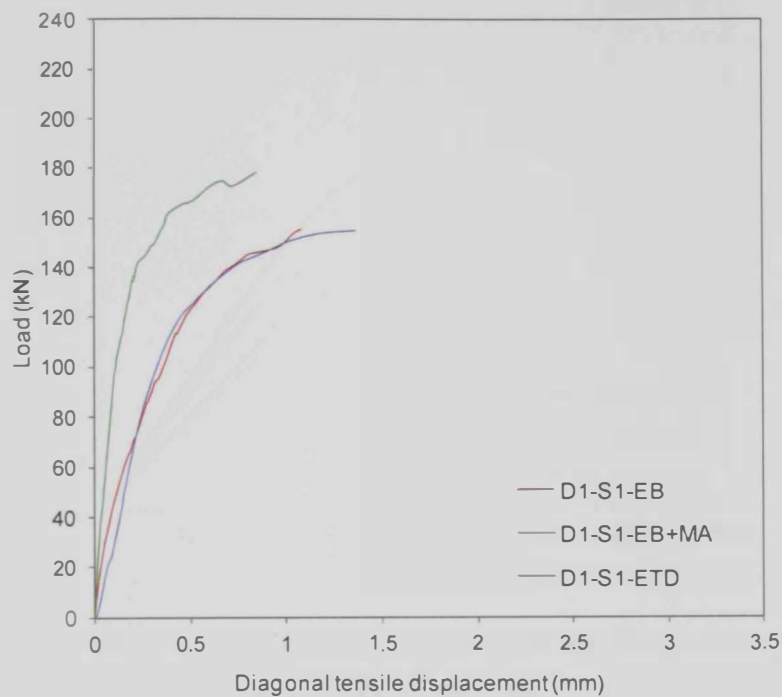
Figure 4.23: Load – diagonal tensile displacement response for specimens of group [B] with damage state D I

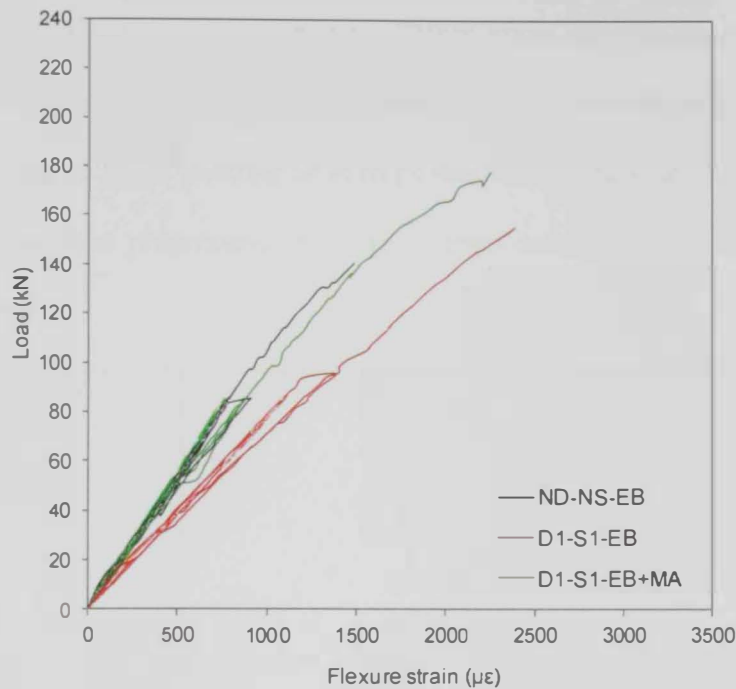
Figure 4.24: Load-flexural strain relationship for specimens group [B] with damage state D1

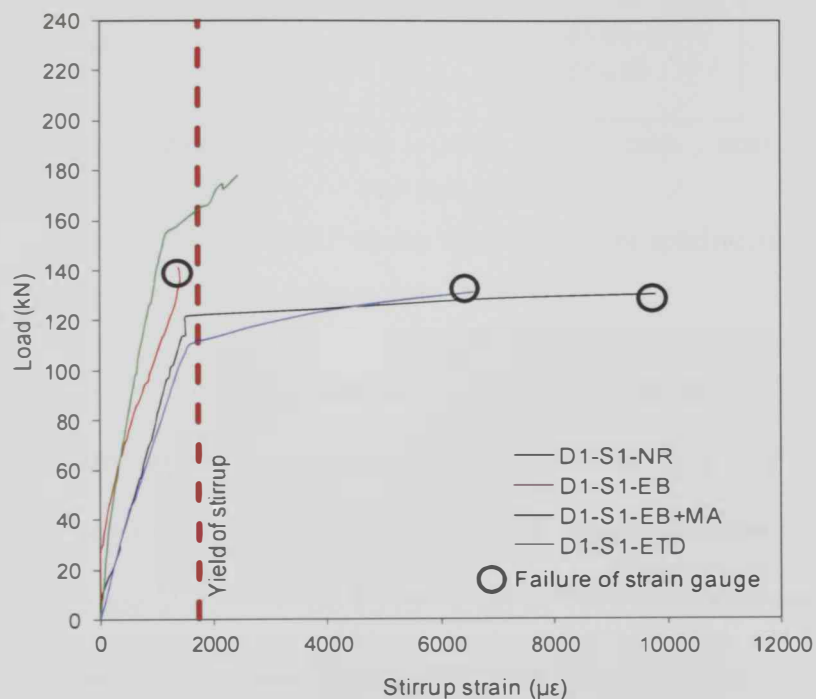
Figure 4.25: Load- stirrups strains curves for specimens of group [B] with damage state D1.

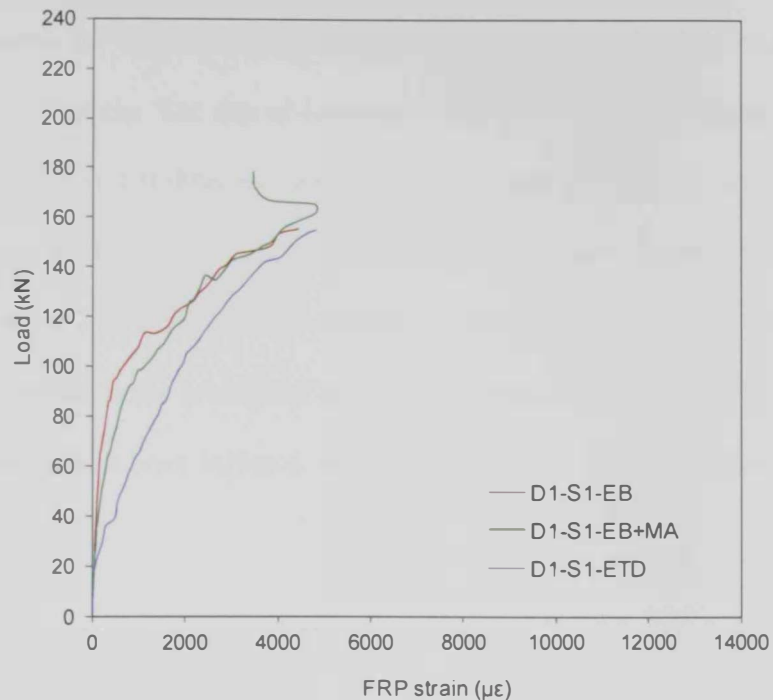
Figure 4.26: Load-FRP strains relationships for specimens of group [B] with damage state D1.

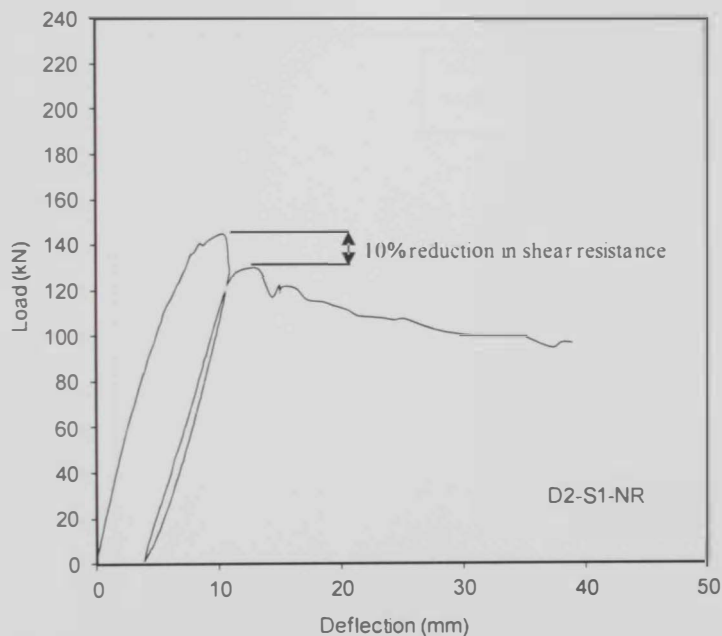
Figure 4.31: Load-deflection curves of specimen D2-S1-NR

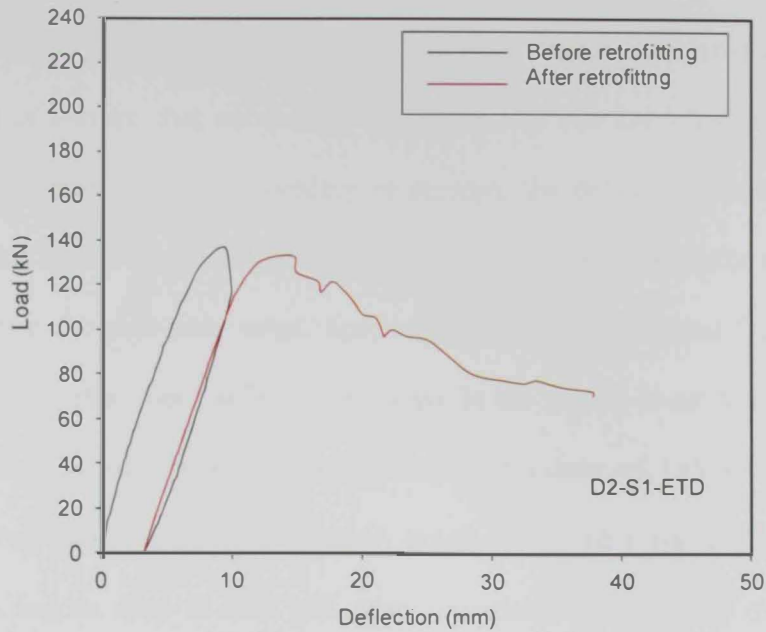
Figure 4.34: Load-deflection curves of specimen D2-S1-ETD

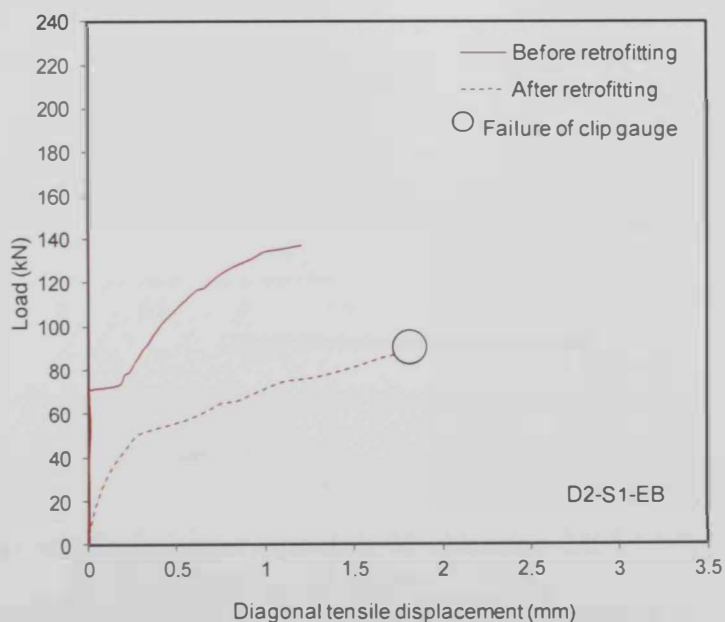
Figure 4.35: Load-diagonal tensile displacement curves for specimen D2-S1-EB

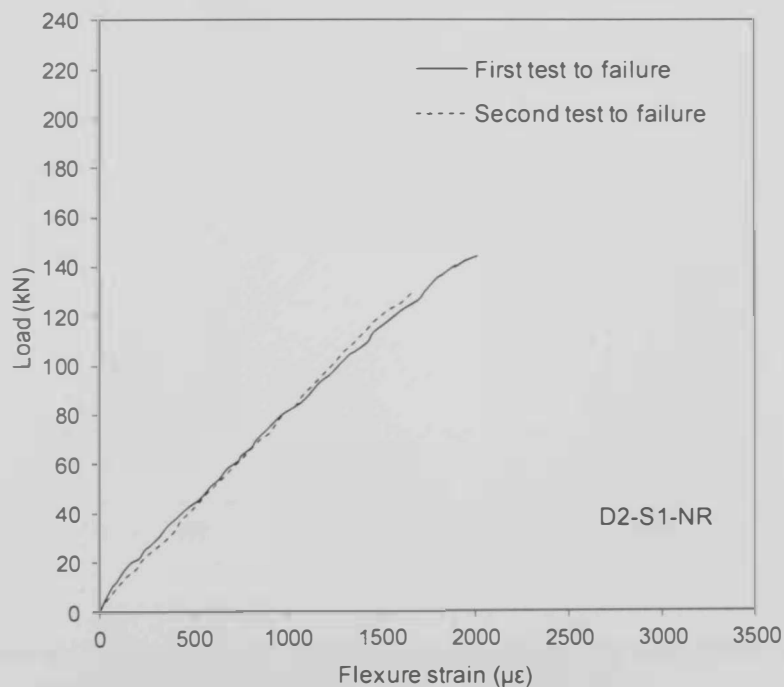
Figure 4.38: Load-flexural strain relationships for specimen D2-S1-NR

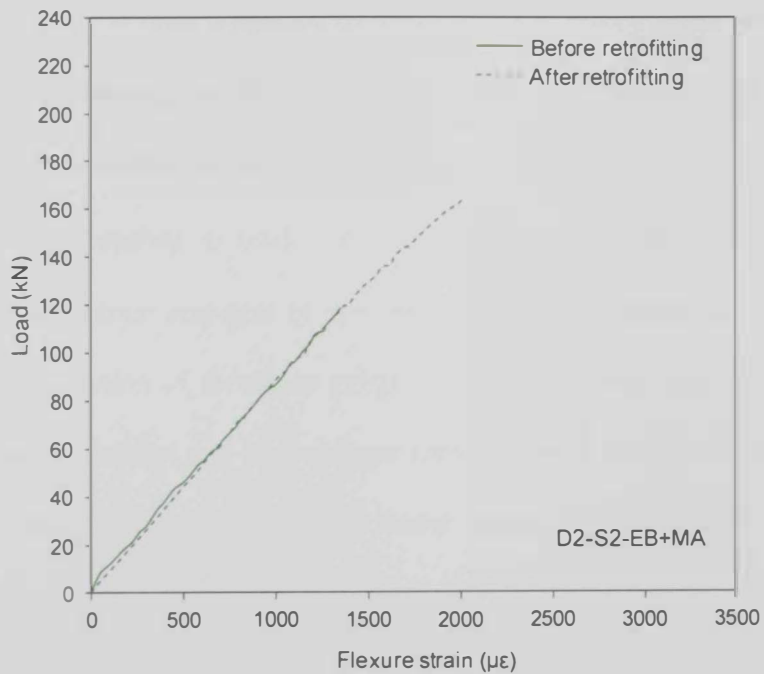
Figure 4.40: Load-flexural strain relationships for specimen D2-S1-EB+MA

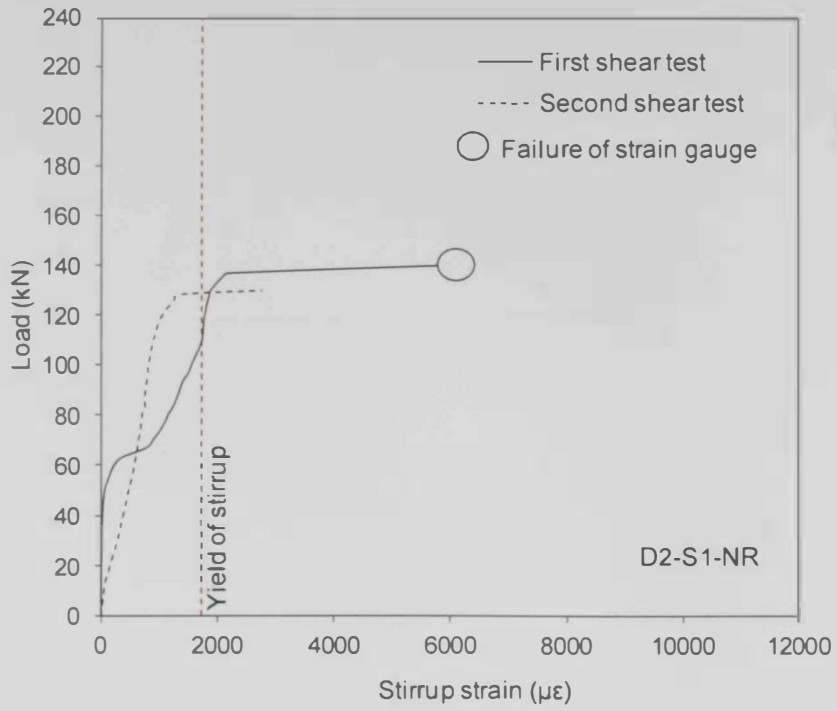
Figure 4.41: Load-stirrups strain response for specimen D2-S1-NR

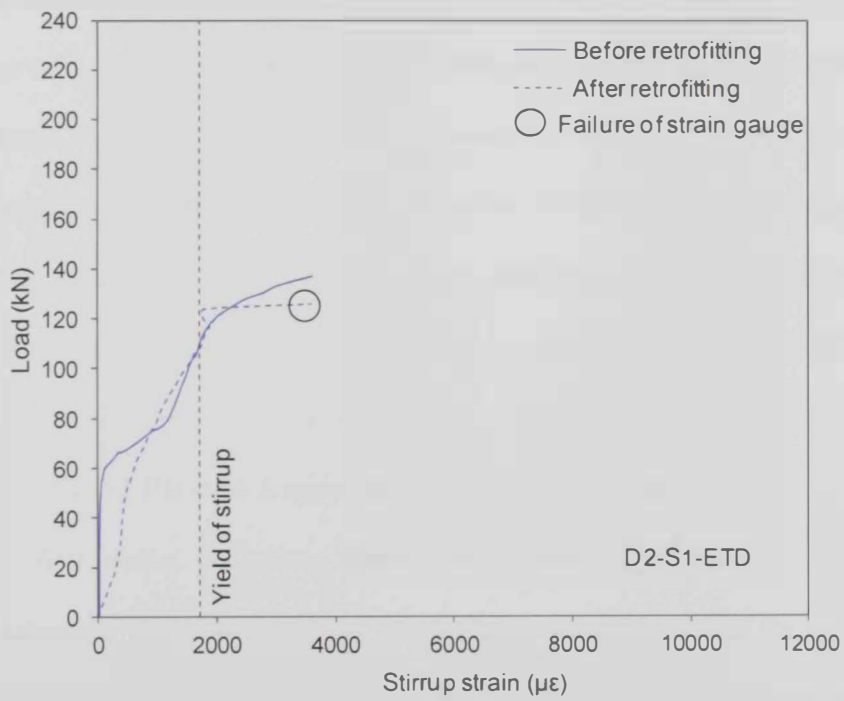
Figure 4.44: Load-stirrups strain response for specimen D2-S1-ETD
