Retrofitting of Shear-Deficient Reinforced Concrete T-Girders with Composite-Based Systems

RETROFITTING OF SHEAR-DEFICIENT REINFORCED
CONCRETE T-GIRDERS WITH COMPOSITE-BASED
SYSTEMS

This thesis is submitted in partial fulfillment of the requirements
for the degree of Master of Science in Civil Engineering

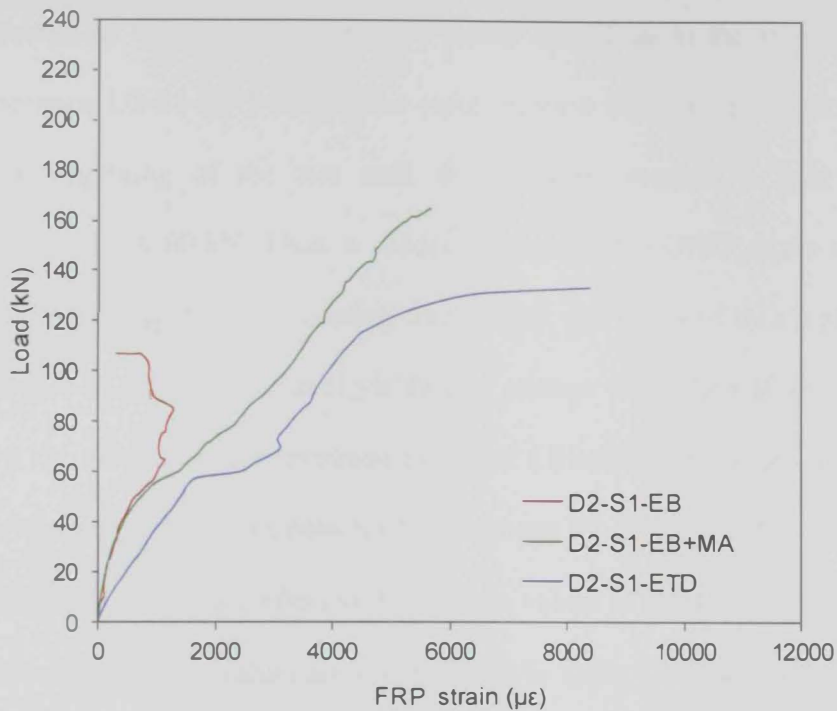
Figure 4.45: Load-FRP strains relationship for specimens of group [B] with damage state D2.

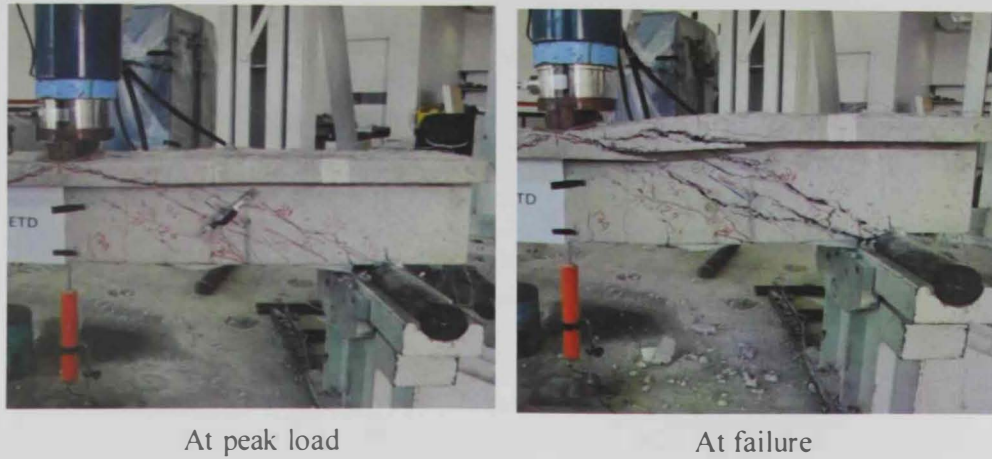
Figure 4.49: Failure mode of specimen ND-S2-ETD

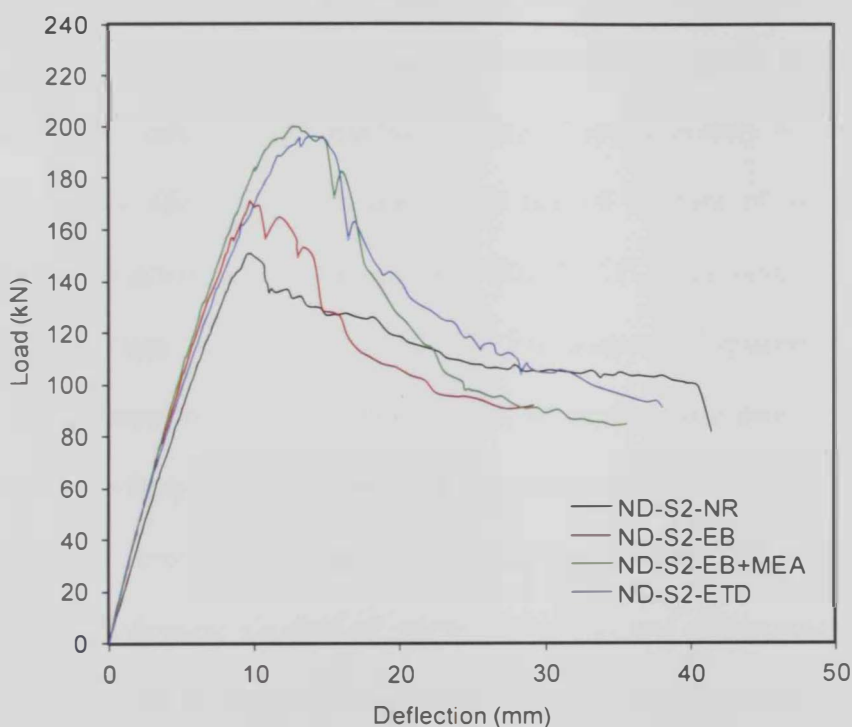
Figure 4.50: Load-deflection curves for the non-damaged specimens of group [C]

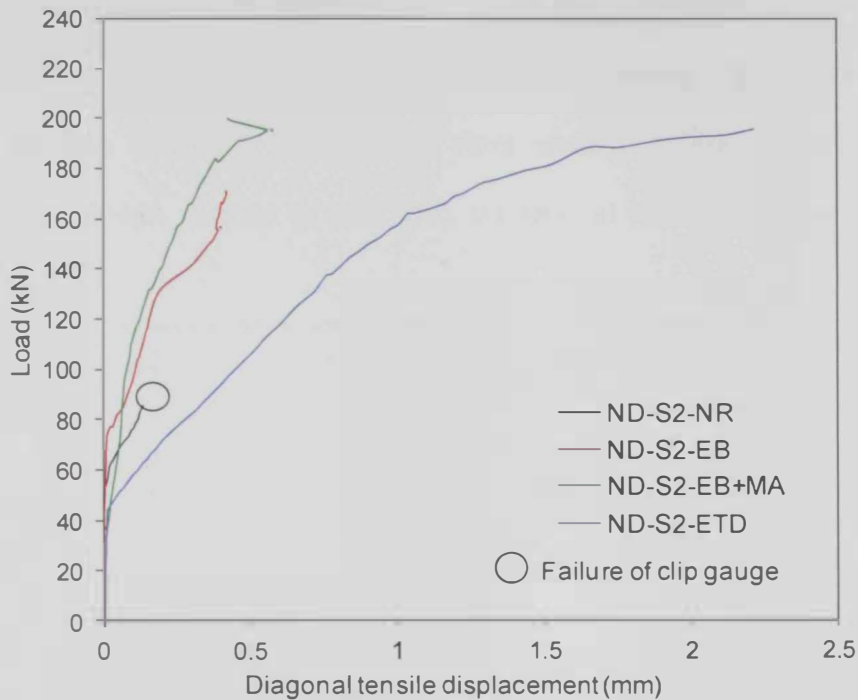
Figure 4.51: Load- diagonal tensile displacement curves for the non damaged specimens of group [C]

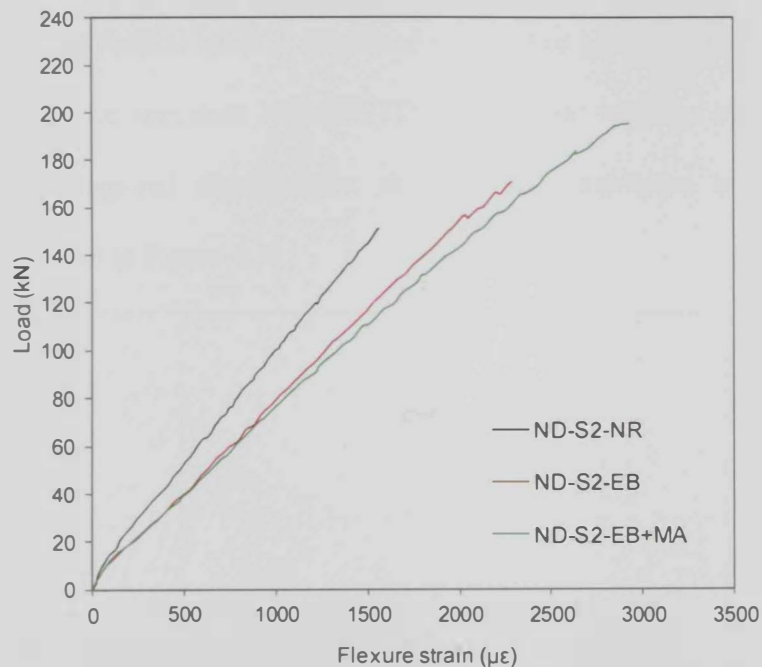
Figure 4.52: Load-flexural strain relationships for the non-damaged specimens of group [C]

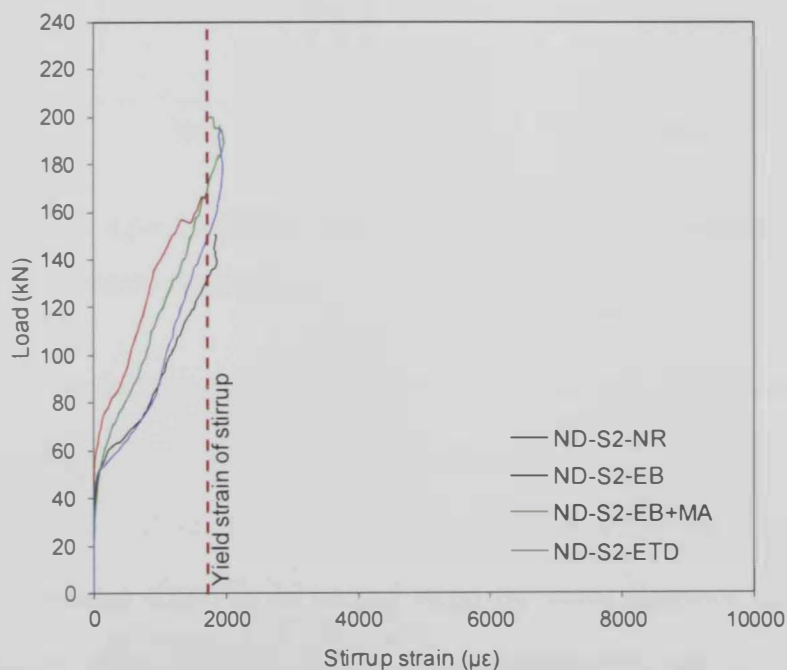
Figure 4.53: Load-stirrups strain response for the non-damaged specimens of group [C]

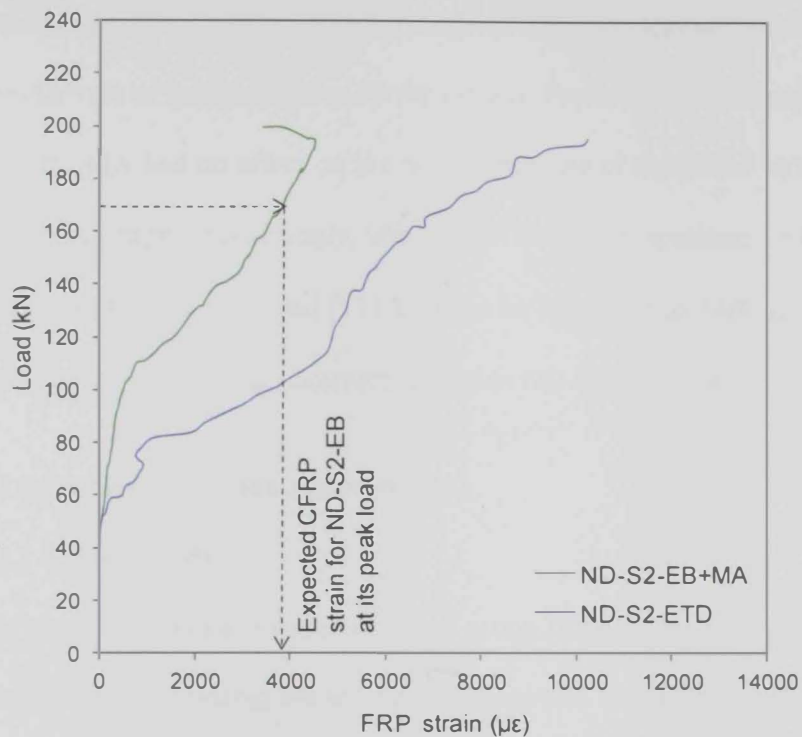
Figure 4.54: Load-FRP strain relationships for the non-damaged specimens of group [C]

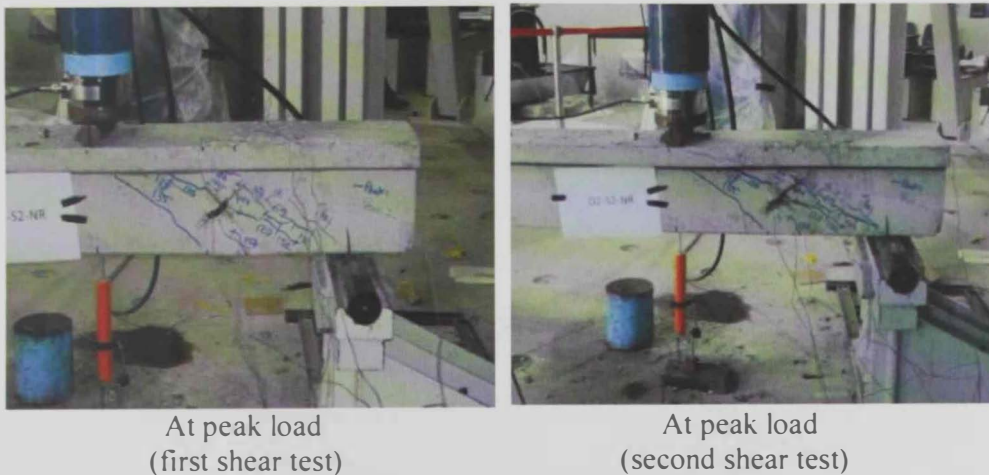
Figure 4.55: Failure mode of specimen D2-S2-NR

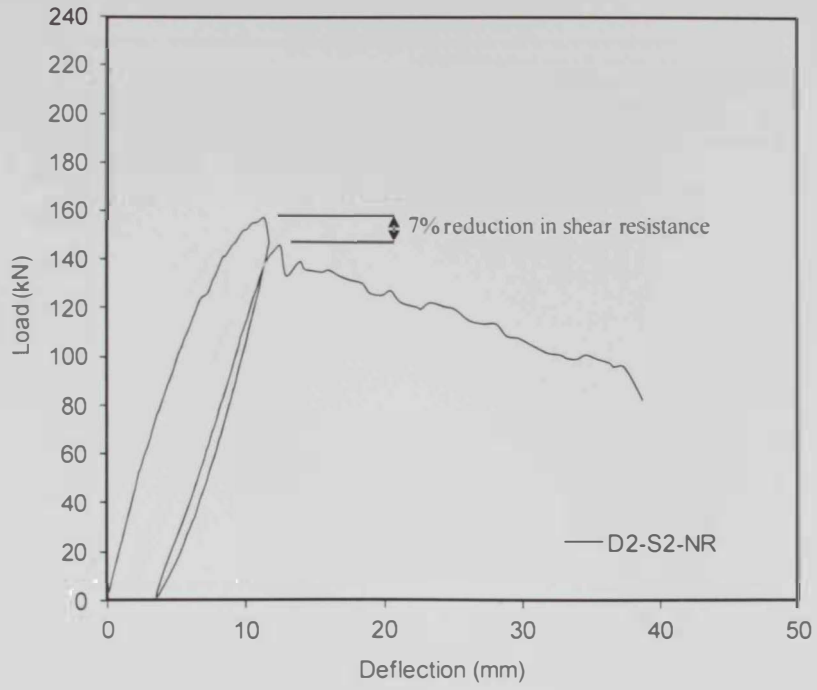
Figure 4.60: Load-deflection curves of specimen D2-S2-NR

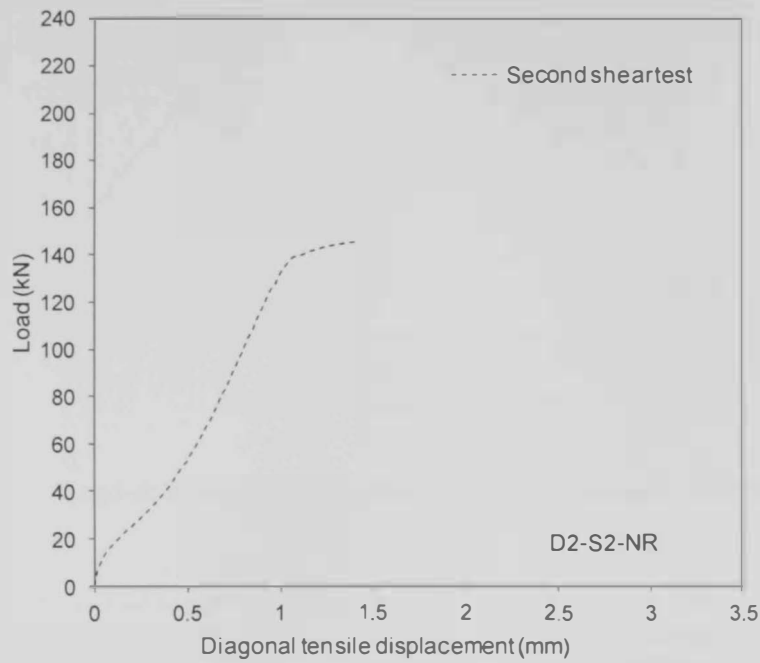
Figure 4.63: Load-diagonal tensile displacement for specimen D2-S2-NR

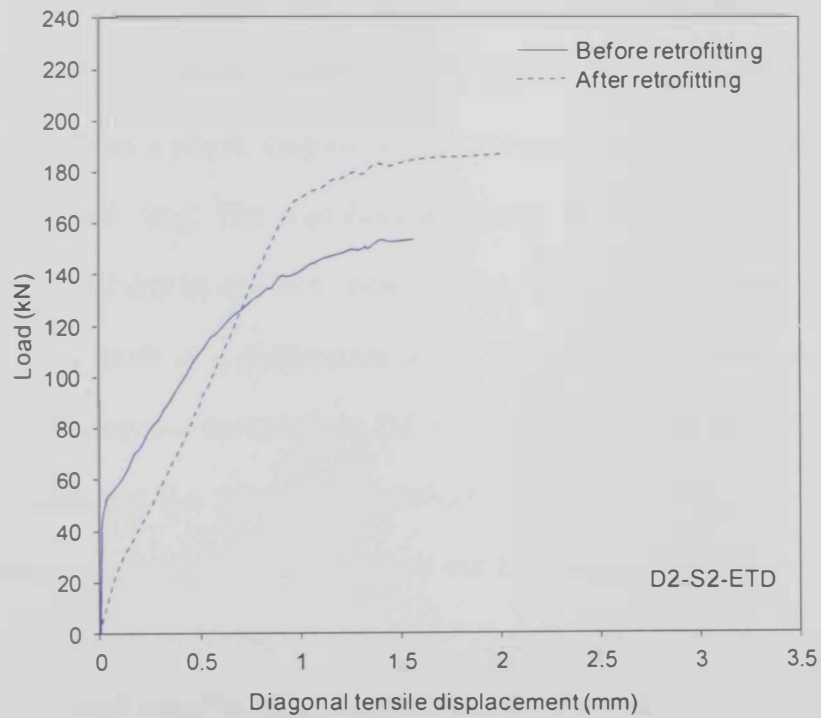
Figure 4.66: Load-diagonal tensile displacement for specimen D2-S2-ETD

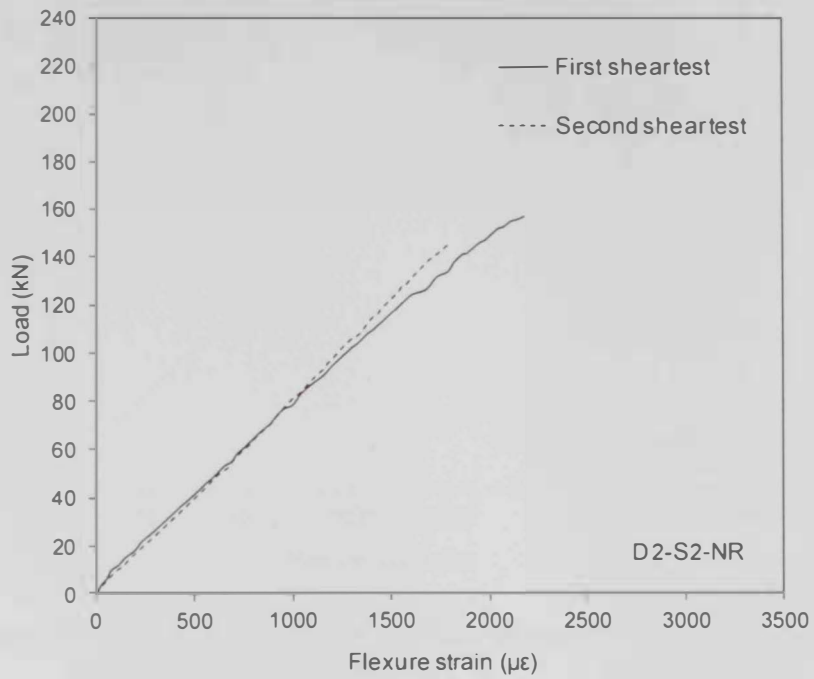
Figure 4.67: Load-flexural strain relationship for specimen D2-S2-NR

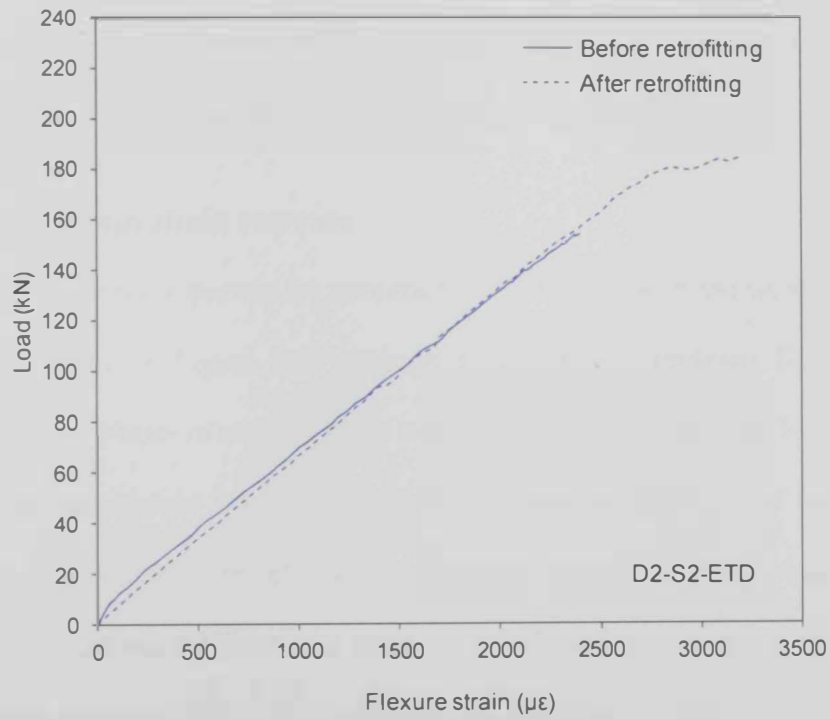
Figure 4.70: Load-flexural strain relationship for specimen D2-S2-ETD

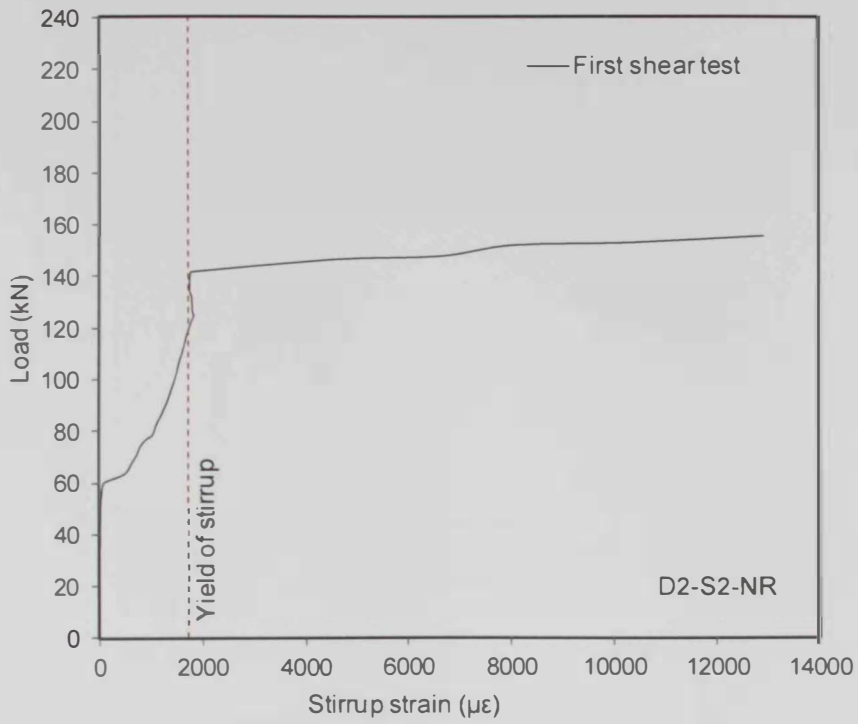
Figure 4.71: Stirrup's strain response of specimen D2-S2-NR

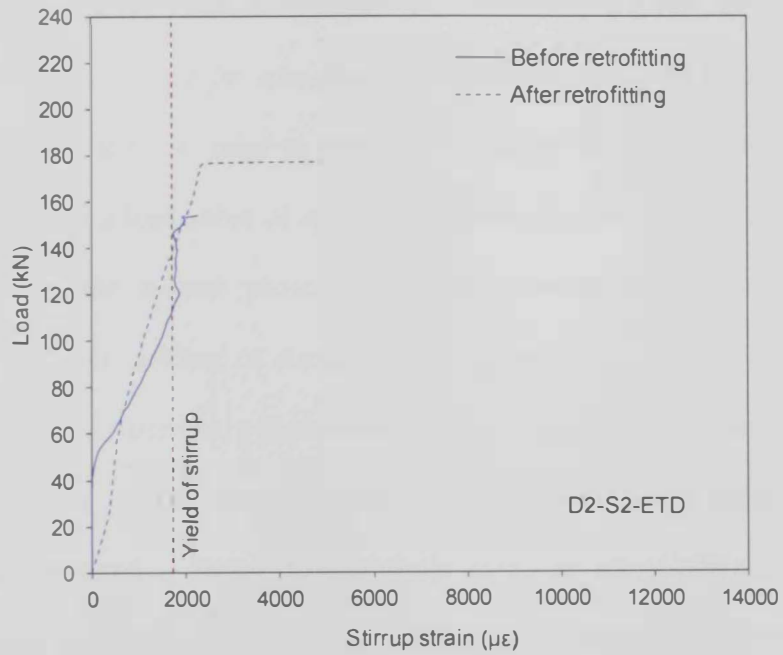
Figure 4.74: Stirrup's strain response of specimen D2-S2-ETD

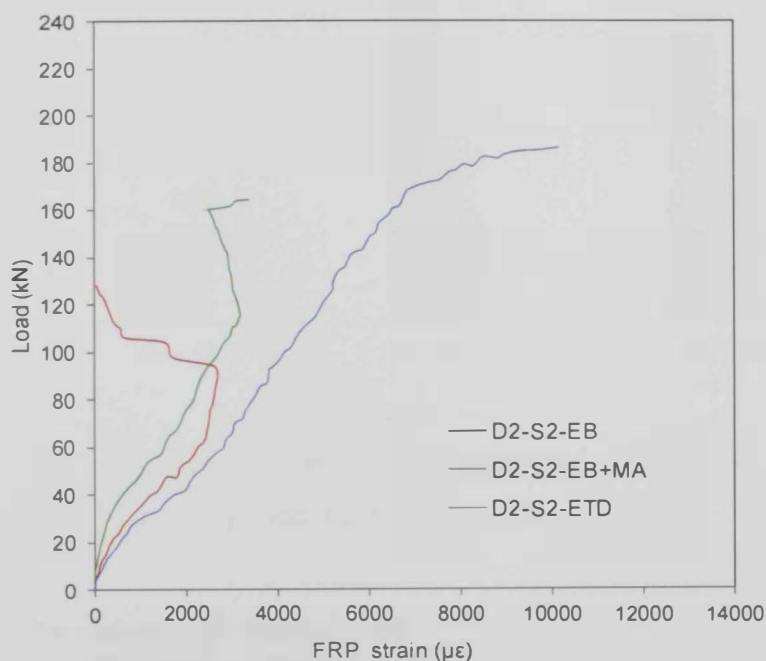
Figure 4.75: Load-FRP strain relationships for specimens of group [C] with damage state D2

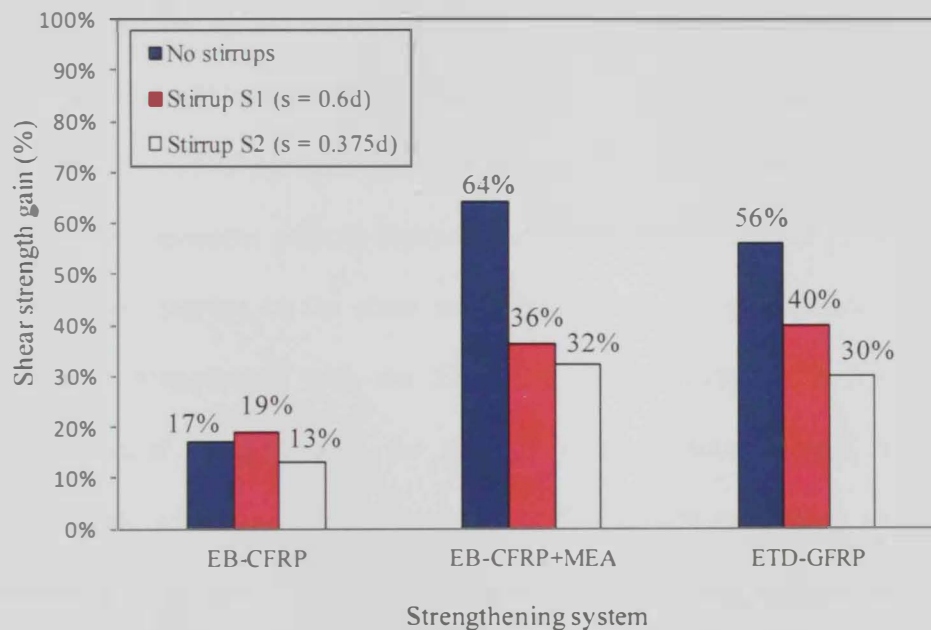
Figure 4.76: Interaction between strengthening system, amount of internal steel stirrups and shear strength gain

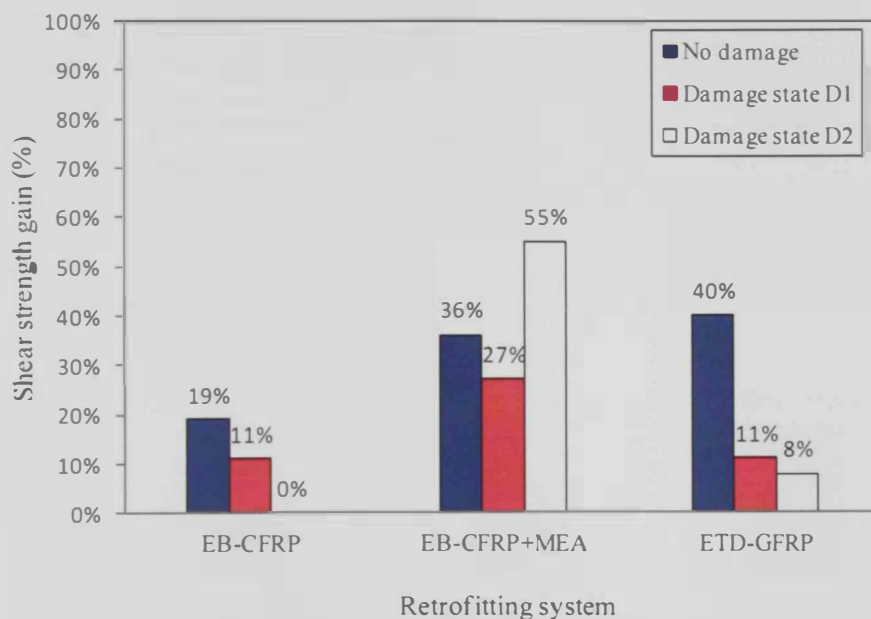
Figure 4.77: Effect of initial shear damage on shear strength gain of the specimens with the lower amount of stirrups

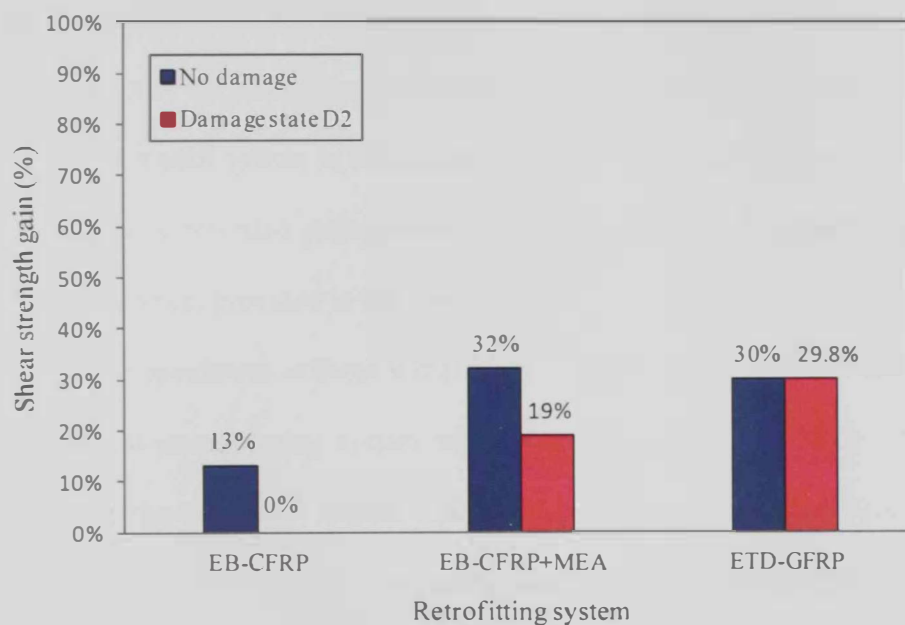
Figure 4.78: Effect of shear damage D2 on shear strength gain of the specimens with the higher amount of stirrups
