A methodology for the analysis of historical bridges, applied to the Jaraicejo Bridge. History and evolution of construction phases

V. Méndez-Hernán^(*), P. Plasencia-Lozano^(**)

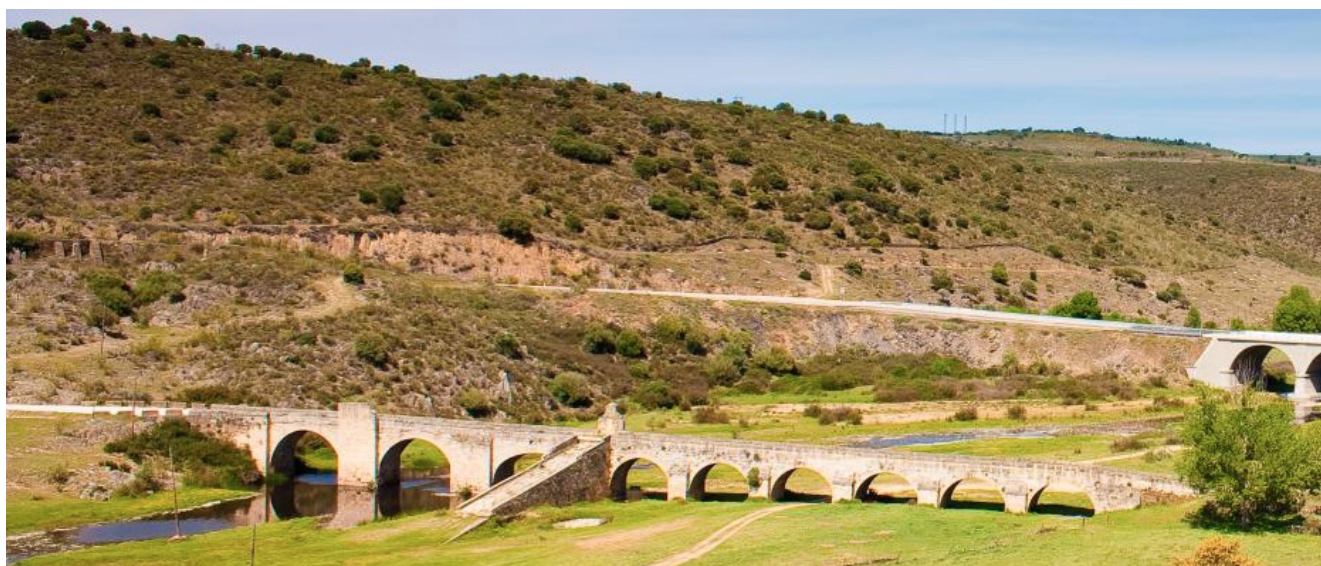
Figure 1. Photograph of the Bridge.

The Jaraicejo Bridge (Figure 1) is one of the most important historical bridges erected in Spain. The most important studies of the bridge to this date have been supported mainly by the historical documents available in archives; in this text, however, we perform a full analysis of the structure, developing a new methodology that brings together fieldwork, archival work and office work, with the analysis stemming from contrasting data for interpretation.

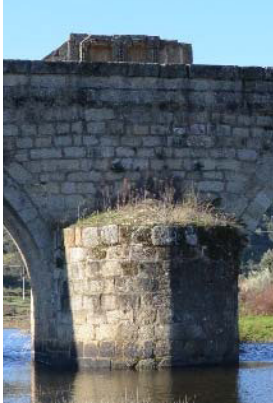
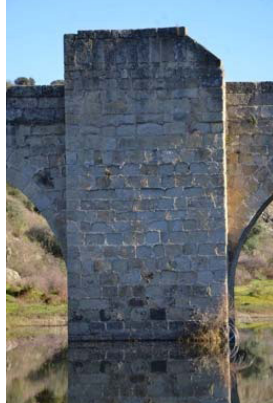
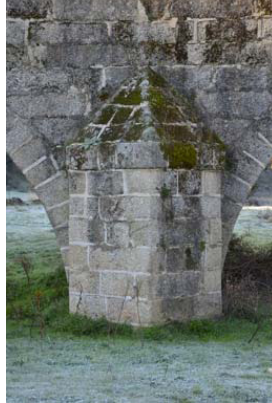
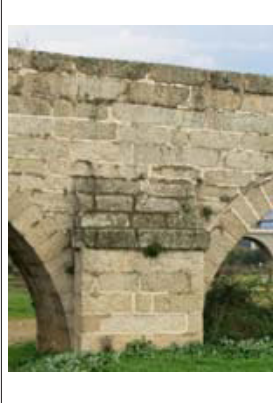
<p>North side breakwater, upriver</p>

<p>North side breakwater, downriver</p>

<p>South side breakwater, upriver</p>

<p>South side breakwater, downriver</p>
<p>Others</p>

The visual analysis (Table 1) shows the existence of two very different construction phases. The arches and breakwaters to the north are different from those on the south side, and the three-centred arch is a joining element between both groups of vaults. It is more complex to determine which part was

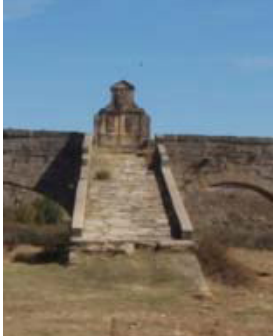
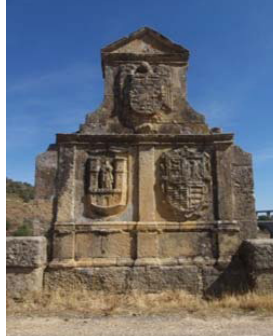
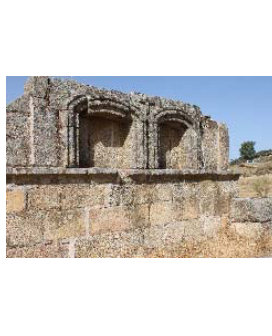
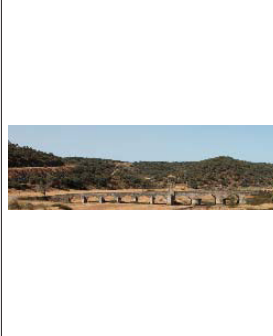
<p>Ramp</p>

<p>Niche</p>

<p>Asymmetry</p>

This could also explain the asymmetry of the niche that stands on pier 1, which would have originally been located elsewhere. It is possible that, during the restoration, they decided to reposition it on the recently built breakwater, adapting its width to that of the breakwater.

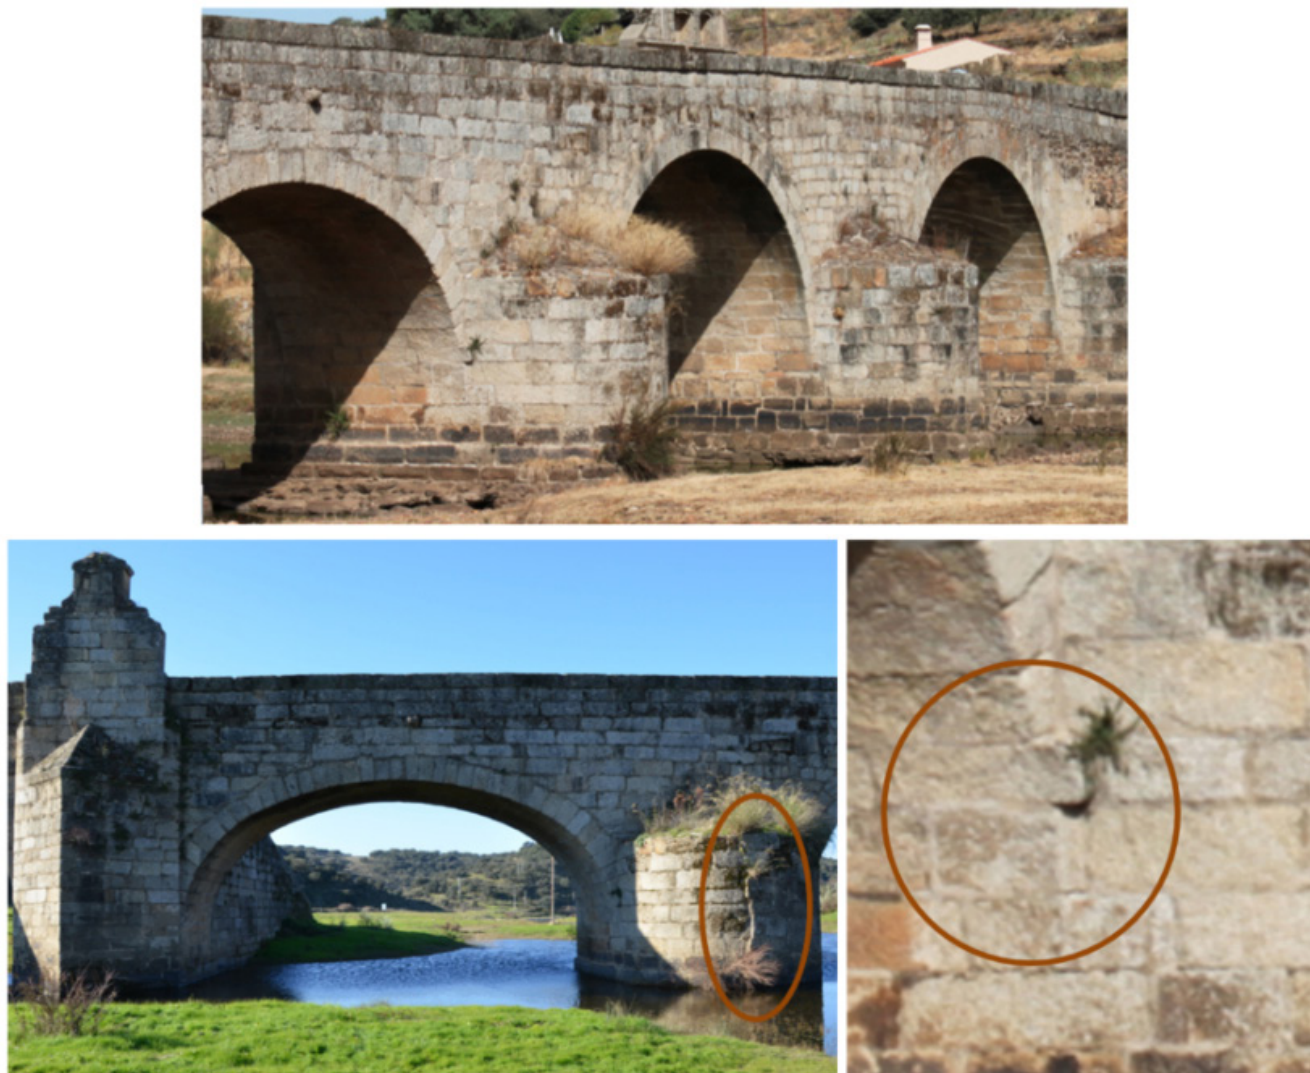
Figure 2. (Up) North Half of the Bridge, (down left) view of third arch and second breakwater with a break line, and (down right) detail of the Springer of the Third Arch.

If we examine the colouring of the ashlar of the bridge (Figure 2), it seems as though there is a difference in the hue between the first two arches and the third: the first two arches and the tympanum on the first pier have a yellowish colour, while the third and the parapet present a more greyish colouring; in addition, there is an ashlar that projects from the intrados in the third arch, perhaps evidence of the existence of a former arch that took off from this point. Finally, a breaking line in the second breakwater can be appreciated.

On the other hand, the colouring of the ashlar mentioned in the Visual Analysis section (Figure 2) coincides with the phase represented in Figure 6.b; the projecting ashlar in the intrados of the second pile, also mentioned, would coincide with the springer for the third semi-circular arch of the bridge described in Figure 6.a, located below the springer of the current three-centred arch; the same thing could be written about the break line already described on breakwater number two.

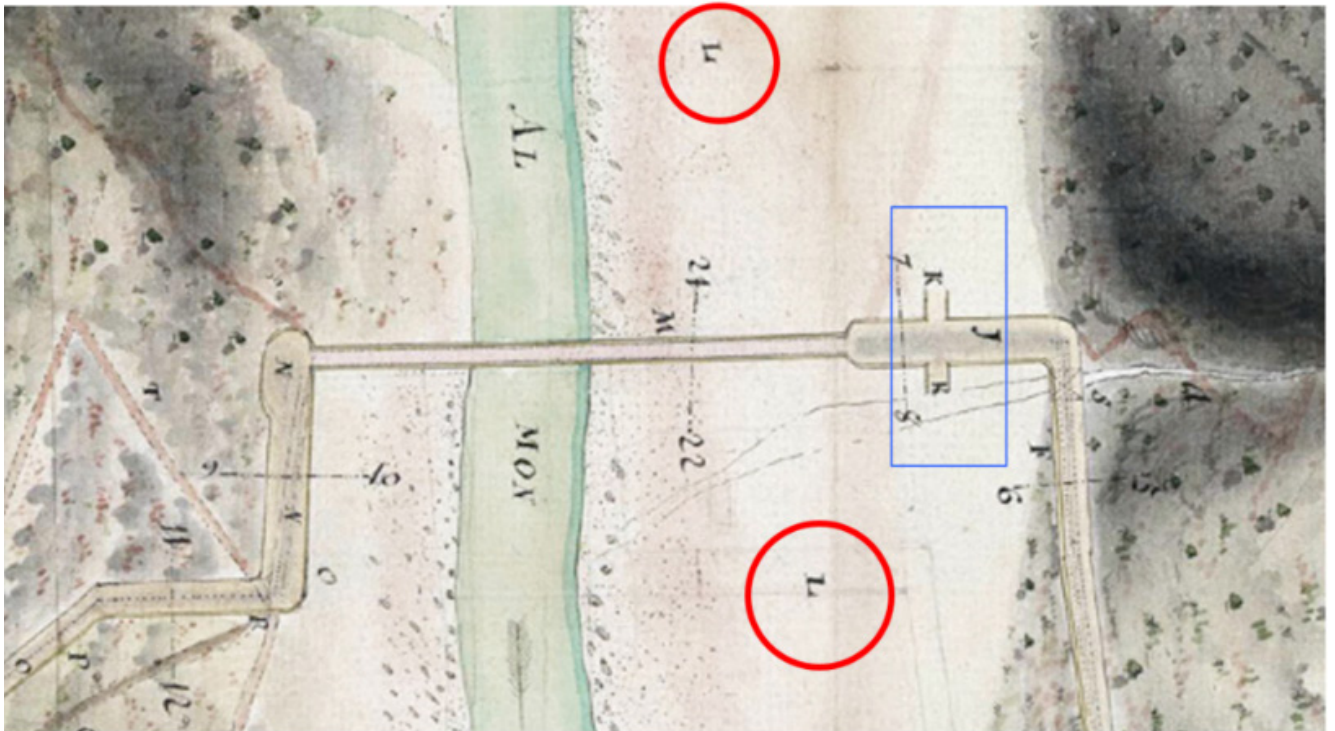
The most interesting element of the plan is the non-existence of the ramp towards the middle of the bridge platform (Figure 4). However, the southern rampart was significantly longer and

had two small access points to the riverbank. The legend on the plan itself indicated the existence of "exits on one and the other part (...) for free transit of the royal bridgeway when they ford the river". Regarding the width of this rampart, it mentions that the road leading to the bridge had a width of 5 toises, about 8.4 m.

Figure 4. Letter K represents access points. Letter J is the road leading to the bridge. Letter L represents the Royal Bridleway.

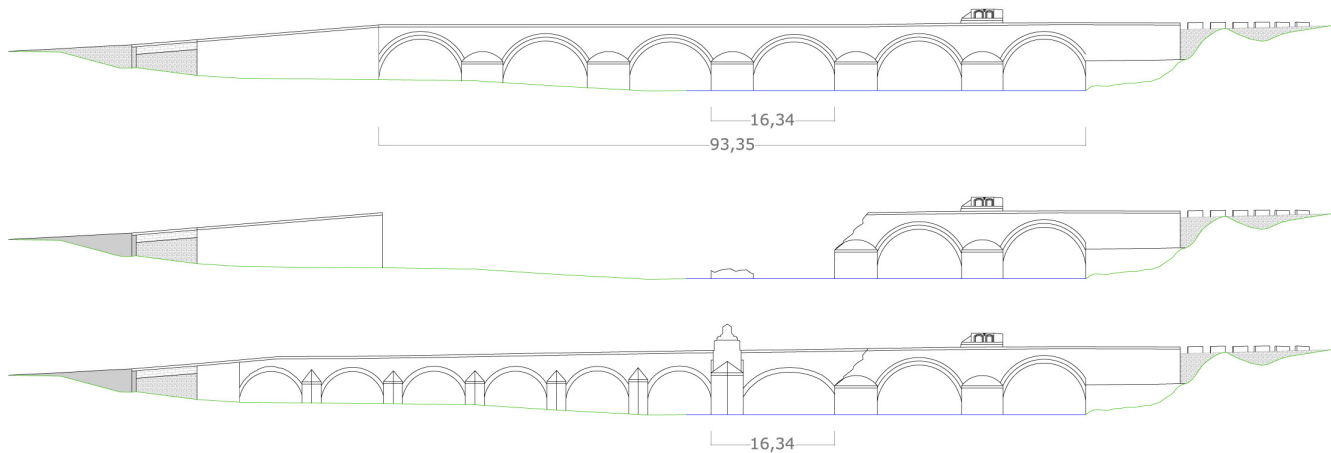
The original bridge, built in 1640, was made up of a succession of similar arches to the two semi-circular arches on the right side (Figure 6.a). After 1764, but before Campomanes

travelled there in 1778, there was a surge that ruined part of the bridge, leaving only the two right arches standing (Figure 6.b).

At the same time, they decided to increase the number of arches to increase the hydraulic capacity. The amplification was done to the south half of the bridge, since the south rampart was noticeably long and allowed for reconversion into a set of arches (Figure 6.c).

Figure 6. (a) The Original Bridge, with Six Arches; (b) State of the Bridge after the Surge; (c) Current State of the Bridge.

In order to analyse the validity of this hypothesis, we have drawn the reconstruction of the original bridge, the collapsed bridge after the surge, and the re-built bridge (Figure 6). The drawing of the reconstruction has been created following these steps:

- The two north arches are measured, along with the two immediate piers.
- The hypothesis that the bridge originally had only one type of arch and pier is formulated.
- The hypothesis that the south face of the original pier 3 coincides with the south face of the current pier 3 is also formulated. This hypothesis considers that the foundations of the old pier 3 must have been used to rebuild the new one.
- We assume that pier 3 must have measured the same as pier 2.
- We assume that the original bridge was symmetrical.
- The measurements adopted are reflected in the attachment, and prolonging the gradient of the current bridge over the north side arches, we have drawn the bridge in its original state (Figure 6.a). Using this drawing, we can draw the moment at which the bridge was partially destroyed by the surge, as well as its reconstruction, which has remained to this day.

The possibility that the different historical phases of the bridge coincide with the hypothesis described above has several solid arguments in its favour. Firstly, the six-span bridge has a length of 93,35 m, making it very close to the 93.66 m on Sánchez's plan. Additionally, it explains the appearance of a ramp in the middle of the bridge. Lastly, this sequence of events fits the totality of the information found in the historical sources, except for one, which is described below.

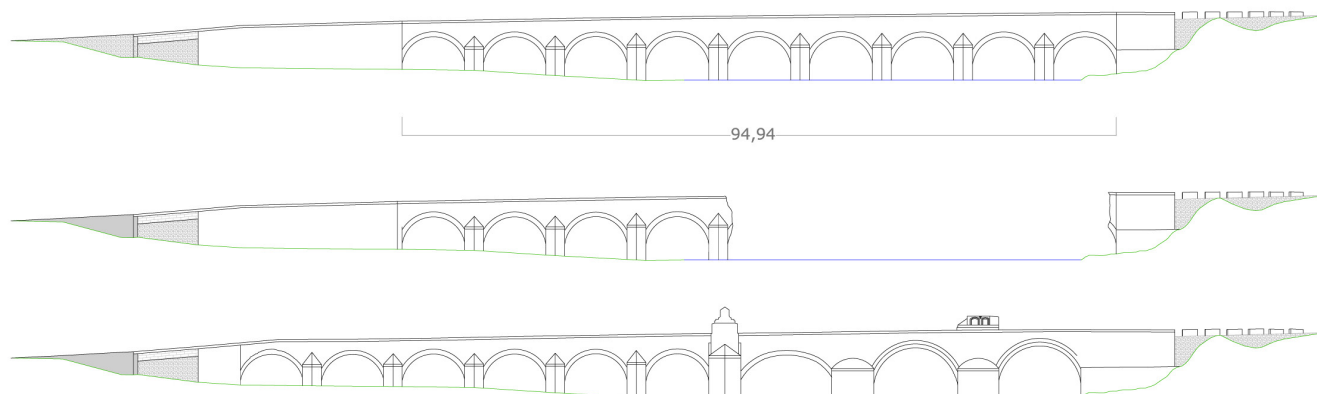
Nevertheless, it could be that some of the current arches on the southern end were added later. The original bridge could have been the one described in Figure 8.a, made up of 9 vaults of the south model and a long southern rampart that included the access points to the Royal Bridleway.

A surge that took place before 1797 (date at which we have evidence of the existence of a ramp) destroyed the five arches located in the lowest part of the valley. The reconstruction that was undertaken consisted of substituting the five collapsed arches with three new arches with greater span and more robust piers. Additionally, another two arches were added on the southern end, imitating the model of the four remaining arches, and thus shortening the rampart on that side and eliminating the possibility of accessing the Bridleway from there. Just as we described in the previous hypothesis, the solution was to create the ramp attached to the theoretically weakest pier in the structure, seeking to reinforce it from a structural point of view.

Figure 8. Different Images of the Bridge Structure: (a) The Original Bridge; (b) the Four Arches that remained after the Surge; and (c) The Rebuilt Bridge.
