# Seismic Performance of One-storey Thatched Roof Wooden Structure Against a Strong Earthquake Ground Motion

**Abstract:** In order to investigate the seismic behaviour of an old one-storey thatched roof wooden structure, 3-D non-linear collapsing process analysis of this wooden structure was conducted against a strong earthquake ground motion with the Japan Meteorological Agency seismic intensity of “6 upper” level. A non-linear behaviour of timber elements in the wooden structure during a strong earthquake ground motion can be simulated by this 3-D non-linear collapsing process analysis based on the Distinct Element Method. The effect of the post fixing condition under wooden structure floor on seismic response of this wooden structure was numerically investigated in this paper.

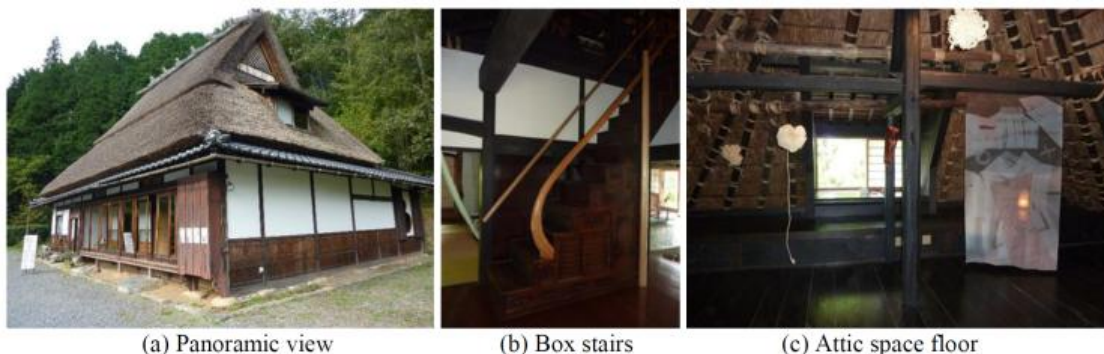
Photo 1. One-storey thatched roof wooden structure

Photo 1 shows a one-storey Japanese-style wooden structure with thatched roof, which was built more than

150 years ago by an old Japanese traditional framed-construction method and have a thatched roof instead of tile. This wooden structure has been used as a regional museum. Using a box stairs makes good use of a limited space under stairs, and an attic space in the past was a storage area for grass or sedge used for thatching material. Figure 1 indicates floor plan, elevation one, and cross section ones of this wooden structure. The width, depth, and height of this wooden structure are 13.23m, 10.26m and 8.25m, respectively.

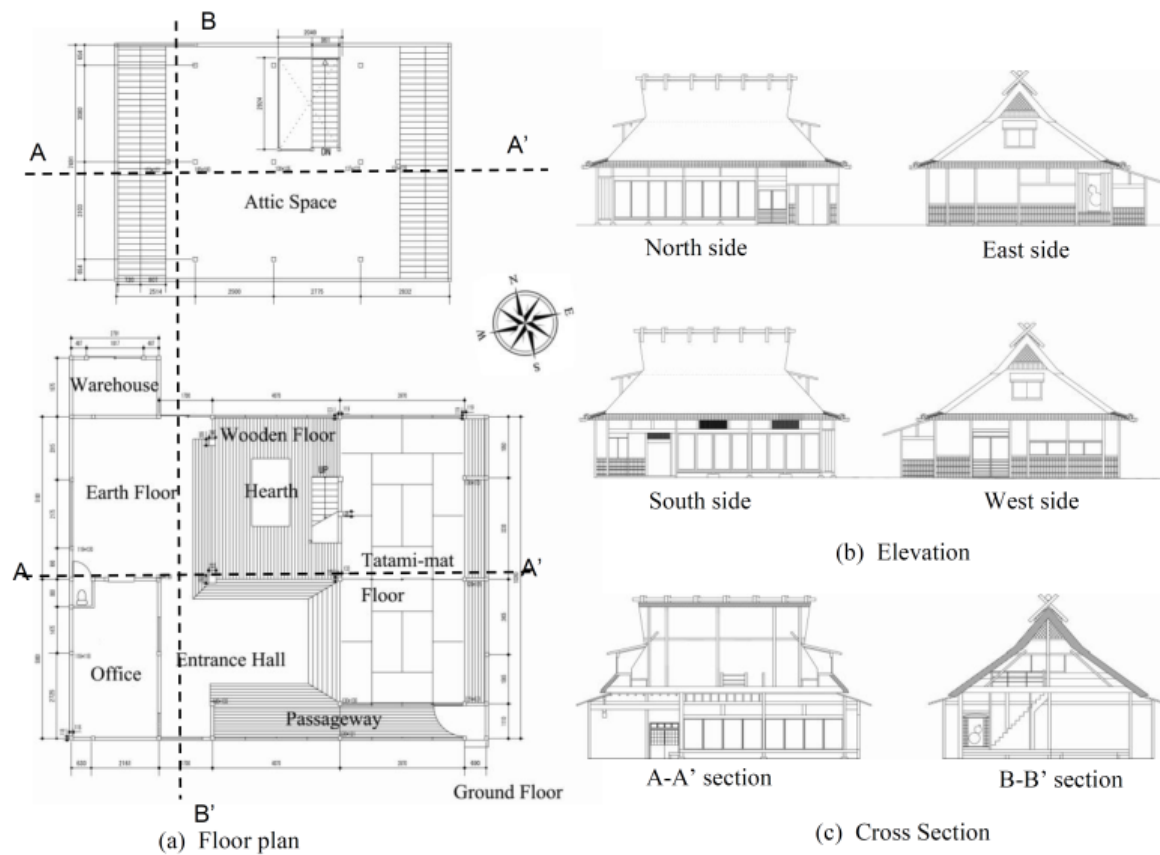
Figure 1. Sketch of one-storey thatched roof wooden house

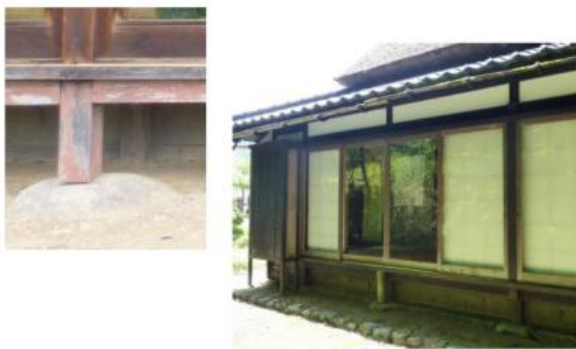
Photo 2. Post erected on a foundation stone

Photo 2 shows a post erected on a foundation stone under this wooden structure floor. There are many posts erected on their foundation stones with flat plane under this wooden structure floor, and they are not fixed on their foundation stones. Consequently, this system is likely to be a seismic base isolation. In this paper, the effect of the post fixing condition under wooden structure floor on the seismic response of this wooden structure is numerically investigated through the seismic response behaviours at several points. However, the details of the collapsing process analysis were described by Takatani et al. (2015[6]), and they are indicated briefly in the next section.

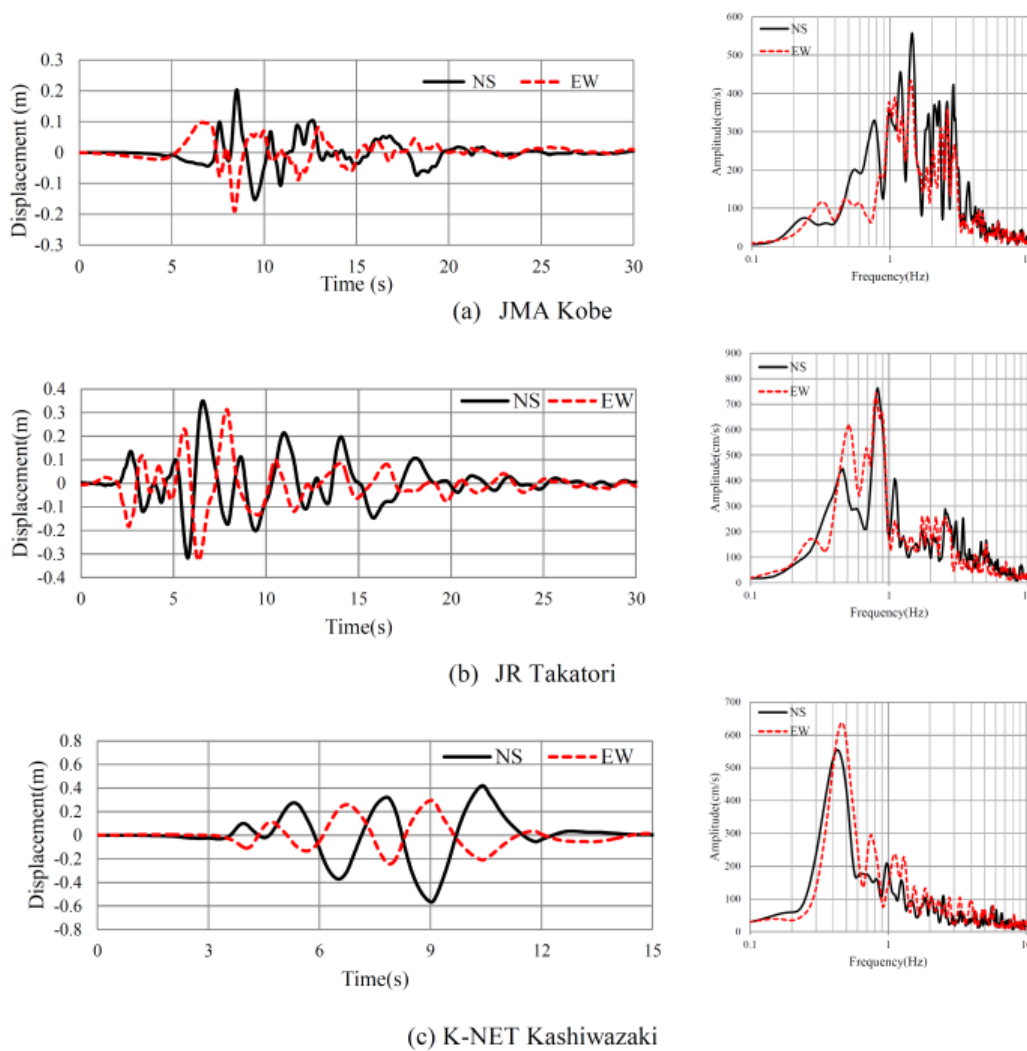
Figure 3. Input earthquake ground motions

Figure 3 indicates three displacement wave data and their Fourier acceleration spectra for both NS and EW components in each earthquake ground motion records shown in Table 4. In the JMA Kobe wave record indicated in Figure 3(a), a peak frequency in each wave component is from 1Hz to 1.5Hz, and also a peak in each wave component of the JR Takatori wave record illustrated in Figure 3(b) exists about 0.8Hz. While, a peak in each wave component of the K-NET Kashiwazaki wave record illustrated in Figure 3(c) is 0.45Hz. Because there are peak frequencies in three earthquake ground motion wave records in the frequency range of about 0.5 to 1.5Hz, their wave records seem to cause severe damage in the collapsing analysis of an old wooden structure against a strong earthquake ground motion as reported by Sakai et al. 2002[8].

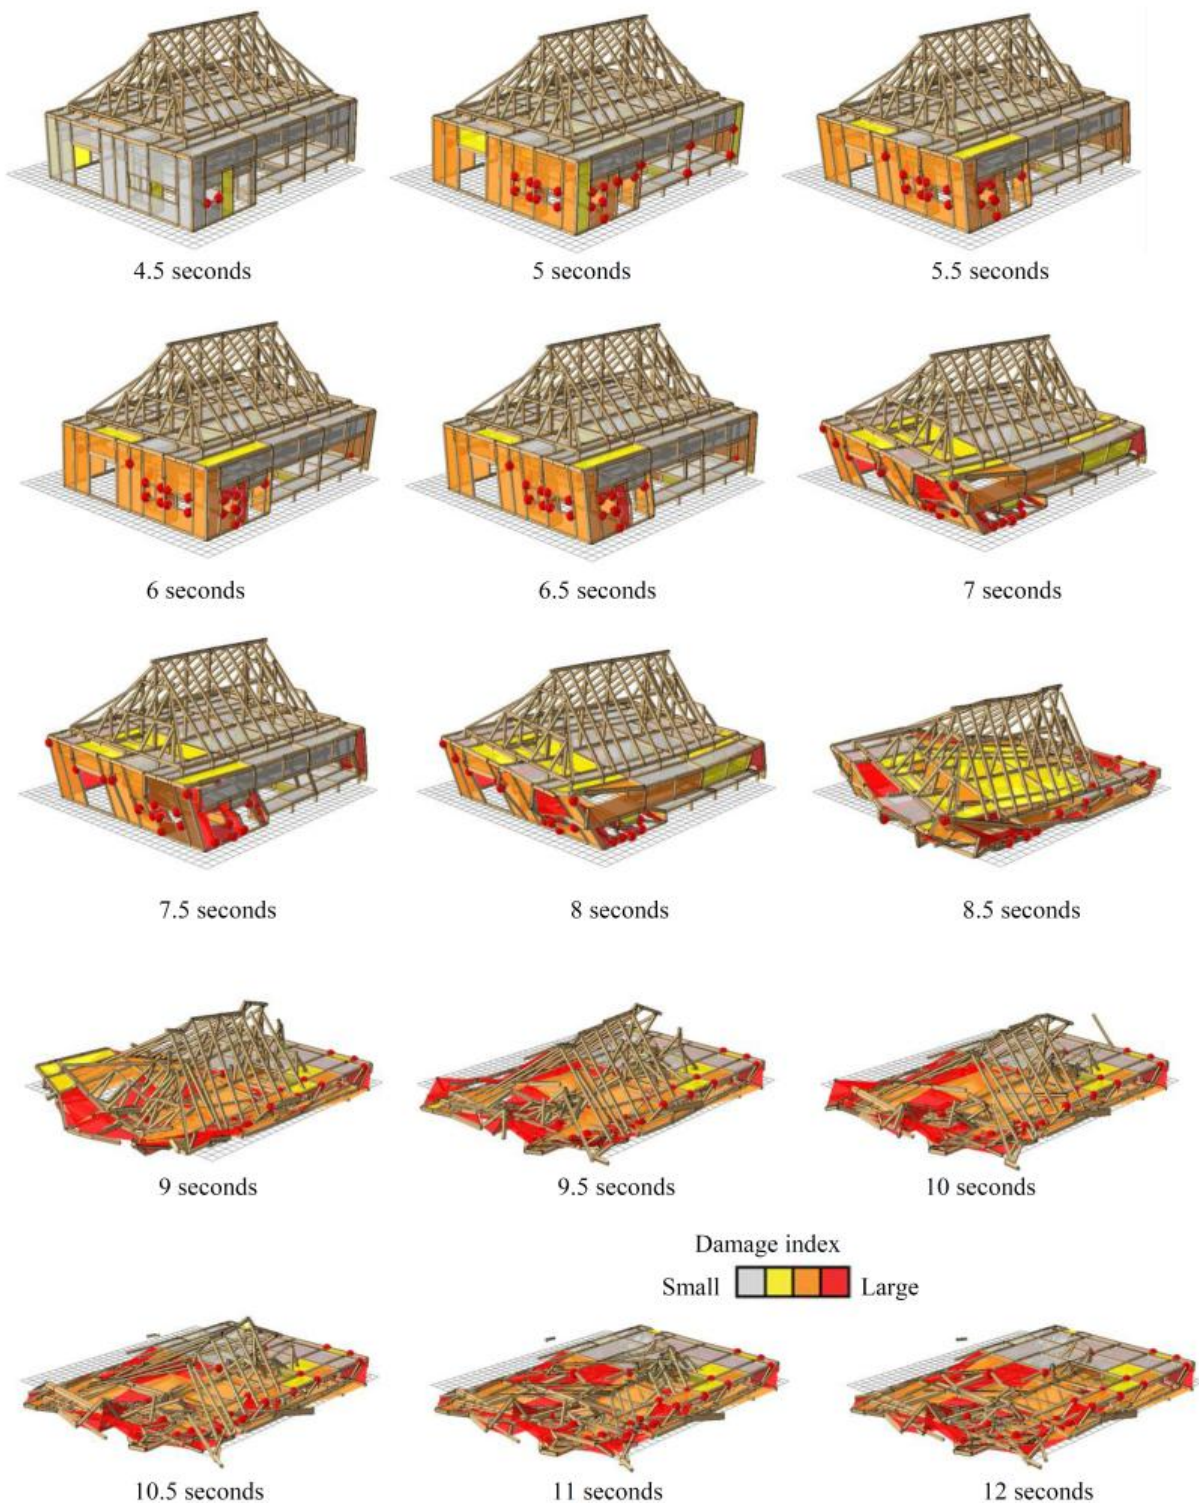
Figure 4. Seismic behaviour during earthquake motion (JMA Kobe, Without seismic retrofit, Post fixed condition)

Figure 4 shows seismic behaviour of one-storey thatched roof wooden structure without seismic retrofit countermeasure during the JMA Kobe wave. This wooden structure suffers seismic damage on walls after 5 seconds, and collapses after 9 seconds. It is found that thatched roof wooden structure trends to collapse the walls on first floor without collapse of the roof part of thatched roof wooden structure and the roof part destroys after the collapse of first floor.

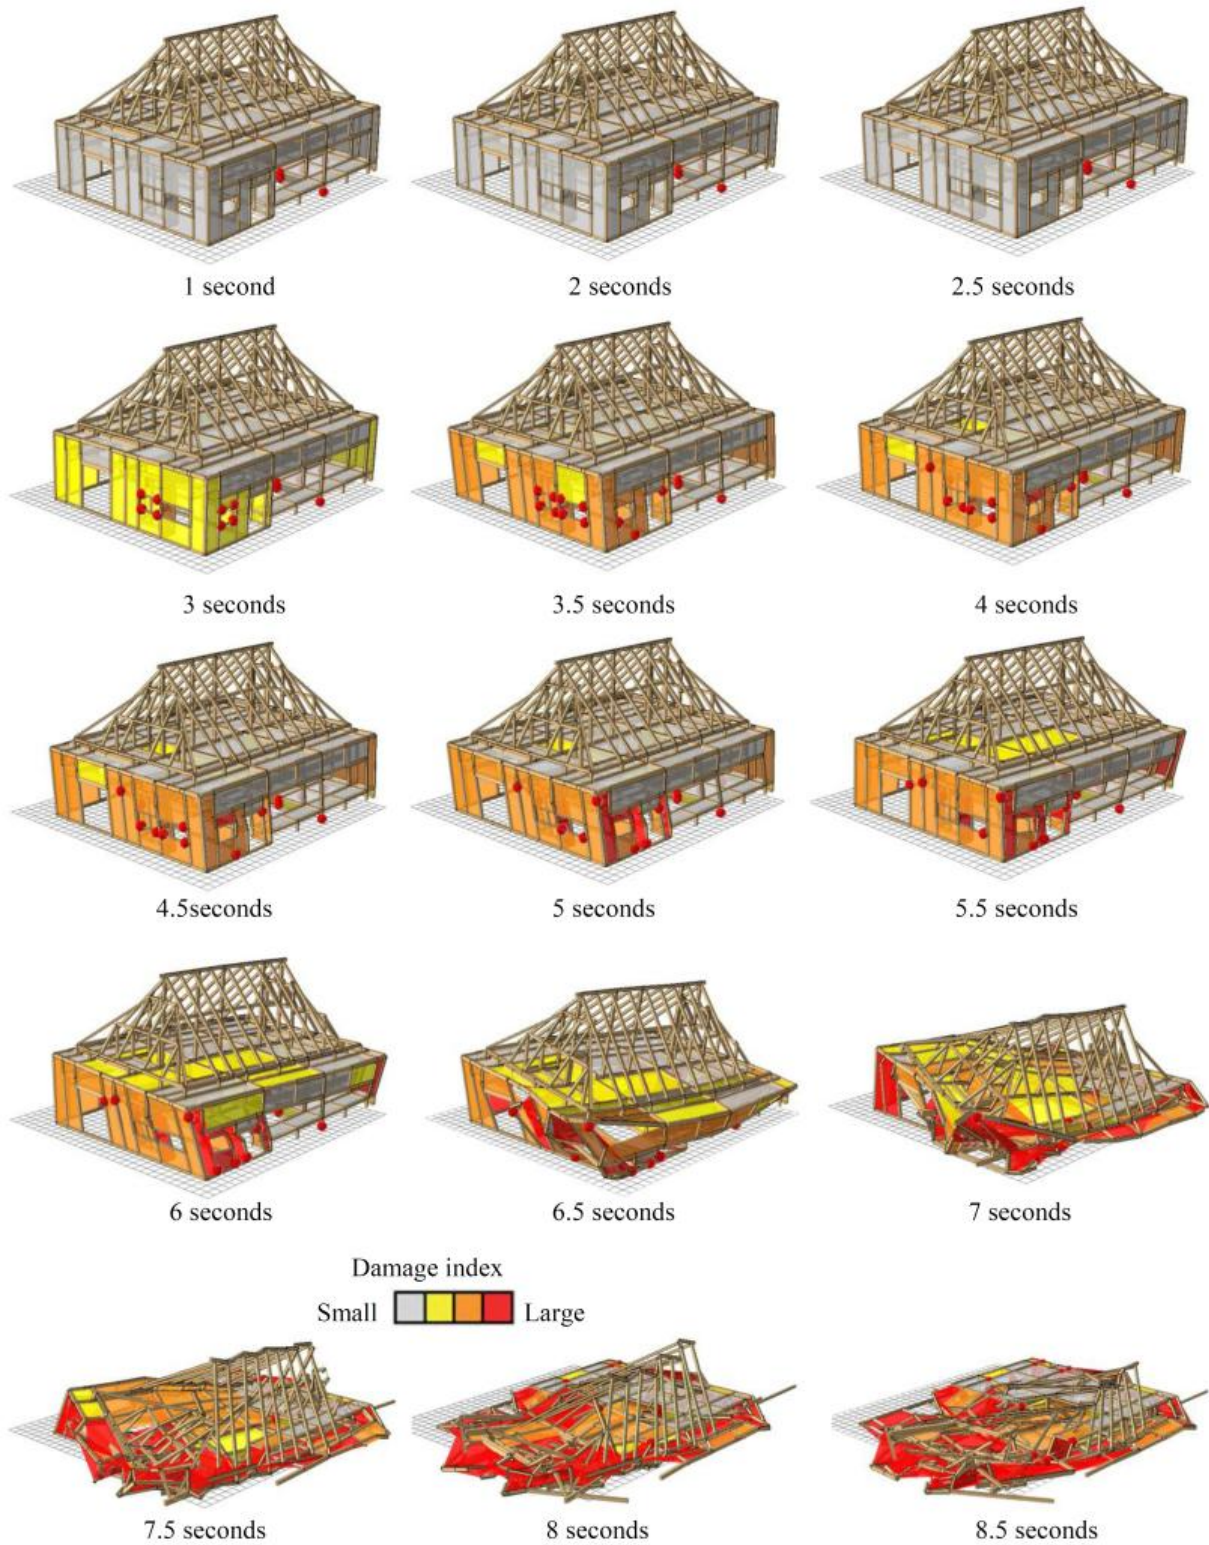
Figure 5. Seismic behaviour during earthquake motion (JR Takatori, Without seismic retrofit, Post fixed condition)

Seismic behaviour of one-storey thatched roof wooden structure without seismic retrofit during the JR Takatori wave is indicated in Figure 5. This wooden structure starts to suffer seismic damage on walls after 3 seconds, and collapses after 8 seconds. In a similar manner to the JMA Kobe, one-storey thatched roof wooden structure collapses the walls on first floor without collapse of the roof part of thatched roof wooden structure and then the roof part destroys after the collapse of first floor.

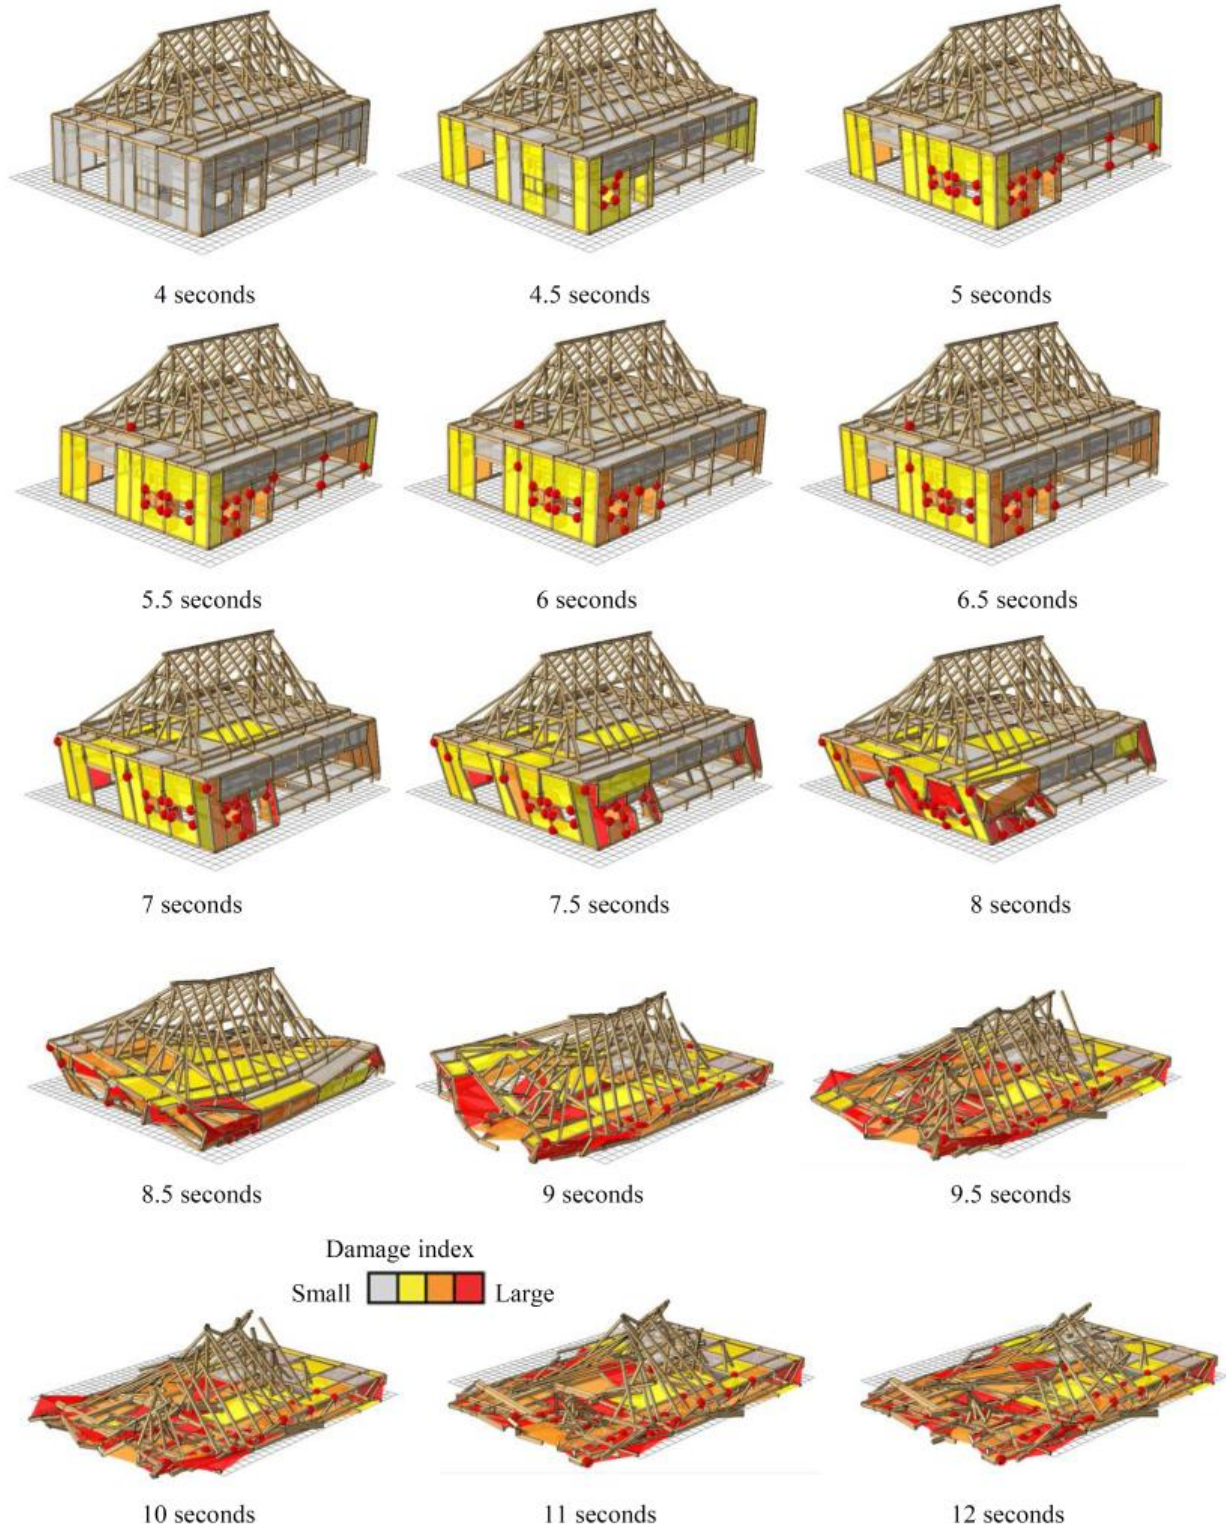
Figure 6. Seismic behaviour during earthquake motion (Kashiwazaki, Without seismic retrofit, Post fixed condition)

Seismic behaviour of one-storey thatched roof wooden structure without seismic retrofit during the Kashiwazaki wave is illustrated in Figure 6. This wooden structure starts to suffer seismic damage on walls after 4.5 seconds, and collapses after 9 seconds. It is found that one-storey thatched roof wooden structure without seismic retrofit collapses against a strong earthquake ground motion with the JMA seismic intensity of "6 upper" level and the maximum velocity of over 90 kine.

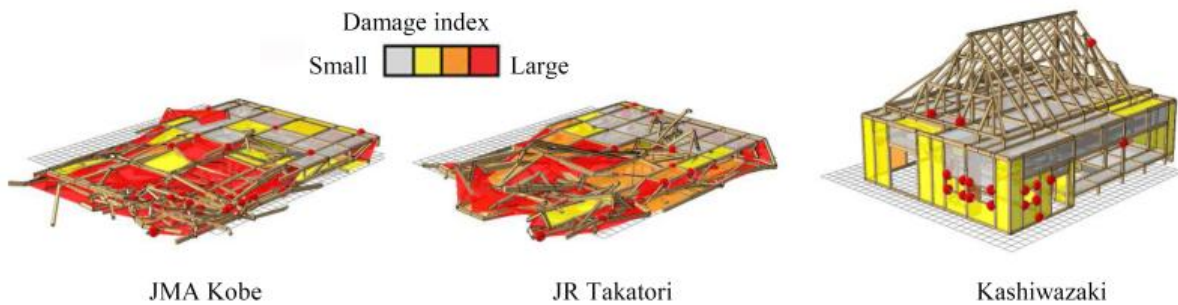
Figure 7. Seismic behaviour after earthquake motion  
(With seismic retrofit, Limit strength calculation method 1.0, Post fixed condition)

Figure 7 shows seismic behaviour of one-storey thatched roof wooden structure with seismic retrofit countermeasure after three earthquake motions. Seismic retrofit for one-storey thatched roof wooden structure was conducted under the condition of the limit strength calculation method of 1.0 value. Even though one-storey thatched roof wooden structure with seismic retrofit under the limit strength calculation method of 1.0 value collapses against both the JMA Kobe and JR Takatori waves, it does not collapse for the Kashiwazaki wave although it has a slight damage on the walls.

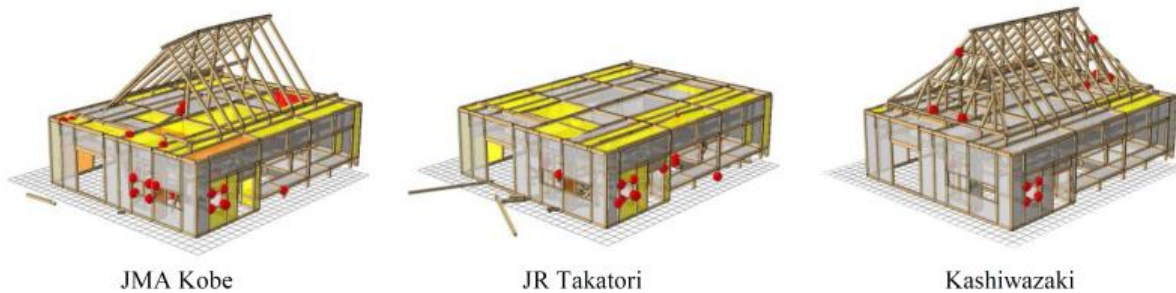
Figure 8. Seismic behaviour after earthquake motion  
(With seismic retrofit, Limit strength calculation method 1.5, Post fixed condition)

Seismic behaviour of one-storey thatched roof wooden structure with seismic retrofit after three earthquake motions is indicated in Figure 8. Seismic retrofit is done under the condition of the limit strength calculation method of 1.5 value. Although the roof part of one-storey thatched roof wooden structure does not completely collapse against the JMA Kobe wave, it completely collapses in spite of no collapse of the first floor against the JR Takatori wave.

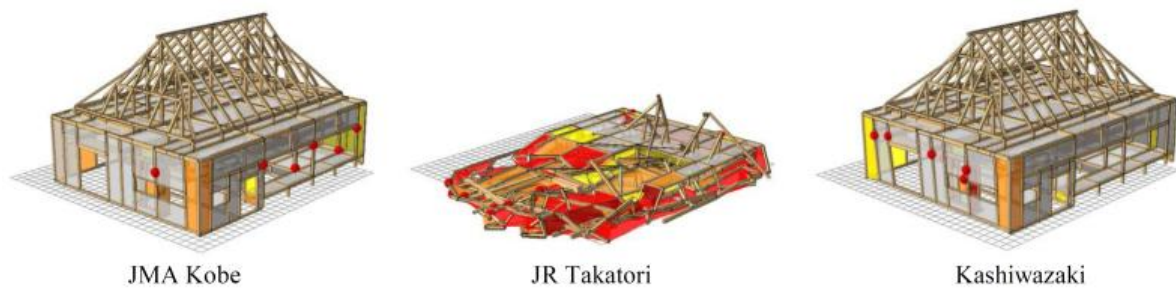
Figure 9. Seismic behaviour after earthquake motion  
(Without seismic retrofit, Unfixed post under first floor,  $\mu_s=0.3$ )

Figure 9 shows seismic behaviour of one-storey thatched roof wooden structure without seismic retrofit after

three earthquake motions under unfixed post condition. Although one-storey thatched roof wooden structure without seismic retrofit against both the JMA Kobe and the Kashiwazaki waves does not collapse, it completely collapses against the JR Takatori wave.

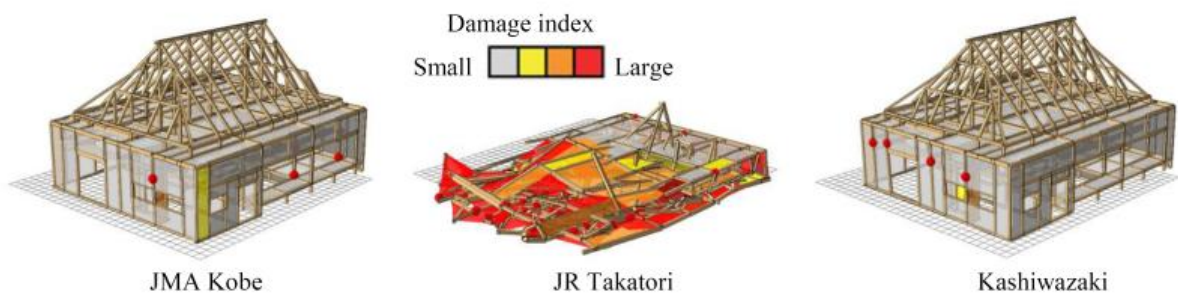
Figure 10. Seismic behaviour after earthquake motion (With seismic retrofit,  
Limit strength calculation method 1.0, Unfixed post condition  $\mu_s=0.3$ )

Seismic behaviour of one-storey thatched roof wooden structure with seismic retrofit after three earthquake

motions under unfixed post condition is indicated in Figure 10. Seismic retrofit is conducted under the limit strength calculation method of 1.0 value. One-storey thatched roof wooden structure with seismic retrofit under the limit strength calculation method of 1.0 value collapses against only the JR Takatori wave. While, seismic behaviour of one-storey thatched roof wooden structure with seismic retrofit after the JR Takatori wave under unfixed post condition is illustrated in Figure 11. Seismic retrofit is conducted under the condition of the limit strength calculation method of 1.5 value. One-storey thatched roof wooden structure has some damages against

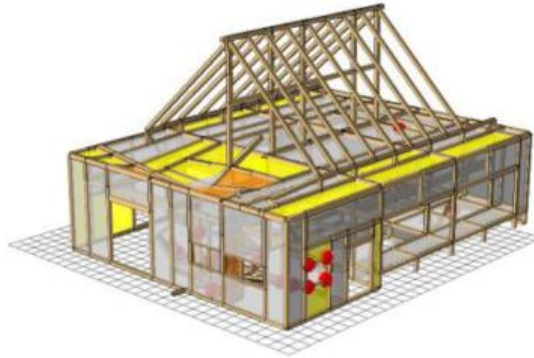
Figure 11. Seismic behaviour after earthquake motion (JR Takatori, With seismic retrofit, Limit strength calculation method 1.5, Unfixed post condition  $\mu_s=0.3$ )

the JR Takatori wave and does not collapse because of the seismic retrofit condition of the limit strength calculation method of 1.5 value. It was found from these figures that the unfixed post condition for one-storey thatched roof wooden structure seems to be similar to a seismic base isolation equipment.

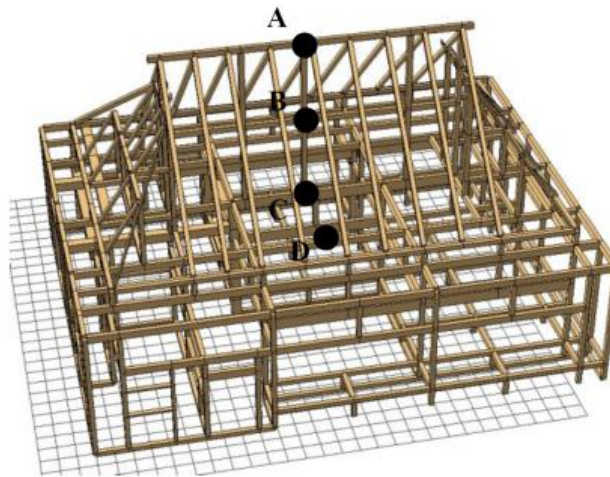
Figure 12. Analytical frame model with calculation points

Seismic response behaviour of one-storey thatched roof wooden structure during a strong earthquake motion is numerically investigated at four points set on the wooden frame model shown in Figure 12.

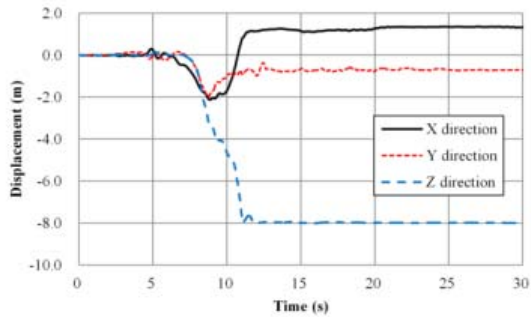
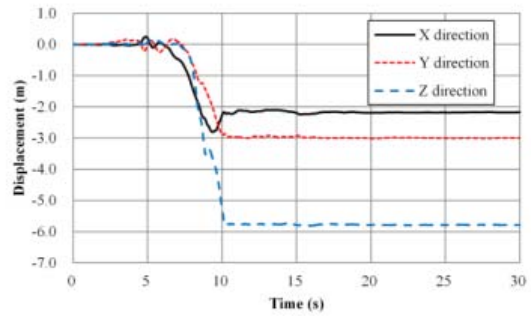
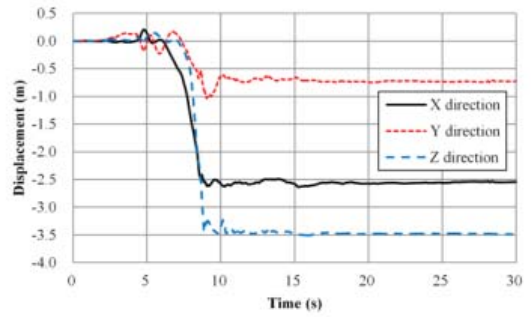
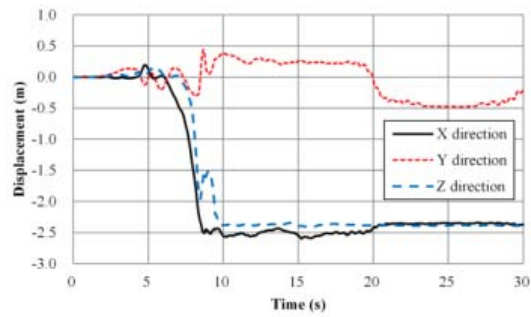
Figure 13. Seismic response behaviour (JMA Kobe, Without seismic retrofit)

Figure 13 shows seismic response behaviour at each point of one-storey thatched roof wooden structure without seismic retrofit during the JMA Kobe wave. As is obvious from Figures 4 and 13, the timber element of

each point falls down and the timber element of point A finally falls down after 11 seconds.

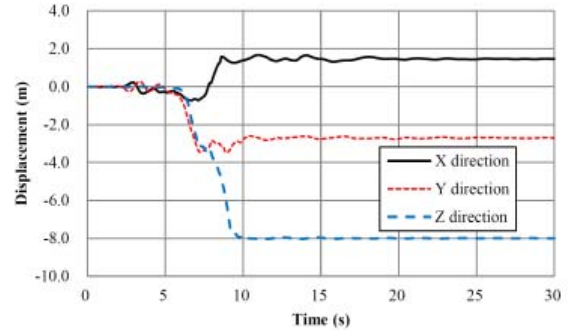
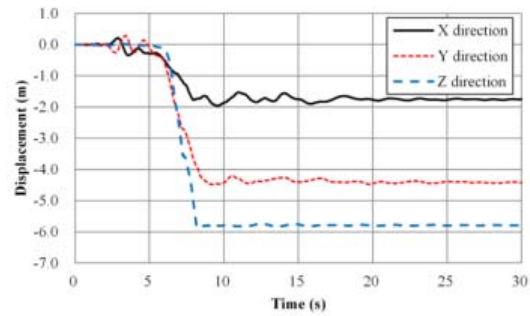
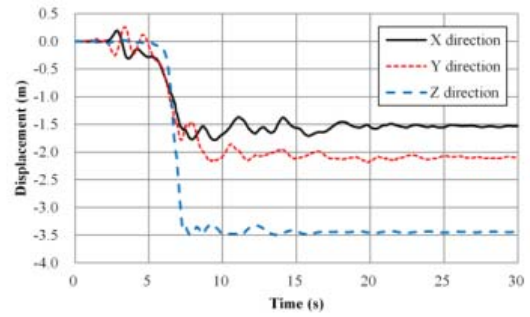
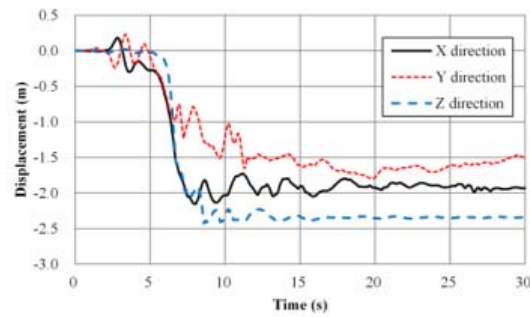
Figure 14. Seismic response behaviour (JR Takatori, Without seismic retrofit)

Seismic response behaviour at each point of one-storey thatched roof wooden structure without seismic retrofit during the JR Takatori wave is indicated in Figure 14. It is obvious from Figures 5 and 14 that the timber element of each point falls down and the timber element of point A finally falls down after 9 seconds.

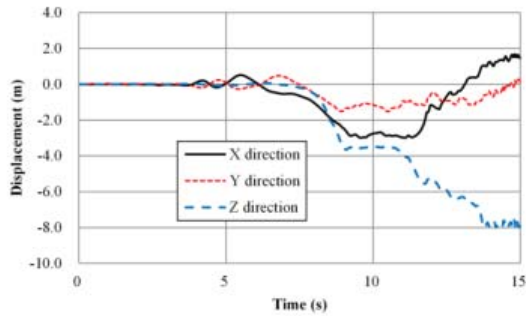
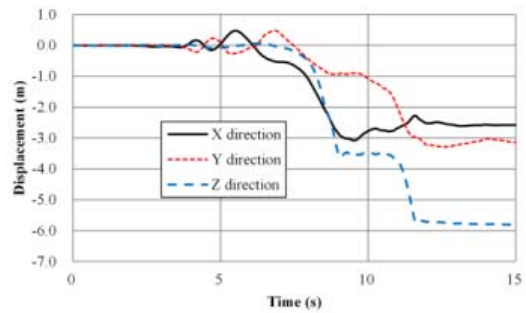
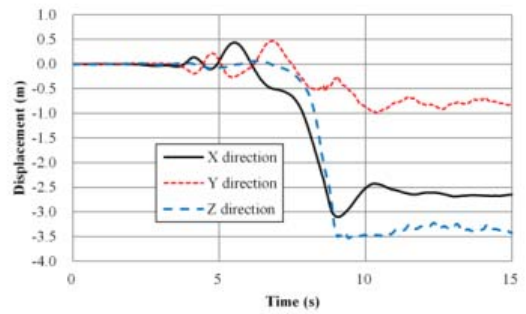
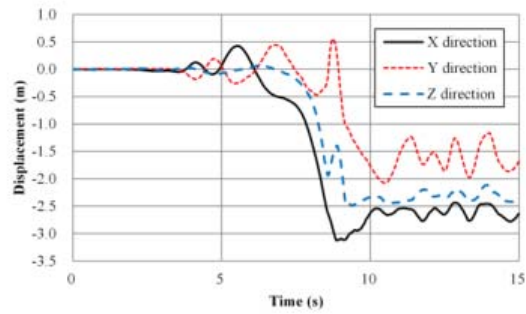
Figure 15 Seismic response behaviour (Kashiwazaki, Without seismic retrofit)

Seismic response behaviour at each point of one-storey thatched roof wooden structure without seismic retrofit during the Kashiwazaki wave is illustrated in Figure 15. As can be seen from Figures 6 and 15, the timber element of each point falls down and the timber element of point A finally falls down after 13 seconds.

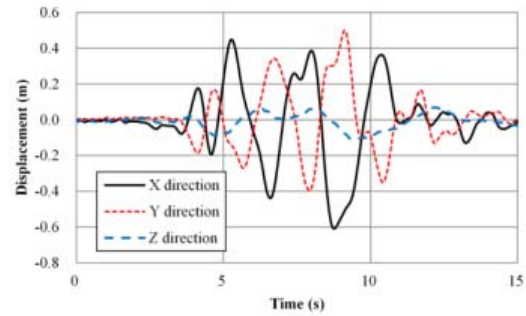
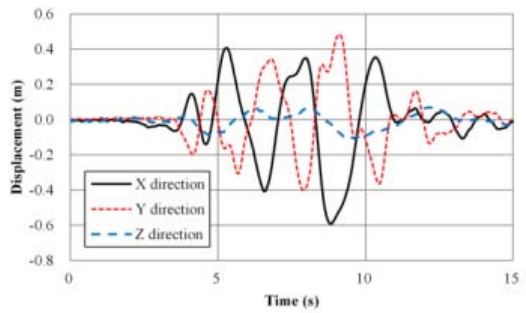
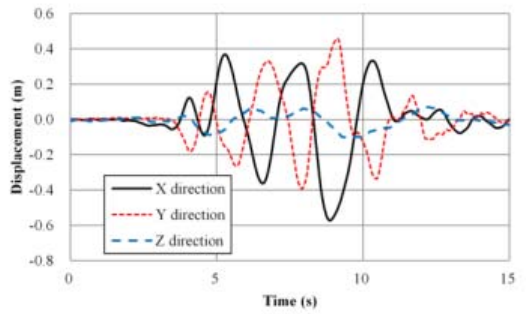
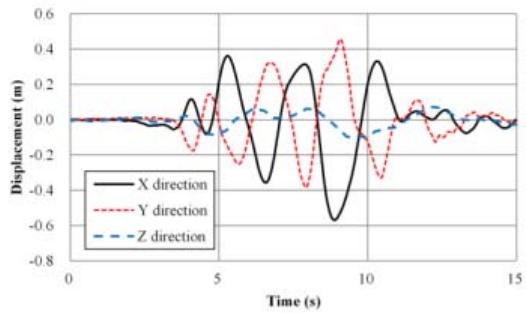
Figure 16. Seismic response behaviour (Kashiwazaki, Limit strength calculation 1.0)

Seismic response behaviour at each point of one-storey thatched roof wooden structure without seismic retrofit under the unfixed post condition during the JMA Kobe wave is shown in Figure 16. As one-storey thatched roof wooden structure without seismic retrofit does not collapse because of the unfixed post condition as shown in Figure 9, seismic response behaviour at each point has a displacement amplitude within 0.2 m.

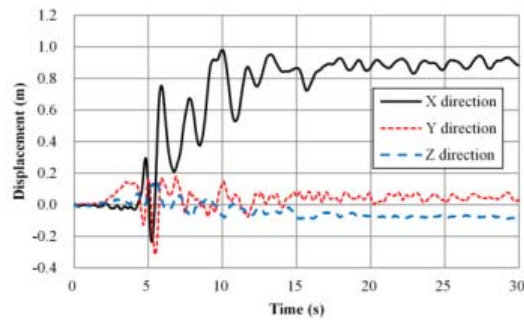
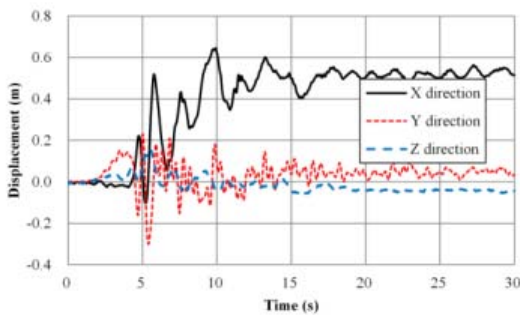
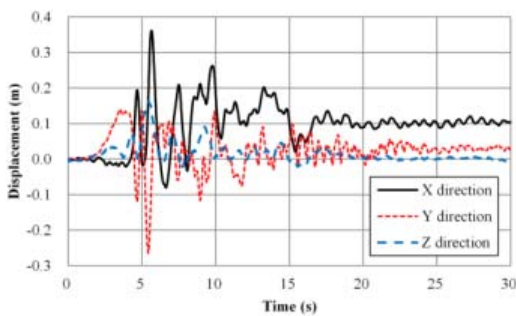
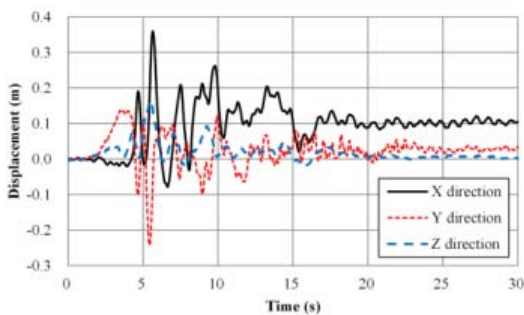
Figure 17. Seismic response behaviour (JMA Kobe, Limit strength calculation 1.5)

Figure 17 illustrates seismic response behaviour at each point of one-storey thatched roof wooden structure with seismic retrofit during the JMA Kobe wave. Seismic retrofit is conducted under the condition of the limit strength calculation method of 1.5 value. As one-storey thatched roof wooden structure with seismic retrofit does not collapse as shown in Figure 8, seismic response behaviour at each point has a displacement amplitude within 1.0 m and the displacements in X direction at points A and B are much larger than other ones at points C and D.

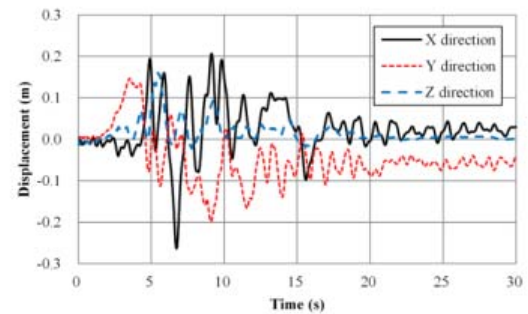
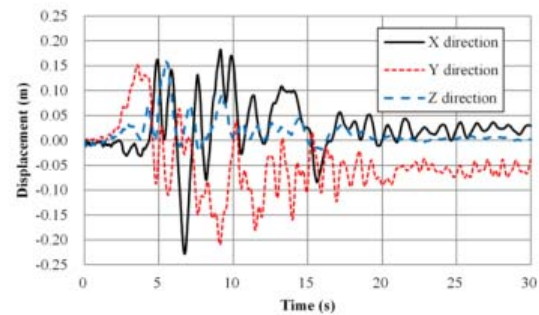
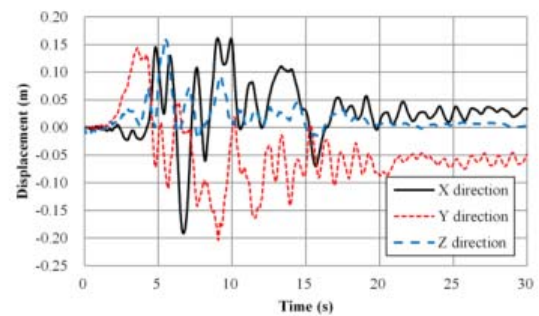
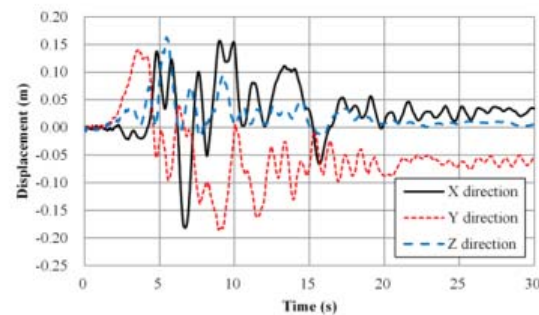
Figure 18. Seismic response behaviour (JMA Kobe, Unfixed post condition,  $\mu_s=0.3$ )

each point is almost similar to that in Figure 18 and also has a displacement amplitude with a slight larger than that in Figure 18 because of seismic retrofit due to the limit strength calculation method of 1.0 value.

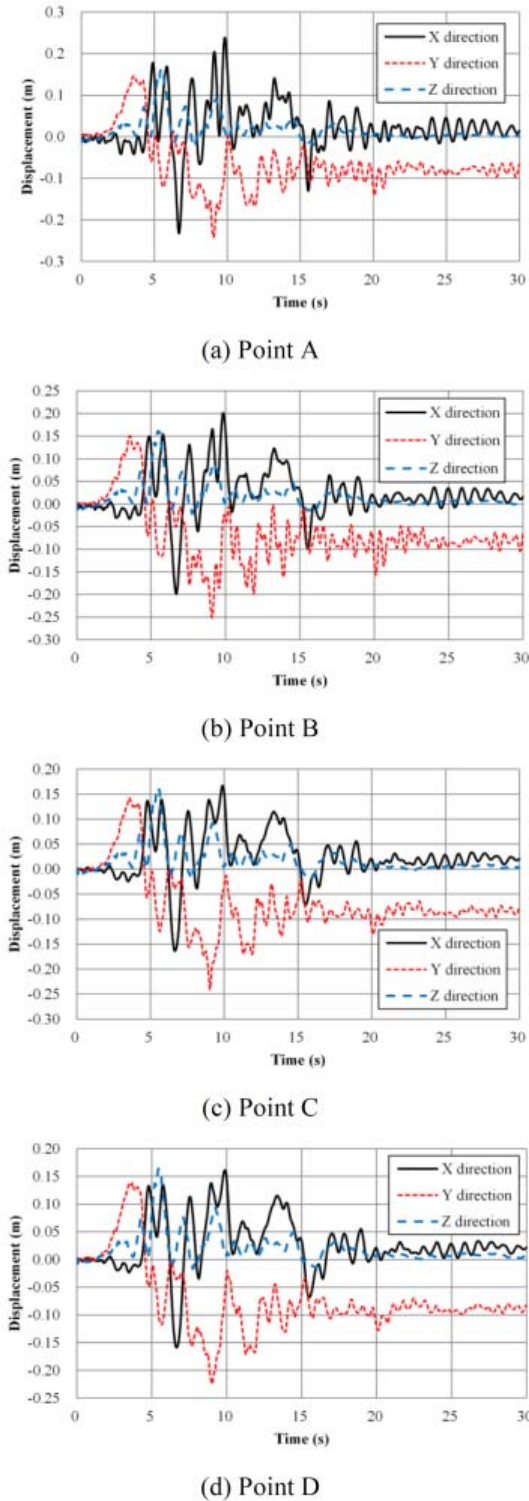
Figure 19. Seismic response behaviour (JMA Kobe, Unfixed post condition  $\mu_s=0.3$ , Limit strength calculation 1.0)

Seismic response behaviour at each point of one-storey thatched roof wooden structure with seismic retrofit under the unfixed post condition during the JMA Kobe wave is indicated in Figure 19. Seismic retrofit is conducted under the condition of the limit strength calculation method of 1.0 value. Seismic response behaviour at

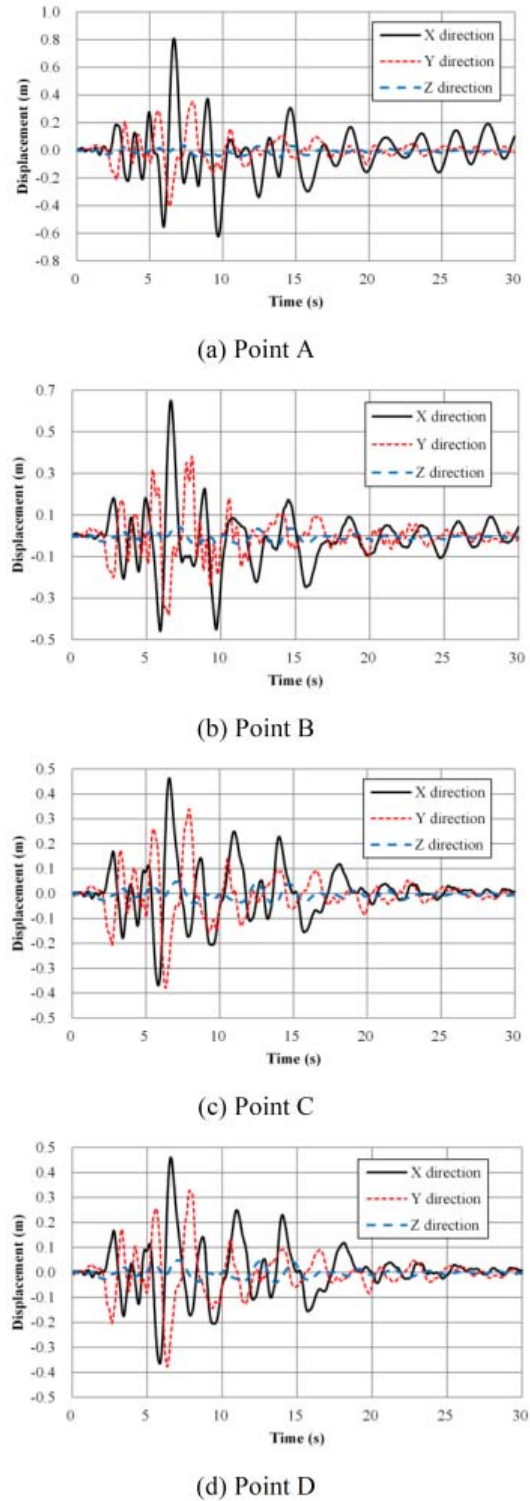
Figure 20. Seismic response behaviour (JR Takatori, Unfixed post condition  $\mu_s=0.3$ , Limit strength calculation 1.5)

Seismic response behaviour at each point of one-storey thatched roof wooden structure with seismic retrofit under the unfixed post condition during the JR Takatori wave is illustrated in Figure 20. Seismic retrofit is conducted under the condition of the limit strength calculation method of 1.5 value. As one-storey thatched roof wooden structure without seismic

retrofit does not collapse as shown in Figure 11, seismic response behaviour at each point has a displacement amplitude within 0.8 m because of the seismic retrofit as well as the unfixed post condition.
