CASE REPORT

Migration of etonogestrel contraceptive implants: Implications for difficult removals services need in southern Africa

S Afr Med J 2019;109(8):559-561. DOI:10.7196/SAMJ.2019.v109i8.14061

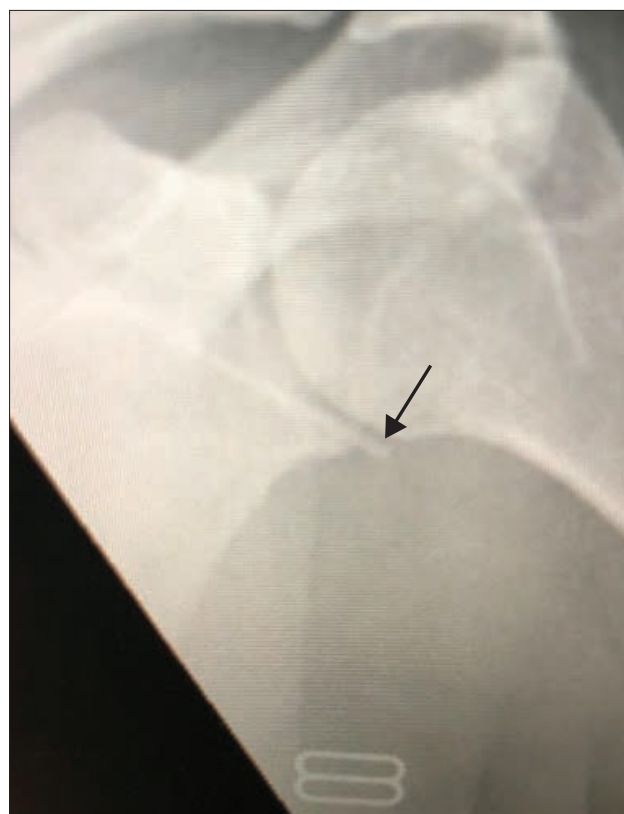
Fig. 1. Case 1. Radiograph of left upper arm demonstrating implant location above the glenohumeral joint, in the deltopectoral groove (arrow indicates tip of implant).

The radiograph revealed a linear foreign body just above the glenohumeral joint in the area of the deltopectoral groove (Fig. 1). The image was compatible with a radio-opaque ENG implant. Surgical removal of the implant under general anaesthesia was performed on the same day by two of the authors. The patient was
