# Способы управления параметрами вибрации пассажирских вагонов

## Methods for Controlling Vibration Parameters of Passenger Coaches

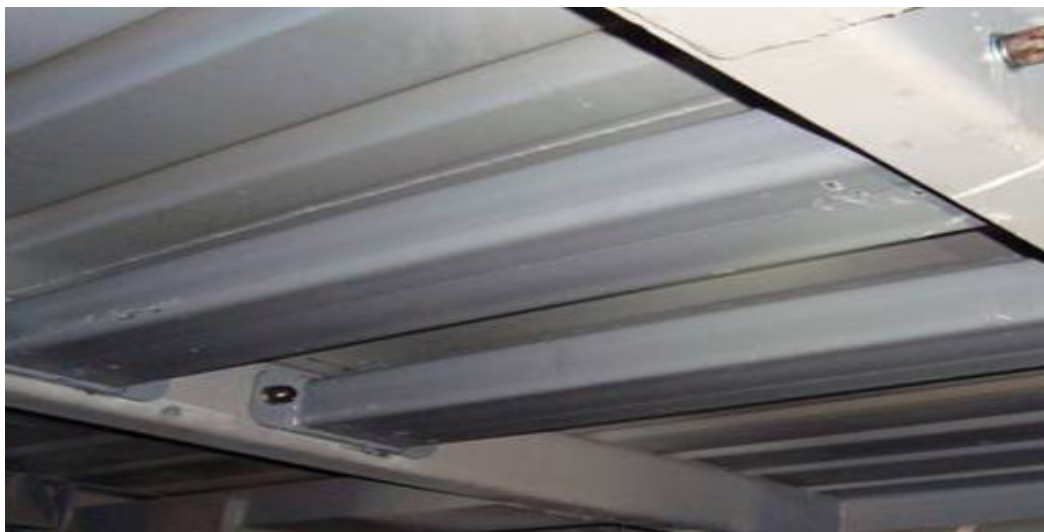
Рис. 2. Рама вагона, усиленная продольными балками.

Усиление рамы вагона демонстрирует рис. 2.

Из таблицы 2 видно, что доработка вагона по 3-му варианту (рама вагона усилена продольными балками (рис. 2)) обеспечивает снижение наибольших максимальных величин вертикальных виброускорений в проблемной центральной части вагона (зона установки акселерометра 4) до уровня ниже допускаемых значений при скоростях движения опытного состава 80, 100 и 120 км/ч.

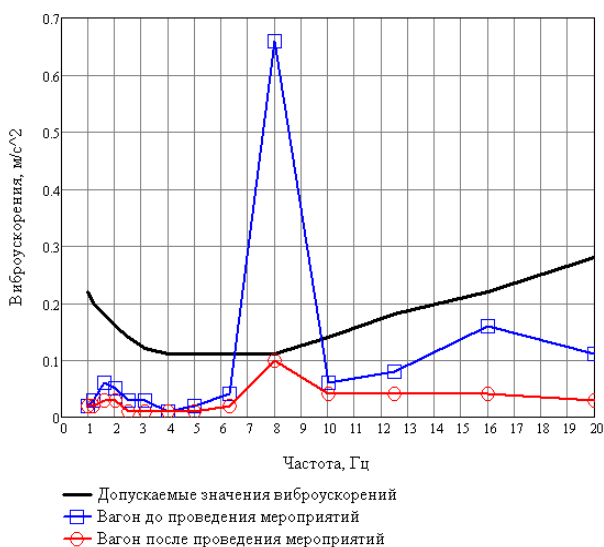
Рис. 5. Средние уровни вибрации при скорости движения опытного вагона 90 км/ч (зона установки акселерометра 9 на рис. 3).

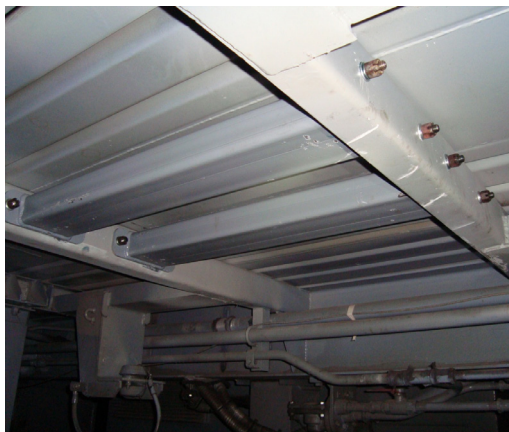
**Pic. 2. Frame of the car, reinforced with longitudinal beams.**

At first, the frame of the car was reinforced in the middle part with longitudinal elements. As the trips and vibration measurements were made, the number

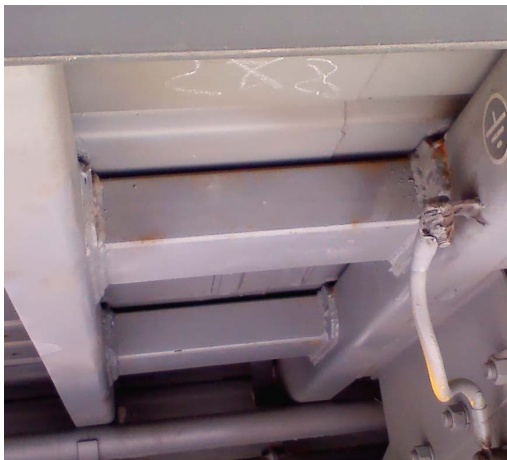
Pic. 4. Car frame reinforced with longitudinal beams.

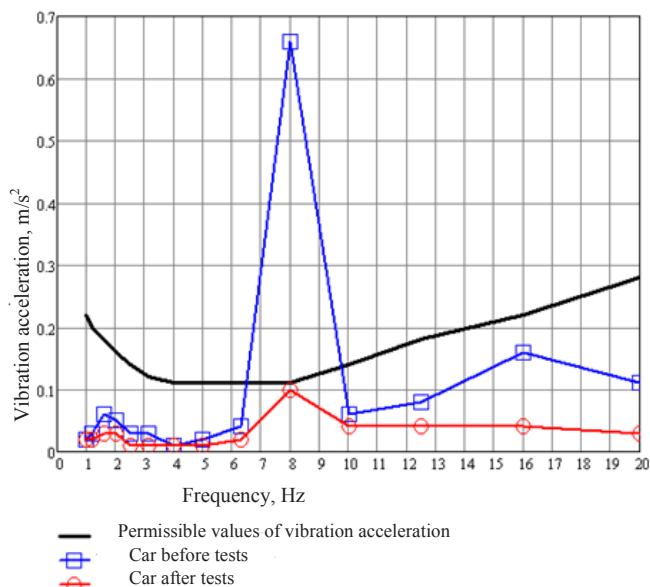
**Pic. 5. Average vibration levels at the speed of the test car of 90 km / h (accelerometer installation zone 9 in Pic. 3).**
