Total Management of Landslide Disaster Risks along Main Roads in Tropical Mountain Ranges

Dissertation

Ngo Doan Dung
Born on 19 October 1981
in Vietnam

Sendai, Japan November, 2017

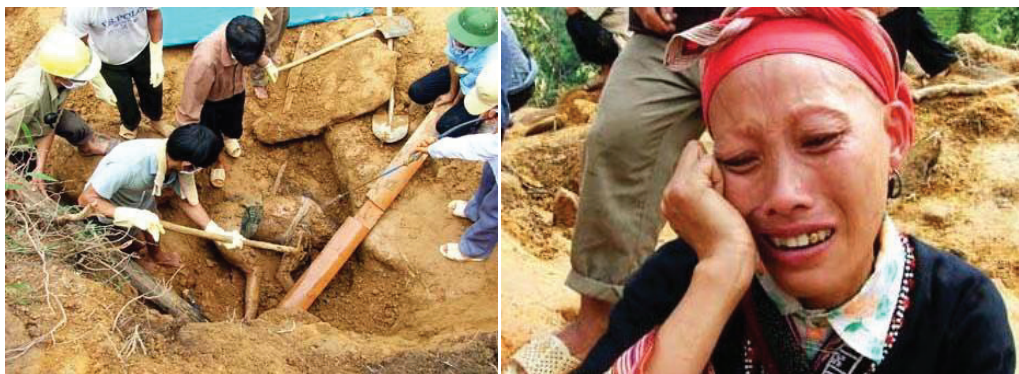
Fig. 1. 6 Landslide in Bat Xat district, Lao Cai province. (*dantri.com.vn*)

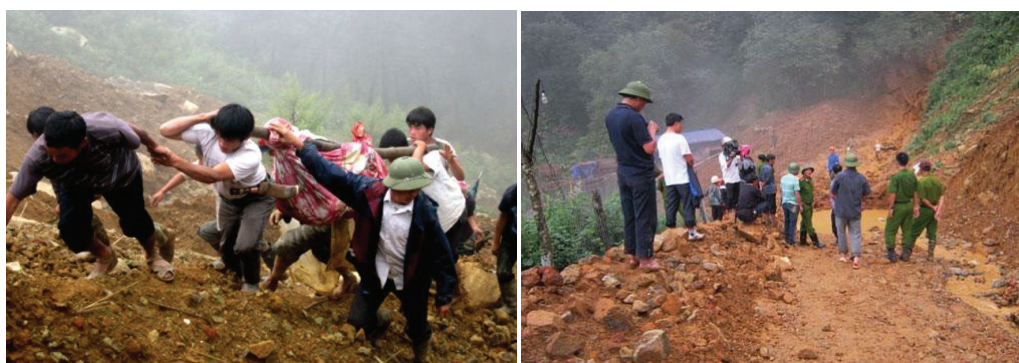
Fig. 1. 7 Landslide in La Pan Tan commune (Yen Bai province). (*HNMO*)

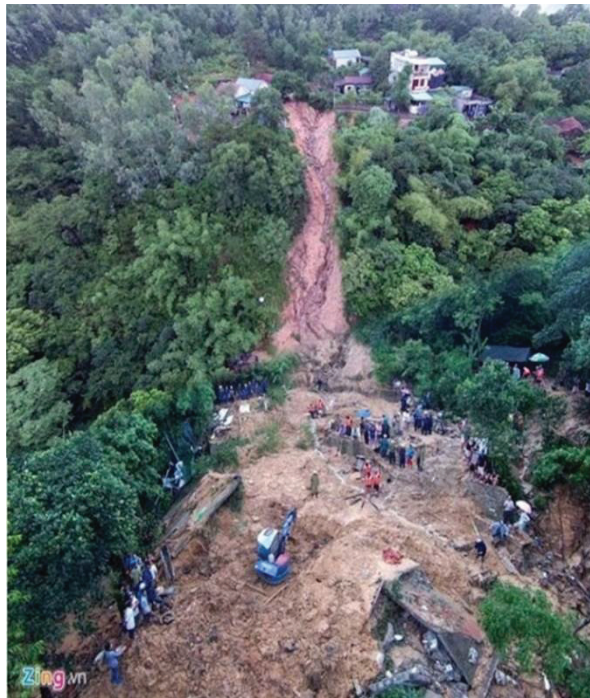
Fig. 1. 8 A landslide in Ha Long city, 9 people buried under hundreds of tons of rock (*zing.vn*)

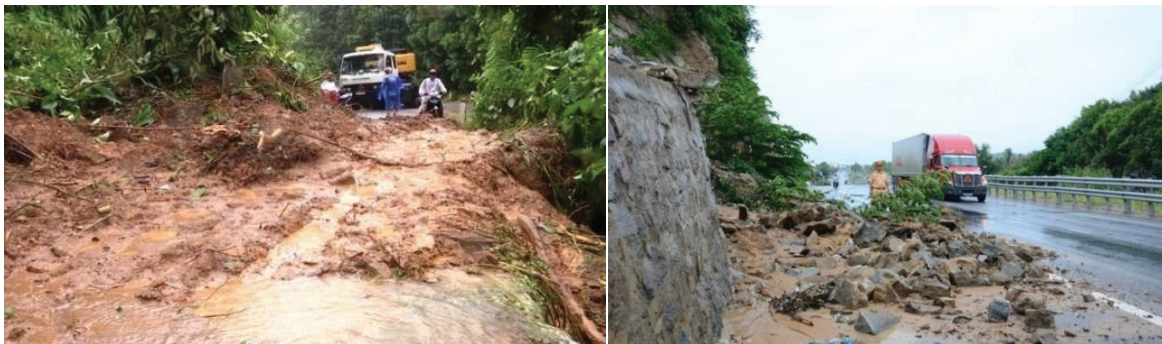
Fig. 1. 9 Heavy rain causes landslide, prolonged congestion in NH4B - left (*vnntimes*)
and Rockfalls on NH No.1 - right (*vnntimes*)

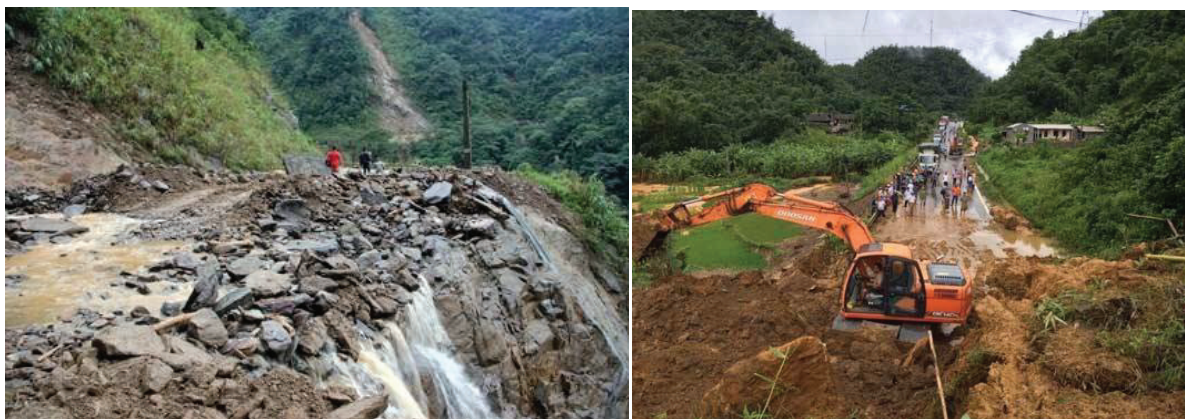
Fig. 1. 10 Landslide on NH8A caused stuck more than one day crossing the Cau Treo border (*dantri*)
and (right) Landslides on NH6 causing prolonged congestion (*24h.com.vn*)

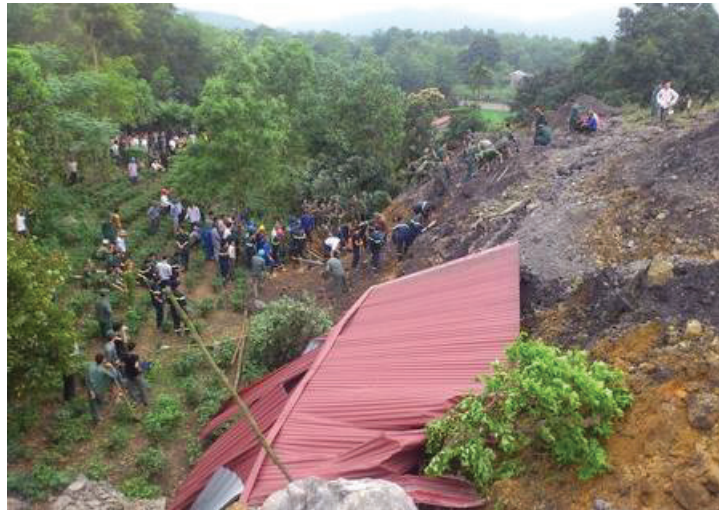
Fig. 1. 11 Landslide at Phan Me coal mine (Thai Nguyen province) killed 7 people

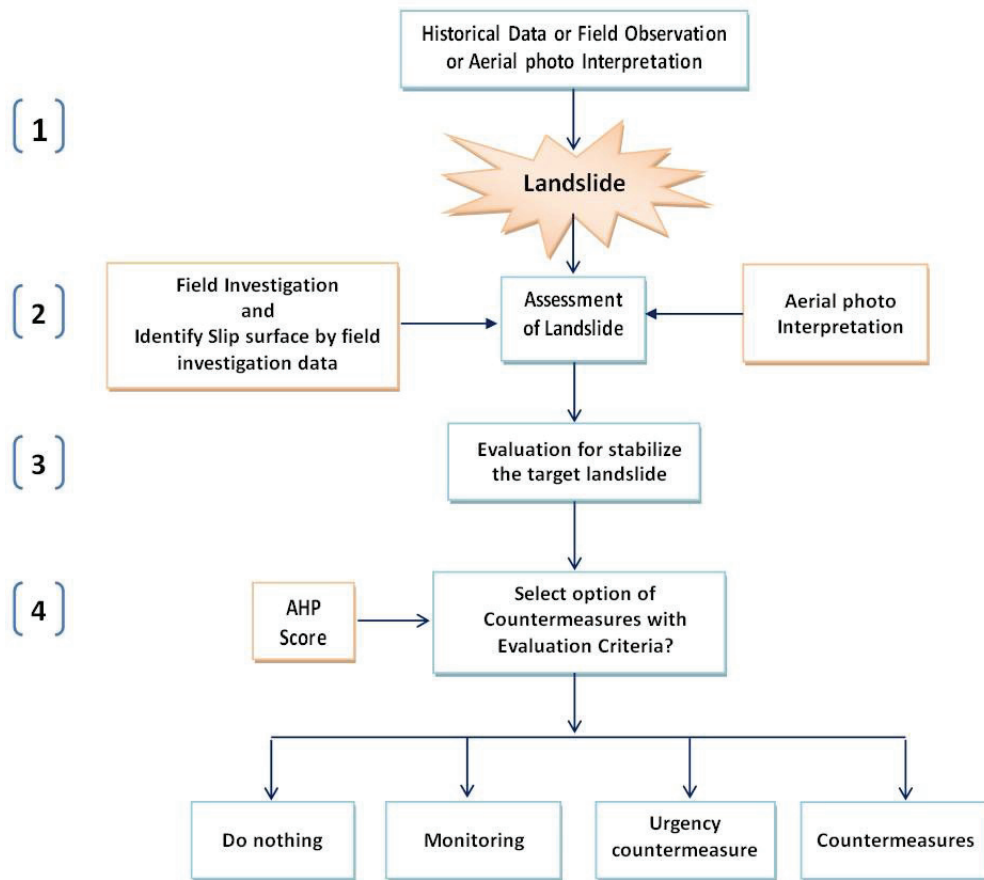
Fig. 1. 12 Flowchart for Total Management of Landslide Disaster Risks along Main Roads in Tropical Mountain Ranges

A concept of countermeasures and monitoring into one workflow, to indicate a procedure to be conducted during each phase, and finally, a management system is proposed. This management system might be applied to Vietnam and also to all of Southeast Asia as a humid tropical zone.

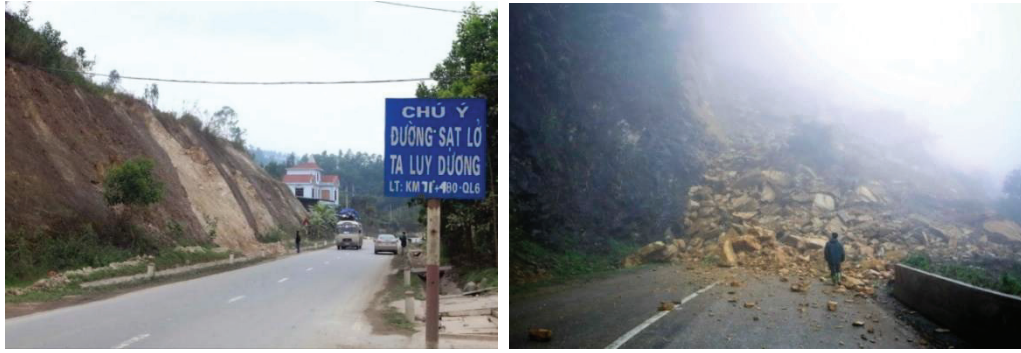
Fig.2. 4 Landslide warning board at Km71+480 and a landslide at Km138+750 along NH6

There are hundred locations of high potential of landslide and more than 50 locations most frequently occurring in the rainy seasons have been recorded on this route.

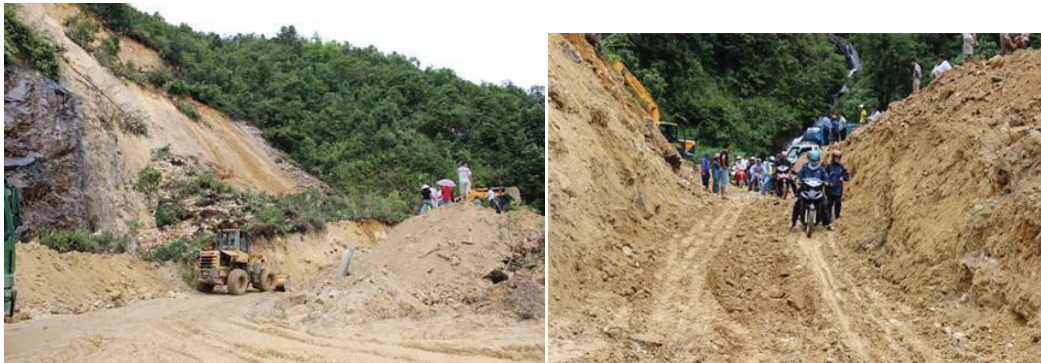
Fig.2. 7 Landslide on National Highway 4D (September 20th, 2014)

On September 20th, 2014, on Km74 + 800 belonging to Hoang Lien Son Pass, Son Binh Commune, Tam Duong District (Lai Chau Province), a serious landslide occurred and caused about 10,000m³ of rock from the mountain to enter the roadway. The traffic on the NH4D is paralyzed, completely separated Lao Cai from Lai Chau Province (Fig 2.7).

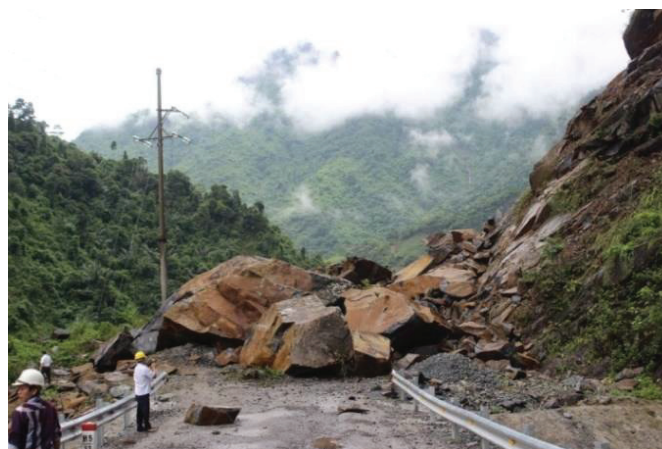
Fig.2. 8 Landslide caused serious traffic congestion on National Route 279

On the National highway 279 (NH279), only from Km33+450 to Km154+080 have about 50 landslides. On July 6th, 1977, at Km33+450, near the Huoi Quang hydroelectric power plant (Muong La district, Son La province), caused by heavy rains was made nearly 800m³ of rock that filled the entire 70m of road and damaged the plumping of many households (Fig 2.8).

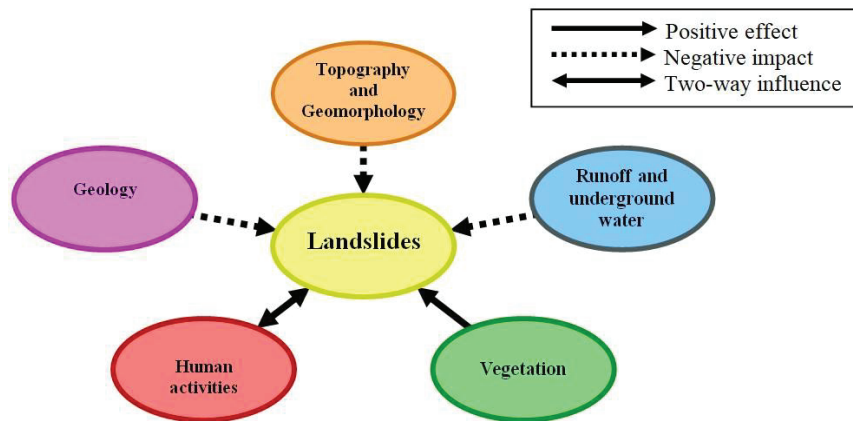
Fig.2. 9 Main factors impact to the appearance of landslides

In fact, the occurrence of landslides phenomenon is as the result caused by synthetic impacts of a series of factors, including geology, topography and geomorphology, meteorology, hydrology, vegetation and human activities. In which, role of each element is also different at each time to induce sliding (Fig 2.9).

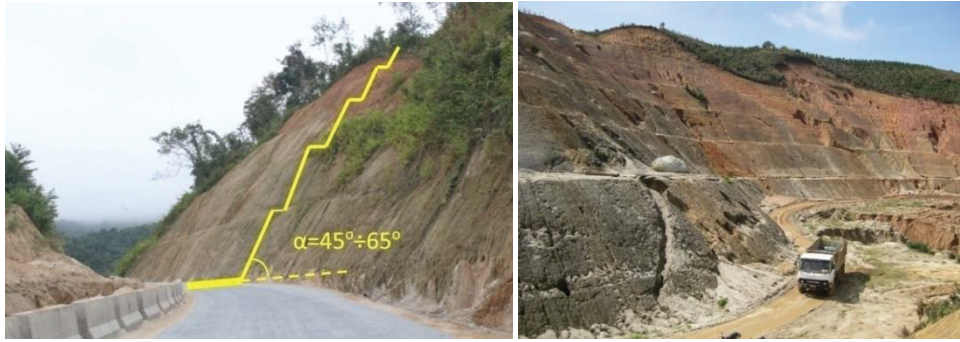
Fig.2. 28 Cross section of cutting road on HCMR (left) and East Truong Son route (right)

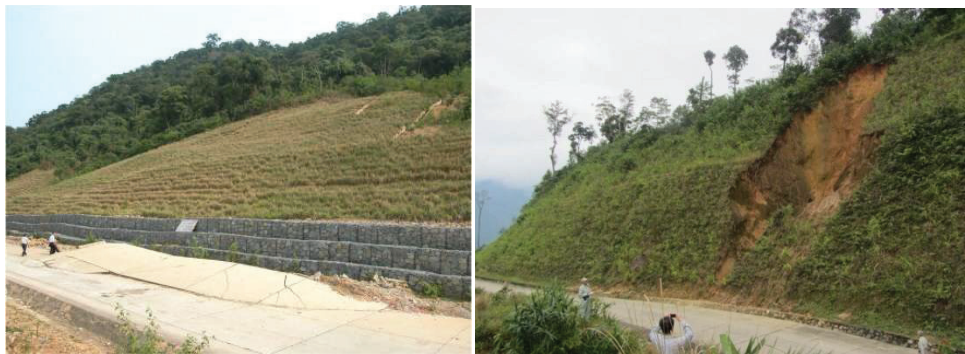
Fig. 3. 4 Landslides caused emerge of pavement (left) and Collapses (right) on HCMR

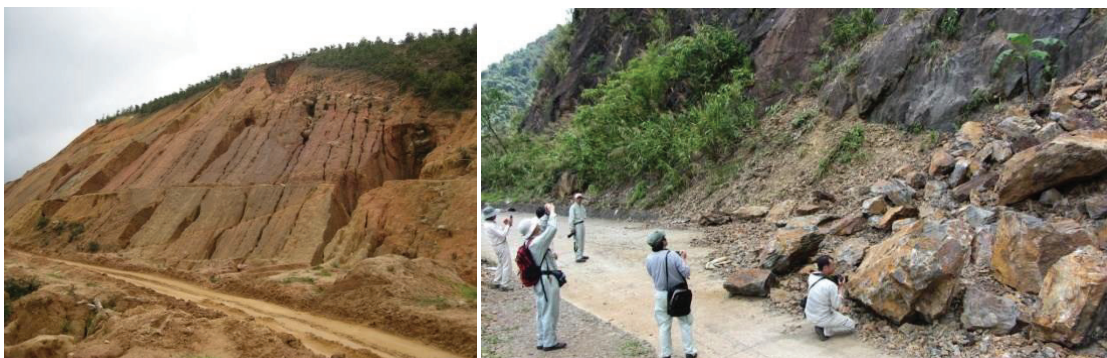
Fig. 3. 5 Erosion often occurred on Truong Son Dong route (left), Topples and rock falls on HCMR (right)

Topples and rock falls usually have some or all the evidence of characteristics such as scarp is rock. Rock is stratified and layered with a sloping angle downward to the road. It is strongly fractured, has streams and fall on the road (Fig 3.5, right).

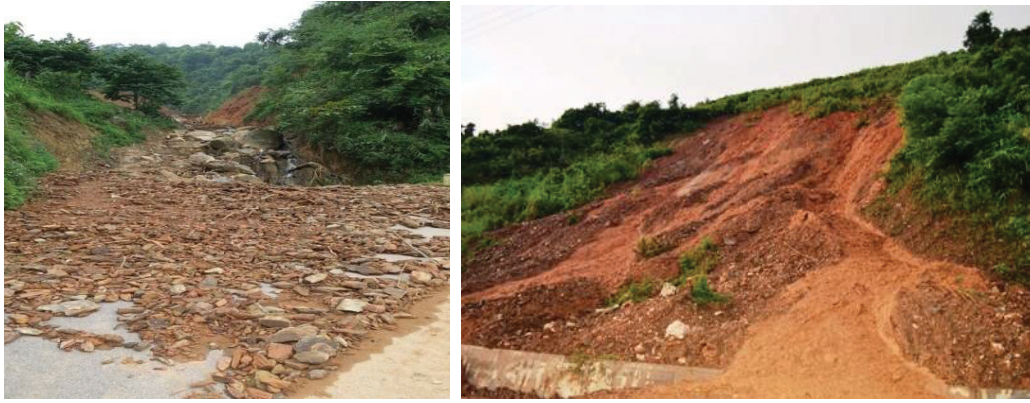
Fig. 3. 7 Flow landslide on NH34 (left) and on NH7 (right)

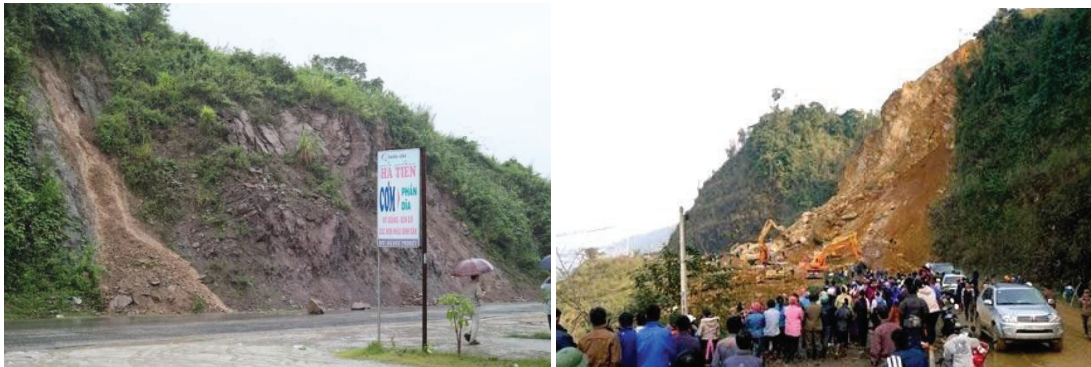
Fig. 3. 8 Complex landslides on HCMR (shallow landslide with earth flow) and NH6 (slump-earth flow with rock fall debris)

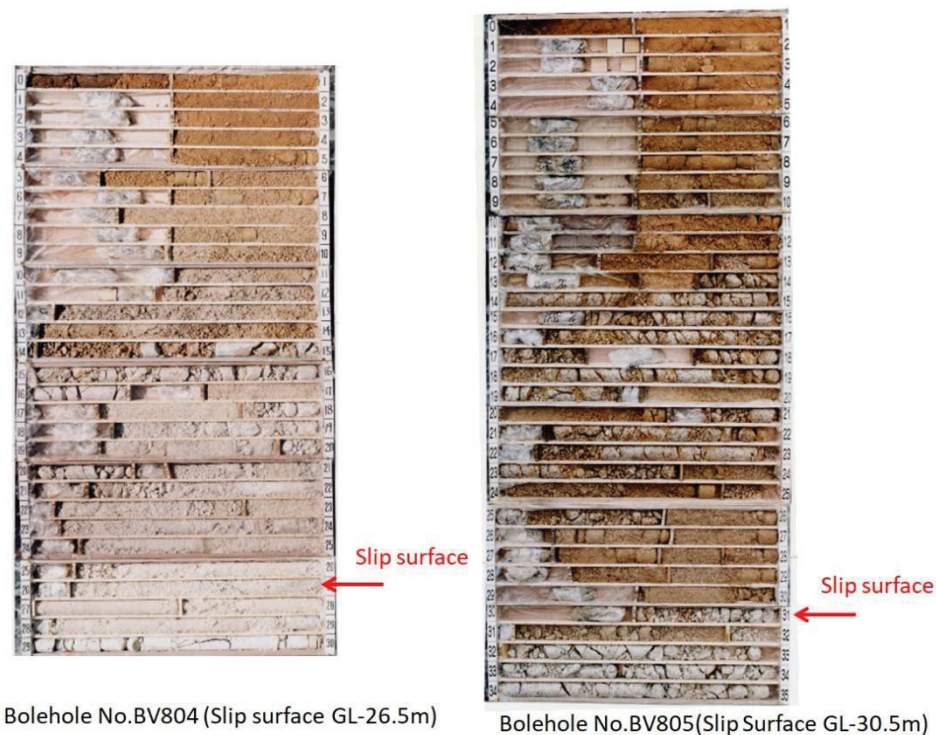
Fig. 3. 9 An example of geological drilling for identifying slip surface of landslides in Japan

Many experiments or measurements should be taken in the field in the period of investigating such as soil hardness testing, Schmidt hammer test or handy seismograph test, etc. in order to investigate the distribution of geological section hardness or identify and check the slip plane. The results of field experiments and in the laboratory will make a great contribution to clarifying the characteristics of soil strength for recognizing the mechanism and estimating the slope movement.

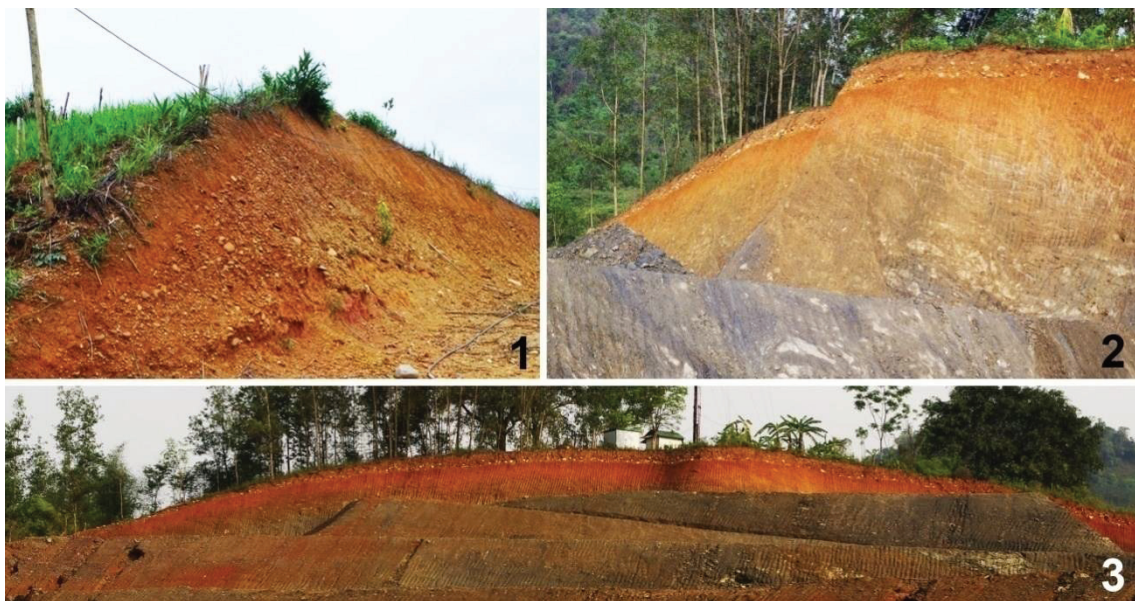
Fig.4. 8 River terrace deposits and its creep features, base rock characteristics: 1) Near Prao town. River terrace deposit clearly creeping at the river side slope. 2) Thin river terrace deposit and creep along the Ca River. 3) Creep phenomena, deep reddish weathering phenomena at the location of photo 2.

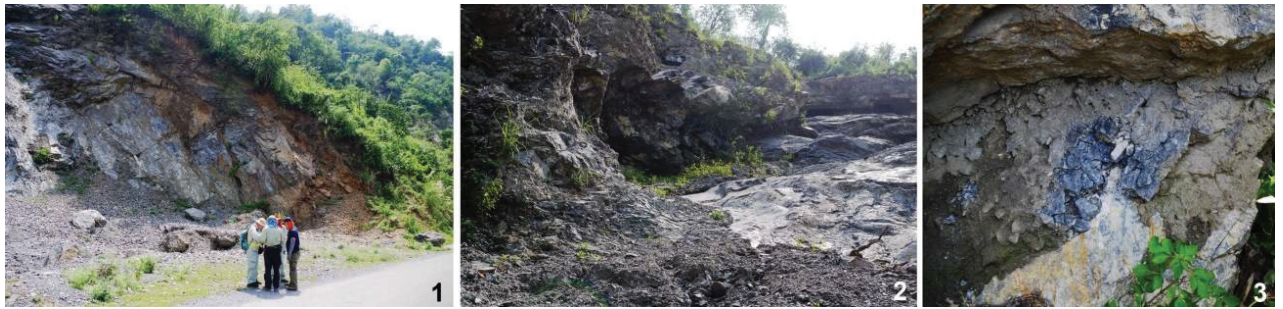
Fig.4. 12 Field photos at LS1. 1 in Fig. 4. , Steep and strongly sheared Paleozoic sedimentary rock. 2, A boundary of the landslide body and the slip surface. 3, Close up the boundary.

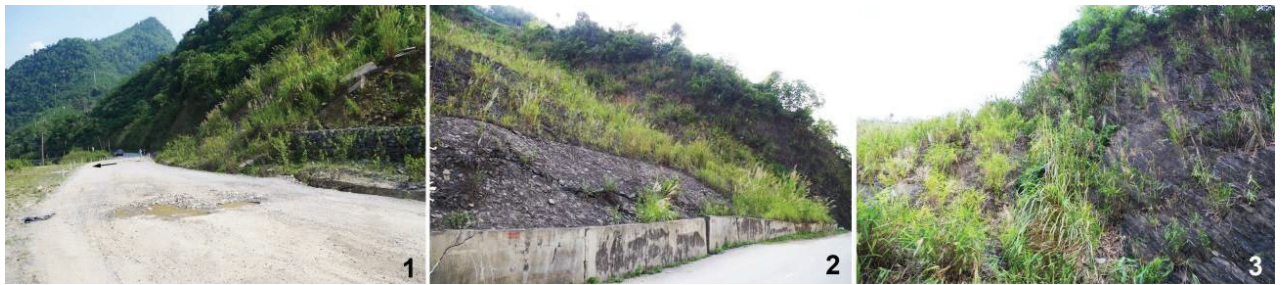
Fig.4. 13 Field photos at LS 2 in Fig. 4.: 1, The toe part of the landslide body deforms the road. 2, The body is pushing the retaining wall 3, The side boundary between the landslide body and non landslide slope.

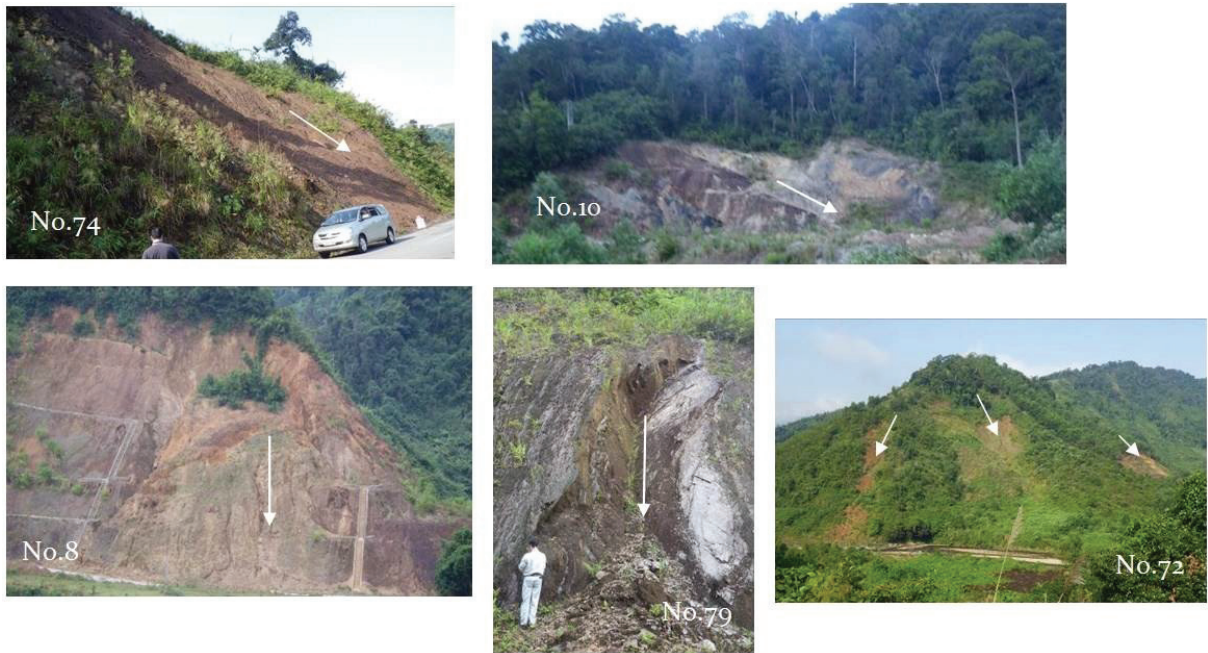
Fig.4. 19 Moving types of landslides along HCMR (No74: Translational shallow debris slide, No.10: Translational rock slide, No8: Rotational slide, No.79: Translational wedge type slide, No.72: Gully type slide and flow) (Abe et al., 2014)

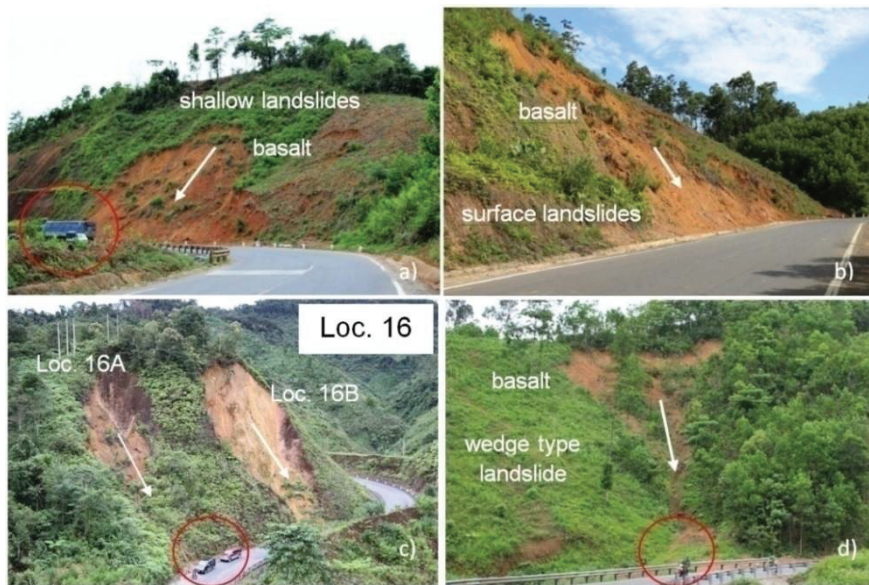
Fig.4. 22 Surface landslides, shallow landslides (photos a, b) and the wedge type (photos c, d) on HCMR, around KhamDuc town

In the other section of HCMR, from Thanh My to Kham Duc have more than 30 ancient and active landslides were recorded. This area appears the surface landslides, shallow landslides and sometimes are deep landslides. The wedge type of landslides was combined by the geological structure and weathering structure. Surface landslides and shallow landslides usually are small sizes of landslides, but the number is much more. Sometimes, some small of landslides combined together to bigger landslide. An important feature is surface landslides and shallow landslides mostly distribution along the road, that were difficult recognition from aerial photographic interpretation, but emergency and dangerous, therefore it is a problem to control and mitigate it (Fig 4.22).

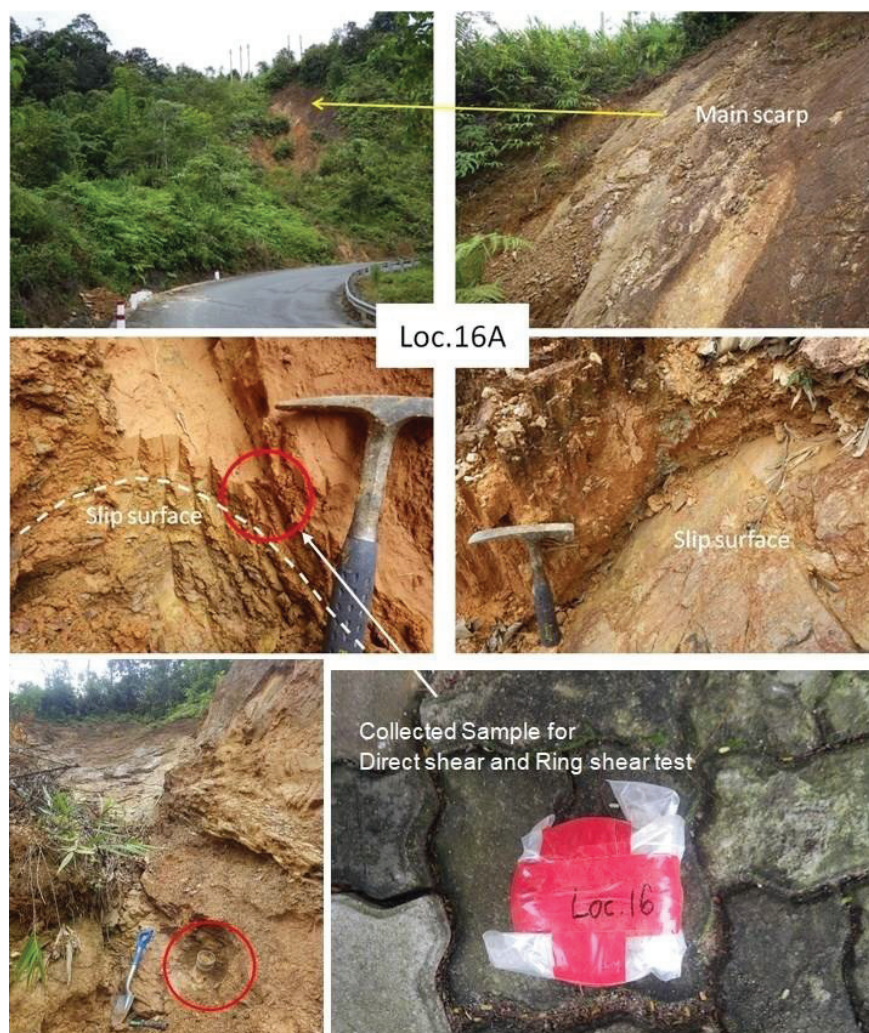
Fig.4. 23 Identified slip surface at the field and collected soil samples at landslide Loc.16A

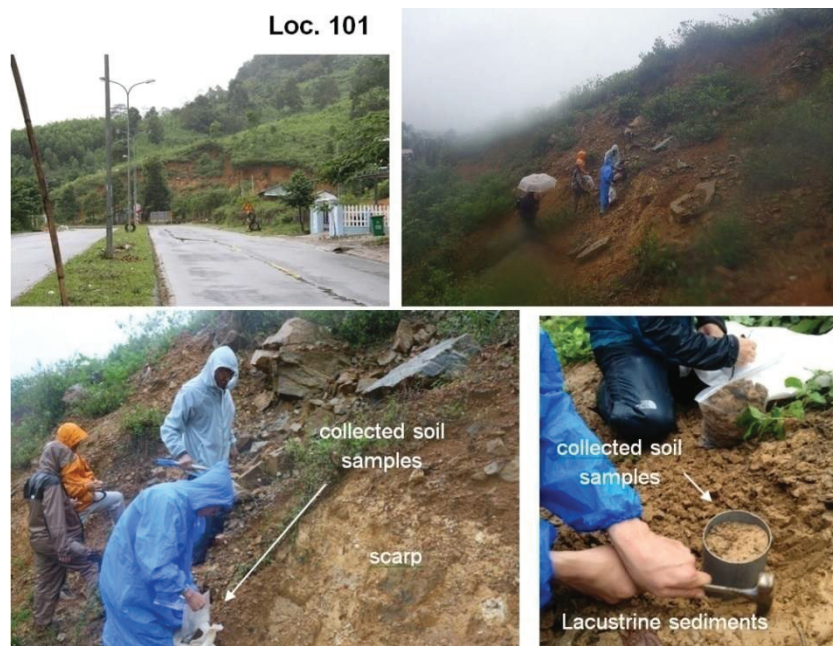
Fig.4. 24 Collected soil samples at landslide Loc.101 on HCMR around KhamDuc area

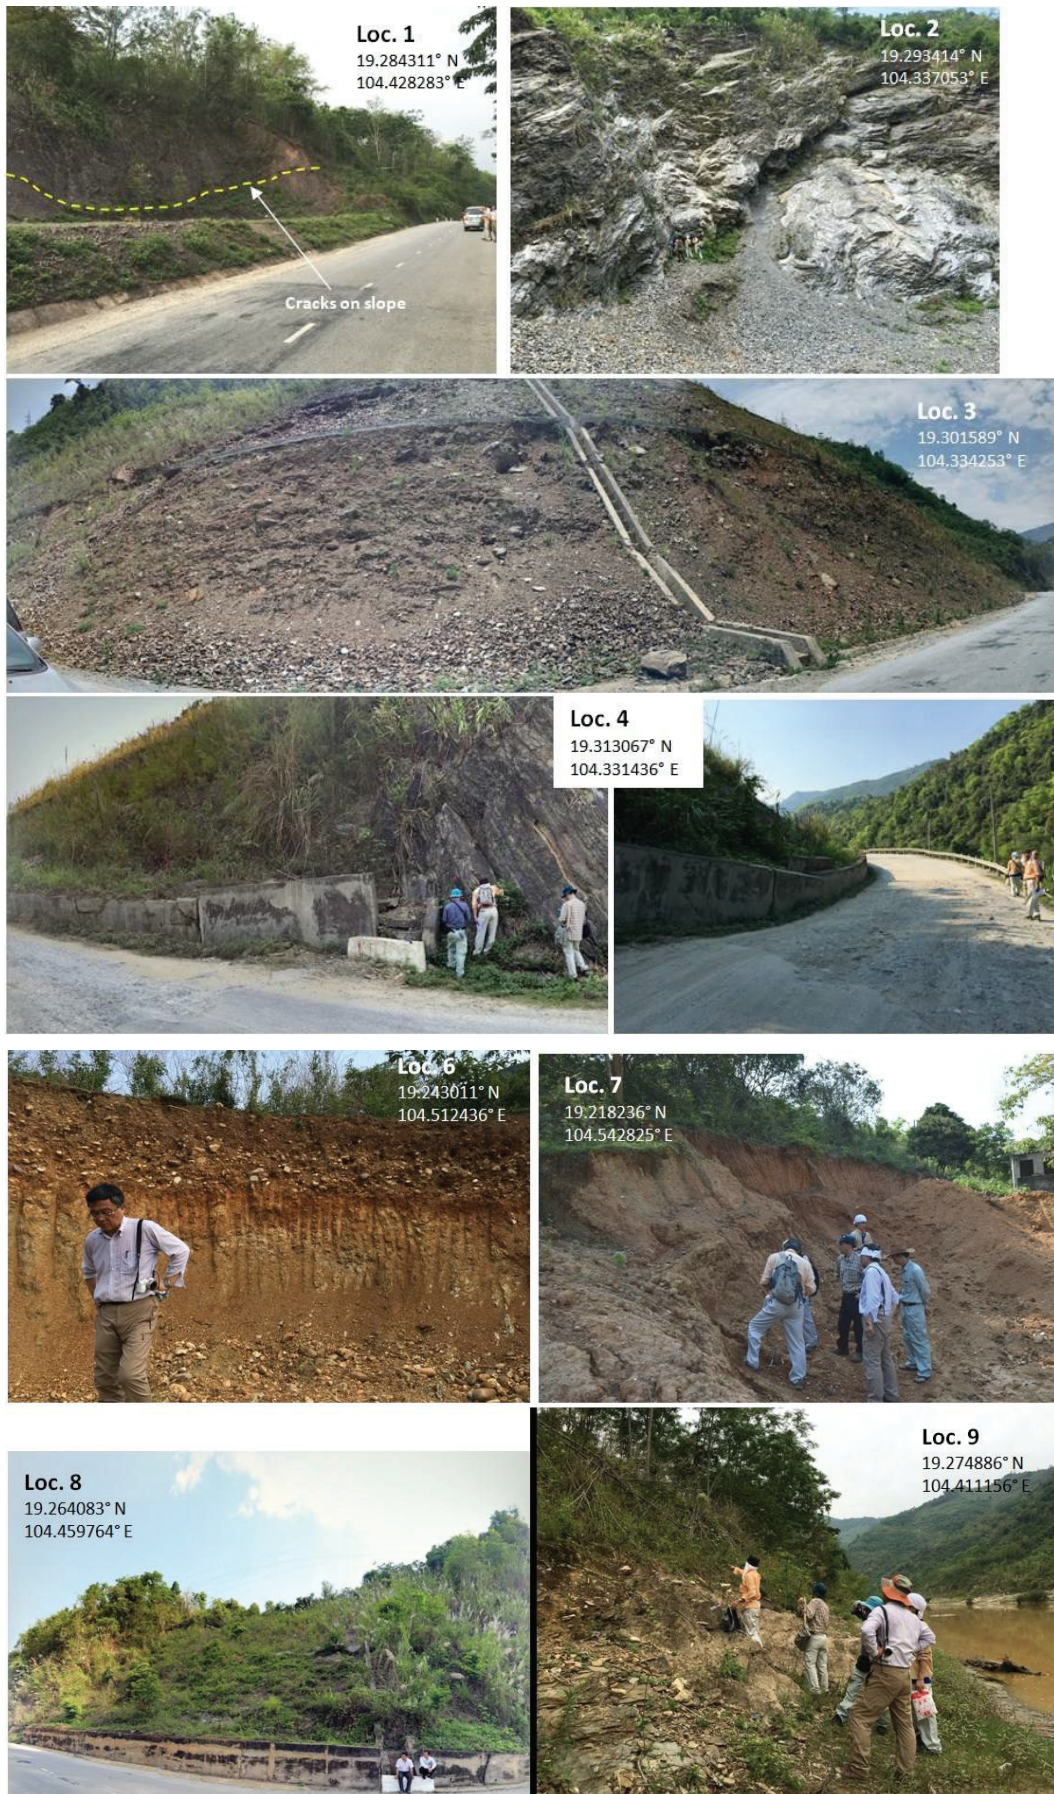
Fig.4. 27 The overview photos of landslides along NH7

Loc.3 landslide is about 250 m wide. The toe of the landslide body was pressed out to the river. A concrete retaining wall has been built at the toe of landslides at the river side. After the landslide occurred again, it has been reinforced with gabion stone layers. But at this time, the route is deviated to the riverside by 2–3 meter and the gabion are pushed out by the landslide body of this landslide. Although this displacement is repaired annually, the continuous movement is always peeling the pavement. Concrete stairs serve also as surface drainage and grating crib works on the surface the slope are severely broken and deformed. Consequently, this landslide was verified as moving actively. The geology of the area is sandstone and mudstone that became schist of the Ordovis period.

Loc.4 located at Km175+600 at NH7, belonging to the Chieu Luu communist, Ky Son district. This section of road is 30m higher than the water level of Ca river. The height of slope is 30m and having the strike of NE and a dip of over 60 deg. Geology of sericite shale belongs to Ca river formation, soft weathered and strong cracking have been observed on and around the slope.

This landslide is reverse funnel shape. It seems to be a complex type and very large scale of landslide, with the estimate of deep about 40-45m. A section 230m long of the route is deviated to the riverside by 2–3 meter and subsidence about 1m. The pavement was broken, and long cracks stretch across over the road also appeared. Concrete retaining wall at the toe of slope were broken, bent and pushed into the road. Reinforcement on the slope surface of stone masonry, the stairs and grooves are also damaged. The bottom of the slope of the river bank is reinforced with concrete retaining walls located on the bored pile foundation. However, erosion by the flow rate of river attack to deep inside of the slope, expose the pile system. This landslide occurred many times in the past, but most recently in 2011. It has moved NH7 toward the river 20m, continues to threaten to cause loss this road and fill part of Ca river.

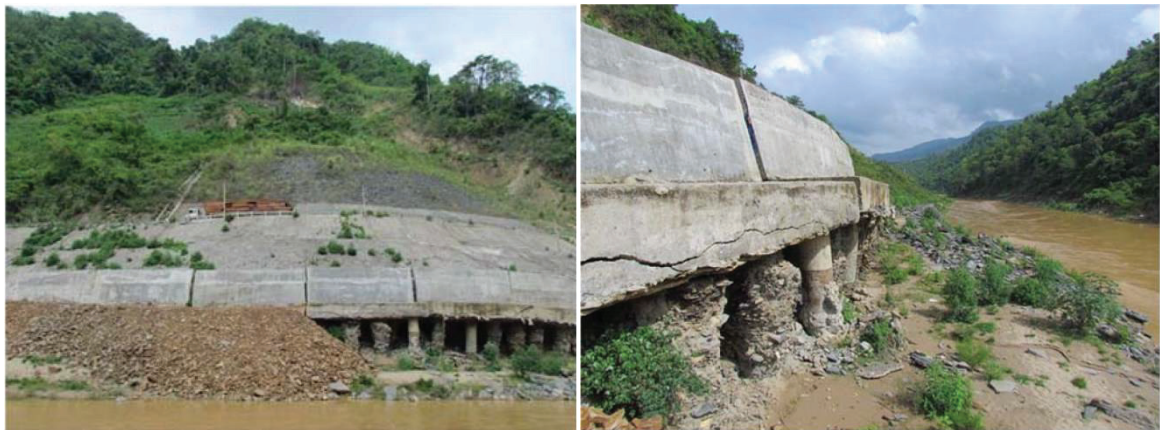
Fig.4. 28 The field photos of Loc.4 landslide: (Left) The boundary of the landslide with the surrounding rocks is quite clear. On the surface of the landslide body has been reinforced by stone masonry, but the sliding block shifted causing the surface to break. (Right) The concrete retaining wall at the foot of the sliding block breaks and moves toward the river.

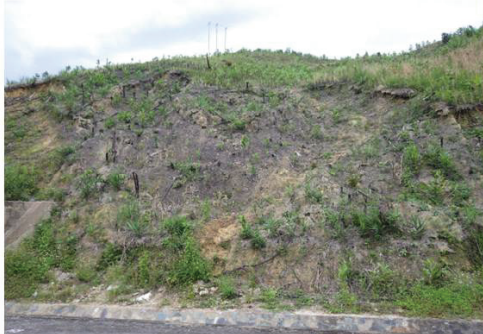
Landslides name:	Location:	o	-	"	Properties of slope	Landslide type:	Gully erosion (shallow landslide)	Height of LS	Length of LS	Width of LS	Estimated depth of LS
Loc.4	North latitude:	15	56	10.43		(Other):	-	25	-	42	-
	East longitude:	107	37	7.23		Cutting slope or natural slope:	Cutting	Slope direction	N25E	Slope inclination	40
Name of place:	Km:	-	-	-	Geological settings	Altitude of schist bedding/joint plane	Strike	?	Dip	-	
Investigator name:	N.D. Dung	T. Shibasaki	Day	20.8.2013	Rock type:	Sandstone, Mesozoic					
Landslide Overview Figure						Other features:	There are clear scarps on slope. Heavy weathered rock on slope easy erosion by water. Many small cave on slope caused by erosion also appeared.

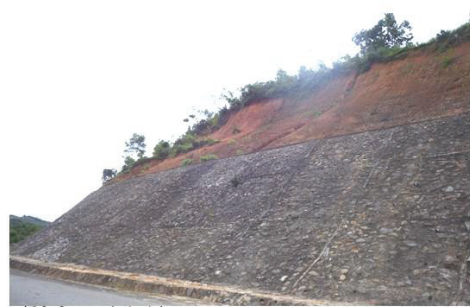
Landslides name:	Location:	o	-	"	Properties of slope	Landslide type:	Gully erosion (shallow landslide)	Height of LS	Length of LS	Width of LS	Estimated depth of LS
Loc.5	North latitude:	15	56	37.17		(Other):	-	35	-	40	-
	East longitude:	107	37	54.31		Cutting slope or natural slope:	Cutting	Slope direction	N15W	Slope inclination	42
Name of place:	Km:	-	-	-	Geological settings	Altitude of schist bedding/joint plane	Strike	N82W	Dip	45S	
Investigator name:	N.D. Dung	T. Shibasaki	Day	21.8.2013	Rock type:	Sandstone, Mesozoic					
Landslide Overview Figure						Other features:	The lower part of slope was covered by concrete. Gully erosion developed at head and left side of the slope.

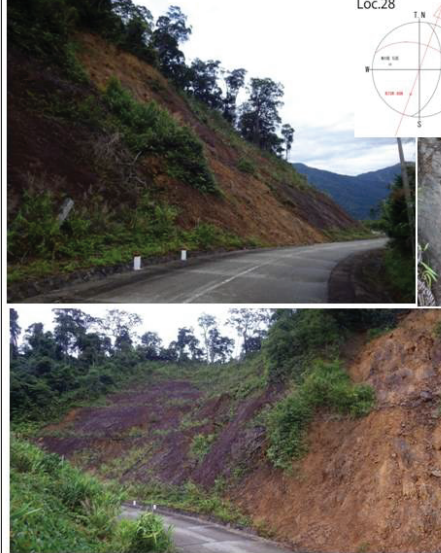
Landslides name:	Location:	o	-	"	Properties of slope	Landslide type:	Slide	Height of LS	Length of LS	Width of LS	Estimated depth of LS
Loc.28	North latitude:	16	2	17.9		(Other):	-	37	-	36	-
	East longitude:	107	30	16.53		Cutting slope or natural slope:	Cutting	Slope direction	N20E	Slope inclination	46
Name of place:	-	Km:	-		Geological settings	Altitude of schist bedding/joint plane	Strike	N10E	Dip	53E	
Investigator name:	N.D. Dung	T. Shibasaki	Day	21.8.2013		Rock type:	Schist				
Landslide Overview Figure						Other features:	-

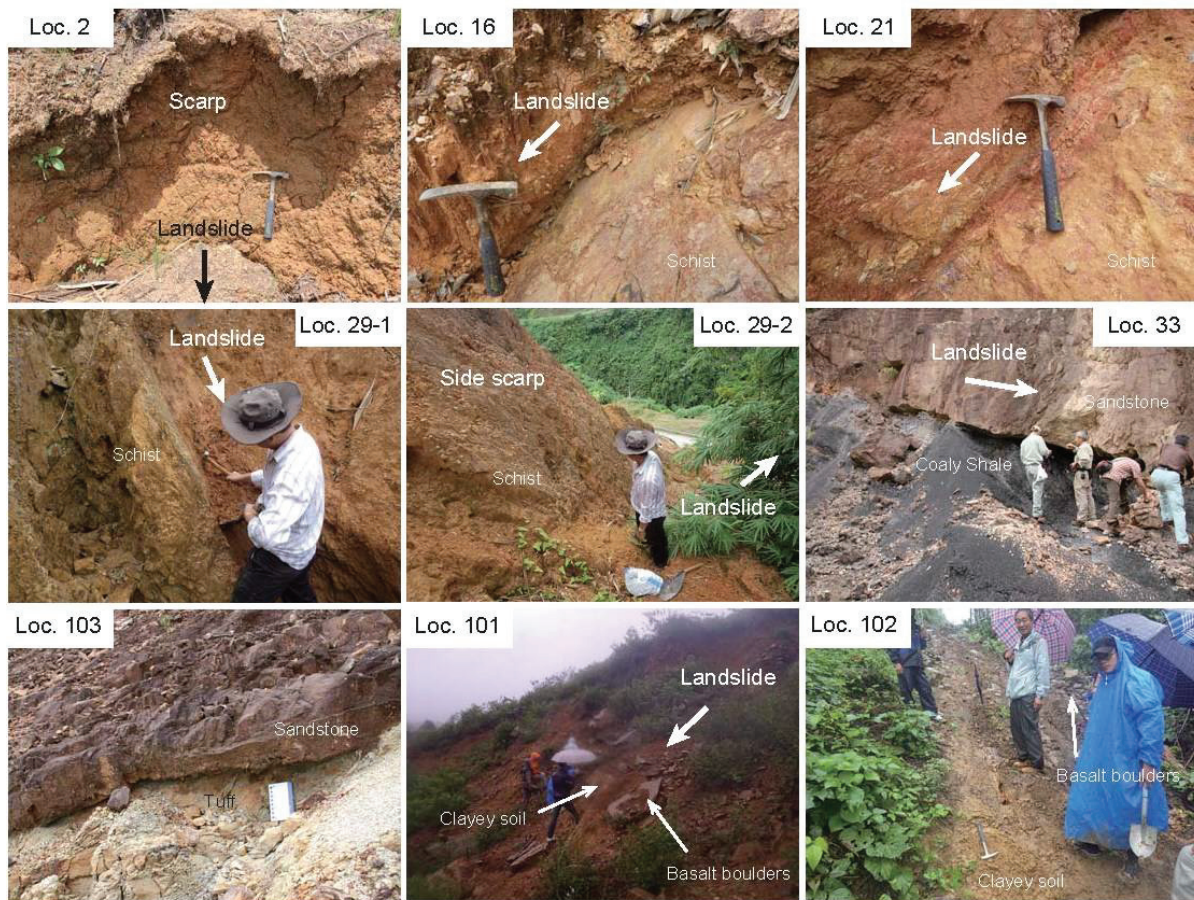
The photograph labeled as Loc. 33 depicts coaly shale of the Mesozoic era, which was found at an exposure of a large scale landslide (side of end part) and which must have formed

a slip surface (Luong et al, 2016). The bottom part of the sandstone was heavily weathered. Argillation was found there. The photograph labeled as Loc.103 is an exposure of a dip slope structure made from sandstone, mudstone, and tuff alternate layers of the Mesozoic era. It was found along a road and showed a geological formation of large scale landslide made from long dip slide (Luong et al, 2016). The tuff there was heavily weathered; argillation was recognized. It might eventually develop into a slip surface. The photograph labeled as Loc.11 in Fig. 4.70 portrays a free surface on a ridge. The layer had an opposite dip structure. A slope cuts made for road construction might have promoted destabilization of that layer. Countermeasure construction done later removed the movable body completely. Upon visiting that site after soil removal work, we confirmed that the weathering had penetrated into deep layers. Visual examination of the rock mass revealed the development of a black vein in the rock body. It was very thin: only a few millim scale. Furthermore, we confirmed the displacement of a rock mass along the black film vein. Separation of the sheared surface exposed a slickenside and clear striations. The slope of that striation developed on sheared surface was reconciled with the slope of landslide movement, which suggested progressive displacement and laxation in the rock mass, taking advantage of weak surface. The black color of the black vein was apparently caused by some oxide of manganese. We found many boulders of basalt on the slope in Locs. 101 and 102. We confirmed exposure of the basalt with a developed column at the upper part of the slope in Loc.102. There were boulders of basalt on the slope formed by landslides. Cohesive soil must have served as the movable body.

Fig.4. 69 Photographs showing 9 locations where soil samples were collected.

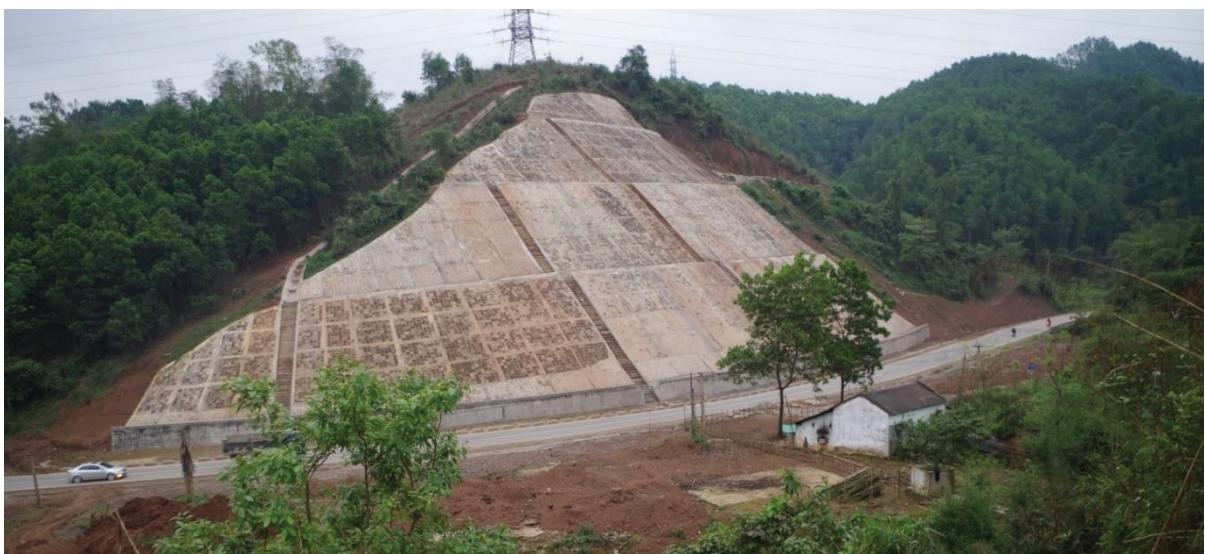
Fig.4. 79 Overview of the Km95 Landslide located at NH6 (photo taken in March 2014)

Because this road is an important artery. The traffic is highly frequent and many people use for daily life. There is hundreds of landslide distribution along this road and some of them are still very active. In the area of Hoa Binh province, there are around 30 landslides and 17 of these landslides are active. Among them, the Km 95 landslide occurred in December, 2009. The size of the landslide was about 100 m in width, 80 m in height and deduced the depth 10~20 m. It's located at a part of the small peninsula like topography. The toe part is exposed to the road surface and uplifting is also occurring.

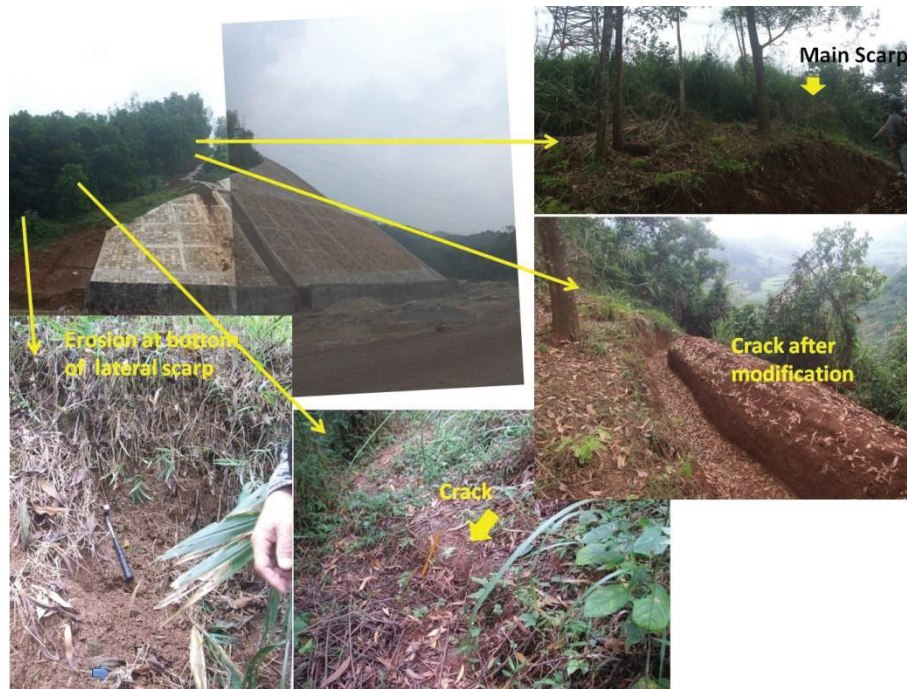
Fig.4. 80 Some micro features of Km90landslide (photos taken in Aug. 2013)

Ministry of Transport and People's Committee of Hoa Binh Province carried the urgent inspection and carried the urgent repair work. That is cut the deformed micro topography and cleaned the surface. The concrete frame works for surface adjustment carried. And concrete steps sat not only for the walking but also for the water discharge. Although, during the job, the new scarp has been appeared in the behind higher part of the countermeasure area. The displacement of the scarp was getting larger and larger. The plan of it is typical horseshoe and the top part displacement is to reach to 1.5 m high vertical. According to such new deformation, the temporal water discharge and shut the infiltration works had carried. It is just setting the small spillway and outlet. The bottom of scarps part was filled with clay. The spillway by concrete was also sat. The scarp deformation was stopped. After the urgent countermeasure work, there are no secondary features of landslide phenomena (Fig. 4.80).

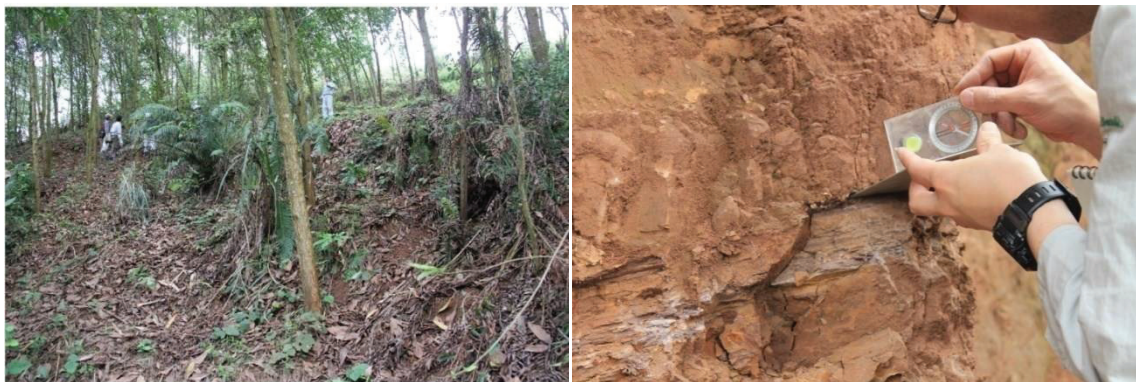
Fig.4. 81 Some distinctive shallow landslide characteristics around Km95 landslide (left) and Relatively fresh rocks at nearby the landslide area (right)

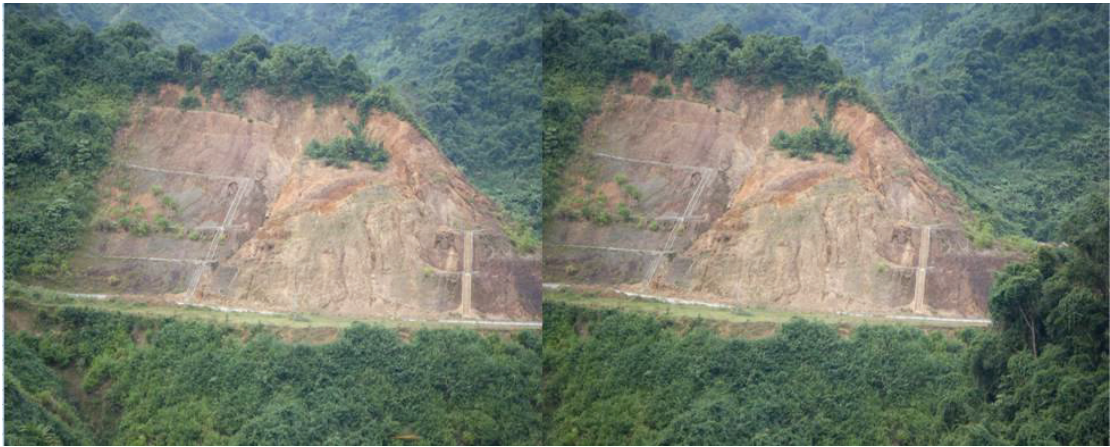
Fig.4. 88 A stereo pair photographs of Landslide Loc.29

Landslide Loc.029 is a wedge-shaped slip that occurred in 2009, which was on HCMR around Prao town in the central of Vietnam. Many field surveys are conducted from 2011 to 2015. Fig. 4.88 is stereo pair photographs of Landslide Loc.29. Evidences at the field and the wedge type of landslide show that it occurred by the rainy season. There are three slip surfaces, including two slip surfaces on the main scarp-side wall N10W 40NE (③), and sides of the N40E 50SE (②) and the slip surface N40E 30 (①) at the bottom (Fig. 4.89). Because of this slip plane is the end point (the right hand side: the north side) from the base side: has become a form of stick to the road surface toward the (left side of the south). Also confirmed a situation where base side is overhanging before as slope, is observed the remnants of a compression hill in the part of the road valley of the base side. There is no groundwater or spring was observed around the surface of the slope during several degrees of exploration. In fact, it is expected that there are many sandy components and high water permeability is high in terms of particle size. Therefore, because water is relatively easy to dissipate, it is highly likely that groundwater will not be stored (Void) if rainfall continues without rain. However, because there are clear gully erosion marks on the legs, it is natural to think that heavy rain suffered from the influence of water (surface water to groundwater) and that temporary groundwater was stored and the wedge part slipped. The geology is red of strongly weathered schist.
