Total Management of Landslide Disaster Risks along Main Roads in Tropical Mountain Ranges

Dissertation

Ngo Doan Dung
Born on 19 October 1981
in Vietnam

Sendai, Japan November, 2017

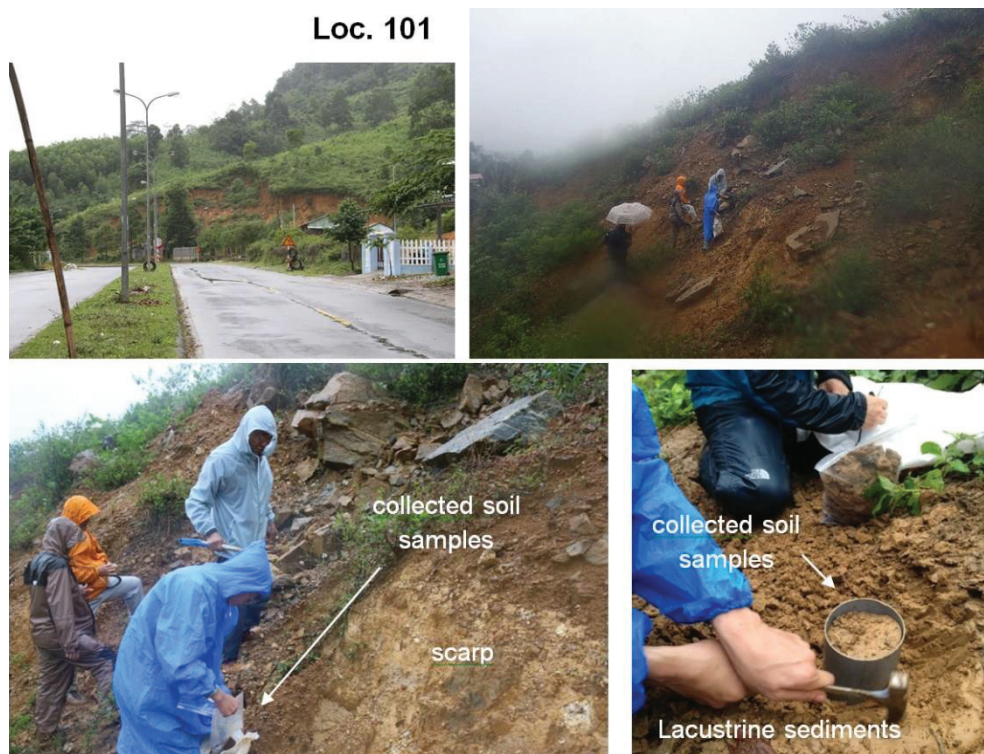
Fig.4. 90 Collected soil samples at Loc.101 landslide

Field investigation at Ls-Loc.101 in December 2014 shows that is not a big landslide, but this is a combine of some parts of small failures. The shape of landslide before occur were estimated by measuring at field combine with the contour topographic map was prepared from W3D data. Soil samples were collected at scarp and at guess slip surface of the landslide. Ring shear test to determine the Residual strength of soil and other test at the laboratory for soil physical characteristics param. The sensitivity analysis for stable or unstable condition of Ls-Loc.101 using RBSM3D, in no groundwater condition (Void) and in full on groundwater condition (Full). The unit weight $\gamma_t = 18 \text{ kN/m}^3$ was adopted in view of the fact that the unit weight γ_t has a density of 1.75 to 1.85 g/cm^3 in many weathering zones of similar samples on HCMR.

Next case study is a shallow landslide on HCMR, in Kham Duc area (Fig 4.90). The Kham Duc town belongs to Quaternary zone, geological structures are usually flat, including lake deposits with extremely weak layers such as organic rich, peat and clayey layers, and volcanic rocks with intruded basalt consolidate hard and heavy rock. The lake deposits are black, reddish brown, but the weathering level is not so deep. The boundary of the volcano and lake deposits is black deeply weathered material, with many holes because of the lava gas. Lake sediments are deeply weathered and changed to clayey materials. Landslides occur as rotational slides along river side slopes, with a complex of small to surface landslides and soil creeps.

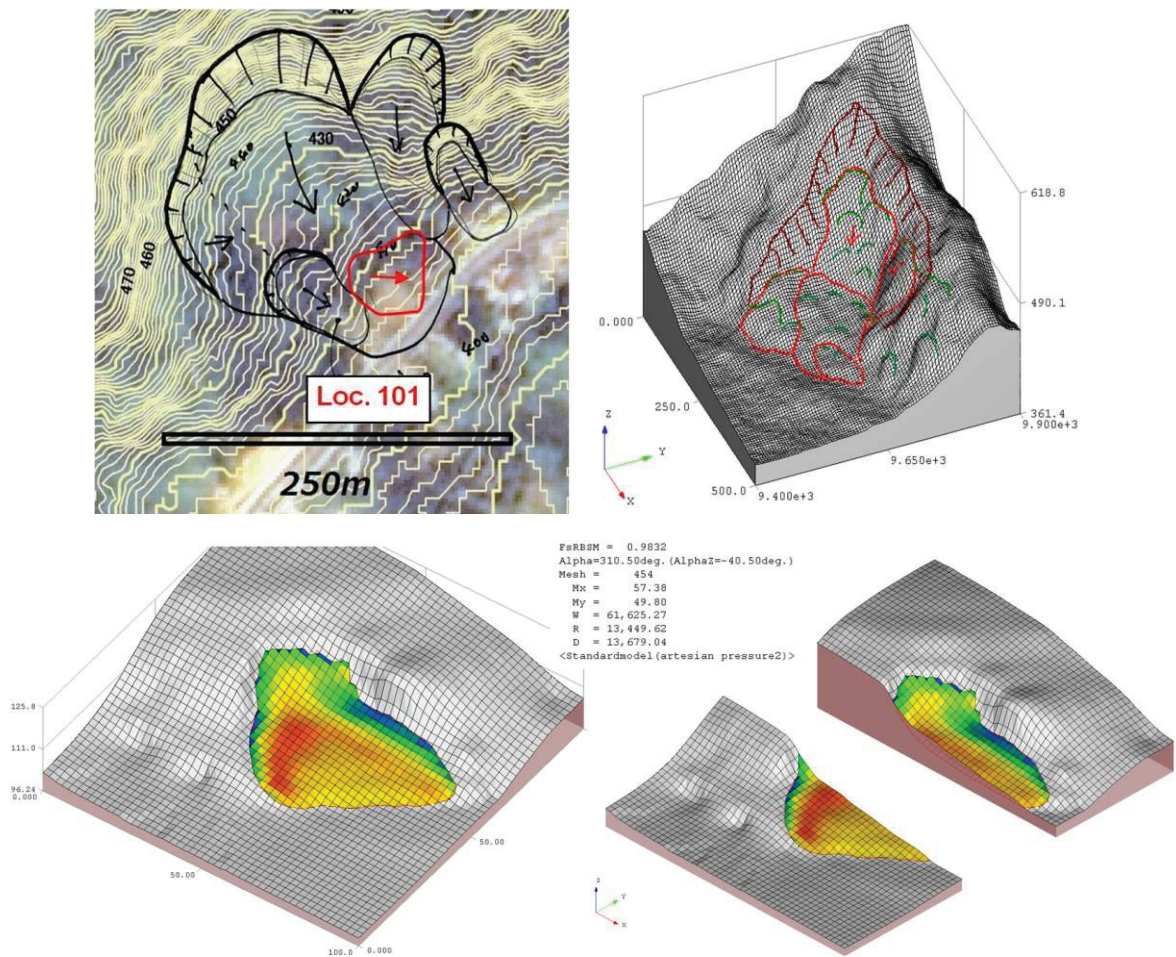
Fig.4. 91 Simulation the slip surface on the contour from W3D data for safety factor evaluation by ADCALC3D
