# Hydroxyl-apatite coated hip implants

Geesink, R. G. T. (1988). Hydroxyl-apatite coated hip implants. Maastricht: Rijksuniversiteit Limburg.

Proefschrift

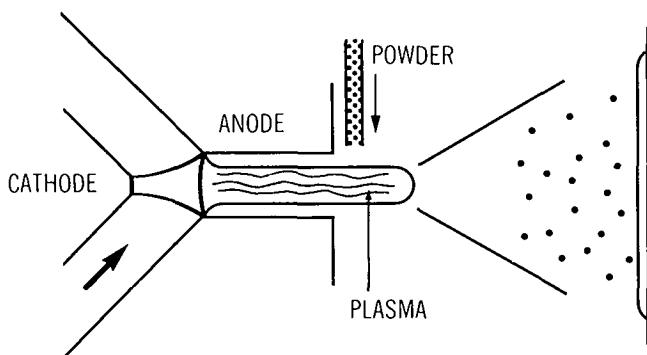
Fig. 2  
Schematic representation of plasma-spraying procedure.

The principle of plasma-spraying is known from industrial technology (Bunshah 1981). A DC-electric arc of high energy (400 Amperes at 100 Volts) is struck between two electrodes, while a stream of mixed gases passes through (Fig. 2). Both an argon-hydrogen mixture or nitrogen are suitable, depending on the required characteristics of the plasma-flame. Argon-hydrogen mixtures produce stronger coatings, but are more difficult to handle with large objects because of the small flame area. Additionally, argon-hydrogen mixtures are more expensive and dangerous because of the presence of the flammable

hydrogen. The passage of the gas through the electric arc results in a ionized gas, called a plasma, of very high temperature, up to 30.000 °C. Due to the high expansion following this temperature increase, the gas obtains a high speed, approaching the speed of sound. Hydroxyl-apatite powder particles of the appropriate size are then suspended in a separate carrier gas stream and fed into the plasma flame. A special powder port (Metco®) allows oblique injection of the hydroxyl-apatite particles at the far end of the plasma-flame, thereby lowering the risk of the particles being burned or evaporated. Due to the very high temperature the still relatively large hydroxyl-apatite particles explode into much smaller particles (1-5 microns) and start to melt at their surfaces. Because of the very high speed of the gas, the hydroxyl-apatite particles will stay in the plasma-flame for only a few milliseconds. If the individual hydroxyl-apatite particles remain too long in the very hot plasma-flame, they will evaporate or the crystal structure will undergo irreversible phase changes with loss of the specific hydroxyl-apatite characteristics. The critical temperature for this crystal phase transition is approximately 1300 °C. For optimal chemical bonding between hydroxyl-apatite and titanium the particles must arrive at the target surface just slightly molten at their surfaces. If on the other hand the temperature of the particles is too

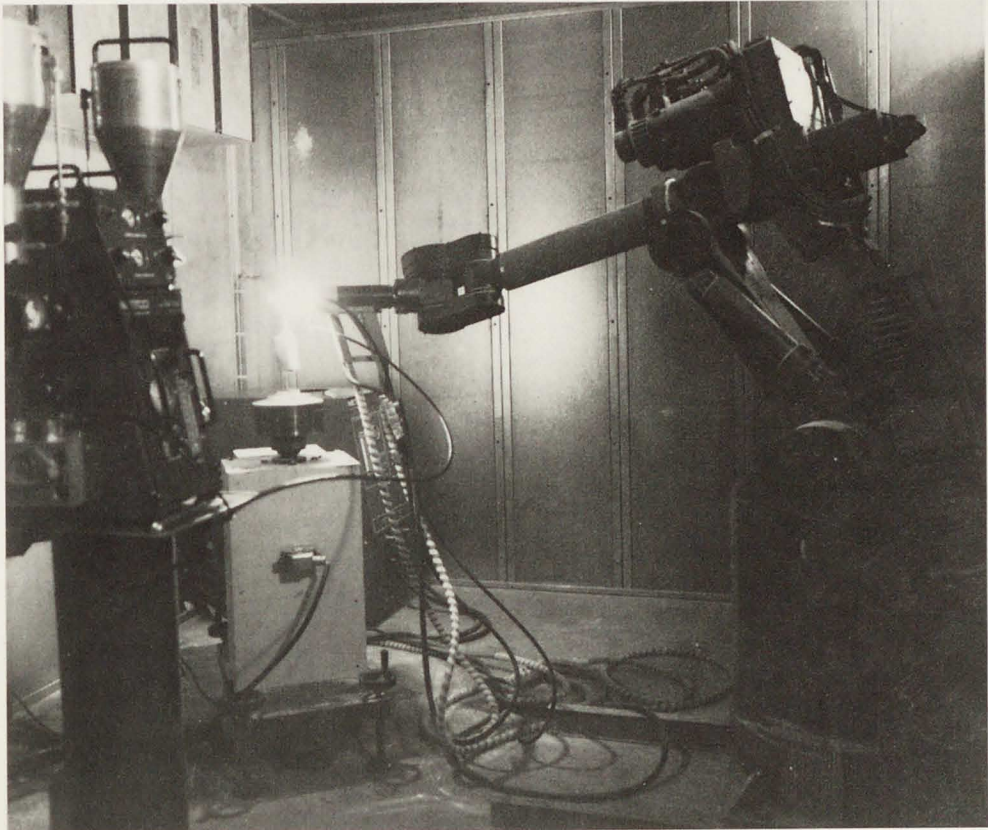
Fig. 3  
Experimental set-up of equipment in use for plasma-spraying.

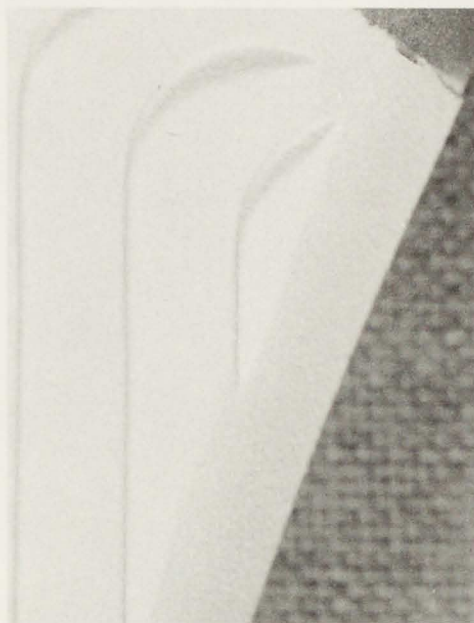
Fig. 4  
Surface structure of hydroxyl-apatite coated implant.

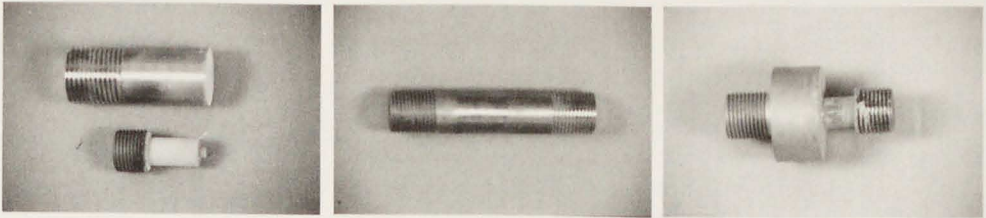
Fig. 6  
Test samples for determination of tensile and shear strength of hydroxyl-apatite coating.

Static strength of the coating was determined in shear and tensile directions until failure. For uniformity of testing a standard test specimen geometry was designed (Fig. 6). For shear testing, each specimen consisted of a 12-mm. diameter test mandrel and was fabricated from the same titanium alloy as the coating test sample substrate. Each mandrel was centered in an annular machined steel housing with a slip-fit guide peg and hole.

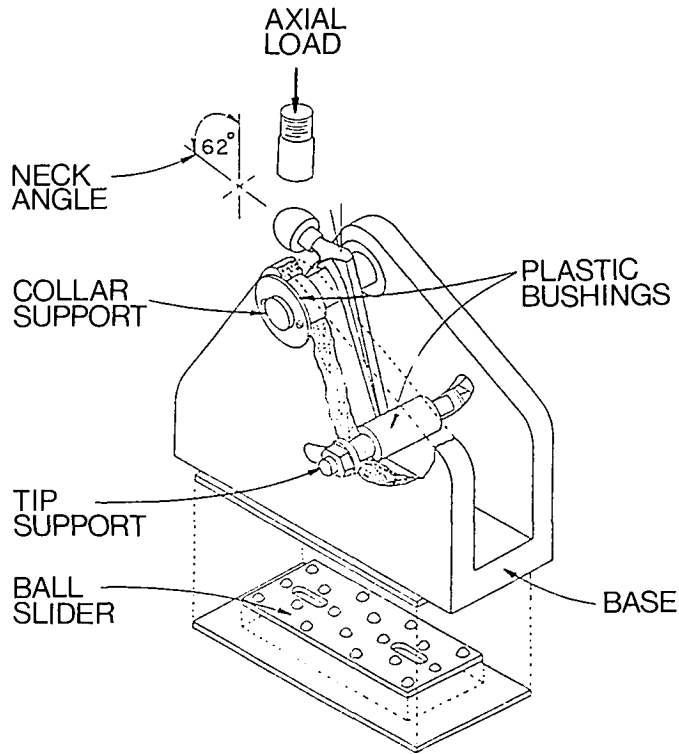
Fig. 10  
Configuration for fatigue testing of hydroxyl-apatite coated femoral prostheses.

Fatigue tests were performed according to H.F. Moore (Moore 1948). The test samples consisted of circumferentially coated tubular structures, the ends of which were mounted under a variable angle of up to three degrees in the testing machine. By rotating the specimen, cyclic loading was obtained under fully reversed loading conditions. Fatigue testing of the coating was then performed according to Moore with tensile/tensile loading of 100 - 6000 Newton in the fully reversed bending mode with cyclic loading during ten million cycles or until failure (Moore 1948). Additionally, functional fatigue studies were performed on fully hydroxyl-apatite coated femoral stems and non-coated controls. The purpose was to measure any deterioration in fatigue strength of the substrate metal during the course of the plasma-spraying procedure. Fully hydroxyl-apatite coated femoral stems, with non-coated control stems, were mounted in a three-point bending set-up (Fig. 10). The loading angle towards the implant neck was 62° and the specimen were subjected

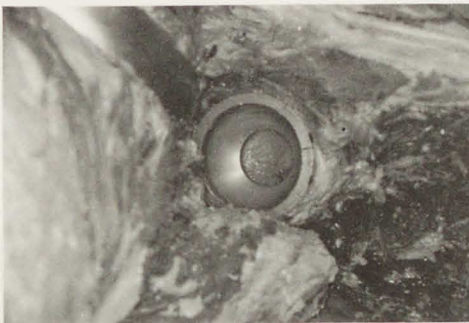
Fig. 11  
Cadaver implantation of hydroxyl-apatite coated acetabular screw ring.

Subsequently the screw-ring was screwed out and retrieved to the laboratory for analysis (Fig. 11). A corresponding procedure was performed on the femoral side. With the aid of conical intra-medullary reamers and corresponding calcar rasps, the proximal femur was prepared. After final sizing a slightly oversized Omnifit® #10 stem was inserted in the femoral shaft until flush with the resection level and subsequently extracted for inspection (Fig. 12). After retrieval the implants were ultra-sonically cleaned in alcohol and photographed.

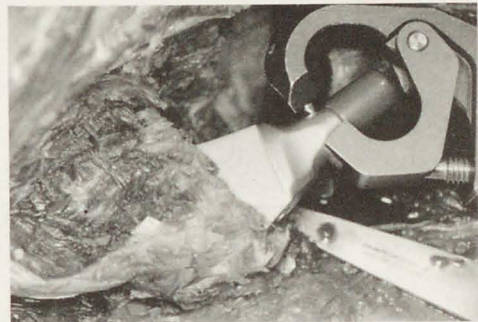
Fig. 12  
Cadaver implantation of hydroxyl-apatite coated femoral stem, prior to full seating of prosthesis.

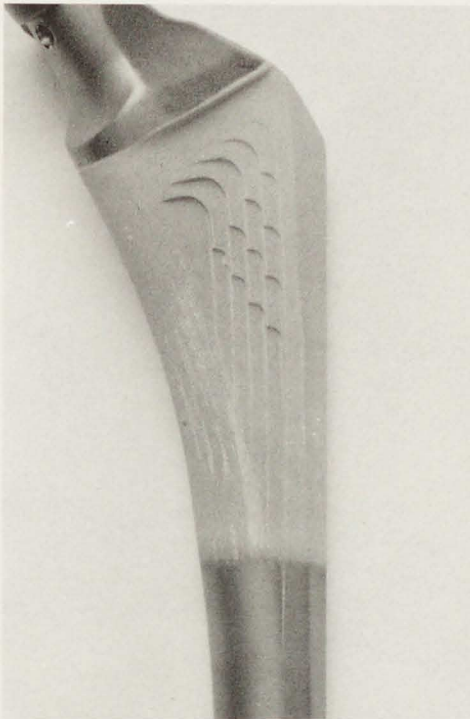
Fig. 13  
Retrieved femoral stem after cadaver implantation.

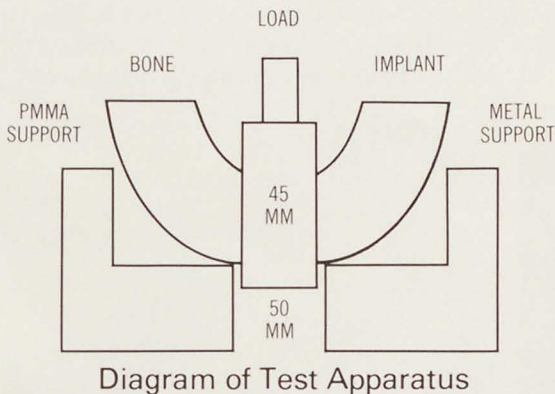
Fig. 16  
Schematic configuration for push-out testing of transcortical plug implants.

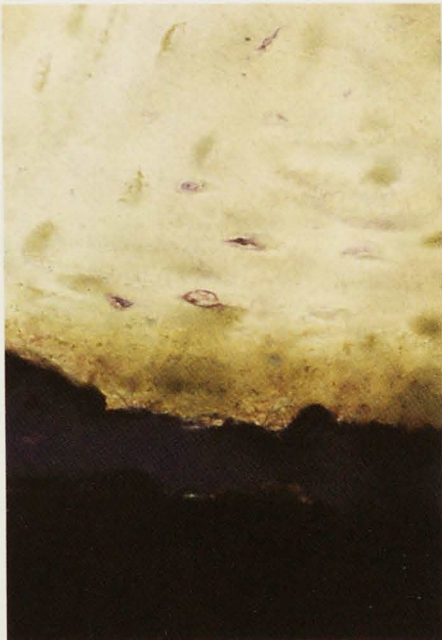
Fig. 30  
Transition characteristics of bone towards hydroxyl-apatite coating. (basic fuchsin, three months, x1000).

The transition area of hydroxyl-apatite coating to bone is of special interest. High magnification views (1000 x) show some darkening of bone in this area with minute speckled particles in some places and smooth transitions under most circumstances (Fig. 30). In polarized light, the structure and orientation of the bone trabeculae is readily visible. Their endings on the hydroxyl-apatite coating have various angles to the implant surface, varying from perpendicular to almost parallel.

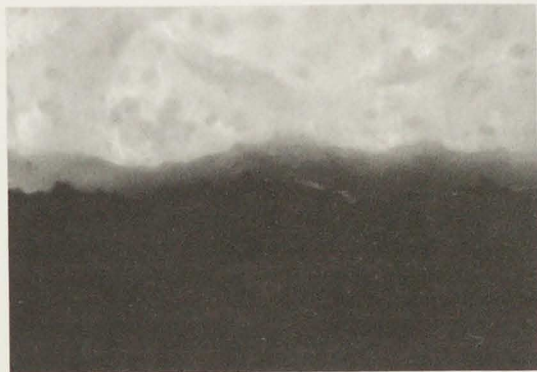
Fig. 33  
Structure of hydroxyl-apatite coating after one year  
(polarization, x200)

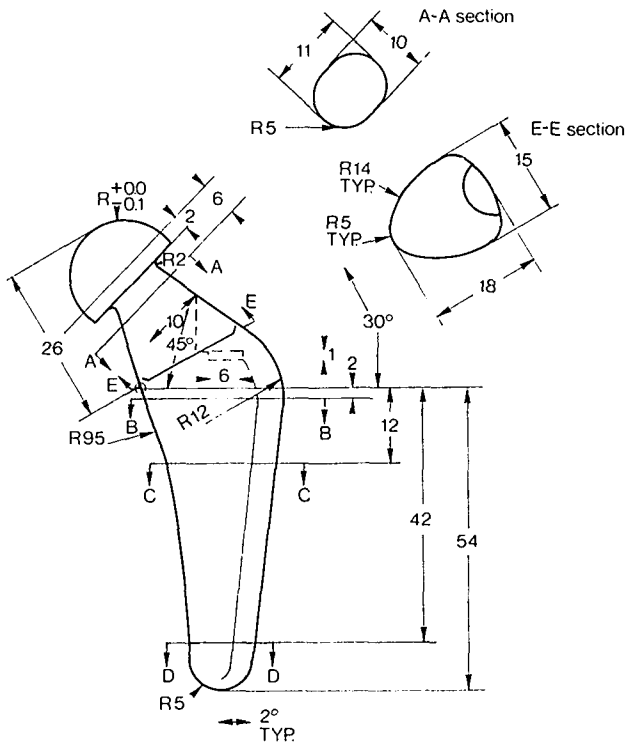
Fig. 37  
 Geometrical characteristics of canine total hip implant.

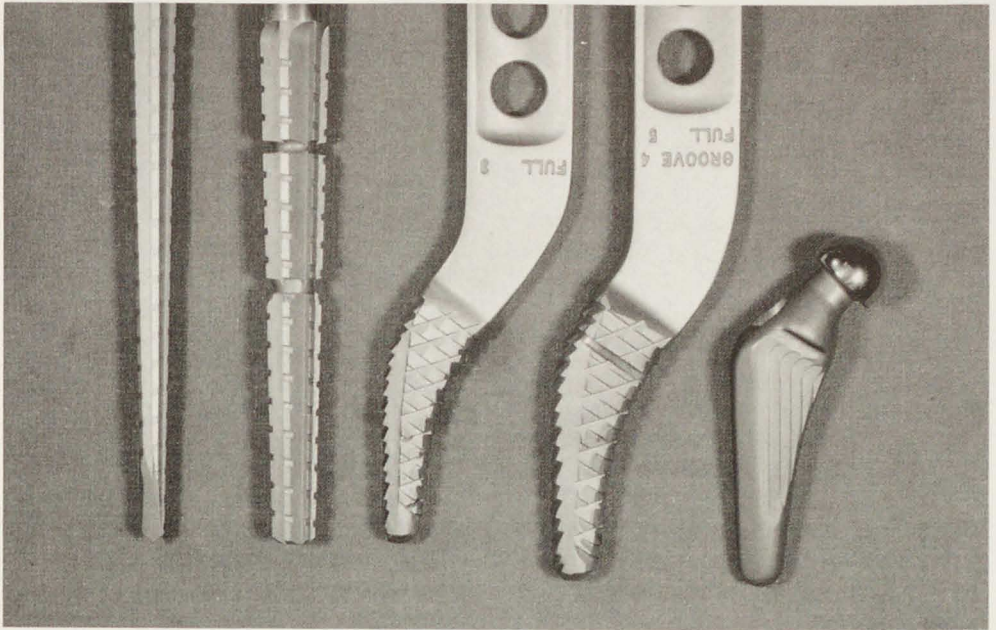
Fig. 38  
Instrumentation and trial prosthesis for canine total hip replacement.

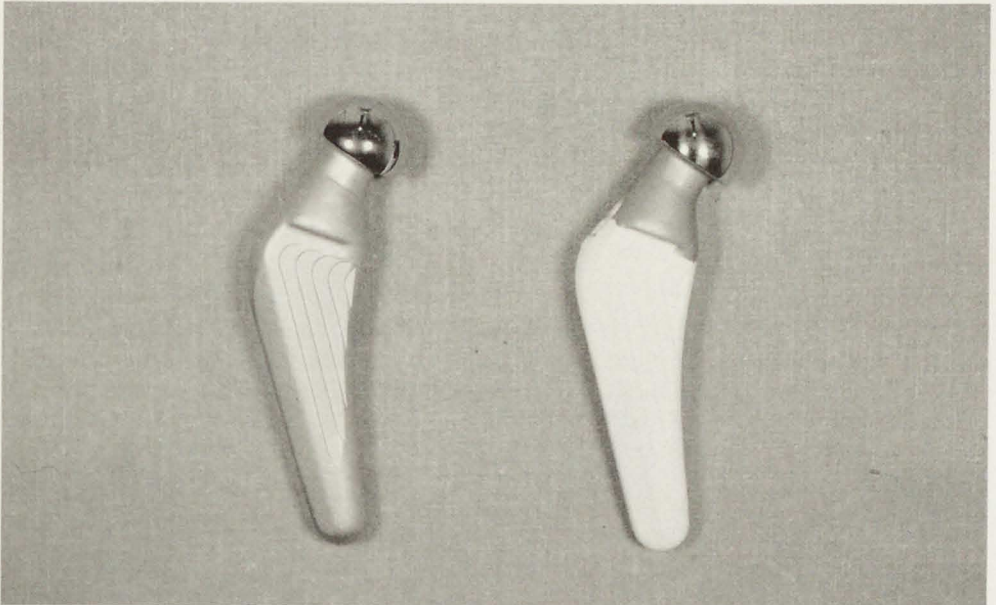
Fig. 39  
Hydroxyl-apatite coated and non-coated canine total hip implant.

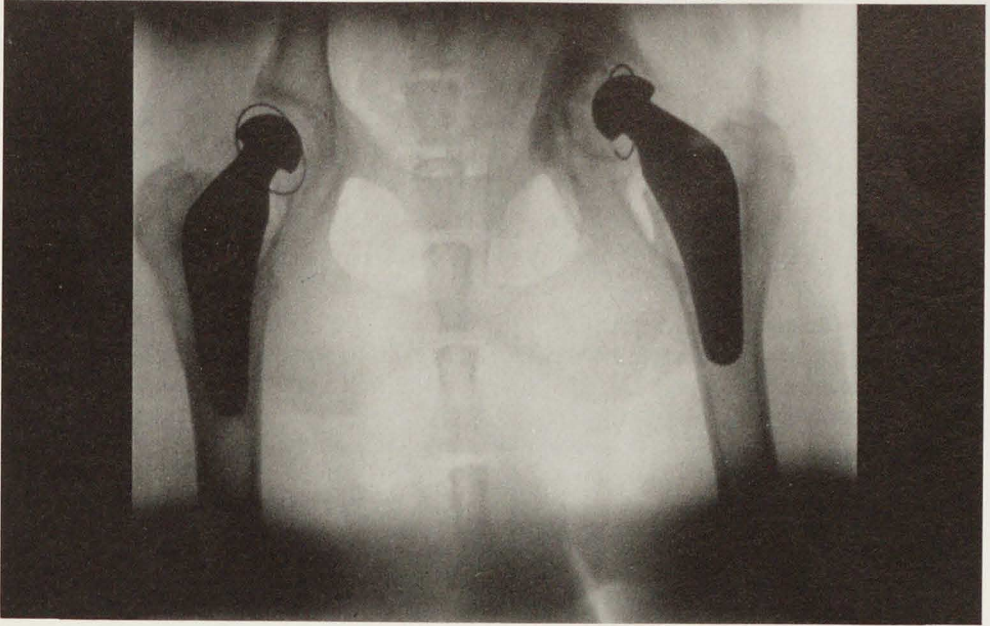
Fig. 40  
AP radiograph of bilateral canine total hip replacement (1 year).

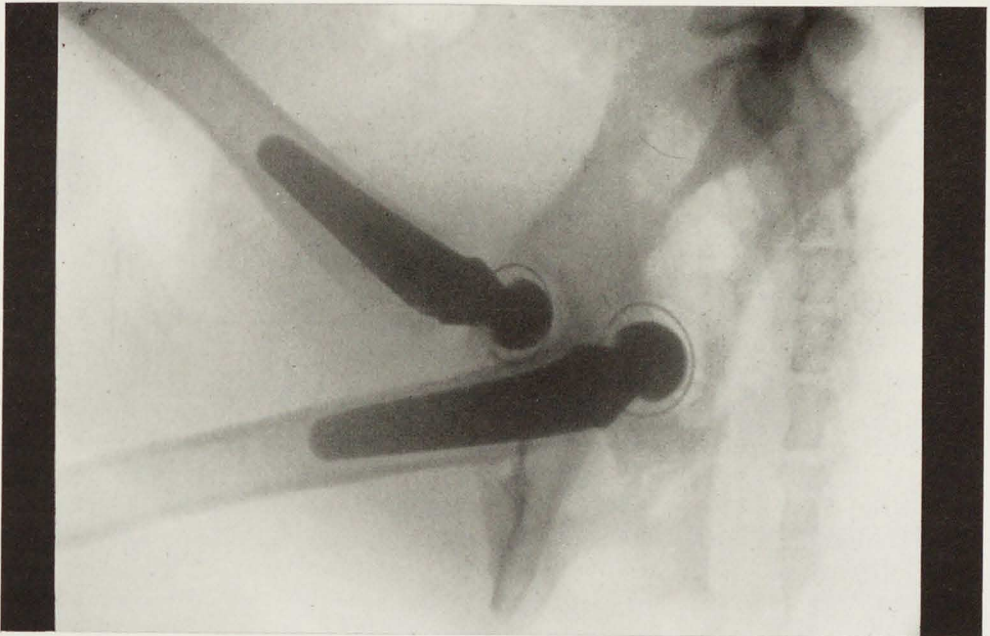
Fig. 41  
Axial radiograph of bilateral canine total hip replacement (1 year).

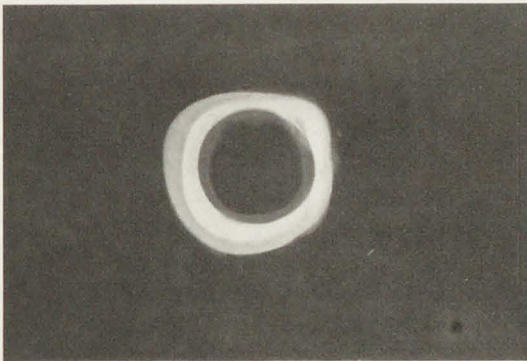
Fig. 45  
Two point bone contact only in lateral trochanteric region. Empty space around implant circumference two weeks after implantation (pilot study). Observe periosteal thickening shortly after implantation. (Micro-radiograph of proximal stem area cross-section, x1).

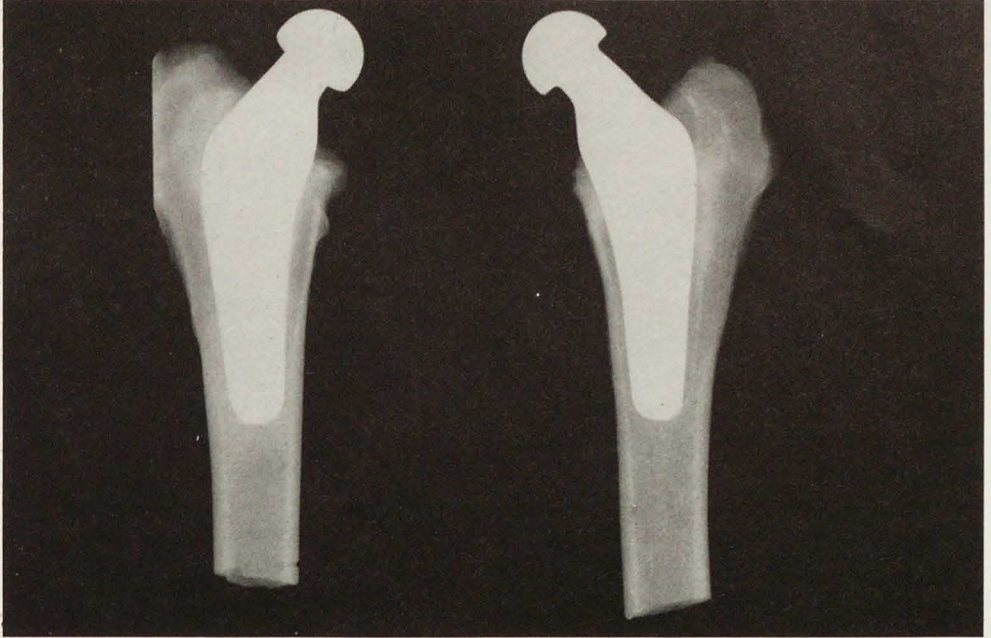
Fig. 46  
Differences in radio-lucent line formation and bone density around coated (left) and non-coated (right) canine implants at one year follow-up. (AP view explant radiograph).

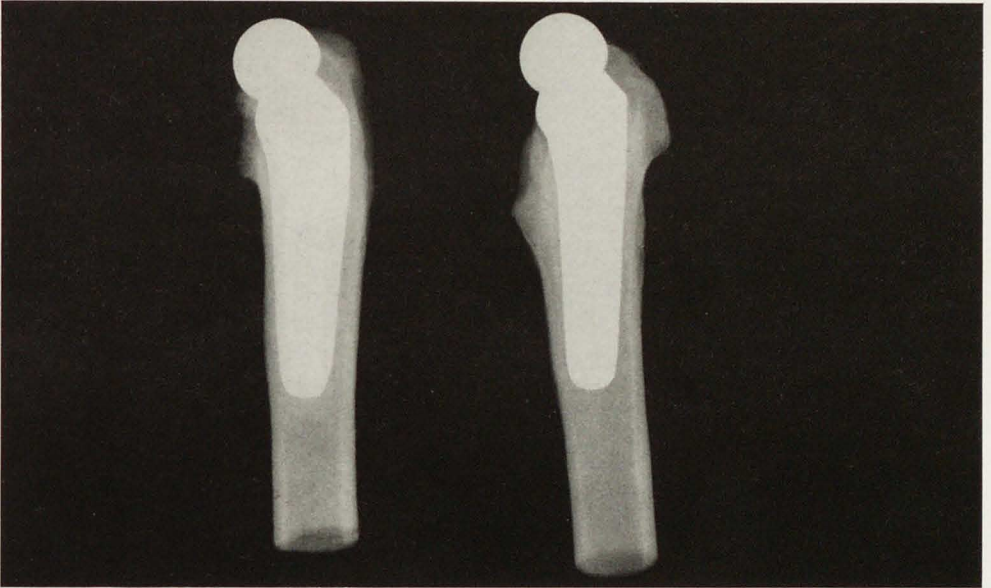
Fig. 47  
Axial explant radiograph of canine hydroxyl-apatite coated (left) and non-coated (right) total hip prosthesis at one year follow-up.

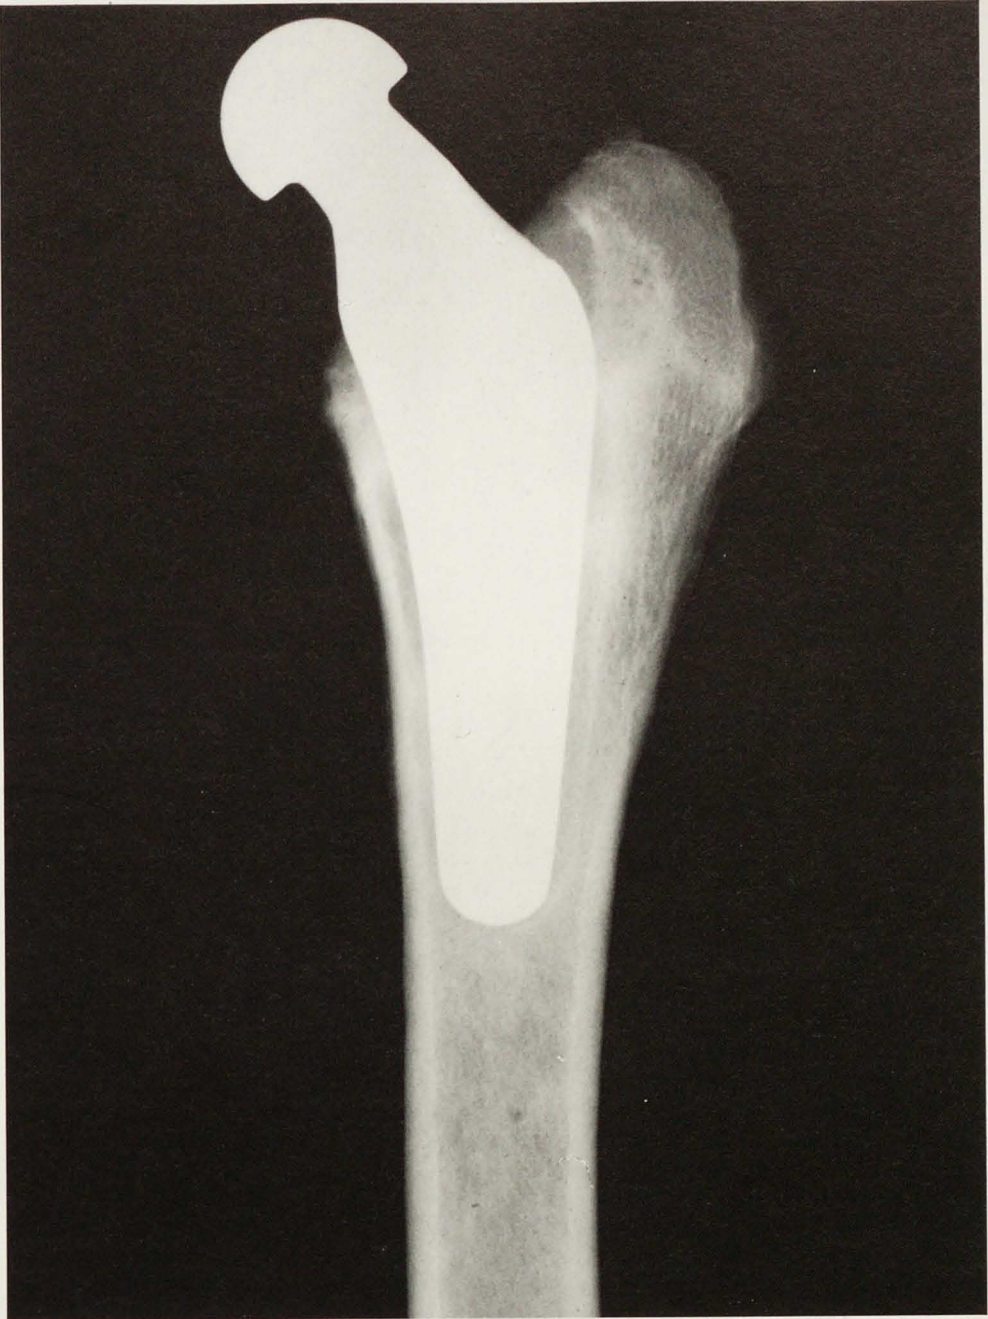
Fig. 48  
Detail of radio-lucent lines and loss of trabecular structure around non-coated canine total hip prosthesis at one year follow-up. (AP explant radiograph).

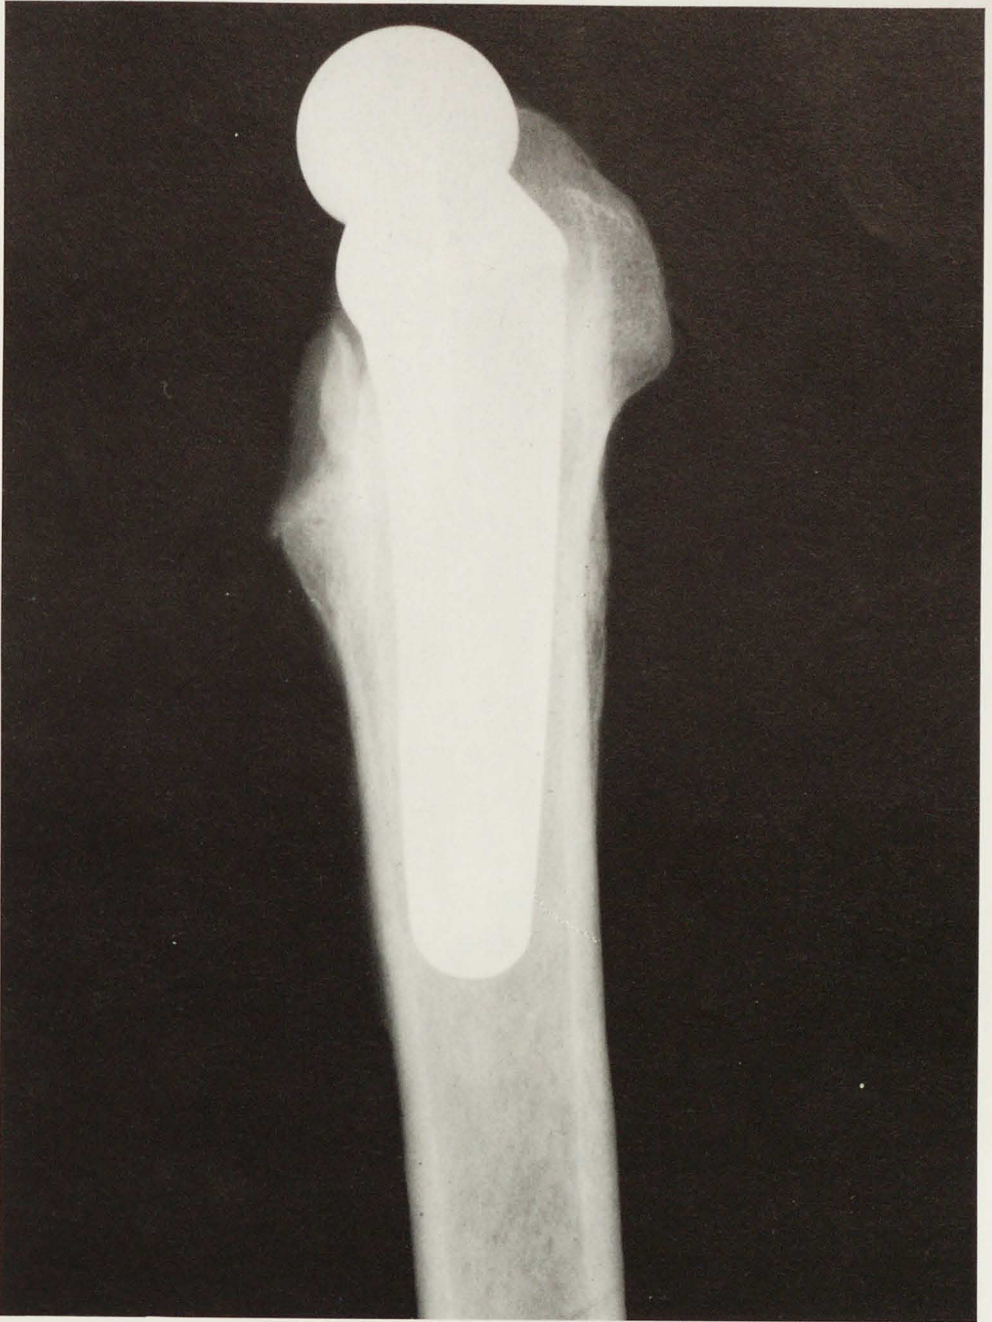
Fig. 49  
Detail of radio-lucent lines and loss of trabecular structure around non-coated canine total hip prosthesis at one year follow-up. (axial explant radiograph).

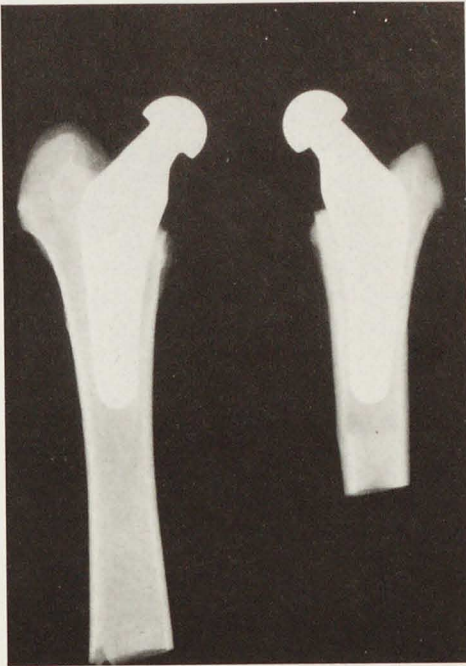
Fig. 50  
Bony defects caused by reaming during surgical implantation three weeks after canine total hip replacement (right, non-coated implant) have almost disappeared at six weeks follow-up (left, hydroxyl-apatite coated implant, AP explant radiographs).

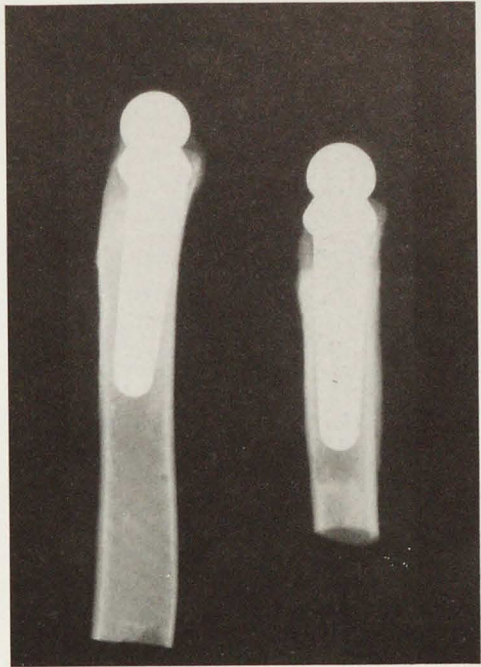
Fig. 51  
Same as previous, axial explant radiographs. Hydroxyl-apatite coated implant left at six weeks, non-coated implant right at three weeks.

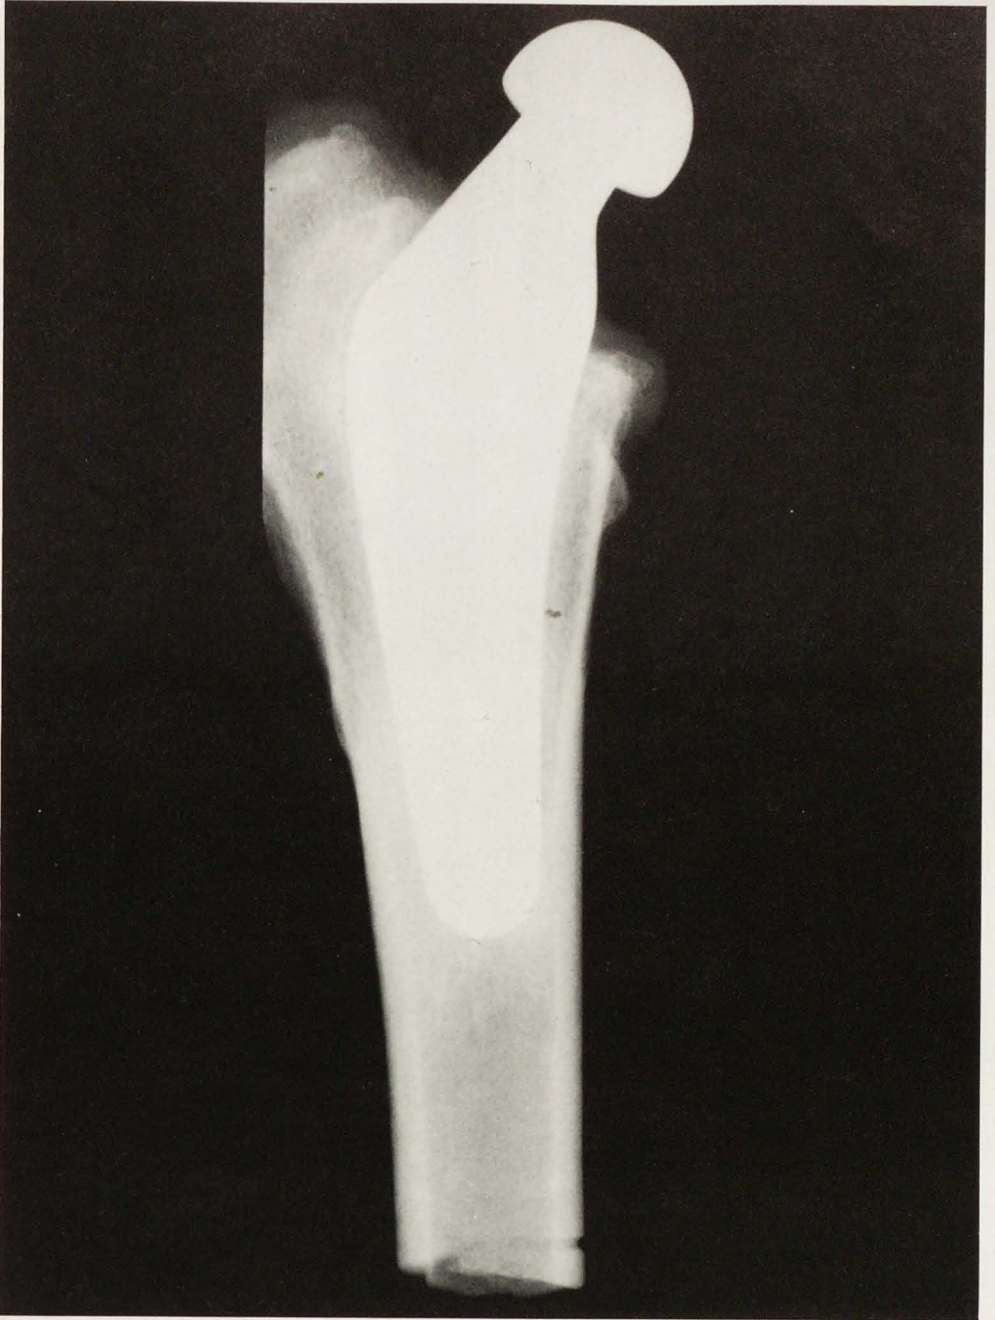
Fig. 52  
Bone densification around hydroxyl-apatite coated implants is especially evident in proximal and distal stem area at one year follow-up. Moderate loss of cortical wall thickness in proximal femur (AP explant radiograph).

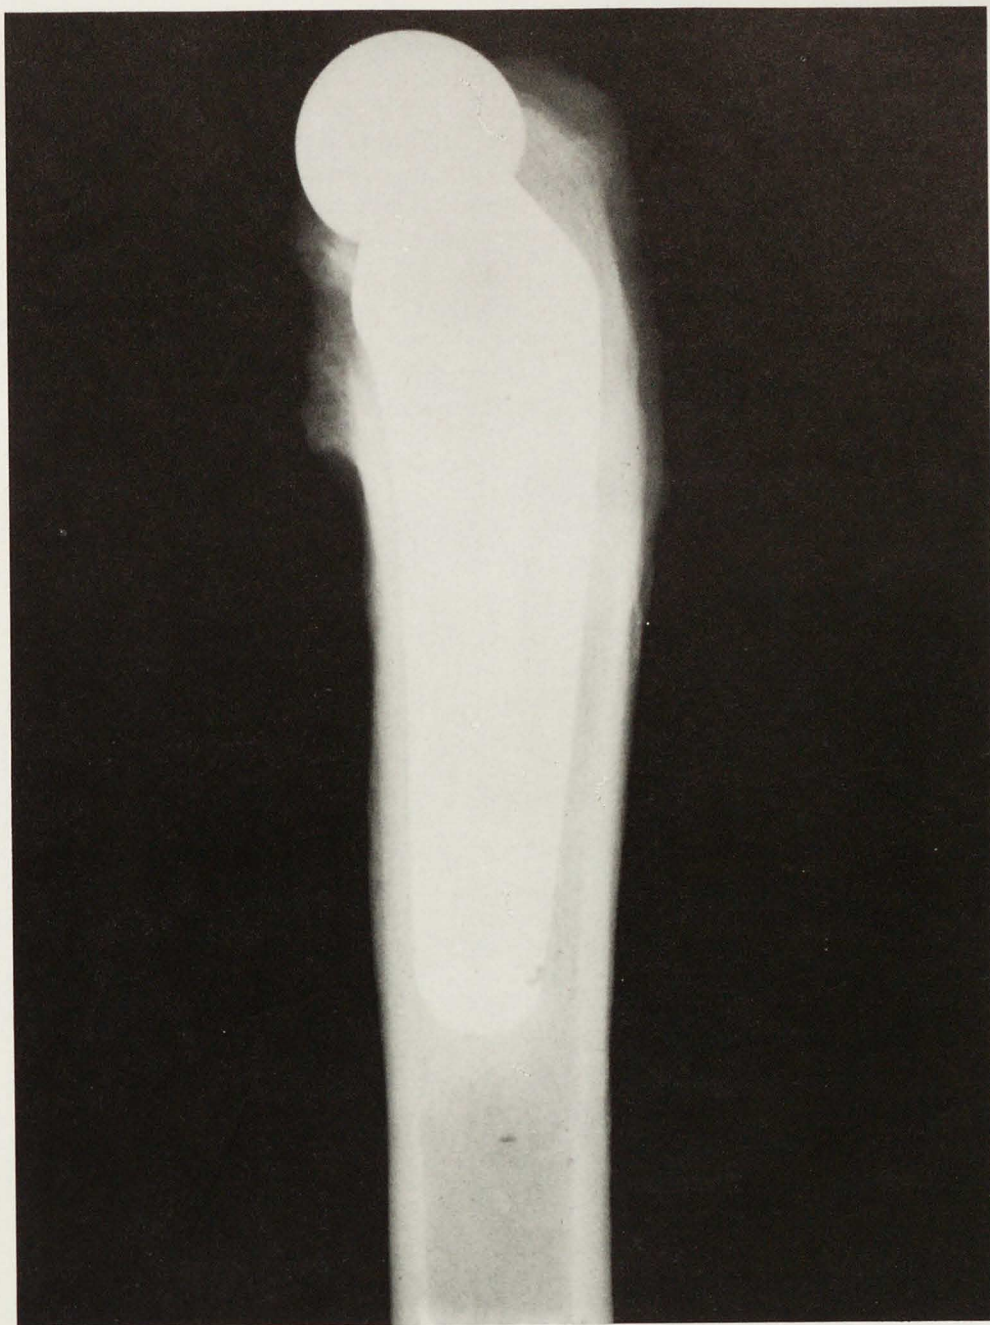
Fig. 53  
Bone densification around hydroxyl-apatite coated implants is especially evident in proximal and distal stem area at one year follow-up. (axial explant radiograph).

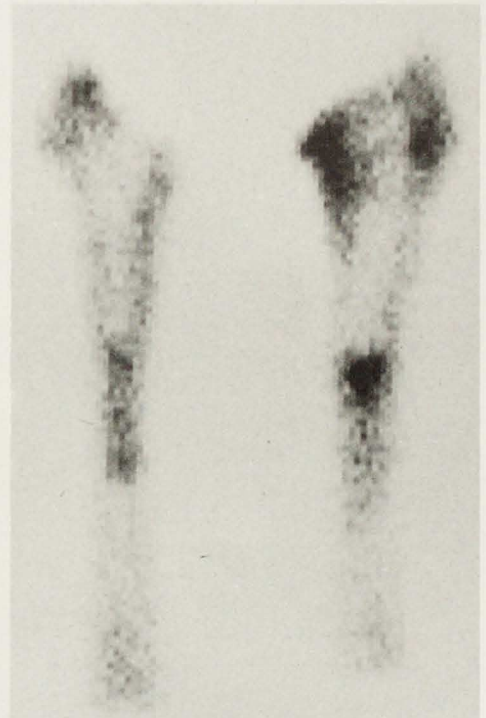
Fig. 55  
AP view of 99m-bone scintigram of hydroxyl-apatite coated prosthesis (left) and non-coated prosthesis (right) at two years follow-up. Same implants as previous radiograph. Even distribution of technetium activity over bone mass around coated implant. Three point hot spot localization over non-coated implant.

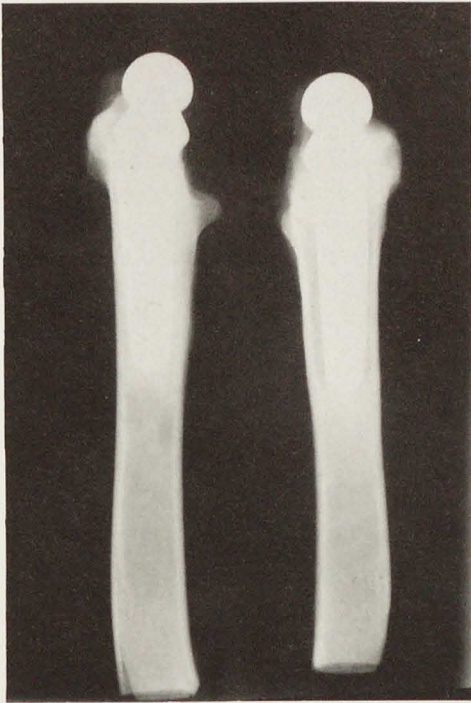
Fig. 56  
Axial explant radiograph of hydroxyl-apatite coated (left) and non-coated (right) implant, showing differences in bone density and trabecular structure, especially around the distal stem area at two years follow-up.

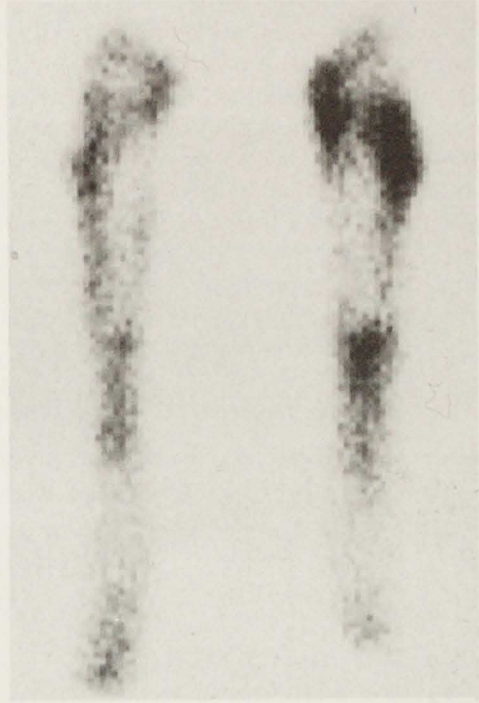
Fig. 57  
Axial view of  $^{99m}$ -bone scintigram of hydroxyl-apatite coated prosthesis (left) and non-coated prosthesis (right) at two years follow-up. Same implants as previous radiograph. Even distribution of technetium activity over bone mass around coated implant. Three point hot spot localization over non-coated implant.

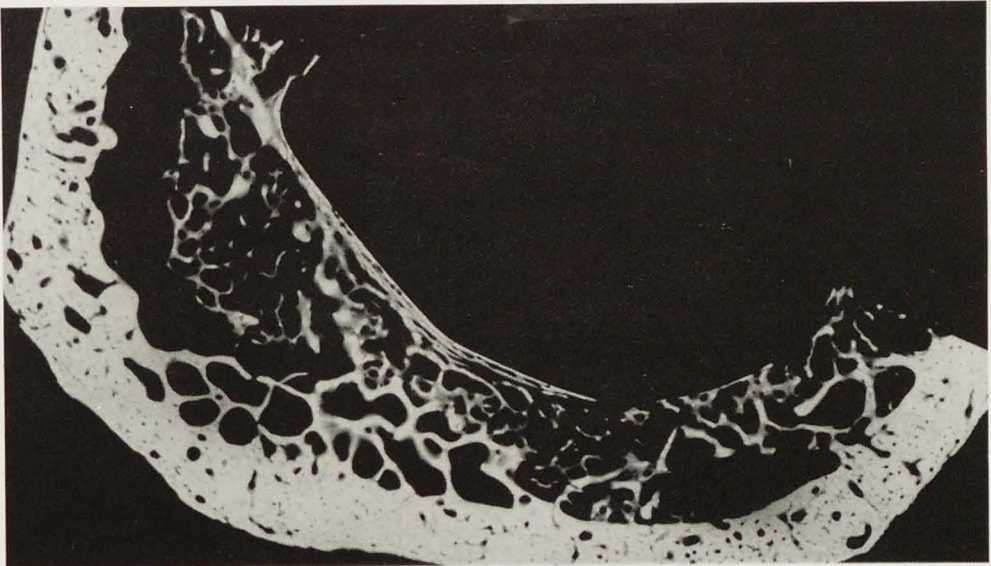
Fig. 59  
Thin layer of bone and connecting trabeculae on hydroxyl-apatite coated implant surface at three weeks follow-up. (Micro-radiograph of proximal stem area cross-section, x1).

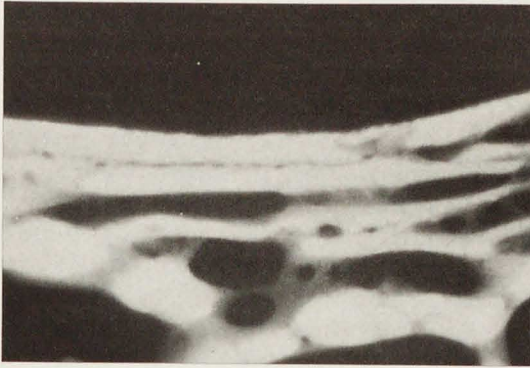
Fig. 60  
Same as previous, magnification x50.

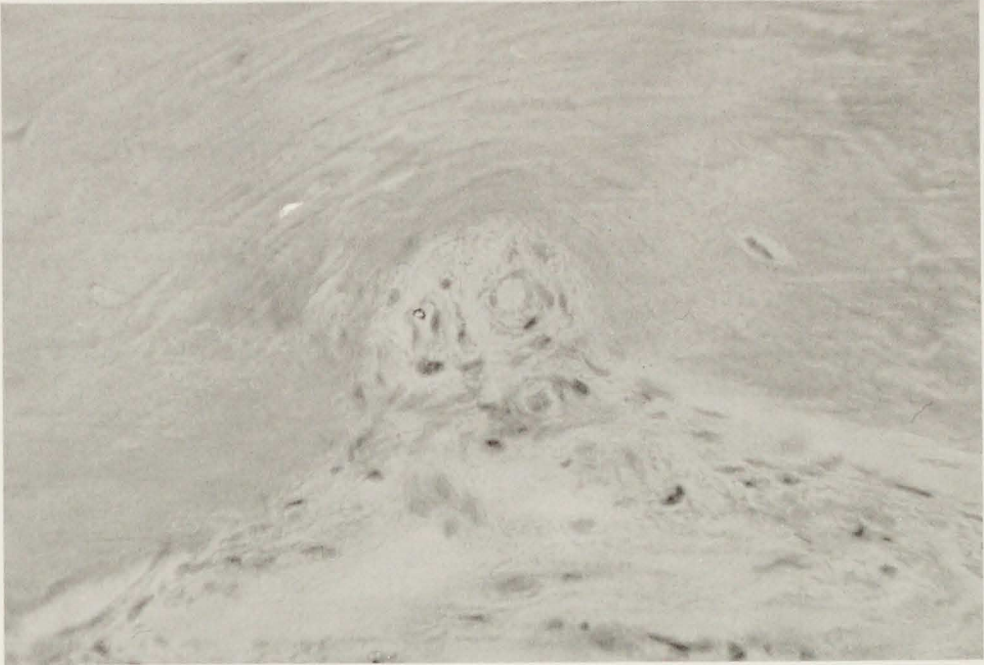
Fig. 61  
Bone-implant interface of cemented canine acetabular cup. Fibrous tissue layer with multi-nuclear giant-cells. (HE, six months, x200).

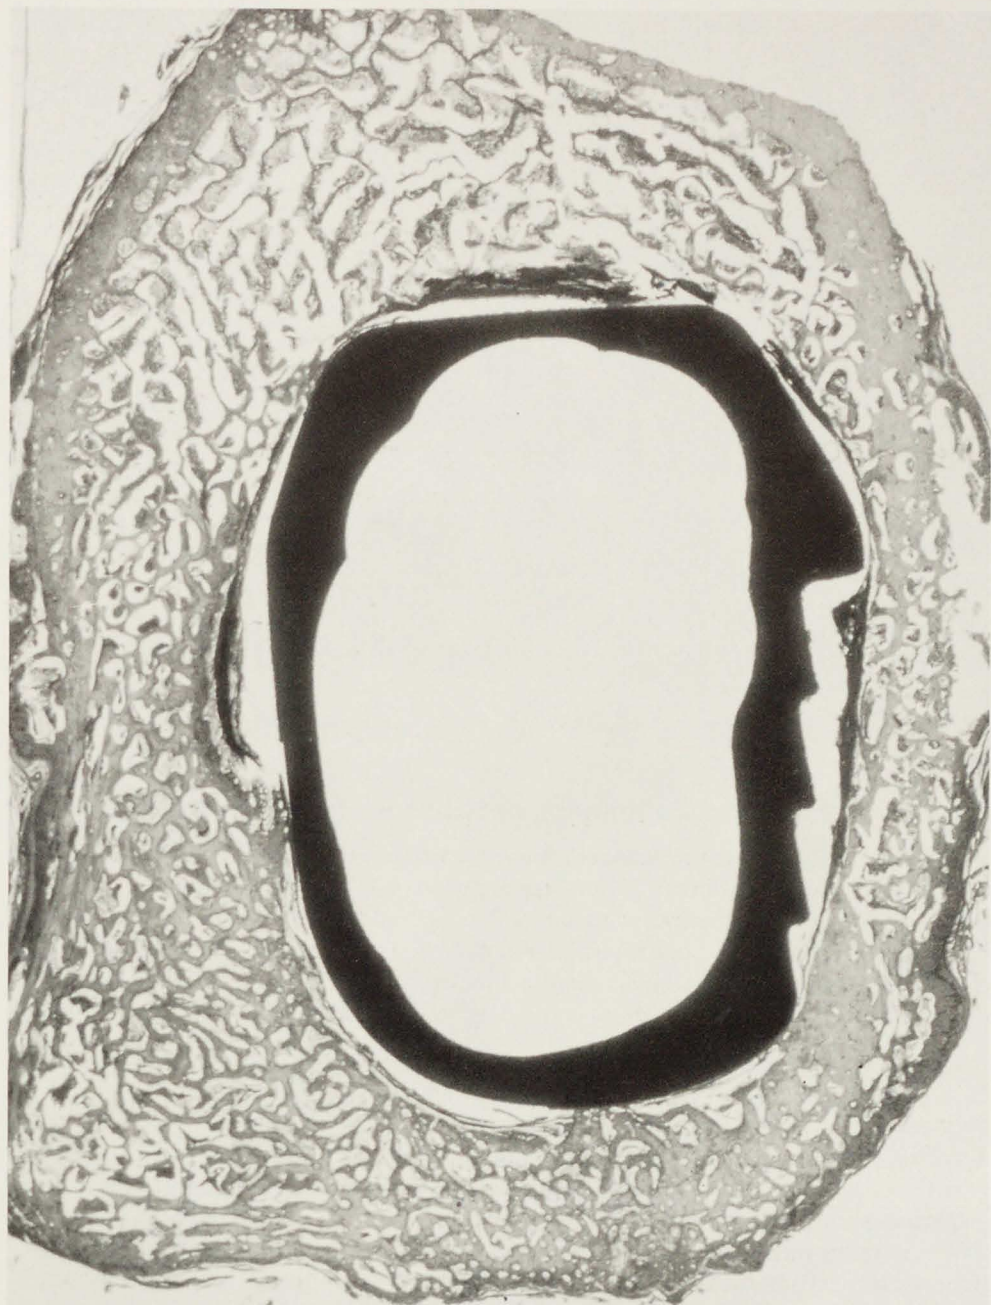
Fig. 62  
Loose area and fibrous tissue around non-coated canine femoral component in proximal stem area. Observe stress-shielding effects: loss of cortical wall and spongialization of cortical bone with transition to almost trabecular bone at medial side of proximal femur. (Masson trichrome, one year, x1).

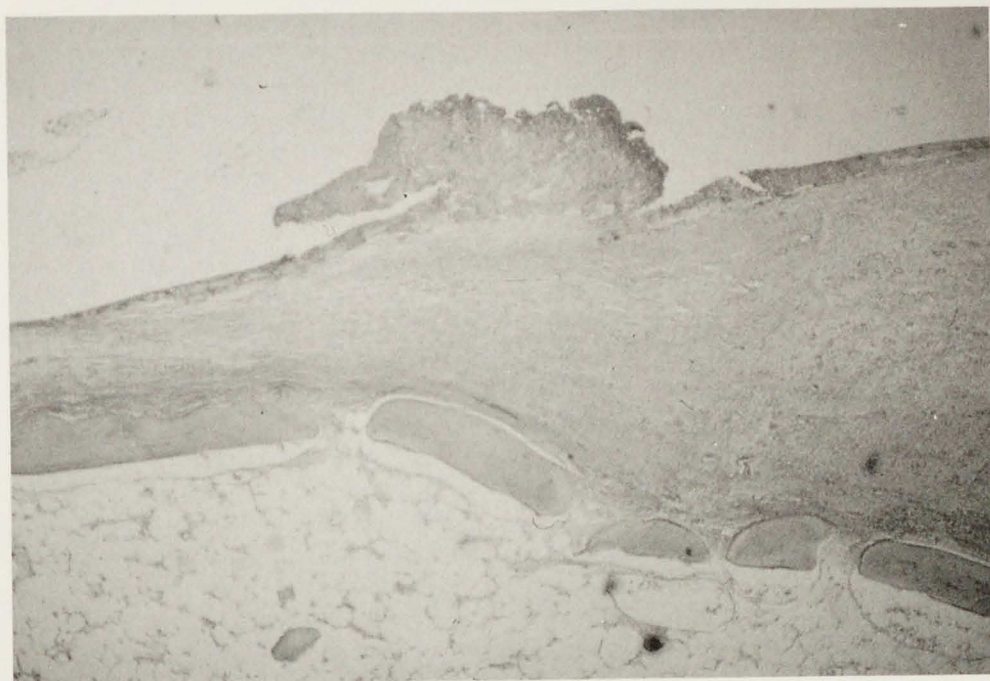
Fig. 63  
Parallel orientation of bone trabeculae to implant surface and fibrous-tissue interface around proximal femoral stem of non-coated implant (Alcian-blue, six months, x5).

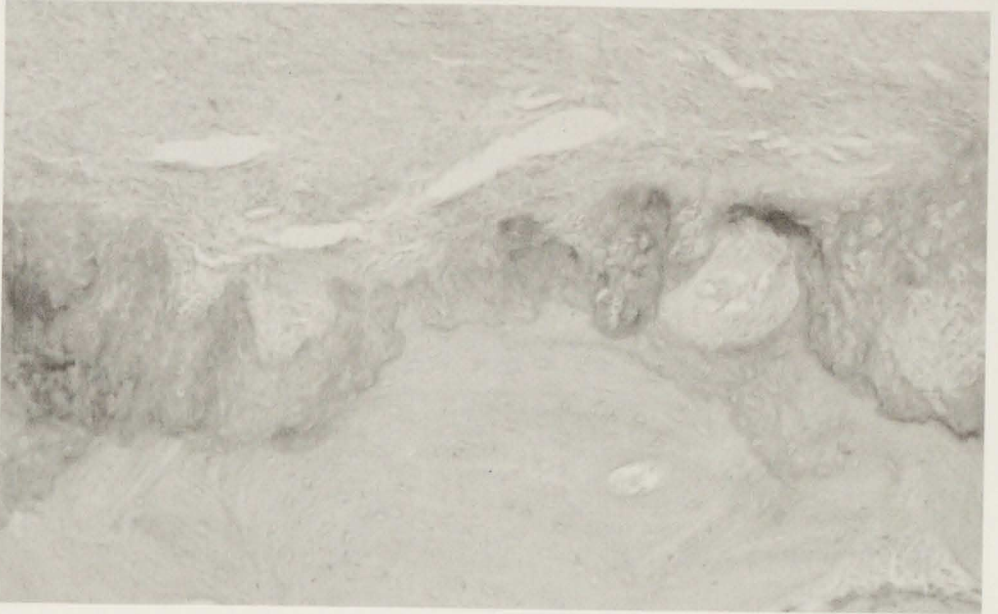
Fig. 64  
Reactive proliferation of bone with osteoid layer below fibrous-tissue layer of non-coated canine total hip prosthesis. (Alcian-blue, six months, x50).

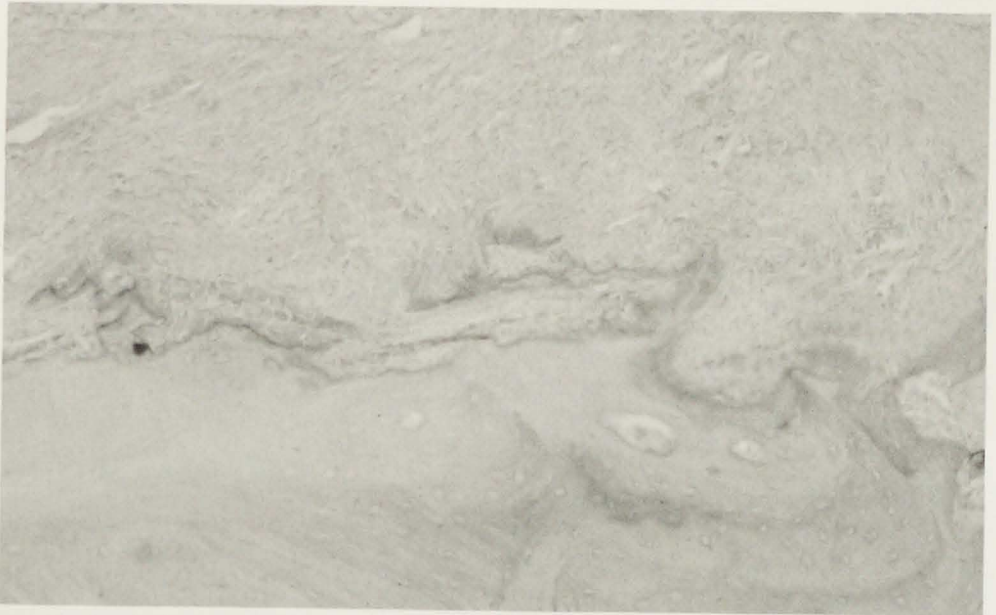
Fig. 65  
Reactive proliferation of bone with thin osteoid layer below fibrous-tissue layer of non-coated canine total hip prosthesis. (Alcian-blue, two years x50).

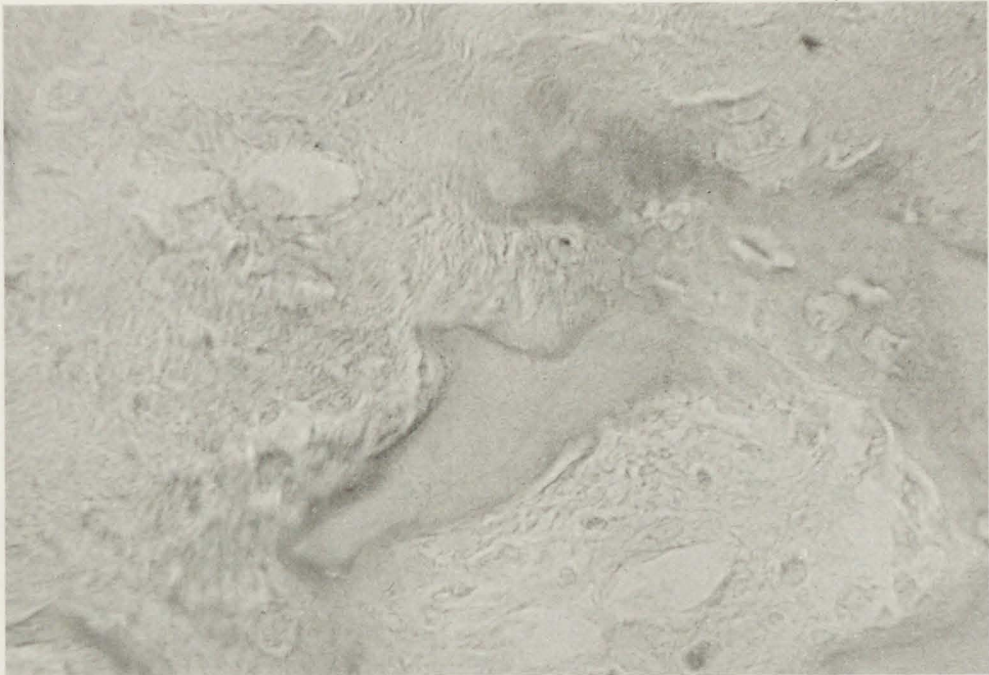
Fig. 66  
Remnants of resorbing bone trabeculae within fibrous-tissue membrane of non-coated canine total hip implant.  
(Alcian-blue, six weeks, x100).
