# Hydroxyl-apatite coated hip implants

Geesink, R. G. T. (1988). Hydroxyl-apatite coated hip implants. Maastricht: Rijksuniversiteit Limburg.

Proefschrift

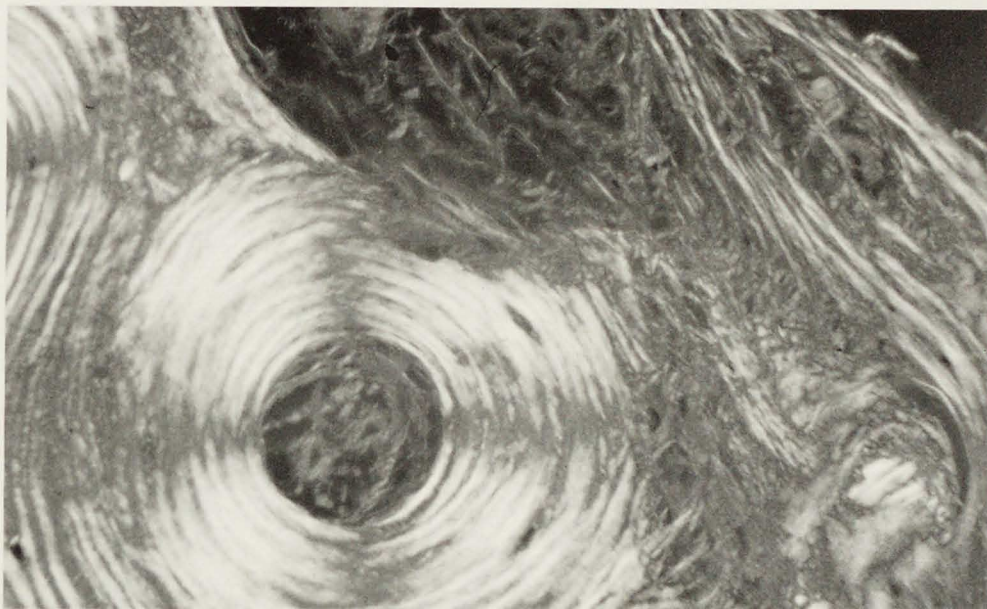
Fig. 68  
Same as previous, haversian system near non-coated femoral stem in process of resorption, showing remnants of calcified material in fibrous tissue near implant-bone interface in right upper corner. (HE with polarization, six weeks, x200).

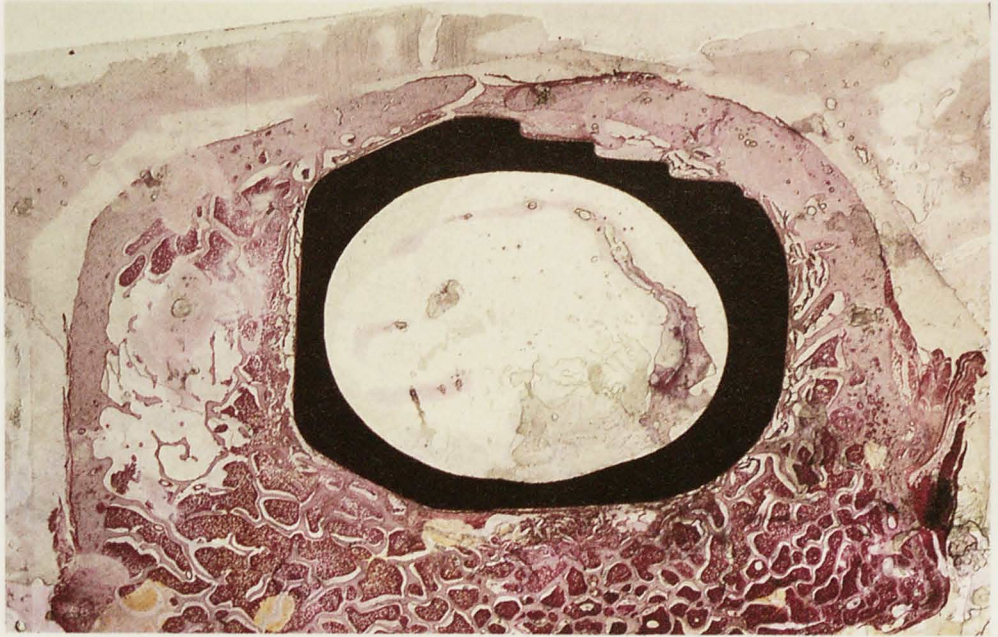
Fig. 69  
Full bony envelope around hydroxyl-apatite coated femoral stem in proximal femur. (basic fuchsin, six weeks, x1).

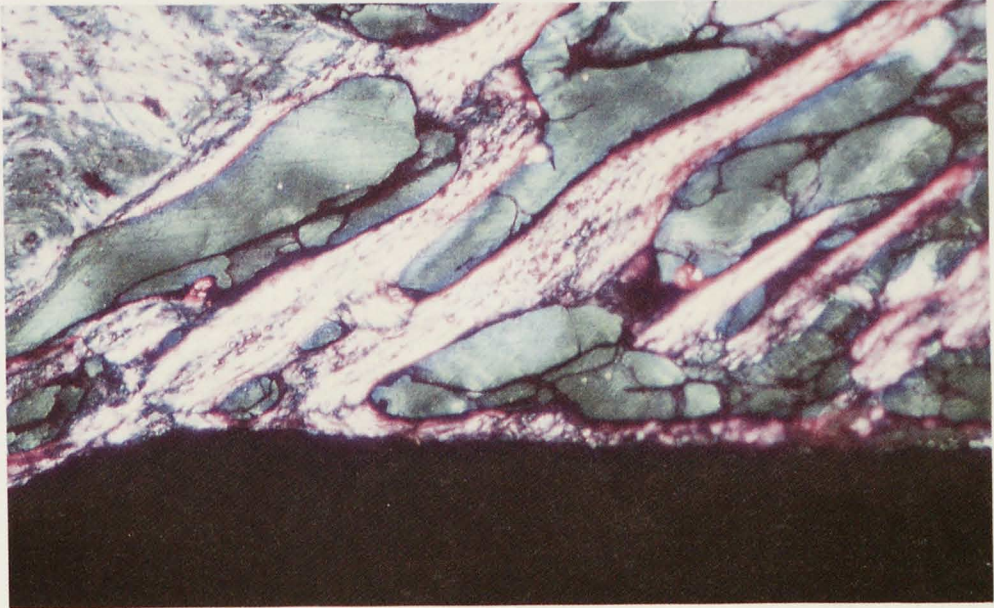
Fig. 70  
Characteristic interface of hydroxyl-apatite coated femoral stem. Thin bone plate on implant surface with connecting trabeculae. Older pre-existent bone in upper left corner (Alcian-blue, three weeks, x100).

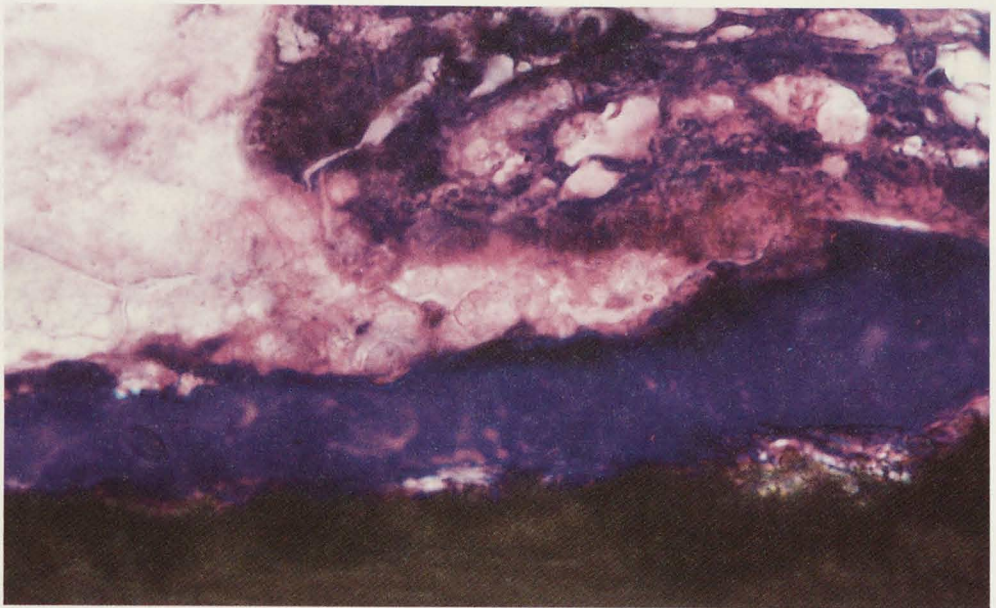
Fig. 73  
Osteoid material deposition on hydroxyl-apatite coating (blue) by group of osteoblasts. (Alcian-blue, three months, x500).

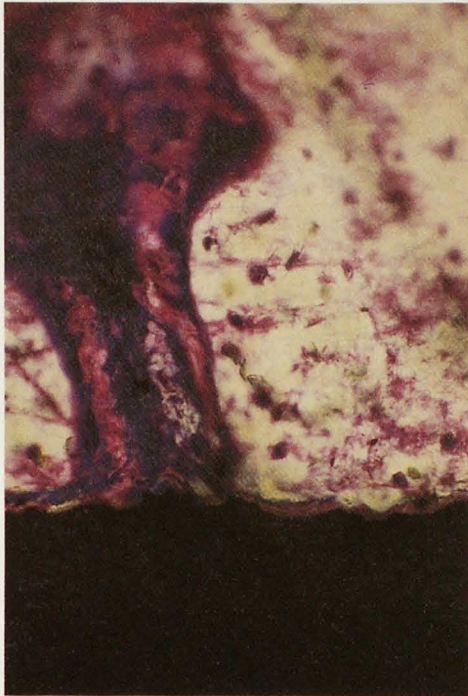
Fig. 74  
Haversian system with ending on the hydroxyl-apatite coating (Alcian-blue, three months, x100).

(1000x) confirm the close bonding between hydroxyl-apatite coating and bone without any interposition of fibrous tissue. The transition area of bone to coating shows apposition of osteoid material on the hydroxyl-apatite coating in the early follow-up period, (Fig. 71) followed later by maturation to bone and increased mineralization at the longest follow-ups of one and two years (Fig. 72). These areas correspond to those of increased calcium content as seen in micro-radiographs. Close approximation of hydroxyl-apatite coatings is not only seen with mature osteocytes, but also with young osteoblasts (Fig. 73). Many haversian systems show direct endings on and bonding with the hydroxyl-apatite coating (Fig. 74).

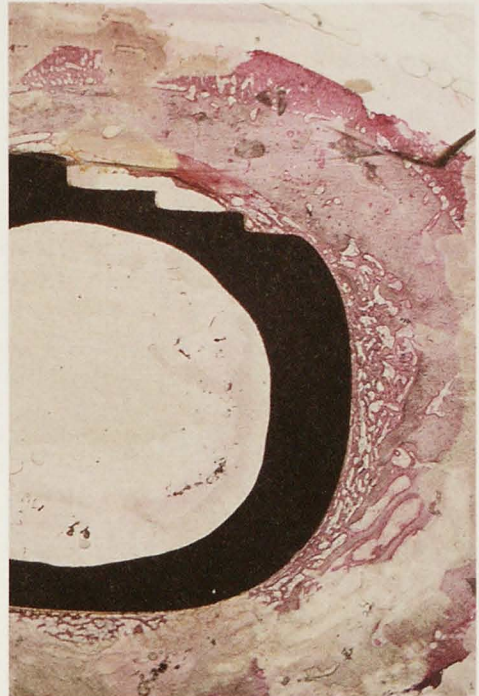
Fig. 75  
Partial filling of bony defects around mid-stem of hydroxyl-apatite coated femoral component (basic fuchsin, three weeks, x2).

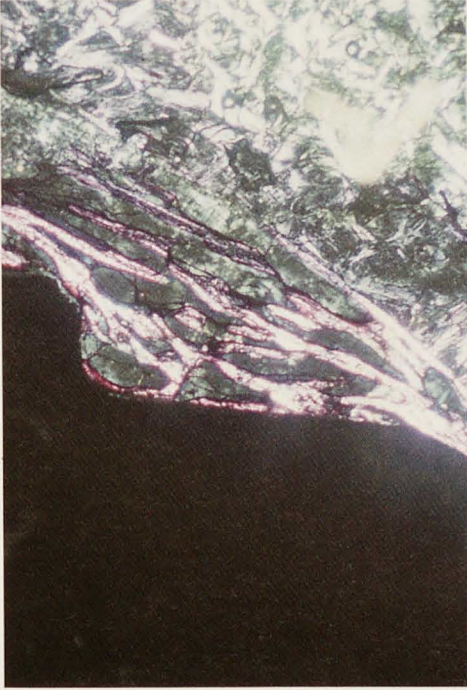
Fig. 76  
Newly formed bone trabeculae stand out against the older bone in proximal femur around hydroxyl-apatite coated stem. (fluorescence with polarization, three weeks, x1).

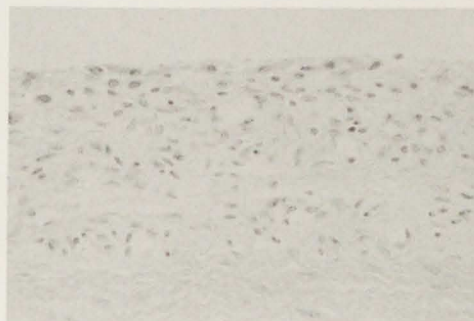
Fig. 84  
Fibroblastic response of prosthetic neo-capsule. Multicellular layer of fibroblasts in neo-capsule of hydroxyl-apatite coated canine total hip replacement. (HE, three weeks, x500).

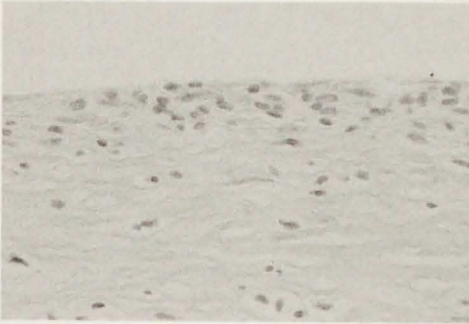
Fig. 85  
Thin layer of fibroblasts in neo-capsule of hydroxyl-apatite coated canine total hip replacement. (HE, one year, x500).

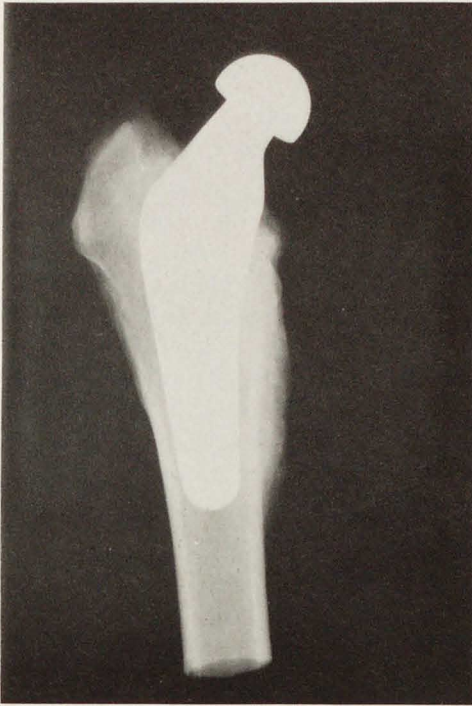
Fig. 86  
Periosteal apposition of new bone in response to infection at hydroxyl-apatite coated implant-bone interface at six months. (AP explant radiograph).

Explant radiography of the femur showed signs of periosteal new bone formation, mainly in the proximal part of the femur (Fig. 86 and 87). There were small cysts visible in the bone, but no gross radiolucencies or scalloping around the implant. There were no radiolucent lines visible, nor radiodense lines peripheral to the implant. Bone quality was good when compared to the contra-lateral side.

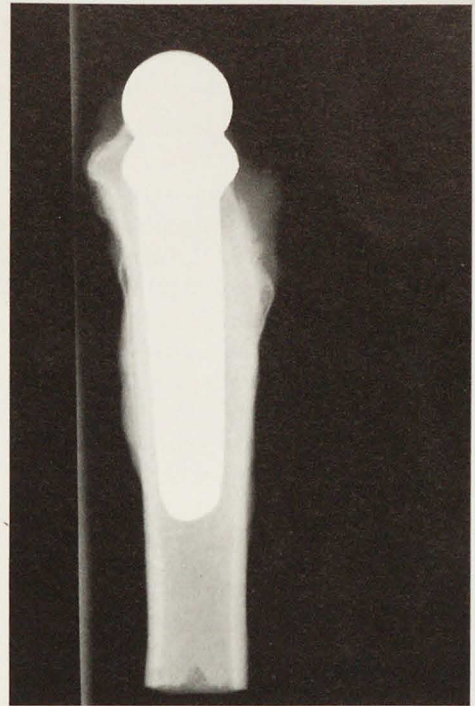
Fig. 87  
Same as previous (axial explant radiograph).

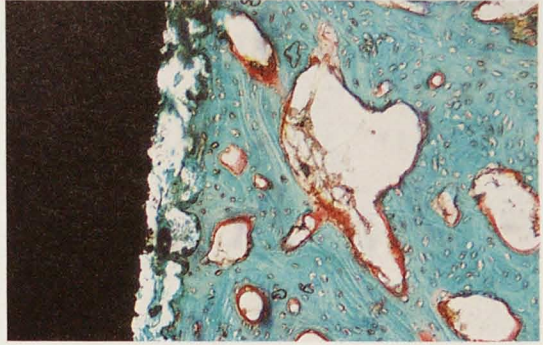
Fig. 88  
Bone resorption, micro-scalloping and fragmentation of coating at implant-bone interface of infected hydroxyl-apatite coated femoral stem (Masson trichrome, six months, x50).

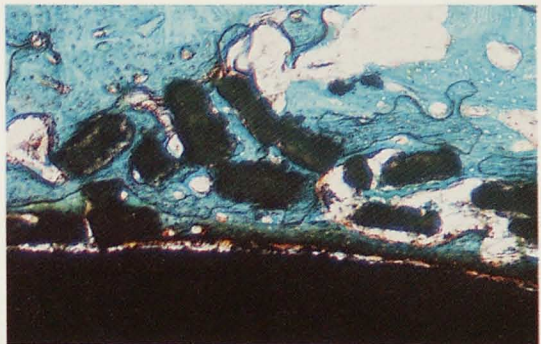
Fig. 90  
Severe fragmentation of infected hydroxyl-apatite coating at interface of coated femoral stem (Masson-trichrome, six months, x200).

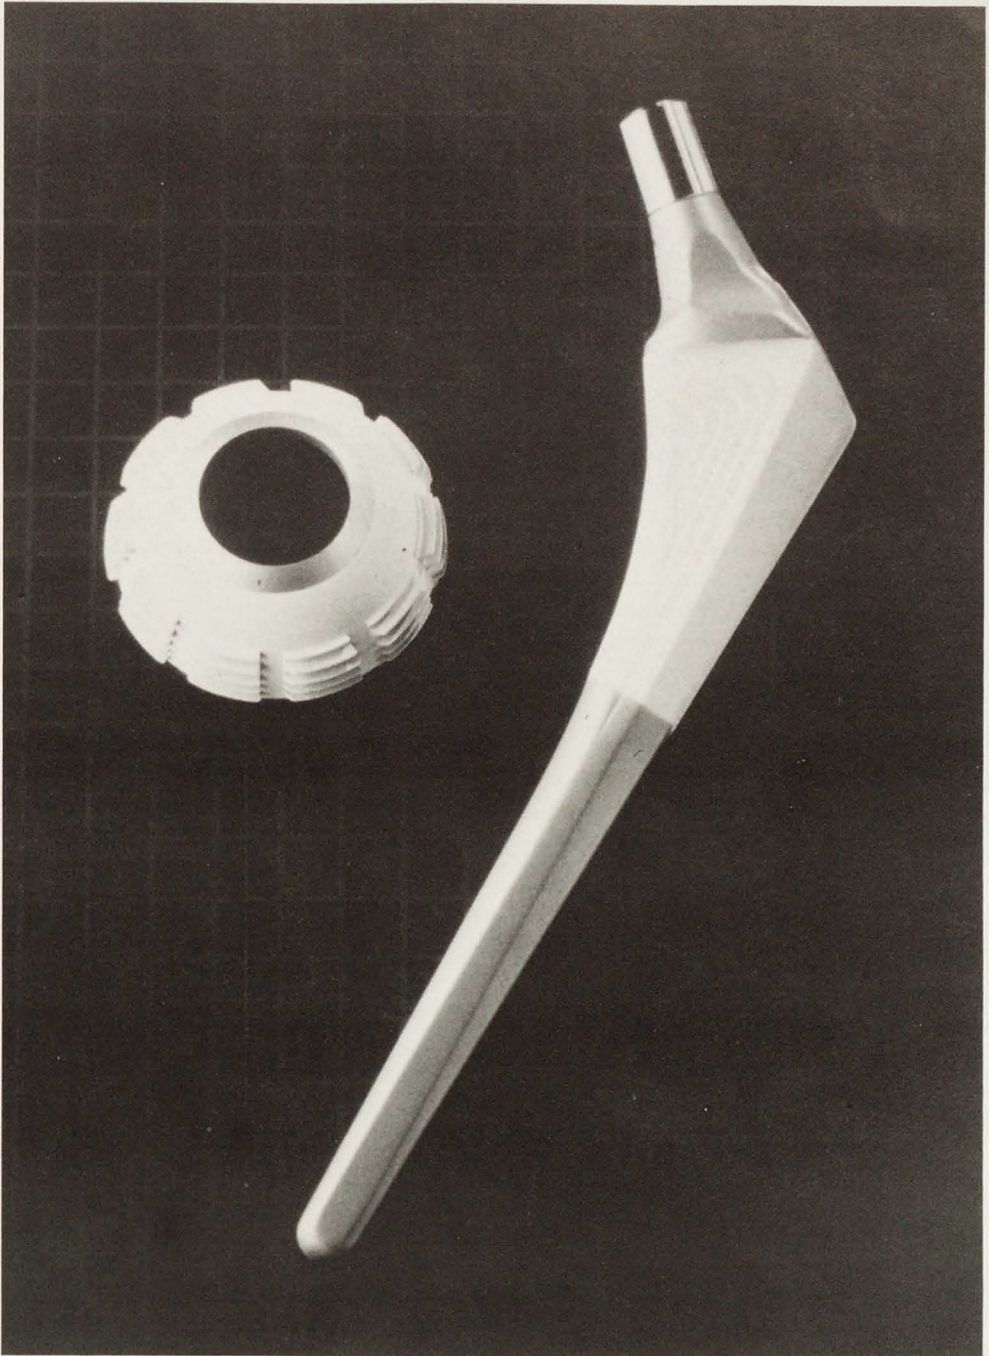
Fig. 91  
Omnifit® hydroxyl-apatite coated total hip prosthesis.

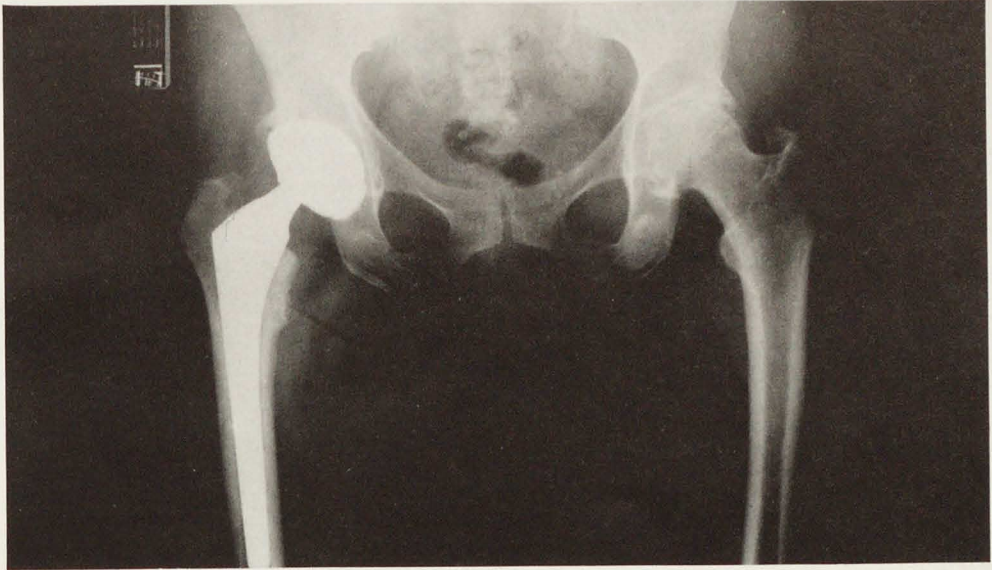
Fig. 92  
Human hydroxyl-apatite coated total hip replacement at six weeks (AP radiograph).

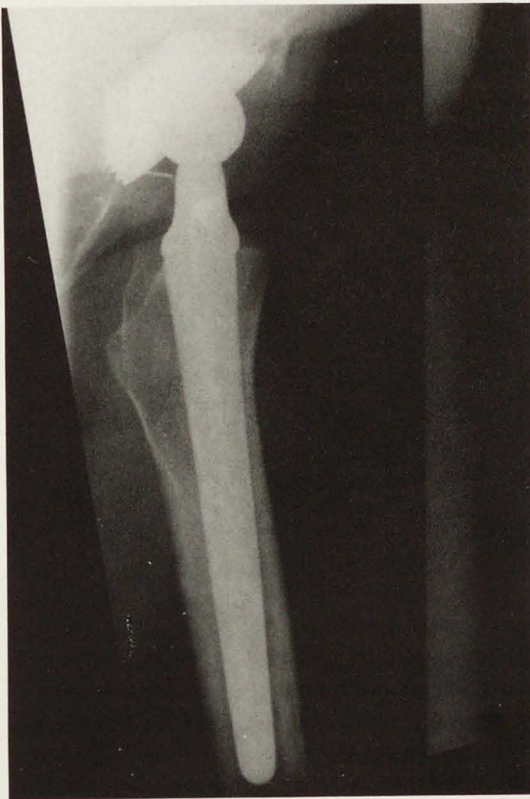
Fig. 93  
Hydroxyl-apatite coated total hip replacement at six weeks (axial radiograph).

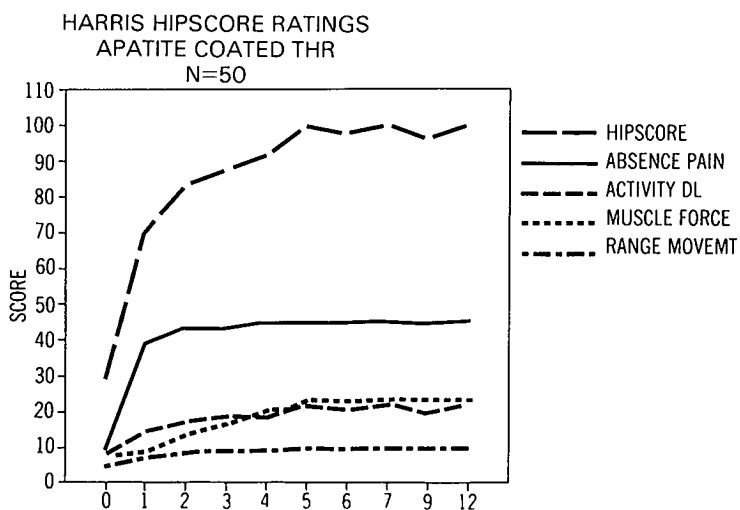
Fig. 94  
 Graphical representation of Harris hip score ratings, together with separate pain, ADL, muscular force and ROM ratings of hydroxyl-apatite coated total hip replacements.

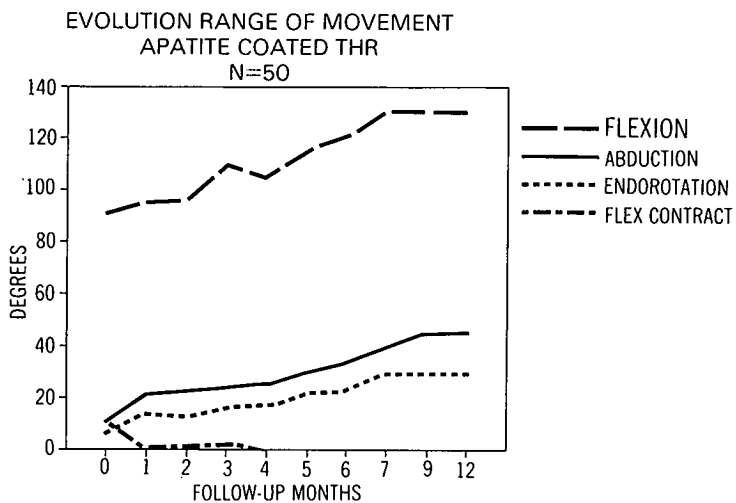
Fig. 95  
 Graphical representation of restoration of hip range of movements after hydroxyl-apatite coated total hip replacement.

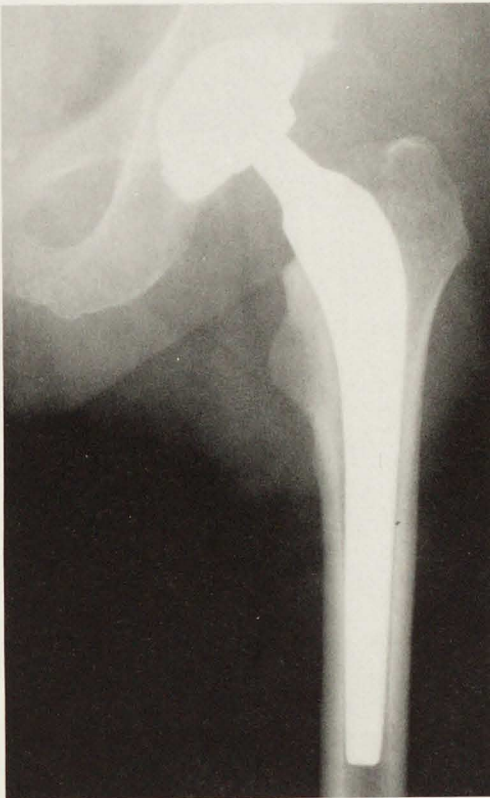
Fig. 96  
Densification of bone around hydroxyl-apatite coated part of prosthesis in proximal femur at six months.

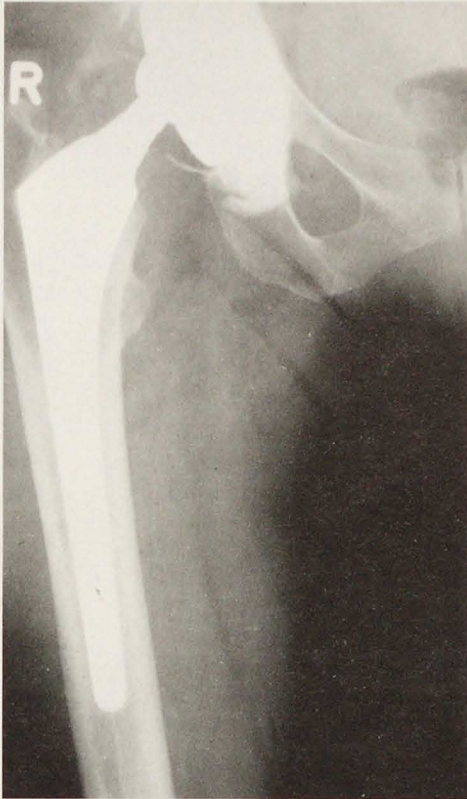
Fig. 98  
 Densification of bone around hydroxyl-apatite coated part of prosthesis in proximal femur, especially near transition to non-coated part of implant in mid-stem. Line formation around distal non-coated part of component at one year. Revision of double cup prosthesis with use of cemented acetabular component.

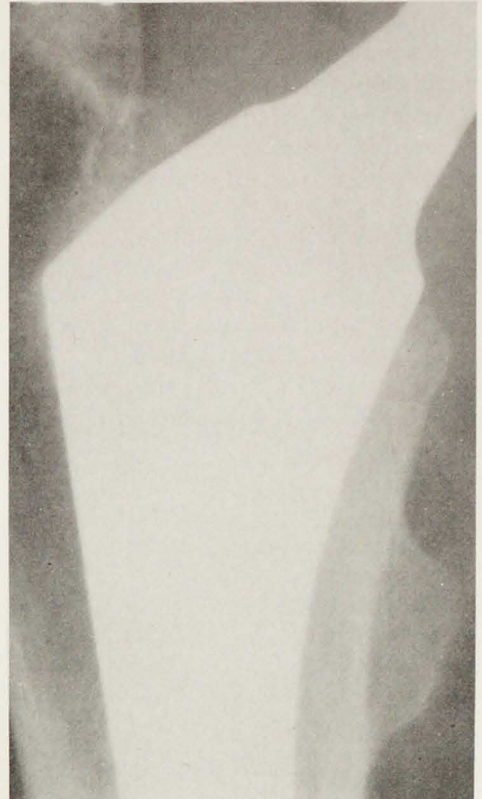
Fig. 99  
 Same as previous, detail of proximal femoral stem. Absence of radio-lucent line formation and densification of bone around hydroxyl-apatite coated part of prosthesis in proximal femur.

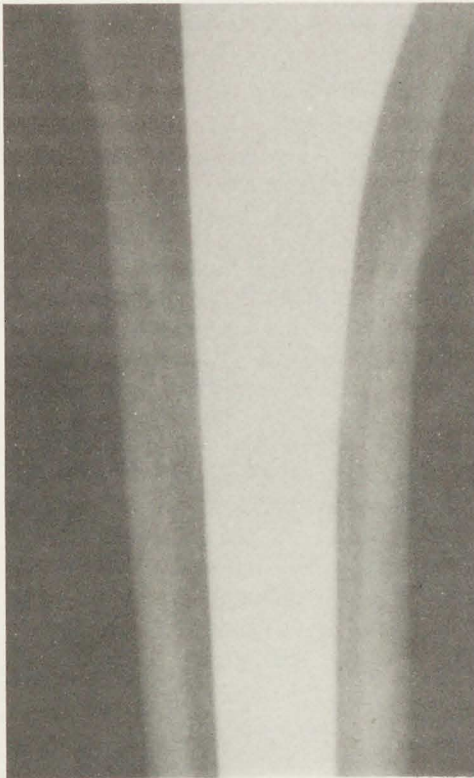
Fig. 100  
Same as previous, detail of mid-stem. Densification of bone around hydroxyl-apatite coated part of prosthesis in proximal femur, especially near transition to non-coated part of implant in mid-stem.

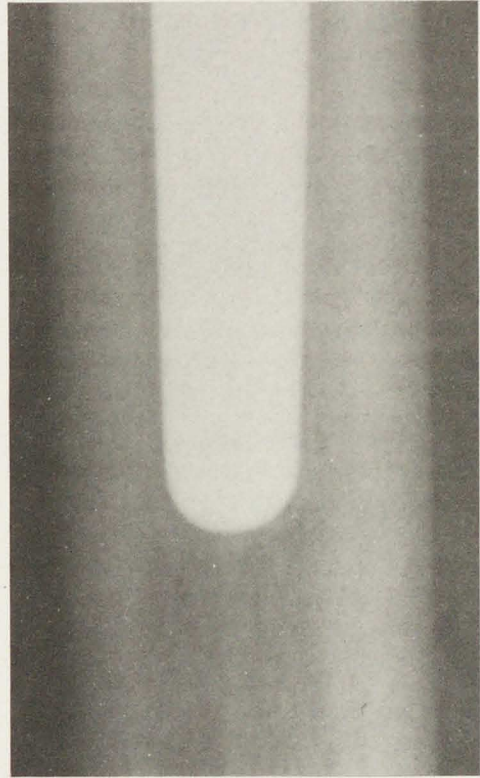
Fig. 101  
Same as previous, detail of distal femoral stem. Thin line formation around non-coated stem tip of prosthesis.

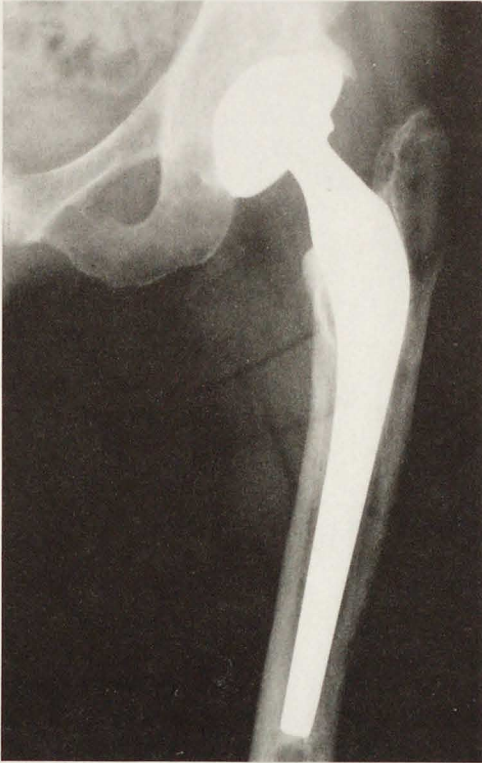
Fig. 102  
Hydroxyl-apatite coated total hip replacement at one year follow-up. Difference in bone density around proximal and distal femoral stem.

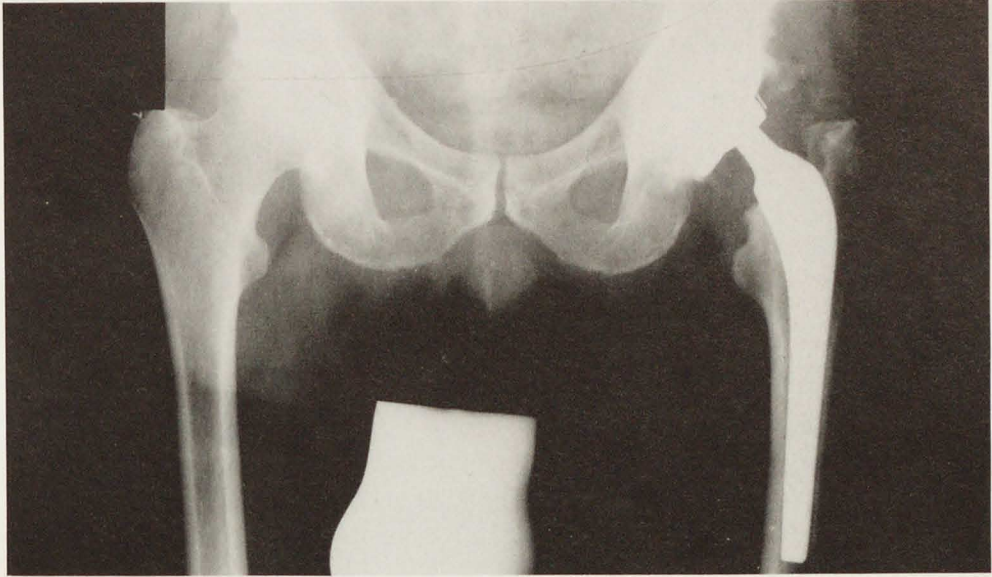
Fig. 103  
Hydroxyl-apatite coated total hip replacement, early post-operative radiograph.

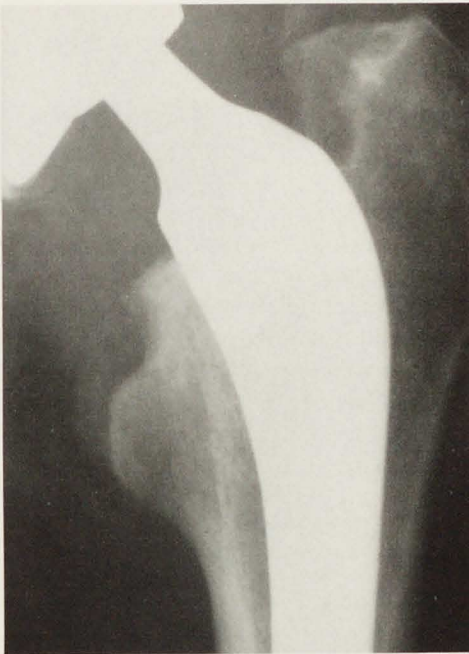
Fig. 104  
Same case as previous, detail of femoral stem three months after surgery.

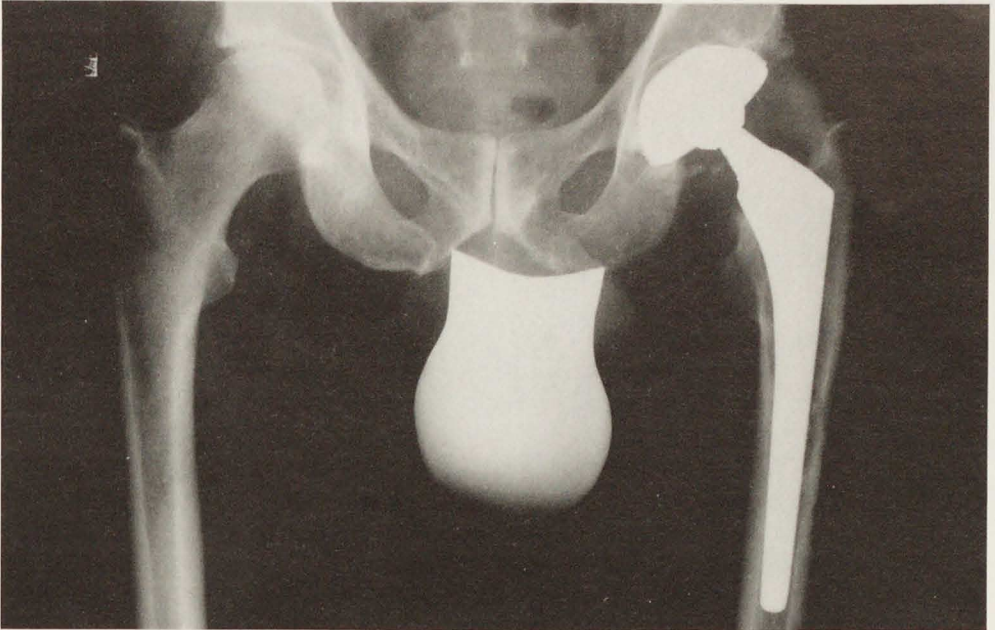
Fig. 106  
Revisional case. Replacement of loose cemented total hip replacement by hydroxyl-apatite coated implant, early post-operative radiograph.

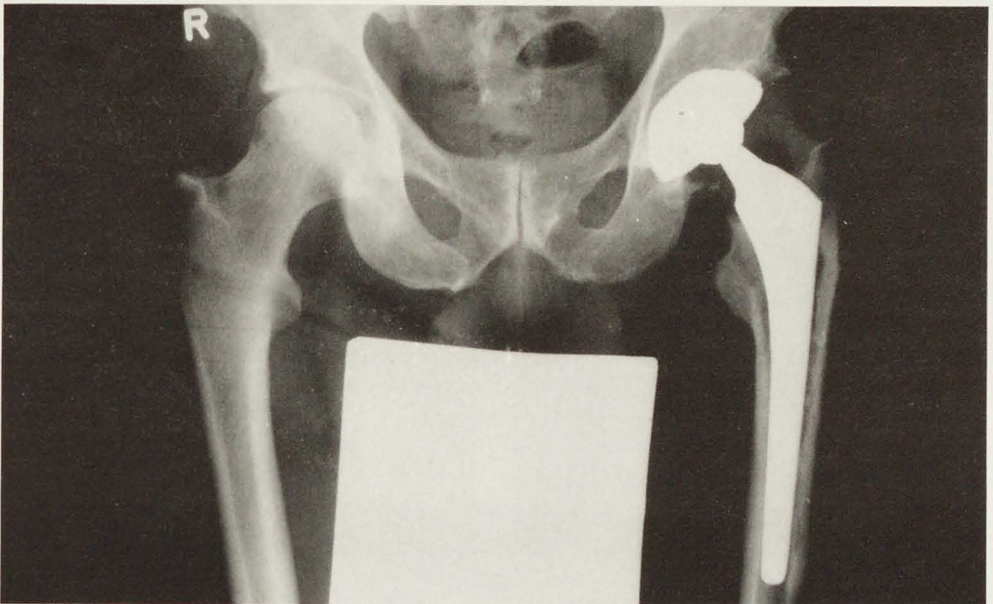
Fig. 107  
Same case as previous three months after surgery.

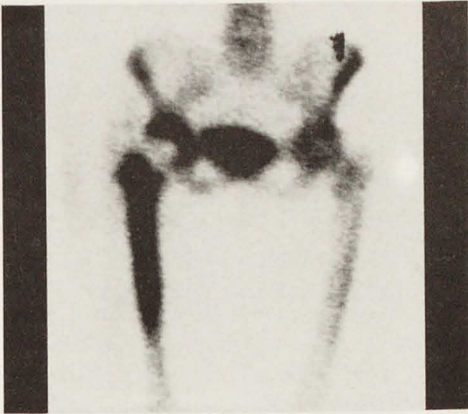
Fig. 108  
Technetium bone-scan of human hydroxyl-apatite coated total hip replacement, two weeks after surgery. High uptake over entire femoral stem and acetabular area.

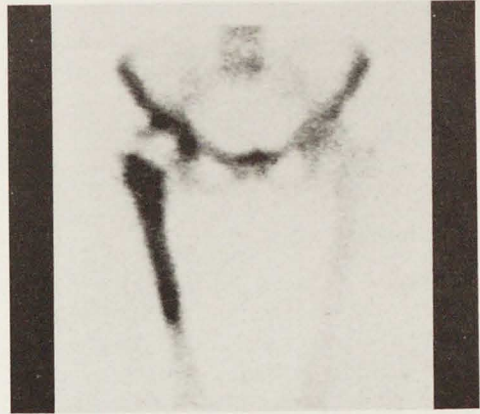
Fig. 109  
Technetium bone-scan six weeks after hydroxyl-apatite coated total hip replacement. Elevated activity over proximal and distal femoral stem section as well as acetabular area.

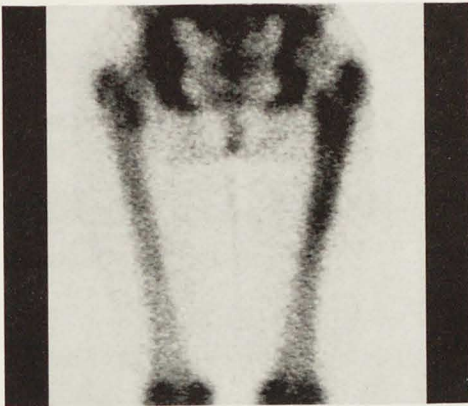
Fig. 110  
Technetium bone-scan of human hydroxyl-apatite coated total hip replacement, three months after surgery. Activity still present in entire proximal femoral stem area, although at a lower rate as compared to earlier postoperatively.

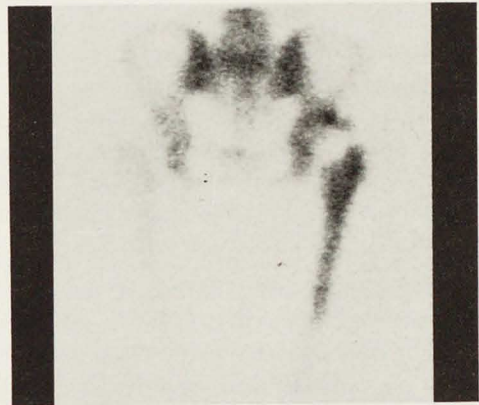
Fig. 111  
Technetium bone-scan of human hydroxyl-apatite coated total hip replacement, six months after surgery. Moderate activity discernible over hydroxyl-apatite coated part of prosthesis in proximal stem area.

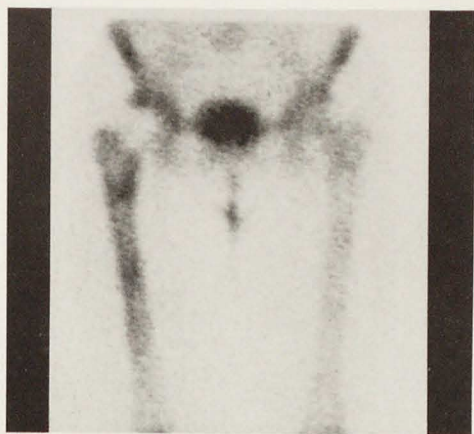
Fig. 112  
Technetium bone-scan of human hydroxyl-apatite coated total hip replacement, nine months after surgery. Moderate activity discernible over hydroxyl-apatite coated part of prosthesis in proximal stem area, with moderate persisting activity over femoral stem tip.

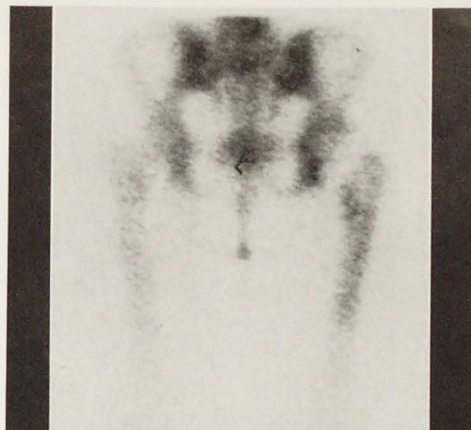
Fig. 113  
Technetium bone-scan of human hydroxyl-apatite coated total hip replacement, nine months after implantation. Activity confined to hydroxyl-apatite coated part of prosthesis in proximal stem area, without persisting activity over femoral stem tip.

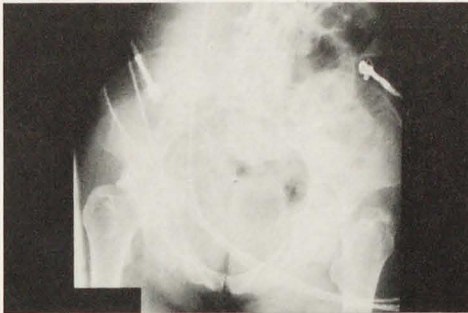
Fig. 114  
Bilateral hip fractures, preoperative radiograph.

One 49 year old female patient, with a spinal fusion and severe backache caused by thoraco-lumbar kypho-scoliosis (116° angle) of neuro-muscular origin, developed spinal convulsions that caused a bilateral fracture of the hip. Both a displaced medial neck fracture of the left hip and a central acetabular fracture of the right hip, were treated with

a hydroxyl-apatite coated total hip implant (Fig. 114 and 115). The left hip developed extensive peri-articular calcifications and became ankylosed. Ten months after primary surgery, the calcifications were removed and the non-coated screw-cup replaced with a cemented one (Fig. 116). She regained 85 degrees of flexion in the left hip, the right hip having a full range of motion. Although both hips are painfree, she still experiences her original backaches.

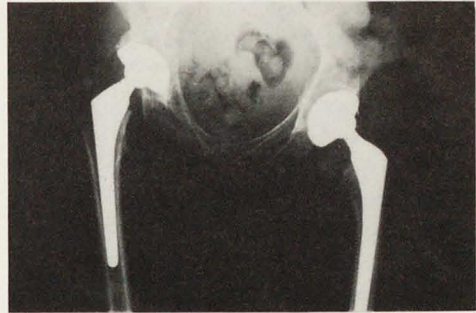
Fig. 115  
Same case as previous six weeks after surgery, peri-articular calcifications of left hip.

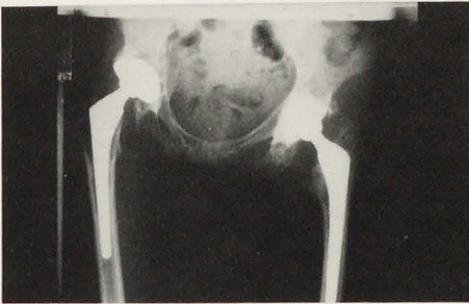
Fig. 116  
Same case as previous after removal of ectopic bone and change of acetabular non-coated screw-ring to cemented cup.

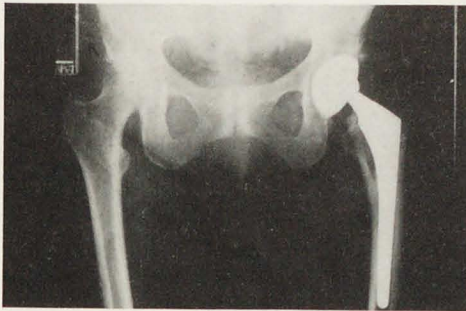
Fig. 117  
Post-operative femoral fissure/fracture with stem subsidence.

A 59 year old lady with advanced osteo-arthrosis of the hip was treated with a hydroxyl-apatite coated total hip implant. The postoperative X-ray showed a correct position of the implant, but at first follow-up, six weeks after surgery, she had some complaints in the upper thigh. The X-ray showed a fissure in the proximal femur with subsidence of the femoral stem of approximately one centimeter (Fig. 117). She was treated for another six weeks on restricted weight-bearing and the fissure/fracture healed uneventfull. Six months after surgery, there is a Harris hip score rating of 96, with a normal range of motion and an asymptomatic one centimeter leg length discrepancy.

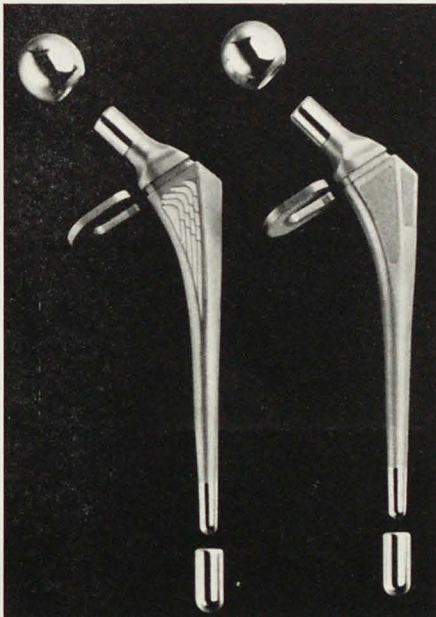
Fig. 118  
Improved stem design with more flexible distal stem section and modular stem tips (Omniflex®).
