**EFFECTIVENESS OF REPAIR METHOD USING HYBRID FIBER  
REINFORCED POLYMER FABRIC ON CONCRETE-FILLED DOUBLE  
SKIN STEEL TUBULAR COLUMNS EXPOSED TO FIRE**

# CHAPTER ONE

## INTRODUCTION

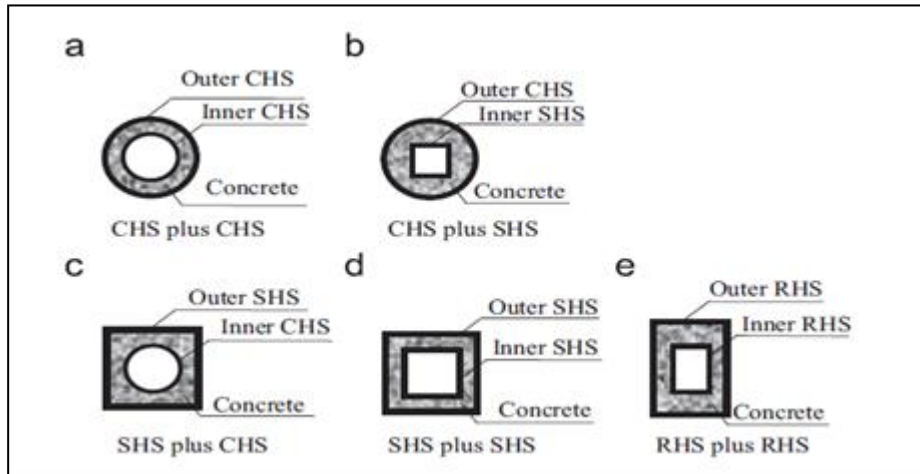
Figure 1. 1: Typical profile of concrete-filled double skin tubular column (Lu, Han, et al. 2010)

The profile of concrete-filled double skin steel tubular (CFDST) column is similar to CFST except for the void in the middle of the column as shown in Figure 1. 1. CFDST columns have been used bridge piers in Japan, owing to its good damping and energy absorption properties as well as light weight cross-section (Zhao et al. 2002). More recently, Han et al. (2014) reported that CFDST columns have been used as an electric pole in China (Figure 1.2). Unlike CFDST columns, CFST

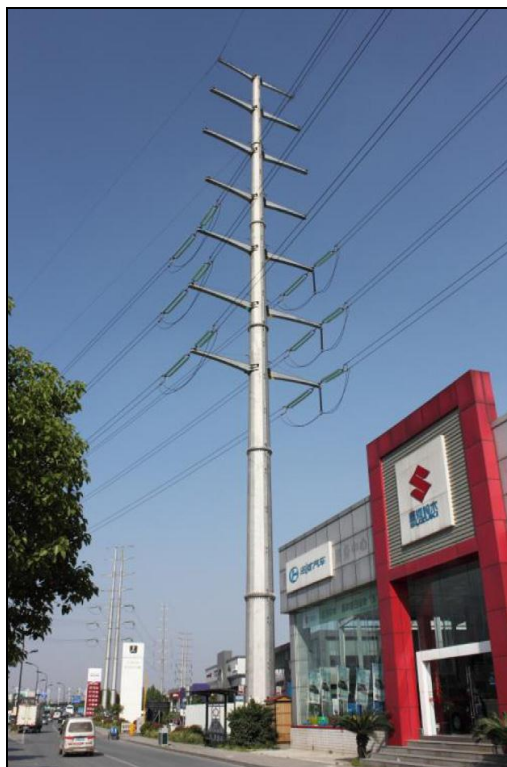
Figure 1.2: A CFDST pole in China (Han et al. 2014)
