Metallurgical and Corrosion Assessment of Submerged Tanker S.S. *Montebello*

The Union Oil Tanker S.S. Montebello was torpedoed and sunk six miles (9.7 km) off the coast of Cambria, California by a Japanese submarine on December 23, 1941, two weeks after the attack on Pearl Harbor. With close proximity to the National Monterey Bay Marine Sanctuary, concern about possible crude oil contamination led to the most recent expedition to the site in October 2011. Assessment of the shell plate found that the average corrosion rate was very low and the structure will remain stable for many decades.

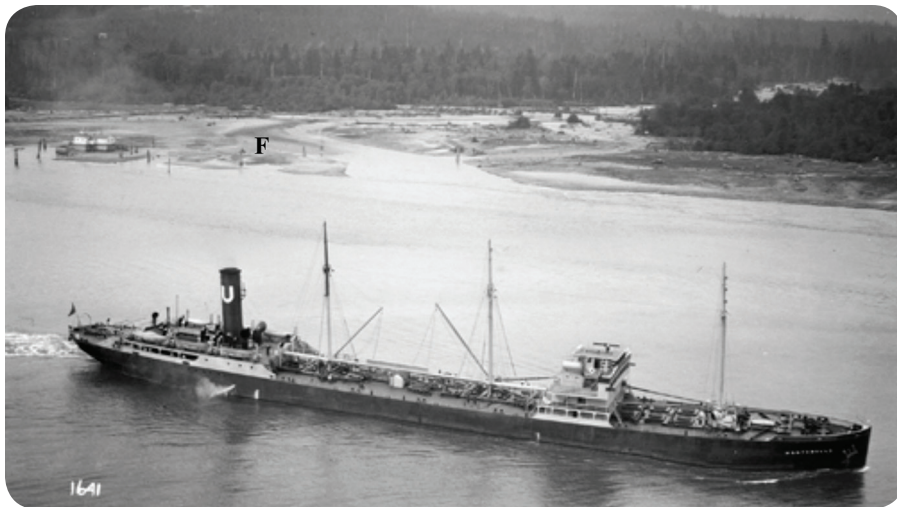
FIGURE 1 The S.S. *Montebello*. Photo courtesy of the Vancouver Maritime Museum.

The shelter deck tanker was built in 1921 by the Southwest Shipbuilding Co. (San Pedro, California). Figure 1 shows a

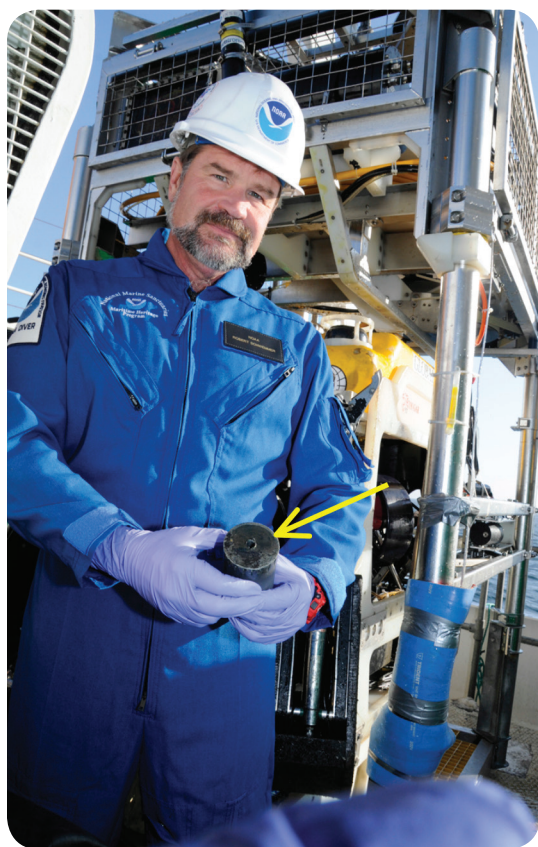
FIGURE 3 Robert Schwemmer, NOAA/ONMS, recovers the hole saw aboard support vessel OSRV Nanuq. Photo courtesy of Kerry Walsh, Global Diving and Salvage.

Core metal thickness measurements were conducted on seven metal coupon samples at ESI laboratories (Omaha, Nebraska). From four to eight measurements were taken around the circumference of each sample in the “as-received” condition. Figure 3 shows the recovered robotic hole saw shipside core sample. Figure 4 shows the hole saw cutting into the hull. Figure 5 shows the sample “as received.” Table 2³ gives original thickness, average core thickness, and corresponding corrosion rates for each sample.

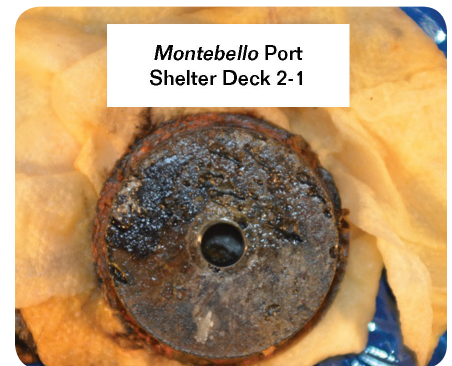
FIGURE 5 Sample received at ESI Omaha. The sample is ~4 in (100 mm) in diameter.
