Fall 2002

# Hydrological and geotechnical investigation of a Sparta, New Jersey landslide

James Talerico

*New Jersey Institute of Technology*

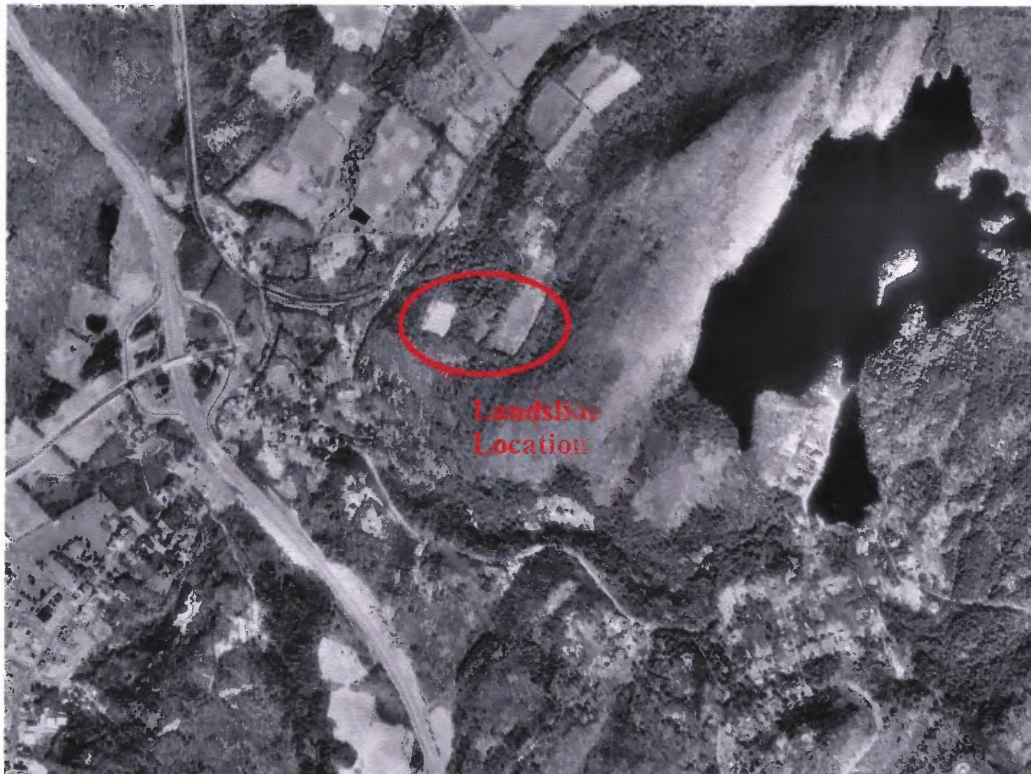
The landslide occurred on the morning of August 13, 2000, shortly after the rainfall had subsided. The landslide occurred in Sparta, NJ just off Route 517 (Glen Road) in a residential development which was under construction [Figure 1.1].

Figure 1.1 Aerial photograph of Sparta Mountain Sparta, Sparta, NJ (4-meter resolution) (Courtesy of teraserver.microsoft.com) (USGS 1991).

The area in which the landslide occurred, is located on the lower portion of the Sparta Mountains. The aerial photographs are shown in Figures 1.1 and 1.2. As seen in Figure 1.1 photograph, some areas of the Sparta Mountains were used as farming even though existing topography were sometimes in excess of 15% grade. A close-up shows the location of the landslide and how the area in which the landslide occurred was most likely used for agricultural purposes [Figure 1.2]. According to one source, the soil was once used for hay, pasture, woodland, and infrequent row crops (Fletcher 1975).

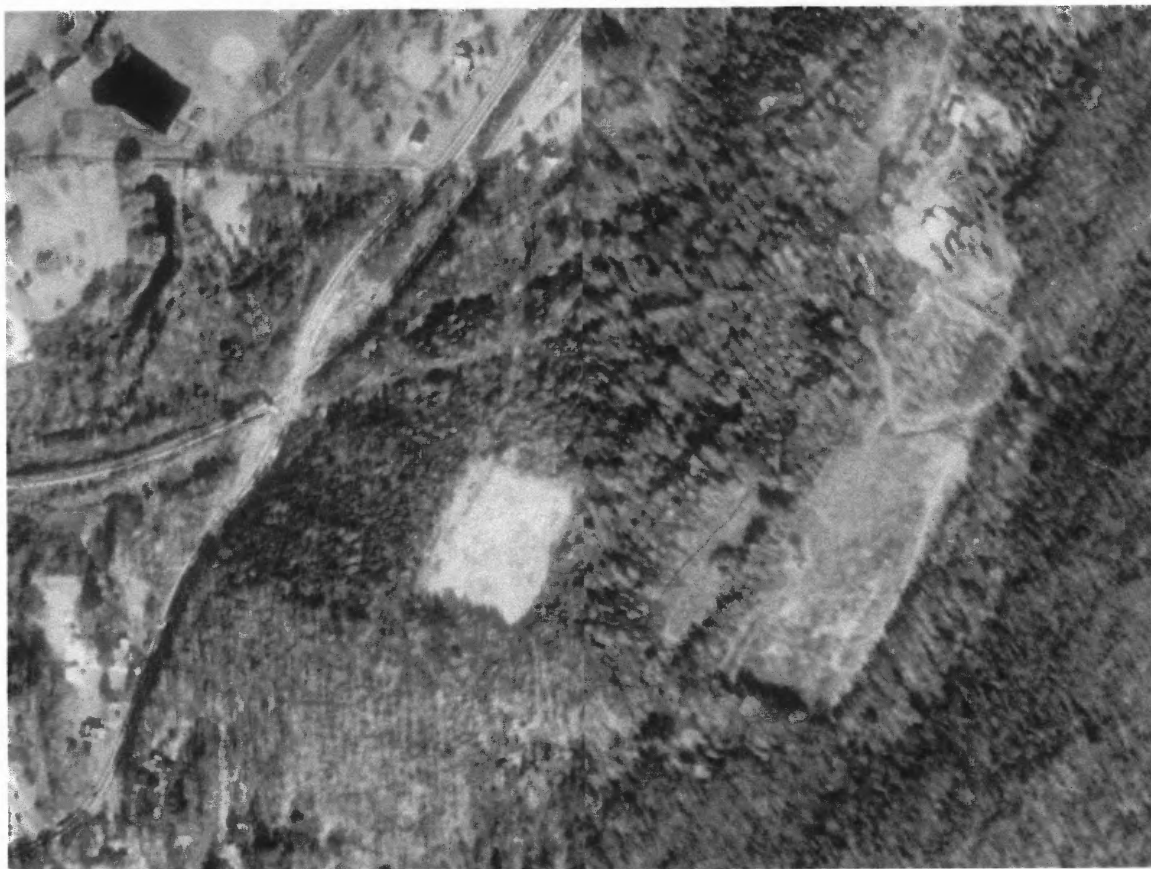
Figure 1.2 Aerial photograph of Sparta Mountain Sparta, Sparta, NJ (1-meter resolution) (Courtesy of teraserver.microsoft.com) (USGS 1991).

By using the aerial maps in Figures 1.1 and 1.2, USGS Quad maps [Figure 1.3], and countless site investigations, determining the actual location of the landslide became quite intuitive. Although the landslide was topographically surveyed, no survey control was found in the area to tie the landslide into a horizontal datum.

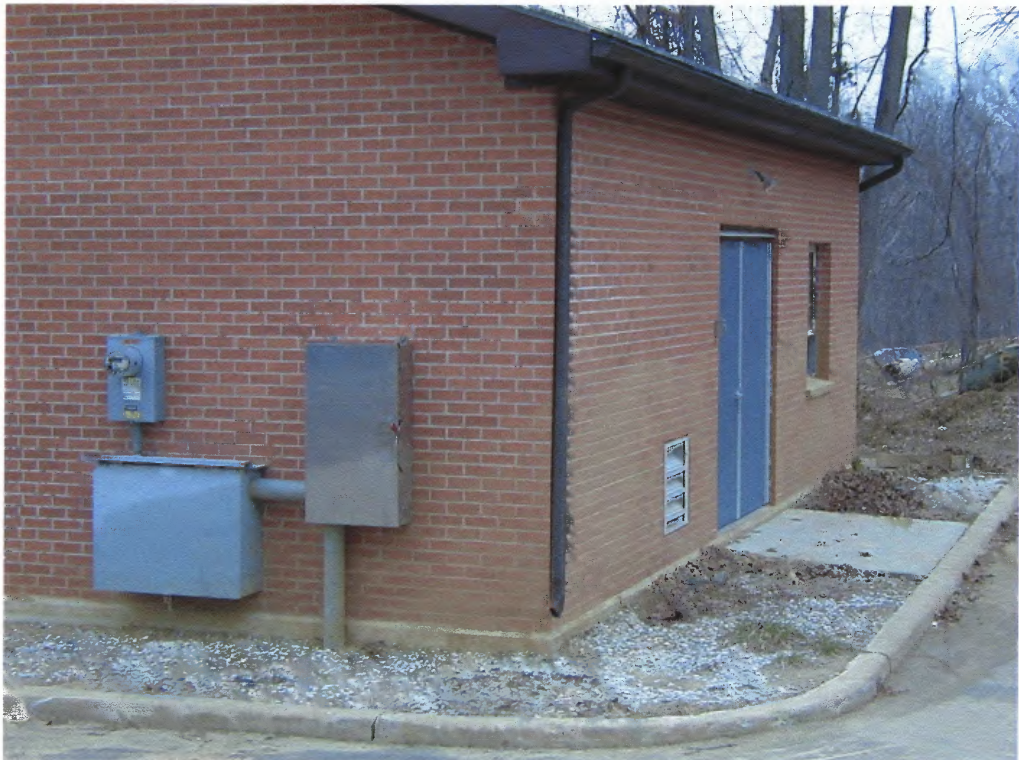
Figure 3.5 Photograph of Sparta pump house after partial clean up of landslide.

The tip and toe of the landslide as well as part of the foot were cleaned up prior to the first site investigation. Information from eye witnesses stated that the foot of the landslide had traveled across Glen Road (Rt. 517). The partially constructed road that led to the future development had also been cleared. One of the Sparta Pump Houses is also located on this road and was affected by the slide [Figure 3.5]. As seen in the photograph, the landslide residue stained the building. The soil rose as high as 4 feet around the pump house which was powerful enough to damage the existing door and window, but not powerful enough to damage the buildings foundation.

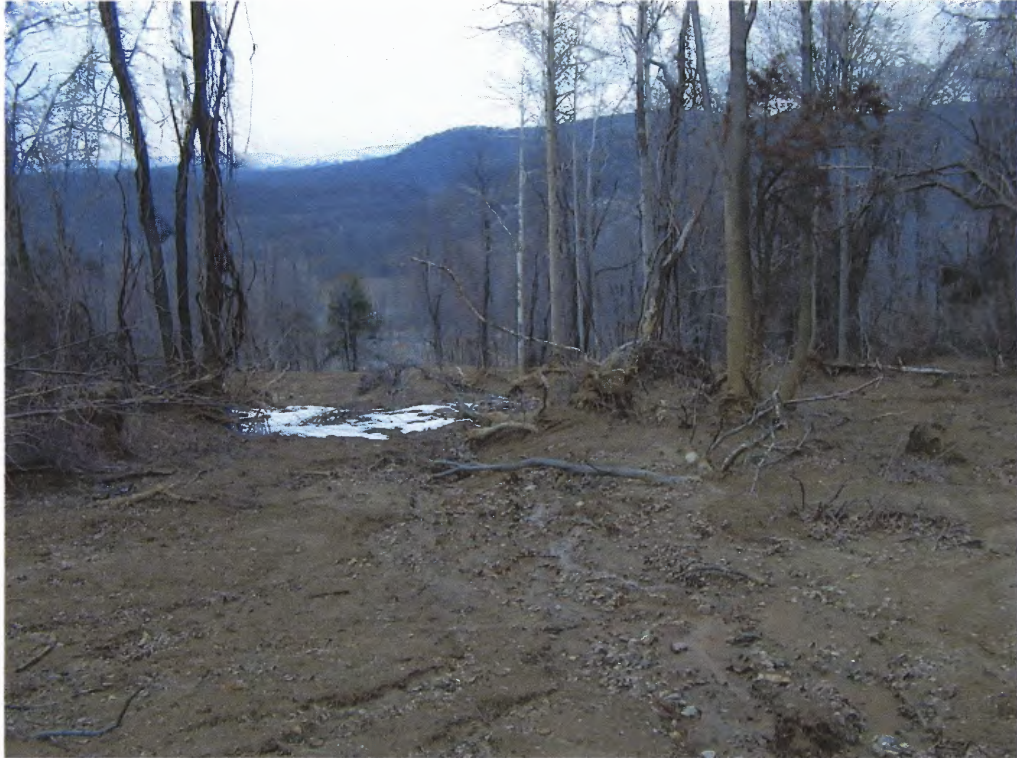
Figure 3.6 Photograph of landslide depicting the path of the foot.

Advancing up the foot of the slide, areas had been cleared for new construction, however the slide was powerful enough to uproot small caliper trees and brush [Figure 3.6]. The landslide seemed to lose most of its energy towards the bottom slope of the mountain, where the landslide encountered an area of dense woods in which no tree damage was apparent.

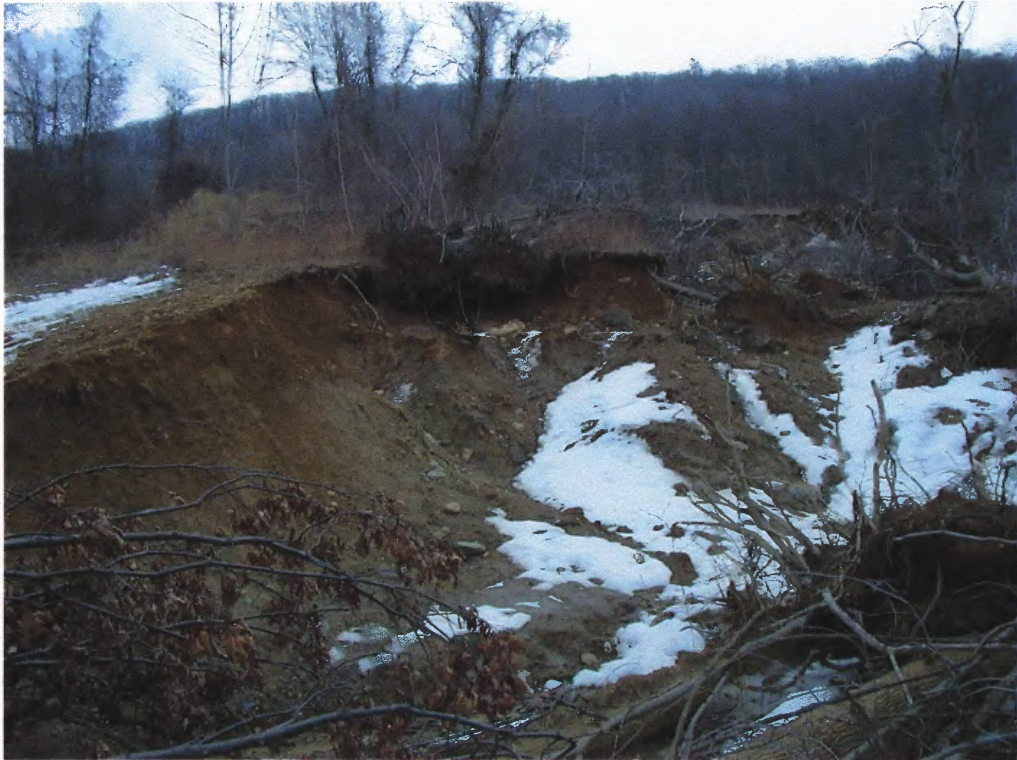
Figure 3.7 Photograph of toe of surface of rupture.

The next photograph depicts the Toe of Surface of Rupture [Figure 3.7]. The far left of the photograph depicts the new slope introduced by the newly constructed roadway. Small trees and debris were also seen in the center of the rupture surface. The soil in the surrounding area was 100% saturated at the time of investigation due to a recent snow storm. The overall width of the surface of rupture was approximately 25 feet wide.

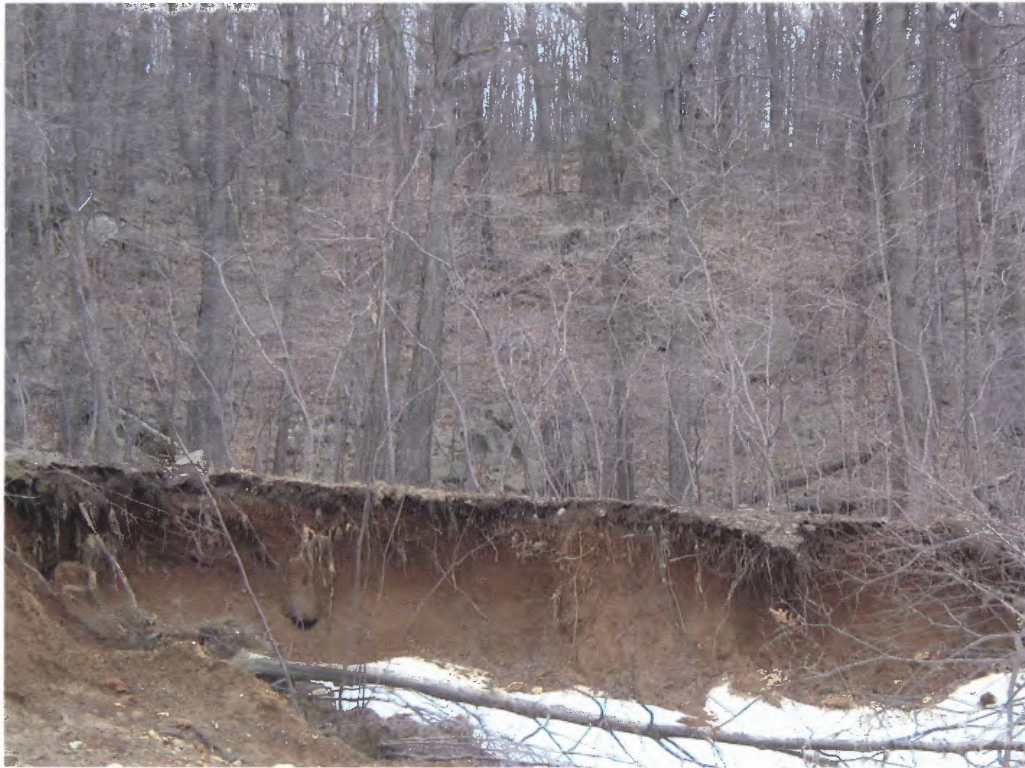
Figure 3.8 Photograph of left flank of landslide.

The left flank is depicted in the next photograph [Figure 3.8]. The wooded area located on the left flank had substantial root reinforcement and mostly likely prevented a larger area of failure. The failure on both flanks was near a vertical plane failure, which suggests a very high degree of saturation. The average width between the flanks was approximately 175 feet.

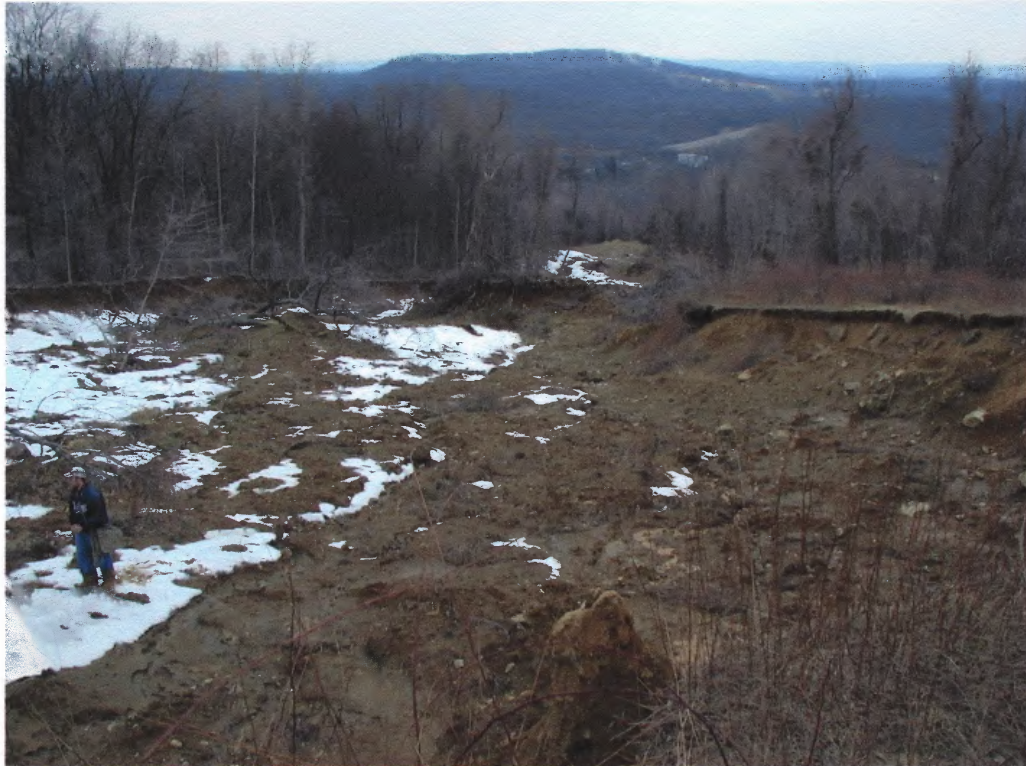
Figure 3.9 Photograph of main body (Taken from crown of landslide).

Standing from the top of the crown, looking into the body of the landslide, it was evident that the depleted mass was quite large due to the fact that a fairly shallow slope failure existed [Figure 3.9]. The main scarp and the area of depleted mass near the scarp were 100% saturated and still unstable. Daylighting was seen at the base of the scarp as well as parts of the head of both the right and left flank. The depleted mass and foot soil were homogenous and had similar soil properties. Visual classification of the soil appeared to be a Silty Sand with gravel. A very small portion of clay may be in this layer. Throughout the landslide there were no visual signs of the actual surface of rupture except along the flanks and scarp. It appeared the extreme saturation of the soil and lack of root reinforcement may have created the actual failure.

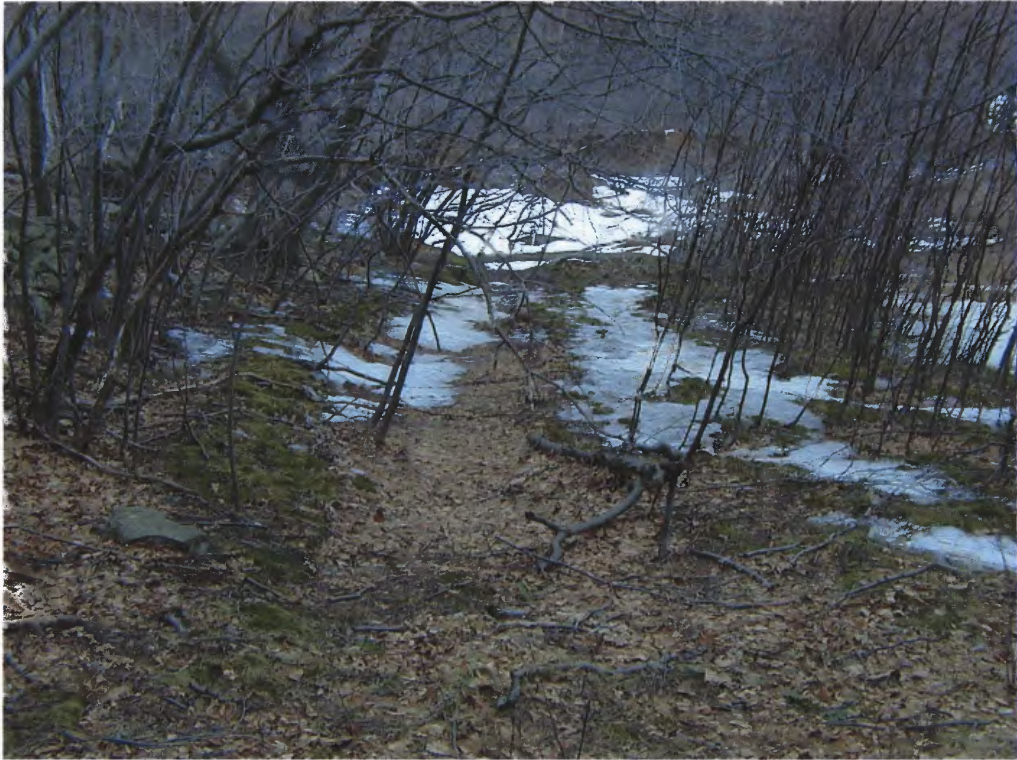
Figure 3.10 Photograph of natural swale located above the crown of landslide.

Traveling above the crown, major rock outcrops, dense vegetation, and poor ground cover were evident. Permeability seemed to be poor in the areas above the slide. Extreme slopes in some areas seemed to be in excess of 45%. Small drainage swales were present and may have increased runoff velocities and created small point discharges towards crown of slide [Figure 3.10]. Small topographic deviations such as the one being discussed are often the most critical with regard to fluid pressures and slope stability, especially in areas of groundwater discharge (Domenico 1998). Extreme runoff also seemed to be a contributing factor and a possible triggering mechanism of slide.

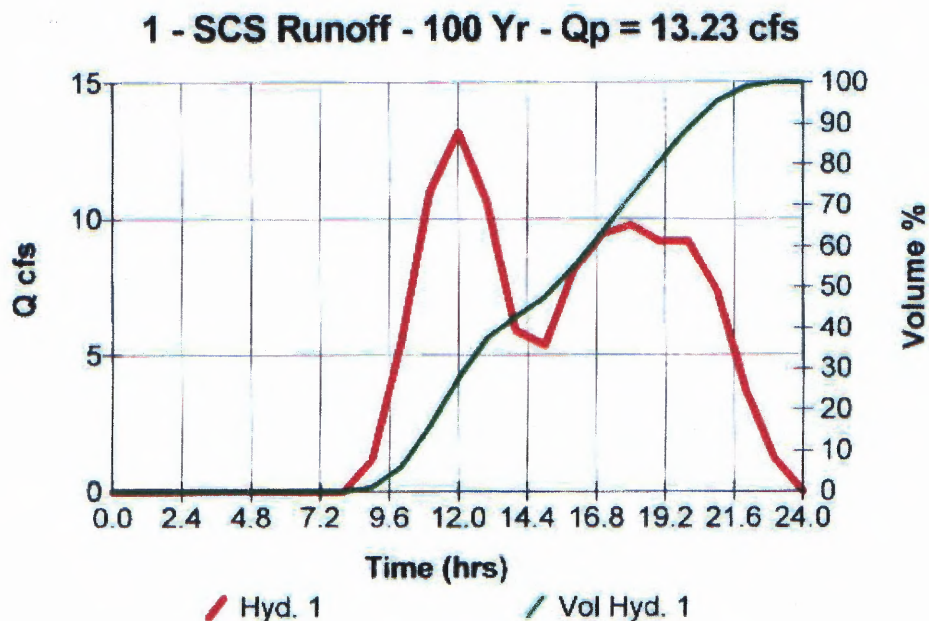
Figure A.2 24-hour hydrograph for Sparta landslide.

Upon completion of entering the final data into Hydroflow, a hydrograph was generated [Appendix A, Figure A.2]. The results yield astounding data, which clearly

show what an intense rainfall can generate for a relatively small drainage area. The peak runoff generated was 13.23 cfs at the 12<sup>th</sup> hour of the rainfall event, which directly correlates to the most intense part of the storm event. From the 8<sup>th</sup> hour of the storm to the 22<sup>nd</sup> hour, an average of 8 cfs per hour was generated by this storm event. This hydrograph was then able to generate the volume of rainfall, in cubic feet, for the entire drainage area. The volume computed was 399,035 cu. ft., which is based on the amount of rainfall and the overall drainage area.

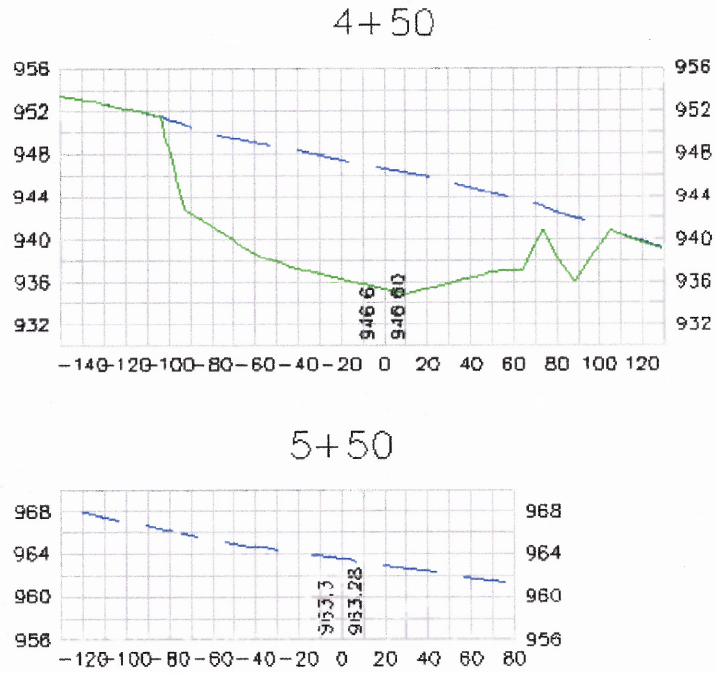
Figure B.4 Cross Sections at 50 feet stations of landslide.

This appendix contains the topographic survey of the landslide. This information shows the existing and proposed topography, a centerline profile, and 50 foot cross sections of the landslide area. This information was then used to generate the overall volume of the landslide which is also included herein.
