Mandibular Fracture Caused by Peri-Implant Bone Loss: Report of a Case

Henny J.A. Meijer,* Gerry M. Raghoobar,† and Anita Visser†

Background: A major complication related to excessive bone loss around implants is fracture of the mandible. This complication is most likely to occur in a very atrophic mandible. A 57-year-old woman presented with progressive pain and swelling that had been present for 5 days in the right frontal region of the mandible. An intraoral radiograph revealed a radiolucency around one of the implants in the interforaminal region.

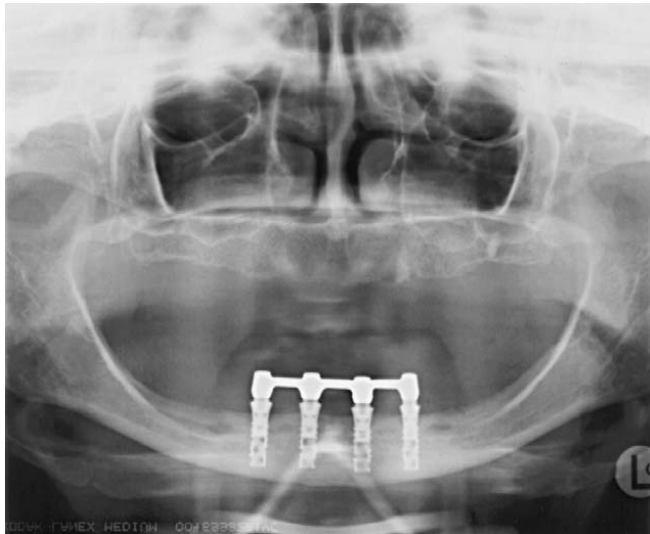
Figure 1.

Panoramic radiograph of the implant system at the beginning of the functional period.

Ten years ago, this patient was referred because of persistent problems with her lower conventional denture. Four hollow-screw implants of 10 mm length[‡] were inserted in the interforaminal region of the edentulous mandible. After an osseointegration period of 3 months, a bar superstructure and overdenture were

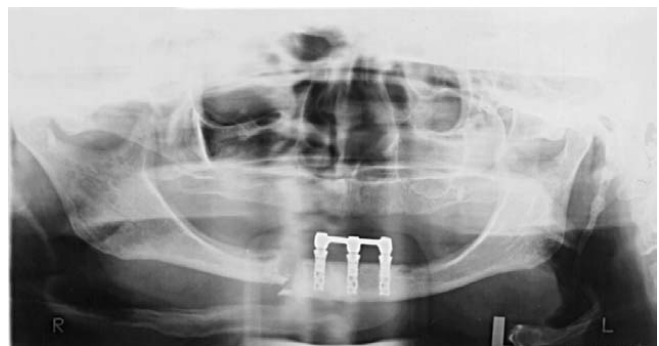
Figure 4.

Panoramic radiograph 2 weeks after removal of the right implant, with a mandibular fracture at the former implant site.

(Fig. 4). Reexamination showed no mobility of the mandible at the fracture sites, and a wound dehiscence could not be detected. There was an undisturbed sensibility in the lower lip. The patient did not recollect any time when this fracture could have happened. It was decided to continue antibiotics for 2 weeks and to follow a conservative treatment protocol. However, in the following weeks, there was an increasing mobility with progressive pain. Five weeks after detection of the fracture, the patient underwent surgery to reposition the mandible. Fibrous tissue at the fracture site was excised. Corticocancellous bone grafts were taken from the anterior iliac crest to bridge the non-union areas. The mandible was fixed with titanium osteosynthesis plates. Postoperative wound healing was uneventful, with a normal sensibility of the lower lip. Construction of a new overdenture on the remaining 3 implants began after 2 months. At the 1-year follow-up (after repositioning), the patient had no pain and functioned satisfactorily with the new prosthetic construction. The radiograph showed a normal aspect (Fig. 5).
