Day Care Monitor Dies After Crash of 15-Passenger Van

Incident Number: 12KY026

**Kentucky Fatality Assessment and Control Evaluation (FACE) Program
Incident Number: 12KY026
Release Date: June 26, 2013
Subject: Day Care Monitor Dies After Crash of 15-Passenger Van**

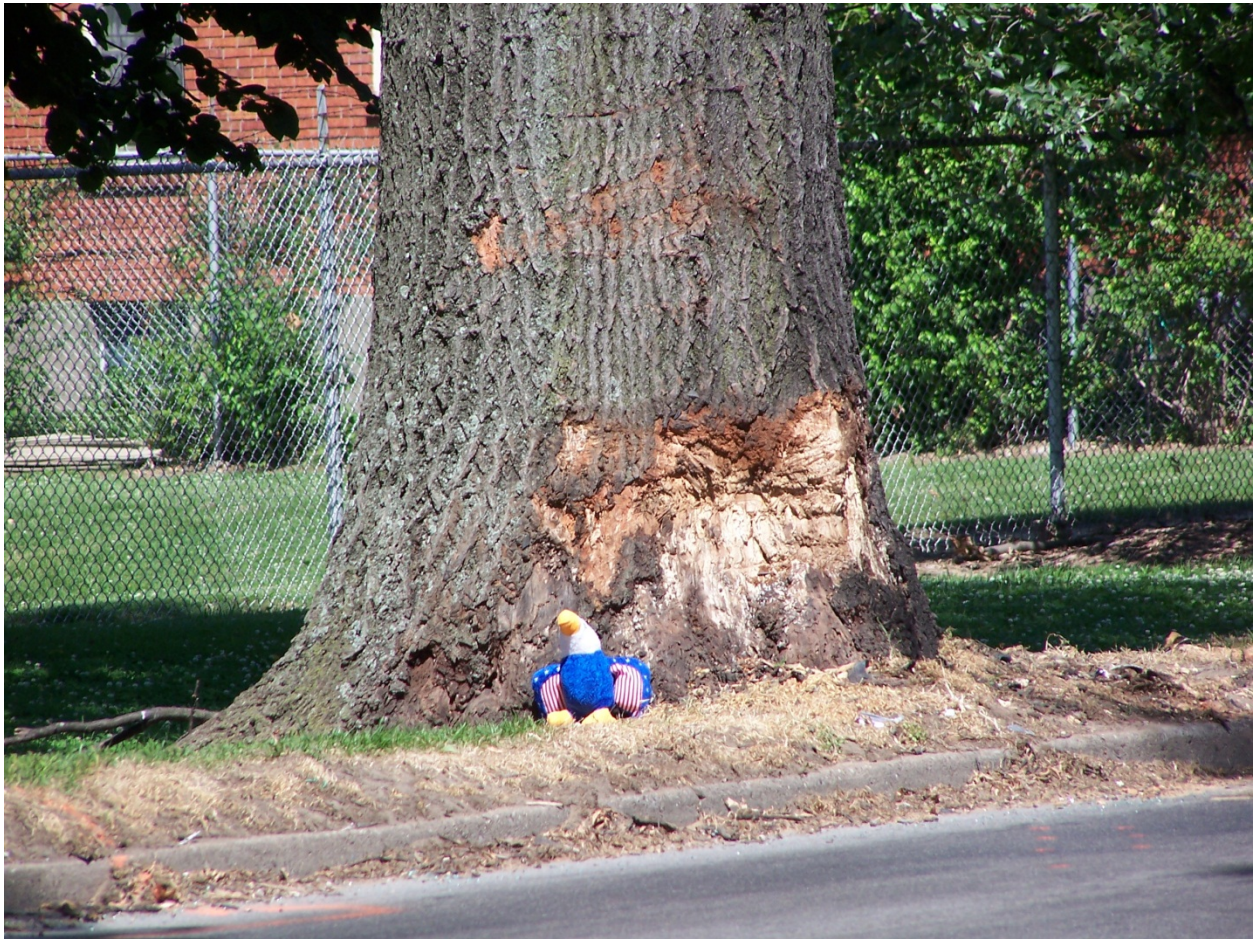
The tree involved in the crash. Photos included in this report are property of Kentucky FACE.

The driver proceeded out of the daycare's parking lot and dropped off two children at their residences, leaving 14 children and 2 adults still in the van. As they drove toward another child's residence, the van was in the left hand lane, traveling approximately 46-50 miles per hour, headed east on a straight stretch of a four lane road. East and westbound lanes were divided by a double yellow line. The roadway was flat and the pavement was dry; the speed limit was 35 miles per hour, and traffic was normal. It was approximately 5:10 p.m. when the right rear tire failed. Upon failure of the tire, the van became uncontrollable and it veered left, crossing both westbound lanes, striking a tree head-on and causing the front axle to break.

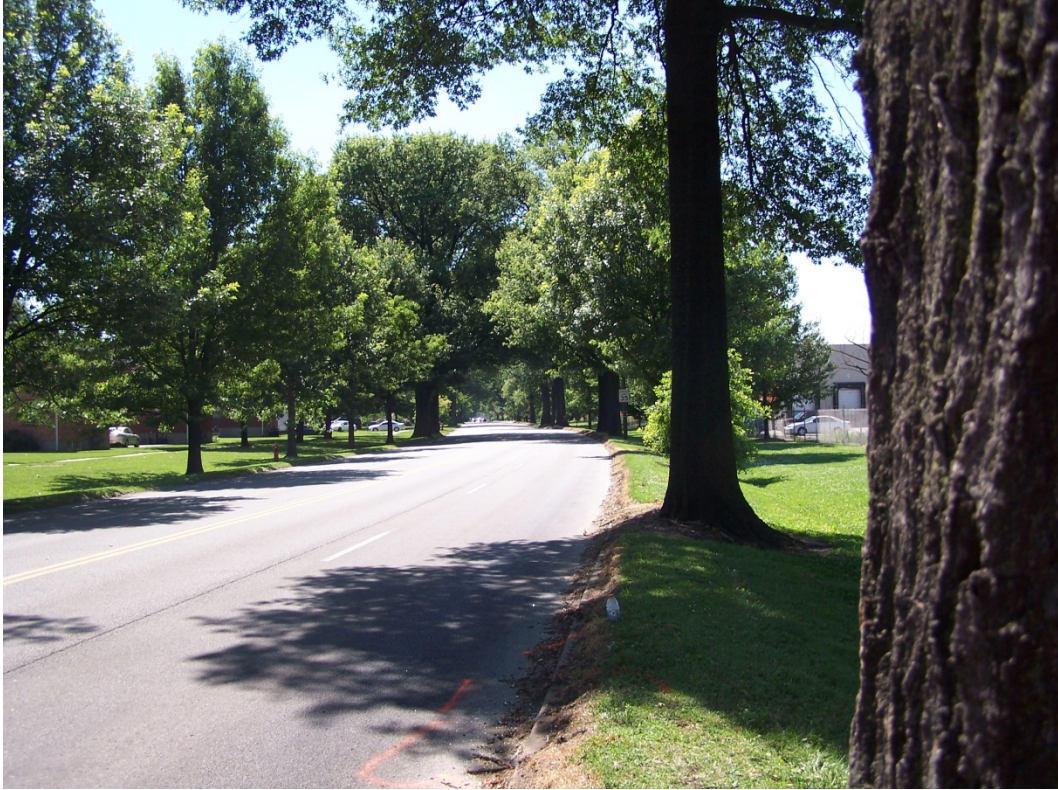
Street scene from the spot where the van crashed into the tree.

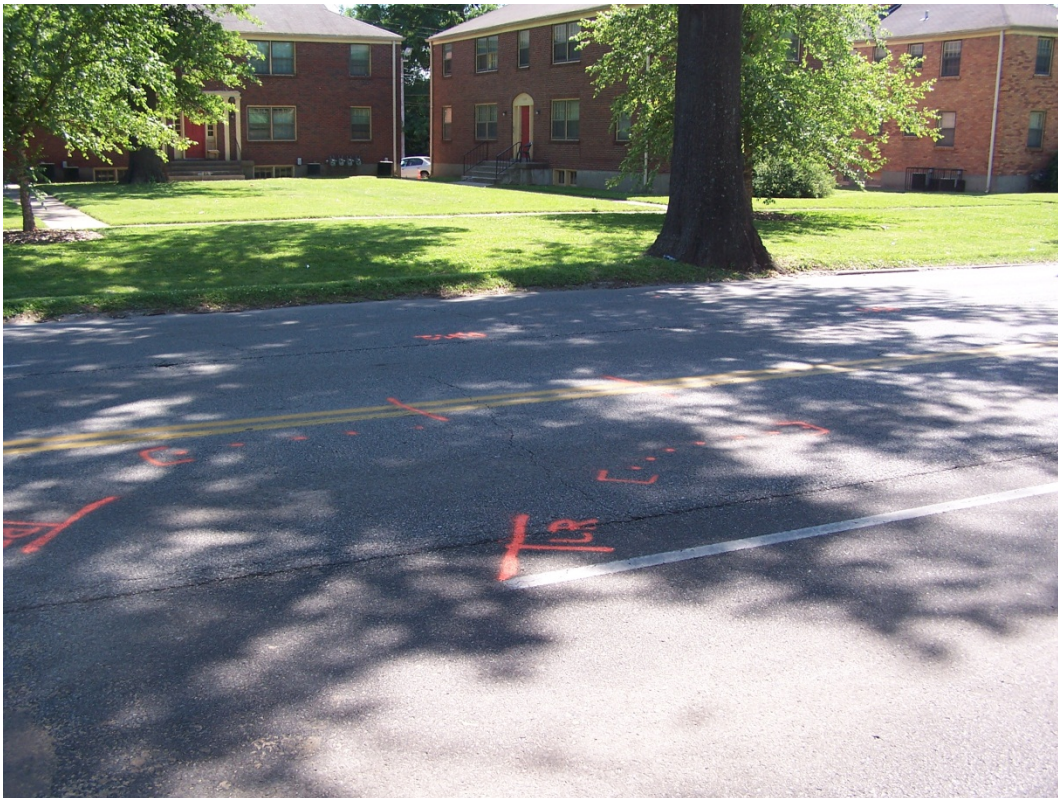
Markings show path of the van after the tire blowout, crossing into westbound lanes.

The reconstruction of the incident revealed damage had occurred in the middle of the rear right tire sometime prior to the crash and the interior tire belt had broken. Also, the tires on the van had less than 2/16" tread. There was no evidence of braking after the tire failed. Both front airbags were reported to have deployed upon impact with the tree. A passenger manifest was not located in the van, nor could one be found at the office of the daycare. It was reported by a witness that four children had been secured together with one restraint system. This would follow from the fact that the capacity of the van had been exceeded by 3 passengers at trip outset. The driving record of the van operator prior to the crash is unknown.
