# Late Removal of Titanium Hardware from the Elbow is Problematic

## Clinical Study

A retrospective review of 21 patients that underwent bone screw removal from the elbow was studied in relation to the type of metal, duration of implantation, and the location of the screws about the elbow. Screw failure during extraction was the dependent variable. Five of 21 patients experienced hardware failure during extraction. Fourteen patients had titanium alloy implants. In four cases, titanium screws broke during extraction. Compared to stainless steel, titanium screw failure during removal was not statistically significant ( $P = 0.61$ ). Screw removal 12 months after surgery was more likely to result in broken, retained screws in general ( $P = 0.046$ ) and specifically for titanium alloy ( $P = 0.003$ ). Bone screws removed from the distal humerus or proximal ulna had an equal chance of fracturing ( $P = 0.28$ ). There appears to be a time-related association of titanium alloy bone screw failure during hardware removal cases from the elbow. This may be explained by titanium's properties and osseointegration.

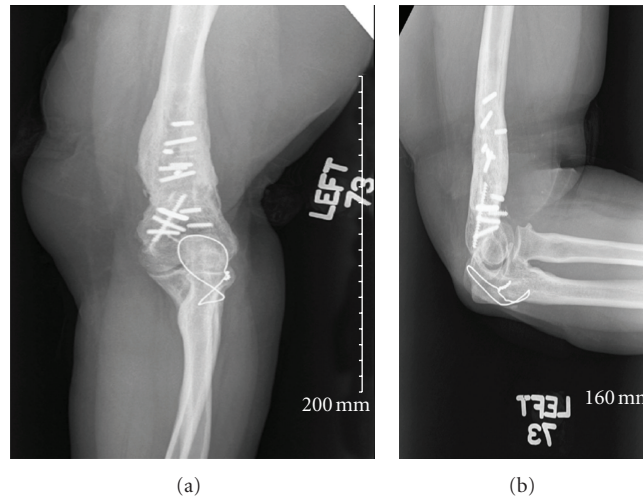
FIGURE 1: Broken hardware often poses a difficult problem and subsequent removal may increase surgical time and complexity of future surgeries. (a) shows an X-ray of an elbow (AP view) with broken and retained screws. (b) shows the same elbow in the lateral position.

Hardware removal is indicated for infection, nonunion, failure of fixation, pain, soft tissue irritation, and anticipated strenuous activity after fracture healing [1–4]. During removal cases however, hardware, especially screws, can break. Subsequent removal of broken hardware increases surgical time, and retained metalwork potentially complicates future surgeries (Figure 1) [5].

Hardware failure during removal cases is a commonly seen problem in orthopaedics [5] (Figure 1). Currently, there is

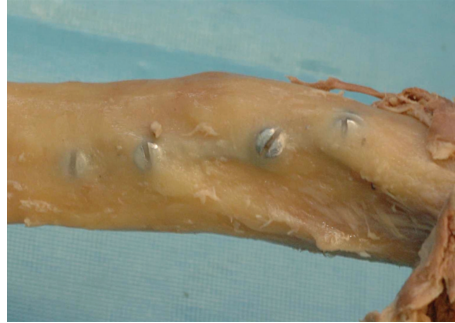
FIGURE 2: Bone ingrowth and on-growth onto metallic hardware in the humerus (cadaveric specimen). Due to a greater extent of osseointegration, greater removal torques will be necessary to extract the bone screws.

Osseointegration has been observed to occur within 3–10 months in titanium alloy [10, 11]. The degree of bone in-growth and on-growth, however, continues to increase for years after initial implantation (Figure 2) [15]. Although there have been studies showing evidence of stainless steel osseointegration, it is generally accepted that commercially pure titanium and titanium alloy are more biocompatible and more likely to osseointegrate than stainless steel [16]. In our series, it is likely that as osseointegration became

more complete, greater removal torques contributed to the failure of titanium alloy screws in this series [17]. Given these properties, we postulate that over longer periods and increased loading cycles, the development of microfractures and osseointegration contributed to screw breakage during implant removal.
