Forensic Pavement Evaluation for US 31 W, Jefferson County, Kentucky Using Ground Penetrating Radar

TECHNICAL ASSISTANCE REPORT

KTC-TA-15-02/KH91-14-1F

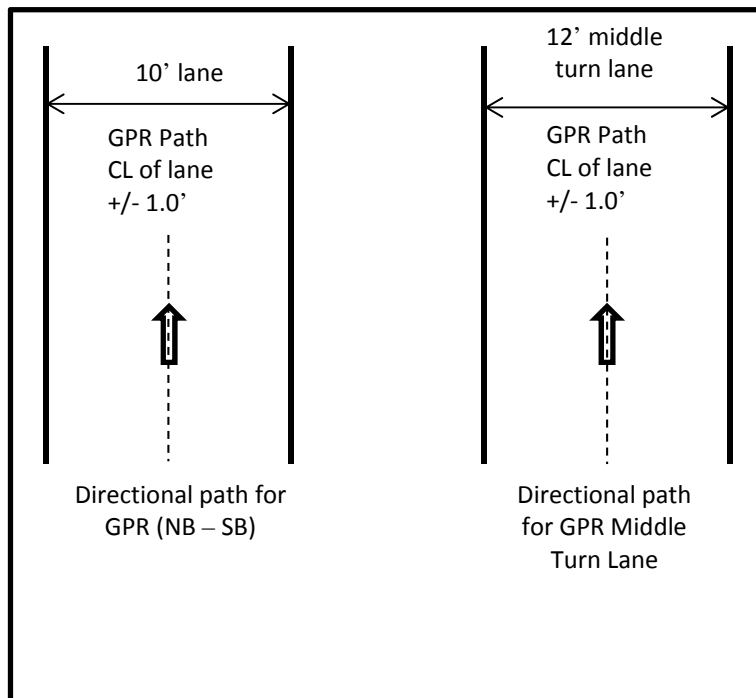
Diagram 1: Radar Paths (n.t.s)

KTC utilized Ground Penetrating Radar (GPR) technology to determine the depths of the pavement along the route. Each lane was scanned along a single path using a 900 MHz antenna. The radar signal and the associated distance were recorded every one inch along the lane. The GPR path taken along the two northbound, two southbound, and the center turn lanes were performed approximately in the center of each lane (see Diagram 1).

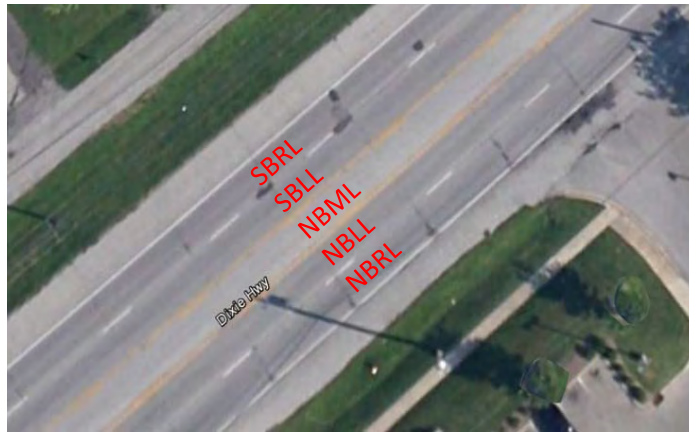
Diagram 2: Lanes Scanned with GPR

A total of five lanes were scanned for the project using GPR. All scans were performed in the lanes direction of normal travel except the middle turn lane. It was scanned in the northbound direction. The northbound scan direction started at pavement change at approximately station number 103+67 and proceeded approximately 25,673 feet to the intersection of Greenwood and Dixie highway, approximate station number 360+40. The lane designations are as follows (Diagram 2):

1. Northbound Right Lane: NBRL
2. Northbound Left Lane: NBLL
3. Northbound Middle Lane: NBML
4. Southbound Right Lane: SBRL
5. Southbound Left Lane: SBLL

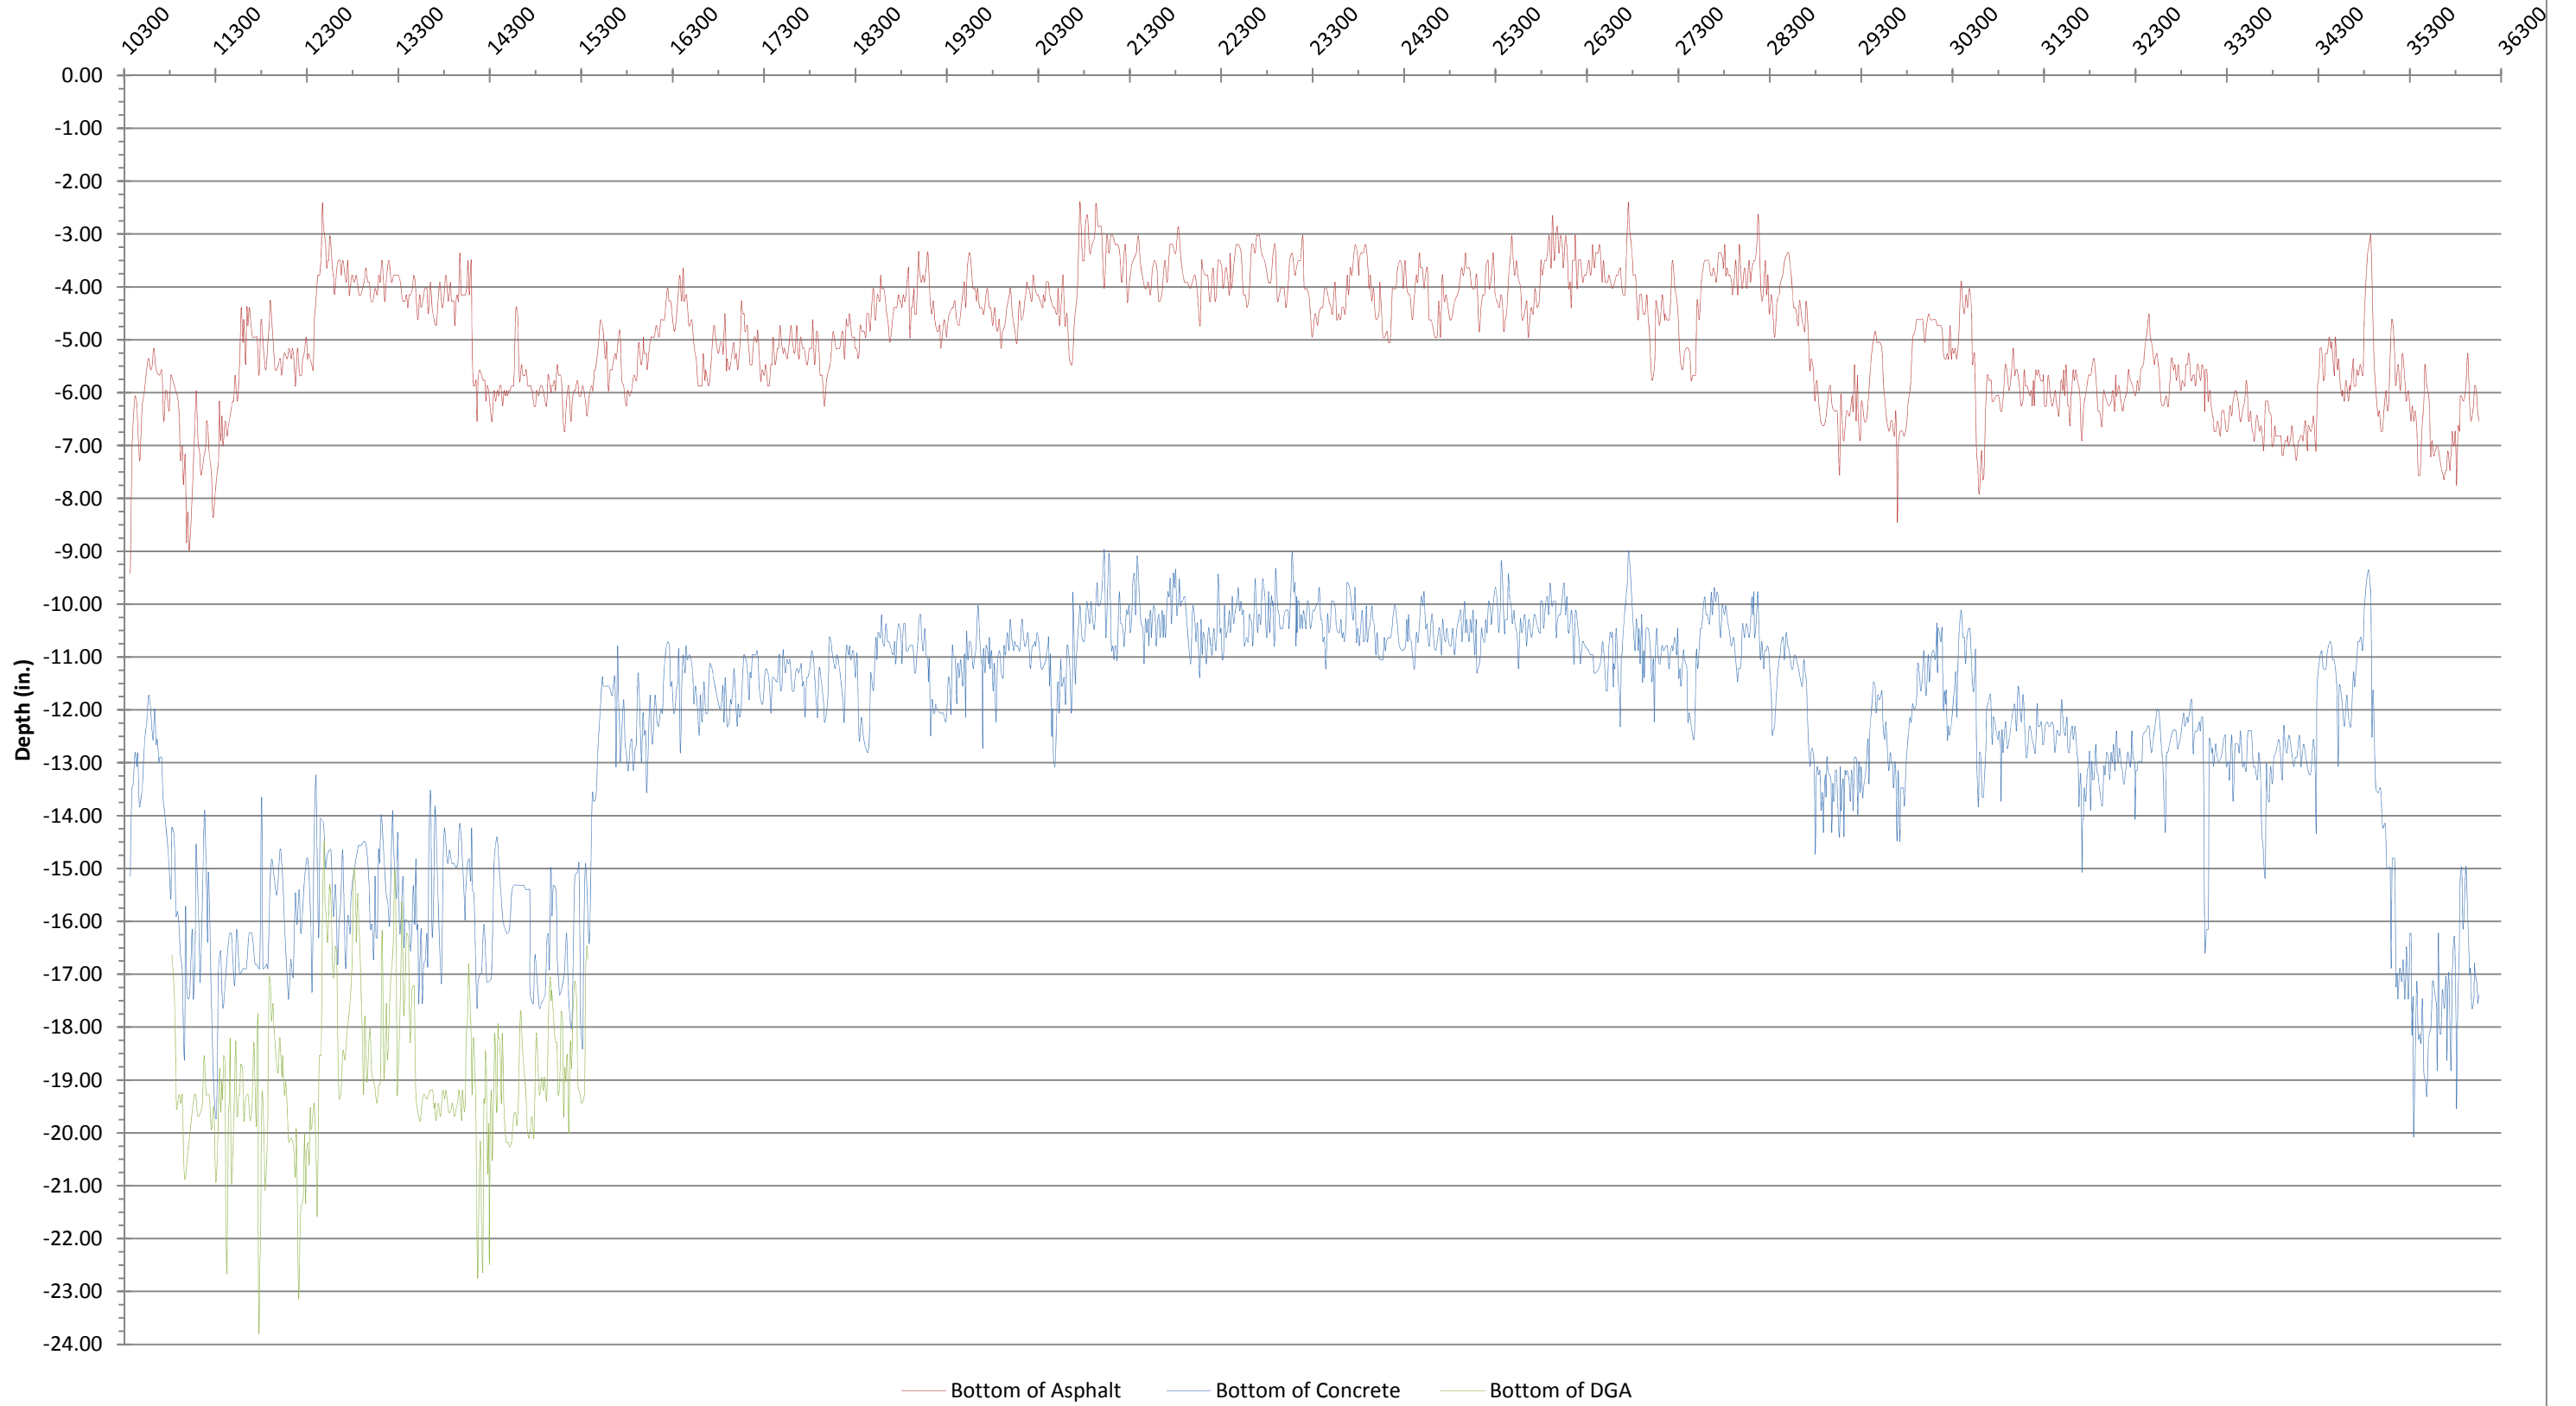
US 31W Jefferson County - Pavement Block Depths - North Bound Right Lane

Each graph shows the pavement depth for a lane along a particular path (Appendix A). The horizontal axis references the mainline station number. The vertical axis is the depth measured in inches from the surface of the pavement to the bottom of the pavement layer type. The data depicted in Appendix A are averaged in Table Two below:

Lane	Avg. Asphalt thickness (in.)	Avg. Concrete thickness (in.)	Avg. DGA thickness (in.)
NBRL	5.03	7.33	6.5 where applicable
NBLL	7.14	6.76	n/a
NBML	7.59	8.12 where applicable	6.14
SBLL	7.04	6.59	n/a
SBRL	4.89	8.00	7.72 where applicable

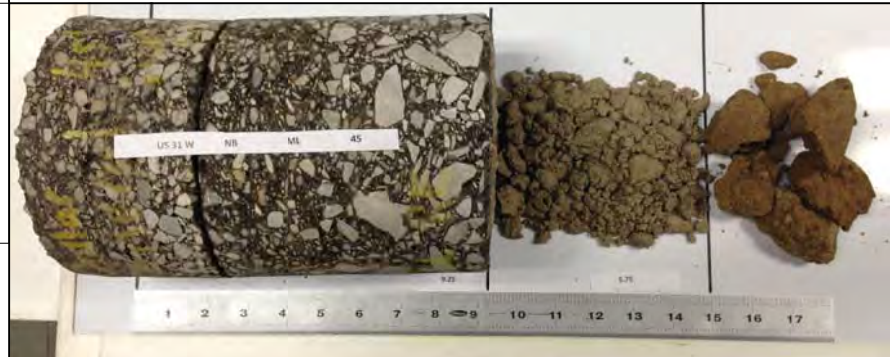
NB MEDIAN ~ STA. 104+10
9.25" AC
5.75" DGA
15" SUBGRADE DEPTH

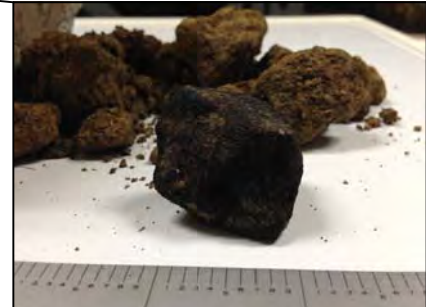
SB LEFT LANE ~ STA. 261+10
 6.25" AC
 6.875" PCC
 13.125" SUBGRADE DEPTH
 (SEE CLOSEUP FOR SUBGRADE DETAIL)

UNKNOWN BITUMINOUS
 FOUND IN SUBGRADE IN SB
 LEFT LANES AT ~ STA. 261+10
 AND STA. 299+33

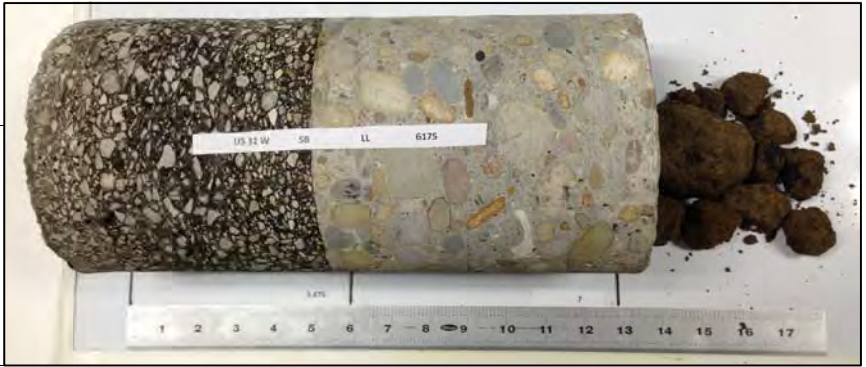
SB LEFT LANE ~ STA. 299+33
 5.875" AC
 7" PCC
 12.875" SUBGRADE DEPTH

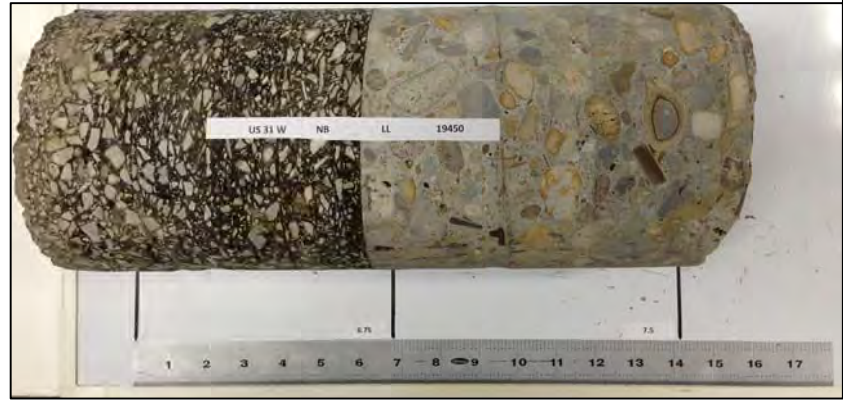
NB LEFT LANE ~ STA. 298+15
 6.75" AC
 7.5" PCC
 14.25" SUBGRADE DEPTH

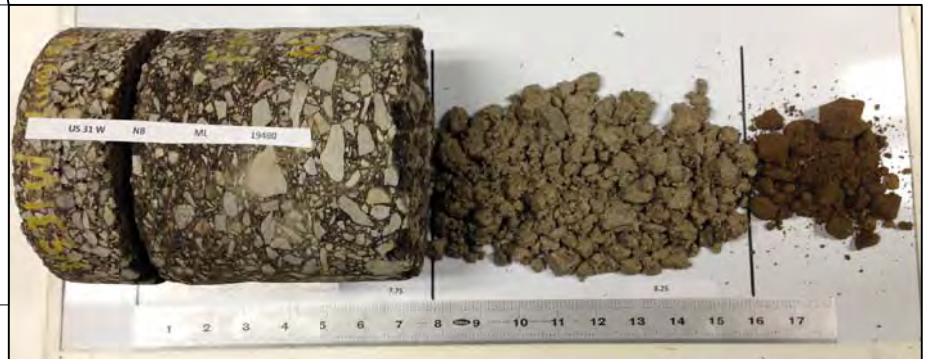
NB MEDIAN ~ STA. 298+45
 7.75" AC
 8.25" DGA
 16" SUBGRADE DEPTH
