**RETROFIT OF THE LOUISA-FORT GAY BRIDGE
USING CFRP LAMINATES**

Research Report
KTC-07-08/FRT118-03-1F

Retrofit of the Louisa-Fort Gay Bridge using CFRP Laminates

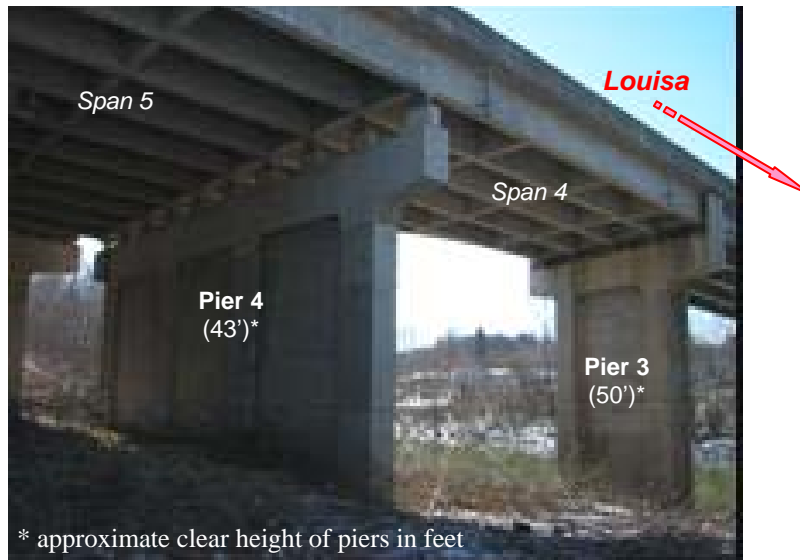
A routine inspection revealed cracks in the reinforced concrete girders in Spans 4, 6 and 7. These cracks were visible at ground elevation. Fig. 1.2 shows the view of the concrete spans and the estimated height of the superstructure from the ground elevation. Fig. 1.3 shows the cracks that had developed at the bottom web of a typical reinforced concrete girder of the bridge. These cracks formed primarily due to high flexural stresses that developed in the positive bending regions of the continuous structure.

(a) Spans 5, 6 and 7.

(b) Spans 4 and 5

Fig. 1.2 – The continuous reinforced concrete middle spans of the Louis-Fort Gay Bridge.

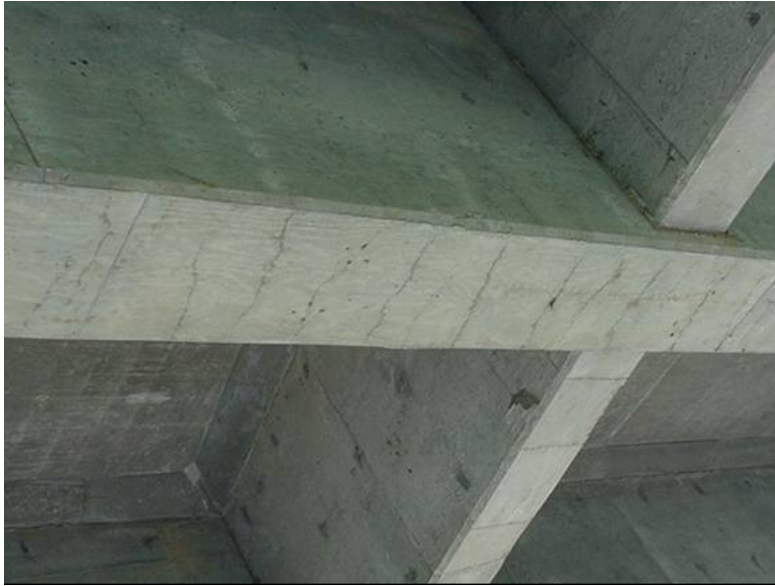
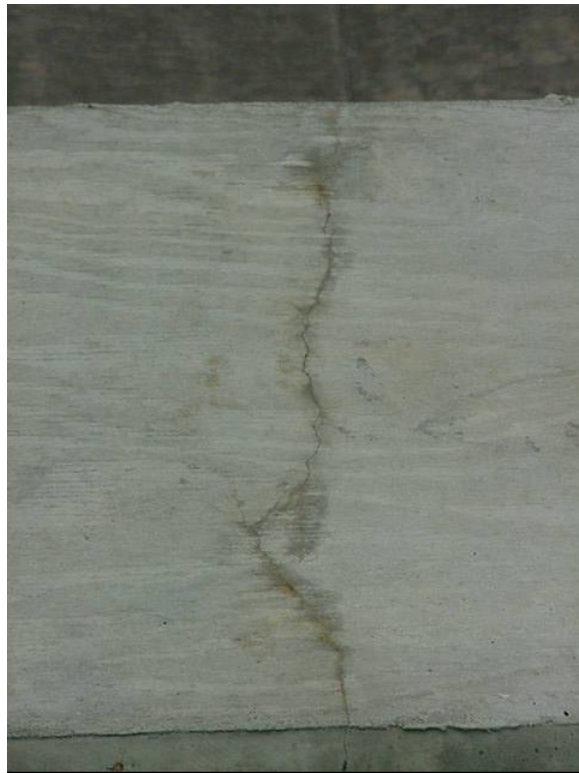
(a) Flexural crack in one of the girder

(b) Close-up of a flexural crack

Fig. 1.3 – Flexural cracks observed in Spans 4, 6 and 7 (see Fig. 1.2).

In this report, the strengthening and repair of the Louisa-Fort Gay Bridge is detailed. The objective of this project is to demonstrate that the use of high-strength carbon fiber reinforced polymer (CFRP) composite laminates can be an efficient and effective way of retrofitting the bridge elements by improving their respective strength and stiffness. It is also expected that such repair will extend the service life of the bridge.

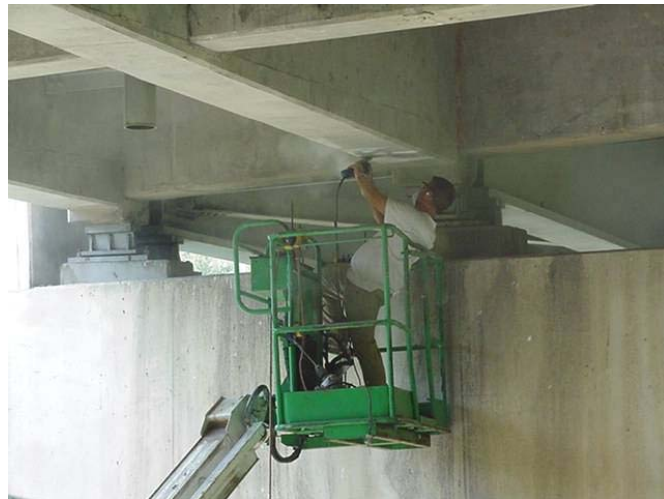
Surface preparation ensures the cleanliness and soundness of the affected areas where bond is critical. The affected areas of selected girders were ground and cleaned to remove all loose concrete particles, debris, and other contaminants that would have affected the bond between the laminates and the concrete substrate. In addition, concrete pull-out tests (ACI 503 1992) were conducted on the concrete substrate of each girder to ensure sufficient tensile strength. In accordance with the ACI code, all affected concrete surfaces were required to possess a minimum strength of 200 psi to ensure successful bonded application of laminates. The surface grinding process is shown in Fig. 3.1. It should be noted that the surface preparation process generally involved light-weight hand-tools (i.e. surface grinder, pressure blower, etc) and only required minimal labor (Fig. 3.1).

Fig. 3.1 – Preparing concrete substrate for CFRP laminates.

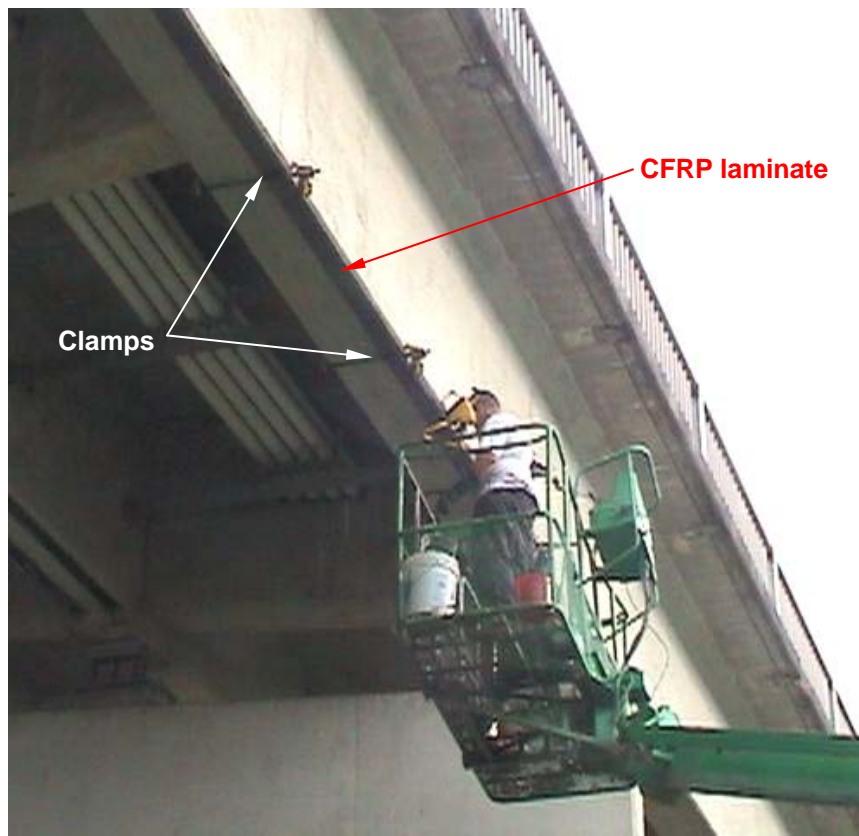
The application of CFRP laminates involved the following phases: (1) applying the mixed epoxy onto the concrete with a trowel or spatula to a specified thickness, (2) applying the mixed epoxy onto the CFRP laminates; (3) placing the CFRP laminates to the affected concrete surfaces; (4) pressing the CFRP laminates using a hard-roller until adhesive is forced out on both sides; and (5) removing excess adhesive. Clamps were used in various locations along the girders to secure the CFRP laminates while allowing the adhesive to properly cure. Figure 3.2 shows the process of a CFRP laminate being attached to a reinforced concrete girder. Completed retrofitting work of Spans 4 and 6 are shown in Fig. 3.3.

Fig. 3.2 – Application of CFRP laminate to RC girder.

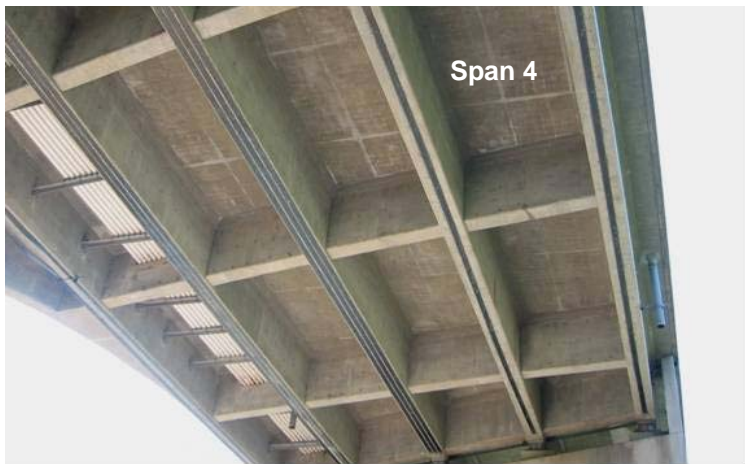
(a) Span 6 of the middle reinforced concrete span

(b) Span 4 of the middle reinforced concrete span

Fig. 3.3 – Reinforced concrete beams retrofitted with CFRP laminates.

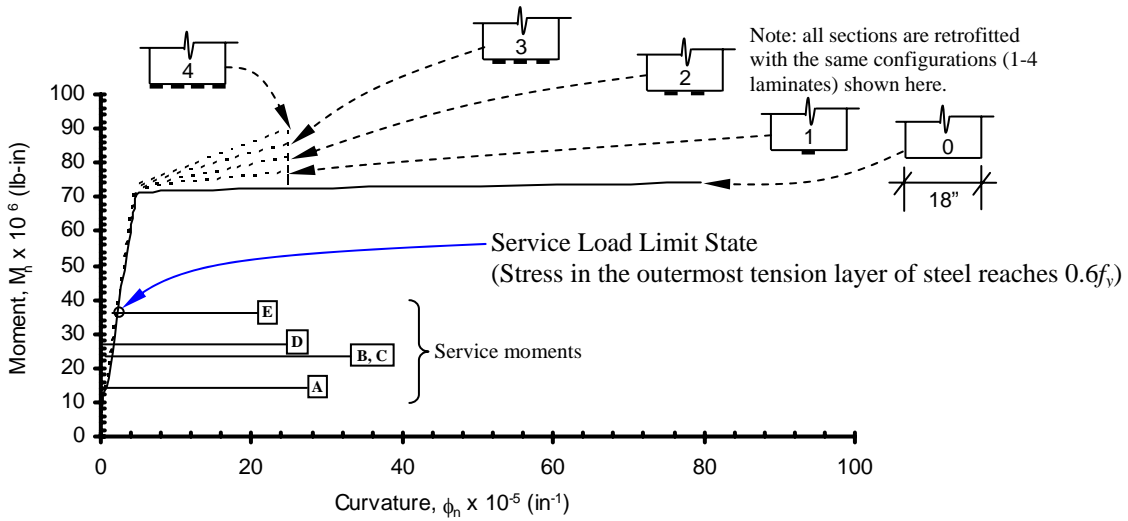
Table B-1. Service loads and design loads of Section 11-11 for Girder 2 in Span 4.

Fig. B.1.a – Comparison of service moments with $M_n-\phi_n$.

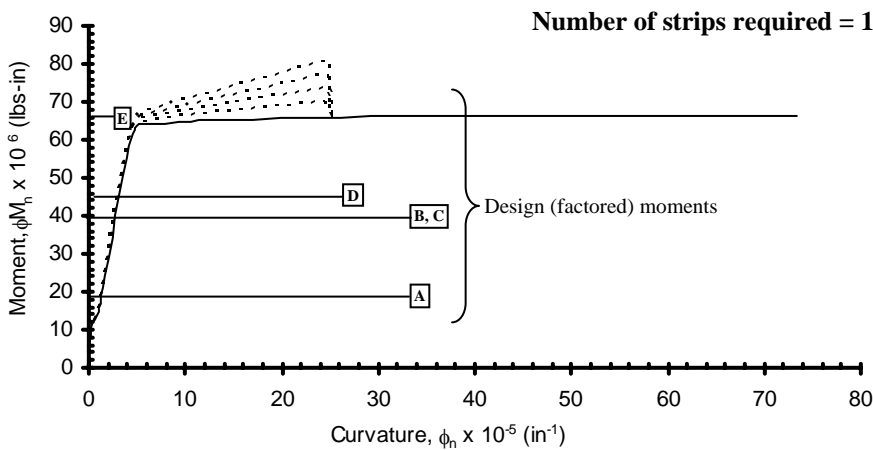
³ bold numbers indicate that the factored applied loads exceed the capacity of the original section

Fig. B.1.b – Comparison of design moments with $\phi M_n-\phi_n$.

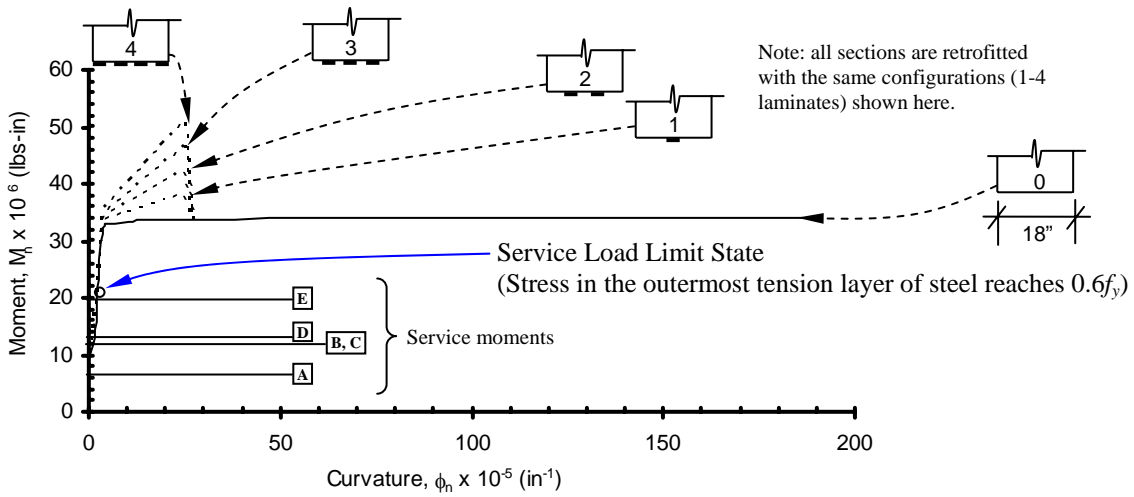
Table B-2. Service loads and design loads of Section 15-15 for Girder 3 in Span 6.

Fig. B.2.a – Comparison of service moments with $M_n-\phi_n$.

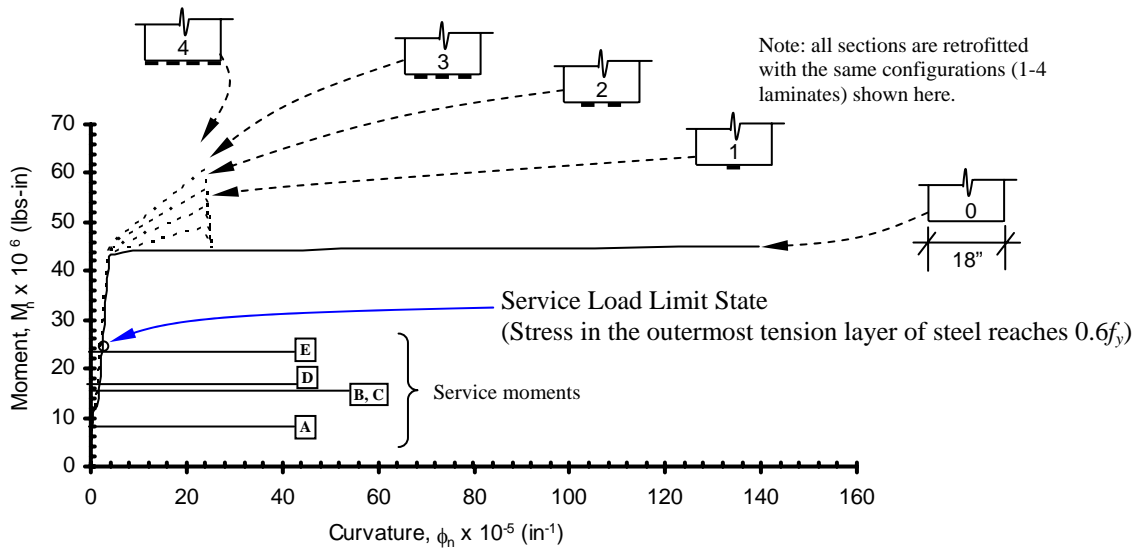
Table B-3. Service loads and design loads of Section 17-17 for Girder 2 in Span 7.

Fig. B.3.a – Comparison of service moments with $M_n-\phi_n$.

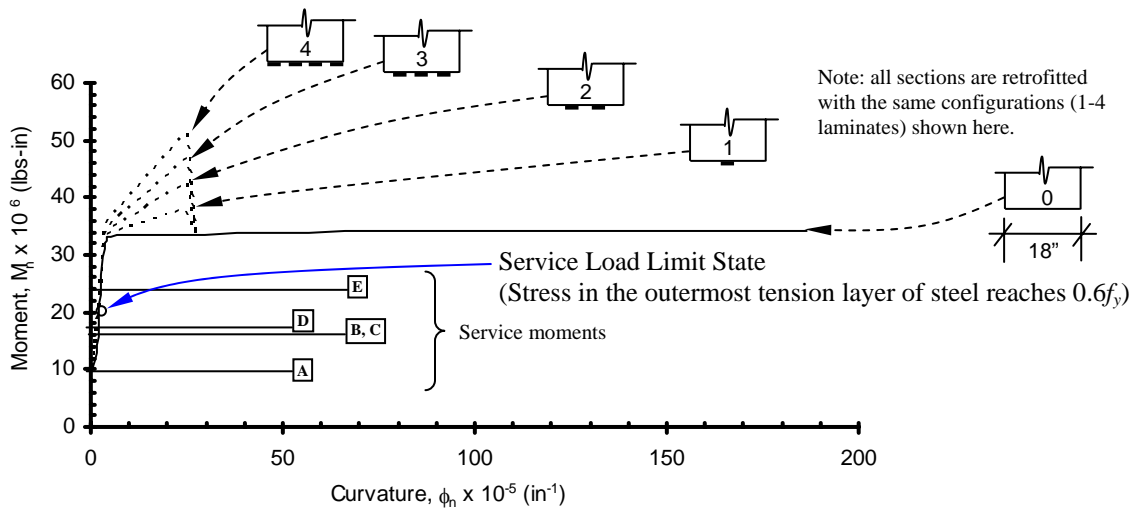
Table B-5. Service loads and design loads of Section 19-19 for Girder 4 in Span 7.

Fig. B.5.a – Comparison of service moments with $M_n-\phi_n$.

Number of strips required = 4

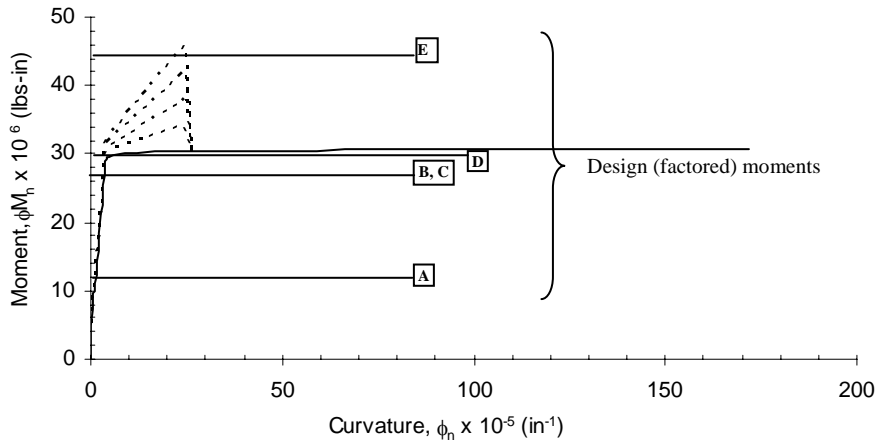
³ bold numbers indicate that the factored applied loads exceed the capacity of the original section

Fig. B.5.b – Comparison of design moments with $\phi M_n-\phi_n$.

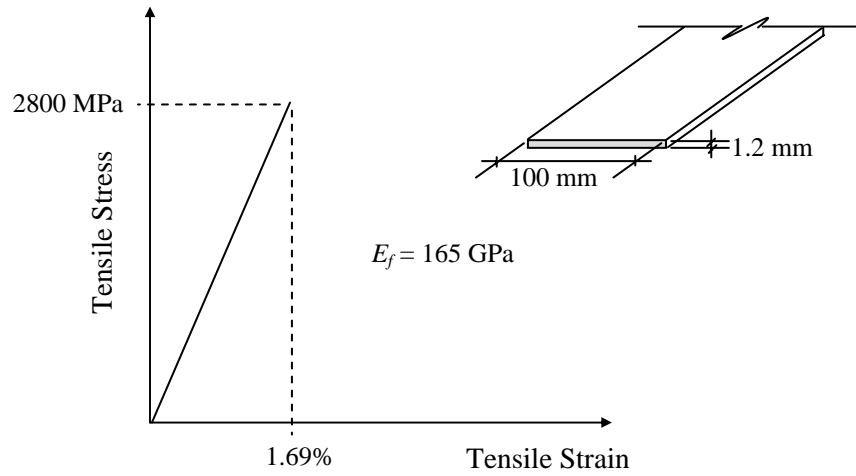
CFRP laminates produced by Sika were used in the project. The following are the properties of Sika CarboDur® laminate, used for flexural strengthening:

Fig. C.1: Physical and mechanical properties of CFRP laminate used for flexural strengthening.
