# TRUCK ROUTE ACCESS EVALUATION

United Parcel Service, Standiford Field Louisville Airport, and Ford Motor Company  
Louisville  
Site # 6

KTC Report No. 99-32

“Freight Movement and Intermodal Access in Kentucky”  
Project No. SPR 98-189

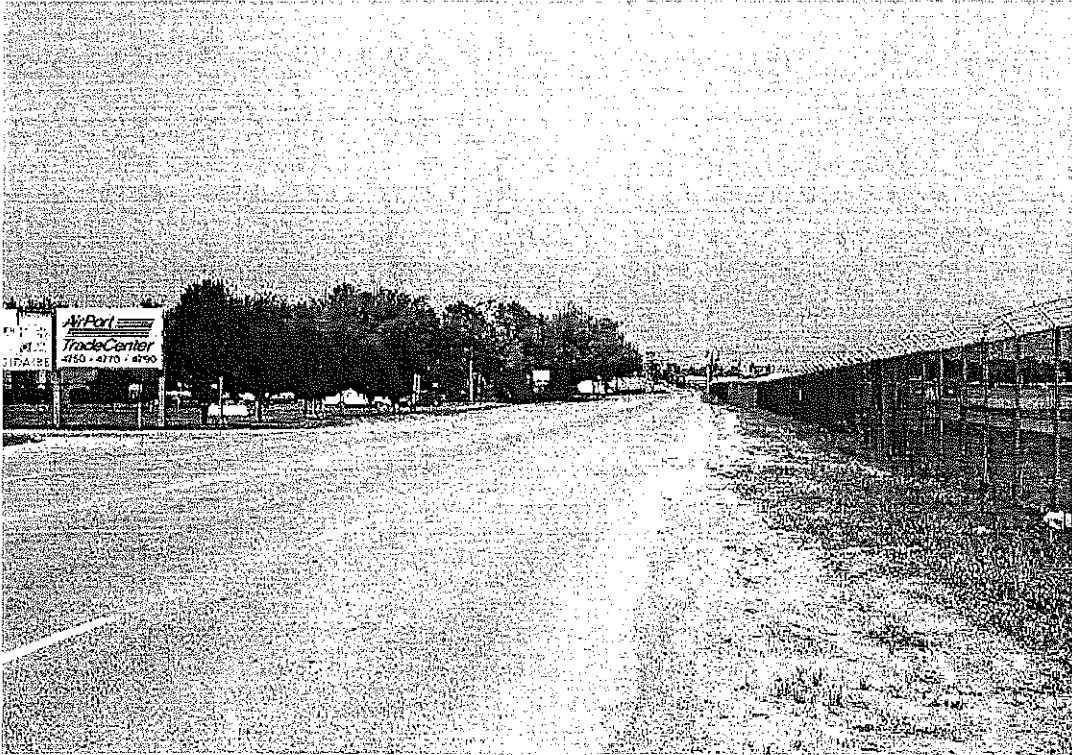
**Figure 2: Crittendon Avenue (west of Airport)**

Crittendon Drive to the west of the airfield (shown in Figure 2) has four 12-foot lanes with a turf shoulder that varies in width. This road has a total length of 1.4 miles and is no longer state-maintained. Fern Valley Road (shown in Figure 3) is KY1631 and has four 12-foot lanes with paved 10-foot shoulders. The western portion of the road has a two-way left turn lane in the center. Fern Valley Road now dead ends approximately 1500 feet beyond the intersection with Grade Lane. A total of 0.75 miles of the truck access route lies along Fern Valley Road. This section has an ADT of 30,819 (KYTC HIS data). Grade Lane is shown in Figure 4. This curbed section has 12-foot lanes (wider in some locations). The section varies from two to four-lanes and has some curbed sections while others have gravel shoulders. The total distance from Fern Valley to I-65 along Grade Lane is 2 miles. Grade Lane is state-maintained and is also known as KY 2843.

The pavement was good on Grade Lane and Fern Valley Road but only fair on Crittendon Avenue. The clear zone on Crittendon Avenue is obstructed by utility poles and the airport fence.

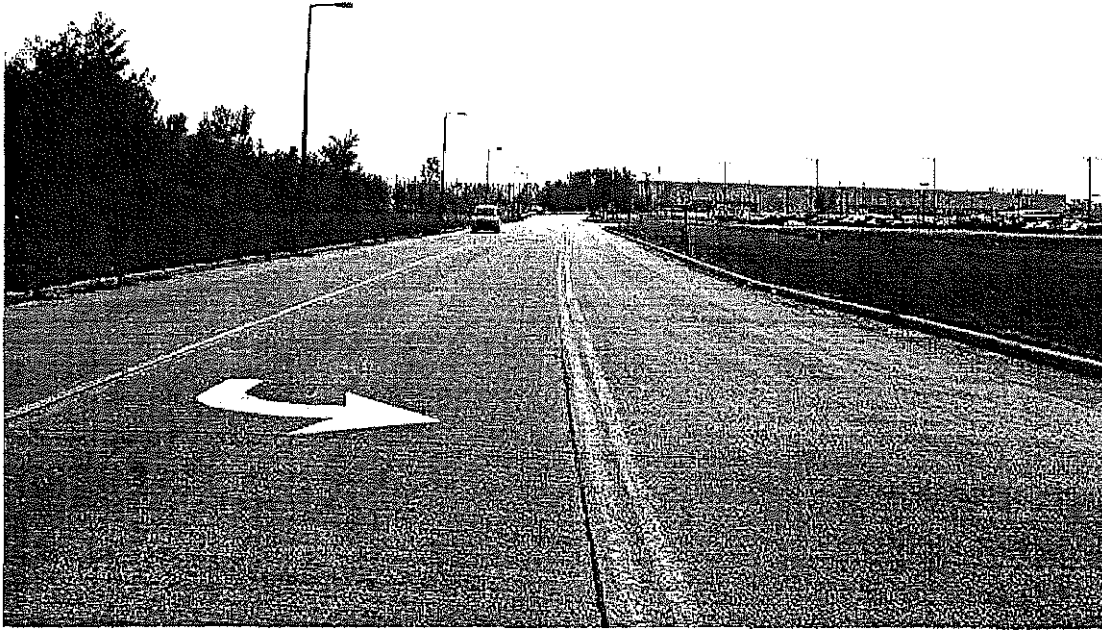
**Figure 4: Grade Lane Between Fern Valley Road and I-65 (looking south)**

A few minor obstructions were noted on Grade Lane.
