## TRUCK ROUTE ACCESS EVALUATION

Logan Aluminum  
Russellville - Logan County  
Site #2657

Report No. KTC-99-44

“Freight Movement and Intermodal Access in Kentucky”  
SPR 98-189

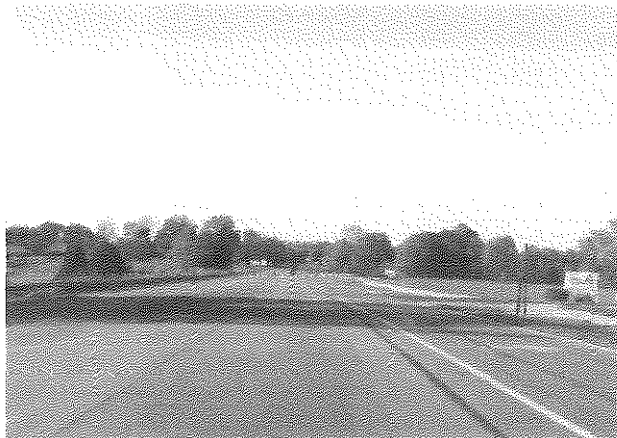
**Figure 2: An Entrance to Logan Aluminum**

Truck access to Logan Aluminum off US 431 is very good via four entrances. One is shown in Figure 2. All are similar in layout and have right and left turning lanes from US 431. Each access is clearly identified by signs. The speed limit through the area is reduced to 45 mph. The terrain is mostly clear and flat. Each entrance crosses a single railroad track approximately 45 feet from the edge of the roadway and running parallel to US 431 as shown in Figure 3. There are no gates or warning lights at these crossing which have standard railroad crossing signs and do not appear to be used frequently.

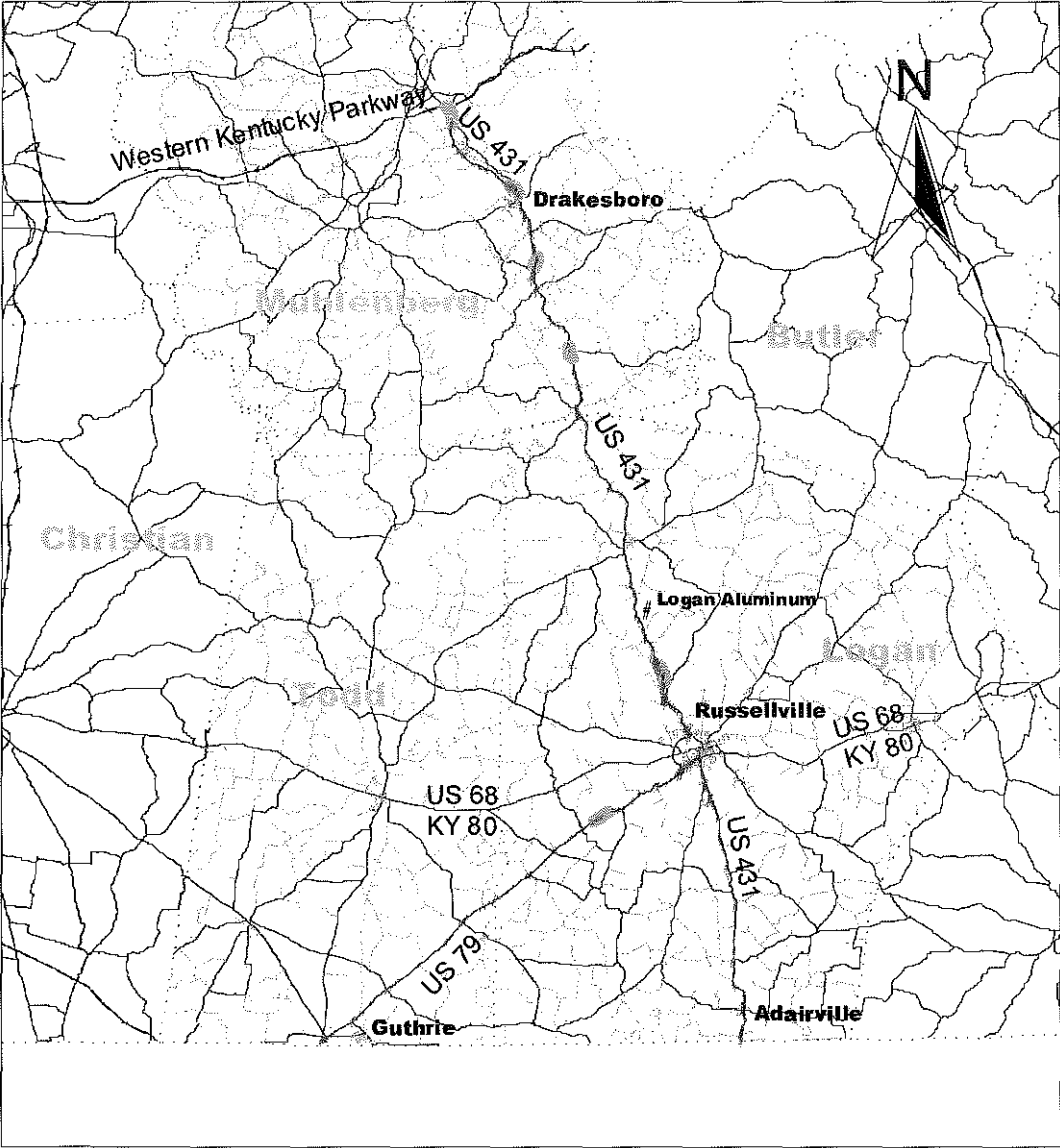
**Figure 4: Accident Locations (1995-1997)**

A section of US 431 in Muhlenberg County, at MP 2.879-3.454 had a high critical accident factor ( the ratio of the actual accident rate to the critical accident rate) of 2.9. Most of the accidents occurred at the Rocky Creek Bridge which is a narrow concrete bridge. Figure 4 shows the locations of accidents during the years 1995, 1996, and 1997. The figure shows that the accidents were scattered along US 431, with a significant number occurring between the site and Russellville and at the Rocky Creek Bridge.

A summary of the accidents along the individual truck routes is shown in Tables 4, 5 and 6 for the same three year period. Truck accidents represent a significant portion of the overall accidents along Route One. The 11.5% of accidents involving trucks is higher than the percent trucks along US 431 (8.9%). The 15.2% of accidents involving trucks on Route Two is also higher than the percent trucks on KY 79 (9.2%) US 431 (8.9%). Route Three had 9.7% of accidents involving trucks which is below the percent trucks traveling along US 431 south of Russellville (12.8%) and KY 79 in Russellville (9.2). The 9.7% is higher than the section of US 431 north of Russellville (8.9%). The high percent of truck accidents along Route One and Route Two suggests there may be some safety concerns from an accident history point of view.

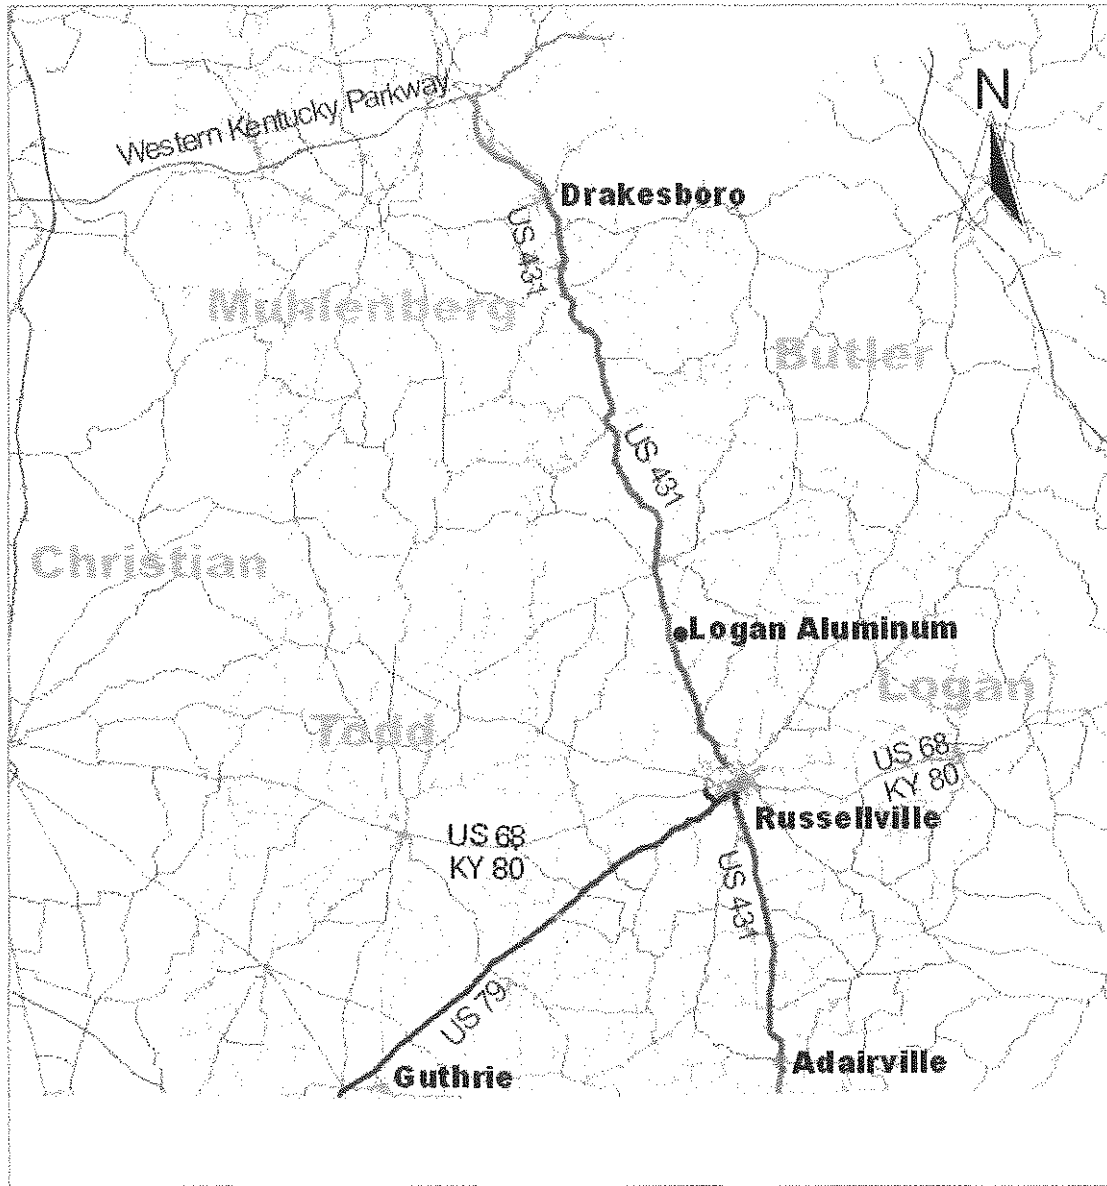
**Figure 5: Lane Widths**

Figures 5 and 6 show the sections of the route having different widths of lanes and shoulders. All access routes to this site are two-lane roadways with the exception of the routes using the bypass west of Russellville. The bypass is a 4-lane divided roadway. US 431 has lane widths of either 11 feet (“adequate”) or 12 feet (“preferred”). US 79 has primarily 10-foot, “less than adequate”, lanes in Todd County and Logan County. All pavements are generally in good condition.

US 431 north from the site to the Western Kentucky Parkway has 11-foot lanes. This feature is rated “adequate” with 12-foot lanes being “preferred.” There are several speed advisory signs posted along this route in Muhlenberg County.

The Six Year Highway Plan Project to widen US 431 from north of the intersection with US 68/KY 80 to the Logan Aluminum entrances will correct deficiencies associated with this section of roadway.

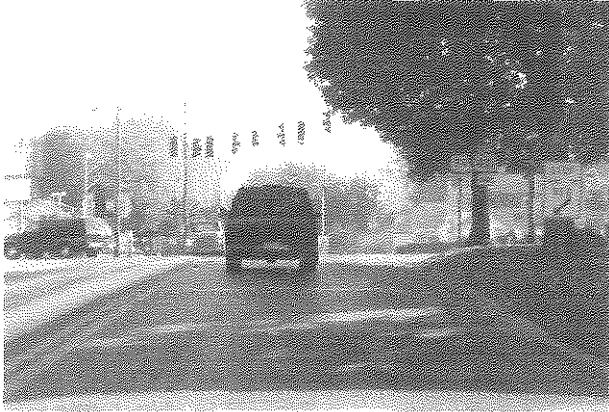
Figure 7: US 79 at US 431 in Russellville.

One turning radius problem was noted and observed. The potential problem is where trucks make any turn at the intersection of US 79 and US 431 in Russellville as shown in Figures 7 and 8 and illustrated in Figure 9. This was a location for concern as reported by the phone survey. Both routes have two 10-foot lanes, curbs, and join at 90 degree angles. There are no turning lanes at this signalized intersection. The stop bars have been set back a considerable distance to allow opposing traffic adequate space to negotiate turns. This turning radius is rated “less than adequate”.

The turning radius problem should be addressed. Major construction to correct other problems should be considered depending on future traffic and truck projections. Continuation of the bypass south of Russellville would correct many problems.
