**Research Report
KTC-99-4**

**AN INVESTIGATION OF THE RECENT DETERIORATION
OF I-75 IN SCOTT COUNTY**

March 1999

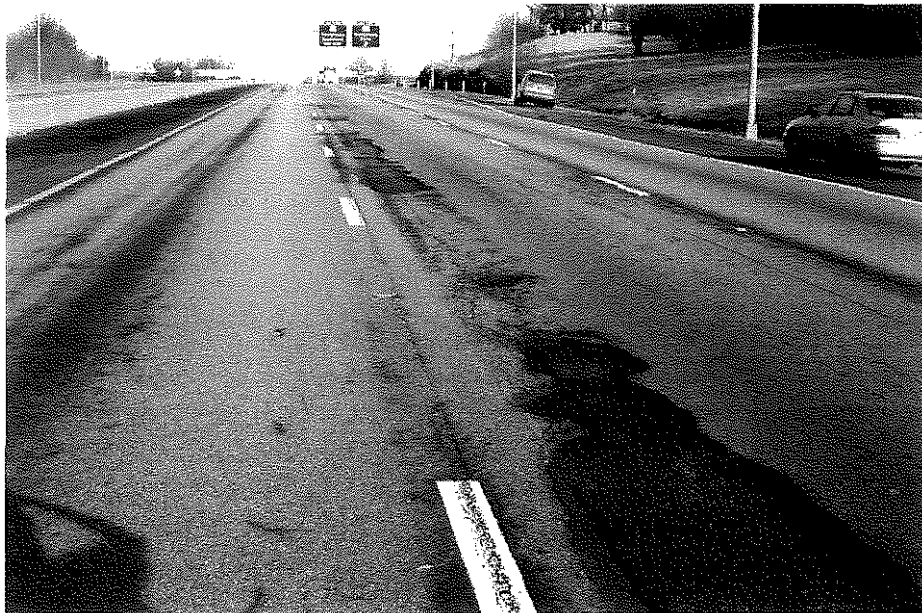
In early January of 1999, approximately 15 miles of I-75 in Scott County began to rapidly deteriorate. The existing pavement exhibited several potholes and delaminations (Figures 1 – 3). The worst section of deterioration fell approximately between mileposts 125 and 133. In this portion, the potholes and delaminations were more numerous. It appeared that many of the delaminations were associated with the construction joints.

Figure 1. Delamination and Potholes on I-75.

In the latter part of January, the condition of the highway had declined to the point that corrective action was necessary. The worst sections were milled and patched with hot-mix asphalt (HMA). These patches continue to perform satisfactorily to date. Despite this temporary improvement to the pavement condition, a desire developed within the Department to investigate the cause of the deterioration in order to prevent a future similar occurrence. The purpose of this report is to relate the findings of that abbreviated investigation.

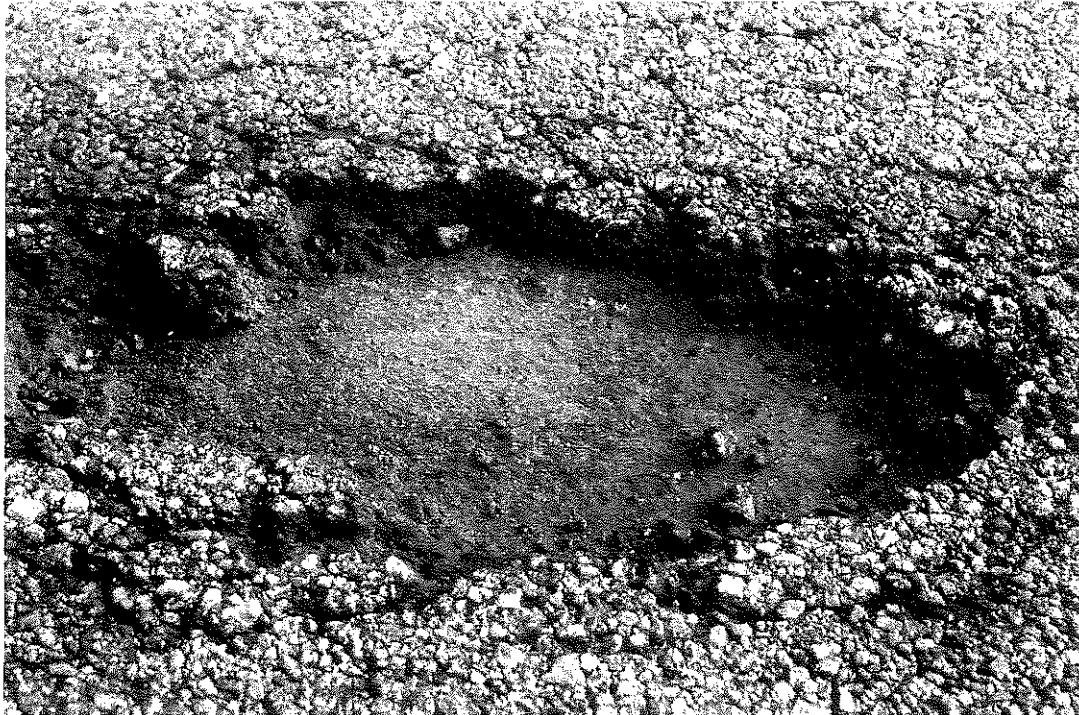
Figure 2. Showing Debonding of the Two Surface Lifts

It is believed that the “dry” condition of the Scott County Class I-20 HT Surface is not providing a satisfactory material for the adherence of the Class A Surface. Therefore, the bond between the two materials fail, and the delaminations occur. The high dust content and low asphalt content of the Class I-20 HT Surface serve to produce a very “dry” layer of material. In addition, given the low in-place density of both surface layers, years of the presence of moisture and traffic action have stripped away much of the already inadequate asphalt coating. Also, this condition may cause whatever tack material was present originally to be stripped away. It is also believed that when the Scott County Class A Surface delaminates and exposes the Class I-20 HT Surface to weather and traffic, very soon thereafter, the Class I-20 HT Surface will begin to deteriorate as well.

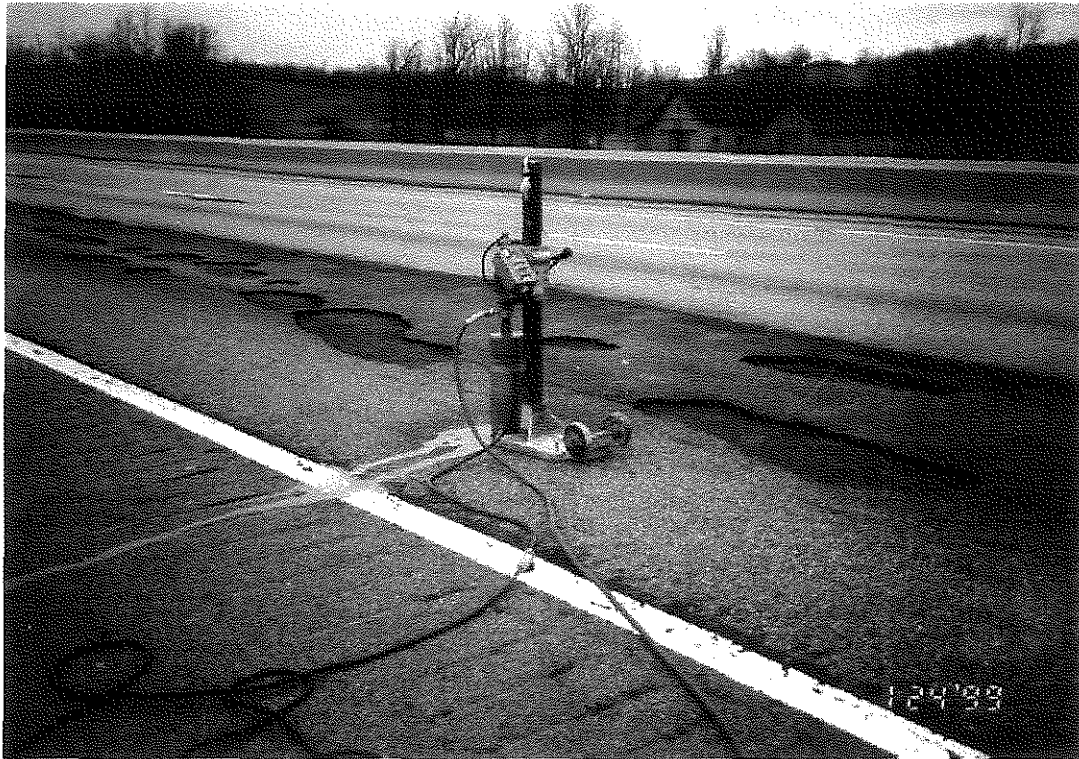
Figure 3. Cores Being Taken in Outside Lane in Delaminated Area.

Early this year, as the condition of the I-75 pavement in Scott County grew worse and more questions developed, the Kentucky Transportation Center (KTC) obtained a number of investigative cores from various locations. Specifically, KTC personnel obtained cores at four locations on I-75, at milepoints 120.0, 131.2, 133.0, and 137.5. The first milepoint, 120.0, is located in the Fayette-Scott County section that is currently performing satisfactorily. The other three milepoints, 131.2, 133.0, and 137.5, are located in the Scott County series. These cores were obtained at two separate times, once in January and once in February. The cores were taken near the construction joint between the inside and center lanes, and at the center of the inside lane. Cores could not be obtained directly from the center of the construction joint in Scott County due to degradation of the joint. Cores were obtained approximately 0.5 to 1.0 inch from the joint. These locations are discussed later in the report.

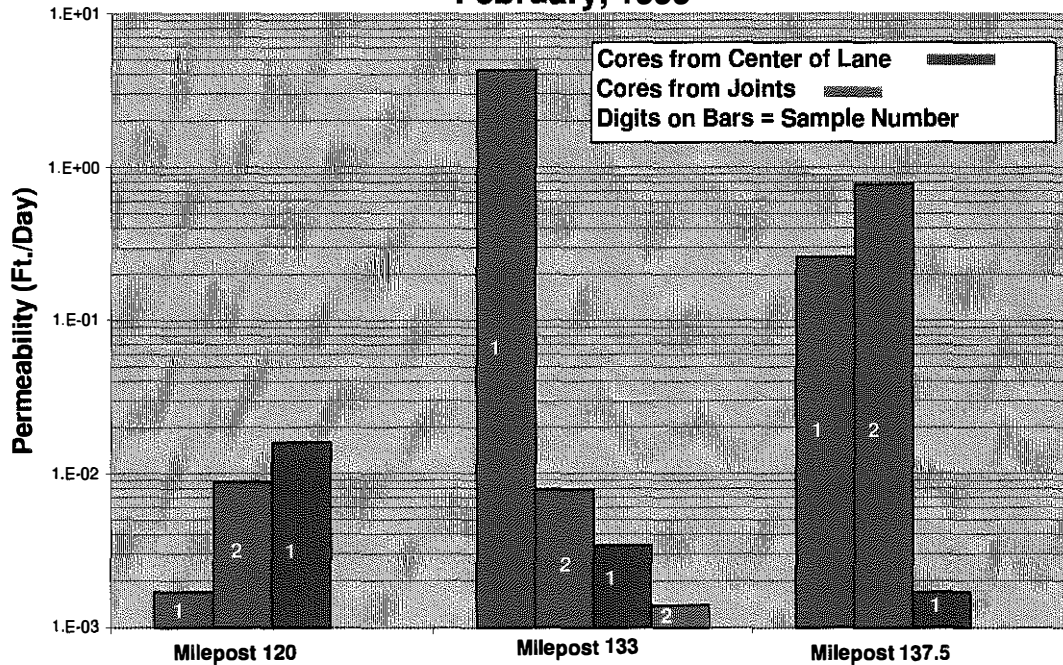
Permeability tests were conducted on 10 Class A Surface cores. Three cores were tested from milepoint 120.0, four from milepoint 133.0, and three from milepoint 137.5. The permeability tests were conducted on cores taken from the center of the lane and next to the joint. As mentioned earlier in the report, cores could not be obtained directly from the construction joint in Scott County due to the degradation of the asphalt pavement at the joint. It should also be noted that during the initial attempts to obtain cores directly from the joint in Scott County, all of the core water was lost into the construction joint of the pavement. However, the cores taken next to the joint were substantially less permeable.

After further analysis of the cores and the permeability test results, it appears that small fractures in the asphalt surface of two of the cores is contributing to the increased permeability of the samples tested near the joint at milepoints 133.0 and 137.5 in Scott County.

The higher permeability of the Class A Surface near the joint, and the loss of the core water at the joint, in the Scott County sections indicate that water is probably entering the pavement at and or near the joint, and is likely causing delamination of the Class A Surface layer from the underlying Class I-20 HT Surface layer.

Permeability of Class A Surface from Cores Collected in February, 1999
