**Research Report
KTC-97-3**

**PERFORMANCE EVALUATION OF RECYCLED PCC
PAVEMENT USED AS A CRUSHED STONE BASE
AND DENSE GRADE AGGREGATE**

Kentucky Transportation Center
College of Engineering
University of Kentucky
Lexington, Kentucky

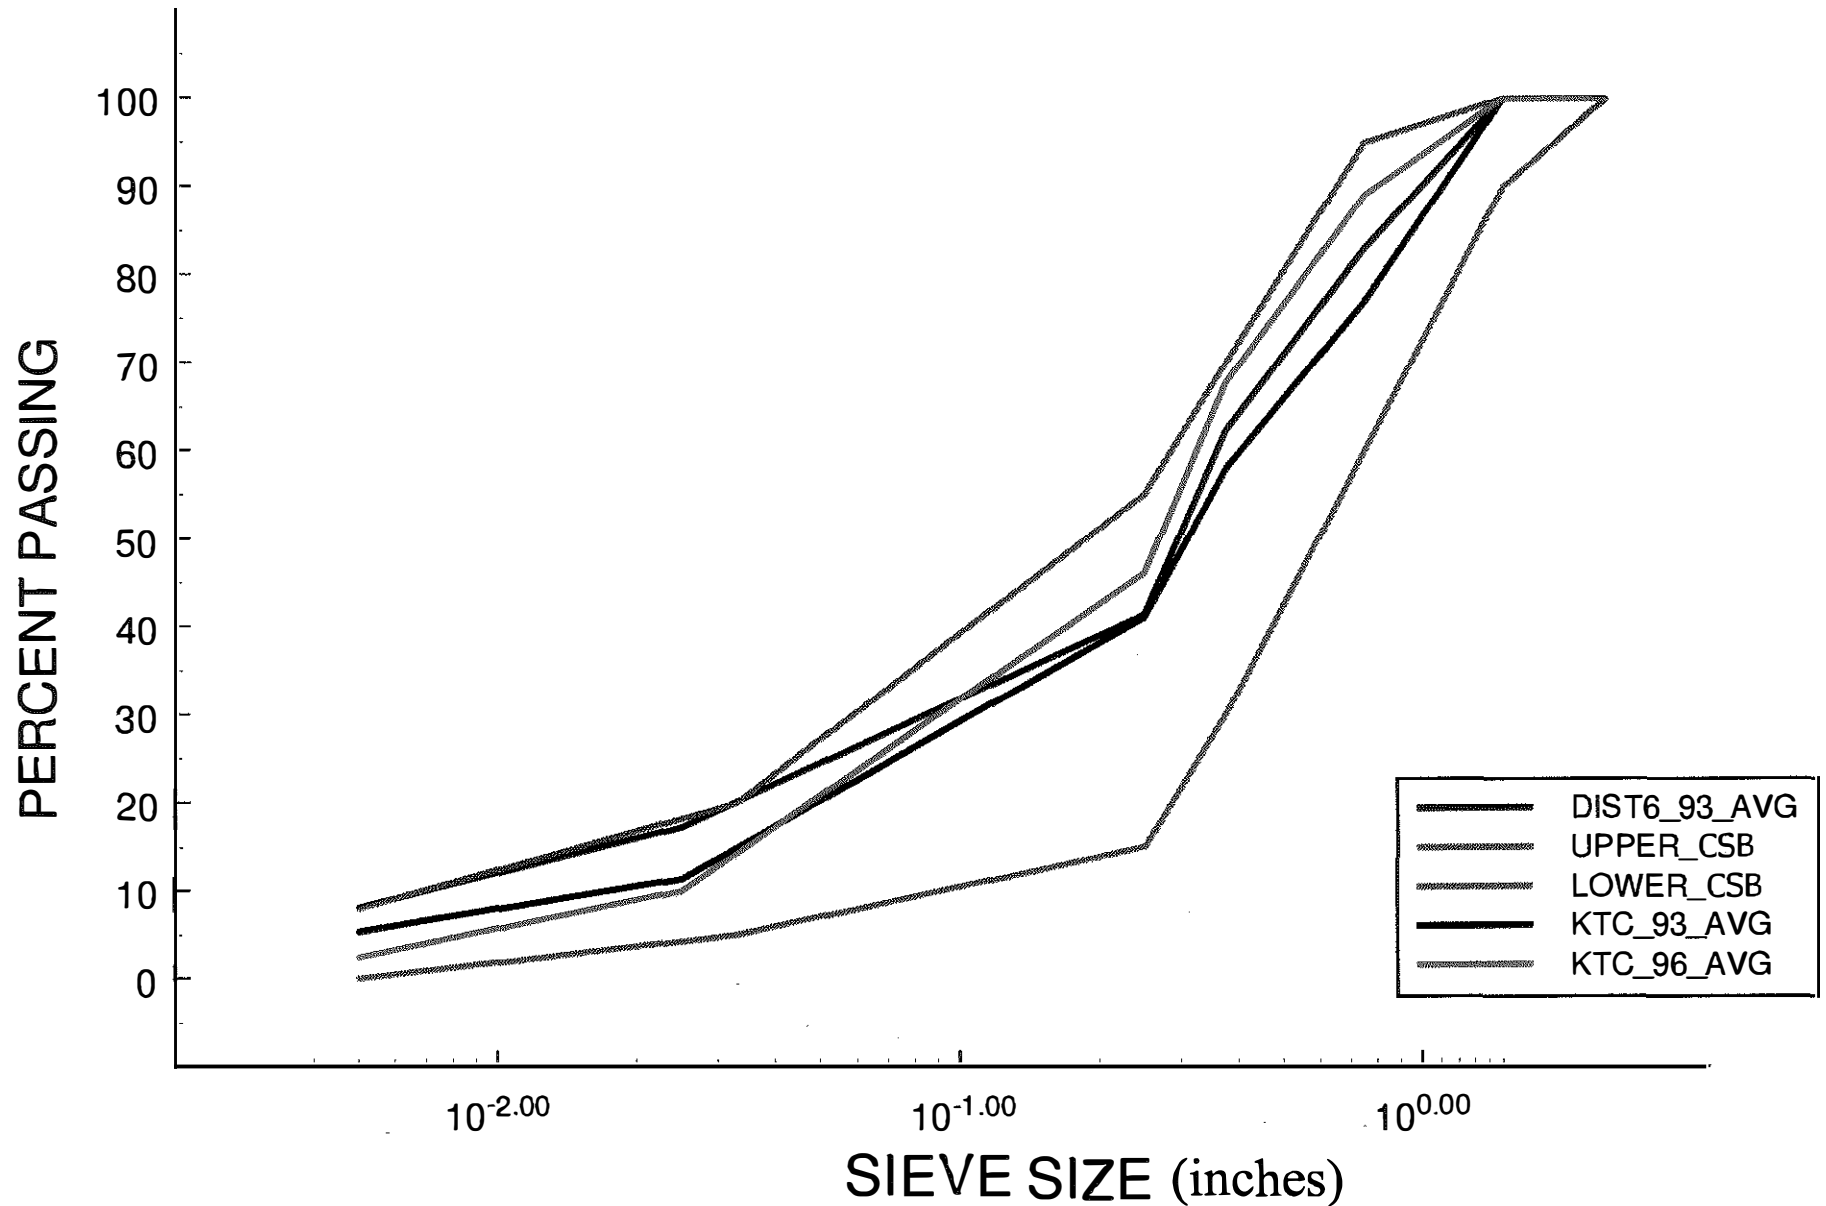
Figure 4, Recycled PCC CSB Percent Passing Averages and Crushed Stone Base Limits.

The major concern with using RPCC instead of the conventional virgin limestone for DGA and Crushed Stone Base (CSB) was that it would deteriorate more quickly. Since conventional DGA is composed of almost 100% limestone and RPCC CSB is composed of both gravel and hydrated Portland cement, a loss in stability was of concern. Two lab procedures were performed on the RPCC aggregate to determine its soundness. First, aggregate samples were collected during construction in 1992 and gradations were performed on them. Later, in 1996, aggregate samples were removed from the roadway and gradation tests were again performed. Both sets of data were evaluated, along with gradation data taken during construction by personnel of District 6 of the Kentucky Department of Highways. The results showed that some breakdown does occur, but the aggregate stays within the specification boundaries. The gradation breakdown of the three sets of data is shown graphically in Figure 4. To insure the accuracy of the sieve analysis, two gradation tests were performed on the same sample. The results were practically identical, indicating good repeatability. The results of the two-test method are shown graphically in Figure 5. The gradation results obtained by KTC, along with error analysis figures, are shown in Table 1. The RPCC aggregate was to be crushed and evaluated according to Crushed Stone Base specifications. However, the aggregate also falls within the acceptable values for dense-graded aggregate. This is shown in Figure 6.

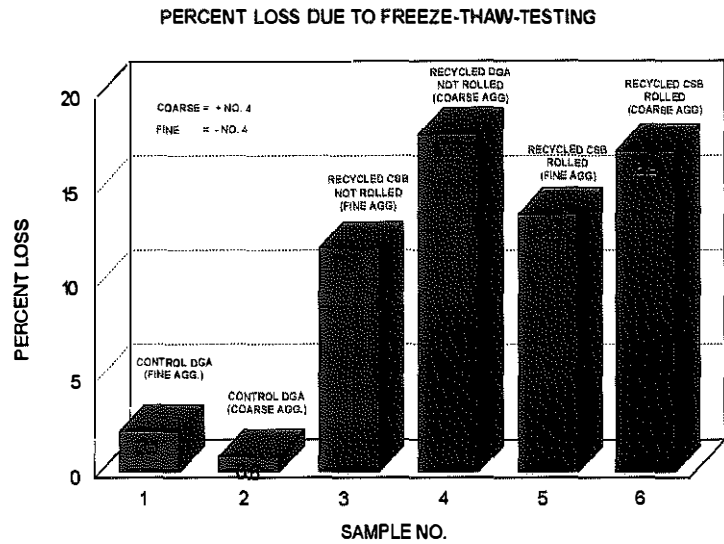
Figure 7. Percent Loss Due to Freeze-Thaw Testing

Freeze-thaw testing was also performed on RPCC CSB used on the I-75 project. Samples from before and after field compaction were obtained, along with a control sample of conventional DGA from I-275. The three samples were then subjected to 50 freeze-thaw cycles. After 50 cycles, the DGA was then graded on a 4.76 millimeter (No. 4) sieve to determine the percent loss and breakdown due to the freeze-thaw process. The test confirmed that the RPCC aggregate deteriorated more quickly than conventional DGA as a result of freezing and thawing. Deterioration of the rolled and unrolled aggregate was comparable after completion of the freeze-thaw tests indicating that normal mechanical stress

and handling does not cause significant breakdown of the RPCC aggregate. The results of this test are contained in Appendix A and are shown graphically in Figure 7.

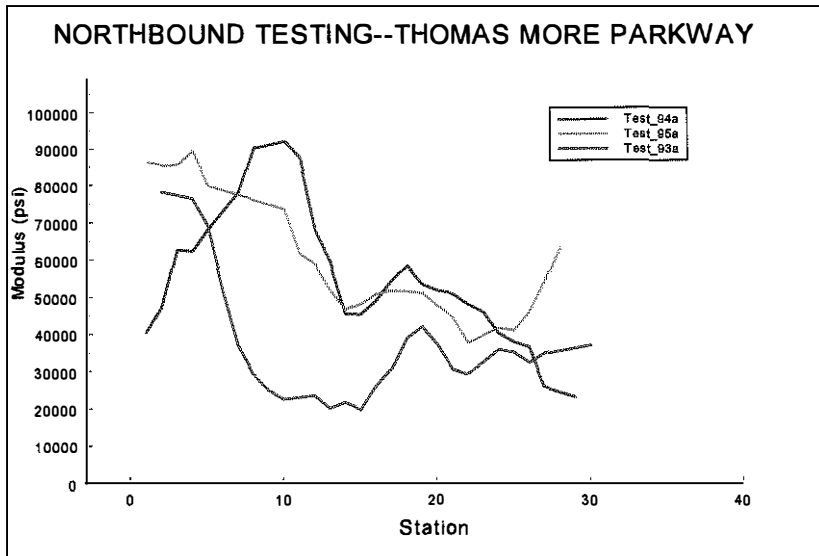
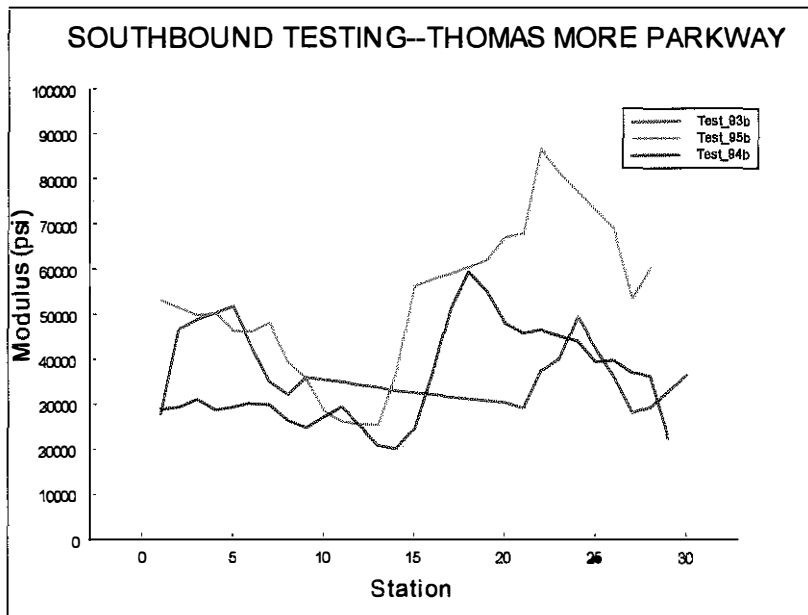
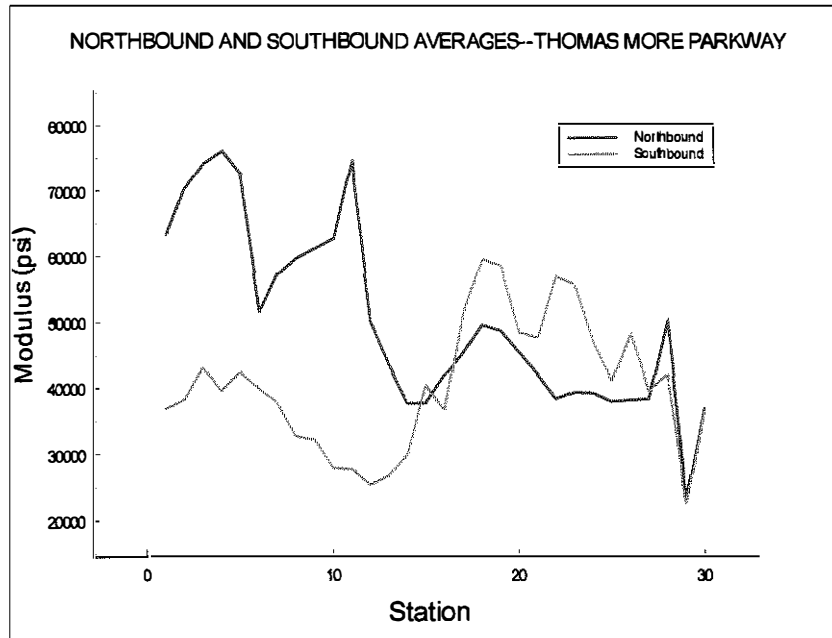
On the Thomas More Parkway, testing was done on each station using three load levels---approximately 62.3kN (14,000 lbs.), 48.9kN (11,000 lbs.), and 35.6kN (8,000 lbs.). Moduli values from the four different testing dates for the aggregate base ranged from 206.85 to 482.65 Megapascals (30 to 70 ksi), typical for aggregate base, especially considering that asphalt pavement moduli is very dependent on temperature and direct sunlight, and temperatures varied over 30 degrees Fahrenheit between some tests. The moduli values for the northbound and southbound tests for each year are shown graphically in Figures 9 & 10. The averages for all three years combined in each direction is shown graphically in Figure 11. The moduli values for each test, along with standard deviation values, are given in Table 2.

Figure 9. Falling Weight Deflectometer Testing, Thomas More Parkway, Northbound (1993-1995)

Figure 10. Falling Weight Deflectometer Testing, Thomas More Parkway, Southbound (1993-1995)

Figure 11. Falling Weight Deflectometer Testing, North and Southbound 3-Year Averages

The program used to evaluate the FWD field data and backcalculate the resilient modulus of the pavement and base layers was MODULUS 5.0. The program uses an iterative process to compute the moduli values. A problem with the calculation procedure is that a "unique" solution may not exist for the moduli values. Because of this, a four-layer roadway may be evaluated and two or more different sets of moduli values may be acceptable to MODULUS. Typically, however, only one set will be logical. Therefore, each moduli value must be scrutinized before it is considered as acceptable in evaluating the pavement and base properties of the roadway. All of the output data from MODULUS were evaluated and all illogical output were discarded. However, the amount of data discarded was nominal and did not significantly affect the accuracy of the evaluation.

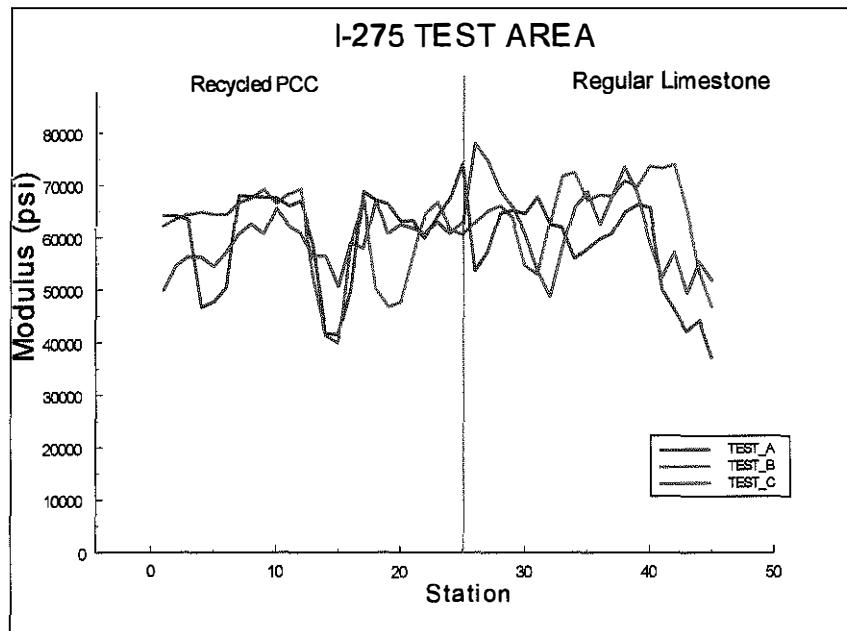
Figure 12. Falling Weight Deflectometer Testing, Interstate 275 (6:30 AM, 10:00 AM, 1:30 PM)

The FWD tests which were performed on I-275 were completed on the same day. Testing was performed on both the RPCC and conventional DGA sections at 6:30 AM, 10:00 AM, and 1:30 PM. A load of approximately 66.7 kN (15,000 lbs.) was used at each station twice.

On the section of I-275 that was tested, only loads of approximately 66.7kN (15,000 lbs.) were used. As the tests progressed throughout the day, the temperature increased, but concrete pavement is not affected by temperature as much as asphalt pavement. Moduli values for the conventional and recycled CSB sections were almost identical. Values ranged from approximately 406.8 to 448.18 Mpa (59 to 65 ksi) throughout both sections. The recycled CSB values were more consistent, showing values of 422.66, 415.77, and 424.04 Mpa (61.3, 60.3, and 61.5 ksi) at times of 6:30 AM, 10:00 AM, and 1:30 PM respectively. These values also fall within the typical range of moduli values for DGA. The moduli values at each station for the three tests are shown graphically in Figure 12. The moduli values for each section on each test, along with standard deviation values, are shown in Table 3.

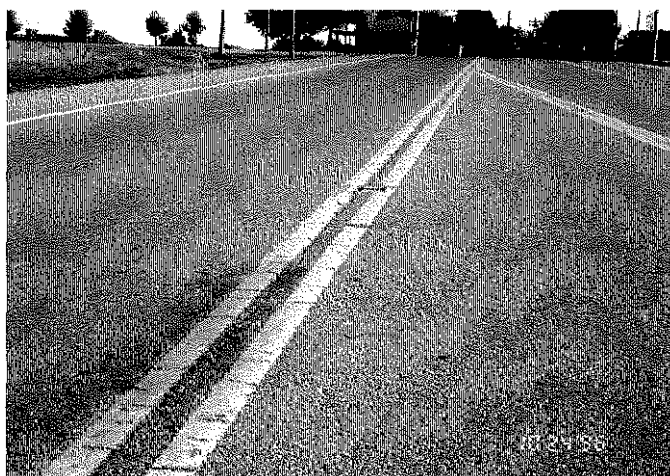
Figure 13. Bleeding observed at Station 183+75.

As part of the project, Center personnel performed annual visual surveys on the Thomas More Parkway from Station 186 + 50 to Station 171 + 00. In 1996, bleeding was observed at Station 183 + 75. This area is depicted in Figure 13. In April 1998, longitudinal cracking in the wheel paths was noted in several areas. A station-by-station depiction of the site is contained in Appendix B.

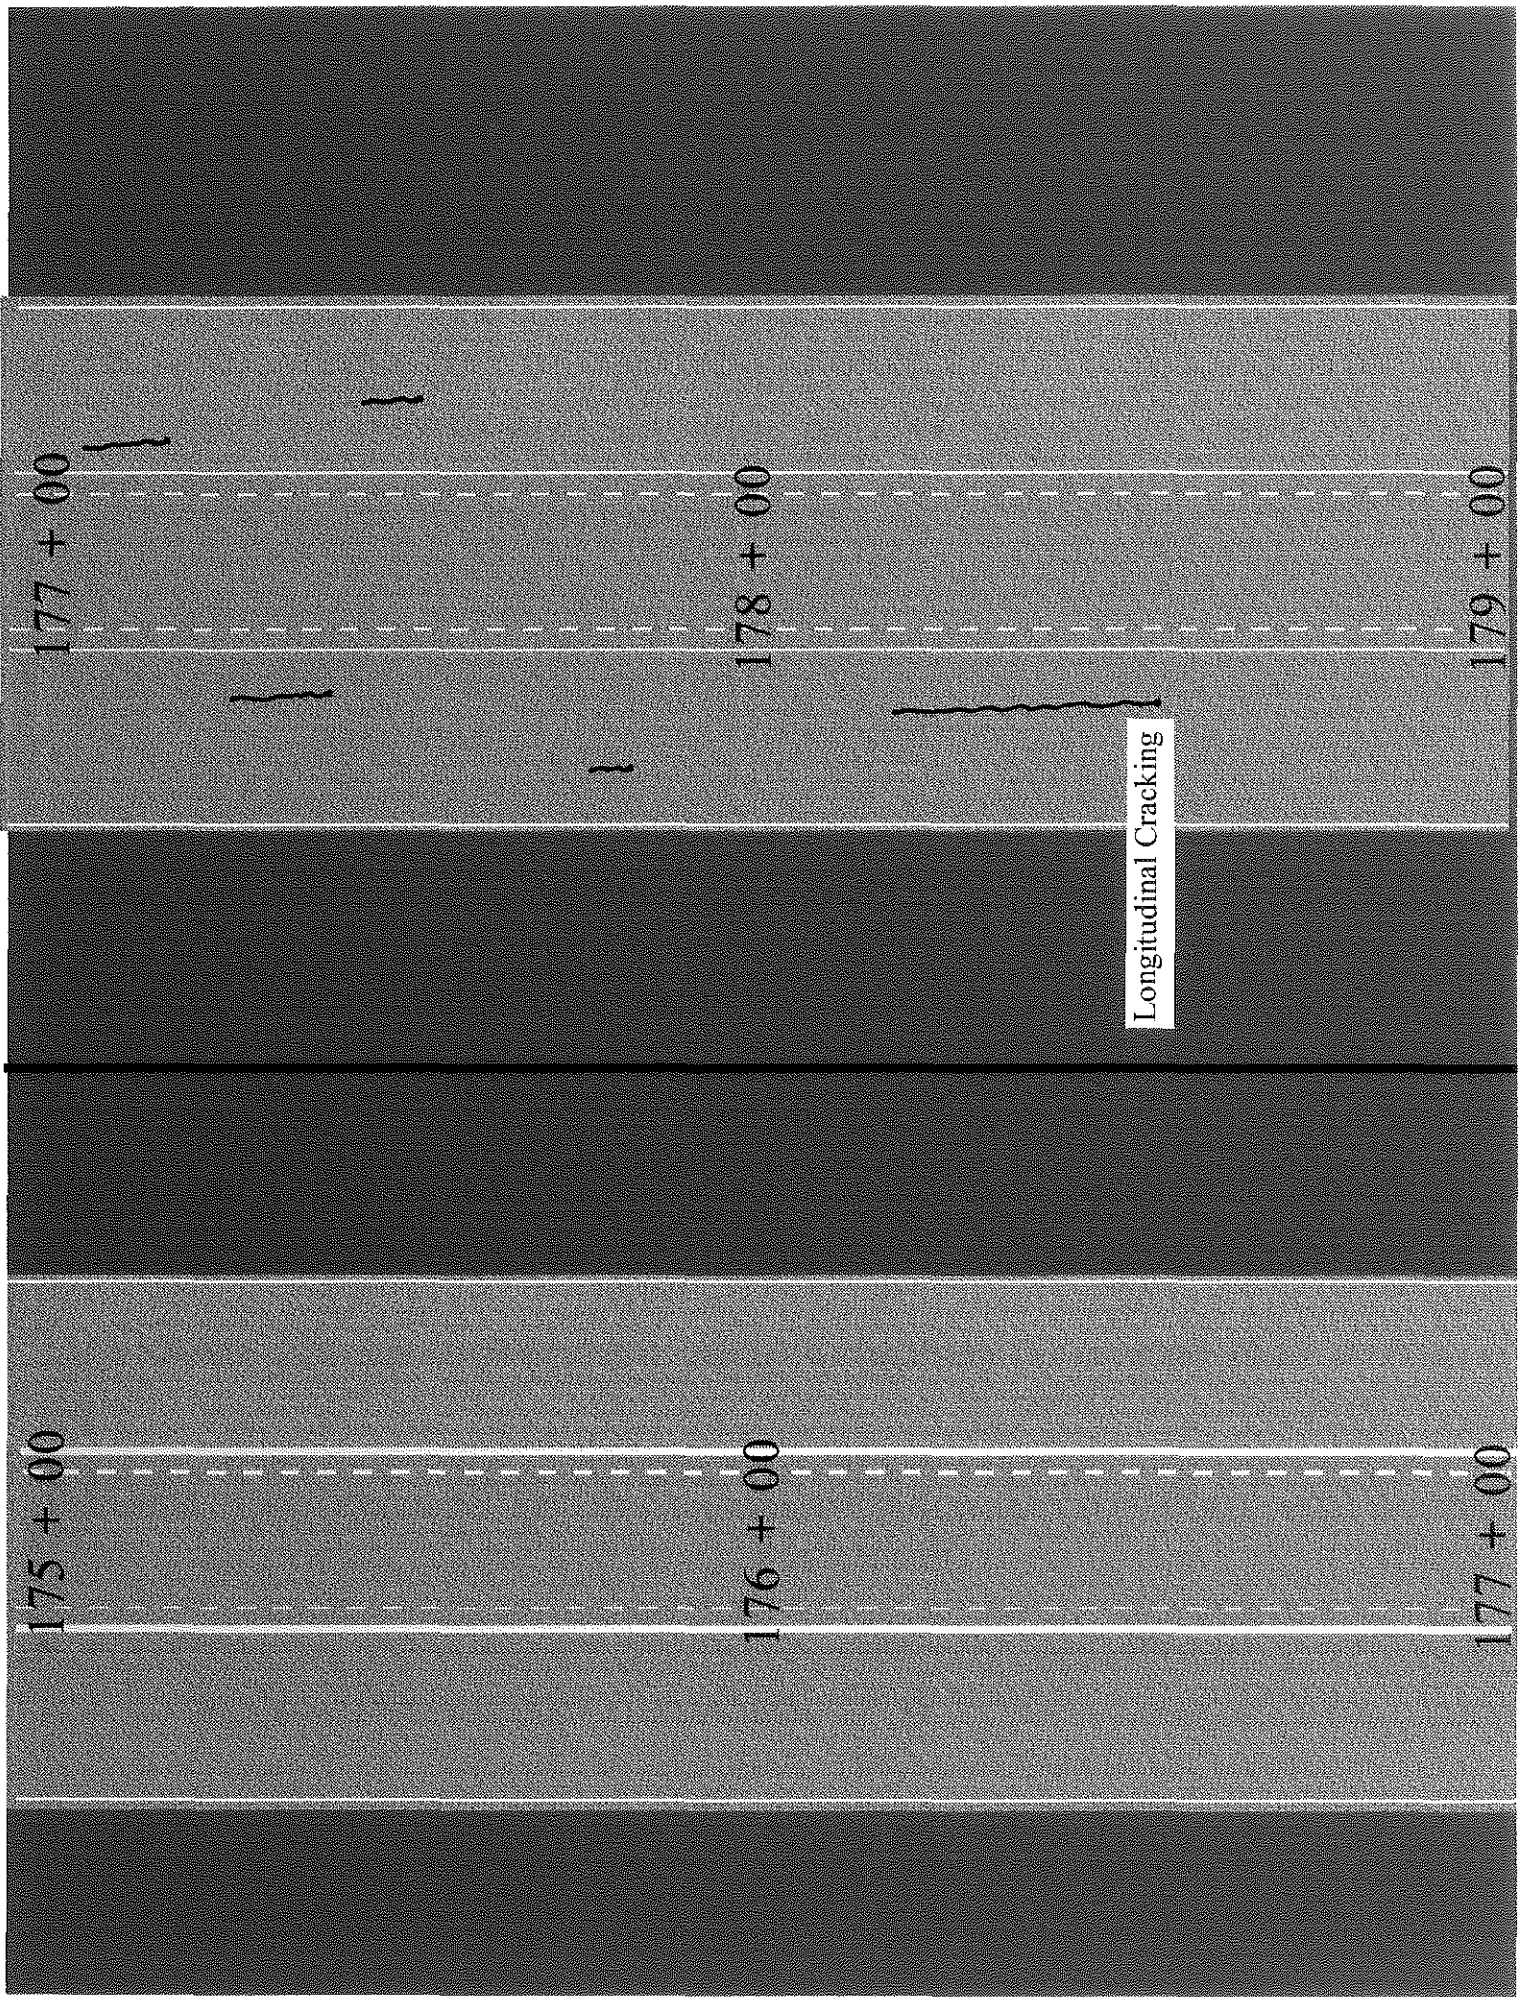
**APPENDIX B
VISUAL SURVEY
THOMAS MORE PARKWAY**

Longitudinal Cracking
