**Research Report
KTC 95-18**

**PAVEMENT DISTRESSES
AT INTERSECTIONS**

Kentucky Transportation Center
College of Engineering
University of Kentucky

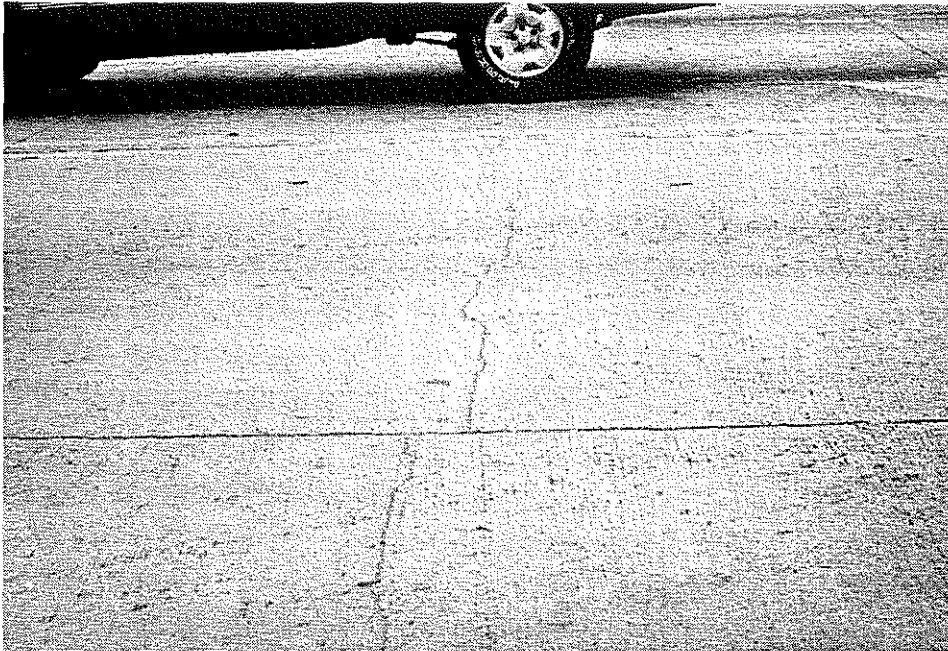
Figure 1. *Typical mid-slab crack of PCC pavement at intersection of US 31E and US 68/80*

Visual surveys of the intersection have been conducted annually. The visual surveys conducted in 1993 and 1994 revealed no significant distress, but a visual survey in June, 1995 indicated seven mid-slab transverse cracks and several expansion joints with missing sections of joint seal and raveling and cracking at those joints. The missing sections of joint seals are the construction related. Previous experience has shown that pavement joint faces must be thoroughly clean and dry prior to installing a silicone joint seal. Deterioration of the joint faces is likely due to weak concrete stemming from high water to cement ratios in the area of the joint. Based upon notes and observations made during construction, it is thought the mid-slab cracking has resulted from inadequate base compaction during construction. The mid-slab cracking observed in the seven slabs was minor and is not anticipated to have a detrimental impact on performance of the concrete pavement. A typical distressed expansion joint and mid-slab crack are shown in Figures 1 and 2.

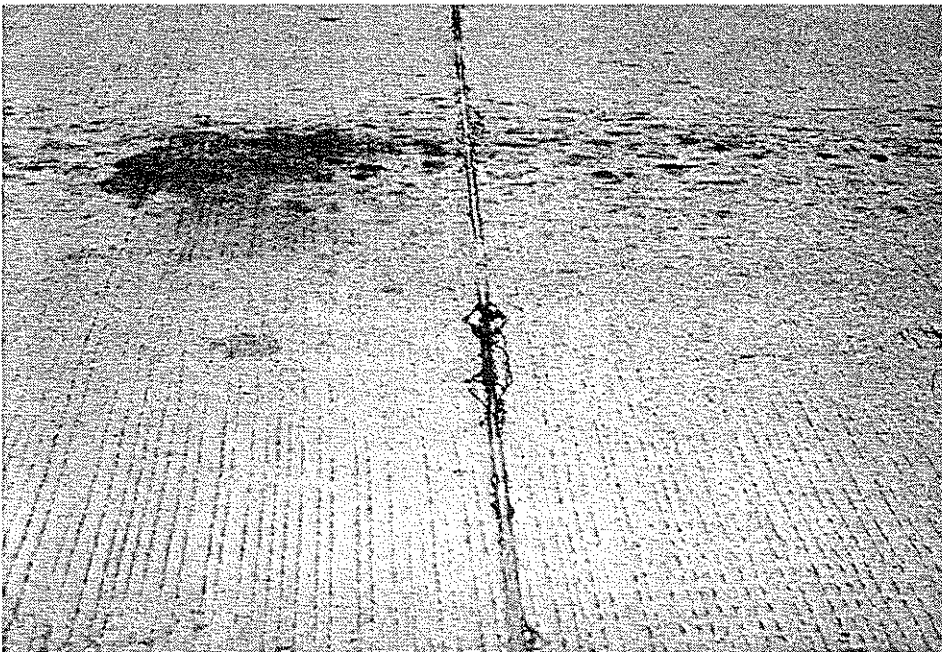
Figure 2. *Typical distressed pavement joint at intersection of US 31E and US 68/KY 80.*

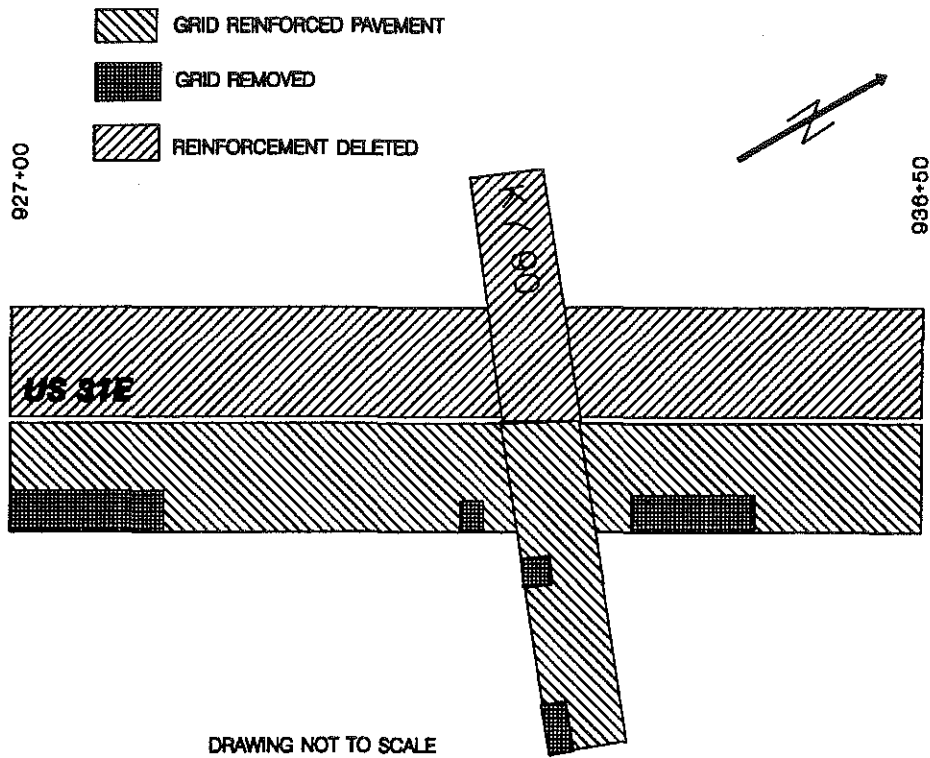
Figure 3. *Design and as-built location of TENSAR® pavement reinforcement at US 31E and KY 90.*

Initially, the general construction procedure was to place TENSAR® AR-1 with the long axis parallel to centerline, secure end to end overlaps with "hog rings", spray TENSAR® AR-1 and Class K base with tack coat, tension and pin the TENSAR® AR-1 to the base, and overlay with the third course of Class K base. The TENSAR® AR-1 was tensioned by pinning one end to the base, affixing a clamp across the free end and to a pickup truck, pulling the TENSAR® AR-1, and pinning the TENSAR® AR-1 to the base (Figures 4 and 5). Pins used were 127-mm (5-in.) concrete nails with washers (Figure 6). The side lap, adjacent strings of TENSAR® AR-1, varied from 0 to 610 mm (0 to 24 in.).

Problems occurred first with construction traffic picking up the TENSAR® AR-1 due to the tack coat. The tack coat was deleted. Another problem occurred when the TENSAR® AR-1 developed rolls or waves between the paver and haul truck (Figure 7). The bituminous mixture would fall through and beneath the TENSAR® AR-1 or the TENSAR® AR-1 would fold. Large areas would either have reinforcement grid near the surface or folds in the grid. In some cases, the reinforcement grid could be seen at the surface of the final base course. Several attempts to increase TENSAR® AR-1 tension sufficiently to eliminate the development of rolls or waves were unsuccessful. The solution to rolls or waves in the TENSAR® AR-1 was to cut the material in 6.1-m (20.0-ft) sections and slide them into place (underlapping by 0.9 to 1.2 m (3.0 to 4.0 ft) the previous piece) as the paver progressed. The

6.1-m (20.0-ft) sections were not fastened together, therefore, the reinforcement grid was not pretensioned where the cut sections were used.

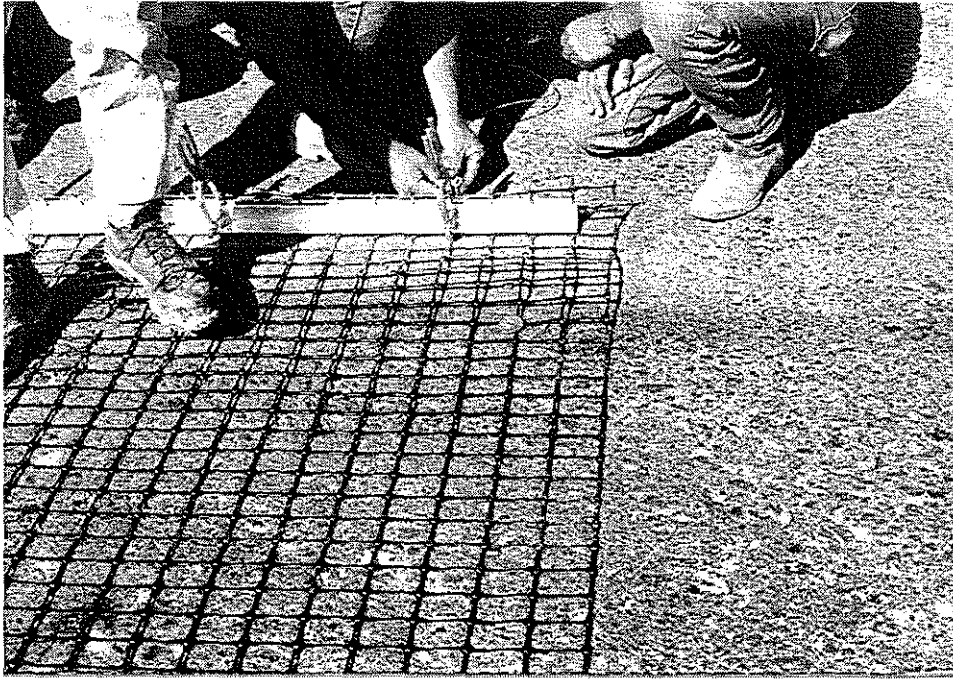
Figure 4. *Tensioning the TENSAR® reinforcing grid.*

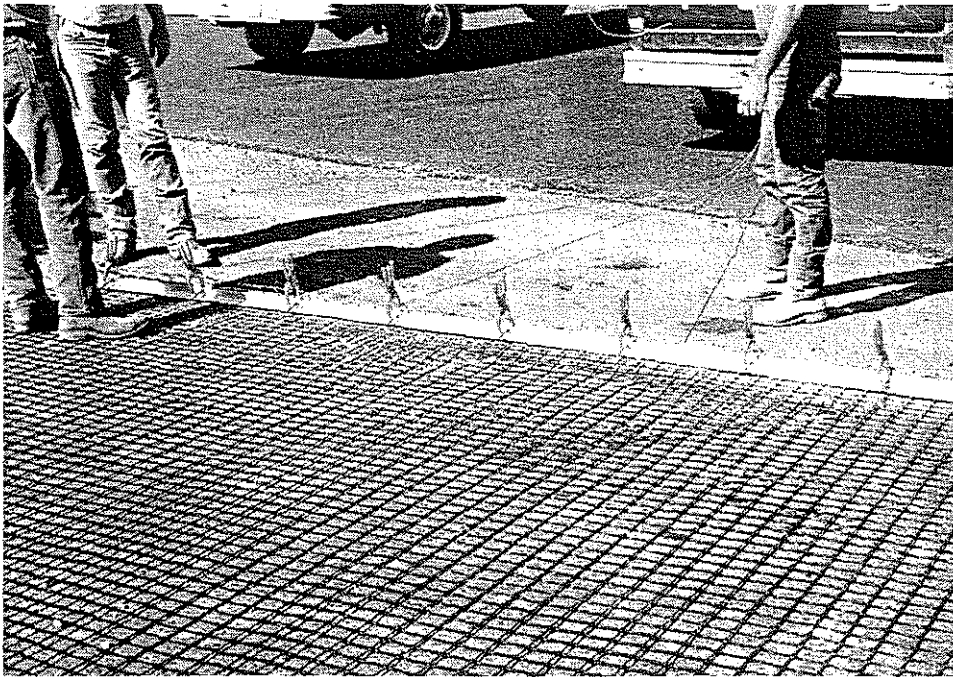
Figure 5. *Tensioning the TENSAR® reinforcing grid.*

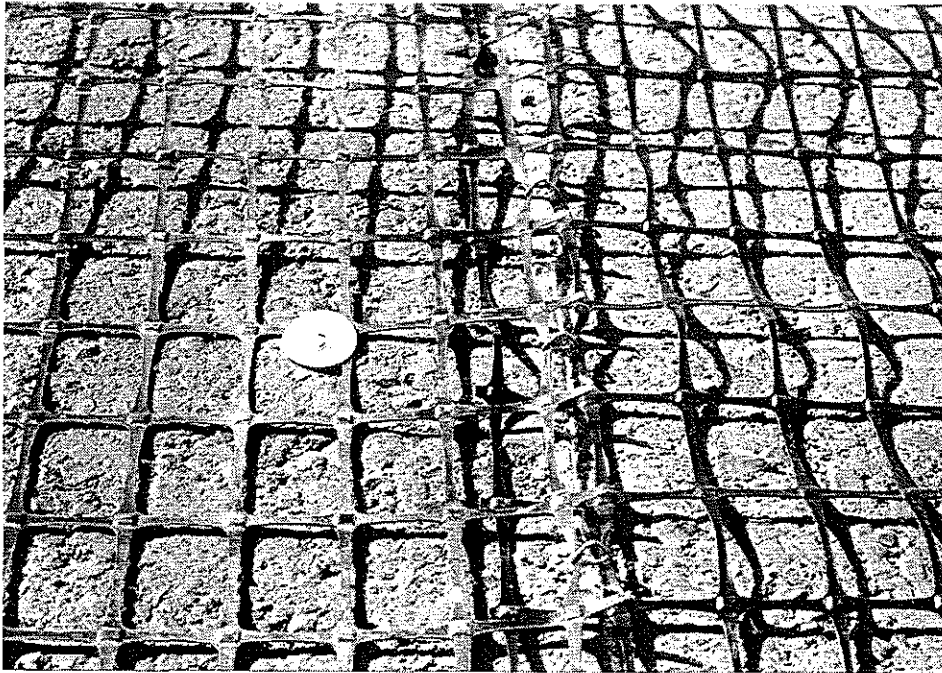
Figure 6. *Pinning the reinforcing grid to the base course.*

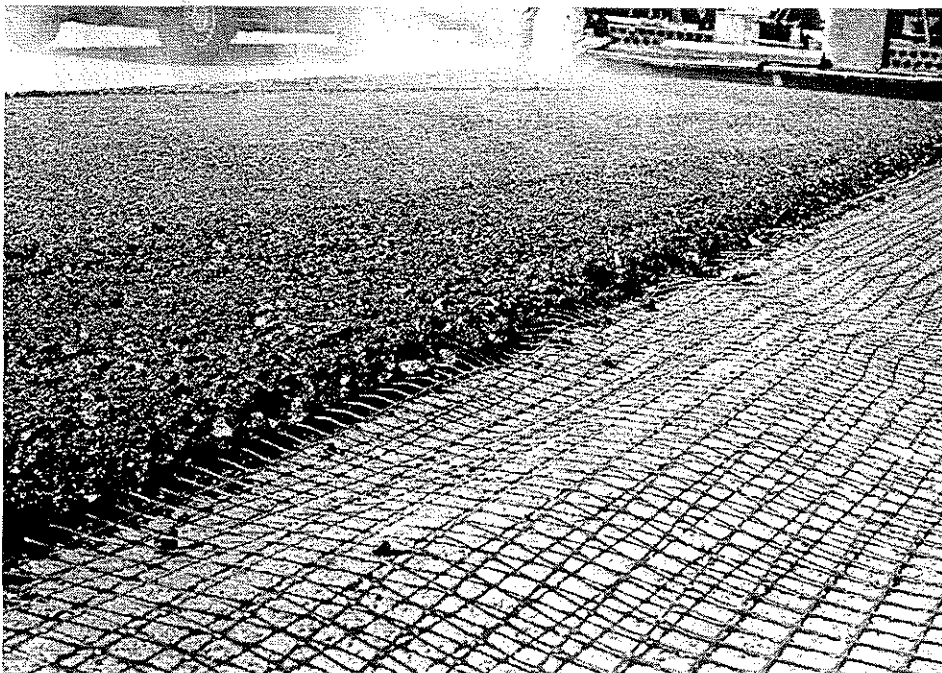
Figure 7. *Waves developed between the paver and the haul truck.*

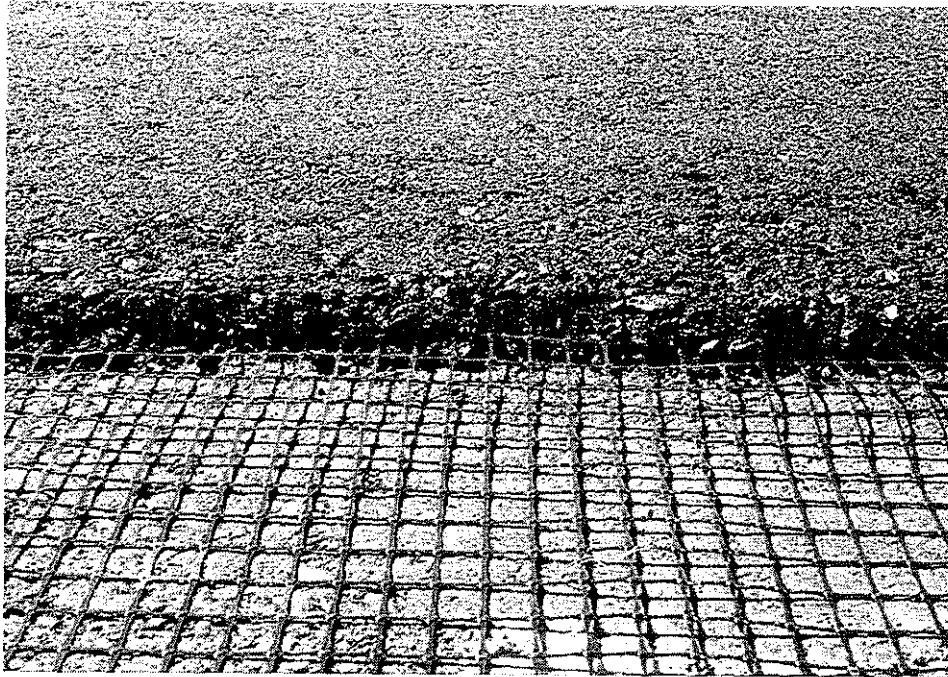
Figure 8. *TENSAR® reinforcing grid too near the top of the base course.*

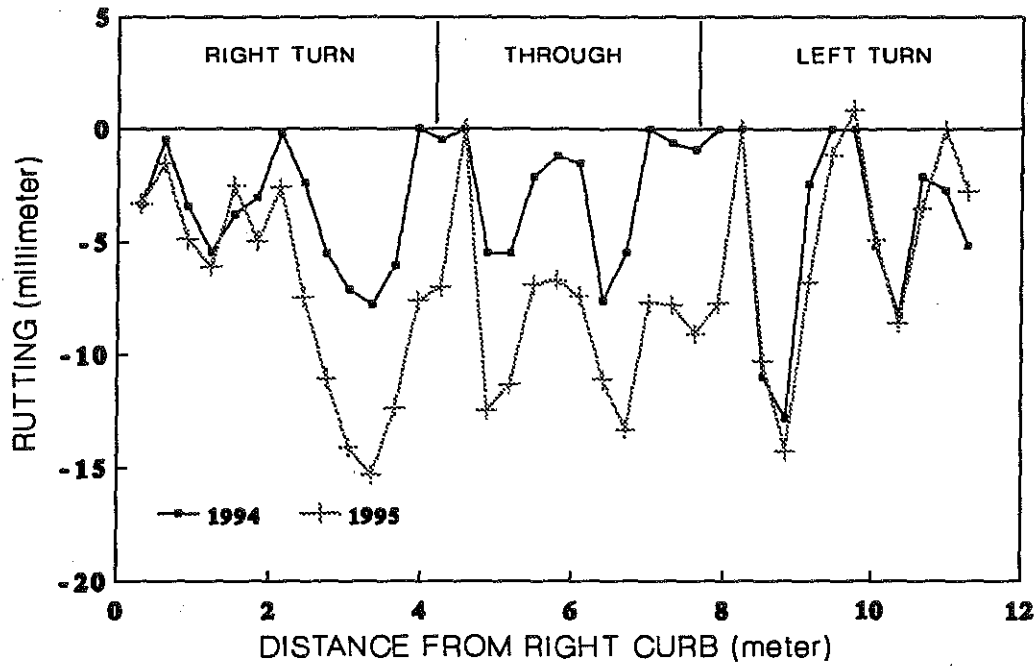
Figure 9. Rutting of KY 90 east bound at US 31E.

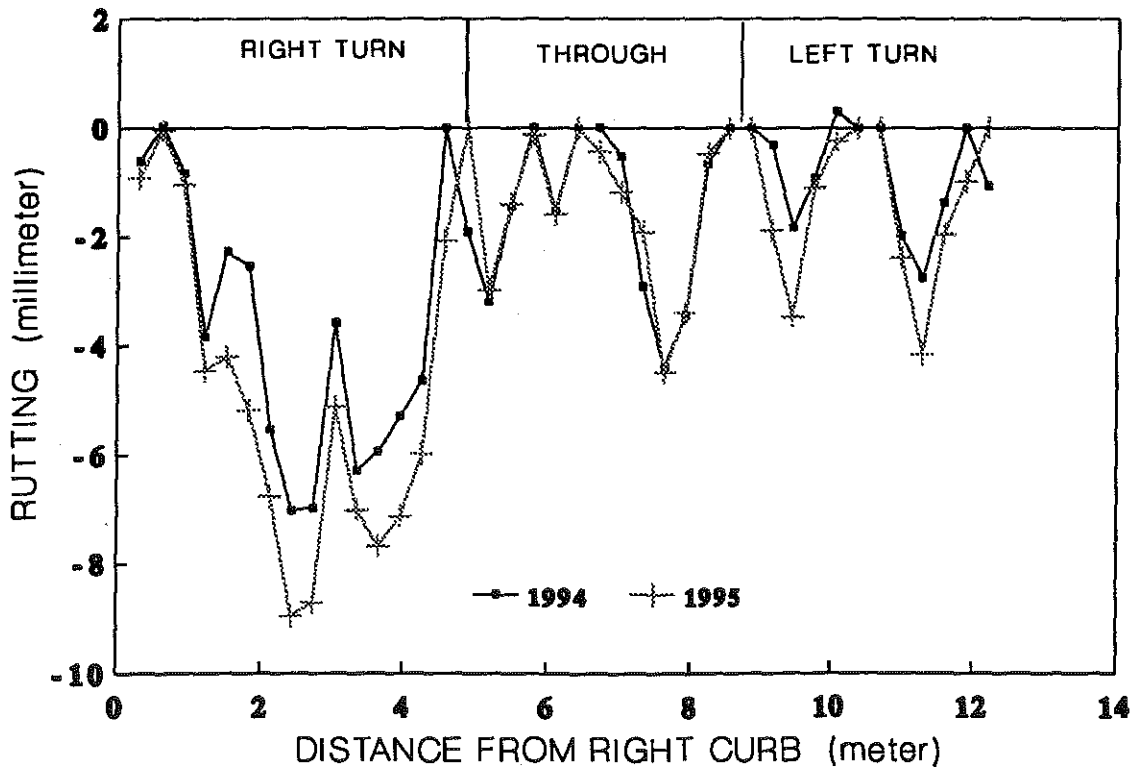
Figure 10. Rutting of KY 90 west bound at US 31E.

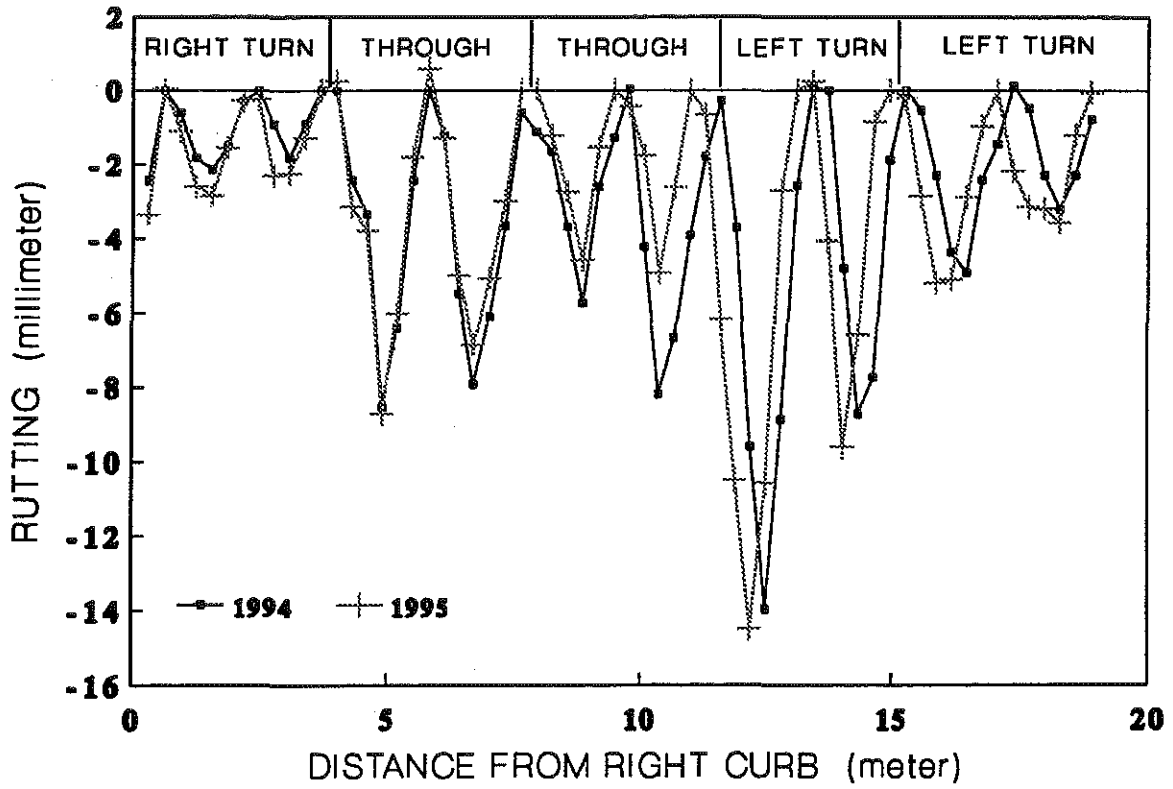
Figure 11. Rutting of US 31E north bound at KY 90.

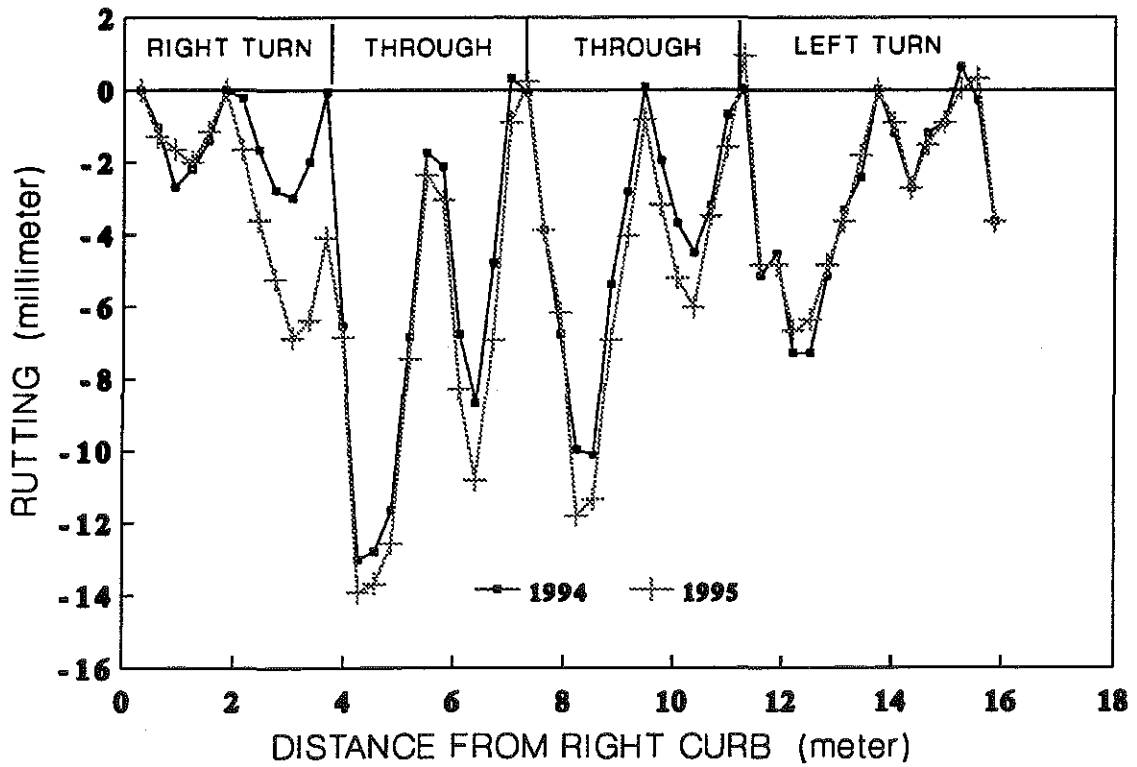
Figure 12. Rutting of US 31E south bound at KY 90.

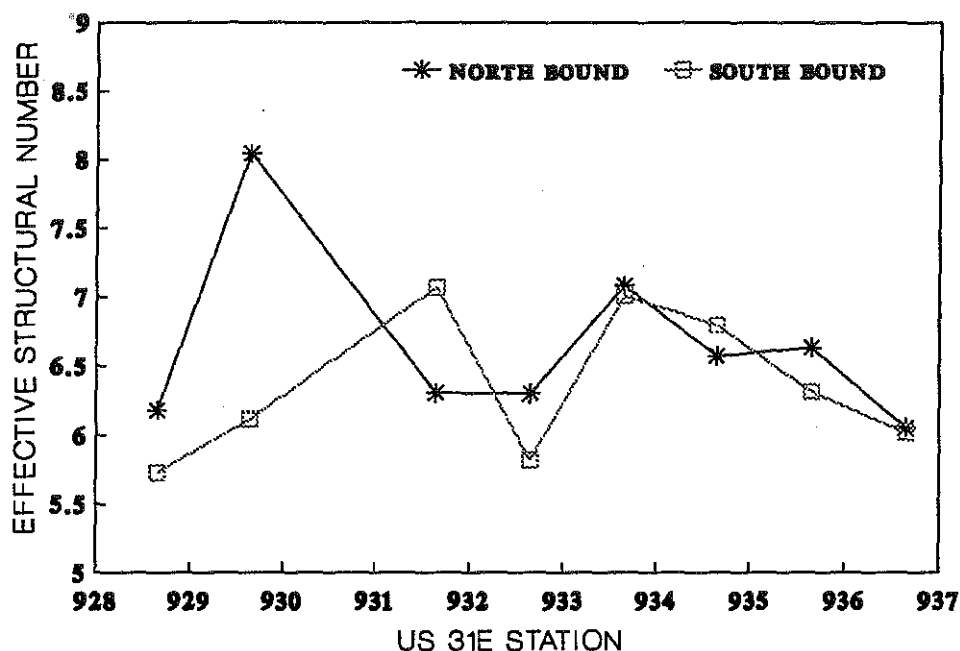
Figure 13. Pavement Structural Number calculated from FWD data.

Falling Weight Deflectometer (FWD) data were collected through the intersection in 1993. The data were analyzed to determine the effect of the reinforcement grid on pavement

response. Also, vertical and horizontal control points were established on the reconstructed surface to monitor potential shoving and/or rutting.

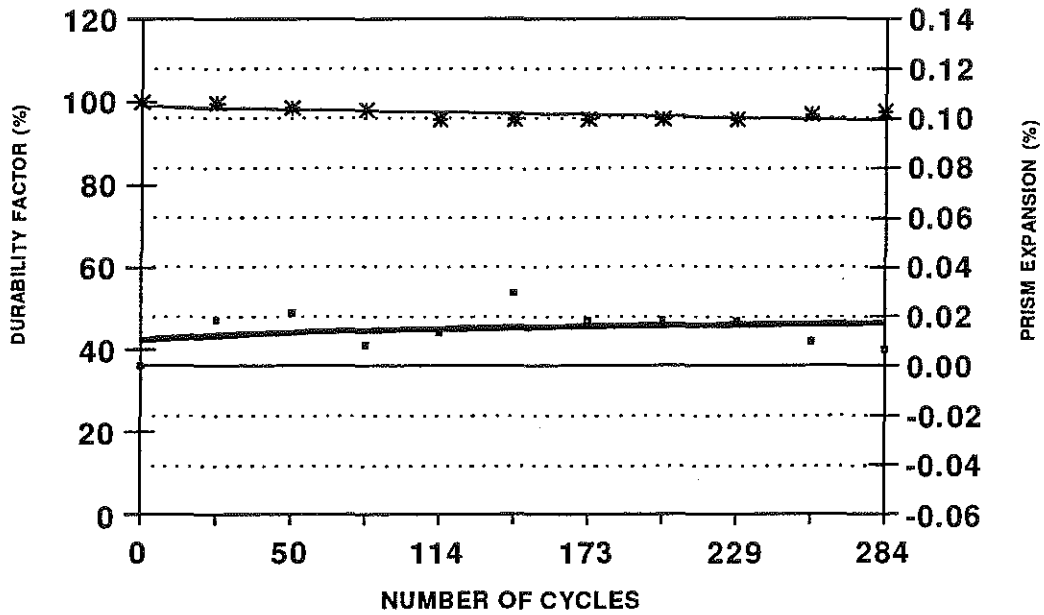
SPECIMEN SERIES G

**GLASGOW BYPASS SITE
RESULTS OF FREEZE/THAW TESTS**

* DURABILITY — EXPANSION

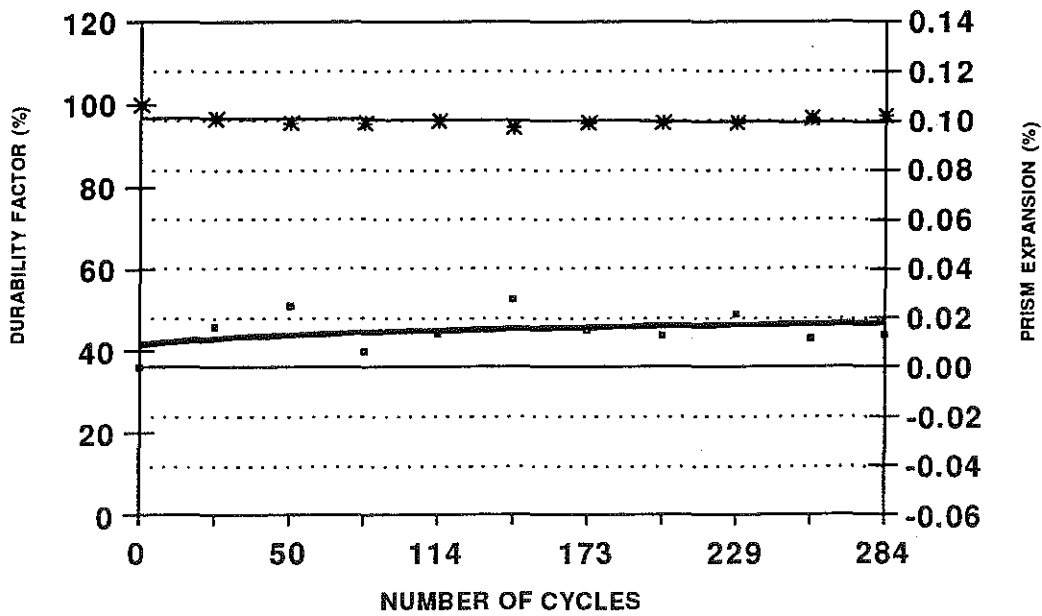
SPECIMEN SERIES G-2

**GLASGOW BYPASS SITE
RESULTS OF FREEZE/THAW TESTS**

* DURABILITY — EXPANSION

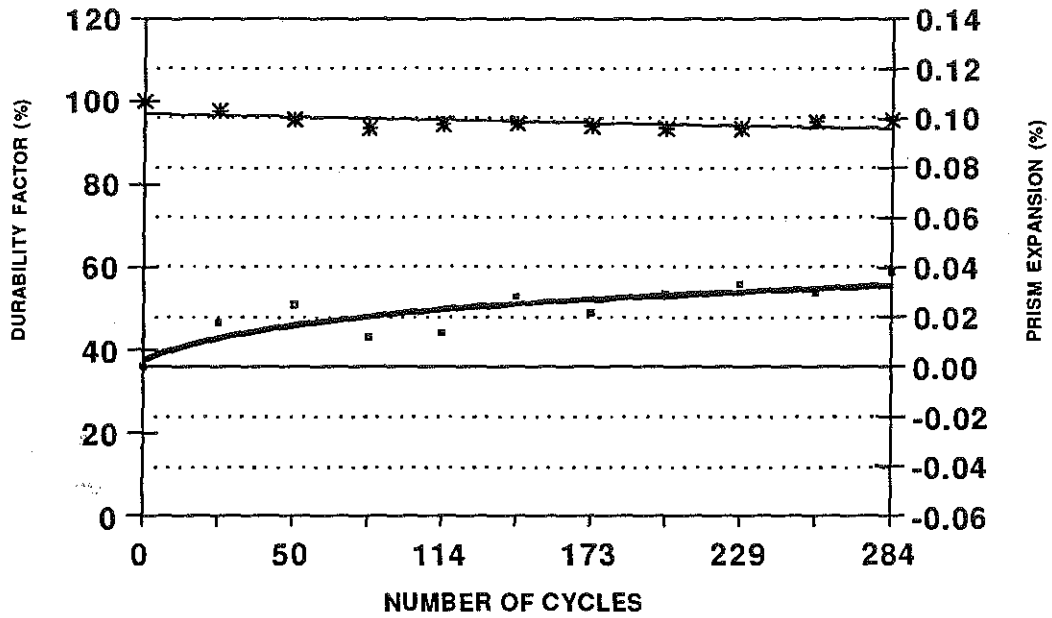
SPECIMEN SERIES G-3

**GLASGOW BYPASS SITE
RESULTS OF FREEZE/THAW TESTS**

* DURABILITY — EXPANSION

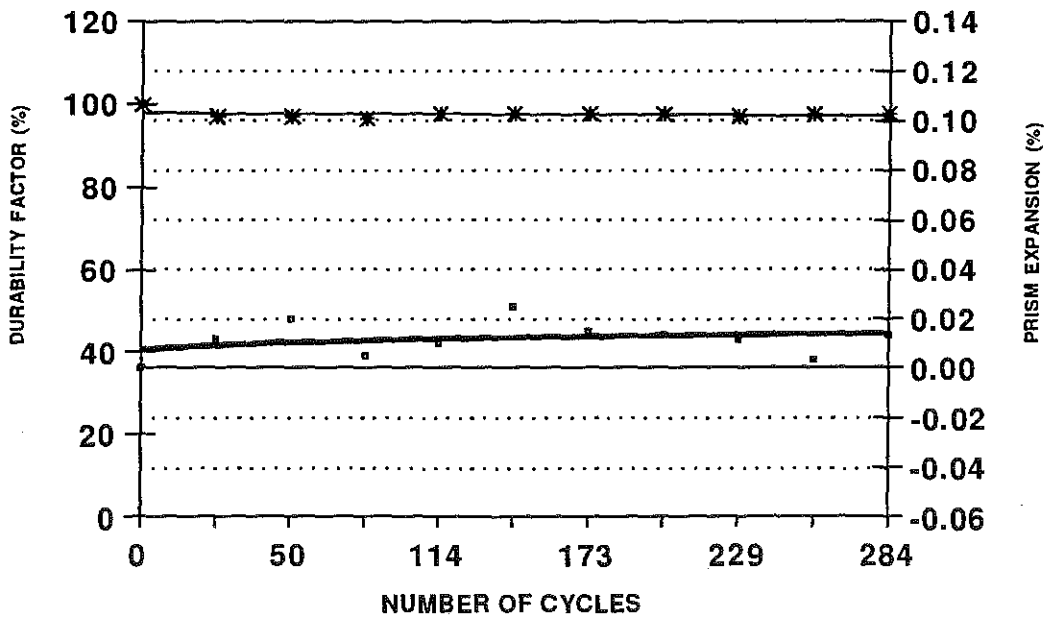
SPECIMEN SERIES G-4

**GLASGOW BYPASS SITE
RESULTS OF FREEZE/THAW TESTS**

* DURABILITY — EXPANSION

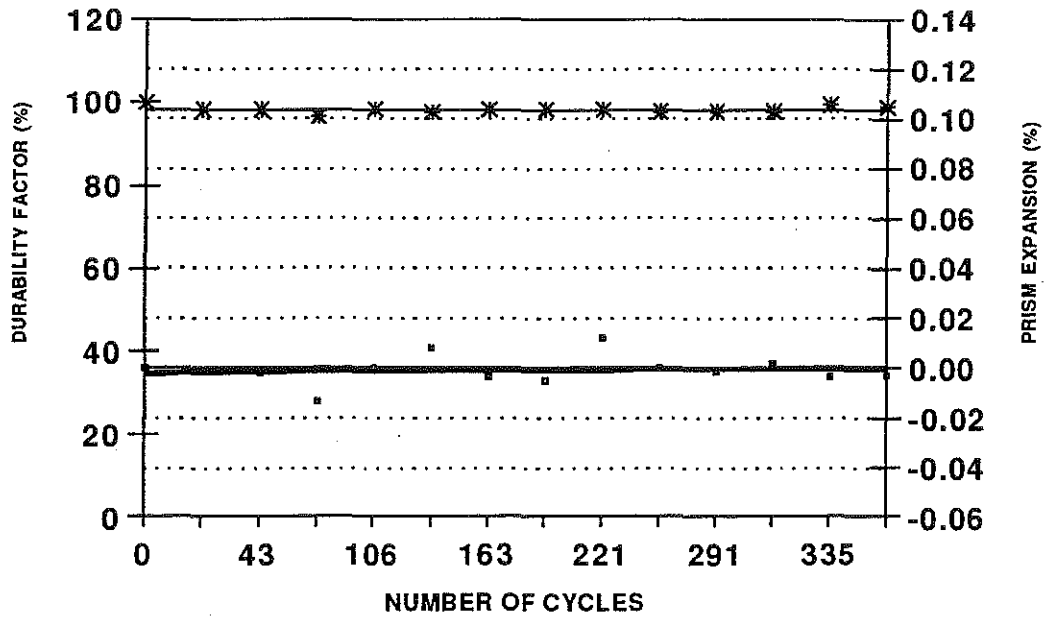
SPECIMEN SERIES G'-A

**GLASGOW BYPASS SITE
RESULTS OF FREEZE/THAW TESTS**

* DURABILITY — EXPANSION

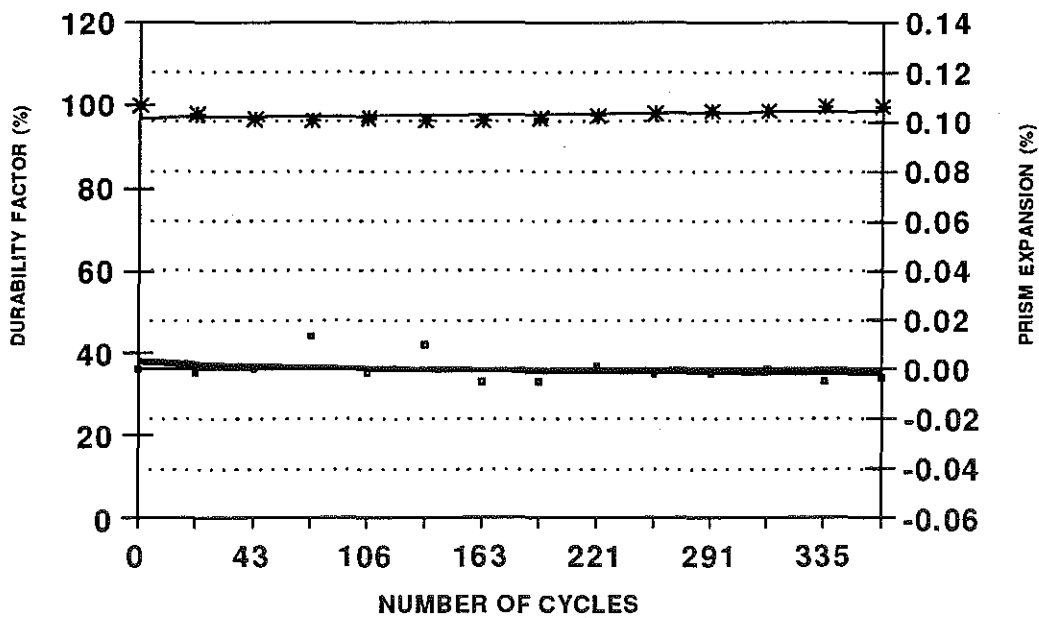
SPECIMEN SERIES G'-B

**GLASGOW BYPASS SITE
RESULTS OF FREEZE/THAW TESTS**

* DURABILITY — EXPANSION

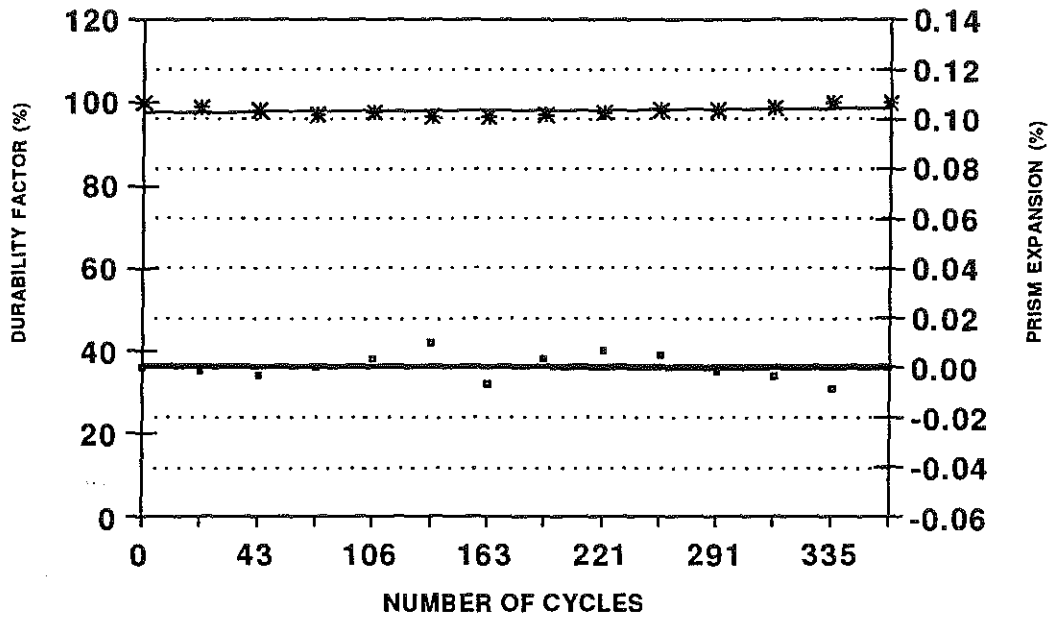
SPECIMEN SERIES G'-C

**GLASGOW BYPASS SITE
RESULTS OF FREEZE/THAW TESTS**

* DURABILITY — EXPANSION
