KTC-90-16

LOUISA BYPASS EXPERIMENTAL PROJECT

Final Report

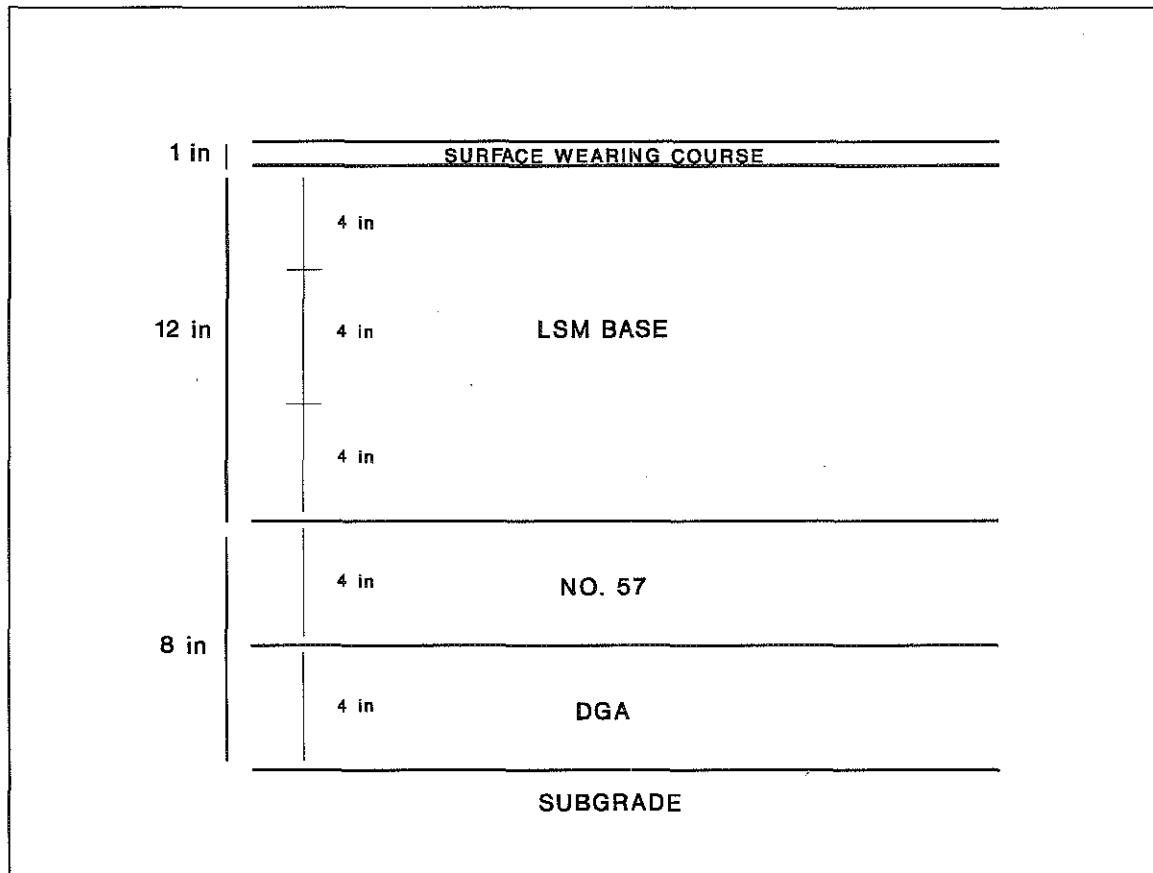
FIGURE 1. PAVEMENT CROSS SECTION, US 23 - LOUISA BYPASS

The Kentucky DOH personnel selected several coal haul sections for field testing of an experimental LSM. The Louisa Bypass on U.S. 23 in Lawrence County (3 miles, 4 lanes) is a newly constructed pavement located on the major coal-haul corridor for eastern Kentucky. The subgrade was constructed under a separate contract (F-23-1-58). This contract required a rock subgrade, defined as a 12-inch lift of shot sandstone. However, the available quantity of sandstone, from excavation, permitted only about 30% of the subgrade to be rock subgrade. The remaining subgrade was constructed with material having on average Kentucky CBR of 9 percent, based upon over 30 tests by Kentucky DOH. The subgrade was then covered with eight inches of granular subbase which consisted of four inches of dense graded aggregate covered by four inches of No. 57 rock. These variations provide an opportunity for evaluation of long-term performance variations due to structural factors. The pavement was originally intended to be a full-depth asphalt structure; however, due to the presence of shale in the subgrade, which is prone to rapid strength deterioration, it was decided to include a granular subbase layer. The subbase layer consisted of four inches of dense graded aggregate (DGA) covered with four inches of an open graded, large-stone drainage layer.

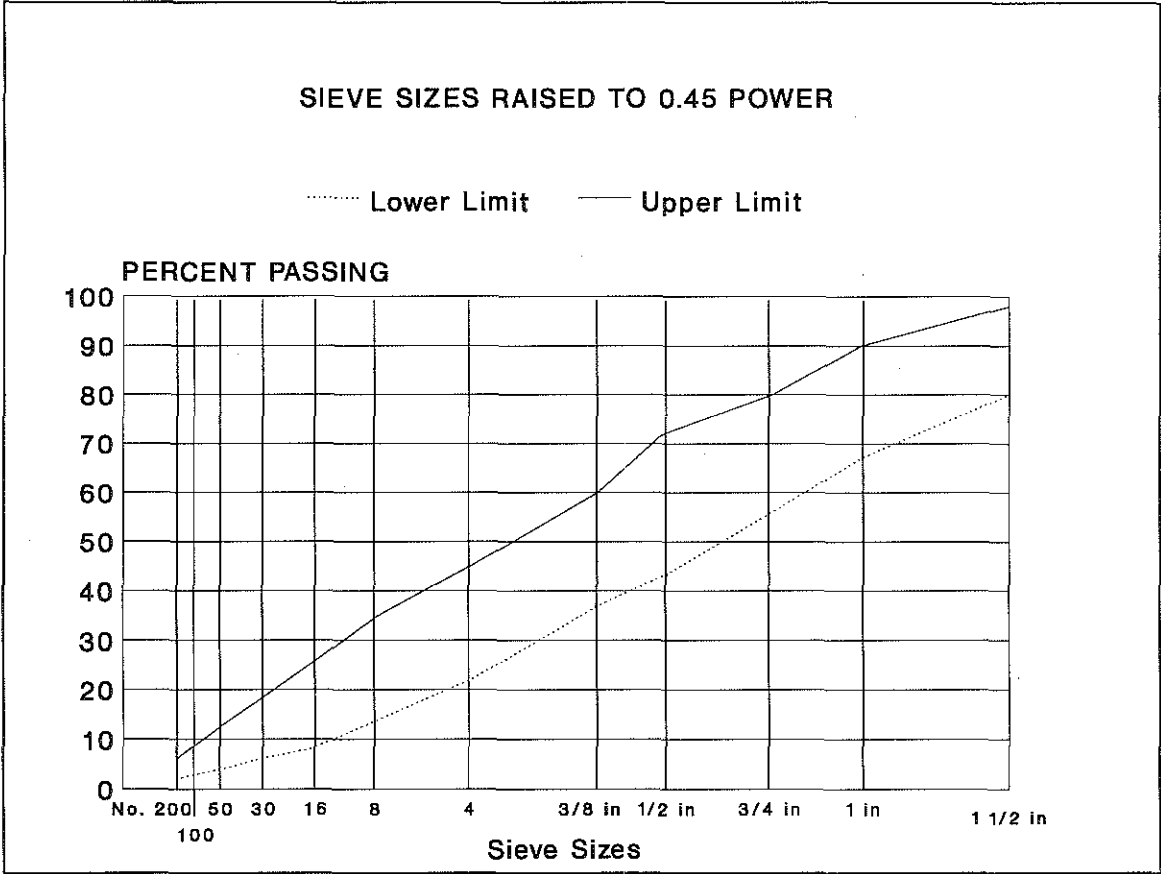
FIGURE 2. GRADATION SPECIFICATION LIMITS FOR KENTUCKY CLASS K BASE

Initially, 11 gradations were considered for laboratory testing. Each gradation was made by blending two or three coarse aggregates and one sand fraction. The blended gradations were within the Kentucky Class K Base specification limits. Figure 2 illustrates the Kentucky specification limits (1) for Class K Base large-stone mix.

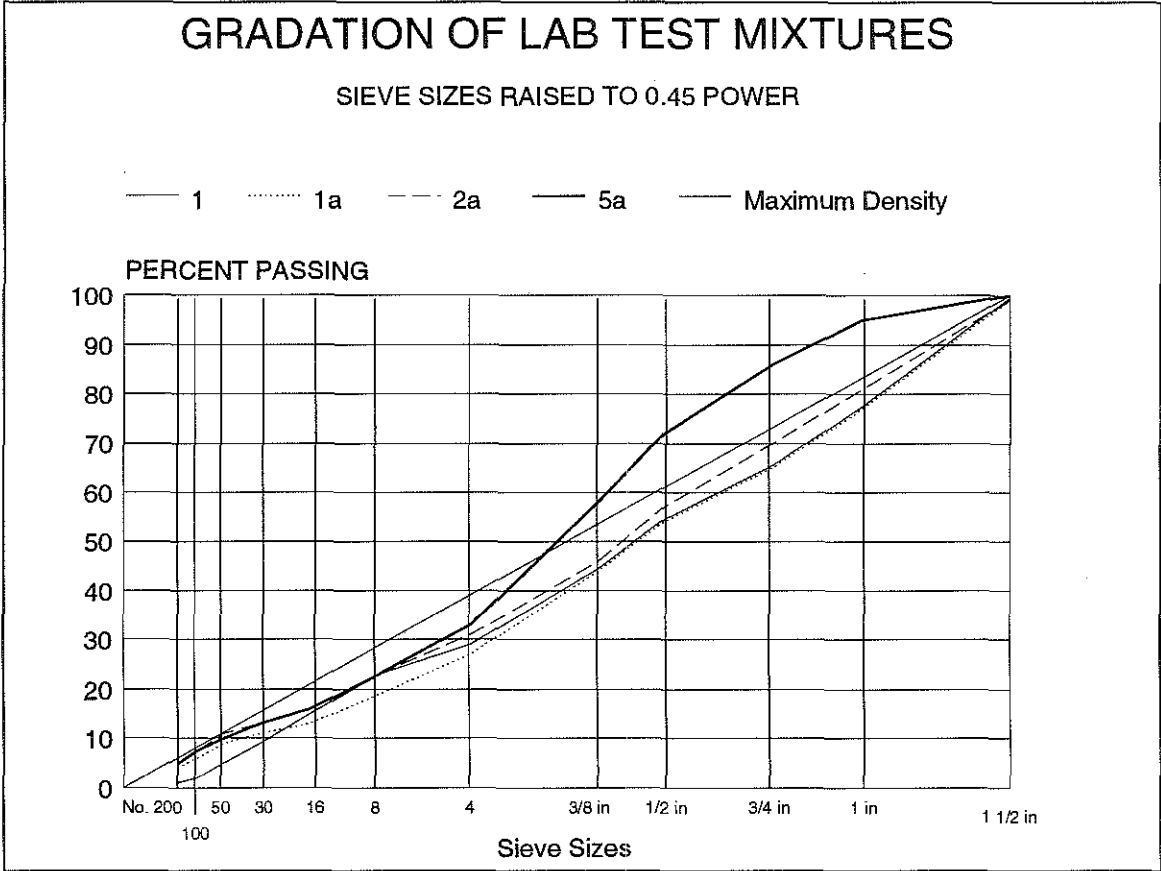
FIGURE 3. TRIAL LARGE-STONE GRADATION BLENDS

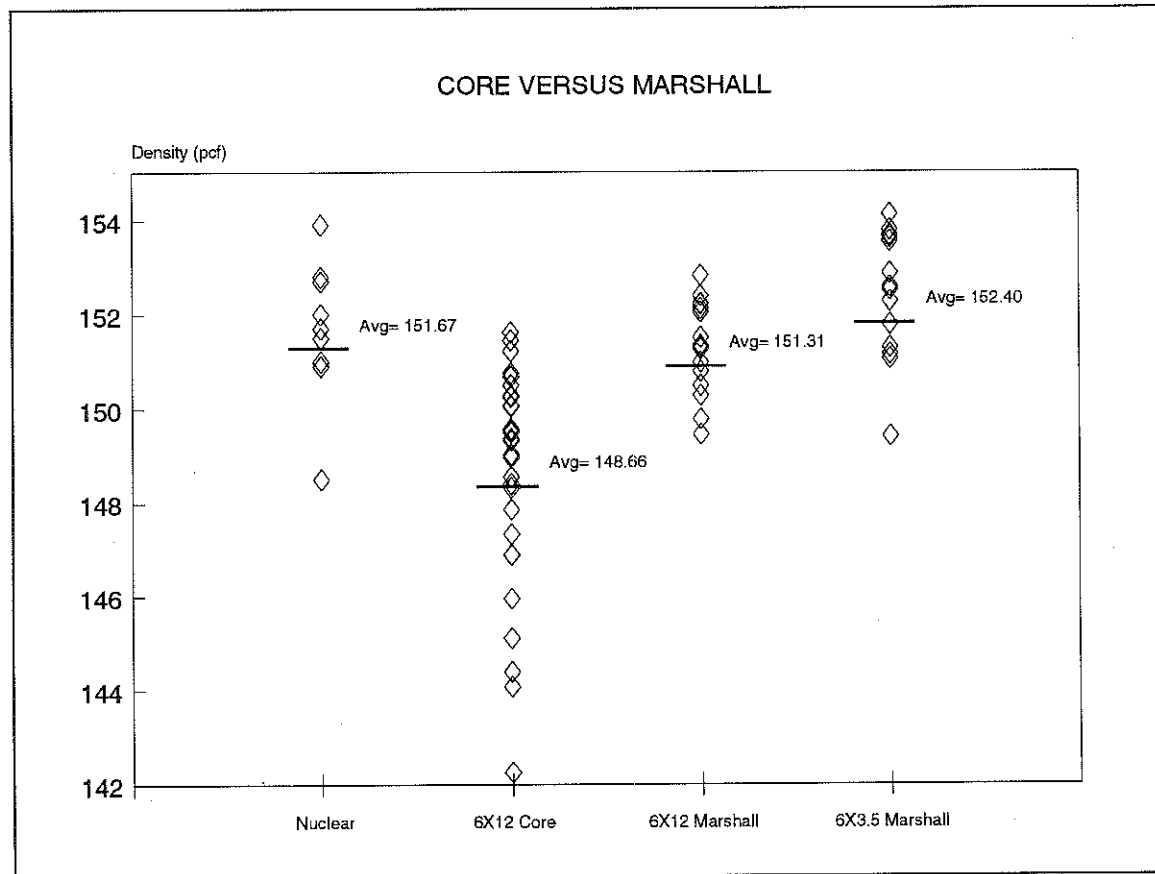
FIGURE 4. LABORATORY AND FIELD DENSITY DATA FOR CLASS K BASE

- 3- Laboratory compaction of 6-inch diameter by 3.75-inch high Marshall specimens may be achieved at 112 blows per side using a 22.5-lb Marshall hammer (9, 15, 16). Densities achieved in the laboratory may be closely duplicated during construction, see Figure 4.

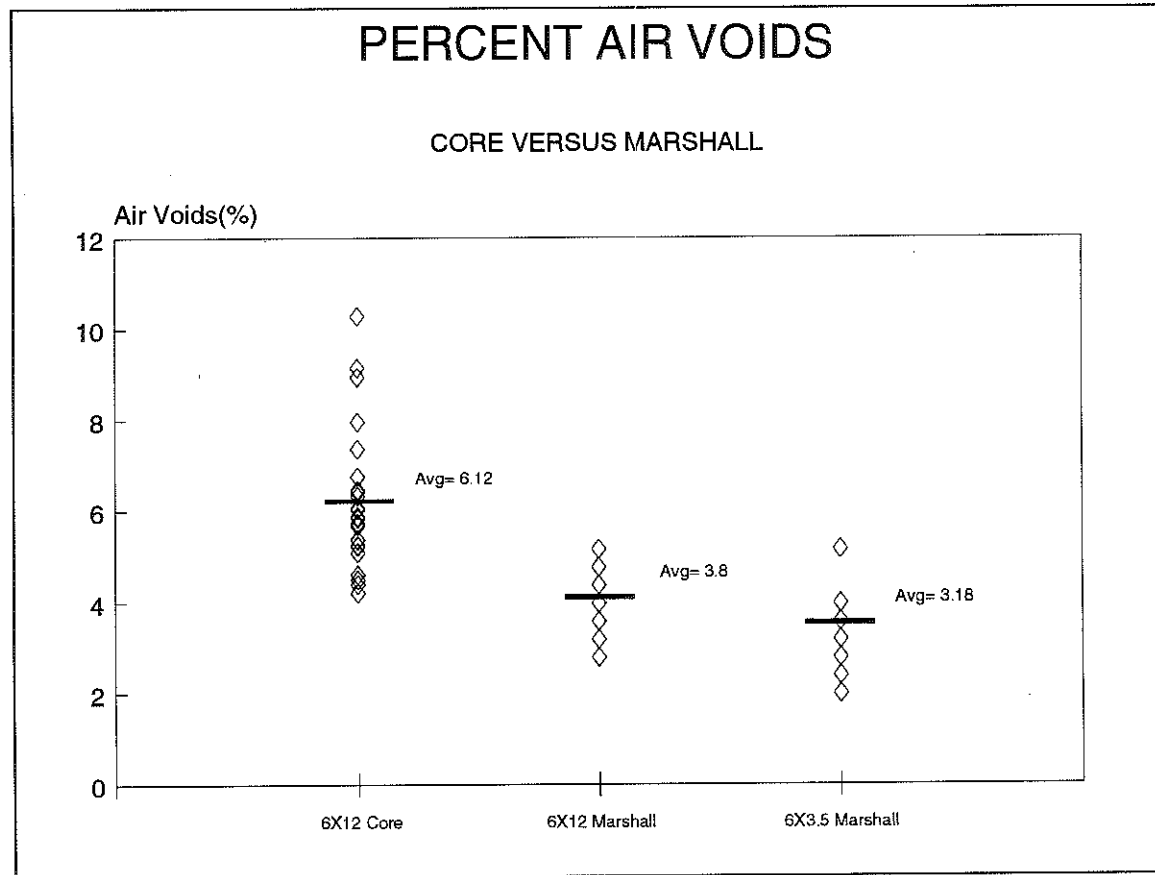
FIGURE 5. LABORATORY AND FIELD AIR VOIDS DATA FOR CLASS K BASE

- 4- Air voids should be in the range of 3.5 to 5.5 percent with the average being 4.5 percent. This range will minimize both air and water permeabilities. Figure 4 illustrates the variations in the air void content of laboratory and field specimens.

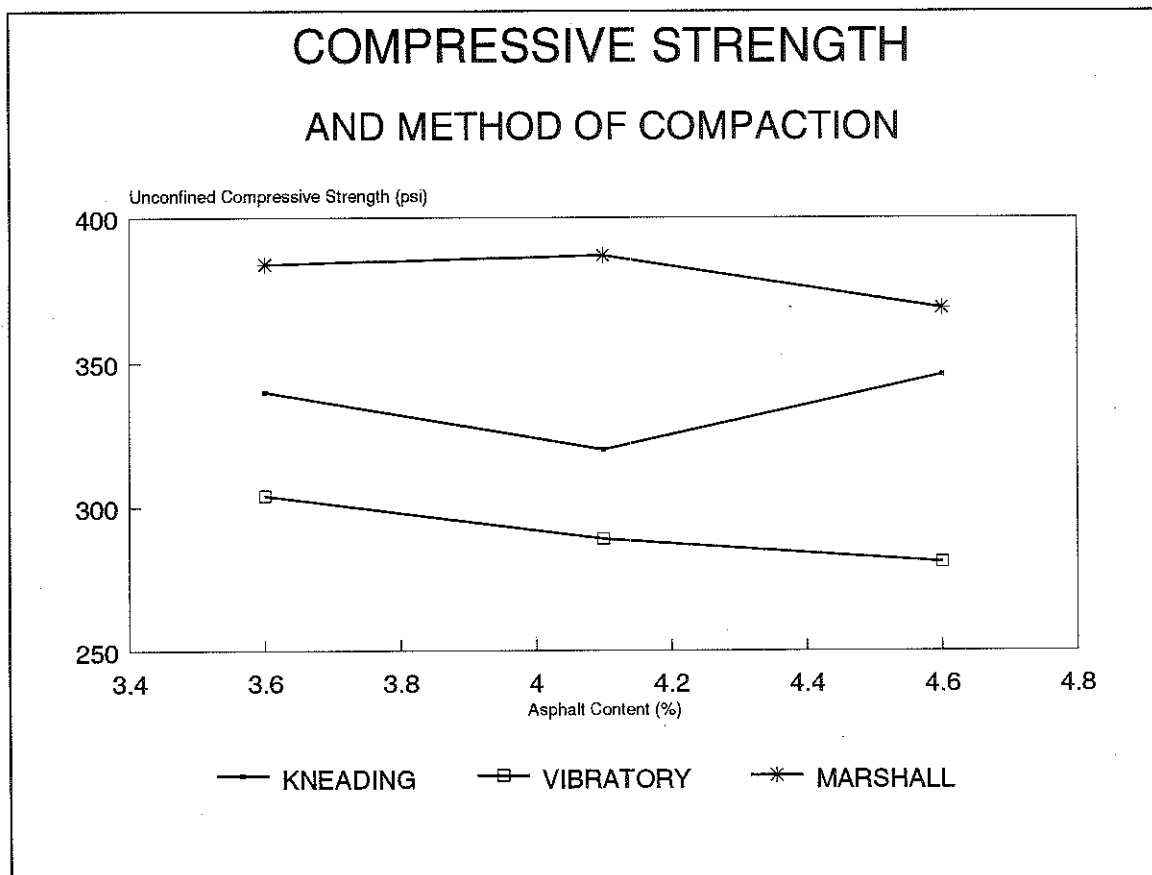
FIGURE 6. COMPRESSIVE STRENGTH AS A FUNCTION OF ASPHALT CONTENT AND METHOD OF COMPACTION FOR LARGE-STONE ASPHALT MIXES

The unconfined compression test is often used as an indirect index test for determining the resistance of an asphaltic mixture to shear flow and permanent deformation; i.e, rutting and shoving. In this study, the compressive strength tests were conducted by the Asphalt Institute. Specimens were 6 inches in diameter and 6 inches in height. Unconfined compressive tests were conducted at 77°F and 0.05 inch per minute rate of loading. These data are presented in Figure 6. The data suggest that the method of laboratory compaction has a significant influence on the compressive strength of LSM.

The stone-on-stone contact of aggregate particles in the LSM reduces the probability of plastic flow due to low air voids and/or high densities. Mix design criteria that are commonly applied to conventional HMA should be re-examined before extrapolating them to LSM design situations. The observation that the method of laboratory compaction significantly influences the mechanical behavior of the LSM is consistent with the compressive strength data presented in Figure 6.

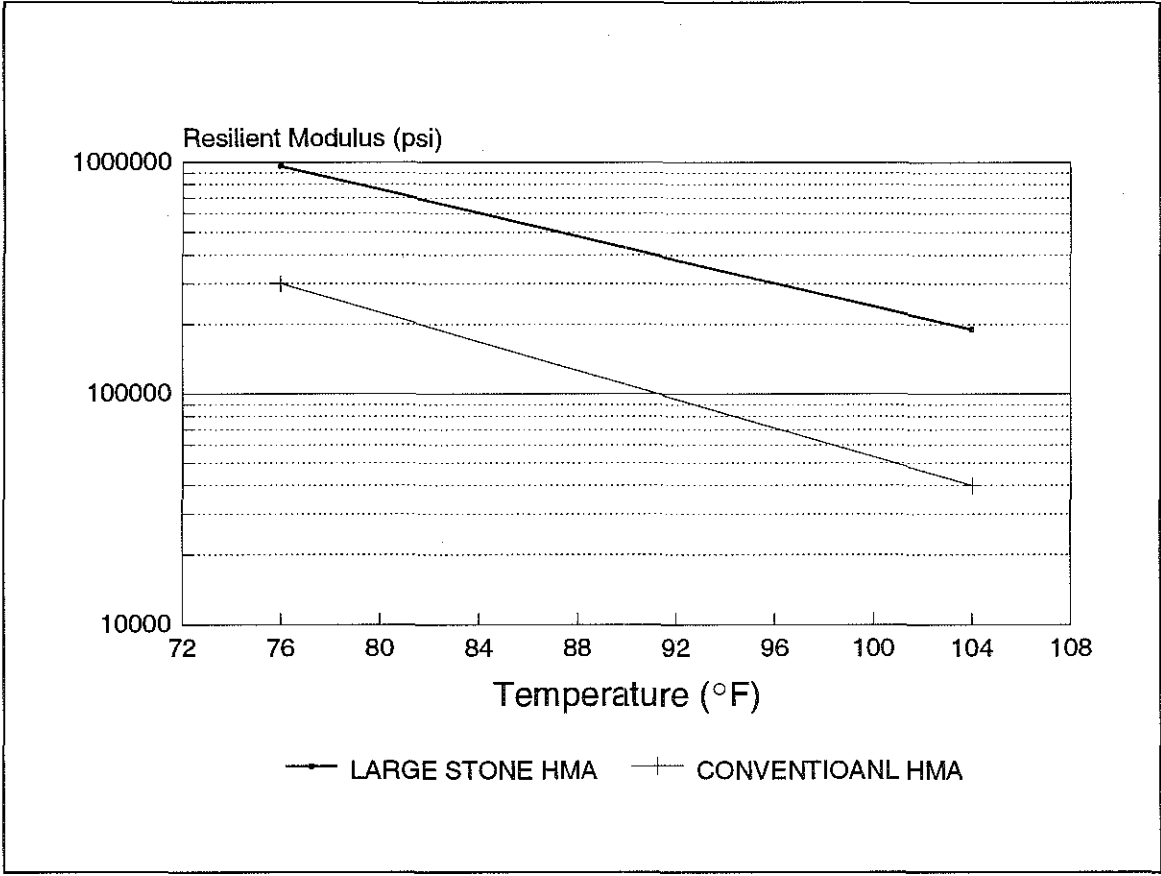
FIGURE 7. RESILIENT MODULUS AS A FUNCTION OF TEMPERATURE

Characterization of the LSM from a structural point of view was of great interest to Kentucky DOH officials. Resilient modulus tests were conducted at various temperatures to better understand the potential structural benefits of the LSM. Chevron U.S.A., Inc., in Richmond, California, participated in the resilient modulus testing program. The resilient modulus data for a range of temperatures are summarized in Figure 7. The data indicate that an LSM pavement layer offers a higher level of structural capacity as compared to a conventional hot mix asphalt (HMA) layer of the same thickness. Large-stone mixes may be very cost competitive in terms of their added structural capacity combined with their lower optimum asphalt content.

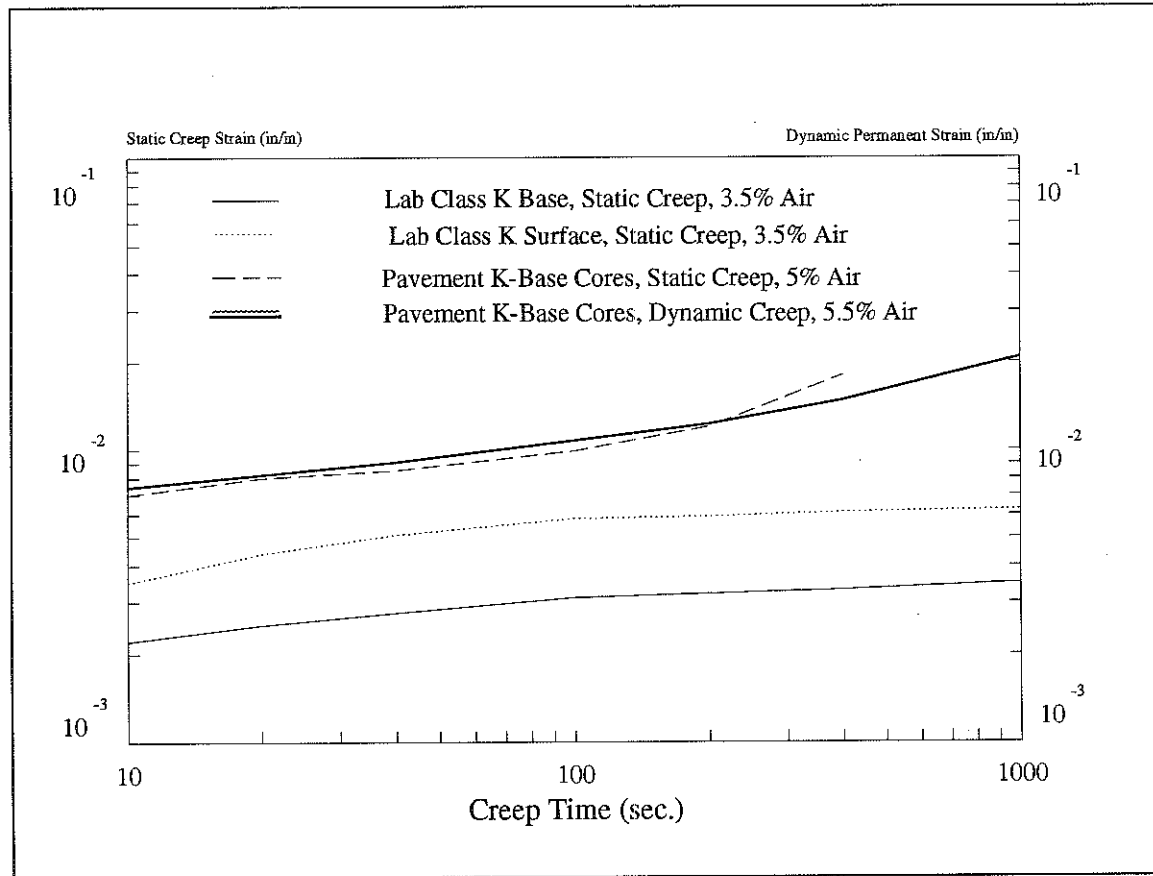
FIGURE 8. CREEP AND PERMANENT DEFORMATION DATA FOR LABORATORY AND FIELD SPECIMENS AT 104°F

is often used for characterizing permanent deformation. Both static and dynamic (cyclic repeated-load) creep tests were conducted at 29 psi. The static creep test consisted of monitoring the creep strain for one hour under a constant load of 29 psi. Dynamic creep tests were conducted under repeated-load, square-shaped pulses at 1-Hertz. The resilient and permanent components of deformation were recorded. The data from both static and dynamic tests were then merged in order to study permanent deformation characteristics of LSM under static and dynamic modes. This was possible under the assumption of linear viscoelasticity. For example, the cumulative creep deformation caused by a set of ten, 1-Hertz, load pulses was assumed to be equivalent to the creep deformation caused by ten seconds of continuous static creep load. The merged data are presented in Figure 8. The trends in Figure 8 indicate that laboratory specimens which were compacted using the modified Marshall hammer are less prone to permanent deformation than the LSM pavement cores. This is due to the fact that higher densities and efficient packing of particles are more likely to be achievable under laboratory conditions.

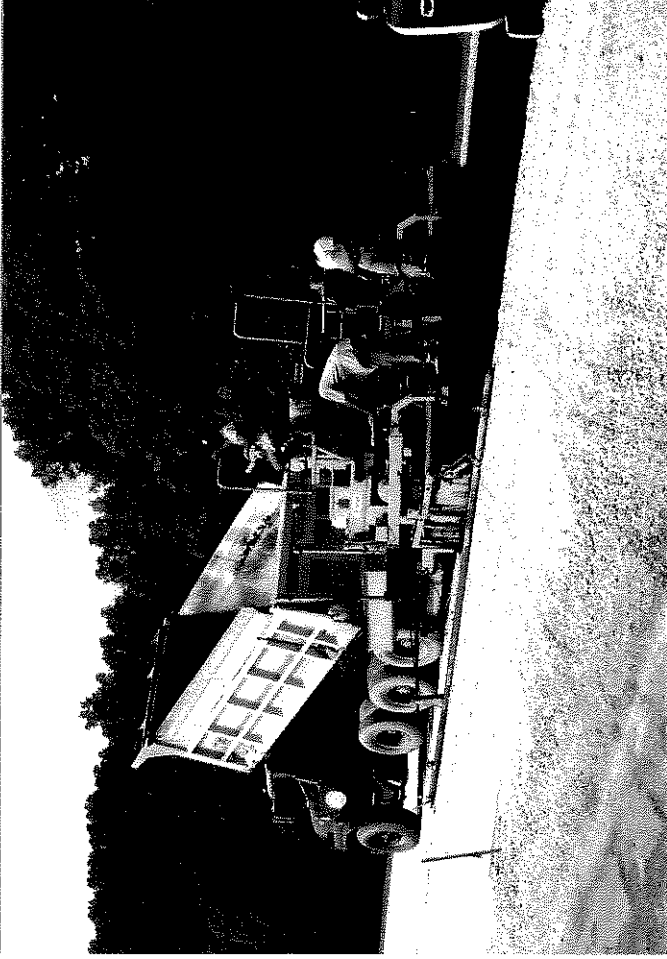
FIGURE 10. LAYDOWN OF THE CLASS K BASE

The contractor used a tracked paver for the first lift on top of the unbound No. 57 subbase layer; other lifts were placed with a conventional rubber tired paver. Generally, contractors seem to prefer a stabilized layer as a working platform, one option that is gaining popularity in Kentucky is an asphalt stabilized No. 57 subbase layer (2% AC content). Figure 10 shows an overview of the laydown operation; mixture temperature ranged from 300°F to 280°F at the time of laydown.

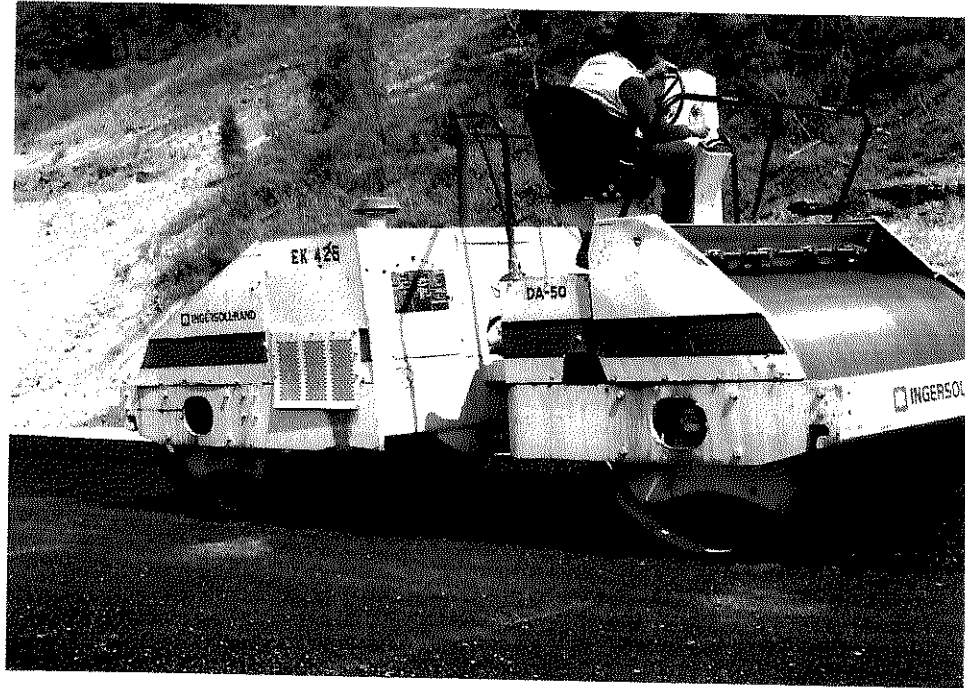
FIGURE 11. VIBRATORY ROLLER, OPERATES IN STATIC AND DYNAMIC MODES

Figures 11 and 12 show typical compaction equipment that was used in this project. The following is a list of observations and recommendations dealing with the LSM compaction operations.

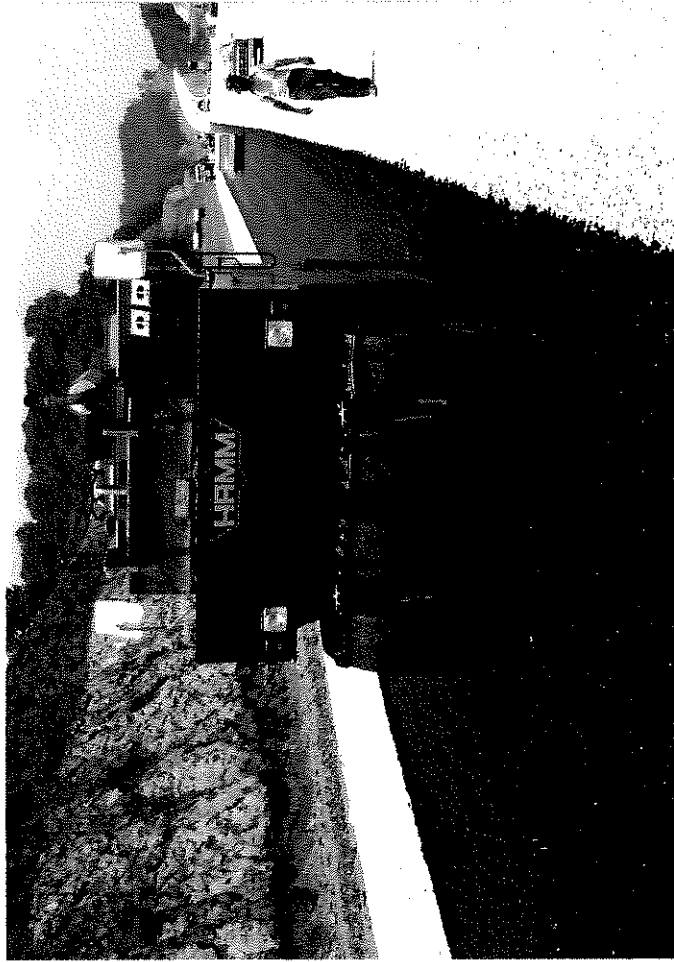
FIGURE 12. PNEUMATIC ROLLER

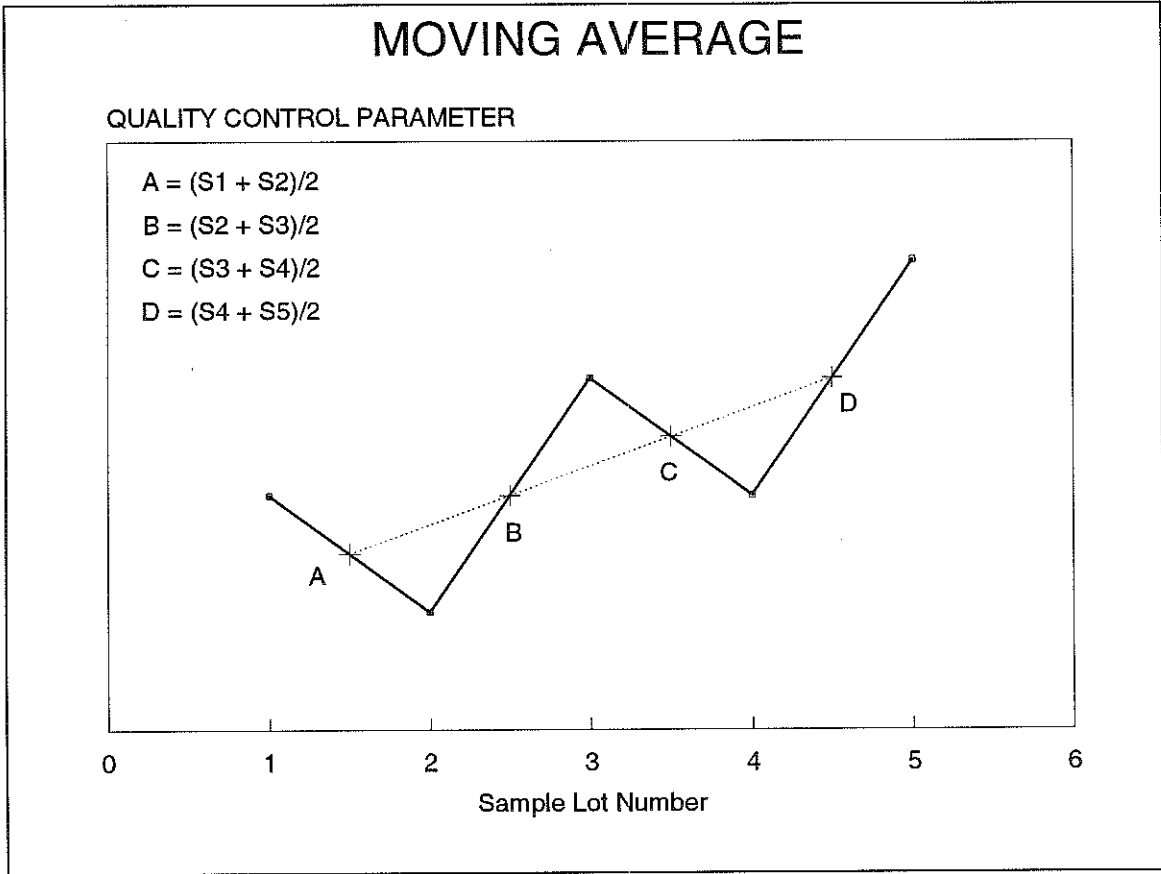
FIGURE 14. SCHEMATIC REPRESENTATION OF THE MOVING AVERAGE CONCEPT

- 1- Quality control should be used in the construction of LSM in order to ensure adherence to design parameters such as aggregate gradation, asphalt content, density, and air void content. Moving averages should be maintained and used as the basis for evaluating variability of mixture parameters. A schematic of the concept of moving averages that is recommended for quality control is presented in Figure 14.

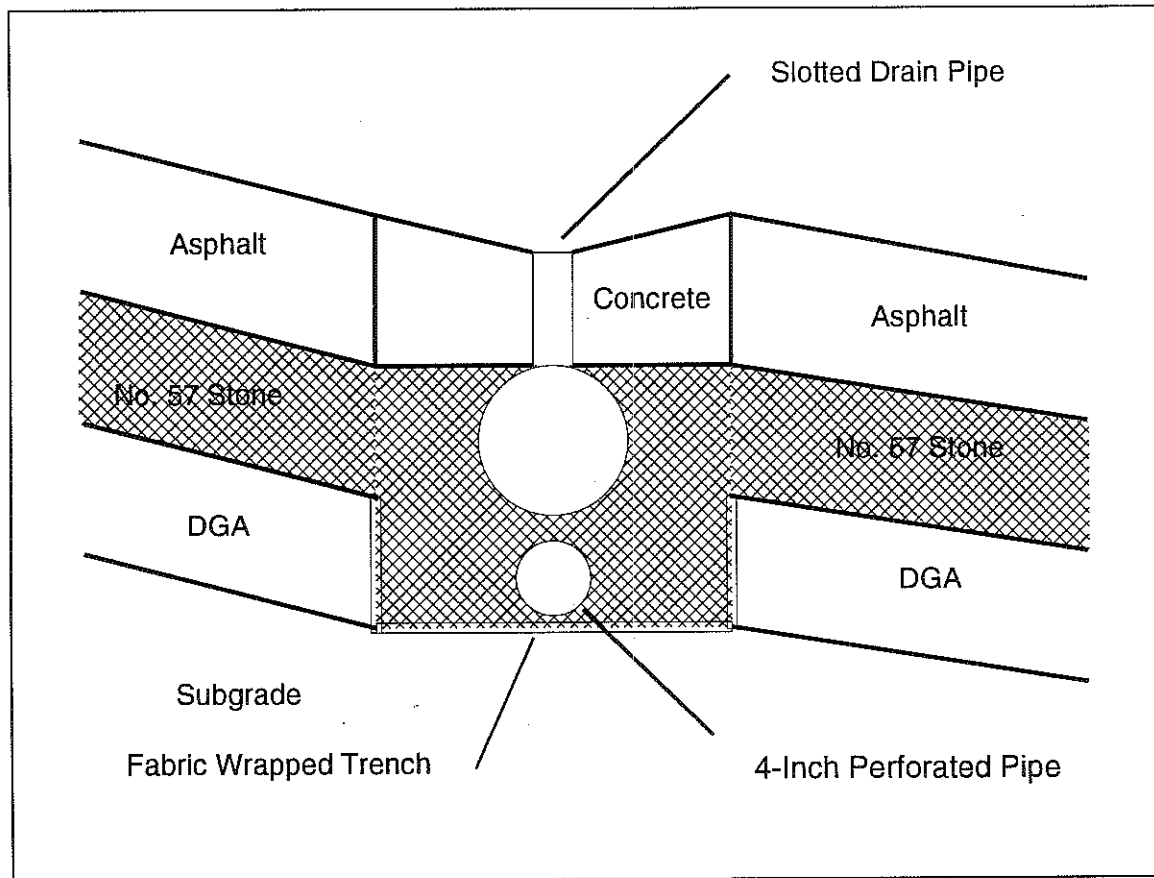
FIGURE 16. MEDIAN DRAIN DETAIL, US 23 - LOUISA BYPASS

Additional surface drainage was added in the superelevated sections where 12-inch slotted drain pipe was placed in the center median (Figure 16).

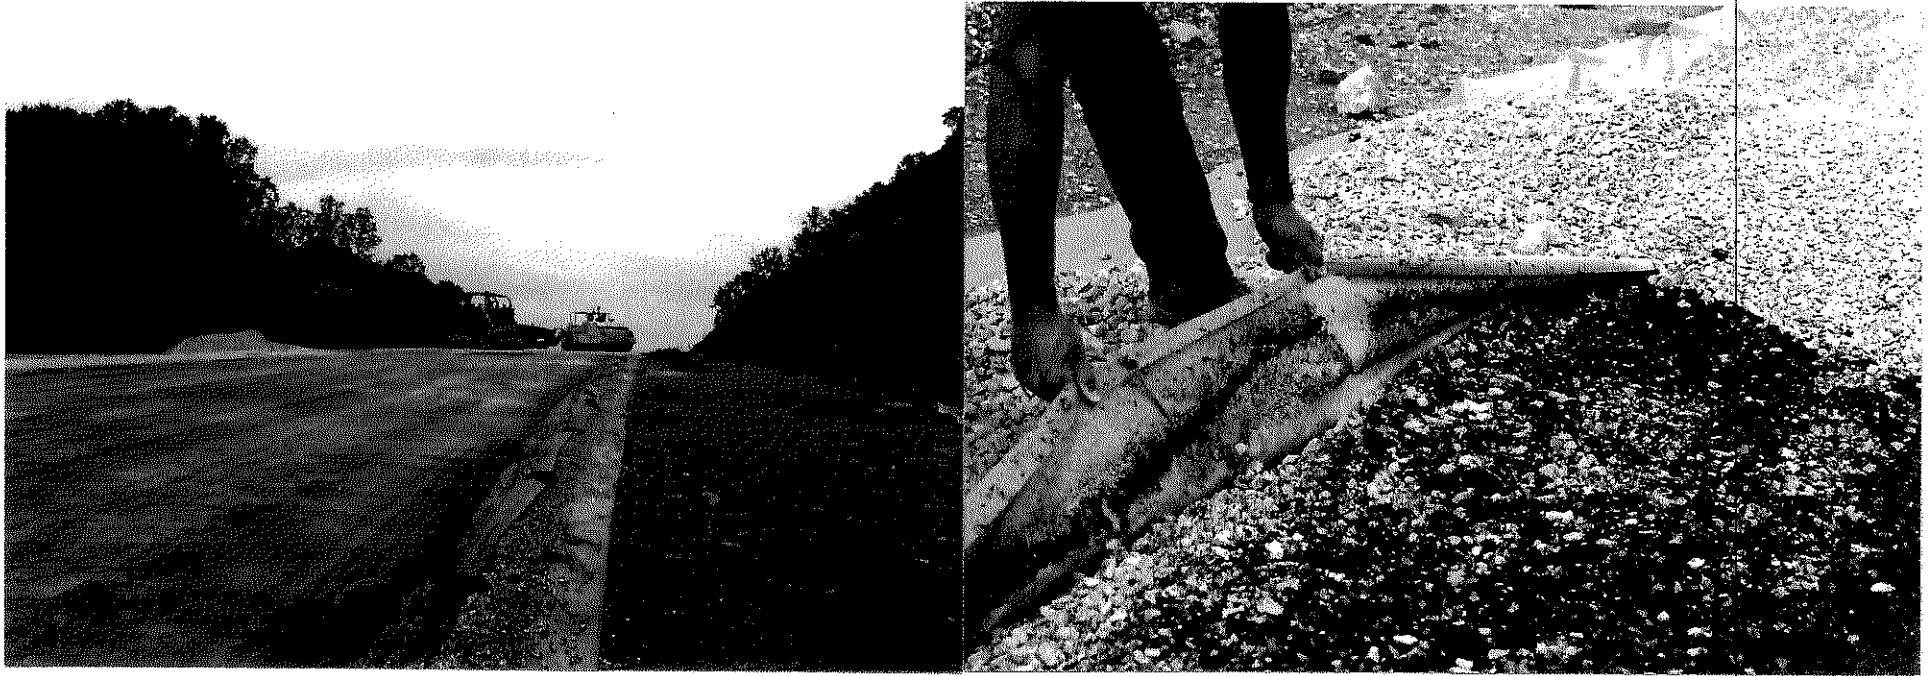
FIGURE 18. SPRAY OF PRIME COAT EMULSION ON THE FILTER FABRIC, A CONSTRUCTION PROBLEM

A full strength asphalt emulsion SS-1h prime was sprayed on the DGA prior to the placement of the No. 57 stone. On July 21, 1988, it was observed that the prime had been over sprayed onto the filter fabric which lined the trench between Station 1164+00 to Station 1322+50, see Figure 18. In summary, the primary purpose of the filter fabric was to keep fines from the subgrade and DGA out of the drainage system. It is possible that the prime coat stained fabric may retard water from entering the edge drain. This condition has clearly provided an opportunity for excessive free moisture accumulation in the subbase and subgrade, a point which will be discussed in more detail under the section devoted to performance of the drainage blanket.

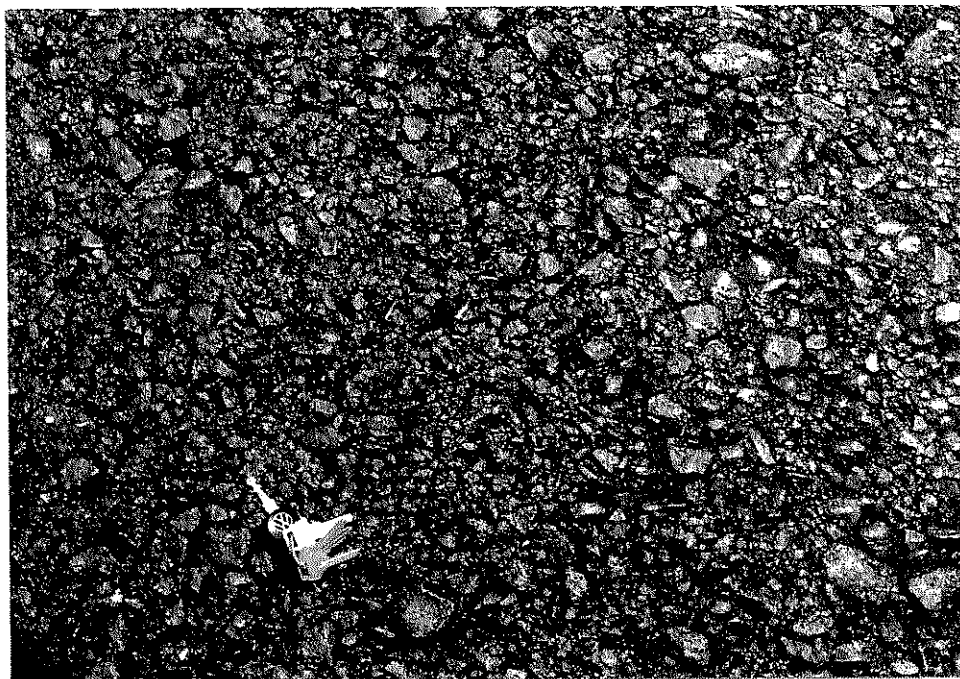
FIGURE 19. SURFACE TEXTURE OF COMPACTED CLASS K BASE

Segregation of HMA is a problem that is very difficult to quantify, Figures 19 and 20 show that the segregation was not a major problem. The contractor made an effective use of test strips to determine two things: a) ways to reduce segregation during laydown, and b) optimum roller coverage during compaction.

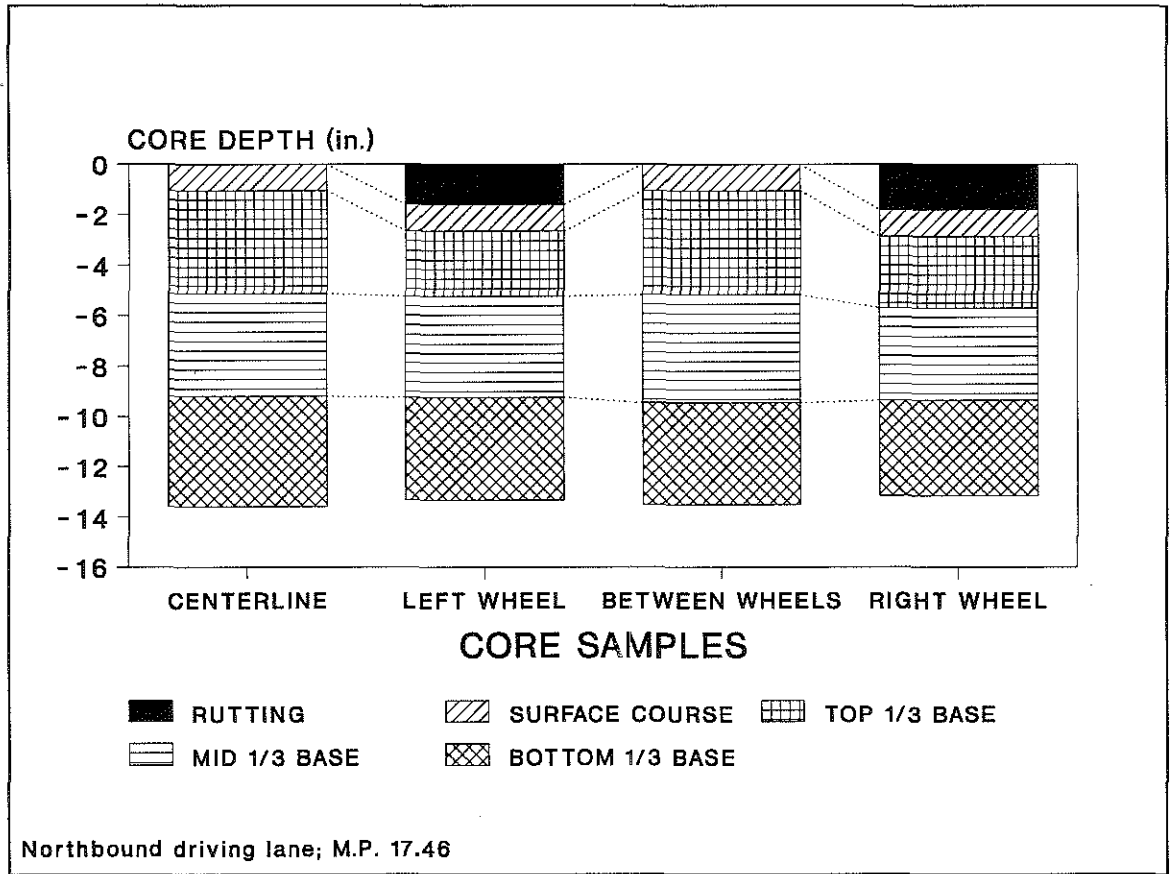
FIGURE 21. A RECONSTRUCTED VIEW OF THE PAVEMENT CROSS SECTION BASED UPON AUGUST 1991 PAVEMENT CORES, US 23 - LOUISA BYPASS

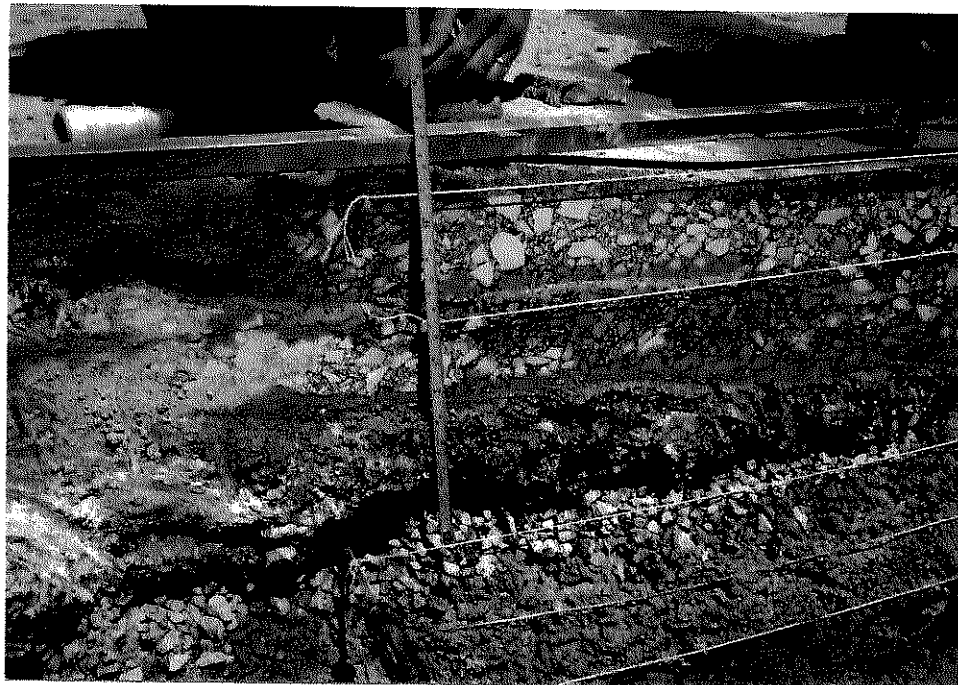
FIGURE 22. PHOTOGRAPH OF PAVEMENT TRENCH AT MILE POST 17.46, US 23 - LOUISA BYPASS
(APRIL 10, 1991)

trenched at a location where rutting was most severe. The analysis of the trench revealed that the initial nominally 8-inch, two-layer, drainage blanket was approximately 6.75 inches in thickness. Considering variations in the construction of such pavement layers, further evidence was sought to characterize this phenomenon. It was noted that the post-construction visual distinction between the two layers has been diminished and the emulsion prime coating was ineffective in this regard.

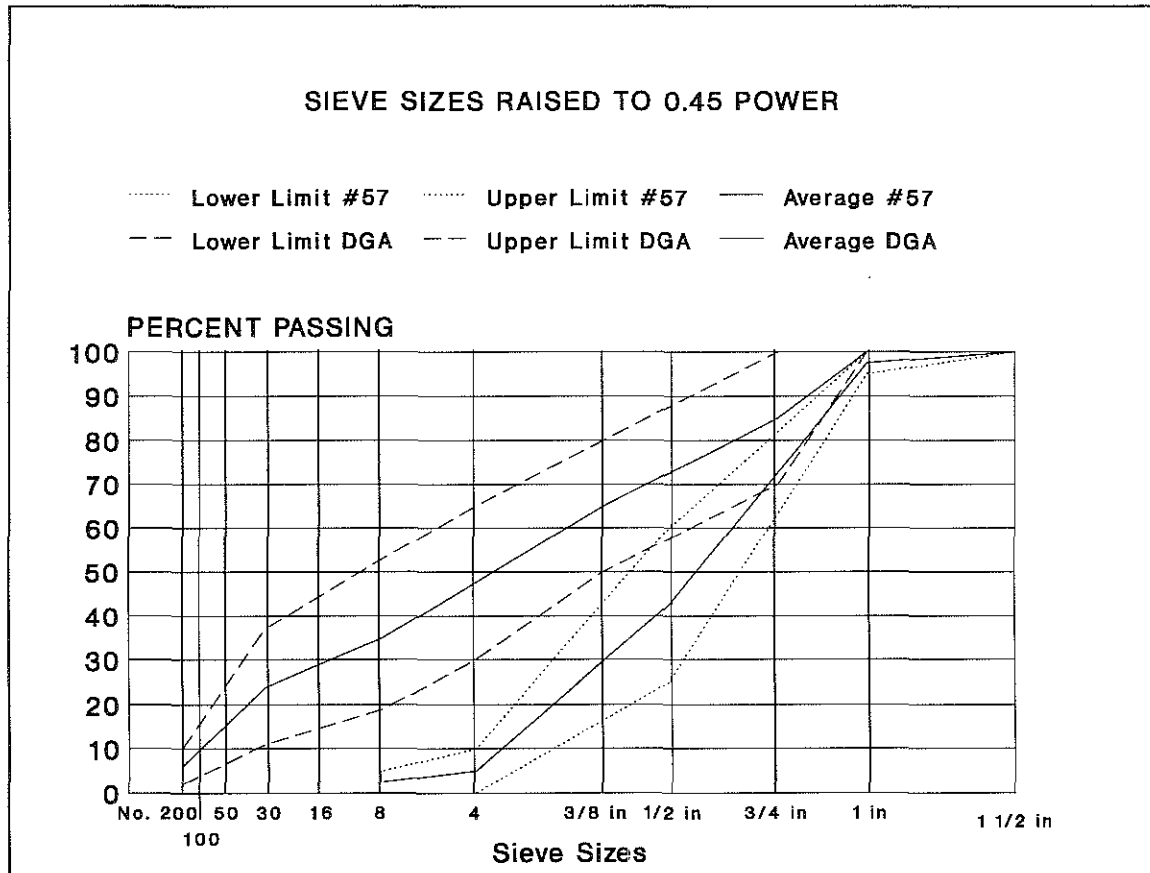
FIGURE 23. GRADATION DISTRIBUTION OF THE DENSE GRADED AGGREGATE (DGA) AND NO. 57 AGGREGATE

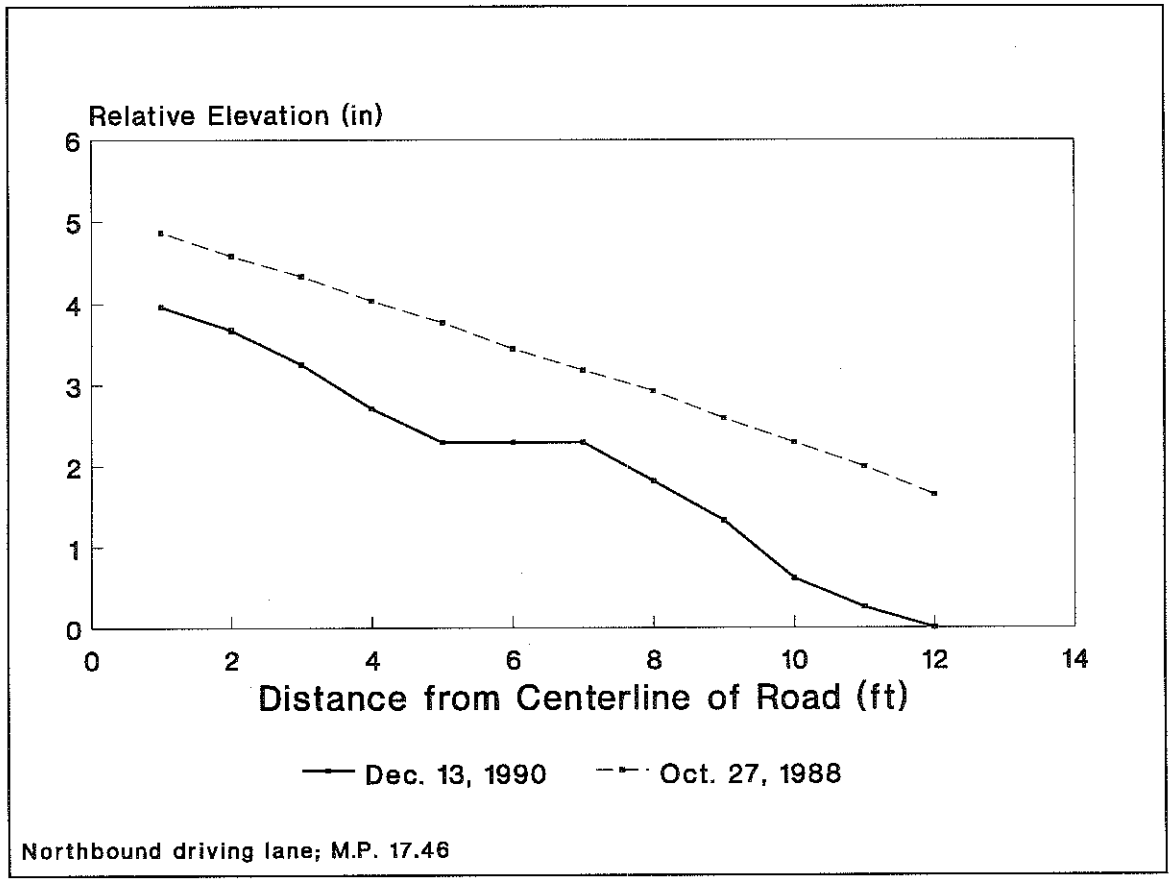
FIGURE 24. ROADWAY ELEVATION DATA, US 23 - LOUISA BYPASS

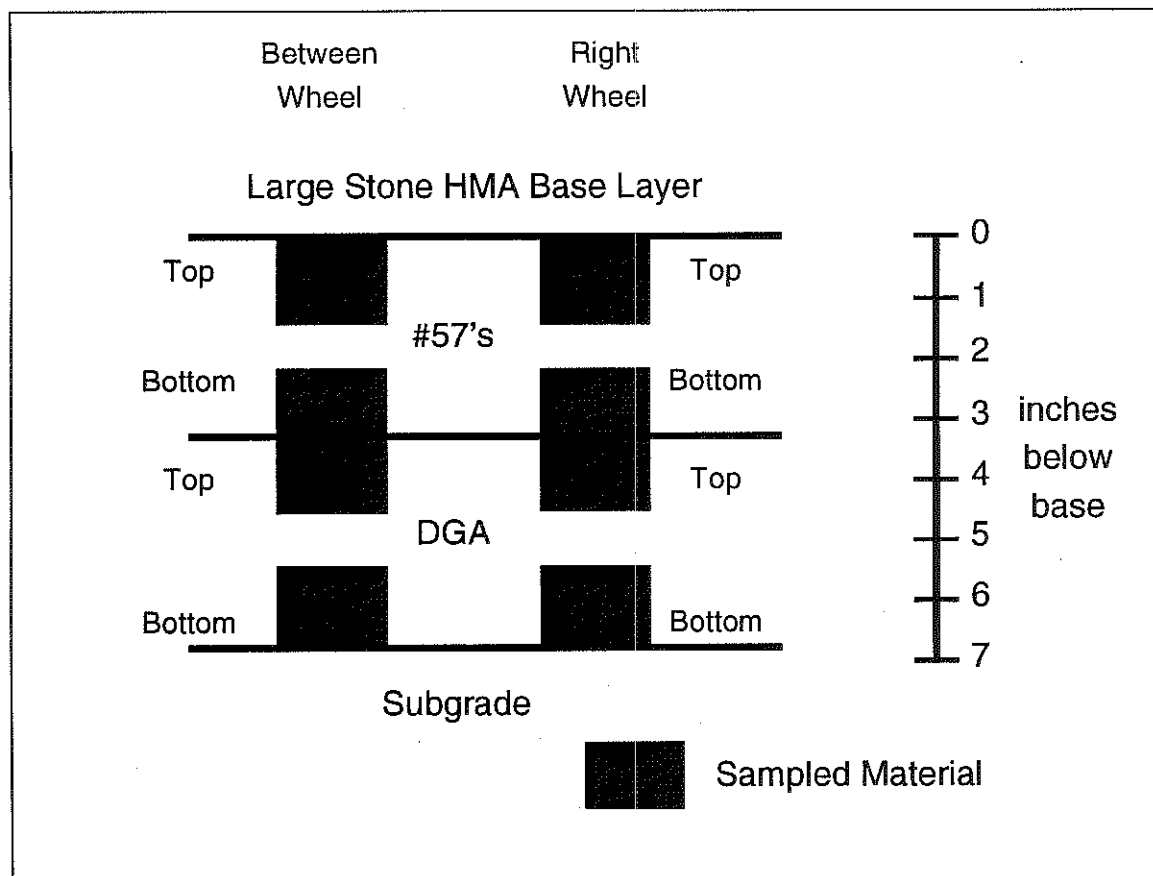
FIGURE 25. SAMPLING LOCATIONS FOR THE DGA AND NO. 57 SUBBASE MATERIAL

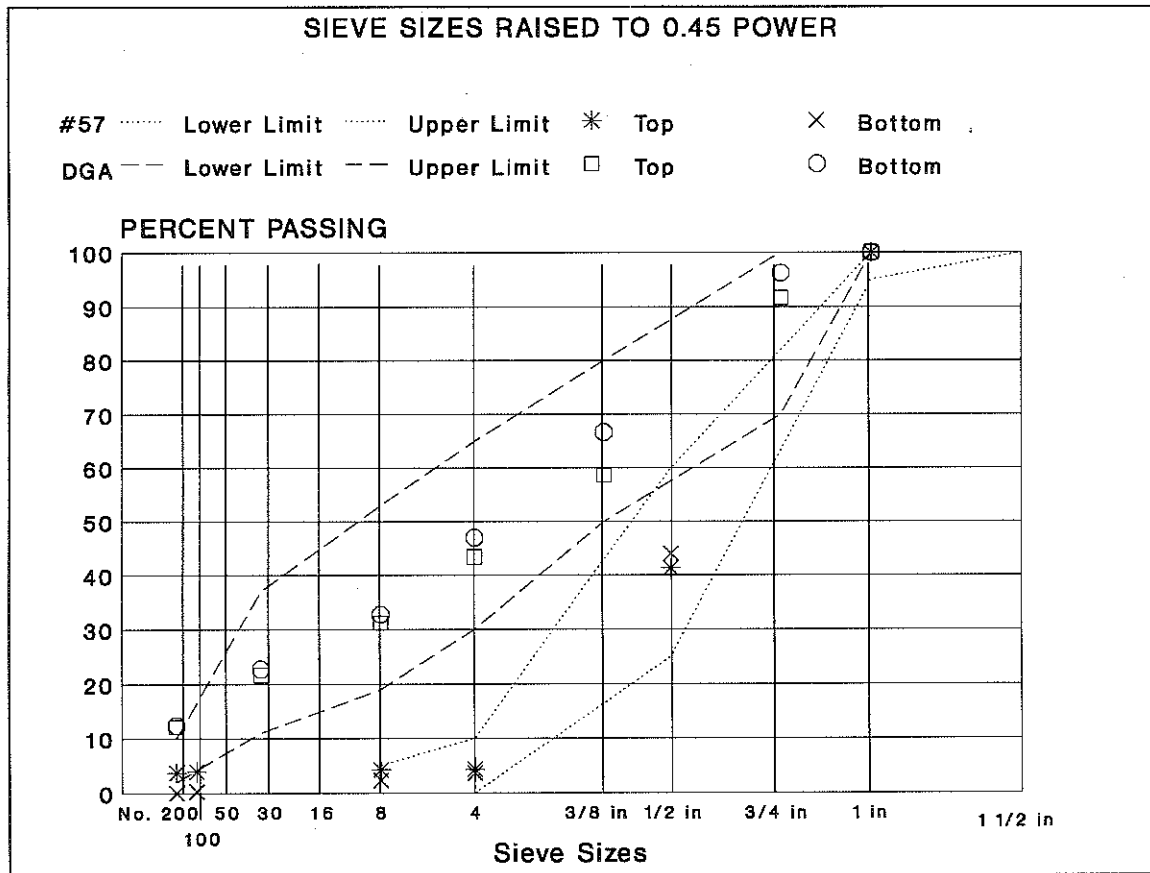
FIGURE 27. GRADATION DISTRIBUTION FOR THE BETWEEN THE WHEELS SAMPLES
