Research Report KTC-89-55

## LOAD INDICATING WASHERS

Subject: IMPLEMENTATION STATEMENT Research Study KYHPR 85-107 Long-Term Monitoring of Experimental Features, Subtask 10, "Direct Tension Indicators"

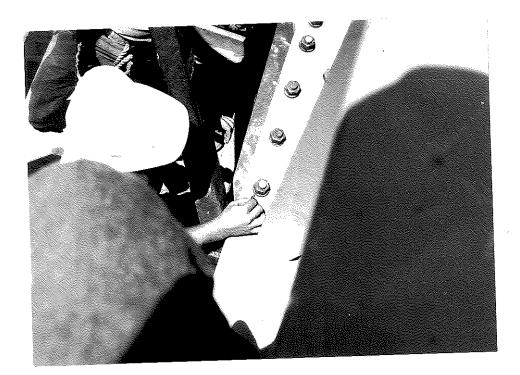
Figure 3. A Workman Installing a LIW/Bolt Assembly with an Air Wrench.

tightened the LIW/bolt assemblies. One operated an air wrench used to turn down the nut or bolt (Figure 3). The other, located on the opposite side of the joint, secured the fixed end of the LIW/bolt assembly with a wrench. Normally, that worker installed LIWs on the stationary side of the bolt assembly. Therefore, he was also able to check the LIW/bolt installation with a feeler gage.
